<b>Name of Hydro Scheme - Inverlochlarig</b>	
Location - Inverlochlarig, near Balquhidder.	File Ref (to be completed by Munro Society)
OS Map - OS Landranger 1:50,000 Sheet 56 (Loch Lomond and Inveraray).	
Date of Survey: 18 July 2017 and 5 August 2017	Surveyor name: Derek Sime
Initial or follow up visit? (please number if known, 1,2,3 etc.) Initial and only. It is suggested that no follow up visit is required to this location.	
Any comments on survey (weather, area walked) - 18 July - Very warm sunny weather and clear; 5 August – Bright with sunny intervals and cloud base c900m.

<b>Development details</b>	
Landowner	Braes Farming Co. Ltd.
Developer (if different)	Braes Farming Co. Ltd.
Contractor (where known)	Campbell of Doune / M.A.M. Contracting / Allt Energy
Planning reference/s	2012/0085/DET.
Date planning permission granted	3 October 2012.
Date work started (if known)	Not known.
Date work completed (if known)	April 2014.
Monitoring period post completion (if any)	Not known.
Size of scheme in generating power (K/W)	100KW.

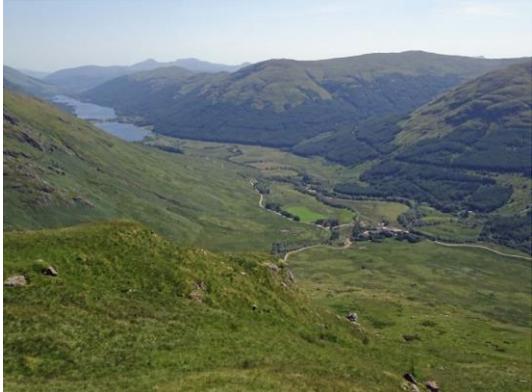
<p><i>Inverlochlarig from B. Tulaichean ridge</i></p>
Is the development next to an access route to hills? Y/N. If so, which?	Yes – in Inverlochlarig Glen, which is often used for access to / from Beinn Tulaichean and

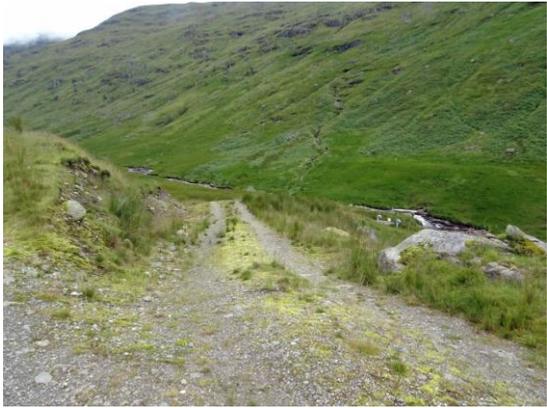
<p><i>Intake access track</i></p>
If yes, how much of track follows line of previous track?	Approximately 2.3km, or approximately 92%.
If no, how much of track is new?	Approximately 100m.
Can the access track be seen from hill summits or ridges? If so which?	Cannot be seen from Beinn Tulaichean summit but is seen from nearby, and some areas on the ascent / descent. Not obvious from Cruach Ardrain summit but likely to be seen from Stob a'Choin, but not from Stob Binnein summit.

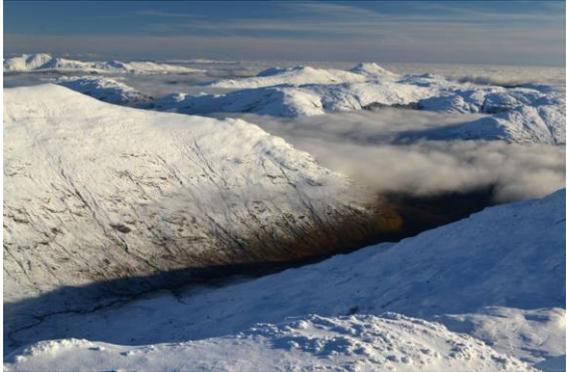
<p><i>A winter view of Inverlochlarig from Cruach Ardrain summit</i></p>

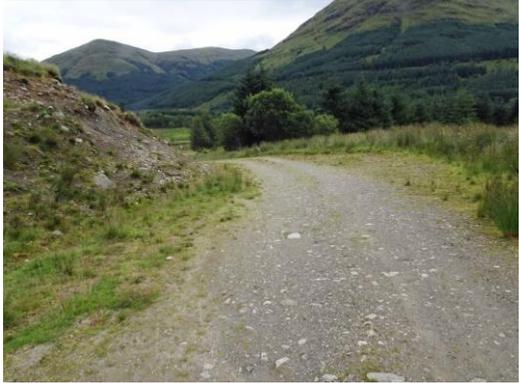
What is maximum width?	c6m over a short length.
Is there evidence of unnecessary passing places / turning points?	No.
Does the upward inclination of the track exceed 14% in any place? (The max for light vehicles) If so how frequently?	The power house access track has a grade of up to 20° (36%). The Intake access track has a grade of up to up to 20° (36%). The pre-existing (main) access track has a grade of up to 15° (27%).
Is there evidence of gulying on the track? If so what is cause of this (e.g. too steep, inadequate drainage)	No.
Is there a vegetated strip running down the middle?	Yes, in the pre-existing track, and on the new section to the intake, although not on the new section to the power house.
Have any of uphill banks / batter slopes been blasted through rock?	No.
If yes, have these been restored?	N/A.
Are any uphill batters too steep (e.g. over 45% or too steep to retain vegetation)?	On the main (pre-existing, but probably widened at this point) access track there is a short length of batter slope of up to 40° (84%).

<p><i>Section of steep batter slope on main access track</i></p> <p>On the intake access track there is a short length of batter slope of up to 45° (84%), with small areas of up to 75° (373%).</p>

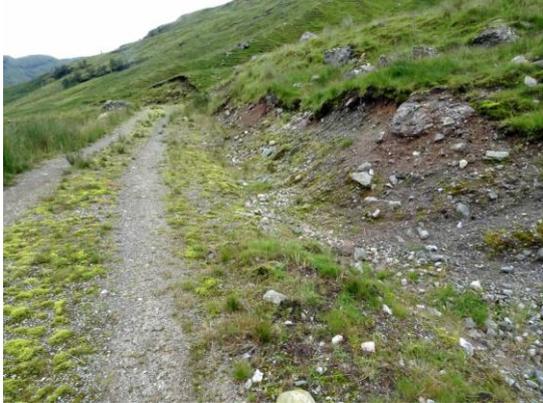
<p><i>Steep batter slope on intake access track</i></p>
<p>Is there any evidence of spoil from track spilling down slopes?</p>	<p>No.</p>
<p>Have the edges of the track been finished through replacement of vegetation?</p>	<p>Generally, yes.</p>
<p>Is there evidence that surface vegetation and different soil types have been stored separately and then replaced separately? (All, most, more than half, less than half, little, none) *</p>	<p>Most.</p>
<p>Has downhill side spoil been moulded to match existing landscape?</p>	<p>Generally, yes.</p>
<p>Approximately how much of the land on either side of the track has been restored through replacement of vegetation? (All, most, more than half, less than half, little, none)</p>	<p>Most.</p>

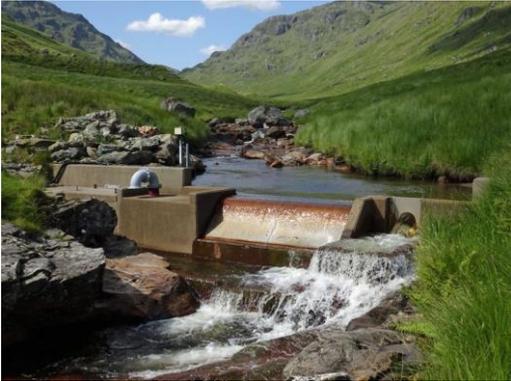
<i>Intake</i>
How visible is intake from neighbouring summits and ridges?	Cannot be seen from Beinn Tulaichean summit but is seen from nearby, and some areas on the ascent / descent. Not obvious from Cruach Ardrain summit but likely to be seen from Stob a'Choin, but not from Stob Binnein summit.
Has the intake dammed the river or is it true "run of river"?	True run of river.
If dammed, length of pool	N/A.
Approx. max height intake walls	1.6m from downstream water level to top of wall.
Have intake walls been faced with natural materials?	No – in situ concrete.

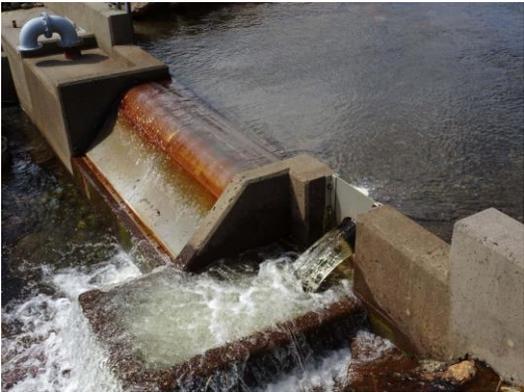
<i>Intake walls</i>
Approx. width of intake (across burn / river)	11m.
Has rip rap bouldering+ been used on upstream side? Extent? Visible from what distance?	Yes – over a short distance (about 8m) on the right bank only.

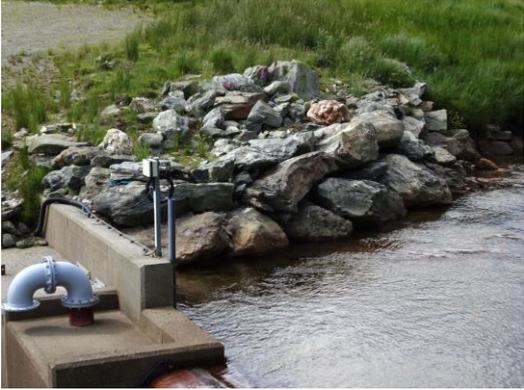
<p><i>Rip rap bouldering</i></p>
<p>Has rip rap bouldering+ been used on downhill side? Extent? Visible from what distance?</p>	<p>No.</p>
<p>Are safety fences metal or wood?</p>	<p>There are no safety fences.</p>
<p>Is exposed pipework in natural colours?</p>	<p>Light grey, similar in tone and colour to the surrounding (dry) rock), so it depends on the definition of “natural”.</p>

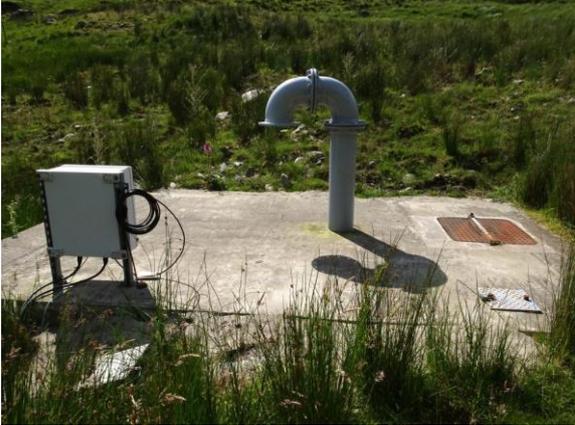
<p><i>Pipework</i></p>
<p>Any other comments (e.g. signs, lifebelts, size of turning area, presence other structures and signs of good or poor practice you wish to highlight?)</p>	<p>No signs or lifebelts. Turning area 12 x 8m. Some cable work appears to be unfinished, with coils of spare cable at the termination box.</p>
<p>Evidence of further restoration work since initial survey</p>	<p>N/A.</p>

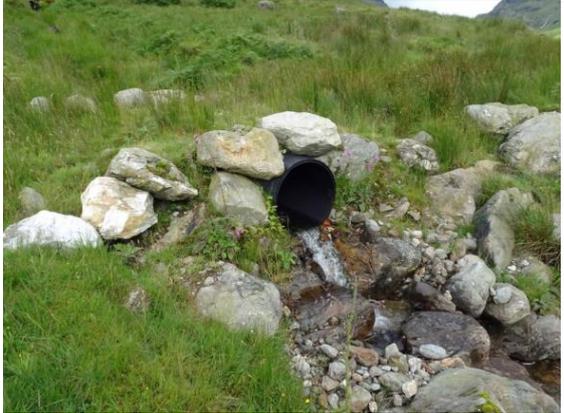
<p><i>The hidden steel bridge</i></p>
<p>Is there evidence that surface vegetation and different soil types have been stored separately and then replaced in the right order above the pipeline? (All, most, more than half, less than half, little, none of the time)</p>	<p>Surface vegetation appears to have been restored along the entire length of the pipeline, as in most areas, it is almost impossible to see where it has been buried.</p>

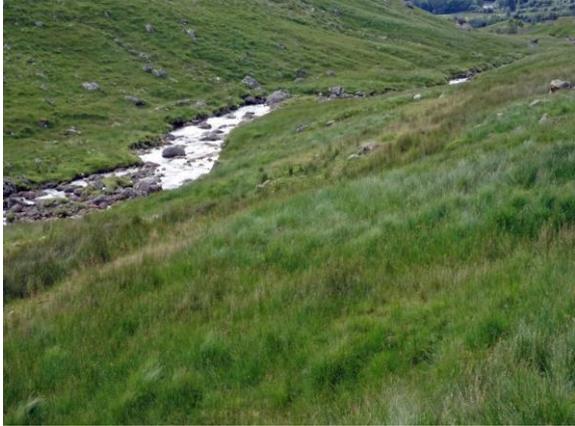
<p><i>Barely discernable line of buried pipeline</i></p>
<p>Have air / pressure release valves / pipeline access points been finished properly?</p>	<p>They appear to have been.</p>
<p>Other comments (including examples of good / poor practice you wish to highlight)</p>	<p>Appears to have been very well installed leaving little trace for most of its length.</p>
<p>Evidence of further restoration work since initial survey</p>	<p>N/A.</p>

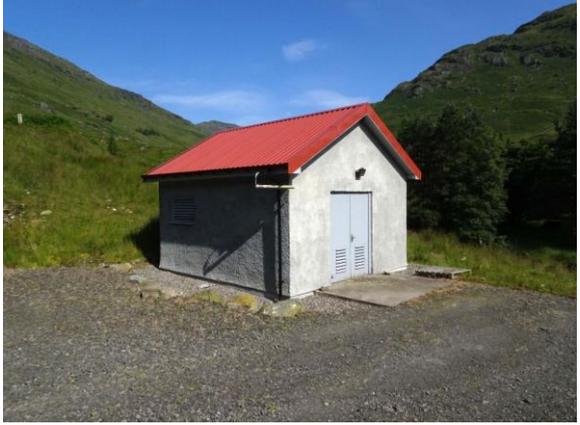
<p><i>The power house</i></p>
<p>How visible is powerhouse from neighbouring summits / ridges?</p>	<p>Cannot be seen from Beinn Tulaichean summit but is seen from nearby and some areas on the ascent / descent. Not visible from Cruach Ardrain summit, Stob Binnein summit, or Stob a'Choin summit (screened from the latter by established trees).</p>
<p>Construction materials walls</p>	<p>Probably blockwork, but rendered with roughcast, painted light grey.</p>
<p>Construction material roof</p>	<p>Corrugated iron, painted red, which matches some of the nearby farm buildings.</p>
<p>Is there tree planting around powerhouse?</p>	<p>No new tree planting, but some established trees nearby, which help to screen it.</p>
<p>Is there hardstanding around powerhouse? If so, how much and what materials?</p>	<p>Approximately 4m<sup>2</sup> in situ concrete immediately outside the doors, and approximately 75m<sup>2</sup> of compacted gravel / type 1 material around 2 sides of the power house – this also comprises the turning area.</p>

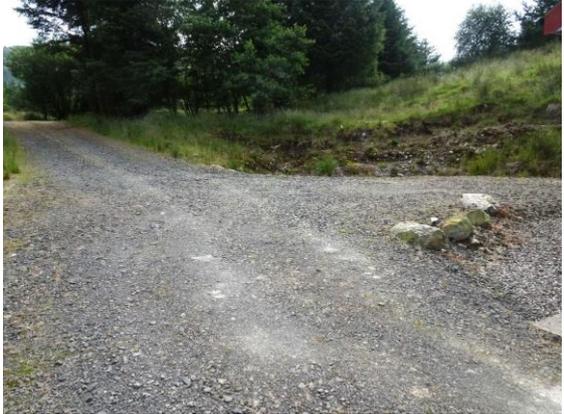
<p><i>Hard standing at the power house</i></p>

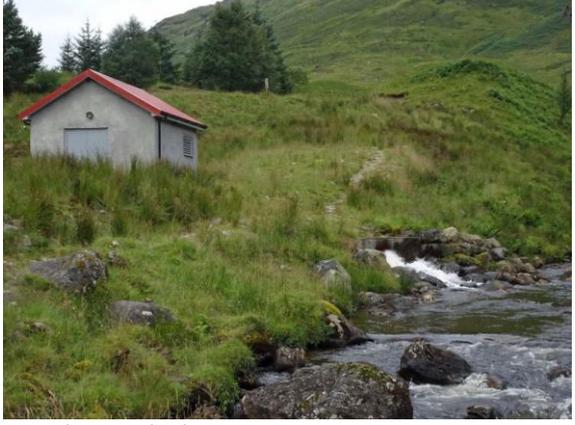
<p><i>Power house and tailrace</i></p>
<p>Any other comments (including examples good or poor practice you wish to highlight)</p>	<p>Generally good practice, as the power house blends in very well with the nearby farm buildings and farmstead environment. An unexpected environmental benefit is that house martins have built 3 nests under the roof.</p>

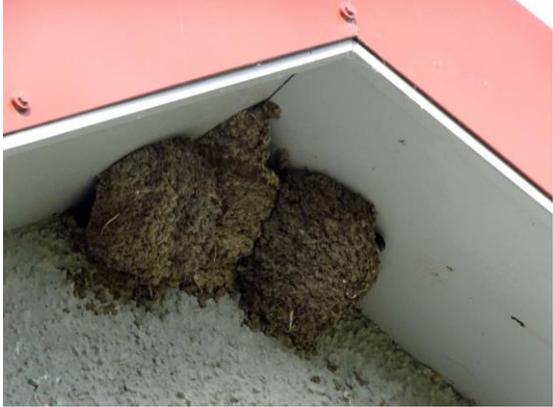
<p><i>House martins' nests on the power house</i></p>
<p>Evidence of further restoration work since initial survey</p>	<p>N/A.</p>

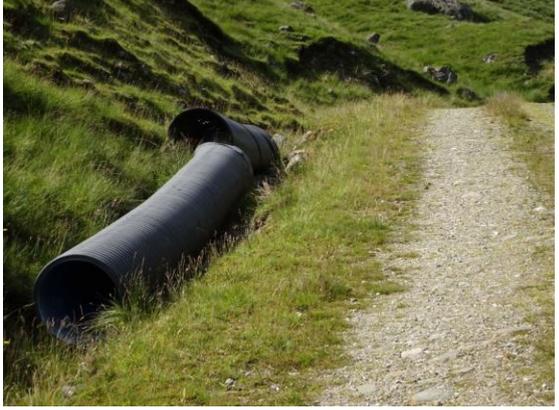
<b>Other</b>	
<p>Have new pylons / overhead wires been required to connect scheme to grid?</p>	<p>No.</p>
<p>If yes, describe extent?</p>	<p>N/A.</p>
<p>Have construction compounds been restored?</p>	<p>Yes.</p>
<p>Was there evidence of construction materials or equipment being left on site (e.g. old pipes, imported aggregate left in spoil heaps) Please describe</p>	<p>Four sections of surplus or damaged pipe have been left lying next to the access track.</p>

<p><i>Surplus or damaged pipe sections left on site</i></p>
<p>Evidence of other rubbish left on site?</p>	<p>Nil.</p>
<p>Are there bridges and if so what materials have they been constructed from?</p>	<p>There is, according to the planning application, one steel bridge, but this is concealed by soil and vegetation. This is at NN 43230 19380. Other bridges – not possible to ascertain the materials used.</p>

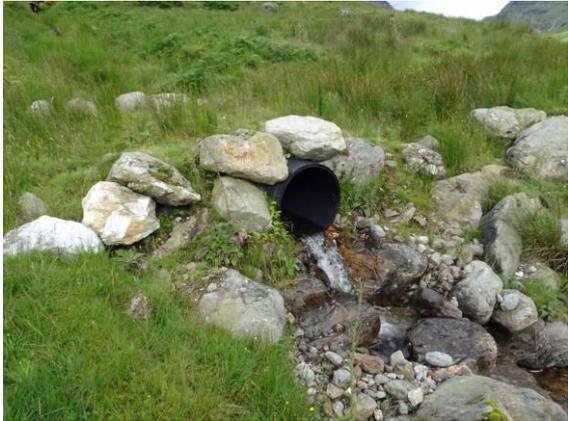
<p><i>Bridge</i></p>
<p>Any other comments on evidence for restoration work since initial survey</p>	<p>Noted that two silt traps had been left in situ, now in a dilapidated state.</p>

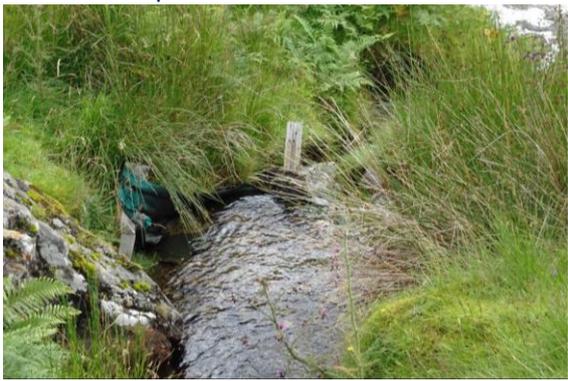
<p><i>Silt trap left in situ</i></p>
