Typical Ciste tower base

Job name: Condition report - Ciste chairlift bases
Job number: 16011
Client: Cairngorm Mountain Ltd
Engineer: Mr Angus Armstrong
Date: October 2016

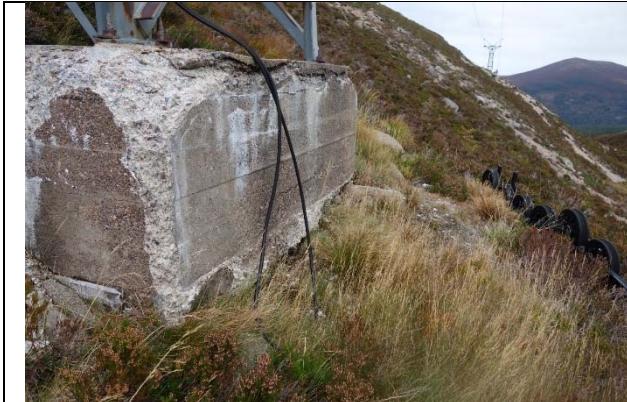
Photo 1:
Lower lift base 4. Note particularly undermining of lower edge and no cover.

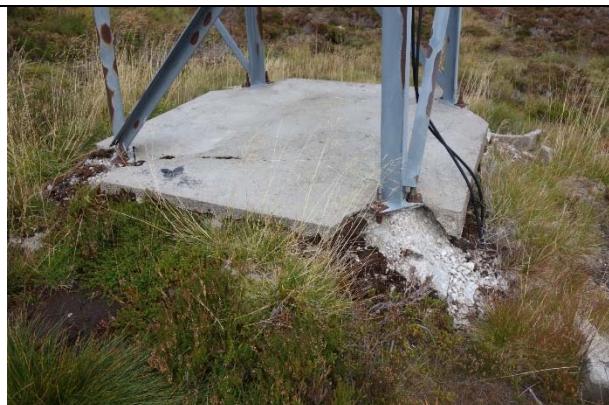
Photo 2:
Lower lift base 5. Note disintegration of concrete around all bolts.

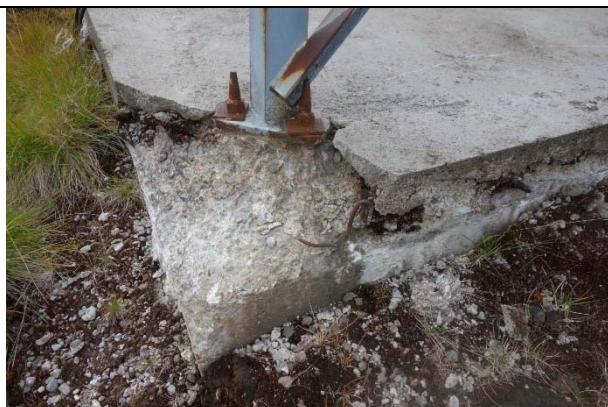
Photo 3:
Detail on one corner of photo 2.

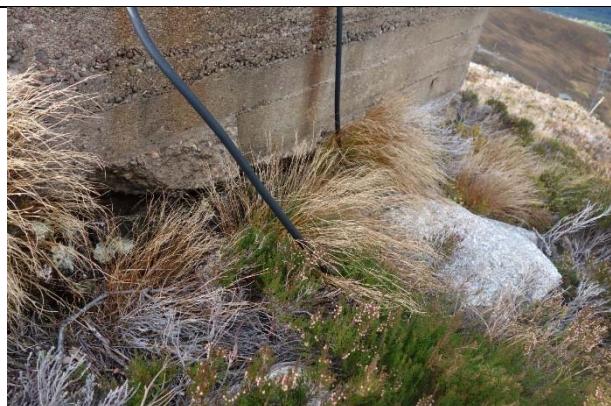
Reference	Observations
Bottom station	Some undermining of the foundations was seen on the down slope site. The concrete was seen to be in a poor but serviceable condition.
1	Fair condition, but spalling corners.
2	Acceptable.
3	Mostly buried, but exposed corners of concrete are disintegrating around the bolts.
4	Base is partially undermined on the slope and is spalling badly. Ref photo 1.
5	Concrete is seriously disintegrating, particularly around the bolts. Ref photo 2 & 3.
6	Areas of spalling have been repaired, but have subsequently failed again. The base is partially undermined and base plate grout has failed.
7	Grout to base plates failed.
8	Buried.
9	Areas of spalling have been repaired, but have subsequently failing again.
10	Top is spalling. Grout to base plates failing.
11	Partially undermined. Grout to base plates failing.
12	Partially undermined. Base decaying under bolts. Ref photo 4 & 5.
13	Acceptable.

Photo 4:
Lower lift base 12. Note undermining of base.

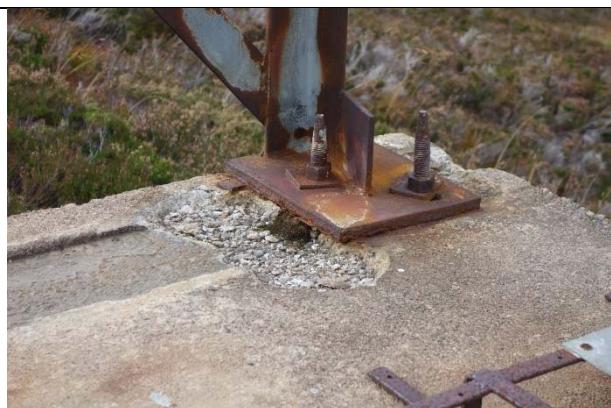
Photo 5:
Lower lift base 12. Note disintegration of concrete surface around all bolts.

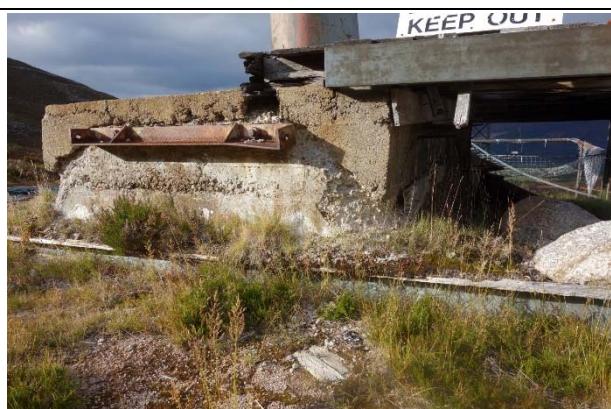
Top station	Main base crumbling. Added cap slab cracked and unstable. Ref photos 6 & 7.

Photo 7:
Lower lift top station. General disintegration.

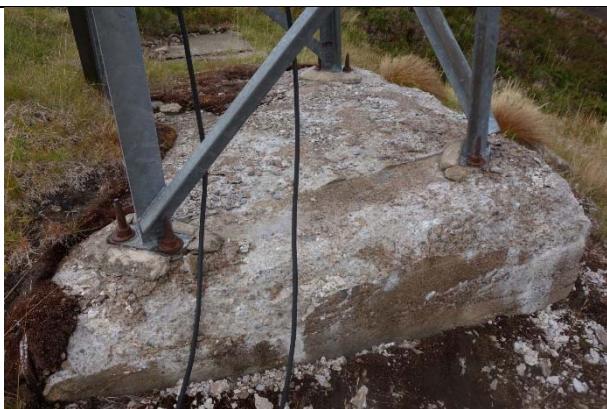
Reference	Observations
Bottom station	Partially buried. General condition reasonable to poor.
1	Acceptable.
2	Some spalling. Grout to base plates failing.
3	Buried.
4	Major disintegration of surfaces. Grout to base plates failing. Ref photo 8.
5	Partially buried. Lower corner around bolt fractures and unstable.
6	Buried.
7	Base cracked through the middle. Two bolt sets no longer effectively supported. Unstable. Ref photo 9.
8	Acceptable.
9	In poor condition. Possible old repair to two sides but in poor condition.
10	Base major fractures, generally disintegrating. Bolts loose. Unstable. Ref photo 10.
11	Buried.
12	Partially buried, but generally acceptable.
Top station	Areas of spalling concrete. Large corner chunk loose. Generally stable.

Photo 8:
Upper lift base 4. General disintegration of base and bolt grout.

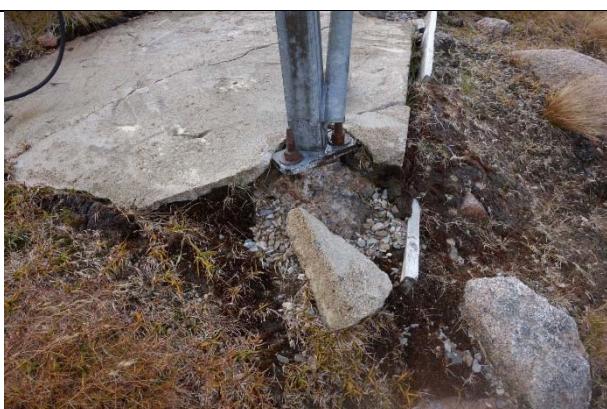
Photo 9:
Upper lift base 7. Major disintegration of base.

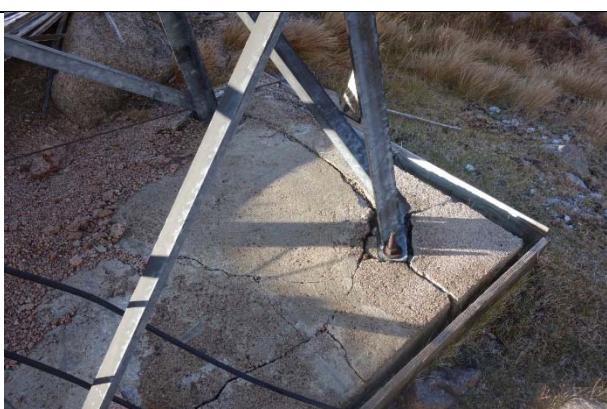
Photo 10:
Upper lift base 10. Major disintegration of base.
