The Glen Falloch hydro schemes (4) – the restoration myth

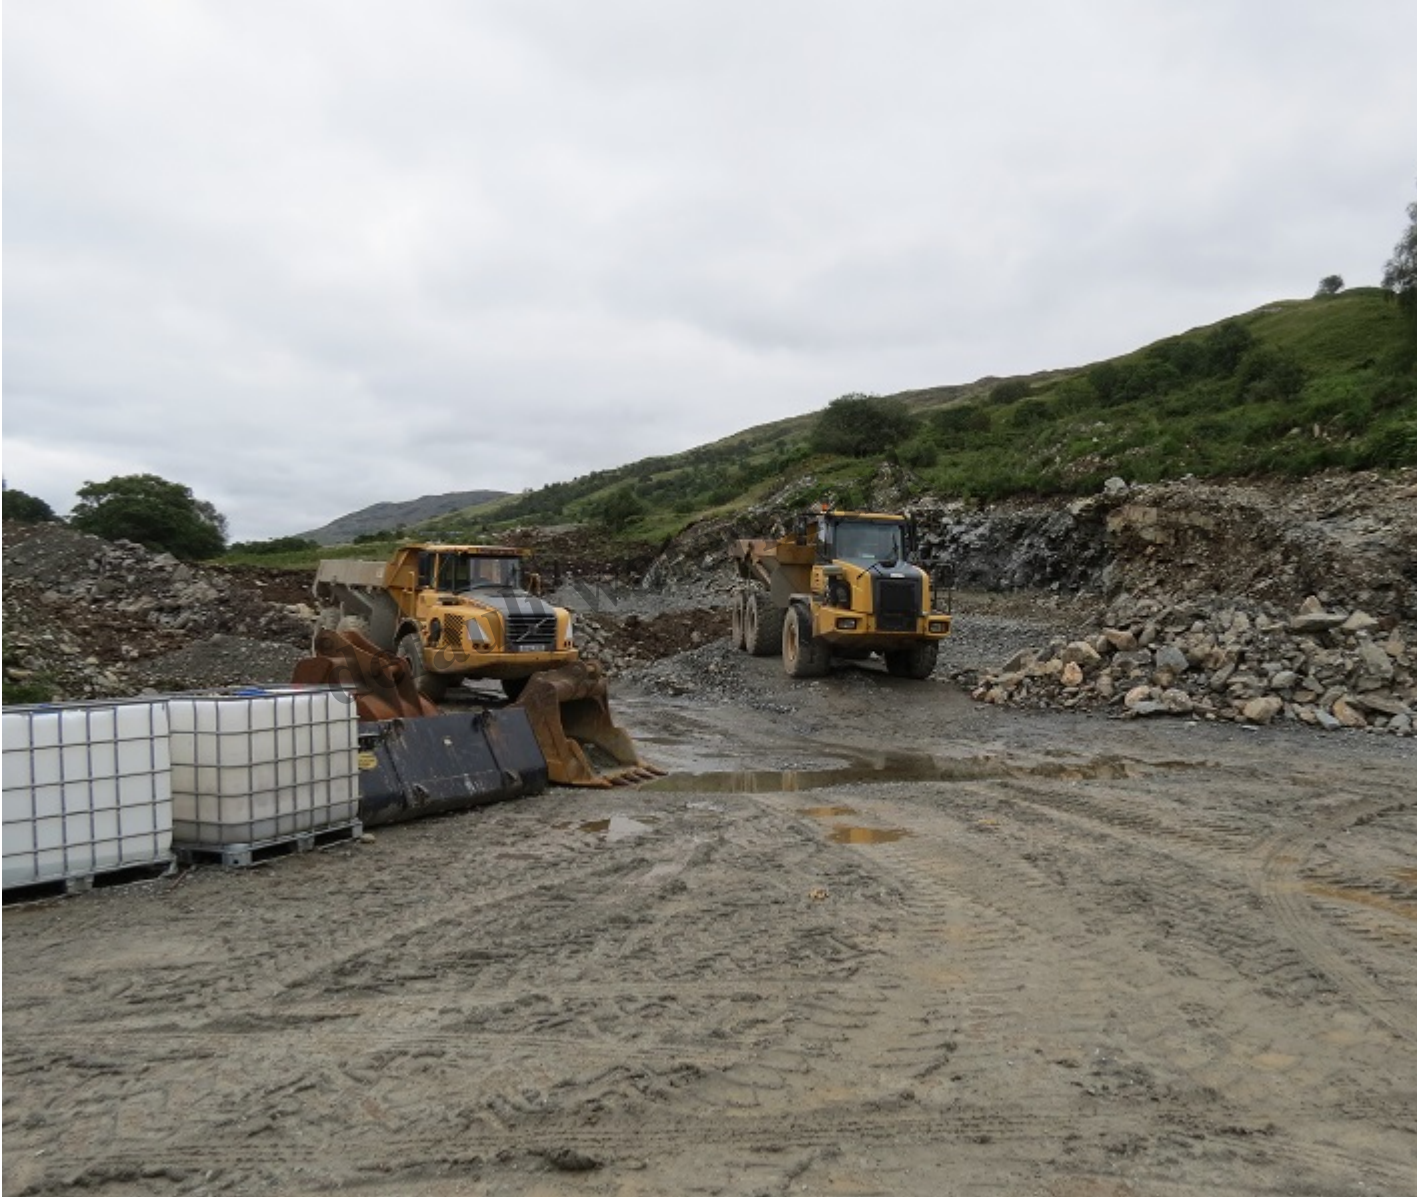
The quarry site at the bottom of new Ben Glas track

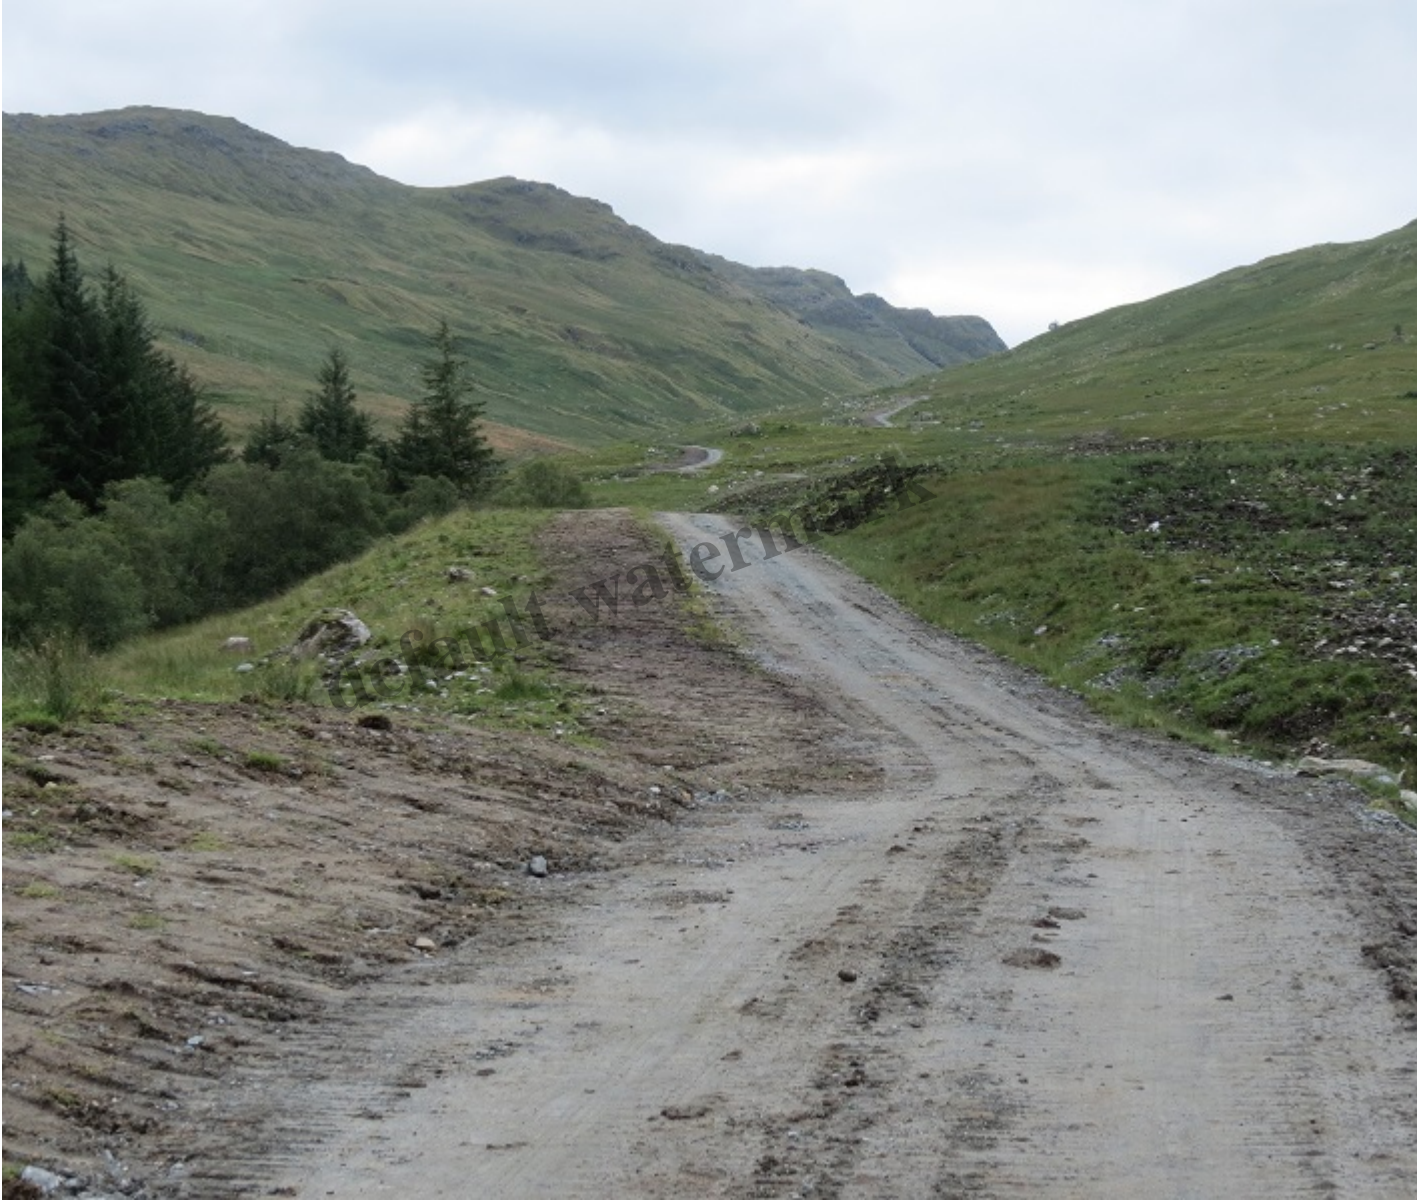
Example of track “restoration” from the upper Falloch hydro scheme. You can see evidence of the aggregate that has been imported on the right of the photo. The imported aggregate results in a track that has been raised above the previous contours in the landscape. In the centre of the photo you can see the imported aggregate has hardly been reprofiled and simply covered up with a thin layer of turf.

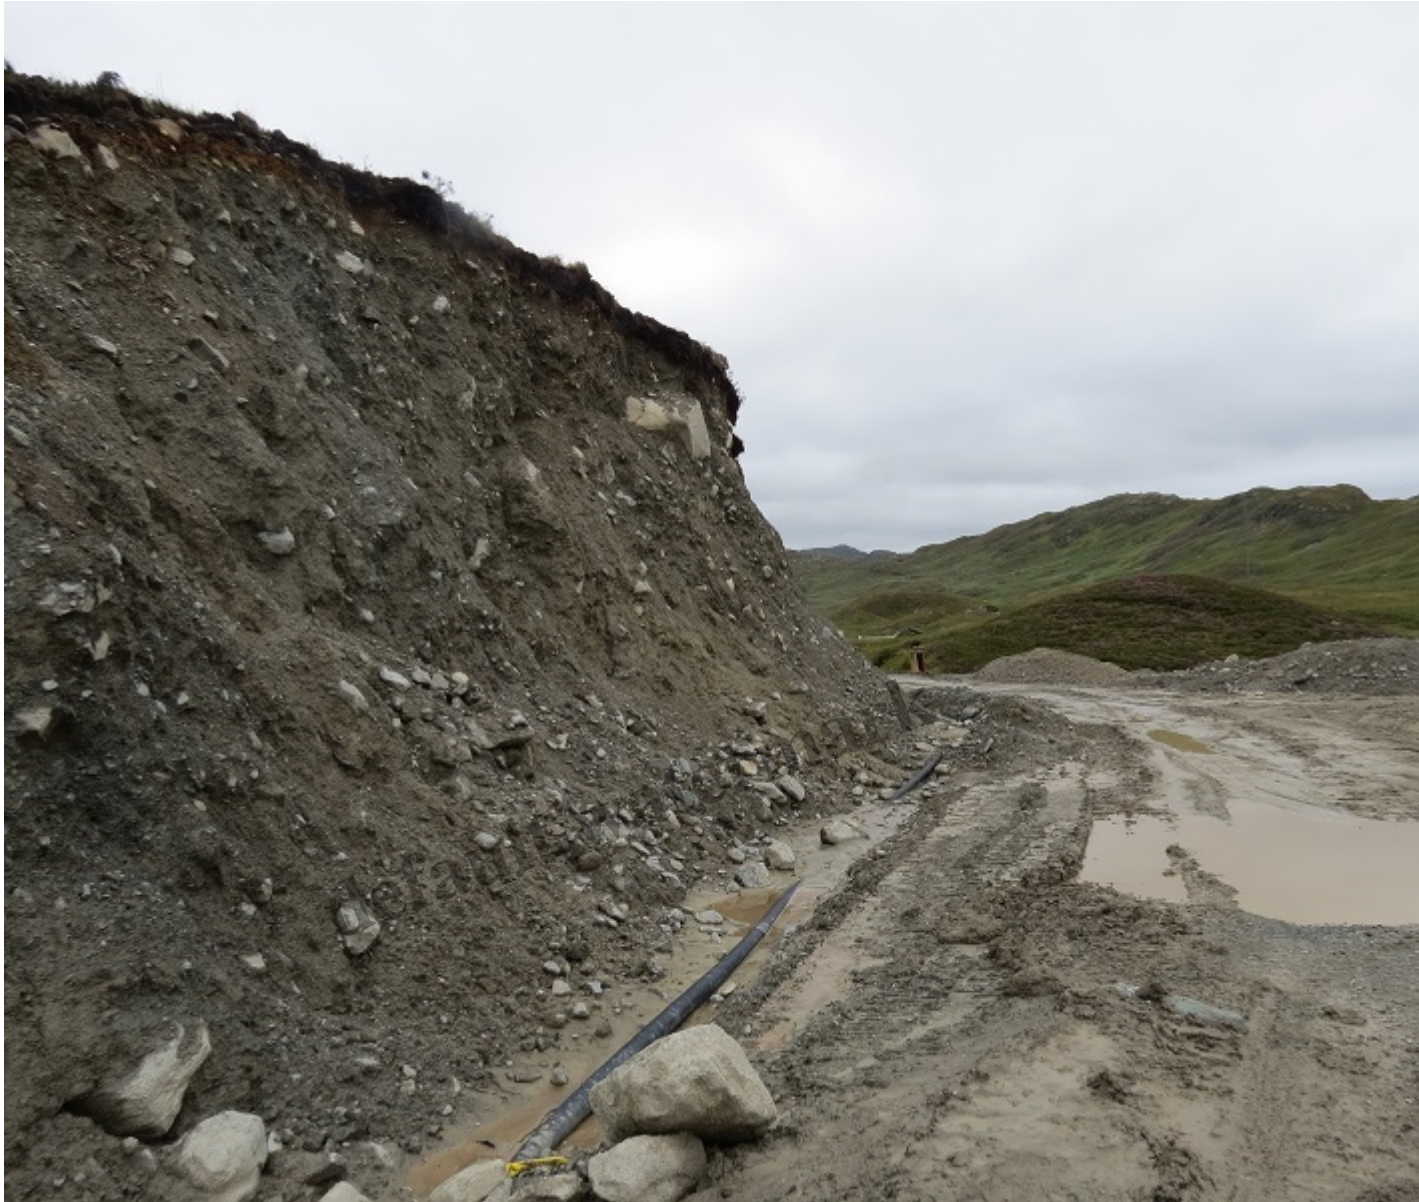
Moraine can be used as a source of aggregate for building tracks, as here approaching the Ben Glas dams, but no restoration will be able to restore this to its former shape. Landscape features that have since the end of the ice age, and would have been well known to the drovers who brought their cattle route, have been changed out of all recognition.

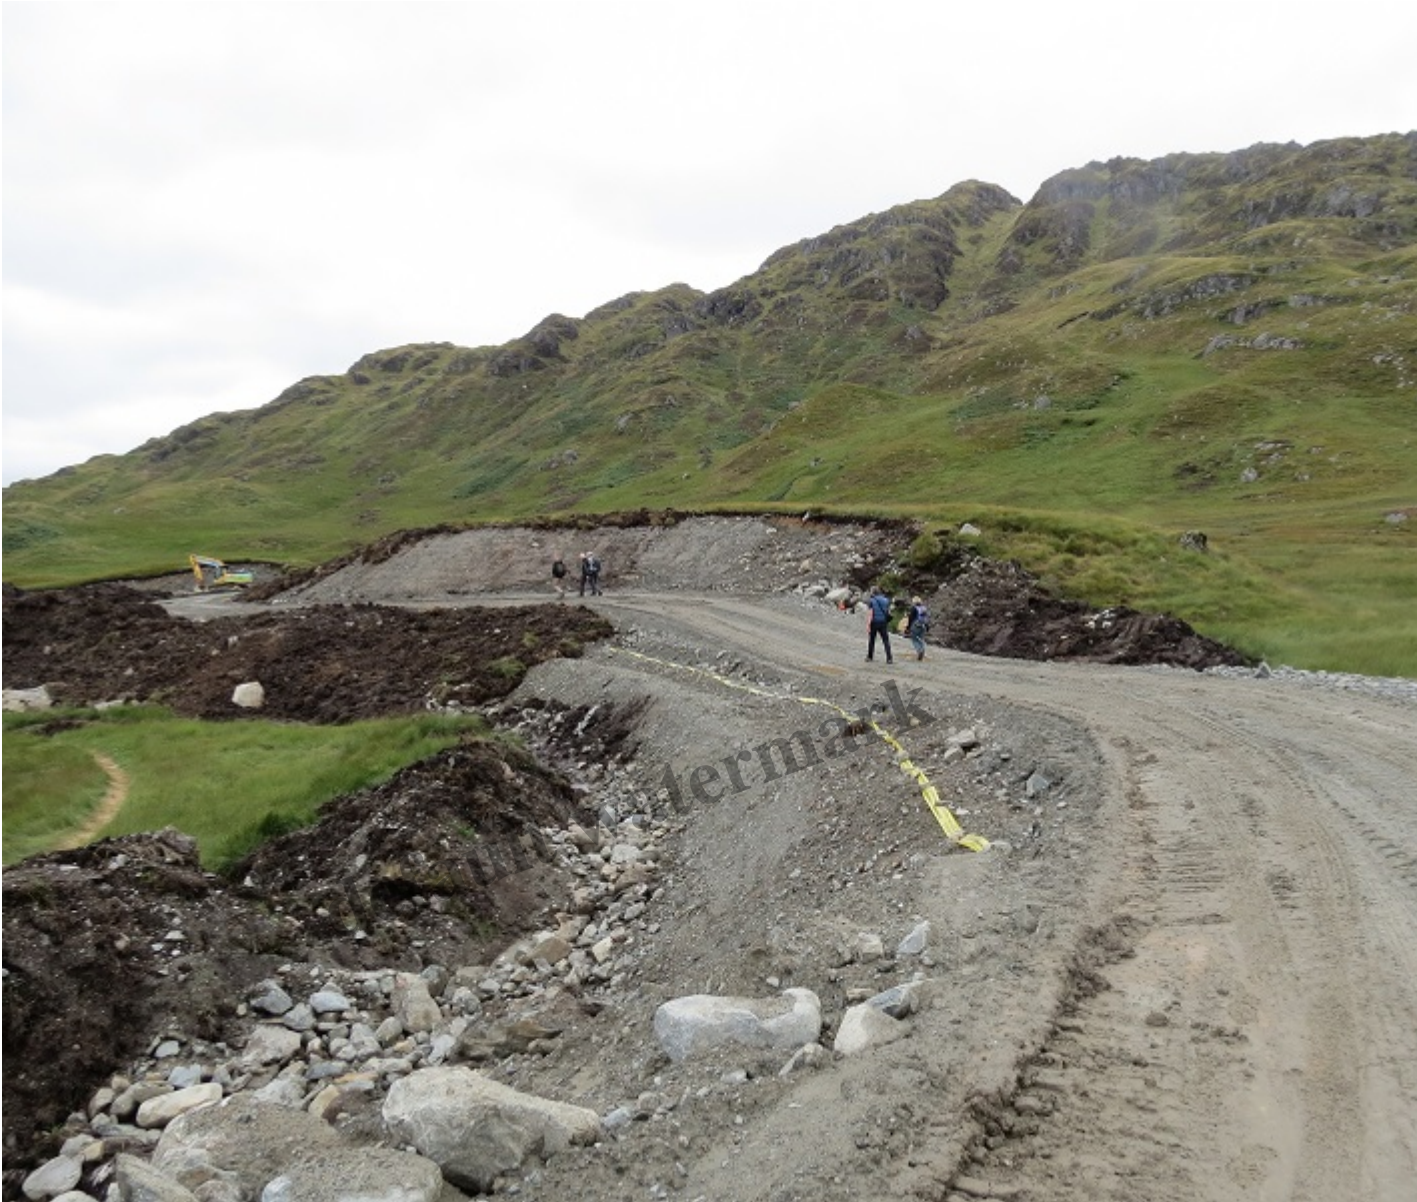
Large amounts of material to build the track have been obtained from this moraine, the contours of which have been changed for ever.

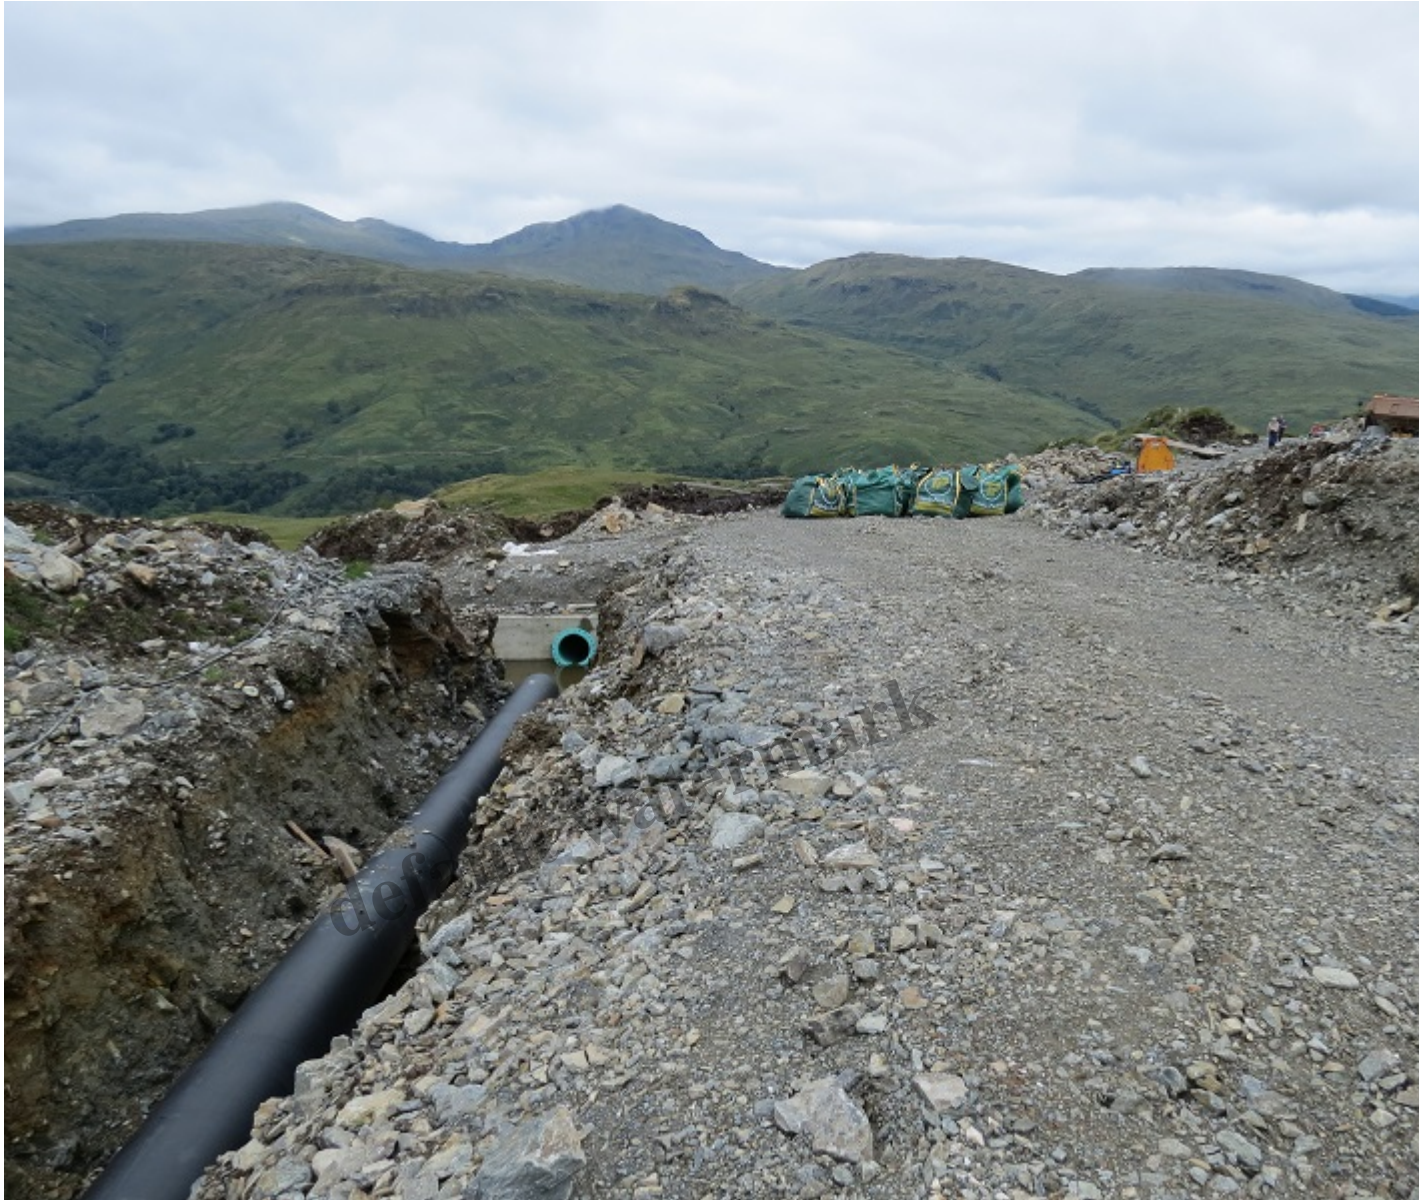
The laying of the water pipe brings material that was once well buried to the surface – it may be related quantities compared to what is imported but it all adds up.

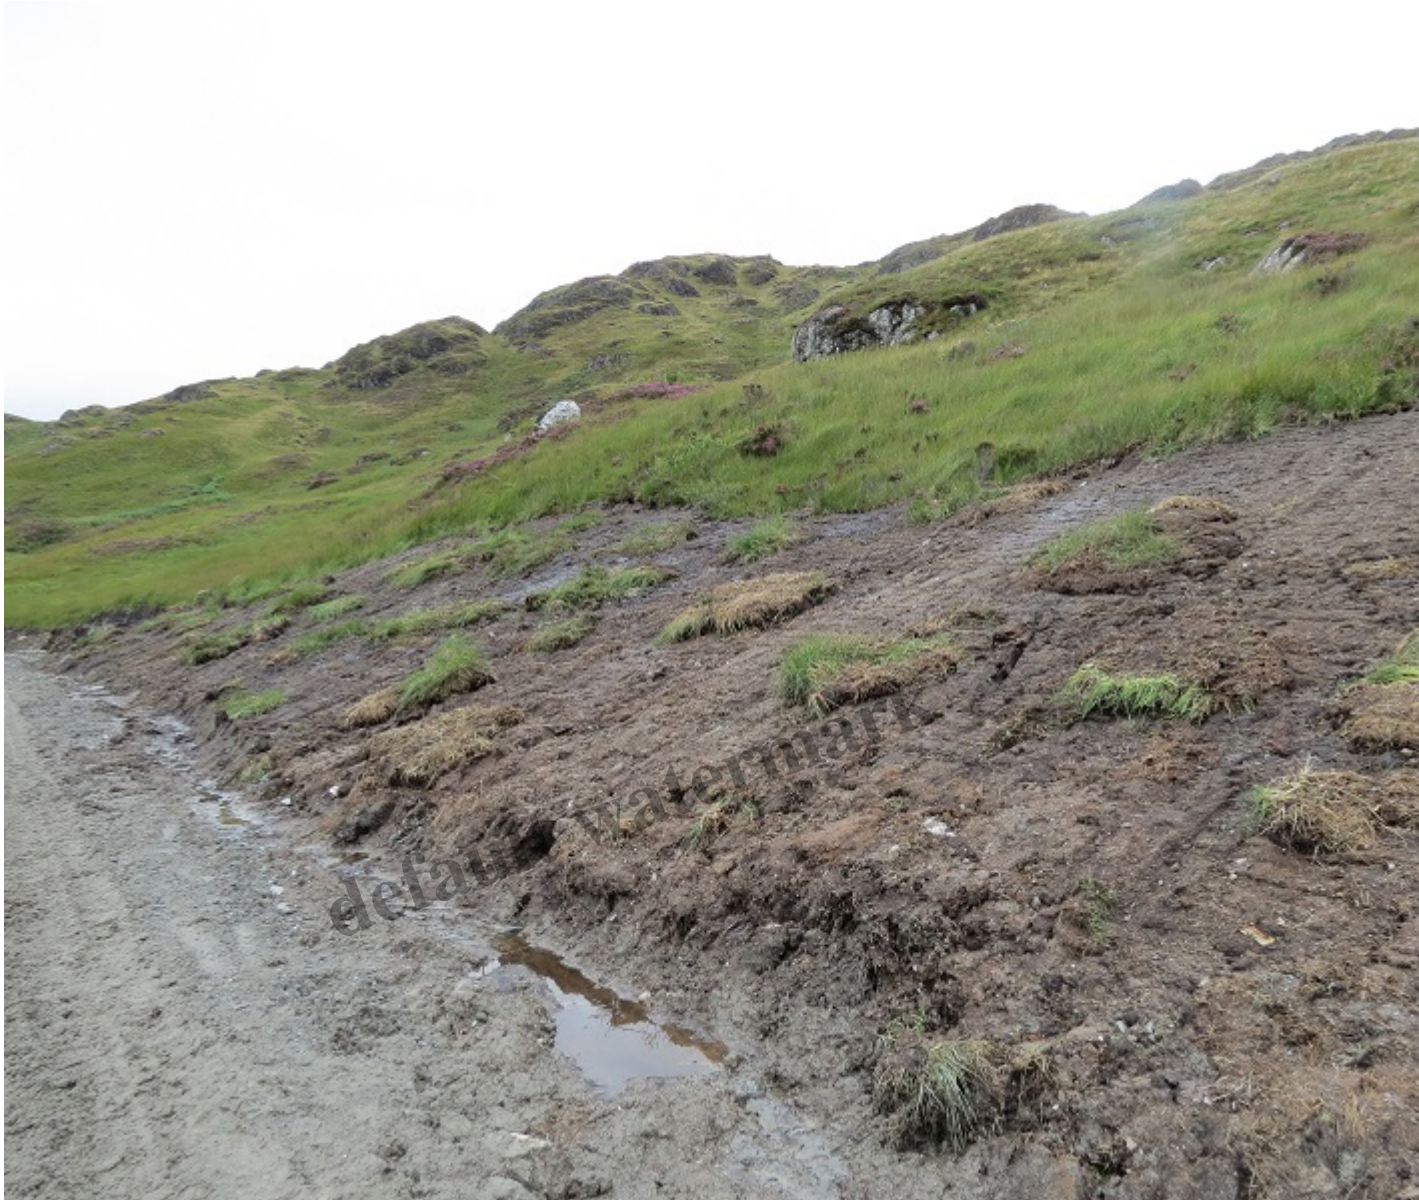
One of the better examples of “restoration” where some turf has been re-used. The reprofiled slope while not entirely uniform, is still in the form of an embankment and is out of place with the natural shillside above. Its very hard to restore slopes over a certain angle, hence the embankment look is re across what was once a wild landscape..

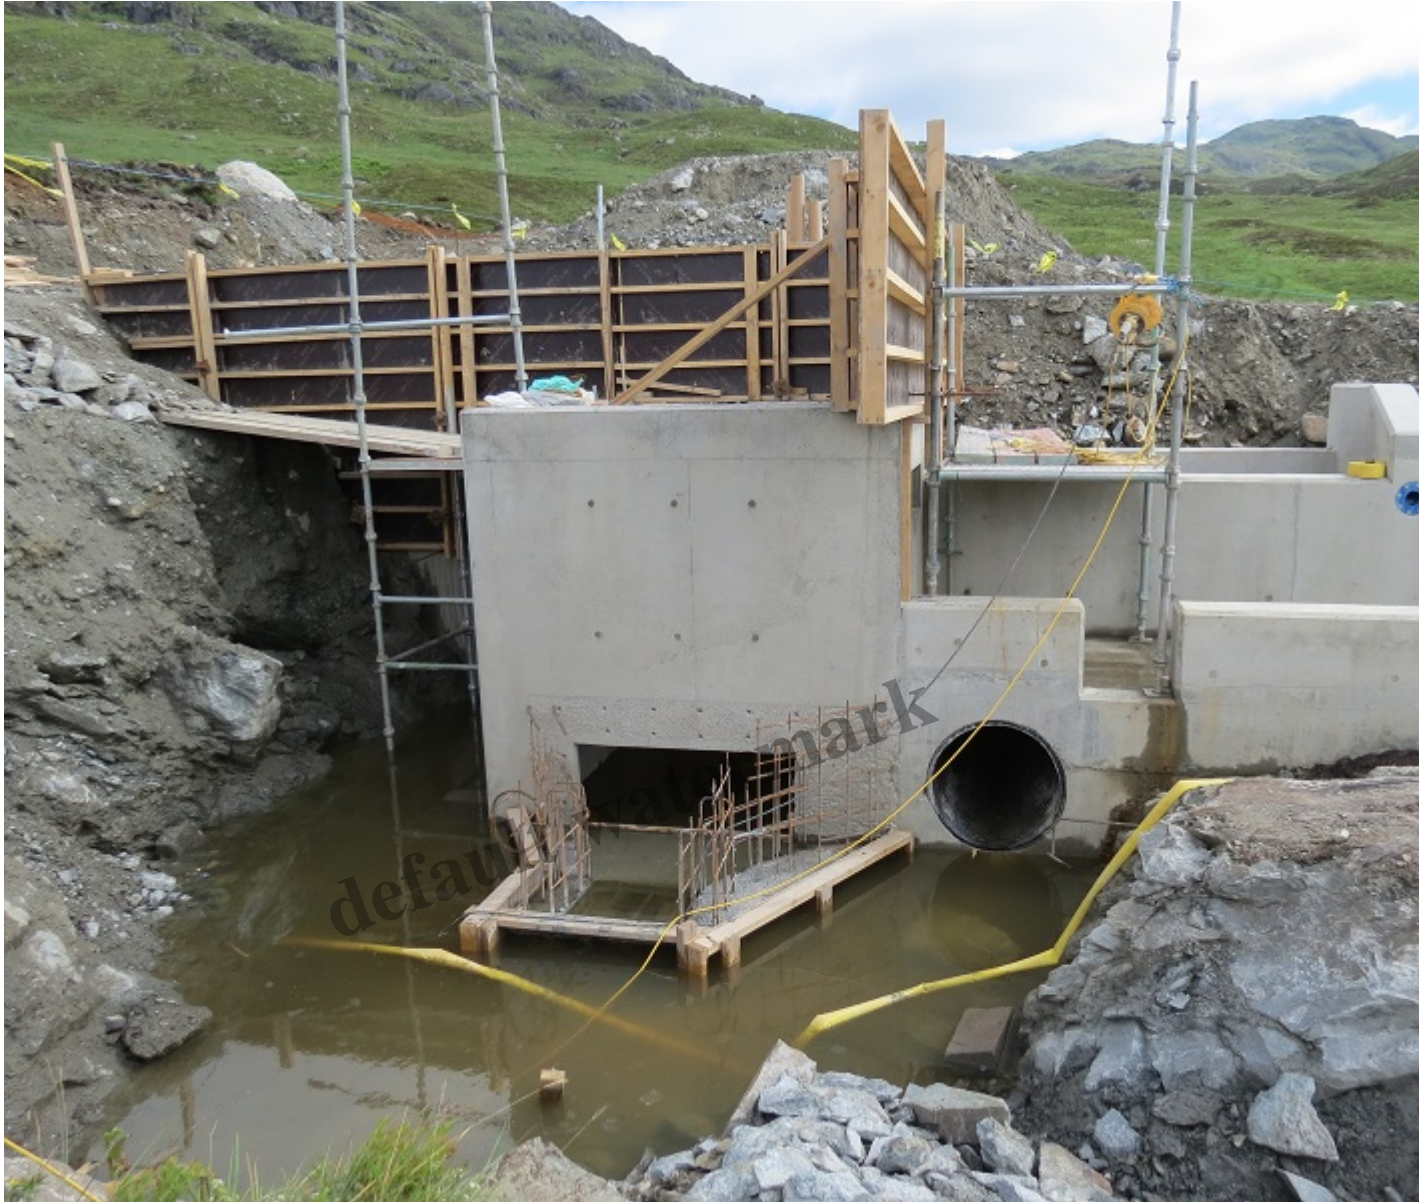
Second Ben Glas intake from below- significant amounts of concrete and other materials have been
into what was once wild land

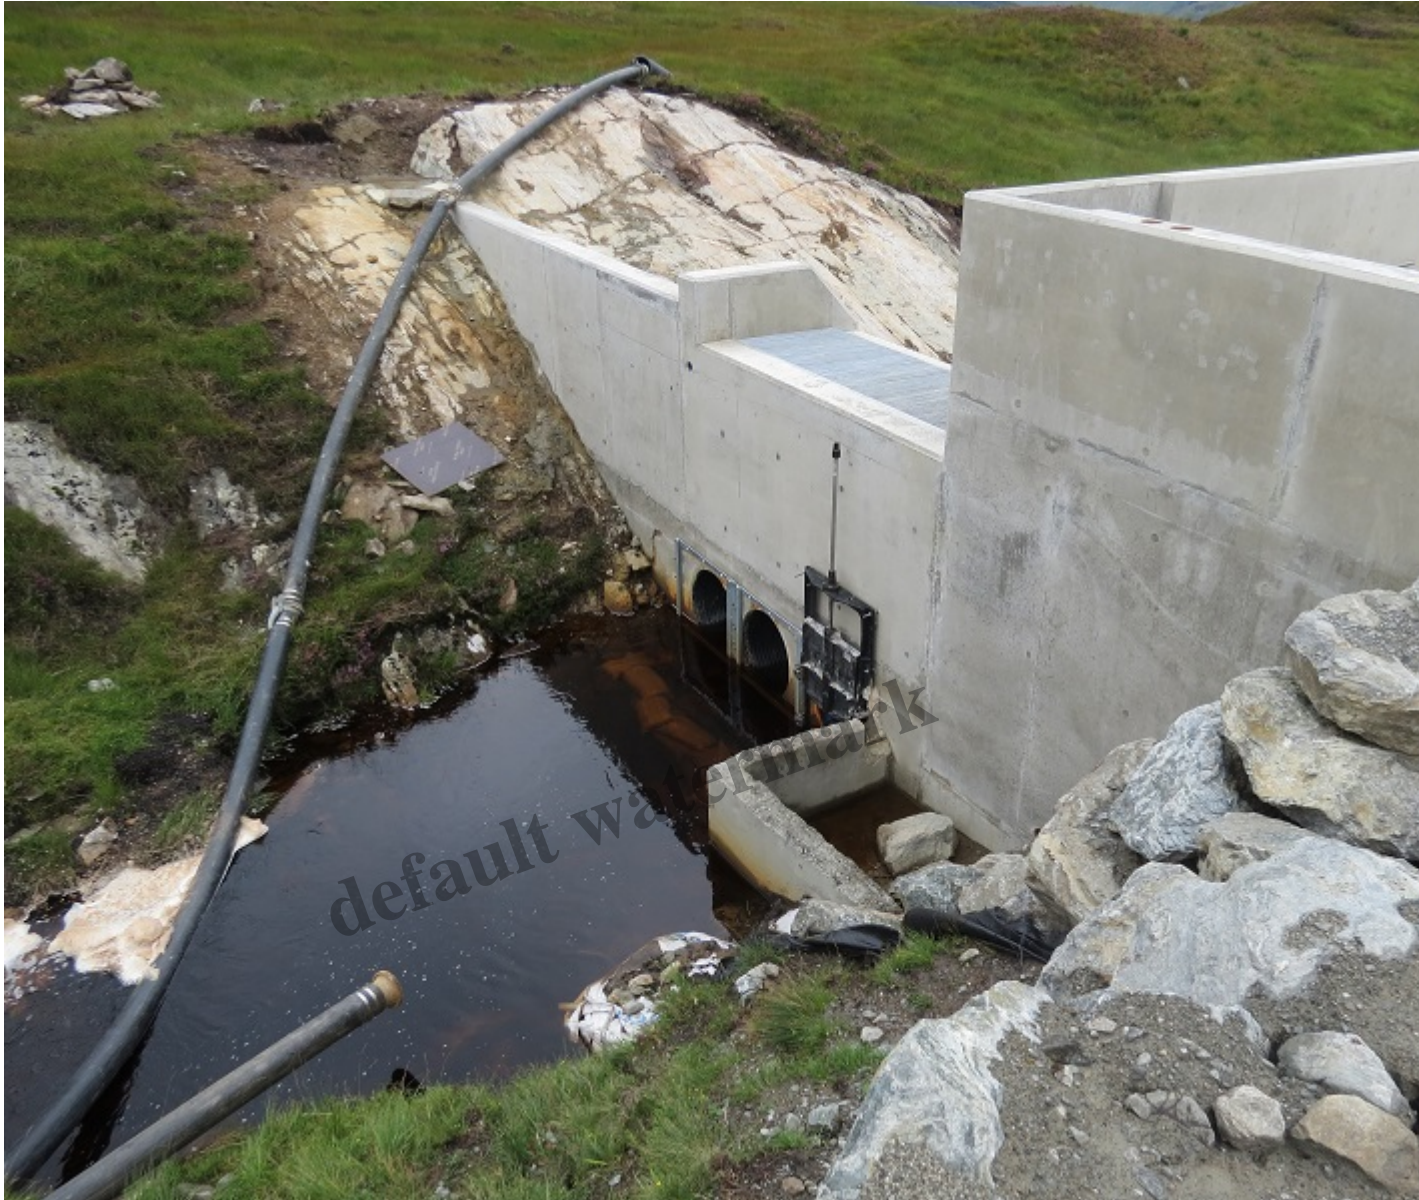
What will become the intake pool at the first dam. A large amount of concrete has been introduced to the landscape.

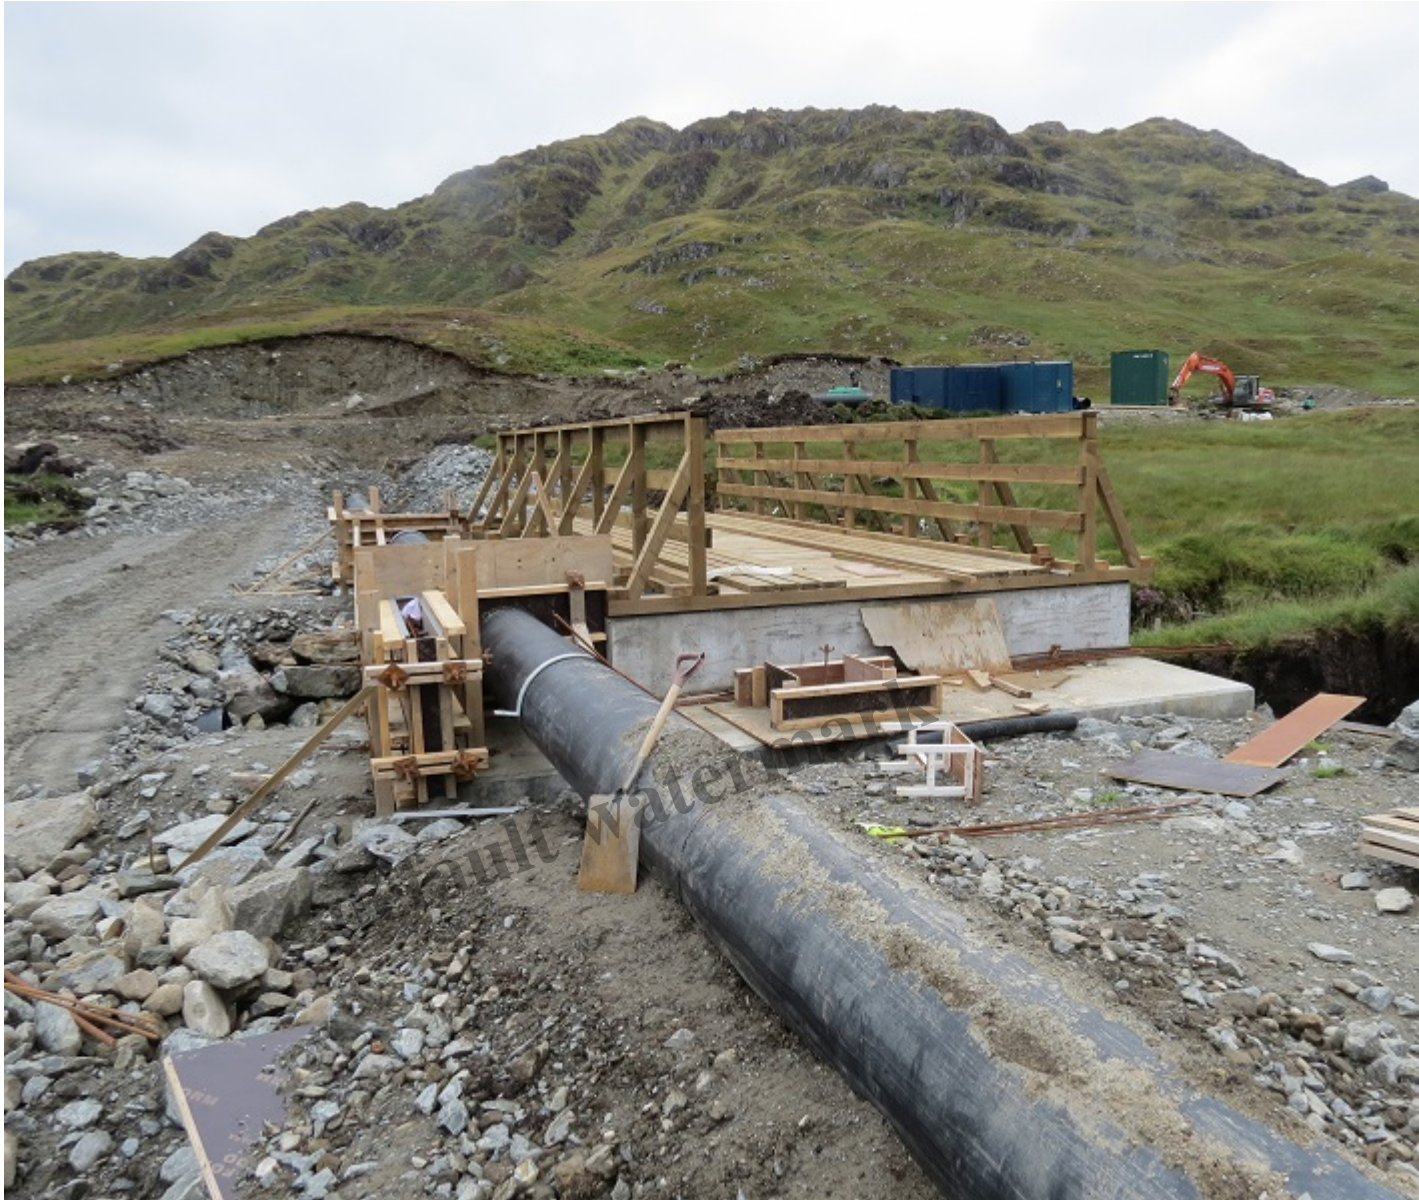
The “need” for a bridge introduces a further new structure into what was previously an almost pristine (there are electricity pylons to the south).
