The Glen Falloch hydro schemes (4) â?? the restoration myth

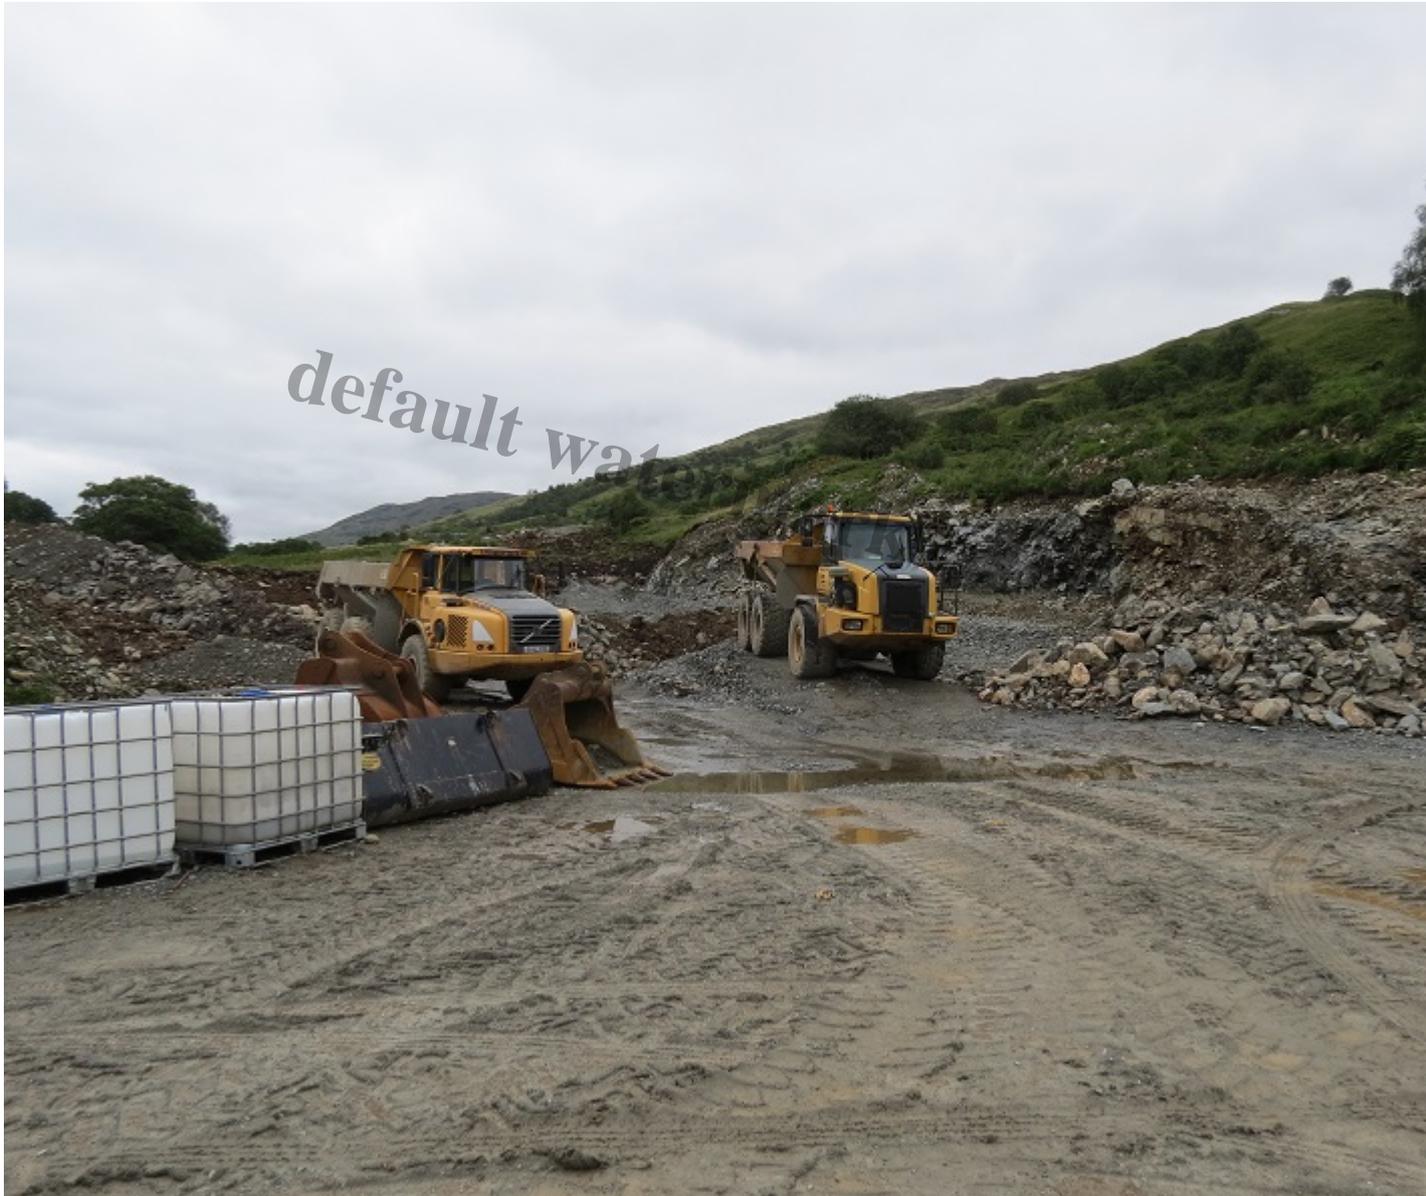
The quarry site at the bottom of new Ben Glas track

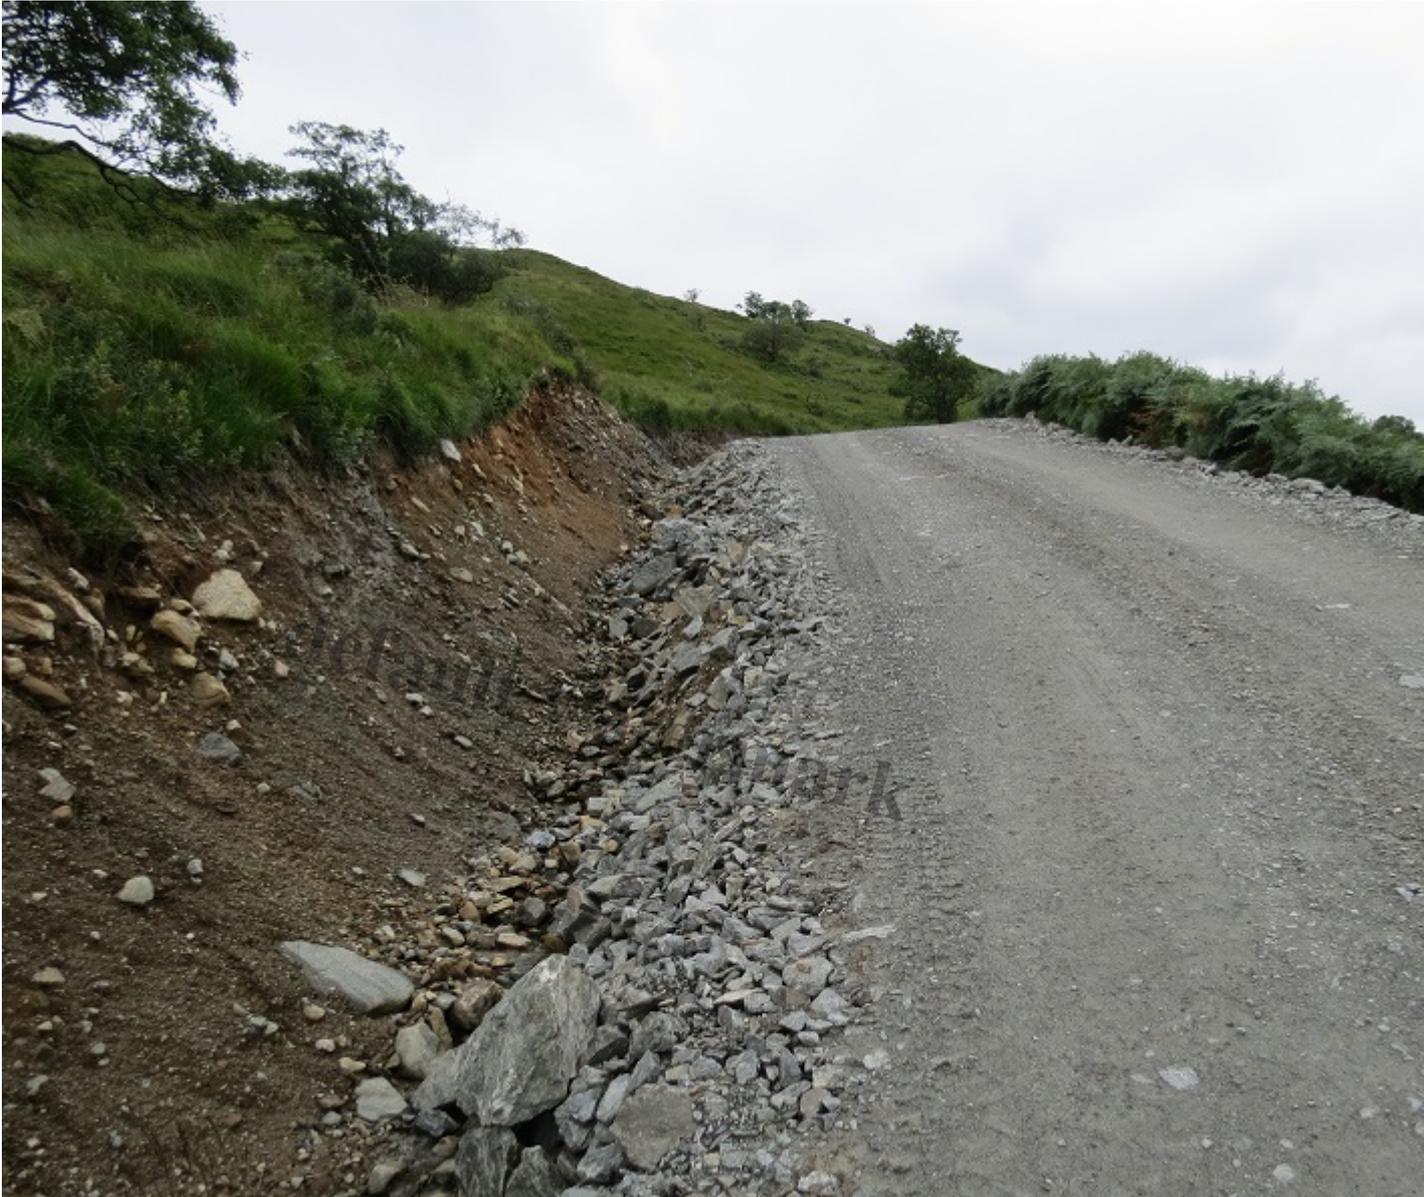
Part of the lower section of the access track to Ben Glas hydro scheme Glen Falloch illustrating the use of aggregate used in its construction

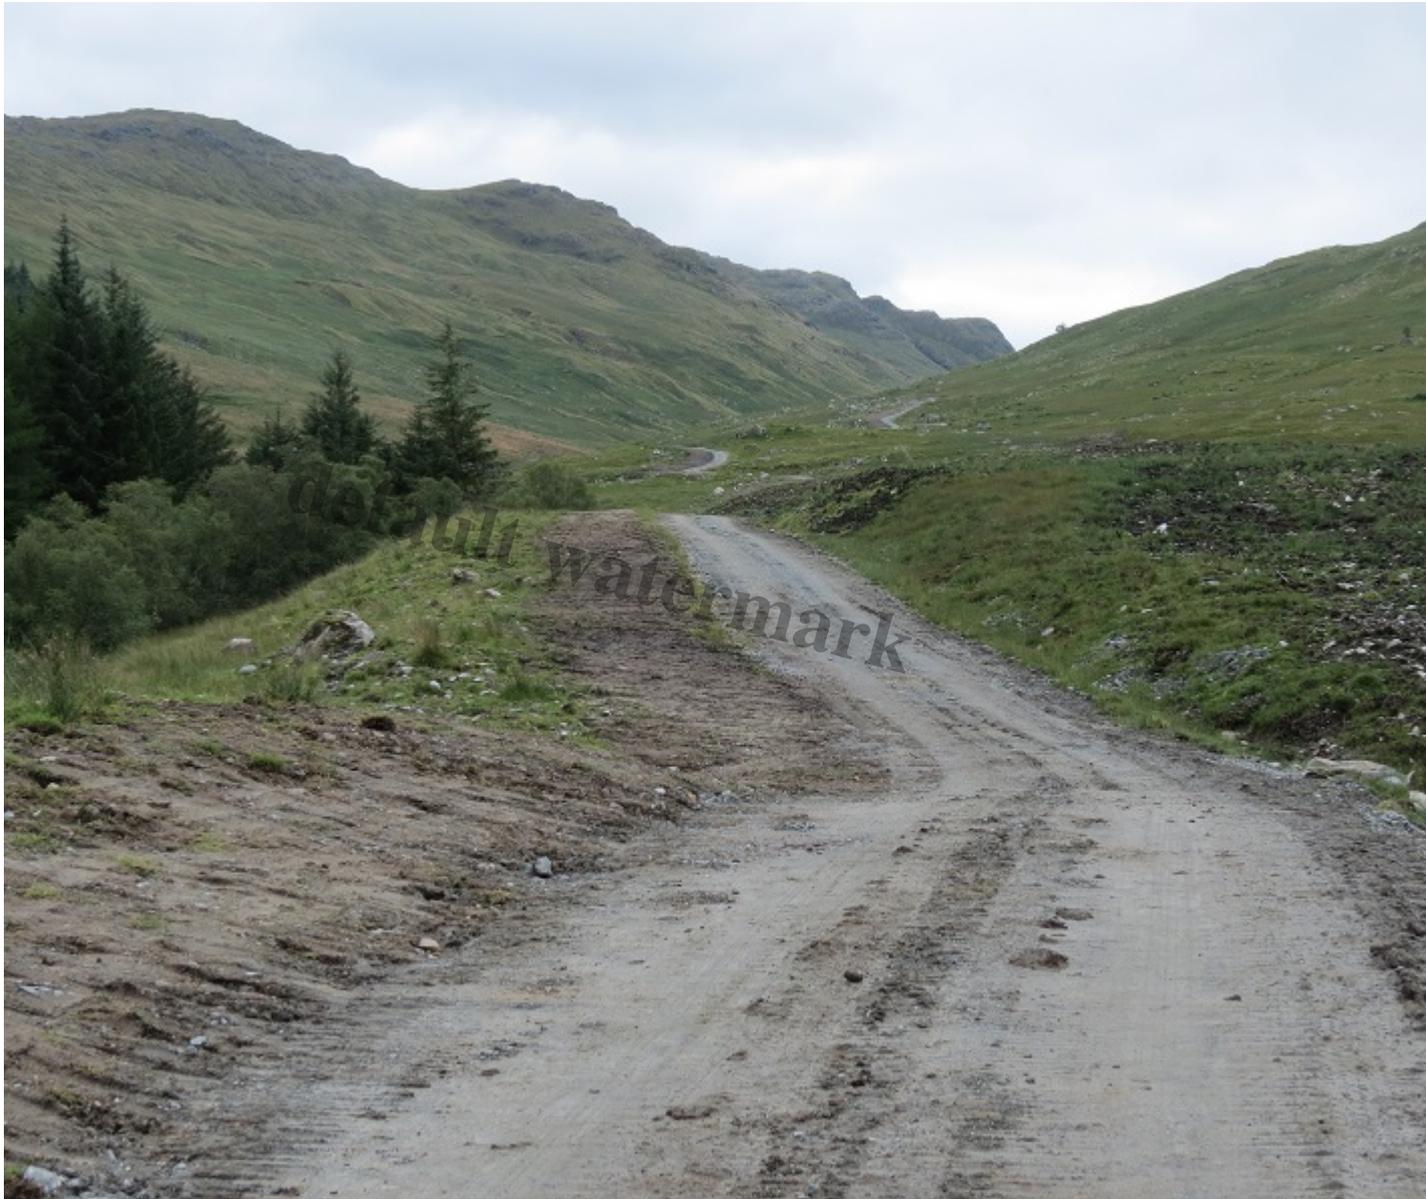
Example of track “restoration” from the upper Falloch hydro scheme. You can see evidence of aggregate that has been imported on the right of the photo. The imported aggregate results in a track that has been raised above the previous contours in the landscape. In the centre of the photo you can see that the aggregate has hardly been reprofiled and simply covered up with a thin layer of turf.

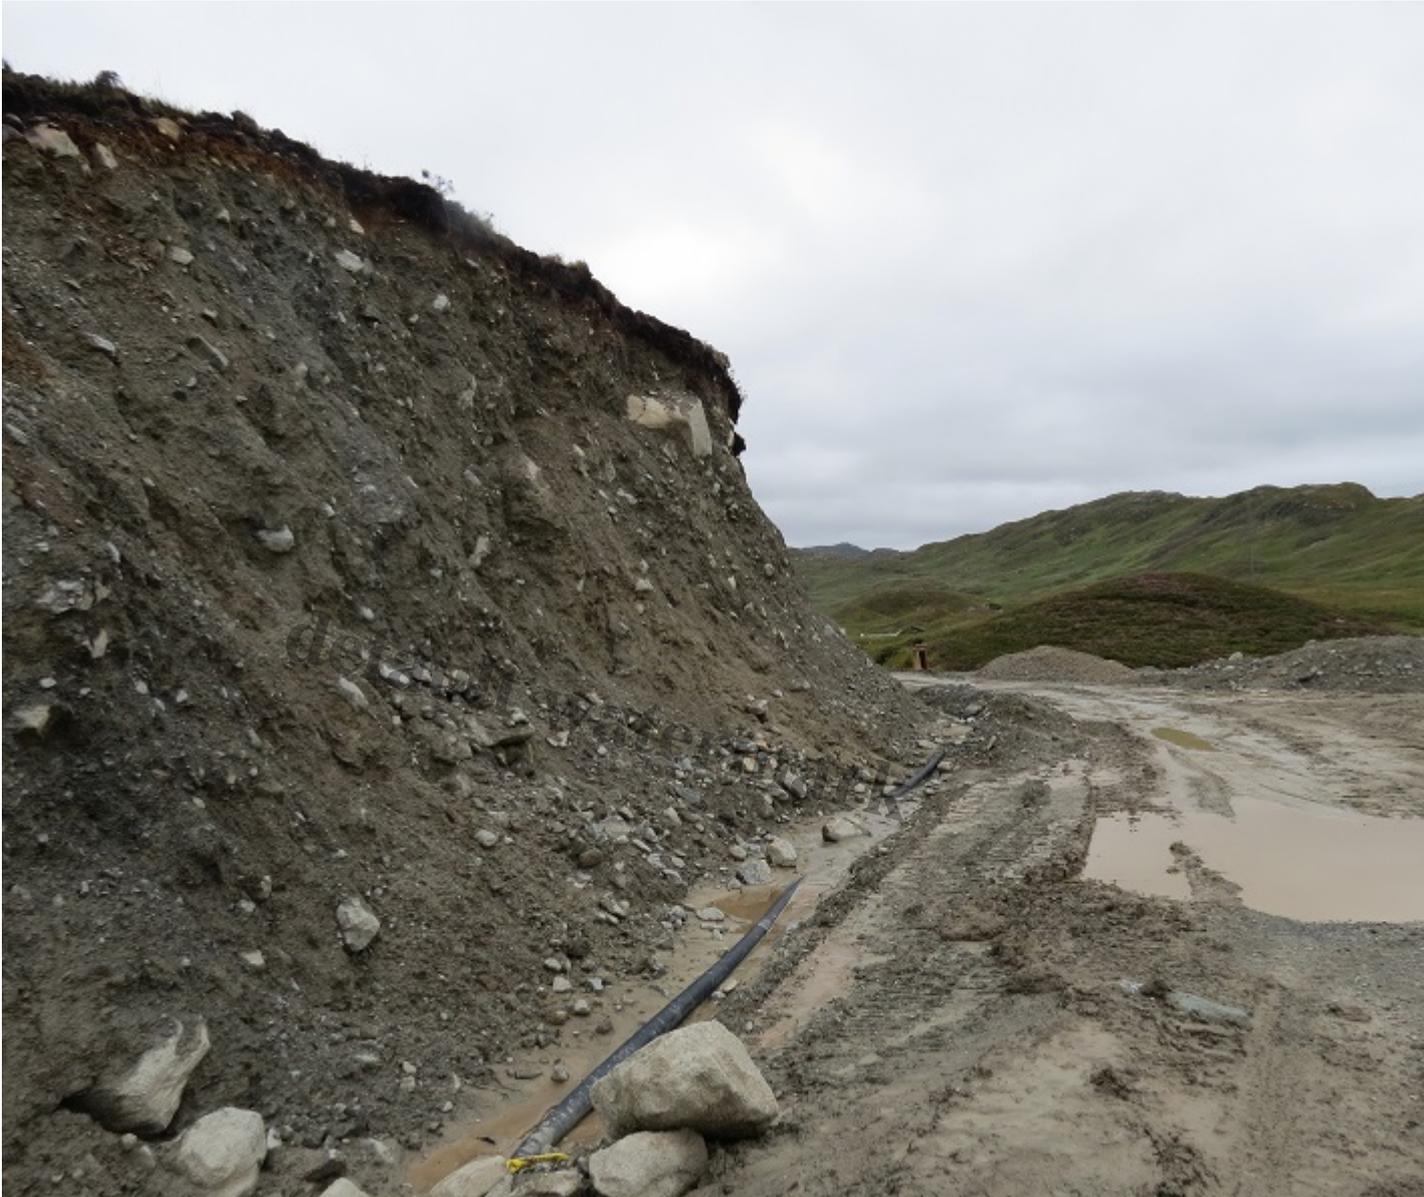
Moraine can be used as a source of aggregate for building tracks, as here approaching the Ben Glas dams, but no restoration will be able to restore this to its former shape. Landscape features that have since the end of the ice age, and would have been well known to the drovers who brought their cattle route, have been changed out of all recognition.

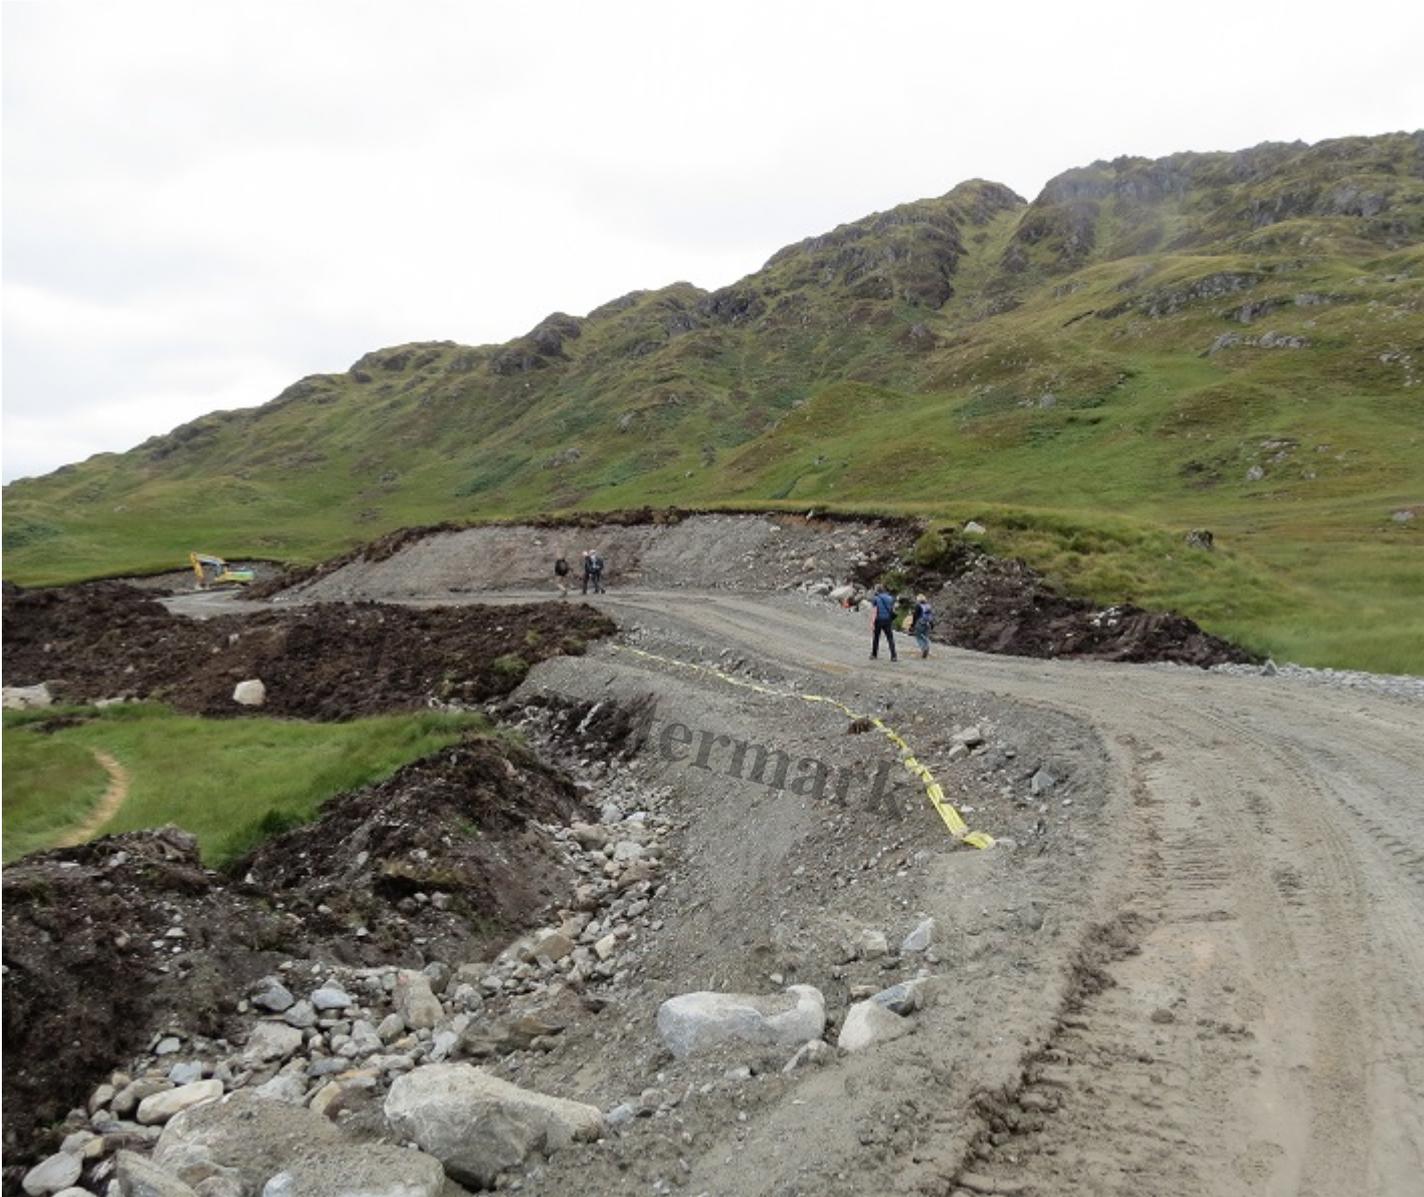
Large amounts of material to build the track have been obtained from this moraine, the contours of which have been changed for ever.

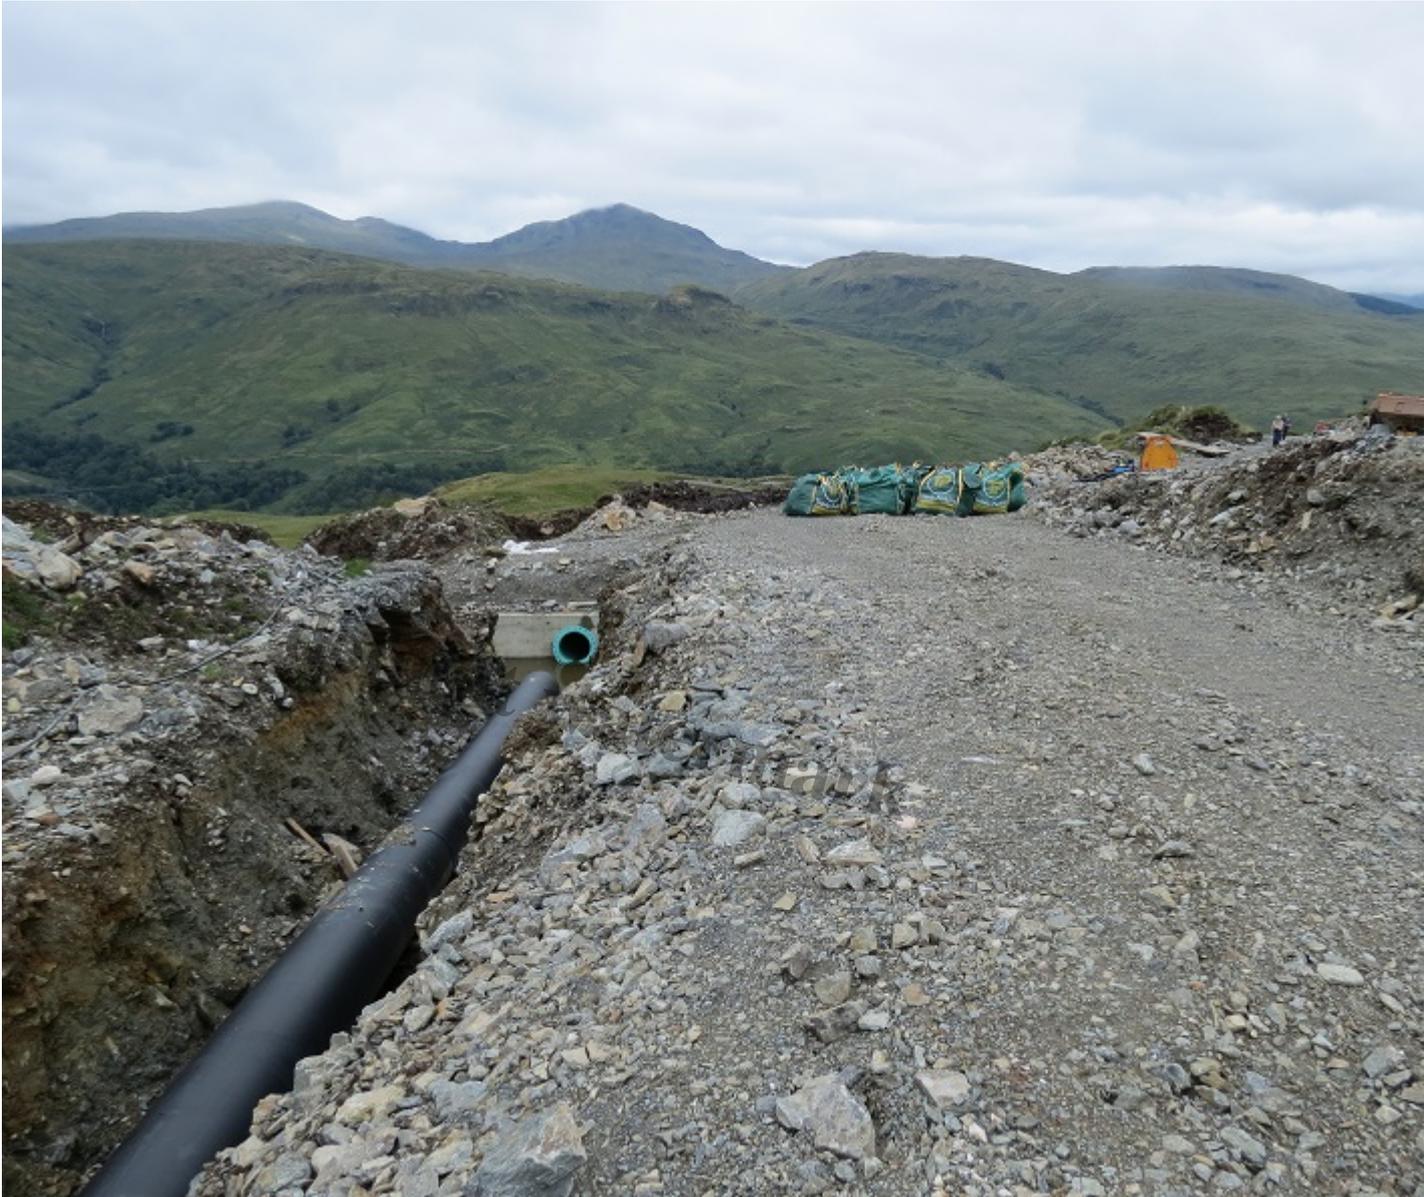
The laying of the water pipe brings material that was once well buried to the surface â?? it may be re small quantities compared to what is imported but it all adds up.

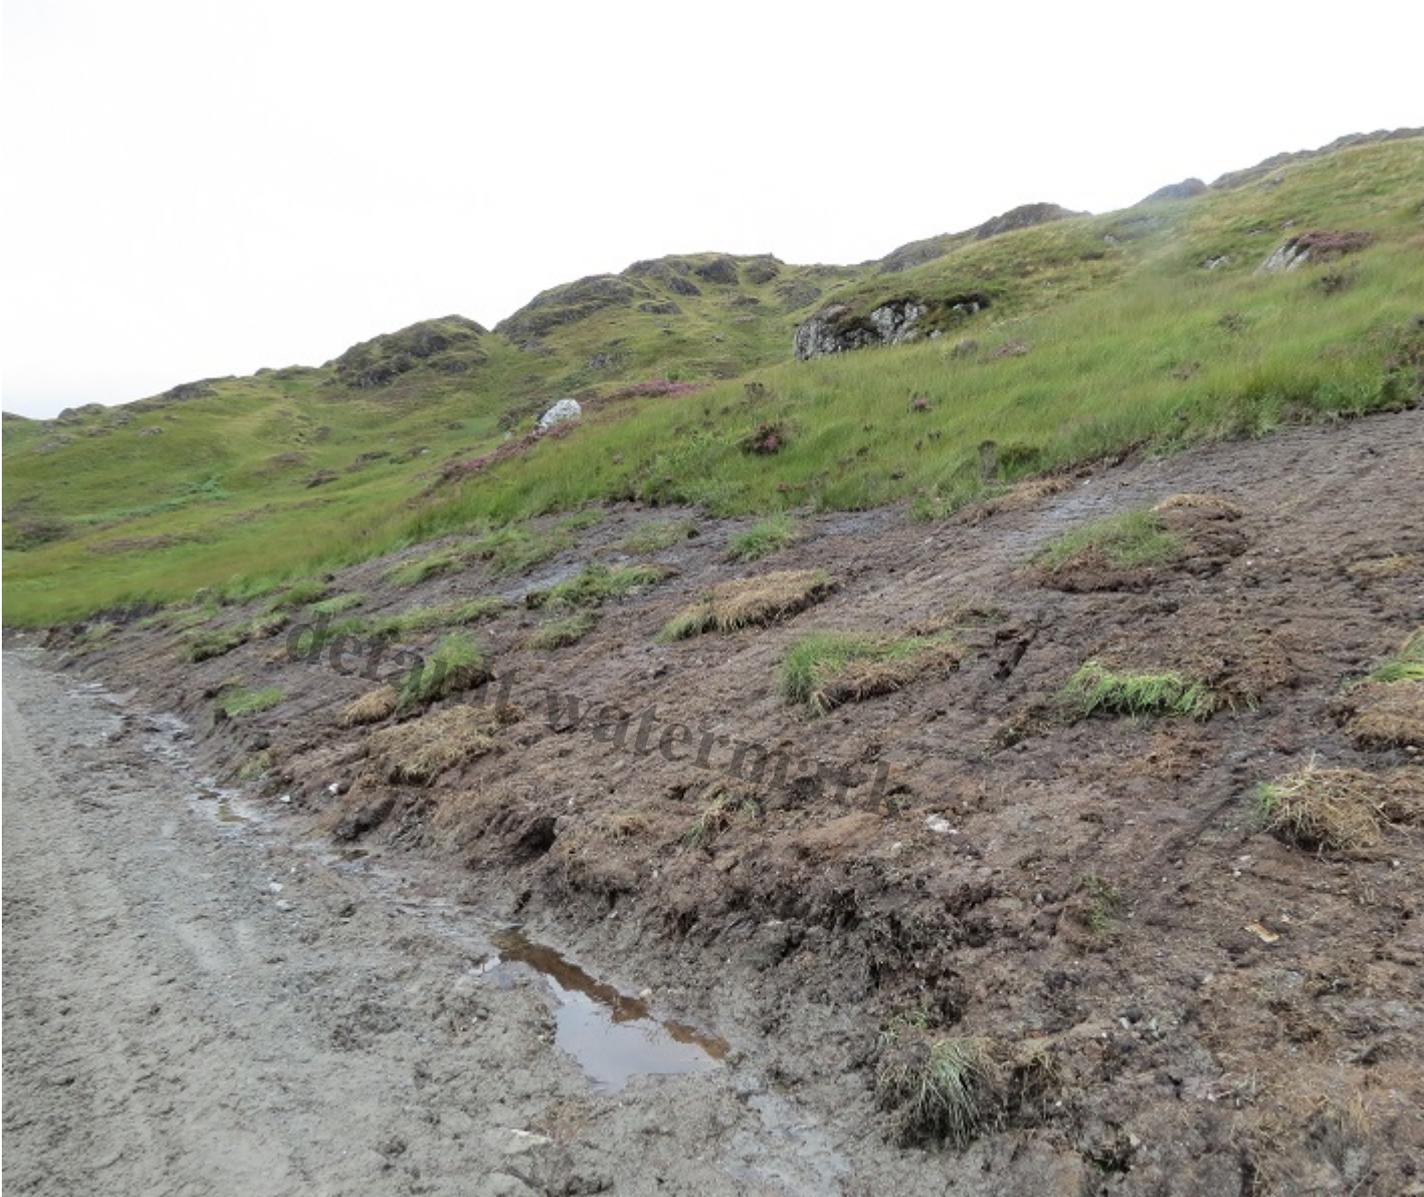
One of the better examples of ‘‘restoration’’ where some turf has been re-used. The reprofiled s however, while not entirely uniform, is still in the form of an embankment and is out of place with the shape of the hillside above. Its very hard to restore slopes over a certain angle, hence the embankment replicated across what was once a wild landscape..

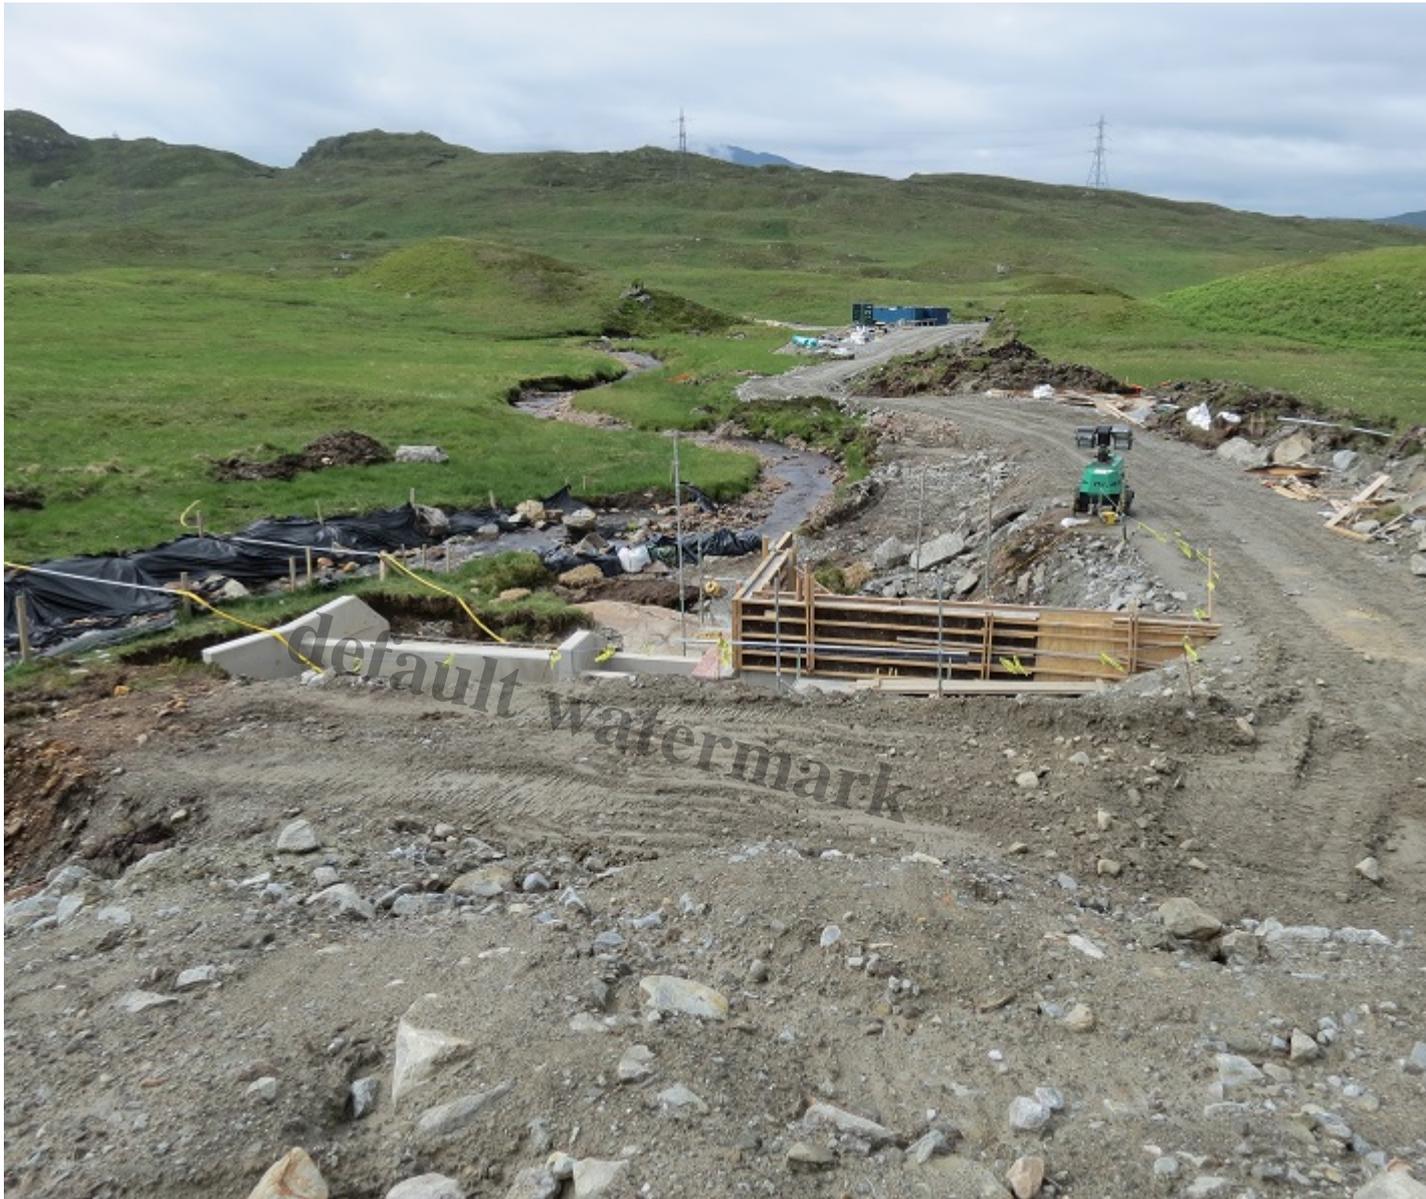
Photo illustrating how the second Ben Glas intake has been excavated out of the ground. The burn has been diverted temporarily to allow the dam to be constructed. The first intake is hidden behind the moraine of the track.

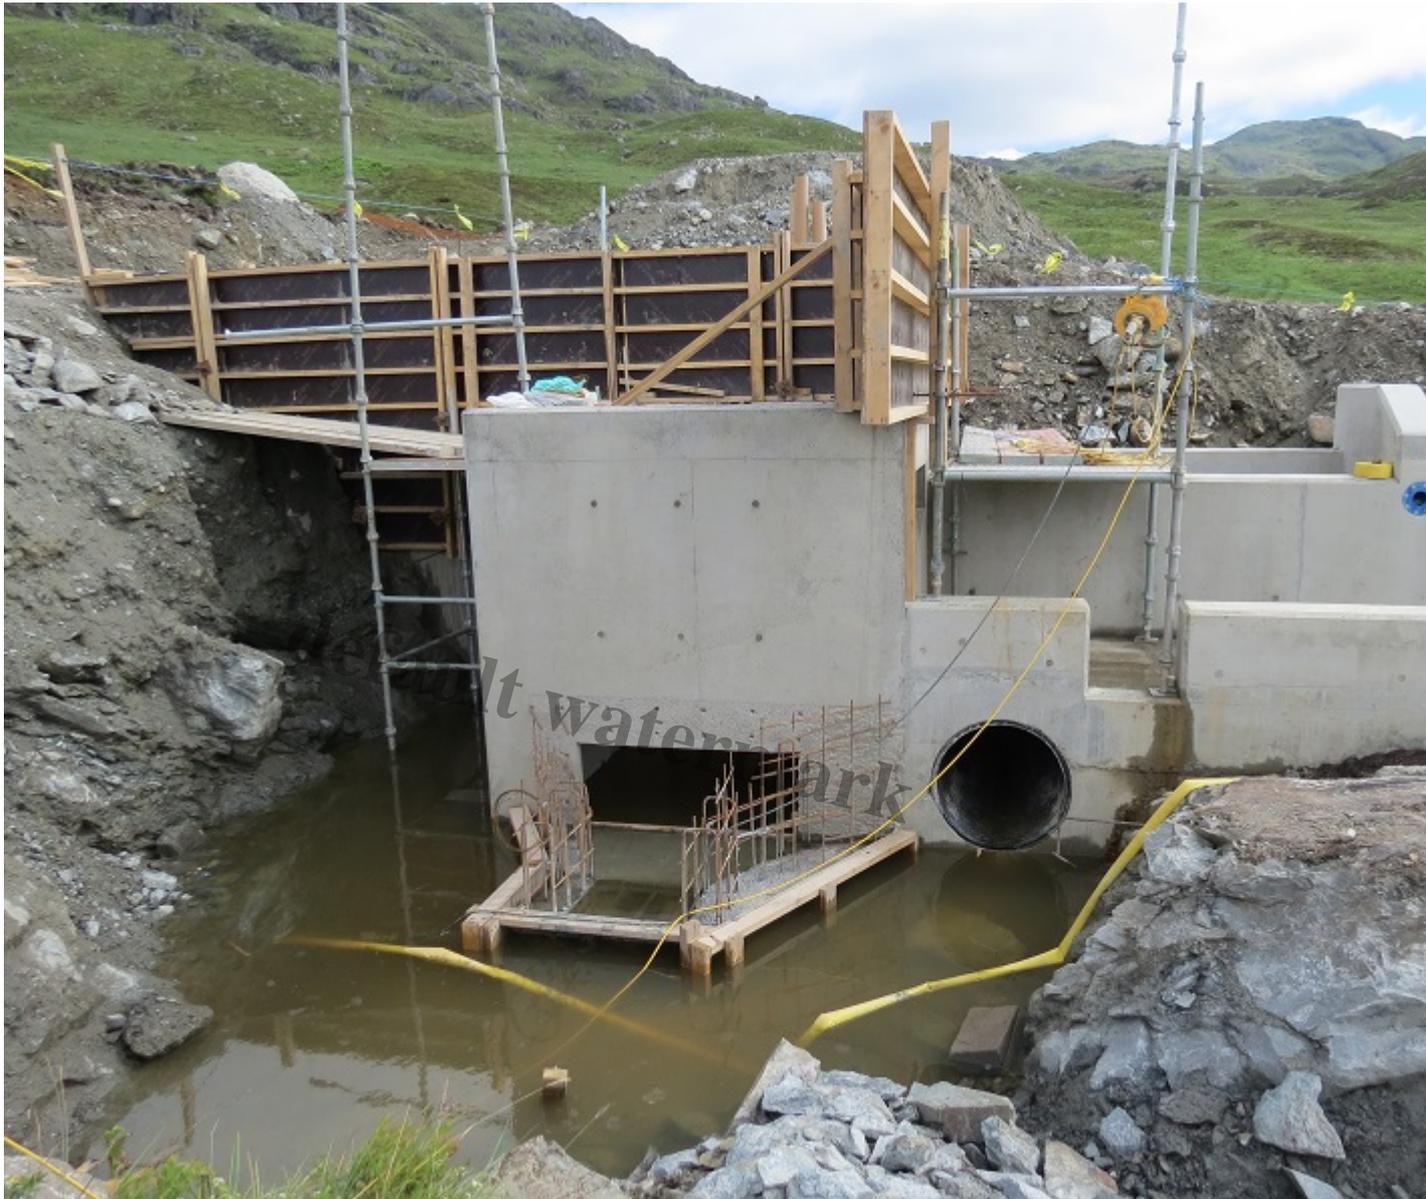
Second Ben Glas intake from below- significant amounts of concrete and other materials have been put into what was once wild land

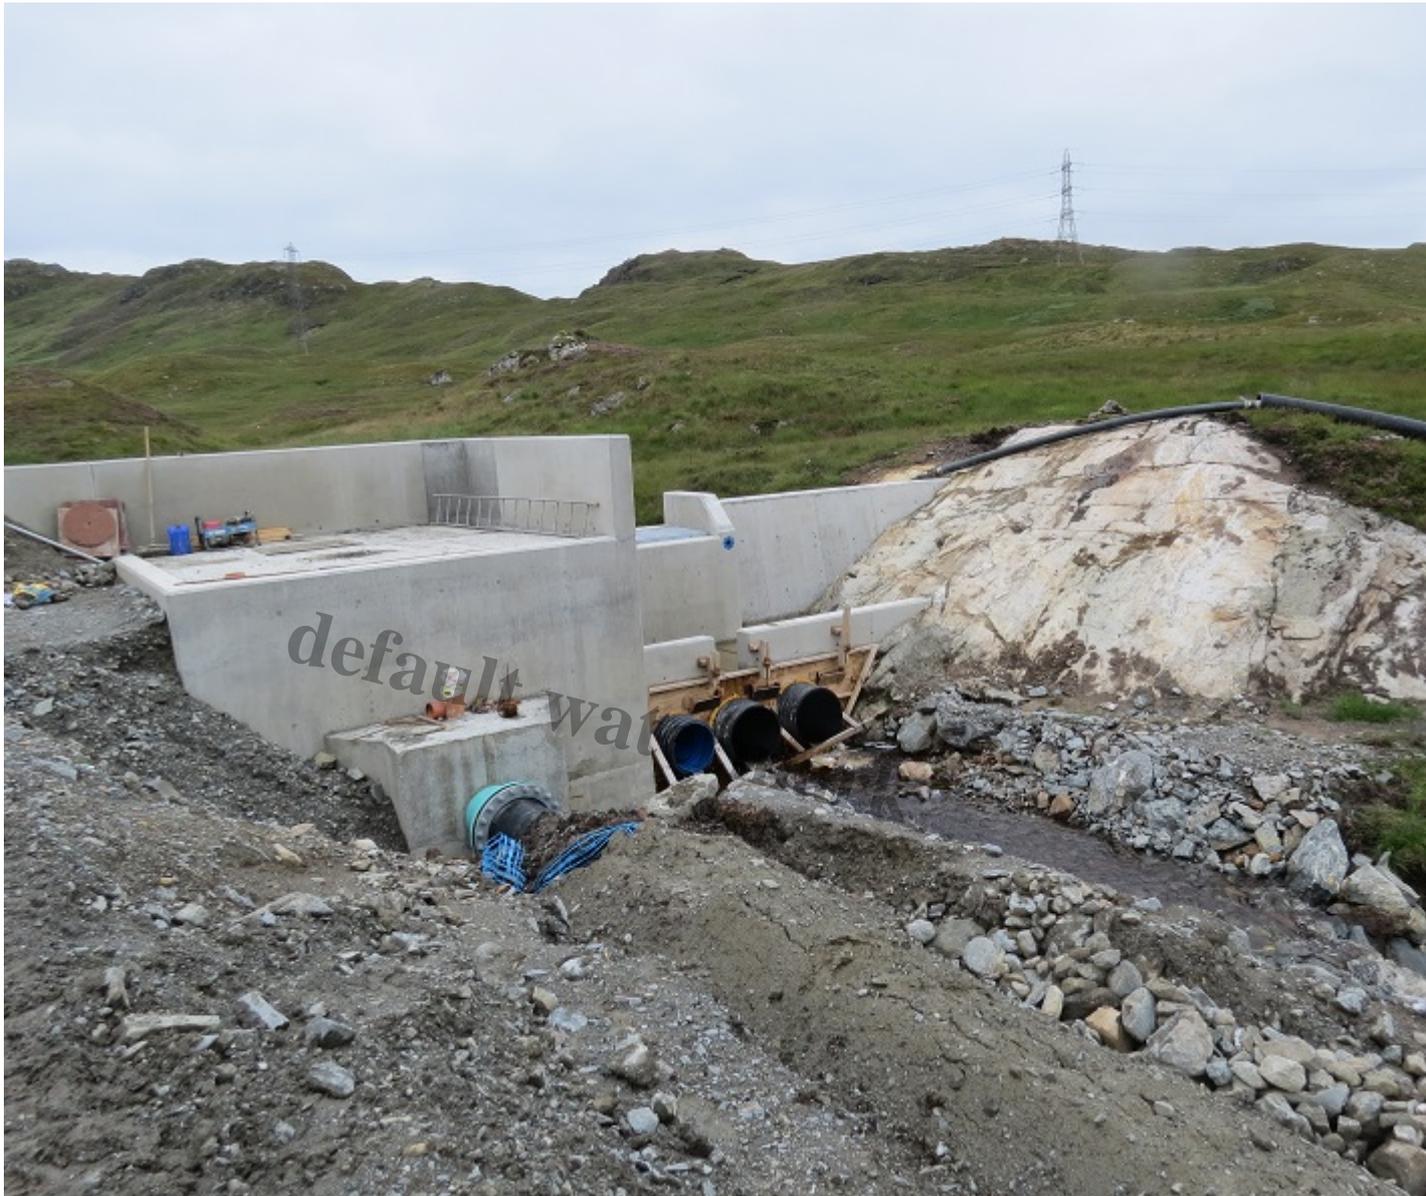
The first Ben Glas intake dam is located between natural features (moraine out of sight on left) but not has required significant amounts of material to be shifted and relandscaped.

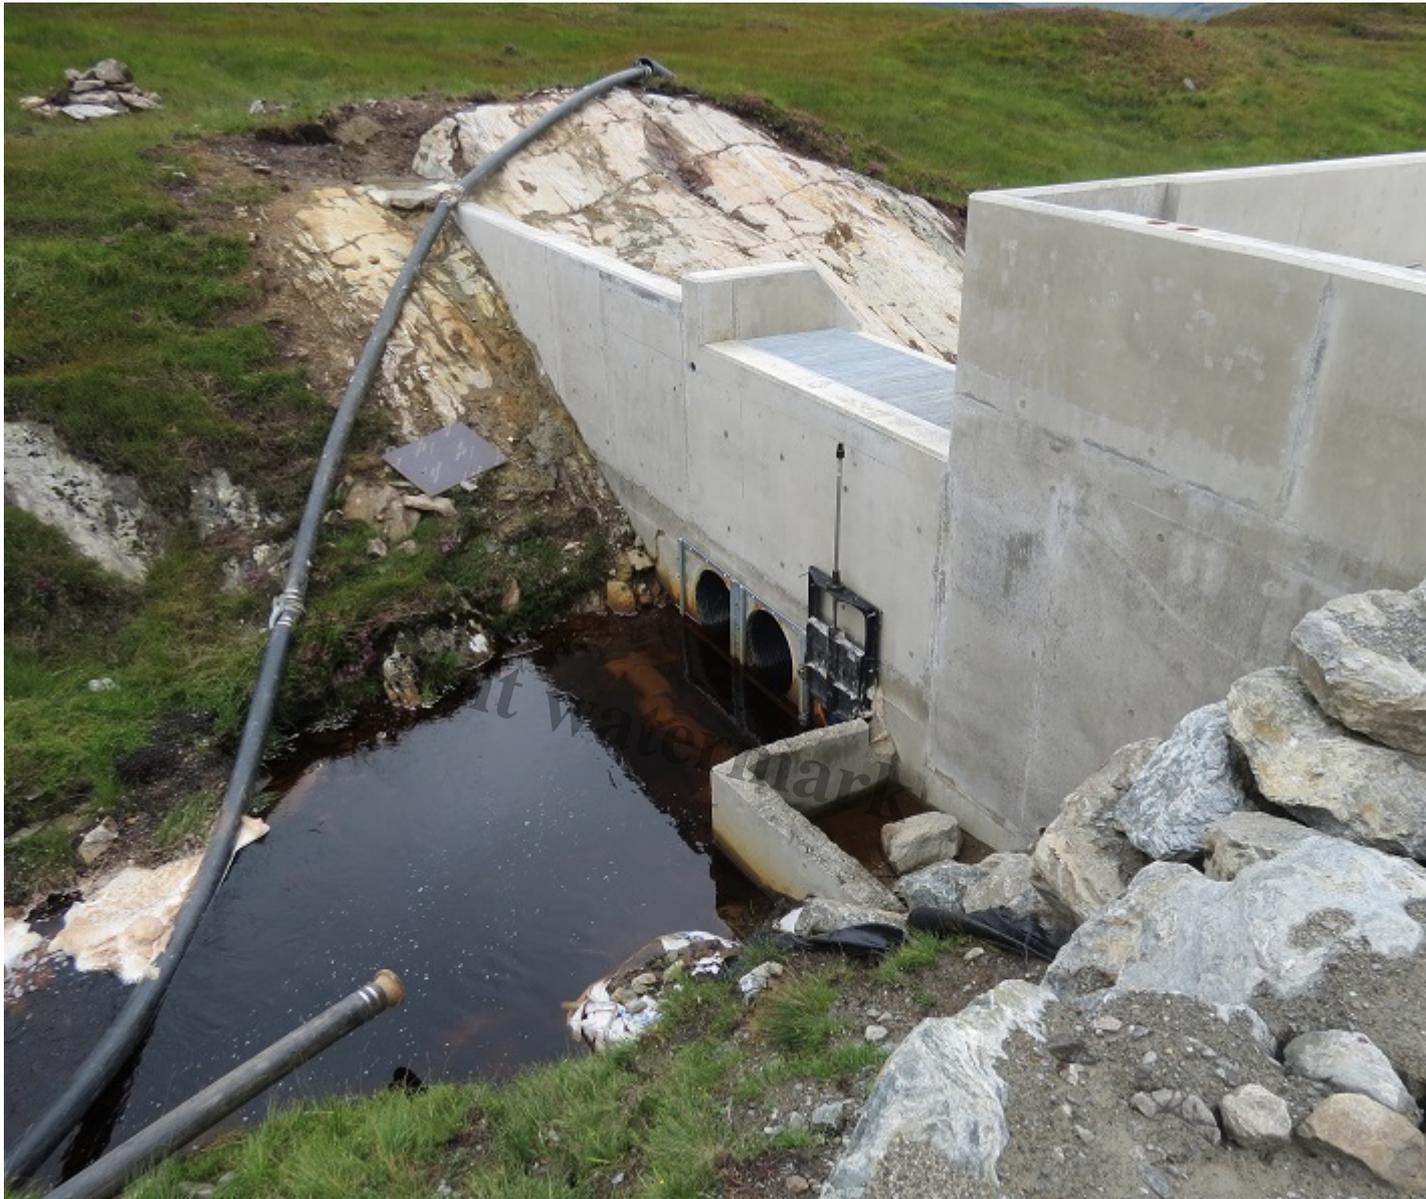
What will become the intake pool at the first dam. A large amount of concrete has been introduced to the landscape.

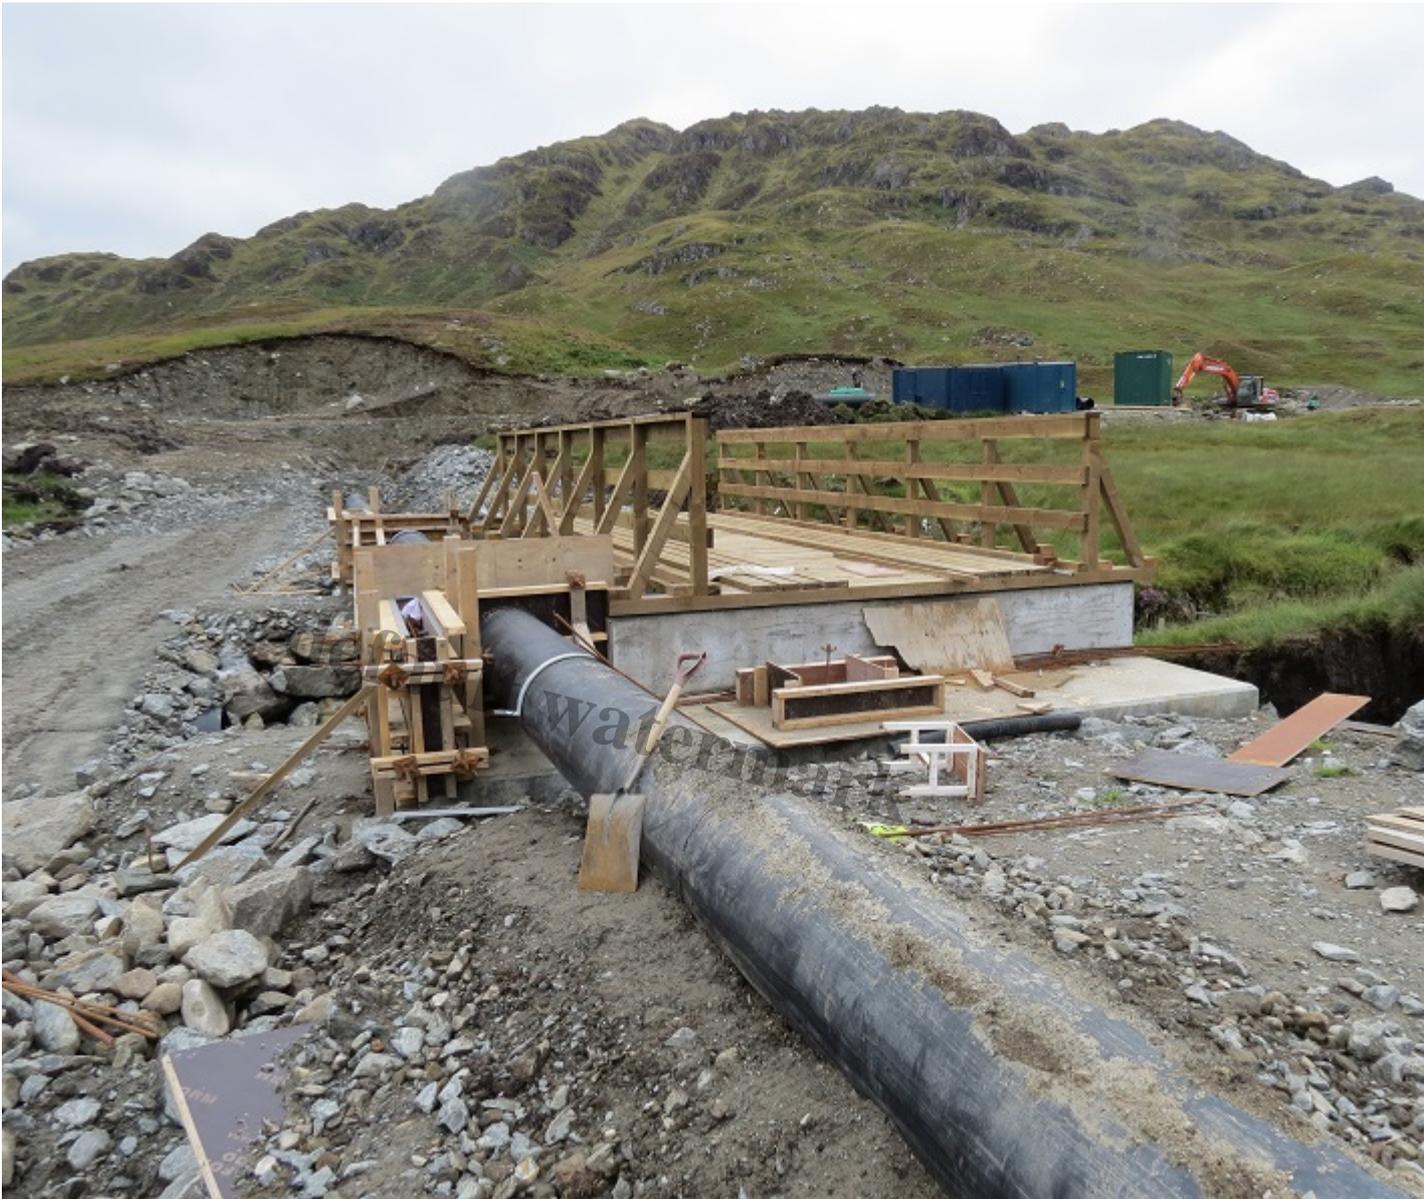
The need for a bridge introduces a further new structure into what was previously an almost natural landscape (there are electricity pylons to the south).
