The Glen Falloch hydro schemes (4) – the restoration myth

August 25, 2016

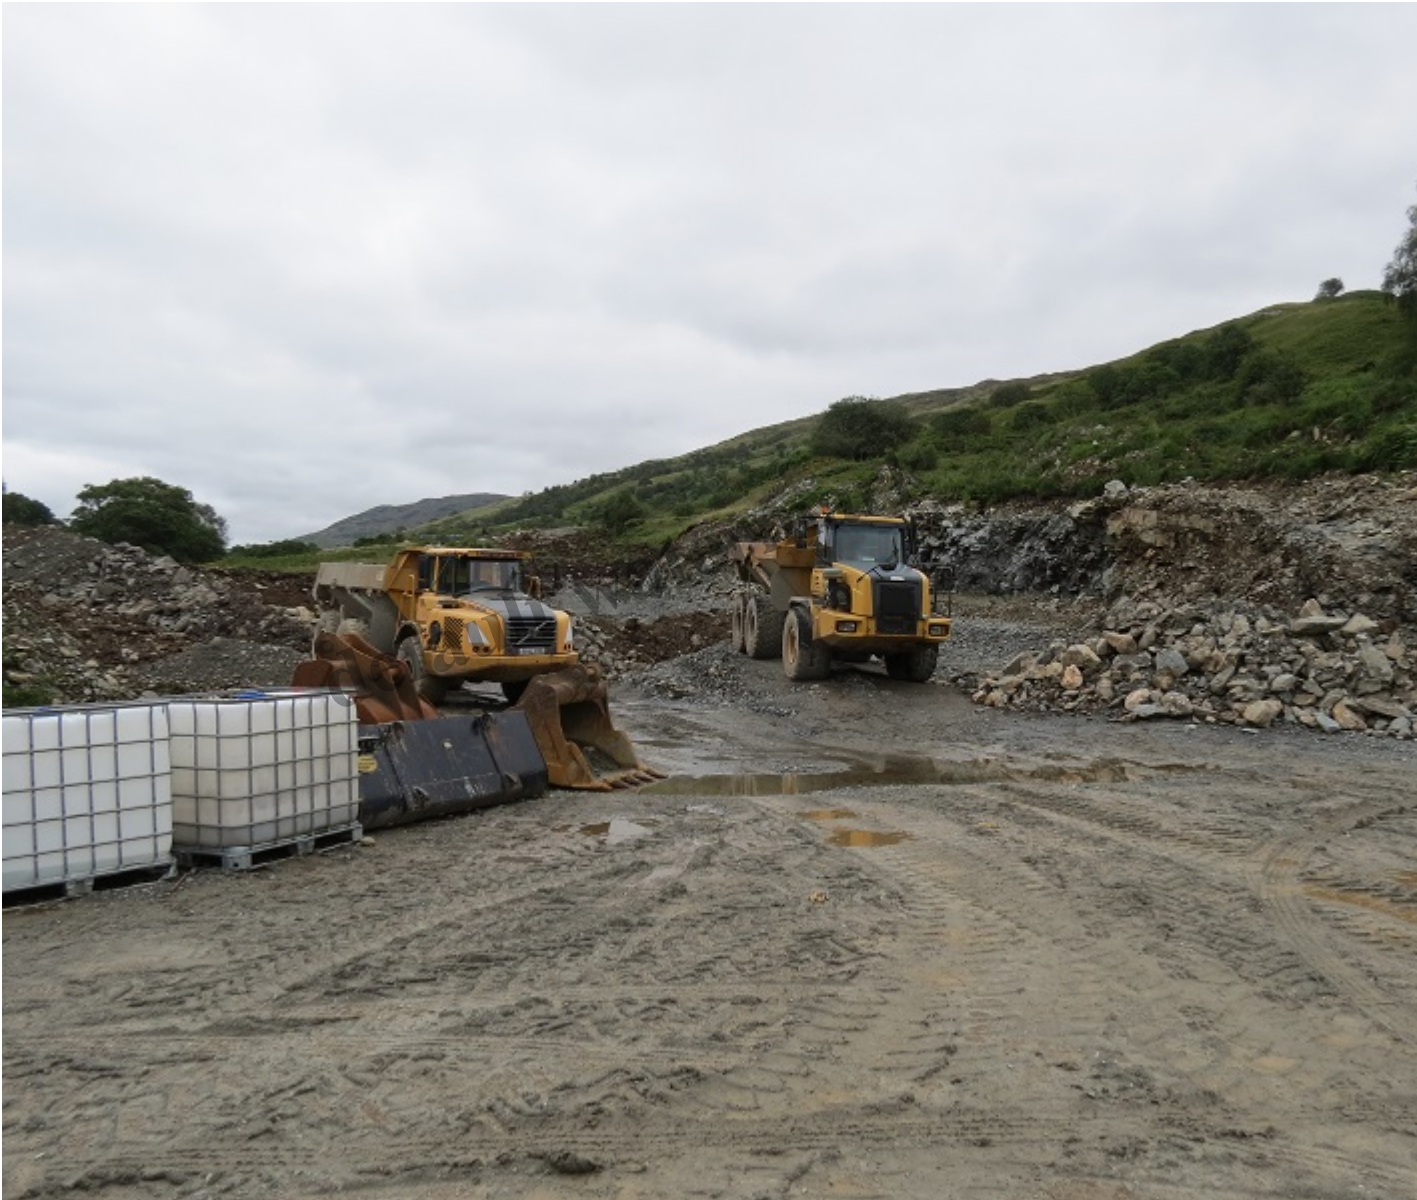
The quarry site at the bottom of new Ben Glas track

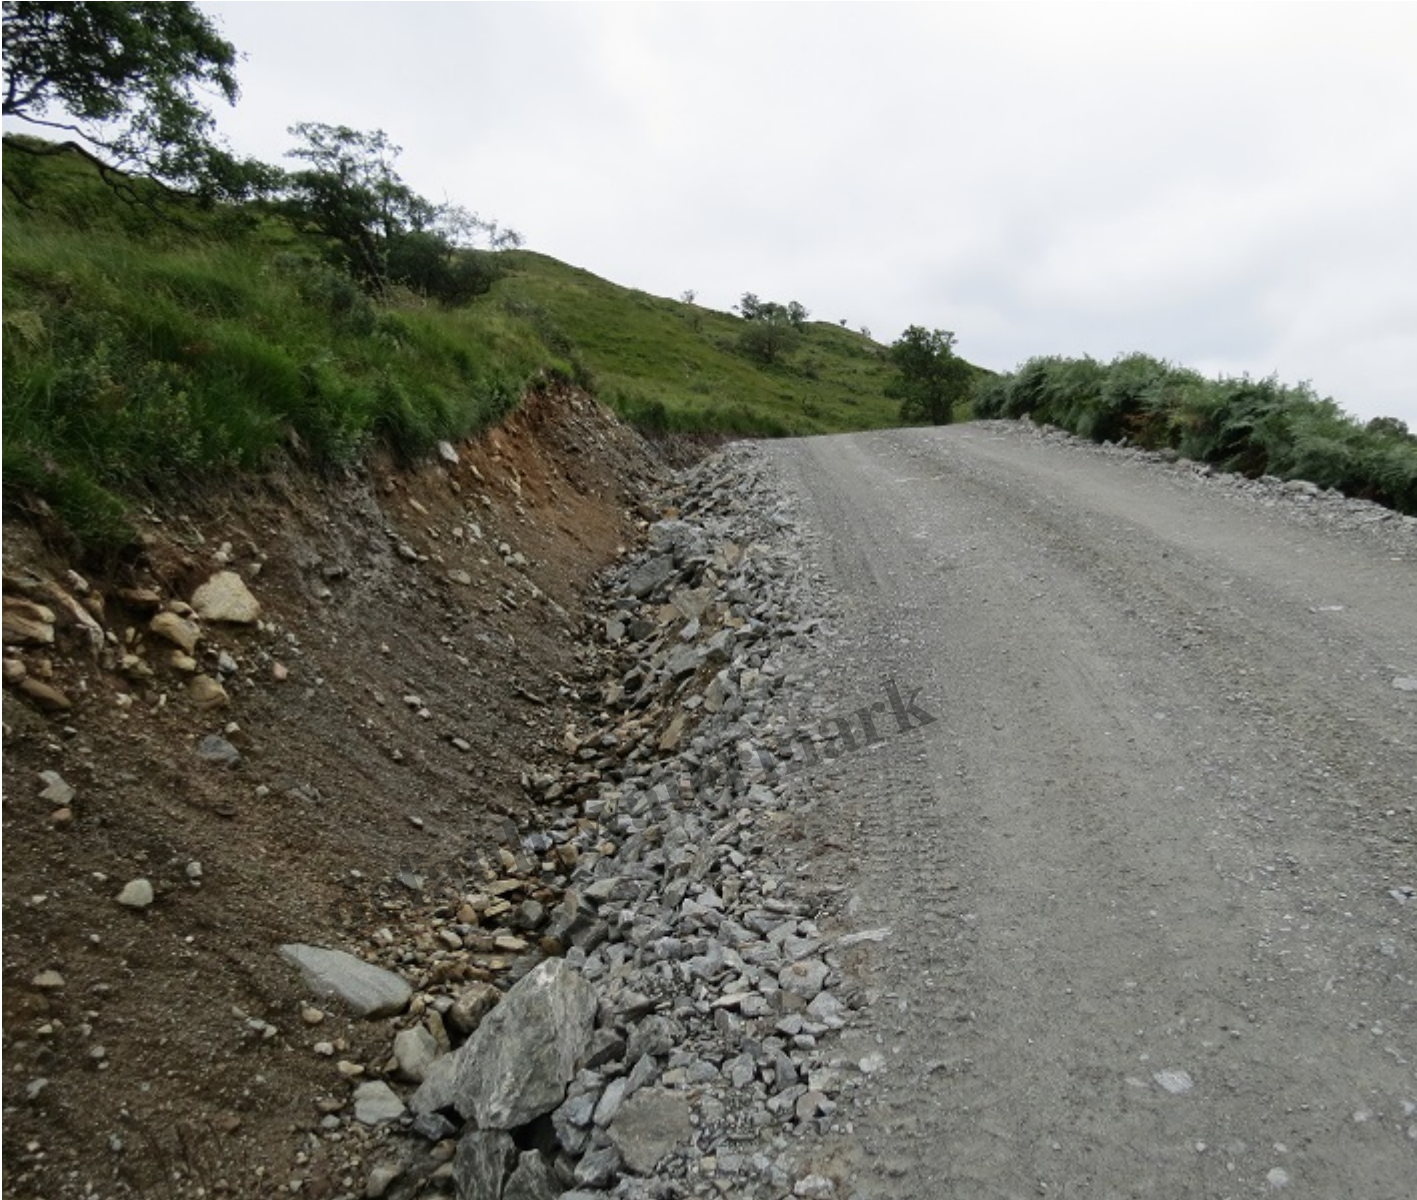
Part of the lower section of the access track to Ben Glas hydro scheme Glen Falloch illustrating the amount of aggregate used in its construction

To fully restore this track would require the materials that have been imported to be returned to the appropriate quarry or "borrow pit". There is no evidence of this happening.

Instead, the new material imported to construct the track is, once the construction has finished, flattened out, reprofiled and then covered up. This has a permanent impact both on the landscape and on the ecology (the ecological impacts will be subject of a forthcoming blog from James Fenton).

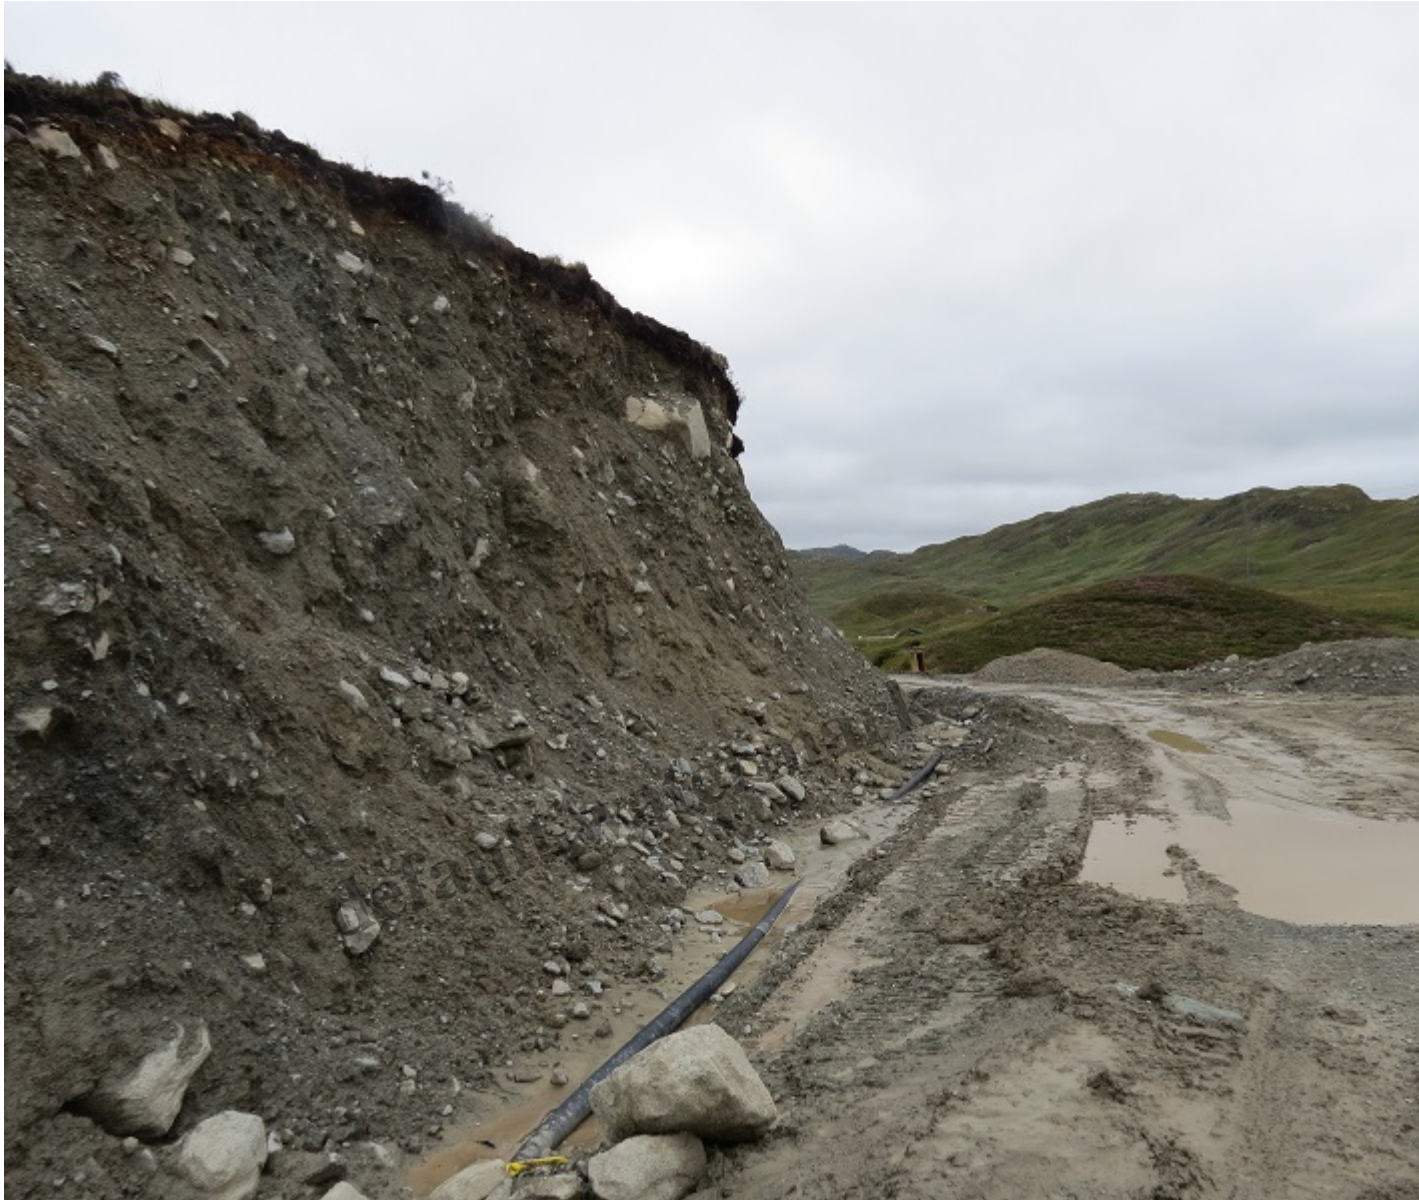
Moraine can be used as a source of aggregate for building tracks, as here approaching the Ben Glas dams, but no restoration will be able to restore this to its former shape. Landscape features that have since the end of the ice age, and would have been well known to the drovers who brought their cattle route, have been changed out of all recognition.

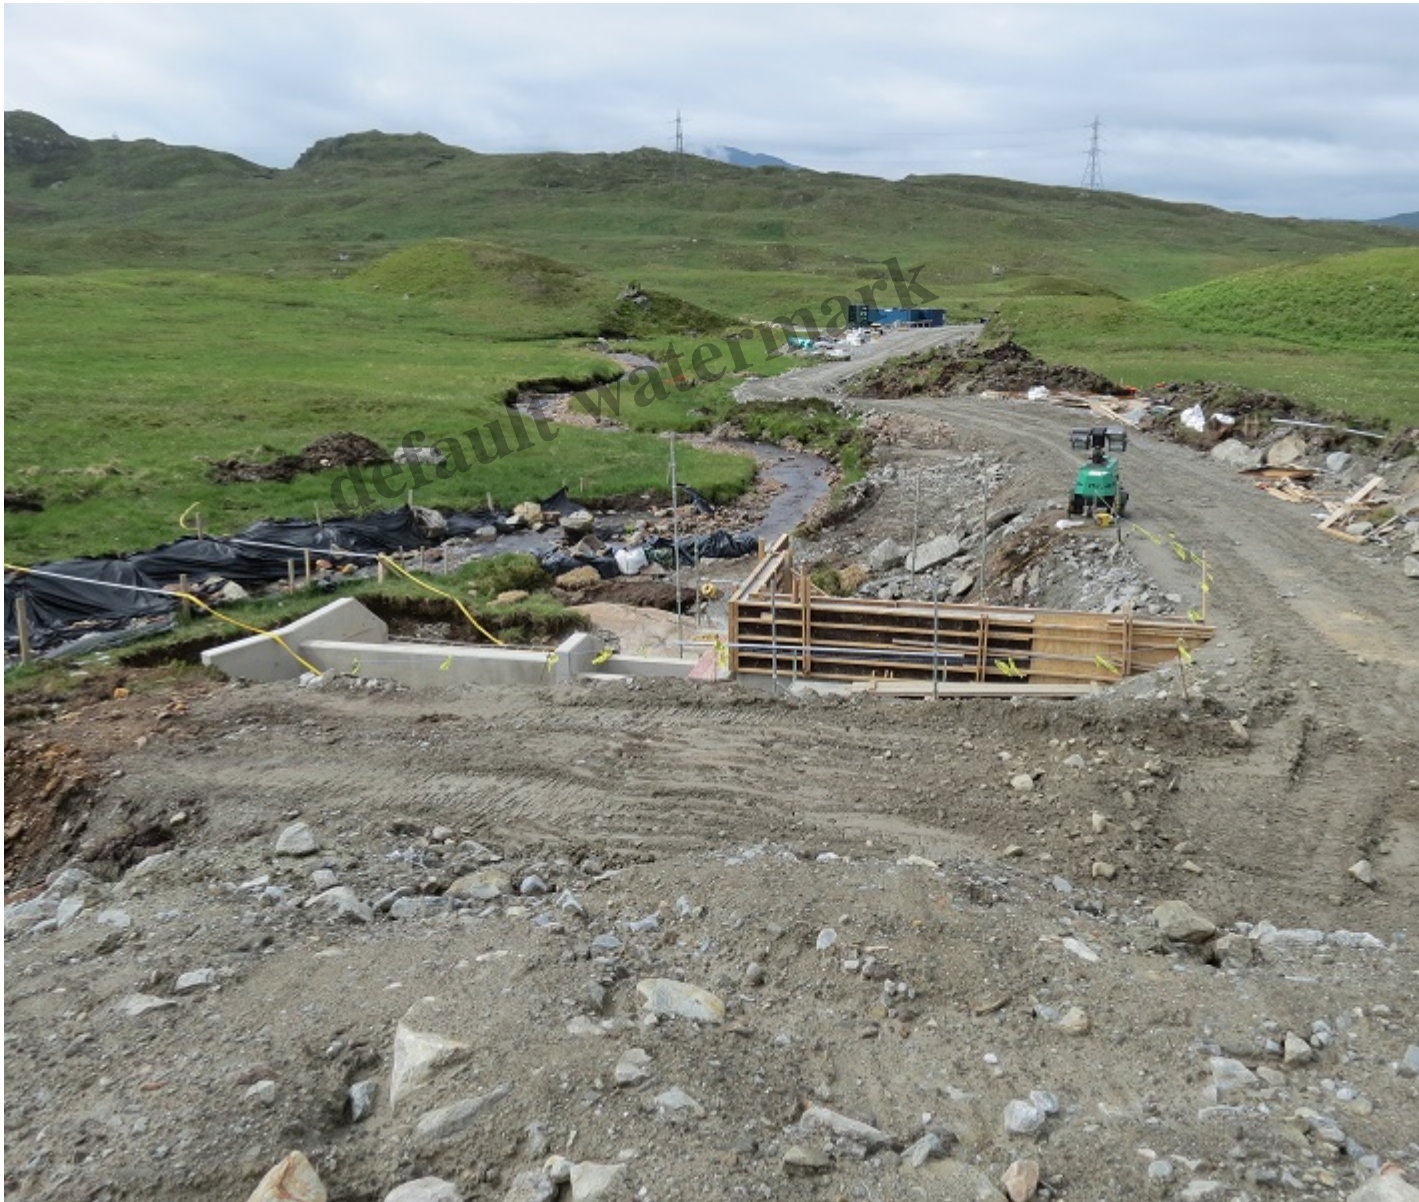
Photo illustrating how the second Ben Glas intake has been excavated out of the ground. The burn has been diverted temporarily to allow the dam to be constructed. The first intake is hidden behind the moraine of the track.

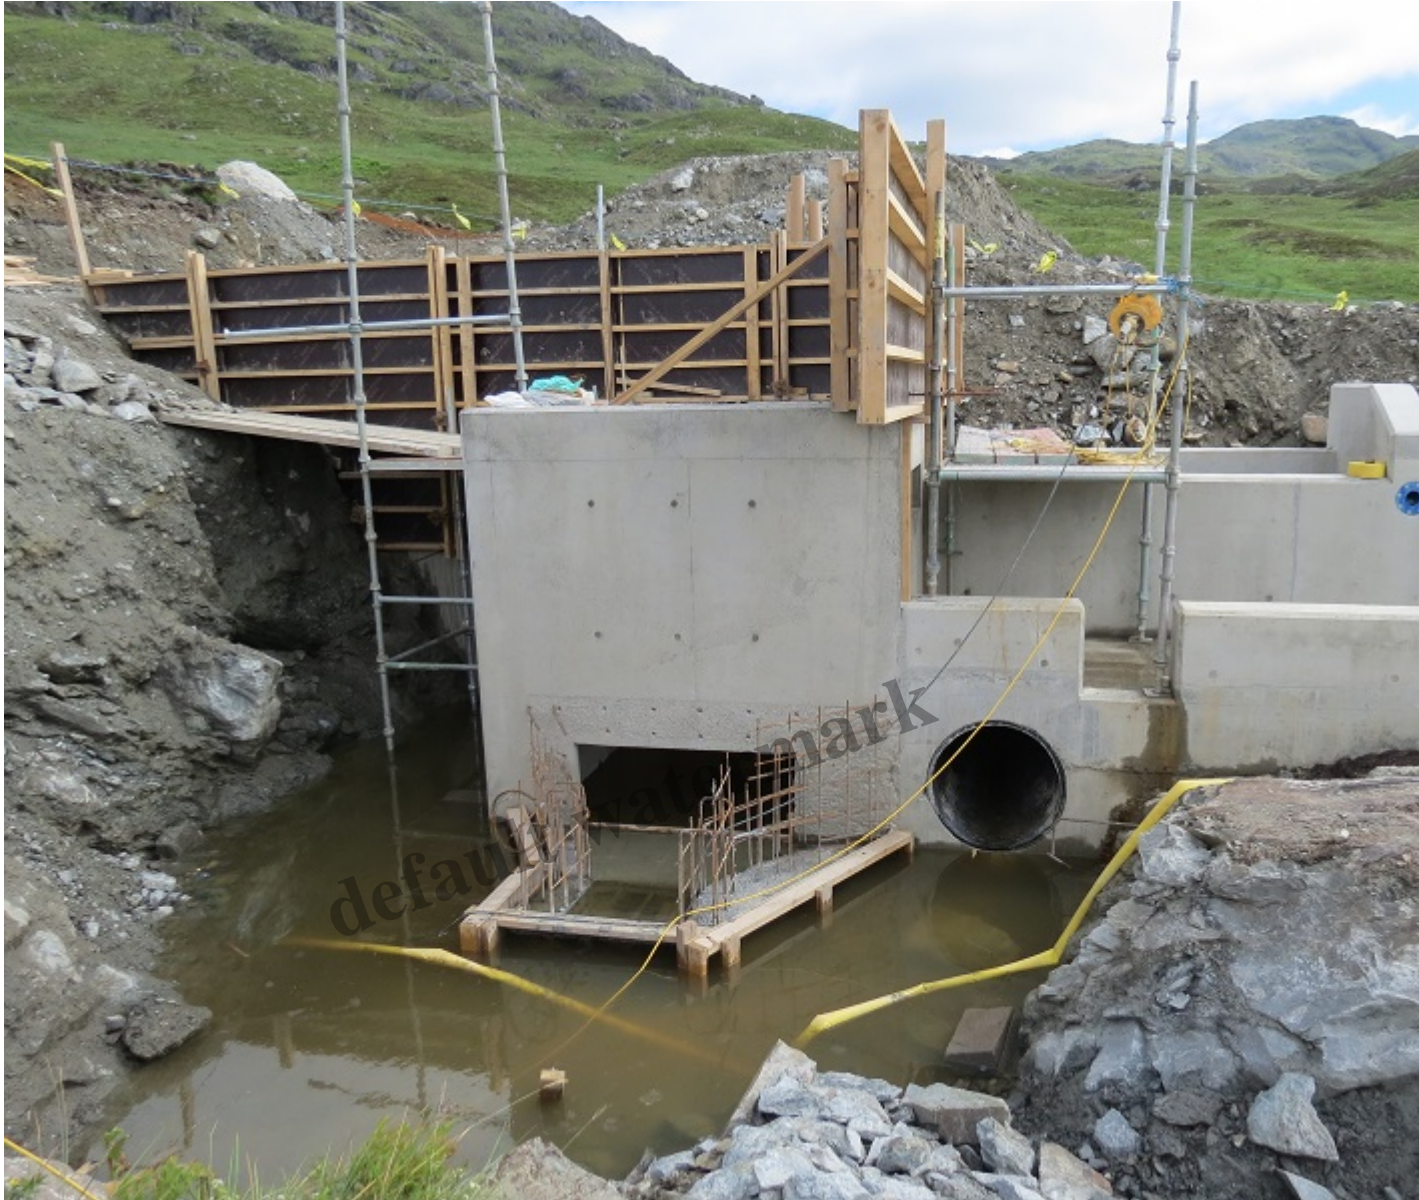
Second Ben Glas intake from below- significant amounts of concrete and other materials have been into what was once wild land

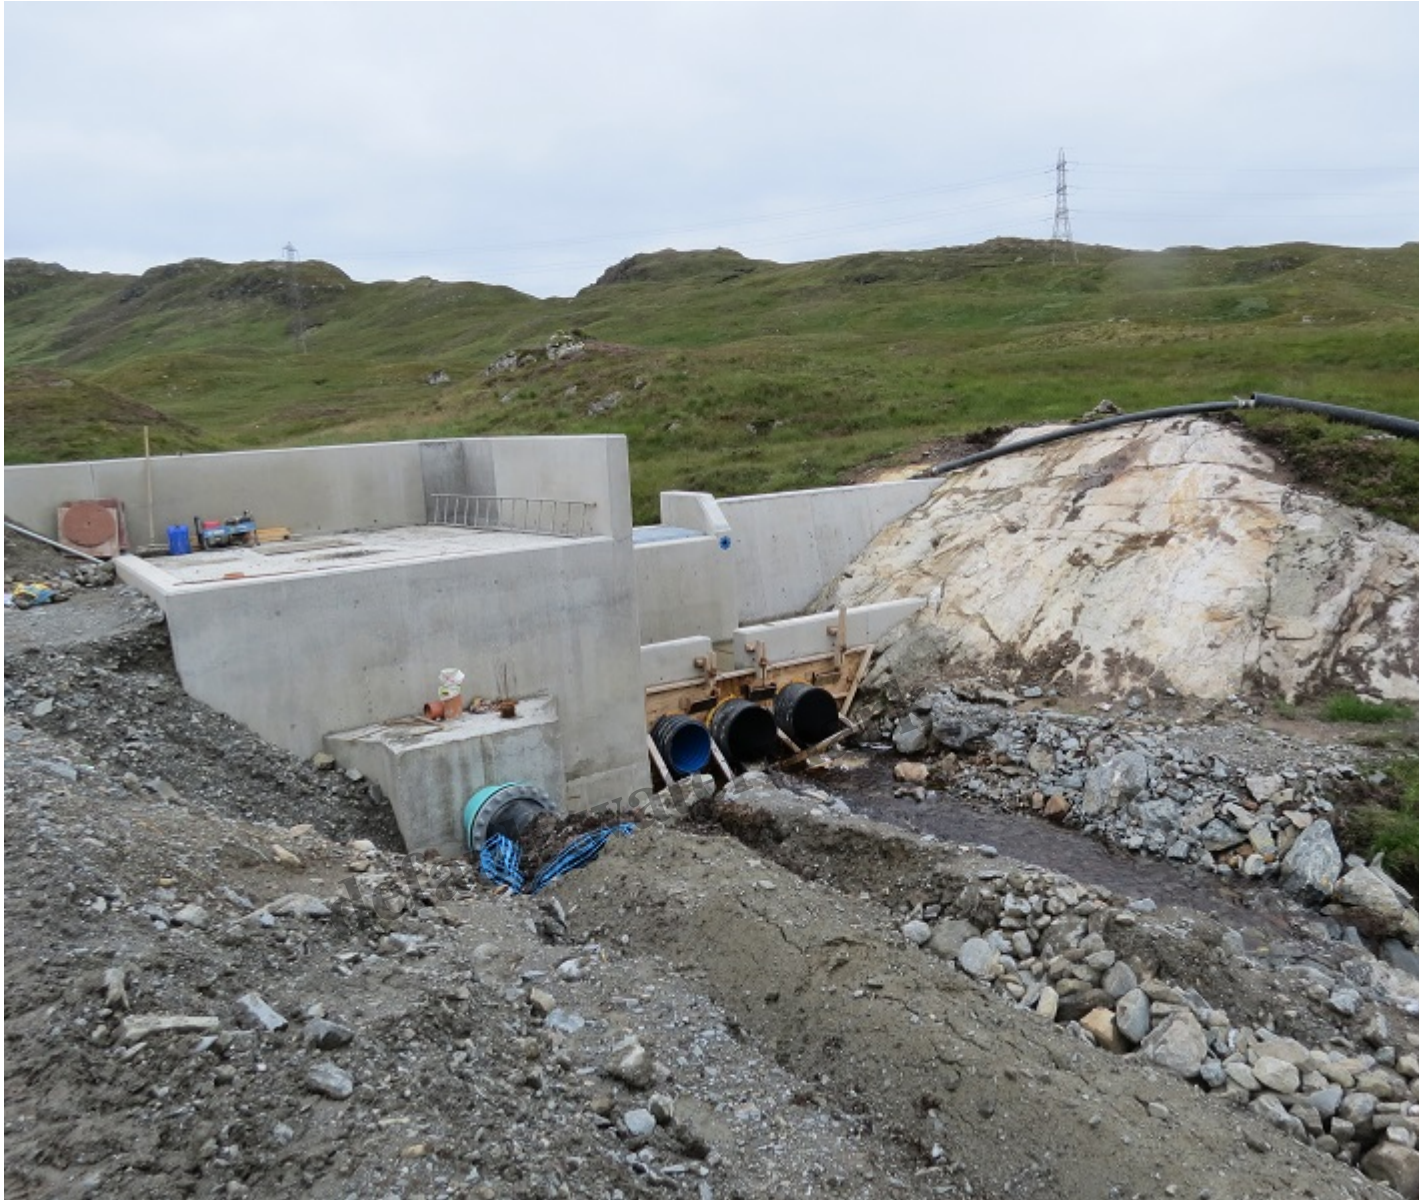
The first Ben Glas intake dam is located between natural features (moraine out of sight on left) but n has required significant amounts of material to be shifted and relandscaped.
