The Glen Falloch hydro schemes (4) – the restoration myth

August 25, 2016

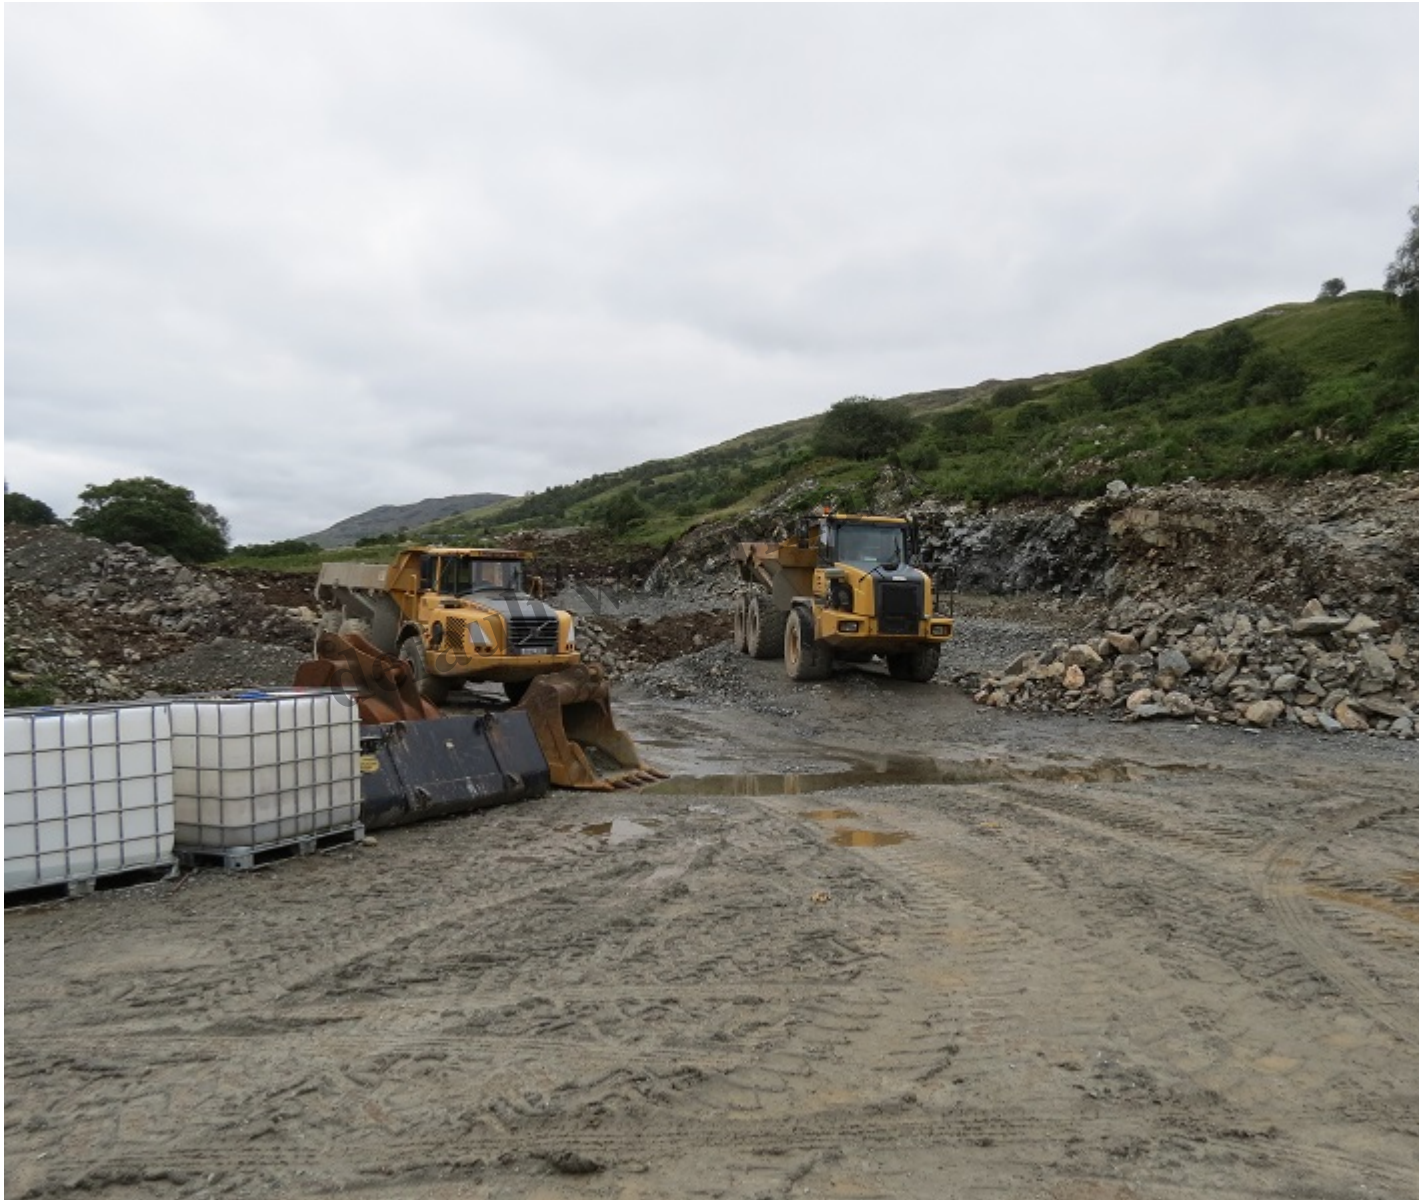
The quarry site at the bottom of new Ben Glas track

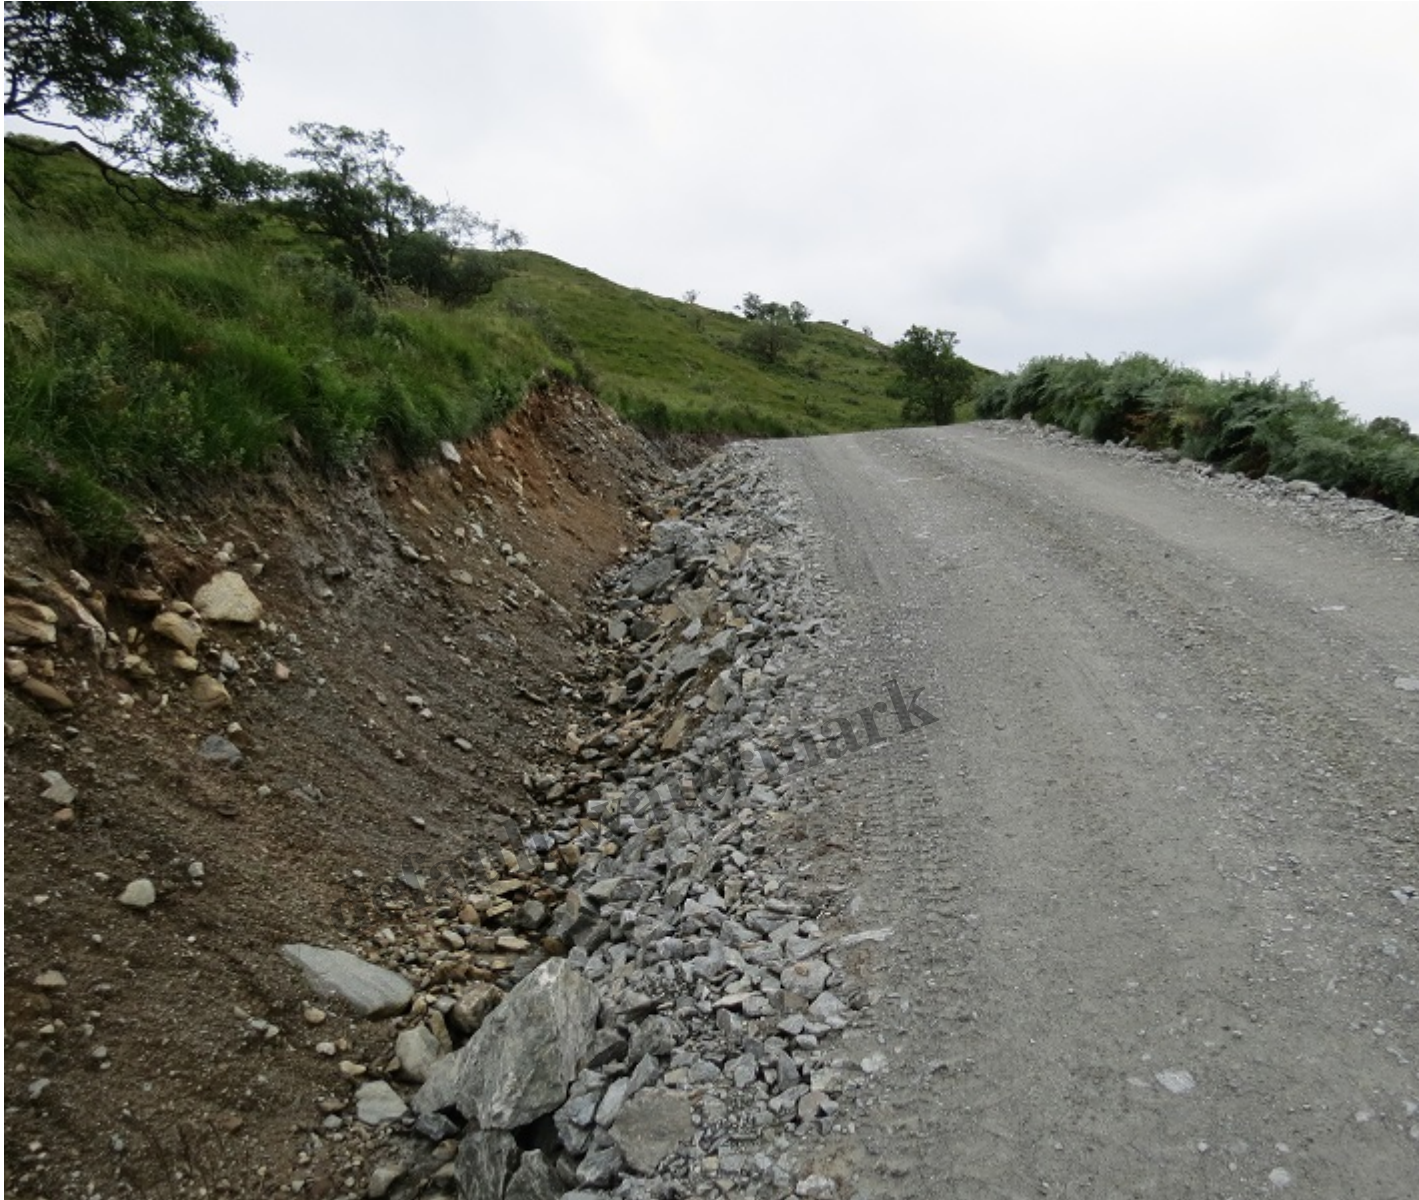
Part of the lower section of the access track to Ben Glas hydro scheme Glen Falloch illustrating the large amount of aggregate used in its construction

To fully restore this track would require the materials that have been imported to be returned to the appropriate quarry or "borrow pit". There is no evidence of this happening.

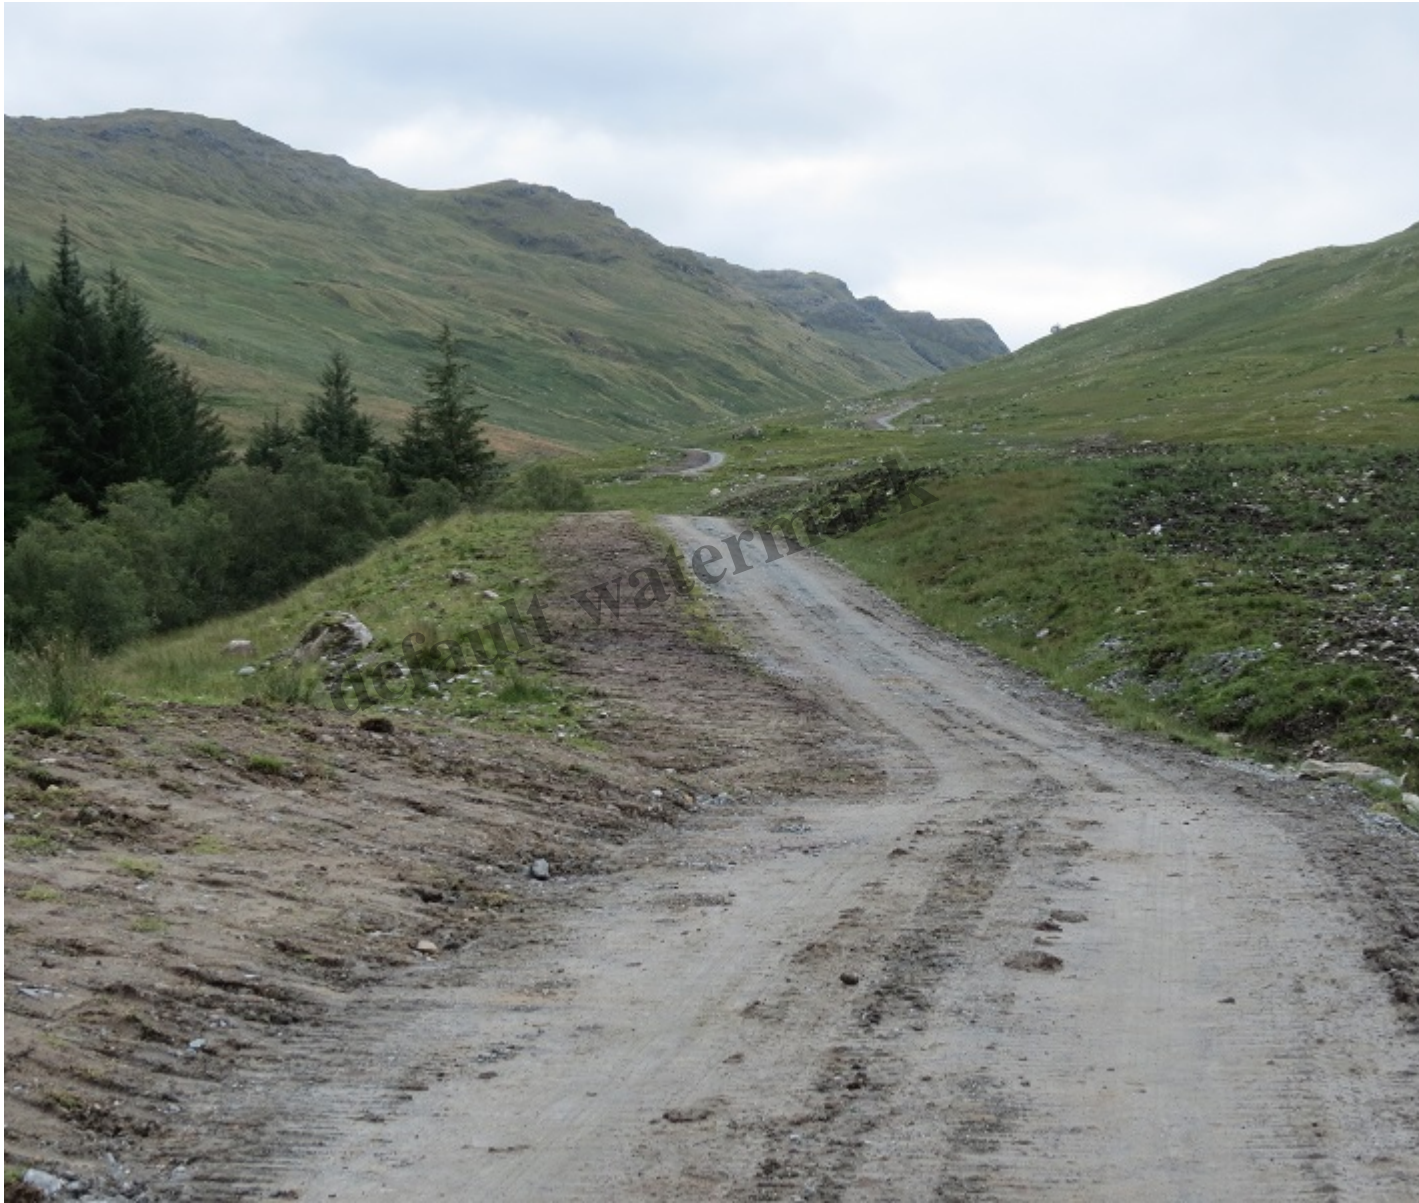
Example of track “restoration” from the upper Falloch hydro scheme. You can see evidence of the aggregate that has been imported on the right of the photo. The imported aggregate results in a track that has been raised above the previous contours in the landscape. In the centre of the photo you can see the imported aggregate has hardly been reprofiled and simply covered up with a thin layer of turf.

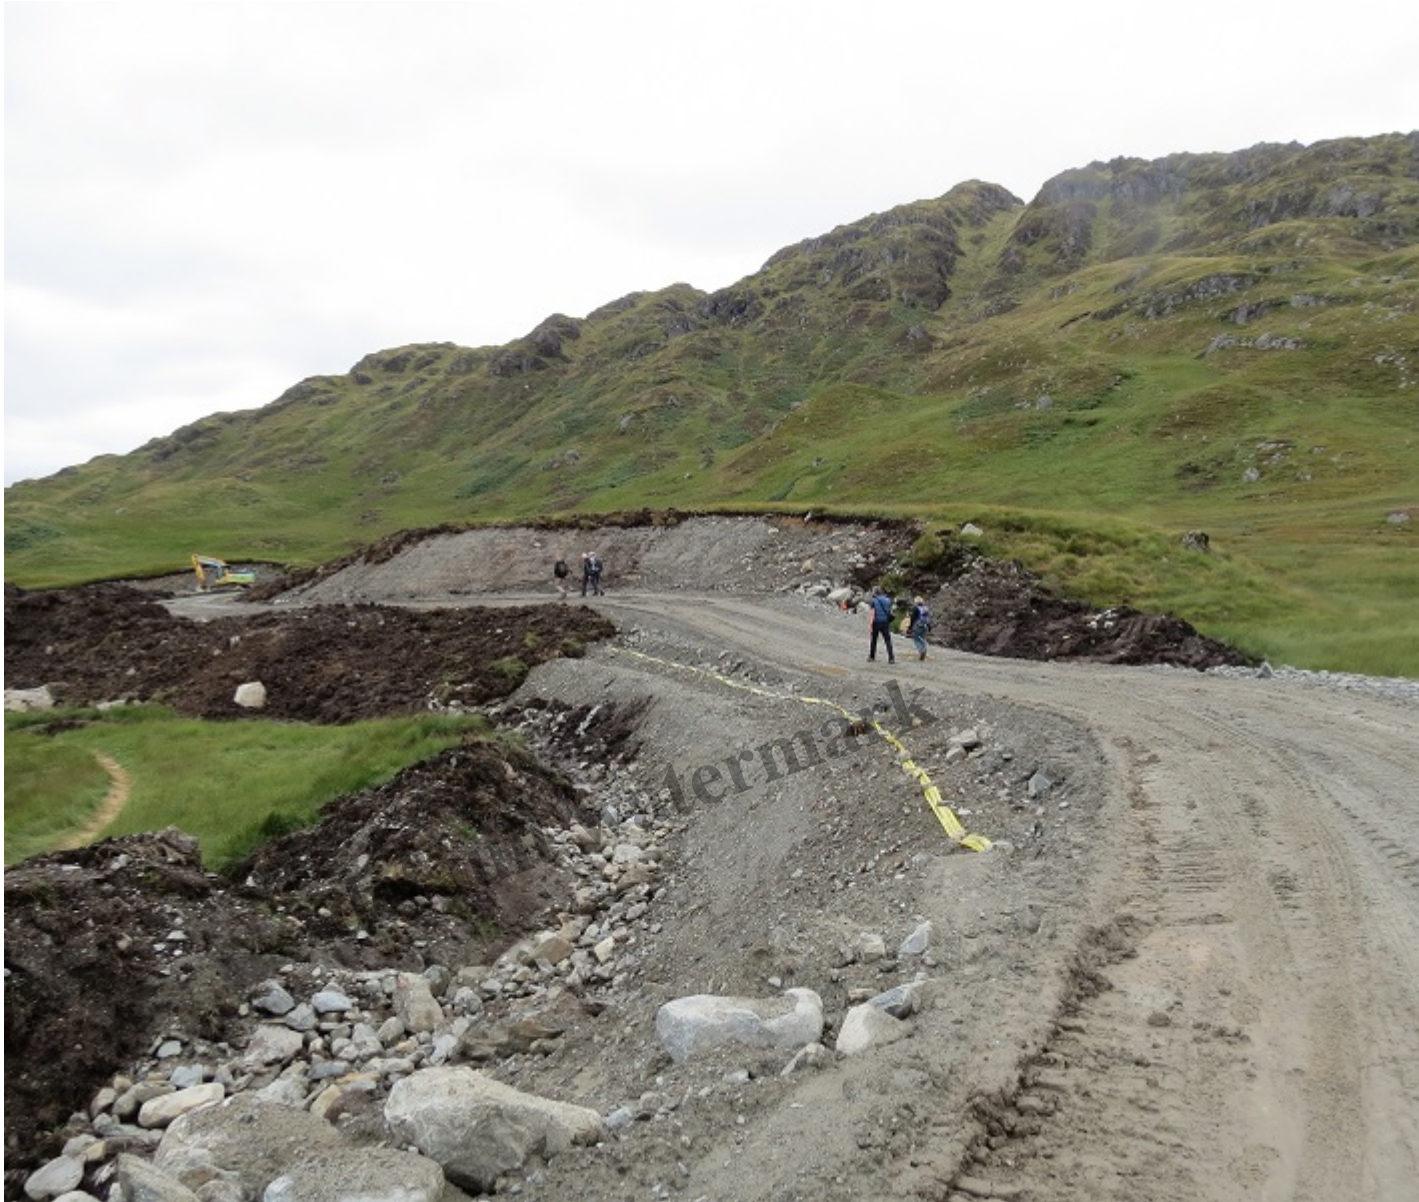
Large amounts of material to build the track have been obtained from this moraine, the contours of which have been changed for ever.

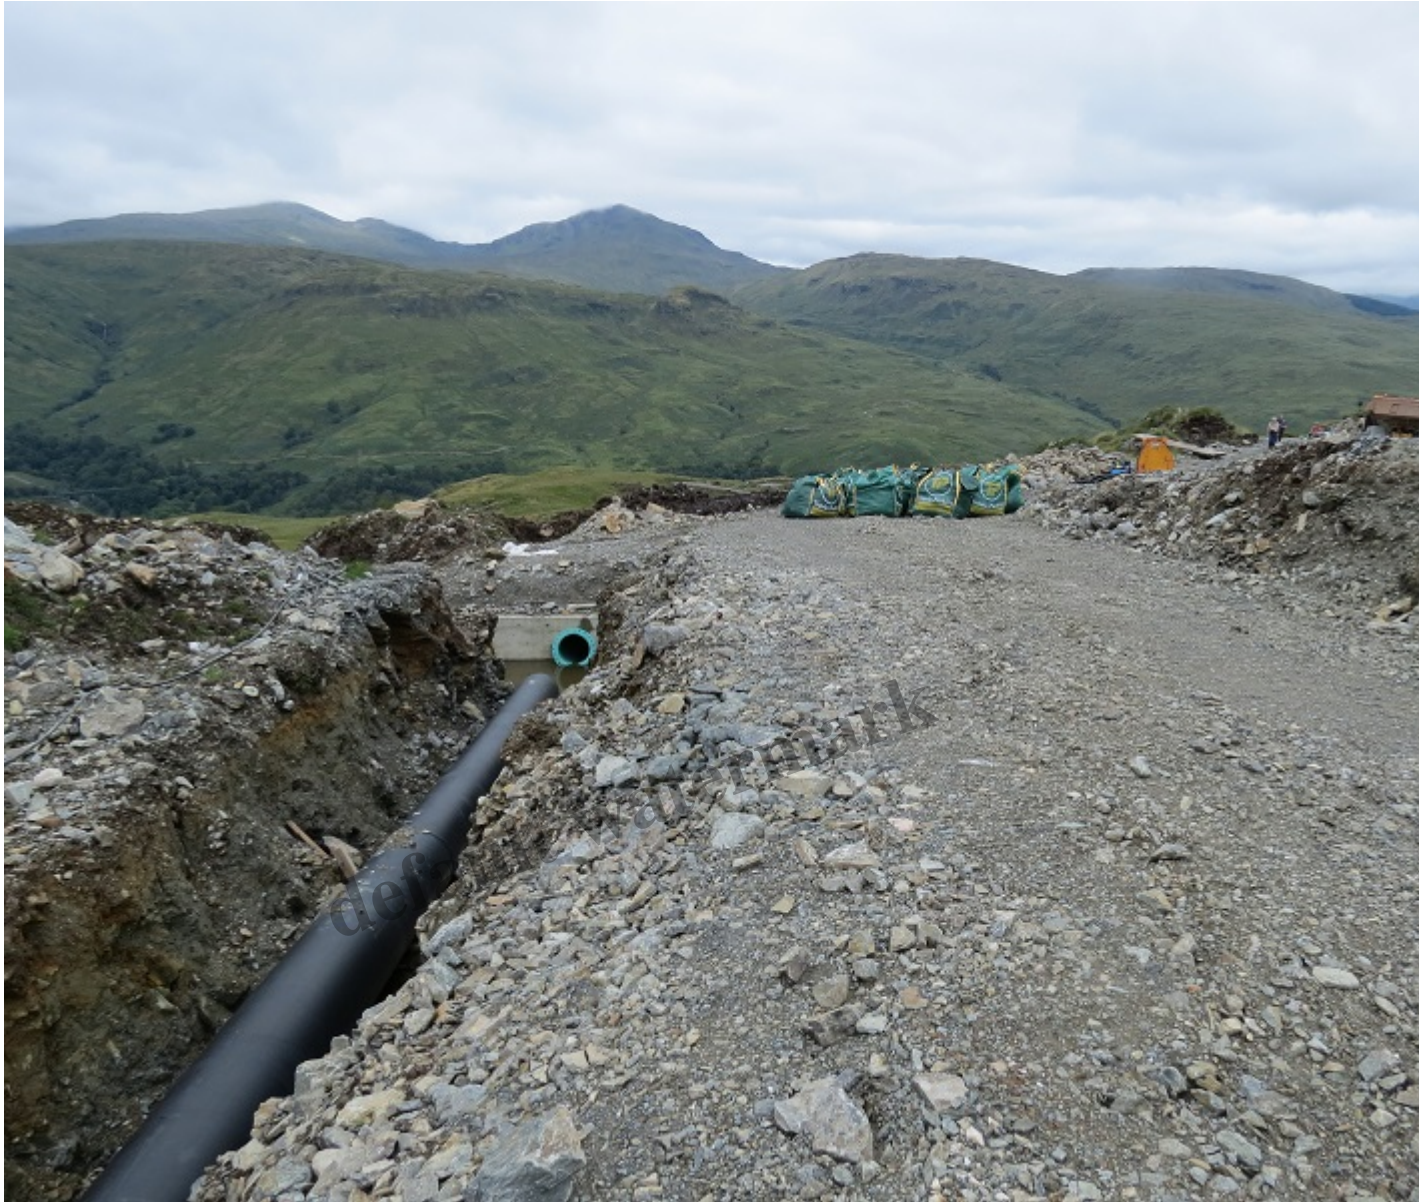
The laying of the water pipe brings material that was once well buried to the surface – it may be relatively small quantities compared to what is imported but it all adds up.
