The Glen Falloch hydro schemes (5) is the end product good enough for a National Park?

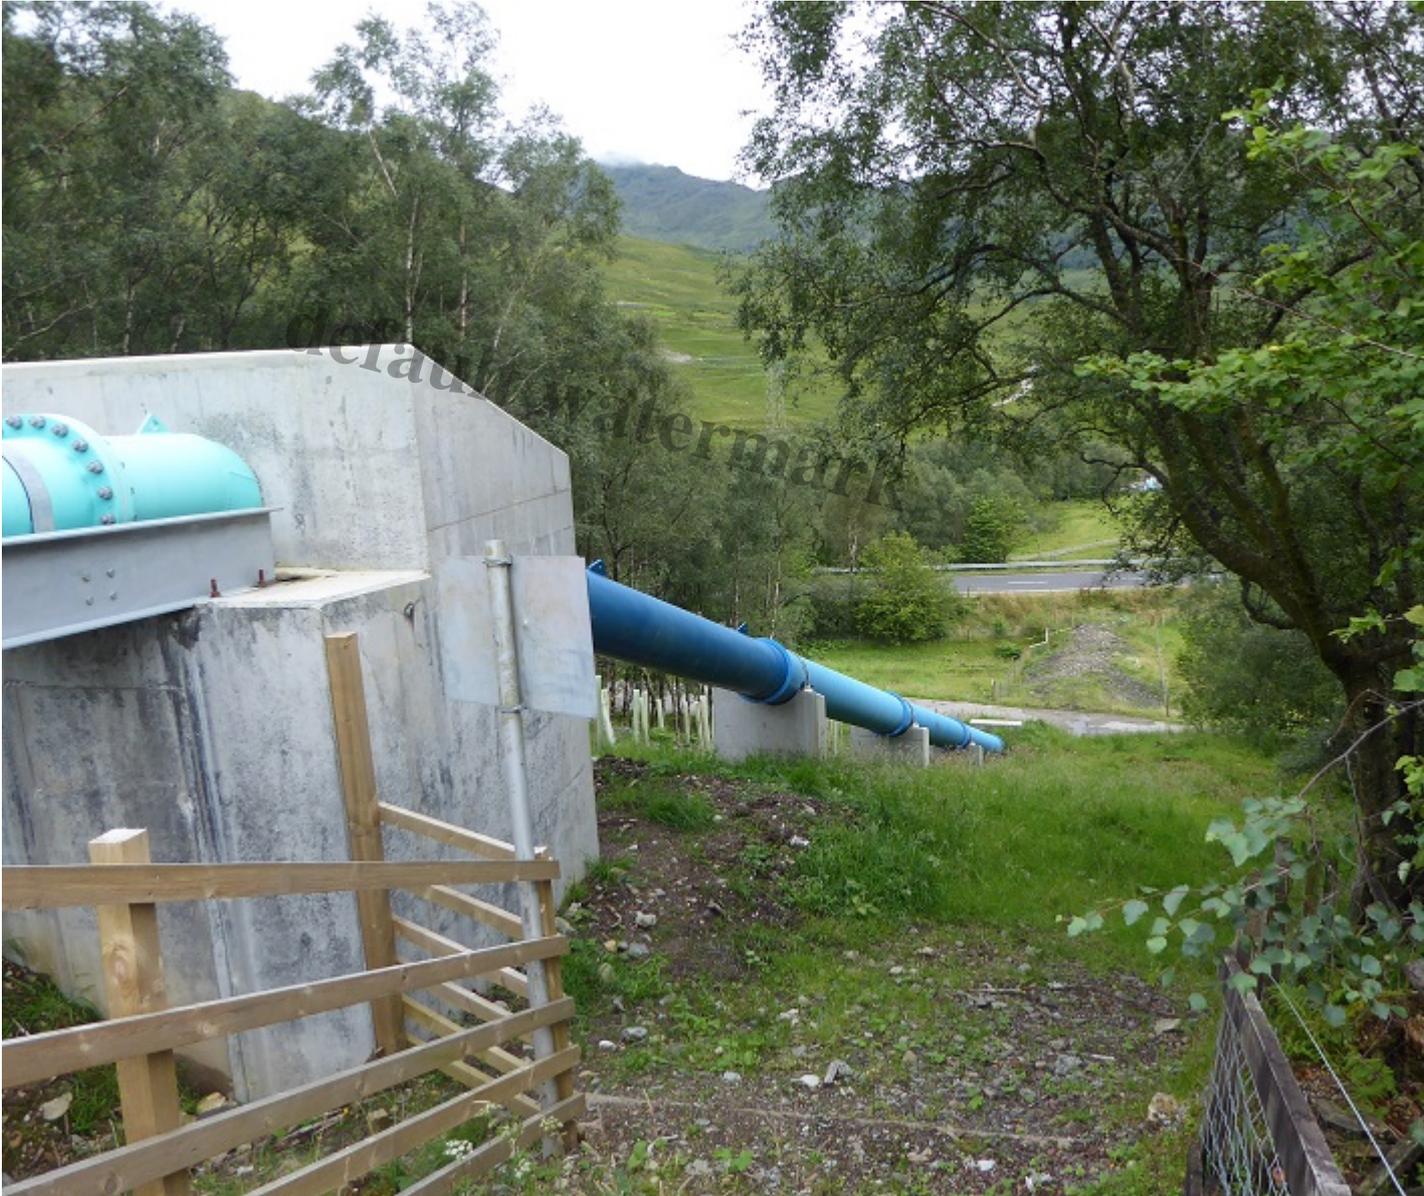
The Derrydaroch penstock which is clearly visible from the A82 and West Highland Way is the end product good enough for a National Park? the Park states that all penstock and pipes should reflect the natural colours of the landscape.

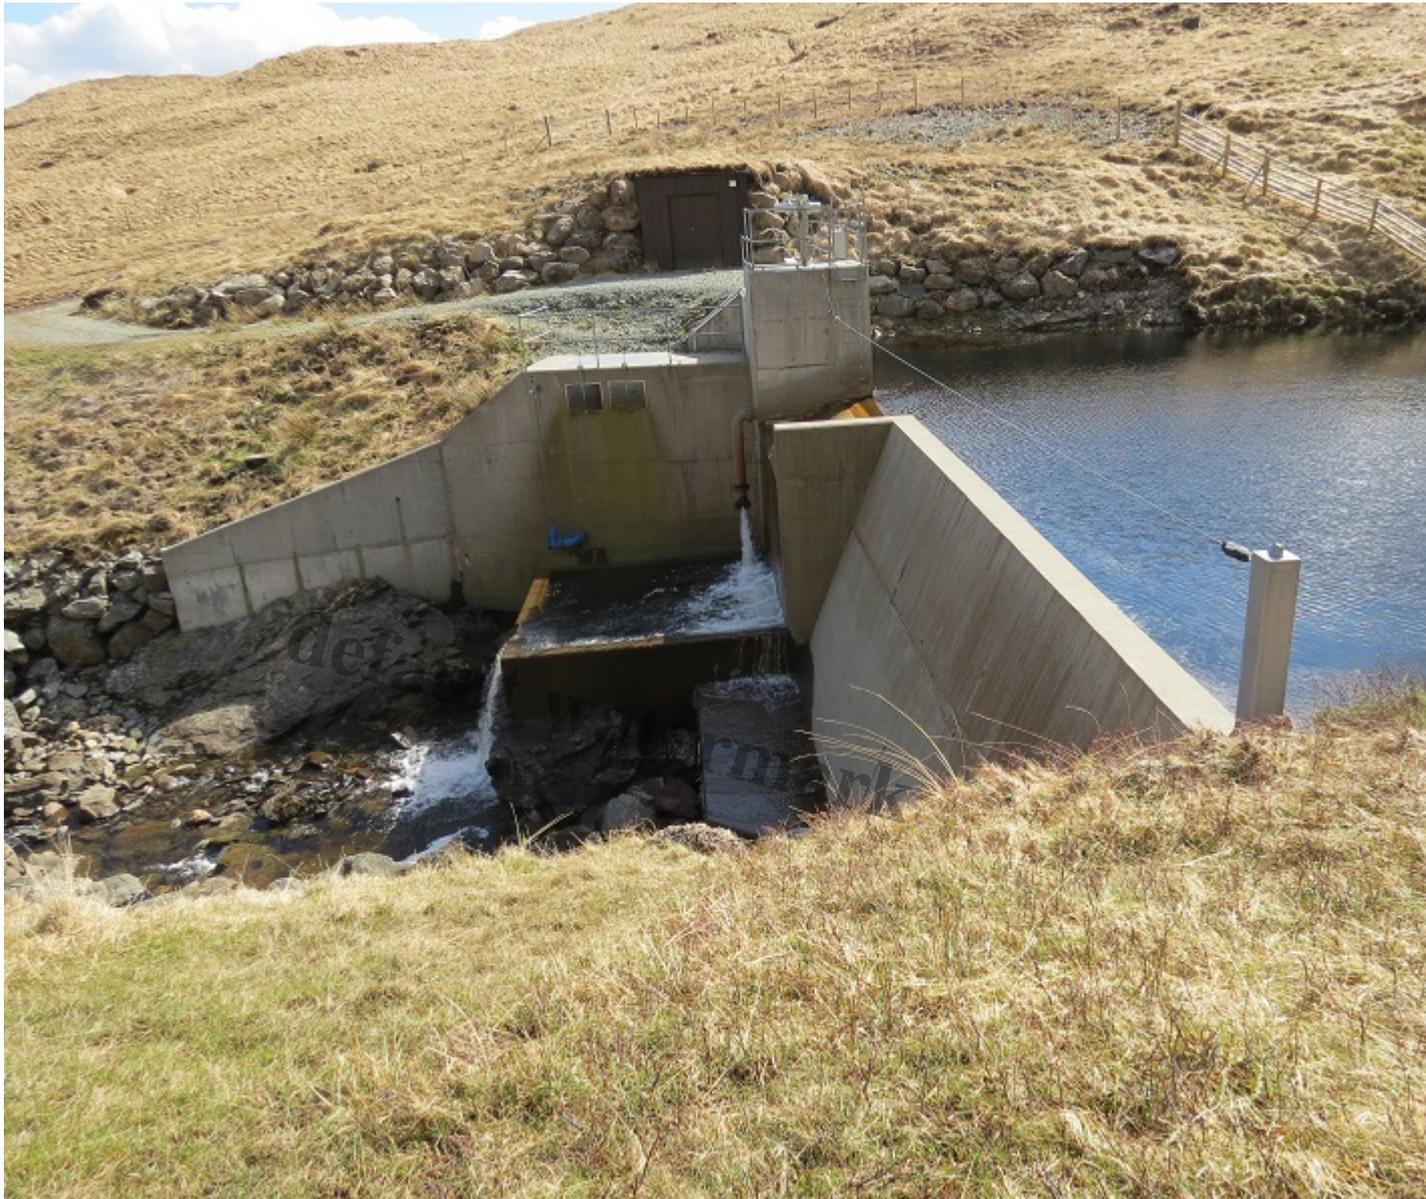
Allt Fionn intake dam

One of the reasons the Allt Fionn Scheme has limited visual impact is that upstream of the dam there was very little engineering â?? just the blocks on the far side of the dam which have been well covered. Other aspects of the dam though do not meet the requirements of the Parkâ??s current guidance.

In fact not a single one of the Glen Falloch dams meets the Park's current best practice guidance • all are concrete without any stone cladding though in some cases boulders have been piled against the wing walls to help screen them.

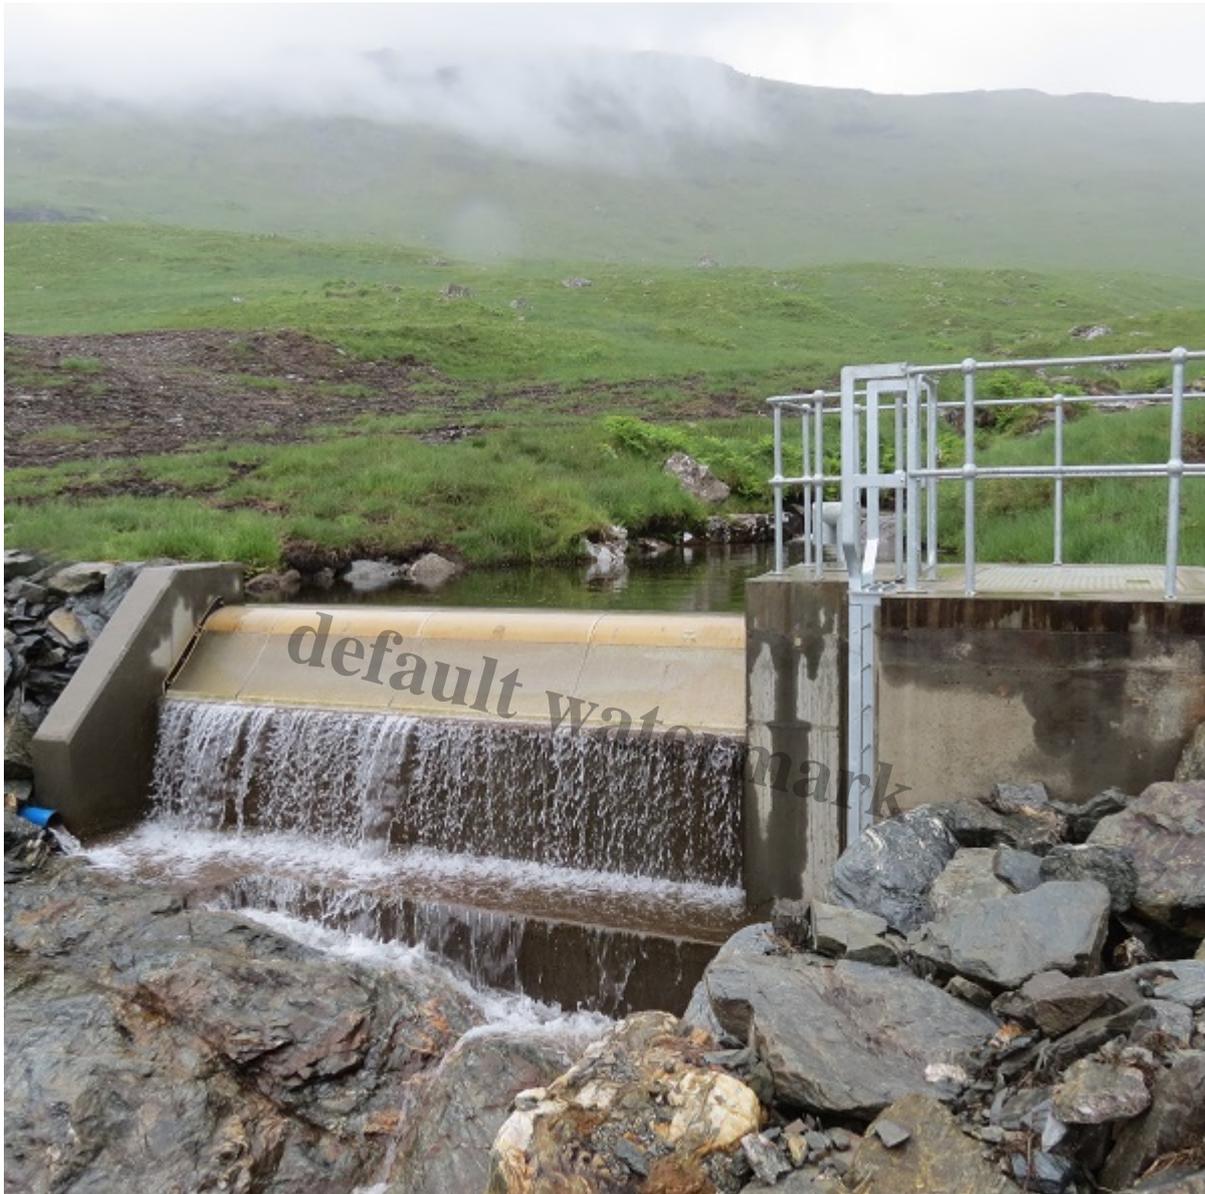
Allt Andoran – note boulders piled below right wall of dam and also lack of engineering of the pool behind – its looks natural

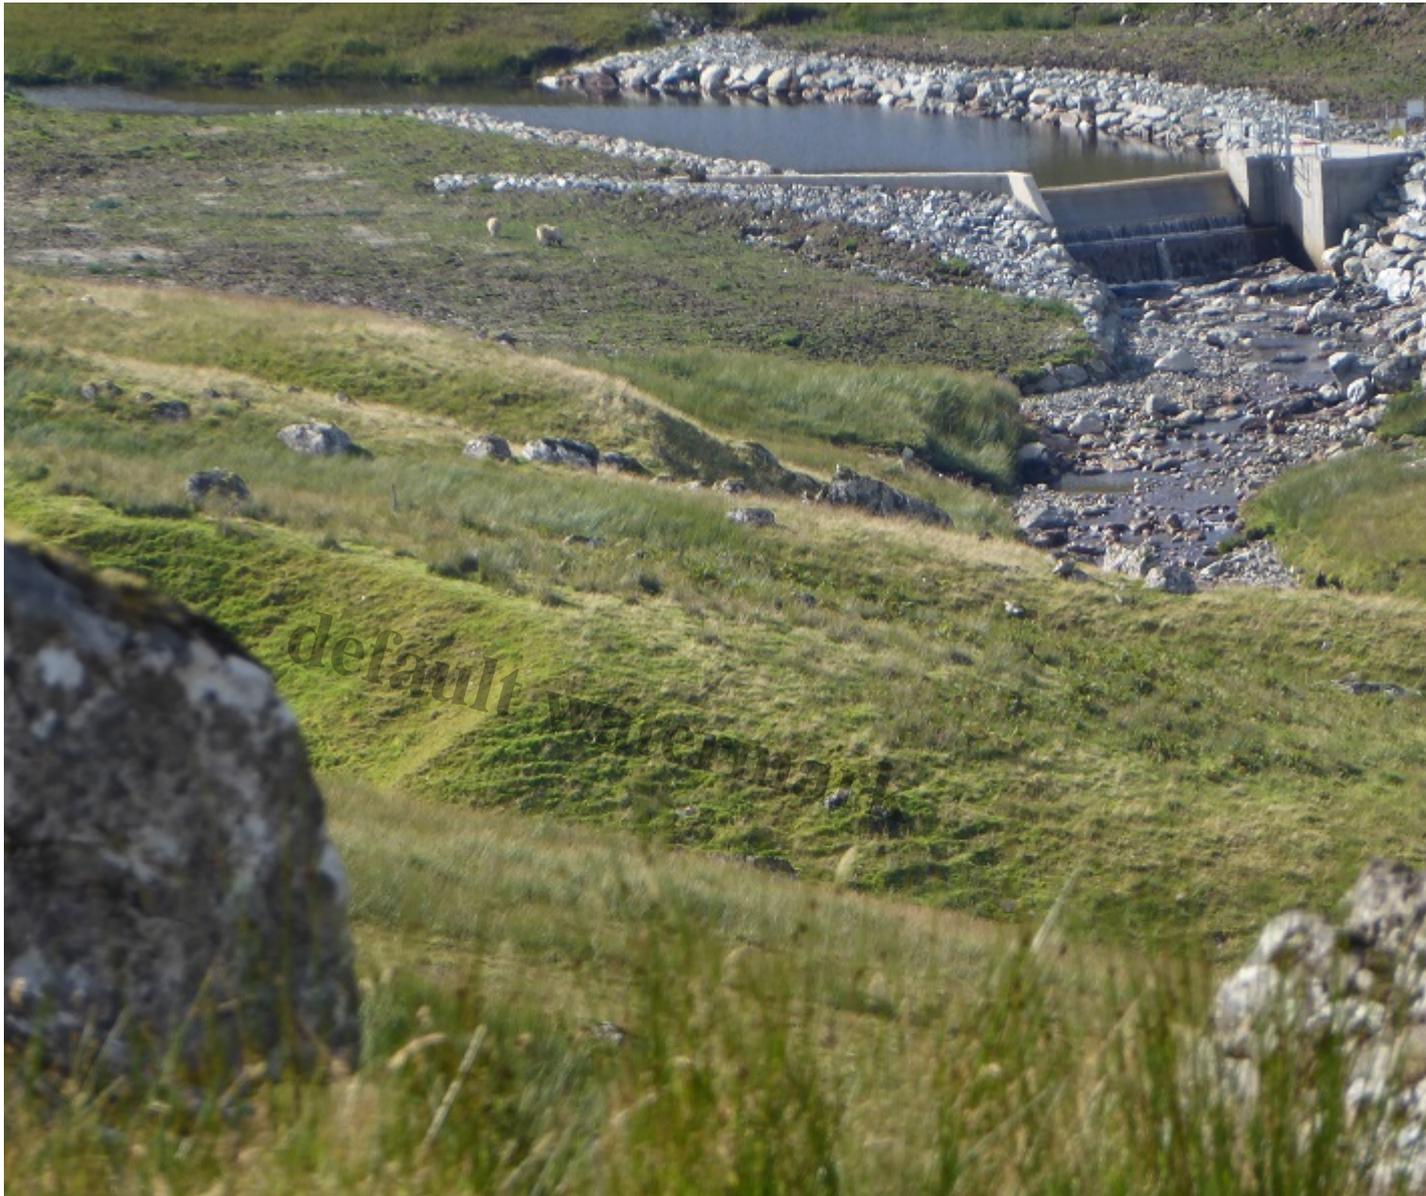
Upper Glen Falloch intake 2016 – its in a slightly different location to where originally planned

The current visual impact of the Upper Falloch must be at least six times the size as in the original landscape assessment and the main reason for this is the use of boulders in screening the dam and in rip-rap retention along the banks of the intake pool but also the river below. Now its possible restoration work is not complete and some of the boulders may be covered in vegetation although its not clear where this might come from as none has been stored locally. In my view the left side wall of the dam would have looked better without the boulders. Its difficult to see anything growing on them for decades and they are likely to continue to look like a pile of boulders dumped by a digger. Its hard to see how anyone could claim this is effective restoration of the landscape. However, it appears to result from the LLTNPA Guidance:

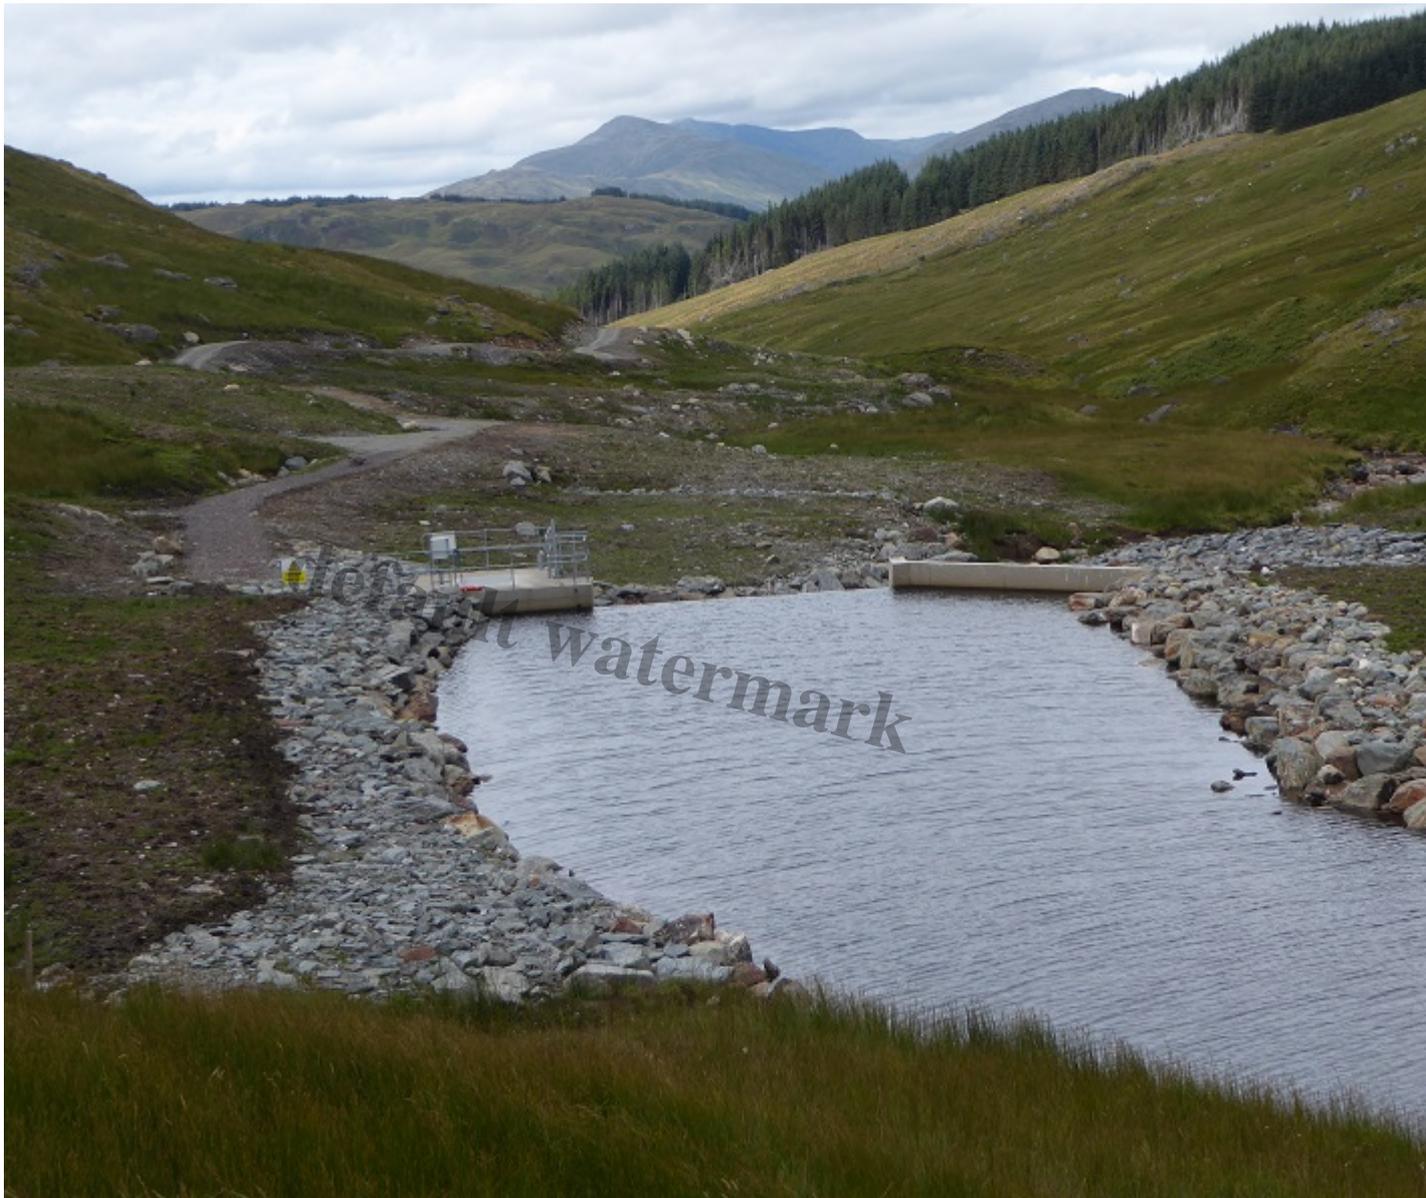
The Upper Falloch Intake â?? large amounts of rip rap engineering has been required to create the p
greatly increases the visual impact of these scheme compared to the Allt Fionn scheme

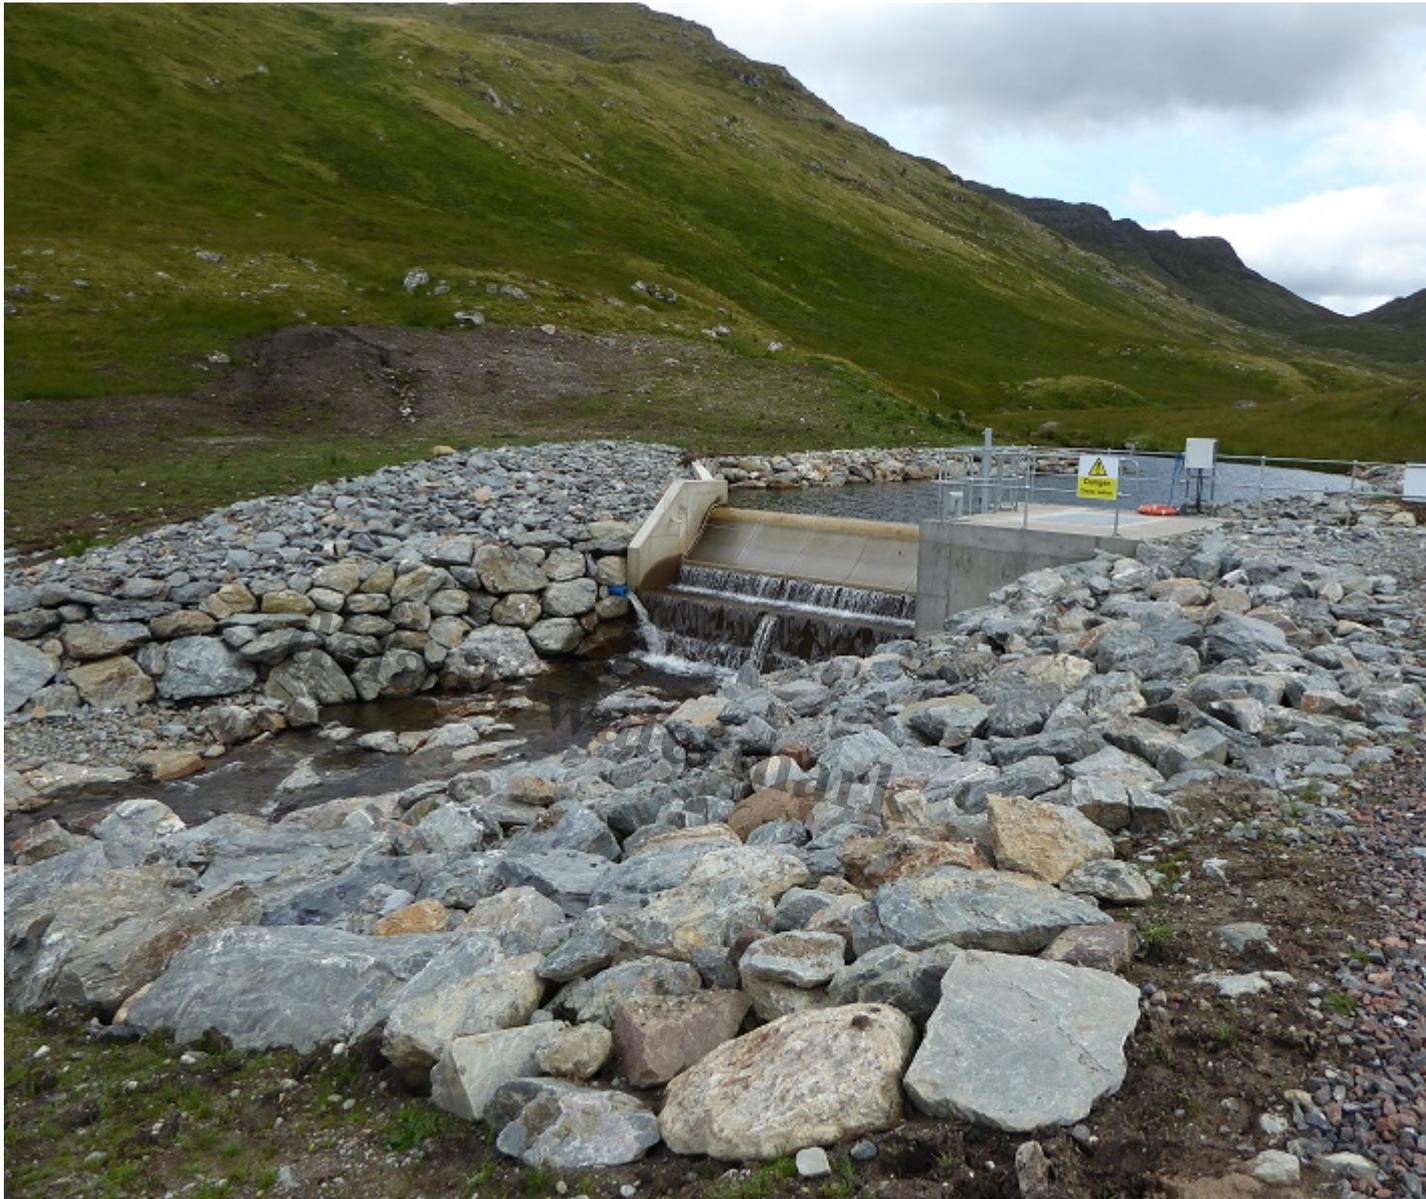
Upper Falloch from bleow â?? its hard to see how vegetation can establish itself in these boulders and likely to scar the landscape for decades

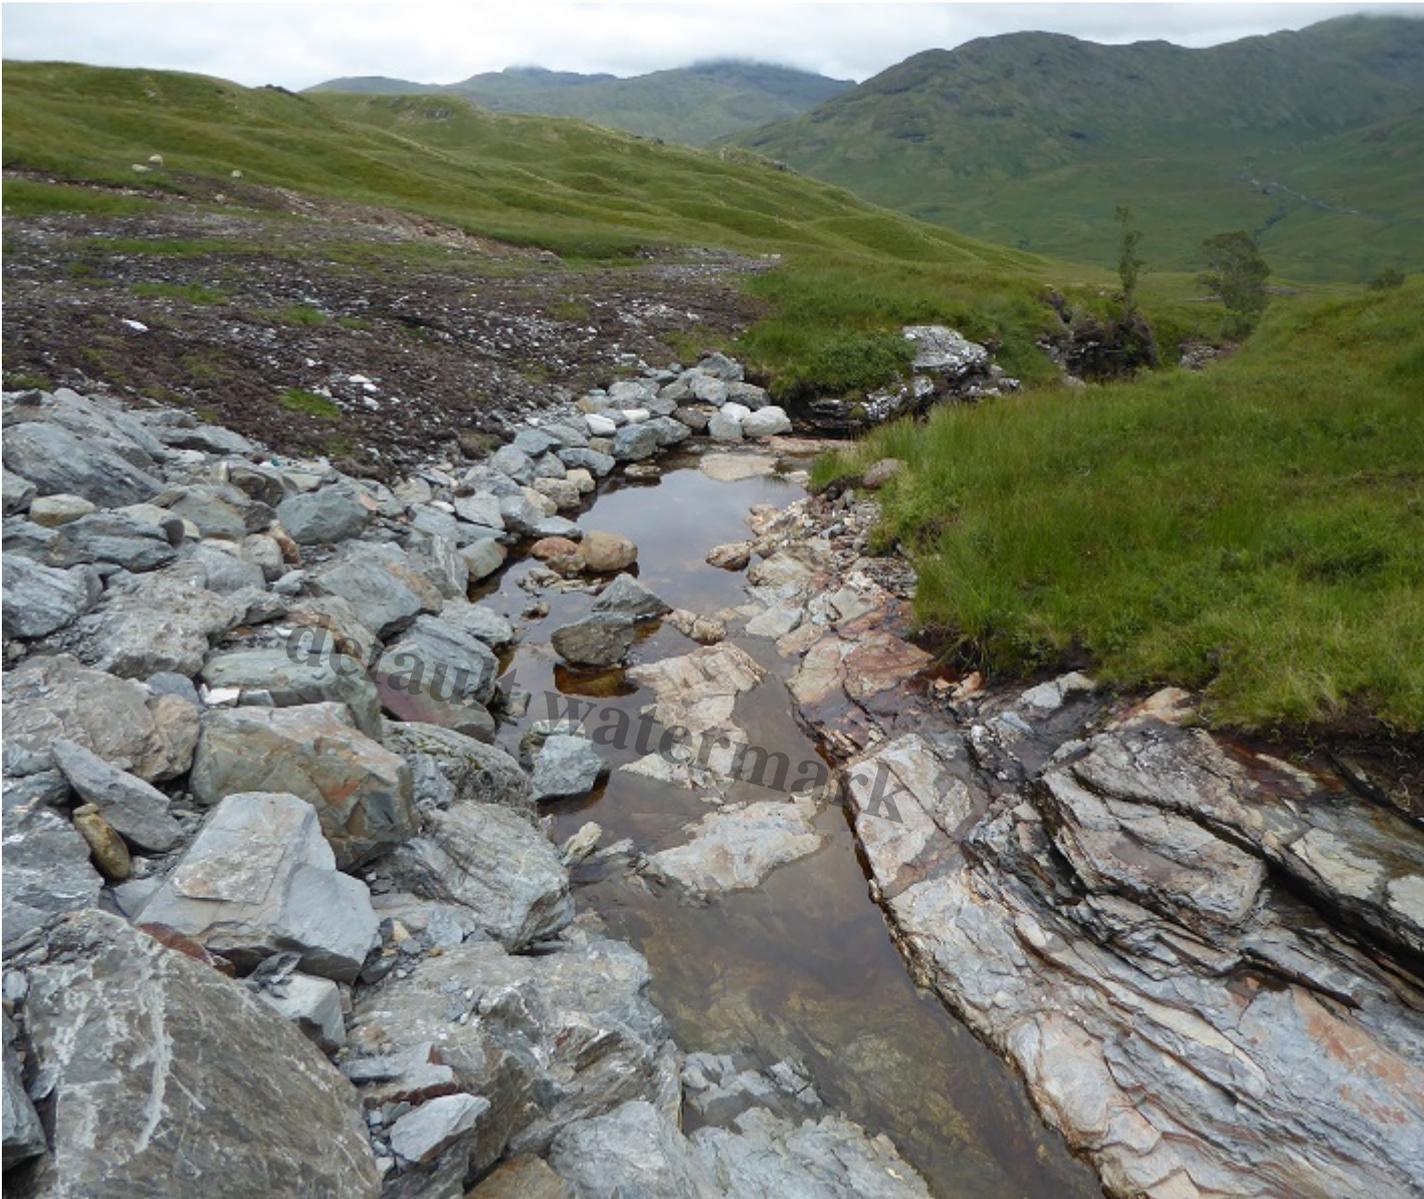
Rip Rap retention on Eas Eonan contrasts with the natural gorge below

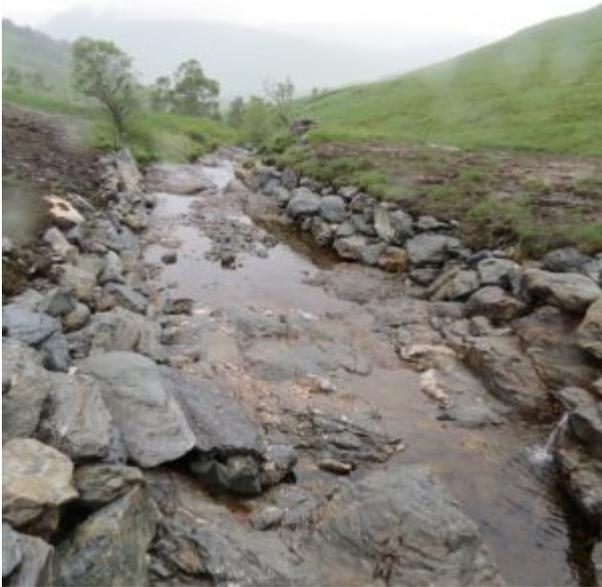
Rip Rap retention below Allt a Chuilinn intake â?? because the boulders have been built into the bank they have a lower landscape impact

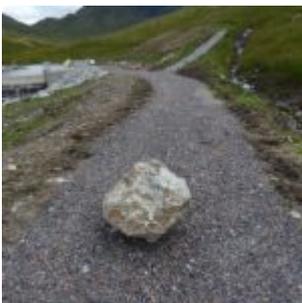
Upper Falloch
alien hard chip

Hard chip, which looks completely different to the local schist, has been imported to at least three of the intake areas. It appears there might have been some spare at the Upper Falloch powerhouse and someone thought it a good idea to bring it up the hill. The LLTNPA's Guidance states:

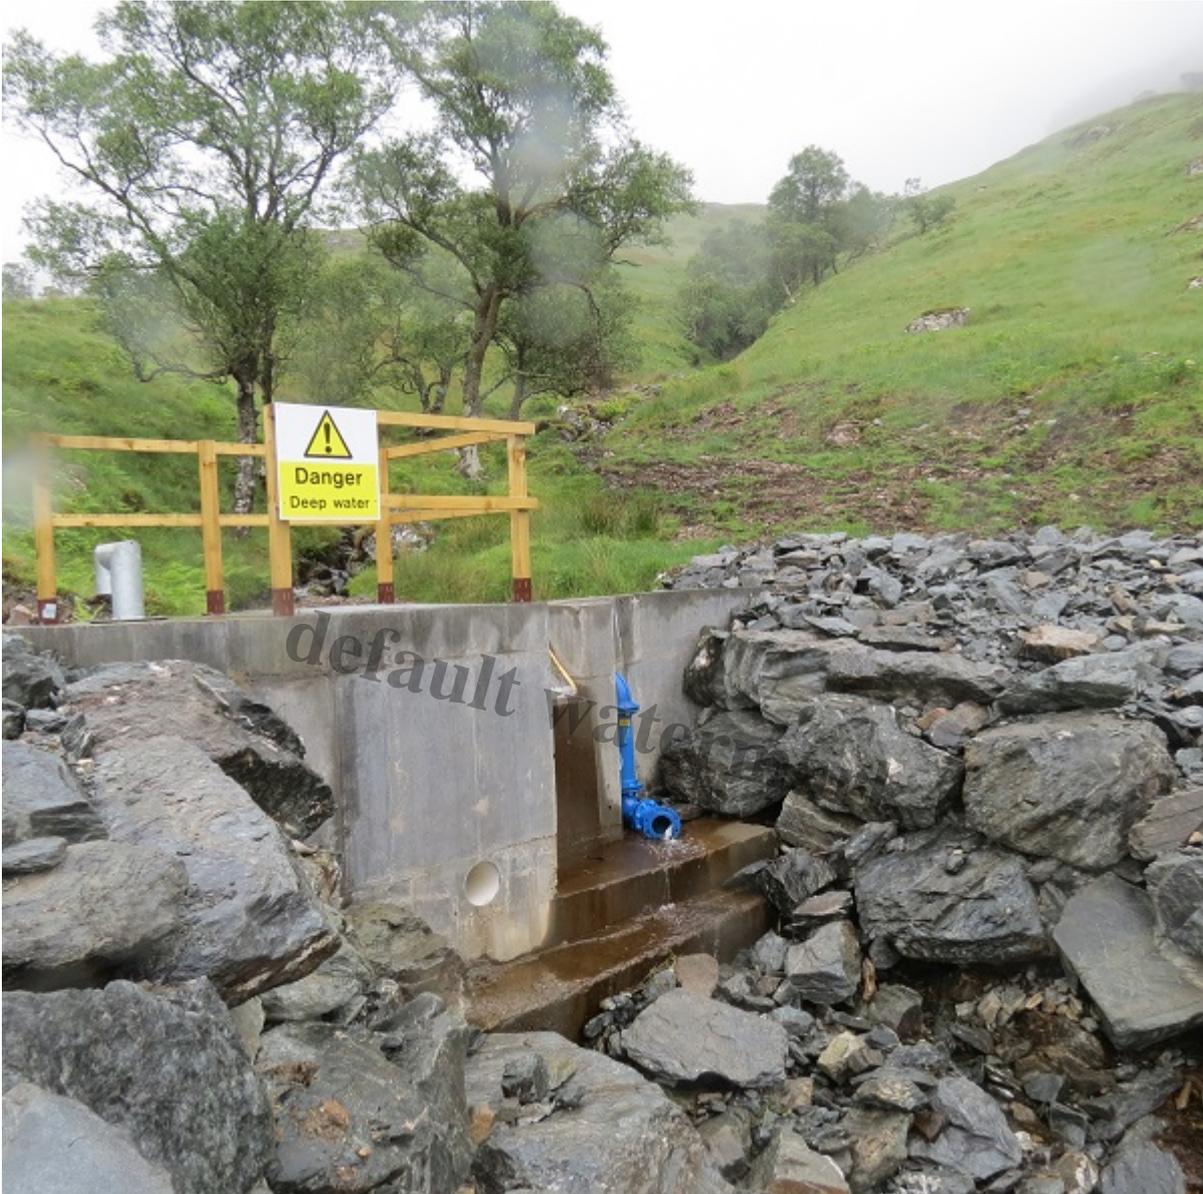
Allt a Chuillin second intake

This small intake is only example in Glen Falloch where wood has been used for the railings, which accords with the Park's policy on use of natural materials where possible - the sign unfortunately spoils the effect as do the metal footings. As with most of the schemes it has a blue outflow pipe - when the Park's Guidance states - "Introduce as few different materials and colours as possible. A mute galvanised finish in a mute grey / green colour will blend in with most upland environments."• This is another place where cladding the concrete with stone would have looked far better than piling up boulders in front of the wing walls.
