The Glen Falloch hydro schemes (5) – is the end product good enough for a National Park?

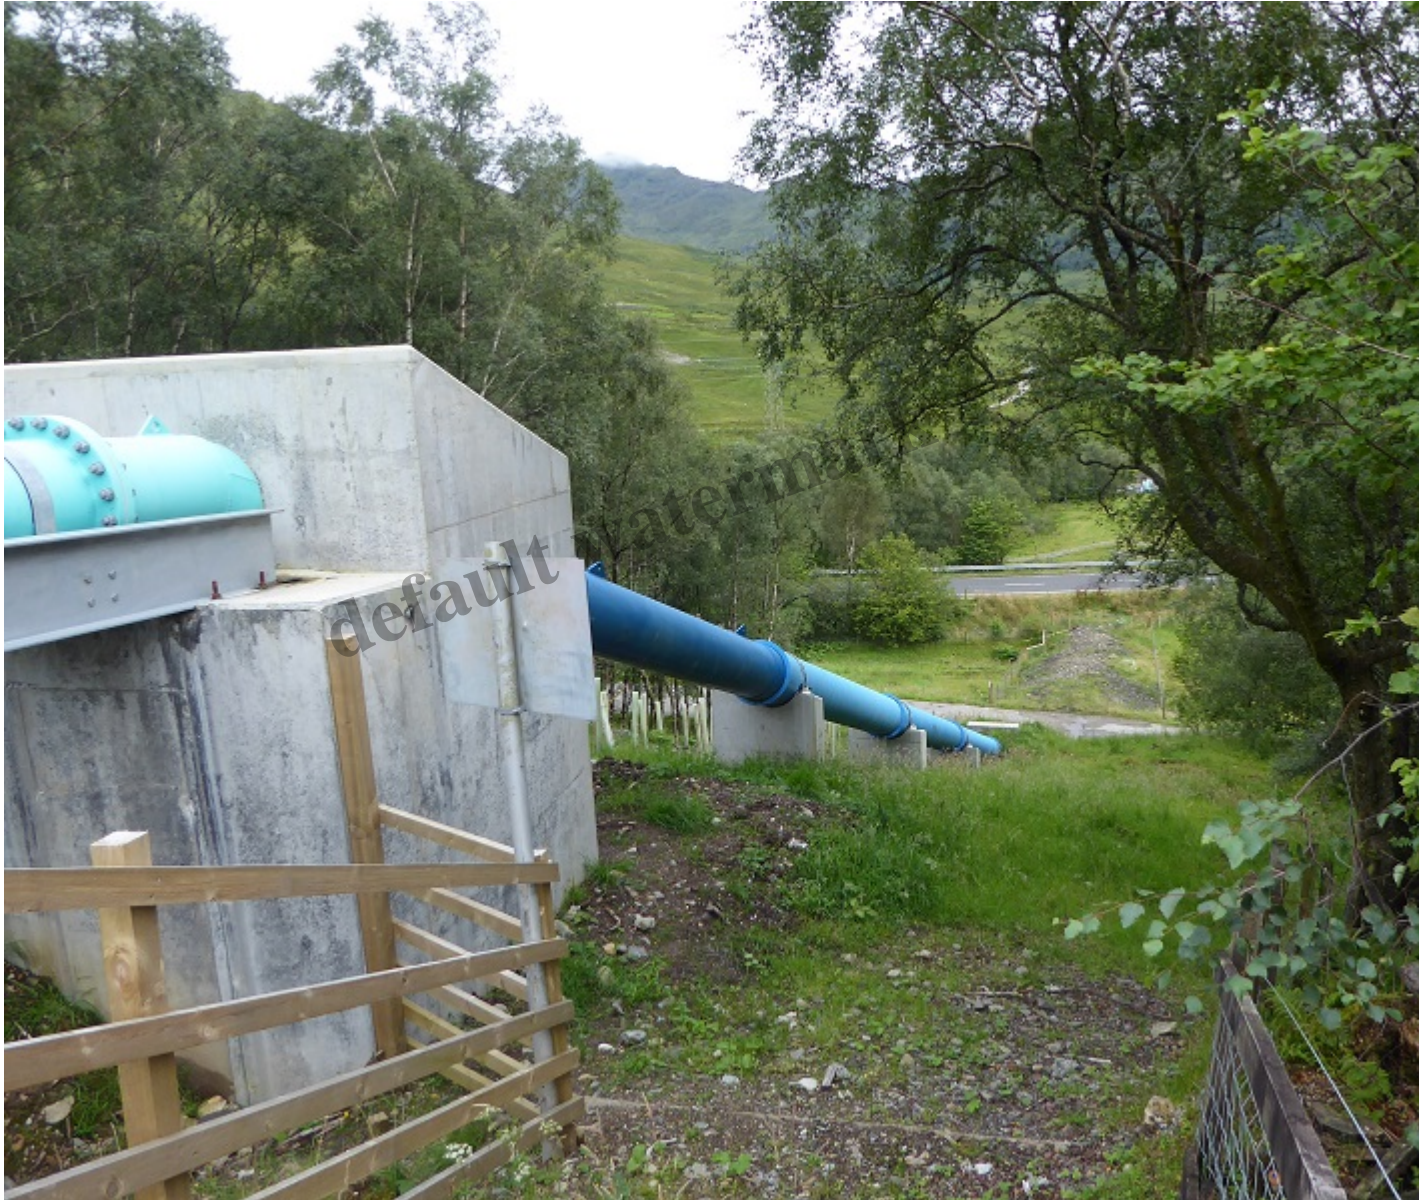
The Derrydaroch penstock which is clearly visible from the A82 and West Highland Way – the Park's states that all penstock and pipes should reflect the natural colours of the landscape.

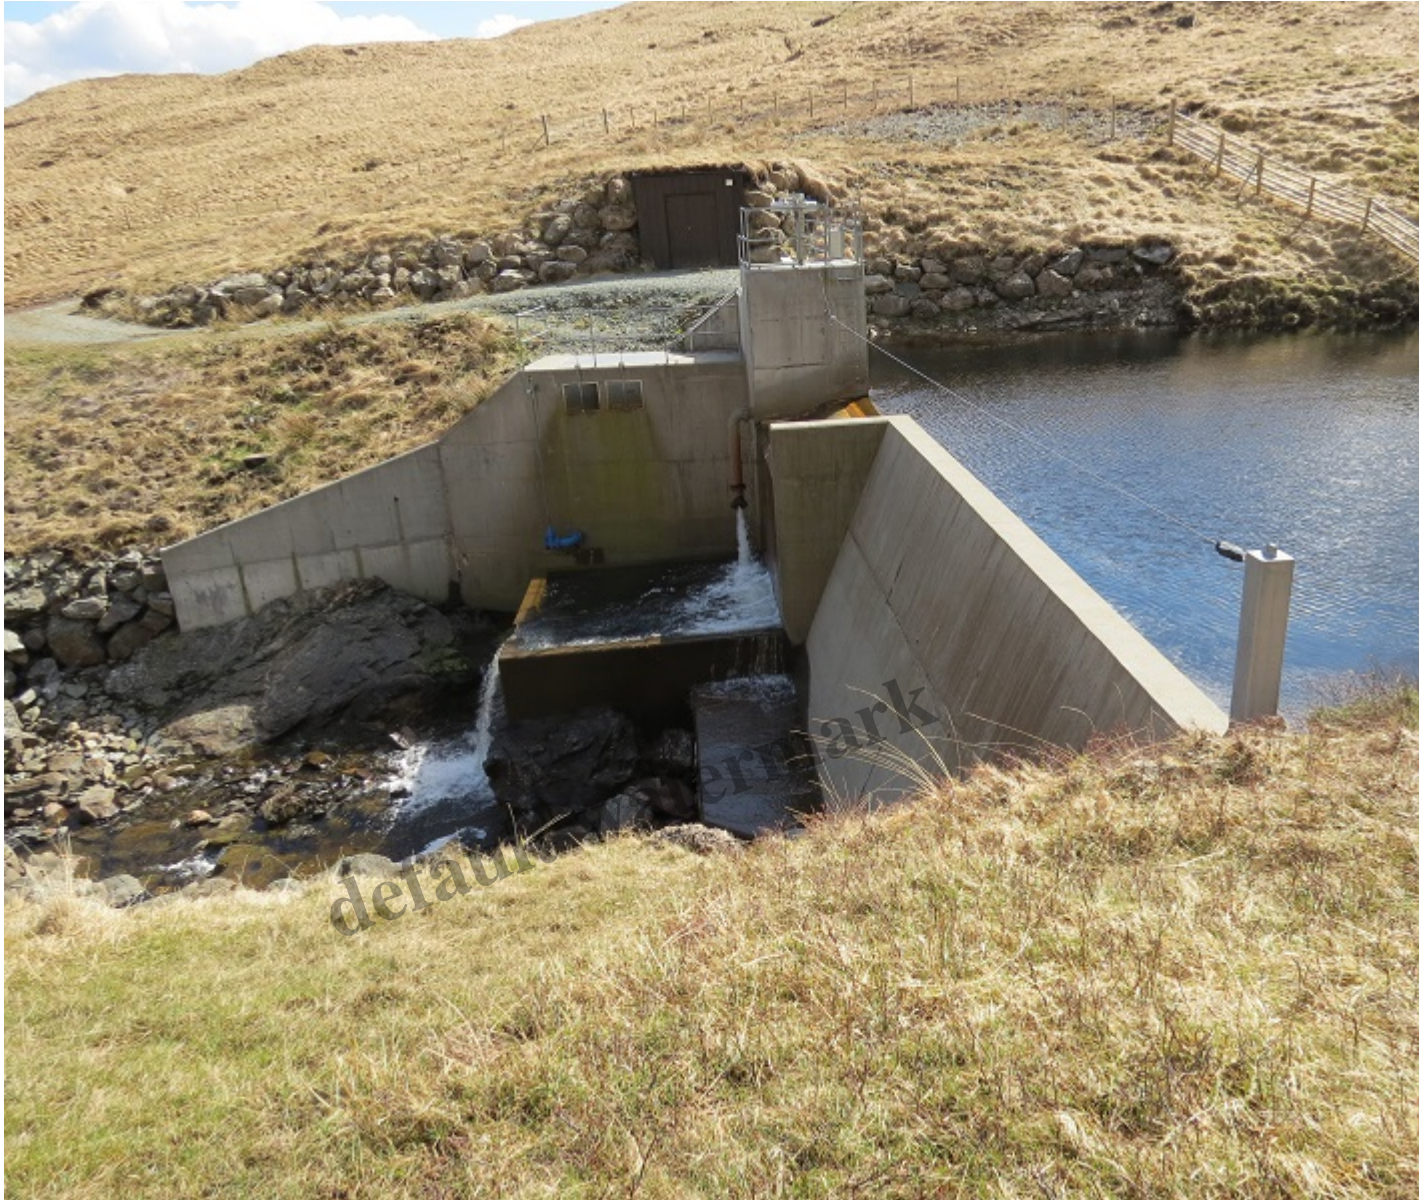
Allt Fionn intake dam

One of the reasons the Allt Fionn Scheme has limited visual impact is that upstream of the dam there was very little engineering – just the blocks on the far side of the dam which have been well covered. Other aspects of the dam though do not meet the requirements of the Park's current guidance.

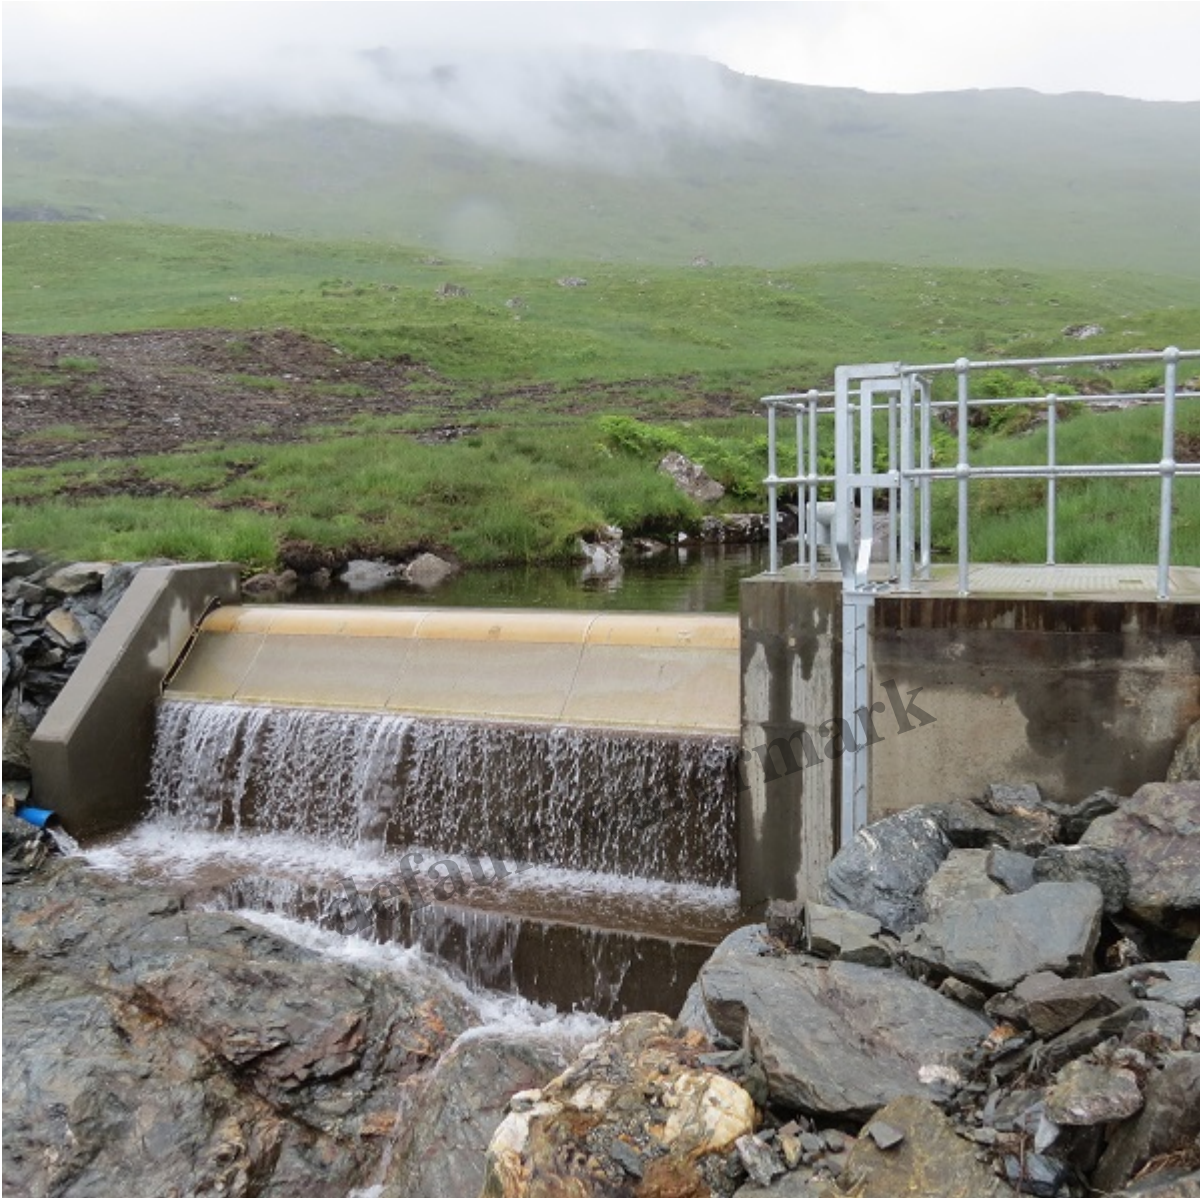
Allt Andoran – note boulders piled below right wall of dam and also lack of engineering of the pool behind – its looks natural

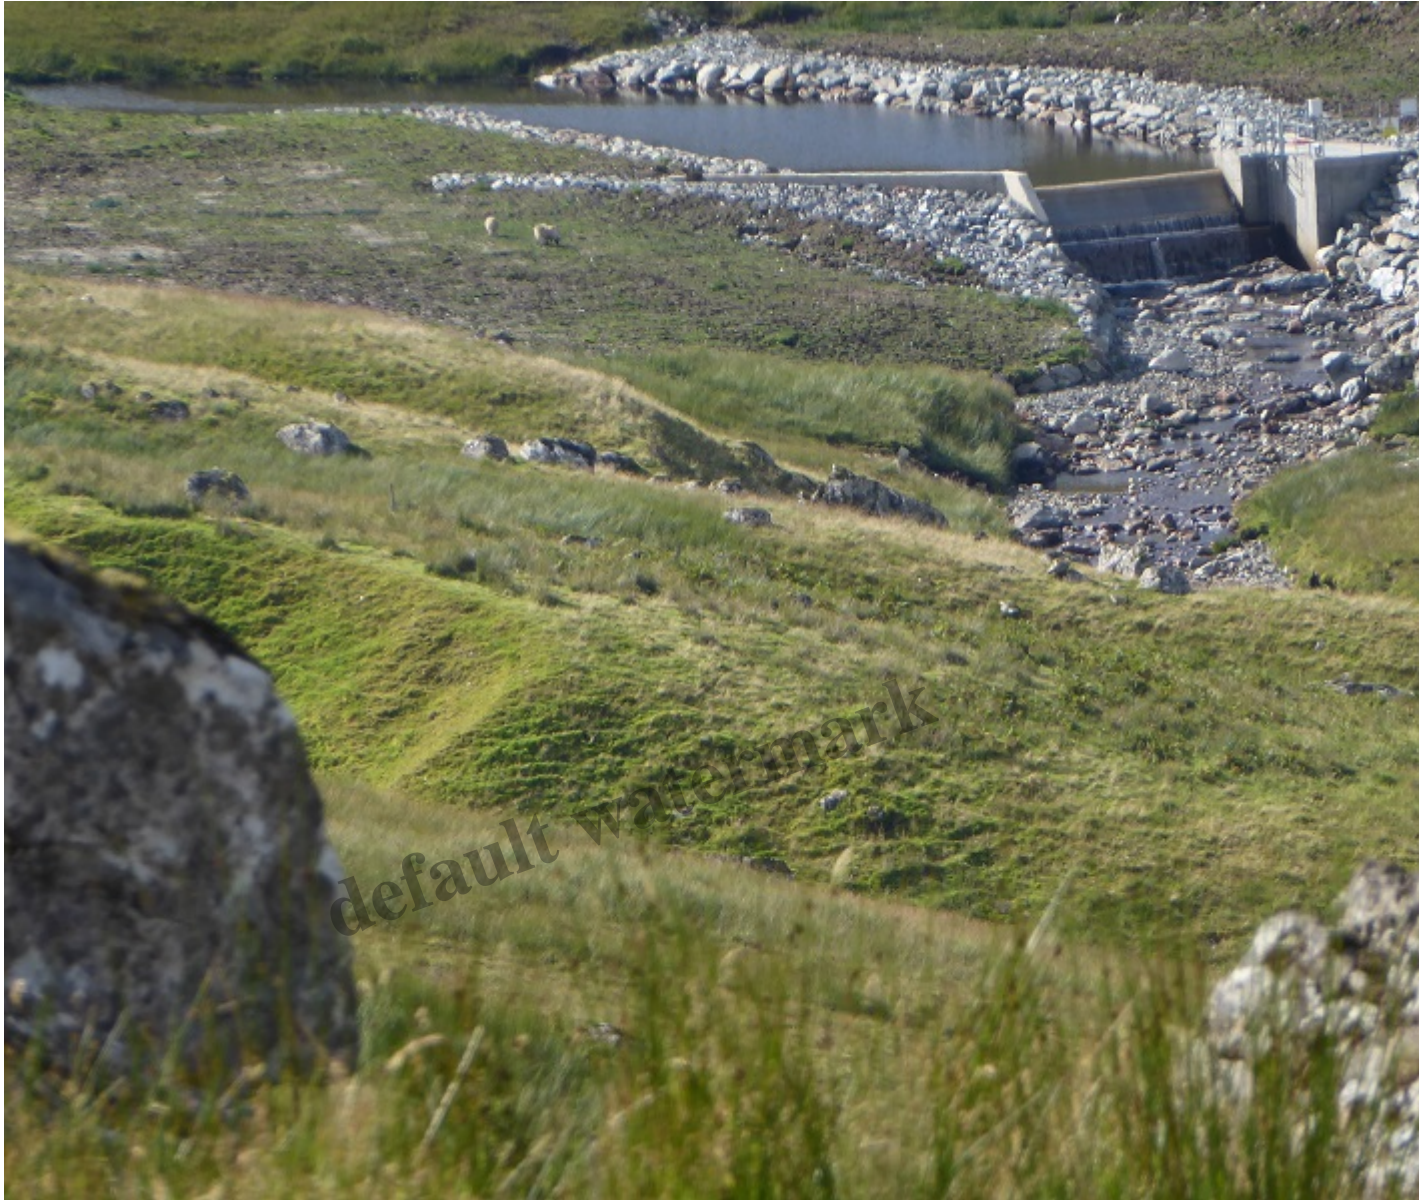
Upper Glen Falloch intake 2016 – its in a slightly different location to where originally planned

The current visual impact of the Upper Falloch must be at least six times the size as in the original landscape assessment and the main reason for this is the use of boulders in screening the dam and in “rip-rap retention” along the banks of the intake pool but also the river below. Now its possible “restoration” work is not complete and some of the boulders may be covered in vegetation although its not clear where this might come from as none has been stored locally. In my view the left side wall of the dam would have looked better without the boulders. Its difficult to see anything growing on them for decades and they are likely to continue to look like a pile of boulders dumped by a digger. Its hard to see how anyone could claim this is effective restoration of the landscape. However, it appears to result from the LLTNPA Guidance:

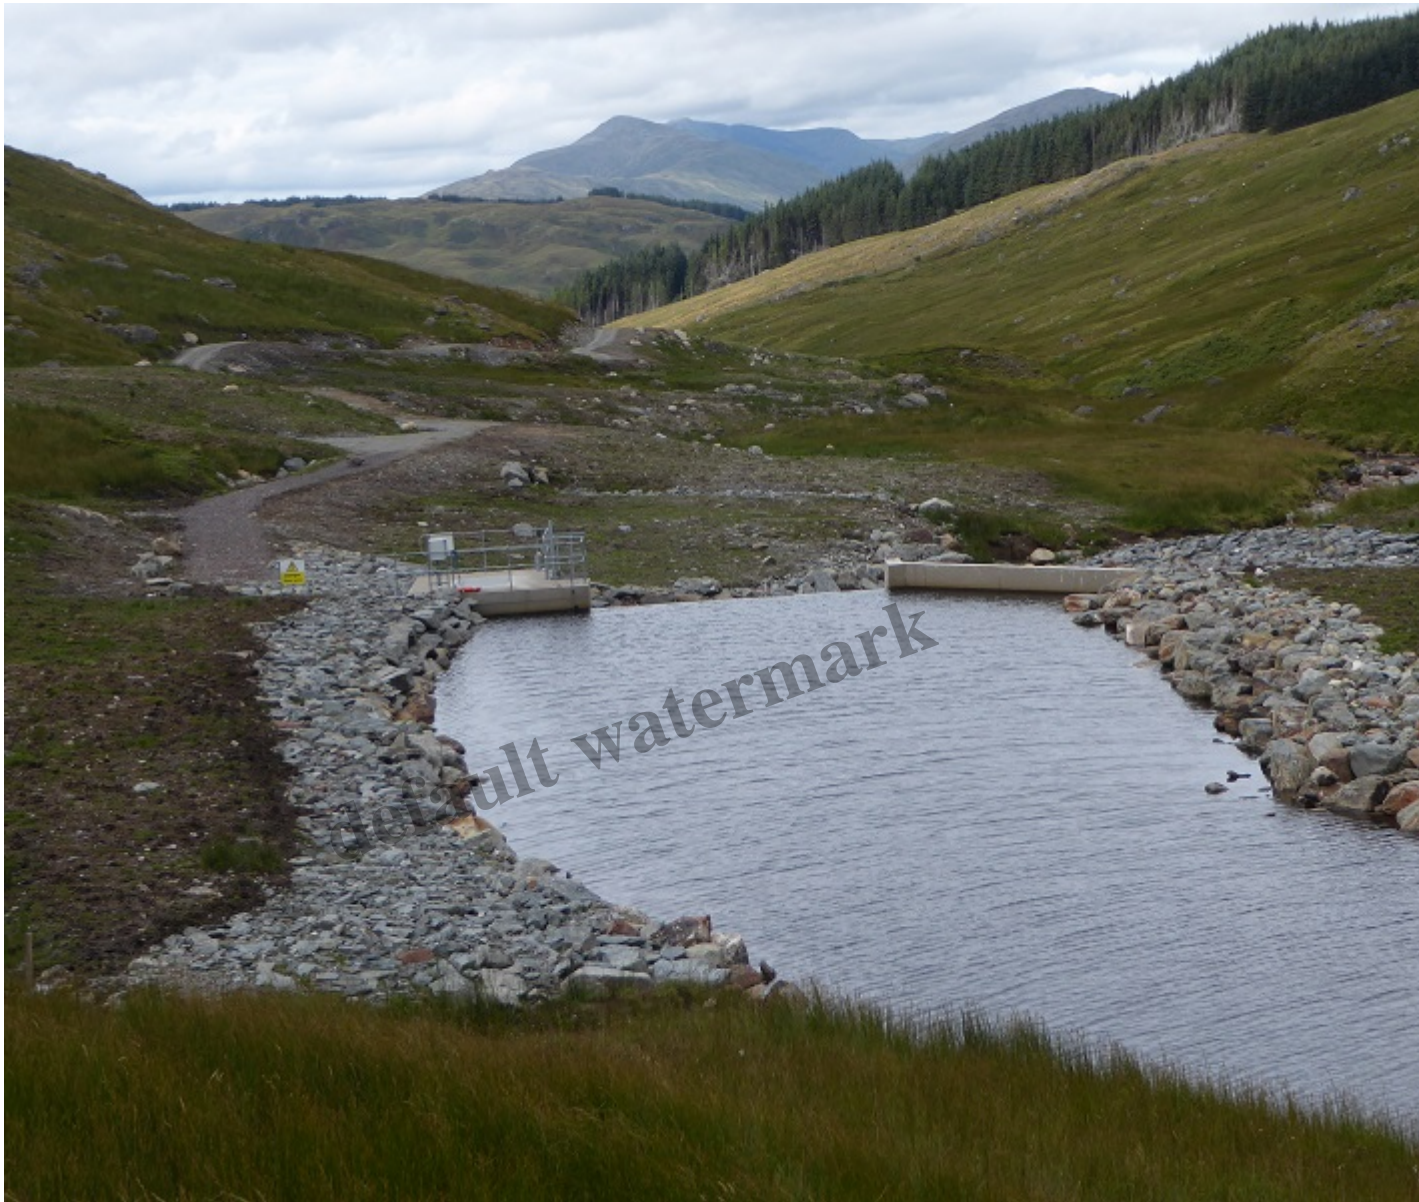
The Upper Falloch Intake – large amounts of rip rap engineering has been required to create the pool, which greatly increases the visual impact of these scheme compared to the Allt Fionn scheme

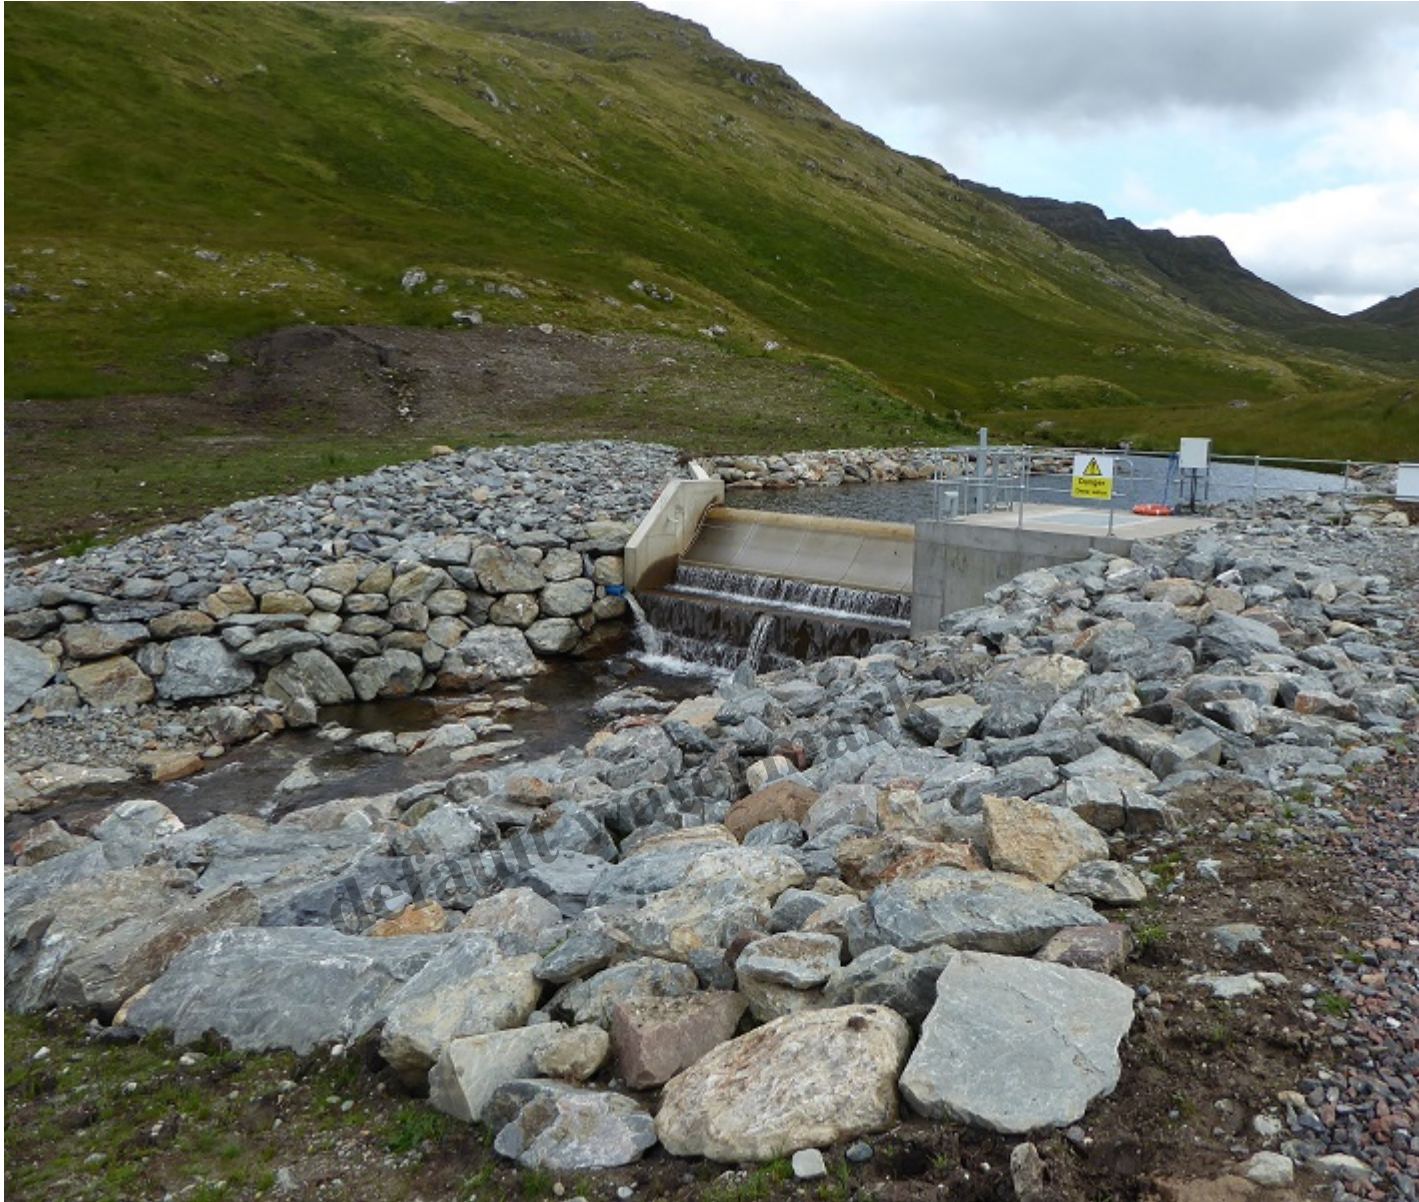
Upper Falloch from bleow – its hard to see how vegetation can establish itself in these boulders and likely to scar the landscape for decades

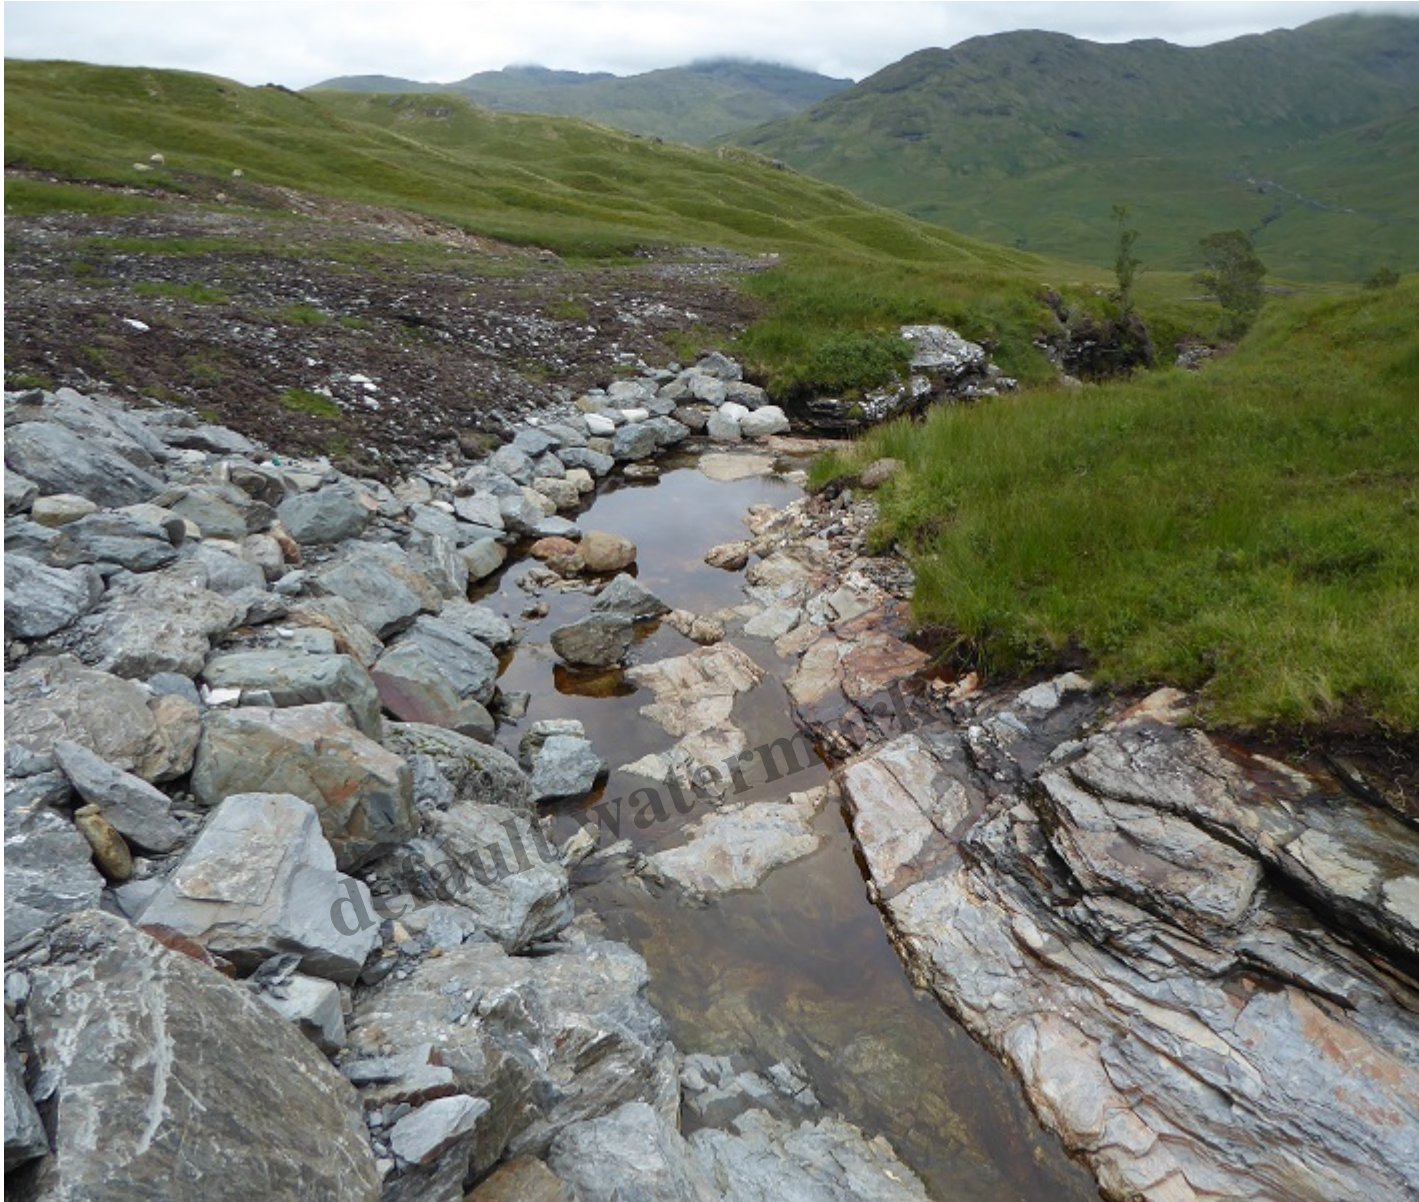
Rip Rap retention on Eas Eonan contrasts with the natural gorge below

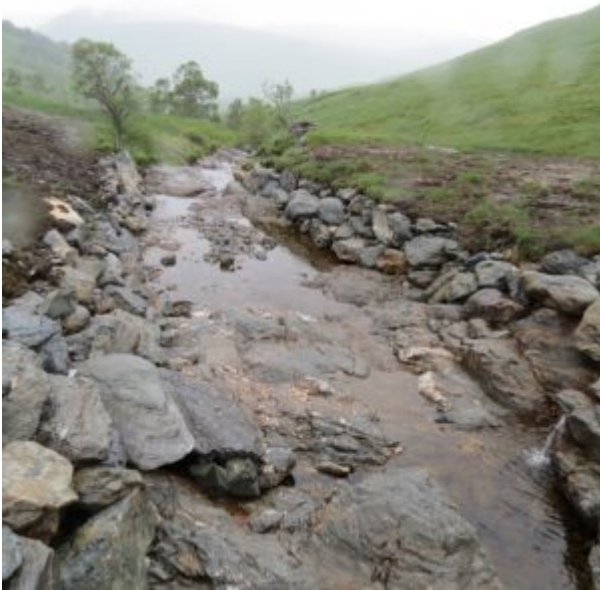
Rip Rap retention below Allt a Chuilinn intake – because the boulders have been built into the bank they have a lower landscape impact

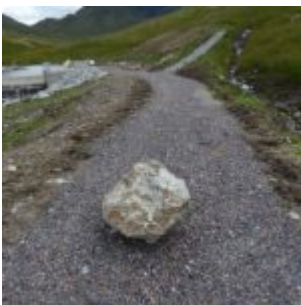
Upper Falloch –
alien hard chip

Hard chip, which looks completely different to the local schist, has been imported to at least three of the intake areas. It appears there might have been some spare at the Upper Falloch powerhouse and someone thought it a good idea to bring it up the hill. The LLTNPA's Guidance states:

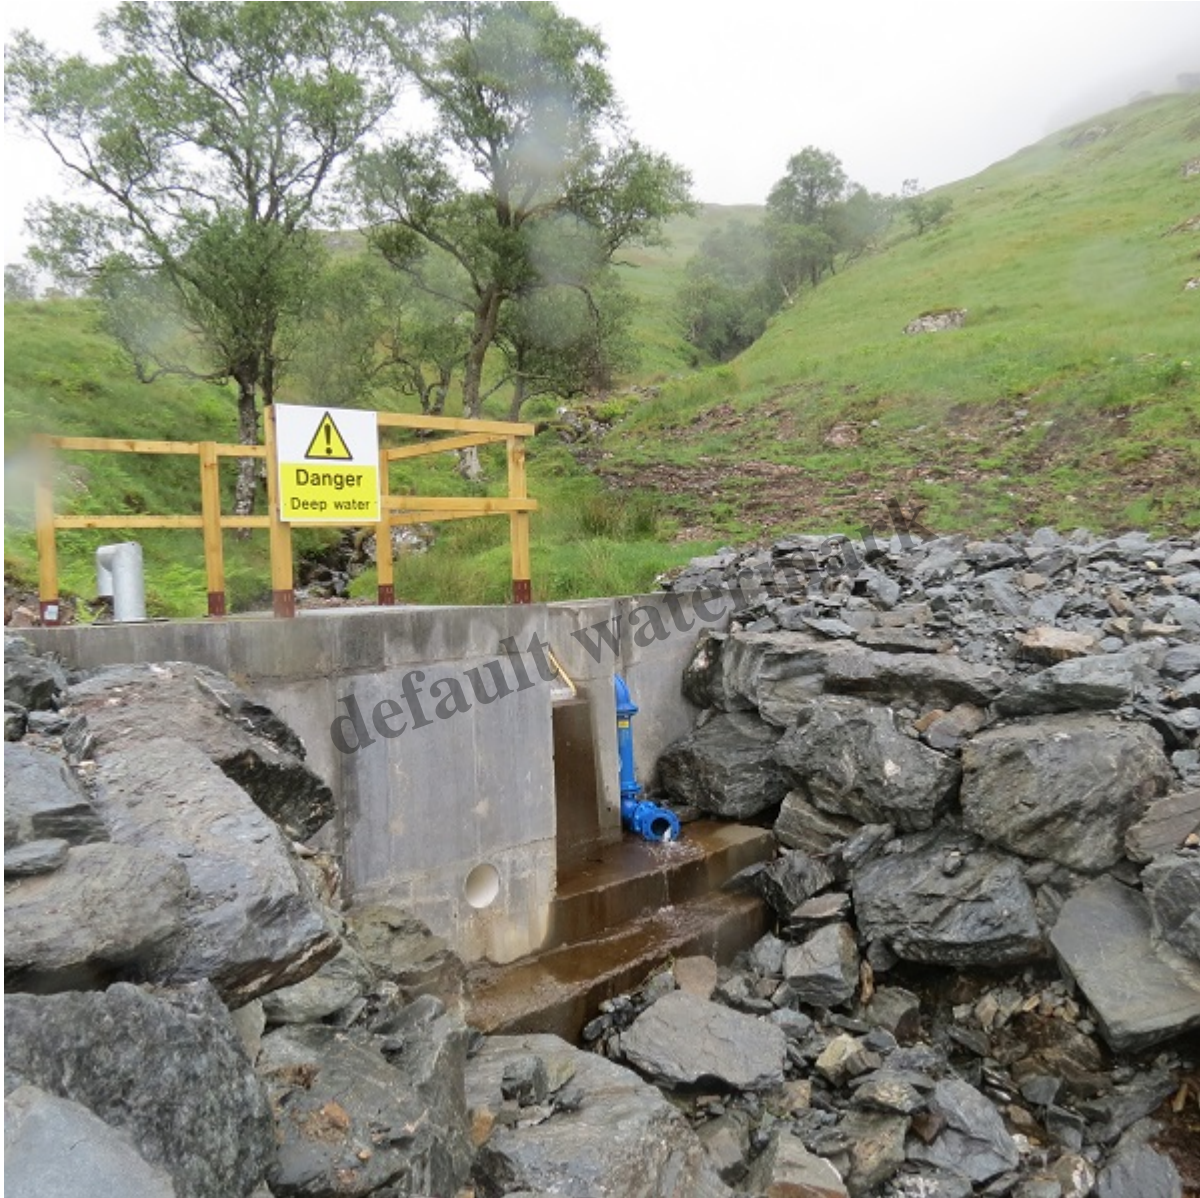
Allt a Chuillin second intake

This small intake is only example in Glen Falloch where wood has been used for the railings, which accords with the Park's policy on use of natural materials where possible – the sign unfortunately spoils the effect as do the metal footings. As with most of the schemes it has a blue outflow pipe – when the Park's Guidance states “Introduce as few different materials and colours as possible. A mute galvanised finish in a mute grey / green colour will blend in with most upland environments.” This is another place where cladding the concrete with stone would have looked far better than piling up boulders in front of the wing walls.
