The Glen Falloch hydro schemes (5) – is the end product good enough for a National Park?

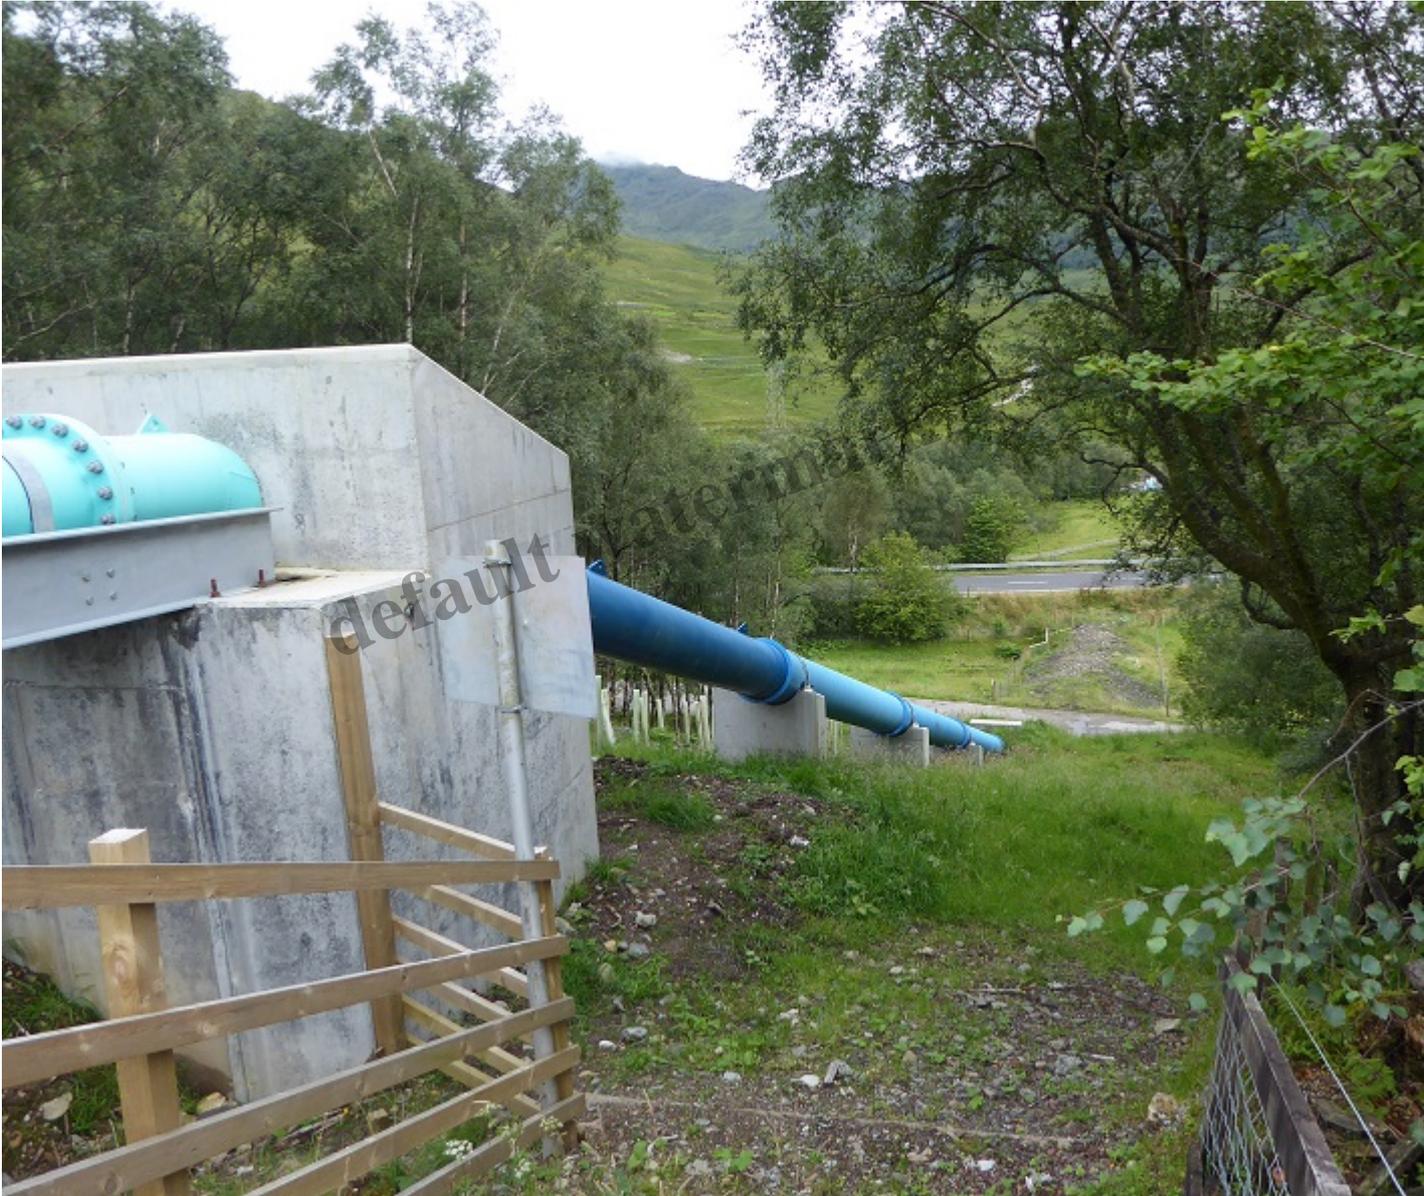
The Derrydaroch penstock which is clearly visible from the A82 and West Highland Way – the Park's states that all penstock and pipes should reflect the natural colours of the landscape.

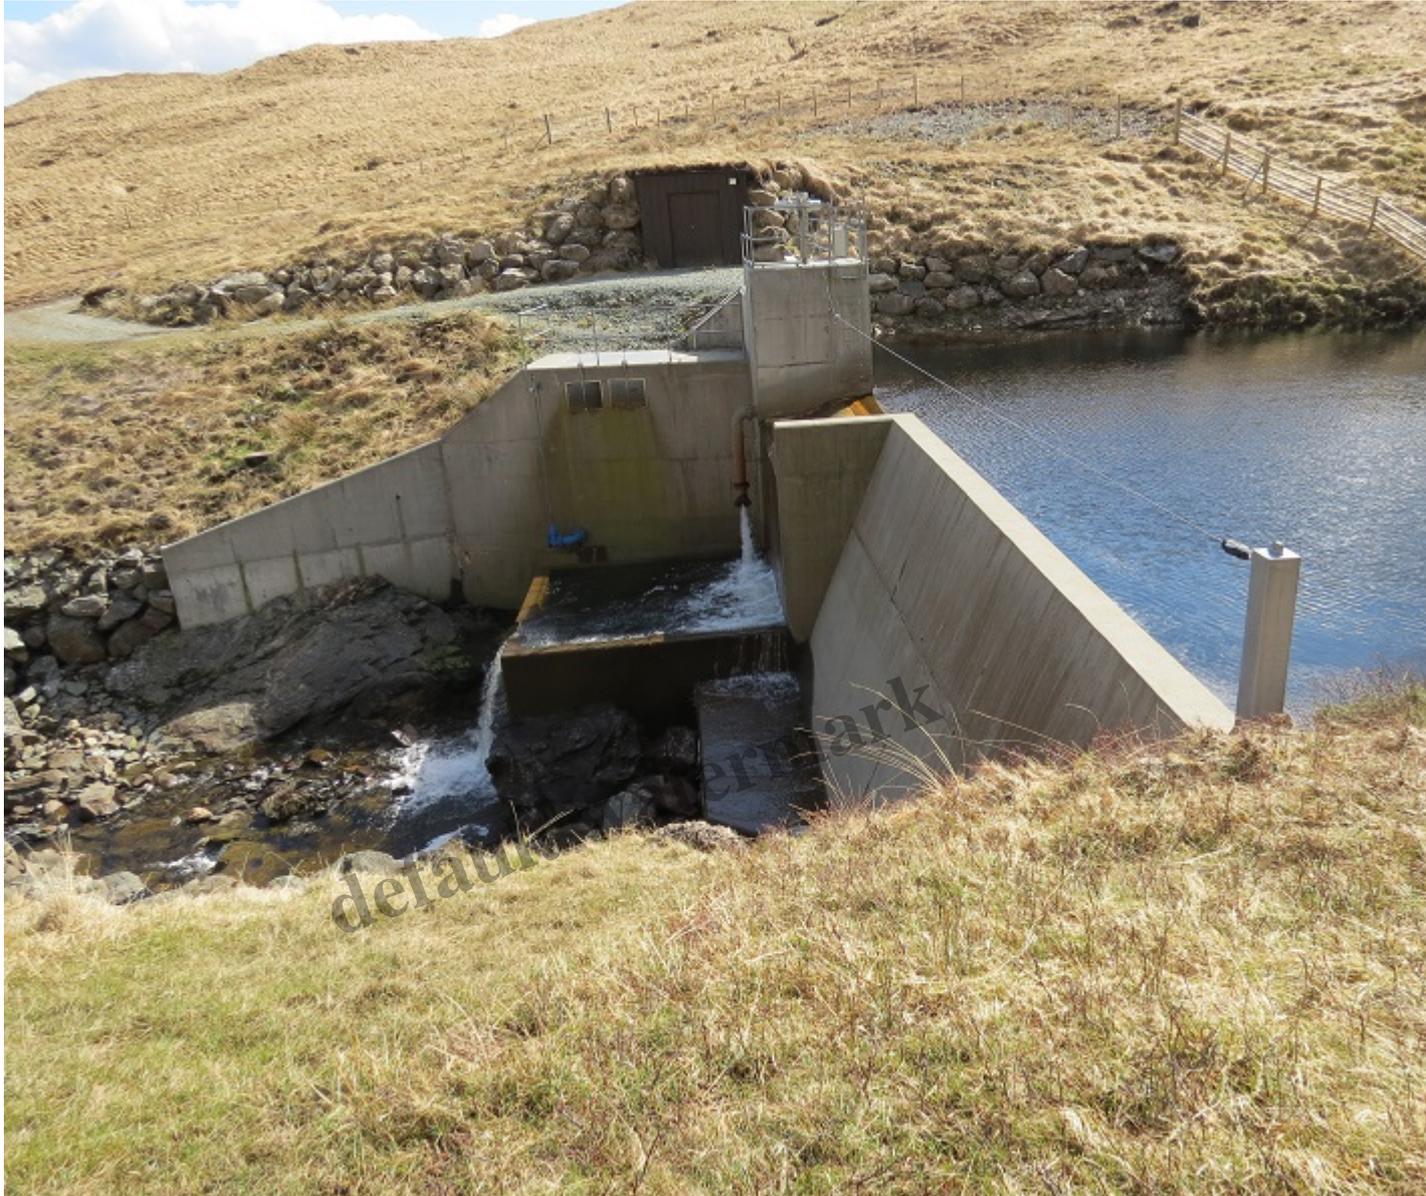
Allt Fionn intake dam

One of the reasons the Allt Fionn Scheme has limited visual impact is that upstream of the dam there was very little engineering – just the blocks on the far side of the dam which have been well covered. Other aspects of the dam though do not meet the requirements of the Park's current guidance.

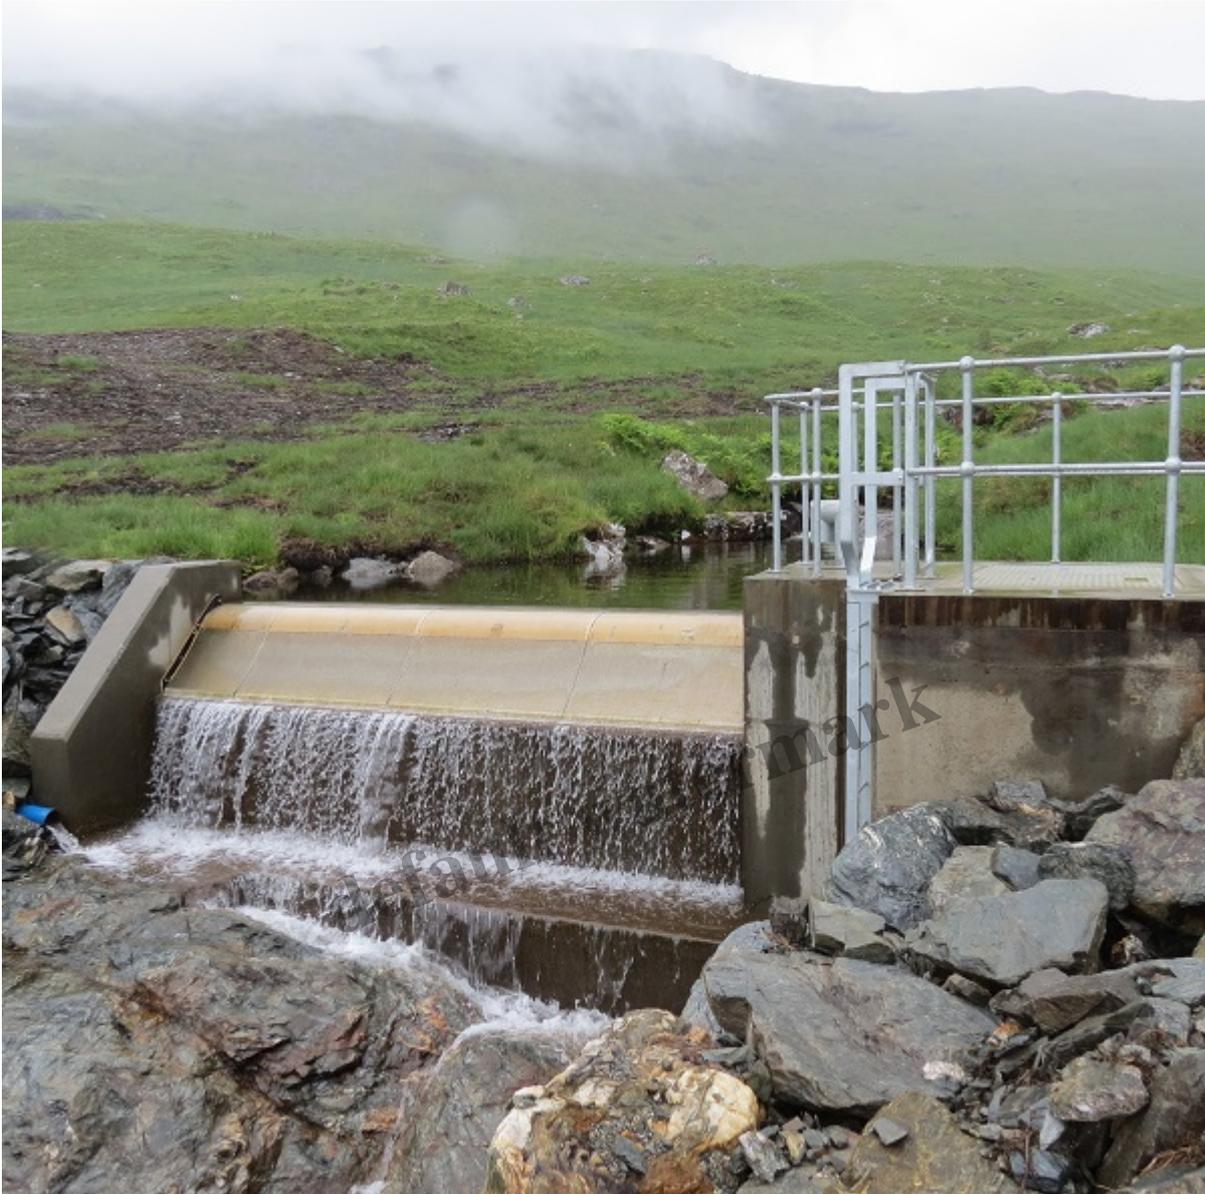
In fact not a single one of the Glen Falloch dams meets the Park’s current best practice guidance – all are concrete without any stone cladding though in some cases boulders have been piled against the wing walls to help screen them.

Allt Andoran – note boulders piled below right wall of dam and also lack of engineering of the pool behind – its looks natural

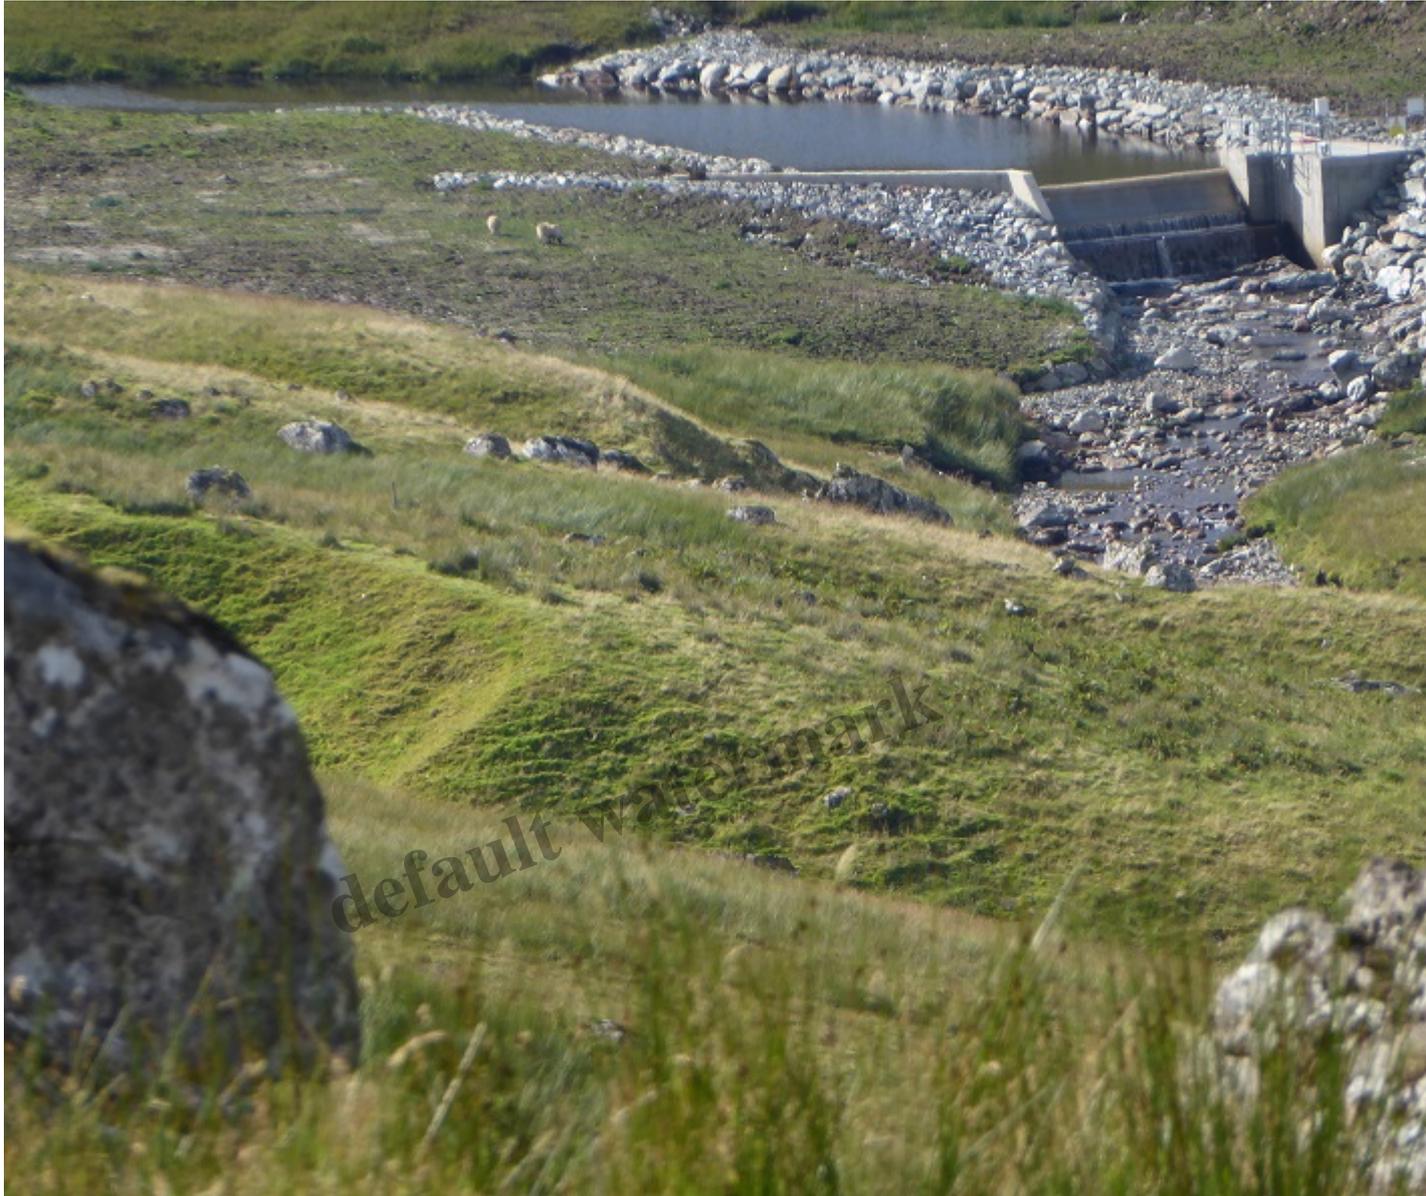
Upper Glen Falloch intake 2016 – its in a slightly different location to where originally planned

The current visual impact of the Upper Falloch must be at least six times the size as in the original landscape assessment and the main reason for this is the use of boulders in screening the dam and in “rip-rap retention” along the banks of the intake pool but also the river below. Now its possible “restoration” work is not complete and some of the boulders may be covered in vegetation although its not clear where this might come from as none has been stored locally. In my view the left side wall of the dam would have looked better without the boulders. Its difficult to see anything growing on them for decades and they are likely to continue to look like a pile of boulders dumped by a digger. Its hard to see how anyone could claim this is effective restoration of the landscape. However, it appears to result from the LLTNPA Guidance:

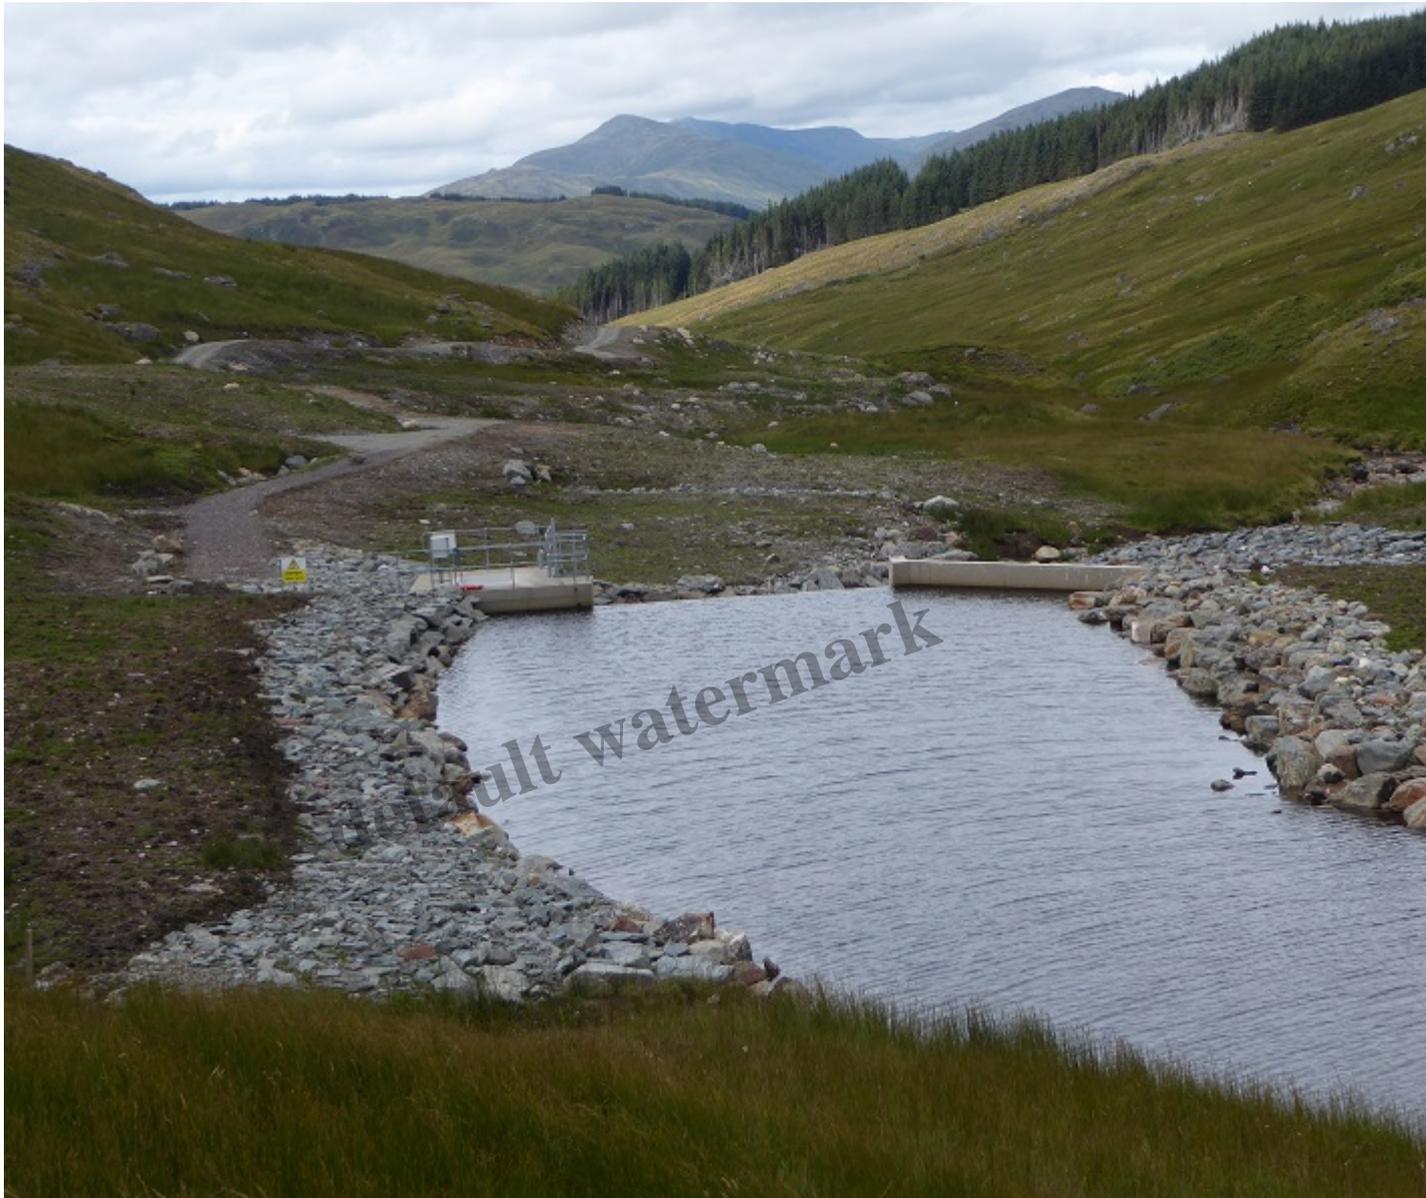
The Upper Falloch Intake – large amounts of rip rap engineering has been required to create the pool, which greatly increases the visual impact of these scheme compared to the Allt Fionn scheme

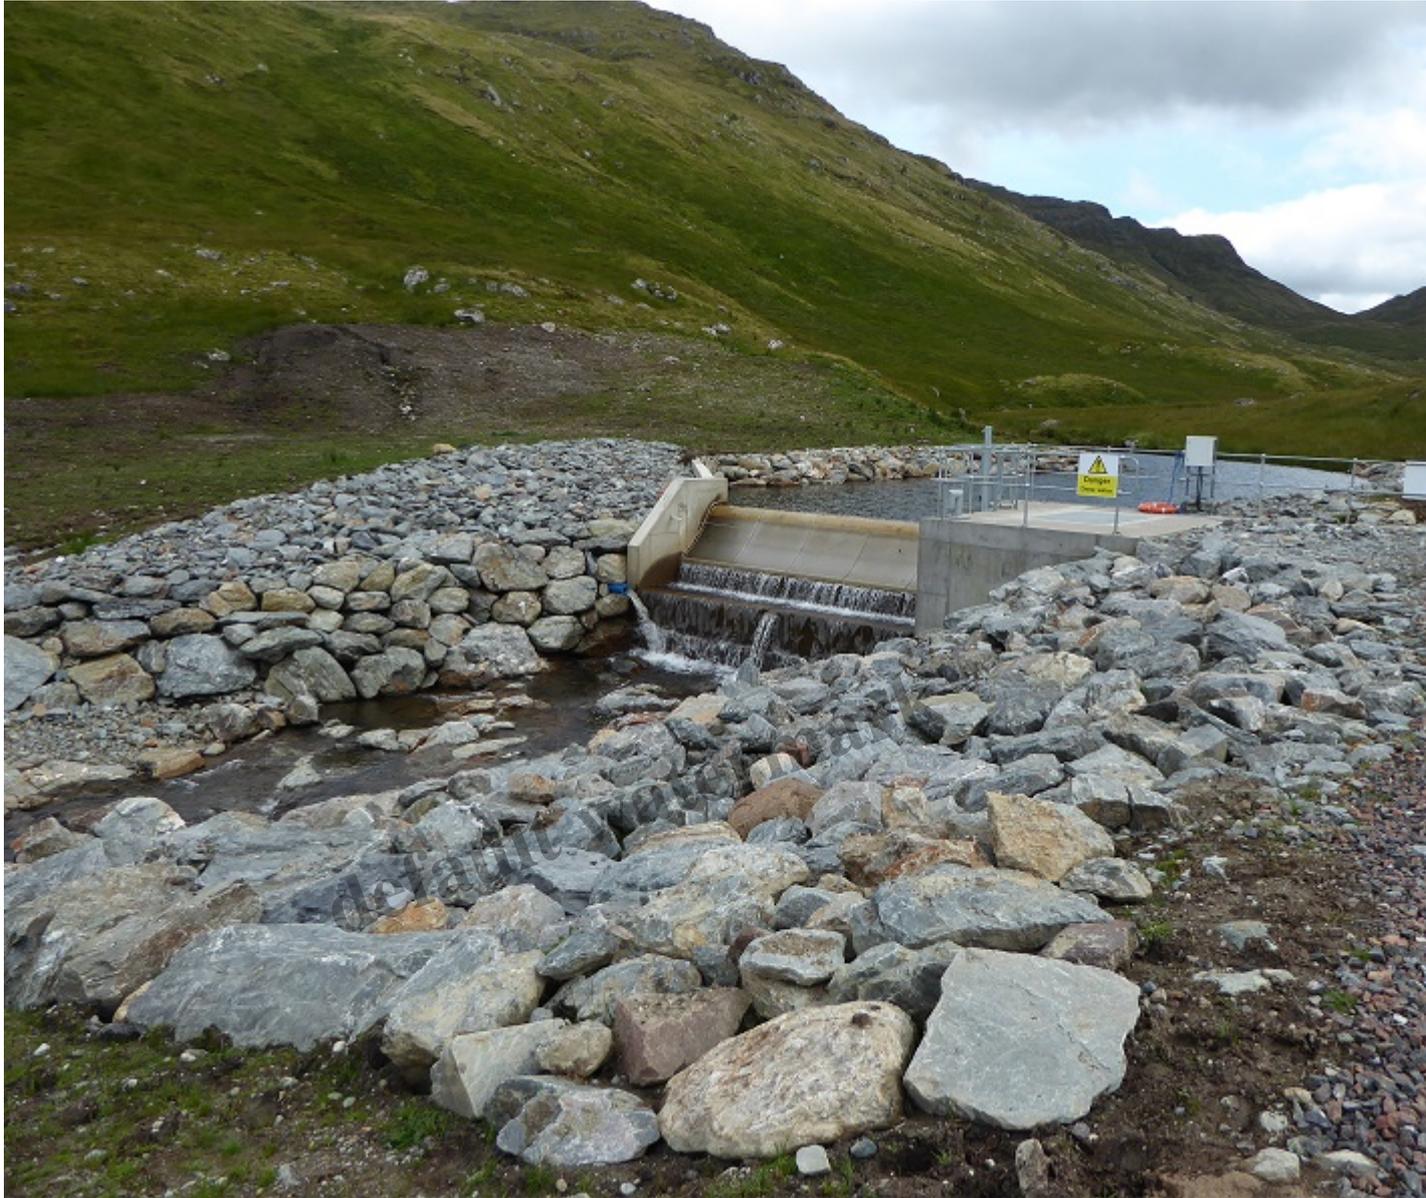
Upper Falloch from bleow – its hard to see how vegetation can establish itself in these boulders and likely to scar the landscape for decades

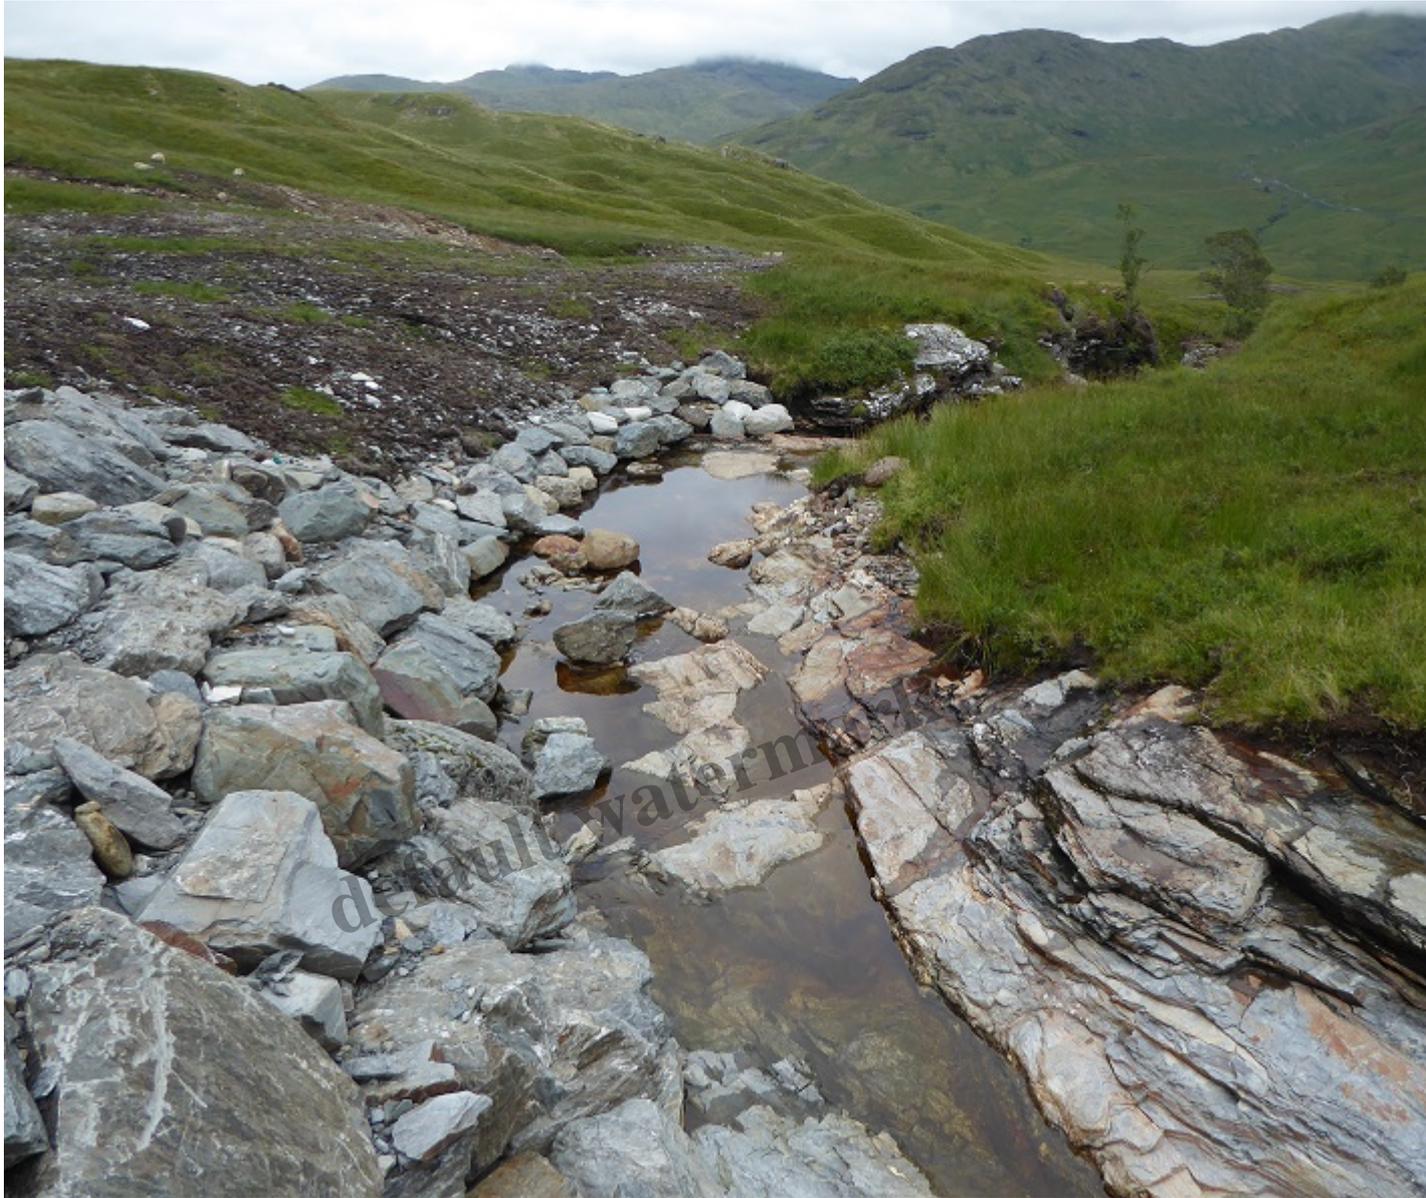
Rip Rap retention on Eas Eonan contrasts with the natural gorge below

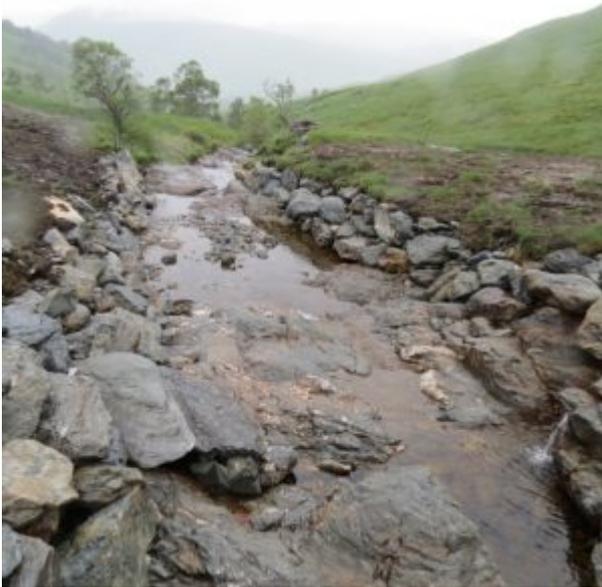
Rip Rap retention below Allt a Chuilinn intake – because the boulders have been built into the bank they have a lower landscape impact

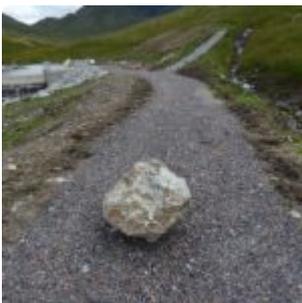
Upper Falloch –  
alien hard chip

Hard chip, which looks completely different to the local schist, has been imported to at least three of the intake areas. It appears there might have been some spare at the Upper Falloch powerhouse and someone thought it a good idea to bring it up the hill. The LLTNPA's Guidance states:

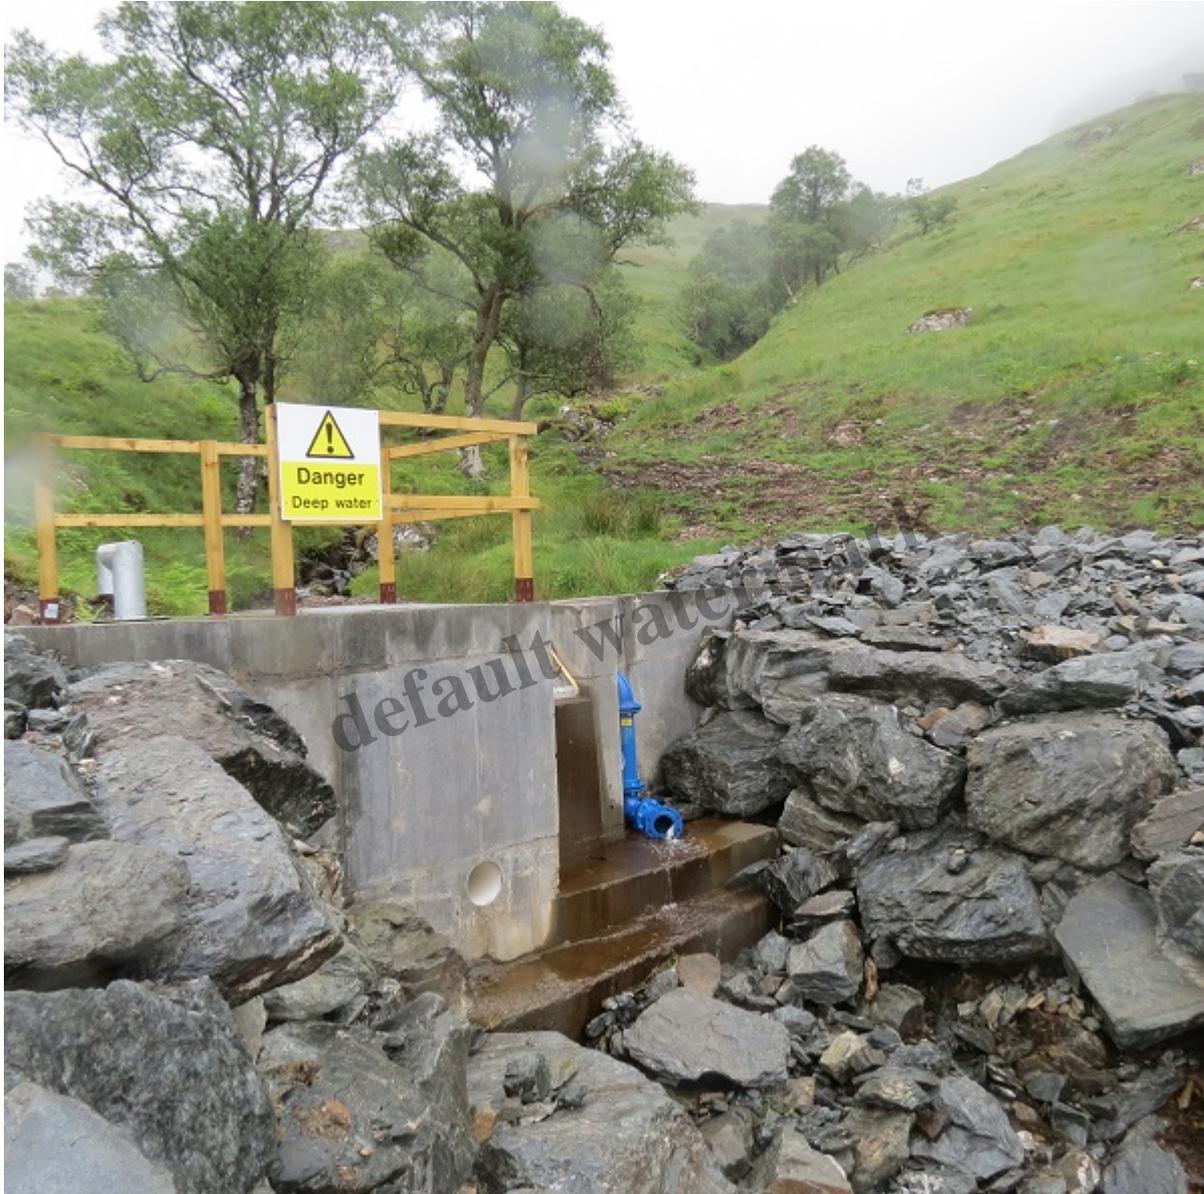
Allt a Chuillin second intake

This small intake is only example in Glen Falloch where wood has been used for the railings, which accords with the Park's policy on use of natural materials where possible – the sign unfortunately spoils the effect as do the metal footings. As with most of the schemes it has a blue outflow pipe – when the Park's Guidance states “Introduce as few different materials and colours as possible. A mute galvanised finish in a mute grey / green colour will blend in with most upland environments.” This is another place where cladding the concrete with stone would have looked far better than piling up boulders in front of the wing walls.
