## Another National Park planning failure – the hydro destruction in Glen Bruar

Bruar hydro scheme in construction May 2014

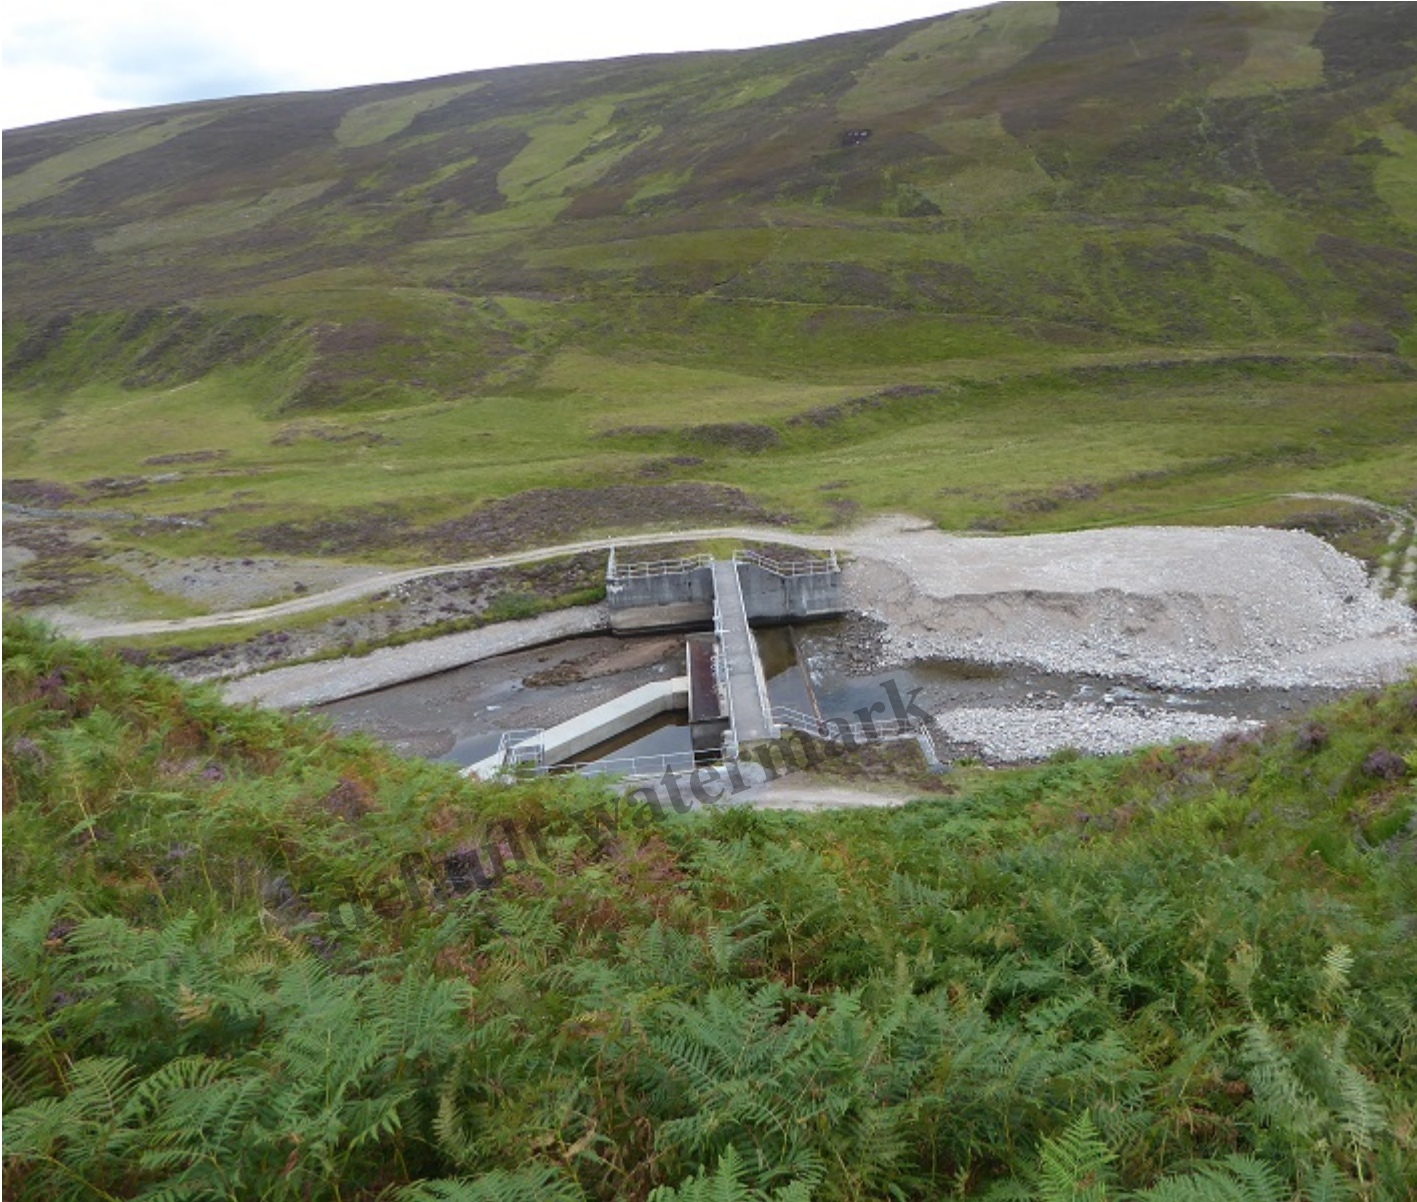
The Scottish and Southern Electric hydro intake just below the new Hydro powerhouse. The intake has been upgraded (the concrete covered culvert takes the water back under the hill). I have been unable to ascertain whether the large heap below the intake dam was created by SSE or the Bruar Hydro construction.

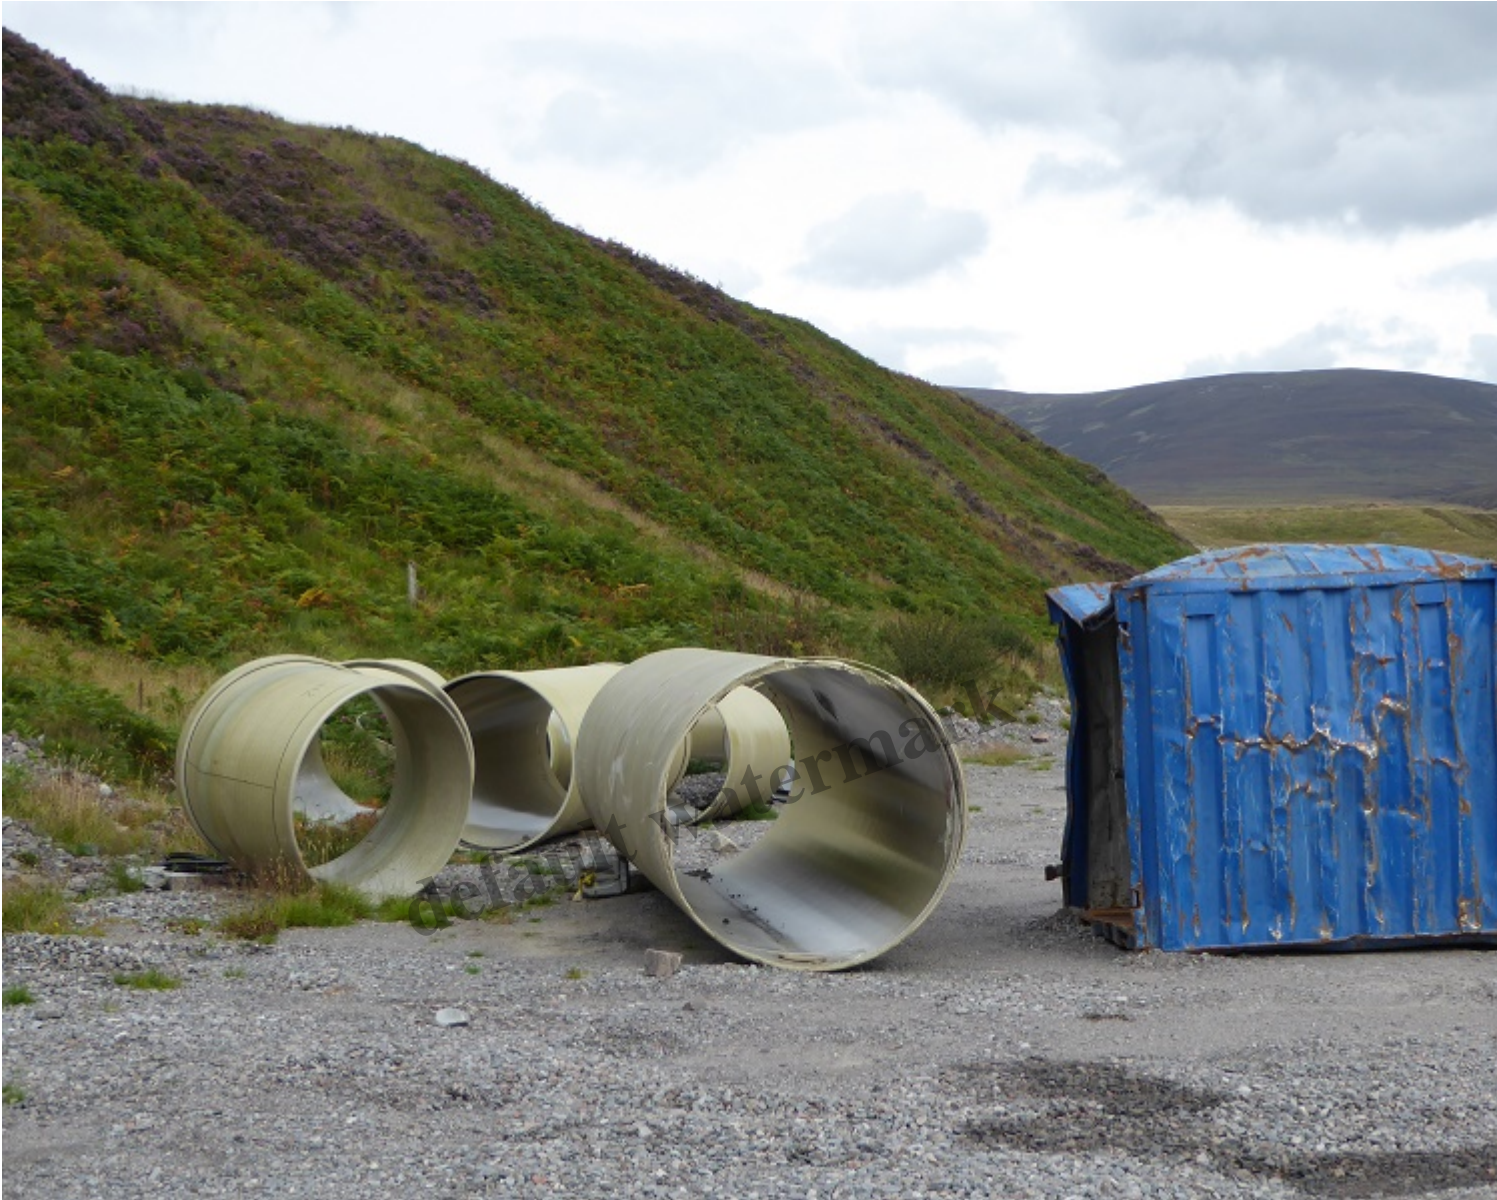
The planning application described two storage areas for pipes, above the power station and at the dam. Broken sections of pipe have still not been cleared away 18 months after construction finished. The CNPA never agreed to a new dump in the planning application. Why is this still here?

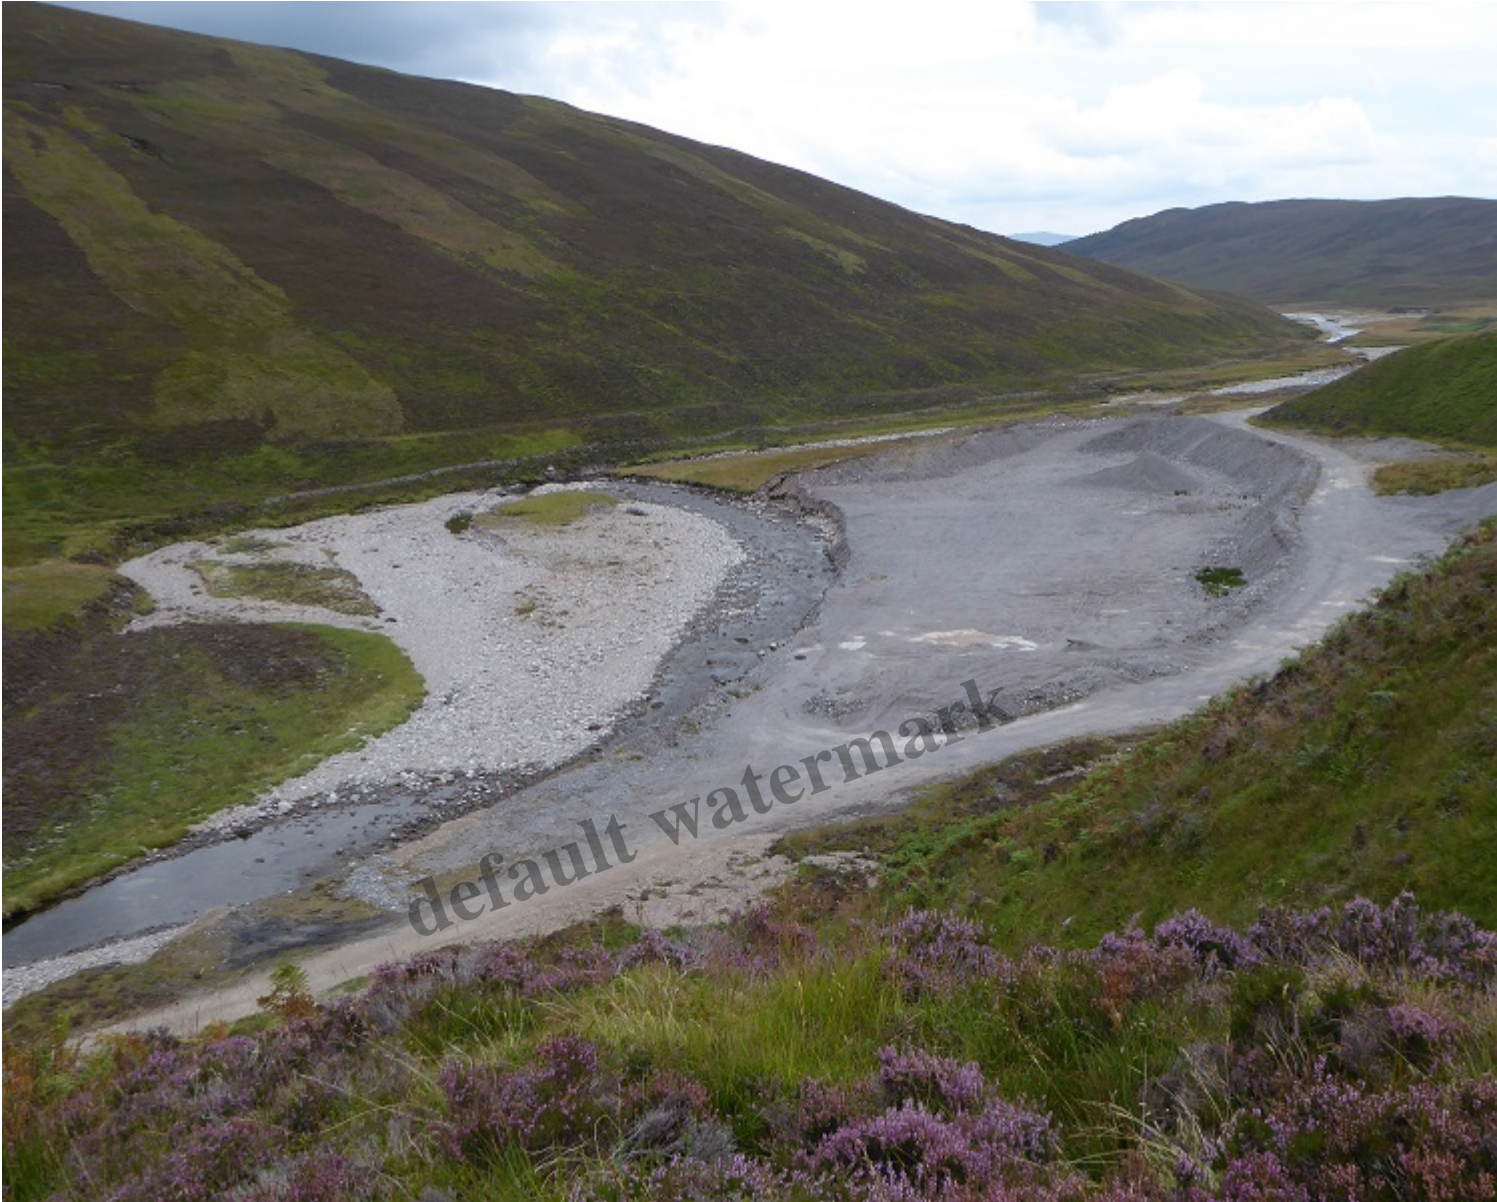
Is this acceptable in a National Park? There appears to have been no attempt at restoration. Maybe the Estate is just hoping the river erodes away the flattened area completely but what about all the silt which is being washed into the river system?

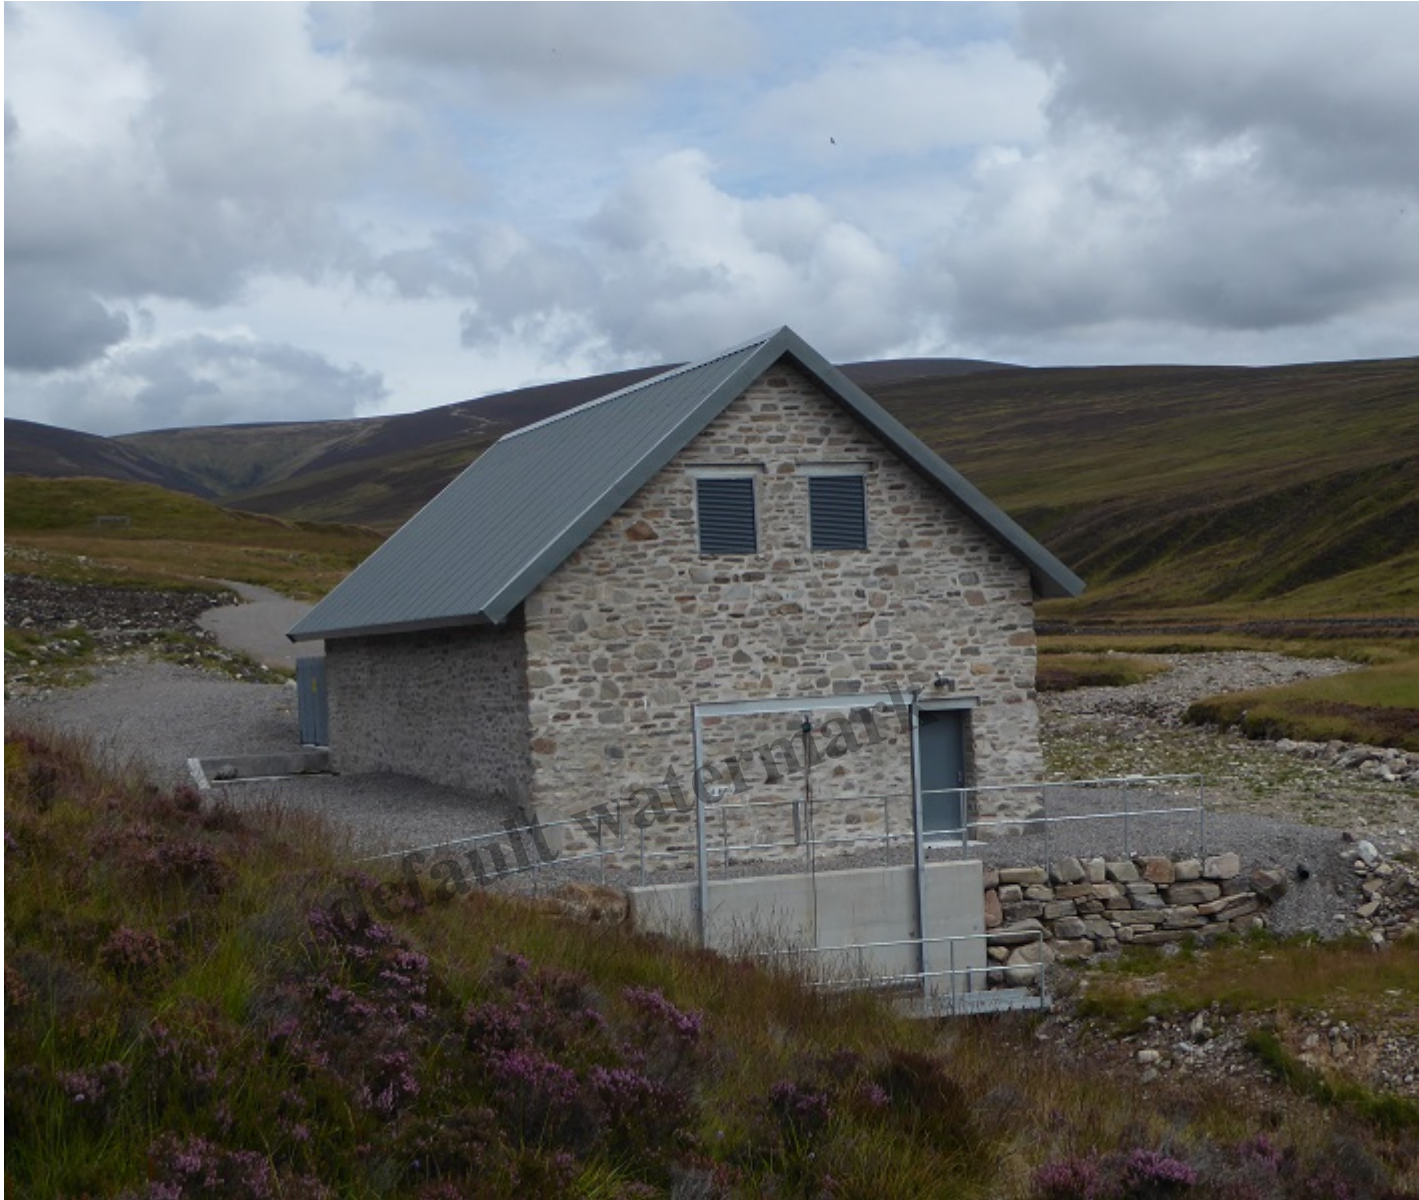
The Bruar power house, the tailrace flows into new channel front centre. Note the failure to finish the right of the tailrace. There are many similar examples of shoddy and unfinished work to be seen further Bruar.

In order to construct the powerhouse in this location, a significant amount of material had to be excavated. The planning statement suggested this should be re-used in track construction but one wonders if it might have been dumped by the SSE intake (see photo above)? The CNPA needs to find out, if it doesn't know, who was responsible for digging and dumping what and then take appropriate action in public. The planning application stated that the amount of hardstanding around the powerhouse should be minimised – you can judge for yourself from the above photo whether this has been observed. The building itself though in my view perfectly acceptable: our planners and developers appear much better at ensuring buildings are sympathetic to the landscape than they are at looking after the land itself.

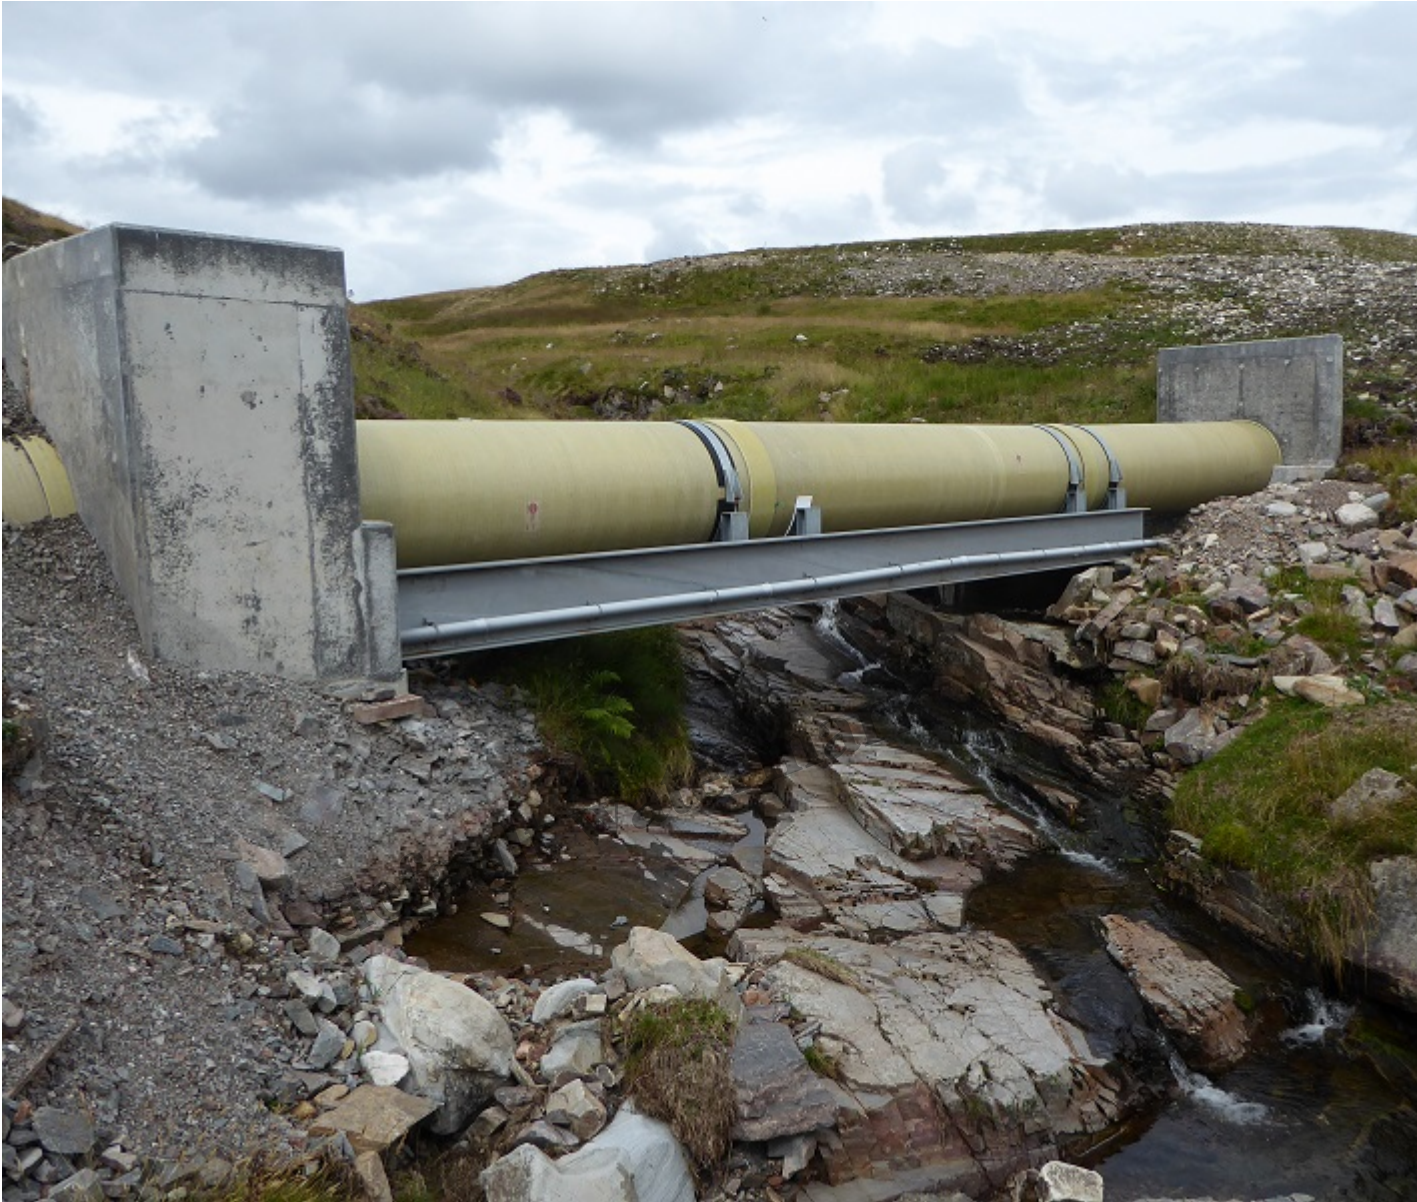
Pipeline – glass reinforced plastic – crossing burn just above power house

CNPA planning guidance on hydro ([see here](#)) states the number of stream crossing should be minimised. This was hard to do on a 4.5k pipeline and at least the colour of the pipe is not bright blue as in Glen Falloch. The poor standard of work is obvious at both the concrete pipe supports and the material on the left is already being eroded away into the burn: its unlikely to survive a spate.

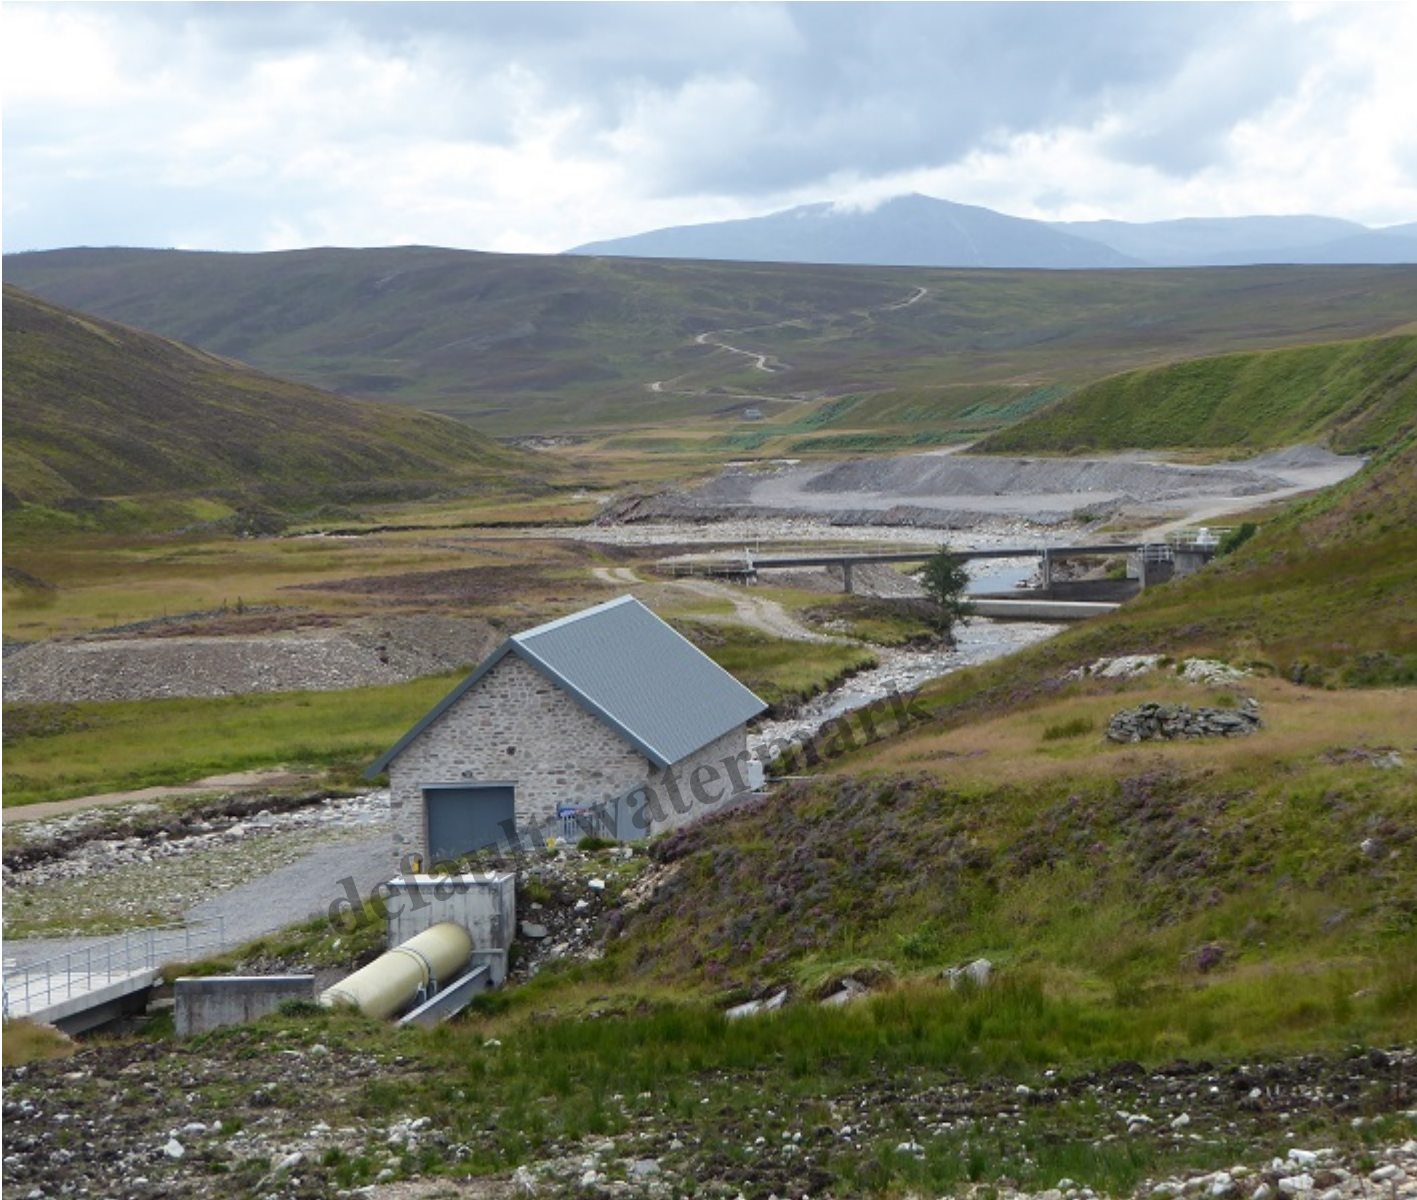
Overview of impact on landscape looking south to powerhouse. Besides dumps featured in earlier photos SSE intake, more material has been dumped middle left. Track and line of powerline out to Calvine and Schiehallion in far distance. The disturbed ground in foreground is where the pipeline has been buried.

The Planning Report approved by the CNPA suggested the construction should re-use old SSE spoil materials from their tunnel, not create new ones. This has had a significant adverse impact on the landscape, a landscape of grouse moors which at present the Park is committed to conserving. So why has this been allowed to happen? How is it compatible with National Park policy?

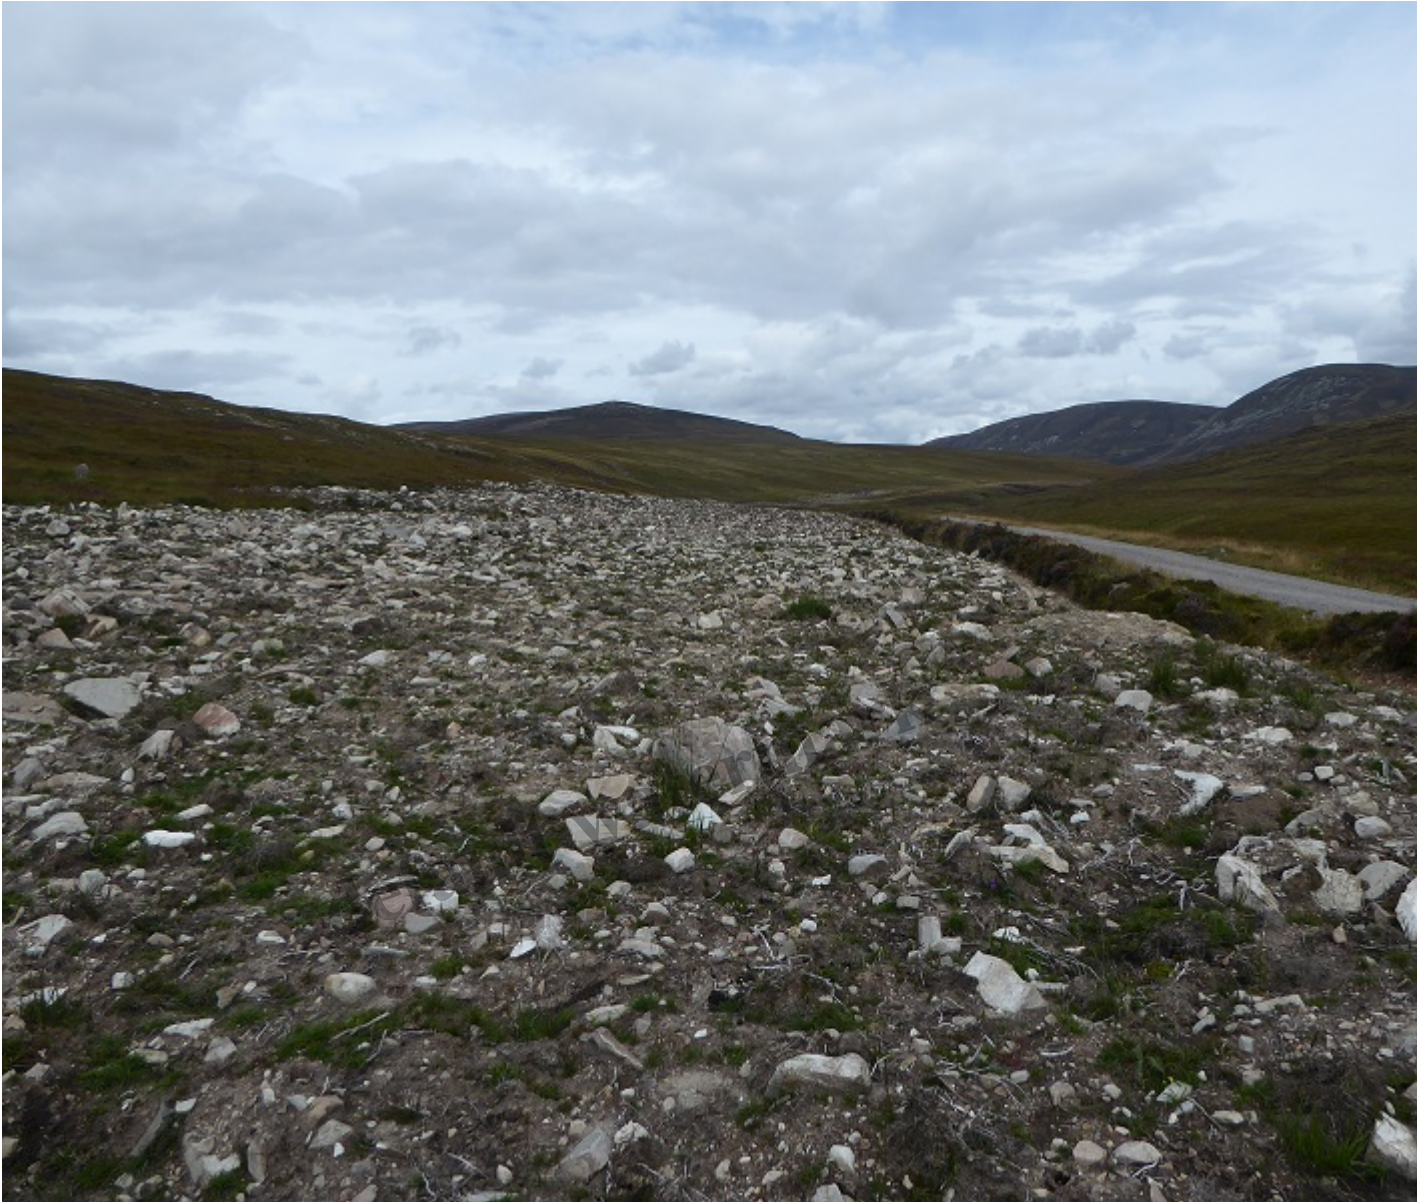
Near the start of the pipeline above the powerhouse

While I have been very critical of the Glen Falloch hydro schemes, some of which should never have been allowed, in general the restoration of the land around the pipeline has been done well – unlike the tracks there – and it will be very hard to see the line of the pipes in a couple of years ([see here](#)). I have never seen such terrible restoration of ground above a pipeline as in Glen Bruar.

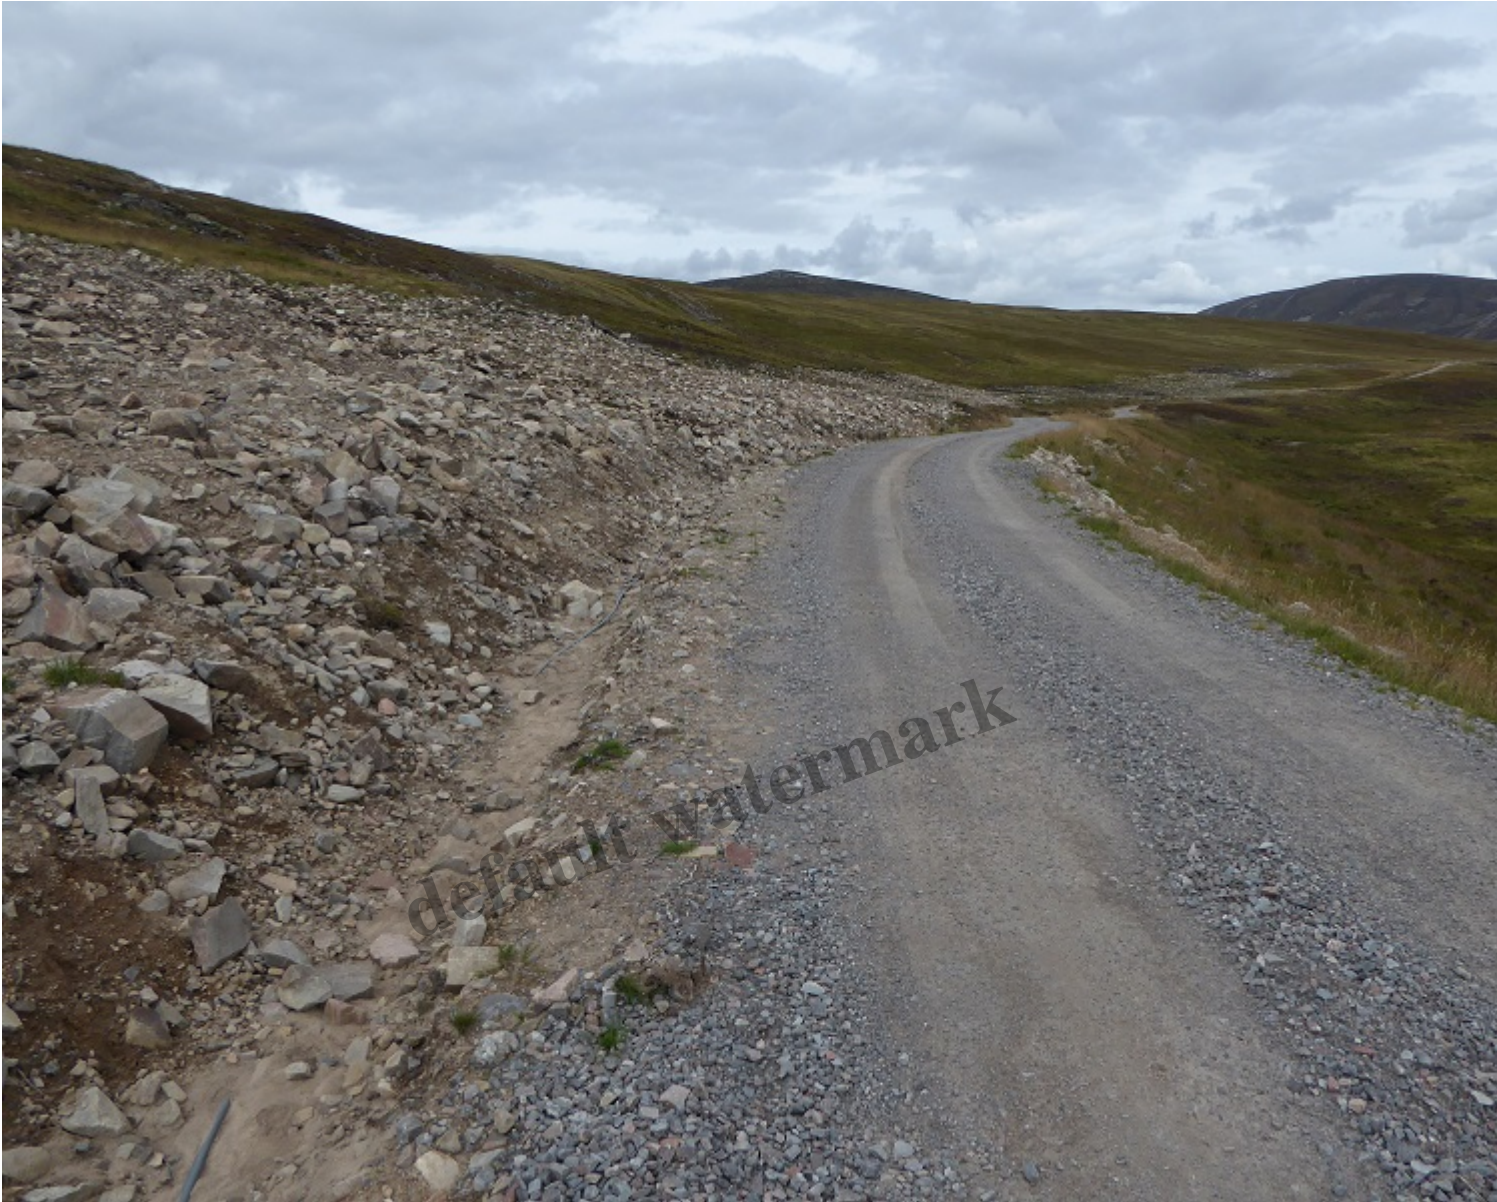
And it goes on for 4.5km.

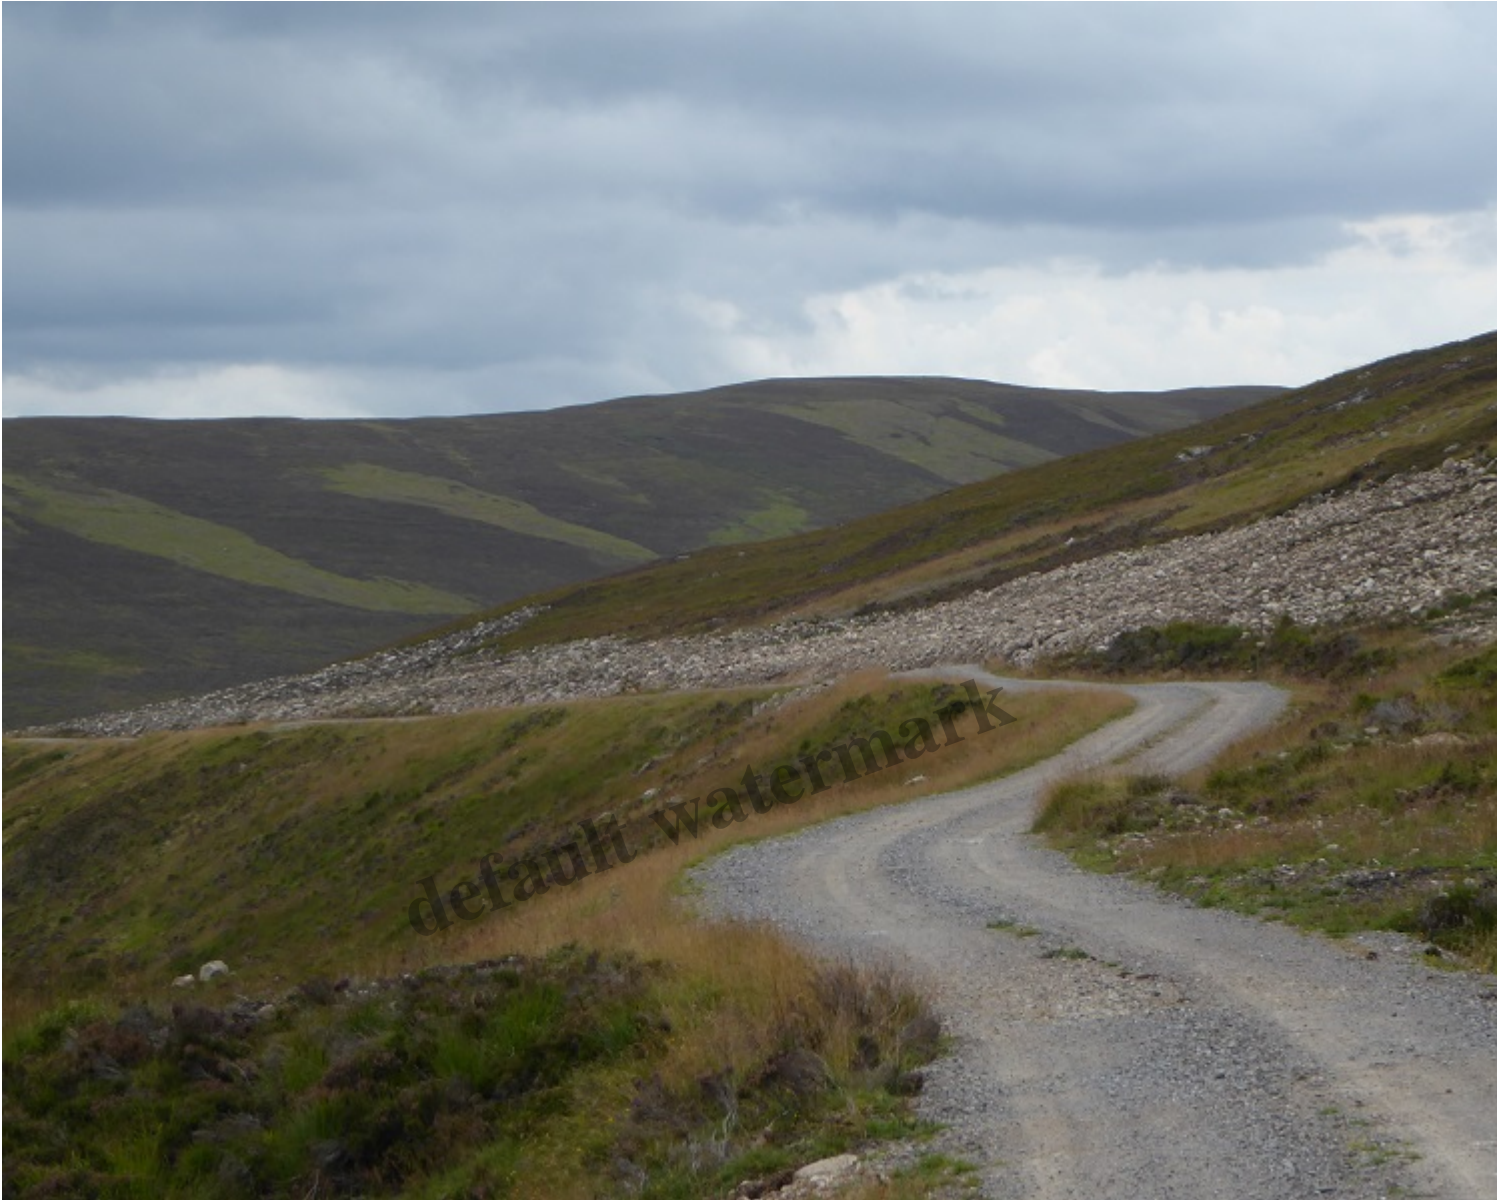
Boulders which were below the surface have been brought to the surface and left there so there is now a 30m wide trail through what was previously peat moorland. According to the method, which set out how the pipeline would be constructed, the vegetation and organic matter would first be removed and stored, the ditch then dug, the pipeline laid on and packed small aggregate (high pressure pipelines need to be well enclosed/supported and then the ground above restored to how it looked before. It did not envisage problems with doing this.

I corresponded with the CNPA about this in September and was sent (which I appreciated, I did not even have to ask under FOI) this [reinstatement note](#) from the Developer. Basically they claimed that the boulder trail resulted from the soil being unexpectedly shallow, that they now proposed to remove the boulders and use to shore up the river bank belong the dam and they would “rob turves” from elsewhere on the moor to cover up the mess. By coincidence this is exactly what Natural Retreats tried to do at the Cairngorm Shieling tow after they had failed to store vegetation properly ([see here](#)).

While on the steeper banks, as in the photo above, the organic material might have been shallow, if enough care had been taken it could still have been saved and replaced. However, the ecological assessment conducted as part of the planning application clearly stated most of the pipeline was through moorland and peat. If shallow organic matter was present, surely the ecological assessment should have identified this before work ever started?

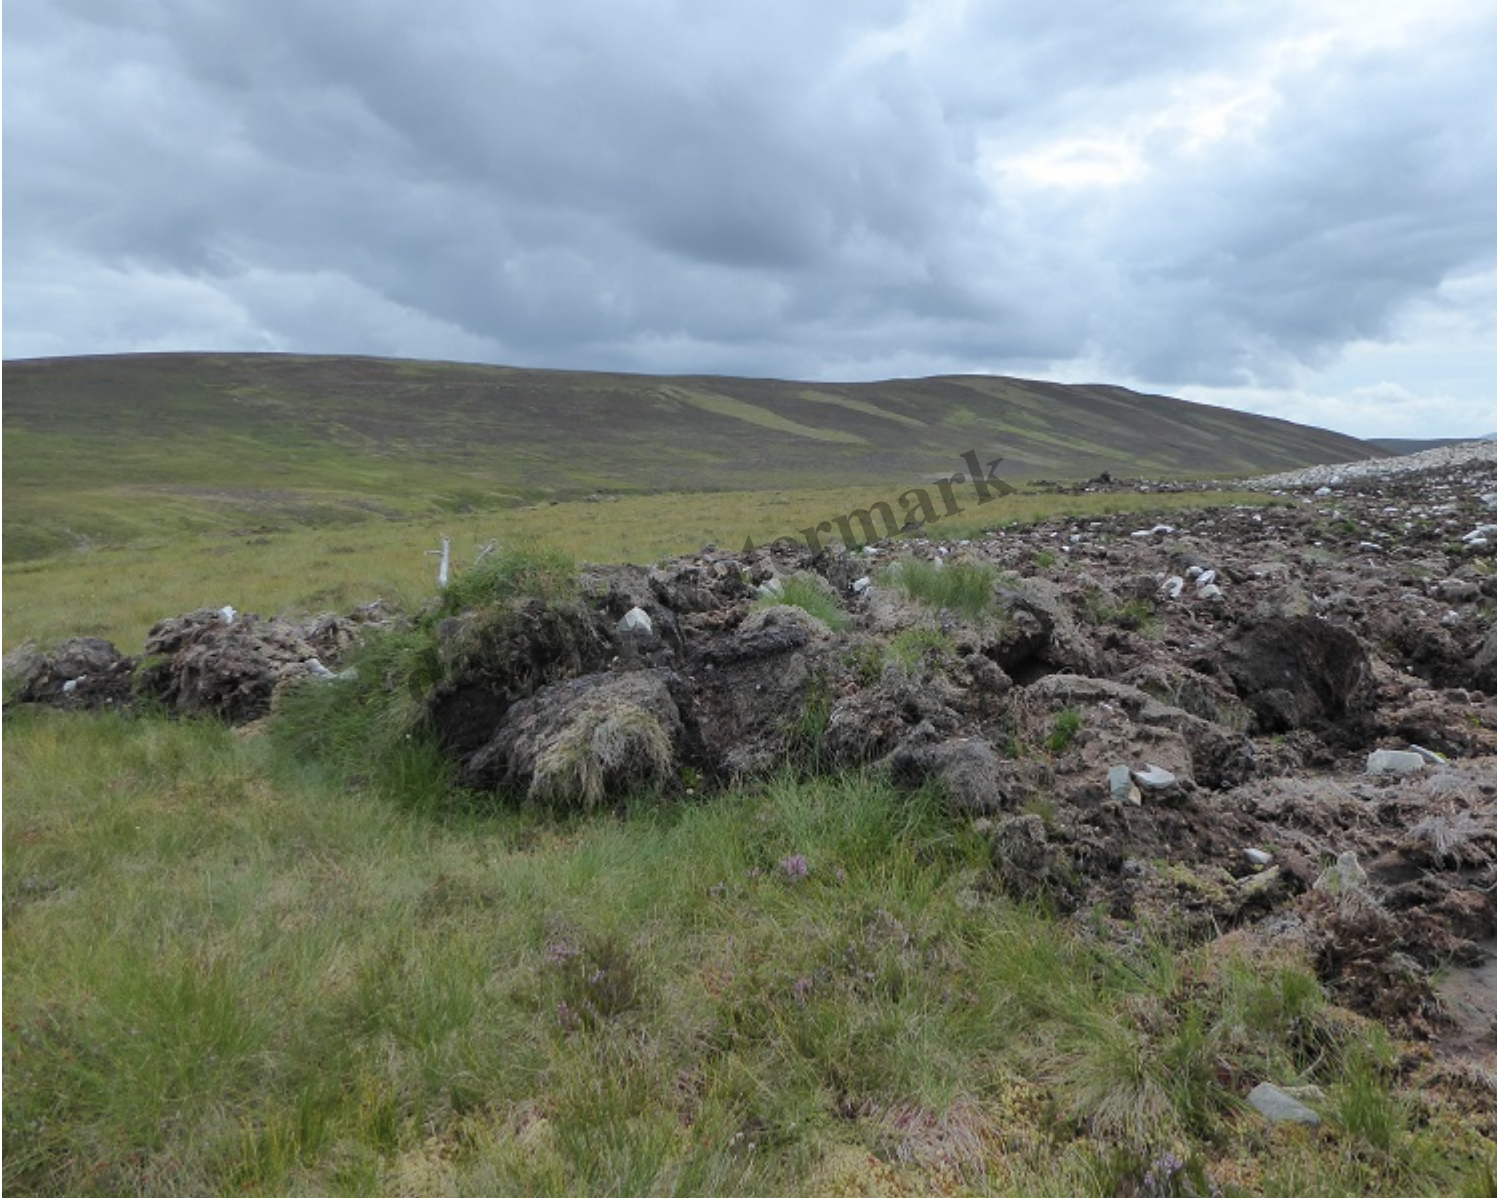
I think the truth is, as this photo shows, is that there was a considerable depth of peat along much of the pipeline and that the developer did make some attempt to store it in places even though where they did so they did not always replace it. The bigger problems was that vegetation and organic matter appears not to have been stored at all, as had been promised in the Method Statement. The fundamental issue is the develop has ignored its own Method Statement and this is therefore another enforcement problem. It demonstrates why our National Parks and other planning authorities should NEVER trust developers to monitor their own work. All that happens without independent monitoring is that the construction companies take shortcuts and ignore what's in the Method Statements. Where

shallow soil was a problem, if it really was so shallow that no turves could be stored, any responsible developer would have contacted the National Park as soon as they discovered this to discuss alternatives. Atholl Estates as far as I am aware never did this.

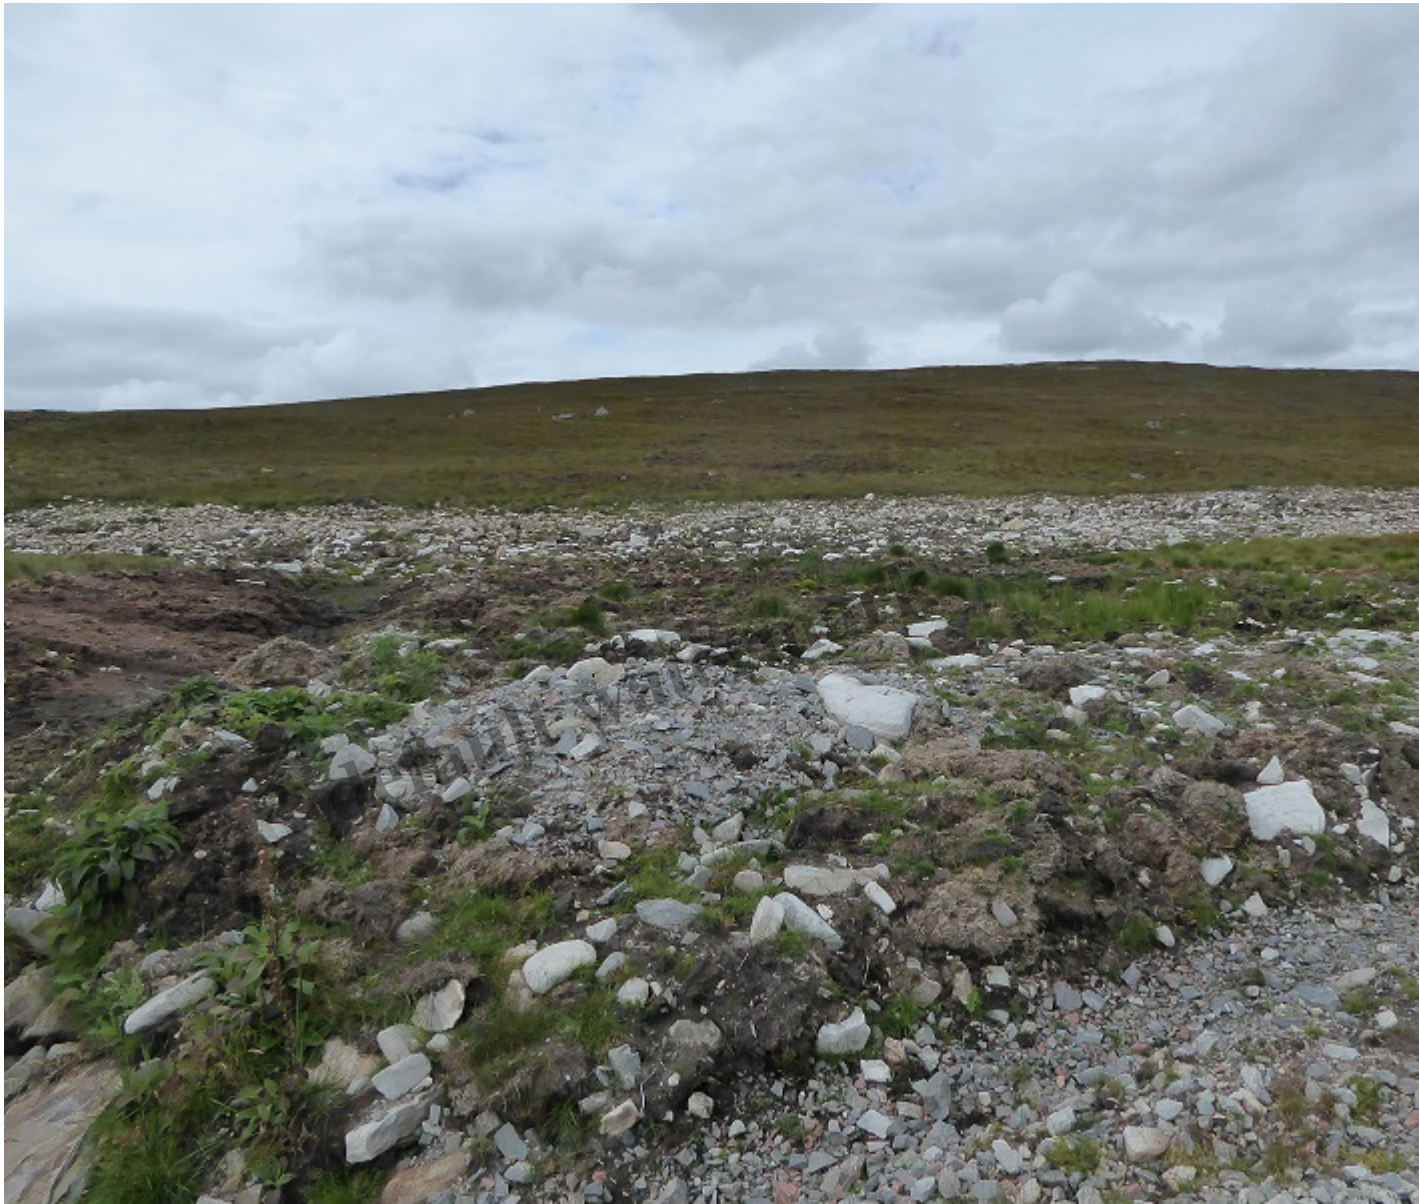
Line of pipeline in background. In foreground, spoil, whether from road or surplus to that needed for round the pipeline has simply been dumped at the edge of the track with no regard for vegetation.

In fact, there is plenty of evidence that the developers have breached their own method statement. Indeed, there is also lots of evidence of them failing to keep to deadlines: for example, in their “reinstatement note” the developers had said they would remove all the boulders by Spring/early summer 2016. There was no sign of this when I visited at the end of August.

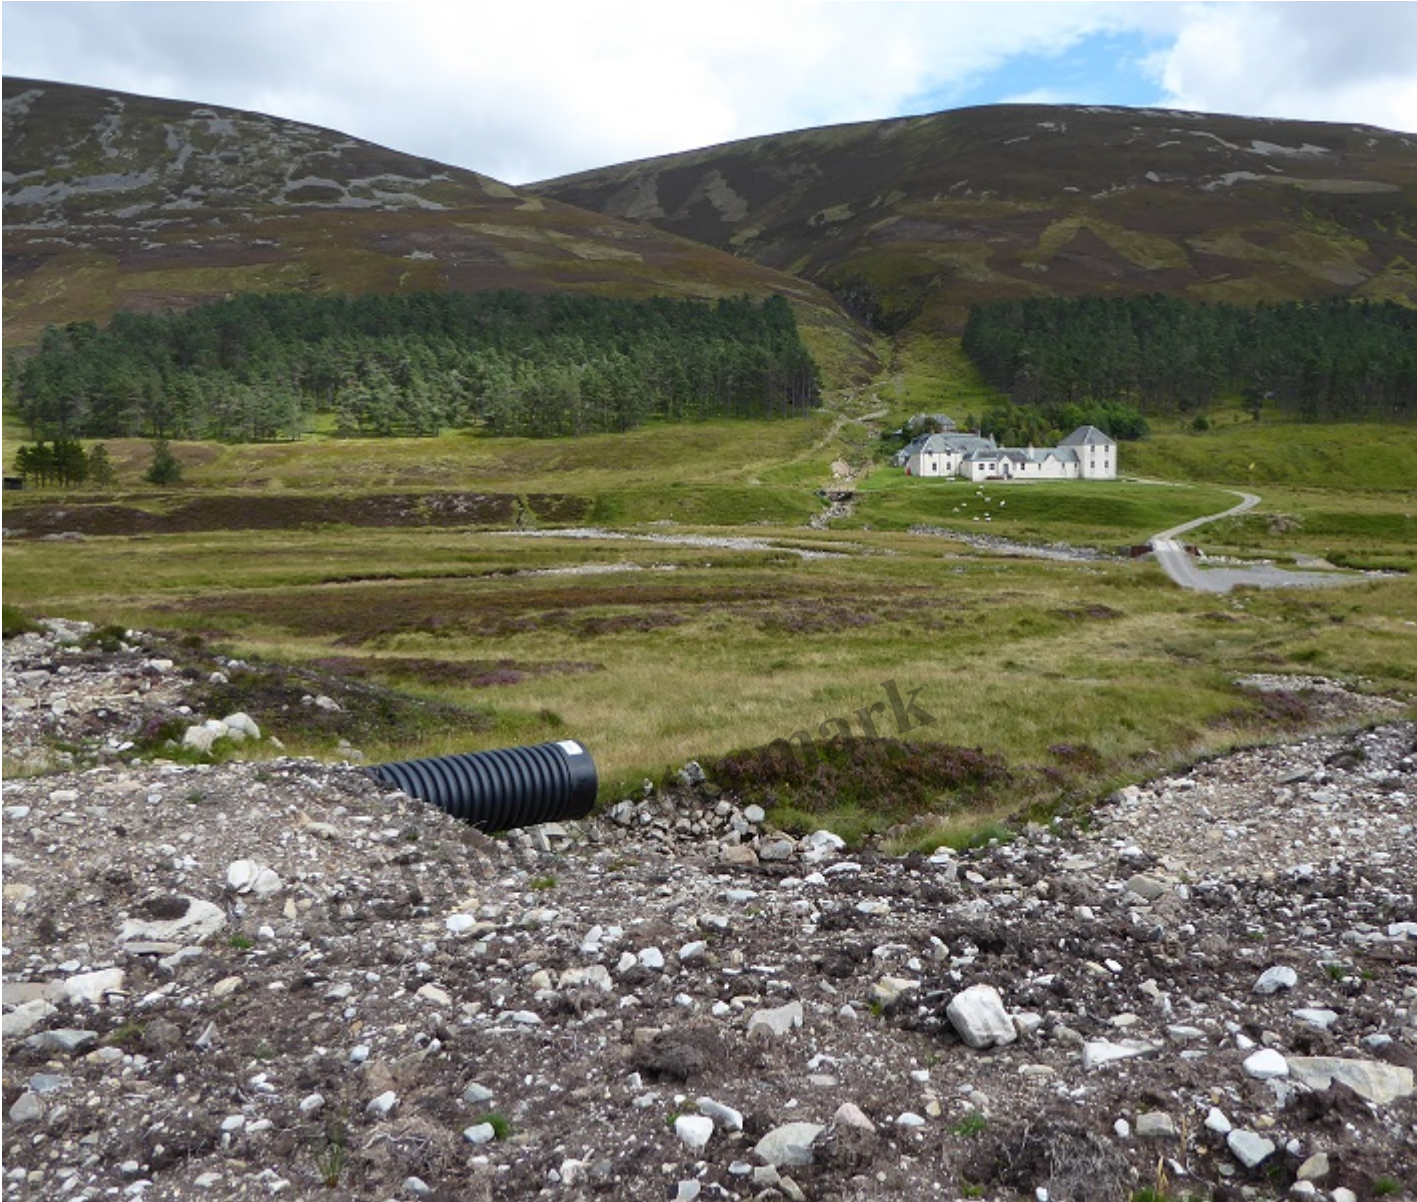
It would be difficult to find a worse example of finishing than this piped culvert opposite Bruar Lodge
