## Another National Park planning failure – the hydro destruction in Glen Bruar

Bruar hydro scheme in construction May 2014

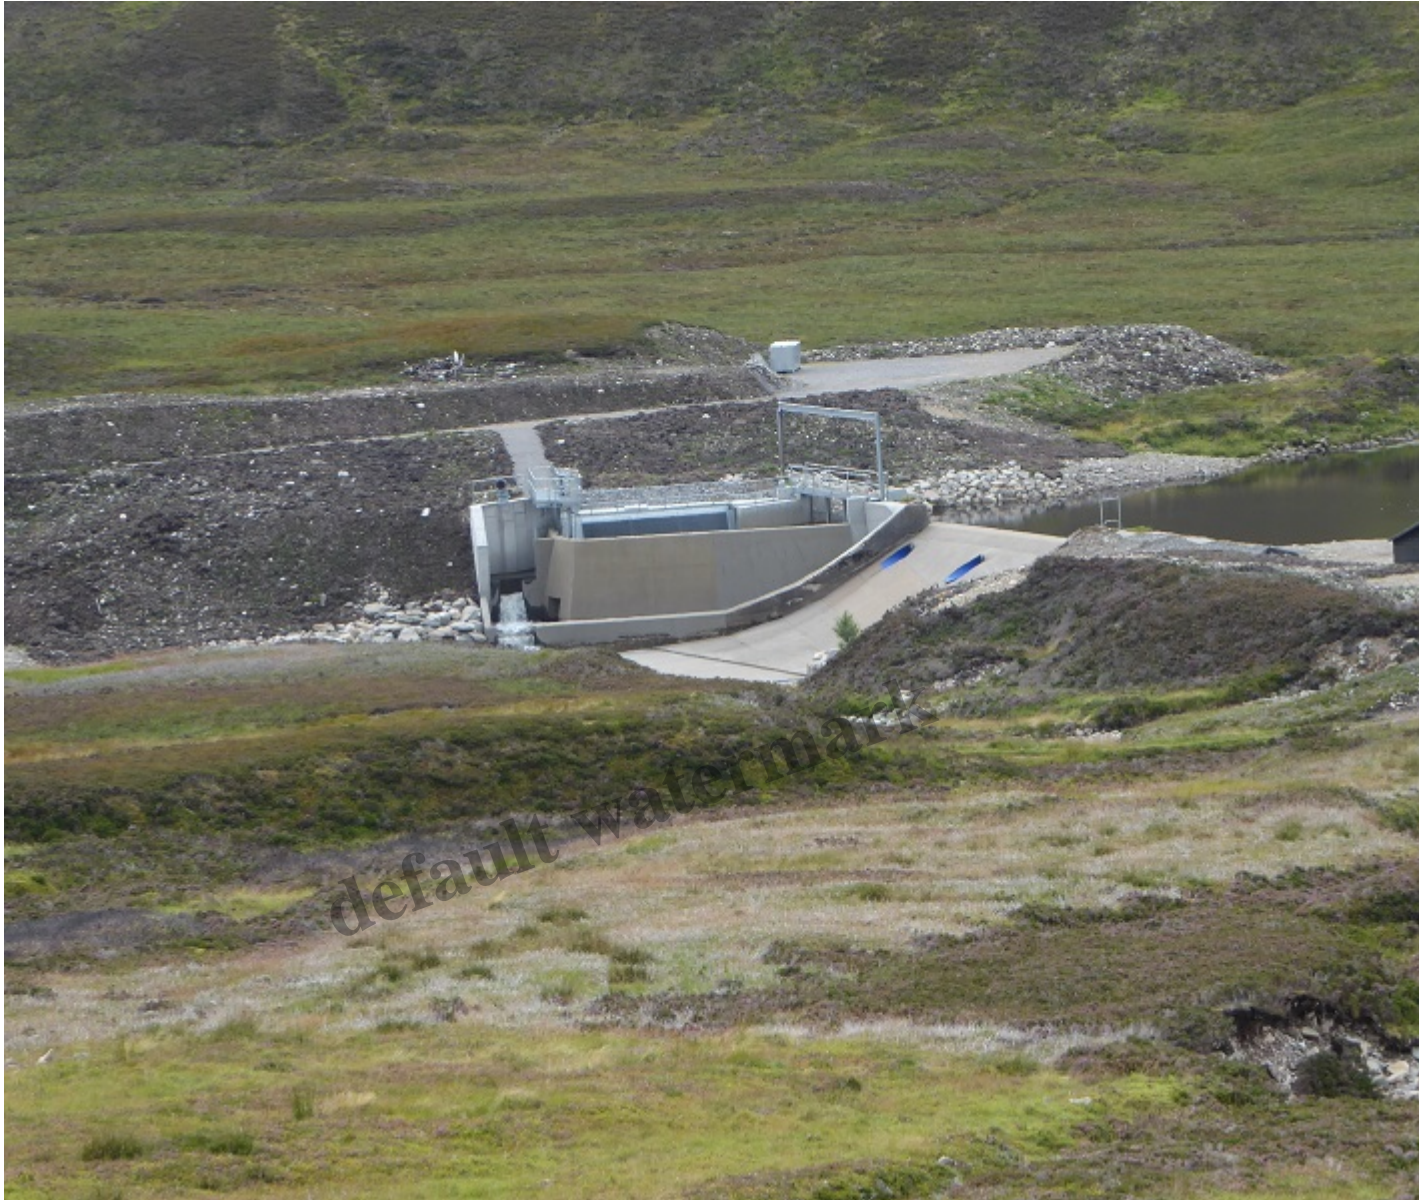
There are far fewer boulders in these peat on the far side of the dam though you can see top right at the large turning area where boulders and peat have been mixed

The old dam here has been raised by c1m. The dam wall itself hardly impacts on the landscape, the new intake wall and structures are more prominent from the angle this photos was taken as are the Lomond blue outlets. However, when you are on the floor of the glen these aspects of the development are hardly visible and in landscape terms the intake is well positioned.

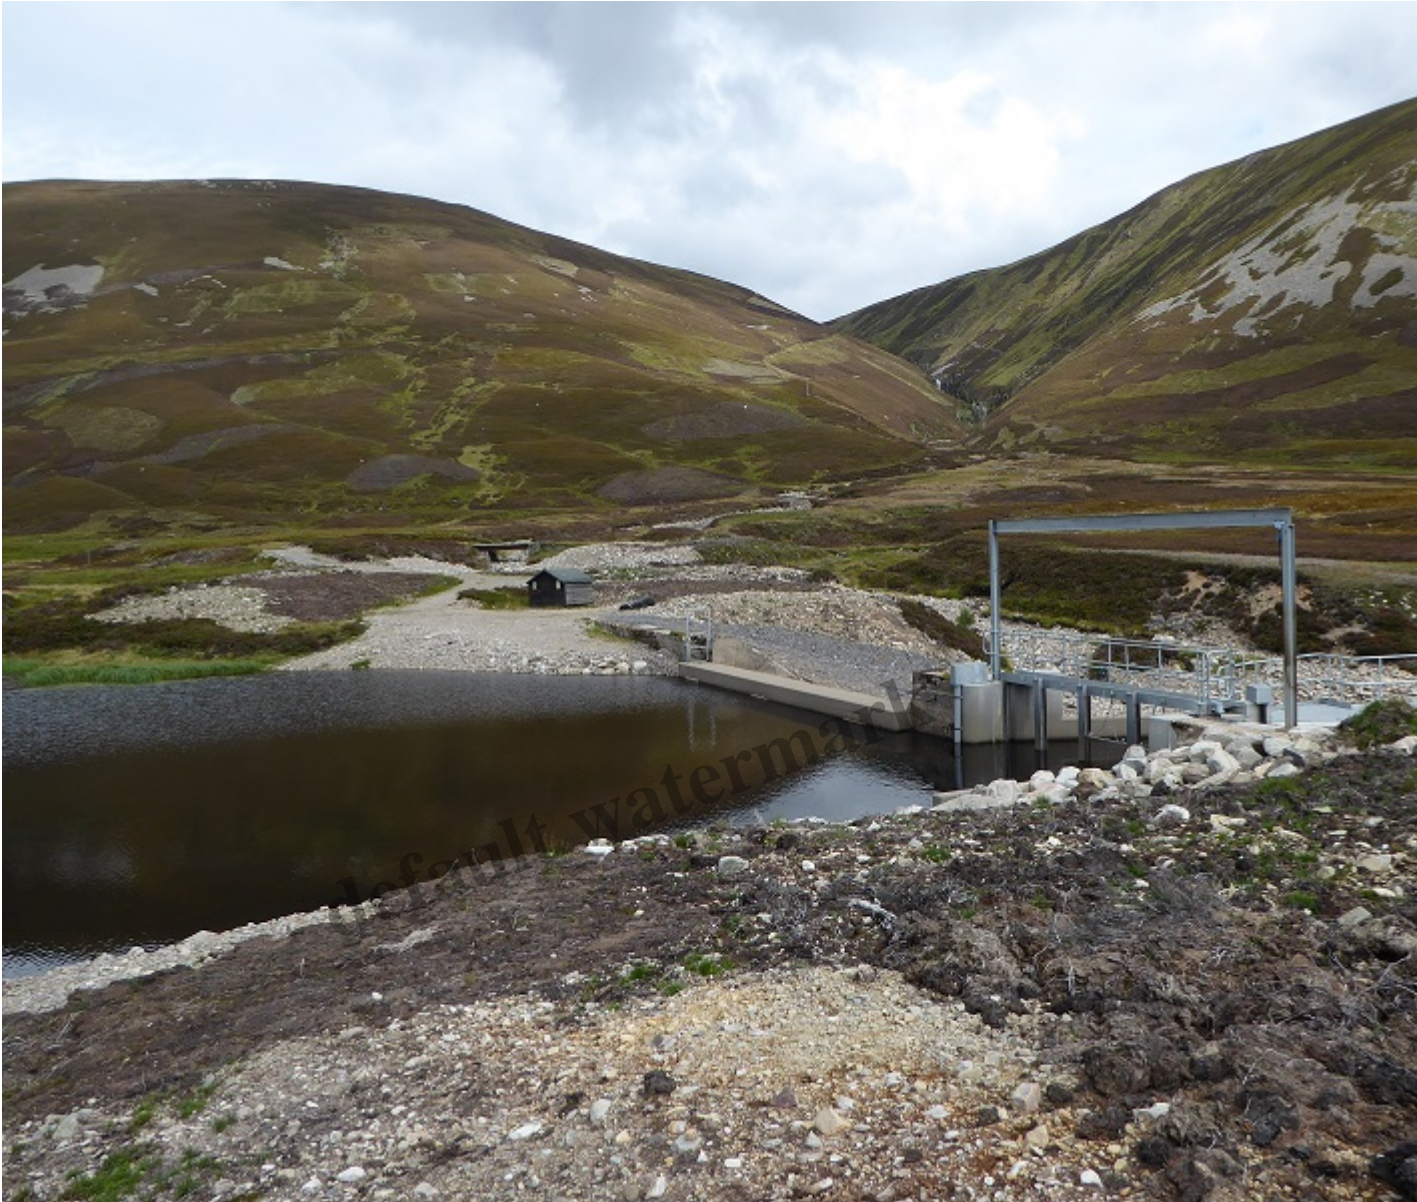
The restoration round the dam looks less good from the west.

Its clear though that even round the dam the restoration is far from complete. Why has the ground to the right been restored with peat but that in the centre foreground left as it is? When the Park granted planning permission in July 2012 a condition was that all of this area should be hidden within a new area of native woodland which would hide it completely and that plans for this would be provided BEFORE any work started. The plans were provided by Atholl Estates in February this year AFTER all the other work had finished and they then committed to planting in the spring of 2016. The CNPA told me in September the contractor was about to commence work.

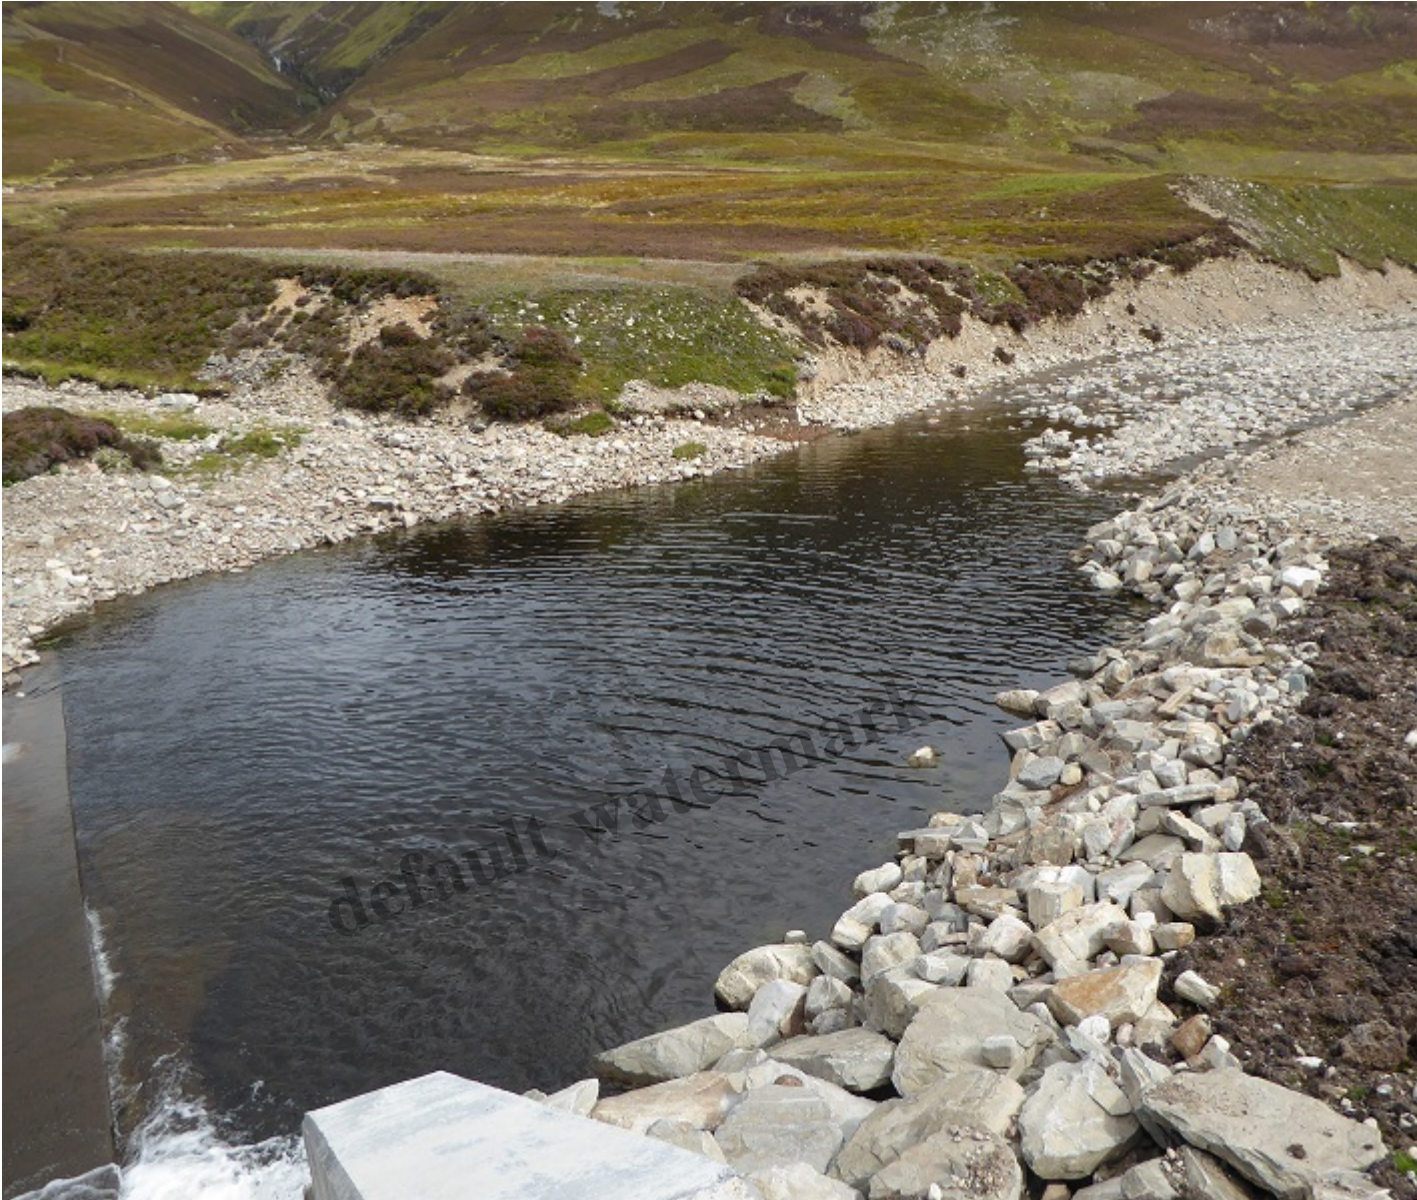
The incomplete landscaping work below the intake dam. The flat bulldozed area middle right awaits which will be taken from where? – and the plan appears to be to reinforce the river bank there with boulders from the pipeline.

The rip rap bouldering along the edge of the river contrasts with the natural erosion of materials that has taken place on the far bank.
