Another National Park planning failure – the hydro destruction in Glen Bruar

Bruar hydro scheme in construction May 2014

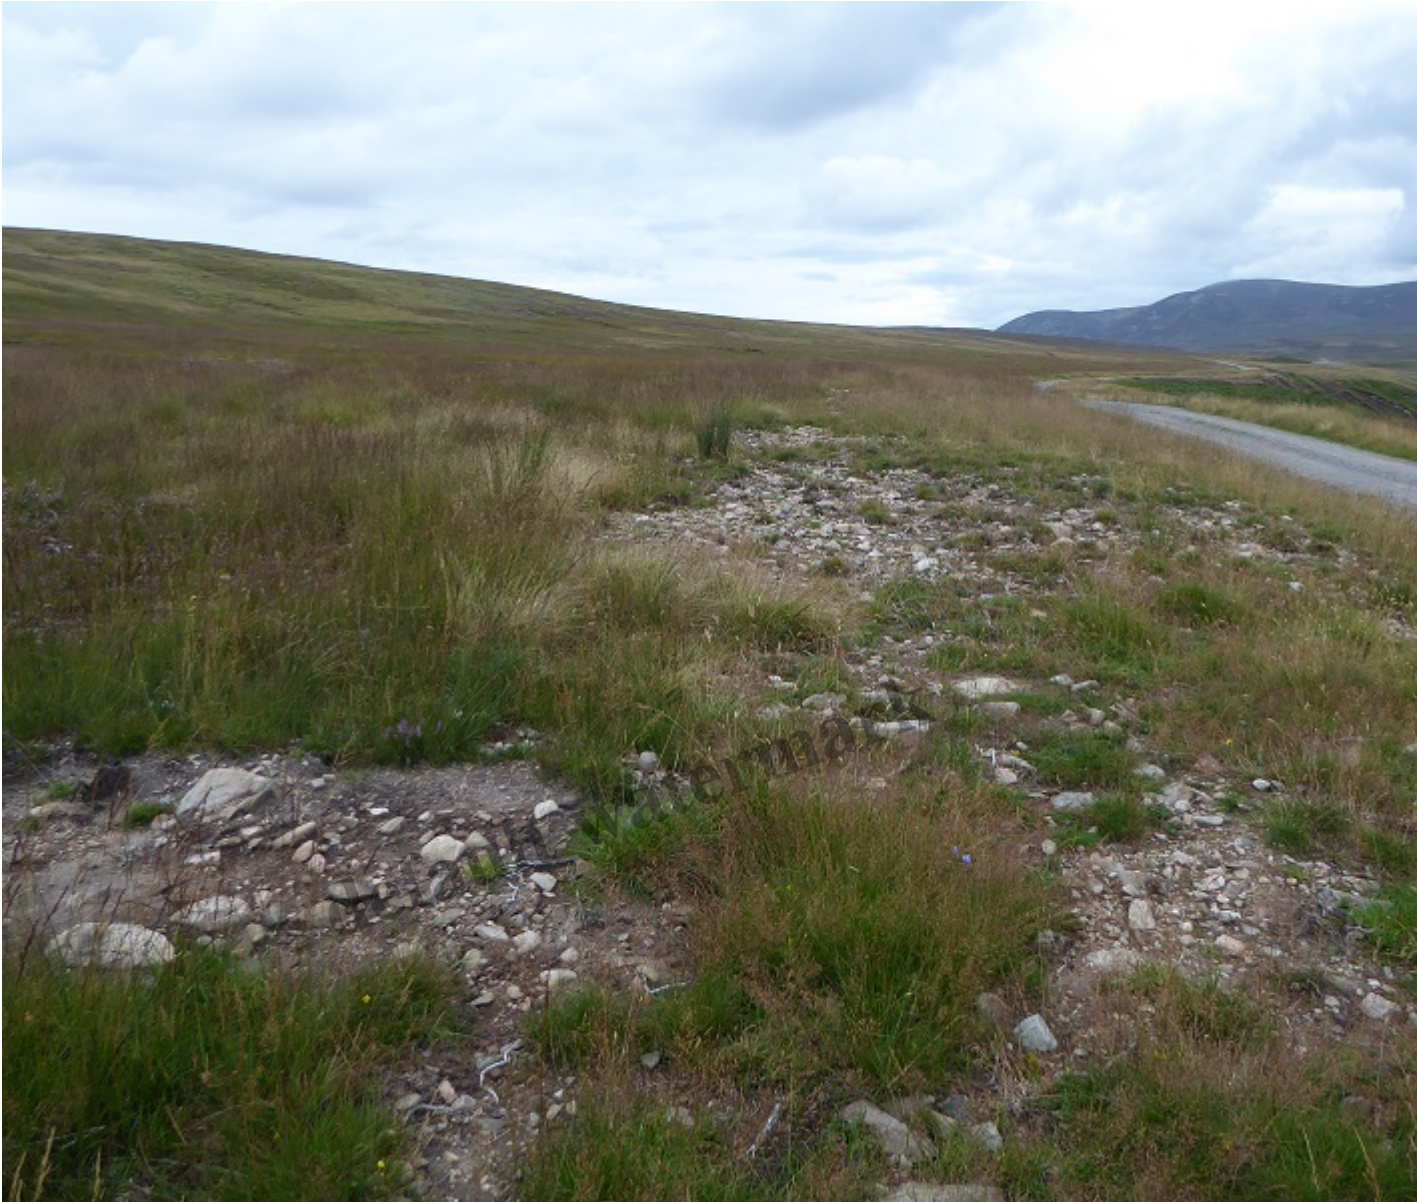
The new powerline runs alongside the existing access track from Calvine to Bruar Lodge.

While the new powerline is over 10k, its impact on the landscape has been relatively slight because not that much material had to be excavated to dig the trench where it was laid. While a lack of care in construction is evident – the photo above suggests that the turf removed to dig the trench was not properly stored as the developer said they would – vegetation is recovering quite quickly and I suspect in another year or so the line of the powerline will not be obvious to the casual observer.

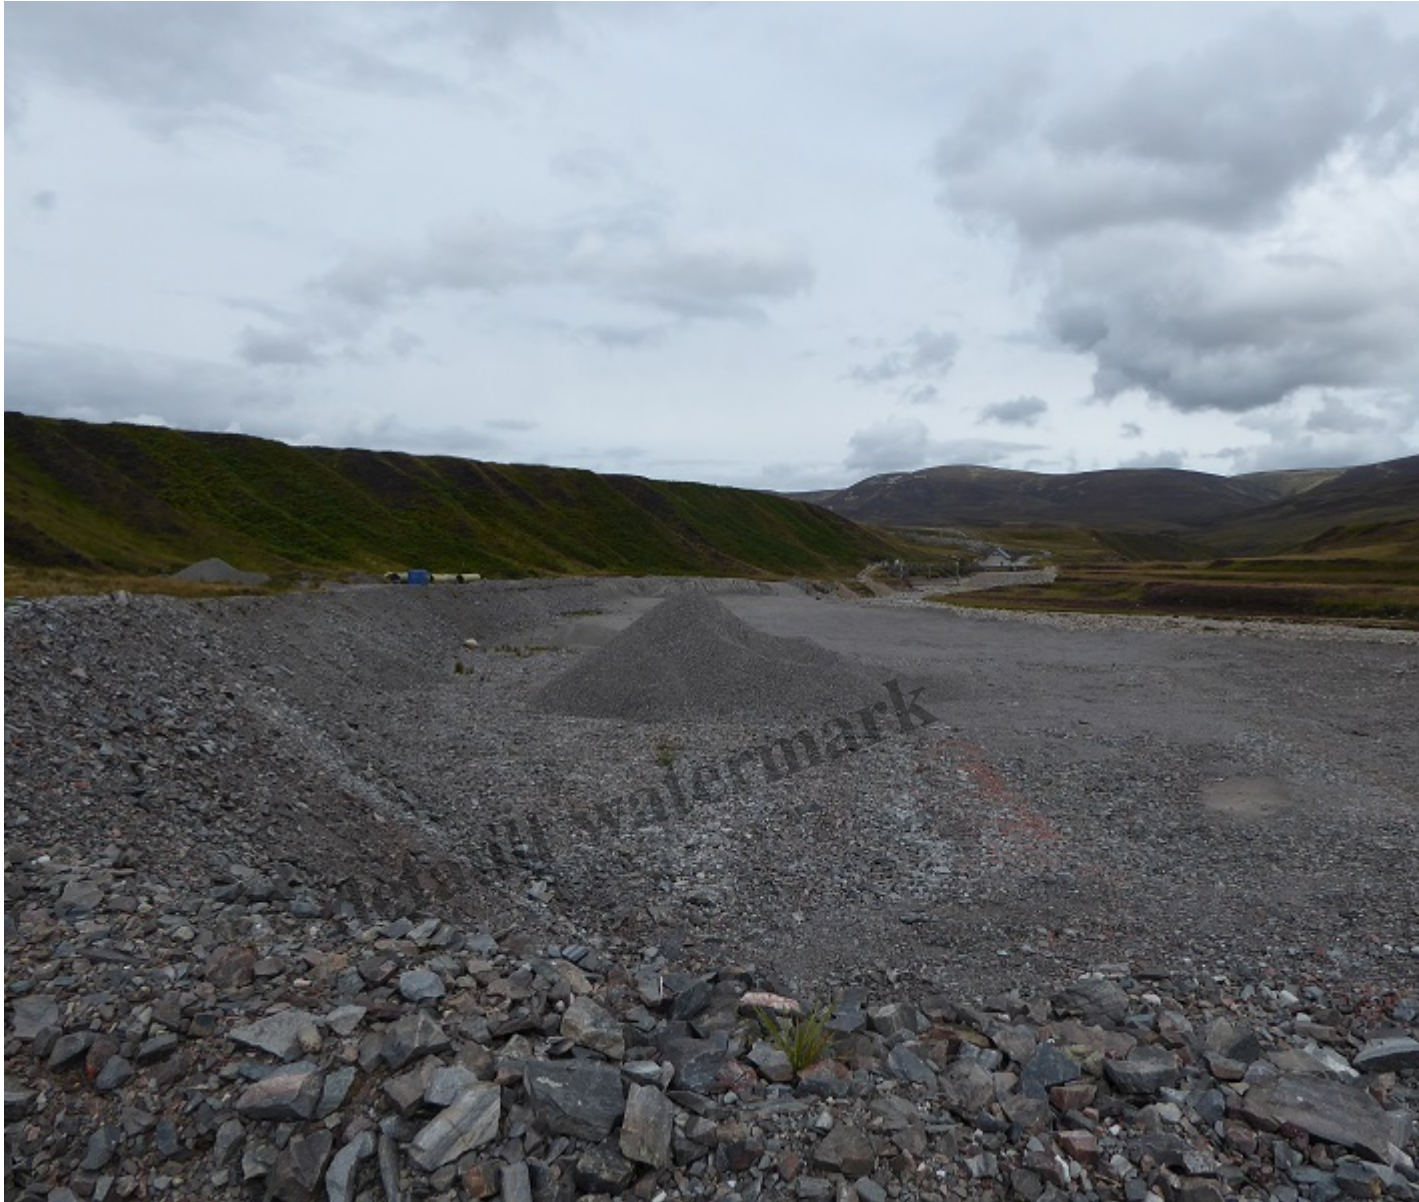
South of the powerhouse and the SSE intake is a large bulldozed area.

I can find no reference to this bulldozed area in the planning application or Committee report. While it probably dates from the construction of the SSE hydro tunnel it has clearly been used as part of Bruar hydro construction (see piles of aggregate top photo from 2014) possibly as a spoil pit to source aggregates to upgrade the track.

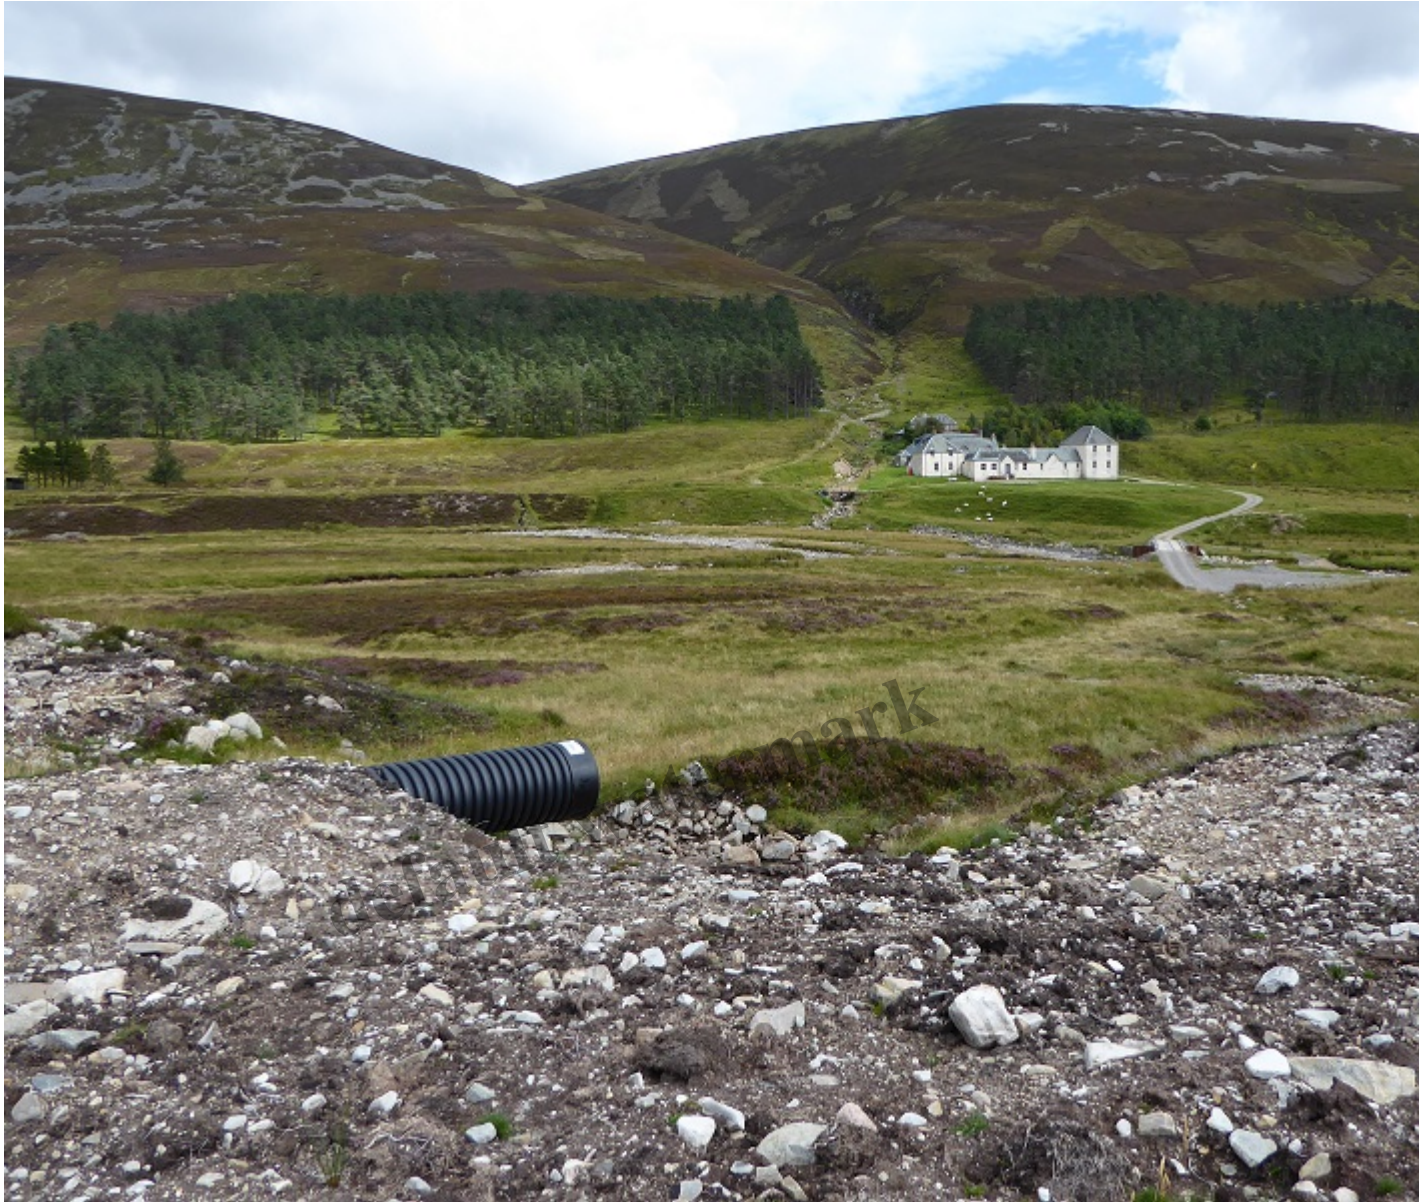
It would be difficult to find a worse example of finishing than this piped culvert opposite Bruar Lodge
