The Glen Bruar hydro track

This is my second post on the Bruar Hydro Scheme ([see here](#)) which I visited at the end of August. I am fairly confident that few of the issues identified in this post will have been remedied since my visit but would welcome more up to date photos from anyone who is in the area.

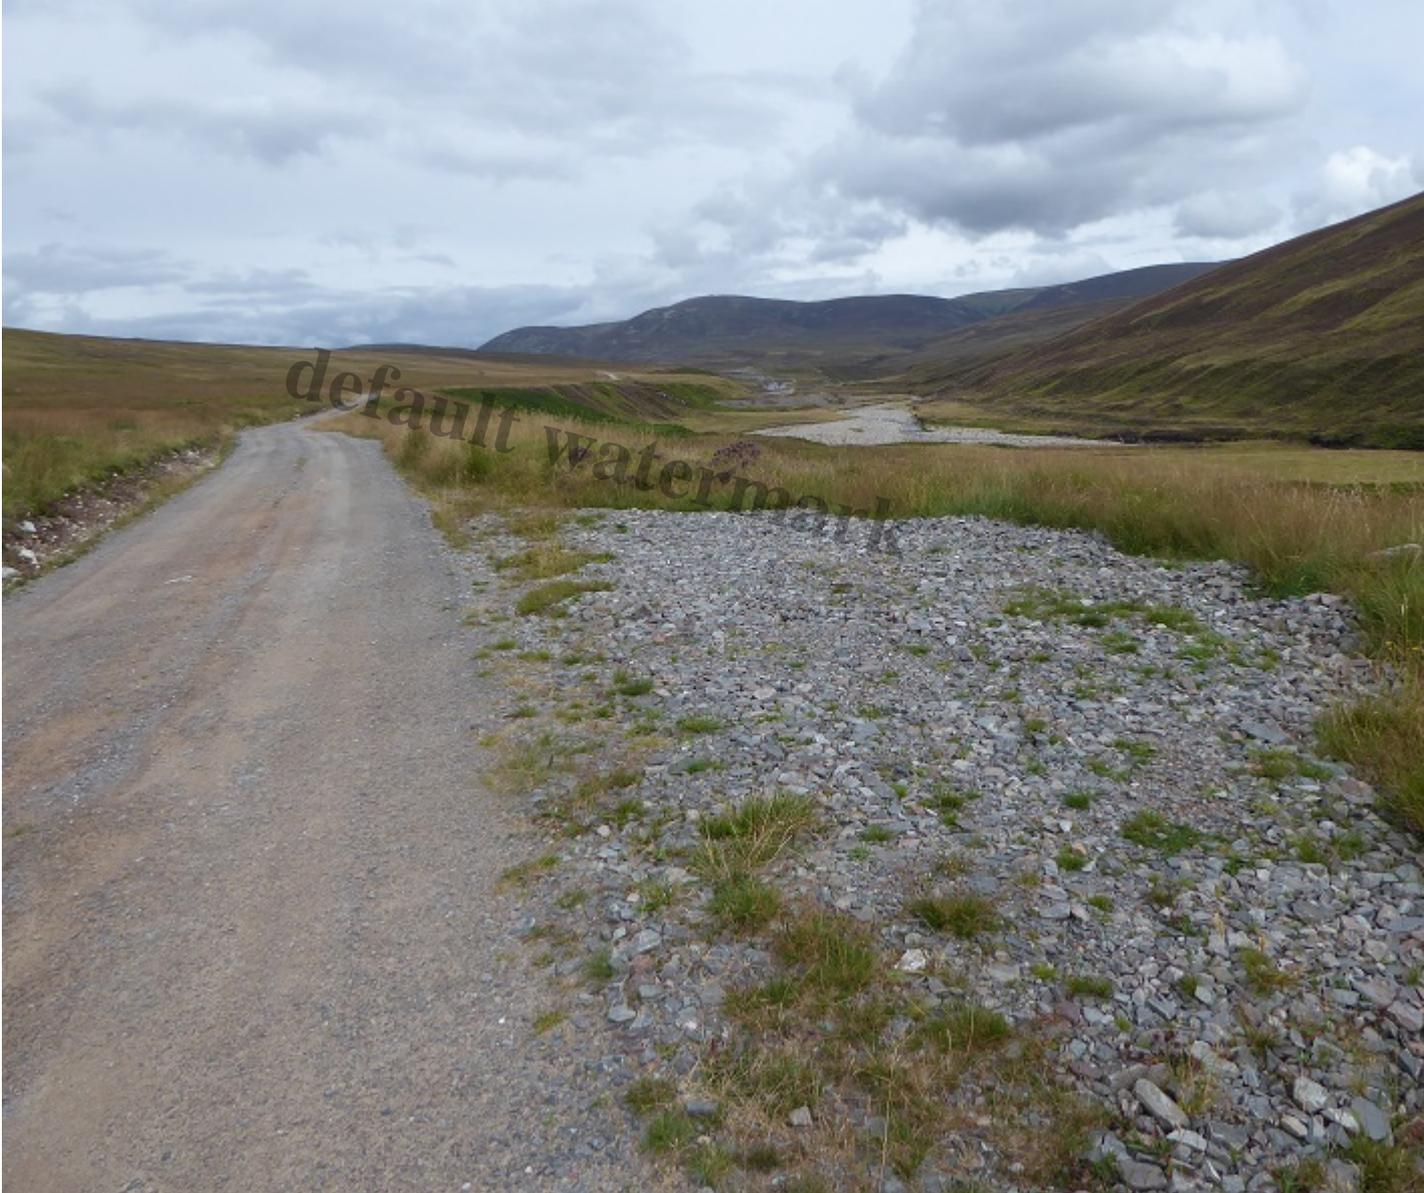
Looking north along the Bruar track, you get a sense of its length. The new hydro power house is re
Note the large expanse of aggregate dumped onto the vegetation on the right of the track.

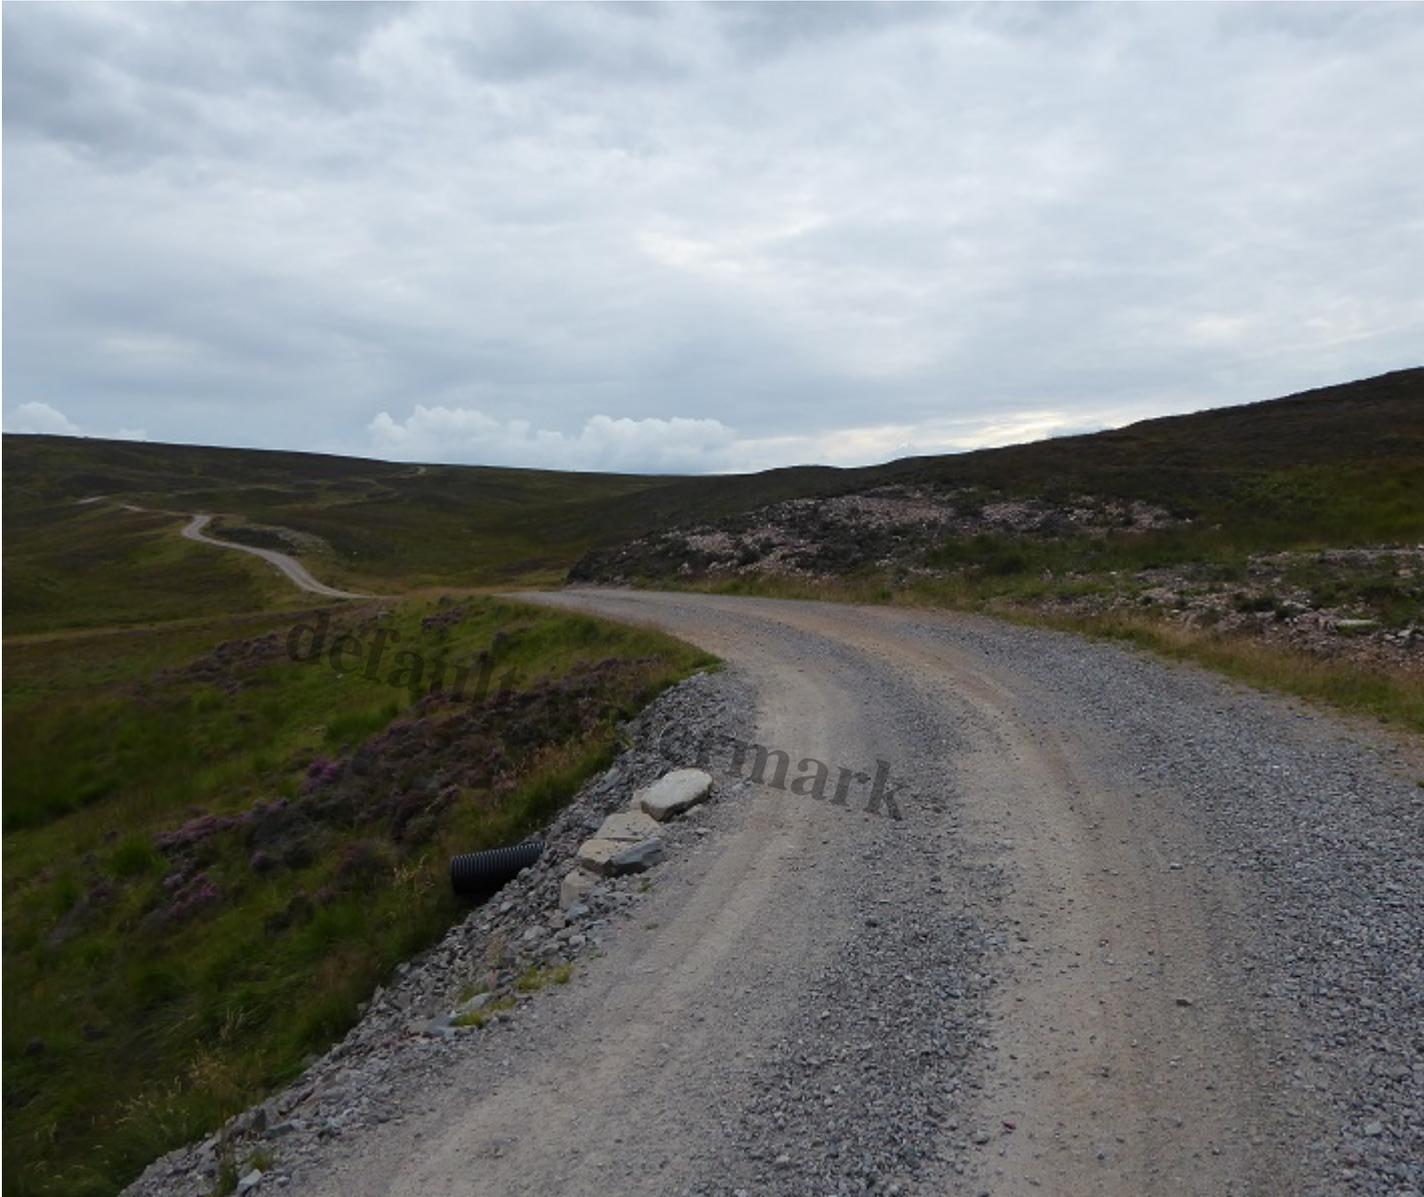
Looking south along the Bruar track as it rises over the hill to Calvine. This section of track has been less upgrading work but note the width of the track, the steep left edge which is unturfed and will erode the culvert pipe projecting into space. None of this meets SNH standards for Constructed Hill Tracks uplands.

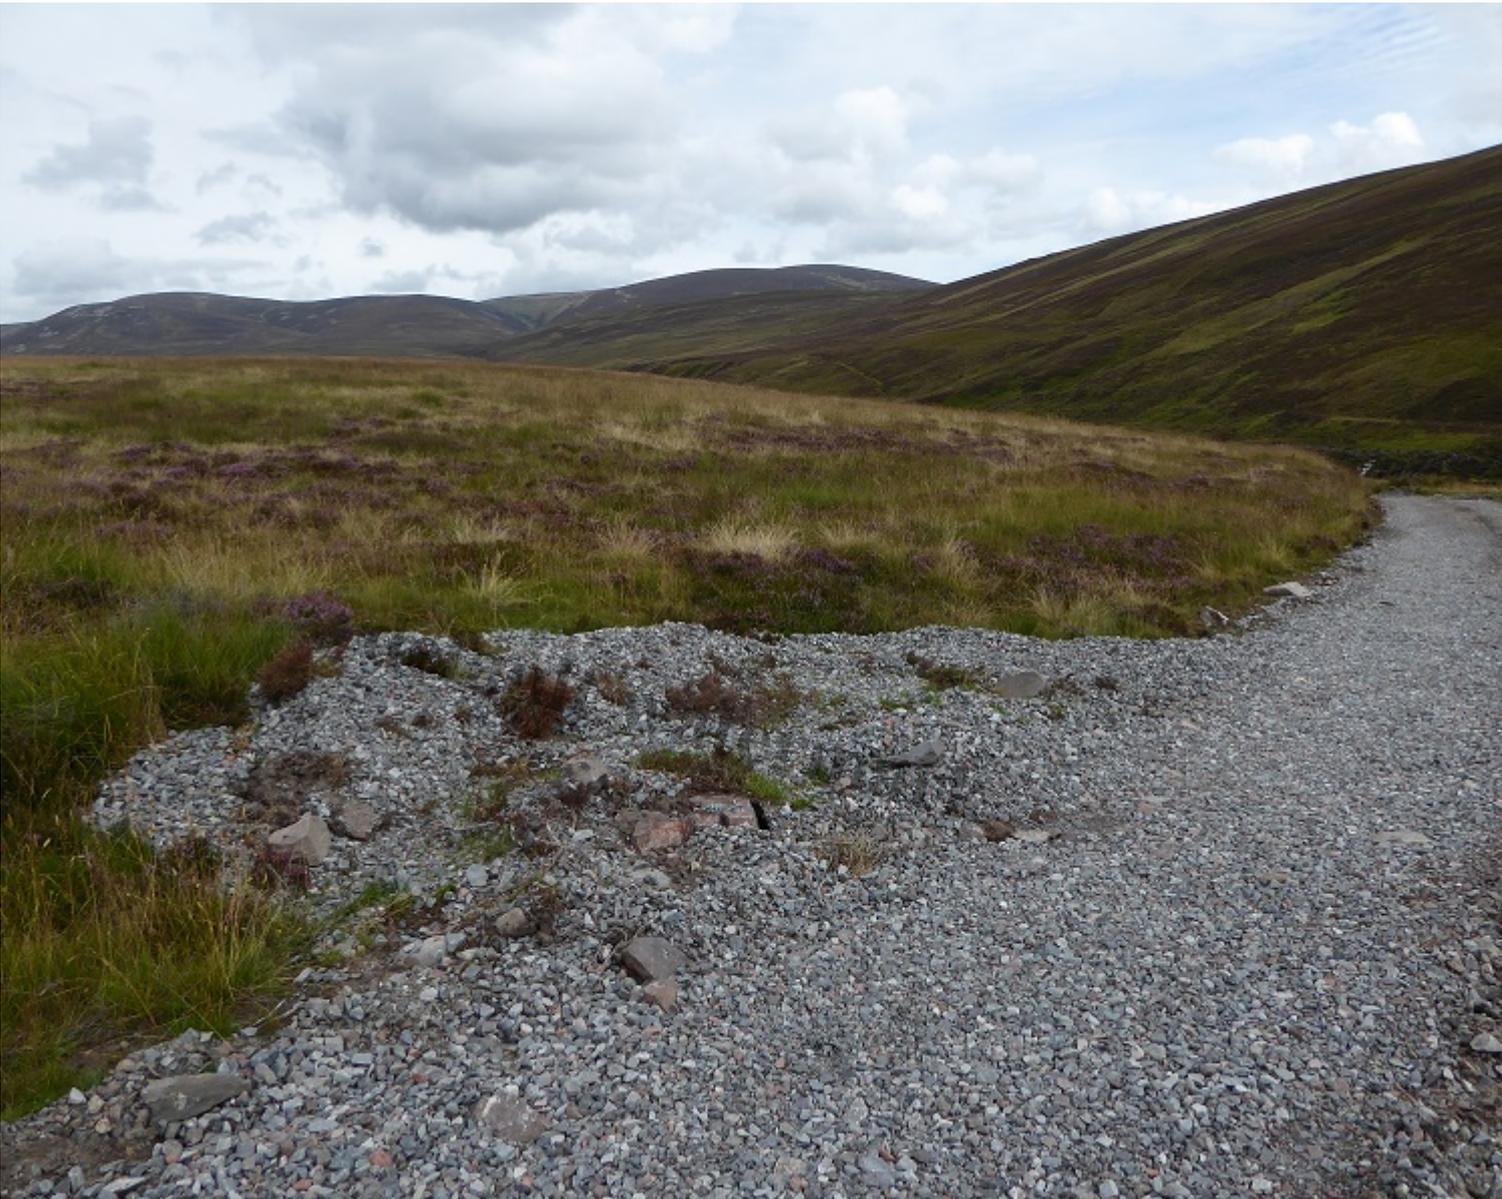
All along the track the remains of piles of aggregate, that have been dumped on vegetation, are clearly evident. The SNH Guidance on hill tracks [snh.org.uk/pdfs/publications/heritagemanagement/cons..](https://www.snh.org.uk/pdfs/publications/heritagemanagement/cons..) does not say anything explicitly about storage of track materials – my guess is that this is because it assumed track constructors would never dump materials in this. Other parts of the guidance make it very clear it expected the verges of hill tracks to be properly restored:

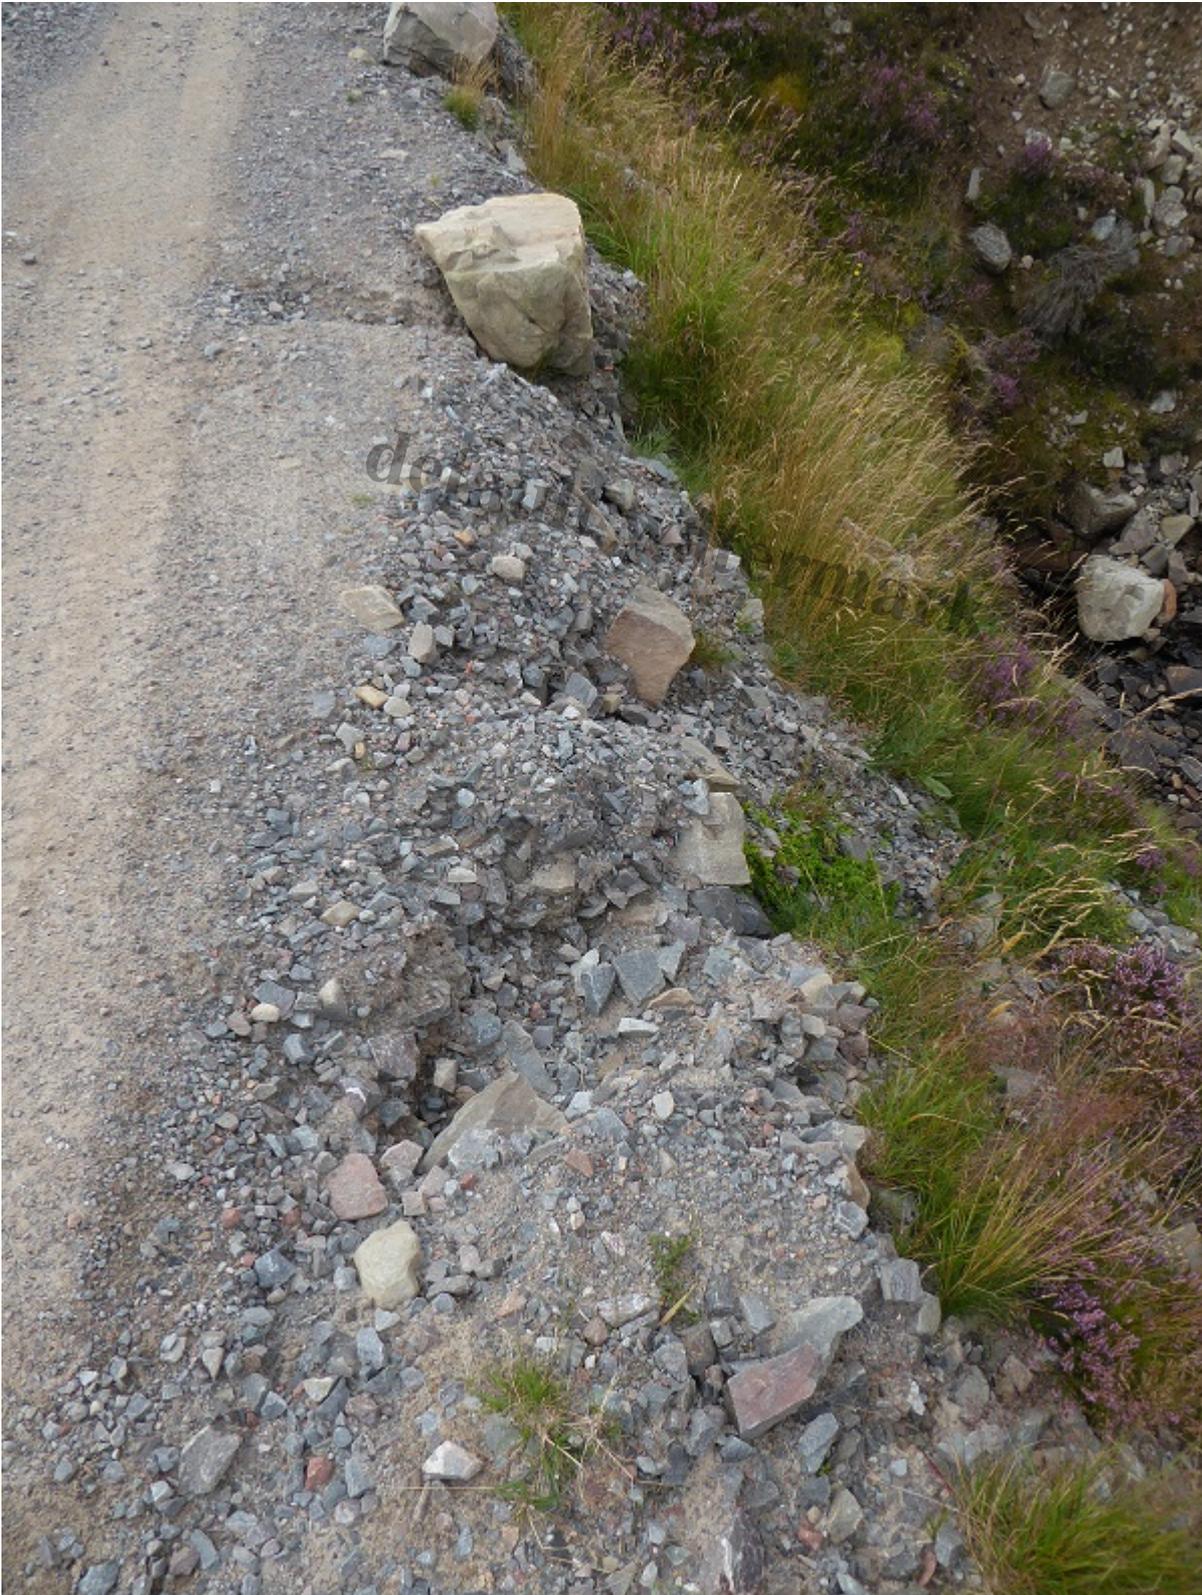
The side of the track here is eroding away and into the burn below. The SNH Guidance is very strong on the need to prevent track materials being washed into burns.

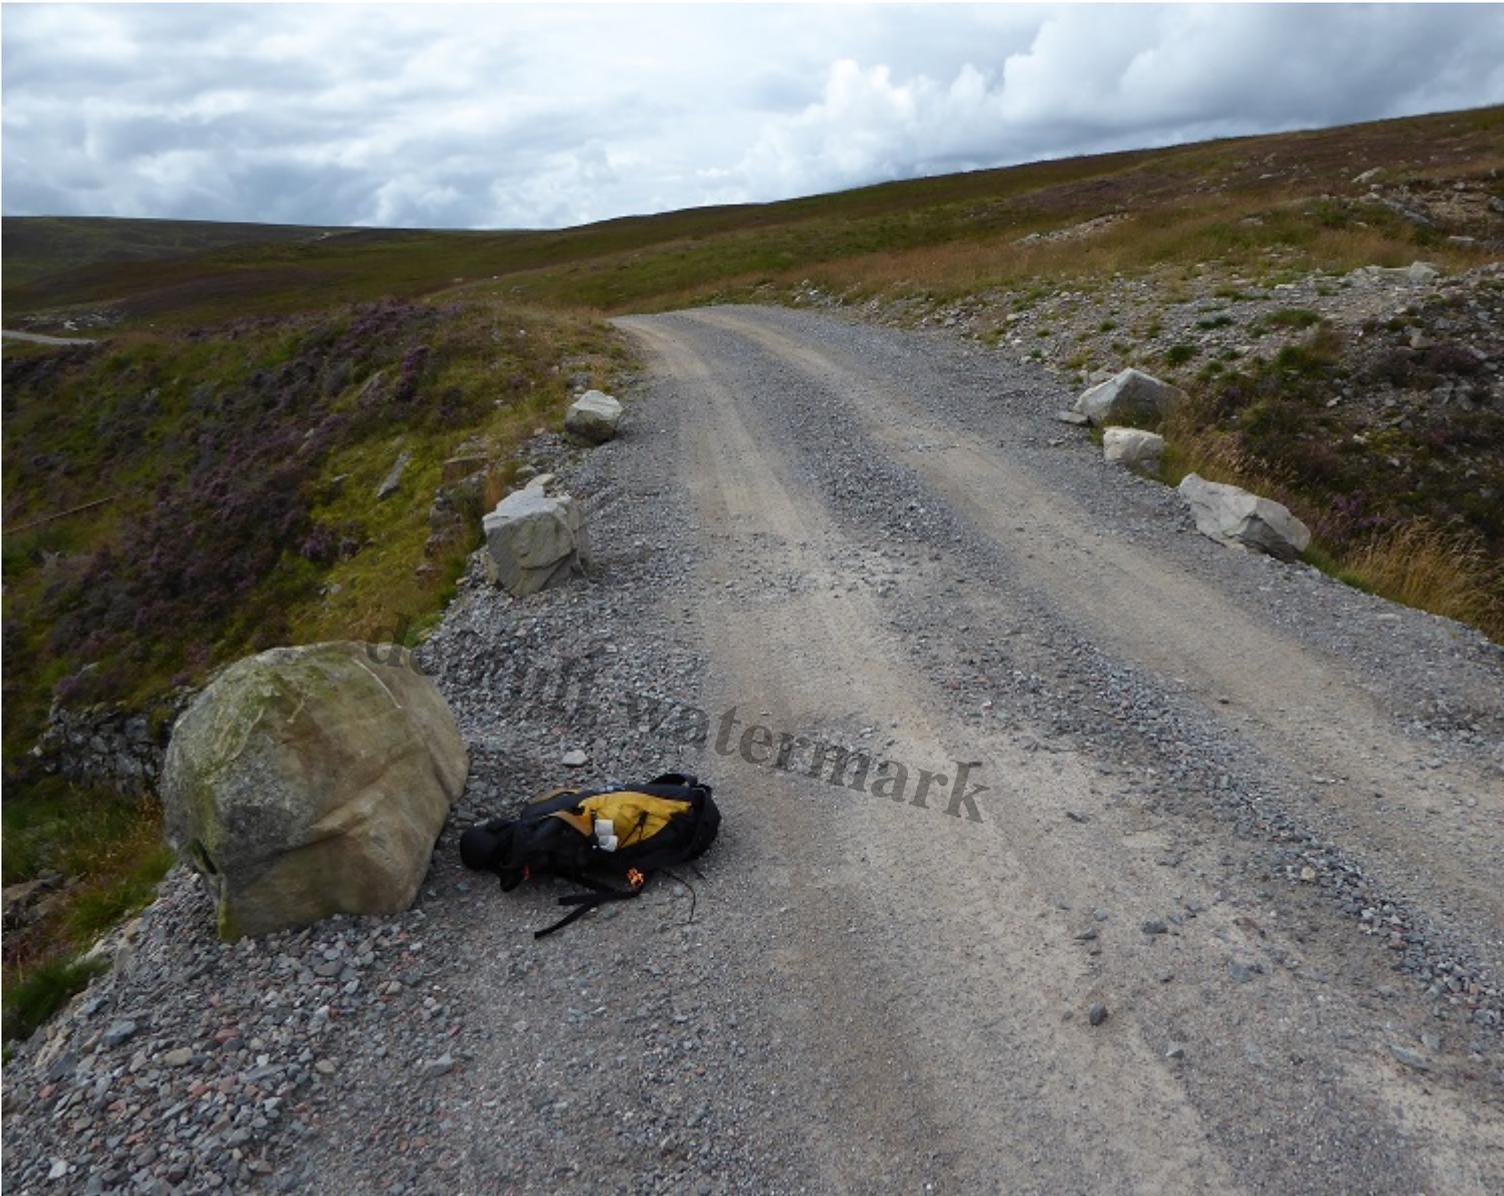
Another view of the eroding track edge. Note the boulders placed to prevent vehicles driving off the edge and the width of the track. Its c4m wide at this point. According to SNH Guidance the maximum required for 4 wheeled drive vehicles is 3m and Lomond and Trossachs National Park Guidance indicates a maximum width of 2.5m on straight lengths of track. This track should have been reduced in width once the construction had finished. There is no sign there has been any attempt to do this.

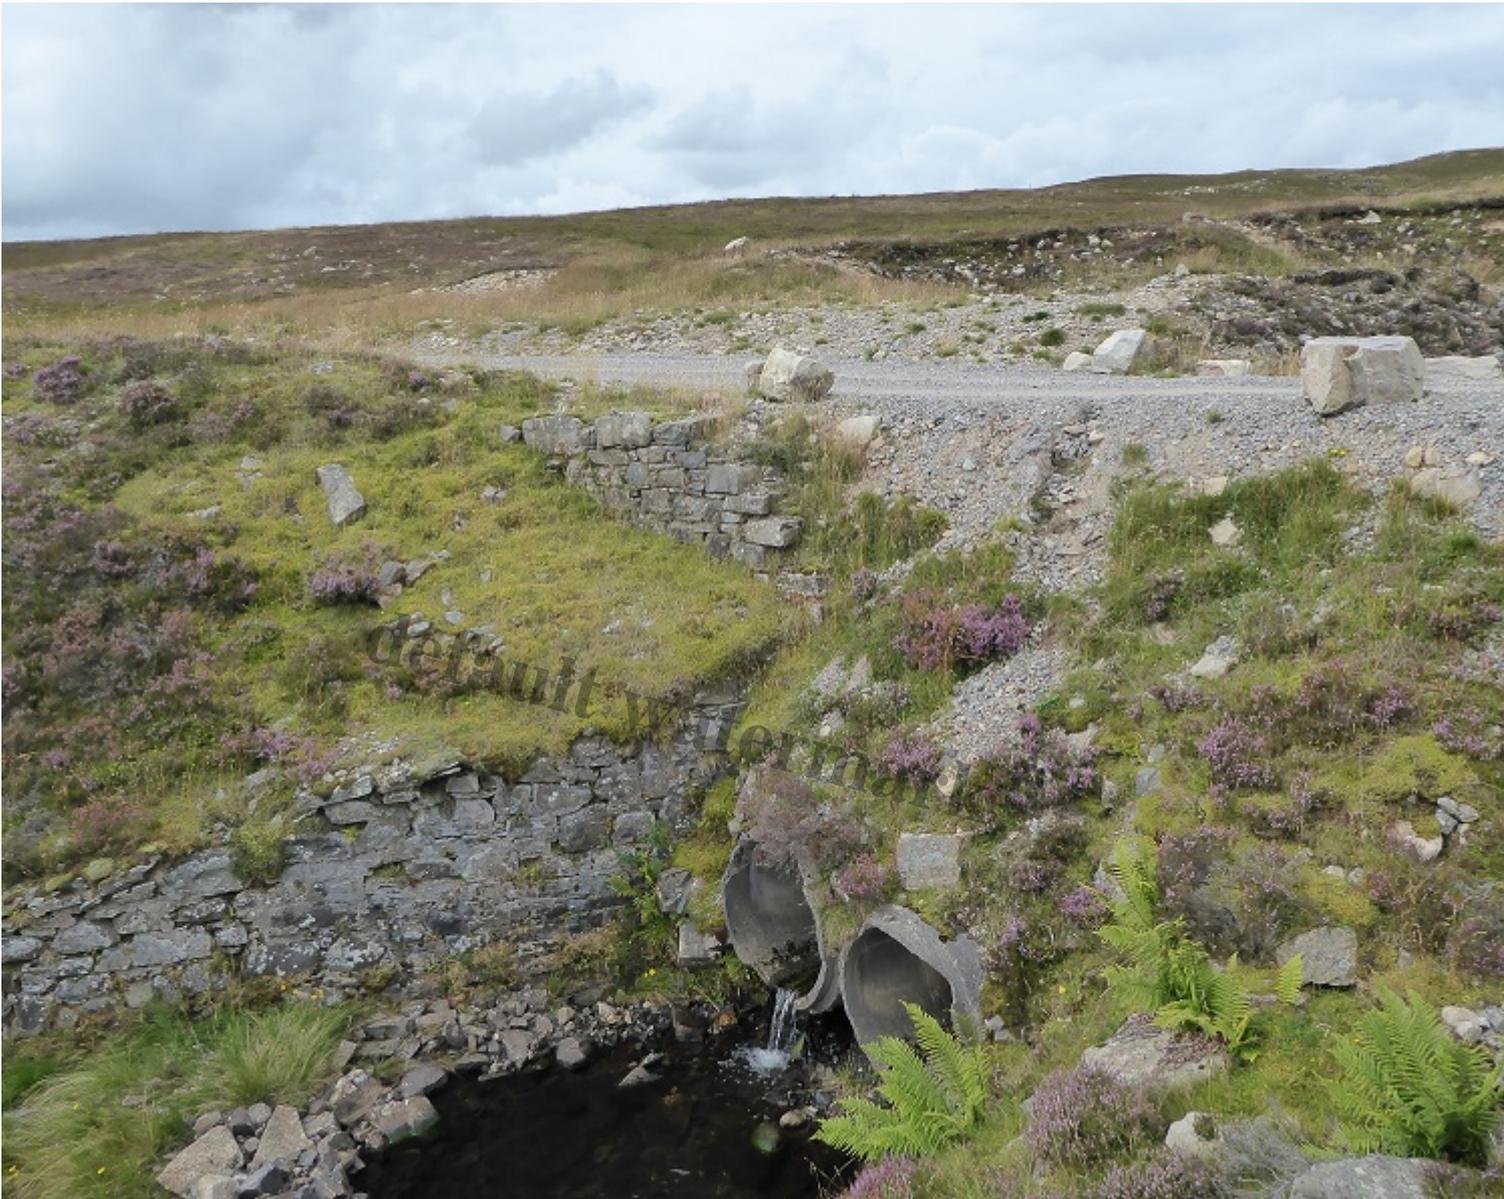
Another view of the same section of track. Contrast the finishing of the original track here – the stone facing – with the latest work which appears to have consisted of dumping aggregate on and alongside the old track without any attempt at finishing.

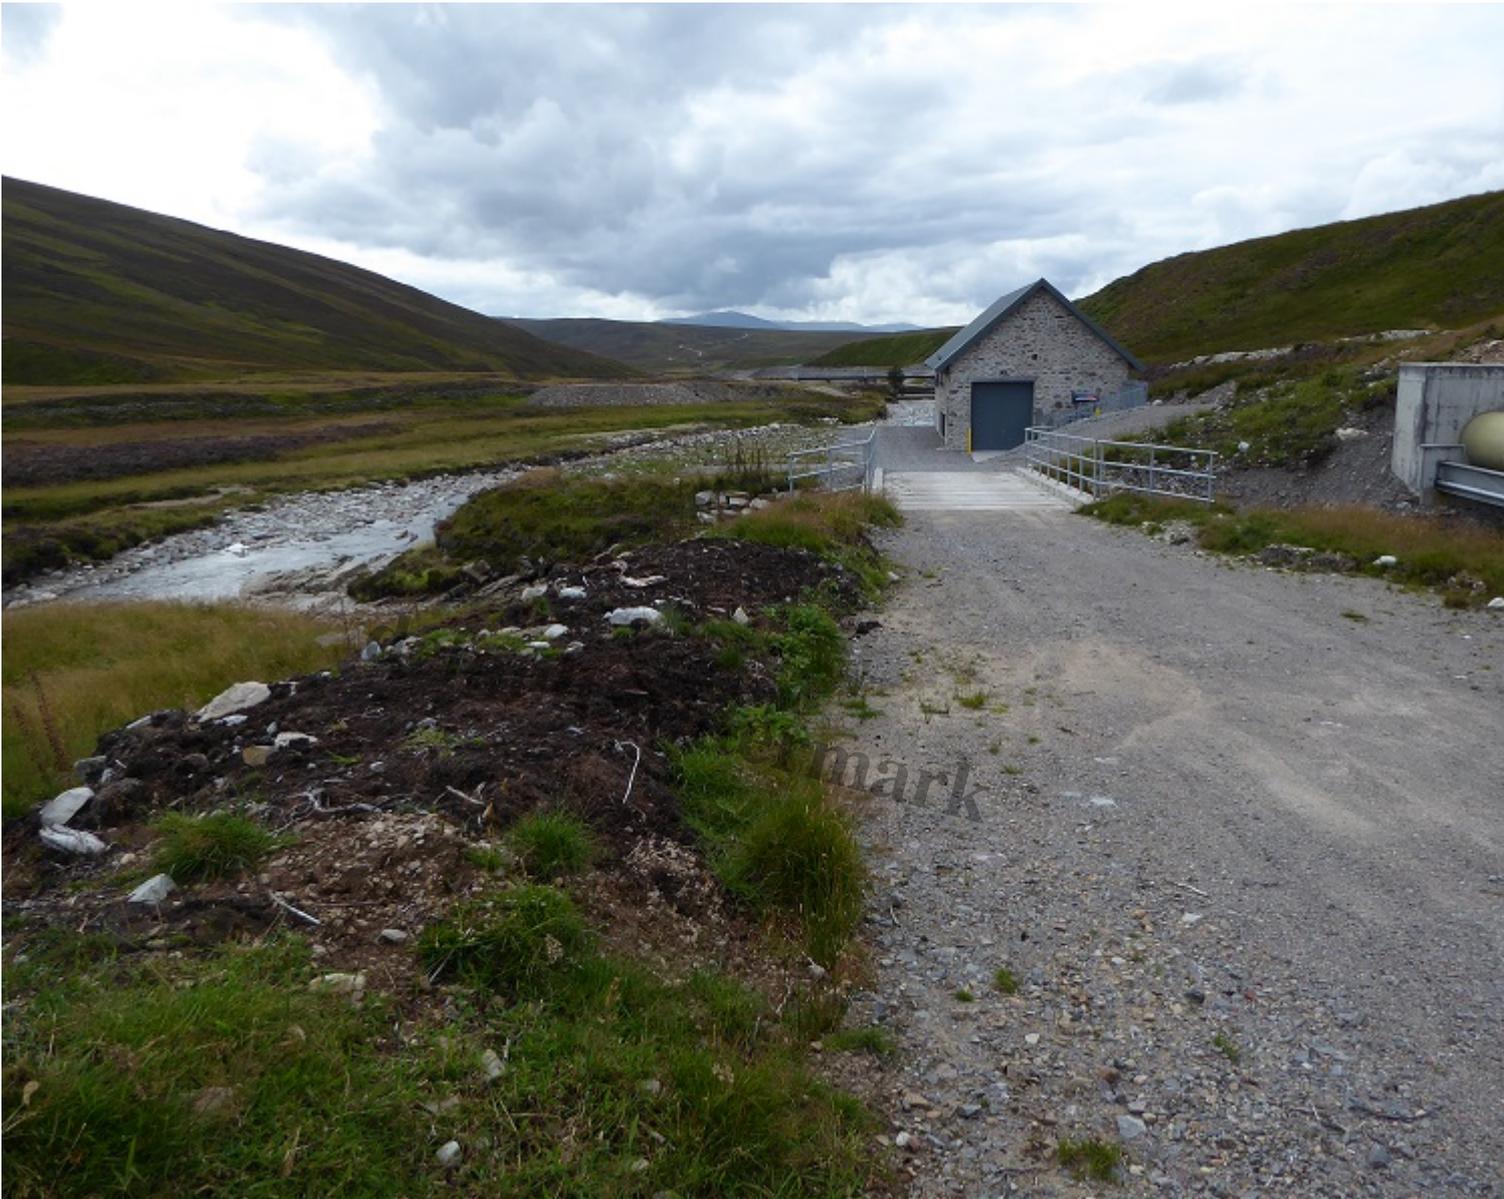
No requirements were made for the new section of track to the powerhouse. While there have been attempts made to revegetate the verges of the new sections of track, the track here is far wider than it need be.

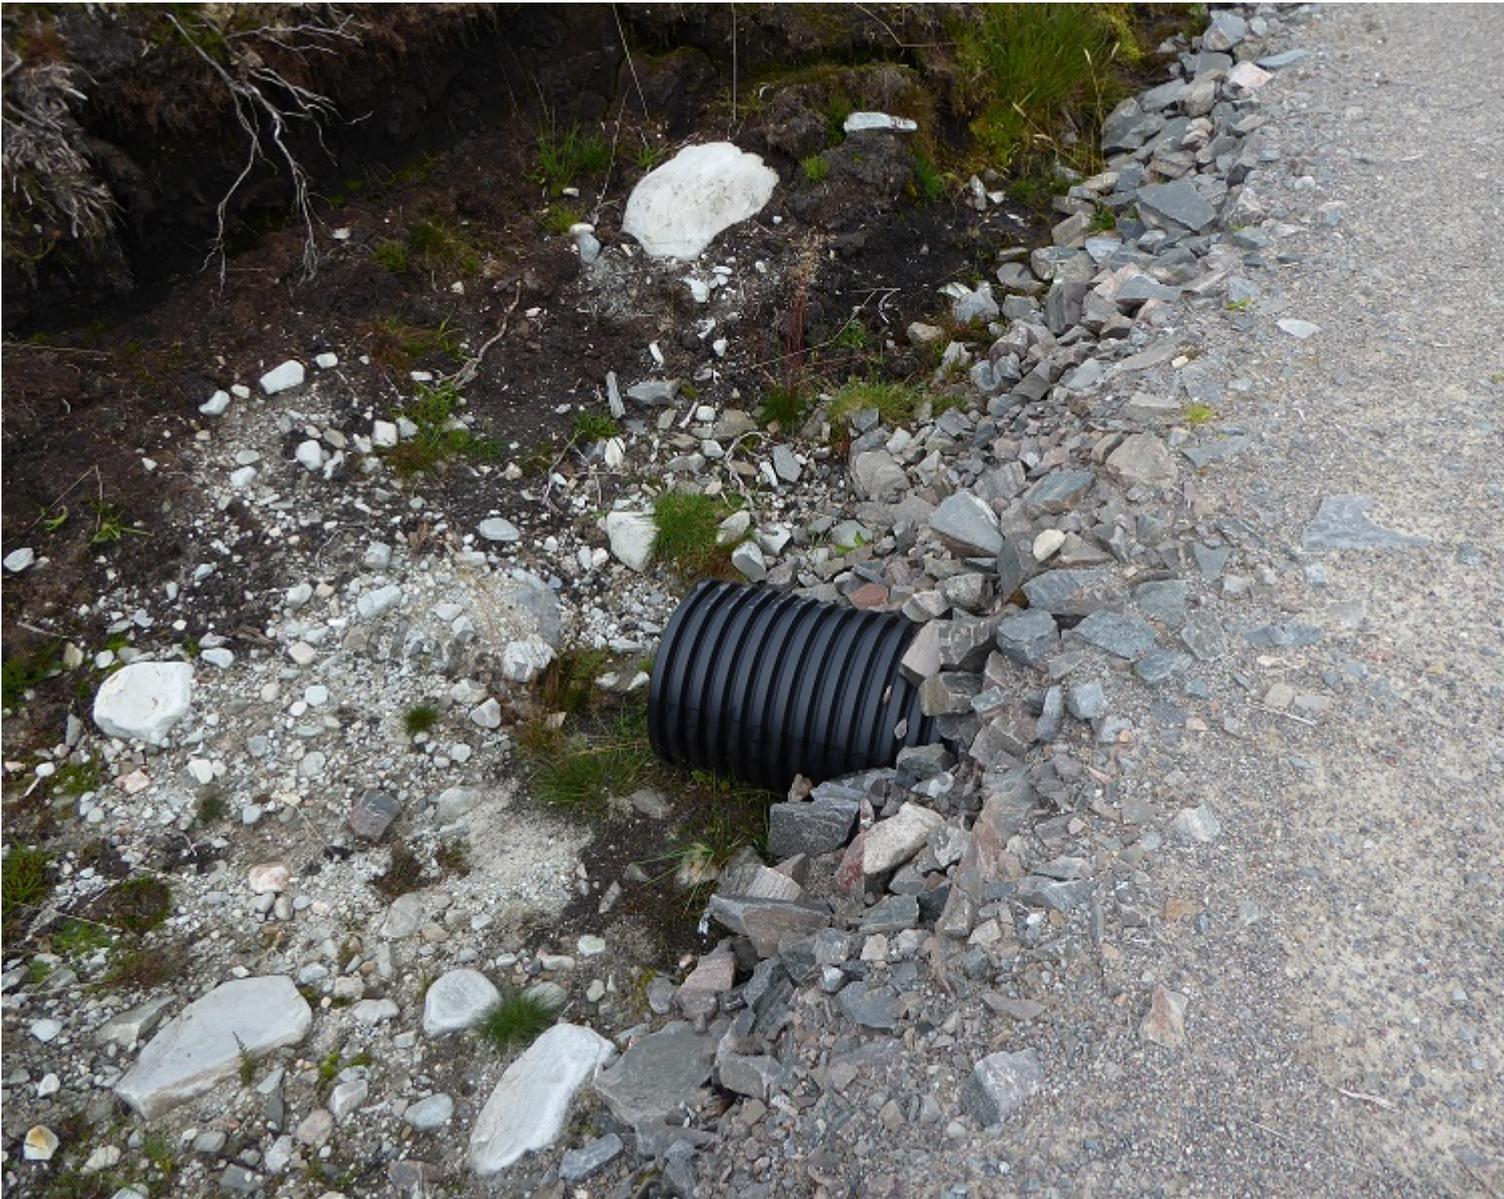
Contrast the way this culvert has been constructed – which is typical of the culverts along the new sections of track – with what the SNH Guidance says on how it should be done:

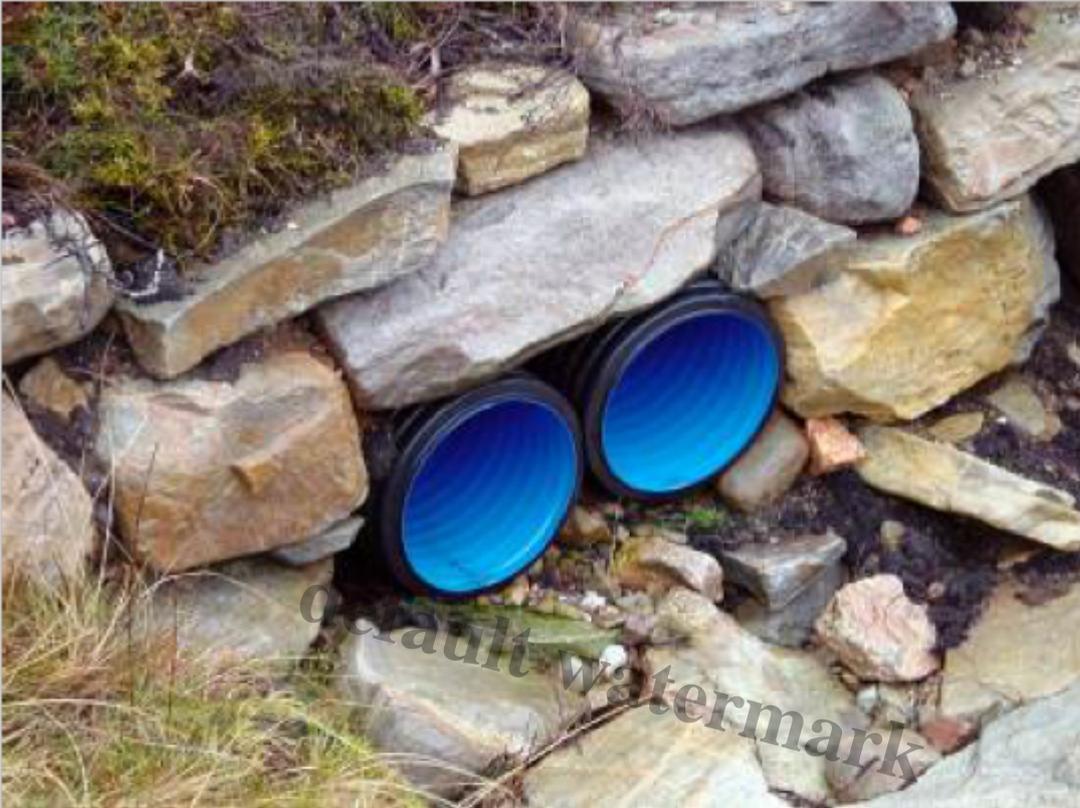
Stone facing can help culverts blend into the surrounding landscape. Culvert pipes should, however be set back into the stonework to minimise their visual prominence. Culverts should be sunk into the bed of the channel to allow access by fish and other species, and not left 'perched' as in this example. It is preferable to use a single larger pipe since this will carry more water and will be less prone to blockage.

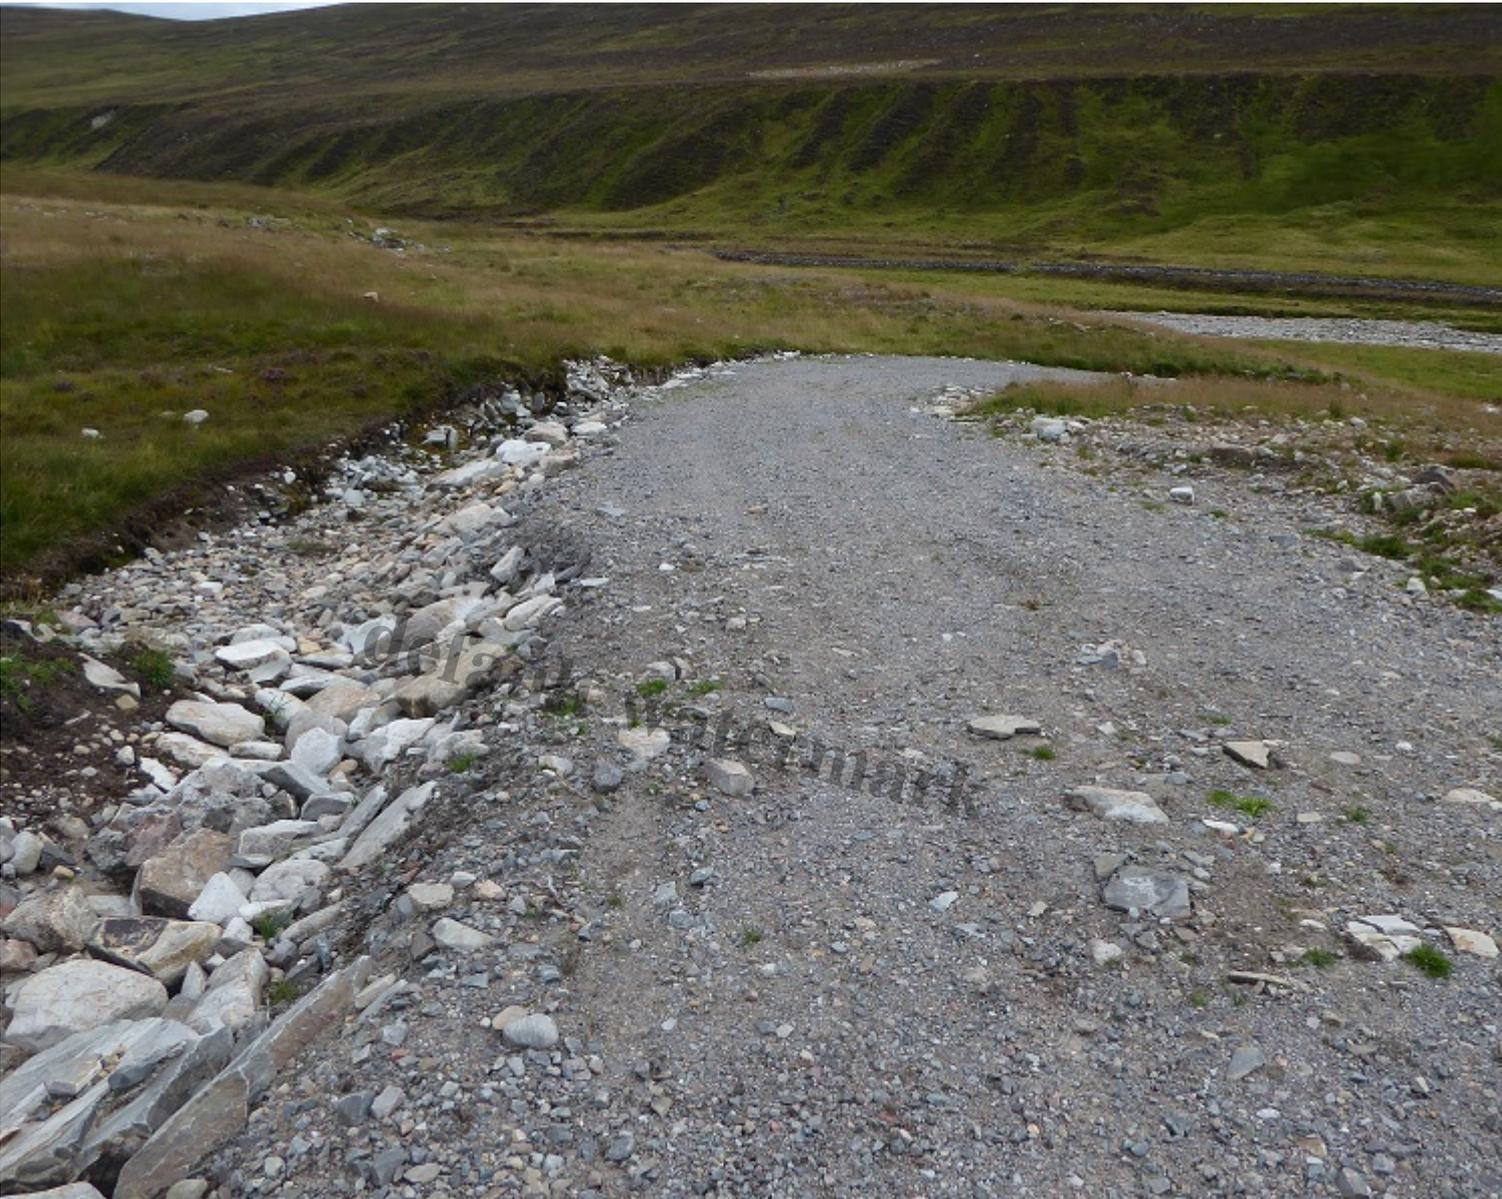
A new drainage ditch has been dug along this section of upgraded track, its unfinished ditches and edge of track on left is unfinished – there has been no attempt to revegetate it, either with turfs or re-seeding.

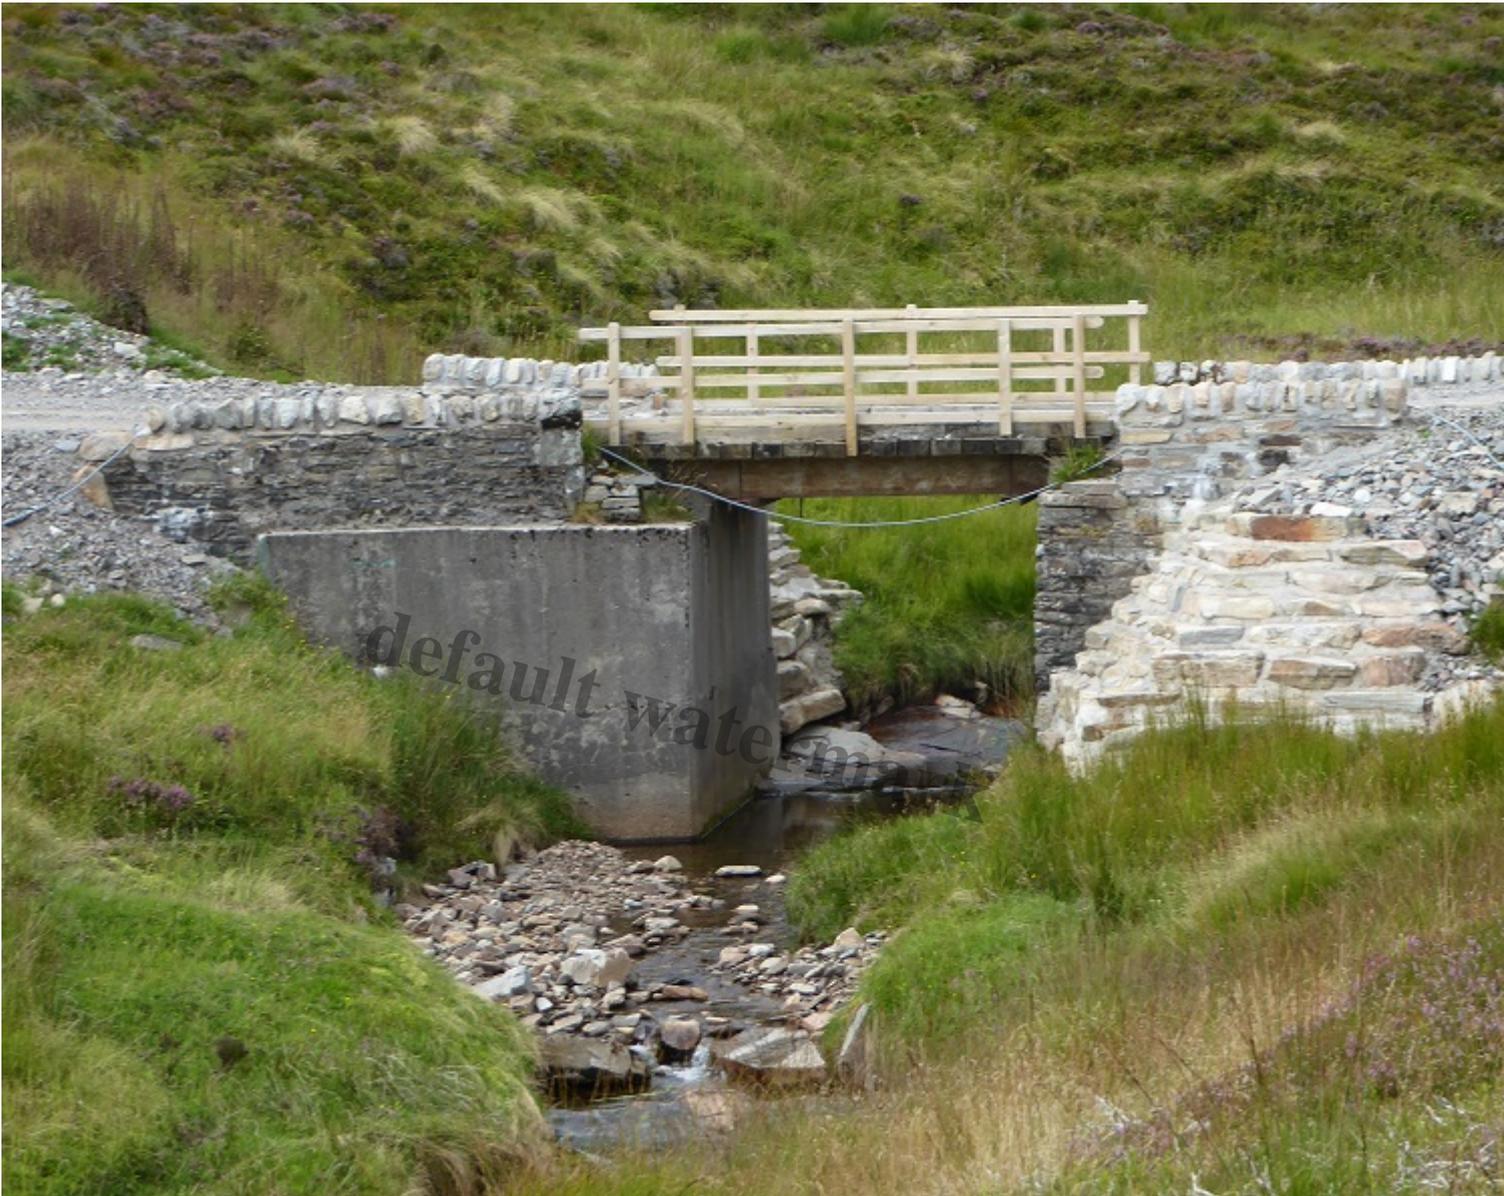
Among the kilometres of upgrade track where there has been little or no attempt to mitigate the landscapes or environmental impacts of the work, this bridge stands out as an exception. Note the new retaining buttress on the right. Unfortunately it appears the work has never been finished as material is still spilling down round the edges of the stone work on either side of the bridge.

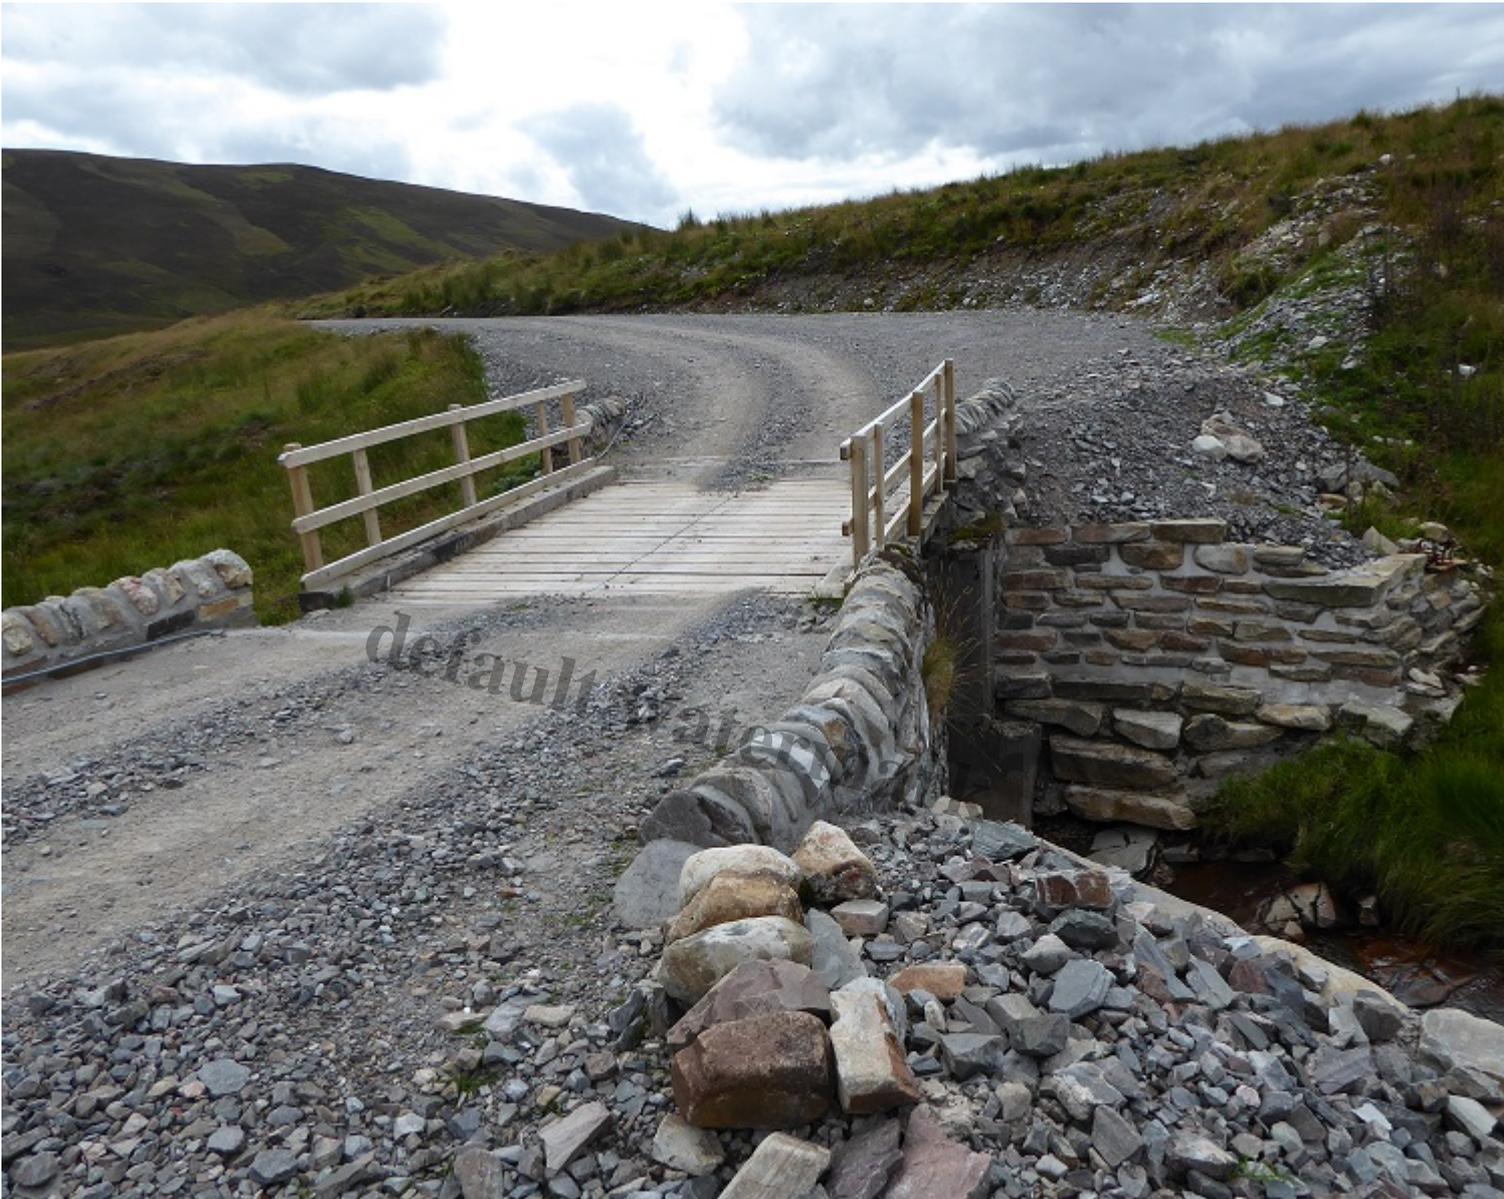
Another view of the not quite finished bridge
