The Glen Bruar hydro track

This is my second post on the Bruar Hydro Scheme ([see here](#)) which I visited at the end of August. I am fairly confident that few of the issues identified in this post will have been remedied since my visit but would welcome more up to date photos from anyone who is in the area.

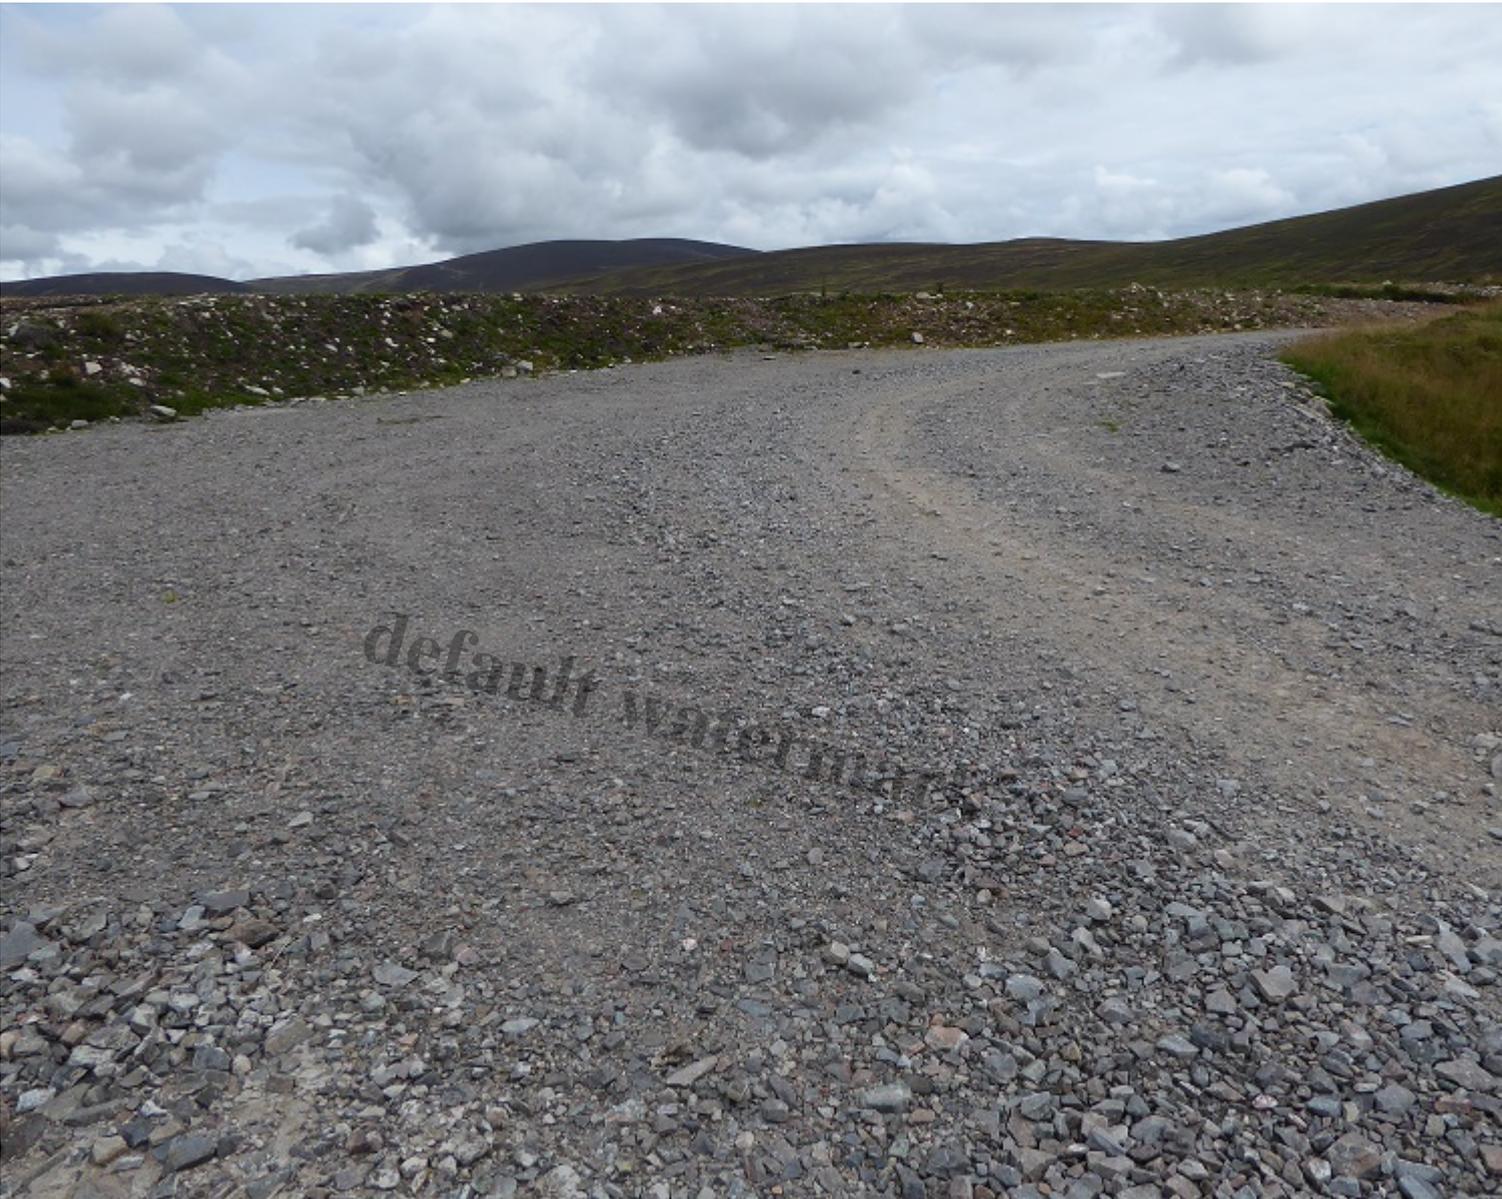
While the SNH Guidance allows for passing places this corner would be more suited to a race track. Large areas of vegetation have been destroyed and never restored. How can this be allowed in a National Park?

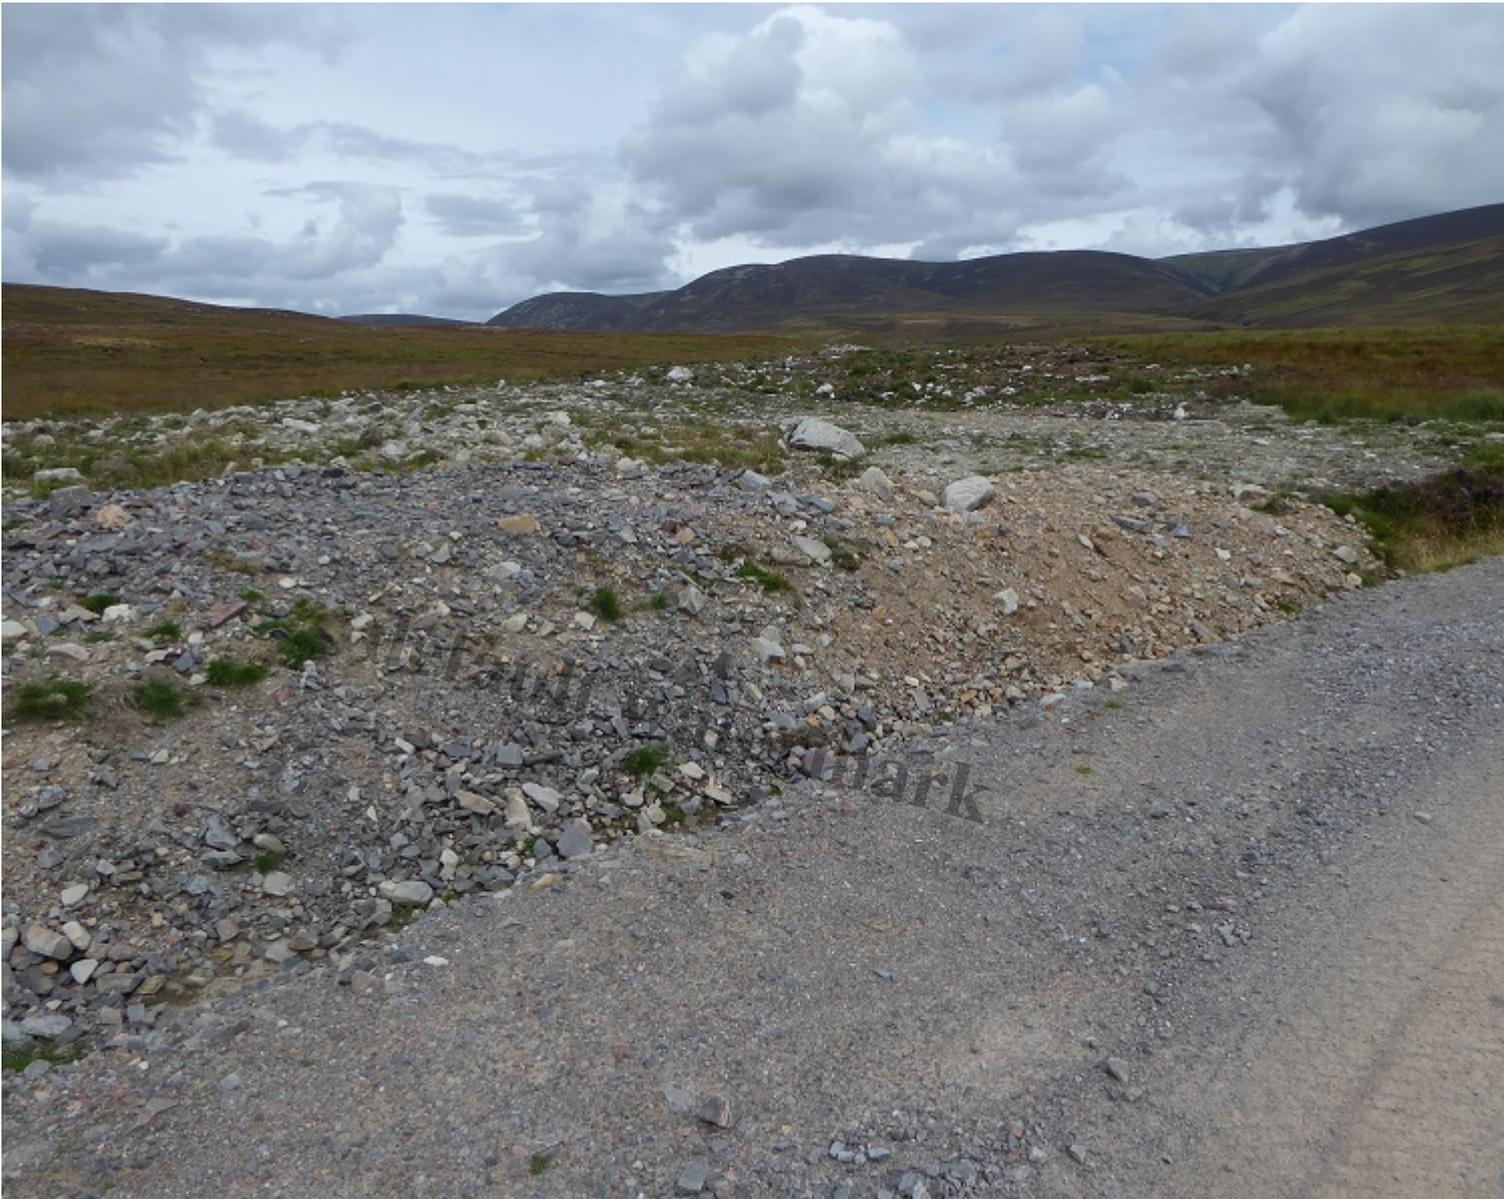
Here aggregate appears to have been dumped on the edge of the area excavated for the pipeline. The Developer claimed the poor restoration of the pipeline was because the organic material was too shallow but said nothing about how they had dumped other materials onto the line of the pipeline. This could only have happened after the pipeline had been “restored” as the road aggregate sits on top of the “pipeline restoration”.

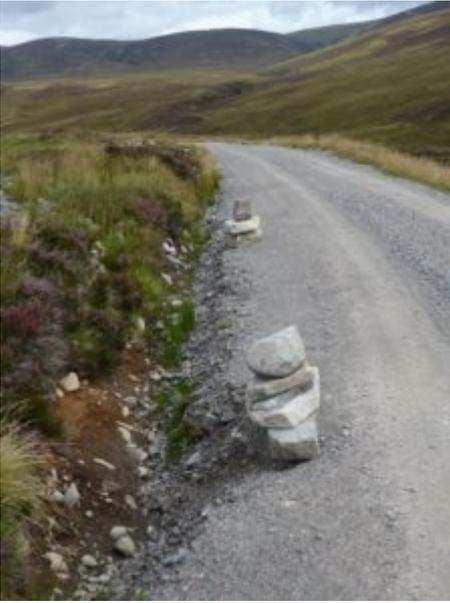
The track is not even good for the people who live or work at Bruar Lodge. Here staff have had to mark the holes that have eroded out of the track. Its not clear to me why Atholl estates would have tolerated such poor work.

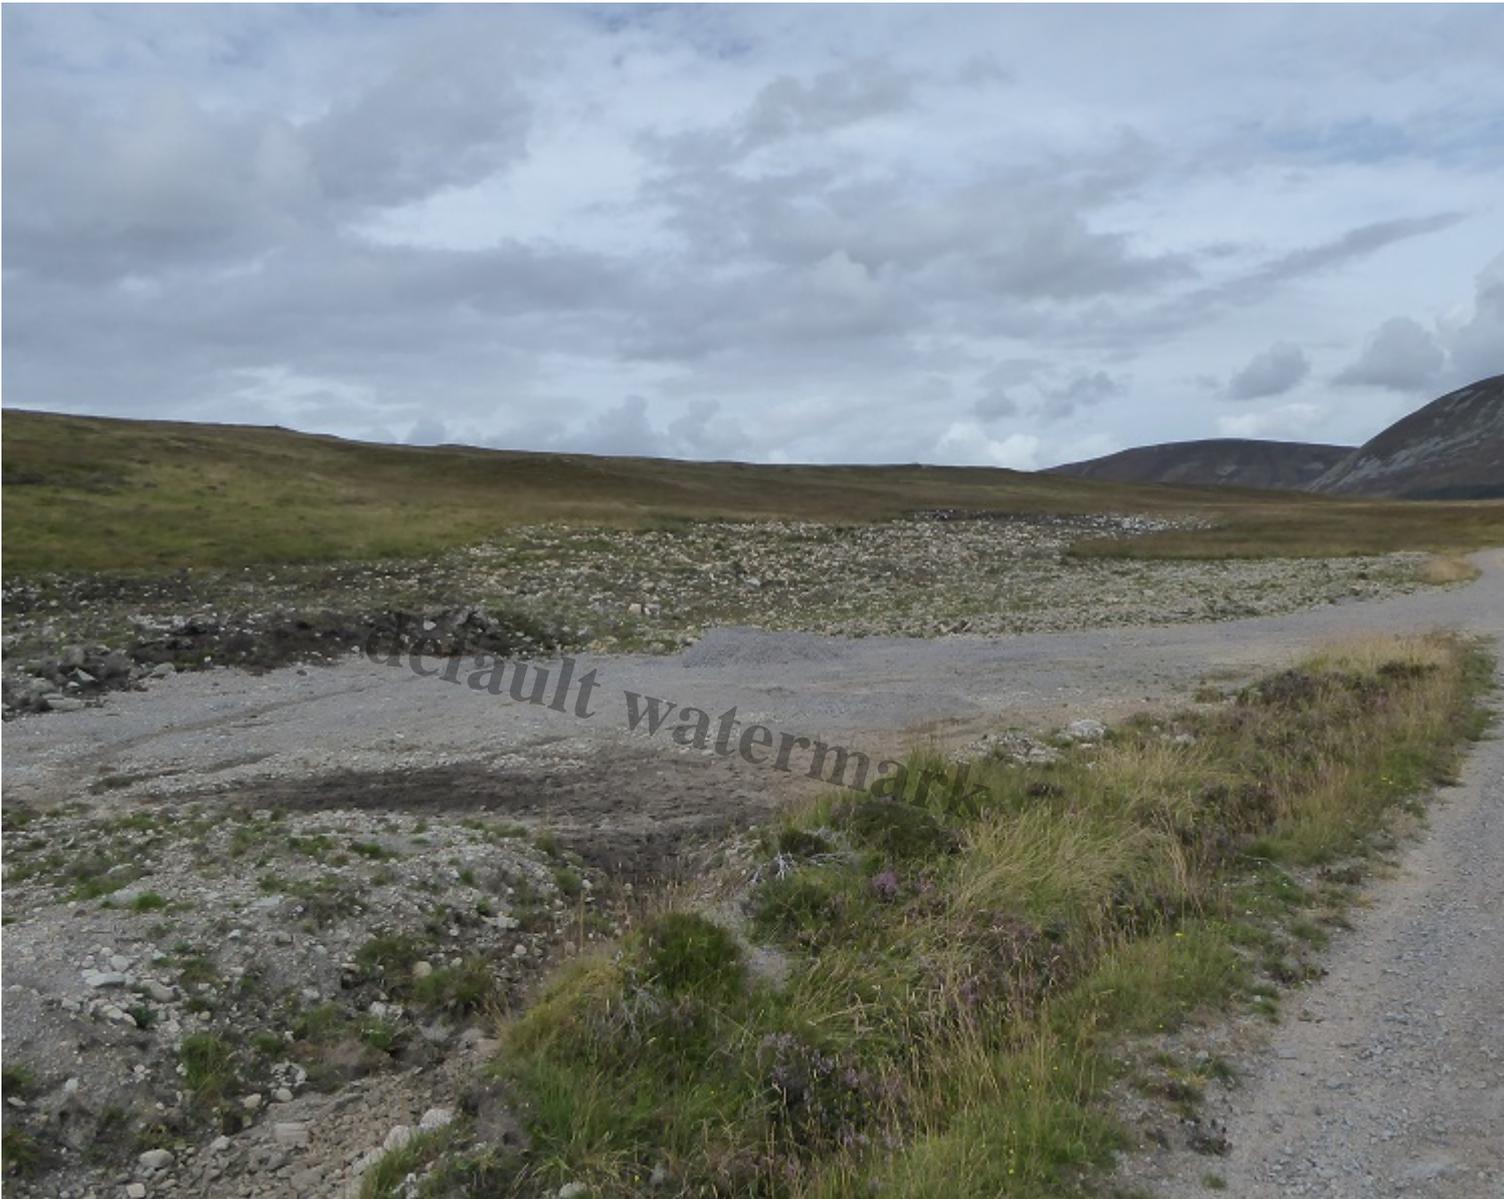
While there was mention of temporary areas of tracks and laydown areas in the planning application all were meant to be restored. Why has this vehicle area been left in the midst of the scar left by the pipeline? Its hard to imagine how restoration of a hydro pipe and track could be worse than this (do send in your photos).

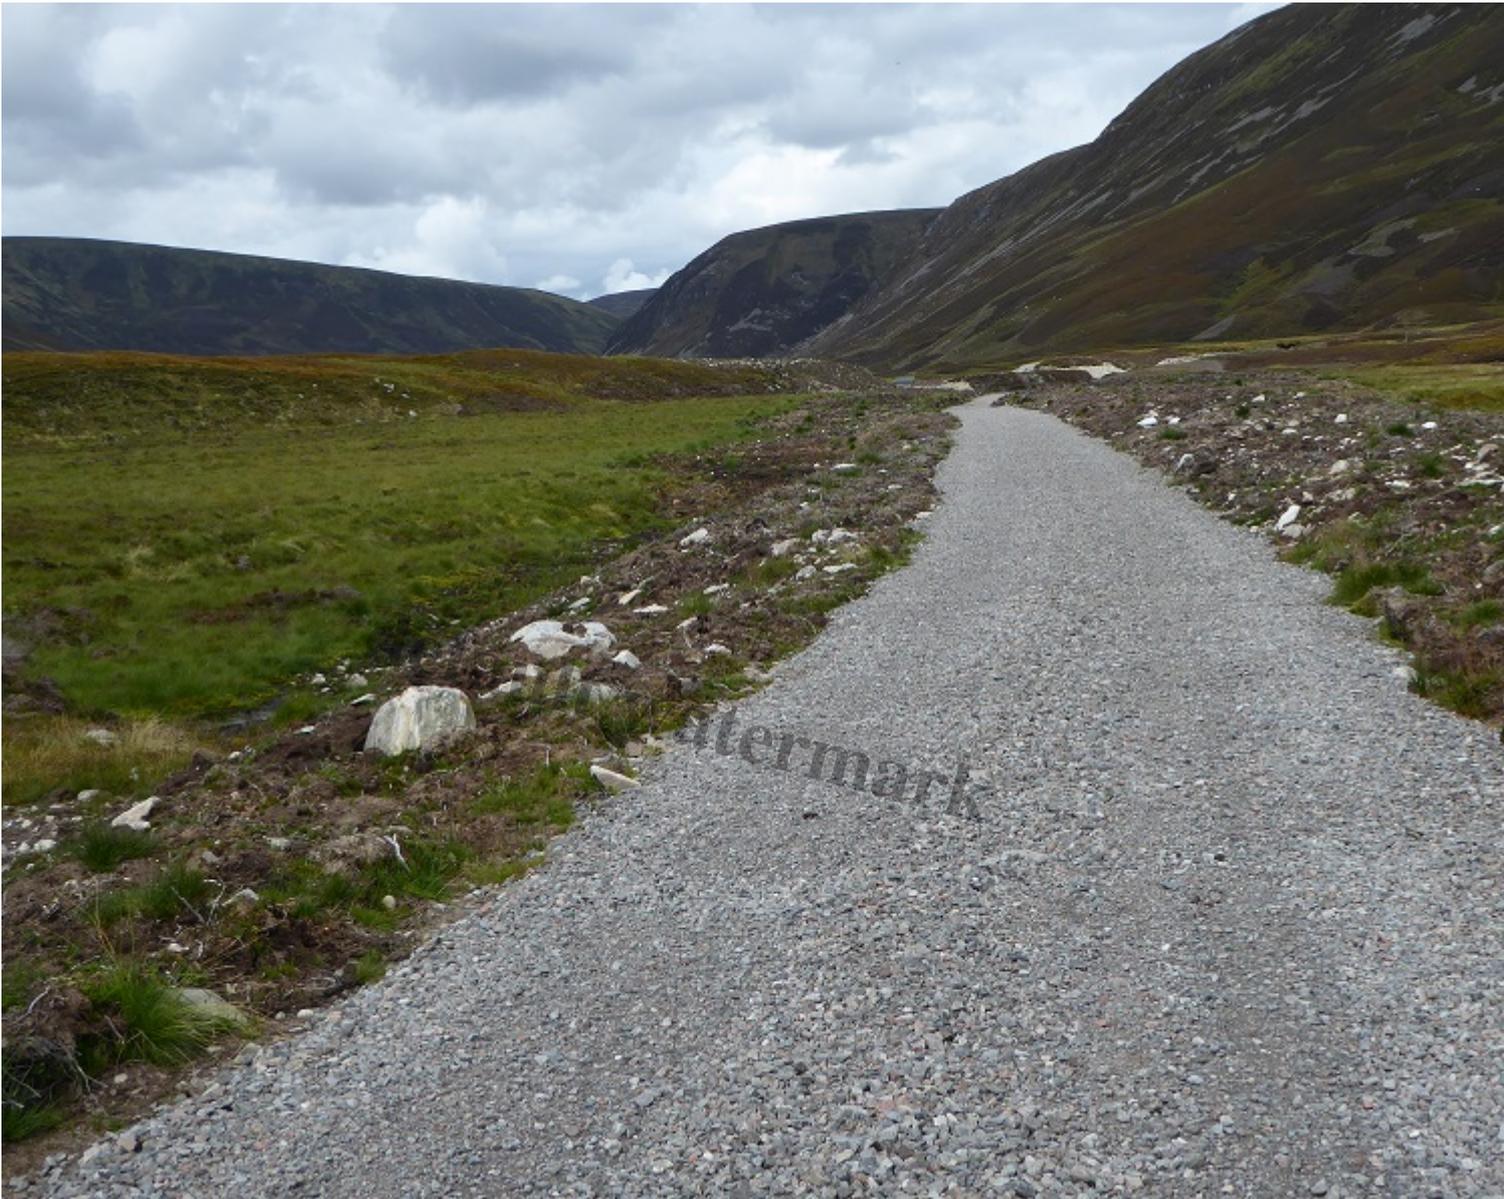
By contrast the work on the new section of track beyond Bruar Lodge appears to have been constructed with far more care. It is much narrower than the section of upgraded track and restoration work has taken place along the verges. This is less than 2k though out of a total track length of 12k. The reason for this appears to be that the CNPA did set out conditions:

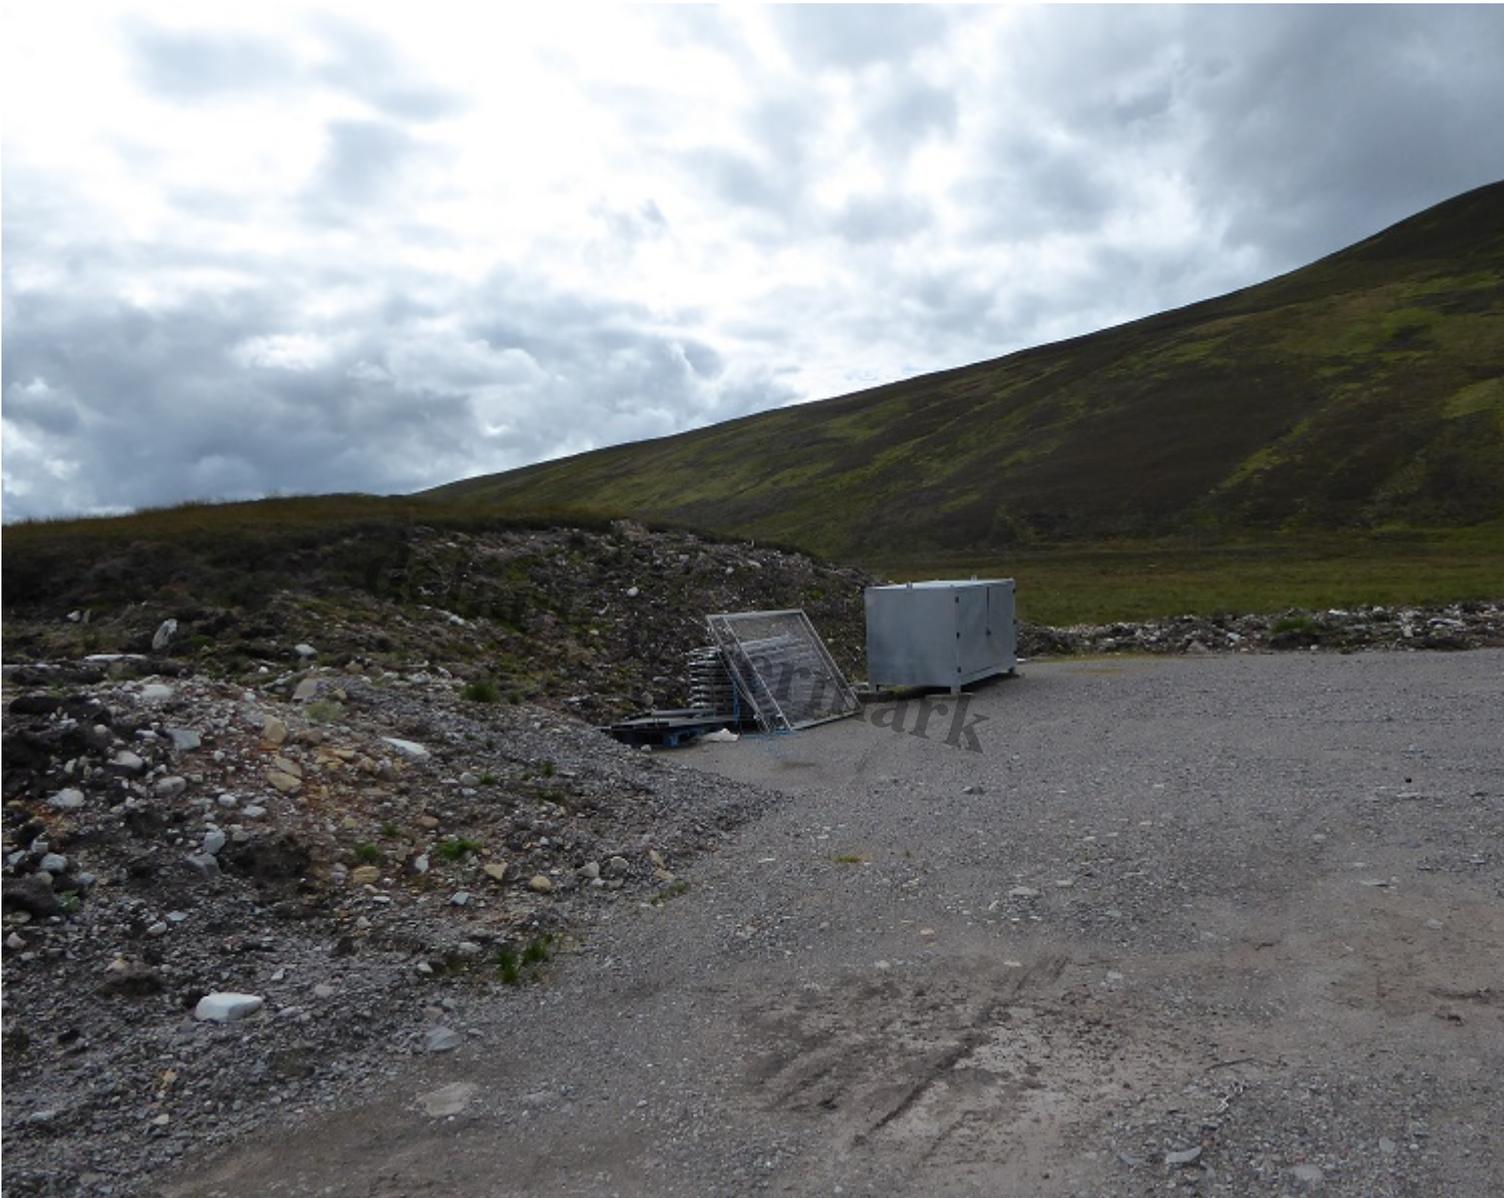
The turning/storage area by the dam however has not been restored or properly cleared up. Again note the track aggregate dumped on the bank on the left.

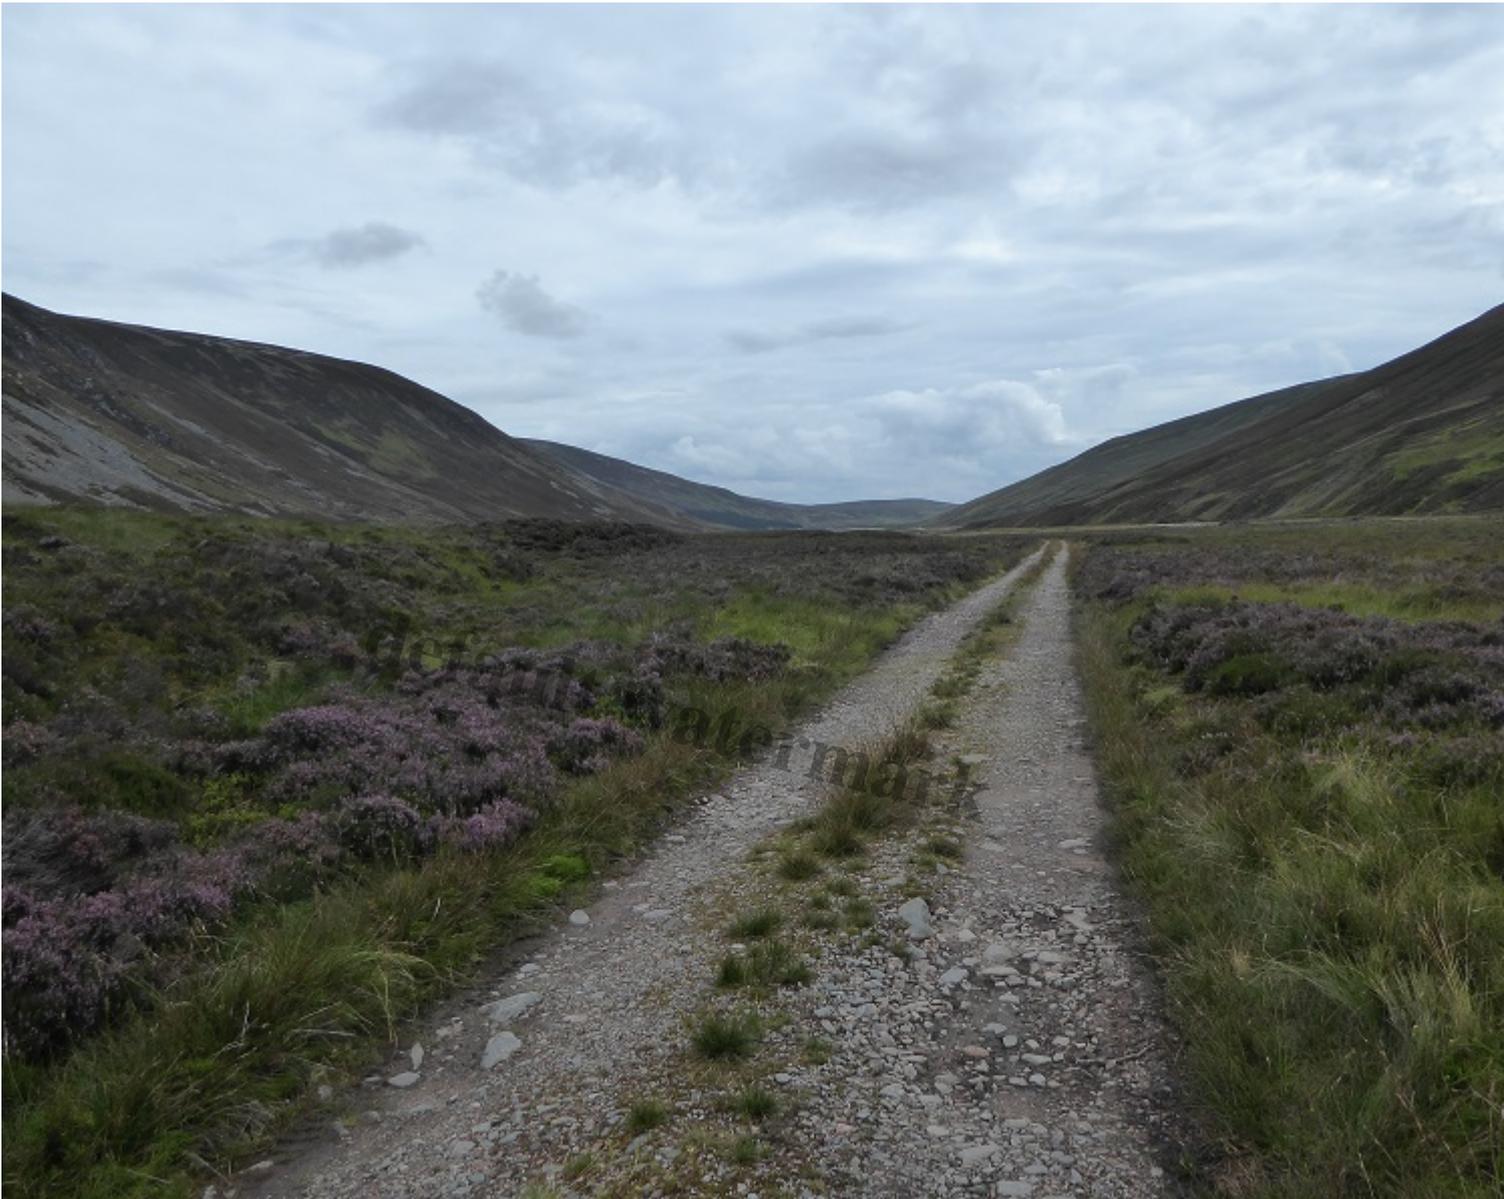
This is the section of the old track north of the dam, ie beyond the hydro scheme. It illustrates a number of features that the CNPA should ensure are applied to the 12k of track to the dam, namely its narrow, the sides are vegetated and a narrow vegetated strip runs down the centre of the track (as recommended in guidance by the Lomond and Trossachs National Park Authority on hydro tracks). While this track penetrates a prime area of wild land, in design terms it illustrates the standards our National Park should be aspiring too where tracks are agreed.

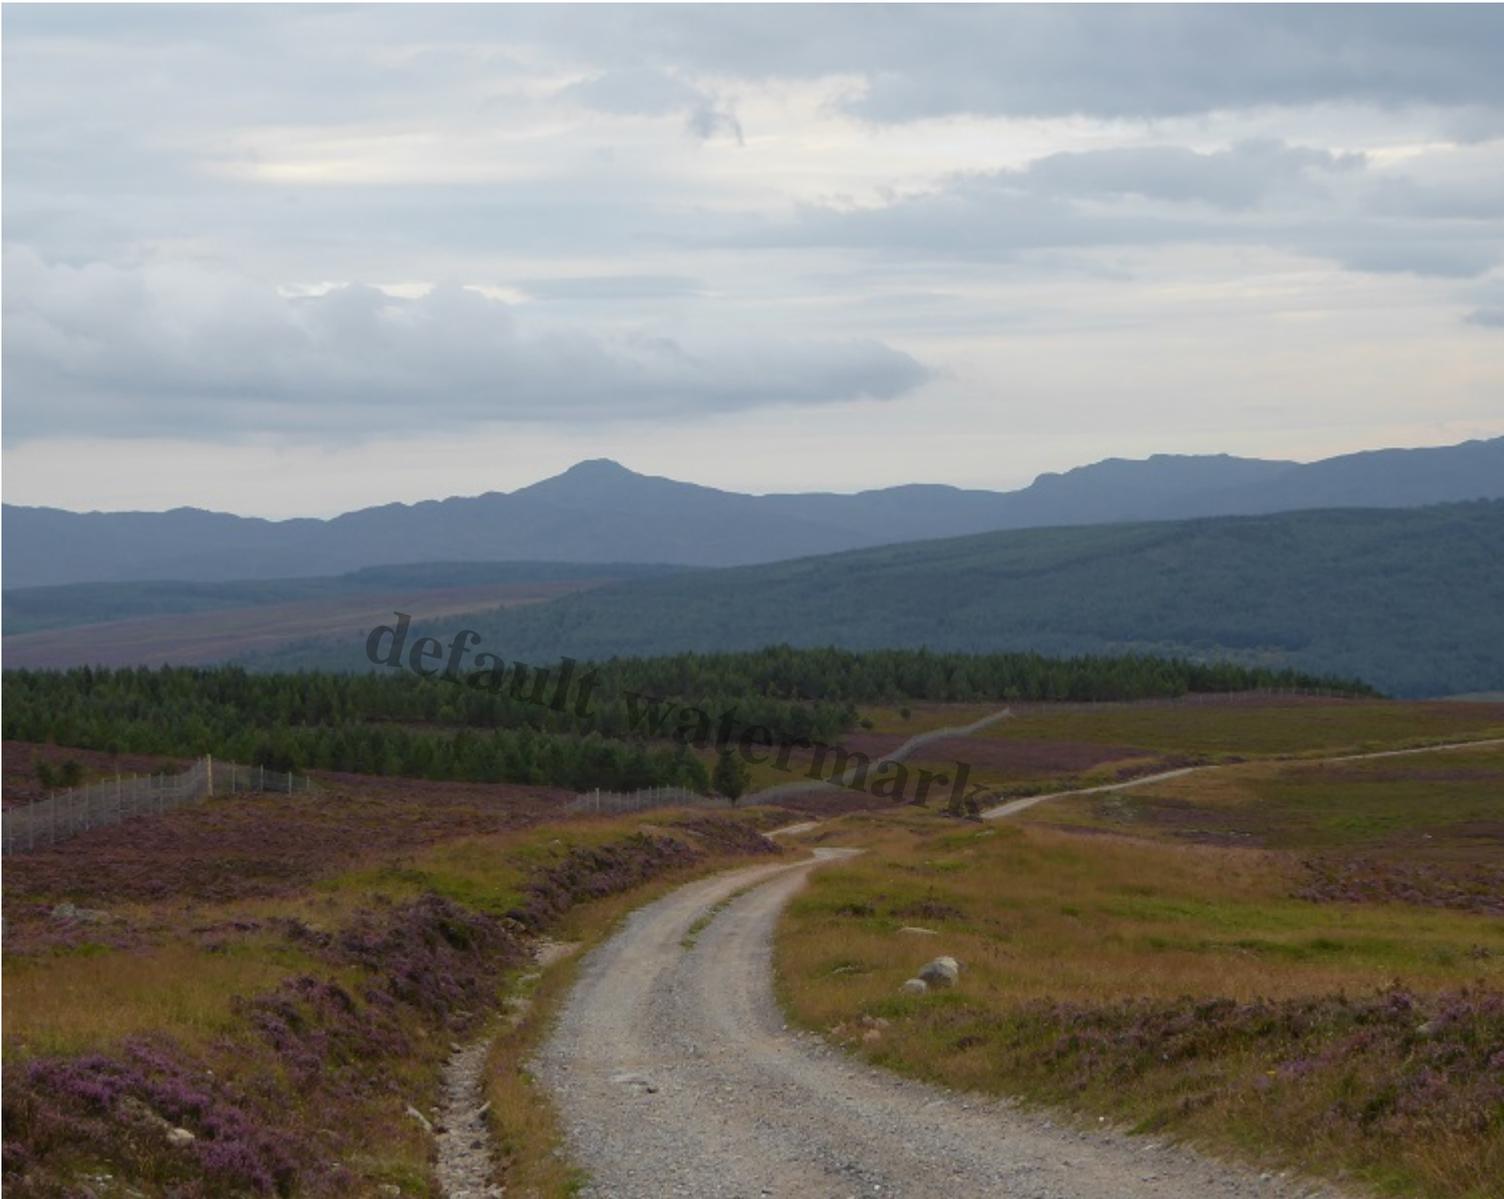
The section of track linking Glen Bruar to Calvine appears to have been subject to far less upgrading work than that in Glen Bruar itself. If construction vehicles could access the Glen by this track, which is far steeper and narrower than any of the track along the glen, it begs the question of why the Bruar track needed to be upgraded. Possibly it was in poor condition but simply dumping tons of extra aggregate on top of the existing track as a quick fix, which is what appears to have happened, should never have been allowed.
