The Glen Bruar hydro track

This is my second post on the Bruar Hydro Scheme ([see here](#)) which I visited at the end of August. I am fairly confident that few of the issues identified in this post will have been remedied since my visit but would welcome more up to date photos from anyone who is in the area.

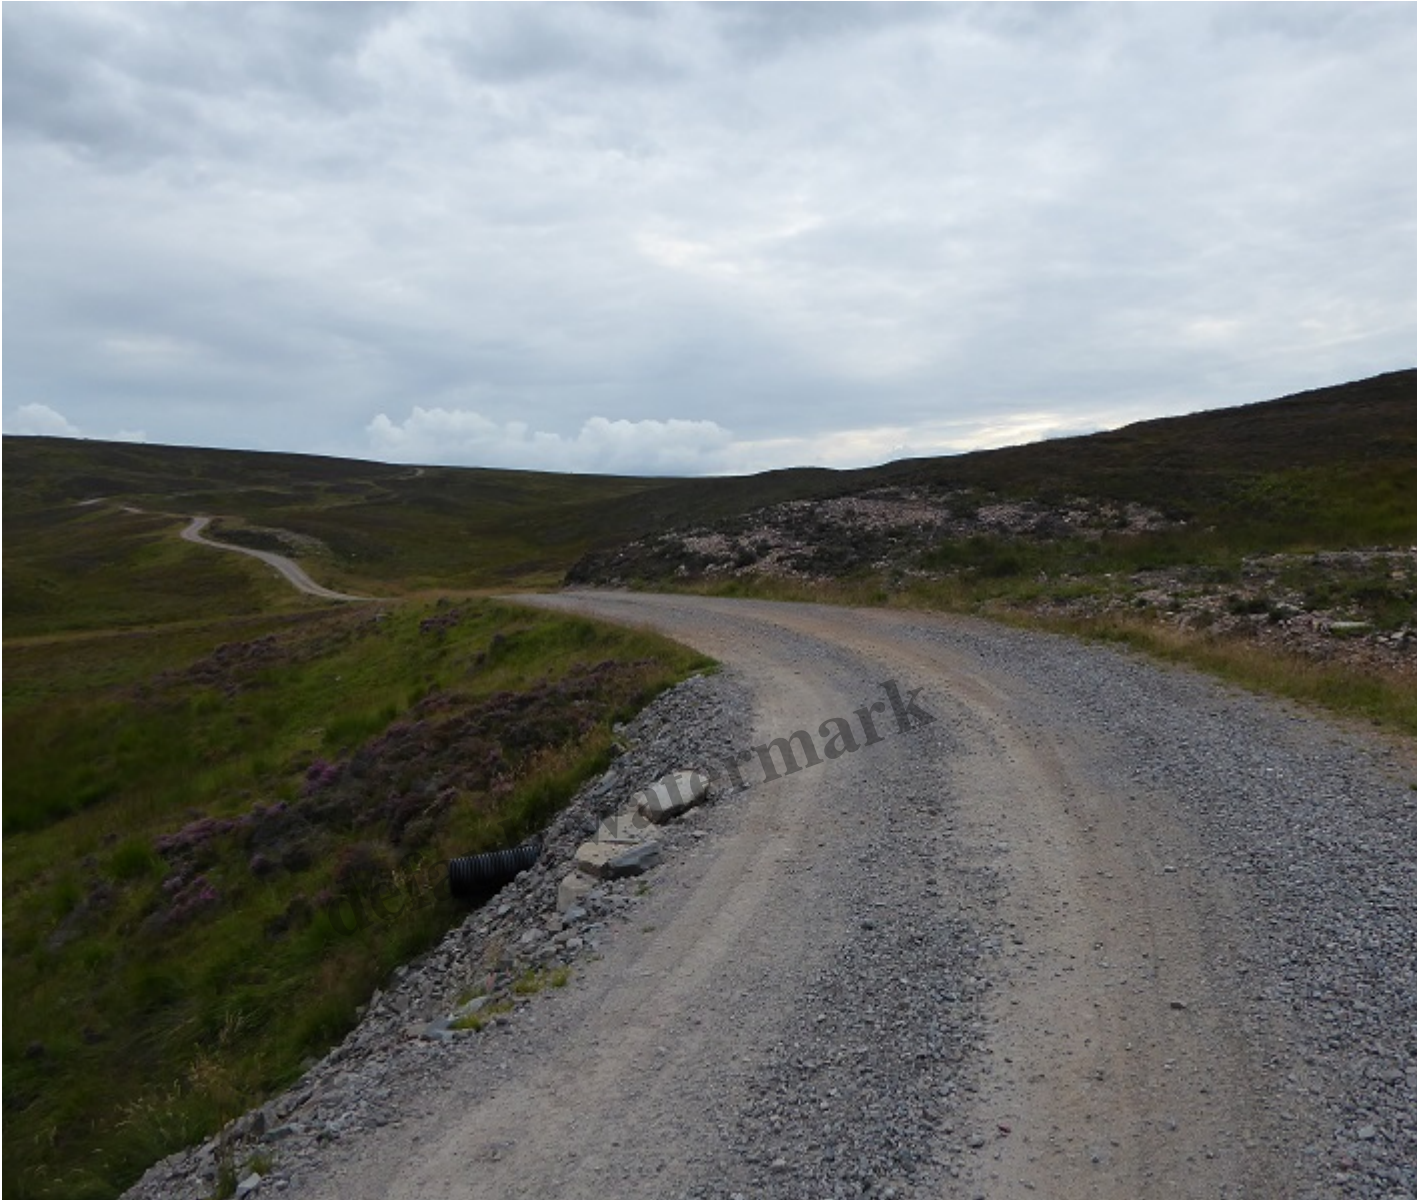
Looking south along the Bruar track as it rises over the hill to Calvine. This section of track has been less upgrading work but note the width of the track, the steep left edge which is unturfed and will erode and the culvert pipe projecting into space. None of this meets SNH standards for Constructed Hill Track on uplands.

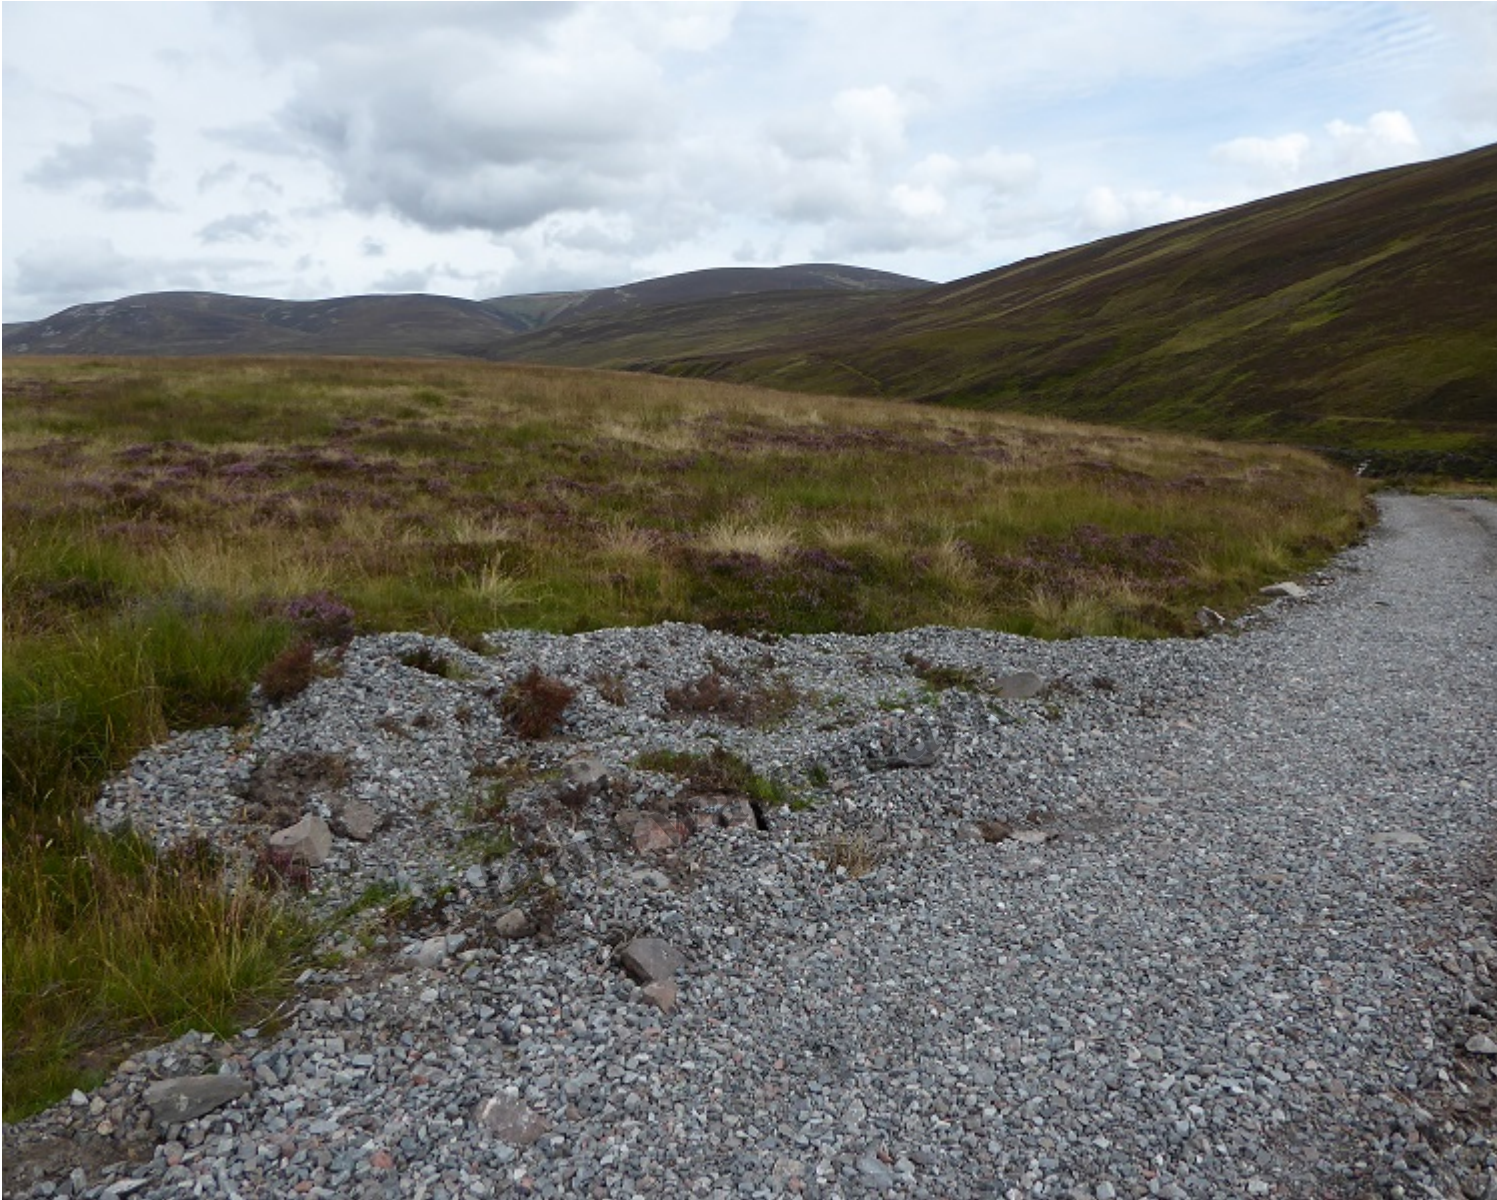
All along the track the remains of piles of aggregate, that have been dumped on vegetation, are clearly evident. The SNH Guidance on hill tracks [snh.org.uk /pdfs/publications/heritagemanagement/cons..](https://www.snh.org.uk/pdfs/publications/heritagemanagement/cons..) does not say anything explicitly about storage of track materials – my guess is that this is because it assumed track constructors would never dump materials in this. Other parts of the guidance make it very clear it expected the verges of hill tracks to be properly restored:

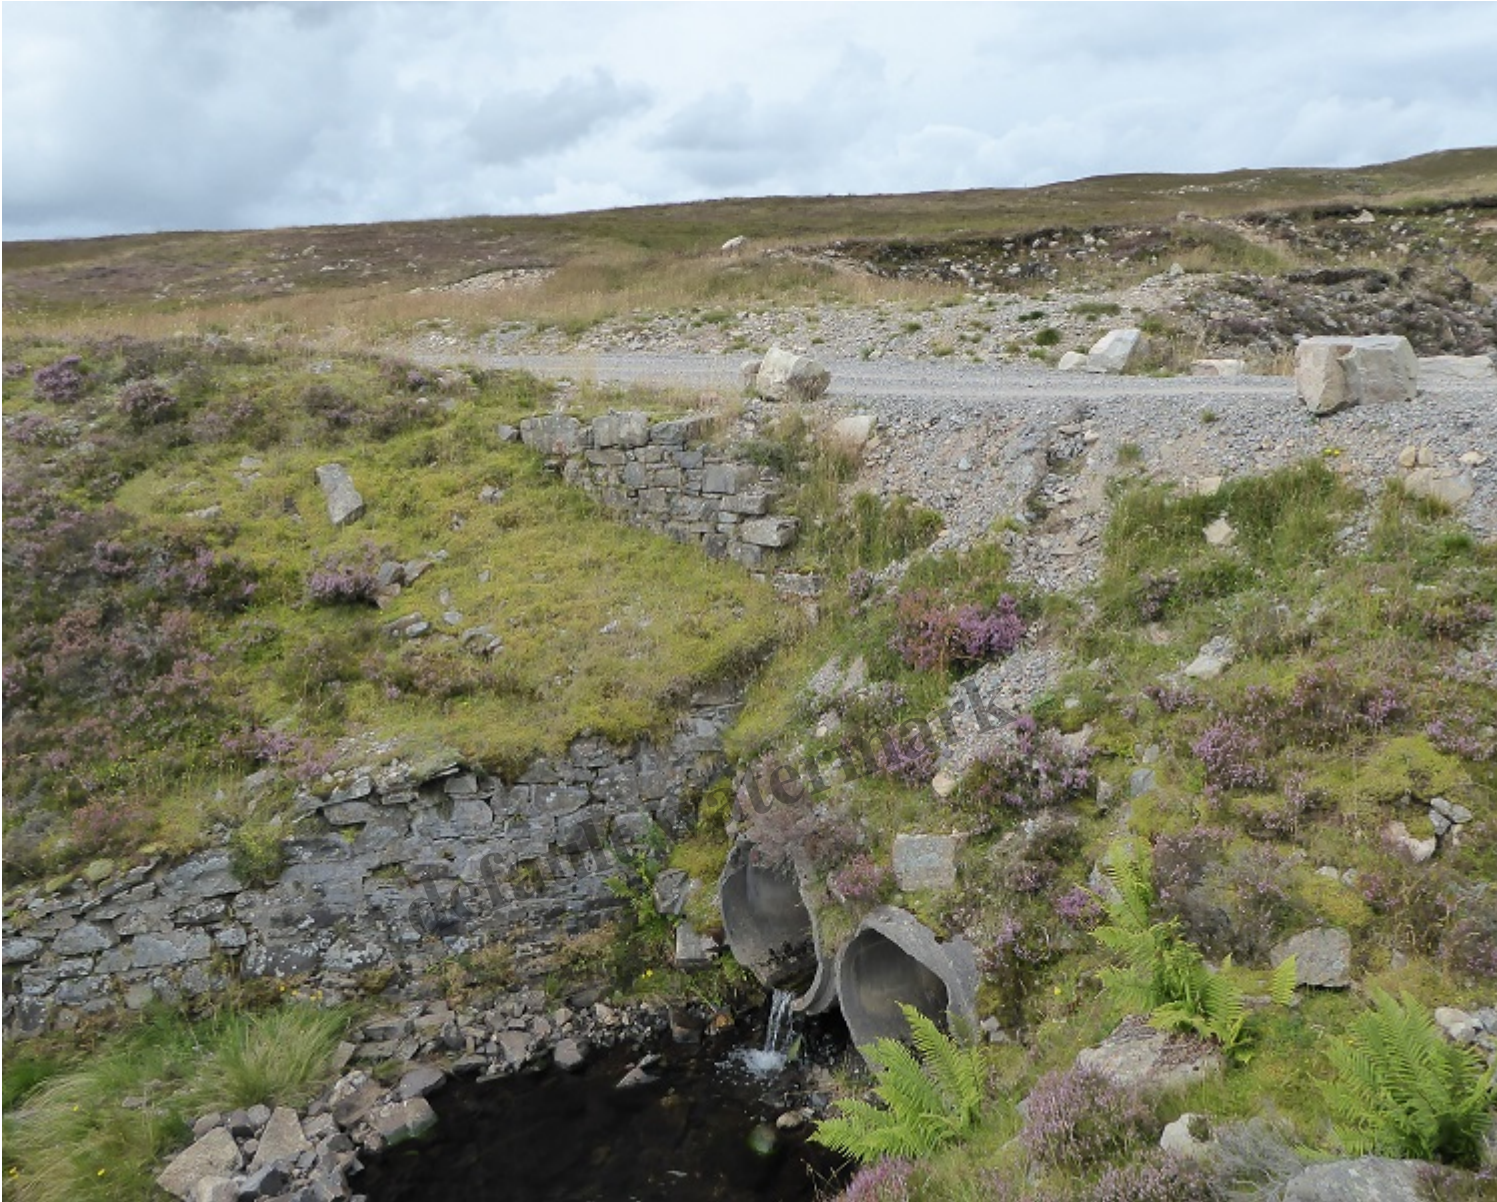
Another view of the same section of track. Contrast the finishing of the original track here – the stone facing – with the latest work which appears to have consisted of dumping aggregate on and alongside the old track without any attempt at finishing.

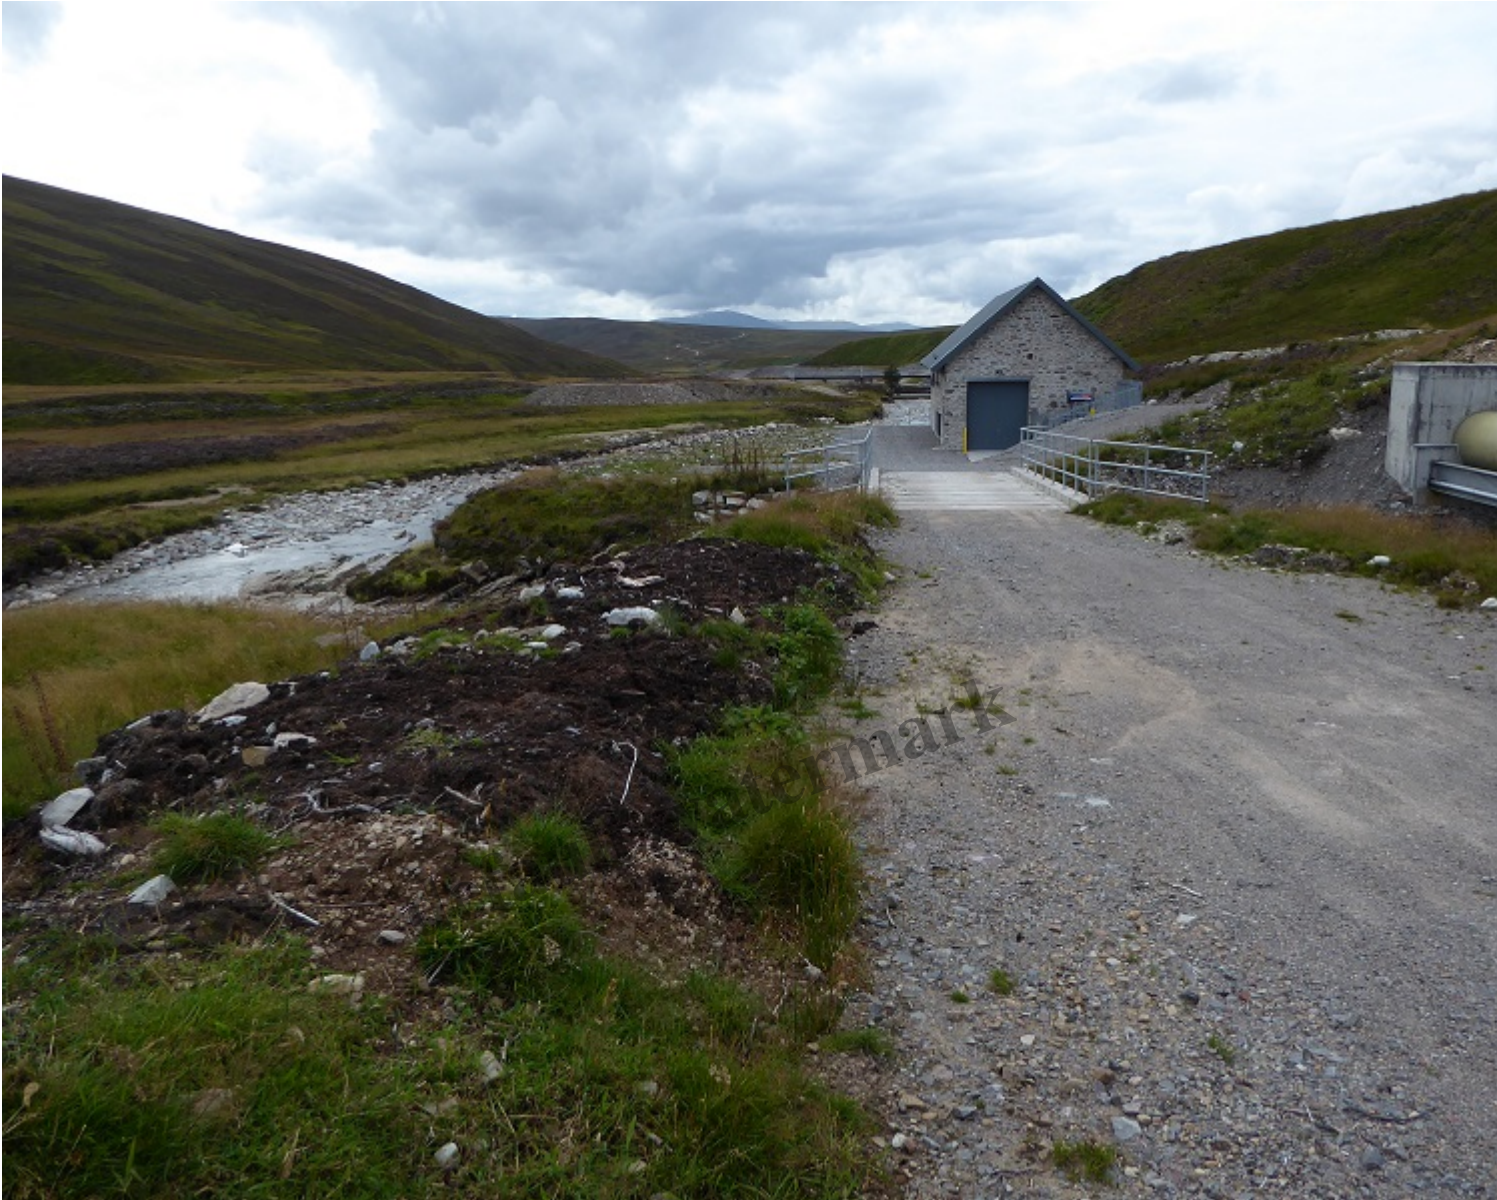
No requirements were made for the new section of track to the powerhouse. While there have been attempts made to revegetate the verges of the new sections of track, the track here is far wider than it need be.

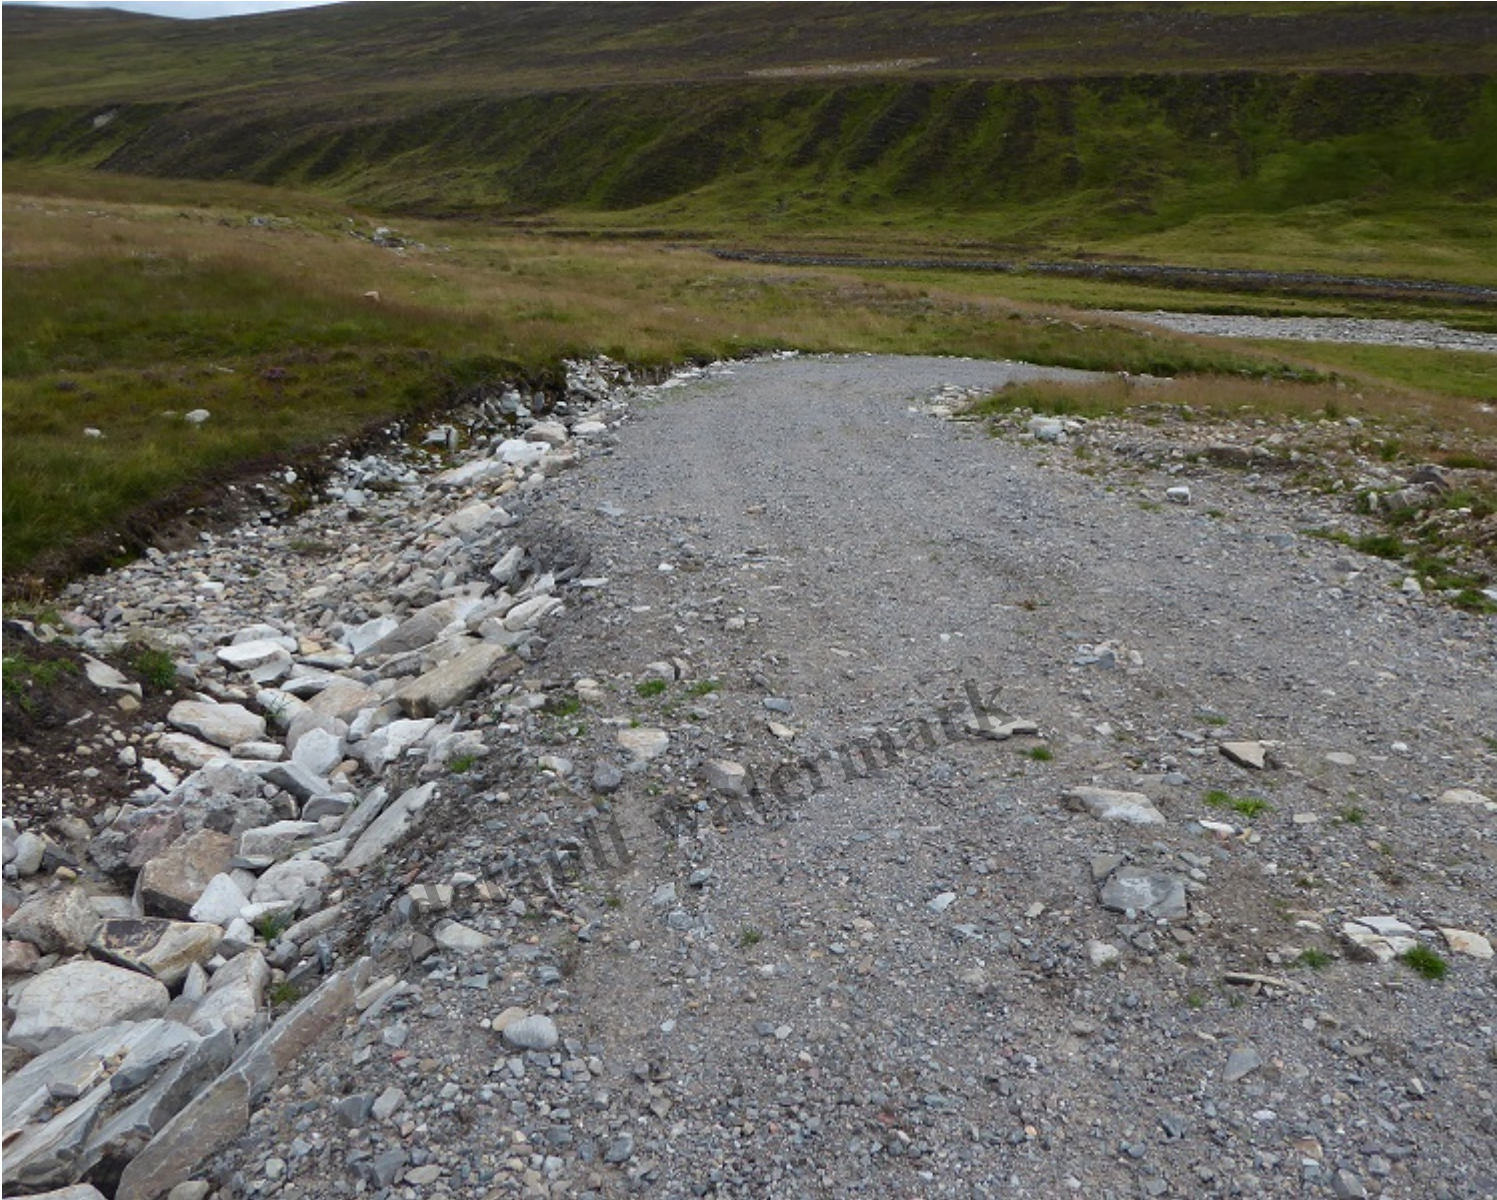
A new drainage ditch has been dug along this section of upgraded track, its unfinished ditches and edge of track on left is unfinished – there has been no attempt to revegetate it, either with turfs or re-seeding.
