## The Glen Bruar hydro track

### Description

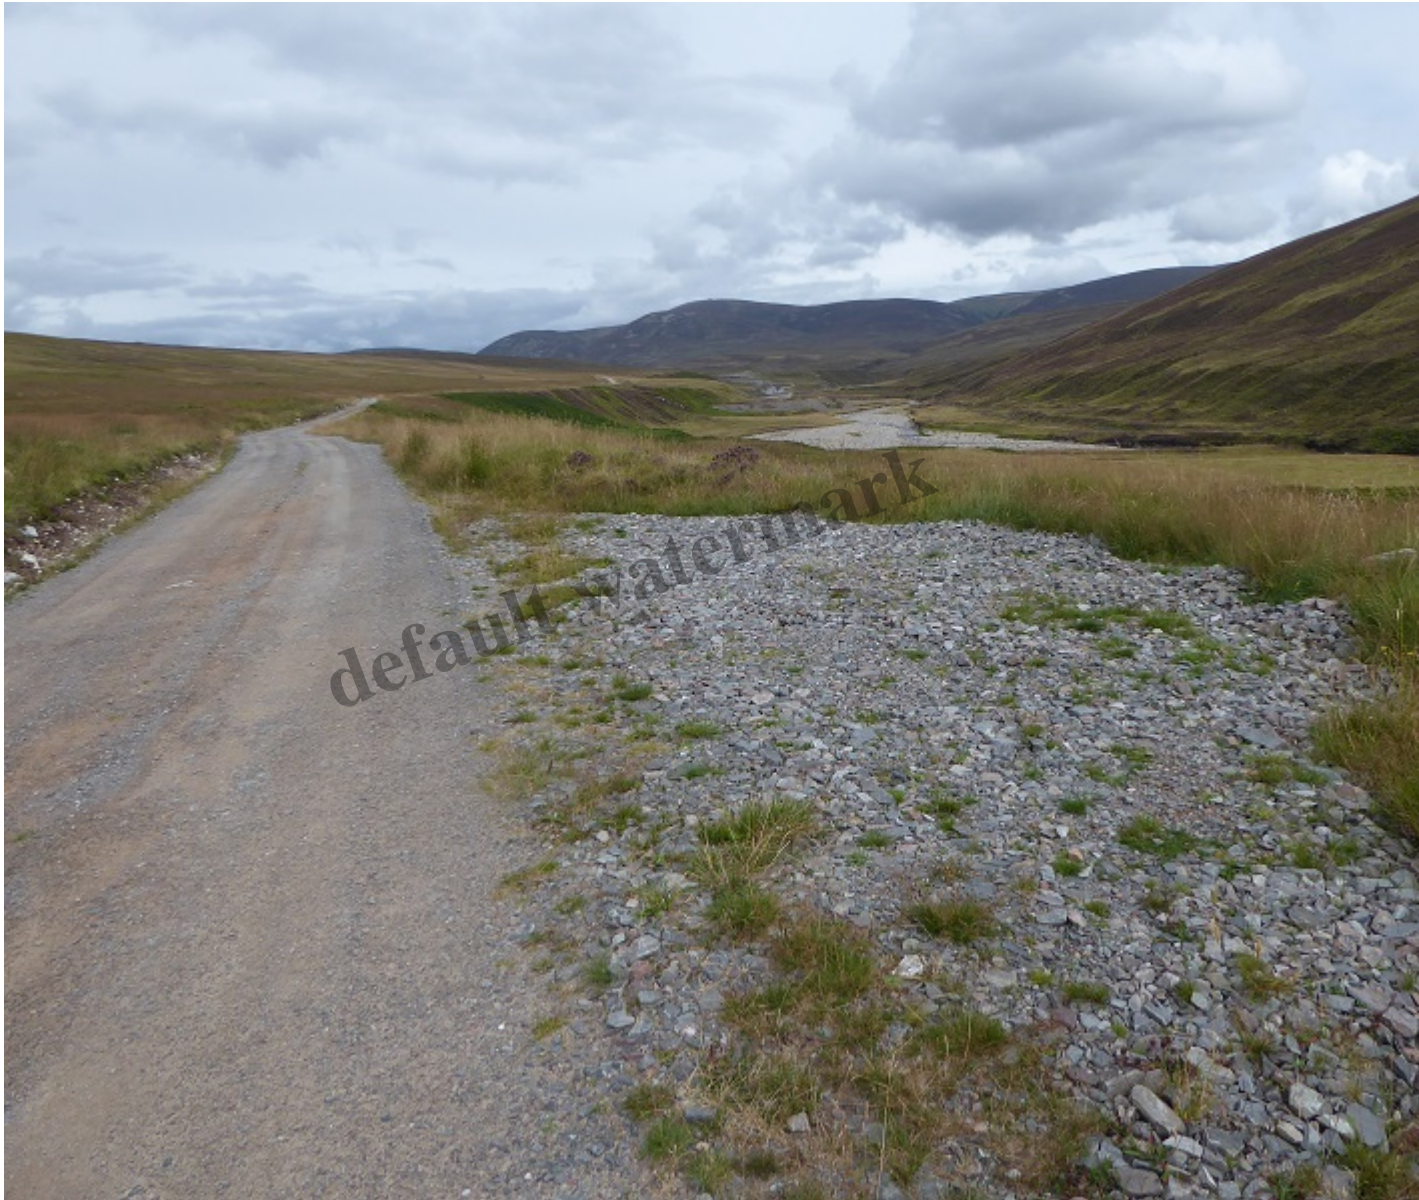
Looking north along the Bruar track, you get a sense of its length. The new hydro power house is re  
Note the large expanse of aggregate dumped onto the vegetation on the right of the track.

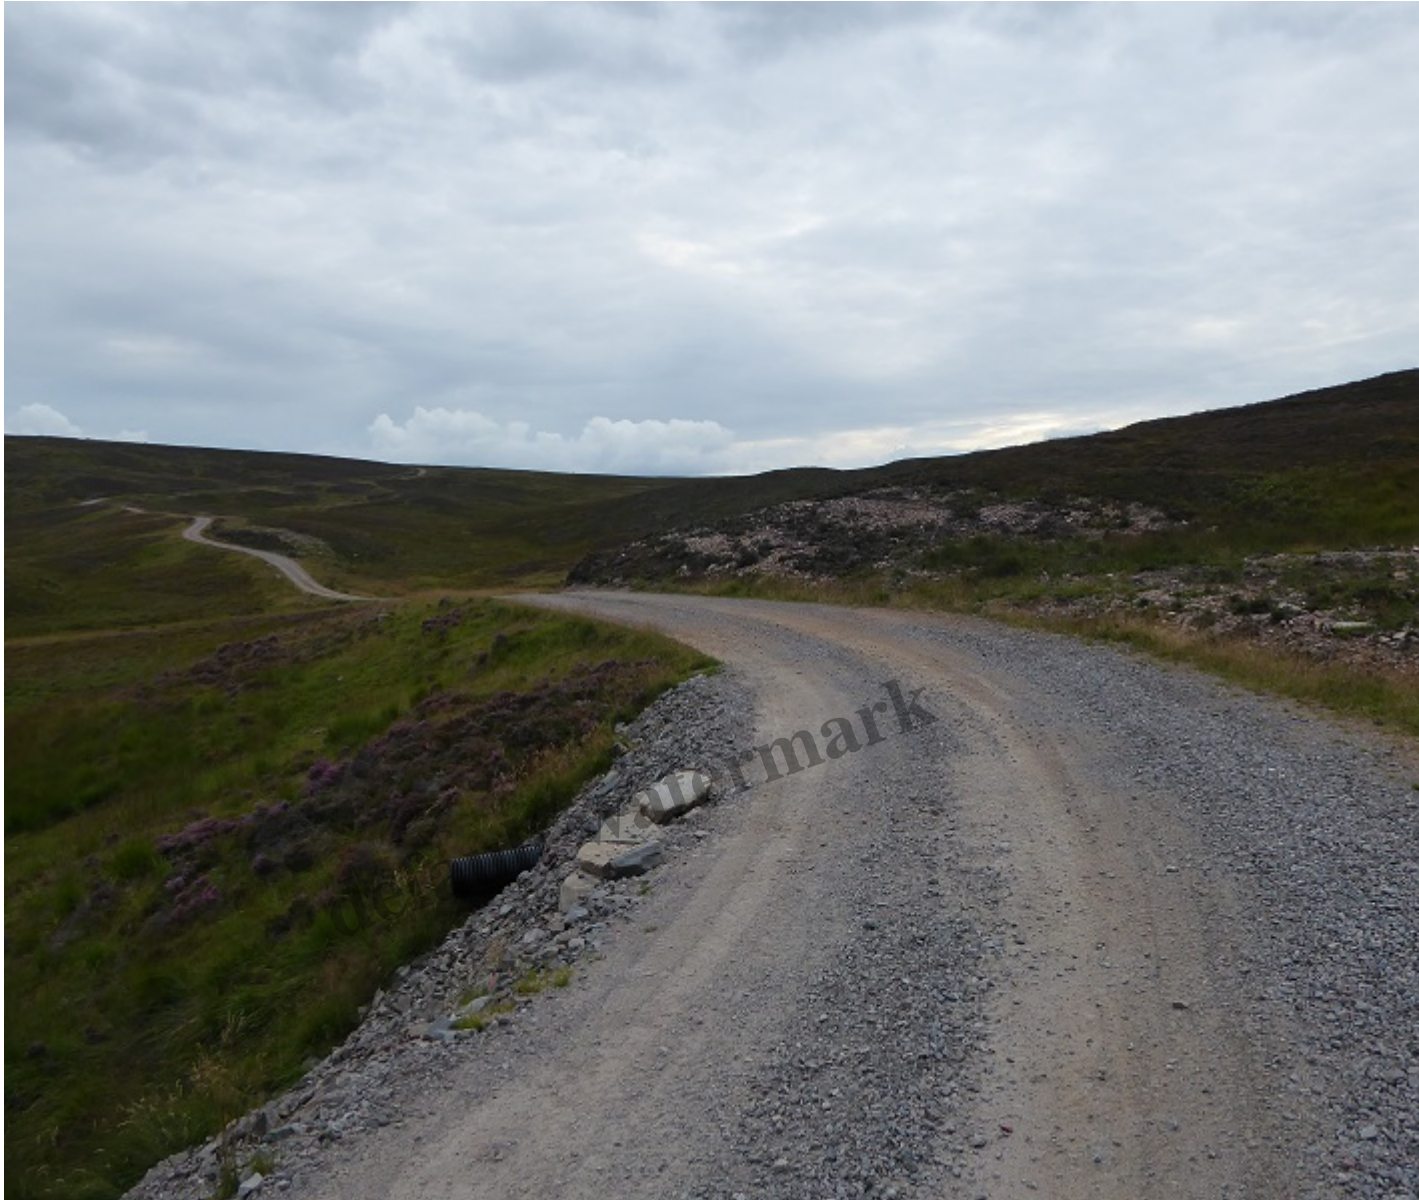
Looking south along the Bruar track as it rises over the hill to Calvine. This section of track has been less upgrading work but note the width of the track, the steep left edge which is unturfed and will erode and the culvert pipe projecting into space. None of this meets SNH standards for Constructed Hill Track uplands.

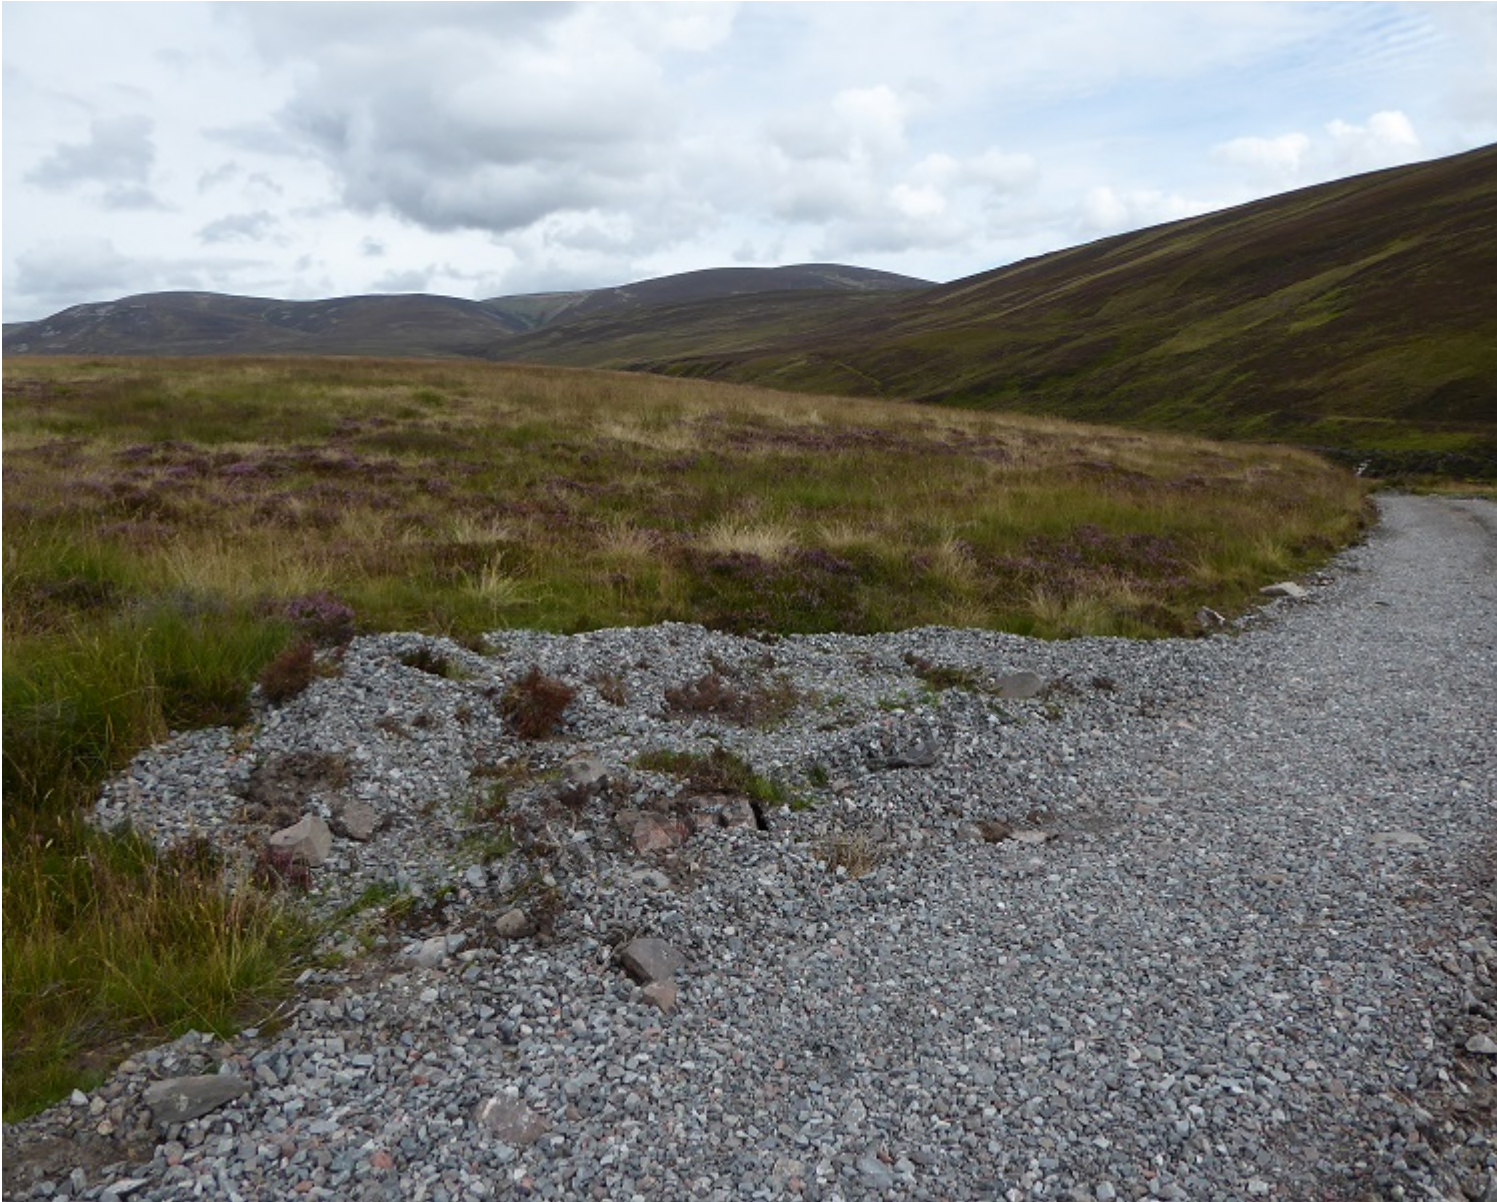
All along the track the remains of piles of aggregate, that have been dumped on vegetation, are clearly evident. The SNH Guidance on hill tracks [snh.org.uk /pdfs/publications/heritagemanagement/cons..](https://www.snh.org.uk/pdfs/publications/heritagemanagement/cons..) does not say anything explicitly about storage of track materials – my guess is that this is because it assumed track constructors would never dump materials in this. Other parts of the guidance make it very clear it expected the verges of hill tracks to be properly restored:

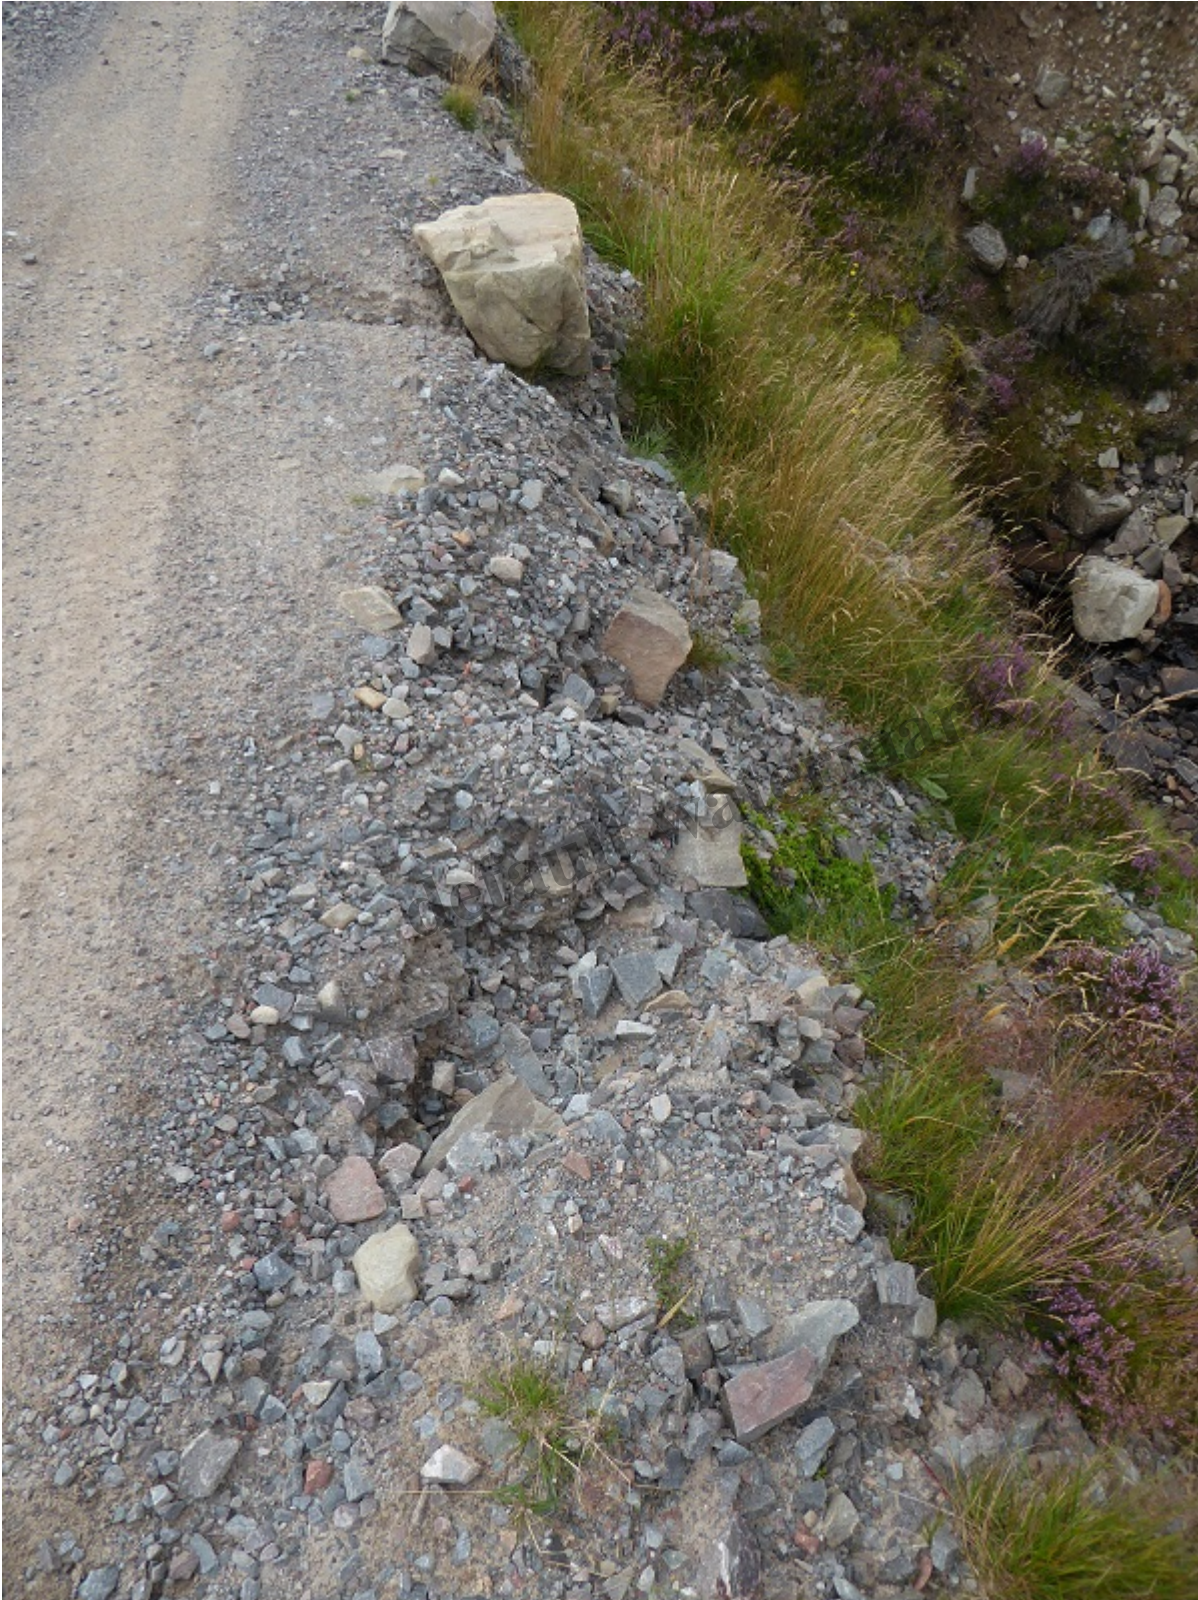
The side of the track here is eroding away and into the burn below. The SNH Guidance is very strong on the need to prevent track materials being washed into burns.

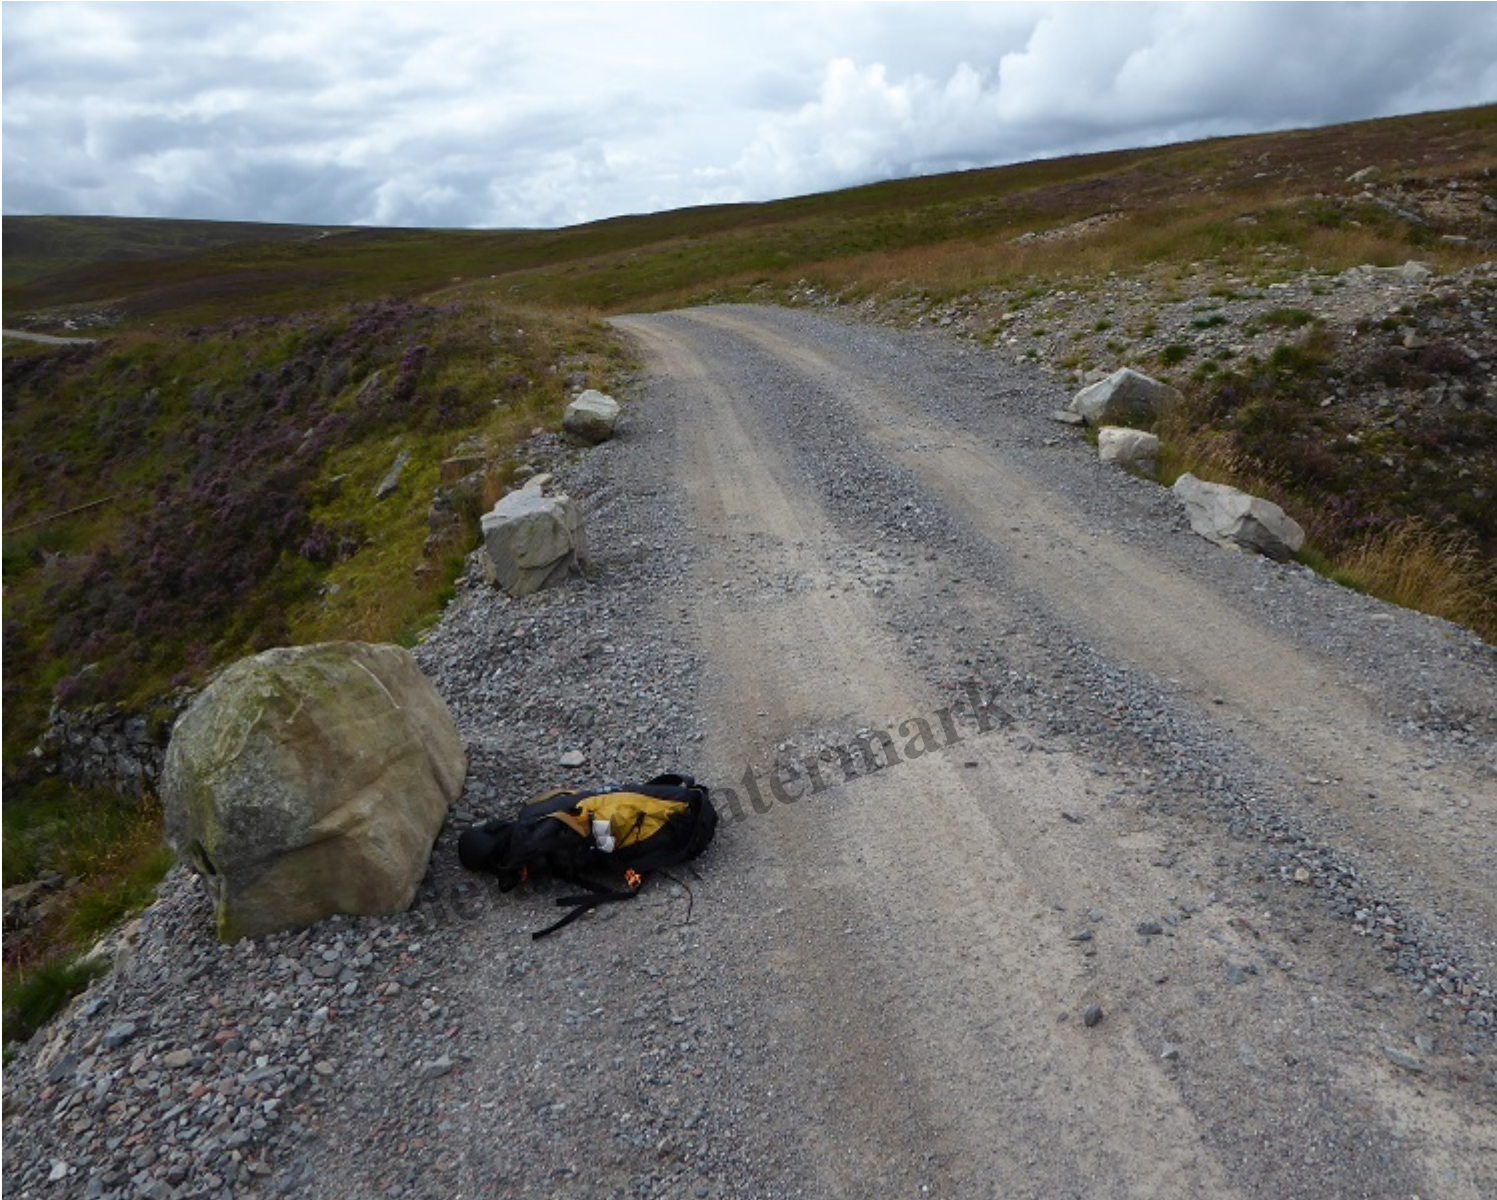
Another view of the eroding track edge. Note the boulders placed to prevent vehicles driving off the edge and the width of the track. Its c4m wide at this point. According to SNH Guidance the maximum required for 4 wheeled drive vehicles – all that is required here – is 3m and Lomond and Trossachs National Park Guidance indicates a maximum width of 2.5m on straight lengths of track. This track should have been reduced in width once the construction had finished. There is no sign there has been any attempt to do this.

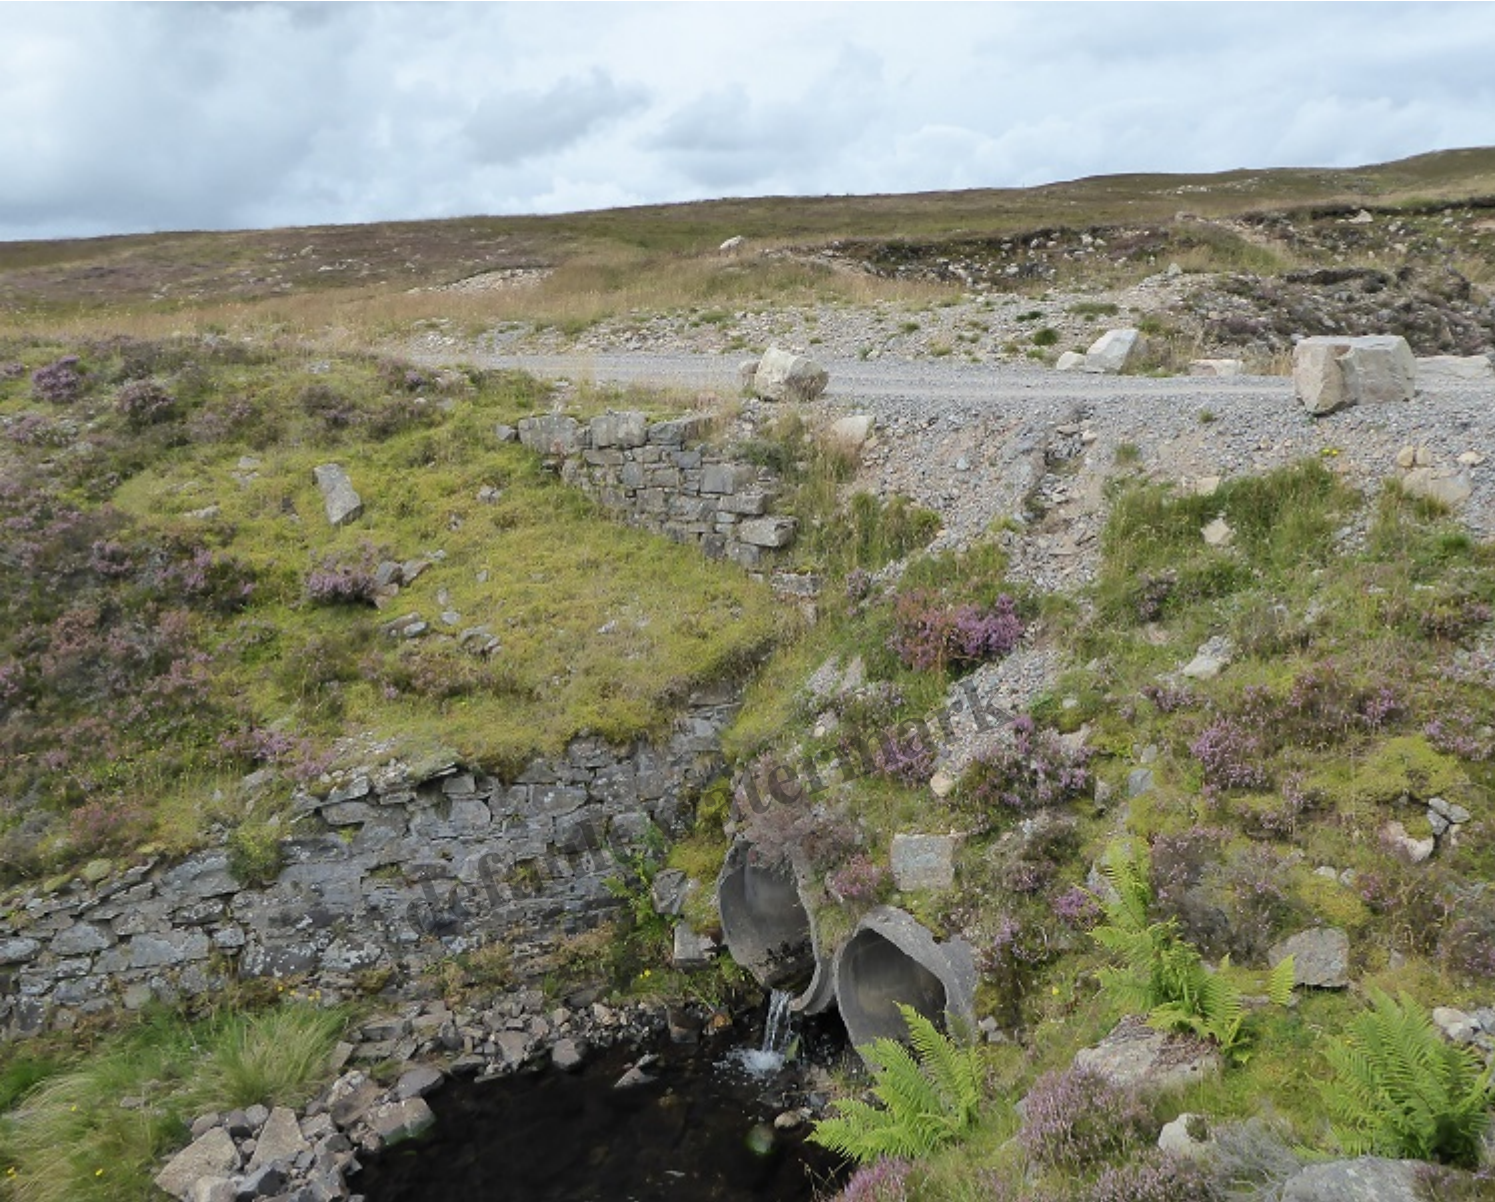
Another view of the same section of track. Contrast the finishing of the original track here – the stone facing – with the latest work which appears to have consisted of dumping aggregate on and alongside the old track without any attempt at finishing.

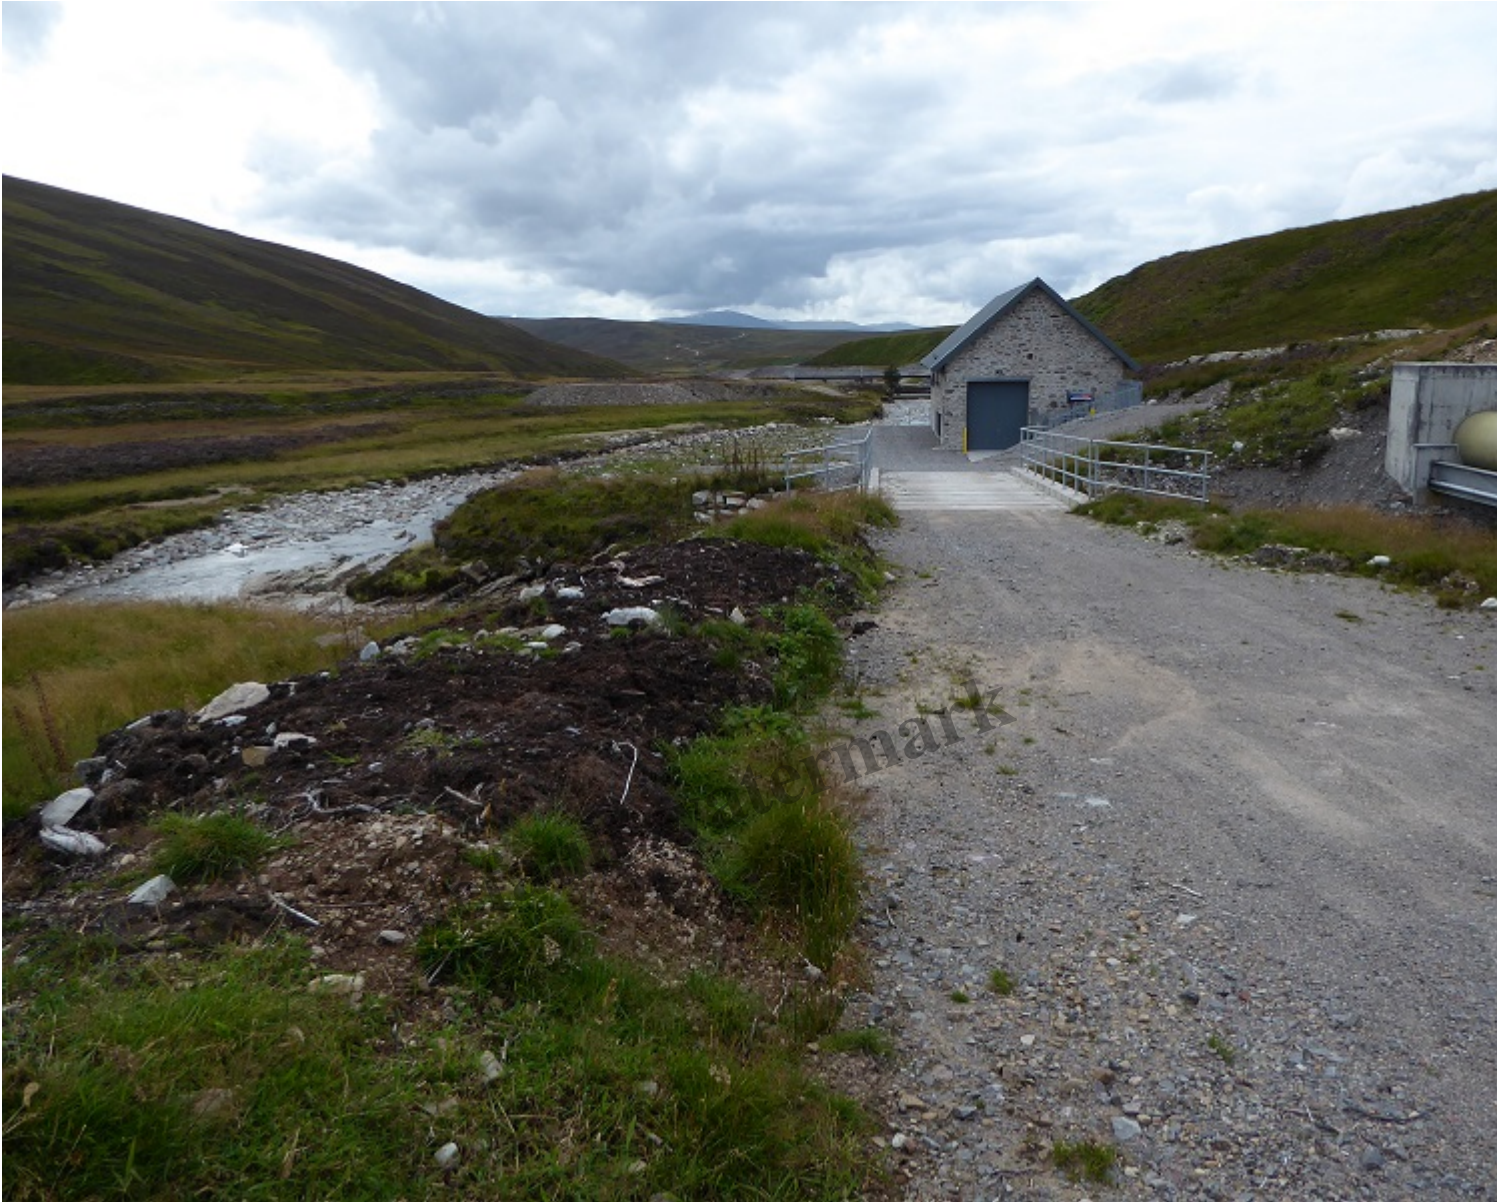
No requirements were made for the new section of track to the powerhouse. While there have been attempts made to revegetate the verges of the new sections of track, the track here is far wider than it need be.

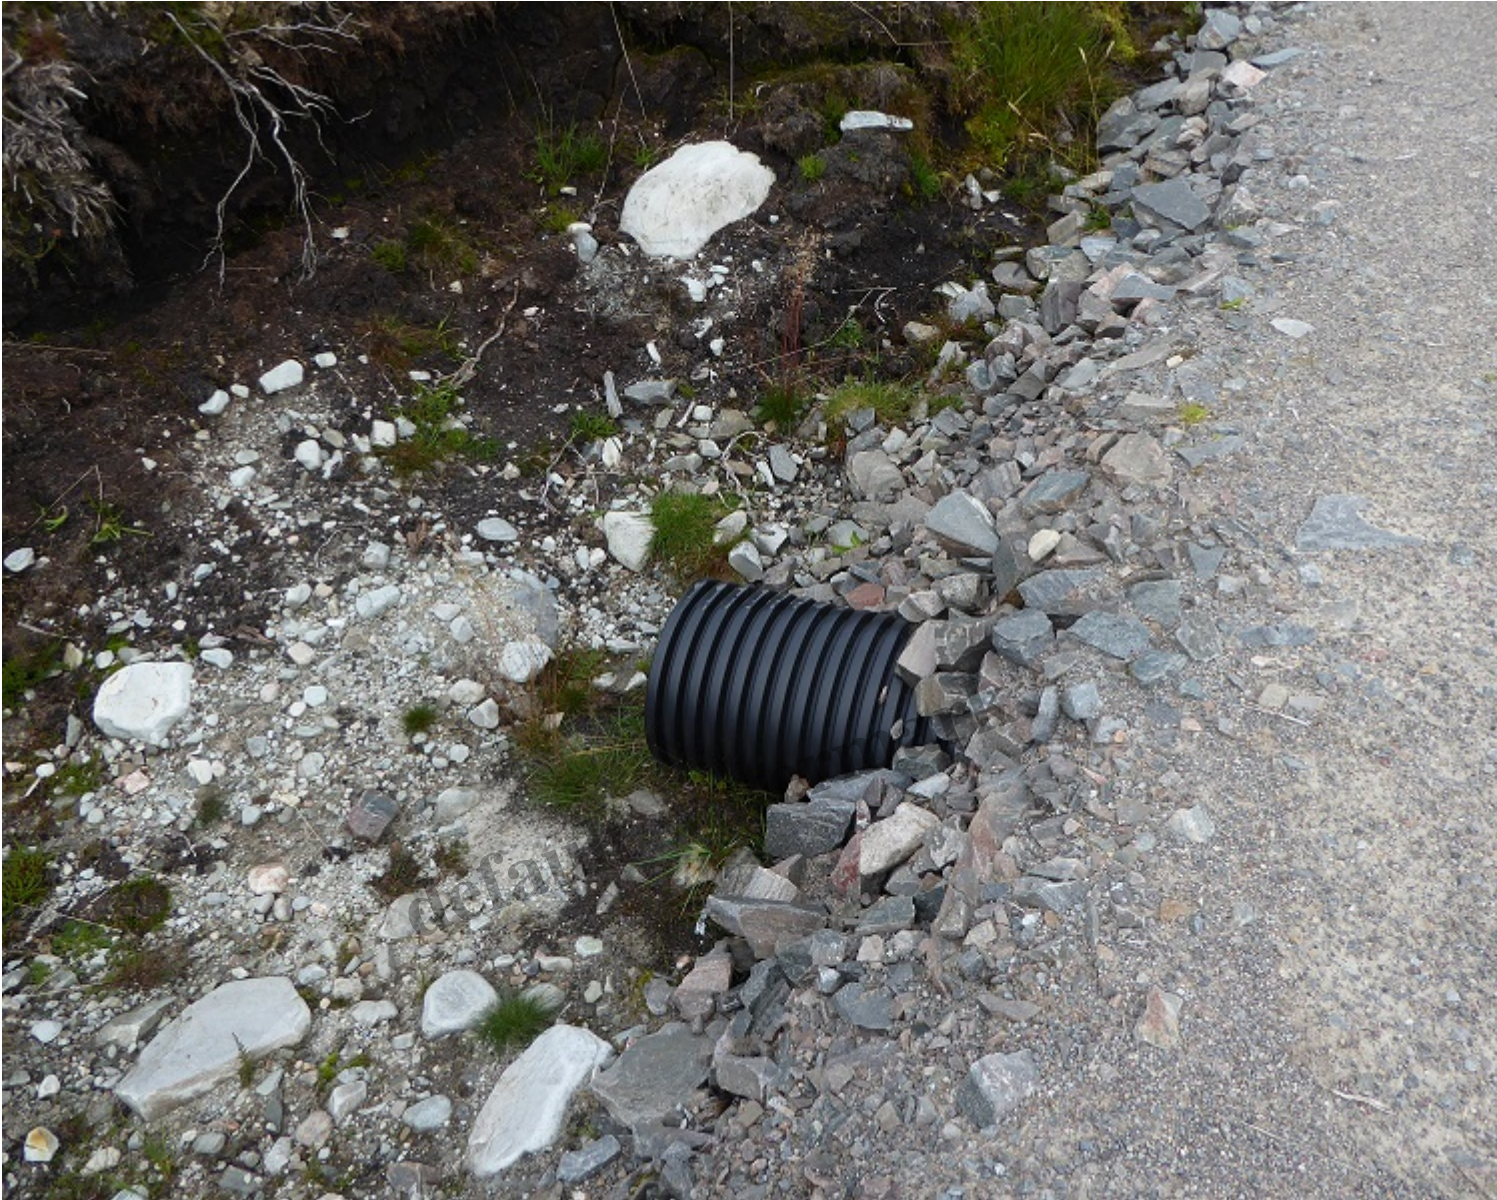
Contrast the way this culvert has been constructed – which is typical of the culverts along the new sections of track – with what the SNH Guidance says on how it should be done:

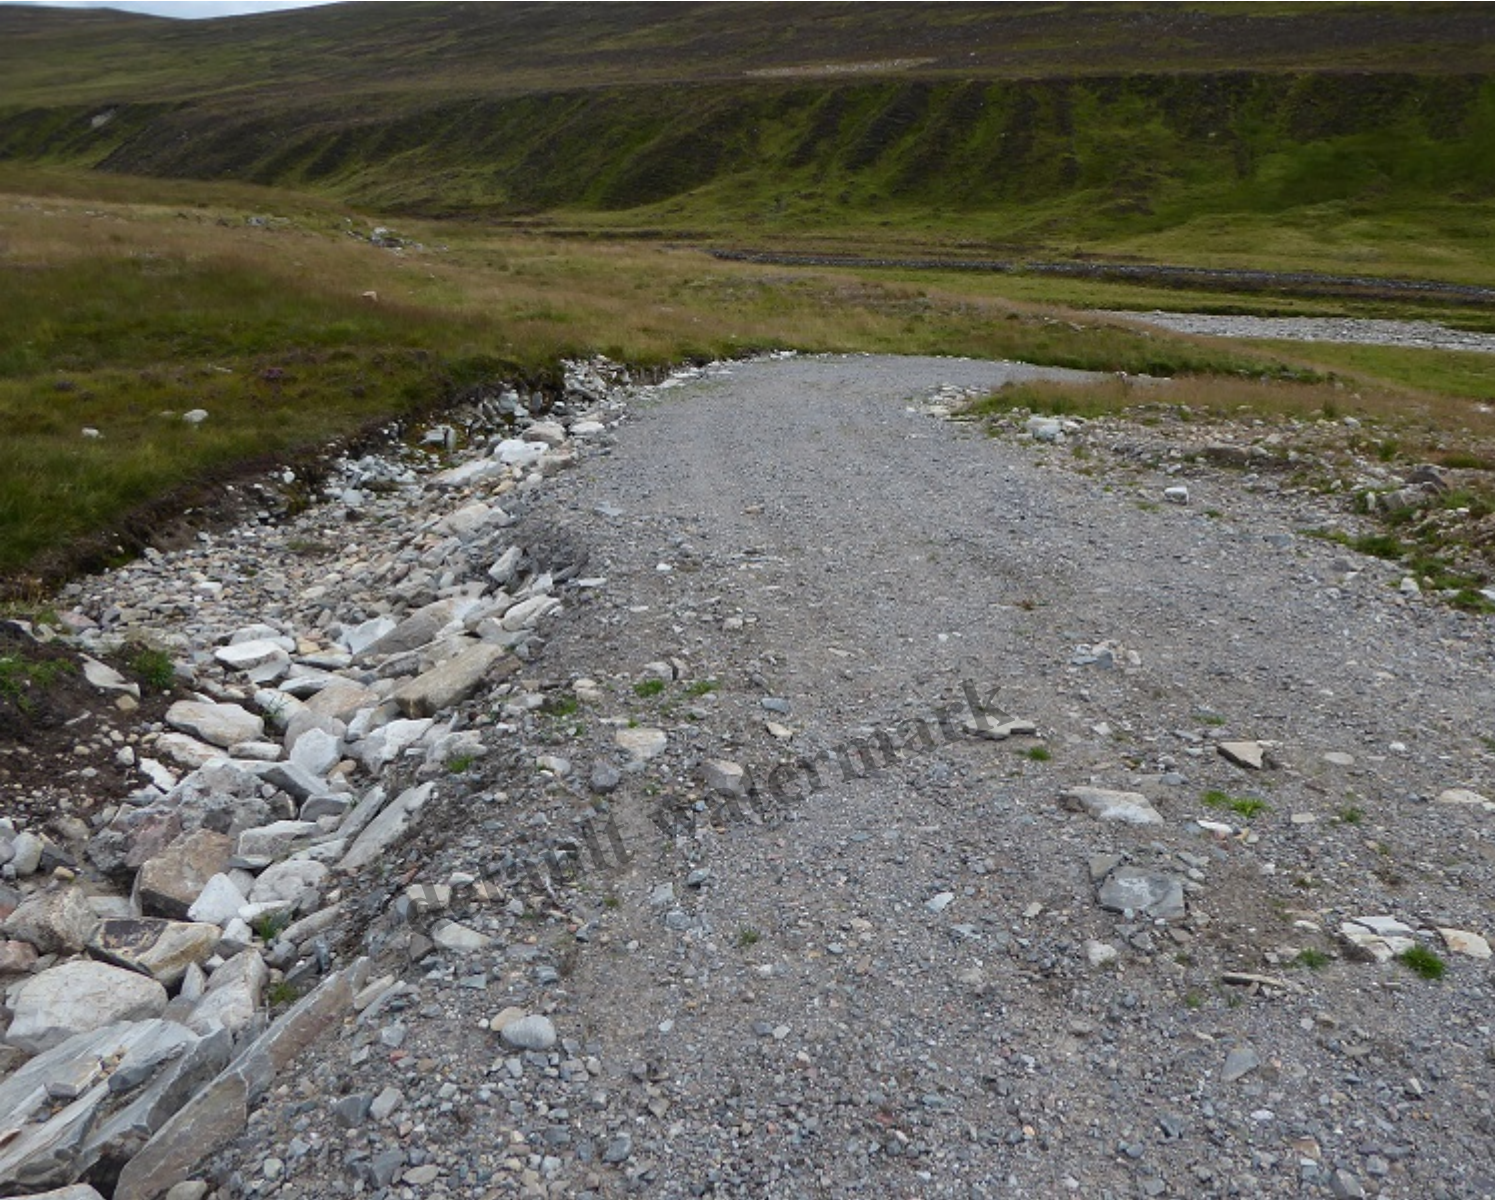
A new drainage ditch has been dug along this section of upgraded track, its unfinished ditches and edge of track on left is unfinished – there has been no attempt to revegetate it, either with turfs or re-seeding.

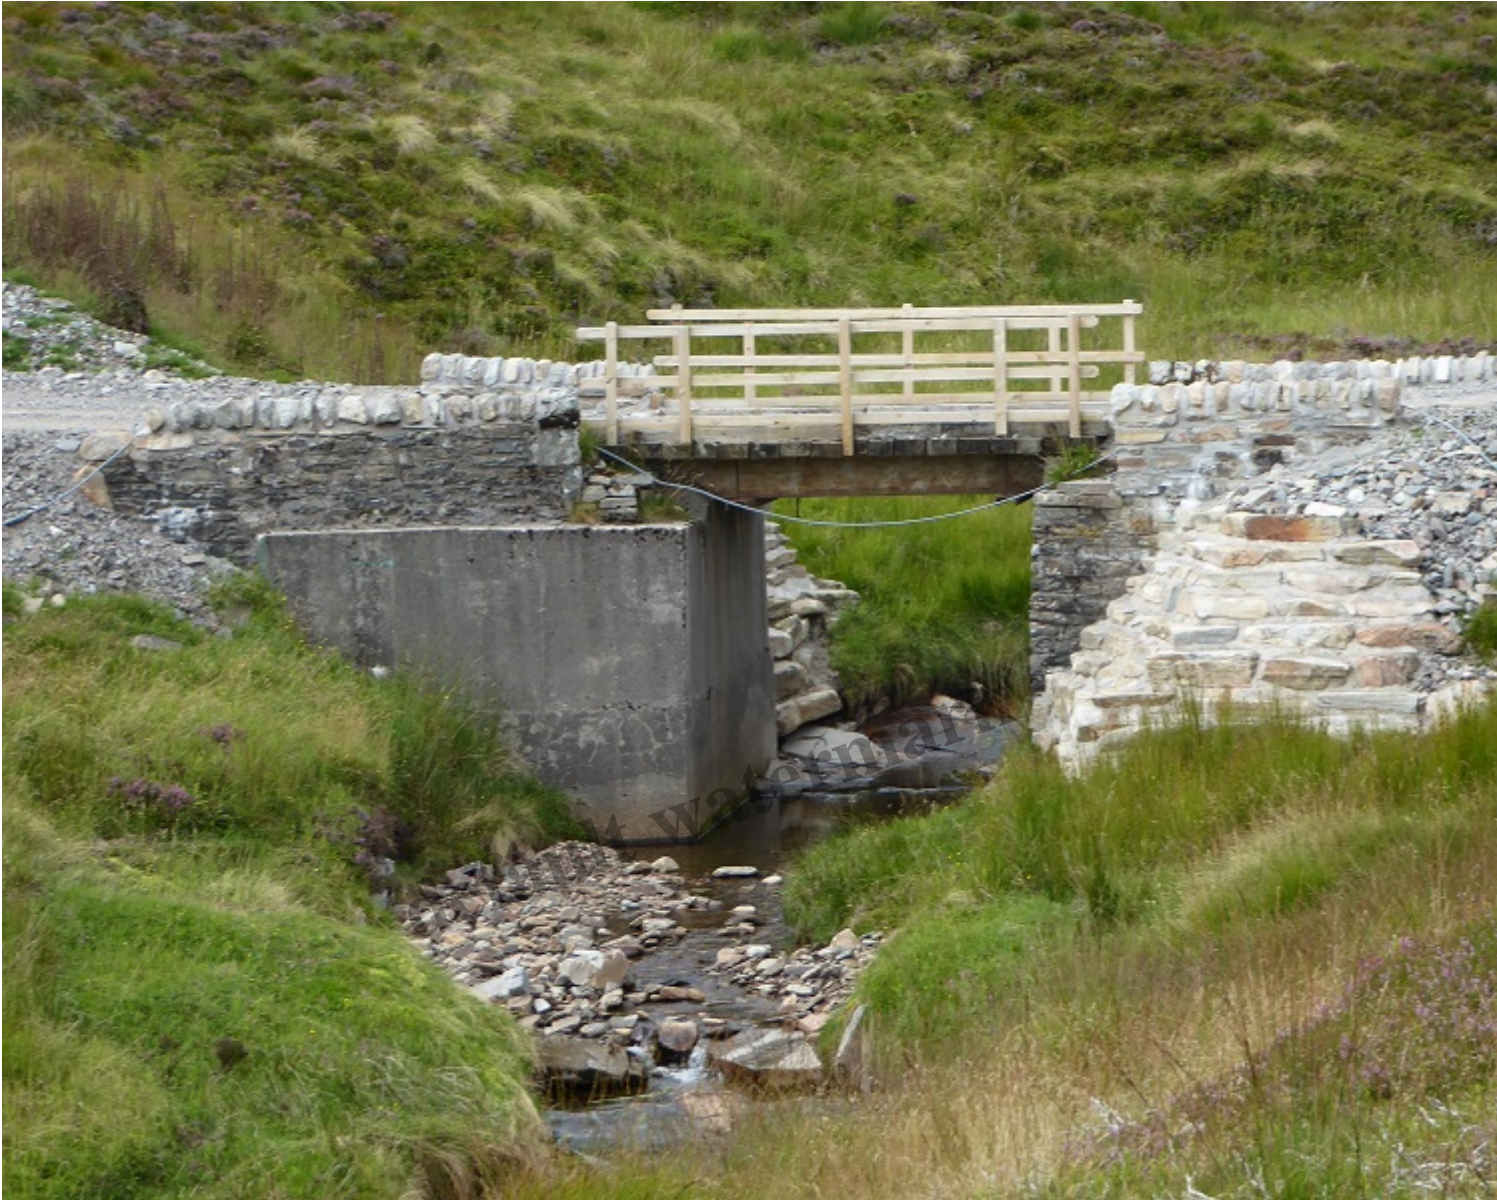
Among the kilometres of upgrade track where there has been little or no attempt to mitigate the landscapes or environmental impacts of the work, this bridge stands out as an exception. Note the new retaining buttress on the right. Unfortunately it appears the work has never been finished as material is still spilling down round the edges of the stone work on either side of the bridge.

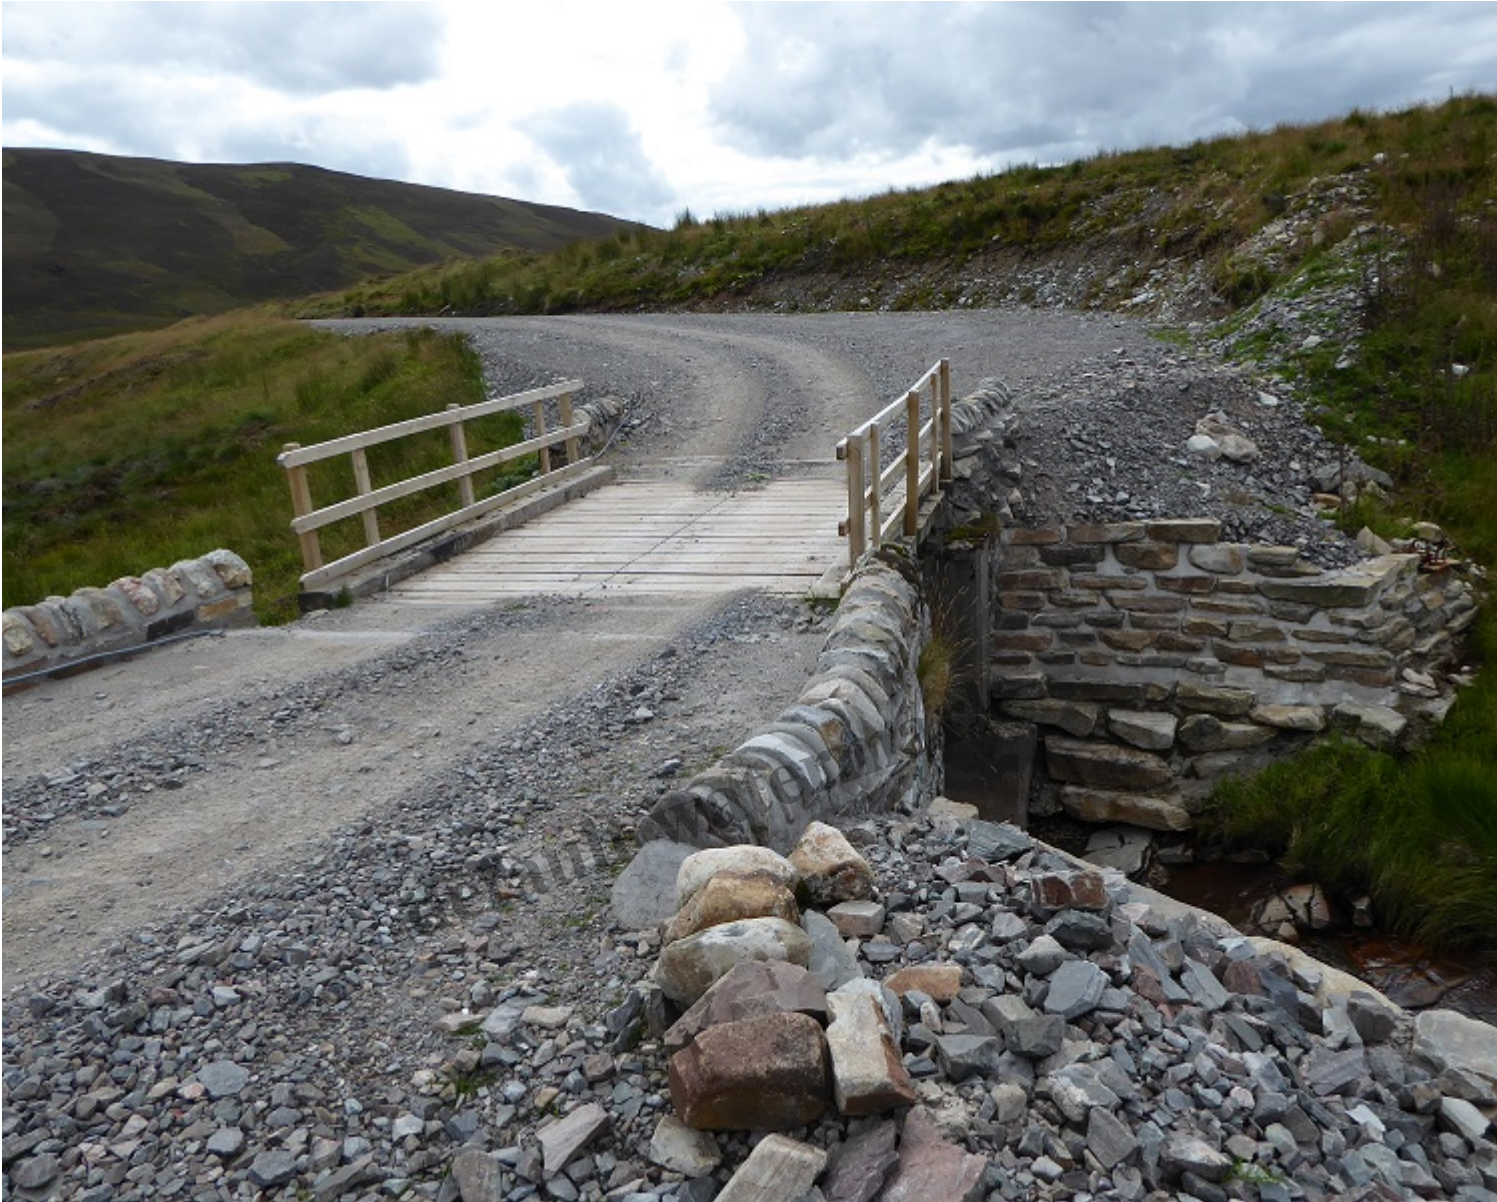
Another view of the not quite finished bridge

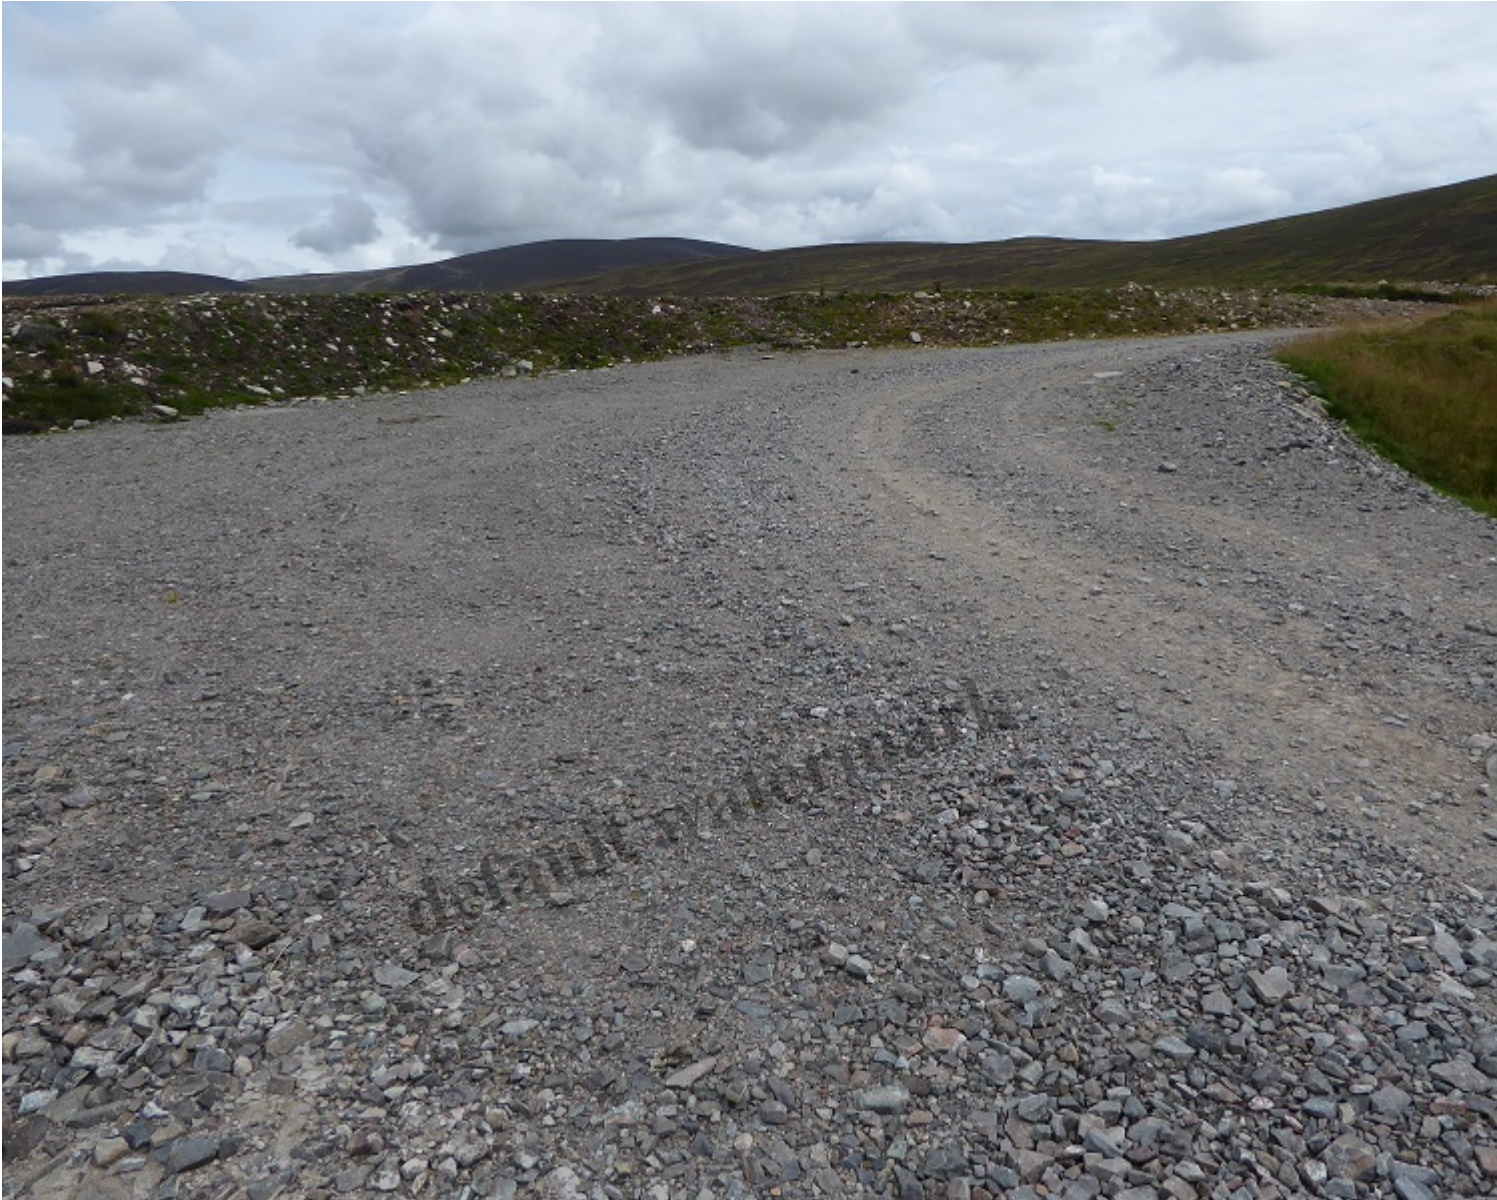
While the SNH Guidance allows for passing places this corner would be more suited to a race track. Large areas of vegetation have been destroyed and never restored. How can this be allowed in a National Park?
