## The Glen Bruar hydro track

### Description

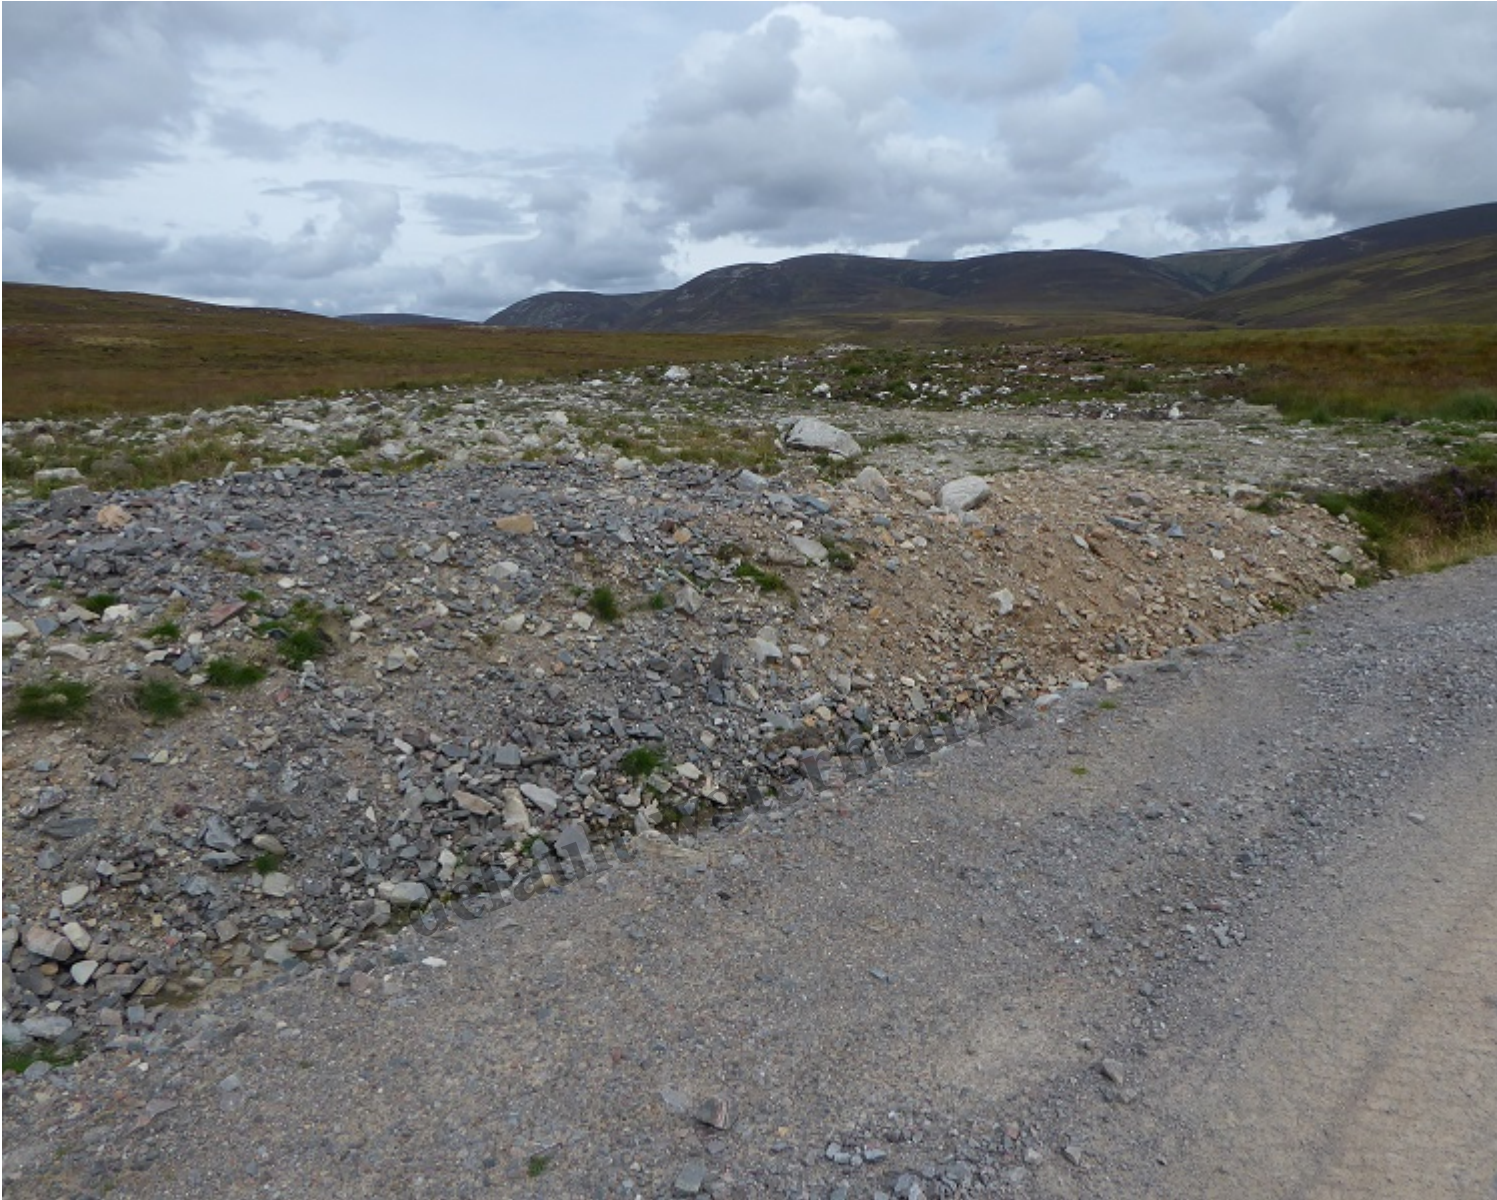
Here aggregate appears to have been dumped on the edge of the area excavated for the pipeline. The Developer claimed the poor restoration of the pipeline was because the organic material was too shallow but said nothing about how they had dumped other materials onto the line of the pipeline. This could only have happened after the pipeline had been “restored” as the road aggregate sits on top of the “pipeline restoration”.

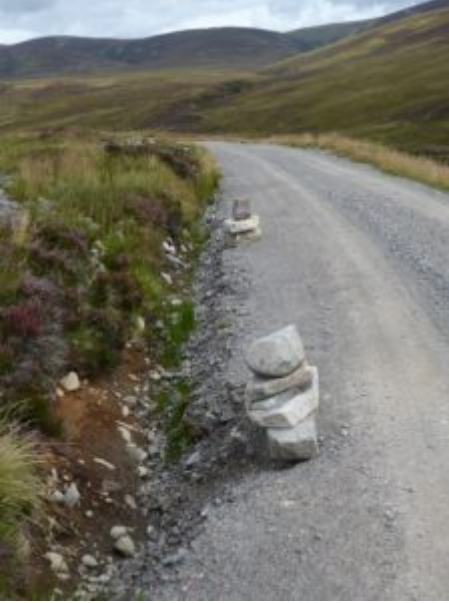
The track is not even good for the people who live or work at Bruar Lodge. Here staff have had to mark the holes that have eroded out of the track. Its not clear to me why Atholl estates would have tolerated such poor work.

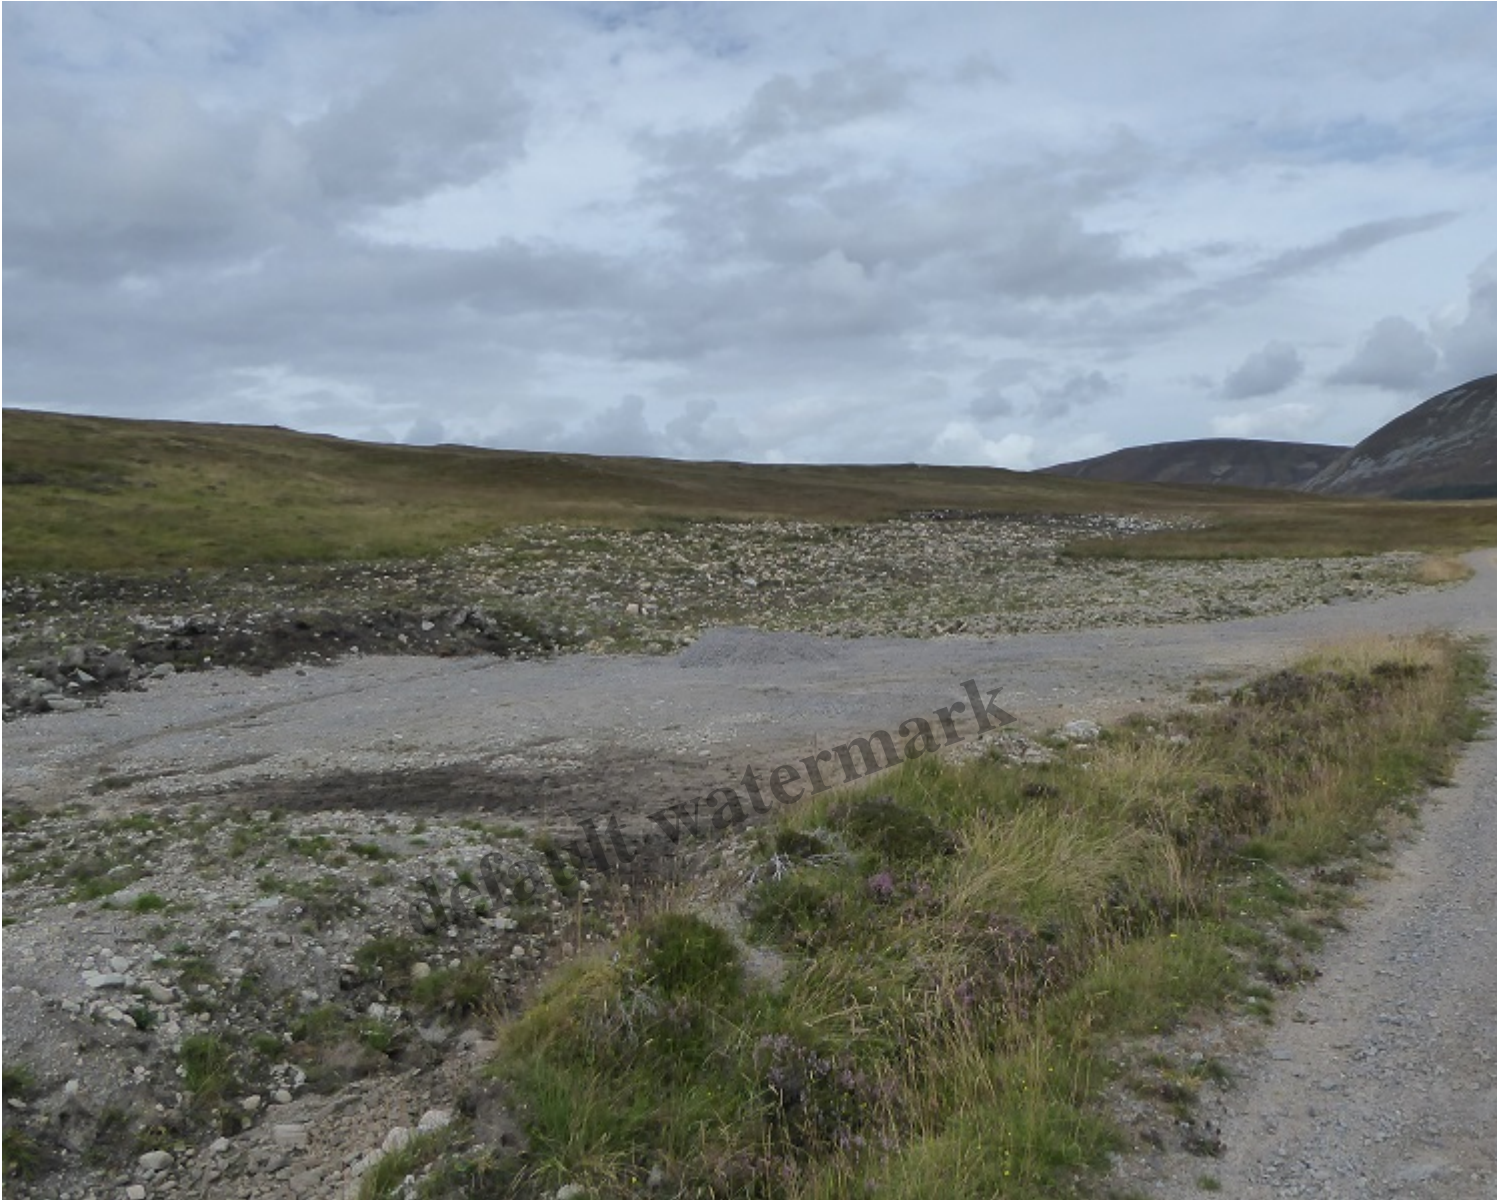
While there was mention of temporary areas of tracks and laydown areas in the planning application all were meant to be restored. Why has this vehicle area been left in the midst of the scar left by the pipeline? Its hard to imagine how restoration of a hydro pipe and track could be worse than this (do send in your photos).

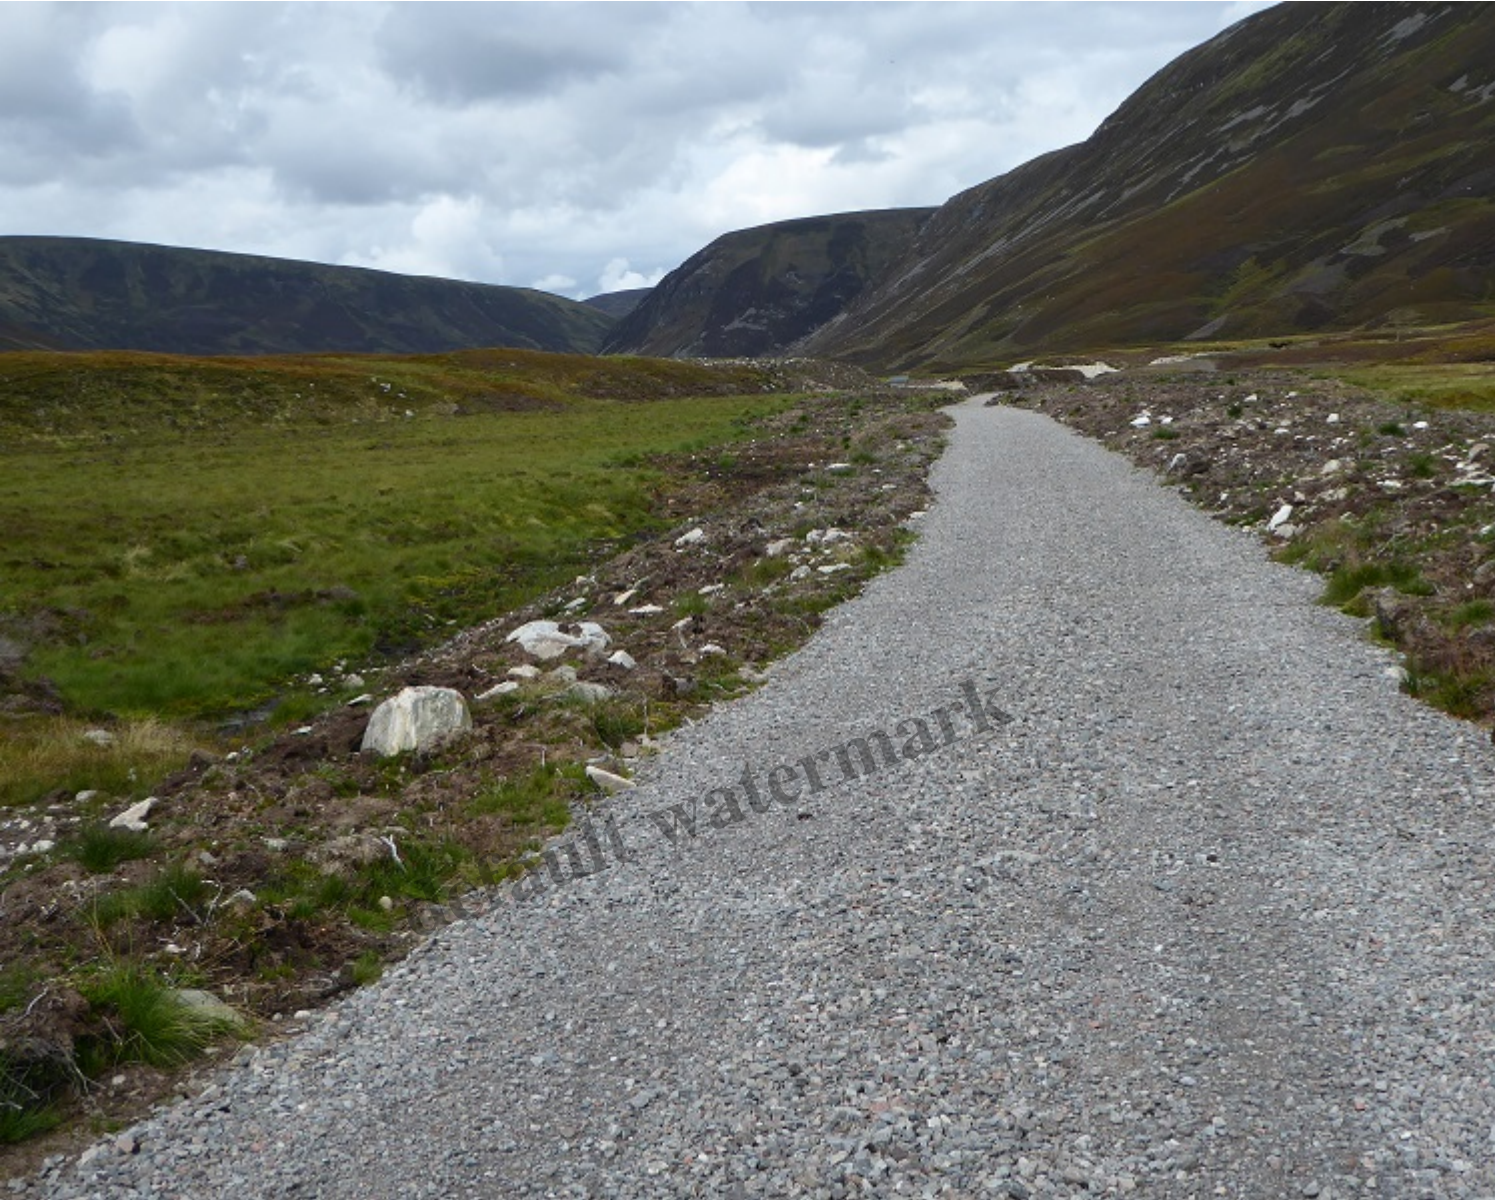
By contrast the work on the new section of track beyond Bruar Lodge appears to have been constructed with far more care. It is much narrower than the section of upgraded track and restoration work has taken place along the verges. This is less than 2k though out of a total track length of 12k. The reason for this appears to be that the CNPA did set out conditions:

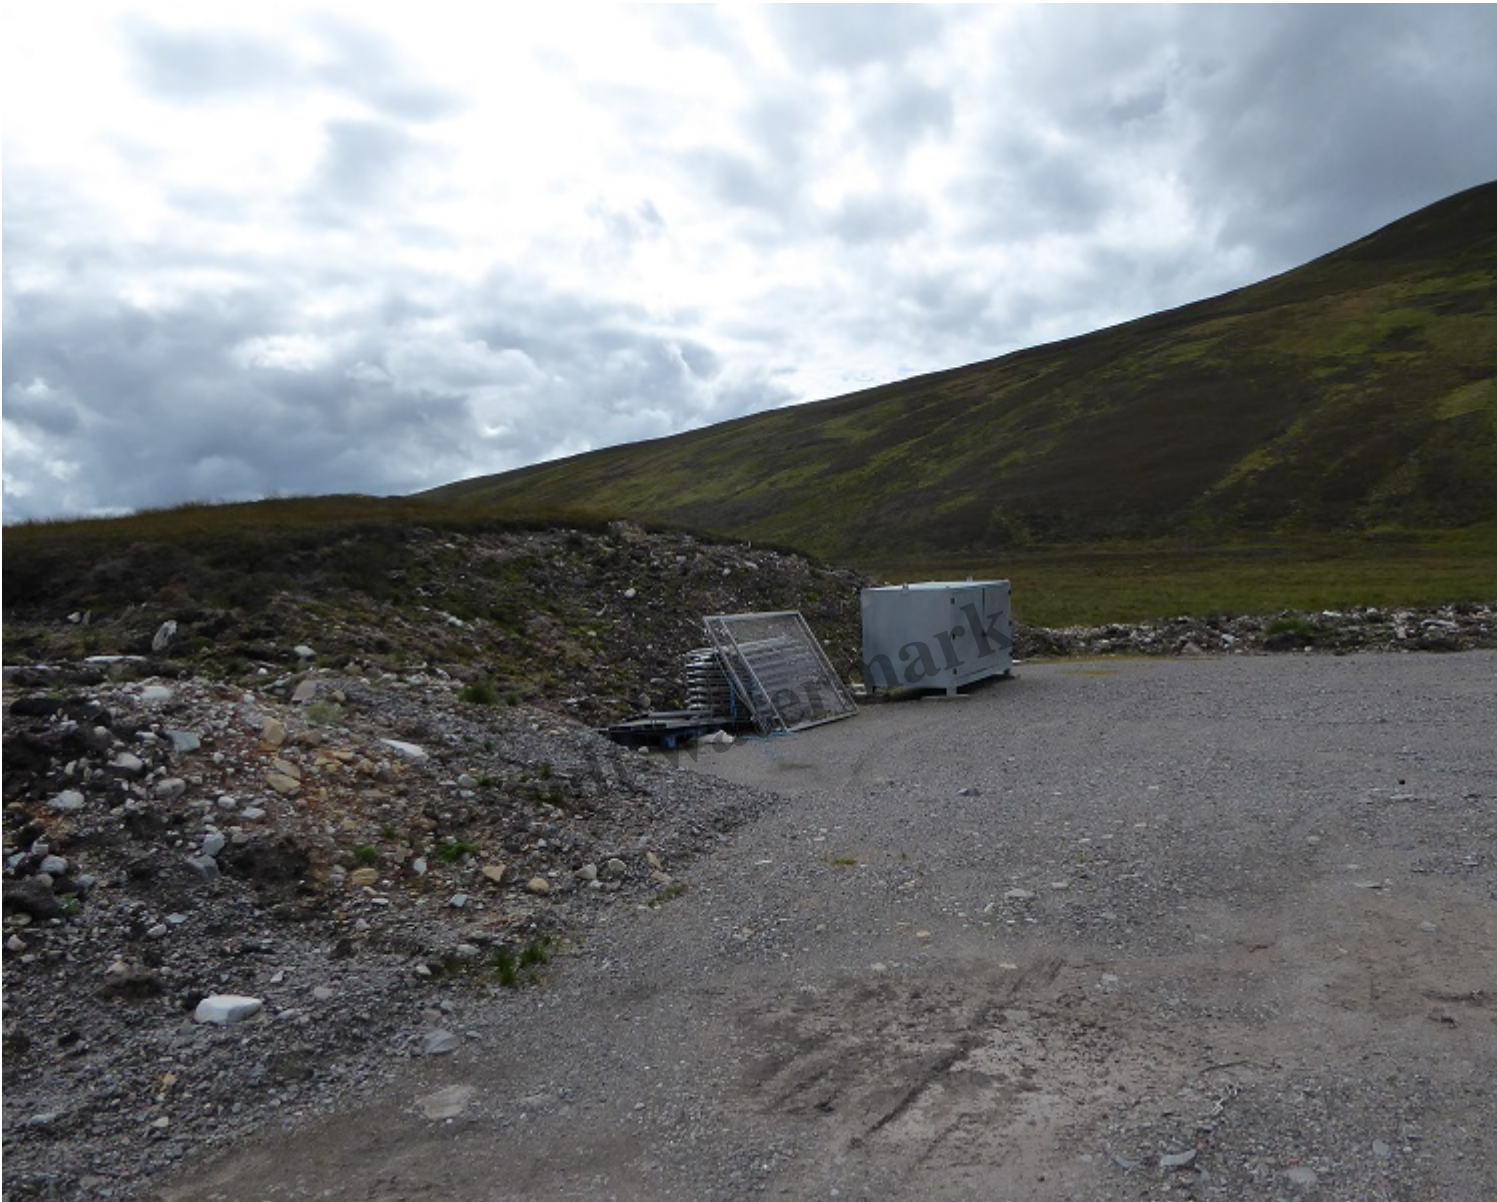
The turning/storage area by the dam however has not been restored or properly cleared up. Again note the track aggregate dumped on the bank on the left.

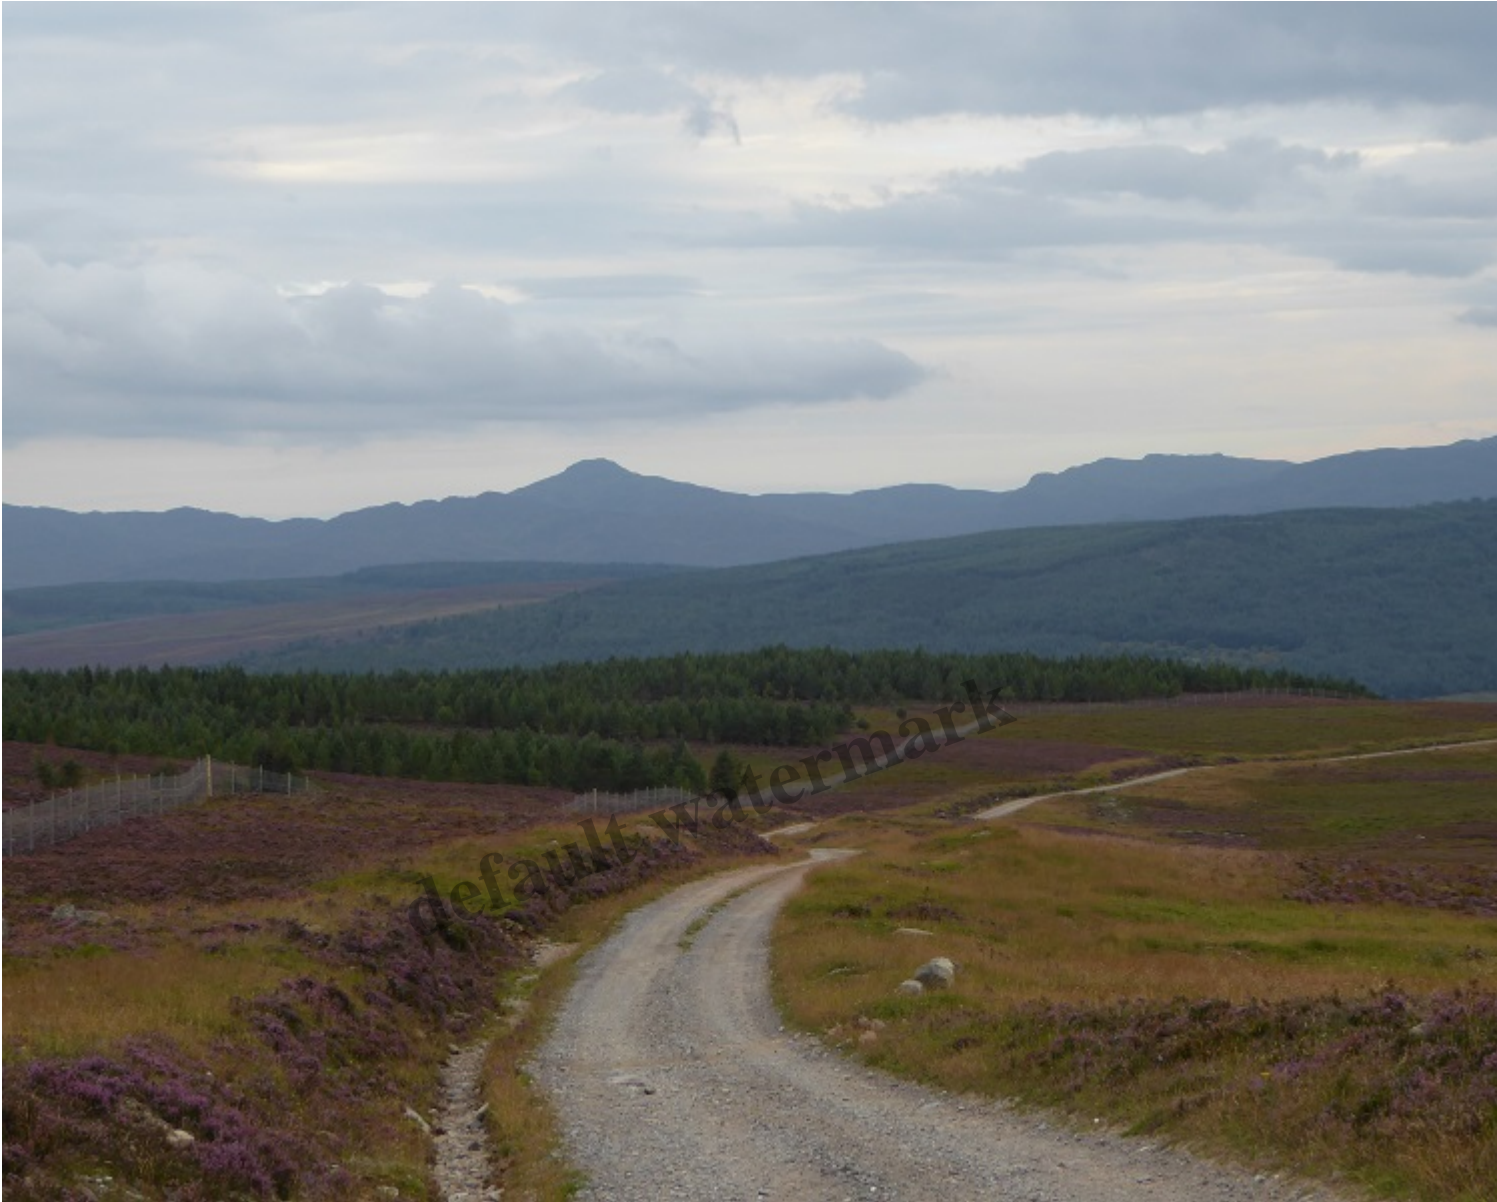
The section of track linking Glen Bruar to Calvine appears to have been subject to far less upgrading work than that in Glen Bruar itself. If construction vehicles could access the Glen by this track, which is far steeper and narrower than any of the track along the glen, it begs the question of why the Bruar track needed to be upgraded. Possibly it was in poor condition but simply dumping tons of extra aggregate on top of the existing track as a quick fix, which is what appears to have happened, should never have been allowed.
