Large scale environmental dereliction in the National Park

**By Nick Halls**

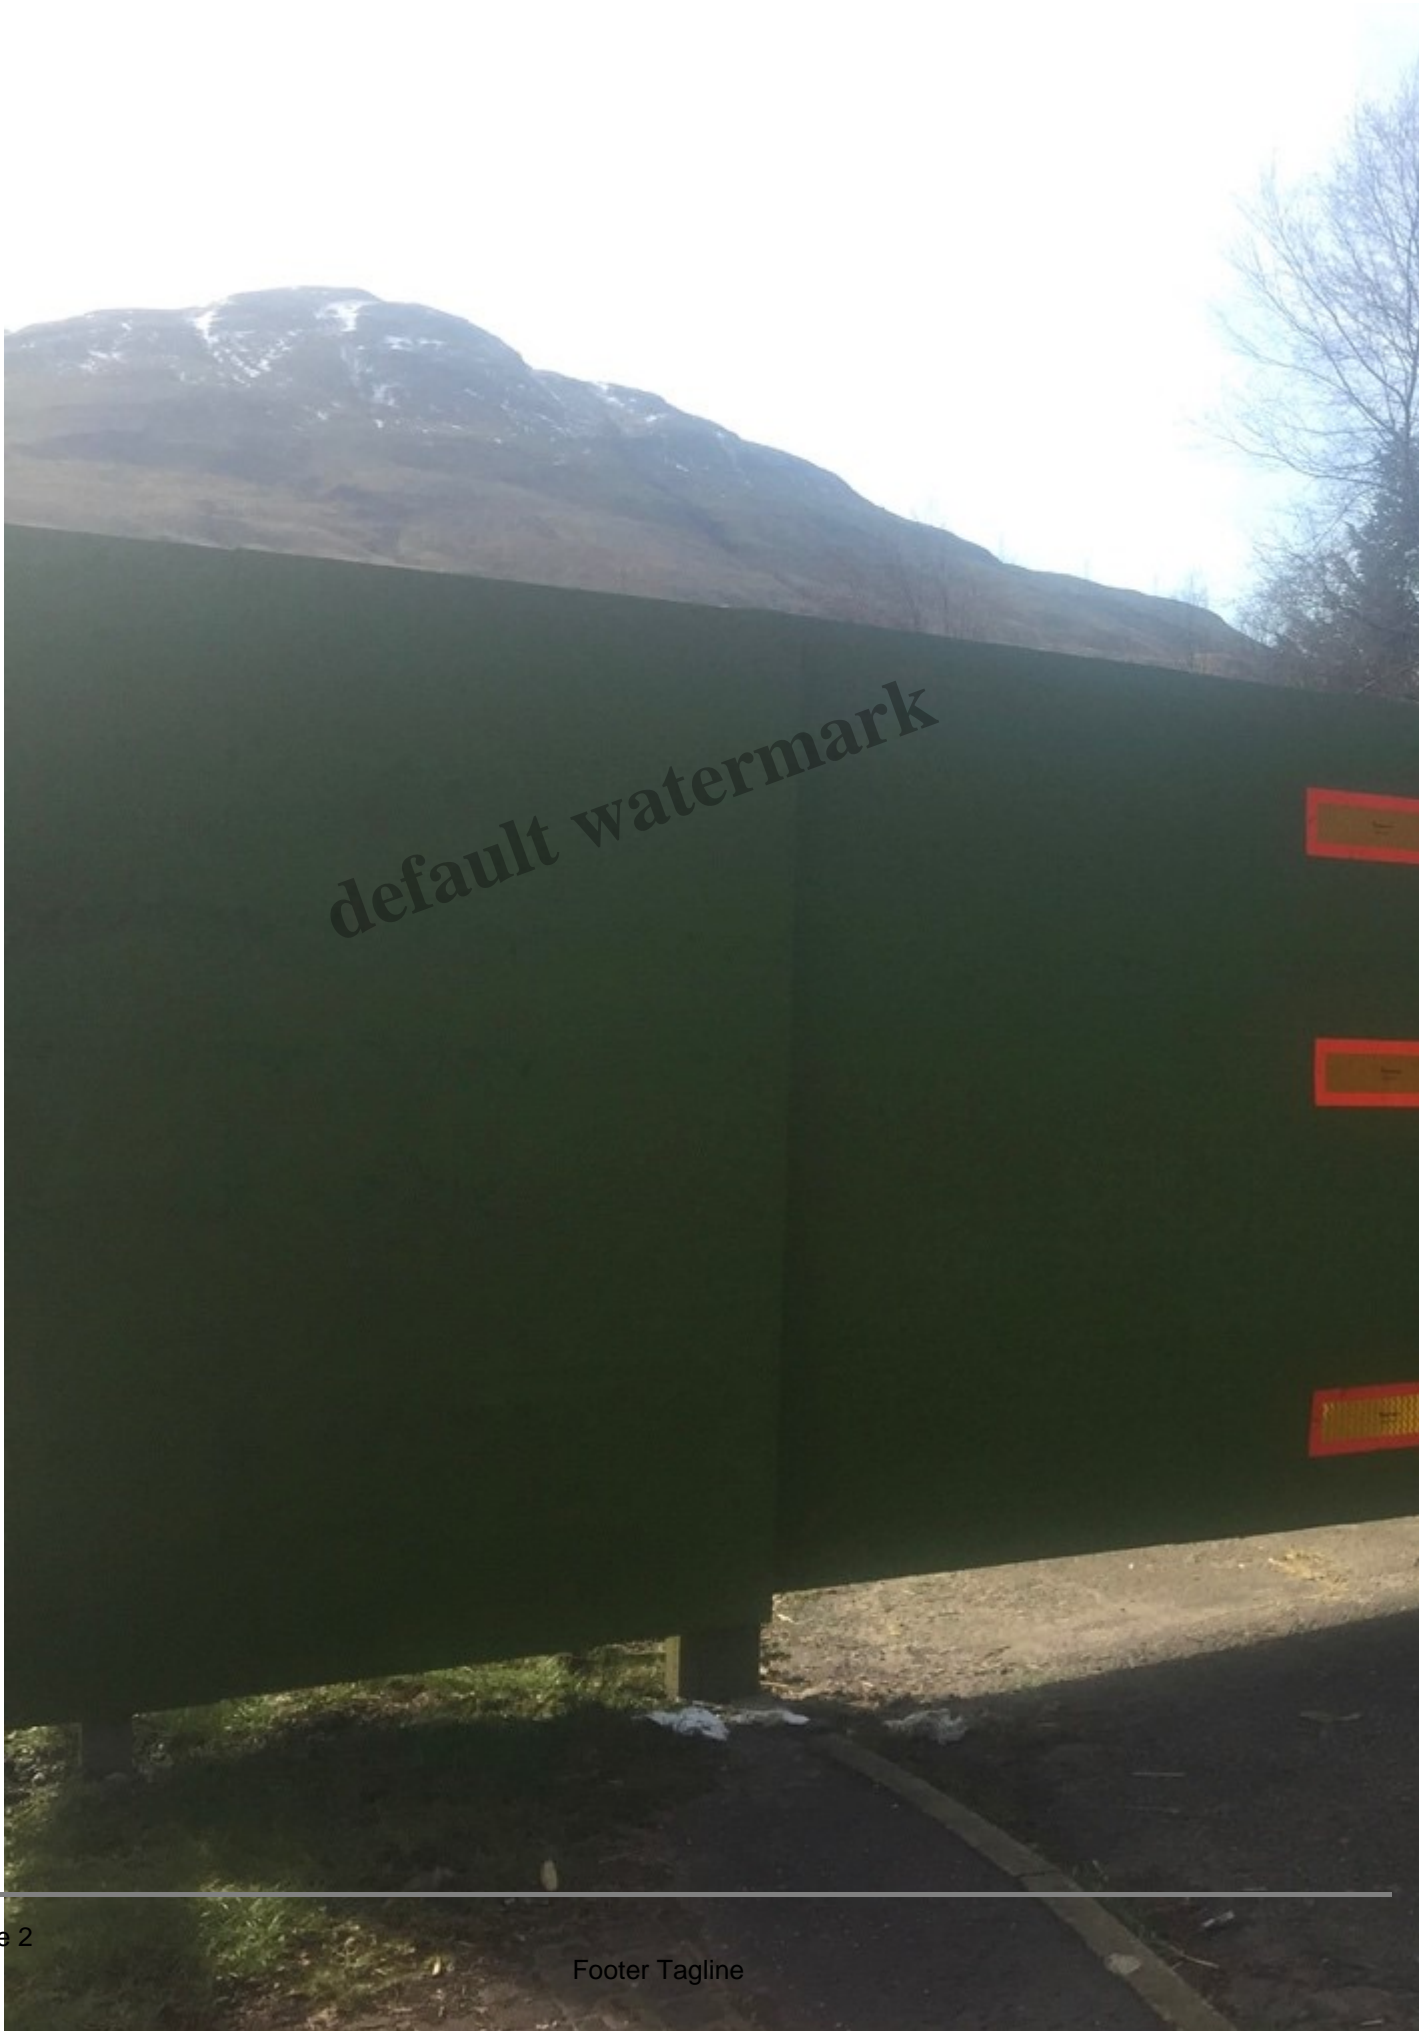
Northern Gate, preventing access to old road and former Torpedo range site. The gate was recently development of the site. That planning permission has however lapsed. All photos Nick Halls.

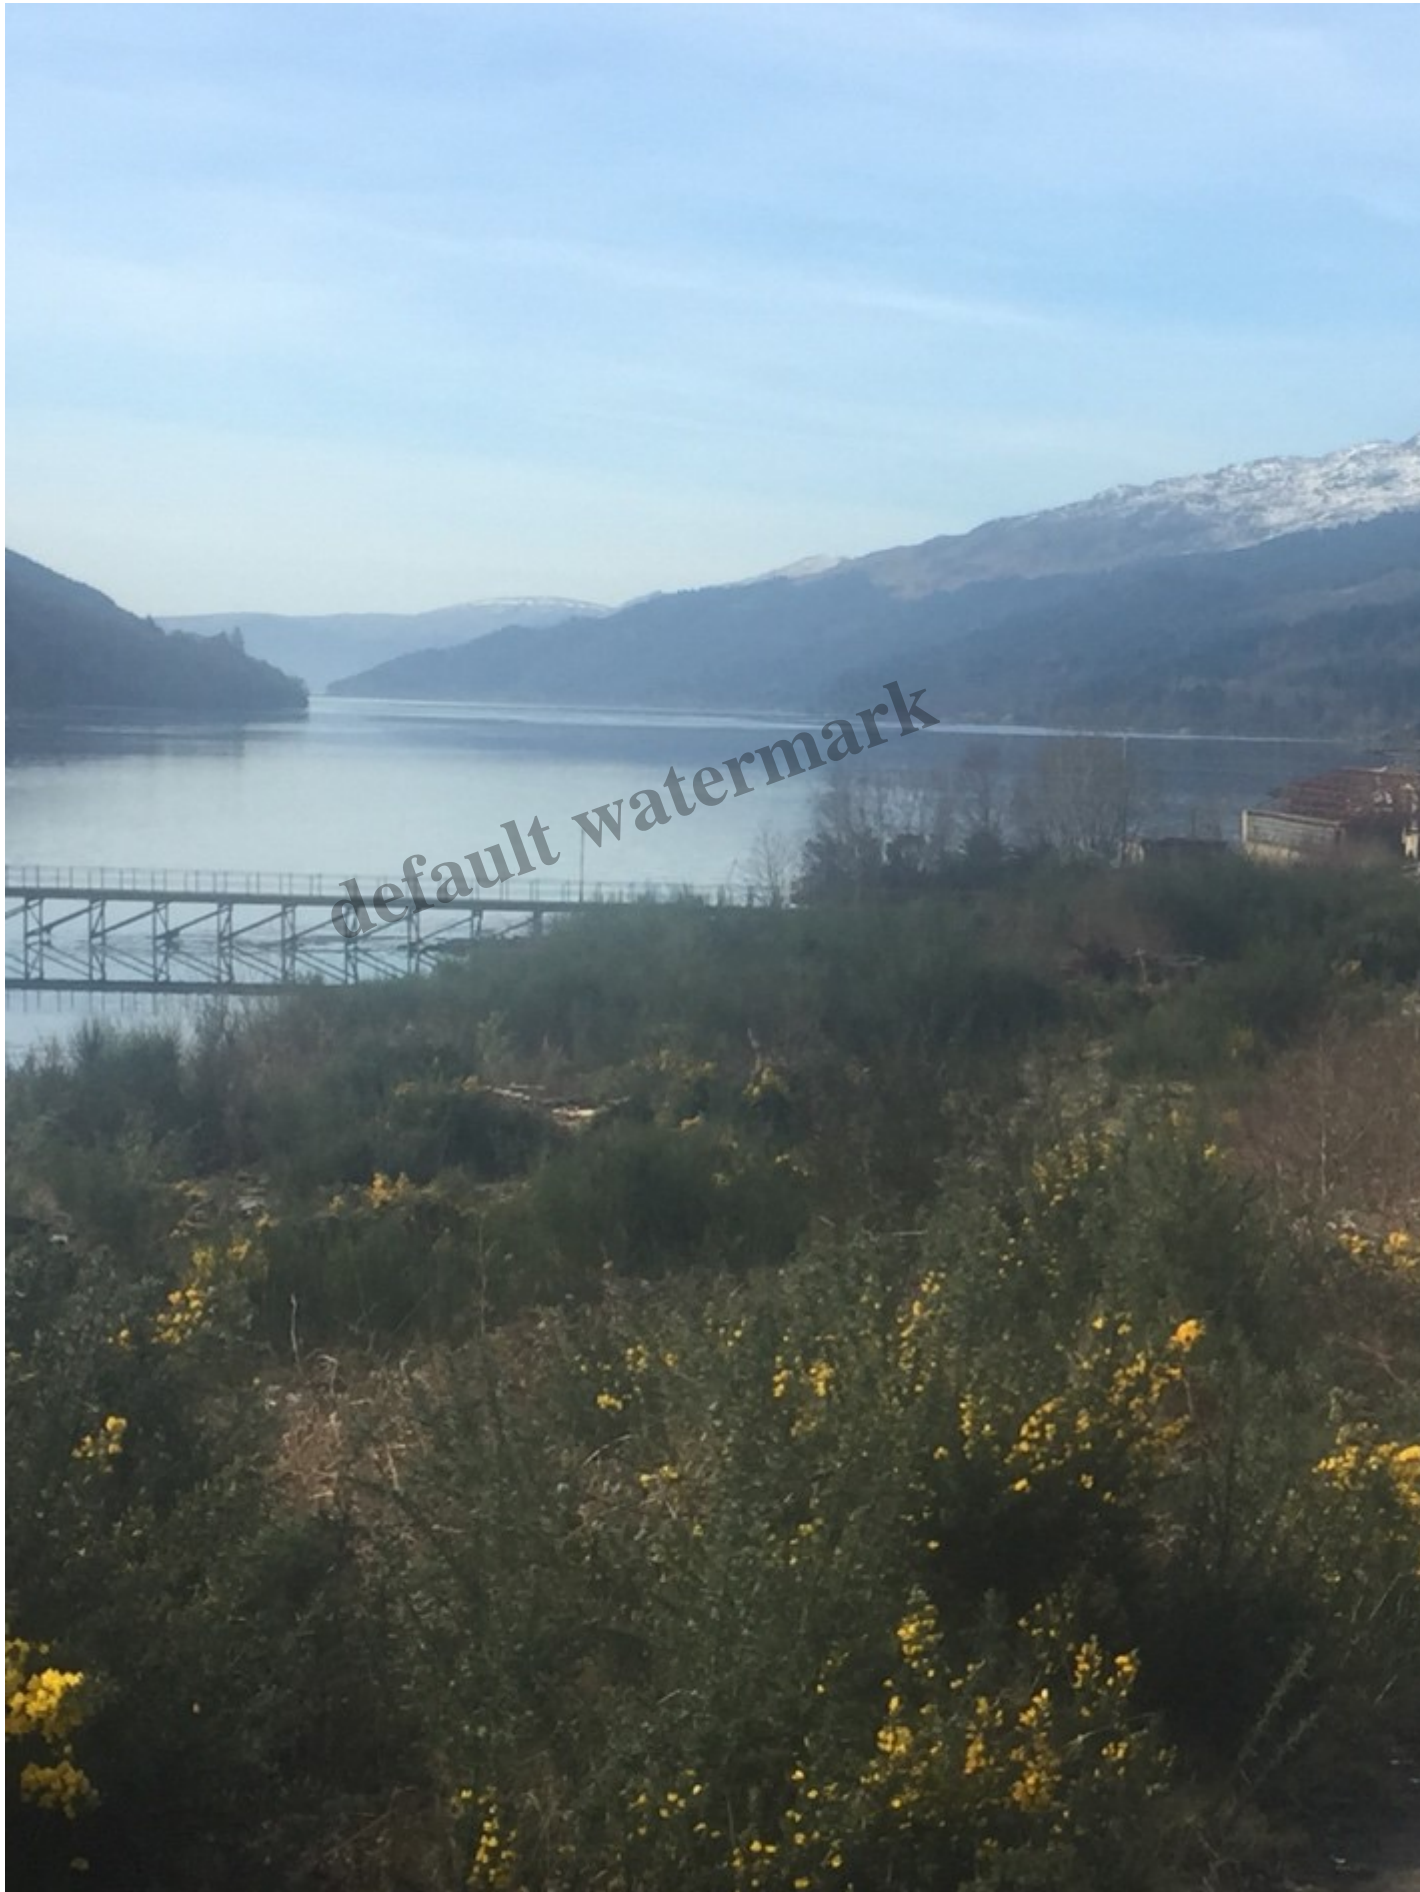
View south down the old main road towards derelict Torpedo factory.

It is possible to by-pass the gate on foot which, in respect of the danger from asbestos renders the gates ineffective, and, although the gate prevents fly tipping from vehicles, it does not prevent people disposing of bags of garbage which are being thrown down towards the shore line.

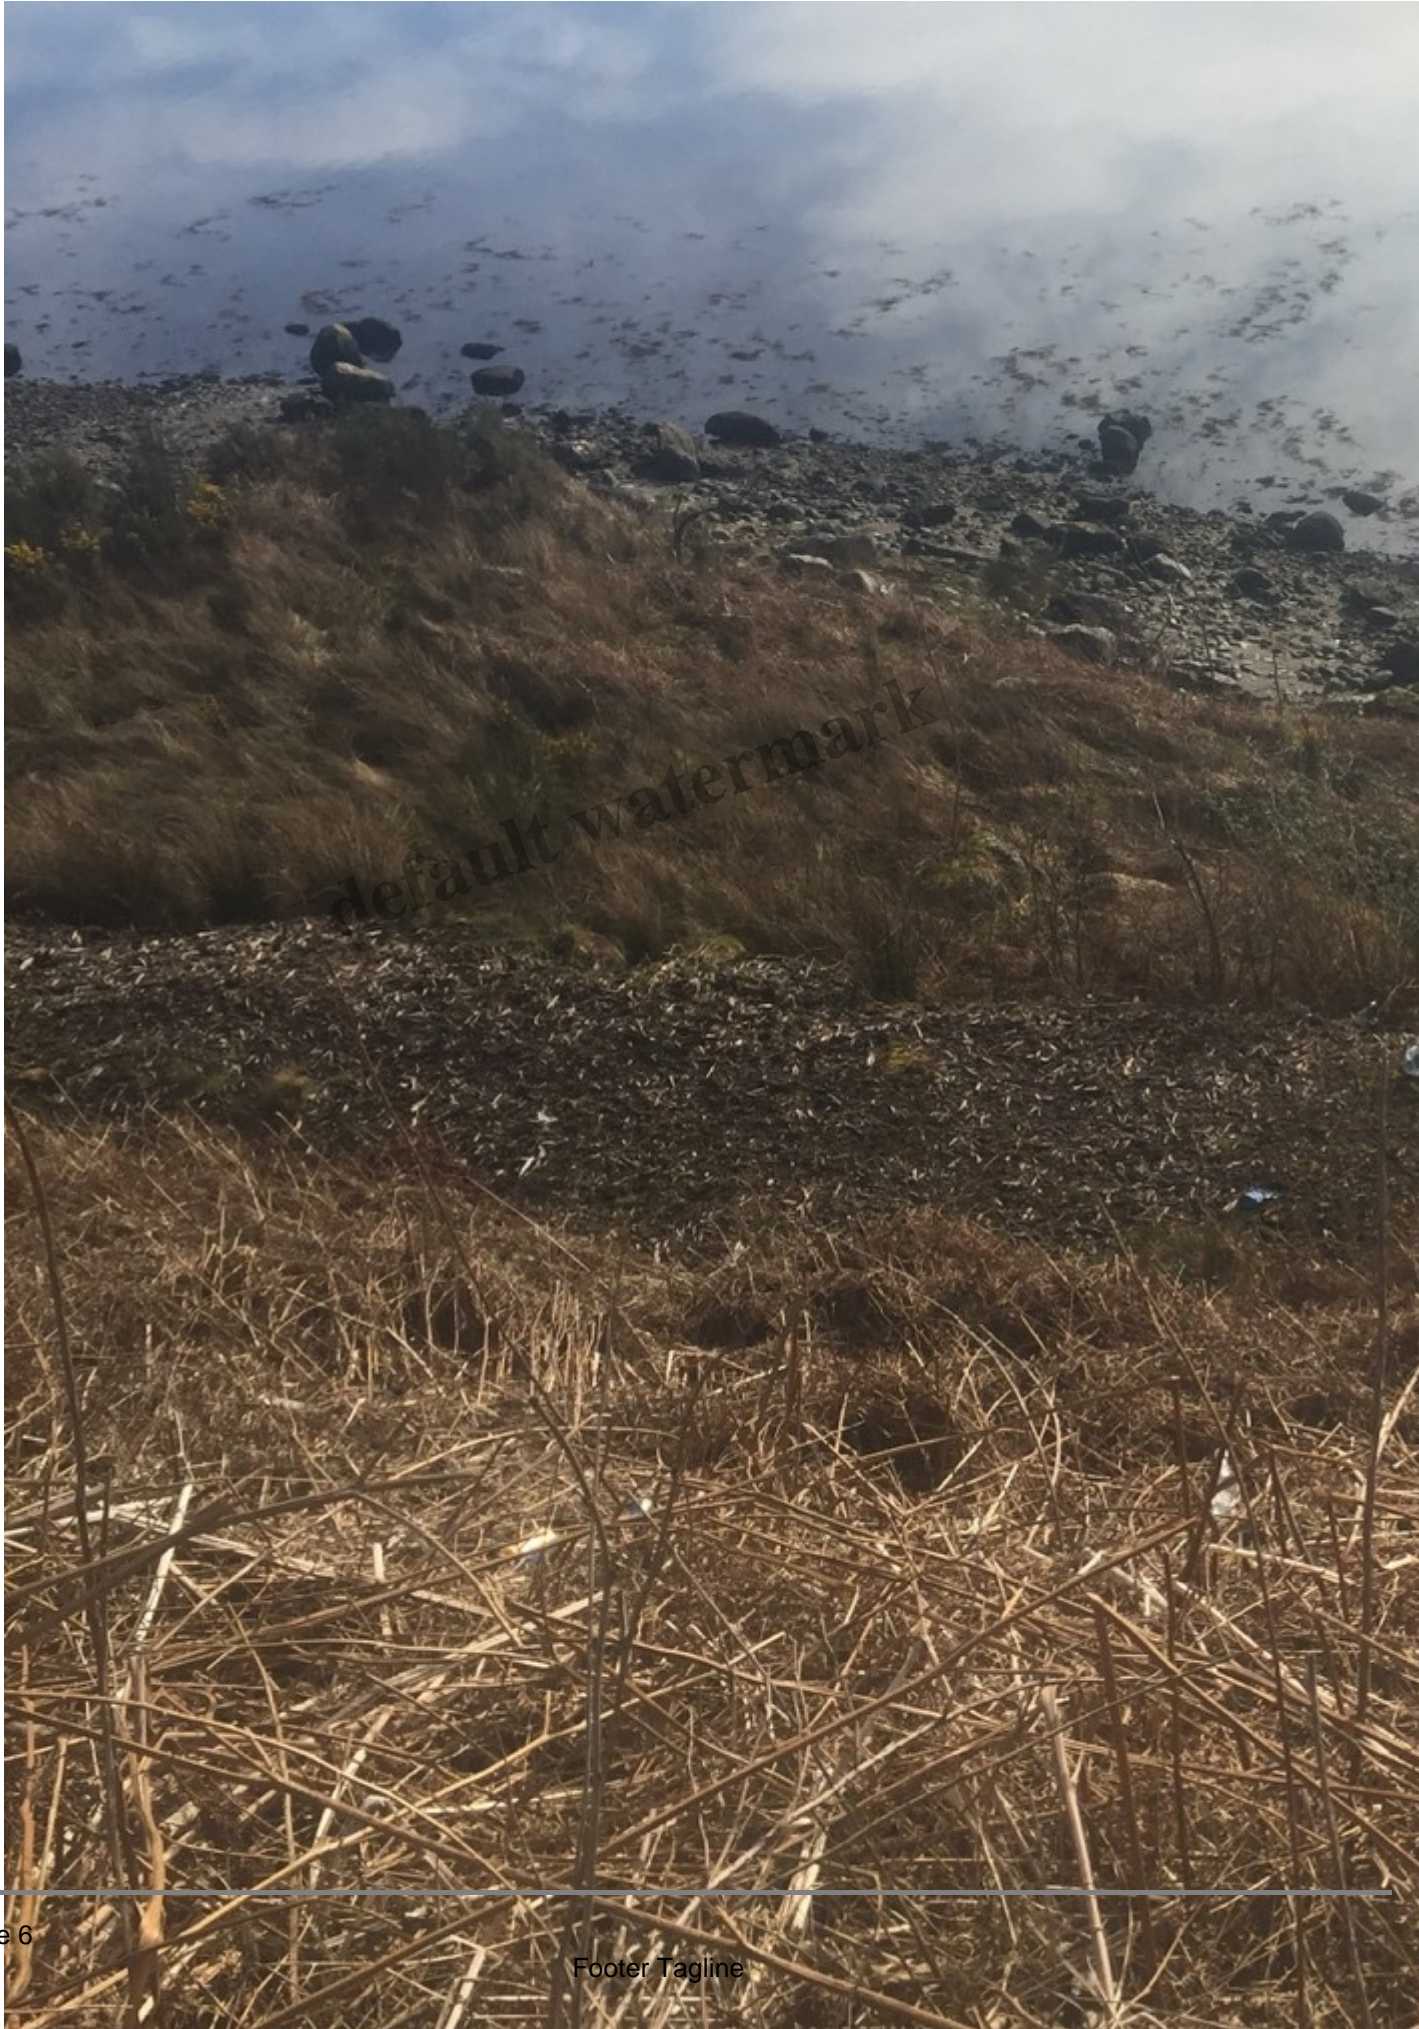
Garbage thrown down from within the northern gate from shore side of old road

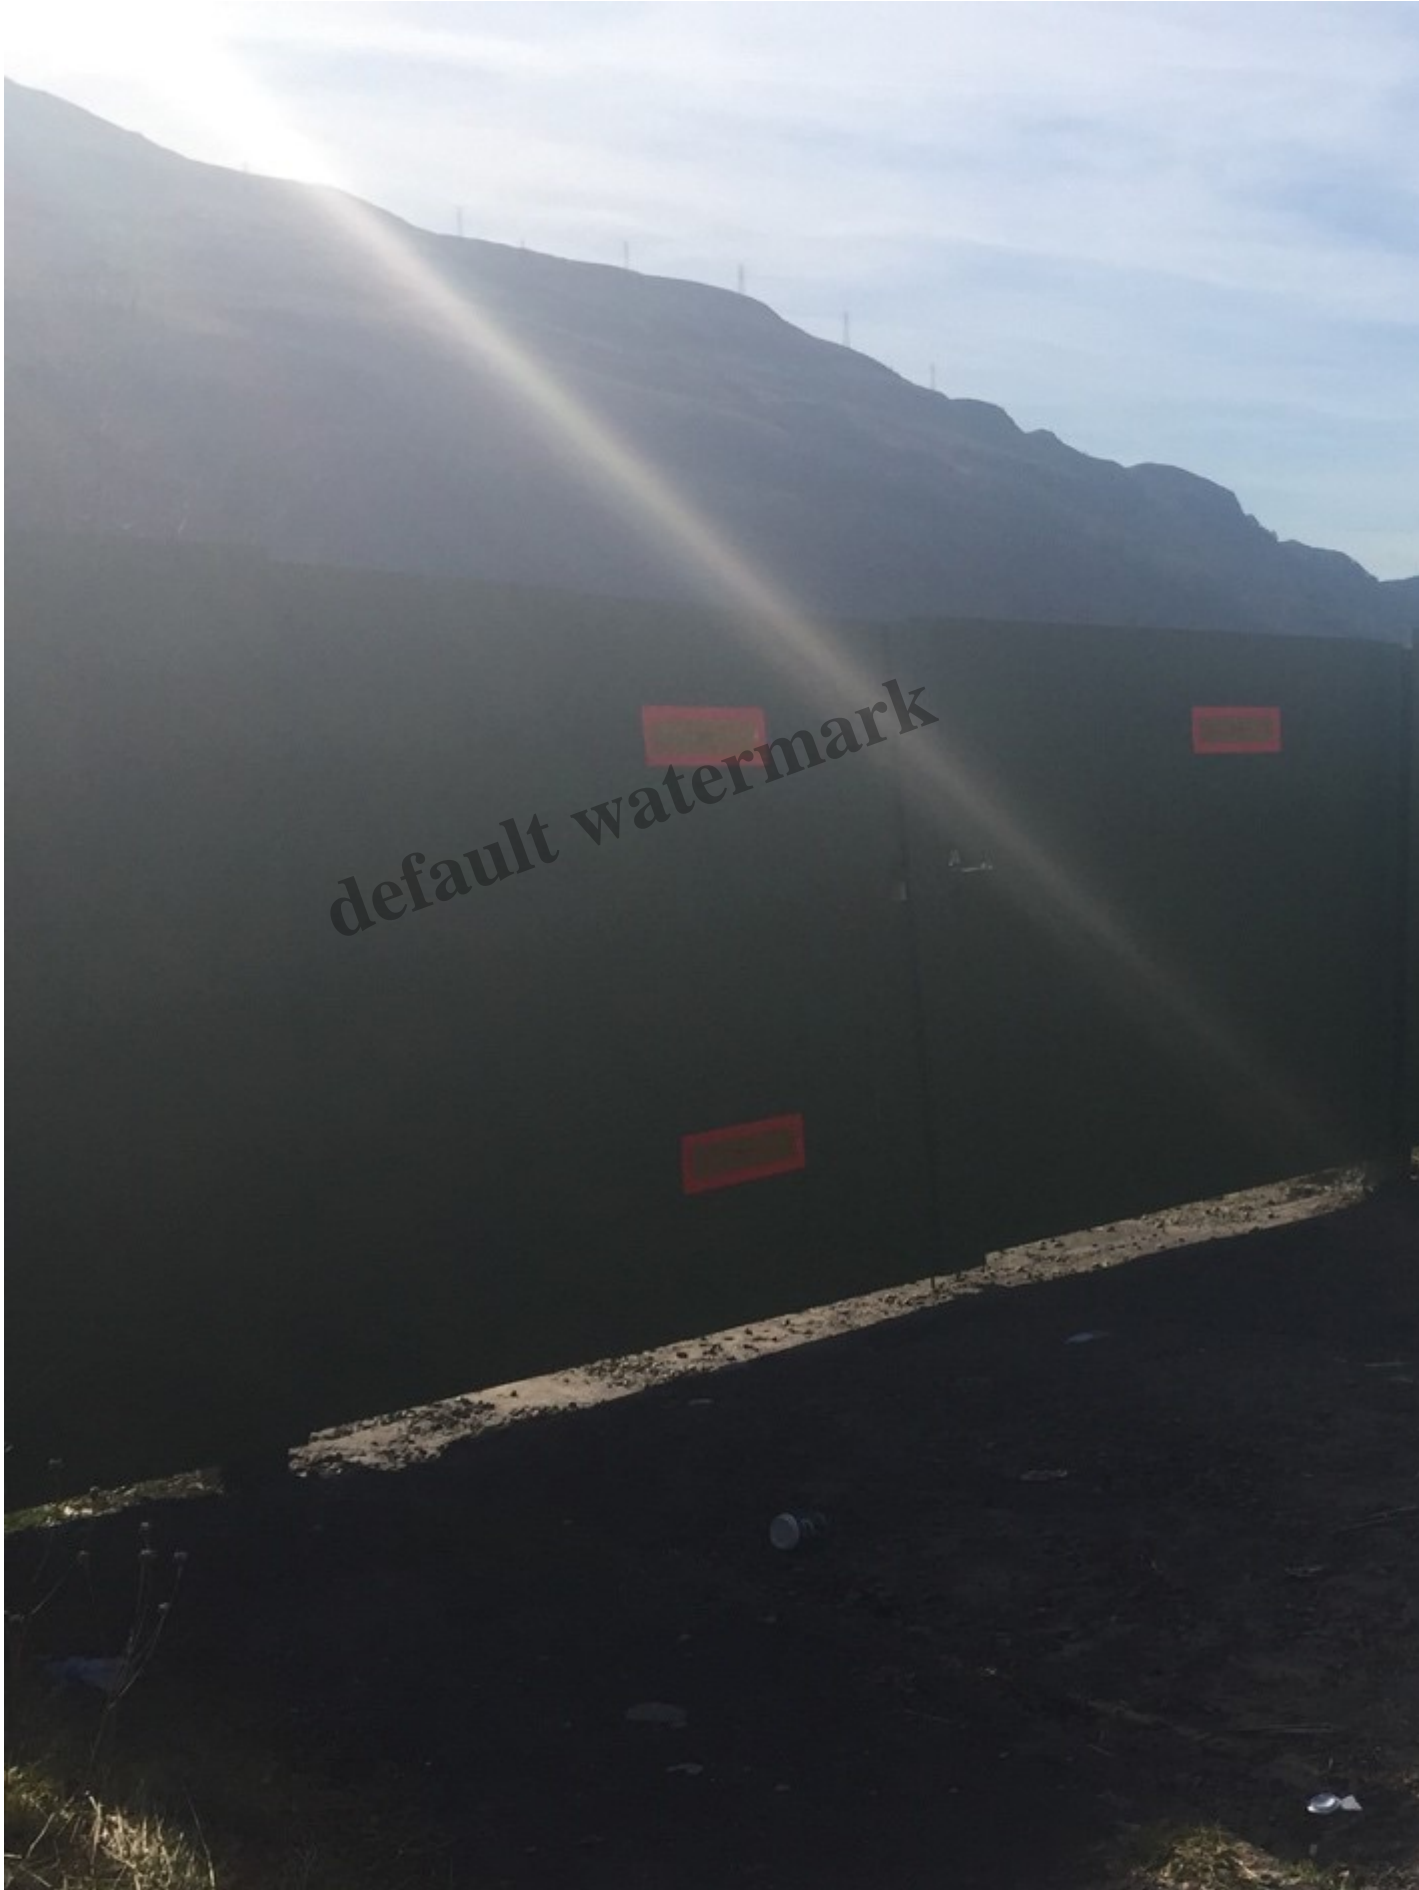
The southern entry to the site and the old A83 has also been blocked off with similar style gates  
Dumping from vehicles is still possible also at the southern gate and is still happening.

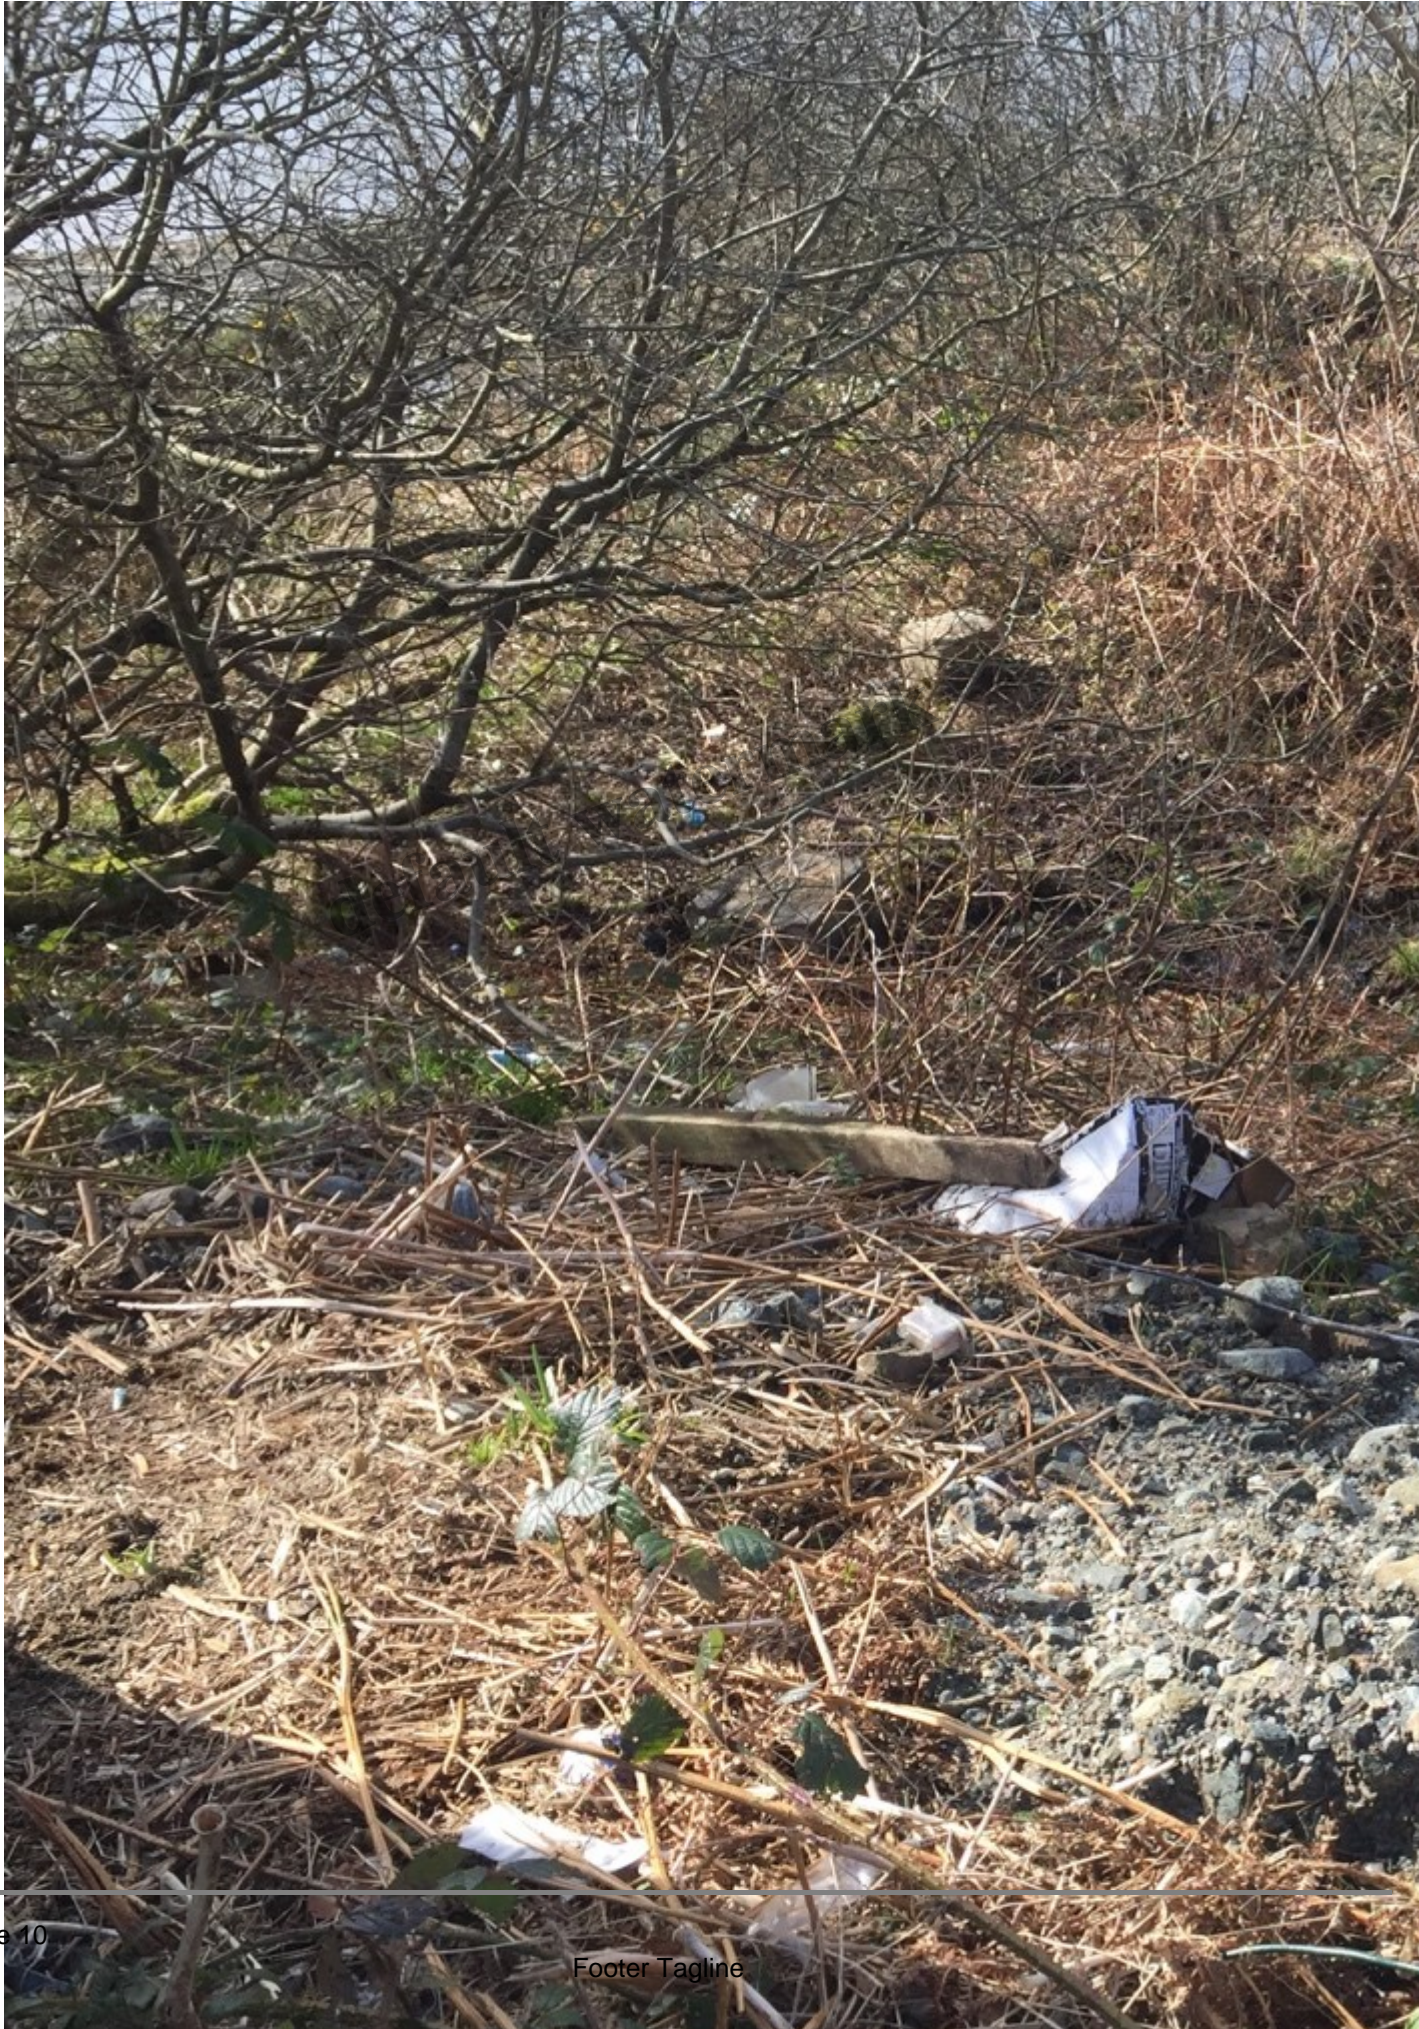
Building materials and general garbage tipped down bank by vehicles on the main road side of the s

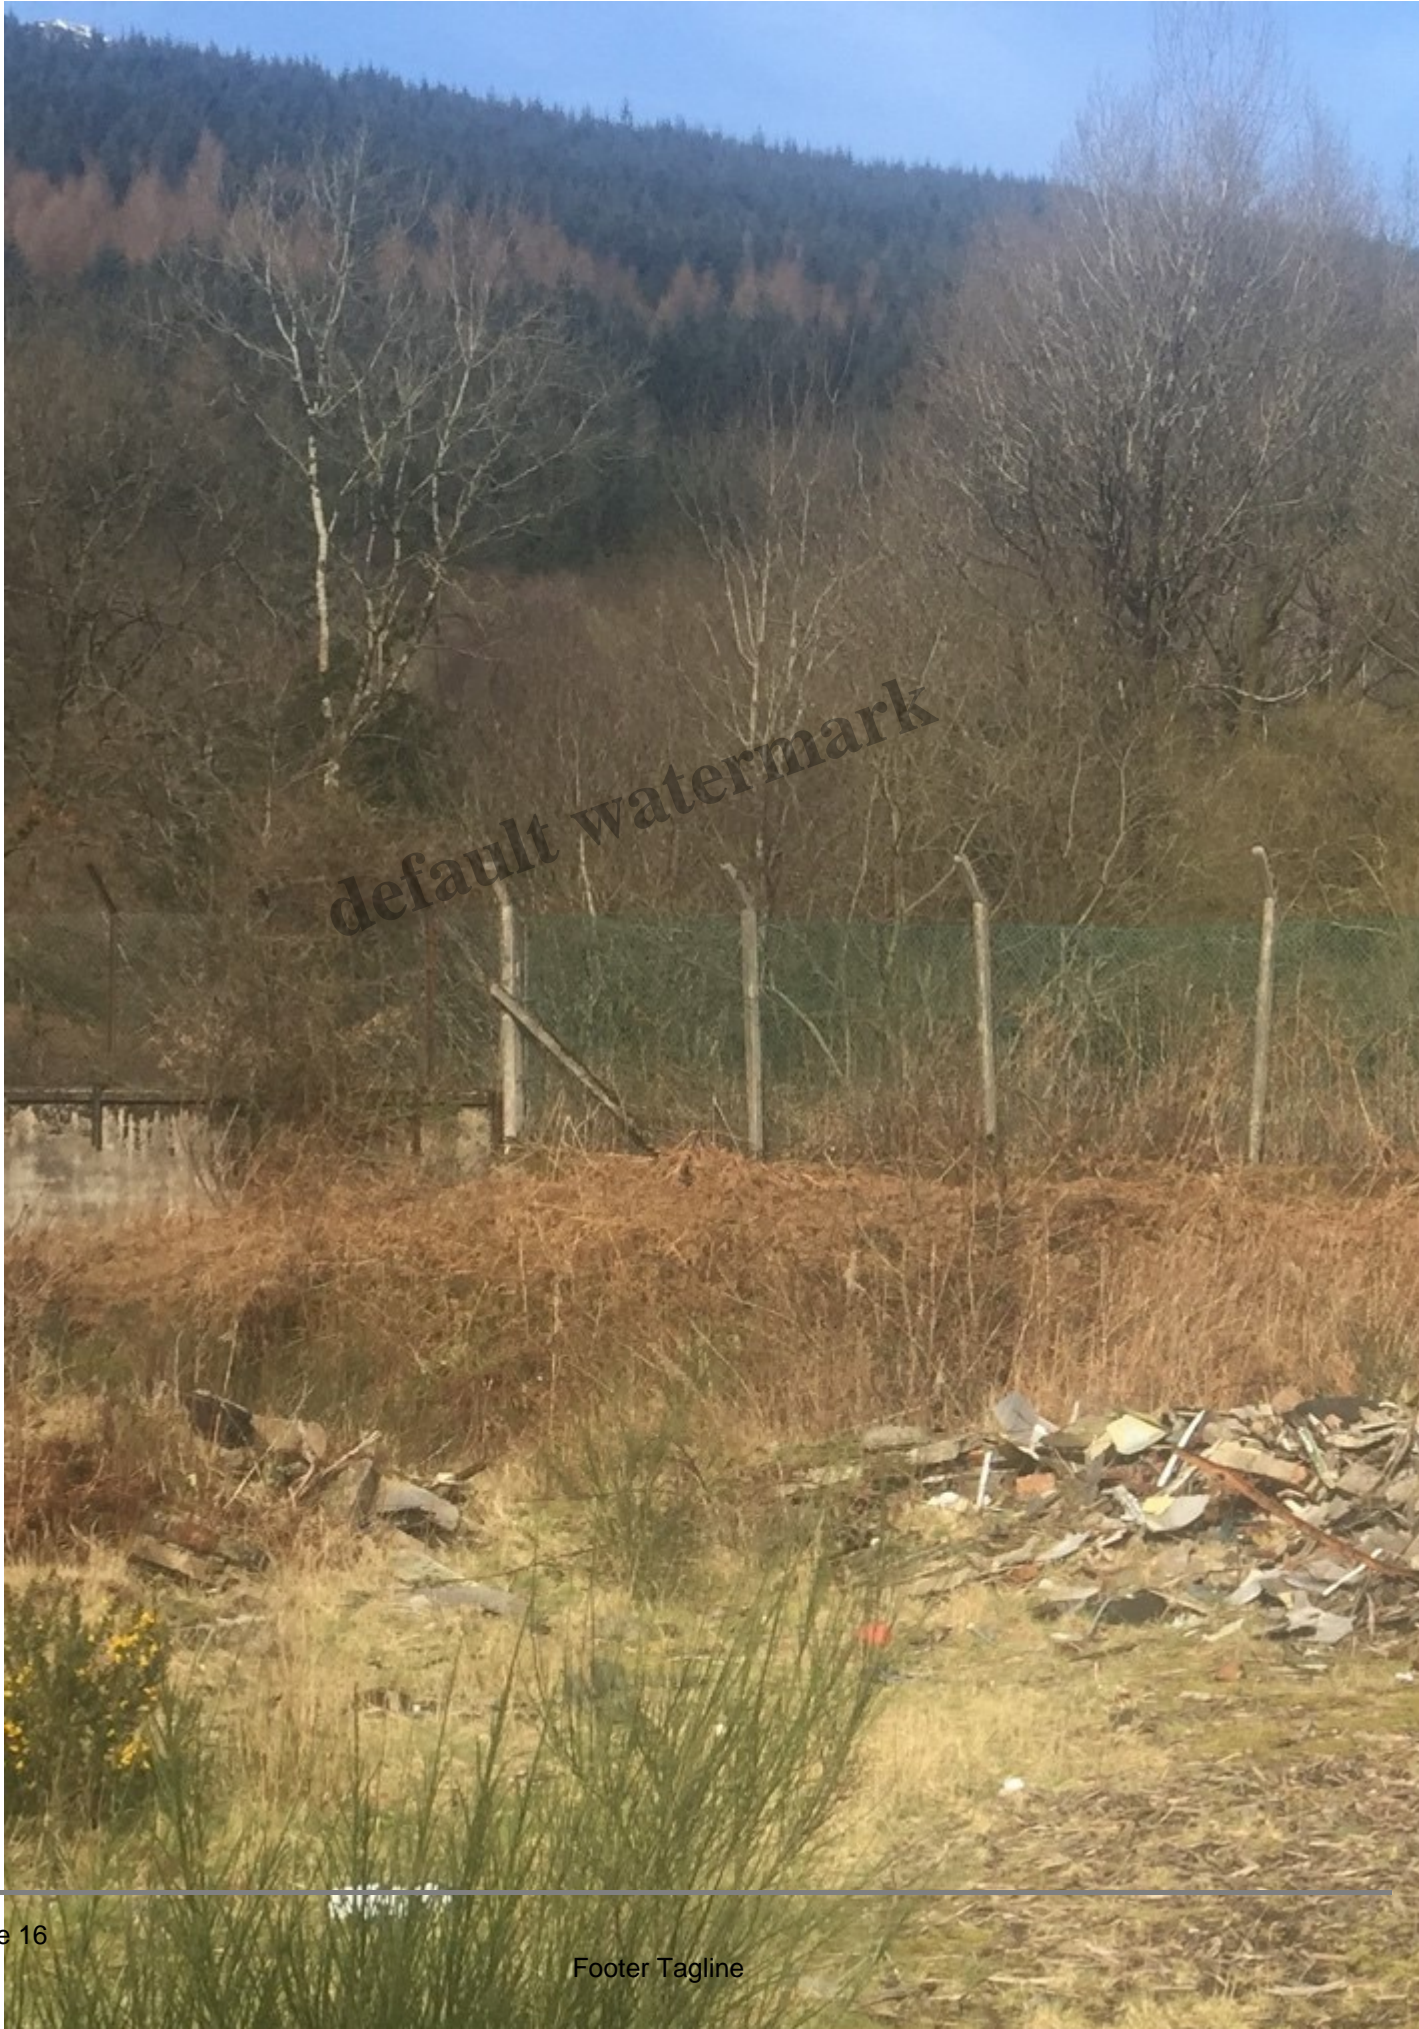
View west

There are a series of dumping spots on the western side of this road (see below) mostly containing what appears to be builders/commercial rubbish.

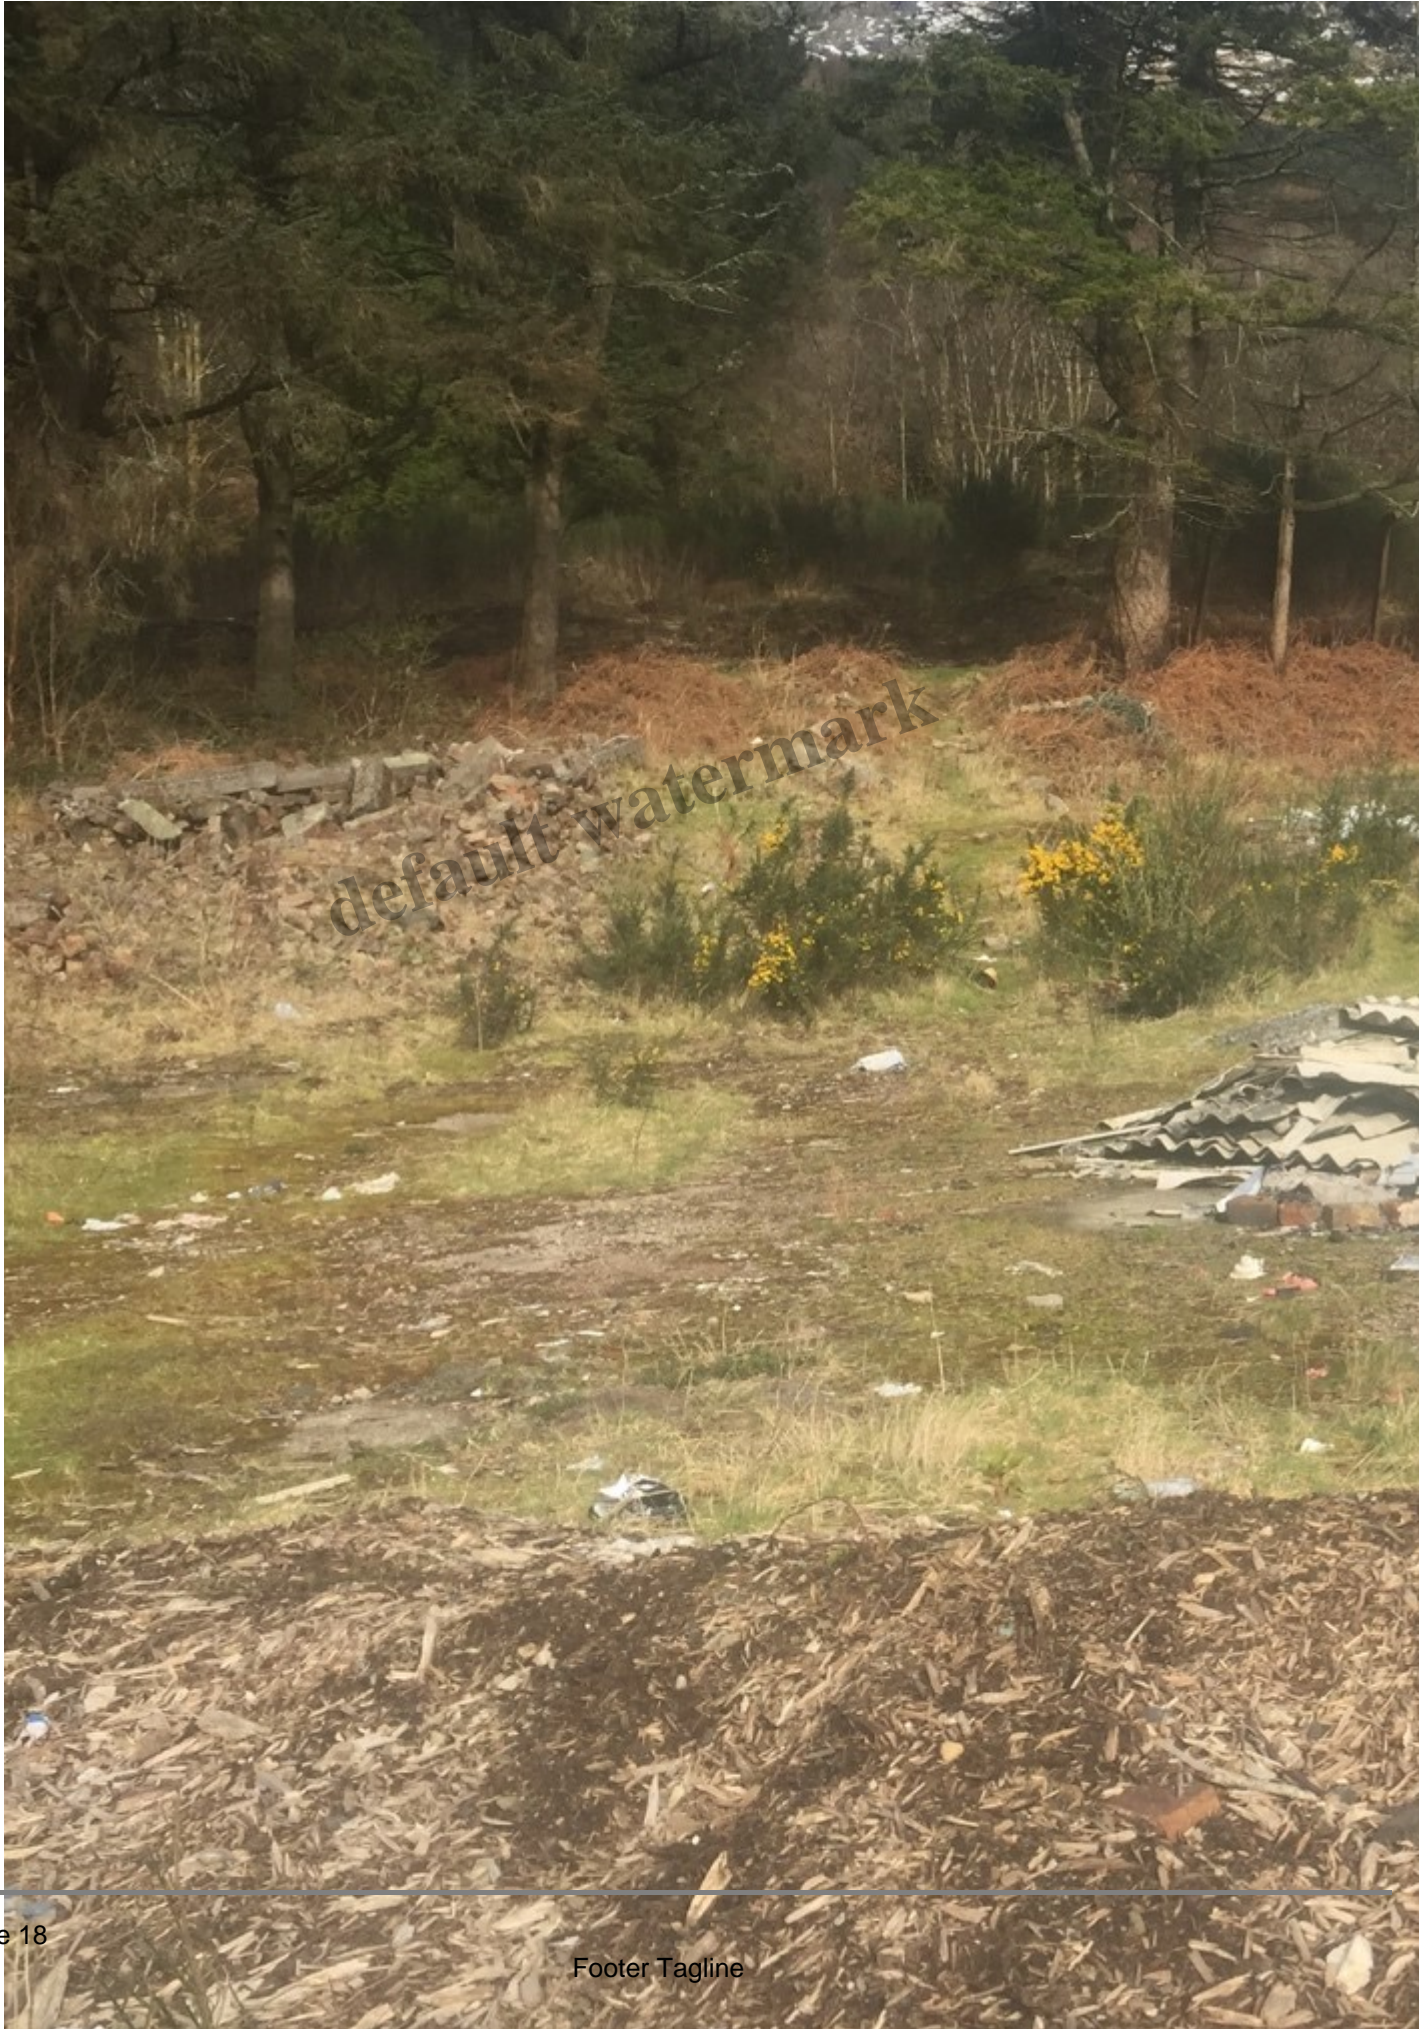
View north west

Two of the fly tipping sites contain what appears to be corrugated asbestos. Both of these sites are east of the old road on what was the site of the torpedo factory.

Note: the old main road runs behind trees in the background, so the asbestos risk is well away from the former public highway.

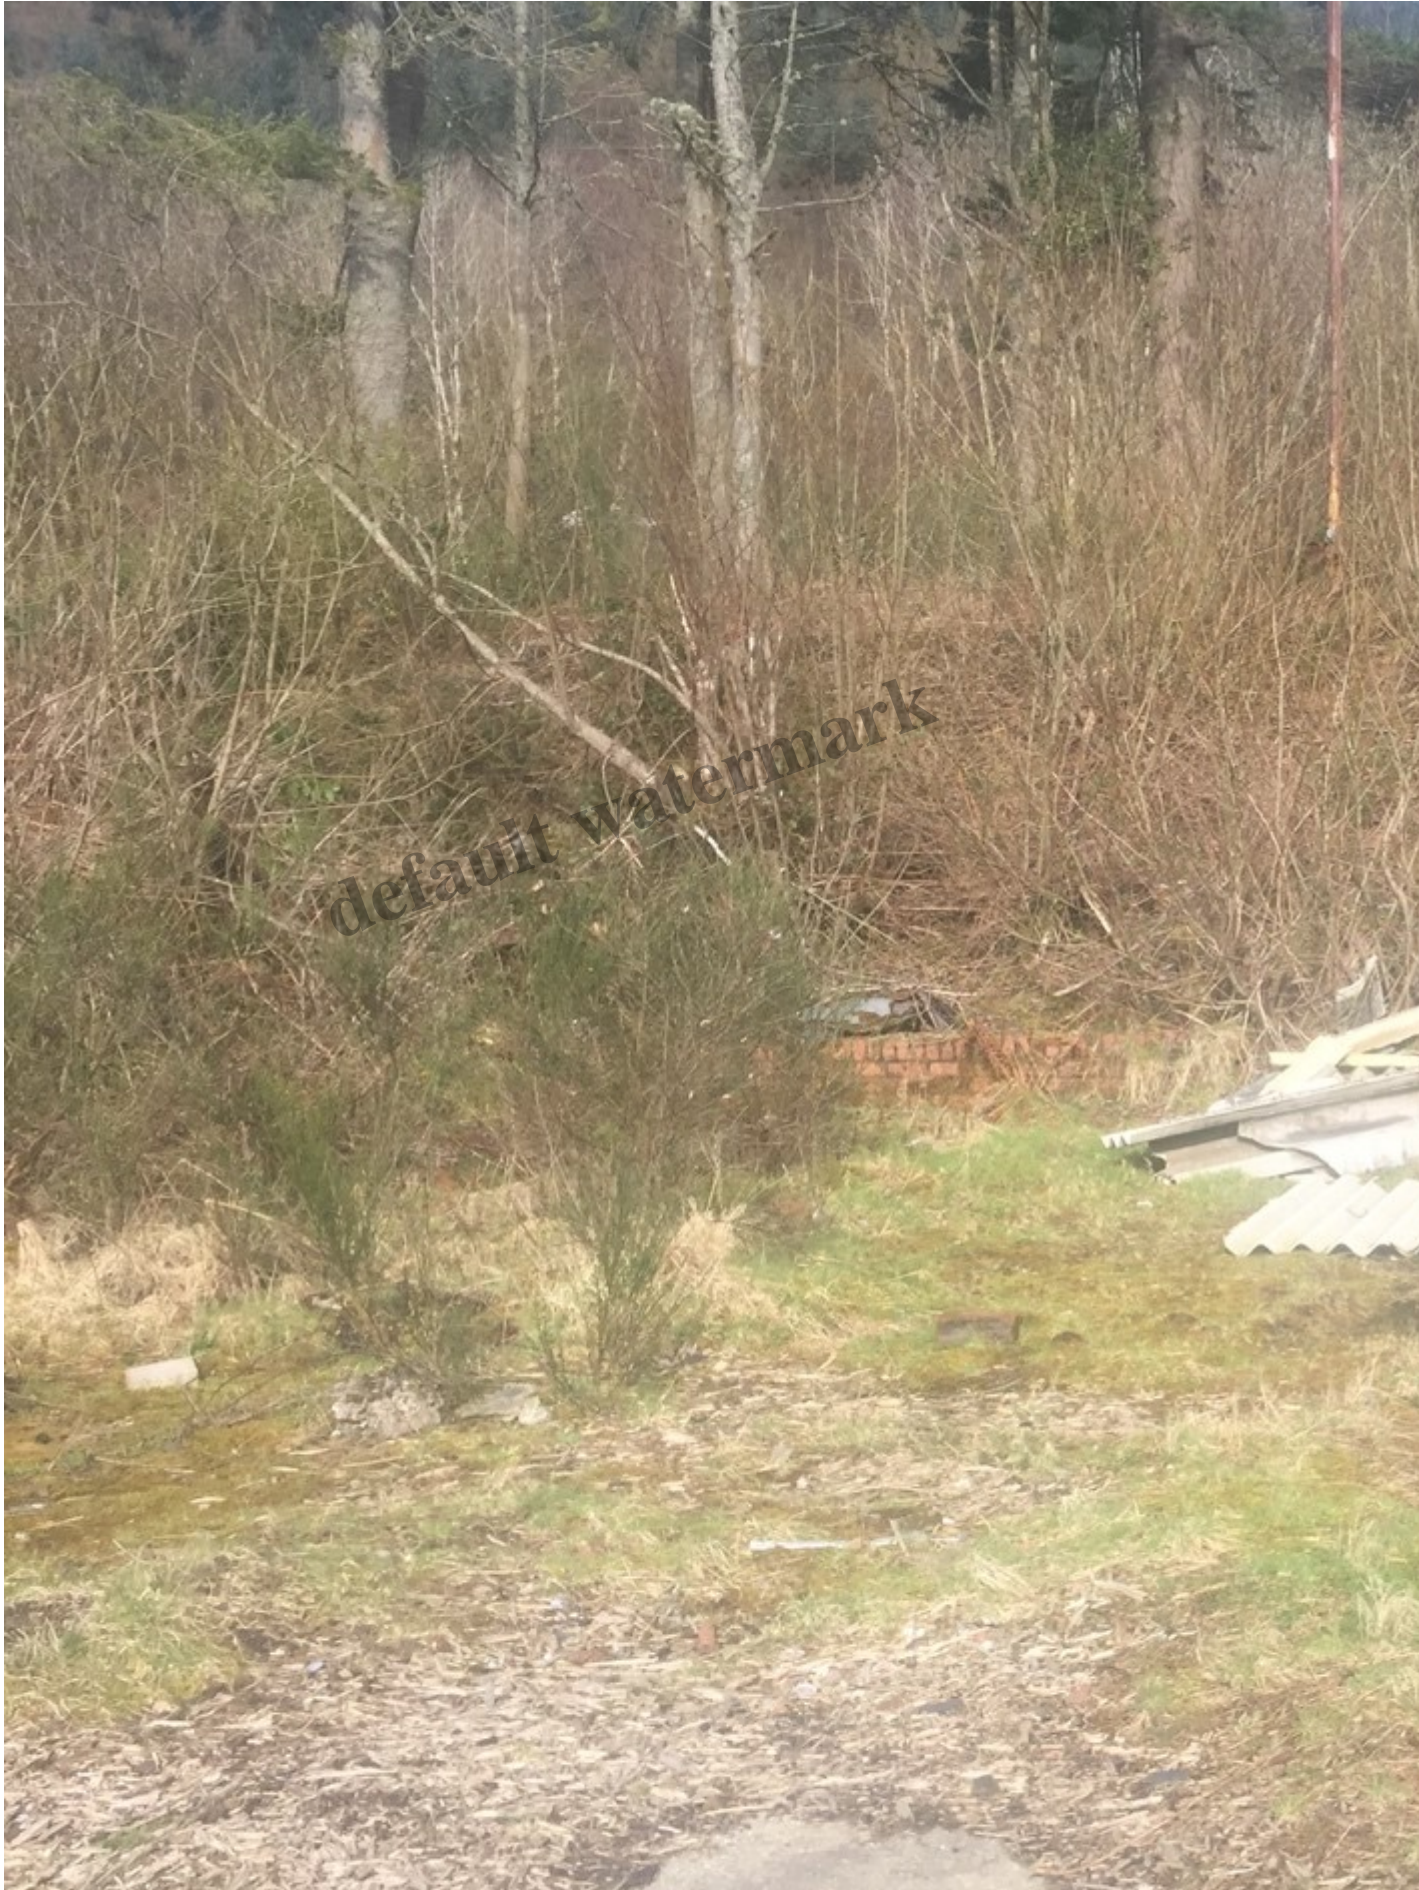
View north west, site immediately beside the one shown above

If this is the asbestos and it influenced the decision to close the old main road, it would have cost less to remove than to install the gates! It is also situated on the grounds immediately beside the industrial ruins of the former torpedo factory – not particularly close to the old main road.
