Large scale environmental dereliction in the National Park

**By Nick Halls**

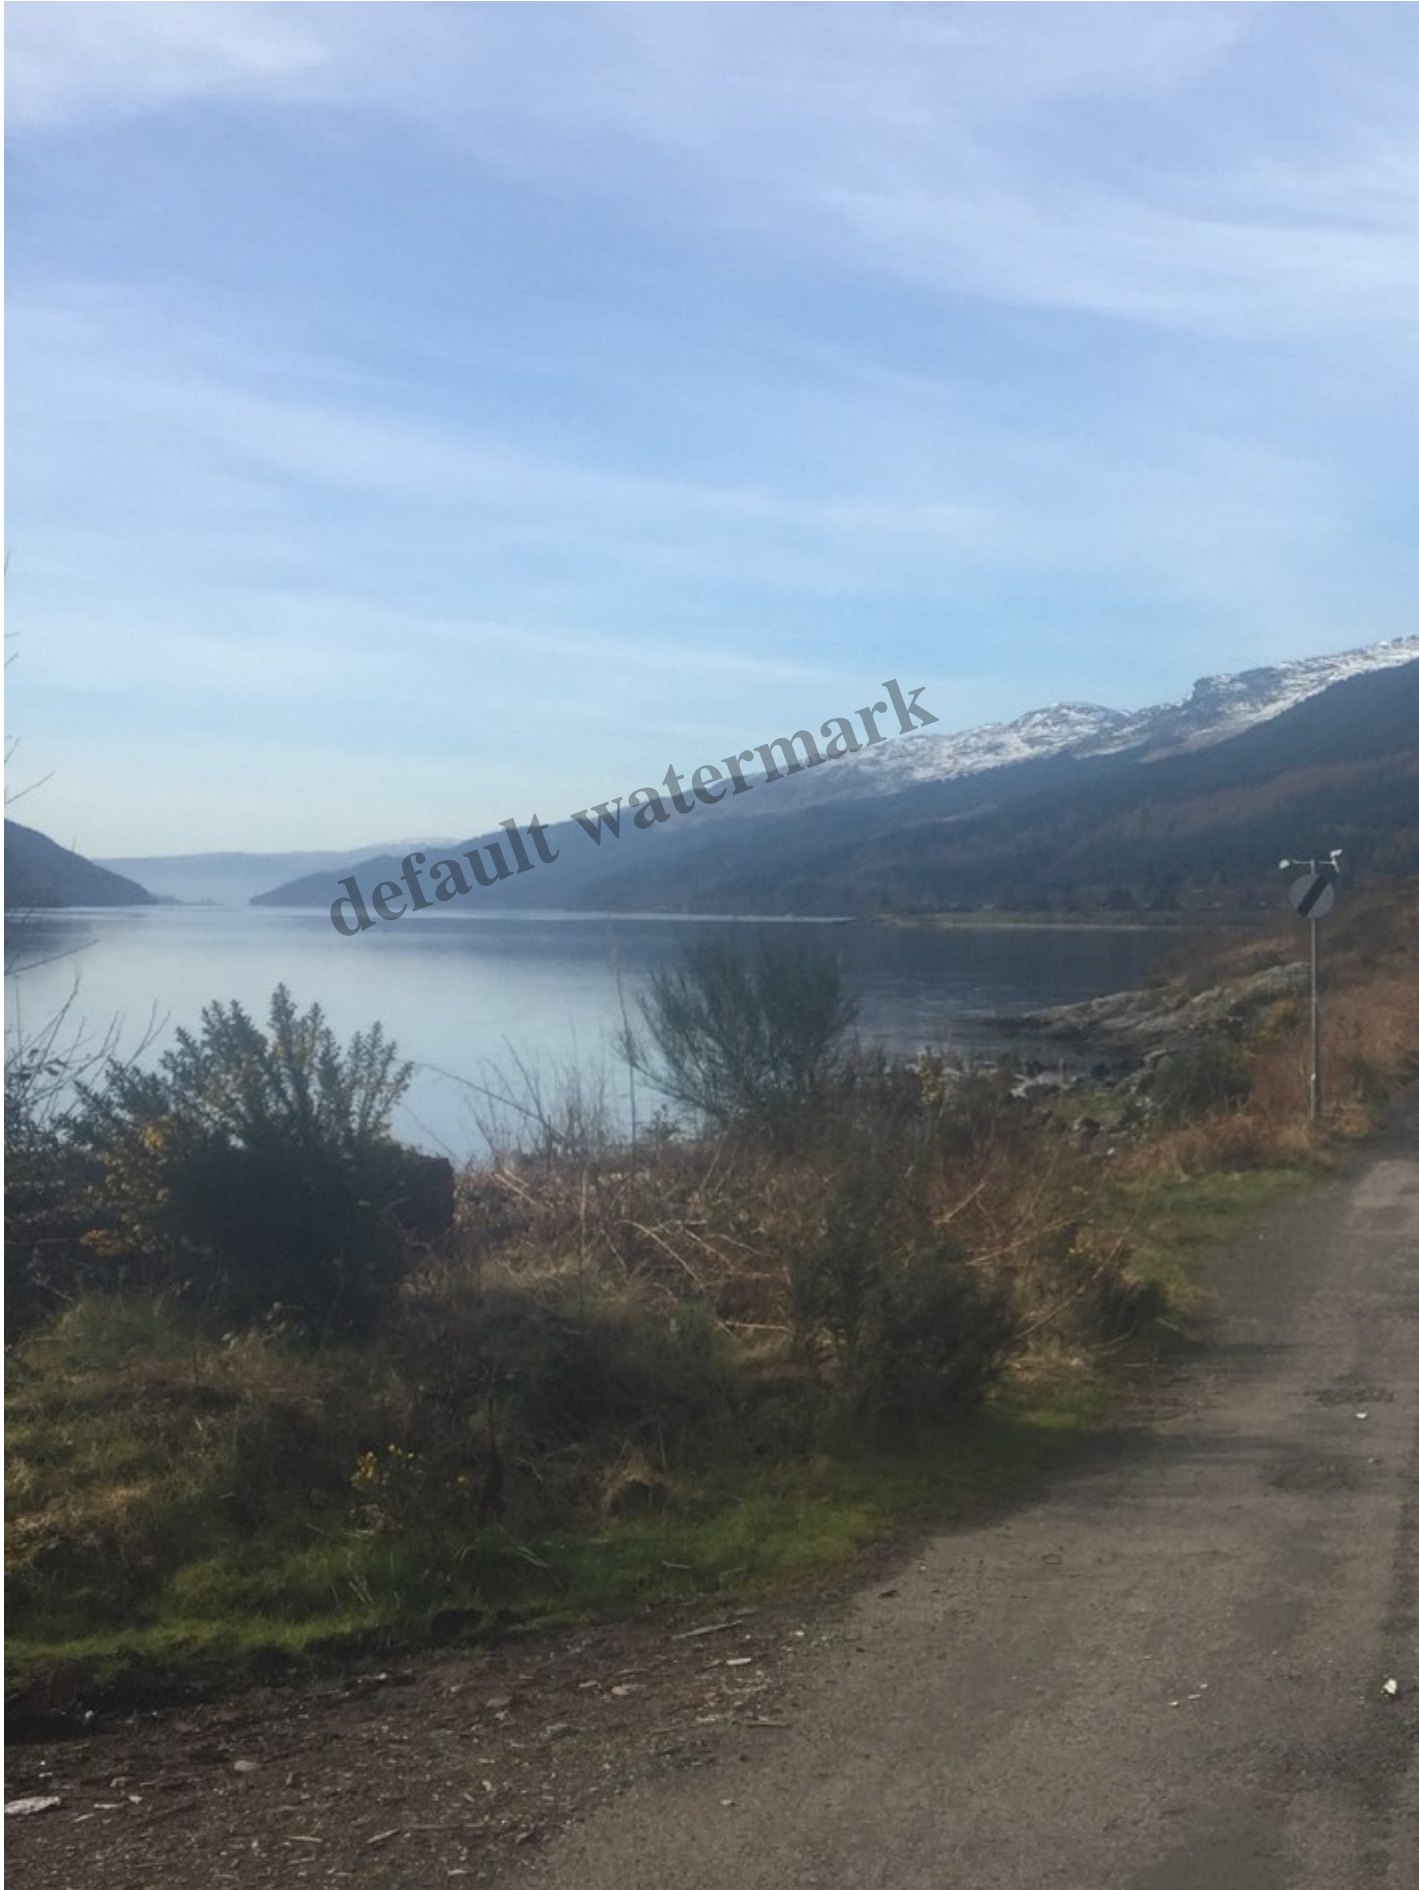
View south along the old main road

There is much less evidence of fly tipping along the southern section of the old main road, beyond the access loop leading through the ruins of the former torpedo factory.

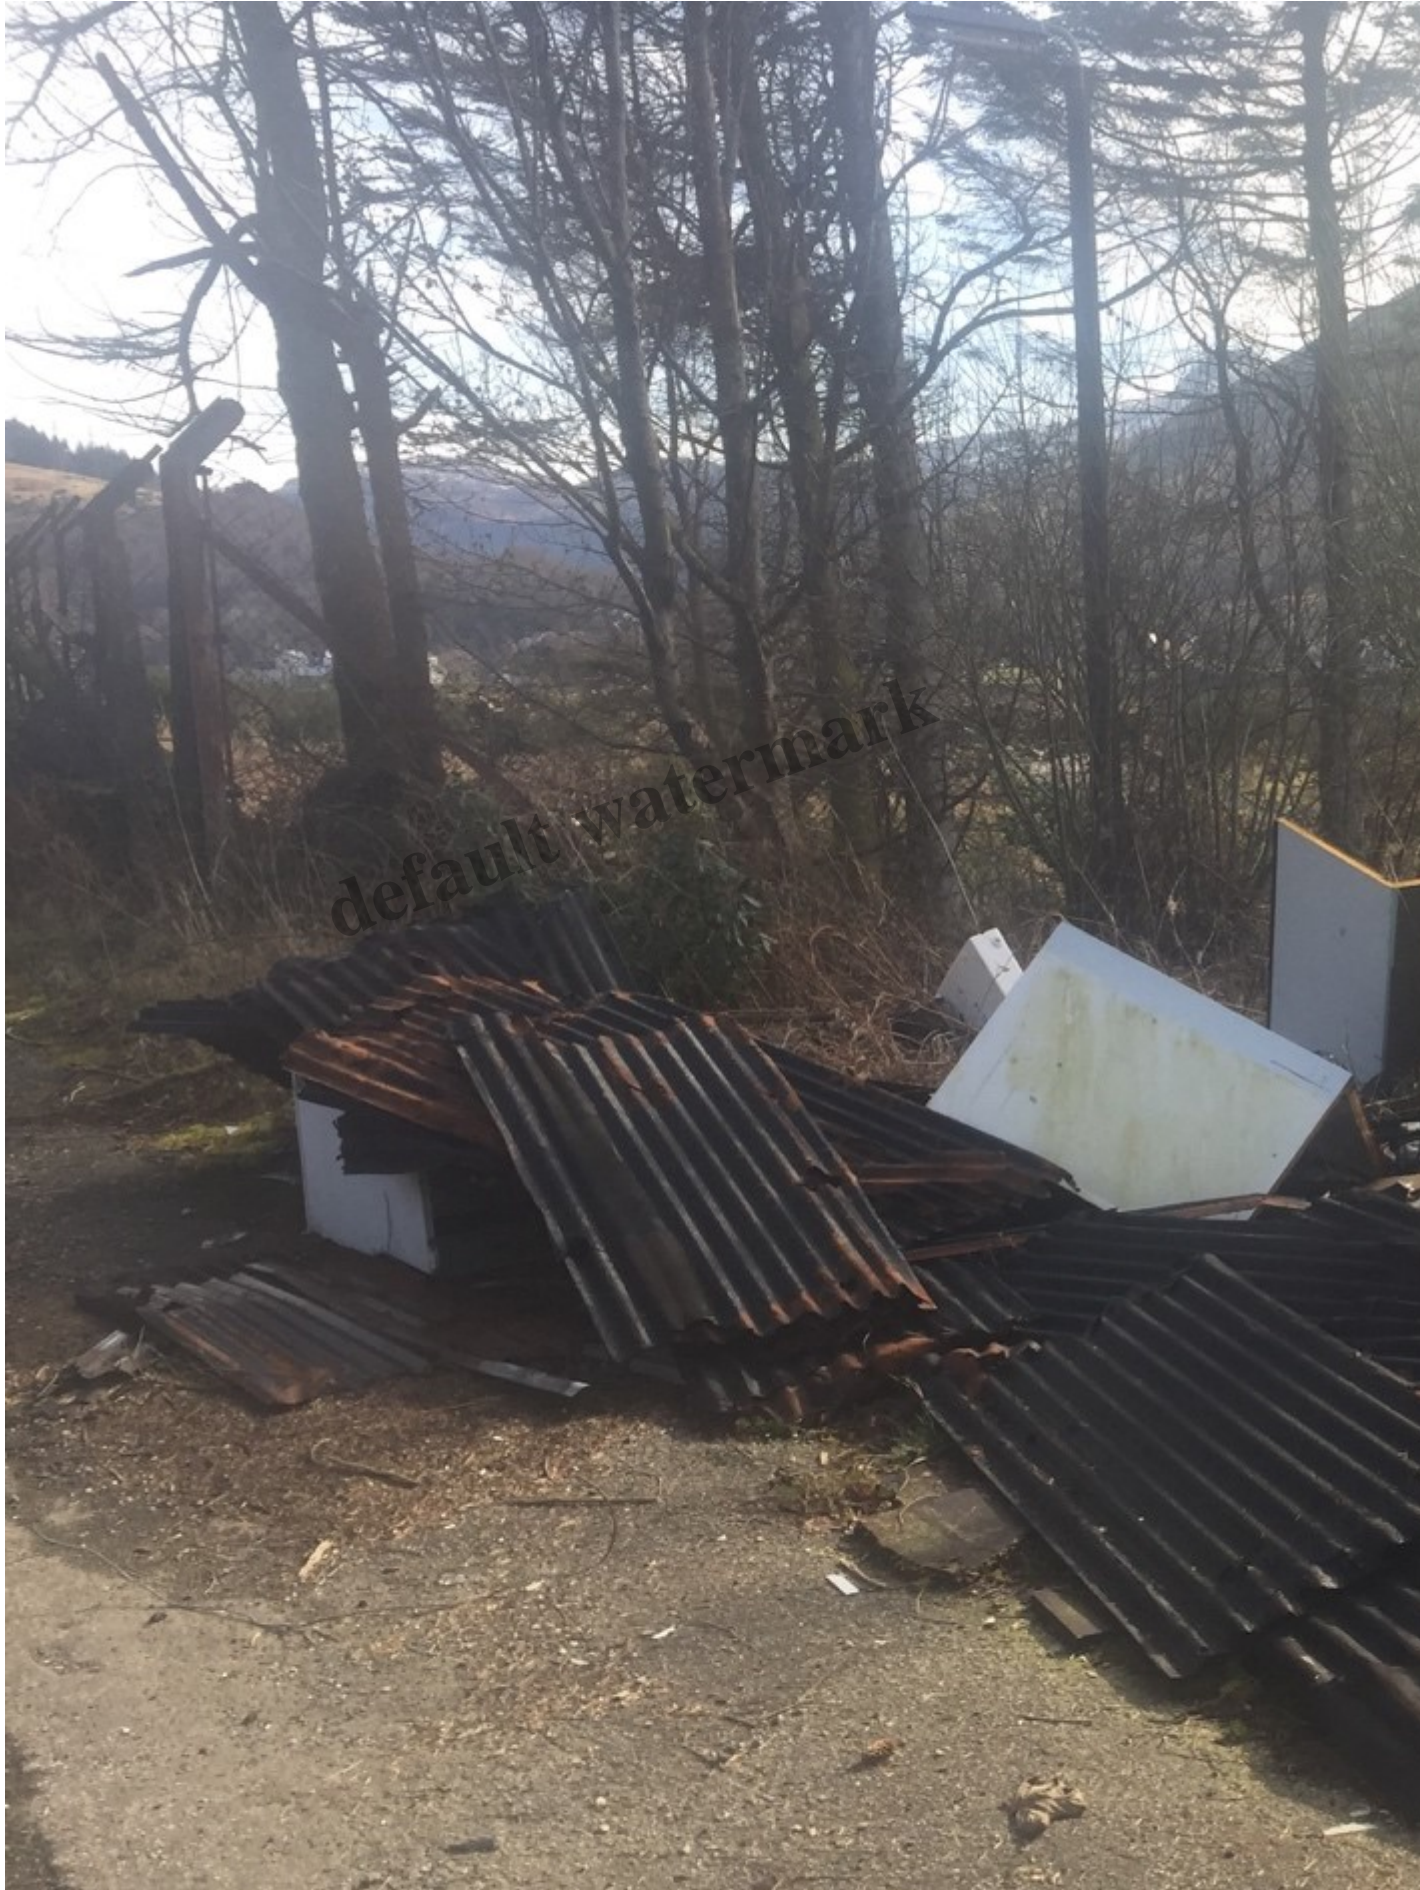
Fly tipping and garbage along the northern part of the old main road

The quantities are not large and appeared to be fairly straightforward to remove. Again, clearing the roadside might have involved less effort than placing the gates – with an unnecessary restriction of access.

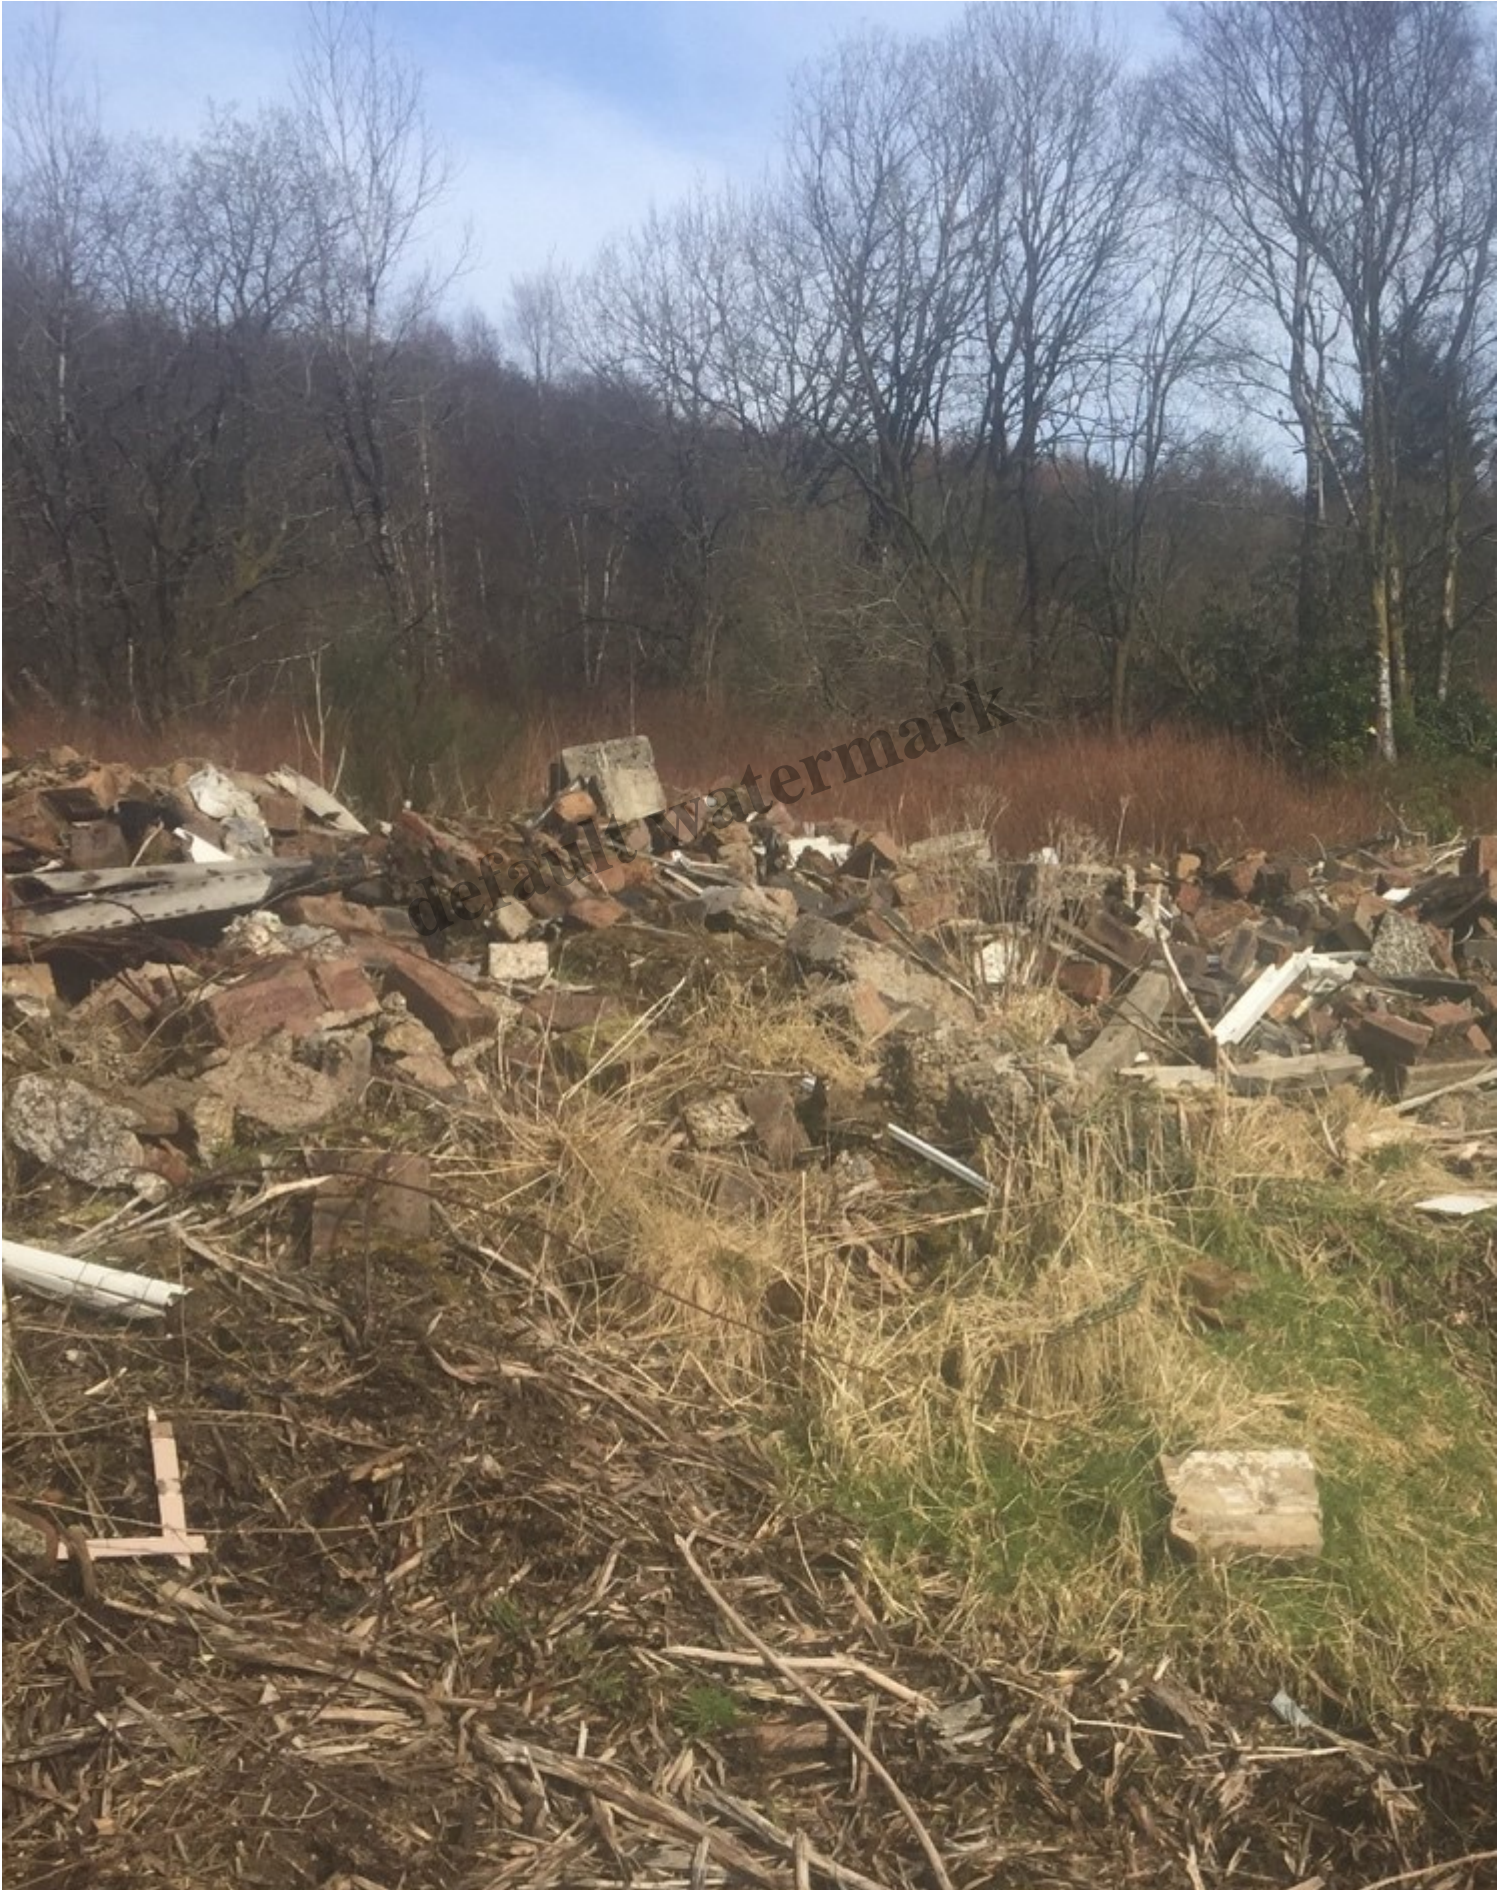
Remains of demolished building, which might have been residential or administrative. Note also the remains from what appears to be some sort of forestry operation involving stripping bark and branches, which presumably took place elsewhere, and then disposed of along the roadside.

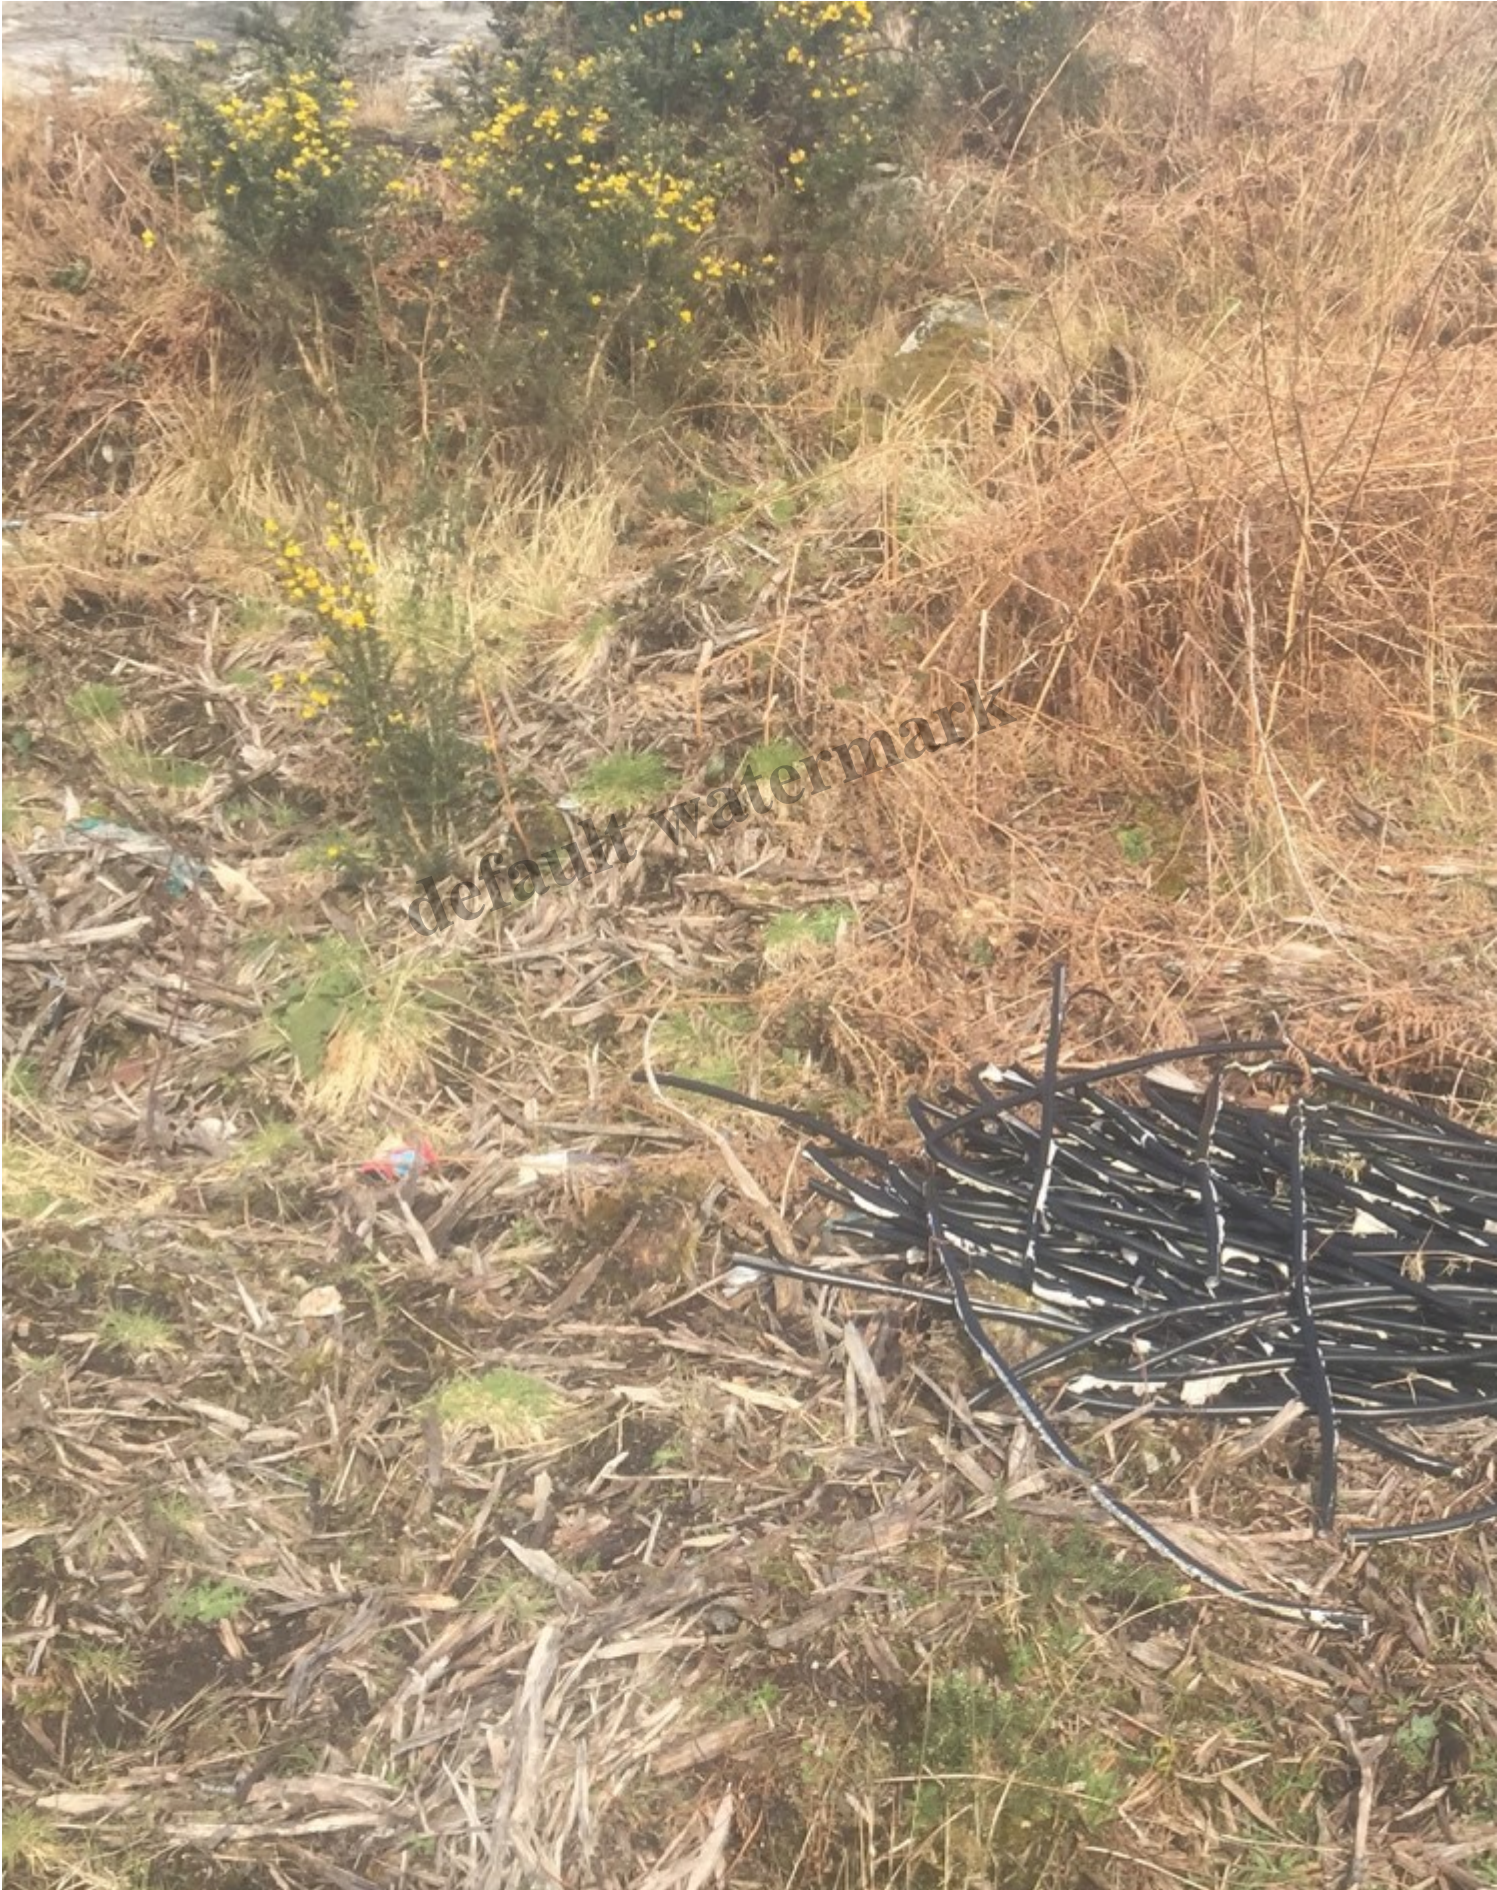
Much of the fly tipping along the sides of the old road is fairly easy to remove, or does not pose a particular health risk.

The forestry operation debris, although unsightly will eventually break down and become over grown – but it still constitutes fly tipping – always assuming it was carried out with the owners consent.
