Keltie Water hydro scheme

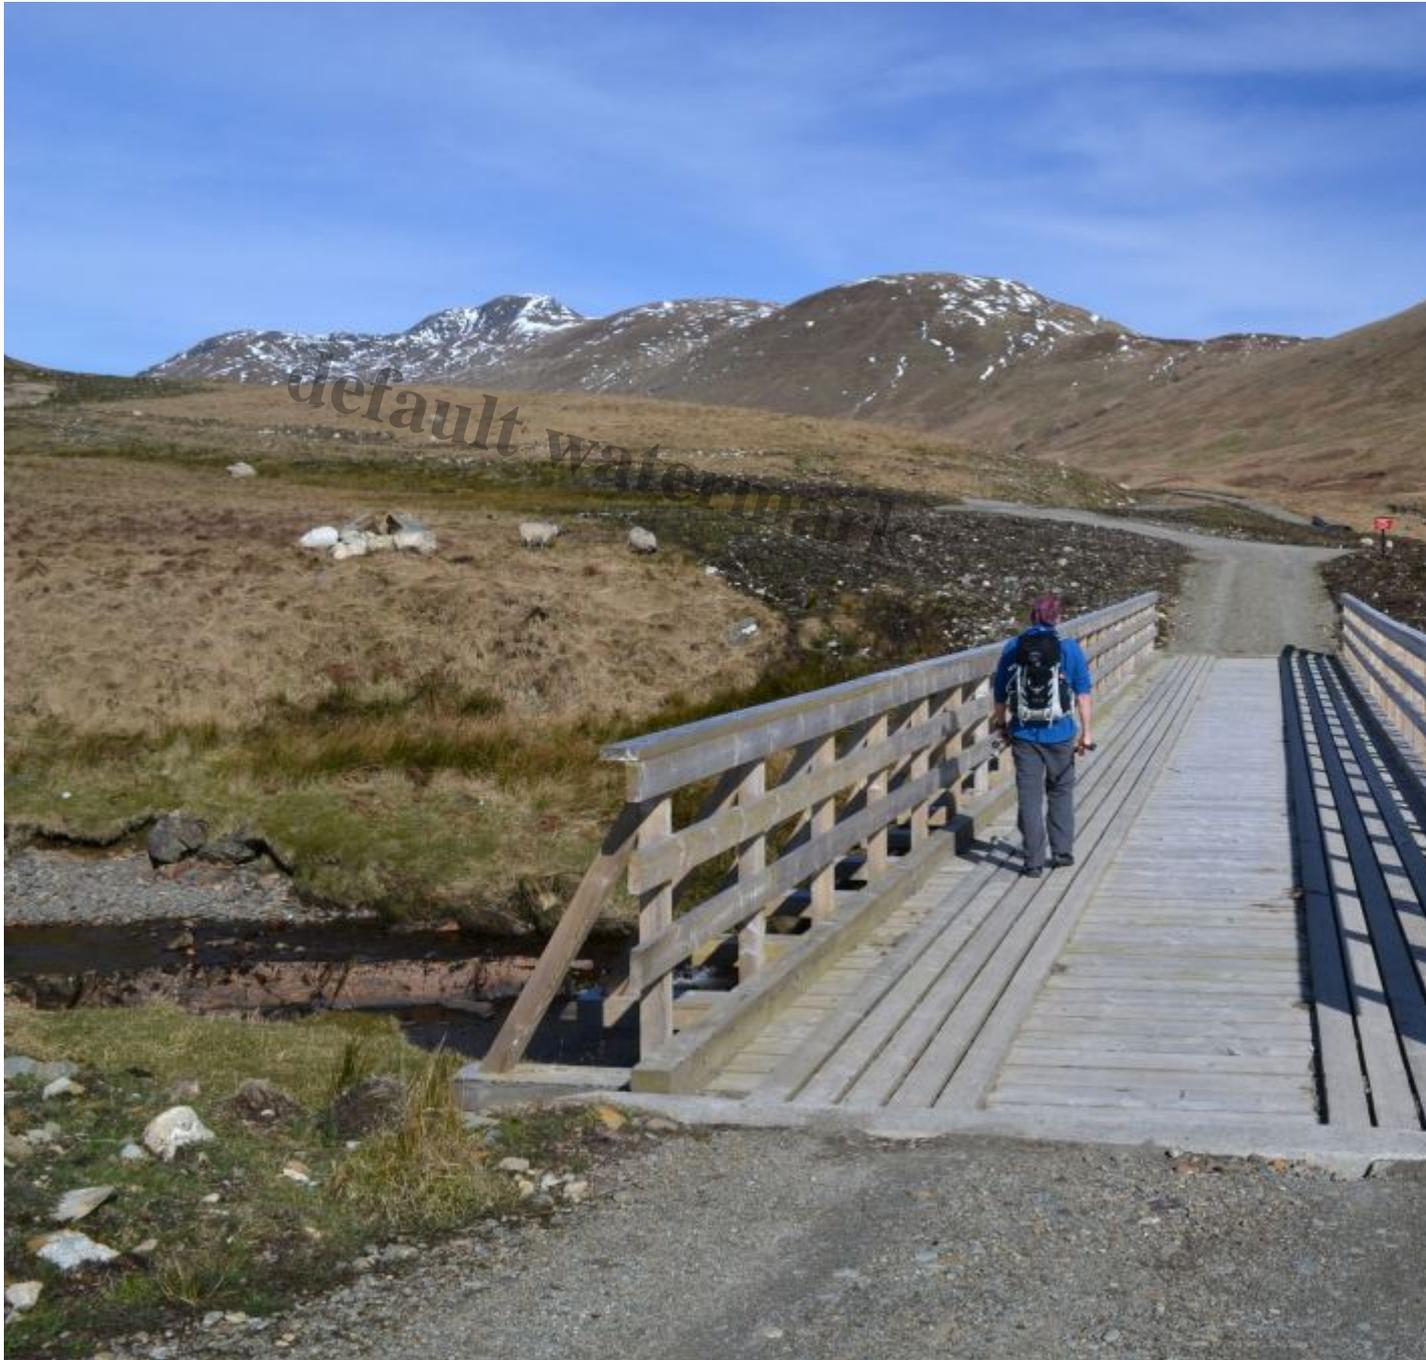
New bridge over the Allt Breac Nic, Stuc a Chroin in distance. The pipe has been concealed under guidance. Photo Credit Derek Sime.

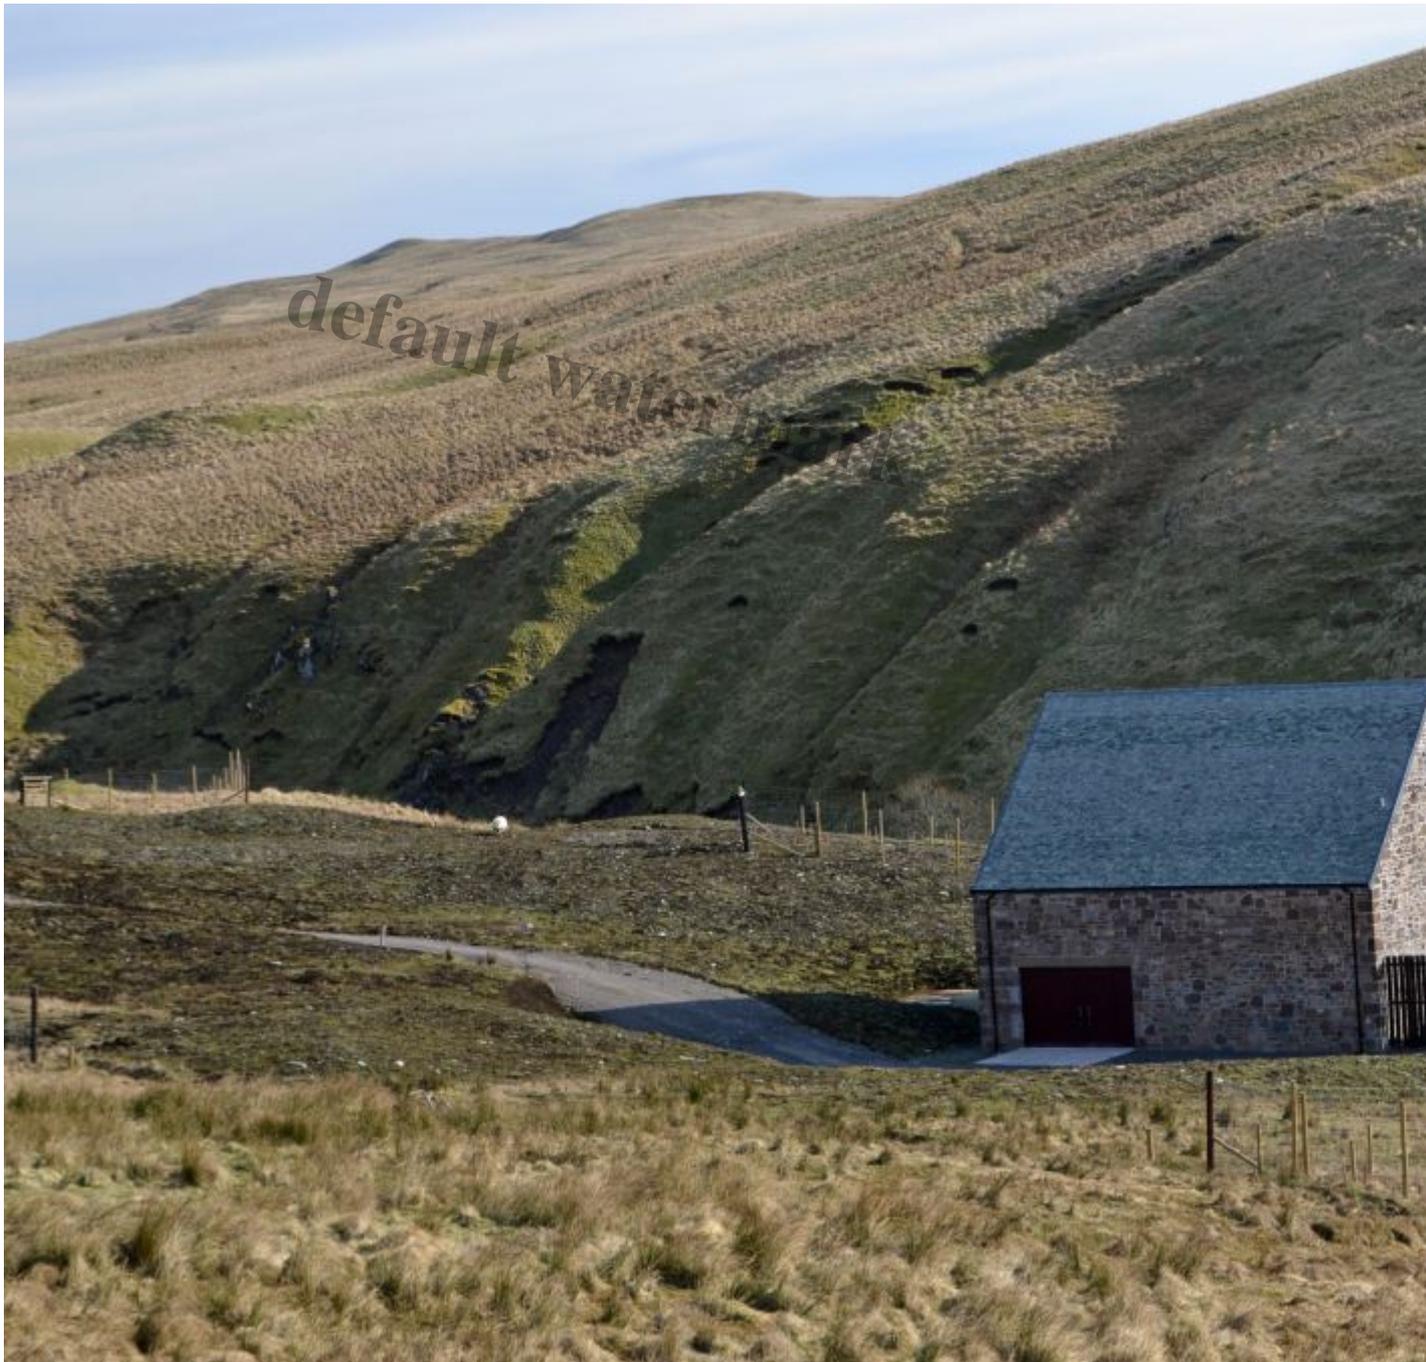
The power house is situated close to Braeleny Farm, has been finished with natural materials and is quite tucked away. It will have almost no landscape impact on the glen, which becomes wide and open higher up. The construction compound to the left of the building has been restored well – from this distance you would hardly know it had been there – and for good measure Drummond Estate have added three blocks of tree planting. While in the wrong place, tree planting can look artificial, not far south of the powerhouse on the far side of the river (outside the National Park boundary) there is a large block of forestry while further south, along the Keltie Water, there is some fine native woodland and the planting here has the potential to link to that.

Generally the LLTNPA has ensured the power house elements of hydro schemes in the National Park have been done well – their planners I think are more comfortable with buildings than landscape – and this is appears a good example.

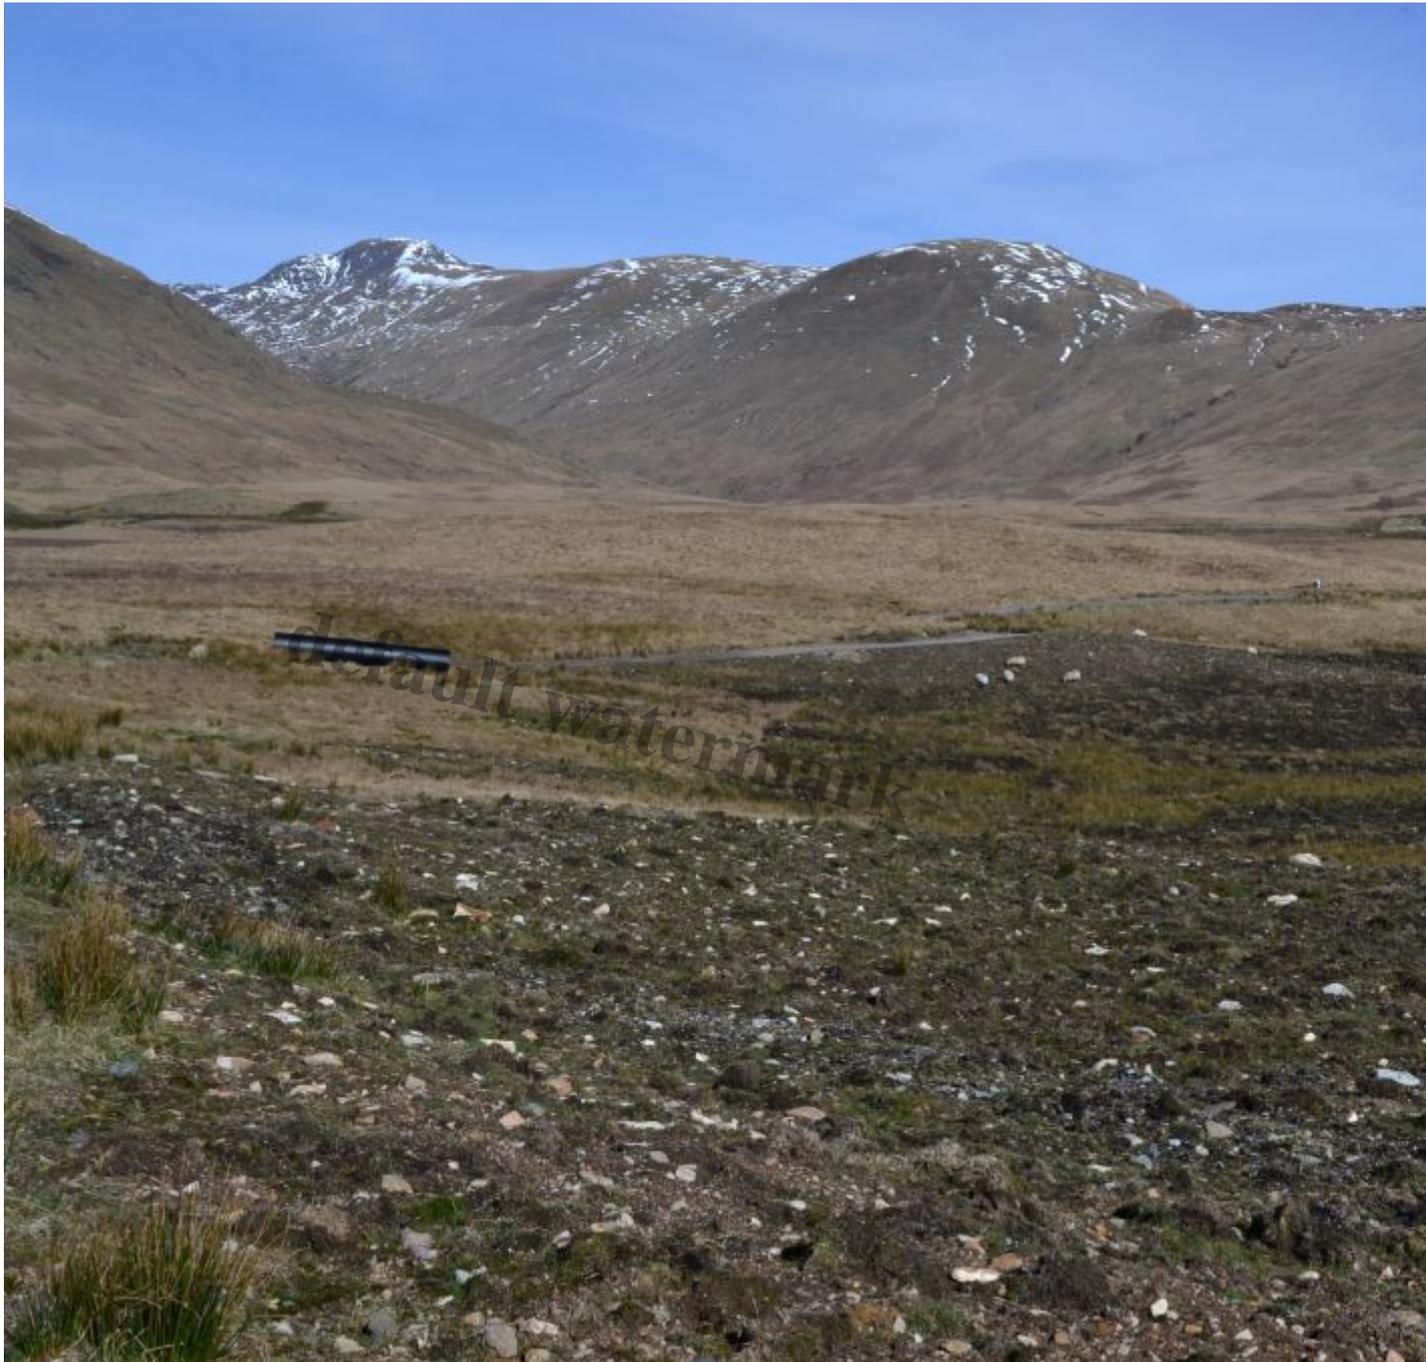
The other element of hydro schemes that the LLTNPA have generally ensured is done well is restoration of the ground in grassland and peatland areas. If peat and turves are removed and stored before the trench for the pipeline is dug, once replaced the ground should recover quickly. A multitude of stones on the surface as along Glen Bruar ([see here](#)) is a sign that contractors have mixed up excavations with top soil and vegetation. While you can see some stones on the surface here, generally this section of pipeline restoration appears to have been done well and is likely to recover quickly. In two years it may not be possible to see the line of the pipeline.

The section of pipe on the left of the photo is another matter. It is one of several which appear to have been abandoned as all machinery has been removed from the site and there is no sign of ongoing works. There is no need for this and it is not acceptable. Sadly abandoned sections of pipe are a feature of a number of other hydro schemes in our National Park â?? its cheaper to leave them in situ than recycle them â?? including Glen Bruar. (Its also yet another example of why the litter left by a few irresponsible campers needs to be seen in perspective).

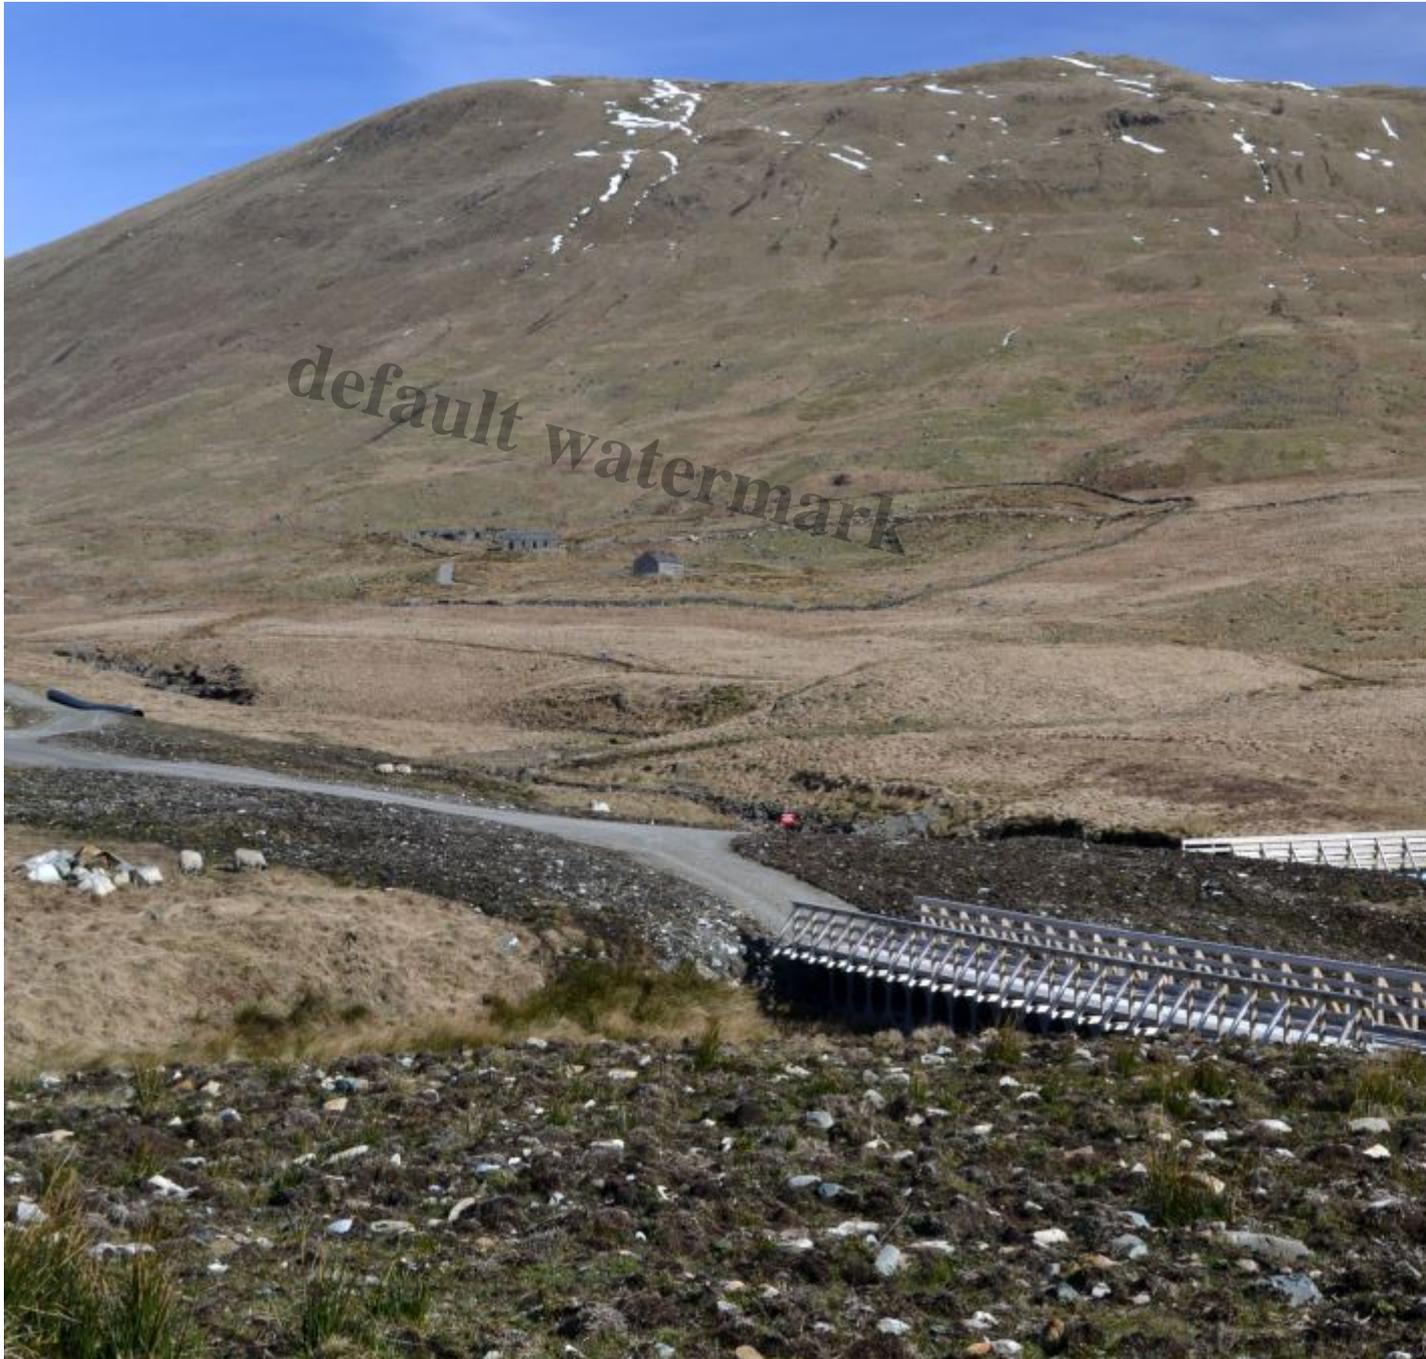
The restoration of the ground just south of the bridge over the Allt Breac Nic and beyond it on the left side of the track appears less successful, with far more stone visible and what appears to be a boulder dump by the sheep on the far left. I suspect part of the reason for this is the ground before the bridge slopes steeply and the depth of soil here was less. Where the soil is shallower its much more difficult to separate vegetation and topsoil from rocks if the work is done by machine as it invariably is nowadays. This is a problem not just at Glen Bruar but on sections of the Beaully Denny powerline. If our National Parks are serious about ensuring the highest standards of restoration I believe they need to consider and support the development of alternative "construction" techniques in areas of shallow soil. Meantime the LLTNPA needs to consider how its going to make the restoration of this area effective.

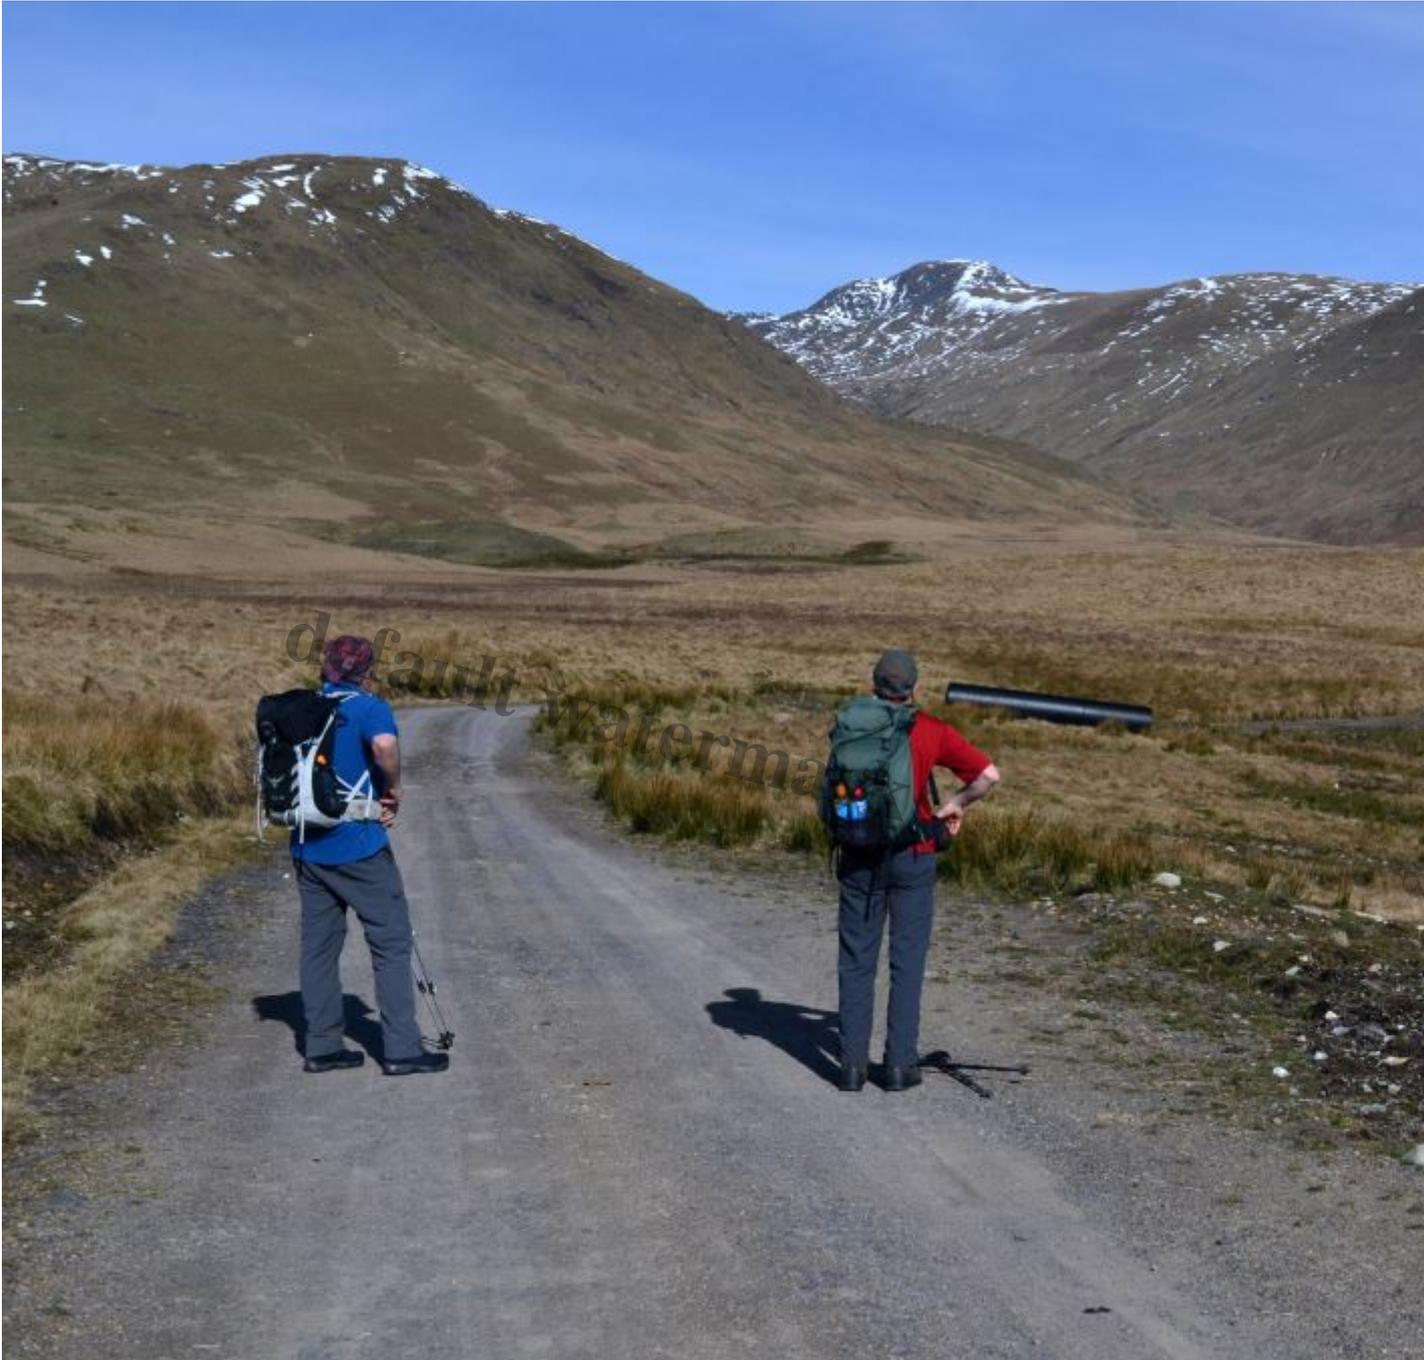
Prior to the construction of the hydro there was an existing track to Arivurichardich. This was upgraded to enable the construction works to take place. Drummond Estate's planning application asked for the tracks, after restoration, to be 2.5m wide. The LLTNPA, stuck by their Planning Guidance and made the following requirements:

What the photo above illustrates is that this requirement has not been met. This straight section of track is more than 2m wide. You can also see how aggregate from the track has spilled down the slope to the right, broadening it still further. There is no sign of a grass central strip. Perhaps that will be put in place this spring? The problem here is not with the conditions the LLTNP required in this case, its the enforcement of them.

Notwithstanding the approved plans and for the avoidance of doubt these tracks shall be reduced to a width of between 2 metres, and 2.5 metres (at essential turning areas and steep gradients only), (to be agreed in writing by the Planning Authority), and shall have a grassed

central strip.

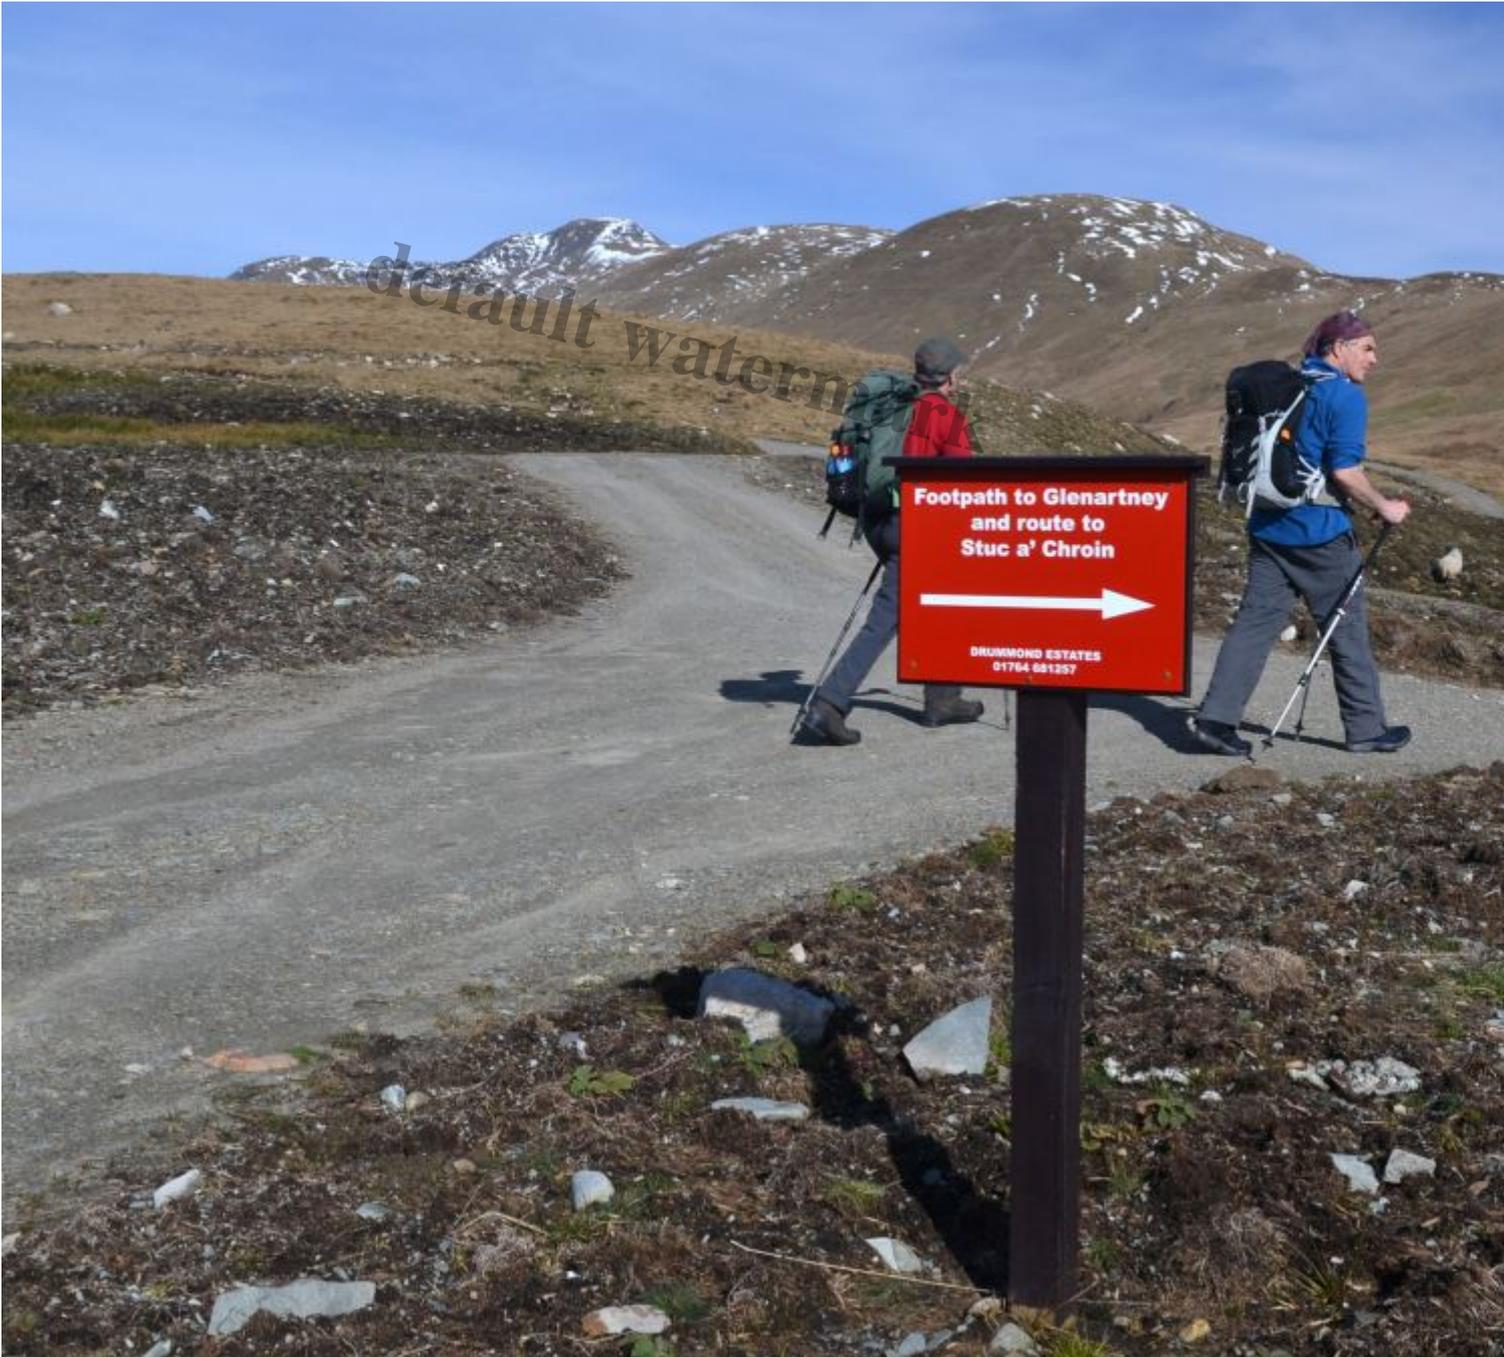
A close up of the area between the two bridges (above) illustrates a number of areas where restoration work could have been better. Left of the track large amounts of stony substrata has been mixed up with the peat and may change the type of vegetation that grows back here . Another piece of abandoned pipe is visible to the right of the sign. The track itself is clearly broader than the 2.5m the LLTNPA allowed for bends and junctions. And, while I am not against all signs â?? this is part of a core path network â?? did it really have to be bright red?

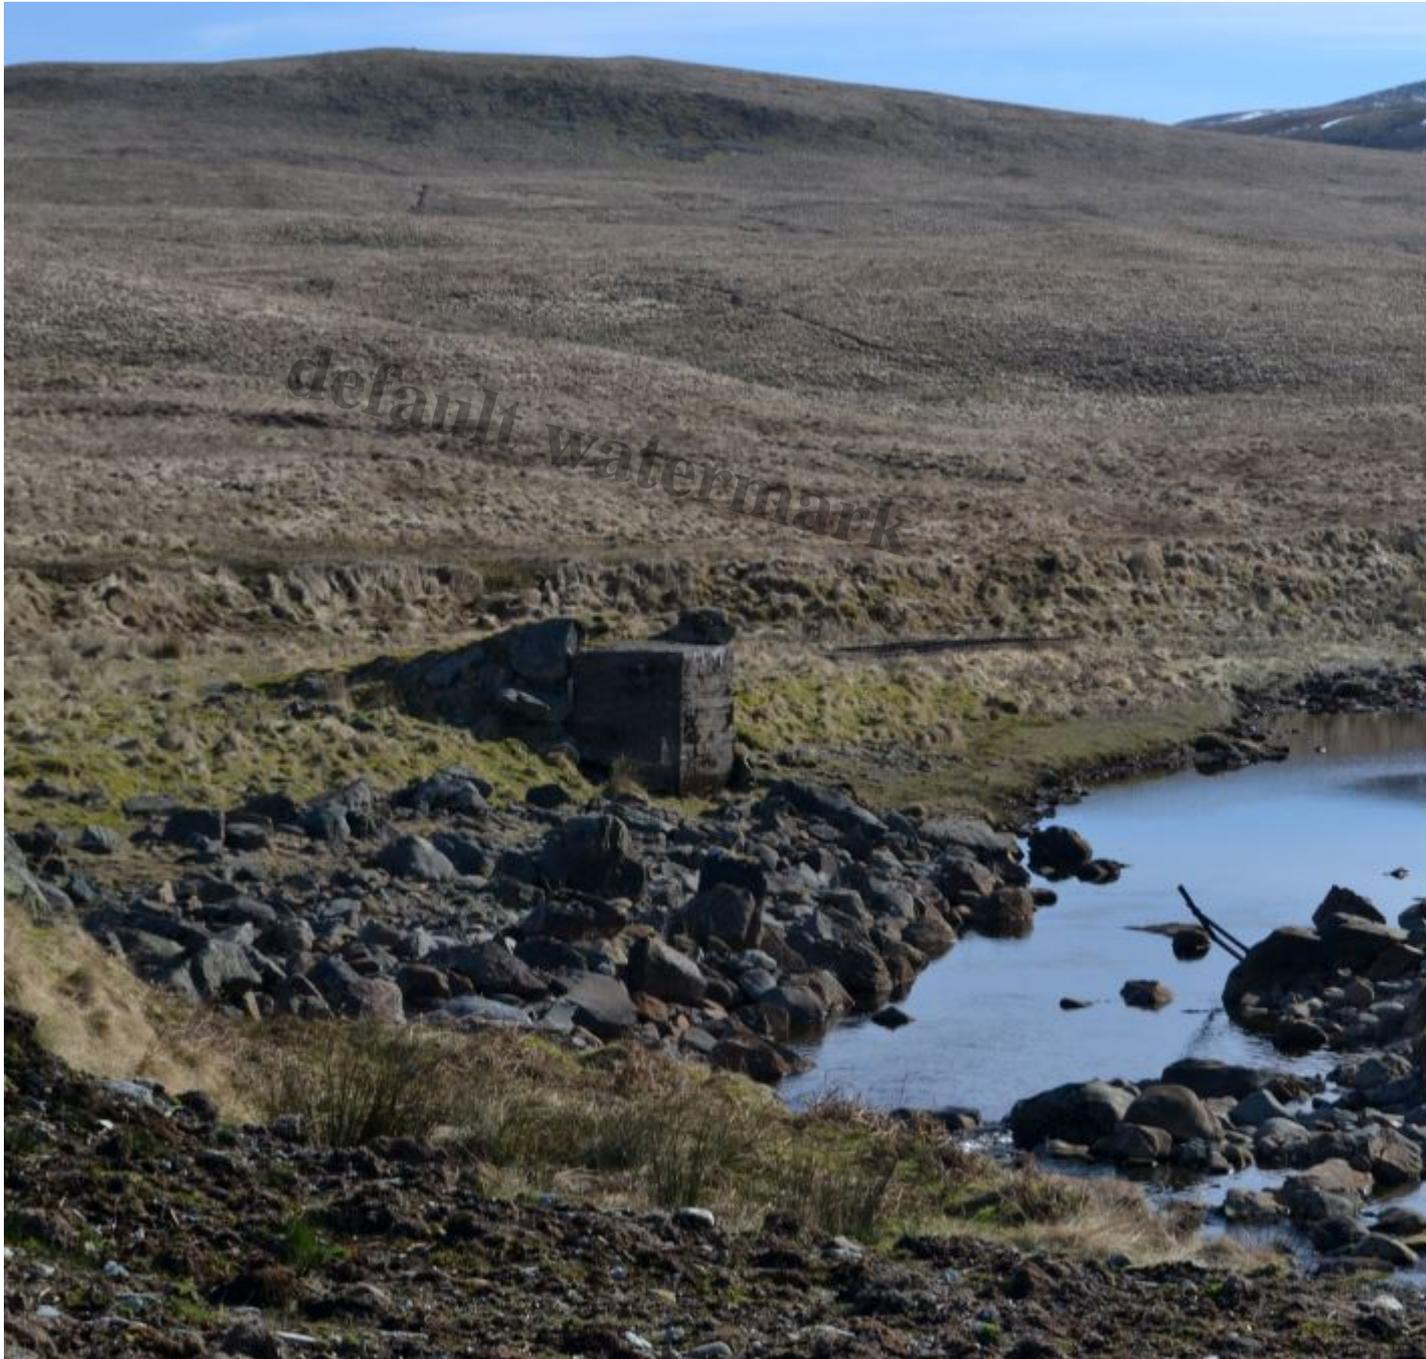
The old bridge south of Arivurichardich (above) over the Keltie Water was washed away on 18 August 2004, during a violent thunderstorm which sat over Stuc â??Chroin, and which was also responsible for sweeping away a number of other bridges in the area, including that on the public South Loch Earn

road at Edinample. Since then the Keltie Water has been uncrossable when it has been in spate, and while of course the hydro pipeline will reduce those levels in future, the two bridges help make the area more accessible. This is a benefit on what is part of a core path network.
