Keltie Water hydro scheme

The Munro Society has started to monitor hydro schemes – a very welcome development – and my thanks to Derek Sime who sent parkswatch a number of photos of the Keltie Water Hydro Scheme,

situated between Callander and Stuc a Chroin. While the Keltie Water forms the eastern boundary of the Loch Lomond and Trossachs National Park all the development associated with the hydro scheme lies within it. The hydro scheme was originally approved in 2013, revised plans approved in 2014 ([see here](#)) and map below and apparently constructed in 2016.

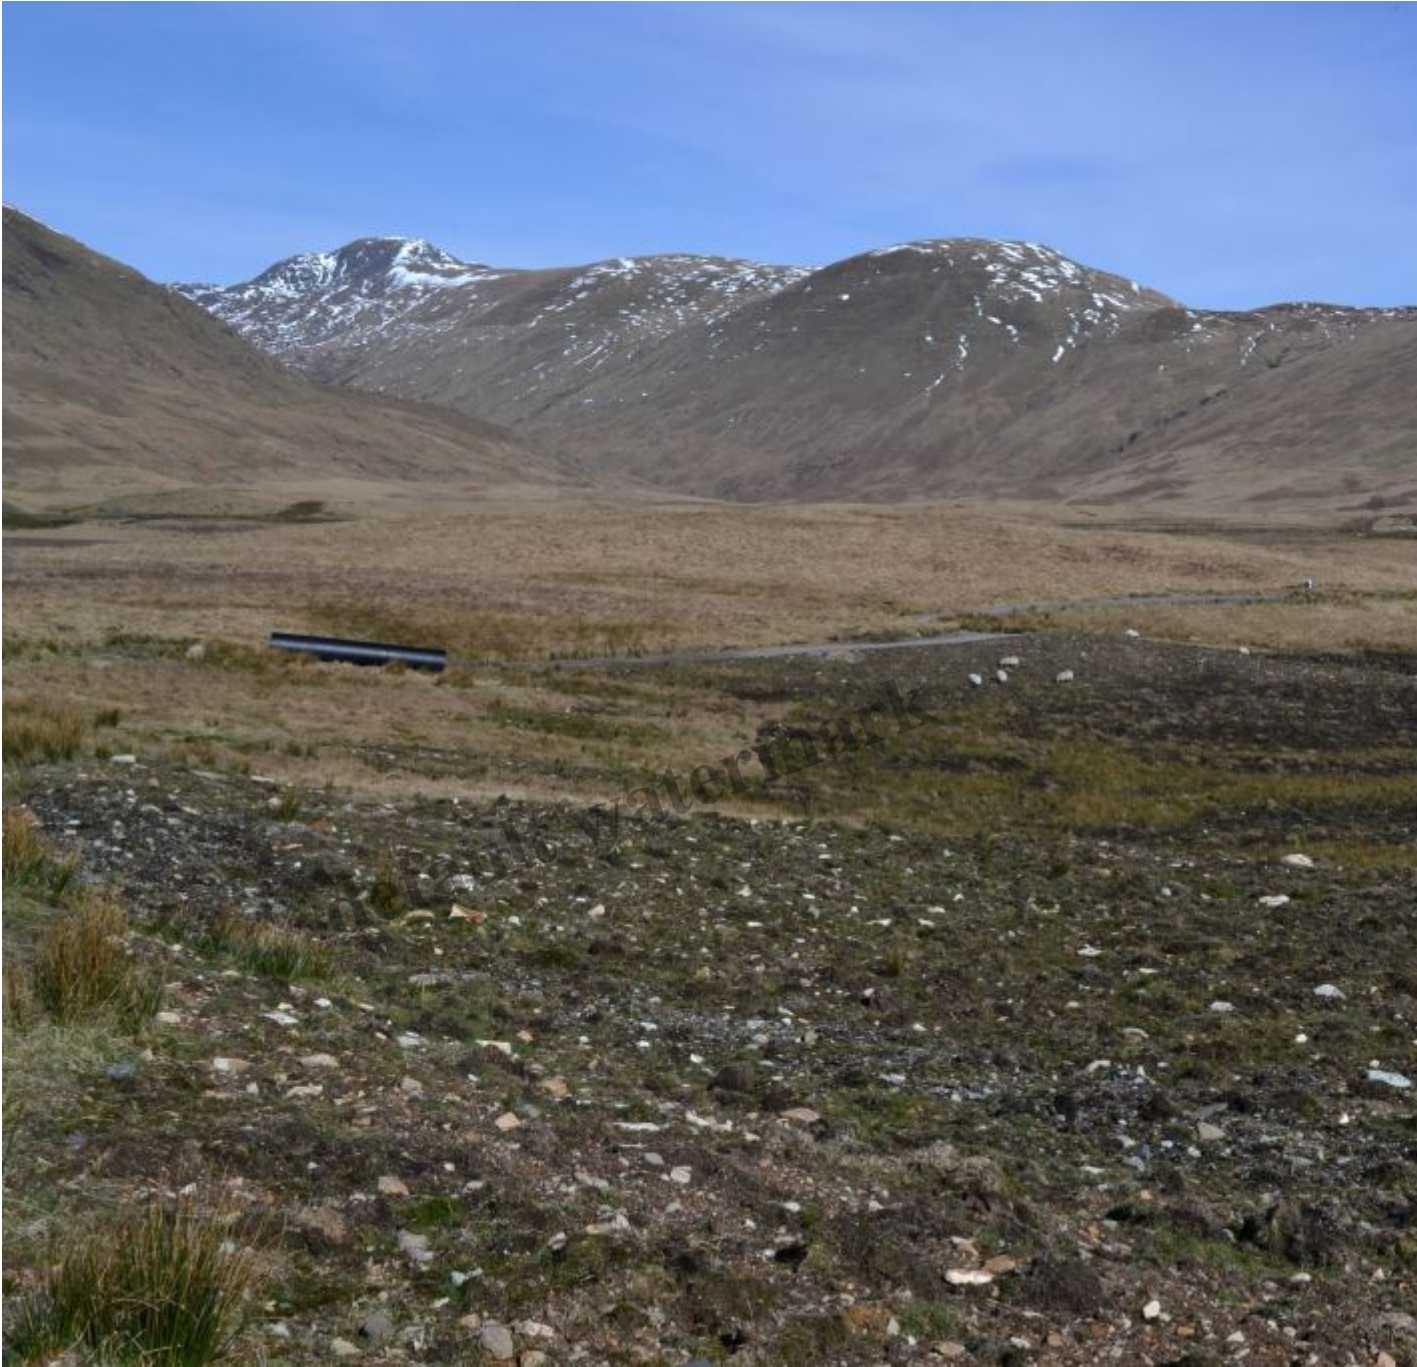
Photo credit Derek Sime

The other element of hydro schemes that the LLTNPA have generally ensured is done well is restoration of the ground in grassland and peatland areas. If peat and turves are removed and stored before the trench for the pipeline is dug, once replaced the ground should recover quickly. A multitude of stones on the surface as along Glen Bruar ([see here](#)) is a sign that contractors have mixed up excavations with top soil and vegetation. While you can see some stones on the surface here, generally this section of pipeline restoration appears to have been done well and is likely to recover quickly. In two years it may not be possible to see the line of the pipeline.

The section of pipe on the left of the photo is another matter. It is one of several which appear to have been abandoned as all machinery has been removed from the site and there is no sign of ongoing works. There is no need for this and it is not acceptable. Sadly abandoned sections of pipe are a feature of a number of other hydro schemes in our National Park – its cheaper to leave them in situ than recycle them – including Glen Bruar. (Its also yet another example of why the litter left by a few irresponsible campers needs to be seen in perspective).

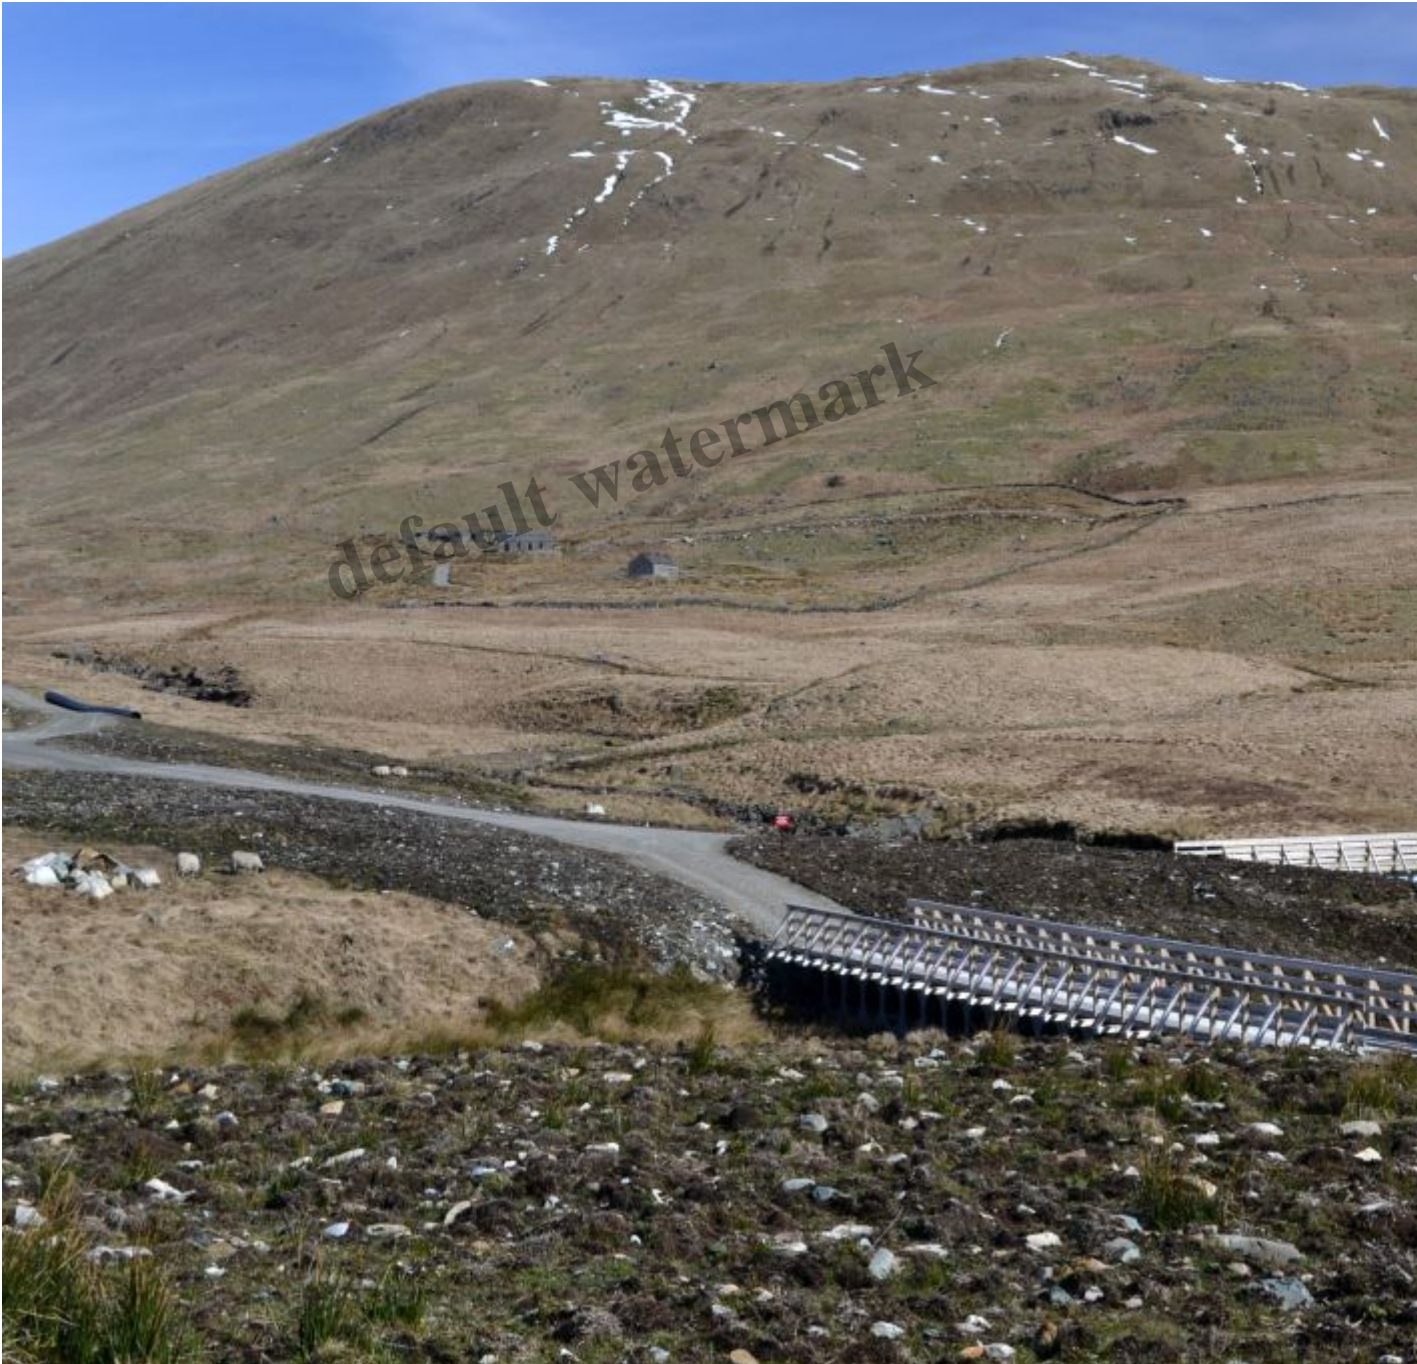
Photo Credit Derek Sime

The restoration of the ground just south of the bridge over the Allt Breac Nic and beyond it on the left side of the track appears less successful, with far more stone visible and what appears to be a boulder dump by the sheep on the far left. I suspect part of the reason for this is the ground before the bridge slopes steeply and the depth of soil here was less. Where the soil is shallower its much more difficult to separate vegetation and topsoil from rocks if the work is done by machine as it invariably is nowadays. This is a problem not just at Glen Bruar but on sections of the Beaully Denny powerline. If our National Parks are serious about ensuring the highest standards of restoration I believe they need to consider and support the development of alternative “construction” techniques in areas of shallow soil. Meantime the LLTNPA needs to consider how its going to make the restoration of this area effective.

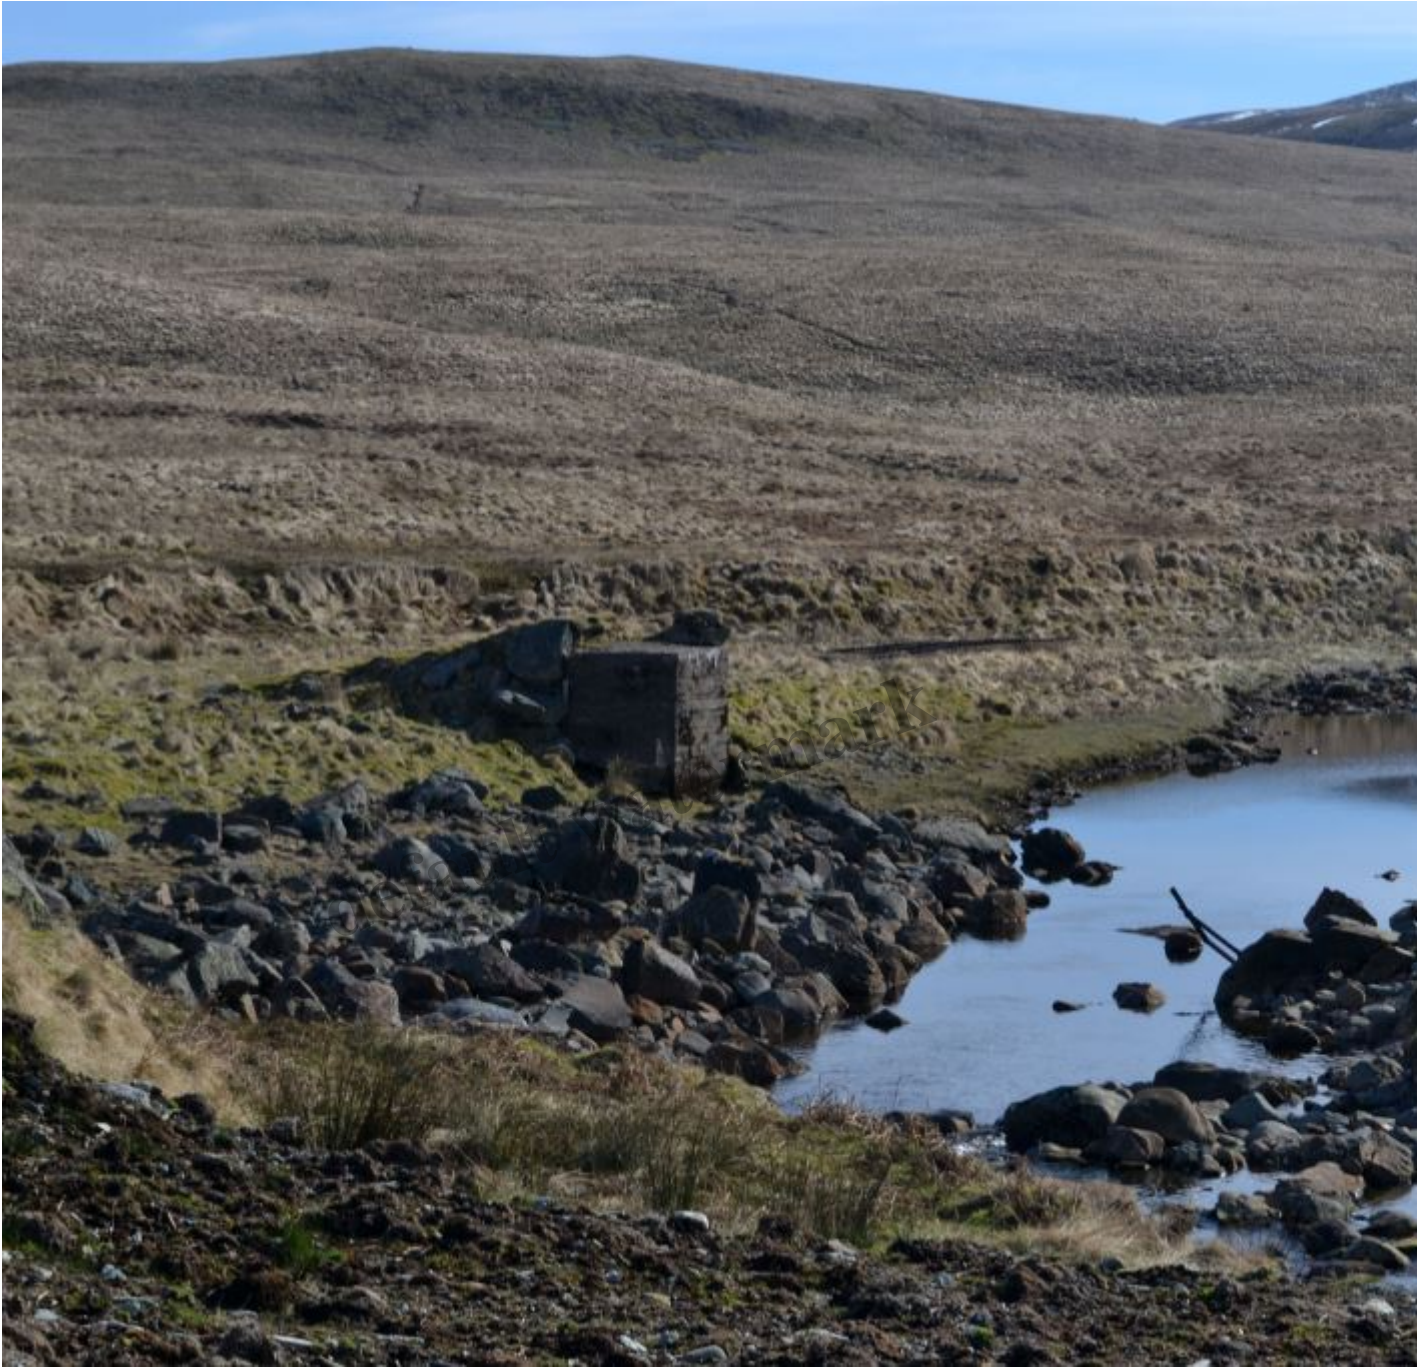
Photo credit Derek Sime

The old bridge south of Arivurichardich (above) over the Keltie Water was washed away on 18 August 2004, during a violent thunderstorm which sat over Stuc a'Chroin, and which was also responsible for sweeping away a number of other bridges in the area, including that on the public South Loch Earn road at Edinample. Since then the Keltie Water has been uncrossable when it has been in spate, and while of course the hydro pipeline will reduce those levels in future, the two bridges help make the area more accessible. This is a benefit on what is part of a core path network.
