Keltie Water hydro scheme

The Munro Society has started to monitor hydro schemes – a very welcome development – and my thanks to Derek Sime who sent parkswatch a number of photos of the Keltie Water Hydro Scheme,

situated between Callander and Stuc a Chroin. While the Keltie Water forms the eastern boundary of the Loch Lomond and Trossachs National Park all the development associated with the hydro scheme lies within it. The hydro scheme was originally approved in 2013, revised plans approved in 2014 ([see here](#)) and map below and apparently constructed in 2016.

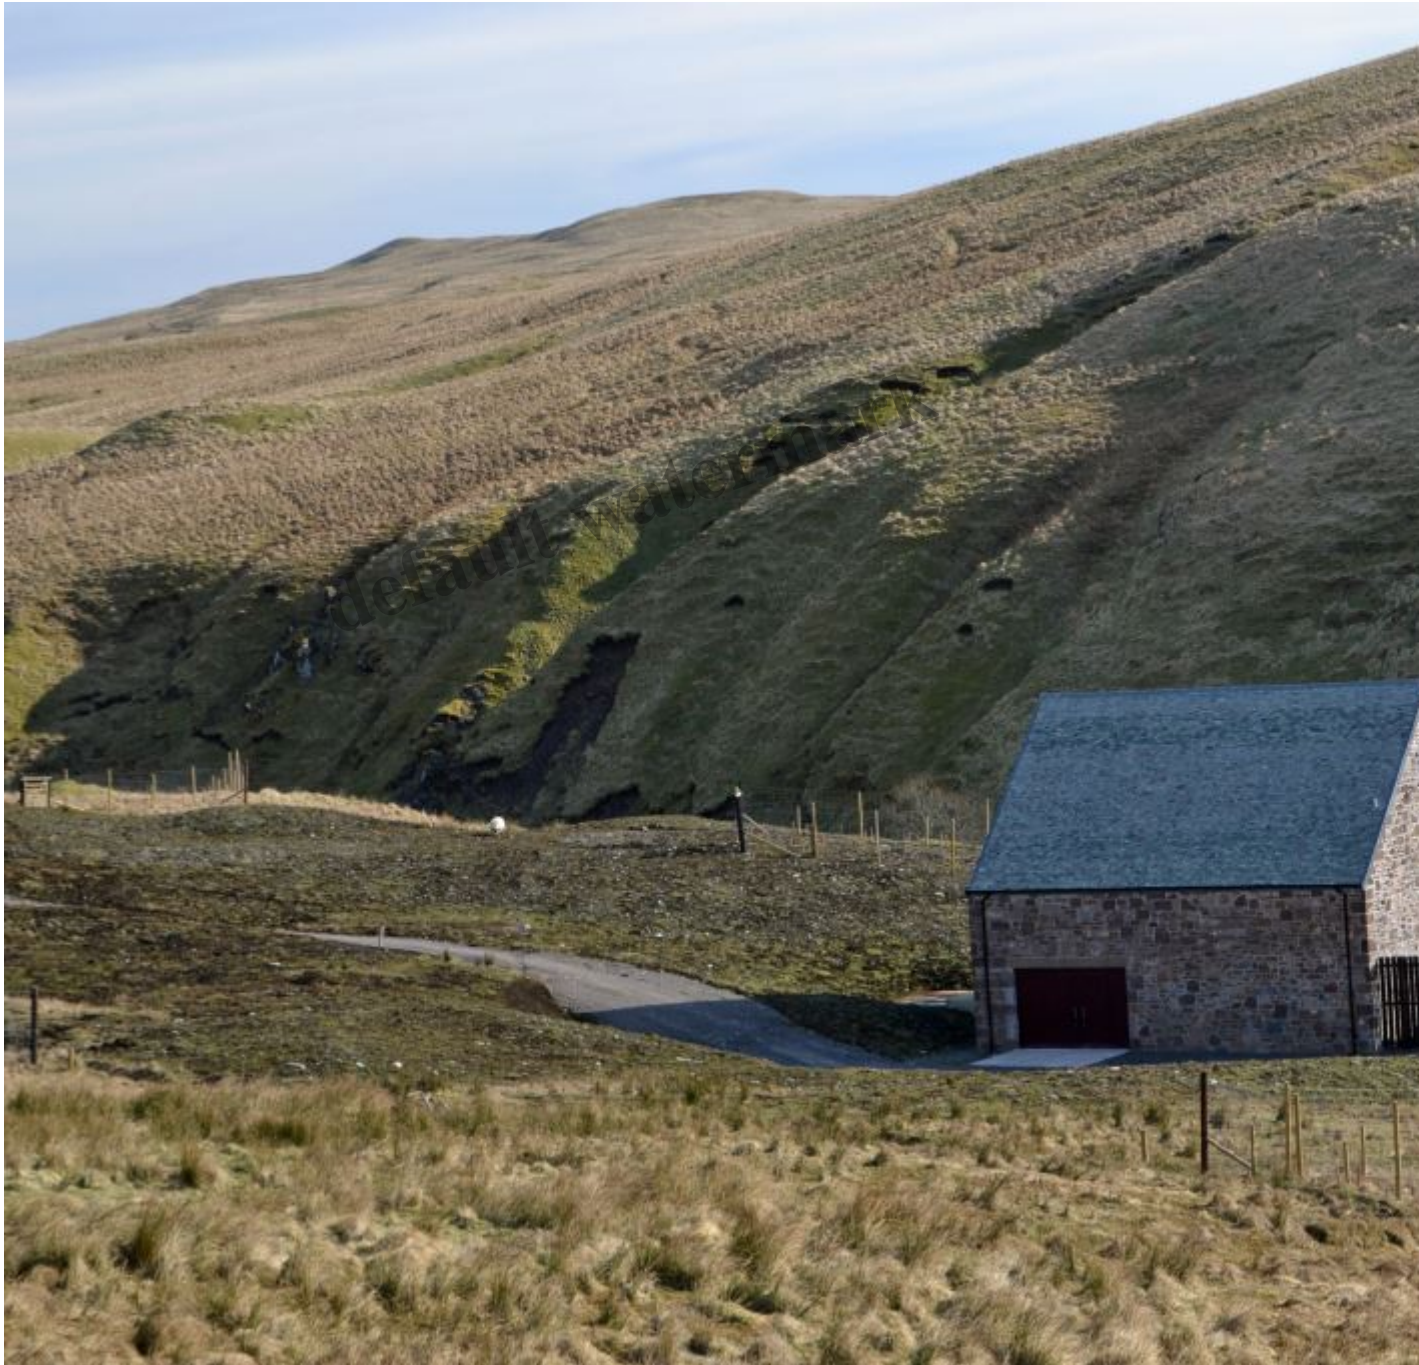
The power house is situated close to Braeleny Farm, has been finished with natural materials and is quite tucked away. It will have almost no landscape impact on the glen, which becomes wide and open higher up. The construction compound to the left of the building has been restored well – from this distance you would hardly know it had been there – and for good measure Drummond Estate have added three blocks of tree planting. While in the wrong place, tree planting can look artificial, not far south of the powerhouse on the far side of the river (outside the National Park boundary) there is a large block of forestry while further south, along the Keltie Water, there is some fine native woodland and the planting here has the potential to link to that.
