Keltie Water hydro scheme

The Munro Society has started to monitor hydro schemes – a very welcome development – and my thanks to Derek Sime who sent parkswatch a number of photos of the Keltie Water Hydro Scheme,

situated between Callander and Stuc a Chroin. While the Keltie Water forms the eastern boundary of the Loch Lomond and Trossachs National Park all the development associated with the hydro scheme lies within it. The hydro scheme was originally approved in 2013, revised plans approved in 2014 ([see here](#)) and map below and apparently constructed in 2016.

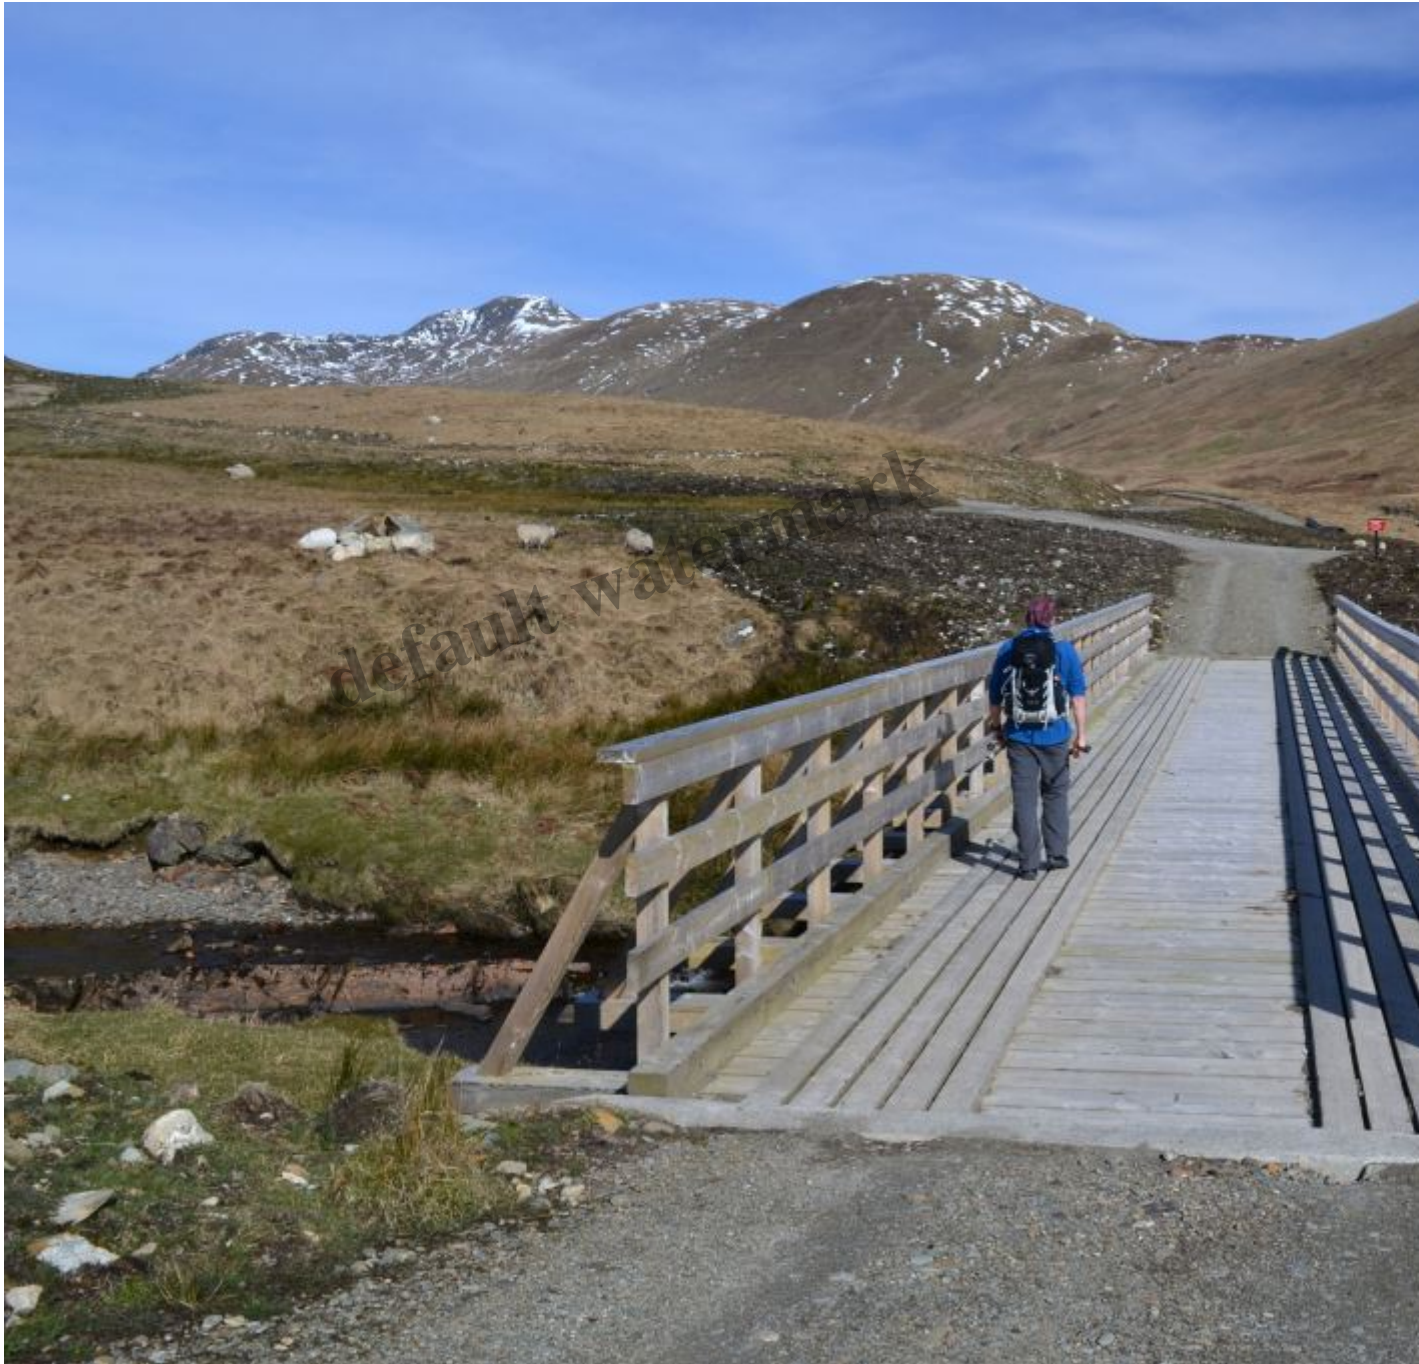
New bridge over the Allt Breac Nic, Stuc a Chroin in distance. The pipe has been concealed under guidance. Photo Credit Derek Sime.
