## Keltie Water hydro scheme

### Description

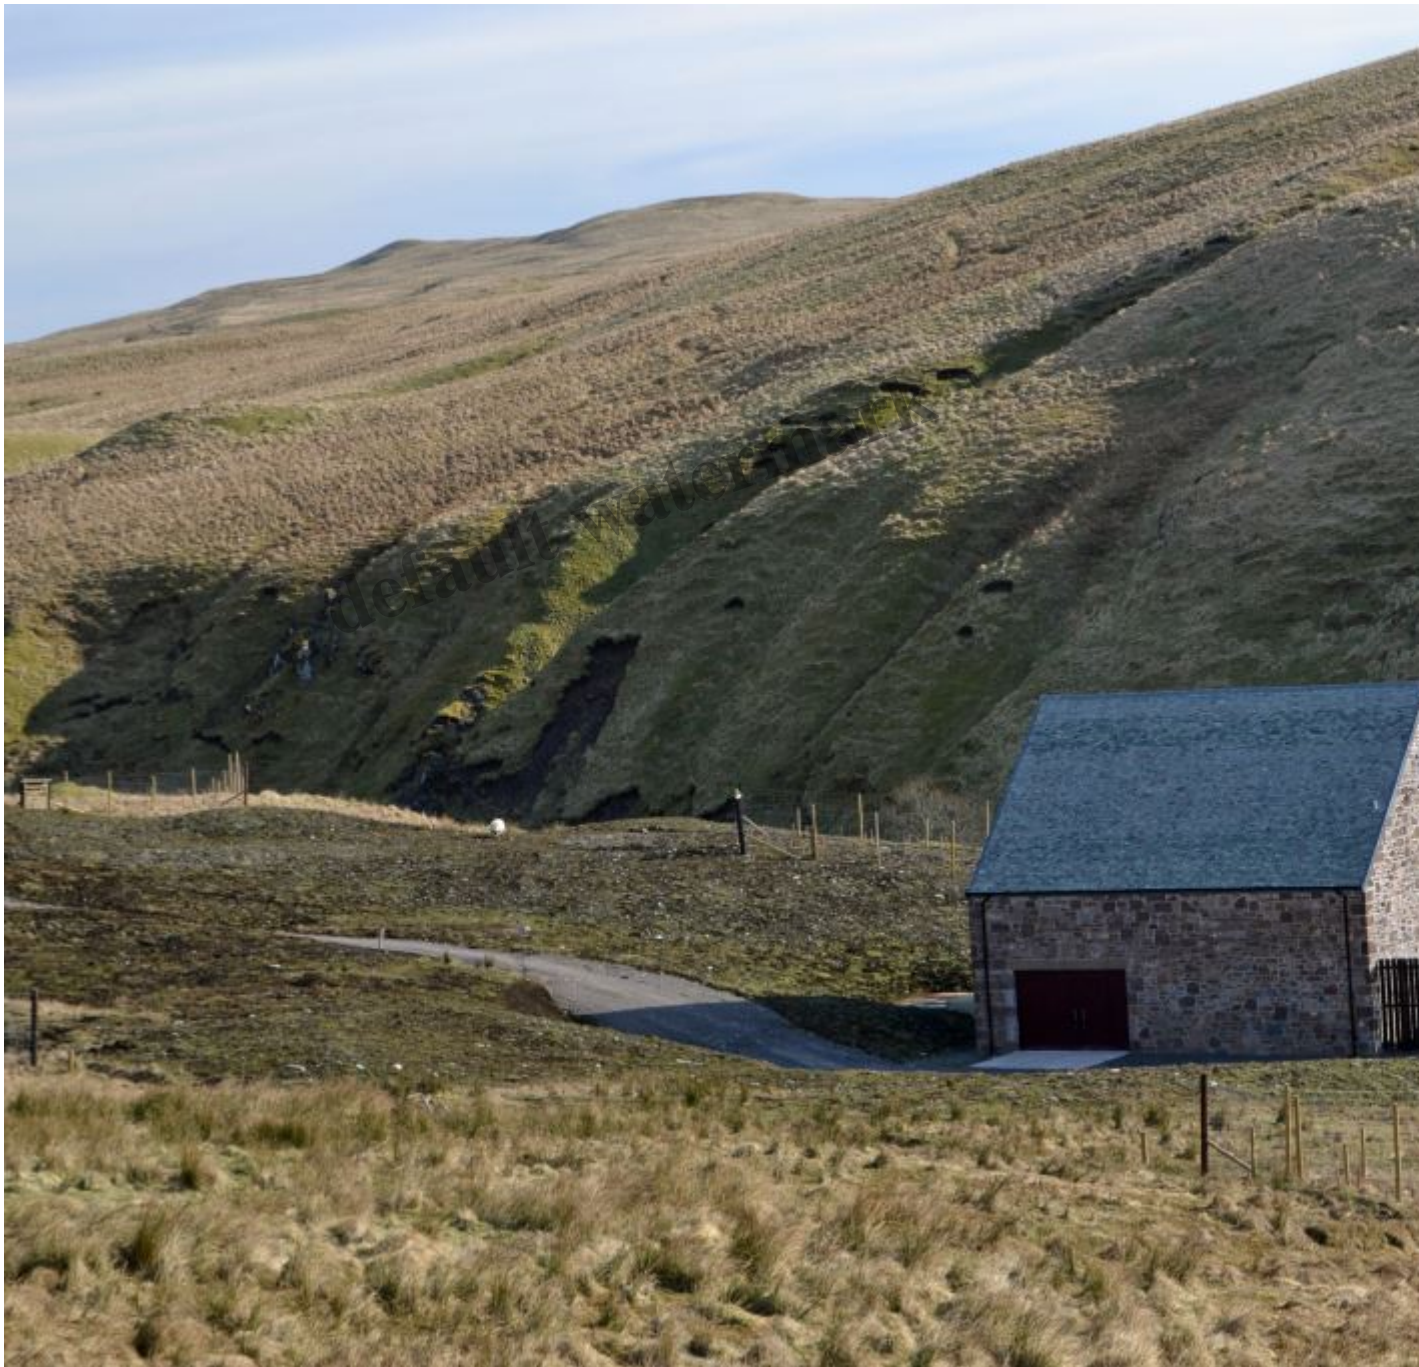
The power house is situated close to Braeleny Farm, has been finished with natural materials and is quite tucked away. It will have almost no landscape impact on the glen, which becomes wide and open higher up. The construction compound to the left of the building has been restored well – from this distance you would hardly know it had been there – and for good measure Drummond Estate have added three blocks of tree planting. While in the wrong place, tree planting can look artificial, not far south of the powerhouse on the far side of the river (outside the National Park boundary) there is a large block of forestry while further south, along the Keltie Water, there is some fine native woodland and the planting here has the potential to link to that.

Generally the LLTNPA has ensured the power house elements of hydro schemes in the National Park have been done well – their planners I think are more comfortable with buildings than landscape – and this appears a good example.

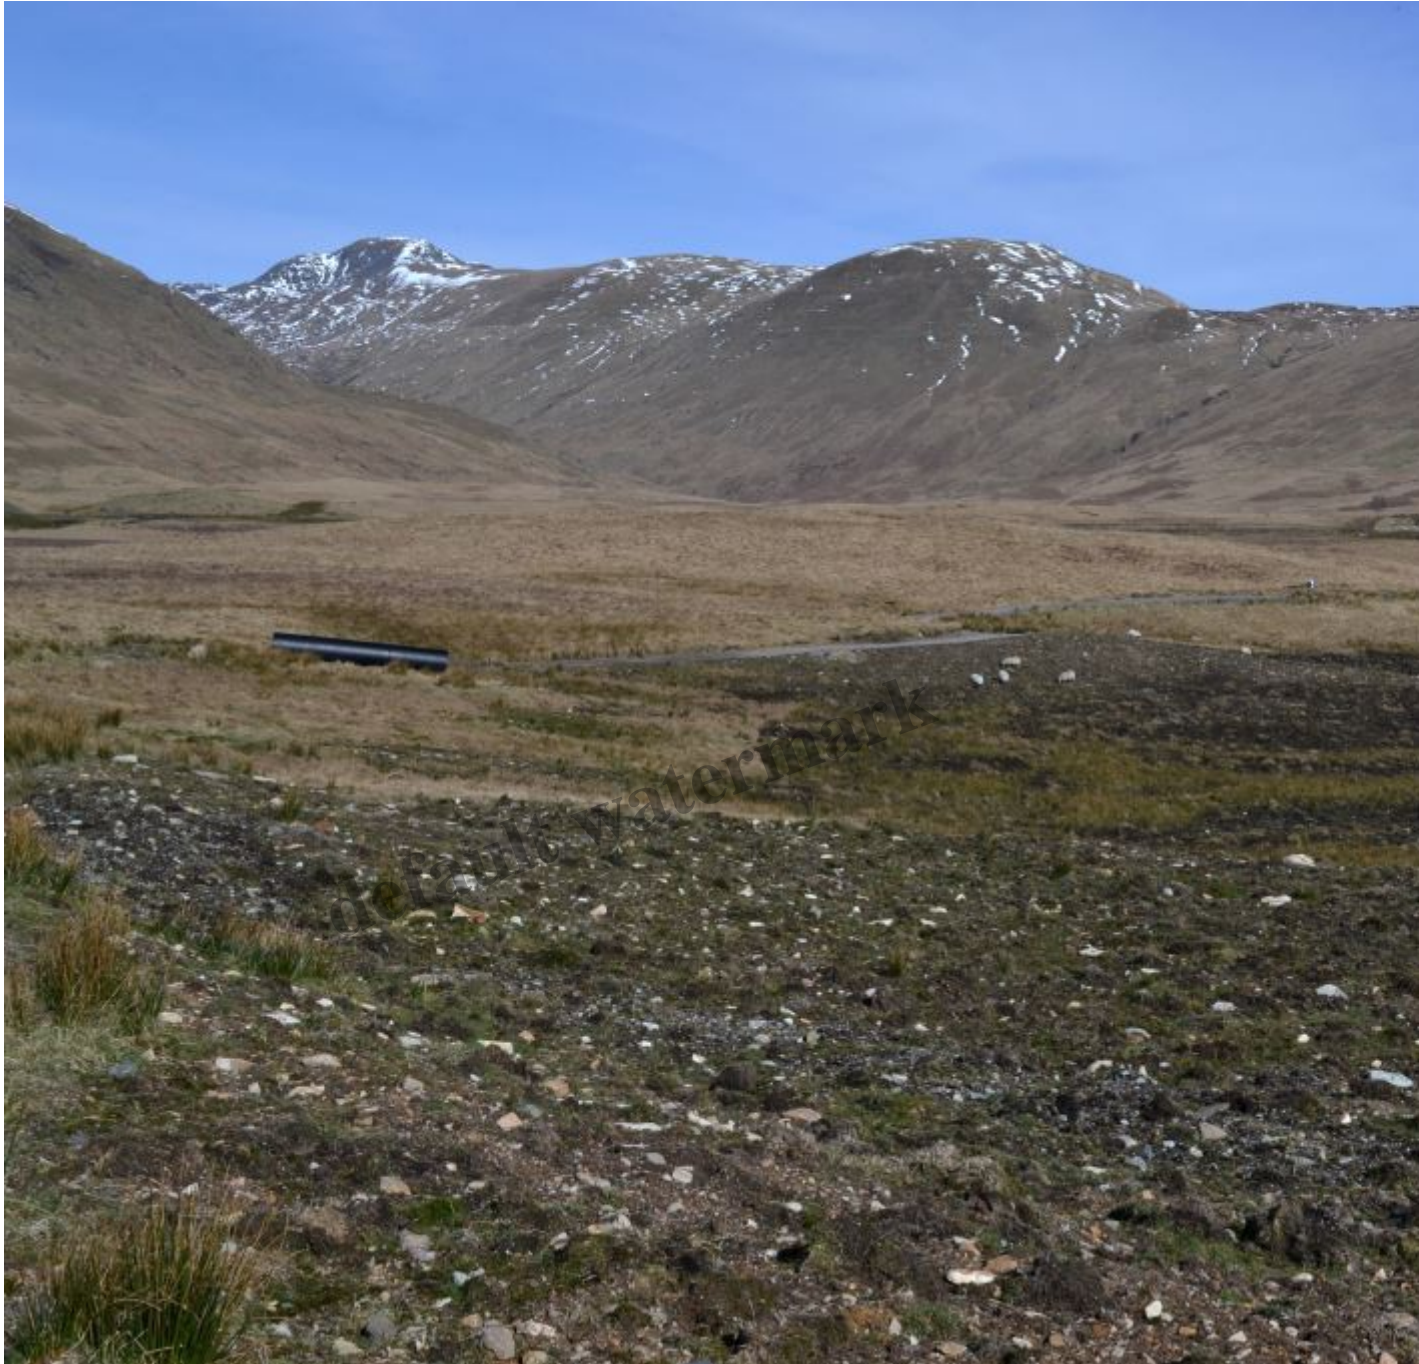
The other element of hydro schemes that the LLTNPA have generally ensured is done well is restoration of the ground in grassland and peatland areas. If peat and turves are removed and stored before the trench for the pipeline is dug, once replaced the ground should recover quickly. A multitude of stones on the surface as along Glen Bruar ([see here](#)) is a sign that contractors have mixed up excavations with top soil and vegetation. While you can see some stones on the surface here, generally this section of pipeline restoration appears to have been done well and is likely to recover quickly. In two years it may not be possible to see the line of the pipeline.

The section of pipe on the left of the photo is another matter. It is one of several which appear to have been abandoned as all machinery has been removed from the site and there is no sign of ongoing works. There is no need for this and it is not acceptable. Sadly abandoned sections of pipe are a feature of a number of other hydro schemes in our National Park – its cheaper to leave them in situ than recycle them – including Glen Bruar. (Its also yet another example of why the litter left by a few irresponsible campers needs to be seen in perspective).

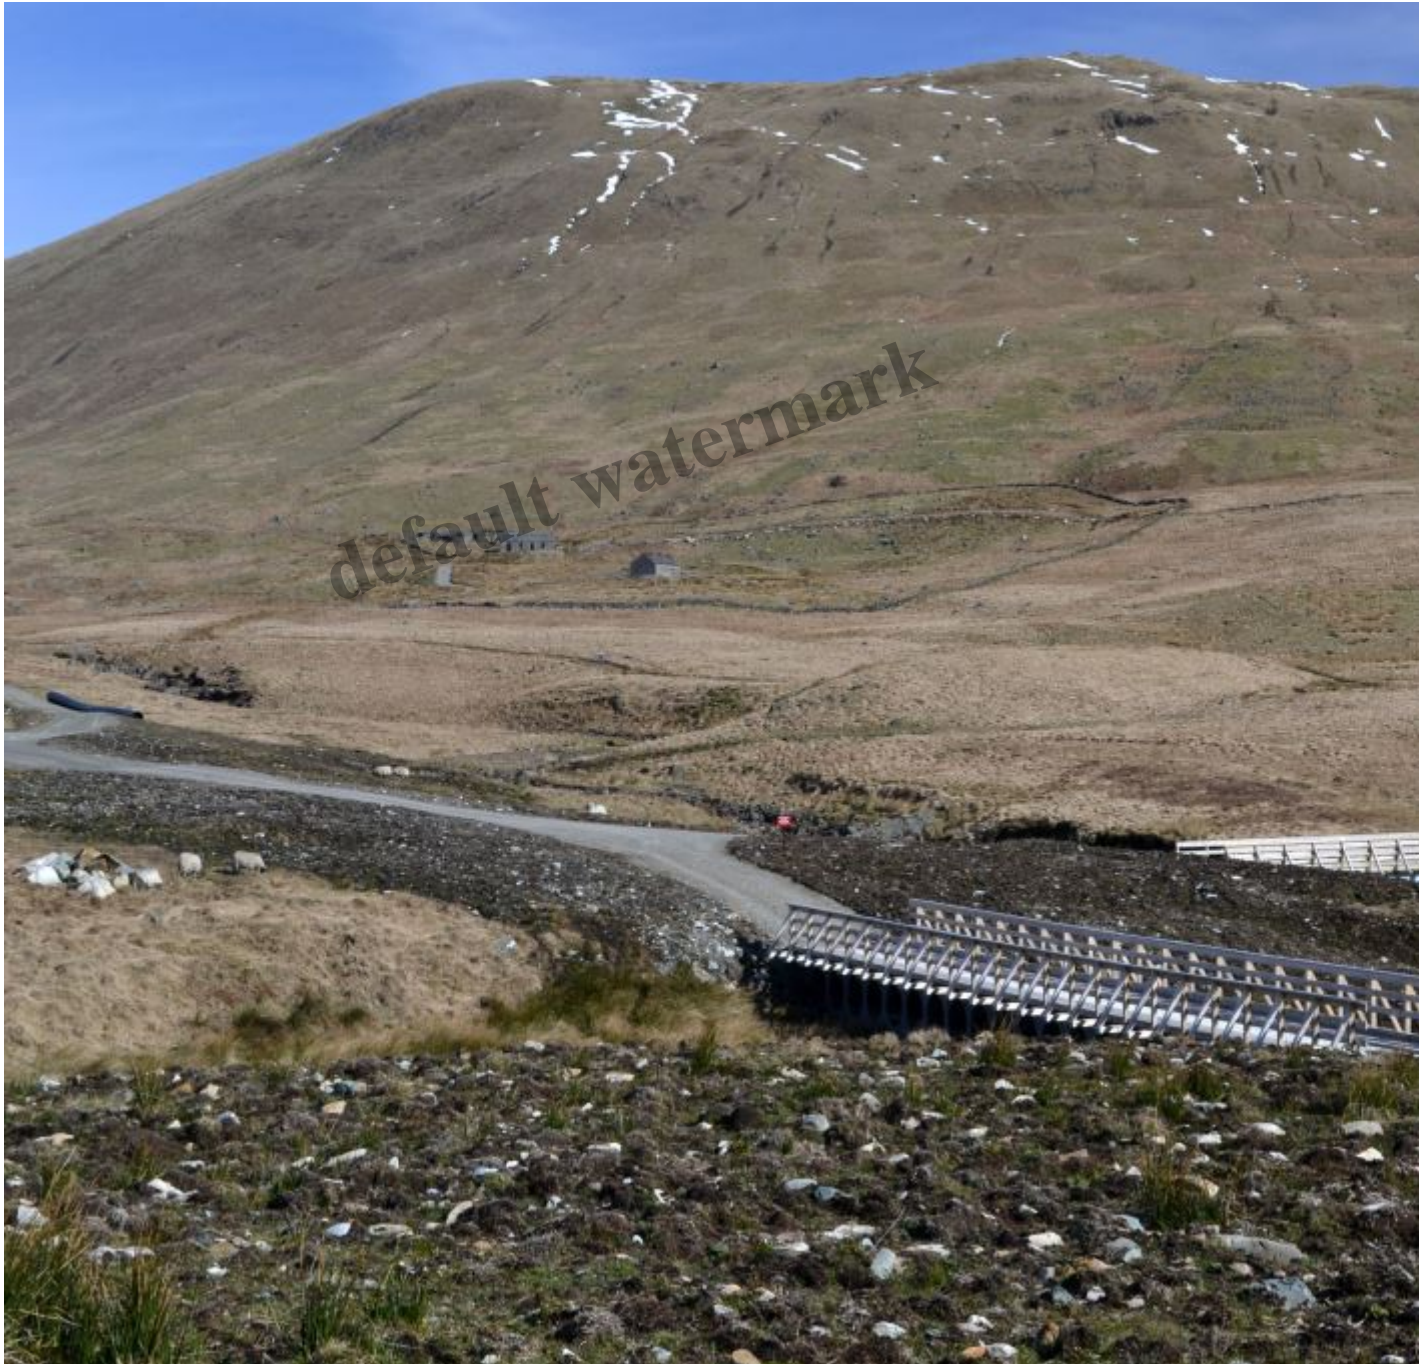
The restoration of the ground just south of the bridge over the Allt Breac Nic and beyond it on the left side of the track appears less successful, with far more stone visible and what appears to be a boulder dump by the sheep on the far left. I suspect part of the reason for this is the ground before the bridge slopes steeply and the depth of soil here was less. Where the soil is shallower its much more difficult to separate vegetation and topsoil from rocks if the work is done by machine as it invariably is nowadays. This is a problem not just at Glen Bruar but on sections of the Beaully Denny powerline. If our National Parks are serious about ensuring the highest standards of restoration I believe they need to consider and support the development of alternative “construction” techniques in areas of shallow soil. Meantime the LLTNPA needs to consider how its going to make the restoration of this area effective.

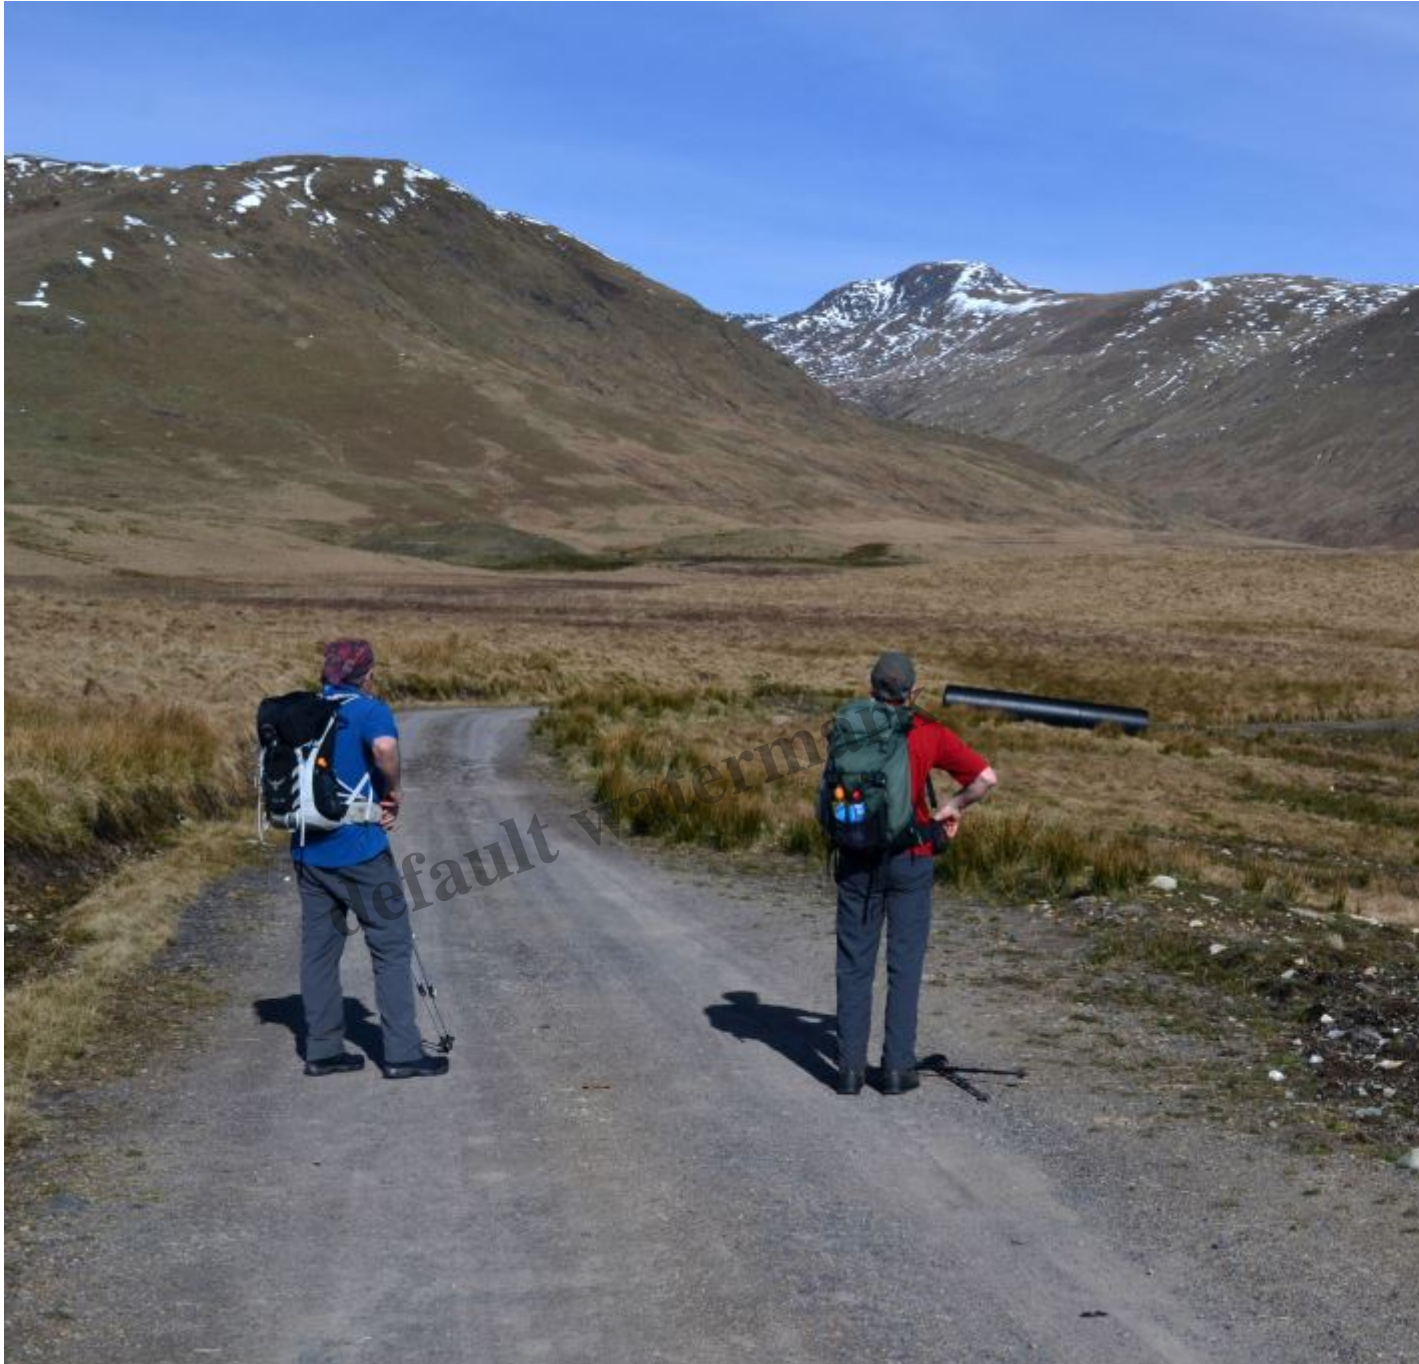
Prior to the construction of the hydro there was an existing track to Arivurichardich. This was upgraded to enable the construction works to take place. Drummond Estate's planning application asked for the tracks, after restoration, to be 2.5m wide. The LLTNPA, stuck by their Planning Guidance and made the following requirements:

*Notwithstanding the approved plans and for the avoidance of doubt these tracks shall be reduced to a width of between 2 metres, and 2.5 metres (at essential turning areas and steep gradients only), (to be agreed in writing by the Planning Authority), and shall have a grassed central strip.*

What the photo above illustrates is that this requirement has not been met. This straight section of track is more than 2m wide. You can also see how aggregate from the track has spilled down the slope to the right, broadening it still further. There is no sign of a grass central strip. Perhaps that will be put in place this spring? The problem here is not with the conditions the LLTNPA required in this case, its the enforcement of them.

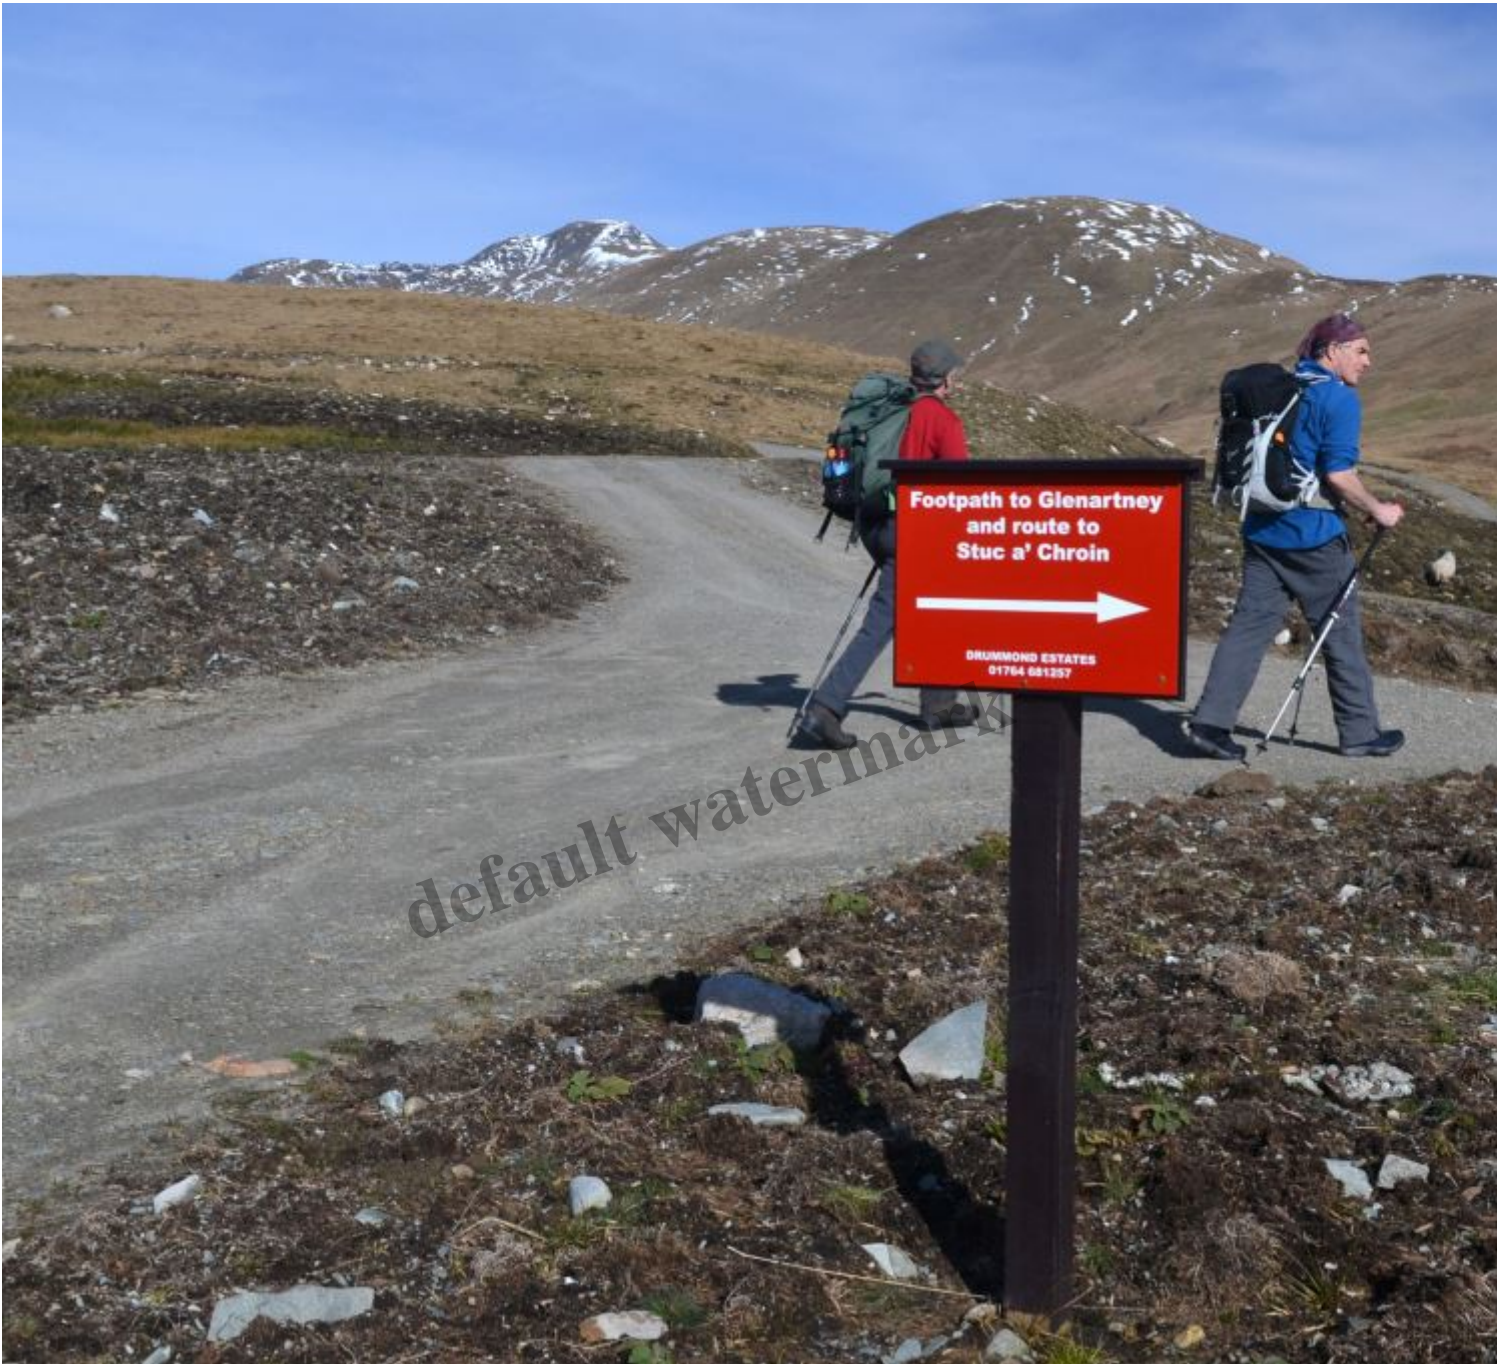
A close up of the area between the two bridges (above) illustrates a number of areas where restoration work could have been better. Left of the track large amounts of stony substrata has been mixed up with the peat and may change the type of vegetation that grows back here . Another piece of abandoned pipe is visible to the right of the sign. The track itself is clearly broader than the 2.5m the LLTNPA allowed for bends and junctions. And, while I am not against all signs – this is part of a core path network – did it really have to be bright red?

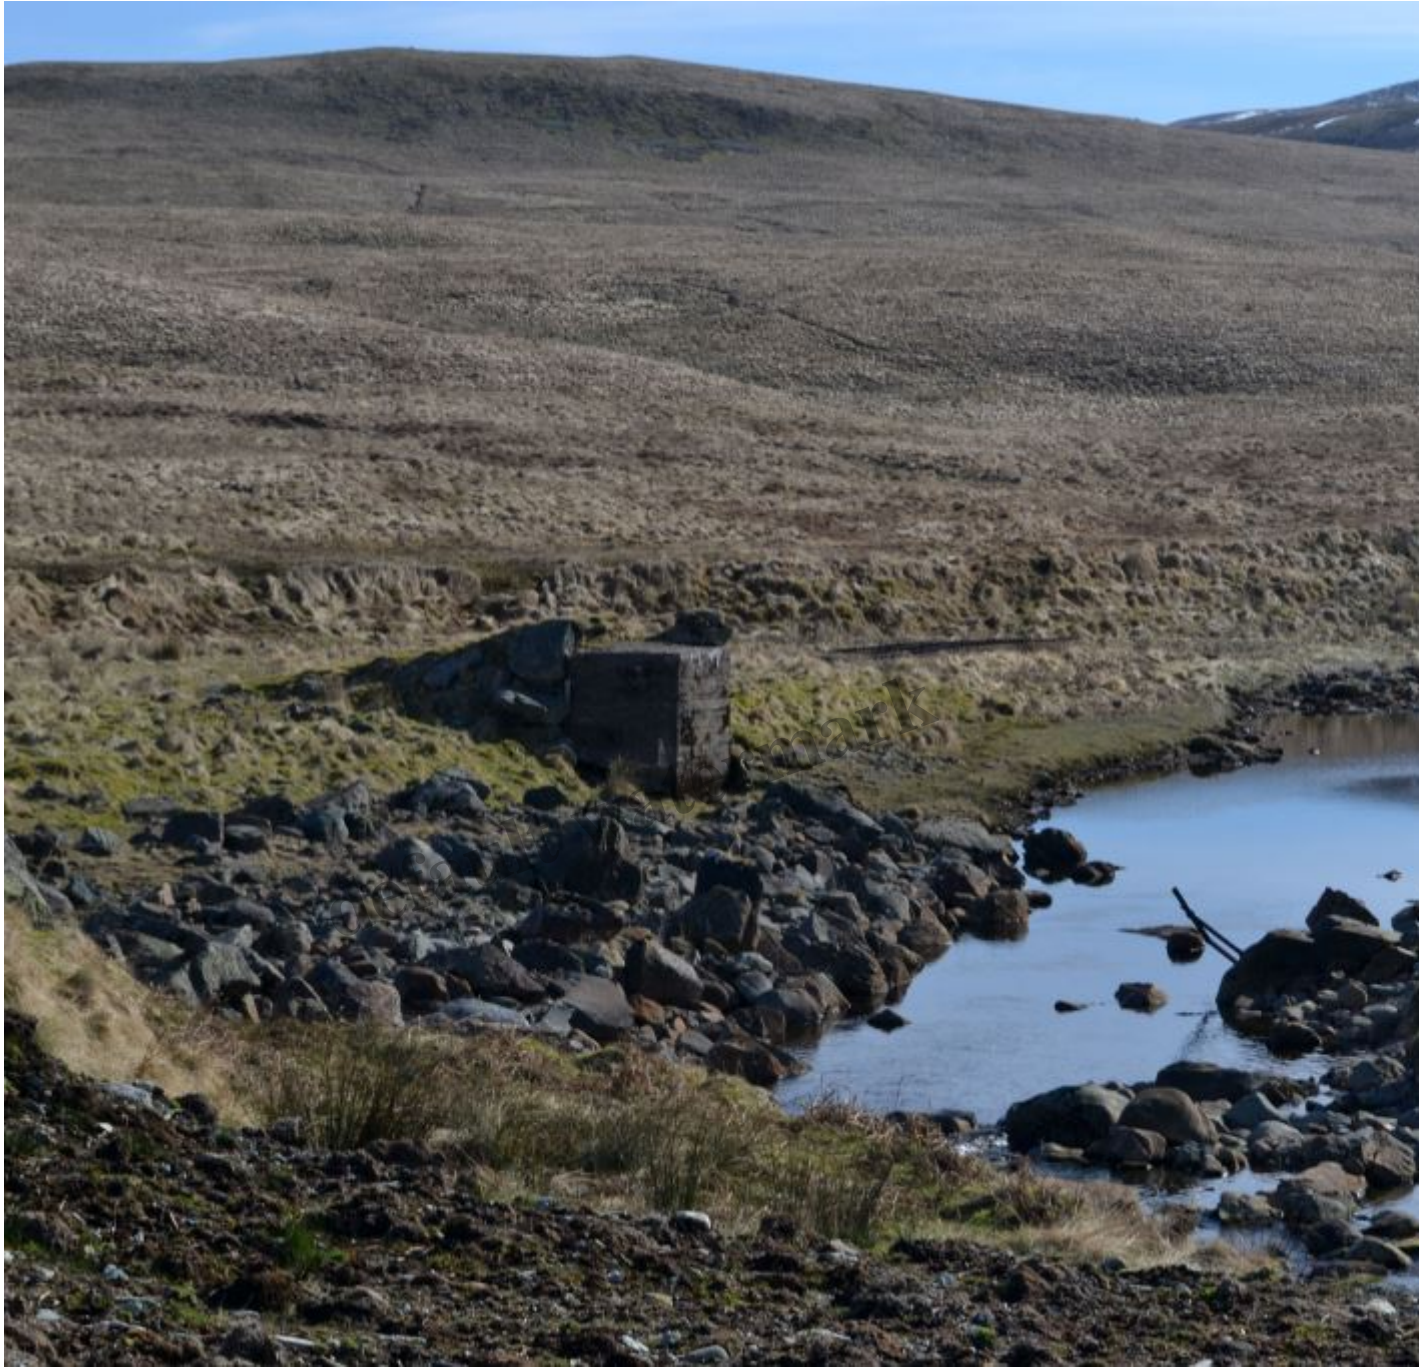
The old bridge south of Arivurichardich (above) over the Keltie Water was washed away on 18 August 2004, during a violent thunderstorm which sat over Stuc a'Chroin, and which was also responsible for sweeping away a number of other bridges in the area, including that on the public South Loch Earn road at Edinample. Since then the Keltie Water has been uncrossable when it has been in spate, and while of course the hydro pipeline will reduce those levels in future, the two bridges help make the area more accessible. This is a benefit on what is part of a core path network.
