The Glen Falloch hydro schemes (8) – their impact on the landscape and what needs to be done

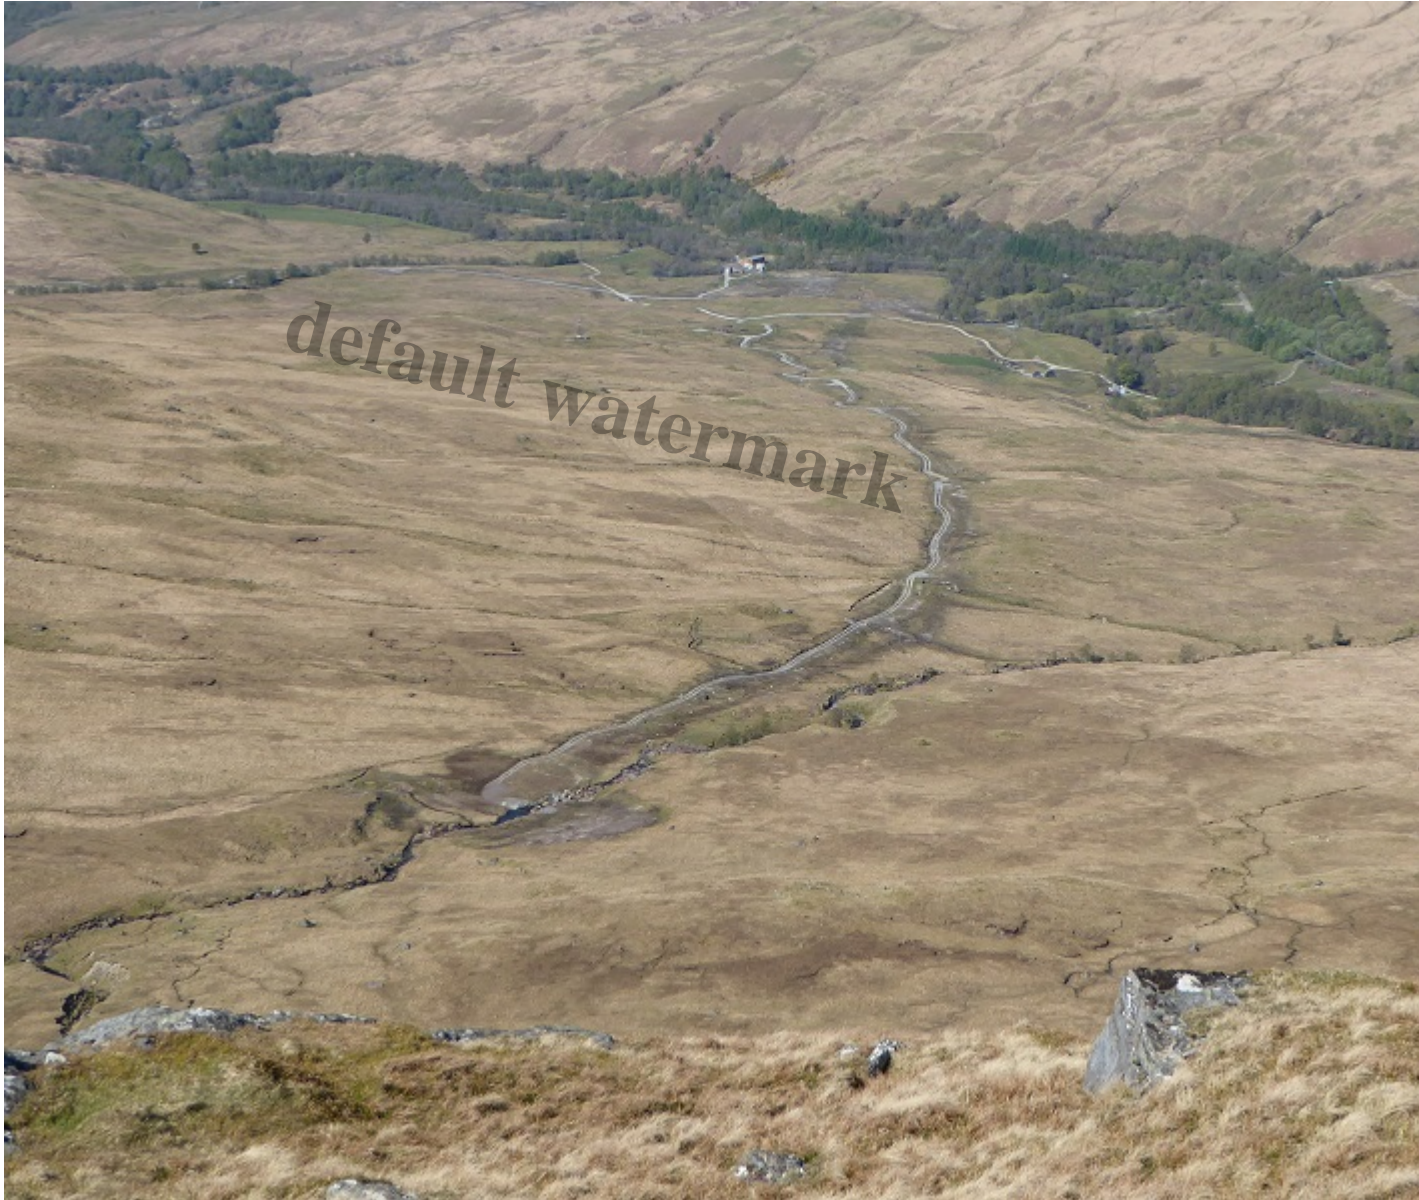
Mid Glen Falloch, viewed from shoulder of An Caisteal. The area It is now a mass of tracks, leading dams. Foreground Allt Andoran, far right Eas Eonan and left background start of track up Allt a Chur hydro powerhouse is centre background, Derrydarroch to the right.

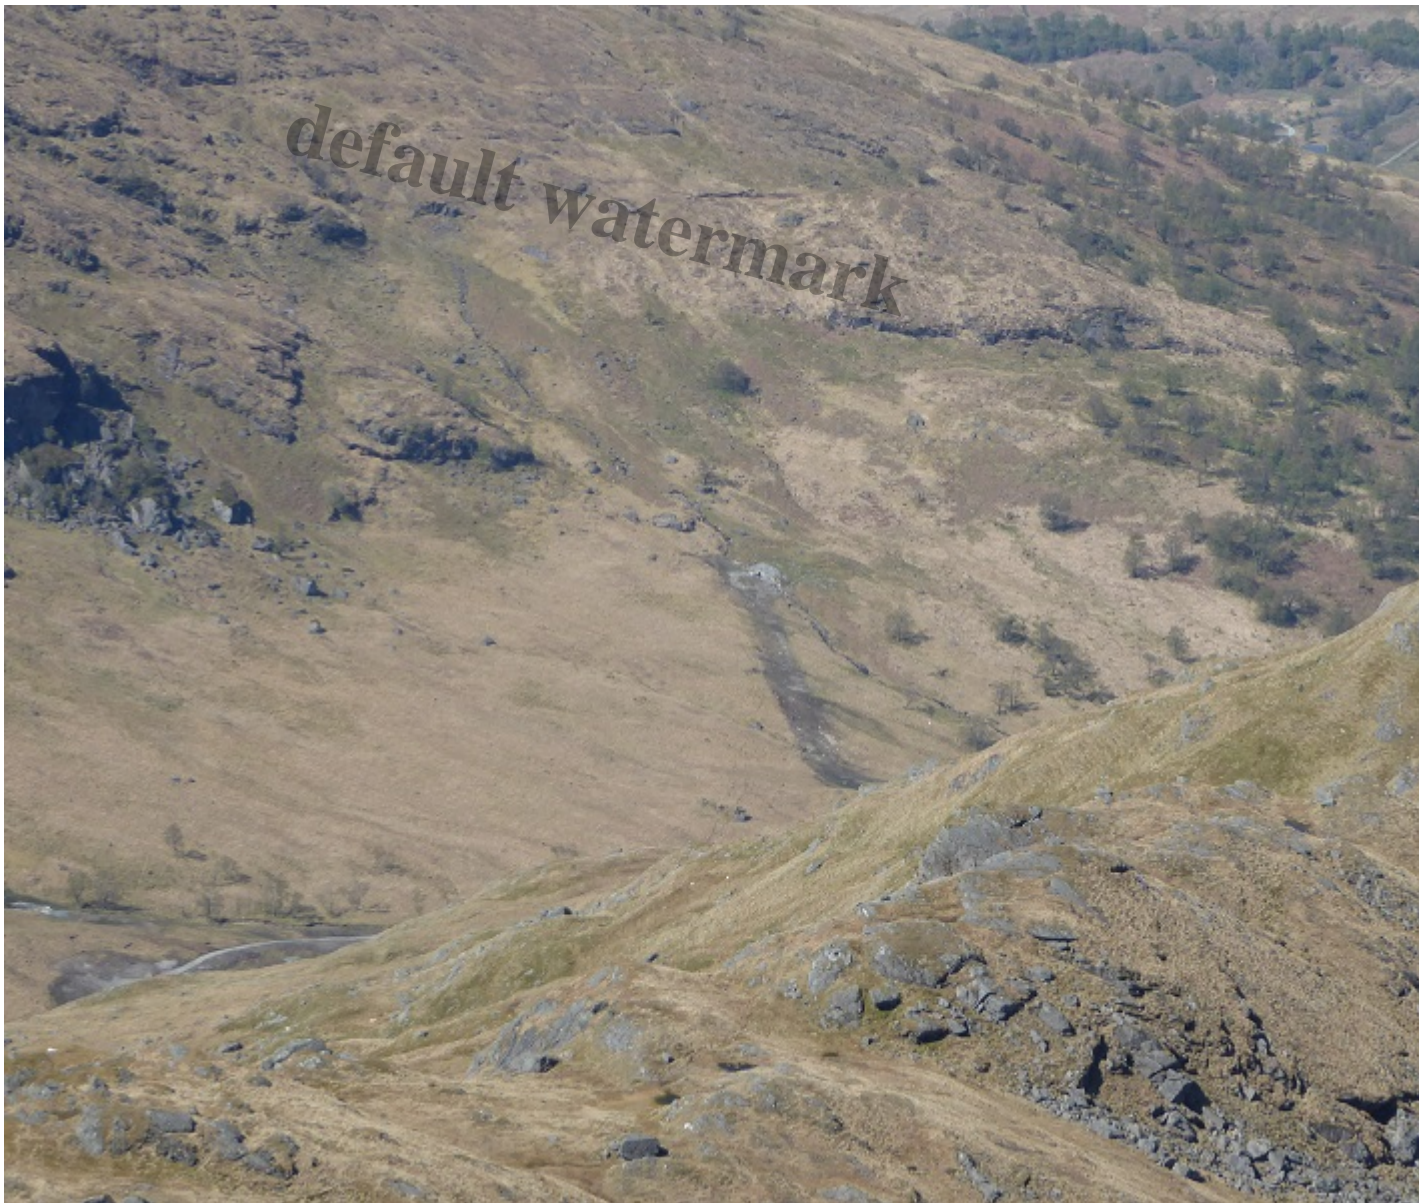
The first Allt a Chuillinn intake centre, the other two intakes are beyond track you can see bottom left

Previously, I have stated that in my view the restoration of the ground in which the pipelines have been buried has generally successful and little cause for concern with it often being quite difficult to make out the line of the pipelines. While I believe that is still sometimes the case, the long dry spell has accentuated the differences in vegetation and its easy to see the landscape scars (above centre). The land may take longer to recover than I had thought.

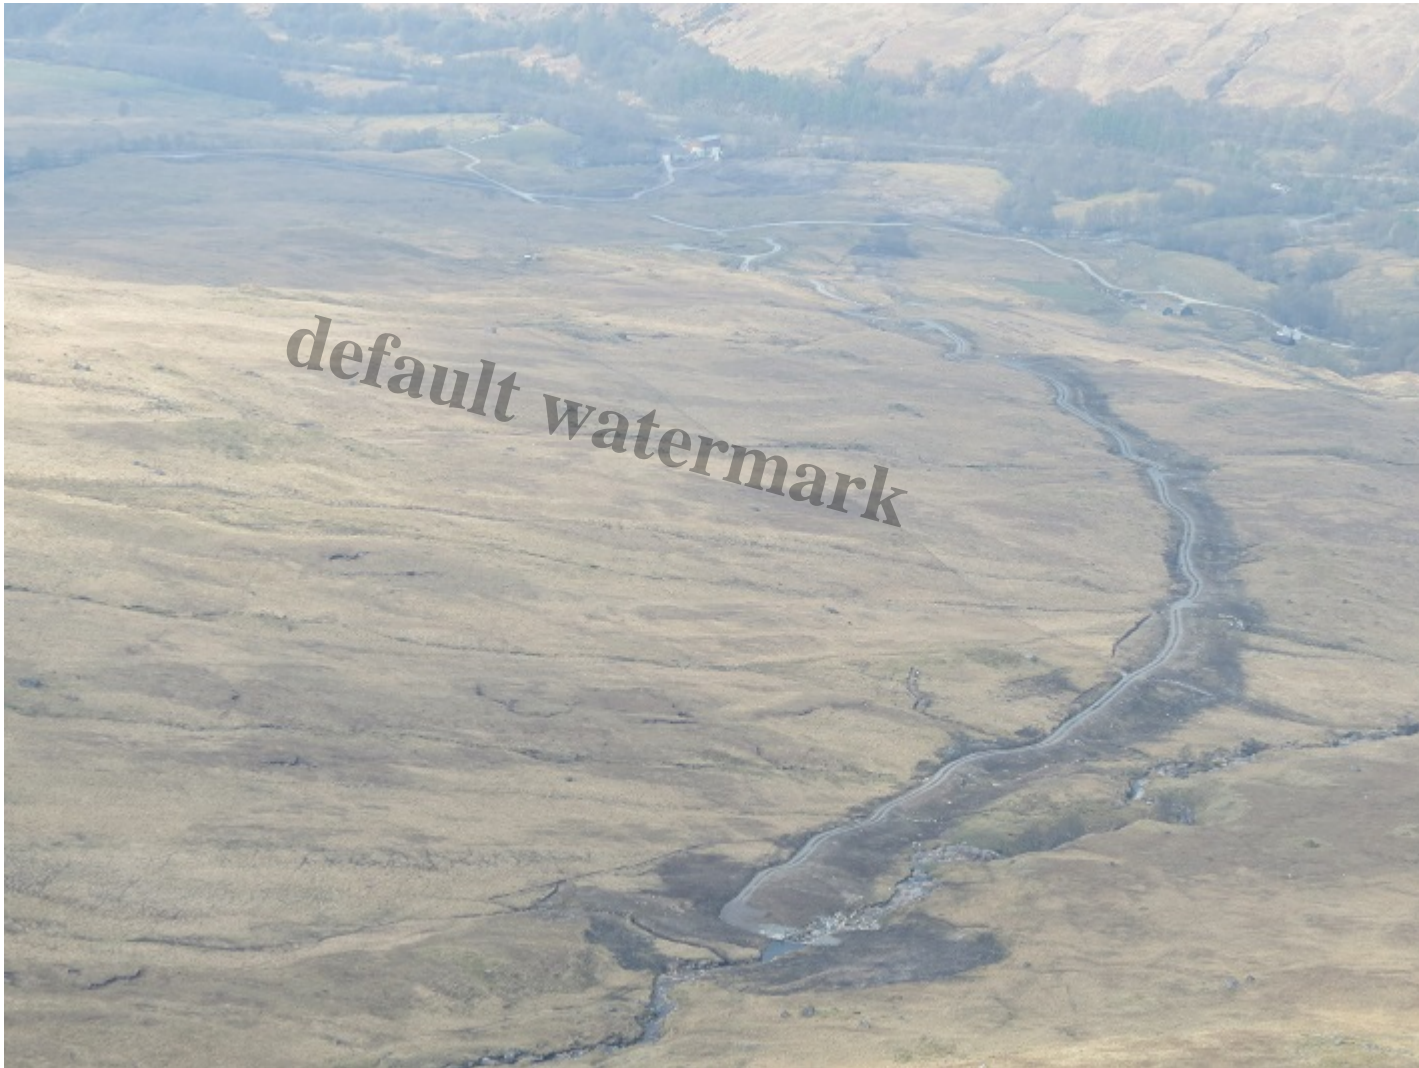
Allt Andoran Track 8th May 2016

Comparing the photo above (taken a year ago on a day with far less good visibility) with the first photo in the post taken a year later, you can see that the ground above the pipeline has recovered to an extent but has a long way to go. The track itself, despite the vegetation down the middle, looks little different and forms a permanent landscape scar.

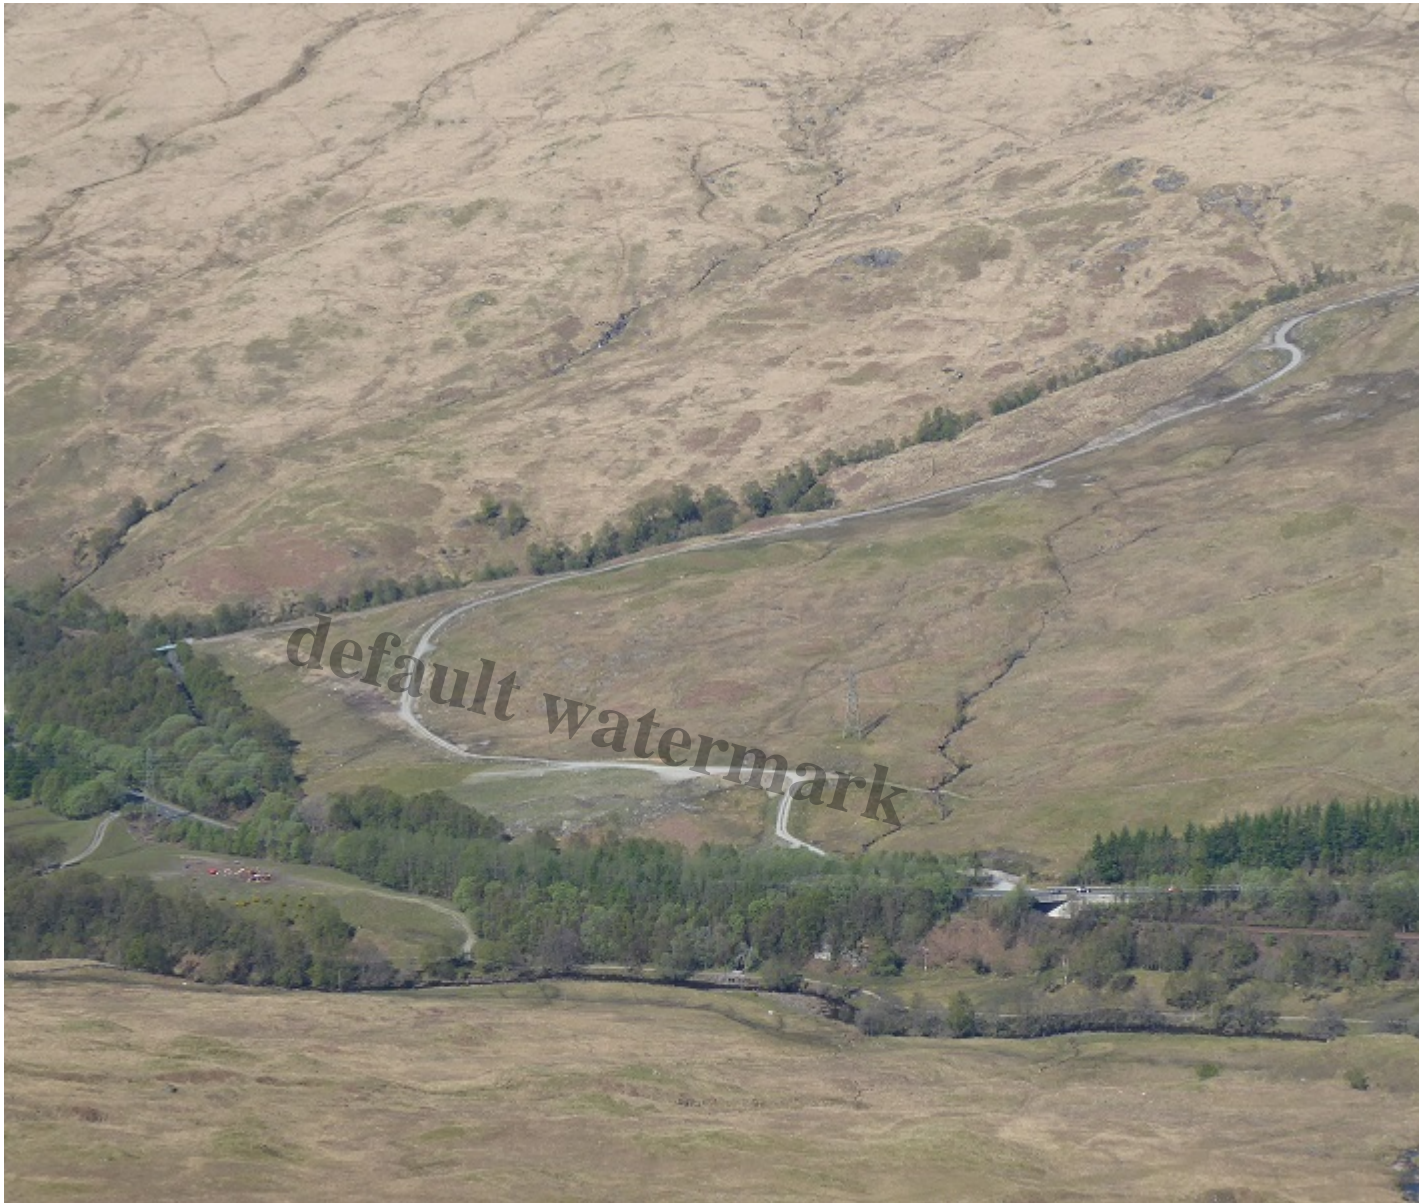
Close up of Eas Eonan track, showing poor restoration of the temporary access track that led to blue West Highland Line (centre left)

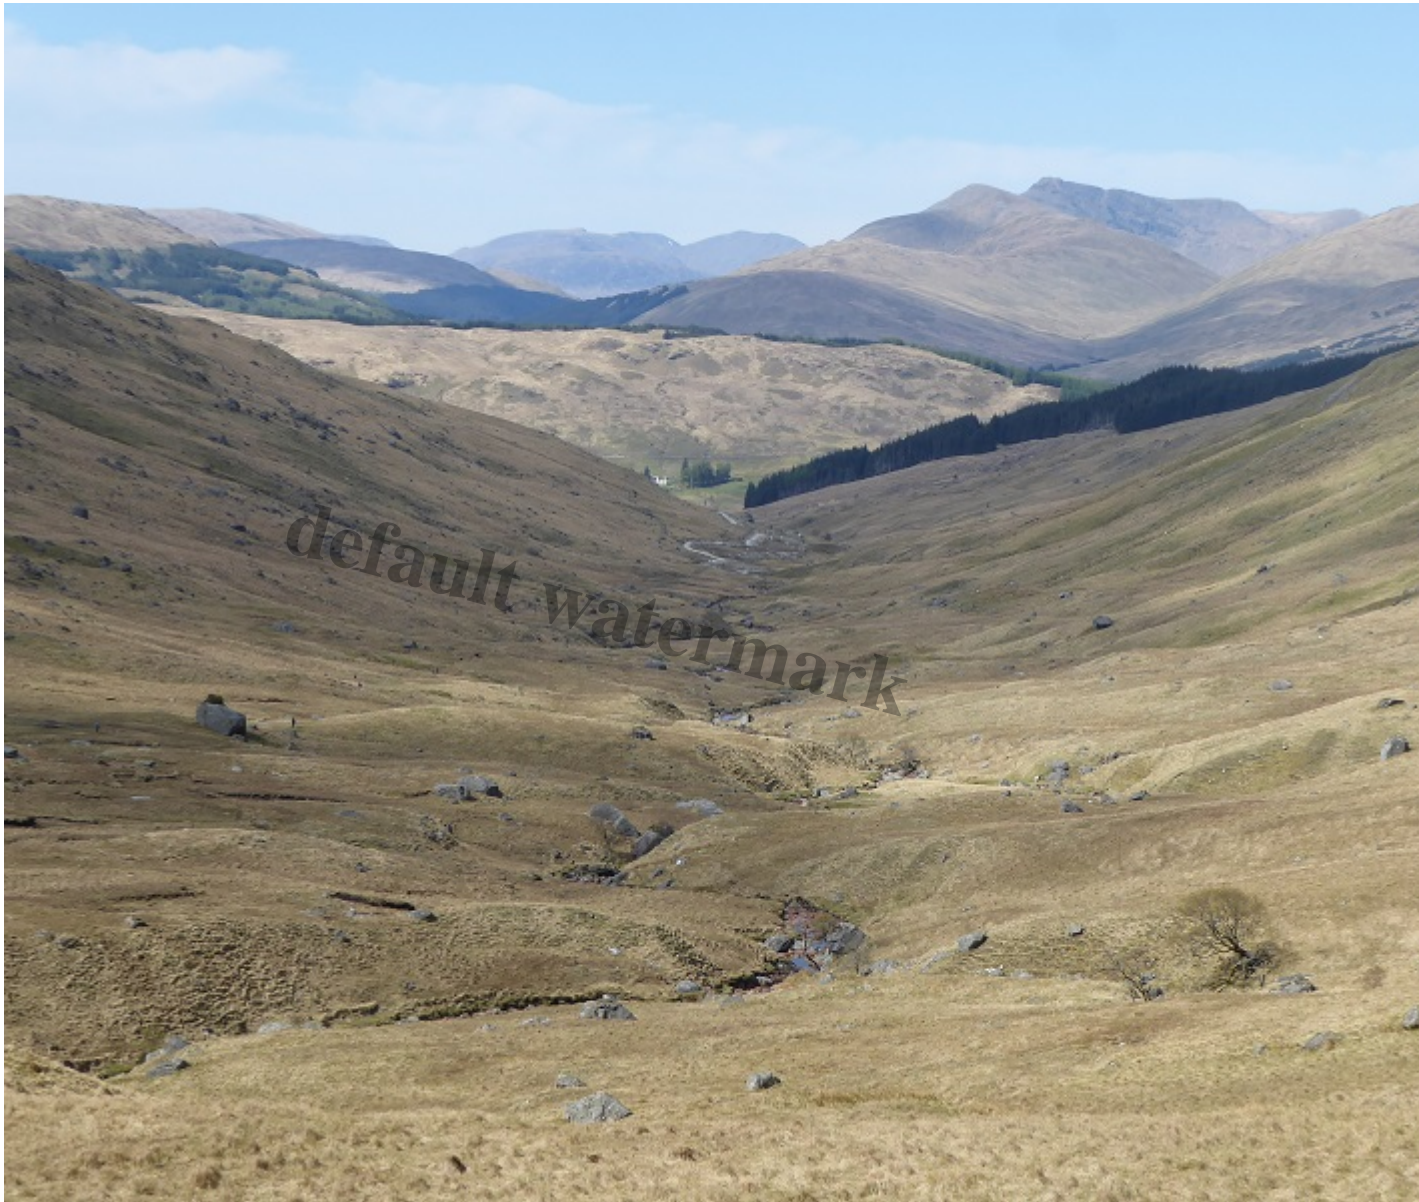
Lower reaches of Coire Earb by the Upper Falloch, Beinn Odhar and Ben Dorain in background

Coire Earb is wild, and indeed falls within a core wild land area. While there was an existing track by the upper reaches of the River Falloch, this ended 1 km before the new hydro dam and formerly was out of sight when you were descending the glen. The decision by LLTNPA staff to allow the track to remain permanently has changed the experience totally.

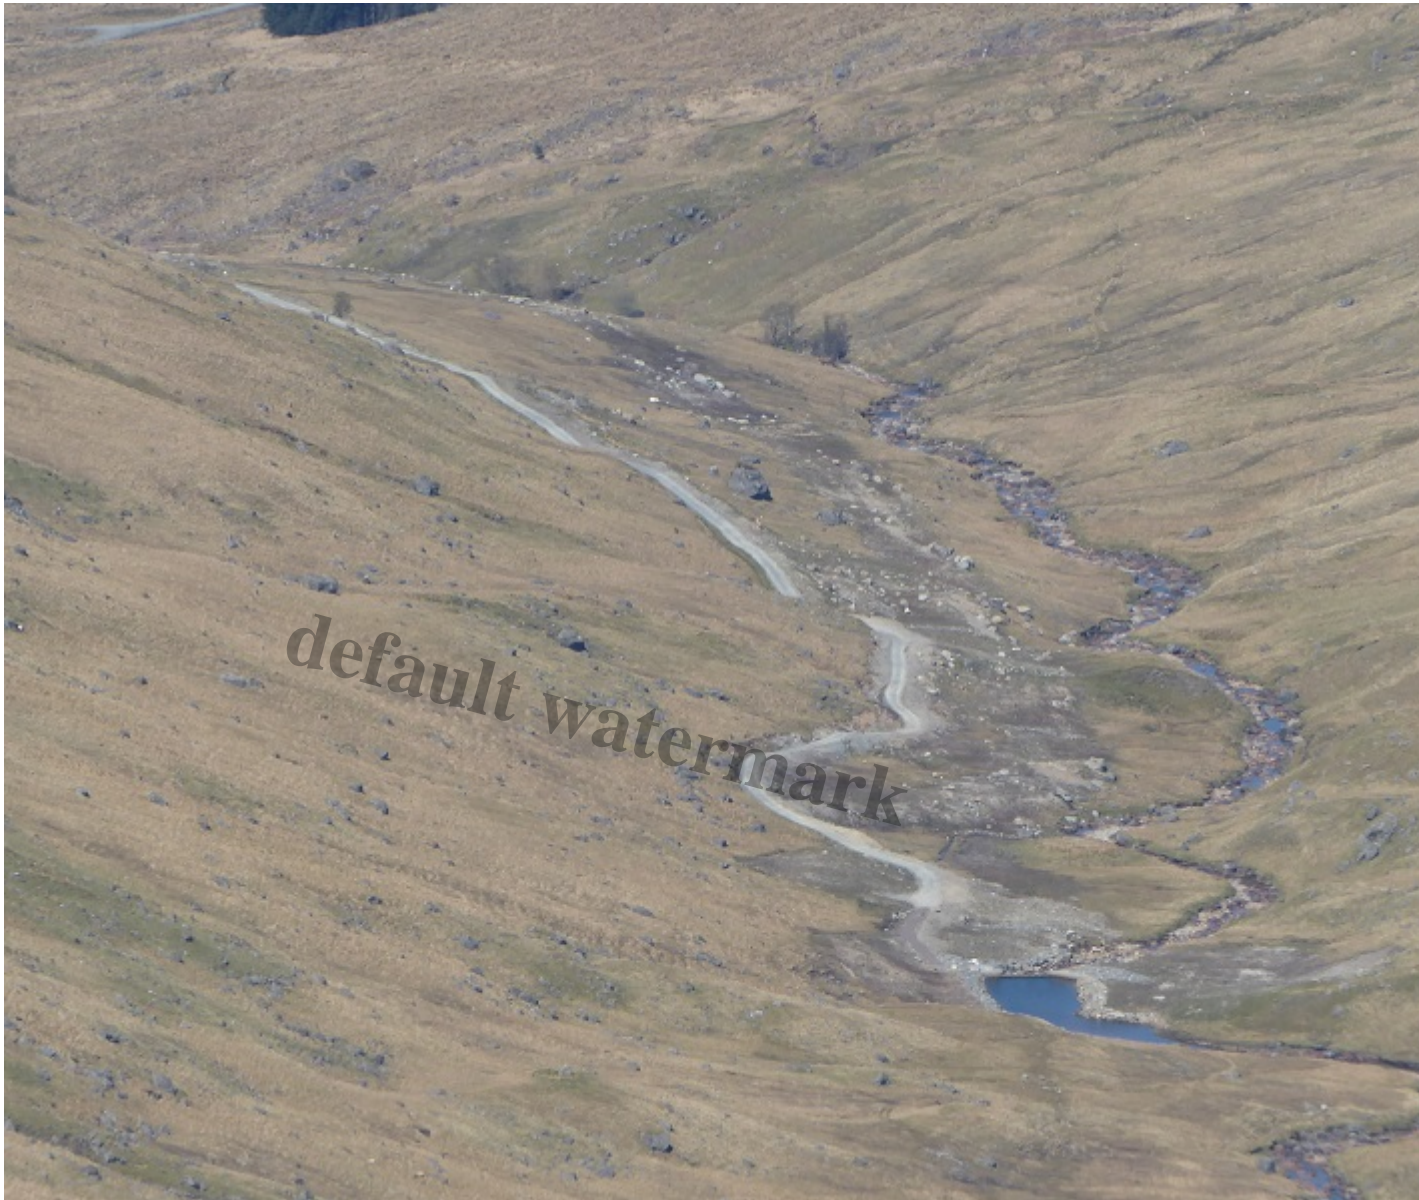
The new section of track. The line of the pipeline is now more visible than it was a year ago.

Would not the hydro here have had far less impact on the landscape if the track has been removed as originally planned?

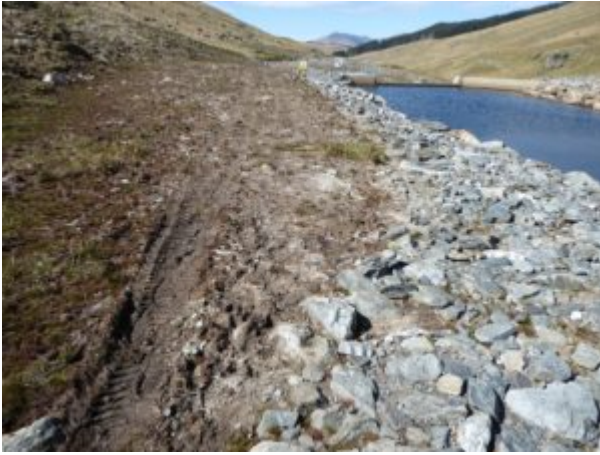
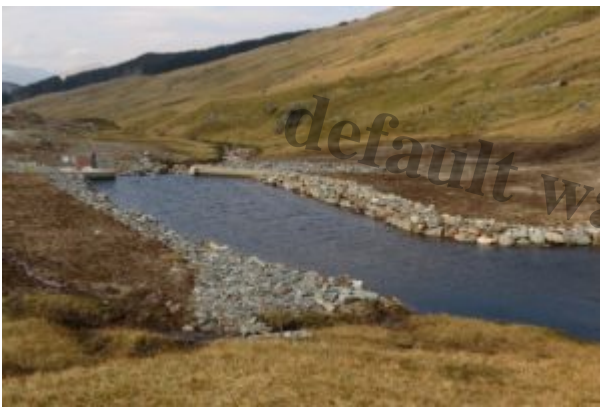
The approval of the LLTNPA to the track extension to the hydro being retained has made it easier for the Glen Falloch Estate to drive vehicles off-road further up the glen. A year ago (right) there was no evidence of vehicles being driven beyond the intake, now there are vehicle tracks beside it which are destroying the ground that was restored.

6. The LLTNPA should put in place measures to control the off-road use of vehicles, particularly in wild land.
7. The LLTNPA Board and senior staff need to get out more and take a look at what is being done in their name.

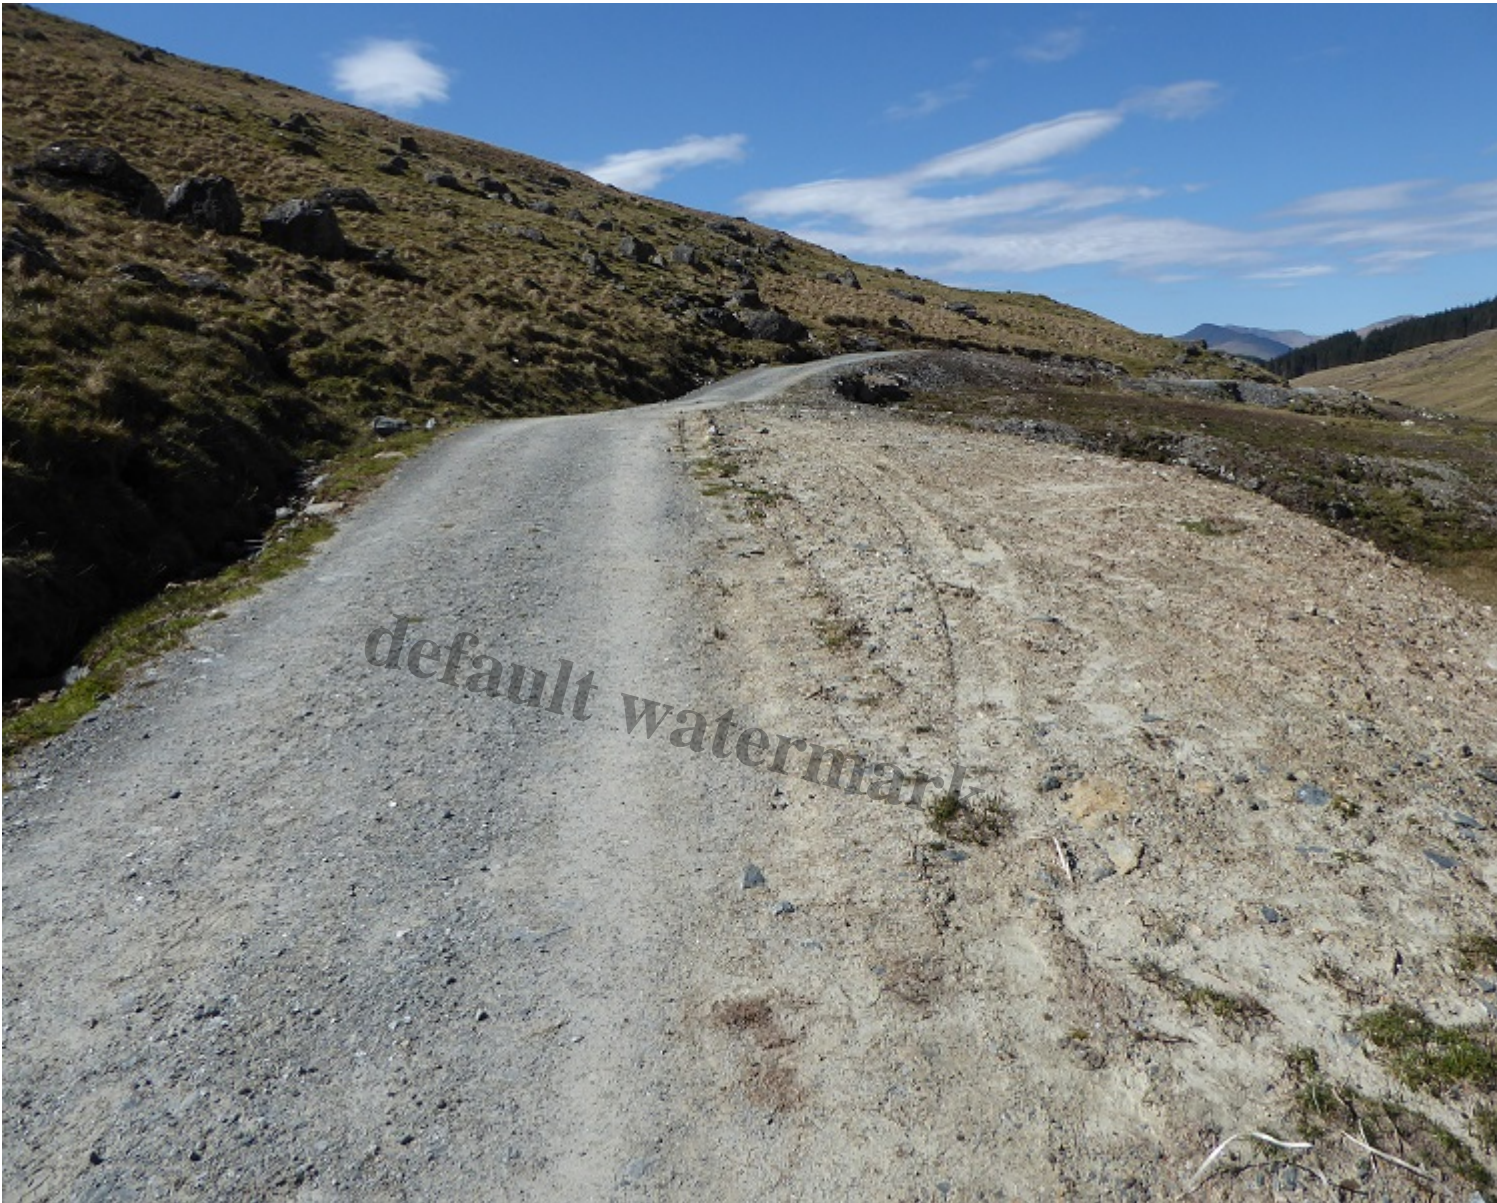
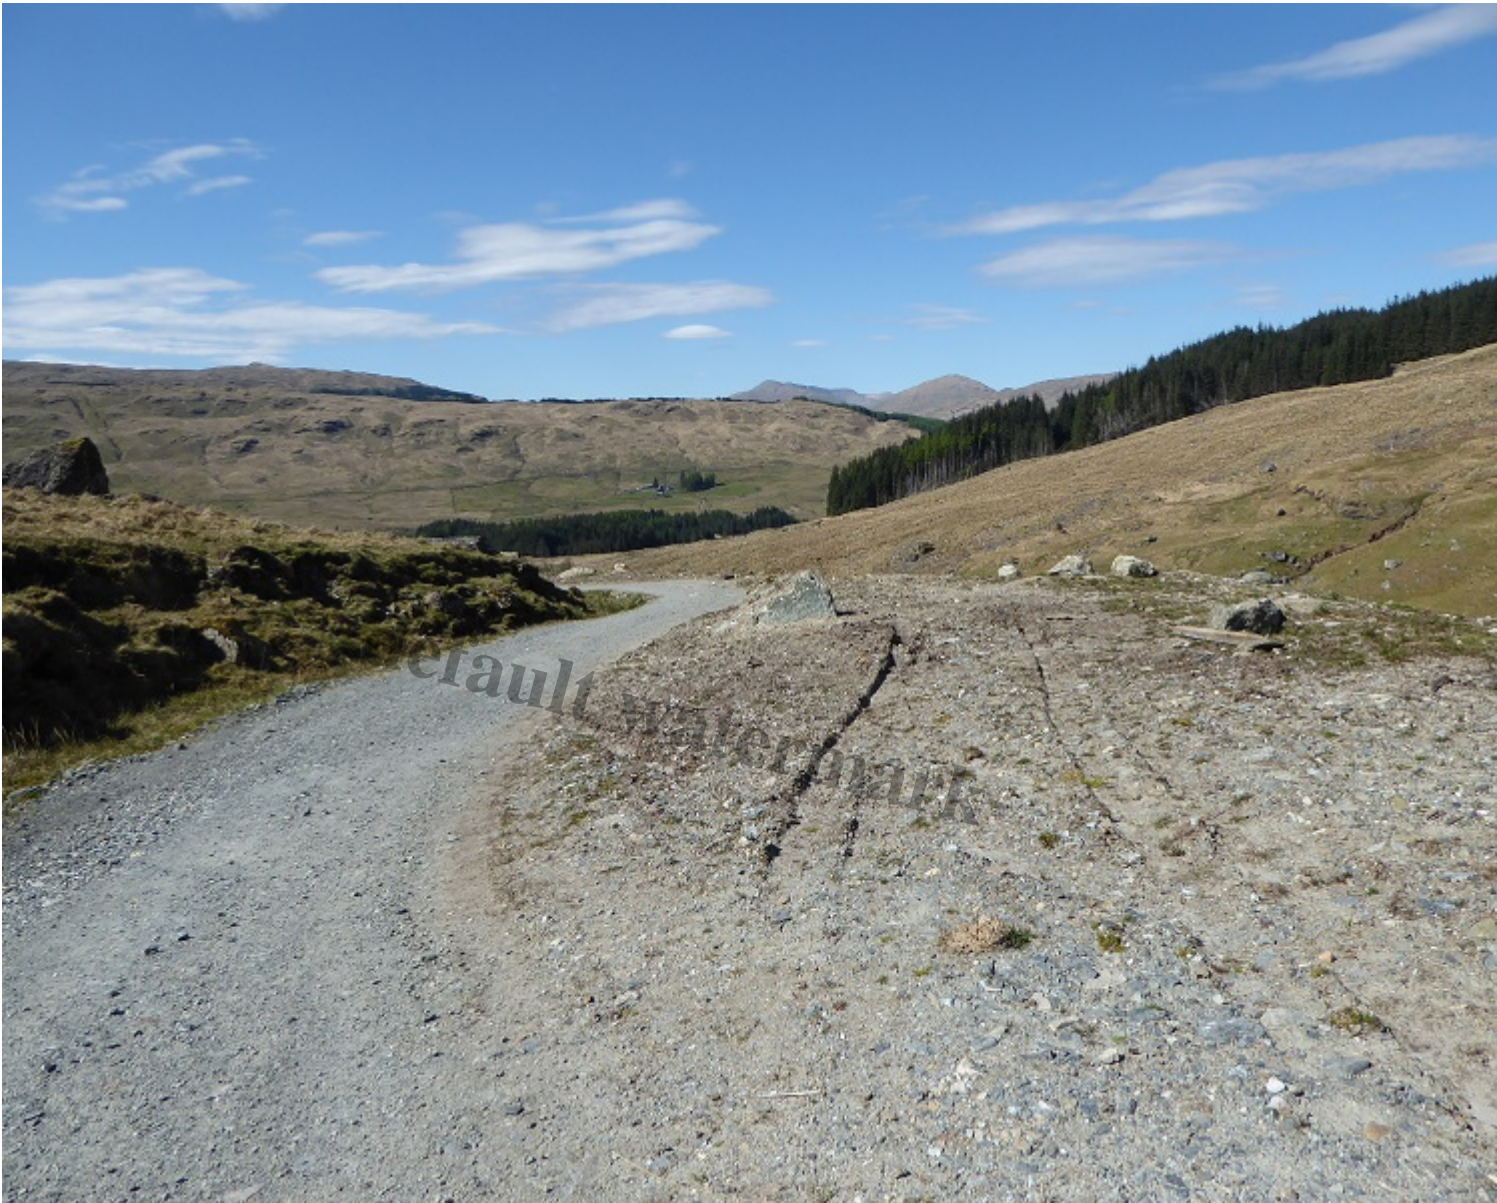
Vehicles are also being driven off the track with no regard for soil or vegetation. The consequence is the track is in places likely to end up being 5-7m wide instead of the 2.5m (and 3m on steep hills and bends) which the LLTNPA recommends in its award winning good practice guidance which it has never enforced.

The reason for this is that the LLTNPA has basically allowed a new wide track to be created to construct the hydro scheme but then allowed the batters (see diagram below) to remain in place with minimum attempts to re-landscape the flat surface of the track (a little bit of soil and peat has just been added to the outside edge of the track). The result is that its very easy for vehicles to drive off the track while in landscape terms the track is still effectively 5-7m broad in most places.

5. Where existing tracks were widened, the LLTNPA needs to ensure that all the restoration meets the standards set out in its good practice guidance. Tracks which are broader than the maximum and unfinished culverts for example should not be tolerated.

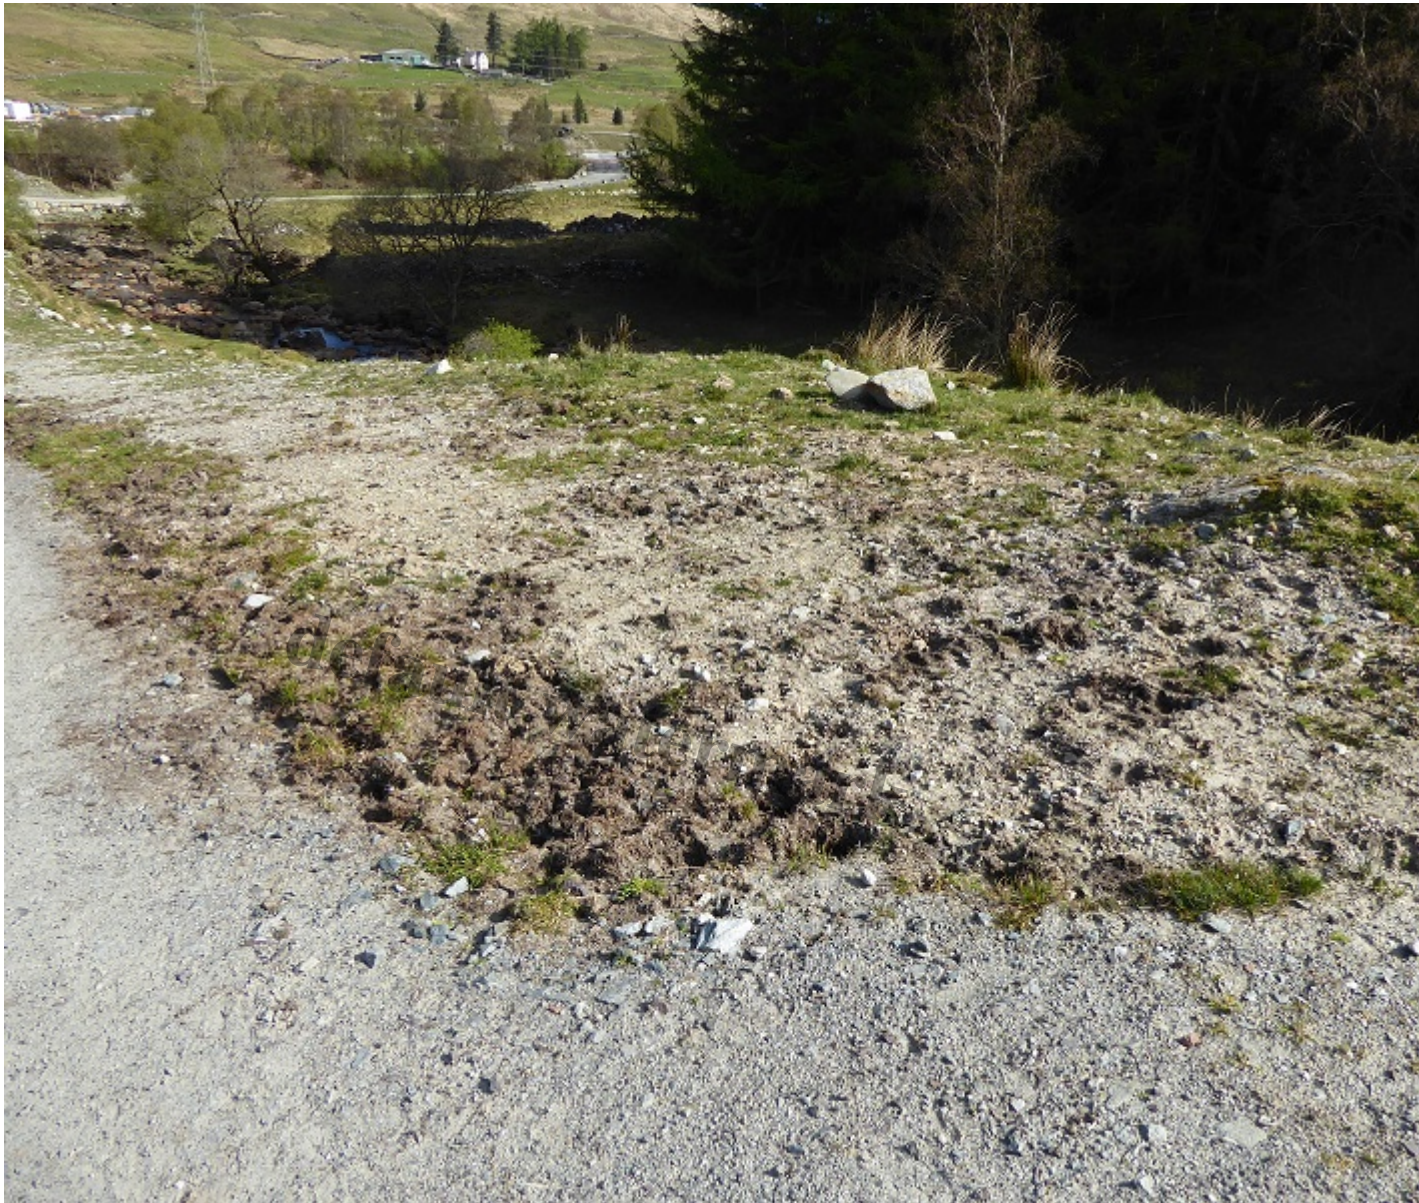
Photo showing how original attempt to cover former track surface is failing, with former surface of co track being revealed as turf has been eroded by cattle.

The design of the track together with the erosion caused by vehicles and cattle have had the result that in most places there is actually now less peaty soil by the track than there was a year ago (see above).

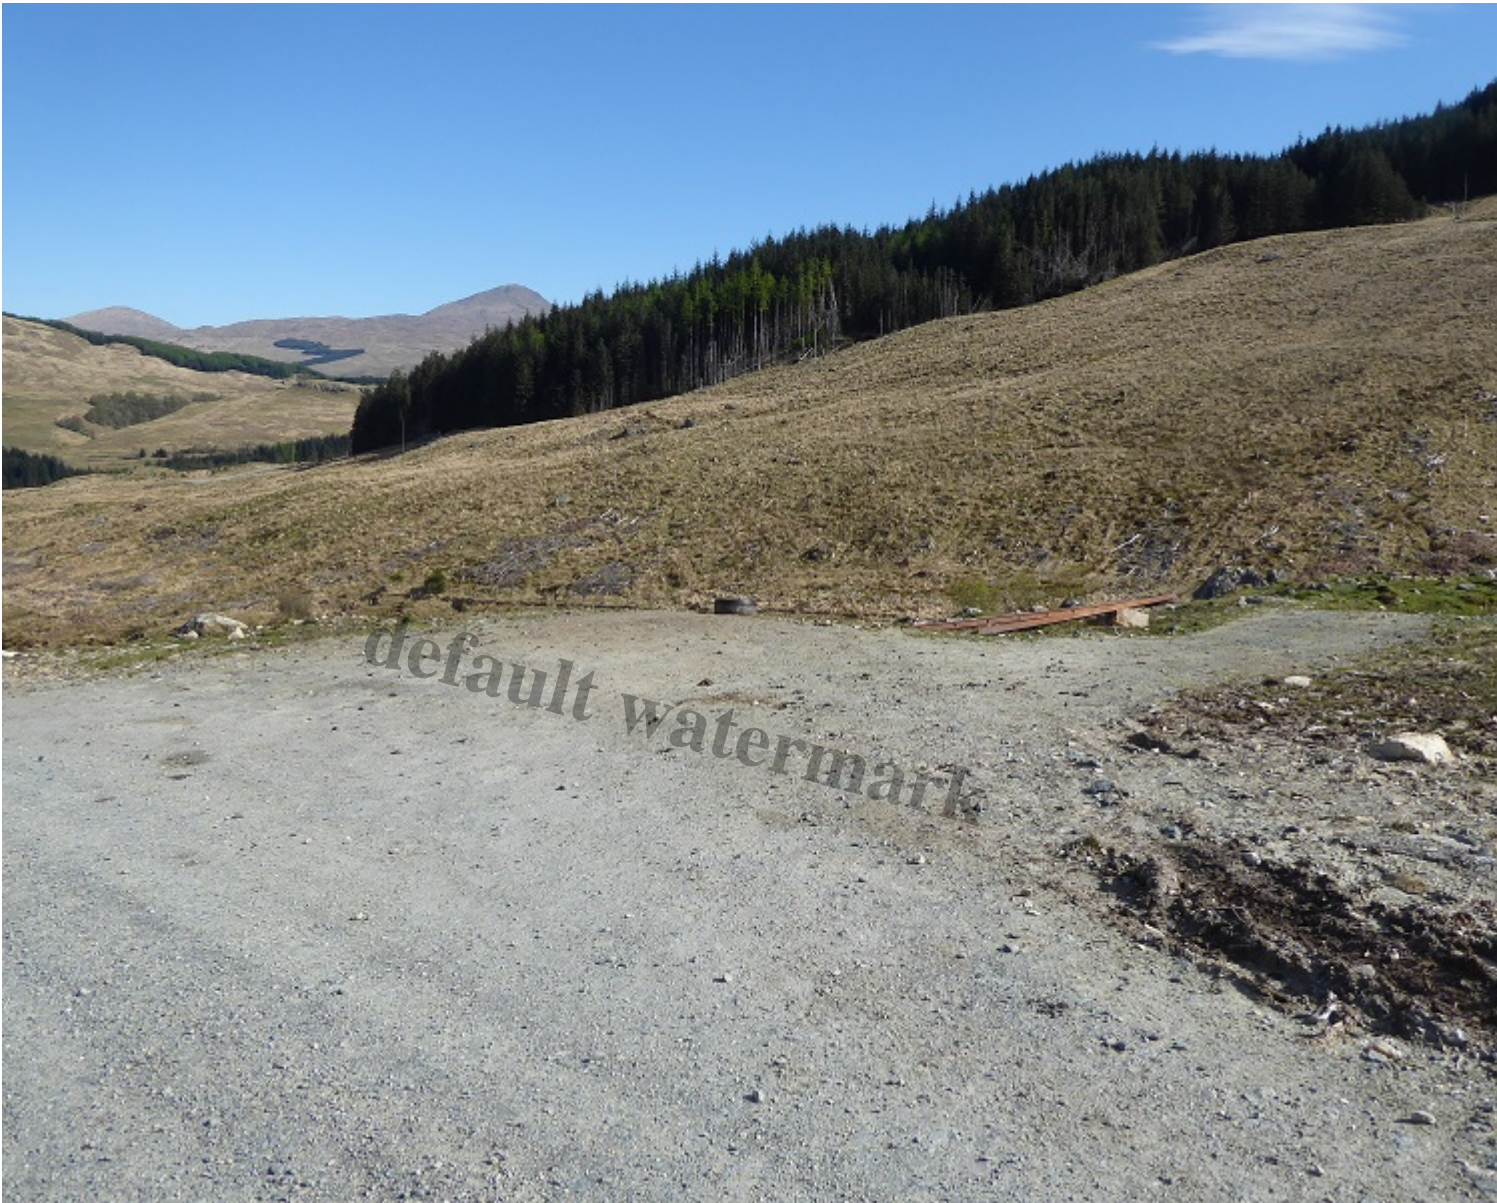
The failure to re-landscape the former road surface so that the remaining track moulds into the contours of the land has also made it easy for the estate to create new parking or working areas which add considerably to the visual impact of the track.

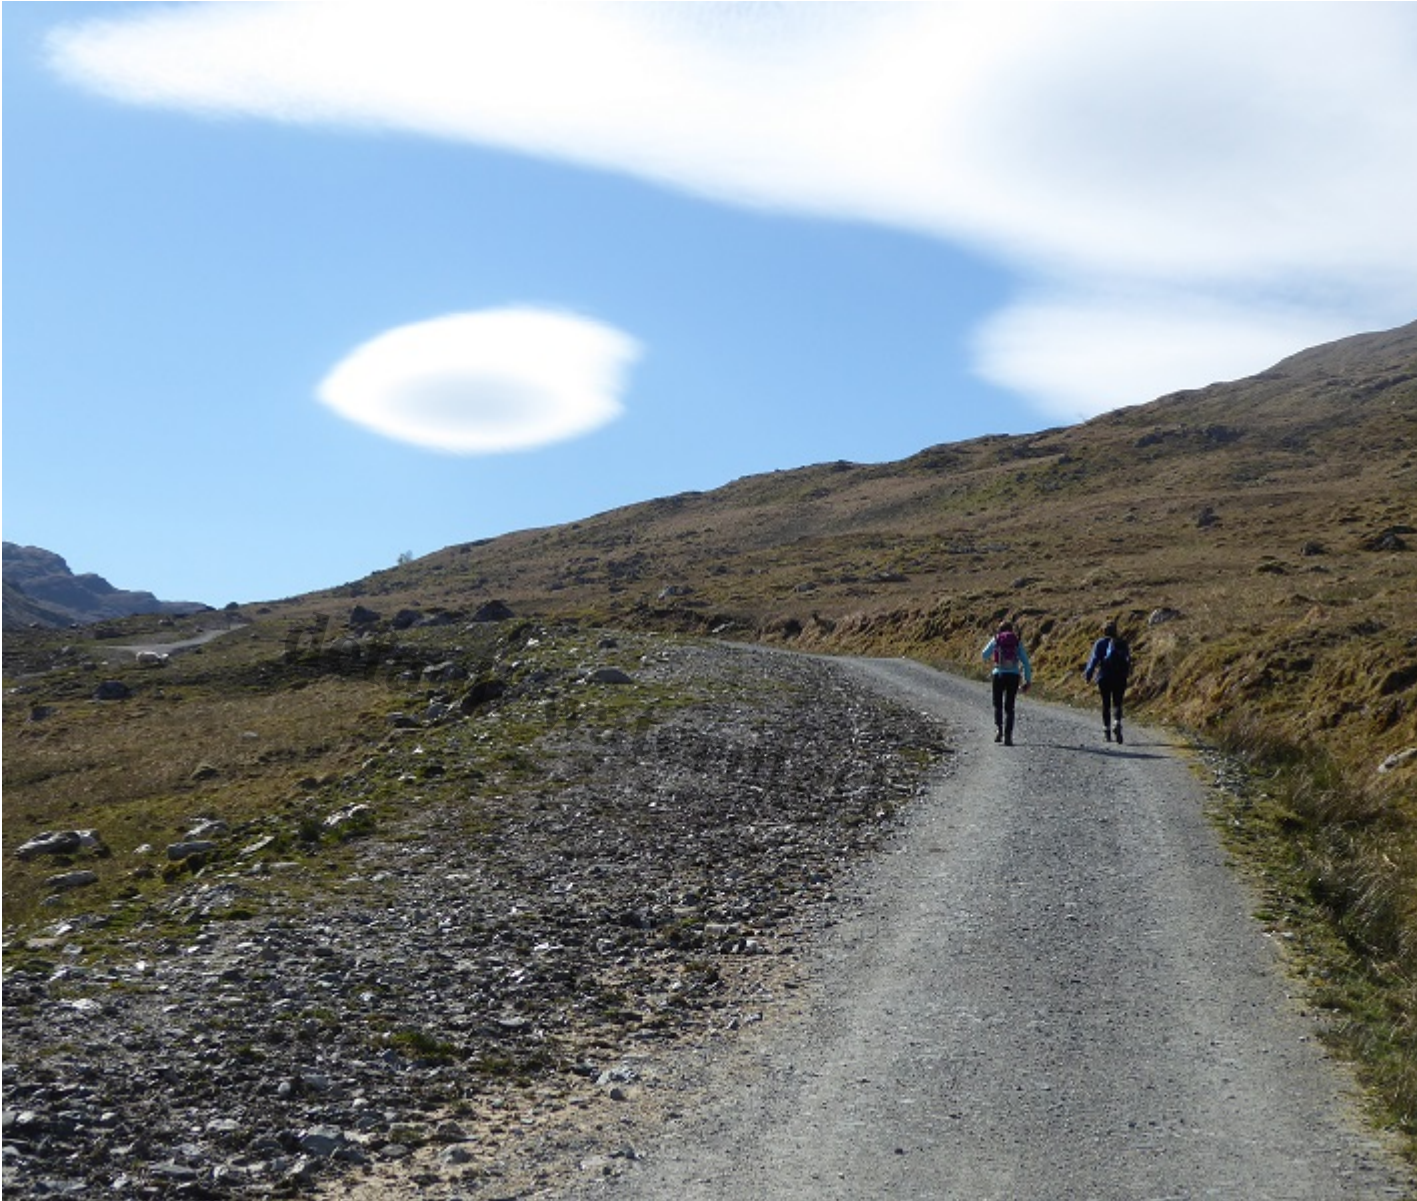
The pre-existing track which ended a little further up the hill, was widened for the hydro construction cutting a further batter but by importing aggregate (left) to use as fill.

There little attempt (photo above) to shape the the fill so it merges into the contours of the land. The result is a broad bench cutting across the hillside. In landscape terms, the track here is in effect still 5-7m wide rather than the 2.5-3m recommended by the National Park.

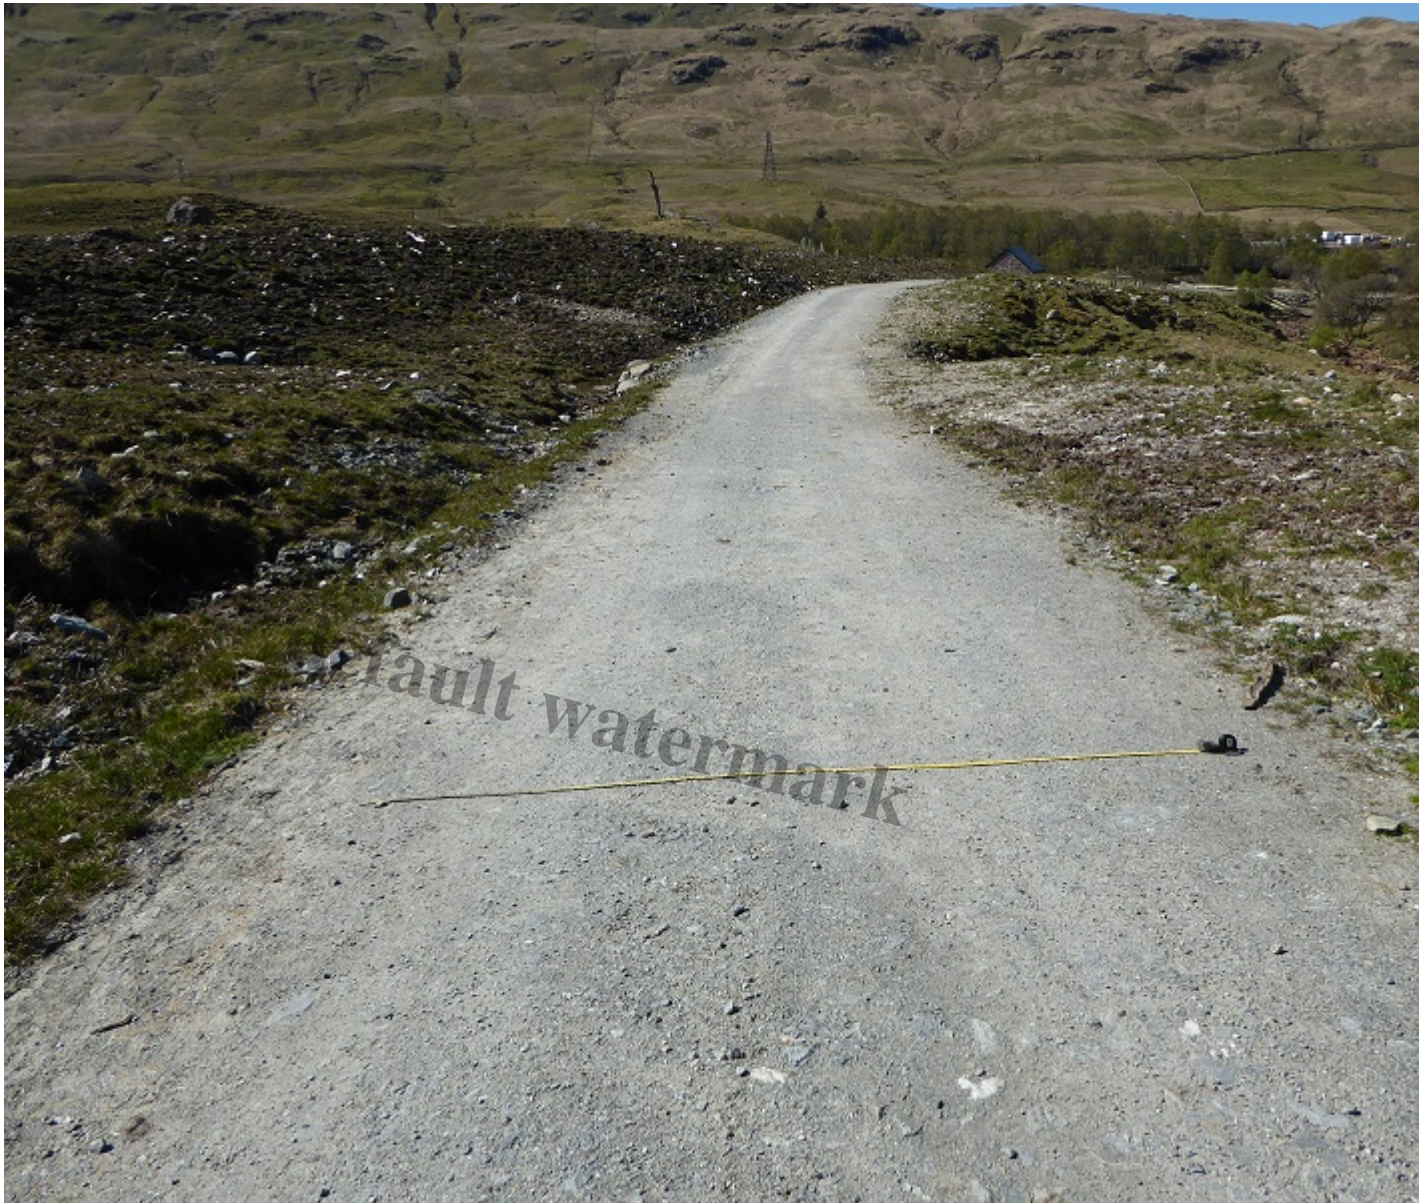
The 3m mark on tape measure is just to the left of the small stone holding the tape measure in place

Even on the better sections, the track is far wider than the LLTNPA requires. I took my 3m tape which is here fully extended on a section of track which slopes gently downhill. I think a 2.5m track would have been more than adequate here (and probably less as you can see from the vehicle marks) but the actual track is more like 3.5m wide. What is the LLTNPA going to do to address this? The wider the track of course, the more it will stand out from a distance. There is no evidence of the central grass strips which grace the Allt Andoran track (top photo).
