The Glen Falloch hydro schemes (8) – their impact on the landscape and what needs to be done

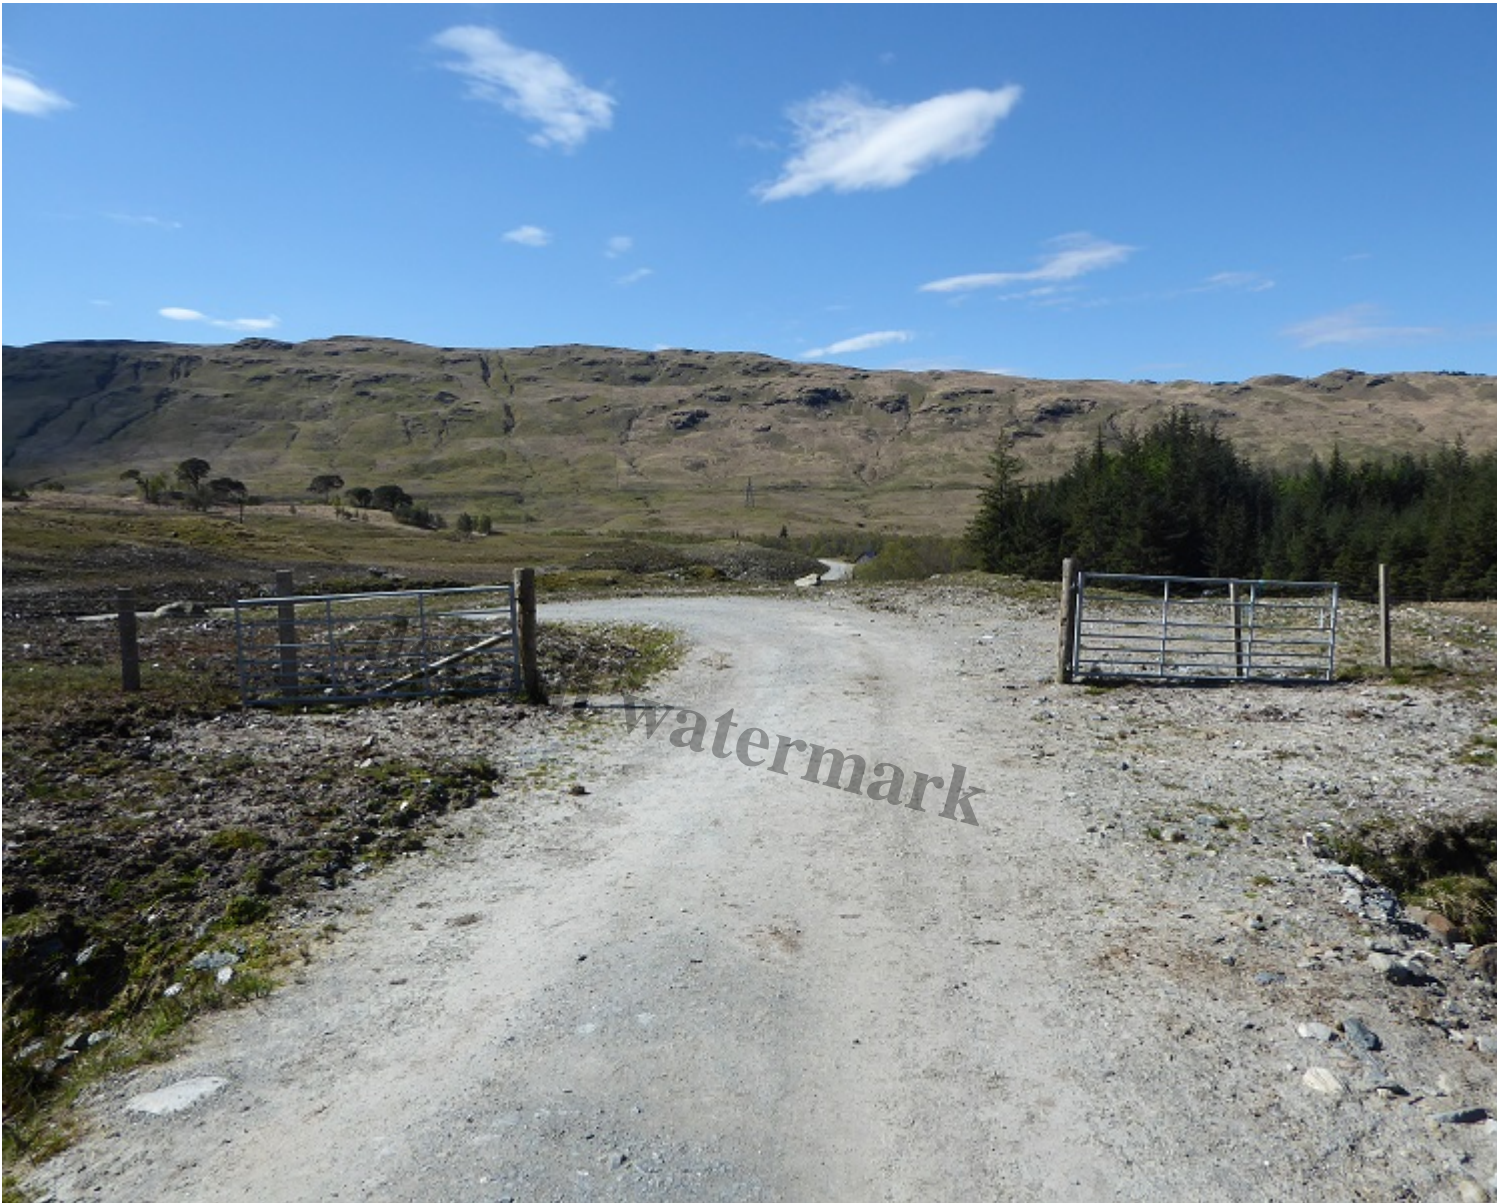
If there was any serious intention to narrow the upper Falloch construction track this double gate would have been removed â?? another illustration of just how wide this track is.

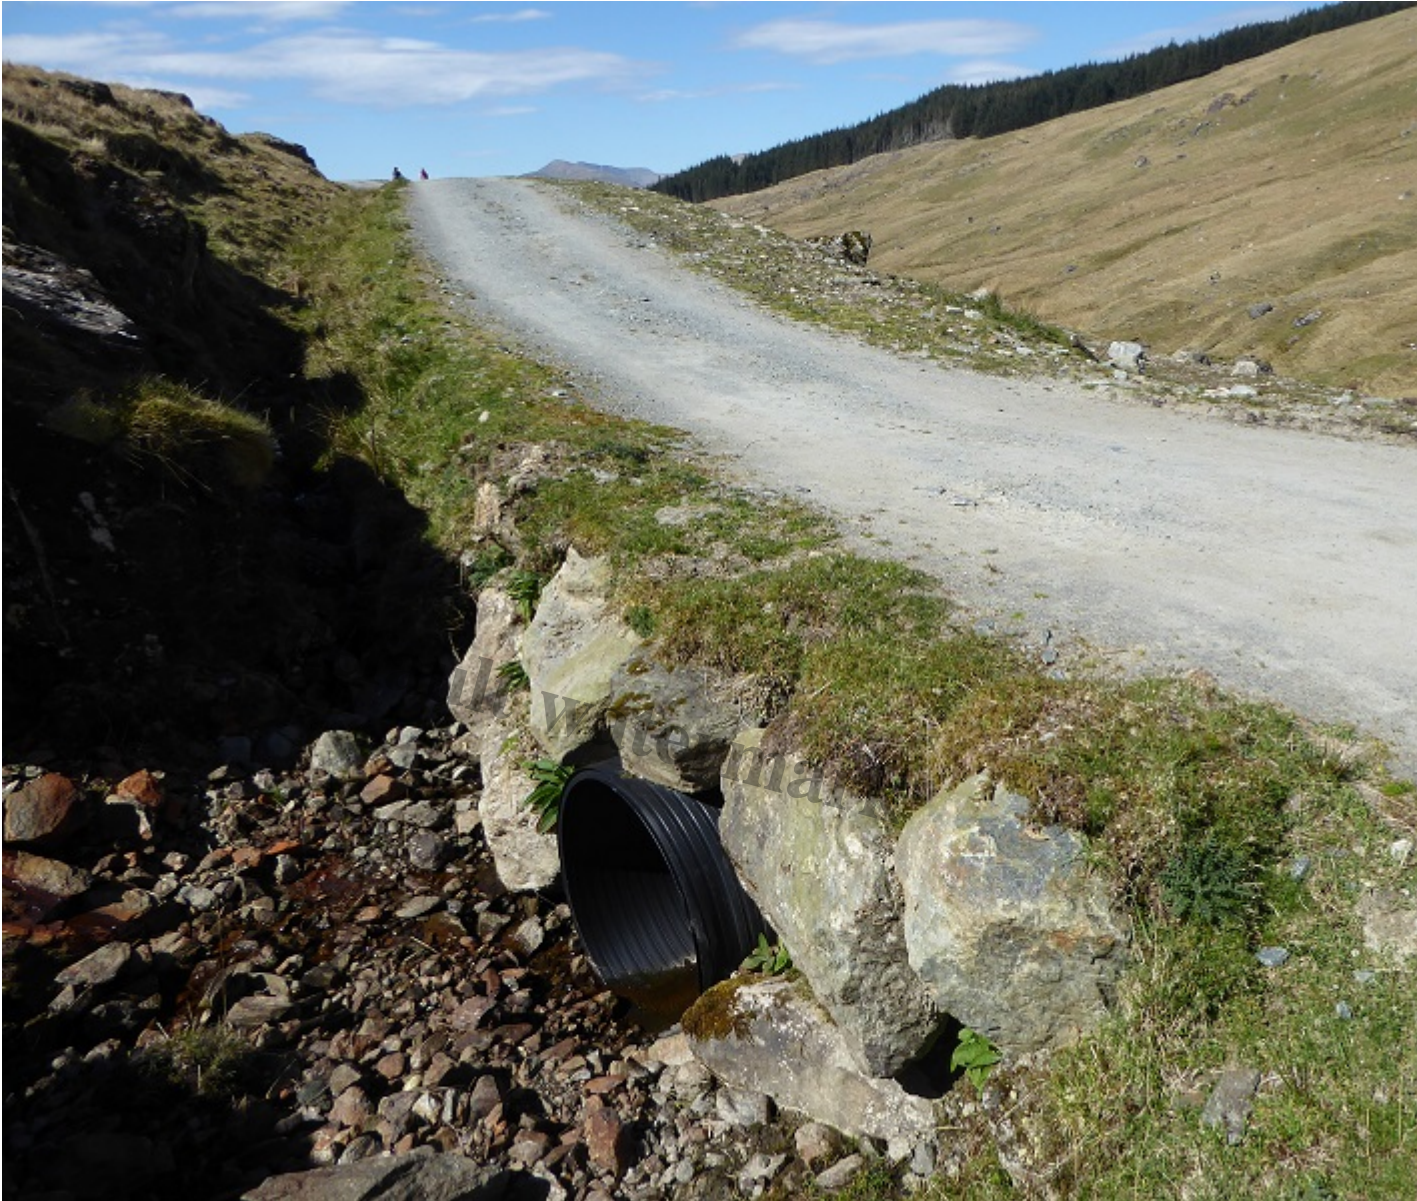
Where turf has been stored successfully, then used alongside the track and cattle have been kept off, the restoration does look better, although the protruding plastic culvert tells a tale

The restored sections however are few in comparison to those that still need attention and at this rate the track is going to take years to restore to anything like an acceptable state. That is unacceptable in a National Park whose current Plan incidentally states (and rightly so):

5. Where existing tracks were widened, the LLTNPA needs to ensure that all the restoration meets the standards set out in its good practice guidance. Tracks which are broader than the maximum and unfinished culverts for example should not be tolerated.
