## The Glen Falloch hydro schemes (8) – their impact on the landscape and what needs to be done

Mid Glen Falloch, viewed from shoulder of An Caisteal. The area It is now a mass of tracks, leading dams. Foreground Allt Andoran, far right Eas Eonan and left background start of track up Allt a Chur hydro powerhouse is centre background, Derrydarroch to the right.

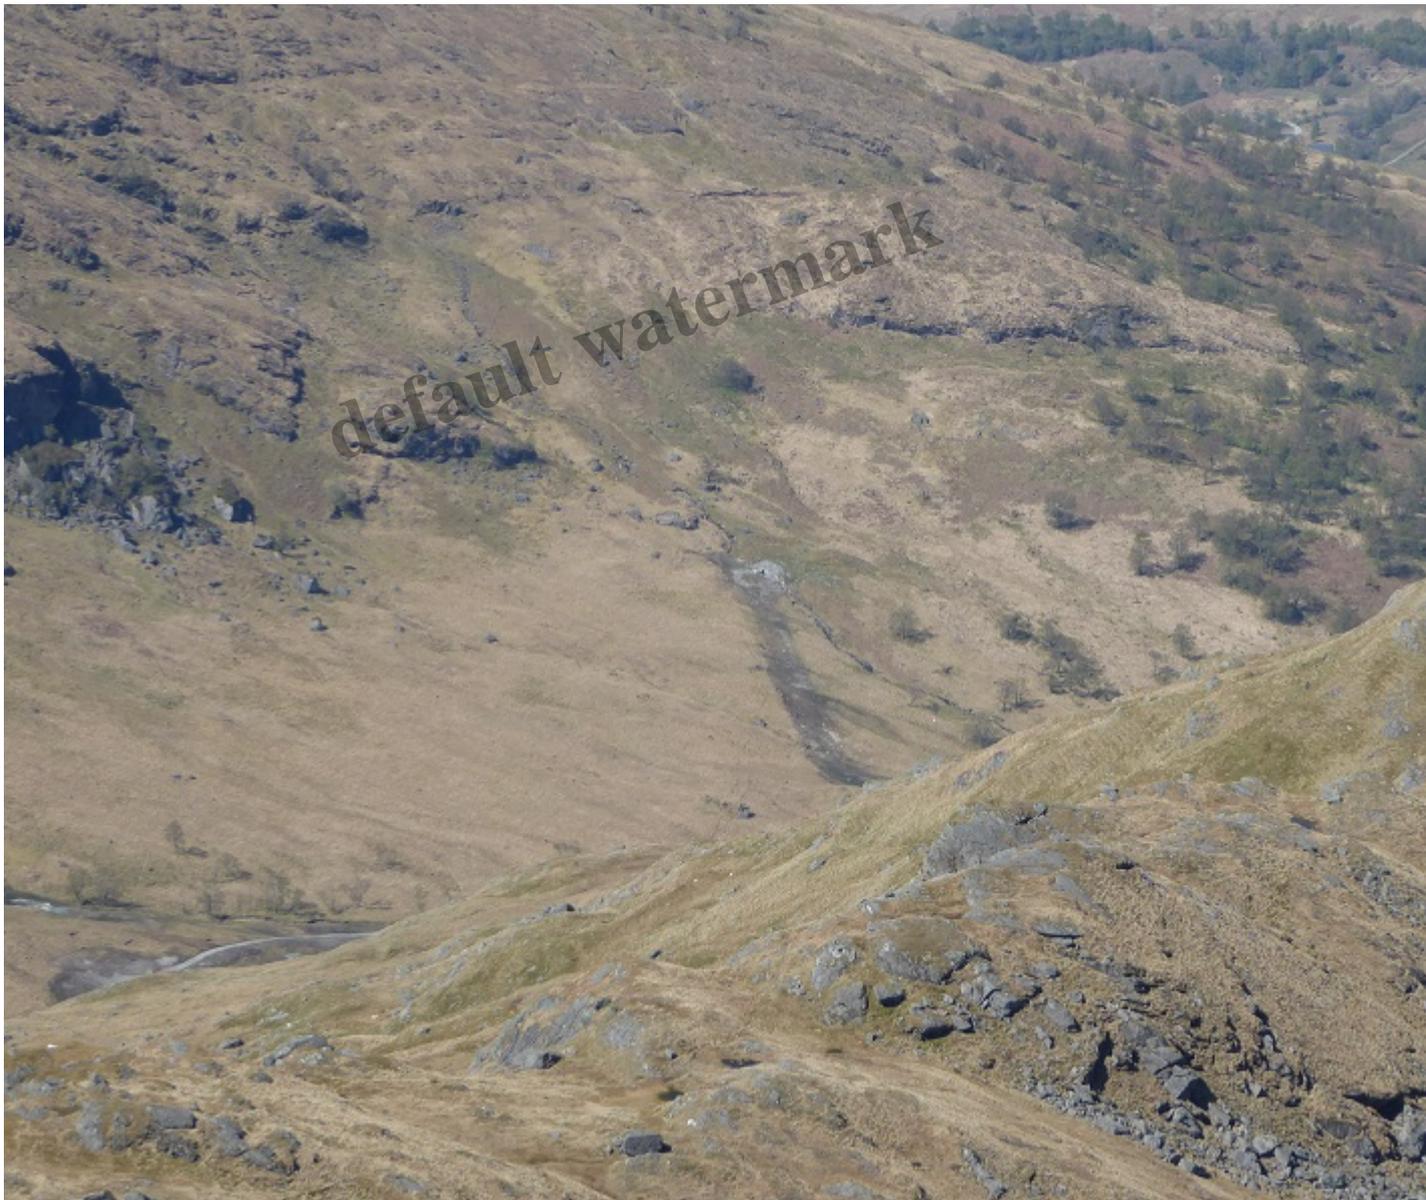
The first Allt a Chuillinn intake centre, the other two intakes are beyond track you can see bottom left

buried has generally successful and little cause for concern with it often being quite difficult to make out the line of the pipelines. While I believe that is still sometimes the case, the long dry spell has accentuated the differences in vegetation and its easy to see the landscape scars (above centre). The land may take longer to recover than I had thought.

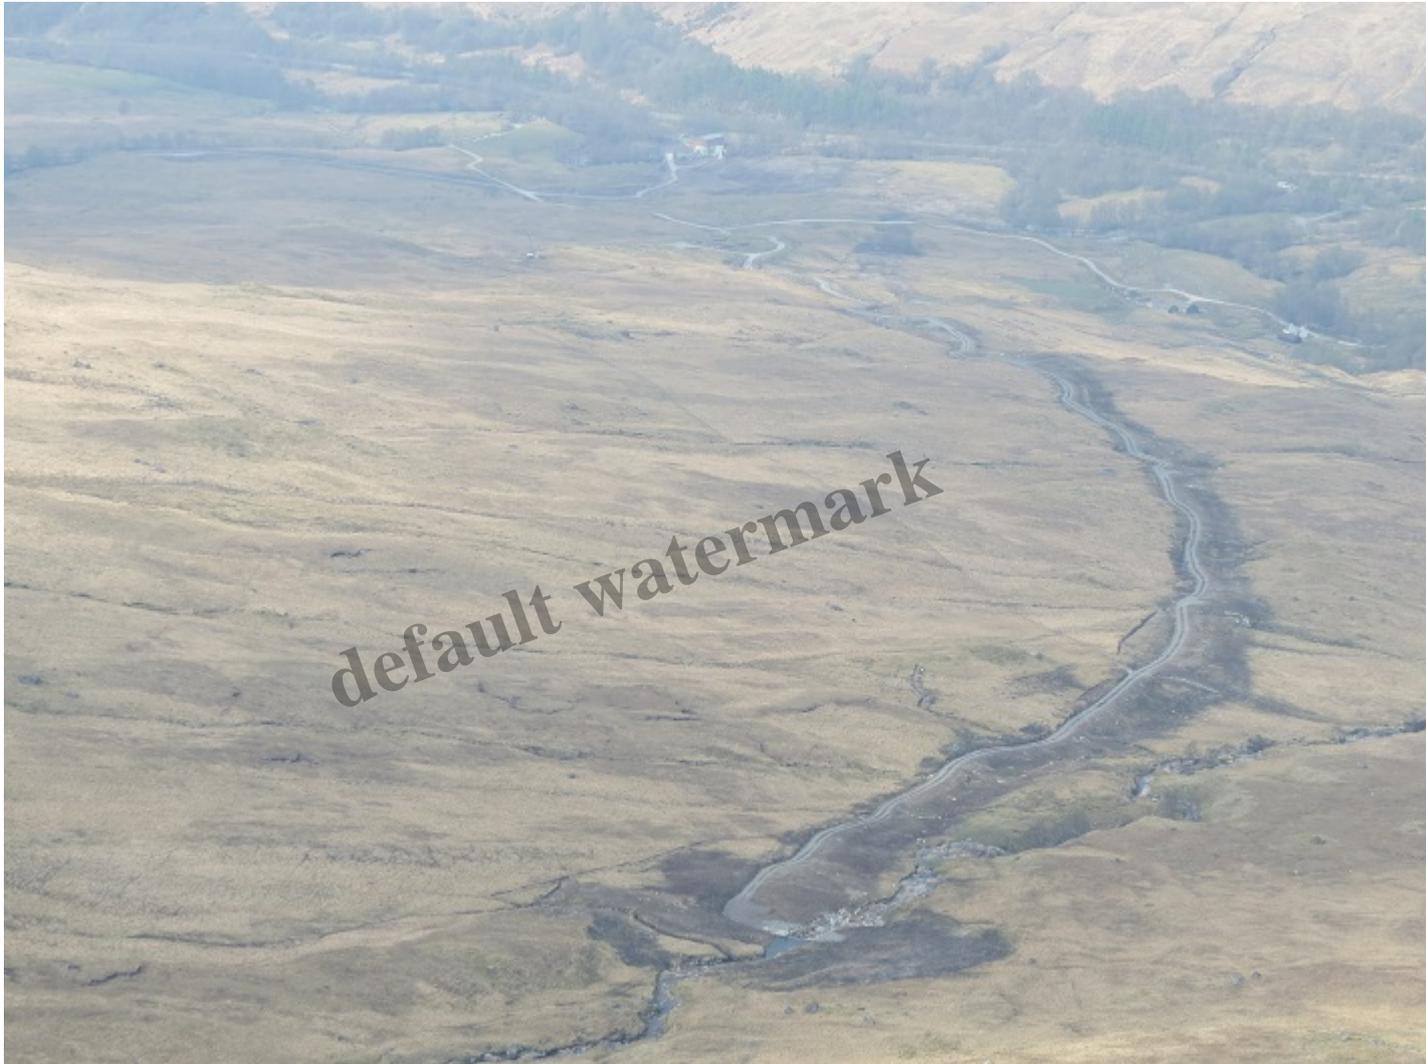
Allt Andoran Track 8th May 2016

Comparing the photo above (taken a year ago on a day with far less good visibility) with the first photo in the post taken a year later, you can see that the ground above the pipeline has recovered to an extent but has a long way to go. The track itself, despite the vegetation down the middle, looks little different and forms a permanent landscape scar.

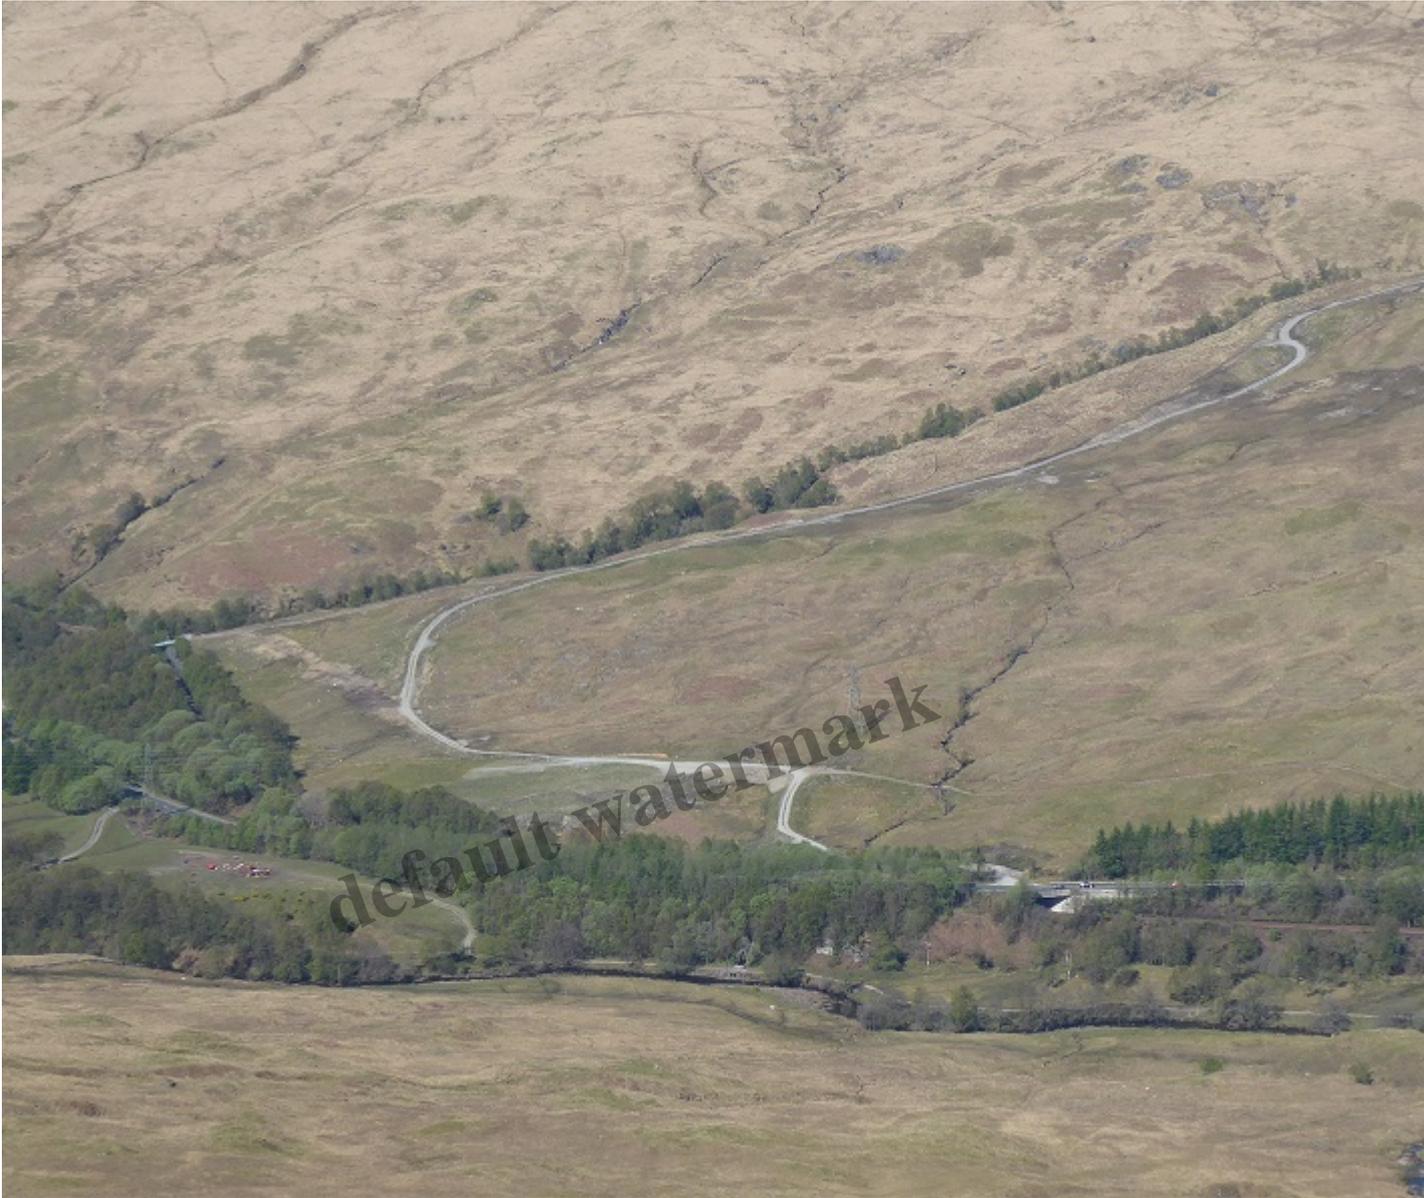
Close up of Eas Eonan track, showing poor restoration of the temporary access track that led to blue West Highland Line (centre left)

The Eas Eonan hydro track leads into an area of core wild land. The new draft Park Plan states:

senior management team believe walking up a bulldozed track is a wild experience? Its becoming harder and harder to have a wild experience in the National Park because of decisions made by the LLTNPA. Removal of the tracks, as originally planned, would have preserved some of that.

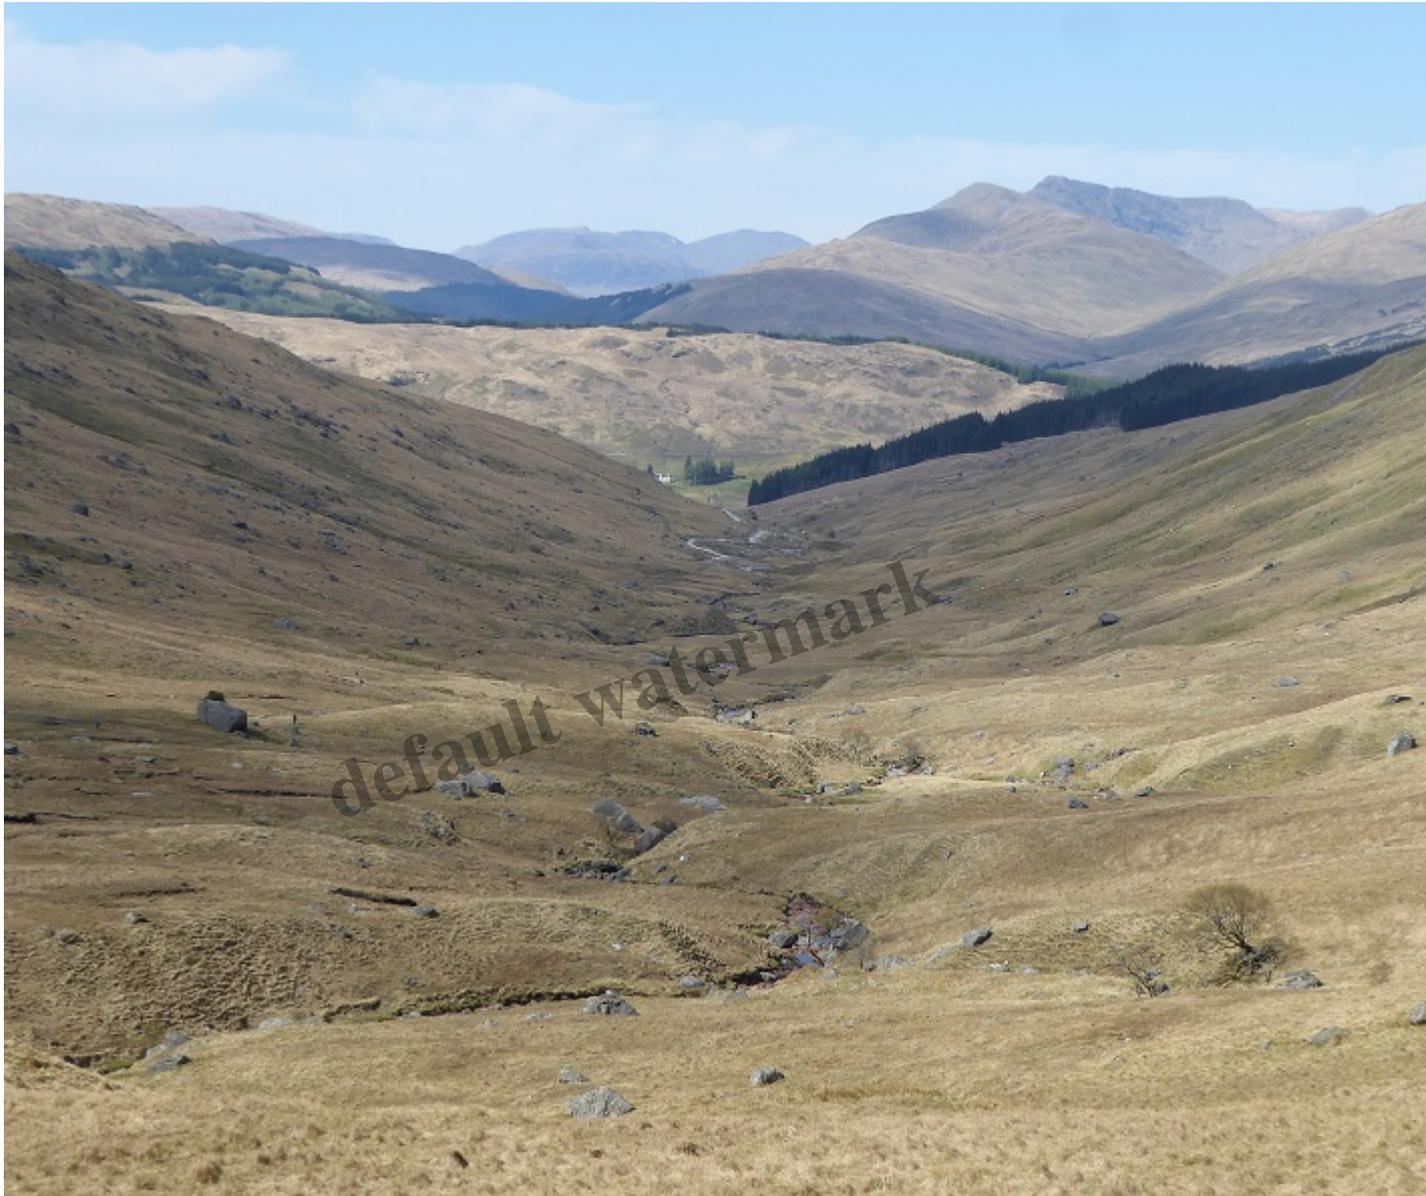
Lower reaches of Coire Earb by the Upper Falloch, Beinn Odhar and Ben Dorain in background

Coire Earb is wild, and indeed falls within a core wild land area. While there was an existing track by the upper reaches of the River Falloch, this ended 1 km before the new hydro dam and formerly was out of sight when you were descending the glen. The decision by LLTNPA staff to allow the track to remain permanently has changed the experience totally.

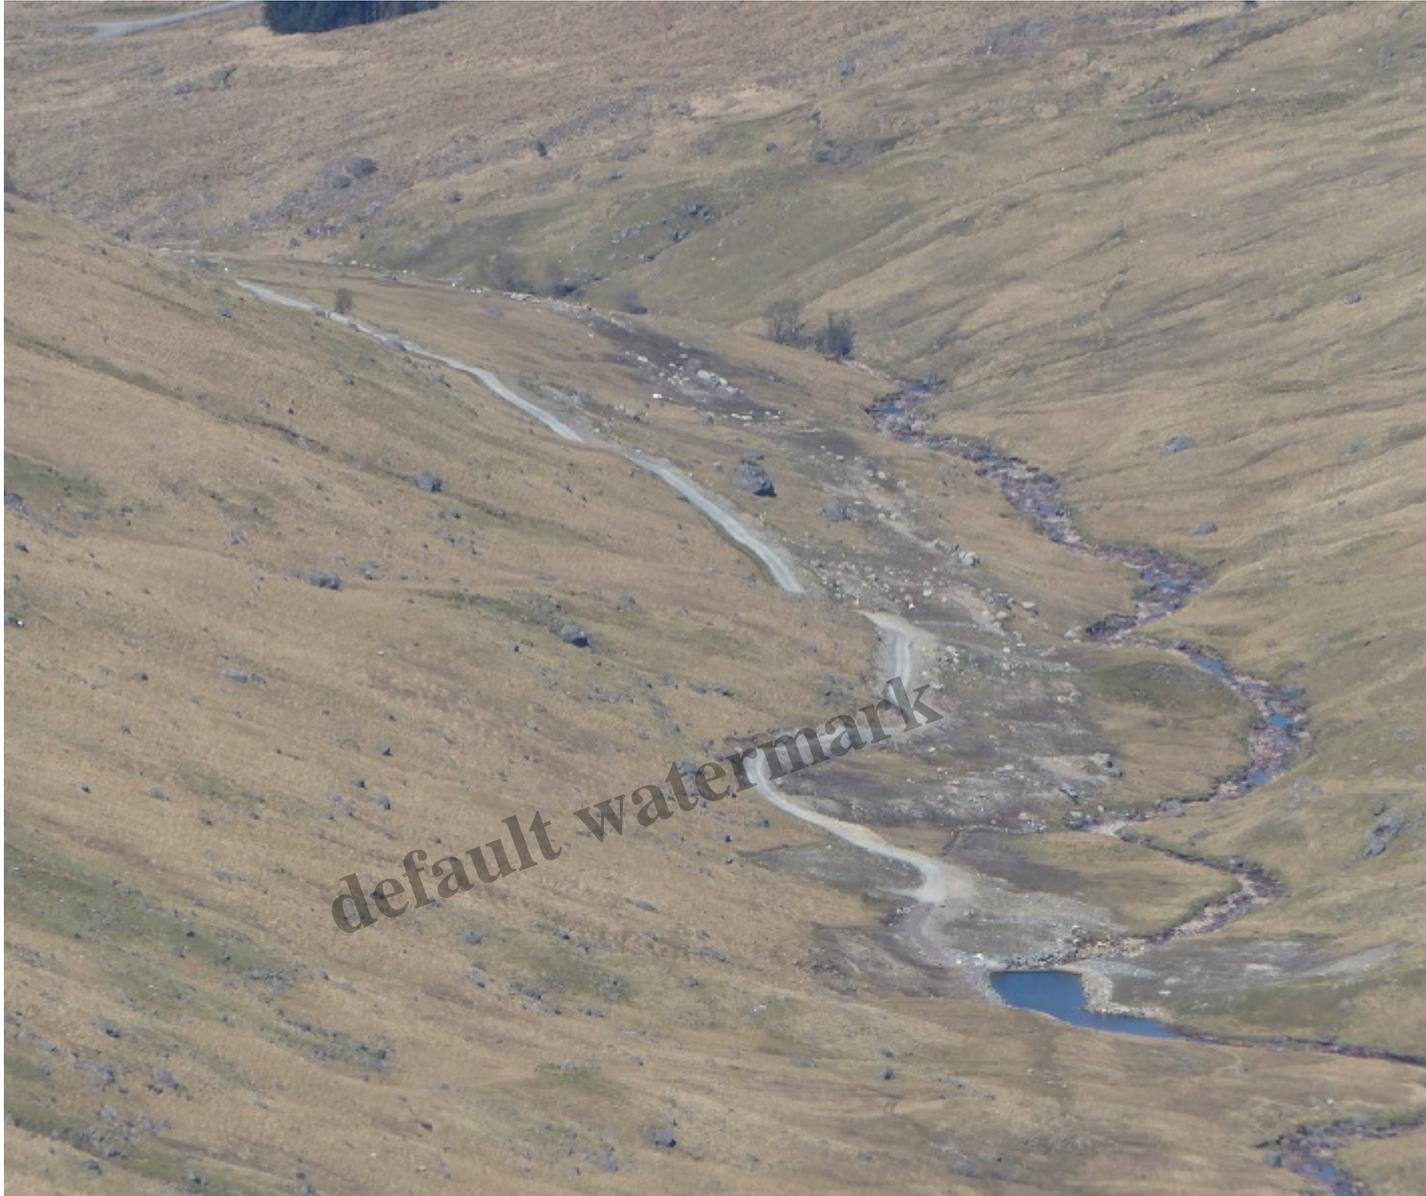
The new section of track. The line of the pipeline is now more visible than it was a year ago.

Would not the hydro here have had far less impact on the landscape if the track has been removed as originally planned?

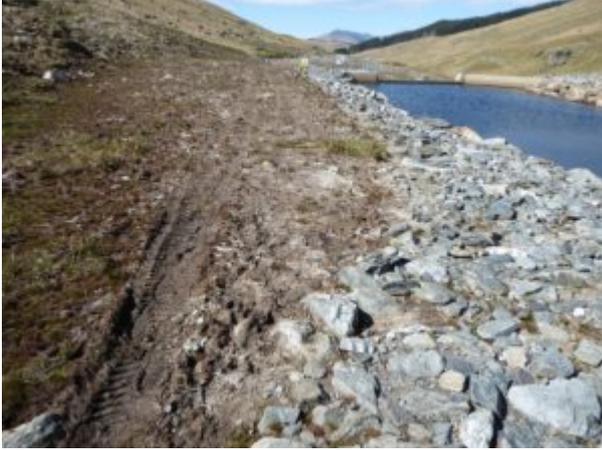
May 2017

The approval of the LLTNPA to the track extension to the hydro being retained has made it easier for the Glen Falloch Estate to drive vehicles off-road further up the glen. A year ago (right) there was no evidence of vehicles being driven beyond the intake, now there are vehicle tracks beside it which are destroying the ground that was restored.

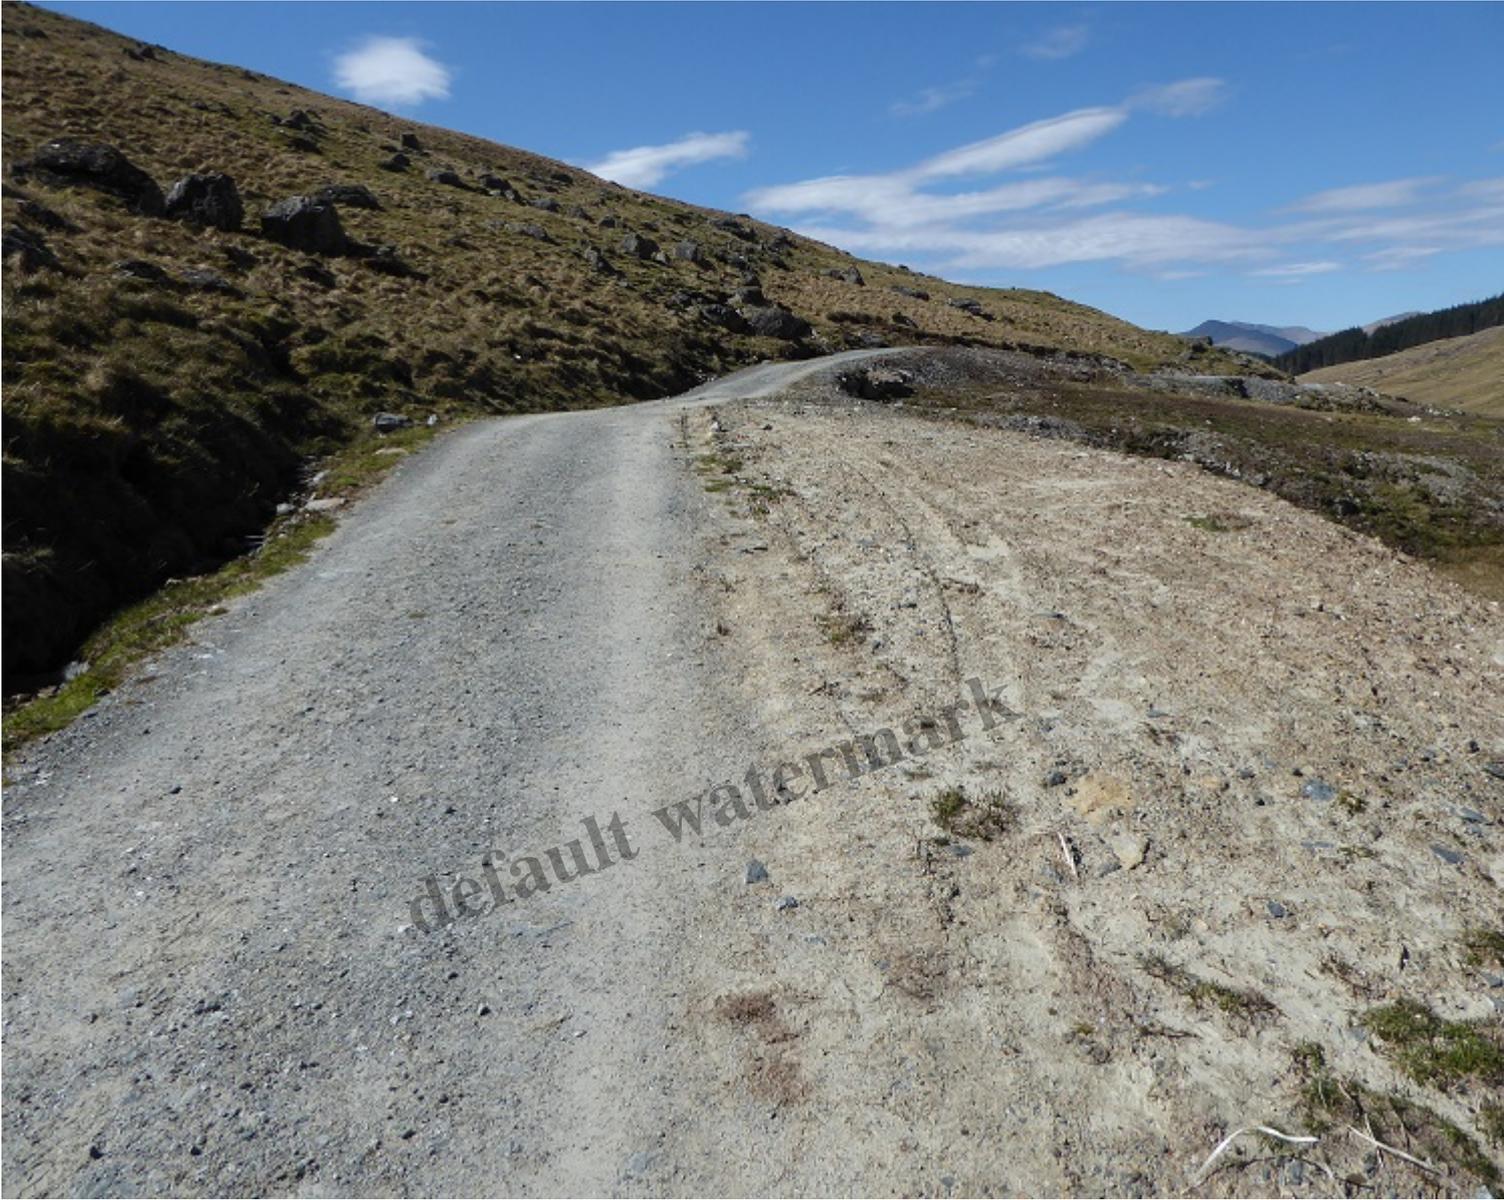
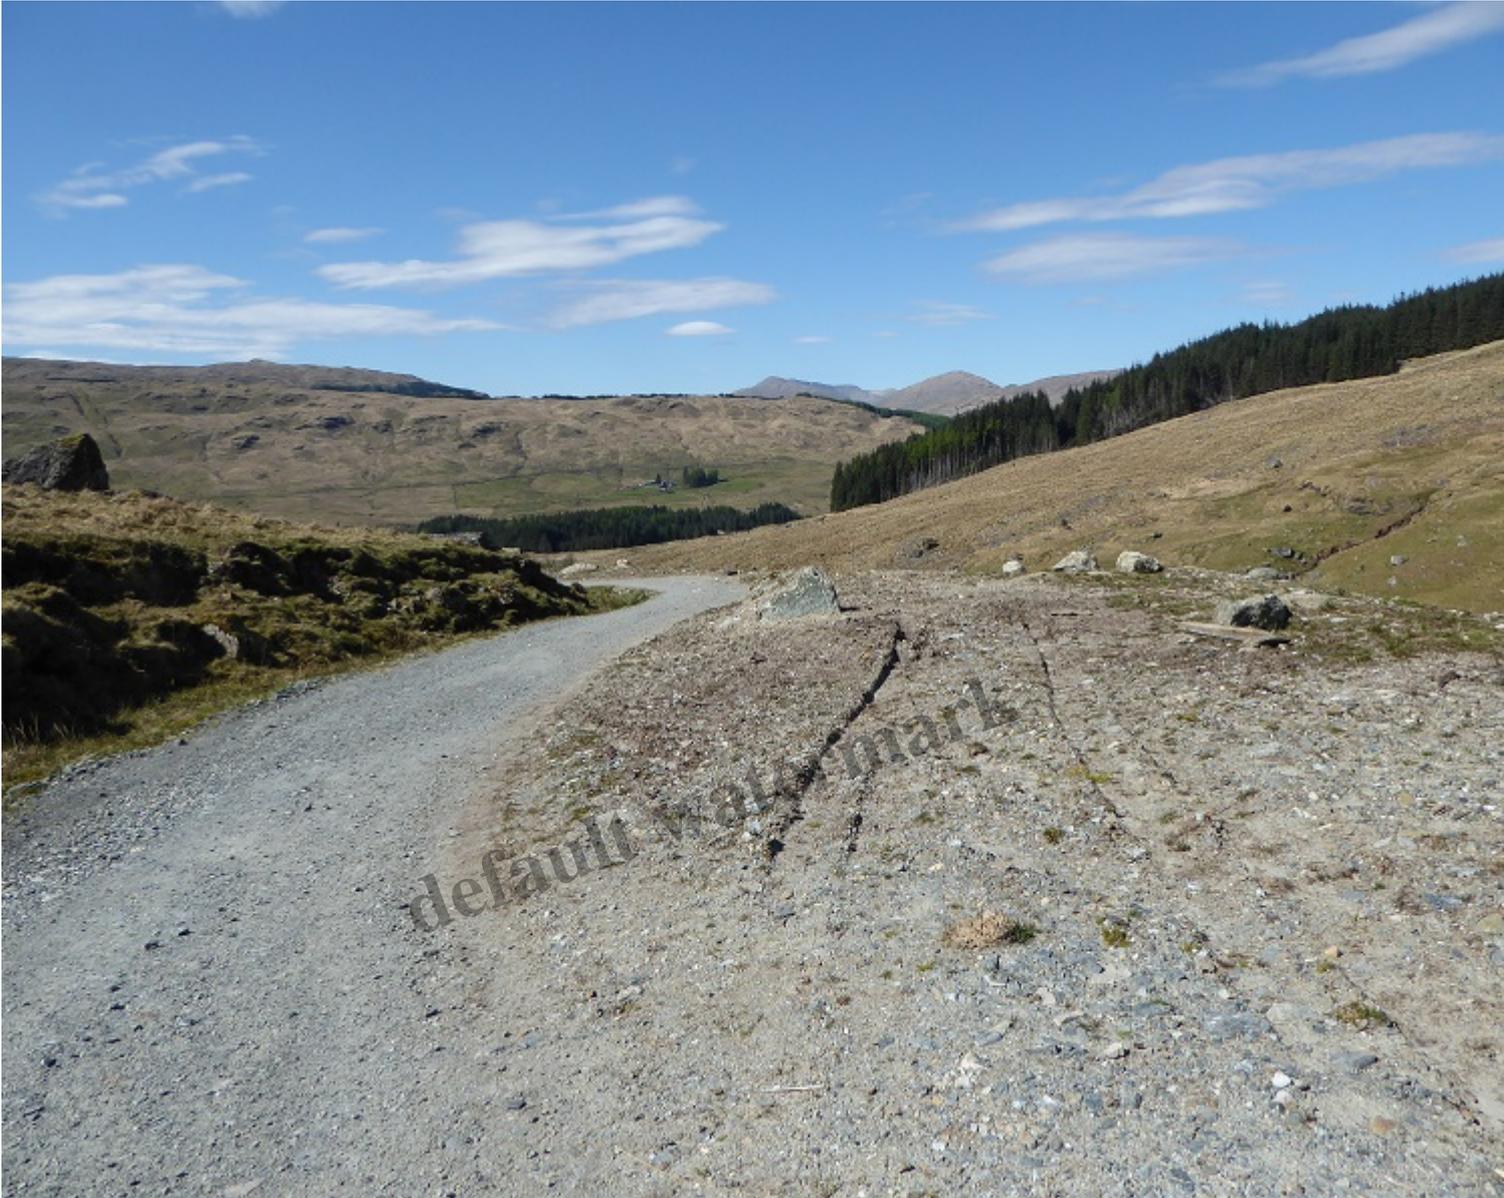
Vehicles are also being driven off the track with no regard for soil or vegetation. The consequence is the track is in places likely to end up being 5-7m wide instead of the 2.5m (and 3m on steep hills and bends) which the LLTNPA recommends in its “award winning” good practice guidance which it has never enforced.

The reason for this is that the LLTNPA has basically allowed a new wide track to be created to construct the hydro scheme but then allowed the batters (see diagram below) to remain in place with minimum attempts to re-landscape the flat surface of the track (a little bit of soil and peat has just been added to the outside edge of the track). The result is that its very easy for vehicles to drive off the track while in landscape terms the track is still effectively 5-7m broad in most places.

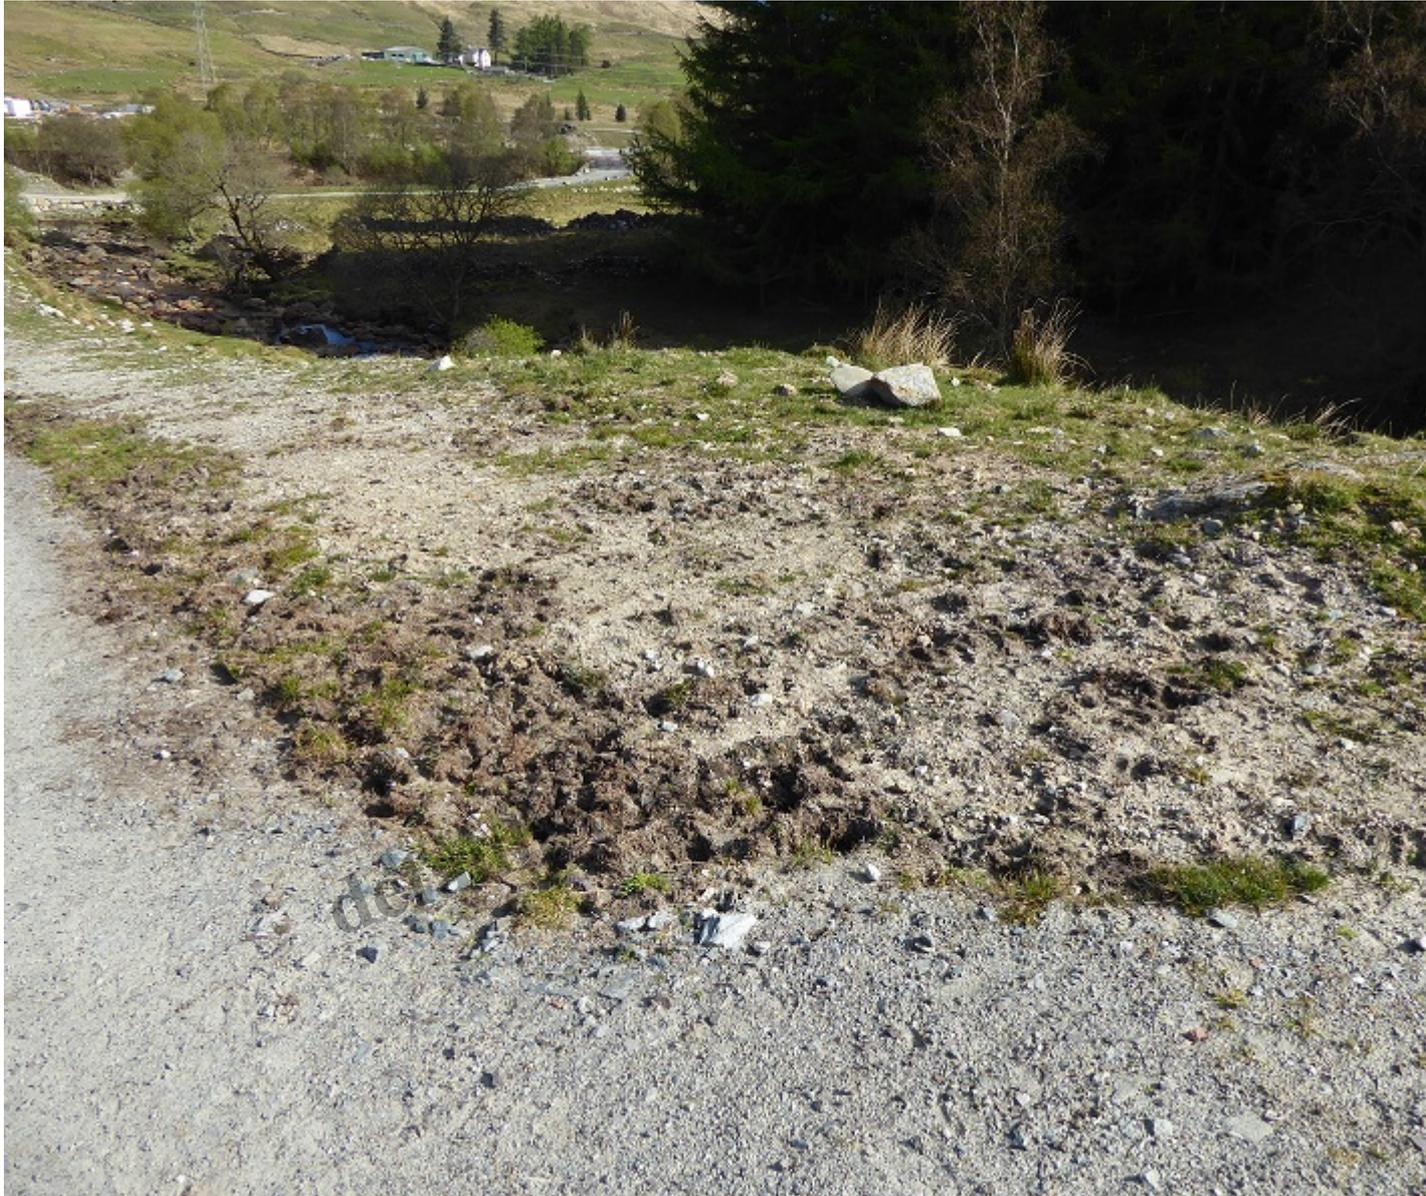
Photo showing how original attempt to cover former track surface is failing, with former surface of peaty soil being revealed as turf has been eroded by cattle.

The design of the track together with the erosion caused by vehicles and cattle have had the result that in most places there is actually now less peaty soil by the track than there was a year ago (see above).

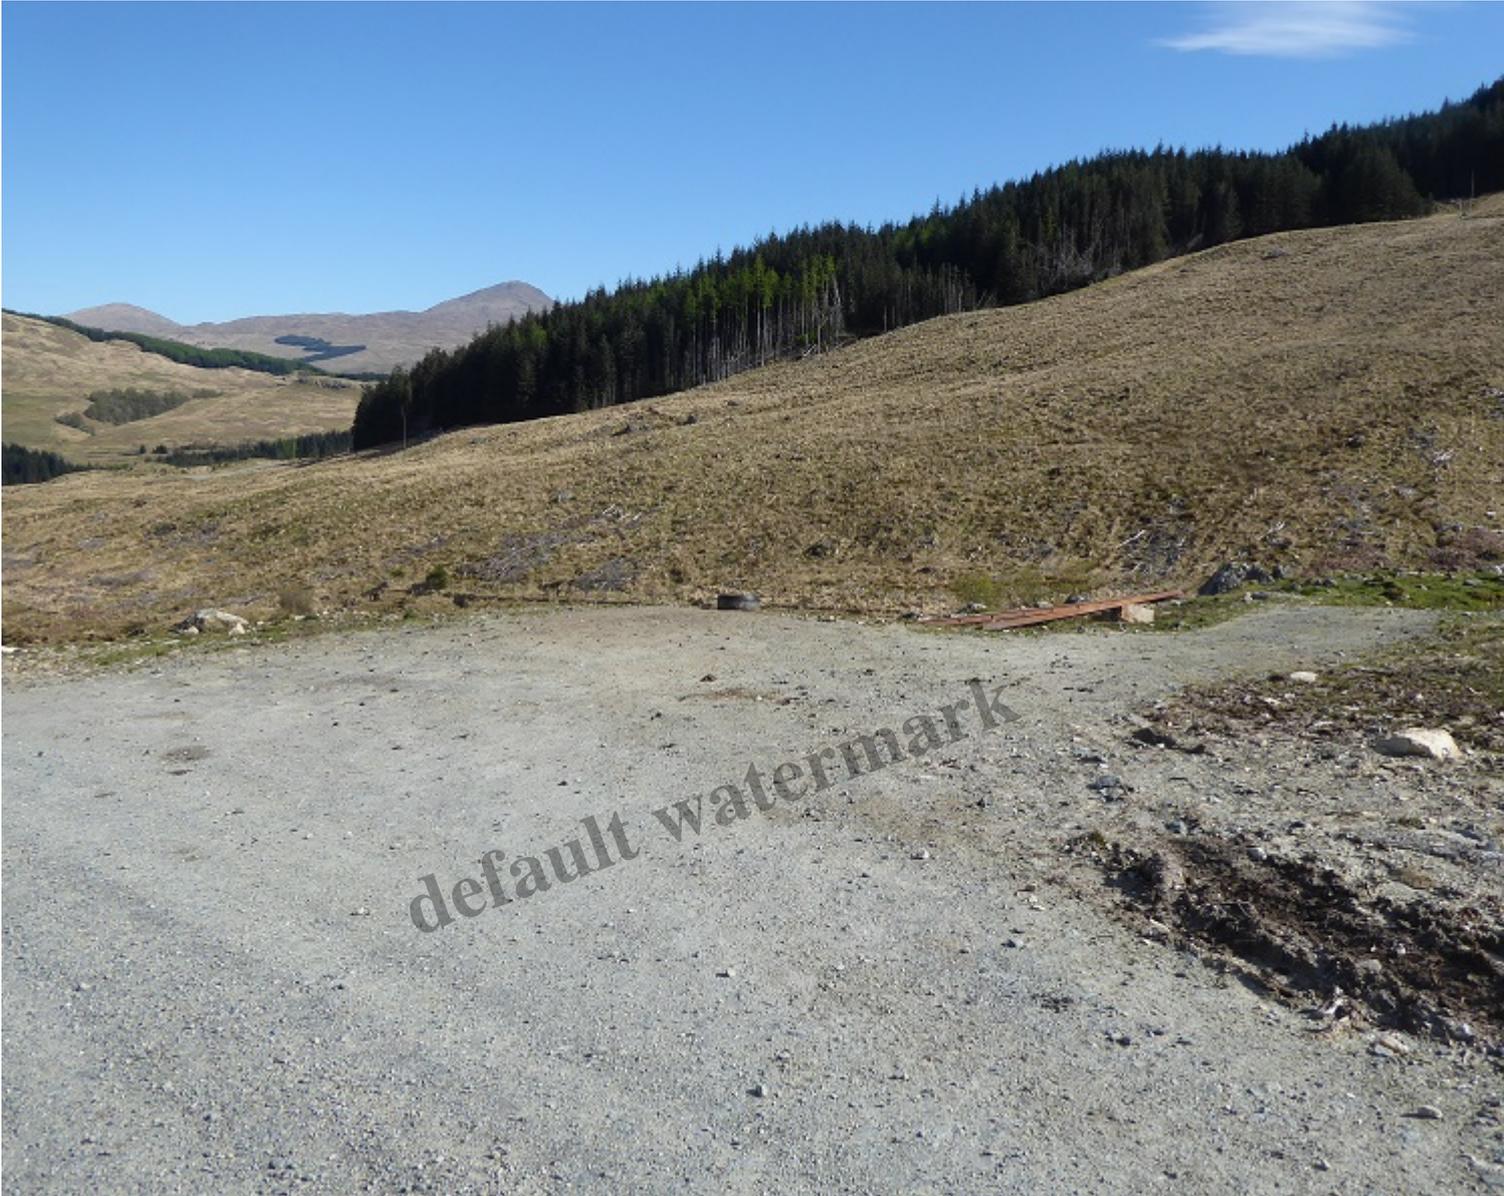
The failure to re-landscape the former road surface so that the remaining track moulds into the contours of the land has also made it easy for the estate to create new parking or working areas which add considerably to the visual impact of the track.

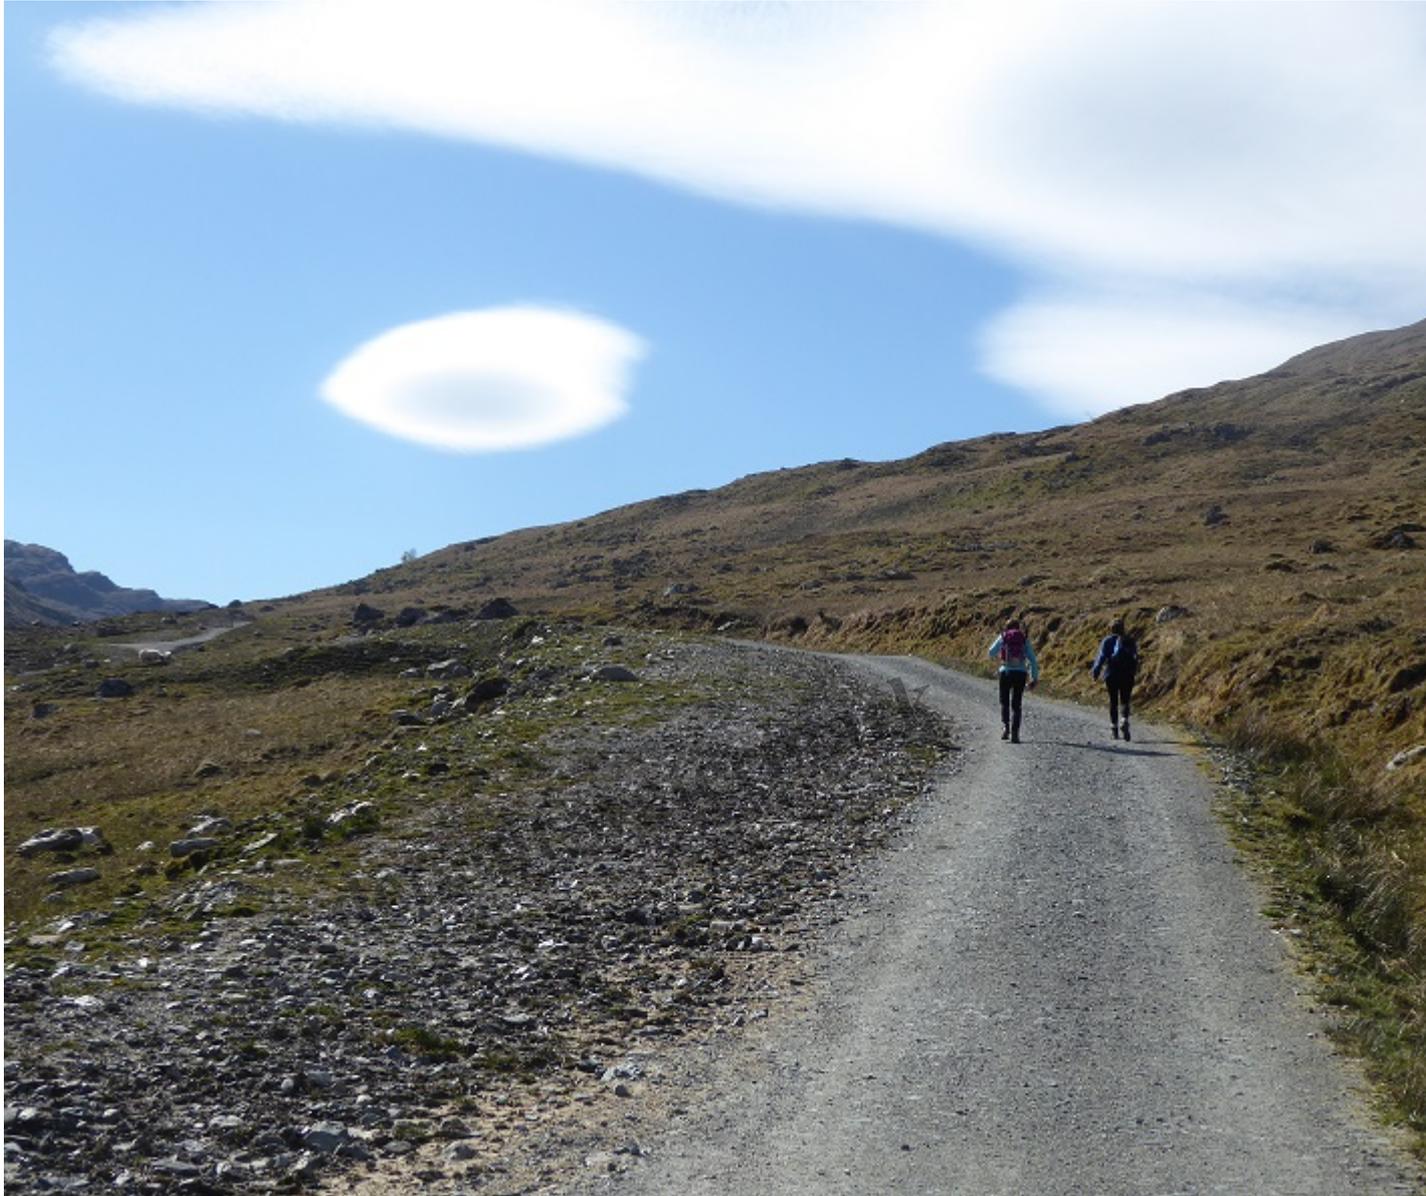
The pre-existing track which ended a little further up the hill, was widened for the hydro construction cutting a further batter but by importing aggregate (left) to use as fill.

There little attempt (photo above) to shape the the fill so it merges into the contours of the land. The result is a broad bench cutting across the hillside. In landscape terms, the track here is in effect still 5-7m wide rather than the 2.5-3m recommended by the National Park.

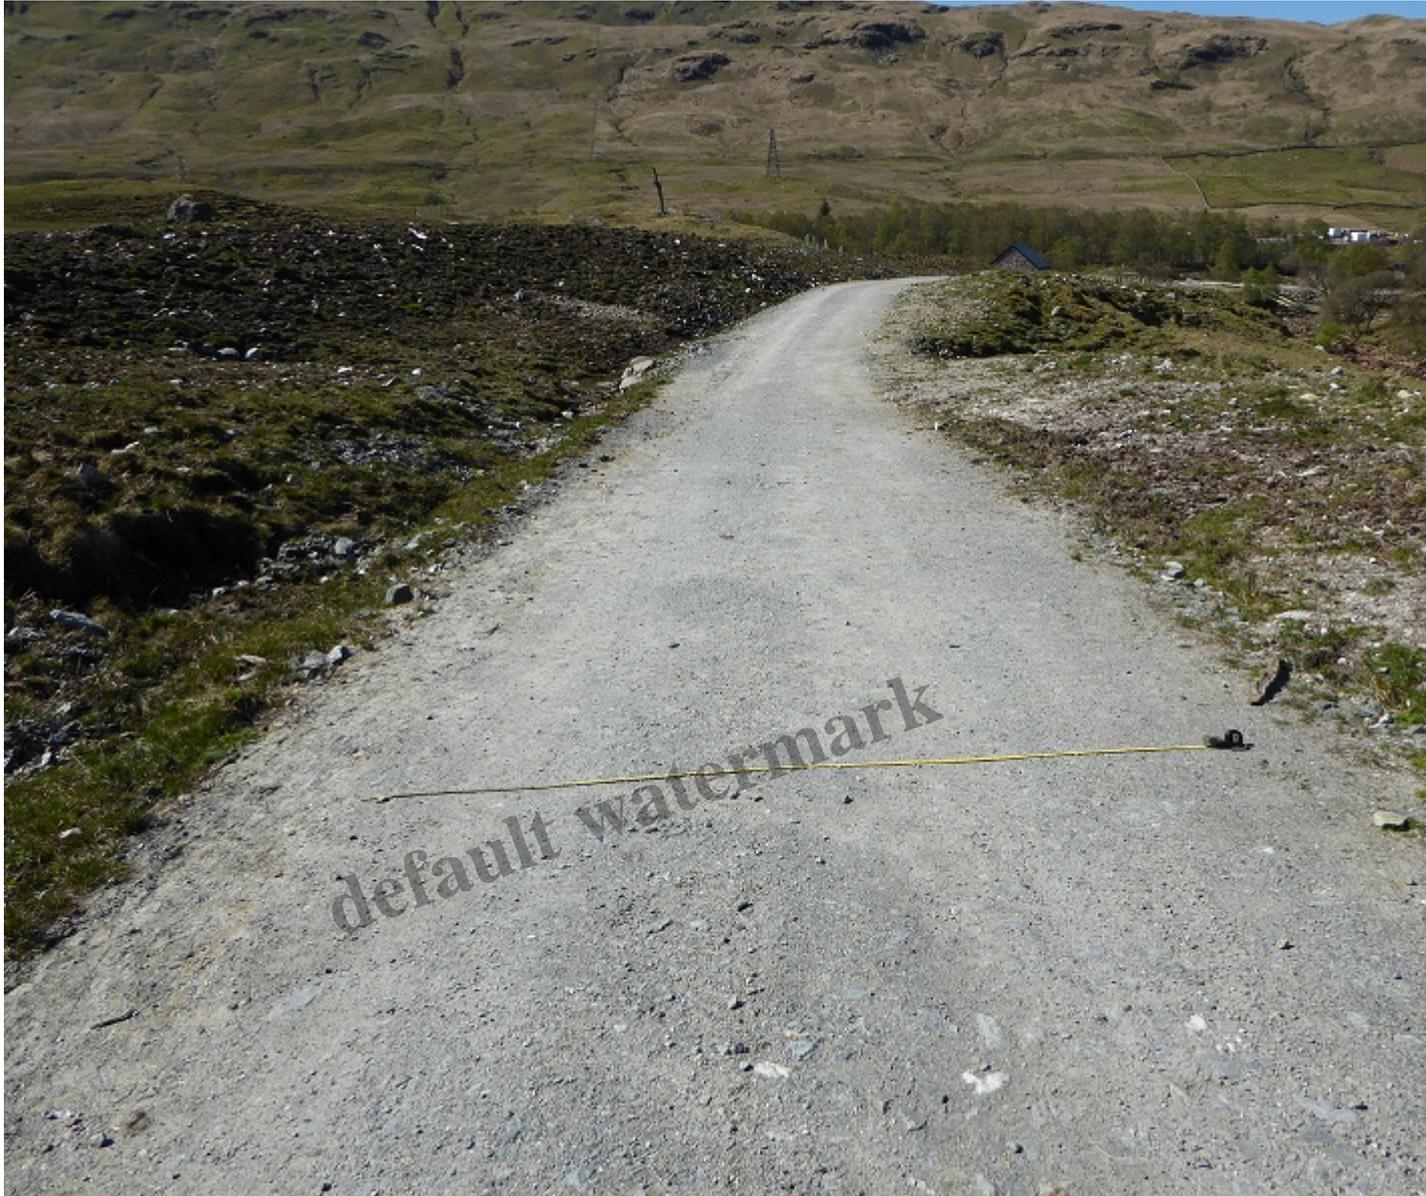
The 3m mark on tape measure is just to the left of the small stone holding the tape measure in place

Even on the better sections, the track is far wider than the LLTNPA requires. I took my 3m tape which is here fully extended on a section of track which slopes gently downhill. I think a 2.5m track would have been more than adequate here (and probably less as you can see from the vehicle marks) but the actual track is more like 3.5m wide. What is the LLTNPA going to do to address this? The wider the track of course, the more it will stand out from a distance. There is no evidence of the central grass strips which grace the Allt Andoran track (top photo).

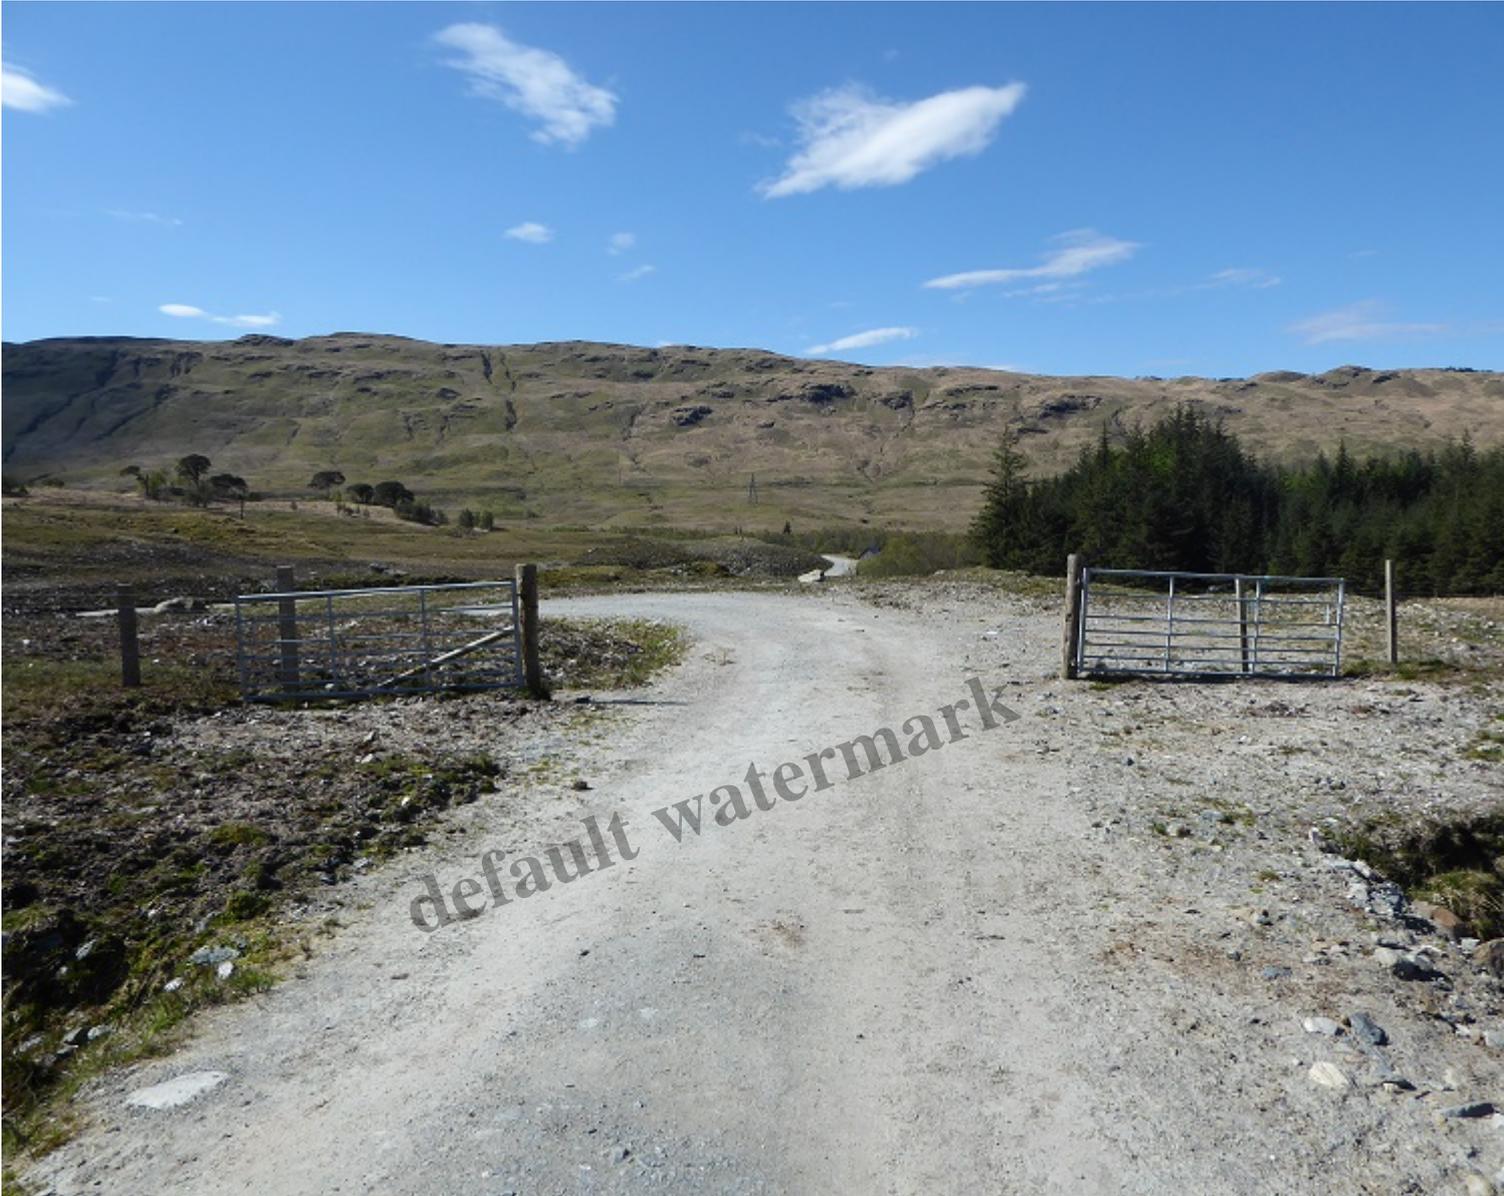
If there was any serious intention to narrow the upper Falloch construction track this double gate would have been removed – another illustration of just how wide this track is.
