## The Glen Falloch hydro schemes (8) – their impact on the landscape and what needs to be done

Mid Glen Falloch, viewed from shoulder of An Caisteal. The area It is now a mass of tracks, leading dams. Foreground Allt Andoran, far right Eas Eonan and left background start of track up Allt a Chur hydro powerhouse is centre background, Derrydarroch to the right.

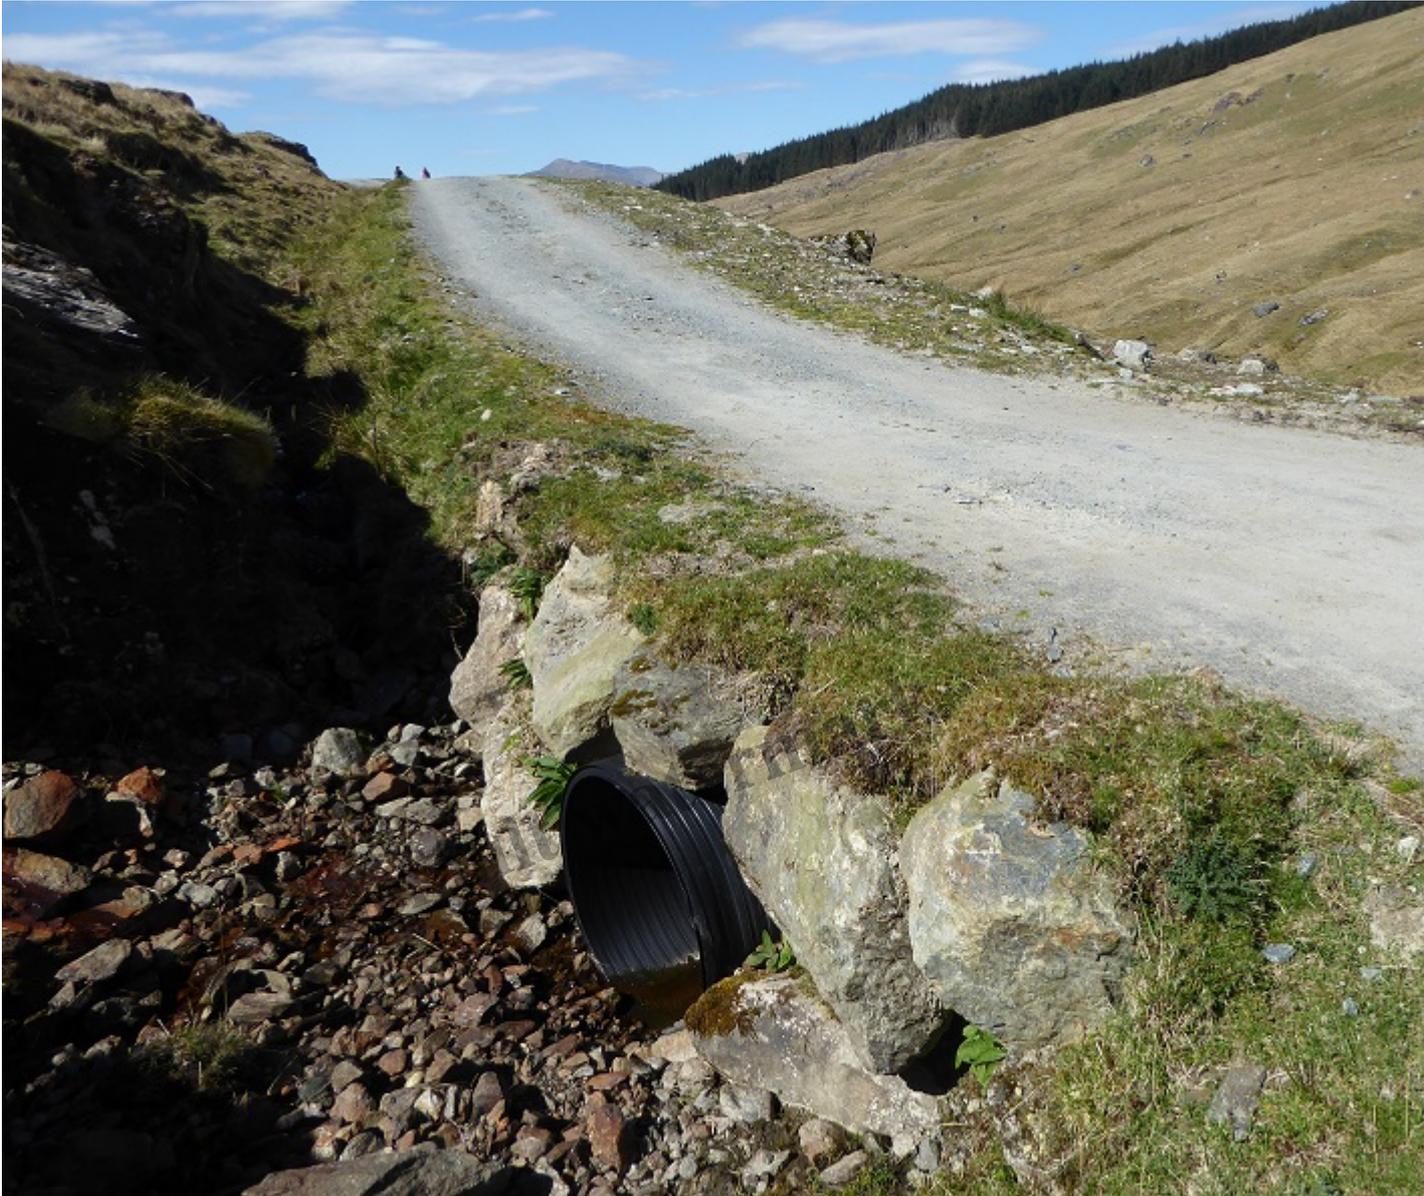
Where turf has been stored successfully, then used alongside the track and cattle have been kept off, the restoration does look better, although the protruding plastic culvert tells a tale

The restored sections however are few in comparison to those that still need attention and at this rate the track is going to take years to restore to anything like an acceptable state. That is unacceptable in a National Park whose current Plan incidentally states (and rightly so):

5. Where existing tracks were widened, the LLTNPA needs to ensure that all the restoration meets the standards set out in its good practice guidance. Tracks which are broader than the maximum and unfinished culverts for example should not be tolerated.
