The Glen Falloch hydro schemes (8) – their impact on the landscape and what needs to be done

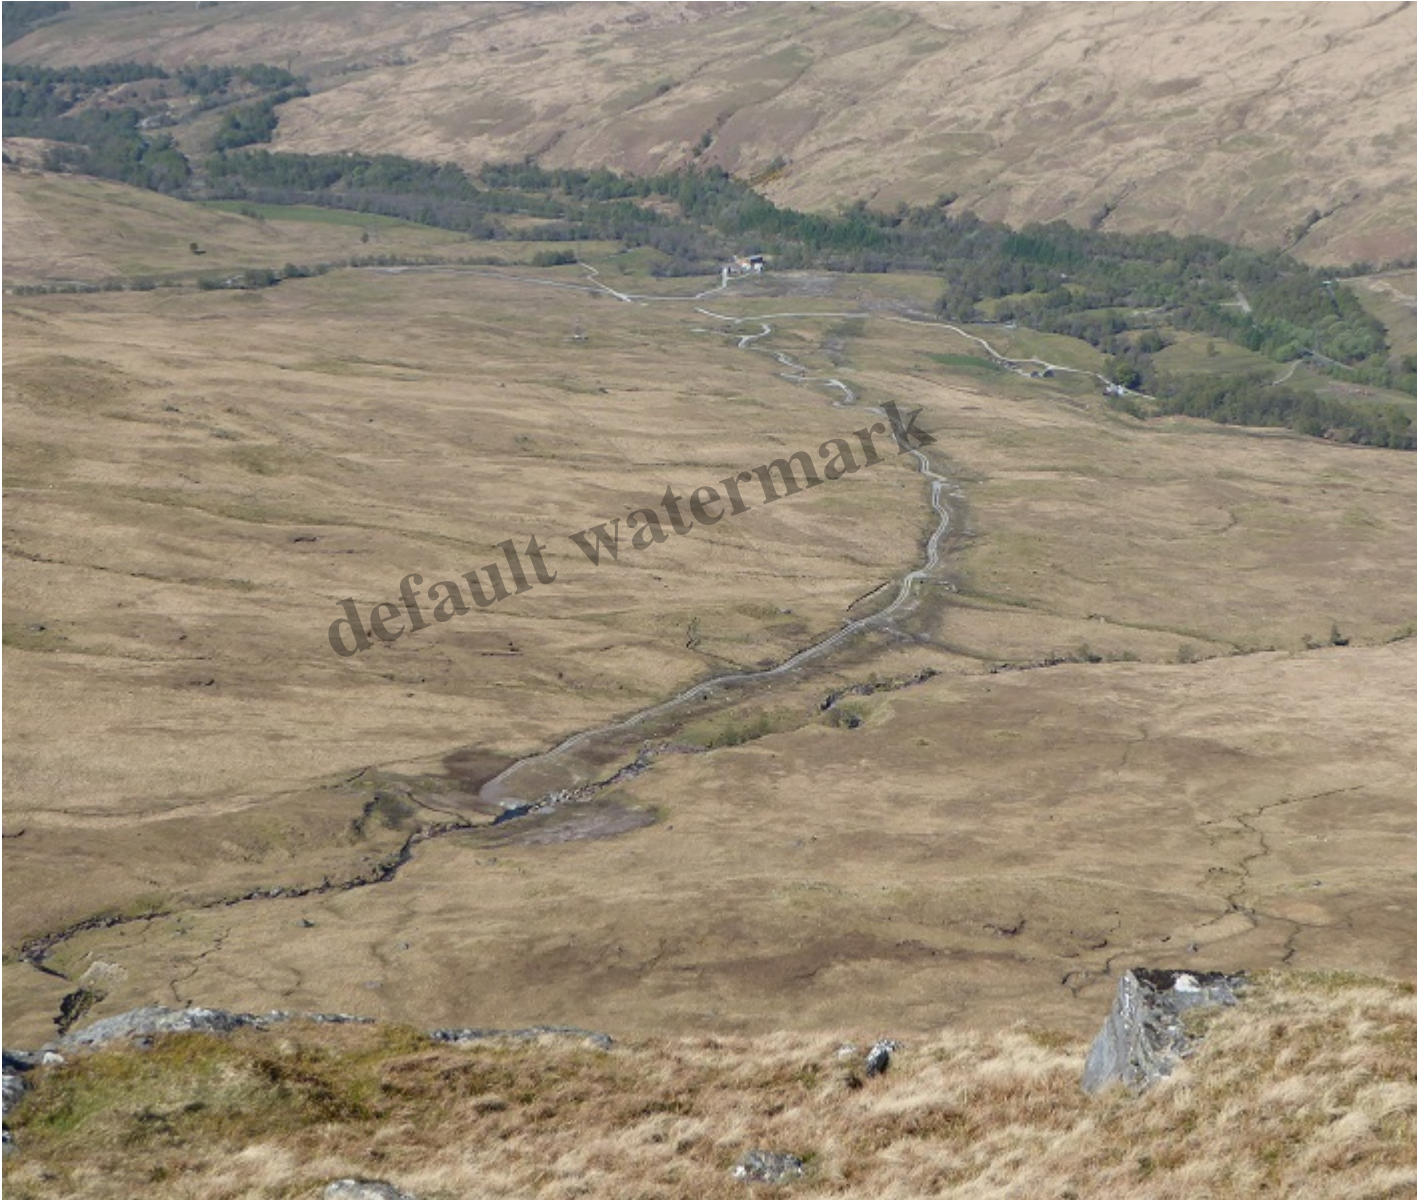
Mid Glen Falloch, viewed from shoulder of An Caisteal. The area It is now a mass of tracks, leading dams. Foreground Allt Andoran, far right Eas Eonan and left background start of track up Allt a Chu hydro powerhouse is centre background, Derrydarroch to the right.

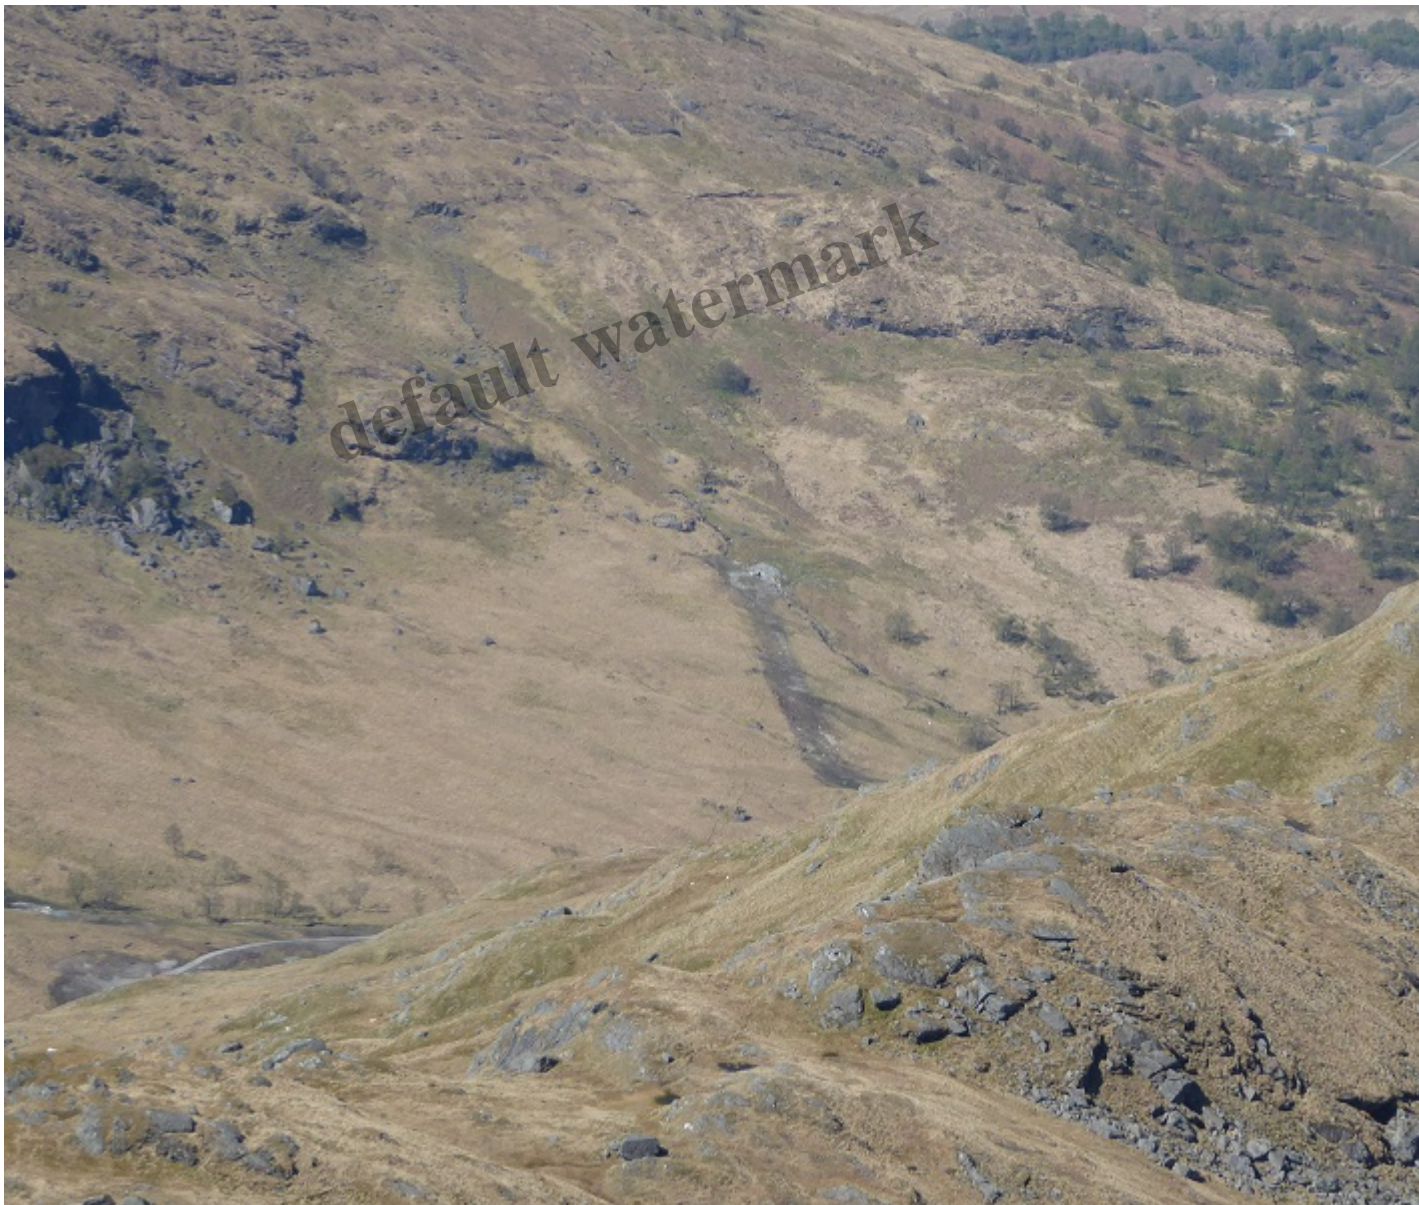
The first Allt a Chuillinn intake centre, the other two intakes are beyond track you can see bottom left

buried has generally successful and little cause for concern with it often being quite difficult to make out the line of the pipelines. While I believe that is still sometimes the case, the long dry spell has accentuated the differences in vegetation and its easy to see the landscape scars (above centre). The land may take longer to recover than I had thought.

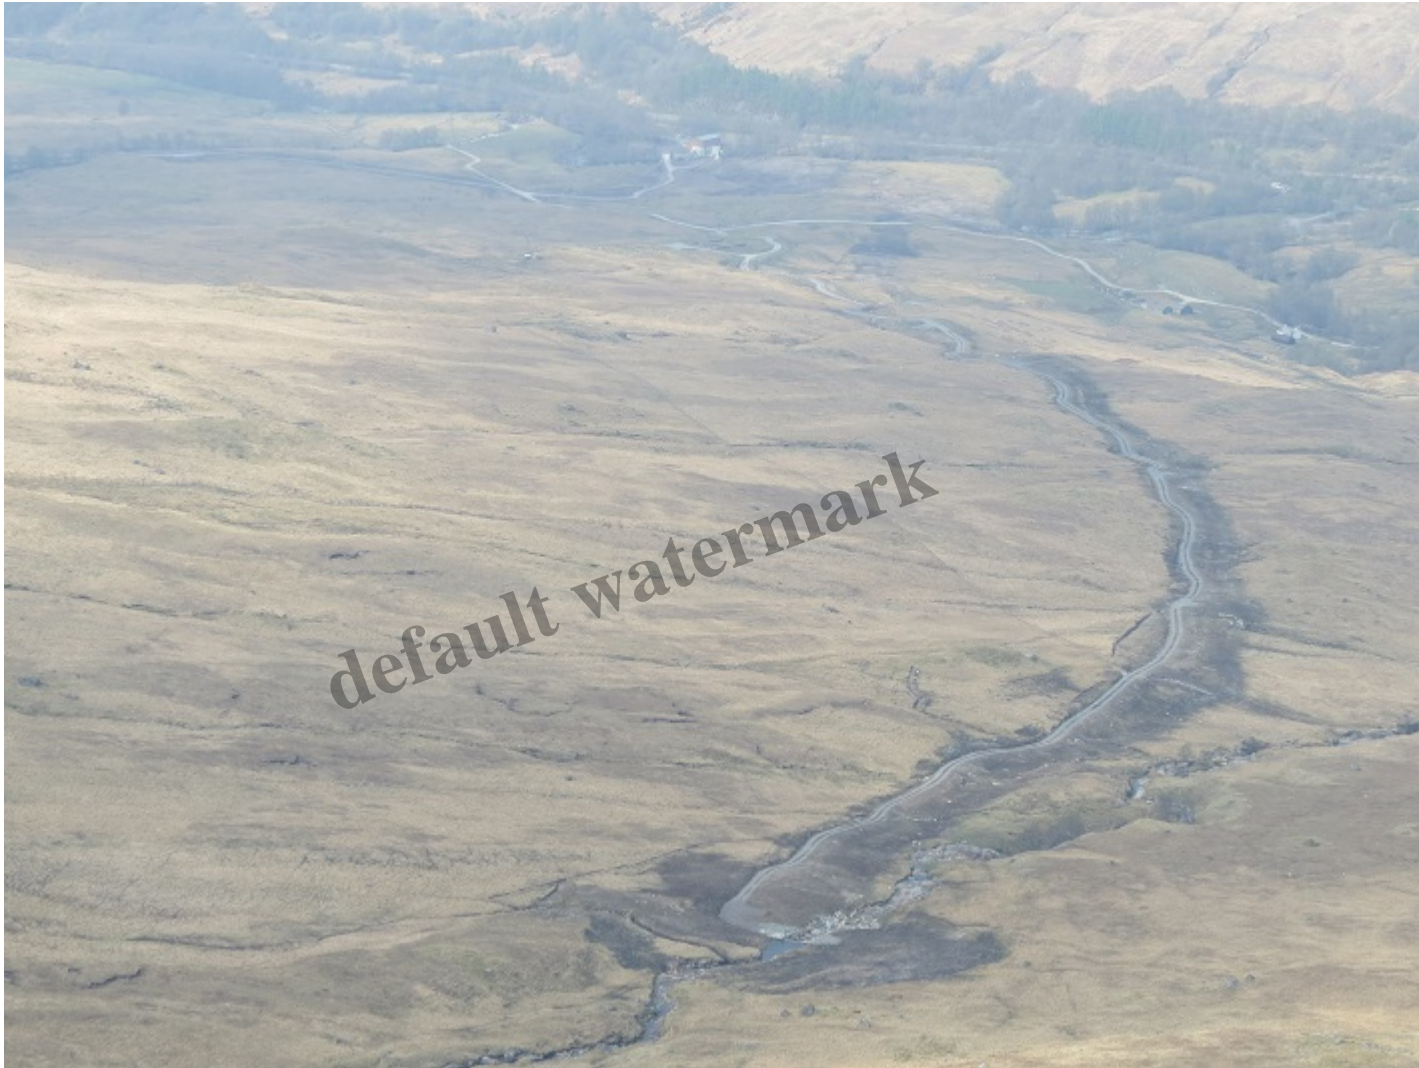
Allt Andoran Track 8th May 2016

Comparing the photo above (taken a year ago on a day with far less good visibility) with the first photo in the post taken a year later, you can see that the ground above the pipeline has recovered to an extent but has a long way to go. The track itself, despite the vegetation down the middle, looks little different and forms a permanent landscape scar.

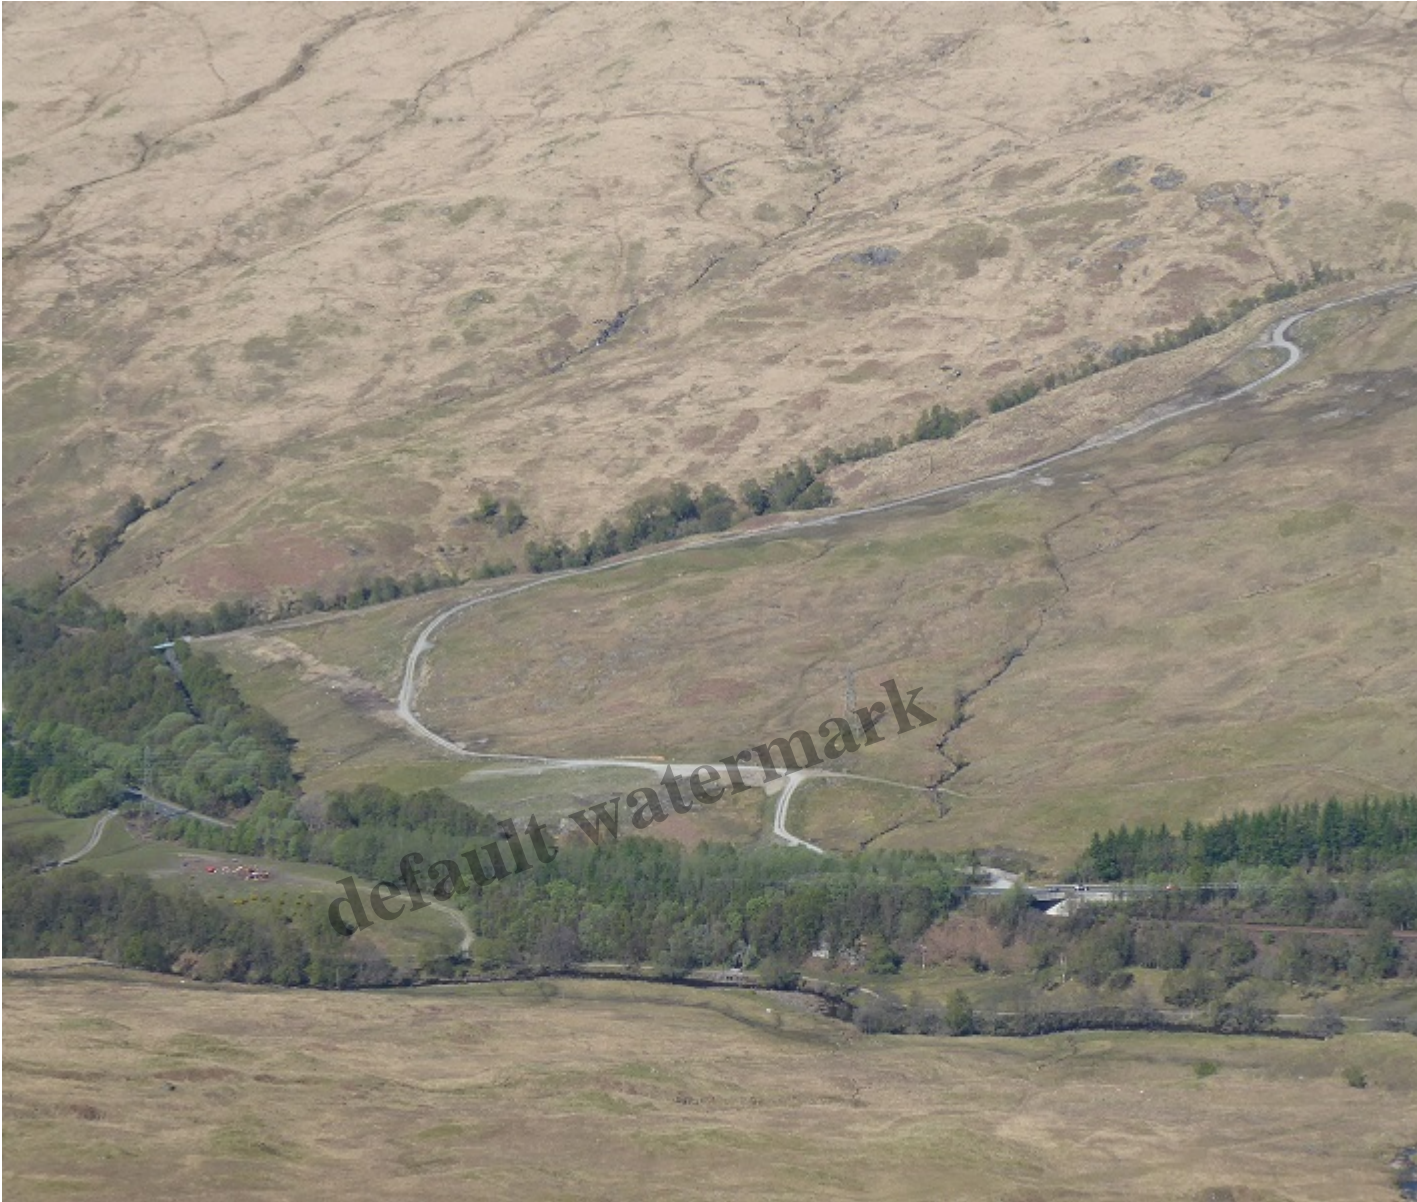
Close up of Eas Eonan track, showing poor restoration of the temporary access track that led to blue West Highland Line (centre left)

senior management team believe walking up a bulldozed track is a wild experience? Its becoming harder and harder to have a wild experience in the National Park because of decisions made by the LLTNPA. Removal of the tracks, as originally planned, would have preserved some of that.

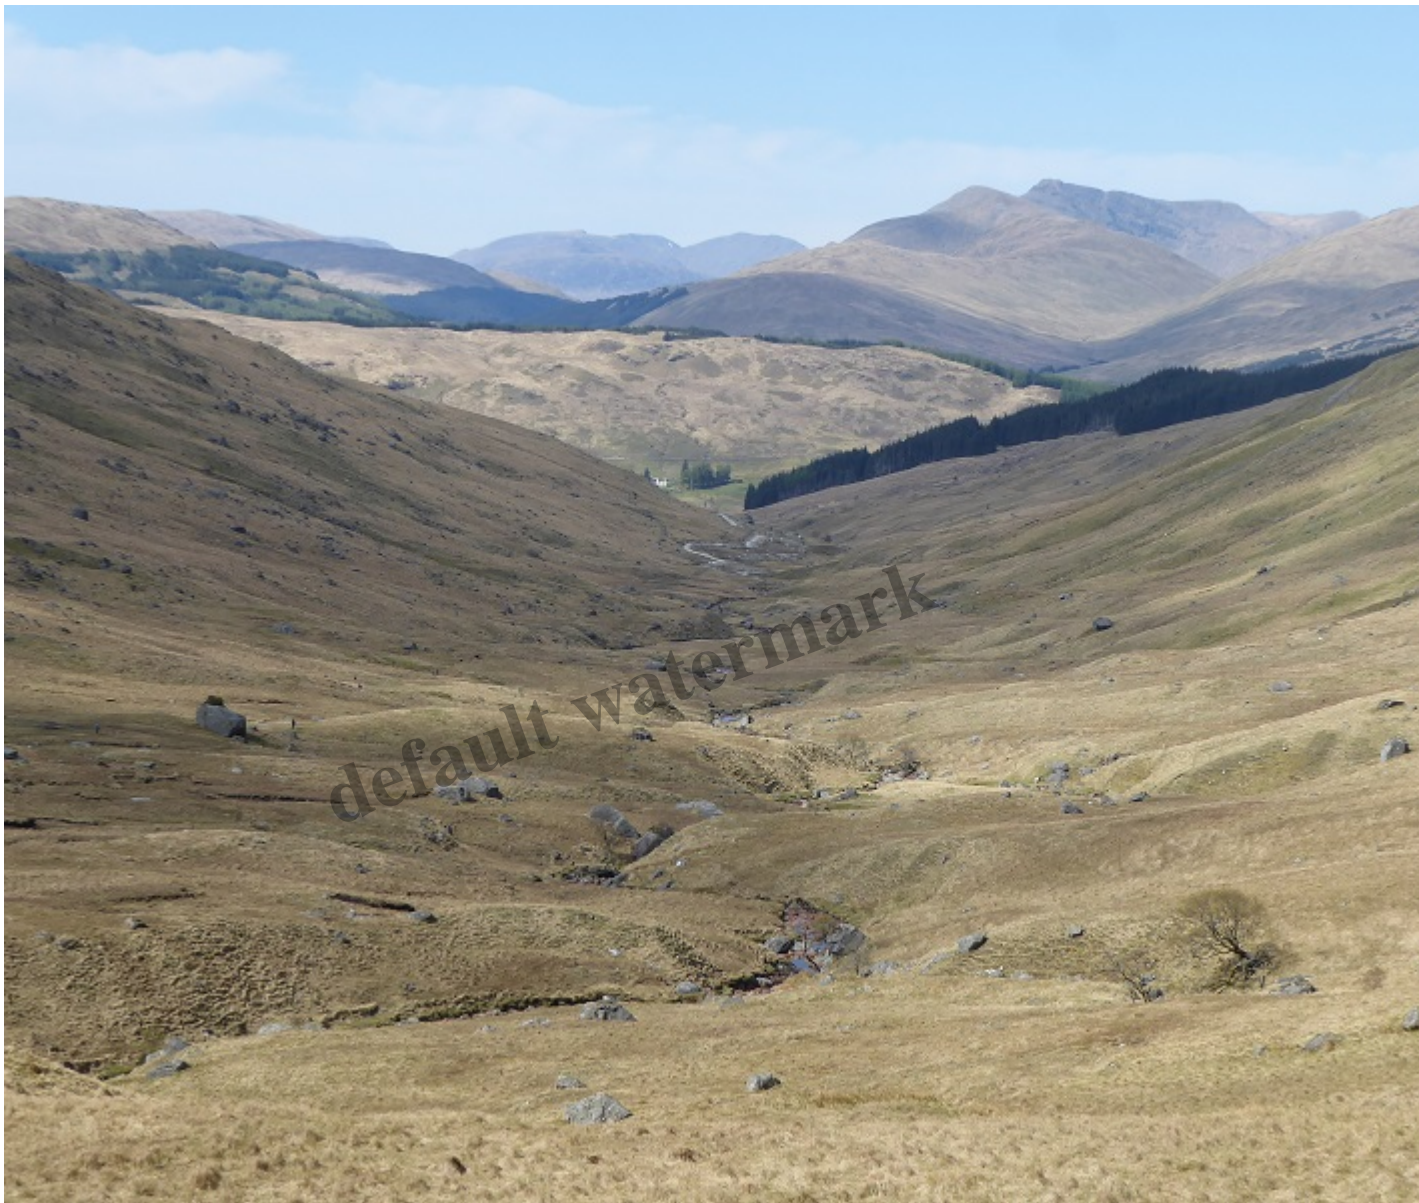
Lower reaches of Coire Earb by the Upper Falloch, Beinn Odhar and Ben Dorain in background

Coire Earb is wild, and indeed falls within a core wild land area. While there was an existing track by the upper reaches of the River Falloch, this ended 1 km before the new hydro dam and formerly was out of sight when you were descending the glen. The decision by LLTNPA staff to allow the track to remain permanently has changed the experience totally.

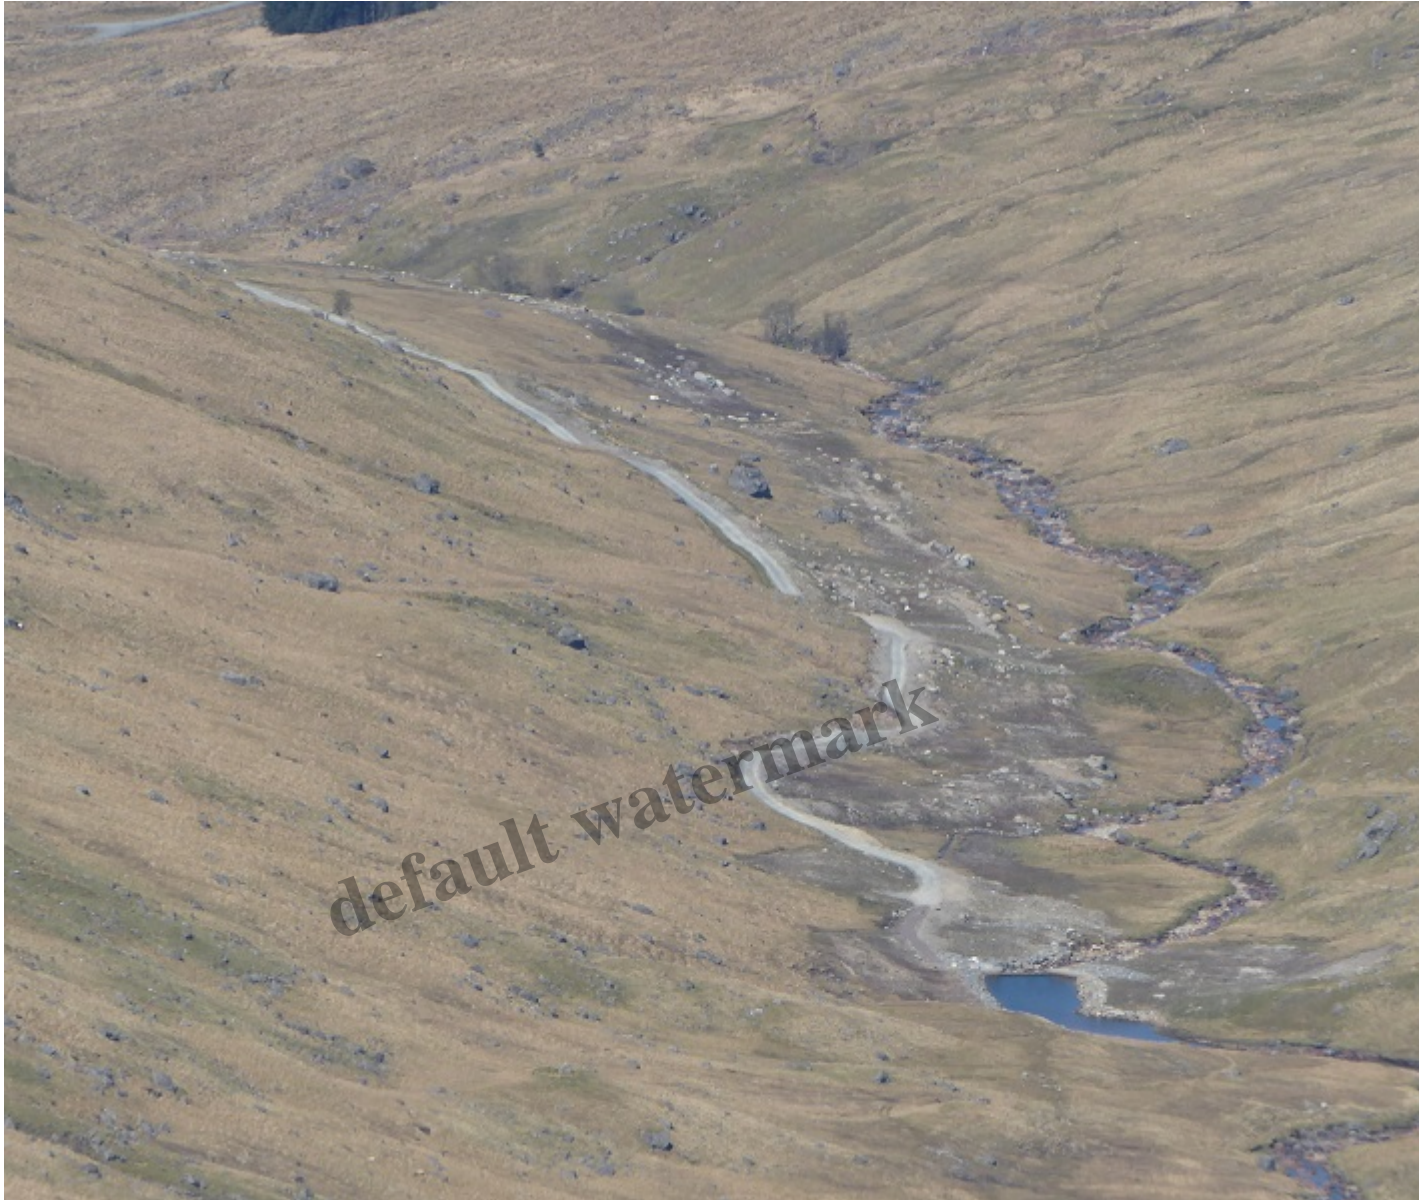
The new section of track. The line of the pipeline is now more visible than it was a year ago.

Would not the hydro here have had far less impact on the landscape if the track has been removed as originally planned?

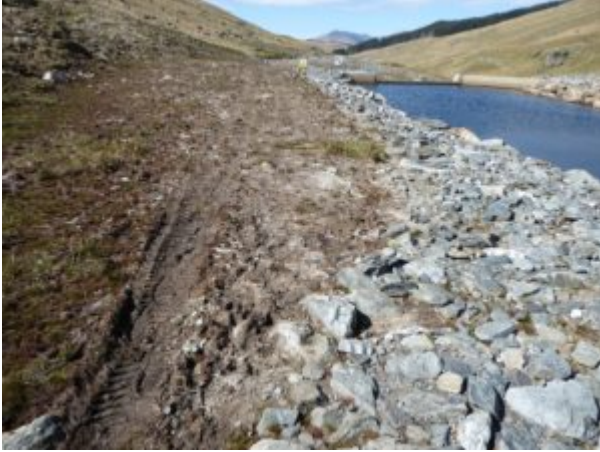
May 2017

The approval of the LLTNPA to the track extension to the hydro being retained has made it easier for the Glen Falloch Estate to drive vehicles off-road further up the glen. A year ago (right) there was no evidence of vehicles being driven beyond the intake, now there are vehicle tracks beside it which are destroying the ground that was restored.

6. The LLTNPA should put in place measures to control the off-road use of vehicles, particularly in wild land.
7. The LLTNPA Board and senior staff need to get out more and take a look at what is being done in their name.

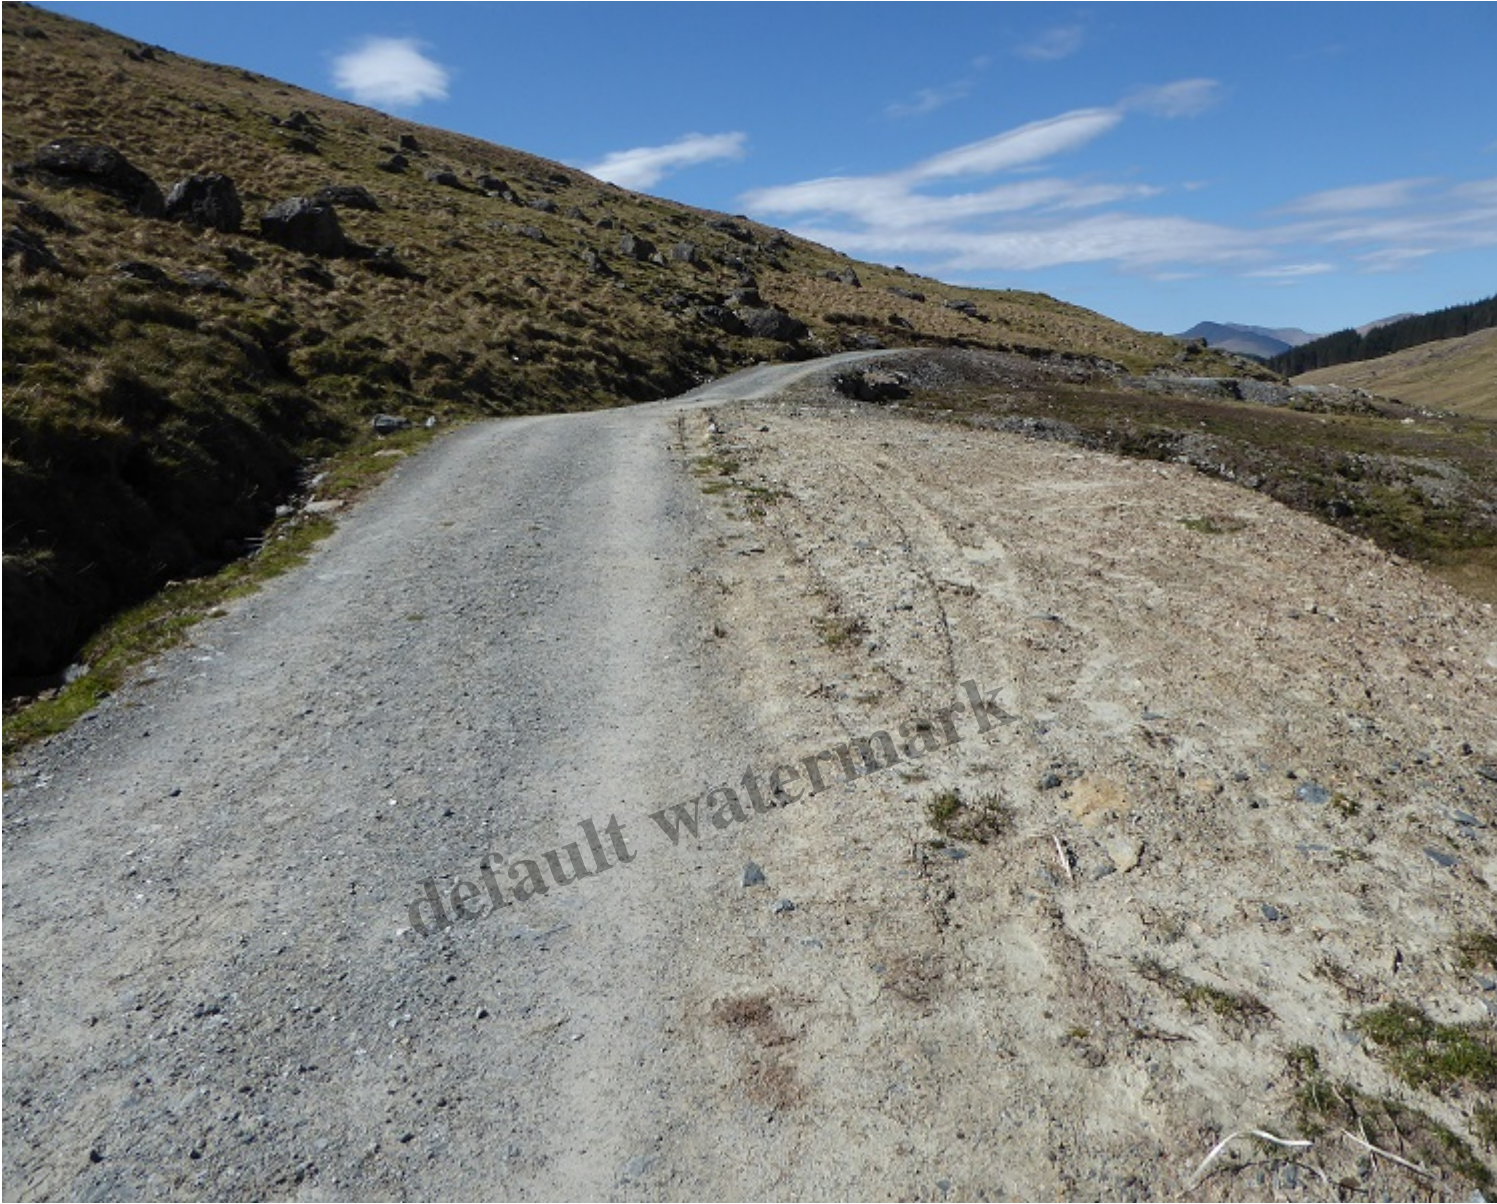
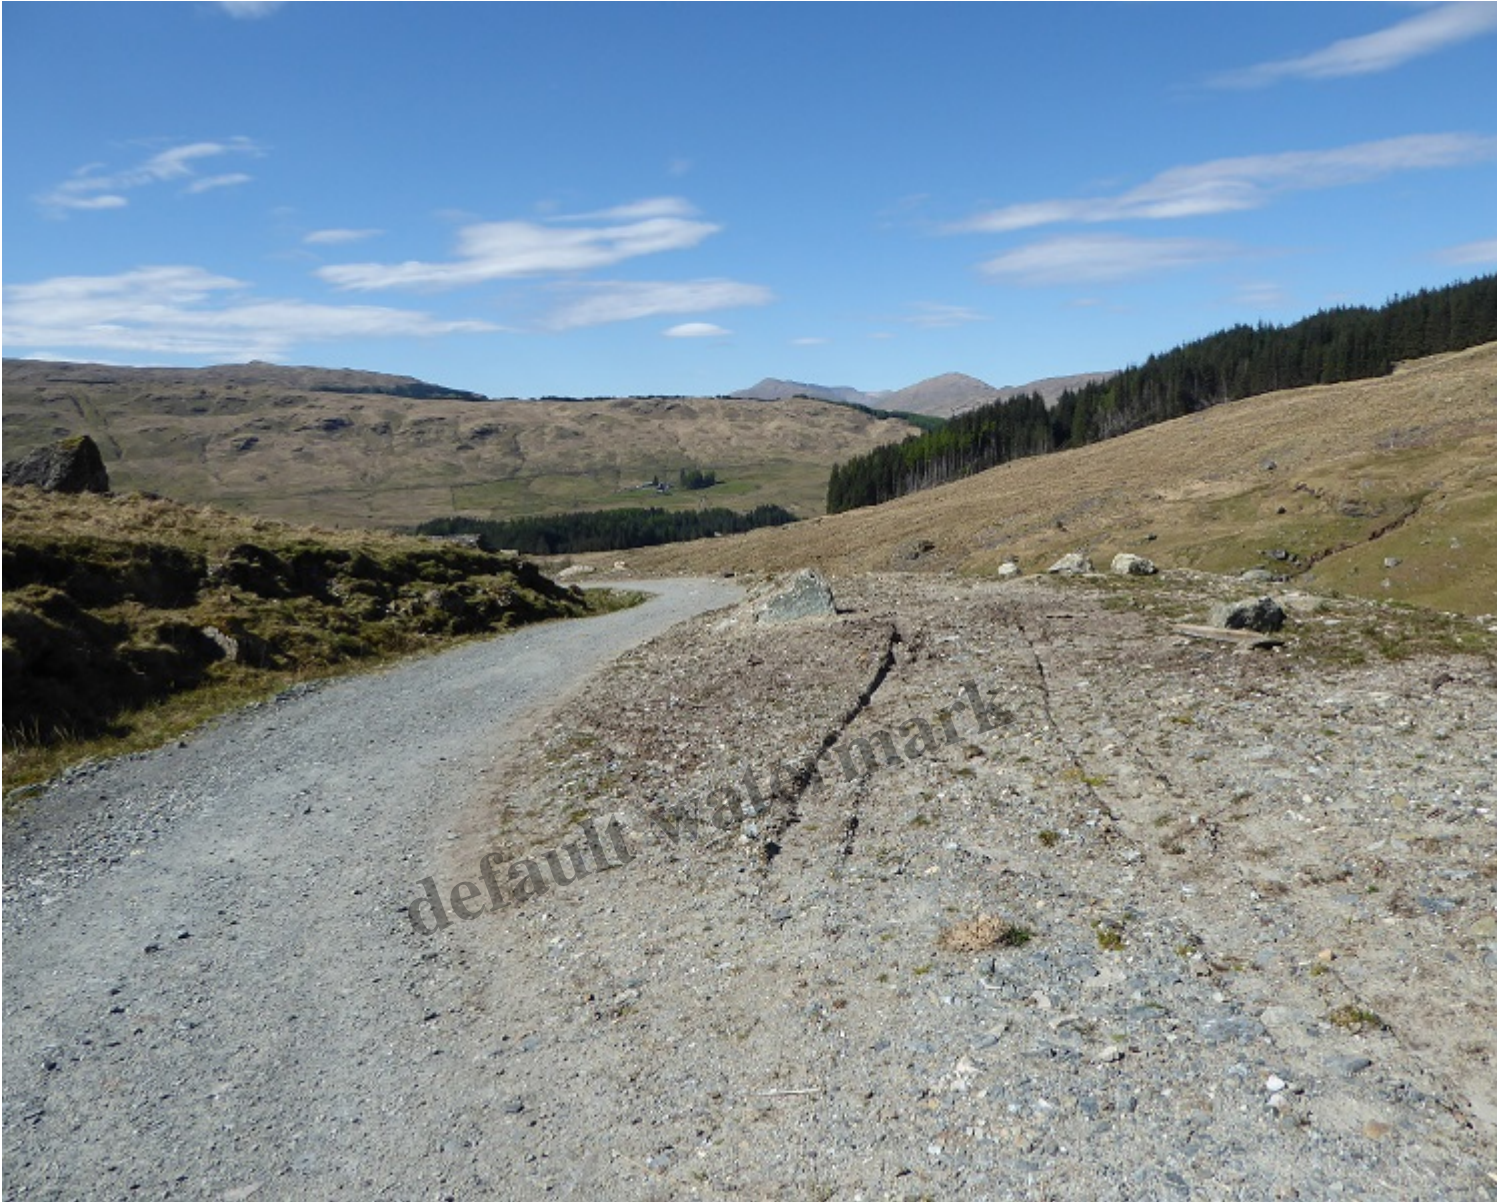
Vehicles are also being driven off the track with no regard for soil or vegetation. The consequence is the track is in places likely to end up being 5-7m wide instead of the 2.5m (and 3m on steep hills and bends) which the LLTNPA recommends in its “award winning” good practice guidance which it has never enforced.

The reason for this is that the LLTNPA has basically allowed a new wide track to be created to construct the hydro scheme but then allowed the batters (see diagram below) to remain in place with minimum attempts to re-landscape the flat surface of the track (a little bit of soil and peat has just been added to the outside edge of the track). The result is that its very easy for vehicles to drive off the track while in landscape terms the track is still effectively 5-7m broad in most places.

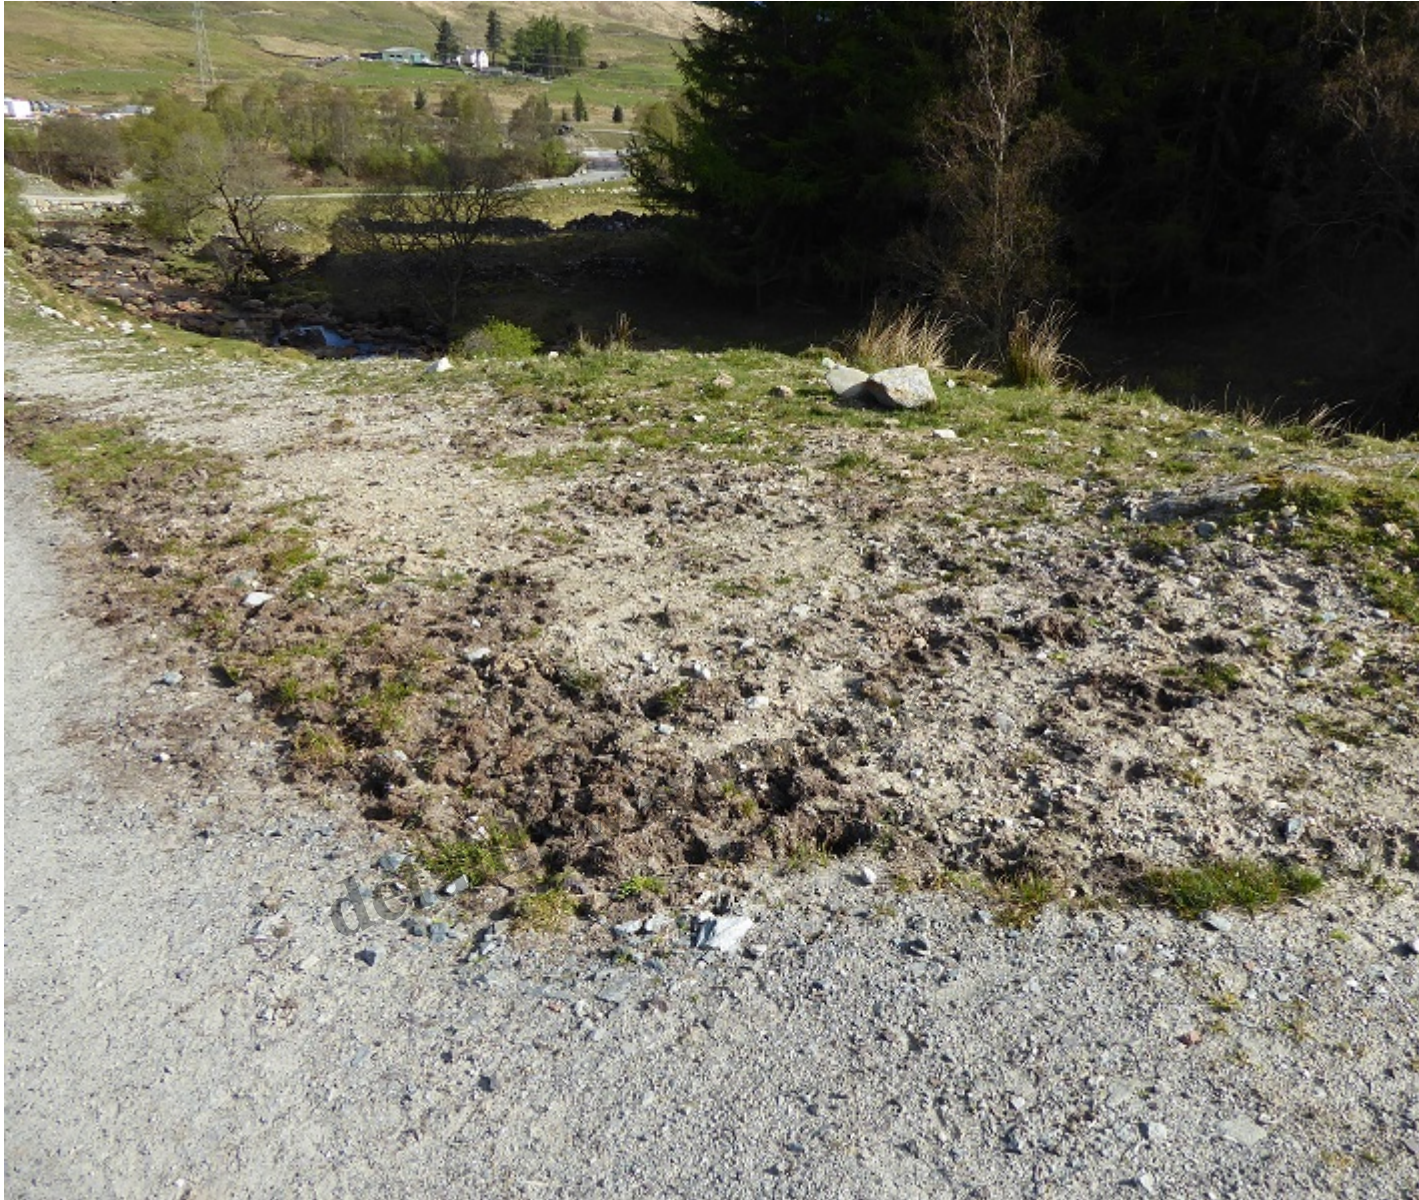
Photo showing how original attempt to cover former track surface is failing, with former surface of peaty soil being revealed as turf has been eroded by cattle.

The design of the track together with the erosion caused by vehicles and cattle have had the result that in most places there is actually now less peaty soil by the track than there was a year ago (see above).

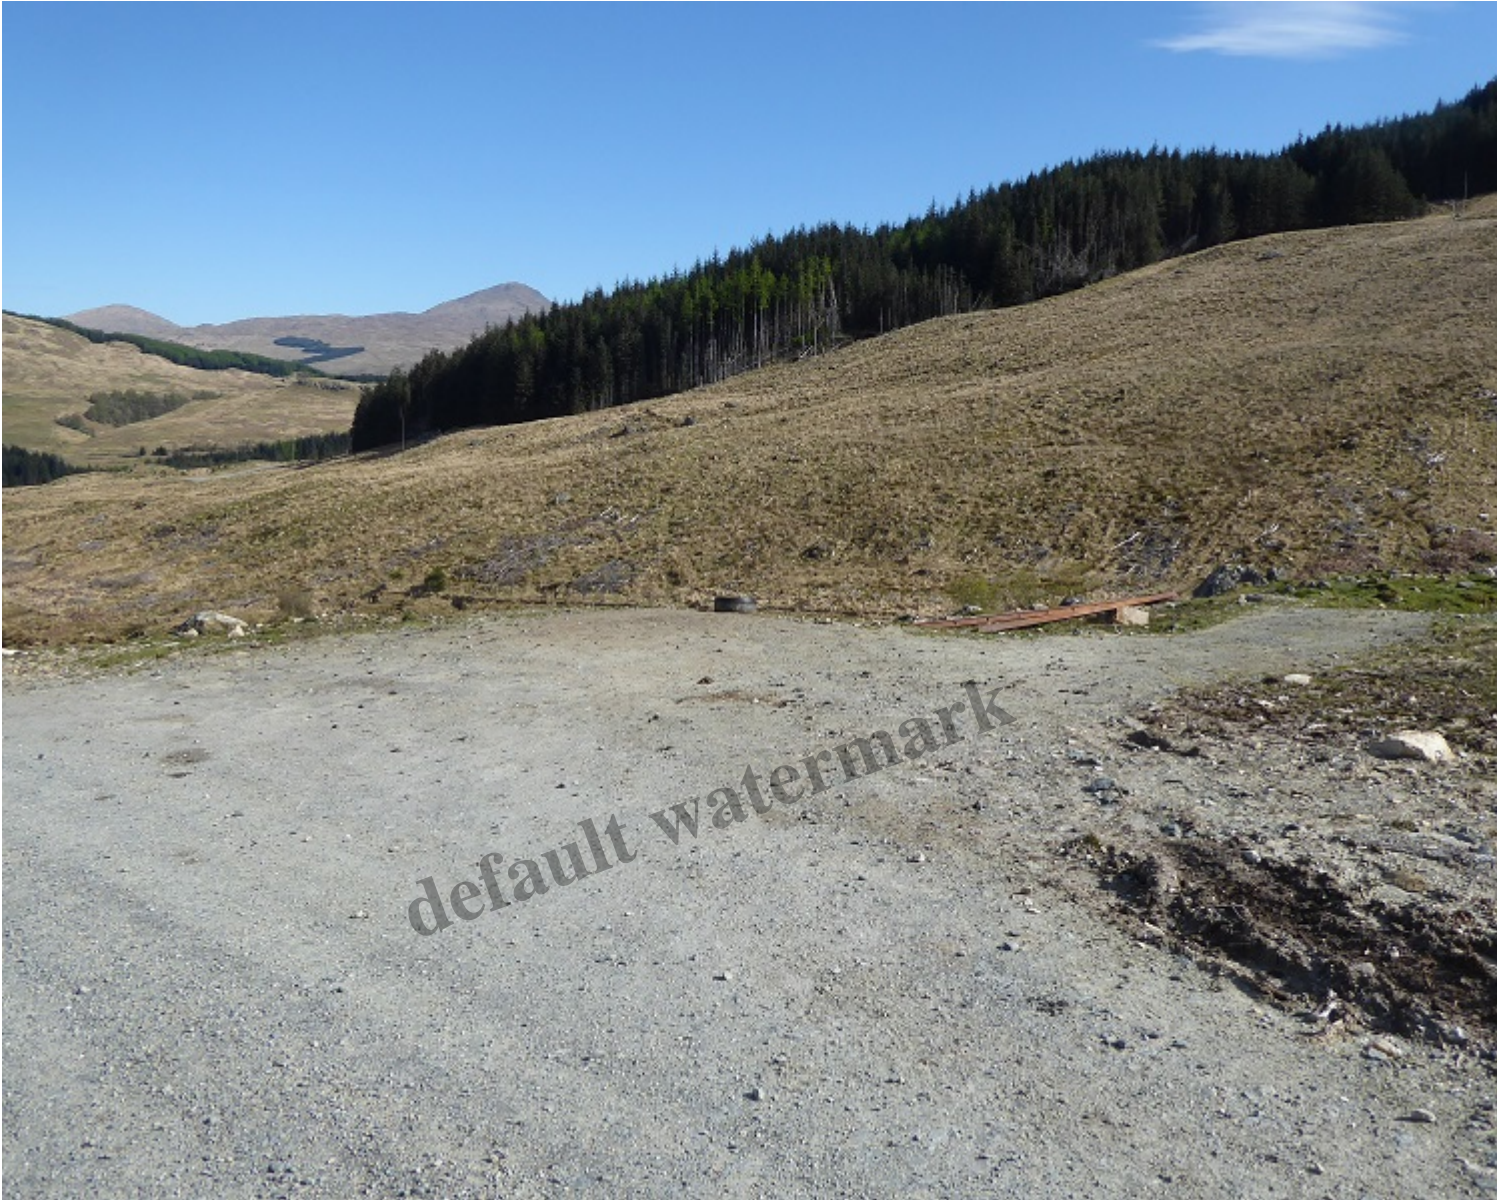
The failure to re-landscape the former road surface so that the remaining track moulds into the contours of the land has also made it easy for the estate to create new parking or working areas which add considerably to the visual impact of the track.

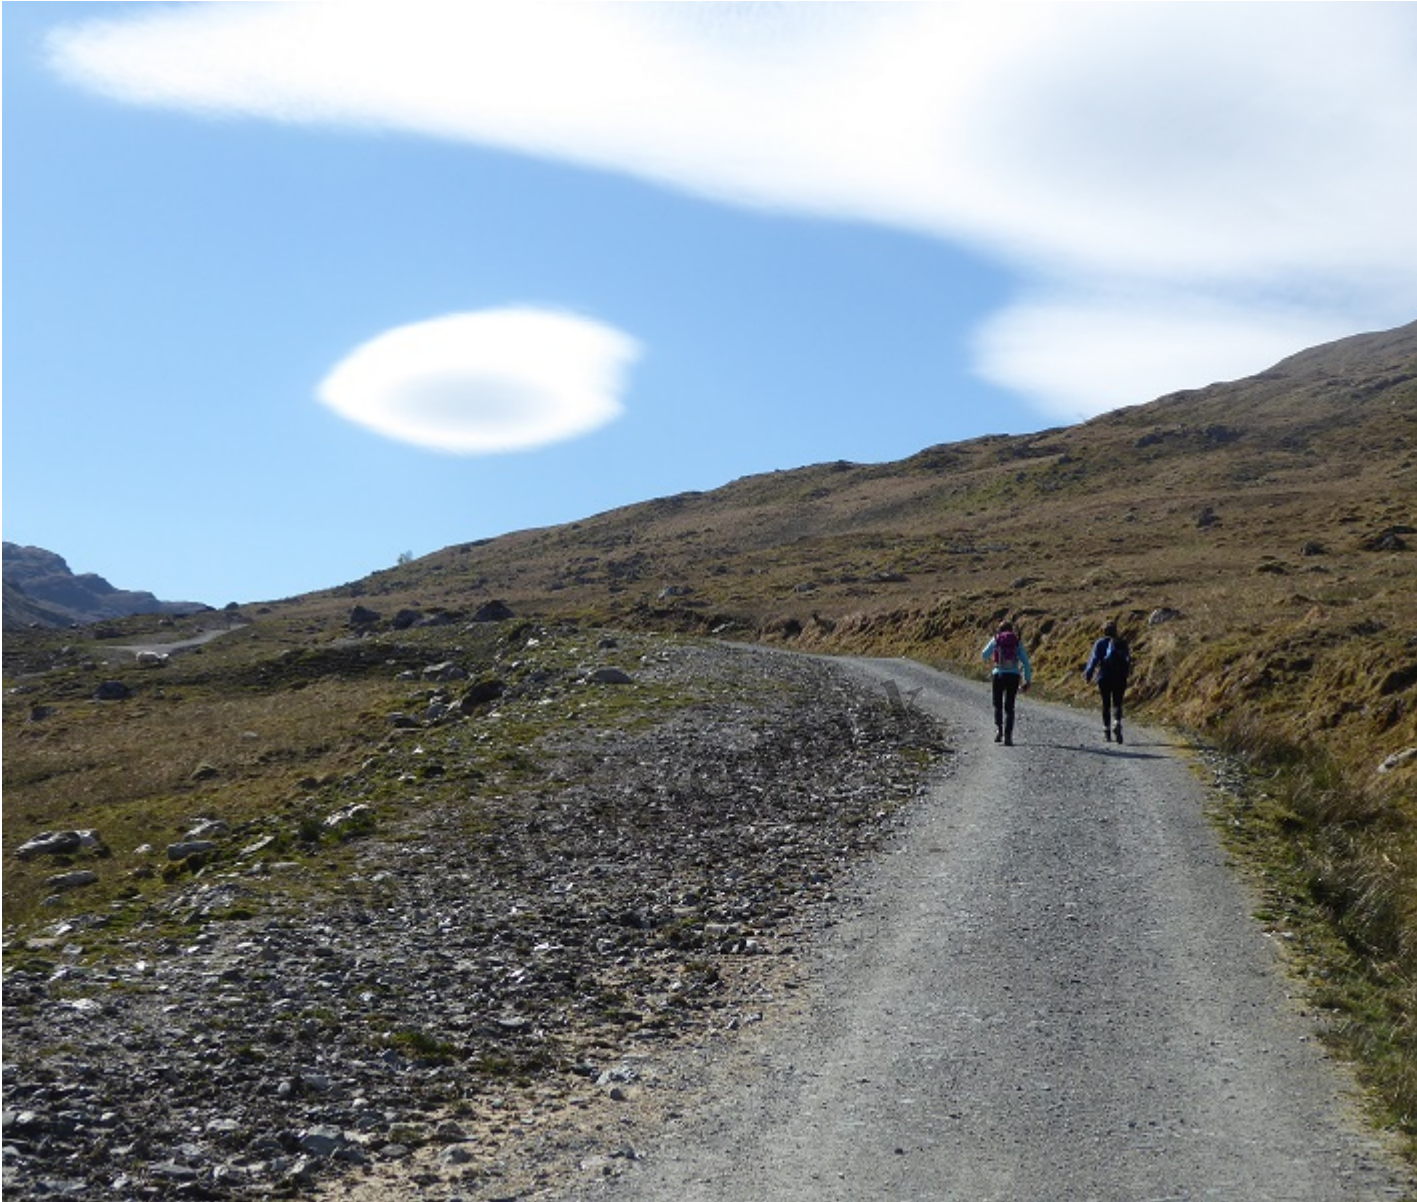
The pre-existing track which ended a little further up the hill, was widened for the hydro construction cutting a further batter but by importing aggregate (left) to use as fill.

There little attempt (photo above) to shape the the fill so it merges into the contours of the land. The result is a broad bench cutting across the hillside. In landscape terms, the track here is in effect still 5-7m wide rather than the 2.5-3m recommended by the National Park.

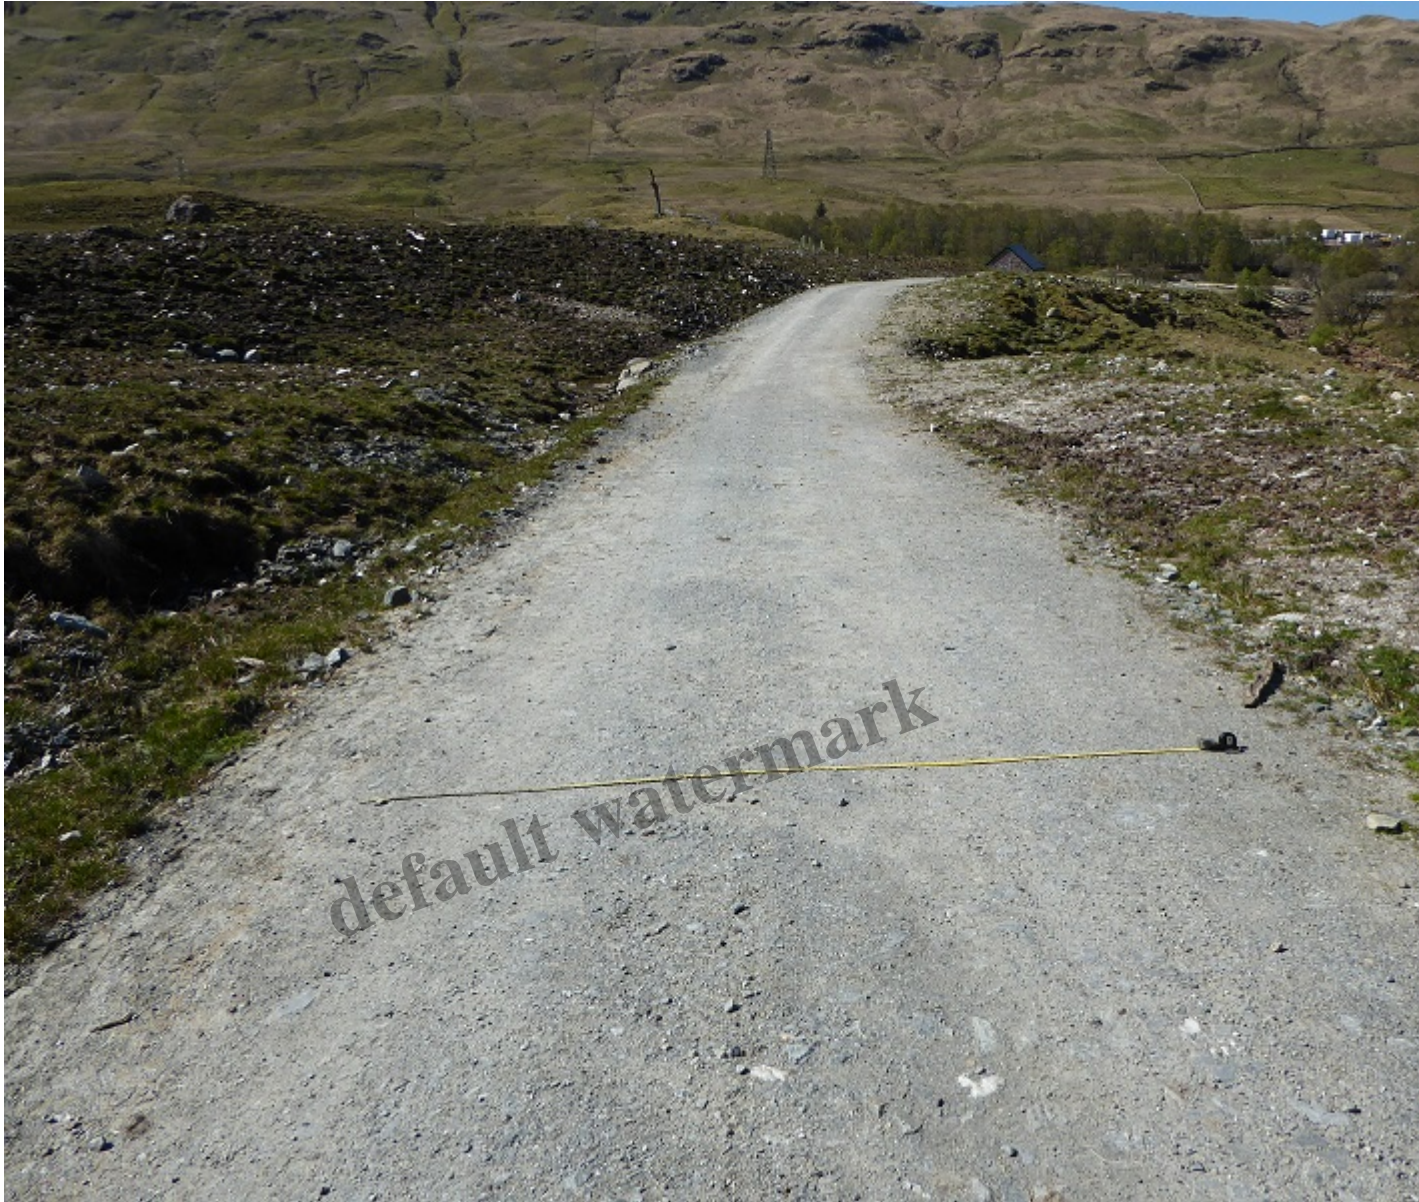
The 3m mark on tape measure is just to the left of the small stone holding the tape measure in place

Even on the better sections, the track is far wider than the LLTNPA requires. I took my 3m tape which is here fully extended on a section of track which slopes gently downhill. I think a 2.5m track would have been more than adequate here (and probably less as you can see from the vehicle marks) but the actual track is more like 3.5m wide. What is the LLTNPA going to do to address this? The wider the track of course, the more it will stand out from a distance. There is no evidence of the central grass strips which grace the Allt Andoran track (top photo).

5. Where existing tracks were widened, the LLTNPA needs to ensure that all the restoration meets the standards set out in its good practice guidance. Tracks which are broader than the maximum and unfinished culverts for example should not be tolerated.
