The Glen Falloch hydro schemes (8) – their impact on the landscape and what needs to be done

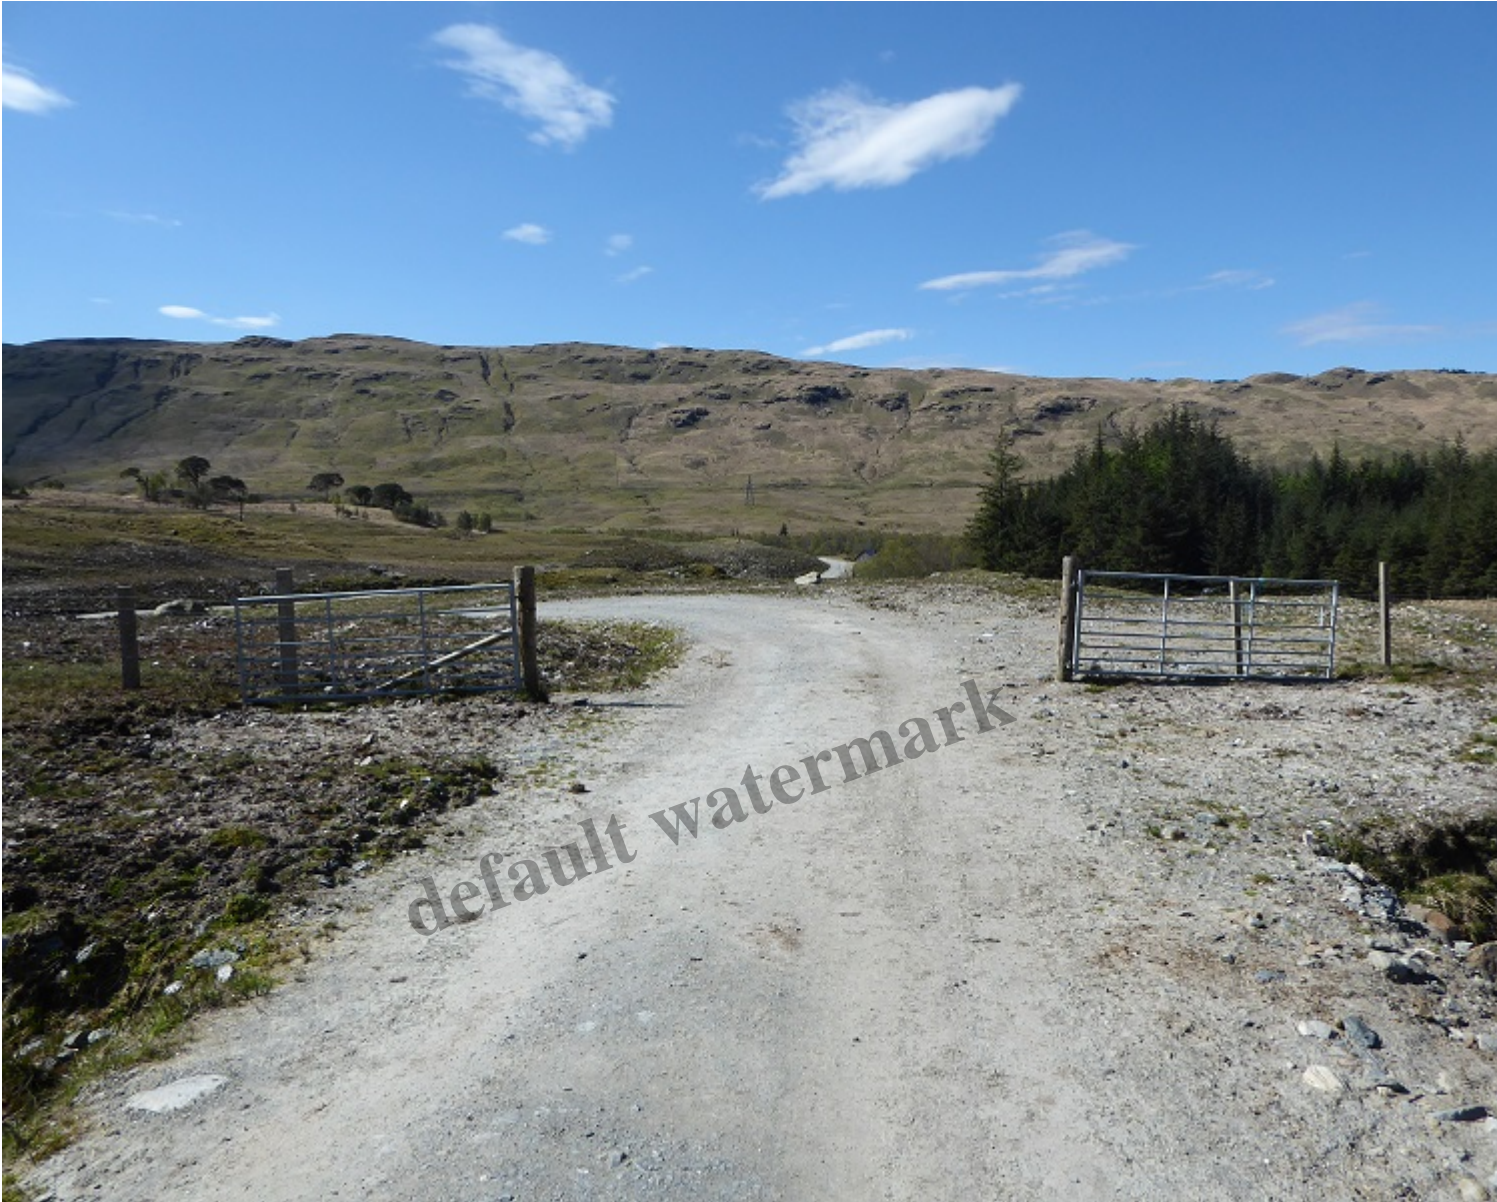
If there was any serious intention to narrow the upper Falloch construction track this double gate would have been removed – another illustration of just how wide this track is.

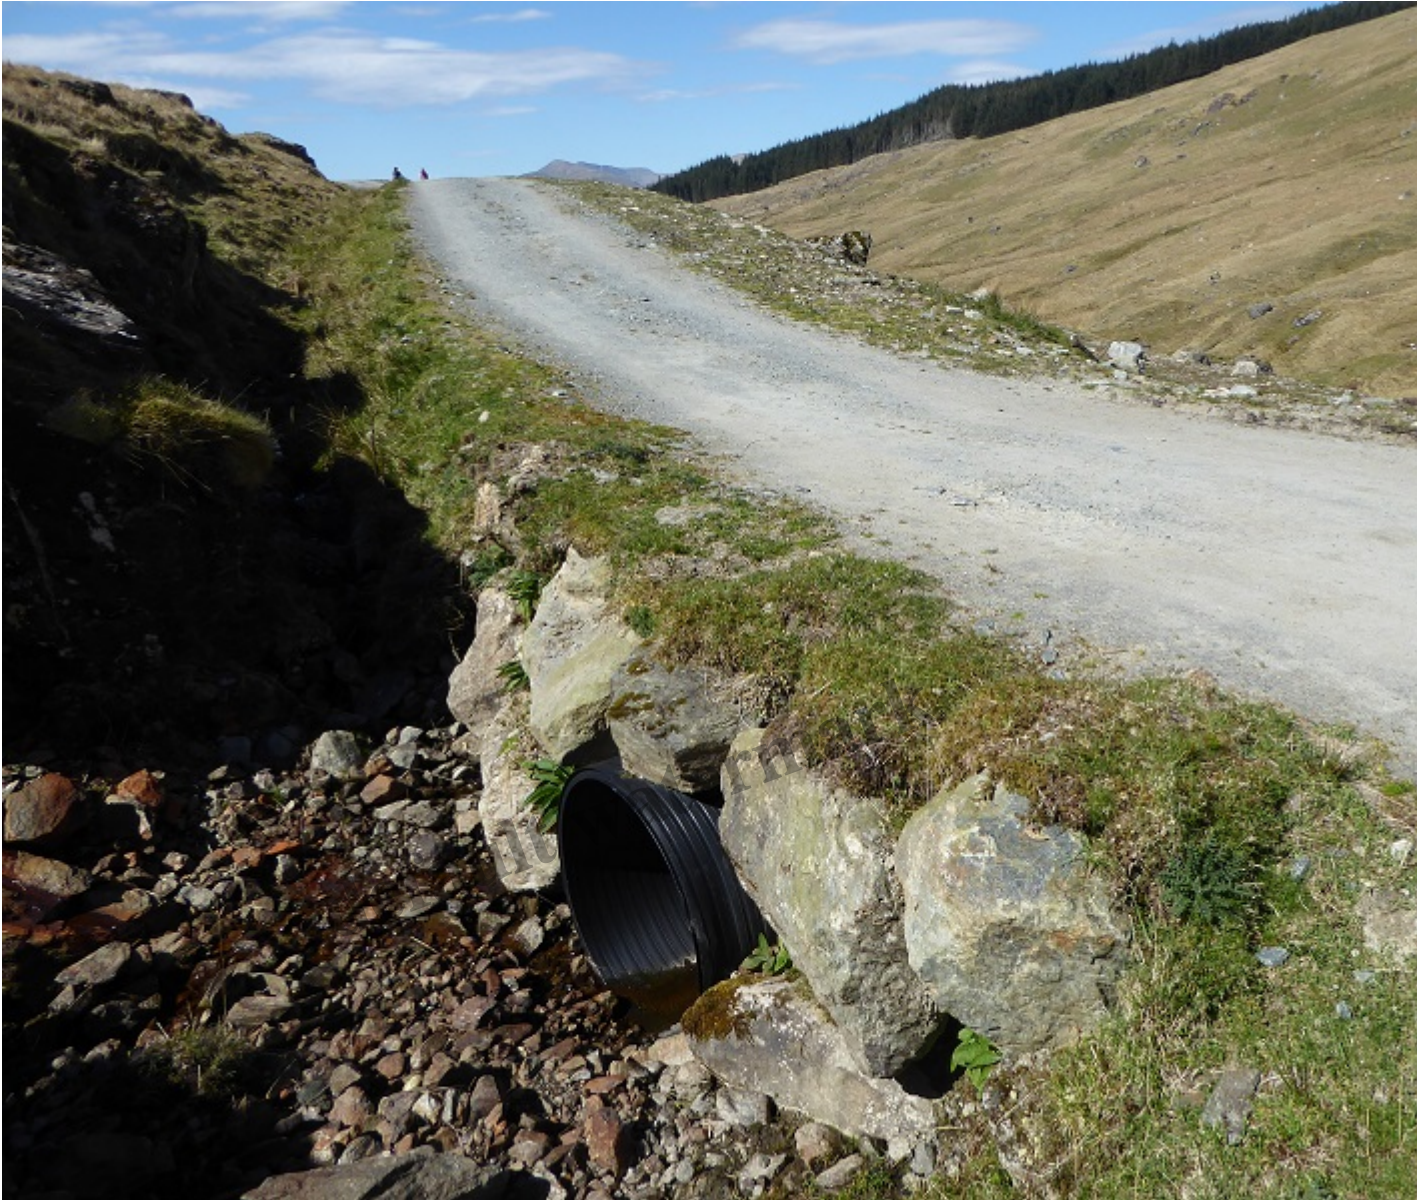
Where turf has been stored successfully, then used alongside the track and cattle have been kept off, the restoration does look better, although the protruding plastic culvert tells a tale

The restored sections however are few in comparison to those that still need attention and at this rate the track is going to take years to restore to anything like an acceptable state. That is unacceptable in a National Park whose current Plan incidentally states (and rightly so):
