Ledcharrie Hydro – another plook in the Park

June 11, 2017

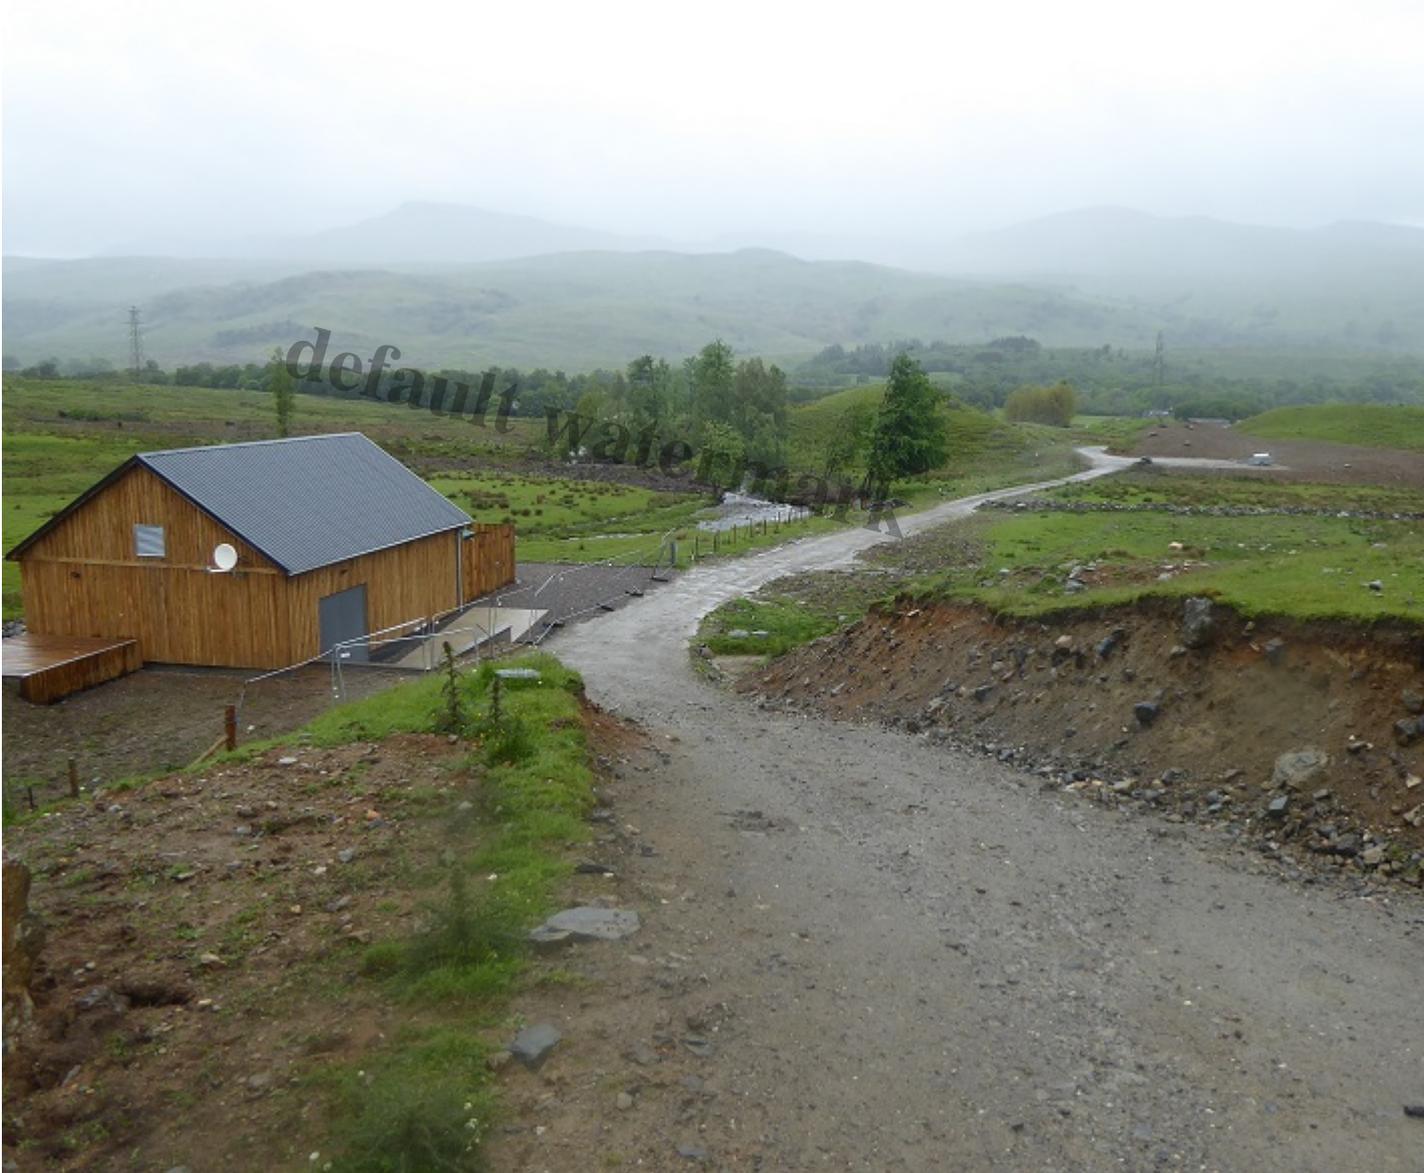
People were generally positive about the design of the powerhouse, liking the use of natural materials, but some were concerned about its impact on the landscape, unlike the scar on the right of the track.

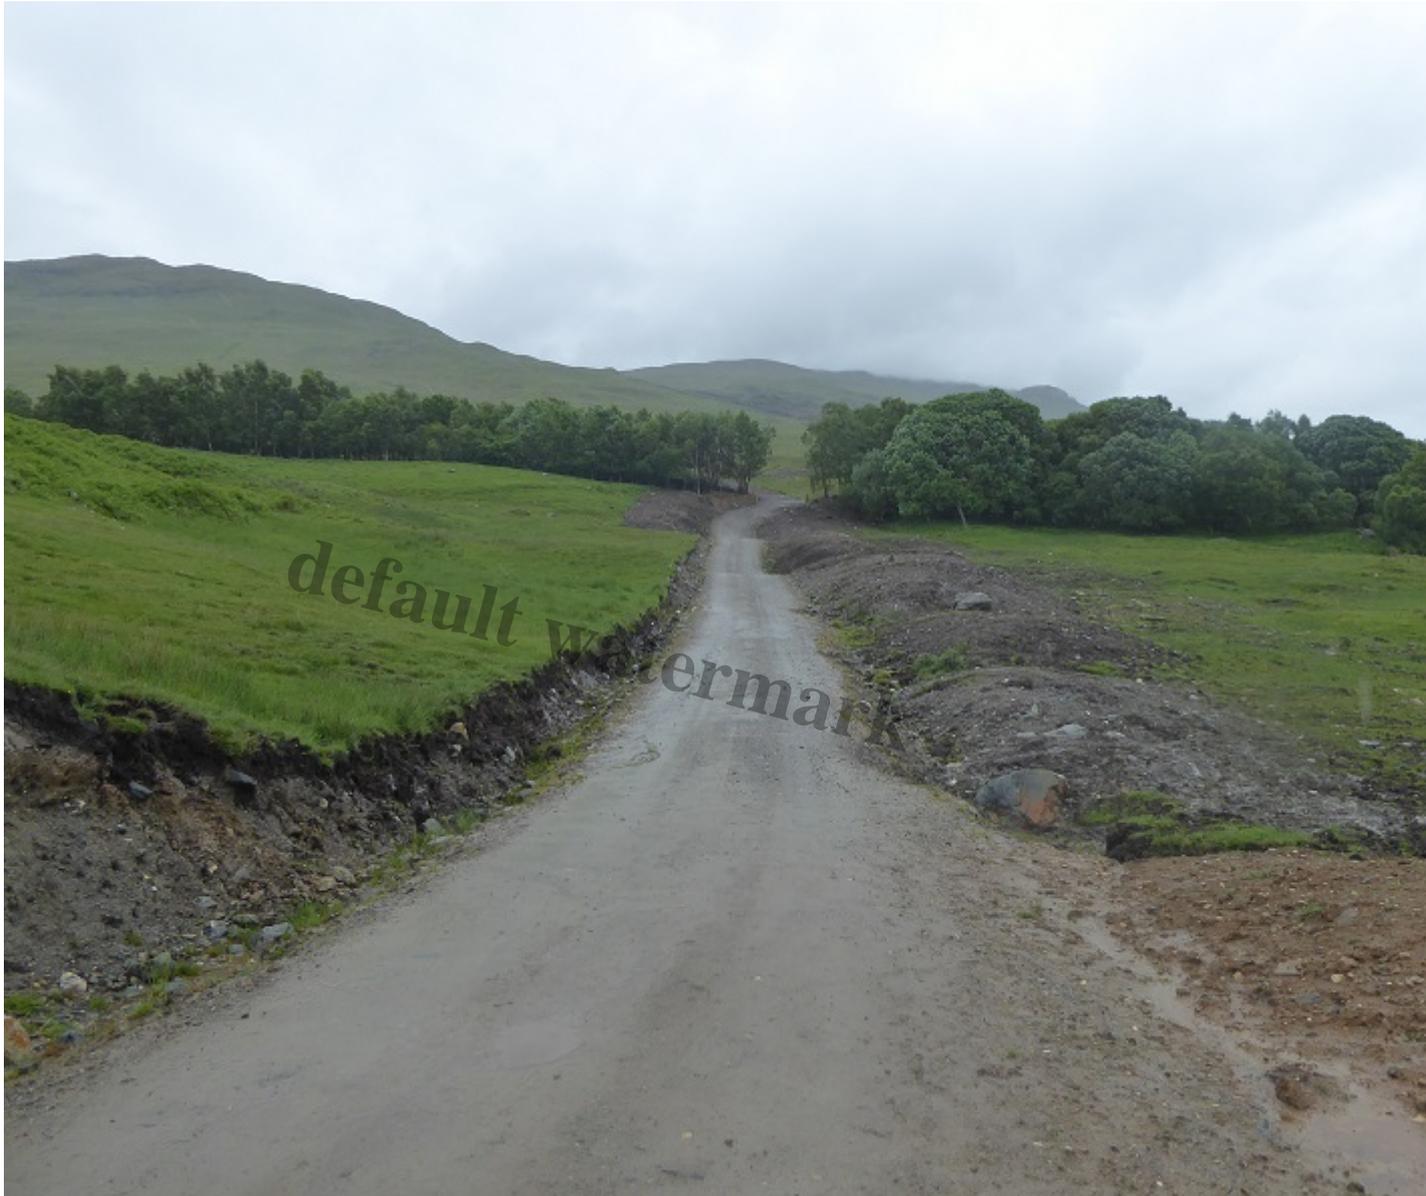
Looking uphill from the same position. The line of trees marks the former Callander â?? Crianlarich r

There was no machinery left of site, which is an indication that the developer, Glen Hydro Development Ltd, believes the work is finished. While I had seen plenty of hydro tracks with oversteep batter sides (banks) â?? which is contrary to the Loch Lomond and Trossachâ??s National Park Authorityâ??s Supplementary Guidance on Renewables ([see here](#)) â?? I had not seen mounds of earth, as on the right. The way the land lies here, they are totally out of place and have changed the landscape. These things should matter in a National park.

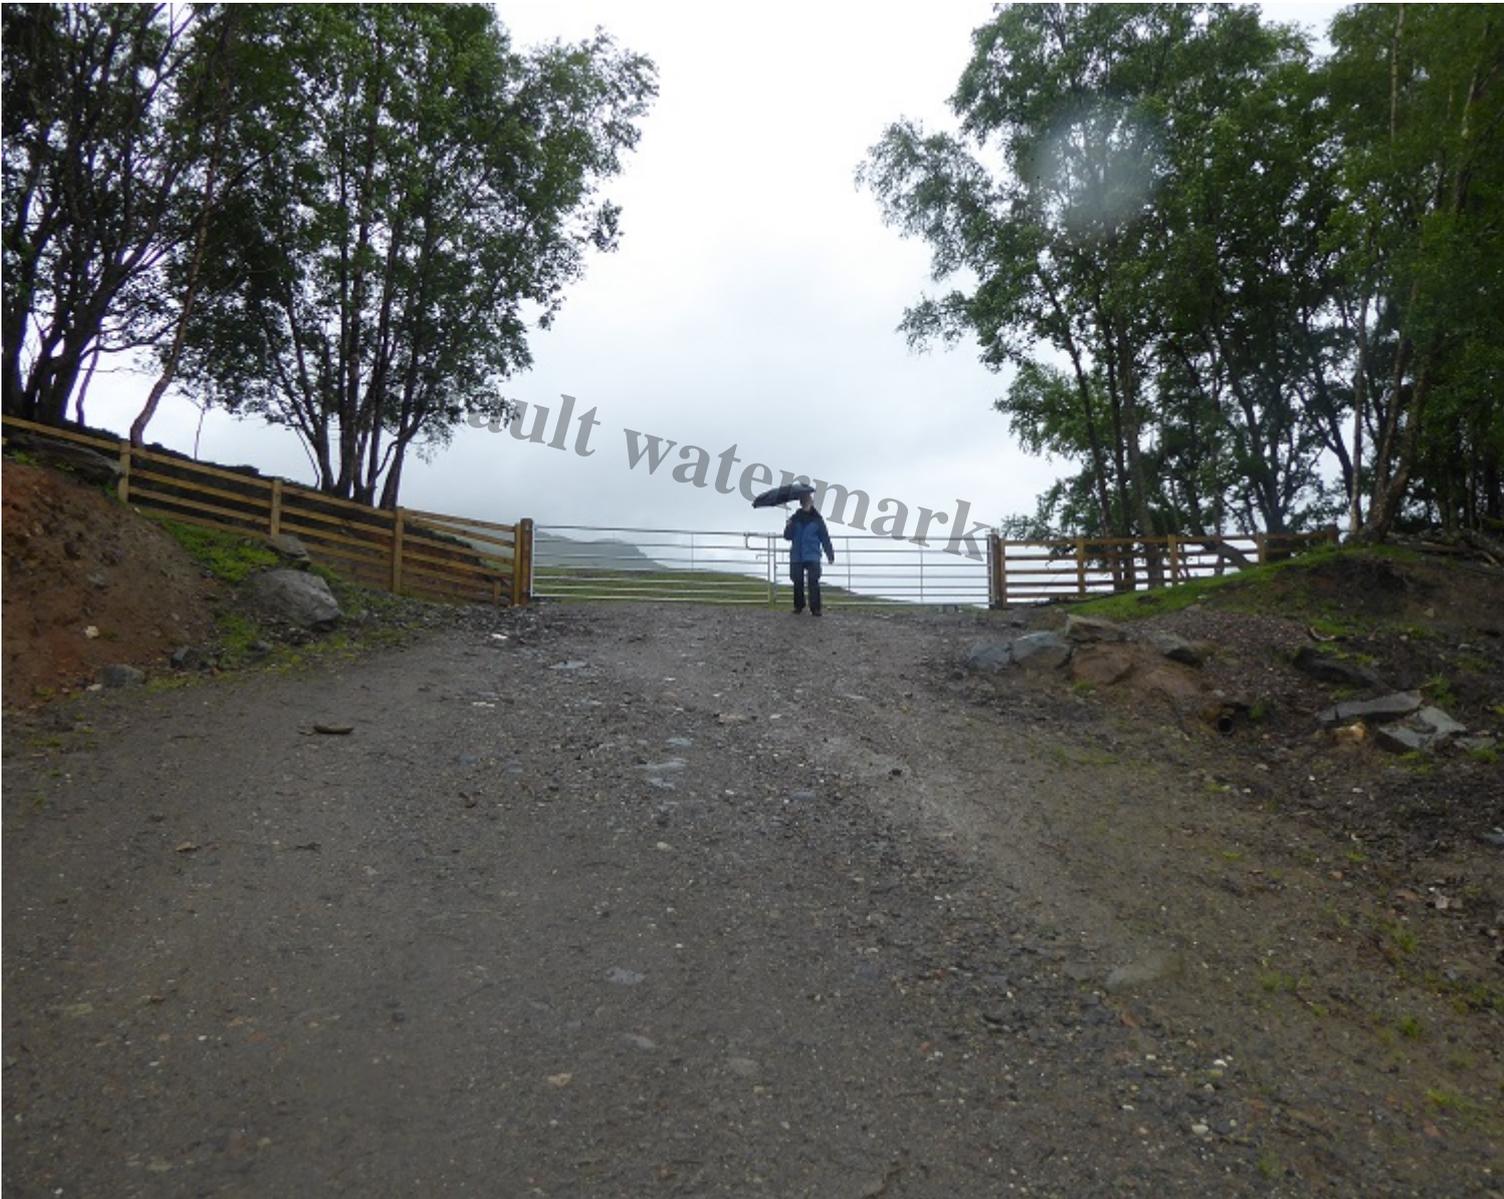
The width of the new track is in places extraordinarily wide, as the double gates illustrate. Double gates have also been left in place at the Glen Falloch Hydro Scheme. One way the LLTNPA could help ensure tracks are narrower is by requiring all double gates to be replaced by single gates after construction has finished.

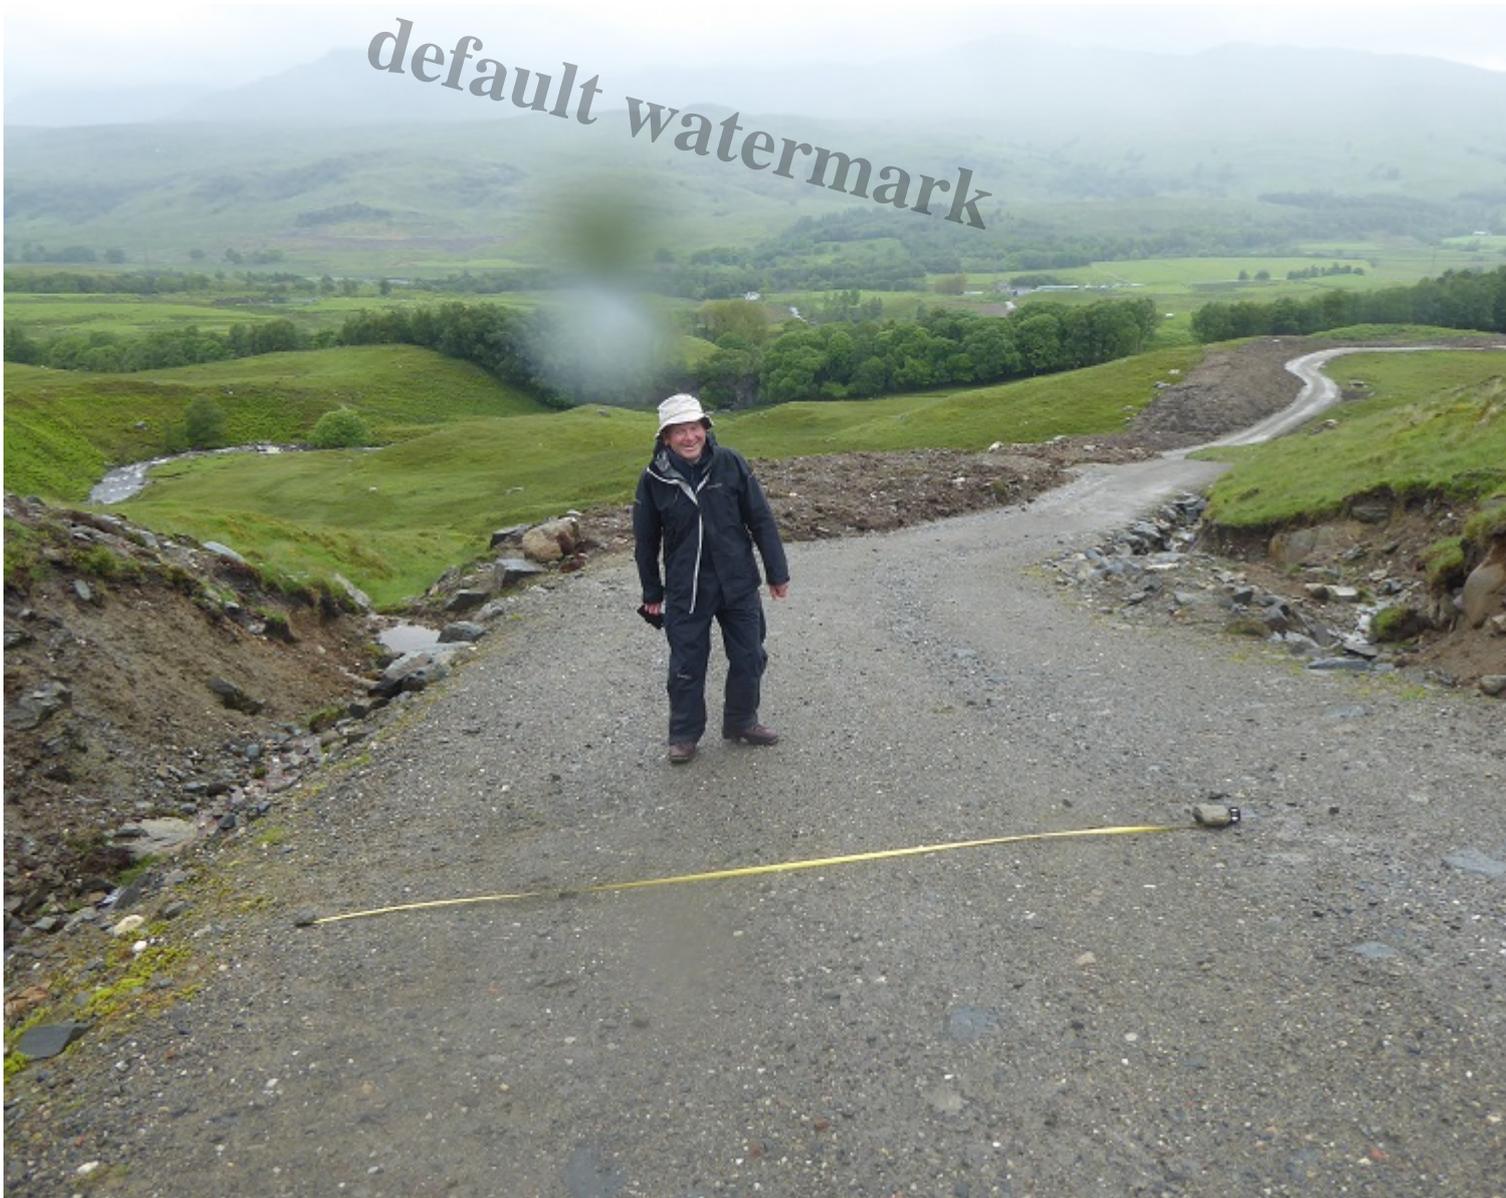
The tape measure here is extended to its maximum, 3m. The width of the track is close to 6m and there has been no attempt to restore the banks on either side creating a 9m broad scar up the hill. This should be totally unacceptable anywhere, let alone in a National Park, which says it believes uphill sections of track should just be 2.5m wide.

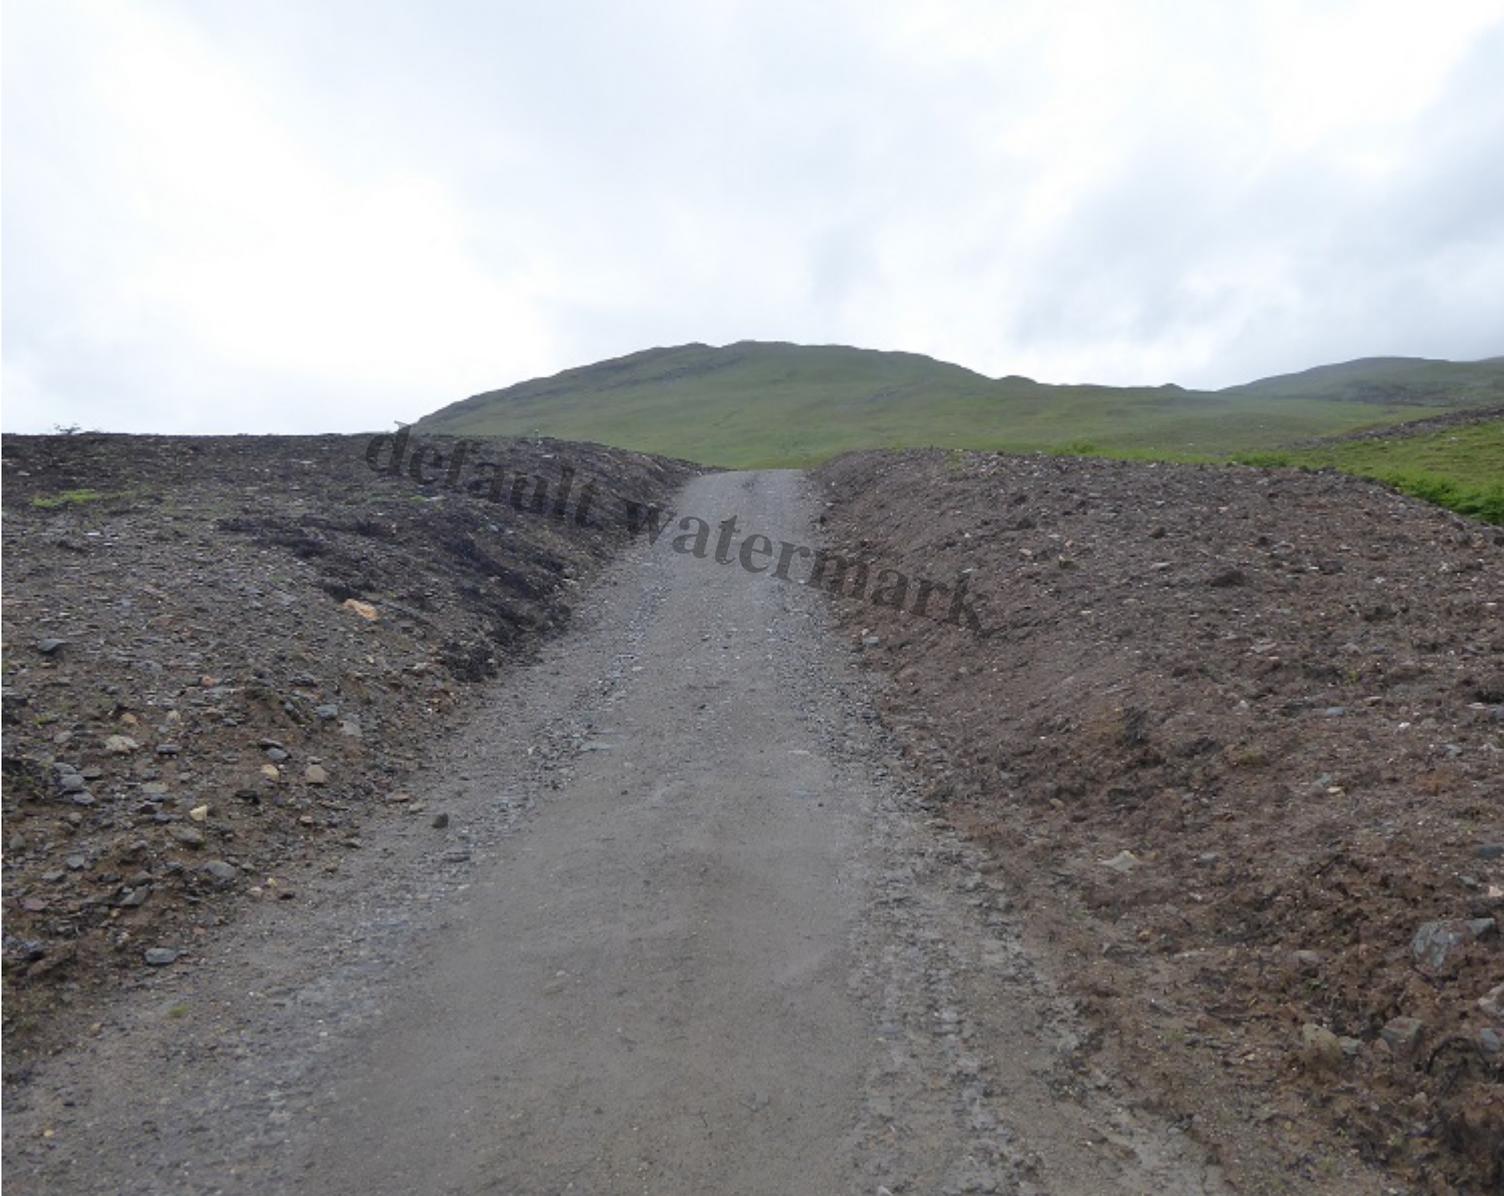
Not all the track restoration is as bad and there is short section above the double gate (above) where it almost meets the 2m specification and there has been a reasonable attempt to restore the land to its original condition. Why here but not elsewhere is a question worth asking? It seems totally arbitrary.

Even here, though, all is not as it should be. On the left bank the developer appears to have run out of peat to place on top of the bouldery soil. The Planning documentation required a:

Unfortunately the LLTNPA does not generally add documents required in a planning consent to the planning portal so its impossible for the public to see plan for retention of turves was agreed. The photos show however that whatever happened, insufficient care was taken in removing and restoring turves, with the result that large areas of ground have been left bare.

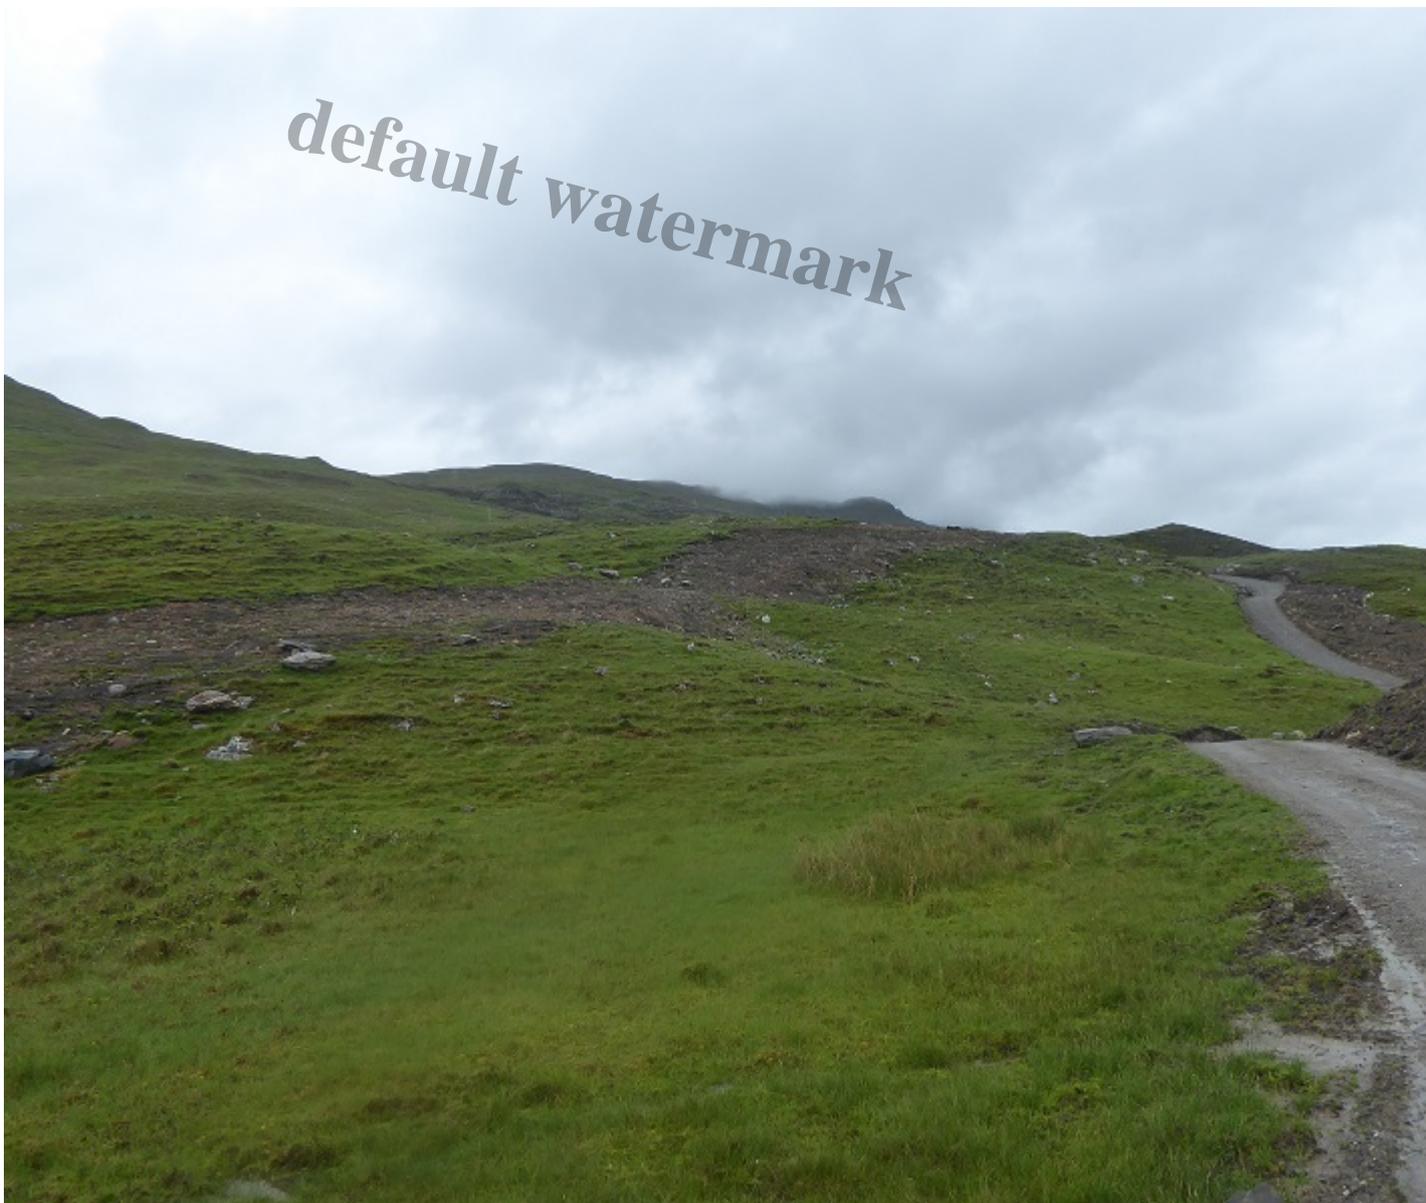
Impact of pipeline (left) compared to track

The photo (above) shows this never happened – the problem is the LLTNPA is not monitoring its planning requirements on an ongoing basis through construction with the result they are ignored. While this is a failure, in landscape terms, the Munro Society members were generally agreed that the main landscape concern is the track because the vegetation above the pipe, although not restored properly, is likely to recover quite quickly.

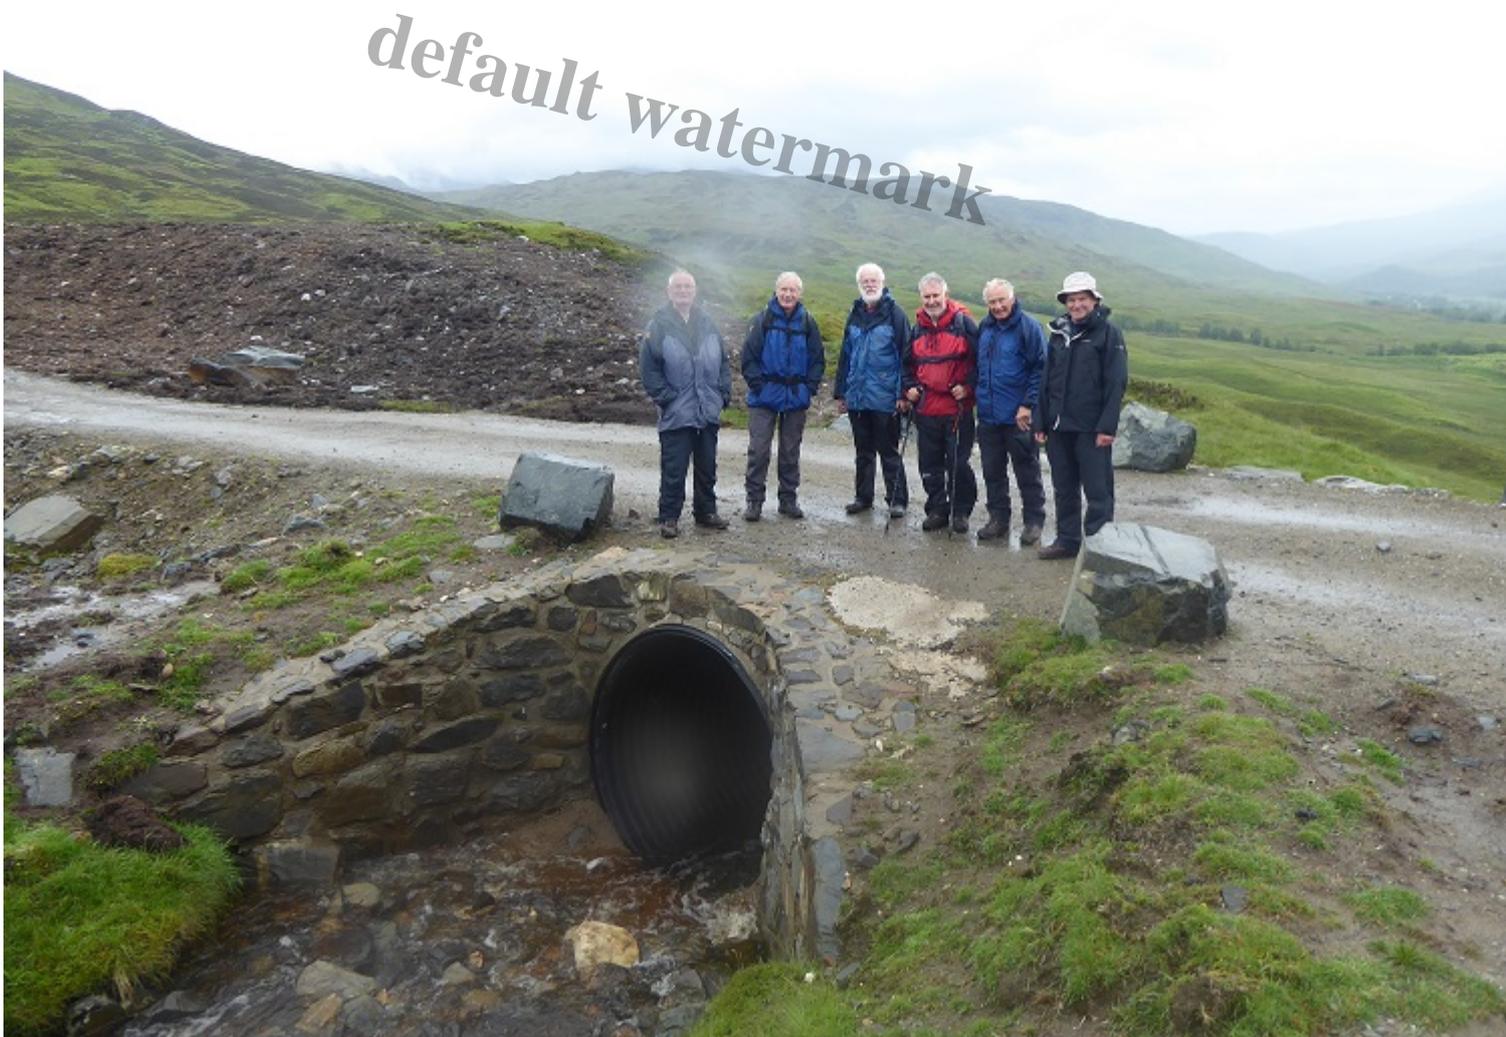
thought about various aspects of the hydro development. I have rarely seen a constructed stone culvert in the LLTNPA hydro schemes as above. They approved. While the track at Ledcharrie is far too broad, increasing its impact on the landscape, almost every culvert pipe had been properly finished, (unlike the Glen Falloch schemes). Just why contractors are good at one thing or in one area but then fail totally in others is another question that needs to be asked. I suspect the problem is a lack of monitoring from the LTNPA to ensure consistent high standards. If the problem is lack of resources to do this, the answer is simple: re-direct resources away from chasing innocent campers and direct them to protecting our landscape. The impact of even the most irresponsible of campers is temporary, the impact of these track is, in human timescales, permanent.

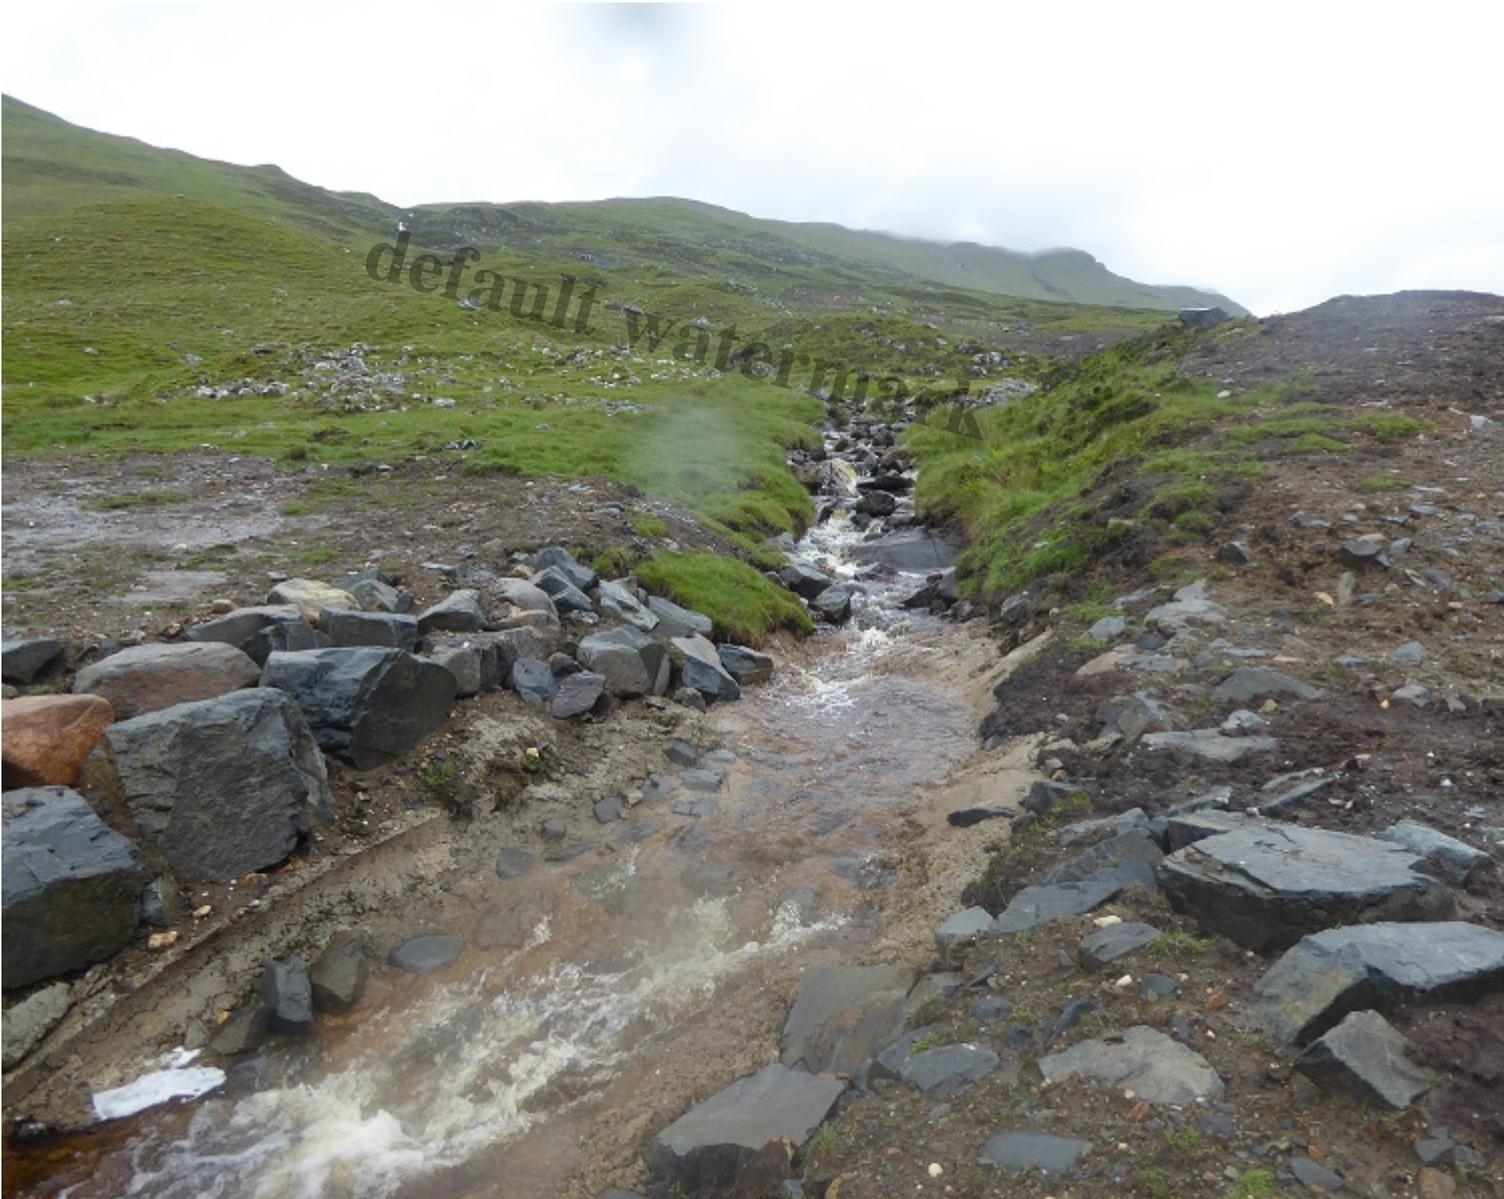
Just upstream of the culvert though, Stuart Logan, Munro Society President spotted that this. No-one present thought that lining stream beds with concrete is acceptable (this was the first time I had seen this). How could this happen in a National Park?

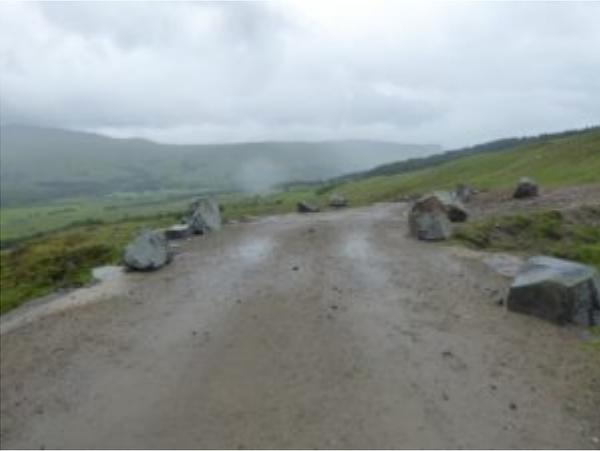
The track above the culvert was also very poor, not only far too wide, but it had been lined with blocks which appear to have been created by the developer blasting through rock bands where the soil was shallow. The end result looked more appropriate for a quarry than a National Park.

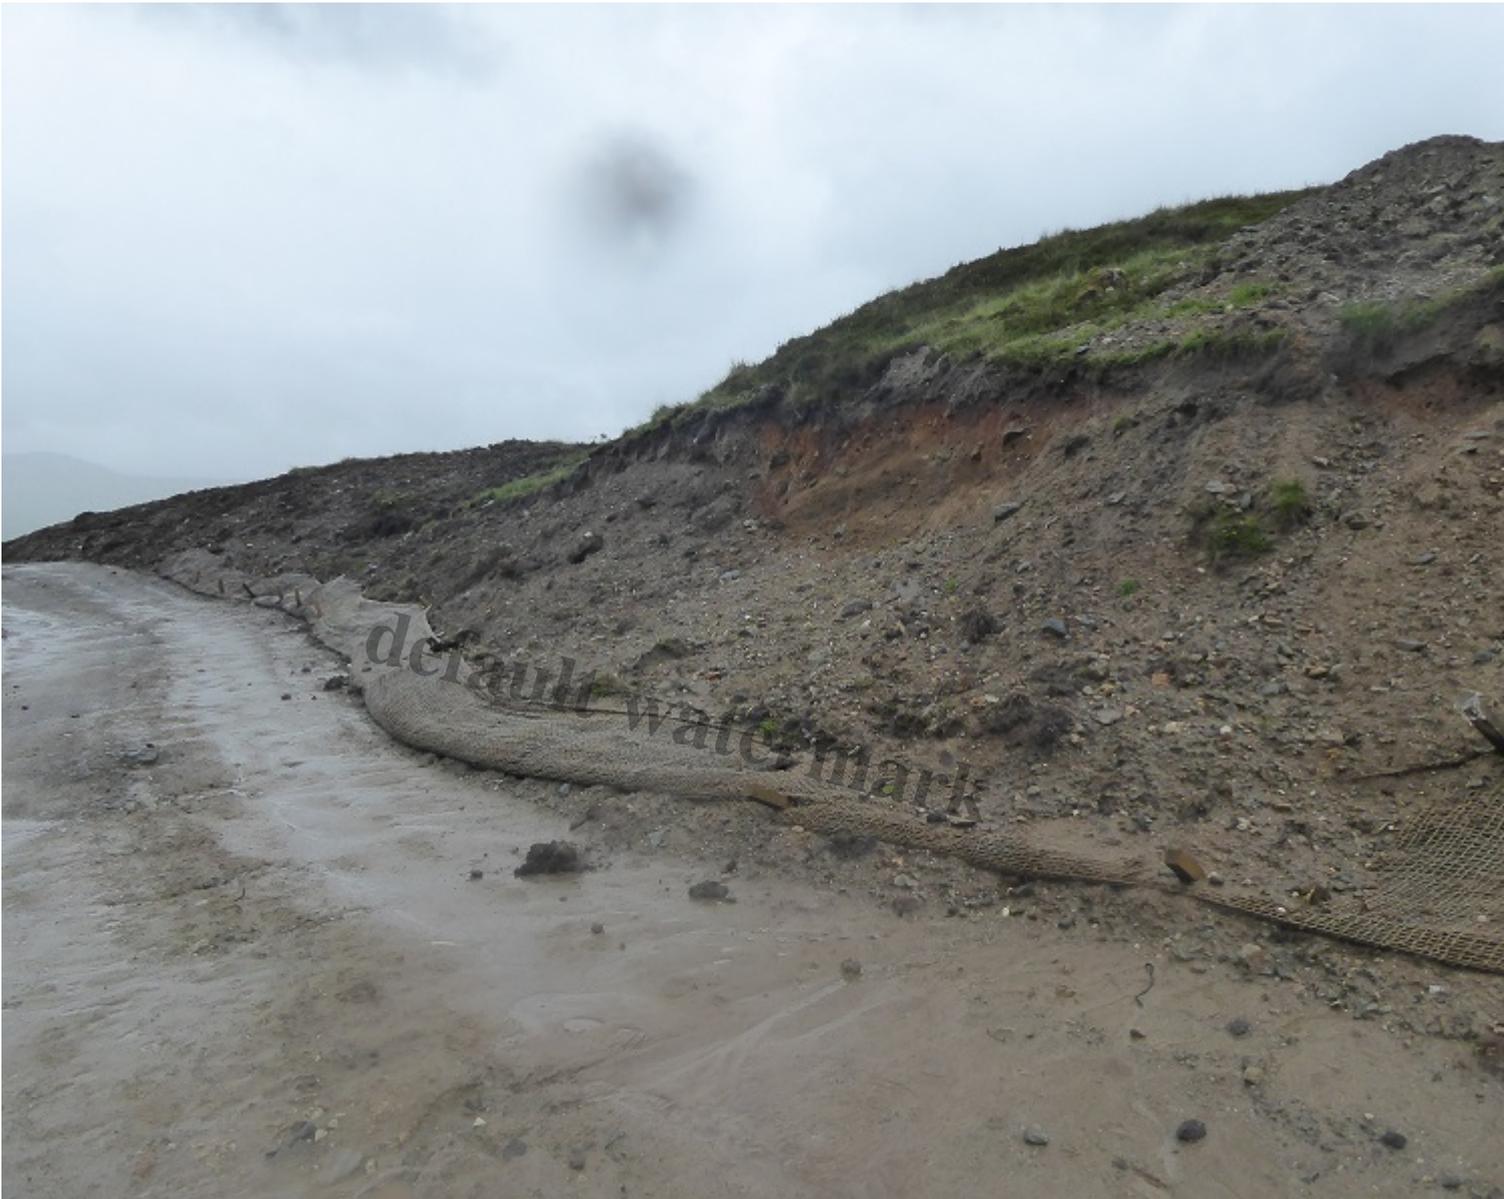
Another thing I had not seen was the use of netting in an attempt to hold soil in place at the edge of a track. Here the netting has totally failed and filled with material that has slumped down the slope, a consequence of the bank/edge of the batter being too steep. On the top right you can see how soil and rock, which could have been used to help reduce the angle of the slope, has been left dumped on top of vegetation.

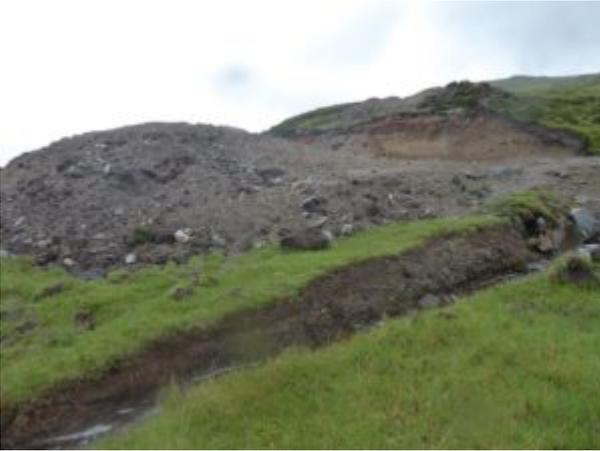
On the downside of the track, below the scar in the photo above, the material excavated to create the track had been dumped on vegetation and no attempt has been made to restore this. The drainage ditch is a later addition but, instead of using the new turves to help restore the ground elsewhere, they had been left scattered on the neighbouring ground (large turf centre)

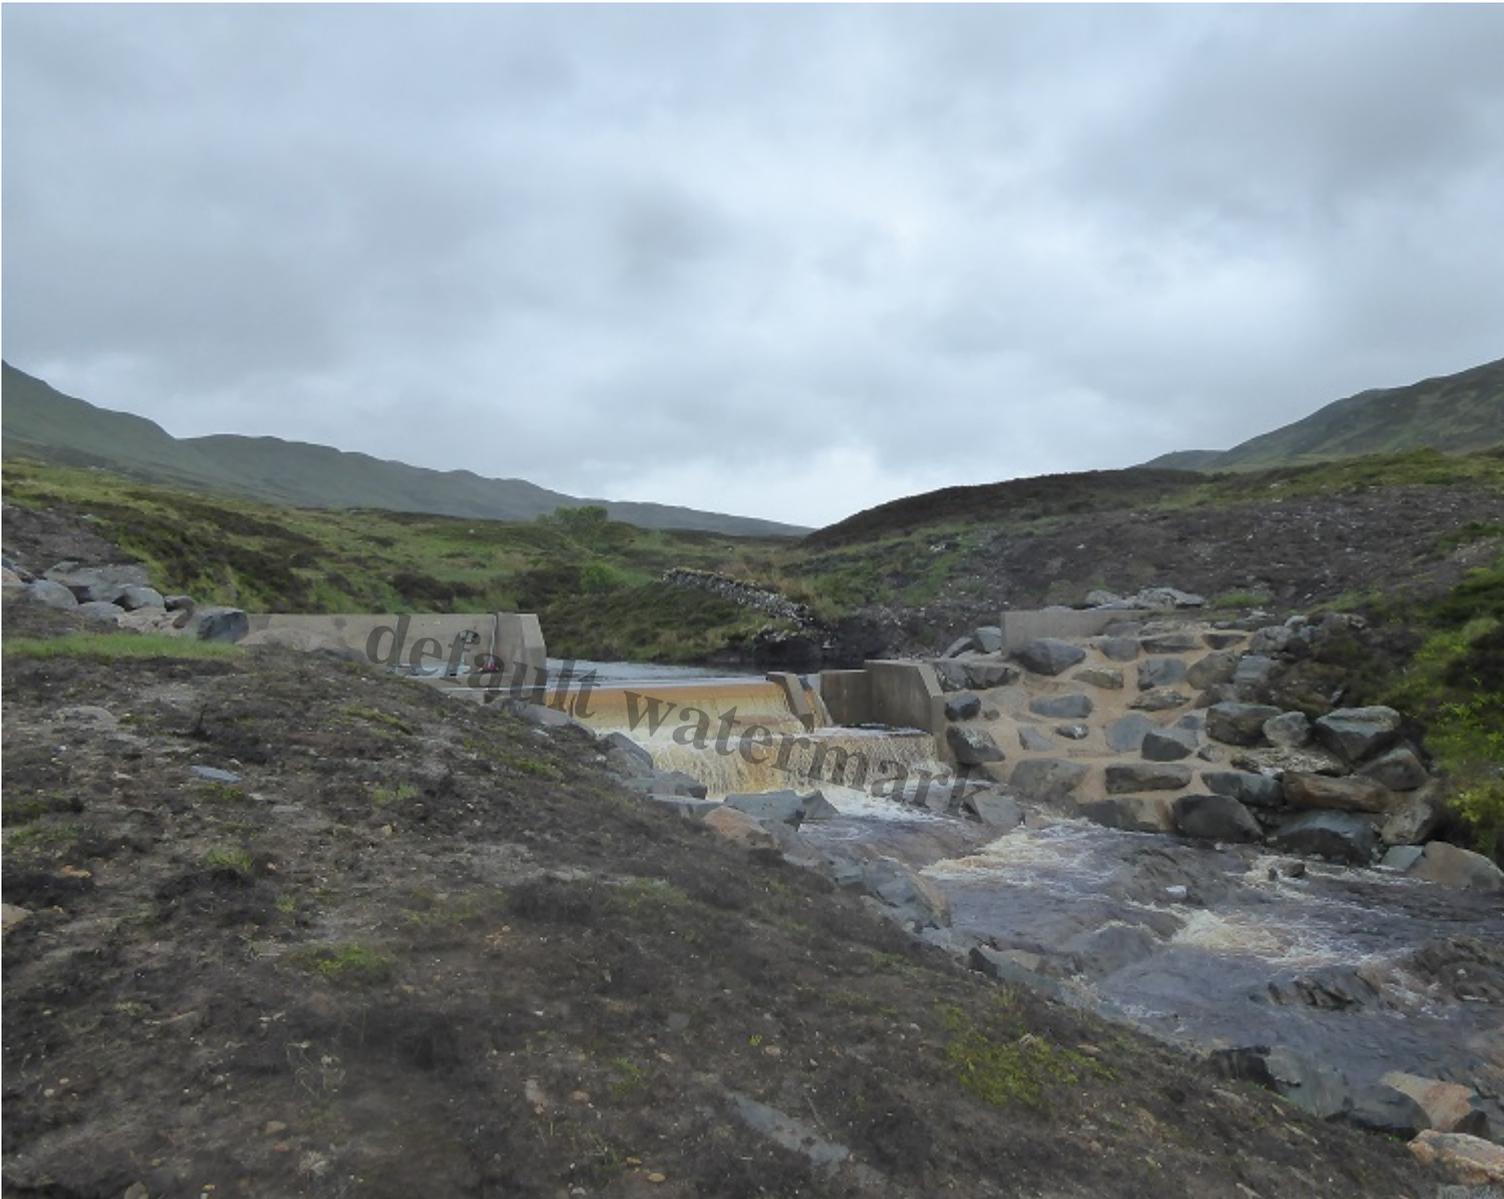
We had a good discussion about the main intake on the Ledcharrie burn. There was general agreement that the intake was well located being tucked below the level of the banks and surrounding ground and would not be visible from afar. There was debate about whether the rip rap embankment, in this case partially embedded in concrete, could have been designed better. I asked people about the concrete dam walls, pointing out the LLTNPA's Supplementary Guidance suggests these could be faced in stone, although I had never seen this. Someone pointed out there was plenty of material available to do this from the old dyke behind the intake (centre of photo). So why not?

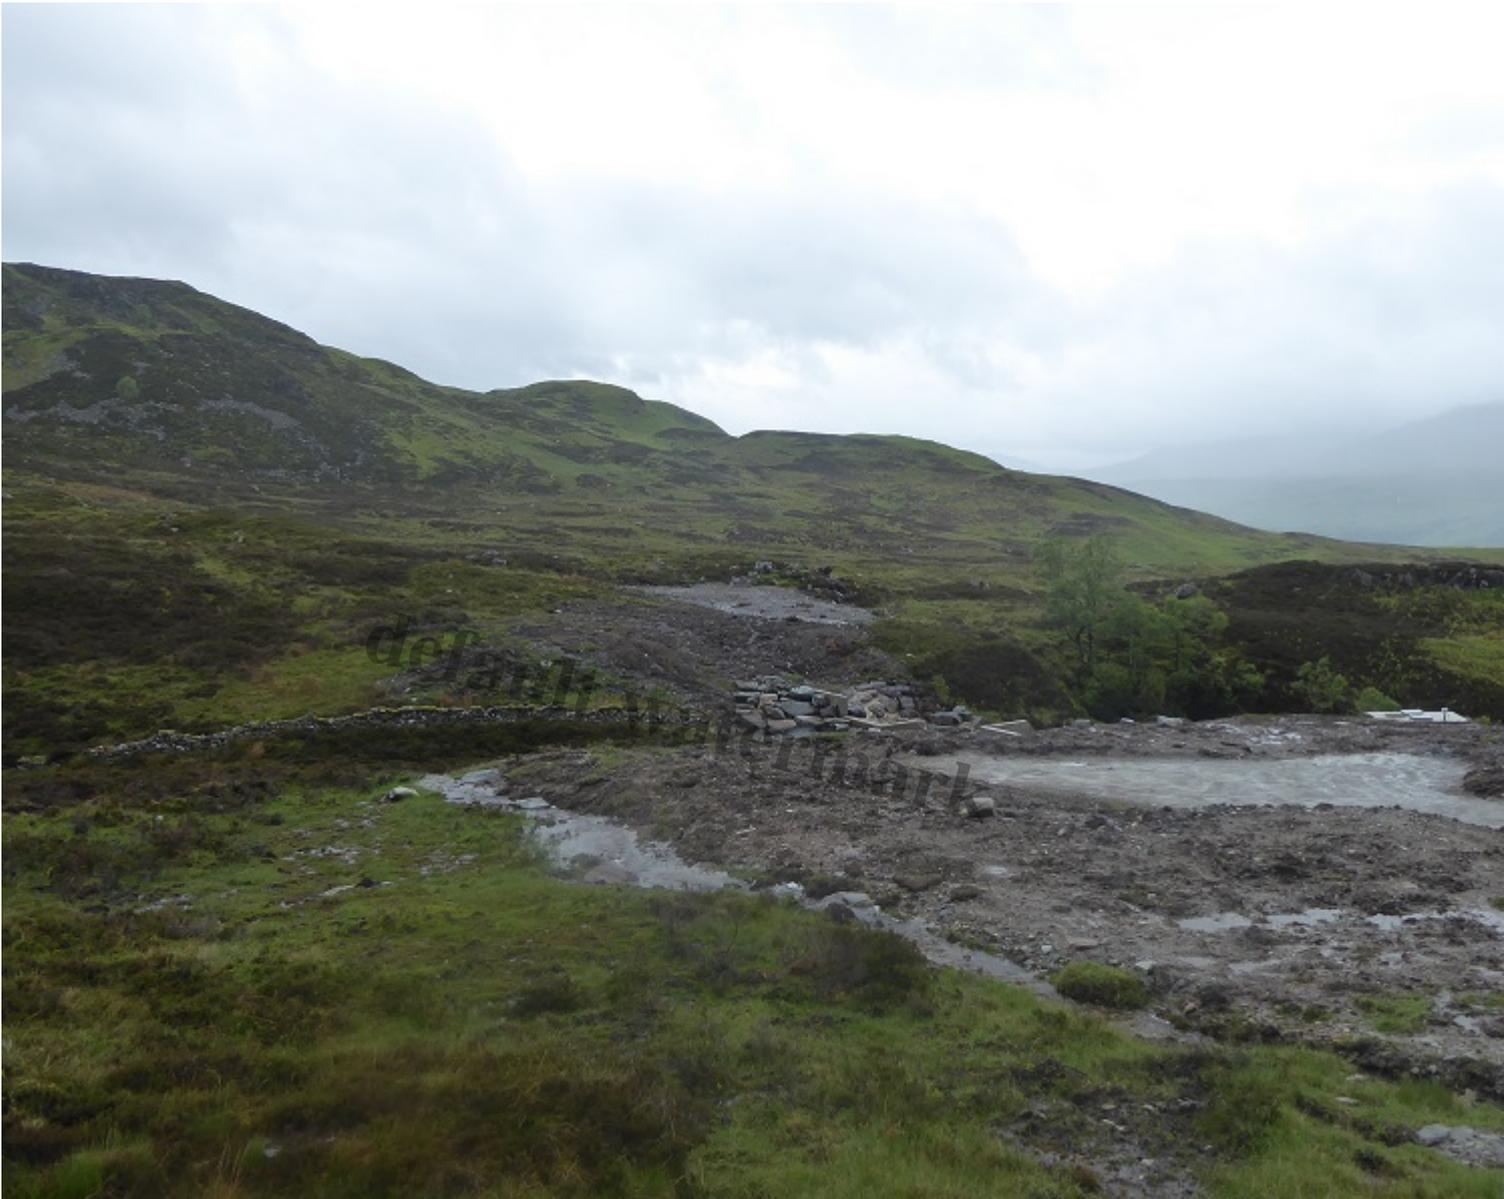
The first intake is hardly visible from 100m away except for the access track and turning area. (The burn slanting right to left has been diverted so it now enters the Ledcharrie burn above the intake. Another restoration failure can be seen centre far side of river – a patch of bare ground created because turves and topsoil were not properly stored).
