Ledcharrie Hydro – another plook in the Park

June 11, 2017

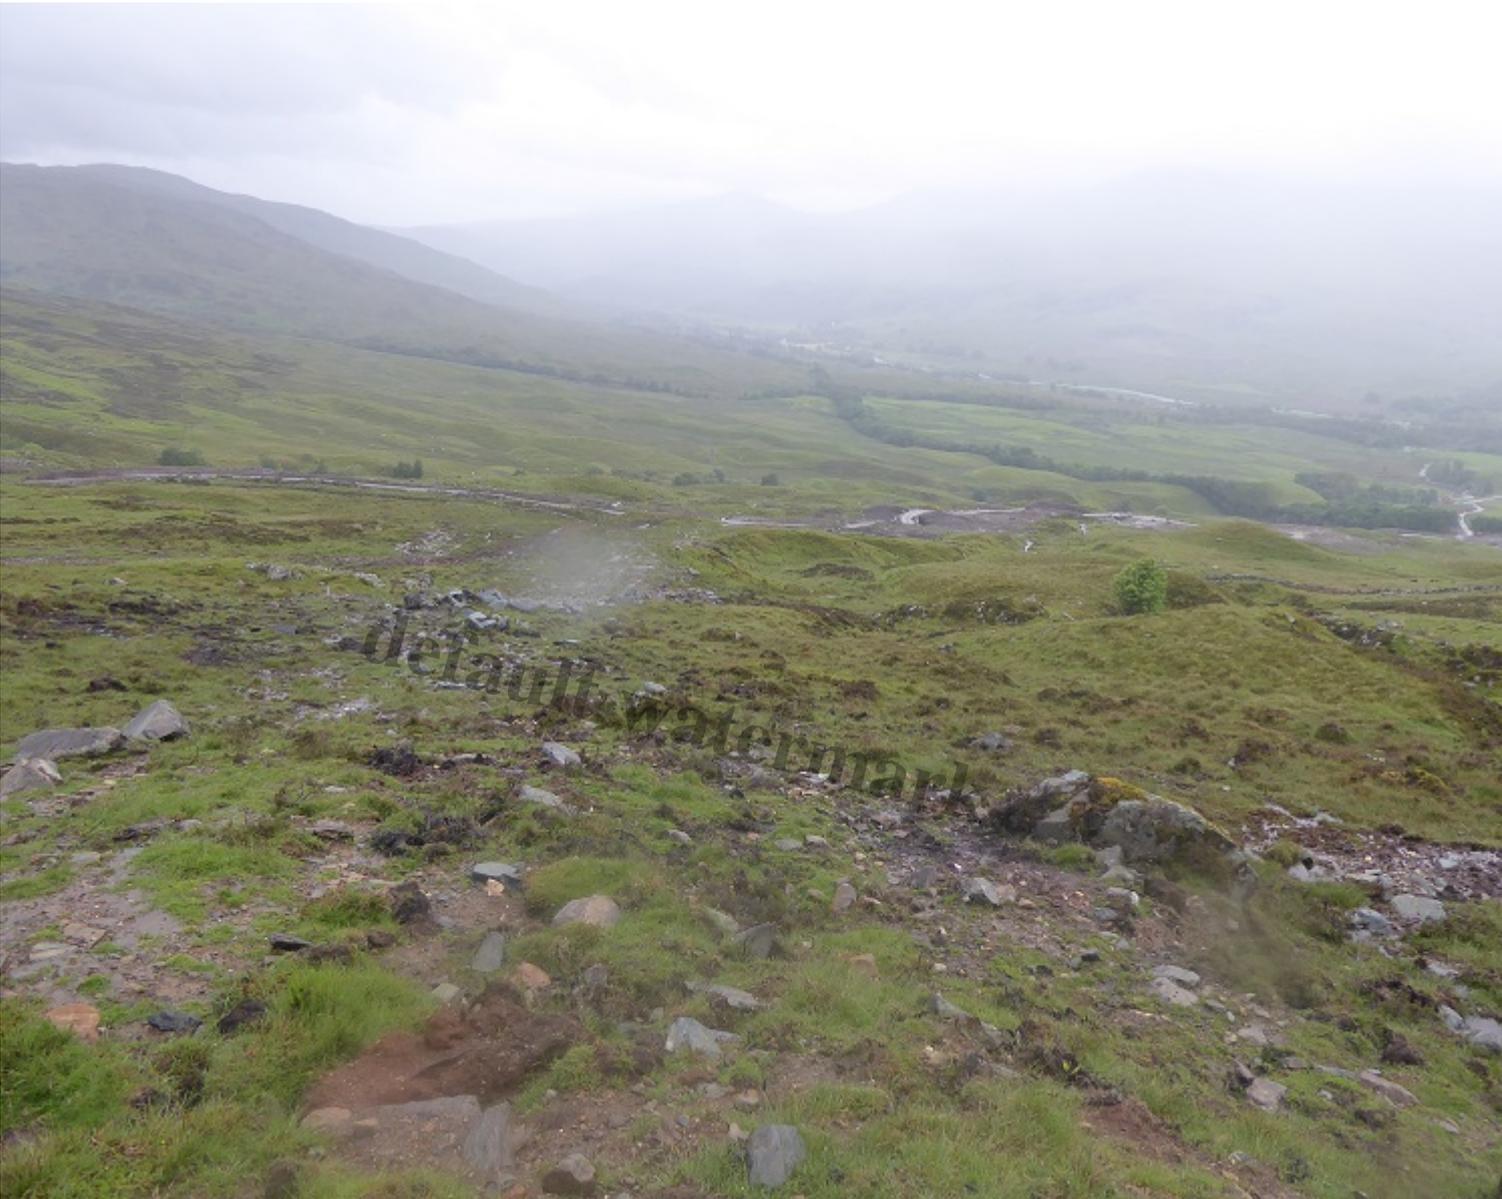
The second, and more minor intake, has no access track and the ground has been completely restored and to a higher standard than that on either side of the track below. The line of the pipe and temporary construction track will probably have disappeared within a couple of years. Everyone thought this was great, its how hydro schemes should be.

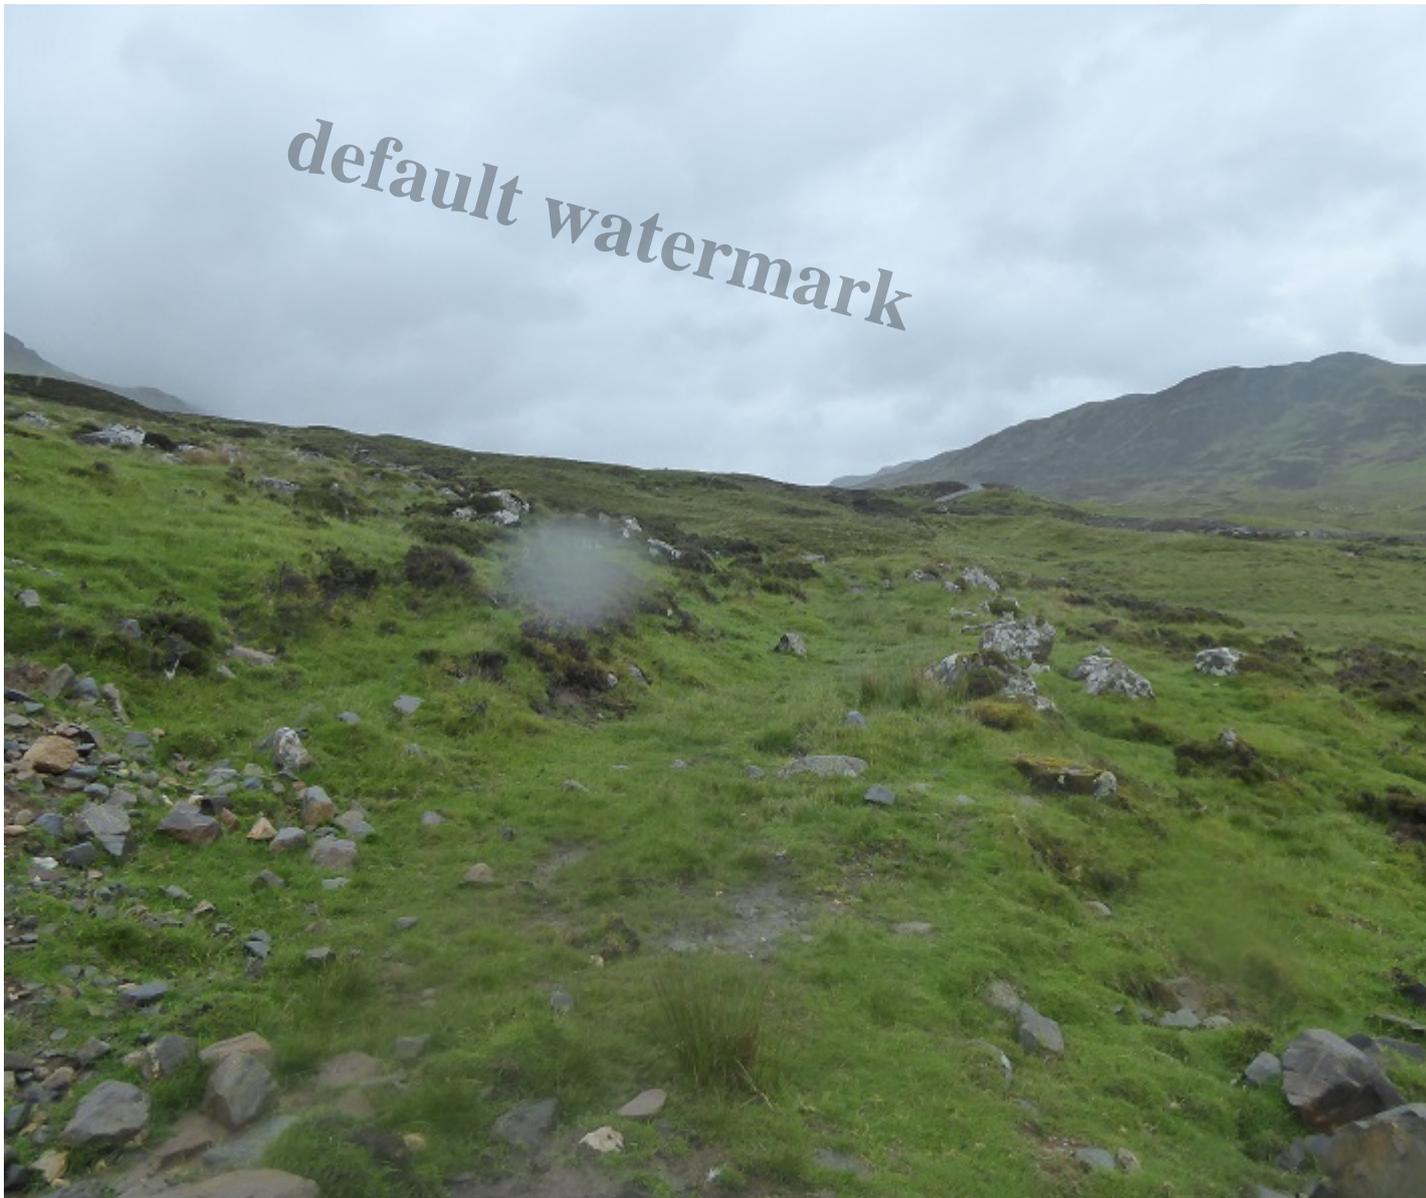
The old track over to Kirkton Glen is a "core path" - quite a contrast to the new track to the r...
Ledcharrie intake. The loose stones in the foreground are "spill" from the recent construction w...
