Ledcharrie Hydro – another plook in the Park

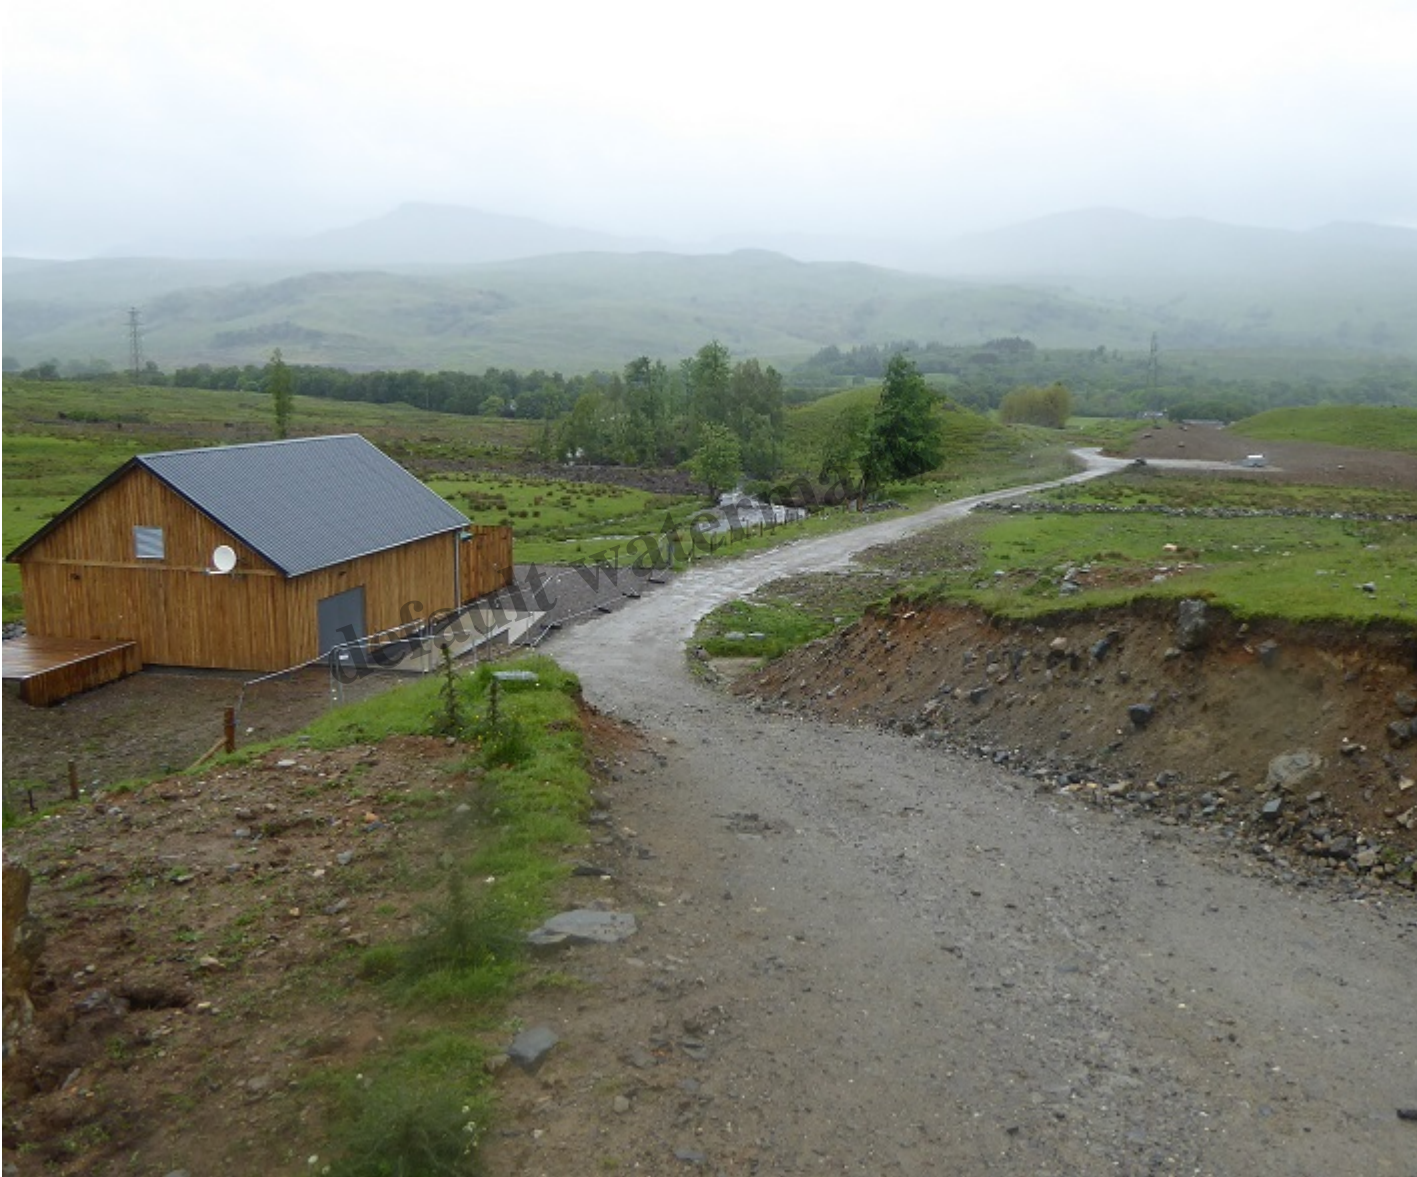
People were generally positive about the design of the powerhouse, liking the use of natural materials, but some were concerned about its impact on the landscape, unlike the scar on the right of the track.

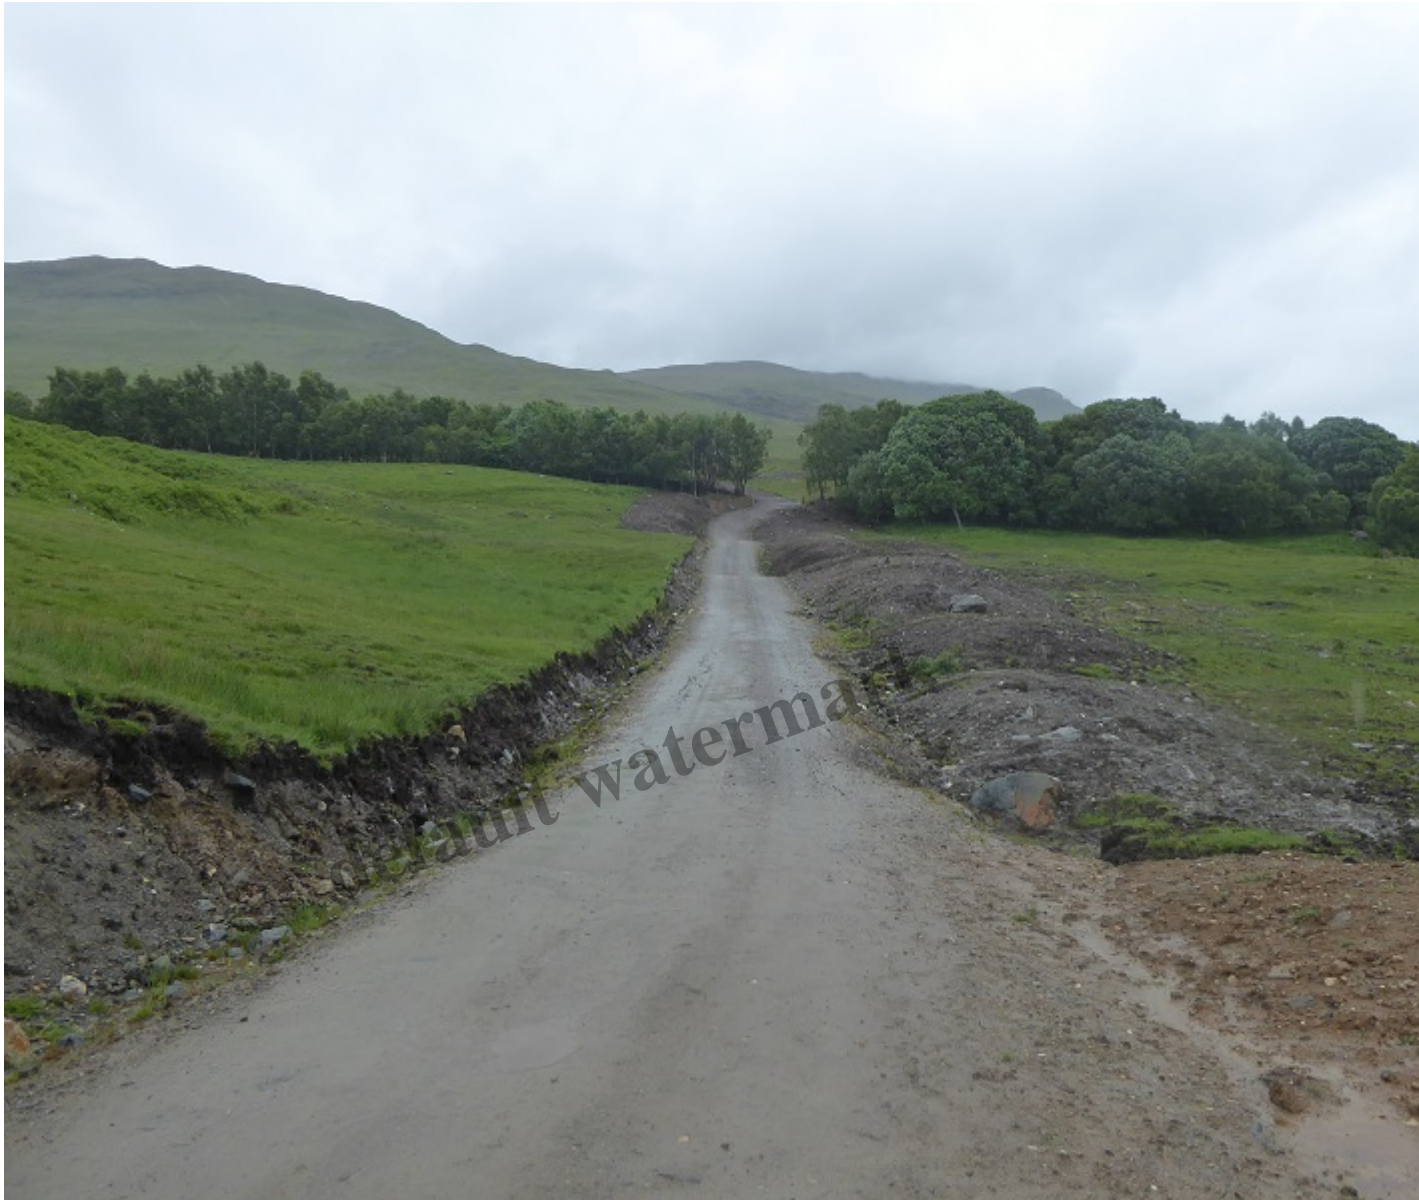
Looking uphill from the same position. The line of trees marks the former Callander – Crianlarich rail

There was no machinery left of site, which is an indication that the developer, Glen Hydro Development Ltd, believes the work is finished. While I had seen plenty of hydro tracks with oversteep batter sides (banks) – which is contrary to the Loch Lomond and Trossach’s National Park Authority’s Supplementary Guidance on Renewables ([see here](#)) – I had not seen mounds of earth, as on the right. The way the land lies here, they are totally out of place and have changed the landscape. These things should matter in a National park.

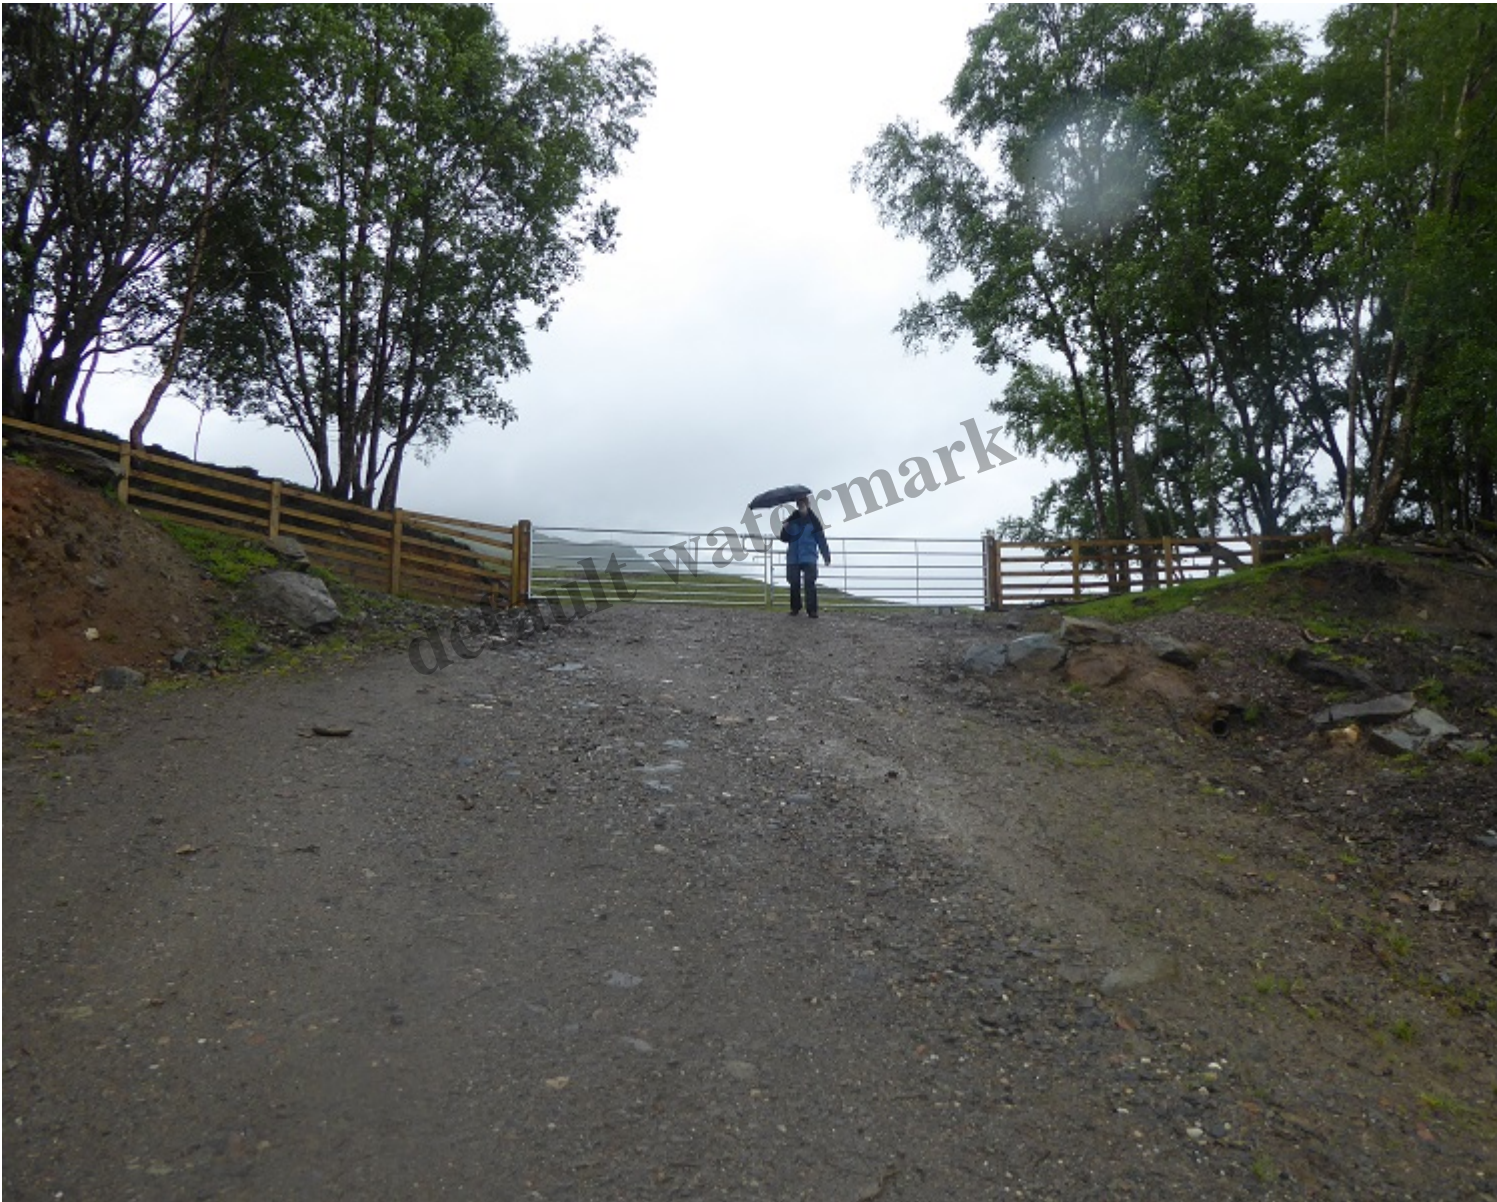
The width of the new track is in places extraordinarily wide, as the double gates illustrate. Double gates have also been left in place at the Glen Falloch Hydro Scheme. One way the LLTNPA could help ensure tracks are narrower is by requiring all double gates to be replaced by single gates after construction has finished.

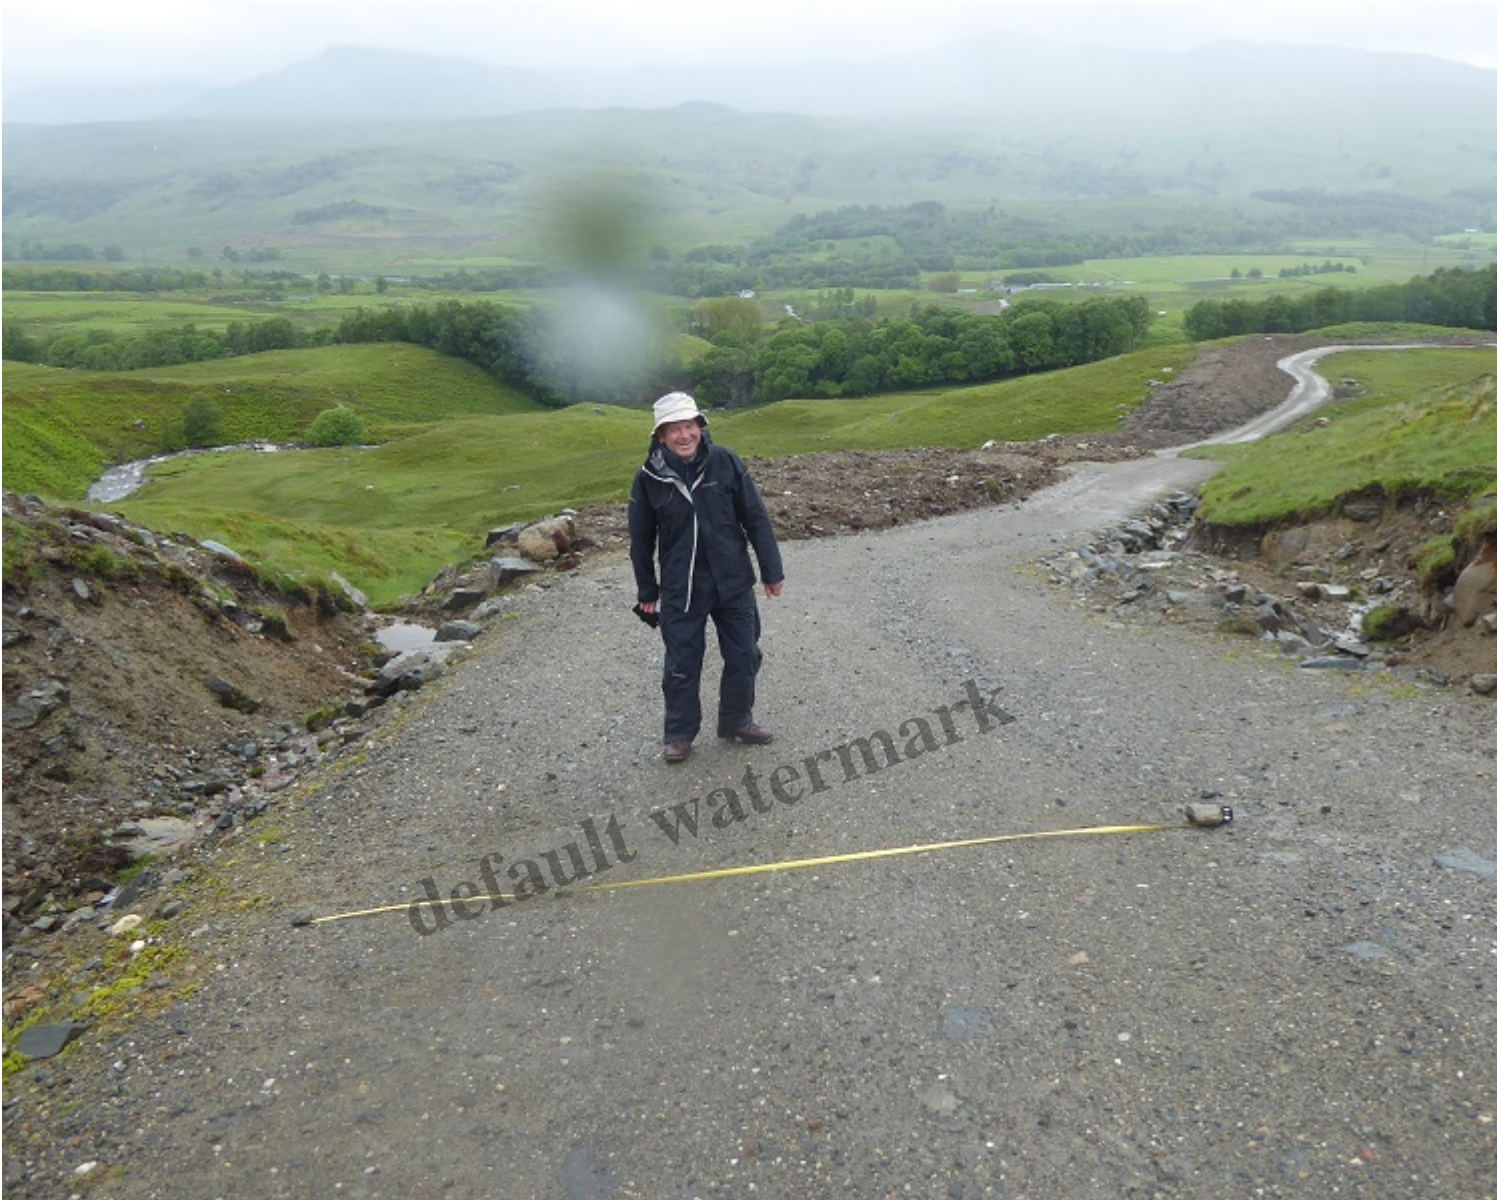
The tape measure here is extended to its maximum, 3m. The width of the track is close to 6m and there has been no attempt to restore the banks on either side creating a 9m broad scar up the hill. This should be totally unacceptable anywhere, let alone in a National Park, which says it believes uphill sections of track should just be 2.5m wide.

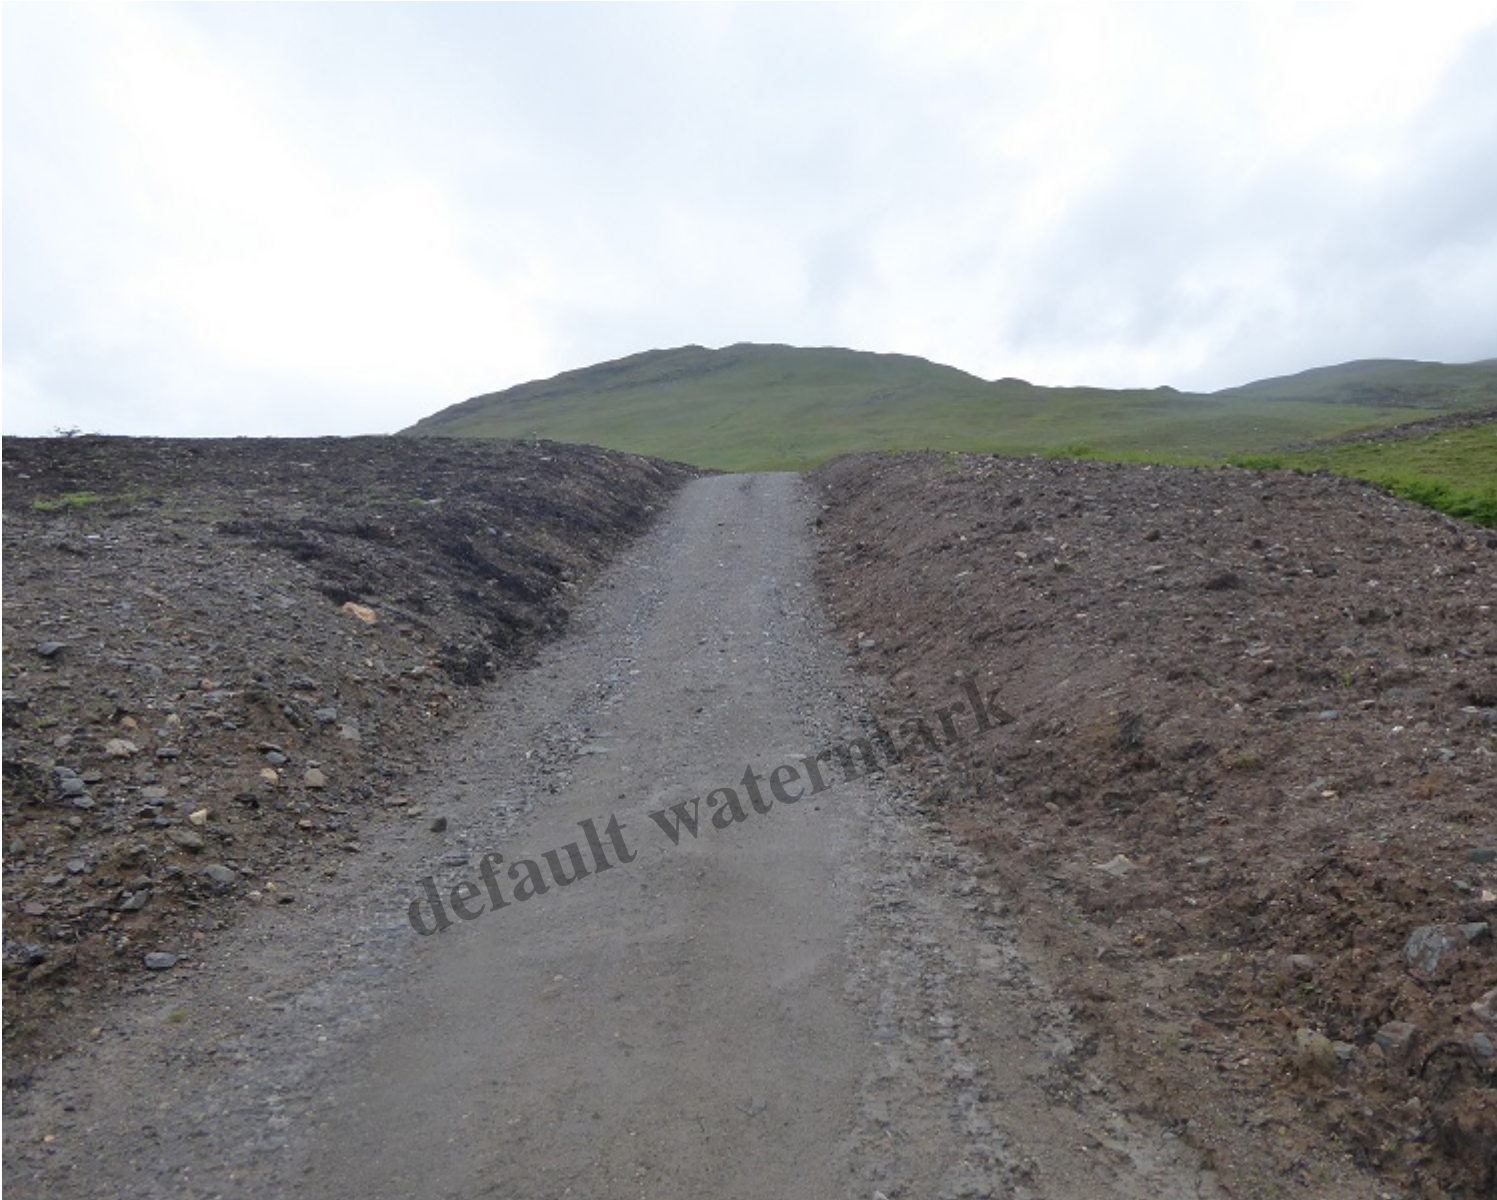
Not all the track restoration is as bad and there is short section above the double gate (above) where it almost meets the 2m specification and there has been a reasonable attempt to restore the land to its original condition. Why here but not elsewhere is a question worth asking? It seems totally arbitrary.

Even here, though, all is not as it should be. On the left bank the developer appears to have run out of peat to place on top of the bouldery soil. The Planning documentation required a:

Unfortunately the LLTNPA does not generally add documents required in a planning consent to the planning portal so its impossible for the public to see plan for retention of turves was agreed. The photos show however that whatever happened, insufficient care was taken in removing and restoring turves, with the result that large areas of ground have been left bare.

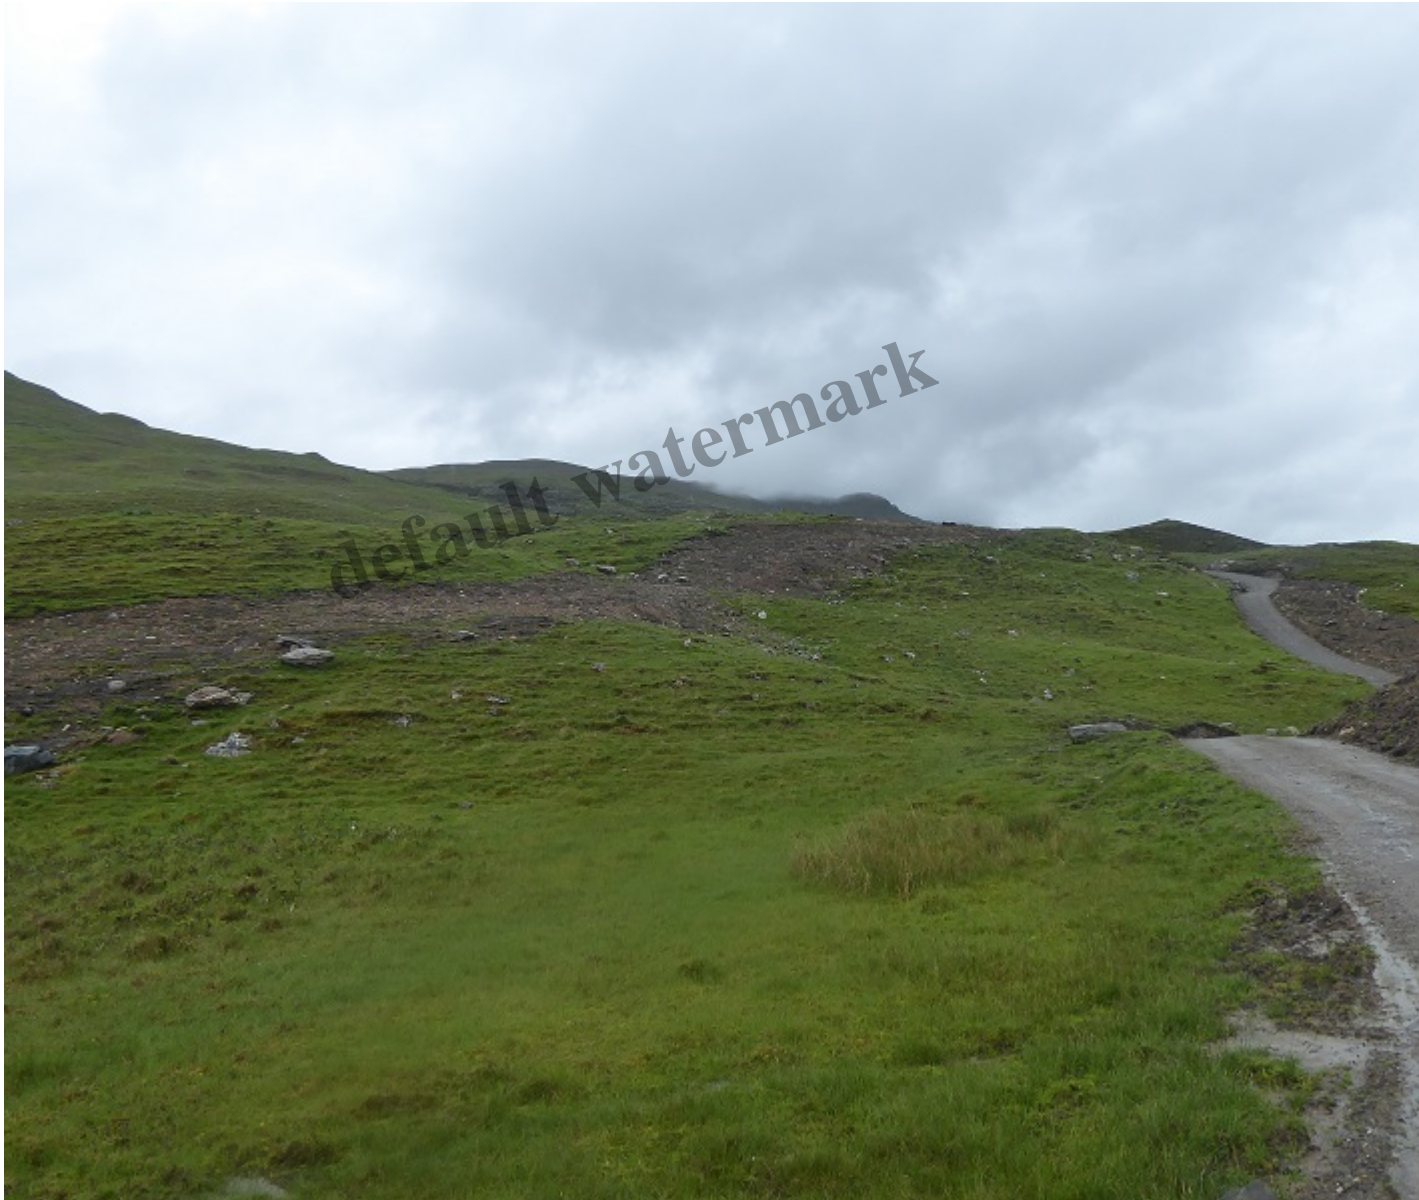
Impact of pipeline (left) compared to track

The photo (above) shows this never happened – the problem is the LLTNPA is not monitoring its planning requirements on an ongoing basis through construction with the result they are ignored. While this is a failure, in landscape terms, the Munro Society members were generally agreed that the main landscape concern is the track because the vegetation above the pipe, although not restored properly, is likely to recover quite quickly.

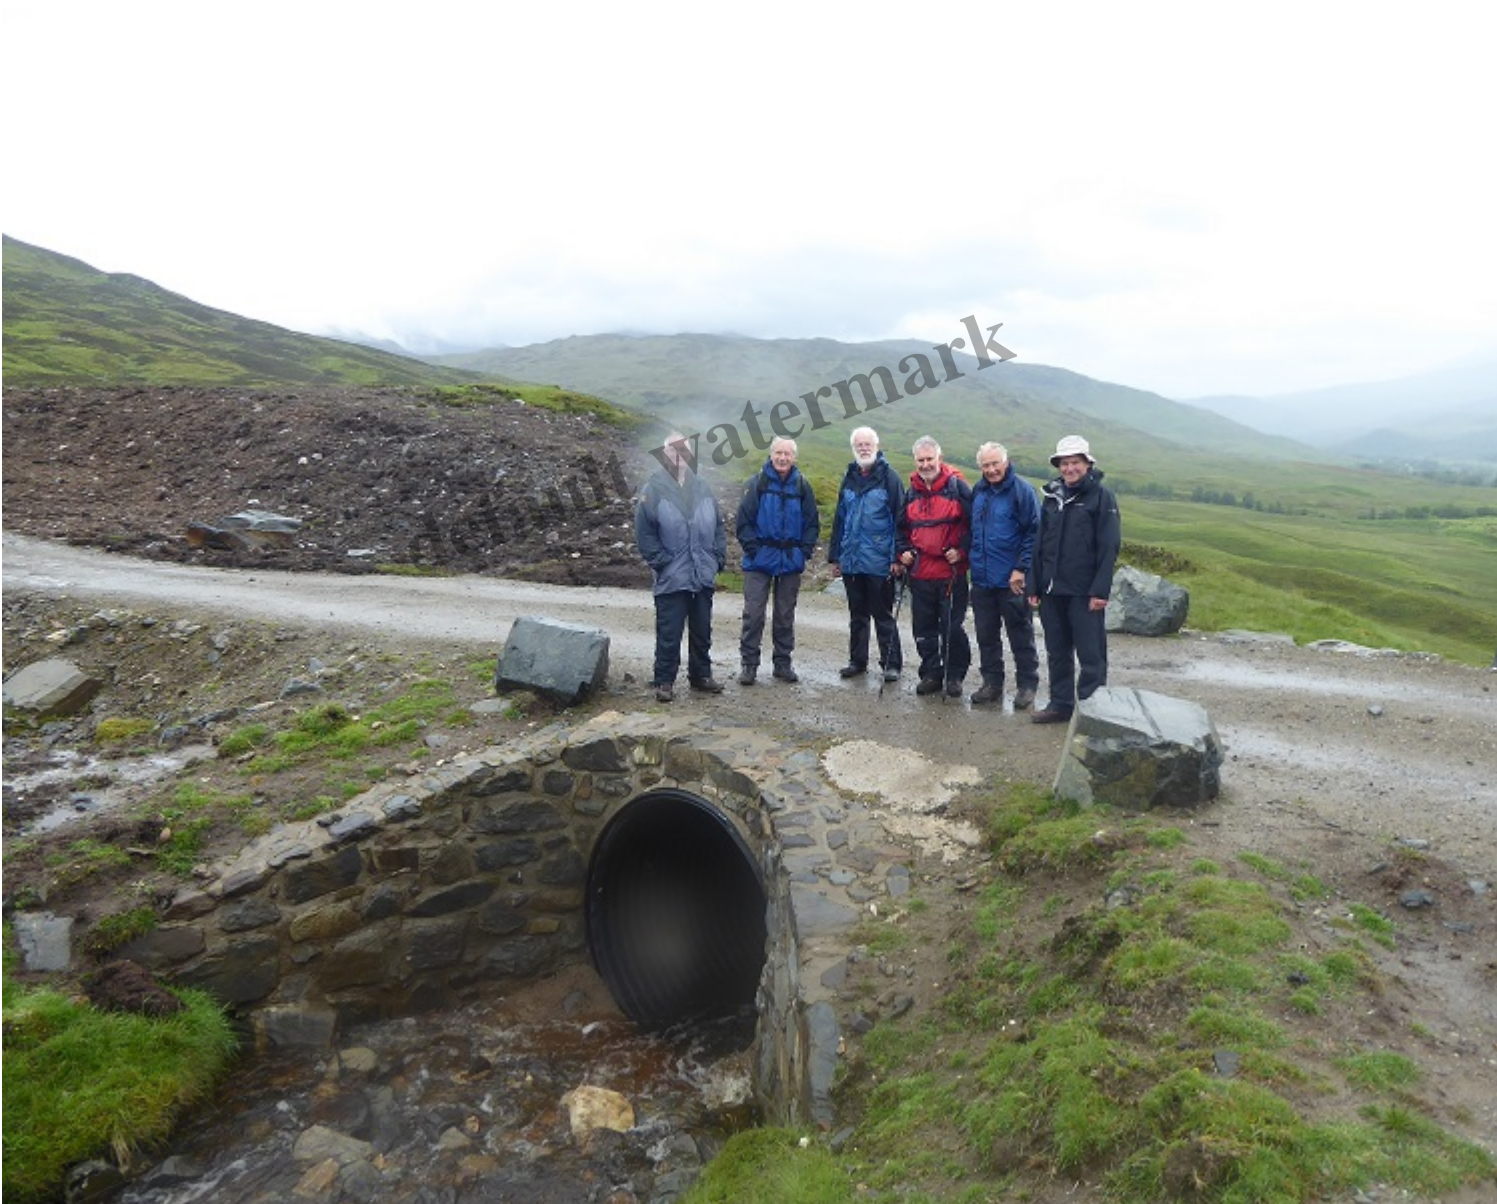
The Munro Society team had between them been up almost every 30m bump in Scotland and besides the hill chat, one of the pleasures of going out with them was hearing what such experienced hill goes thought about various aspects of the hydro development. I have rarely seen a constructed stone

culvert in the LLTNPA hydro schemes as above. They approved. While the track at Ledcharrie is far too broad, increasing its impact on the landscape, almost every culvert pipe had been properly finished, (unlike the Glen Falloch schemes). Just why contractors are good at one thing or in one area but then fail totally in others is another question that needs to be asked. I suspect the problem is a lack of monitoring from the LTNPA to ensure consistent high standards. If the problem is lack of resources to do this, the answer is simple: re-direct resources away from chasing innocent campers and direct them to protecting our landscape. The impact of even the most irresponsible of campers is temporary, the impact of these track is, in human timescales, permanent.

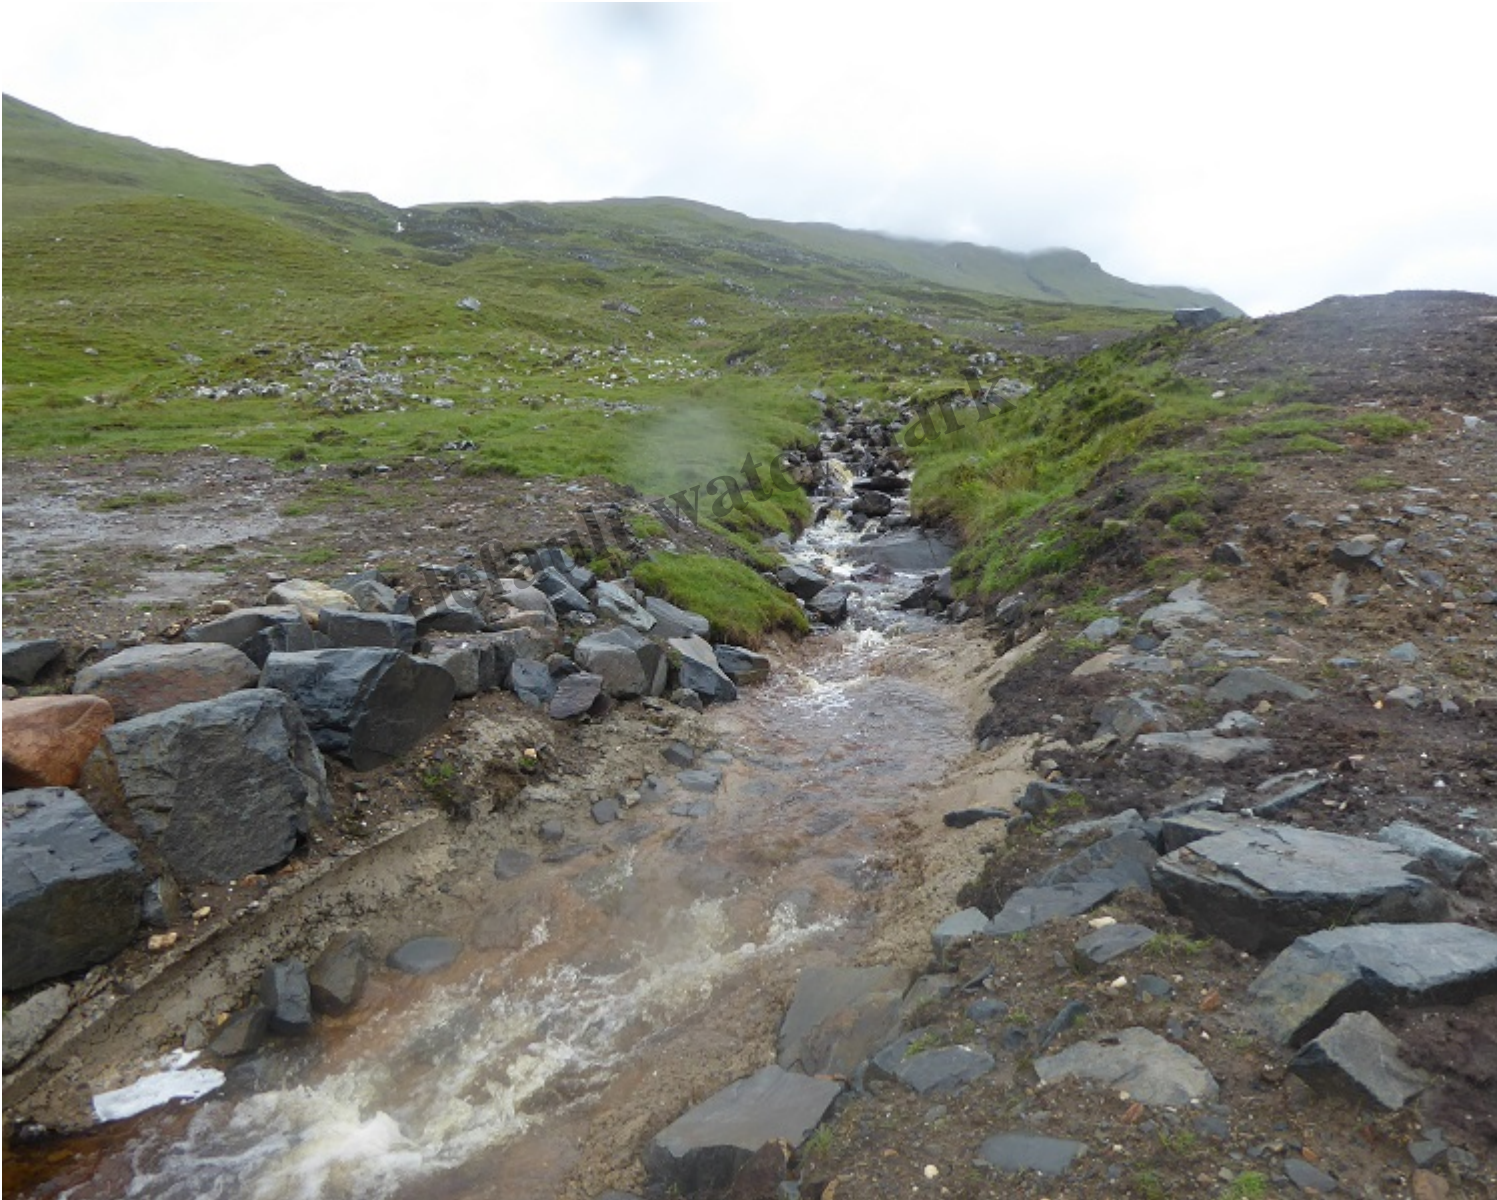
Just upstream of the culvert though, Stuart Logan, Munro Society President spotted that this. No-one present thought that lining stream beds with concrete is acceptable (this was the first time I had seen

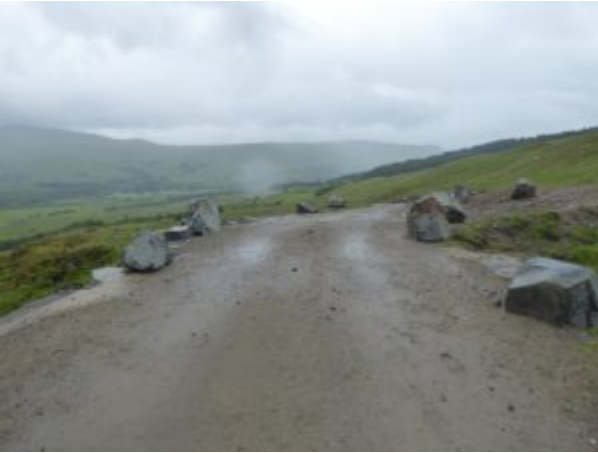
The track above the culvert was also very poor, not only far too wide, but it had been lined with blocks which appear to have been created by the developer blasting through rock bands where the soil was shallow. The end result looked more appropriate for a quarry than a National Park.

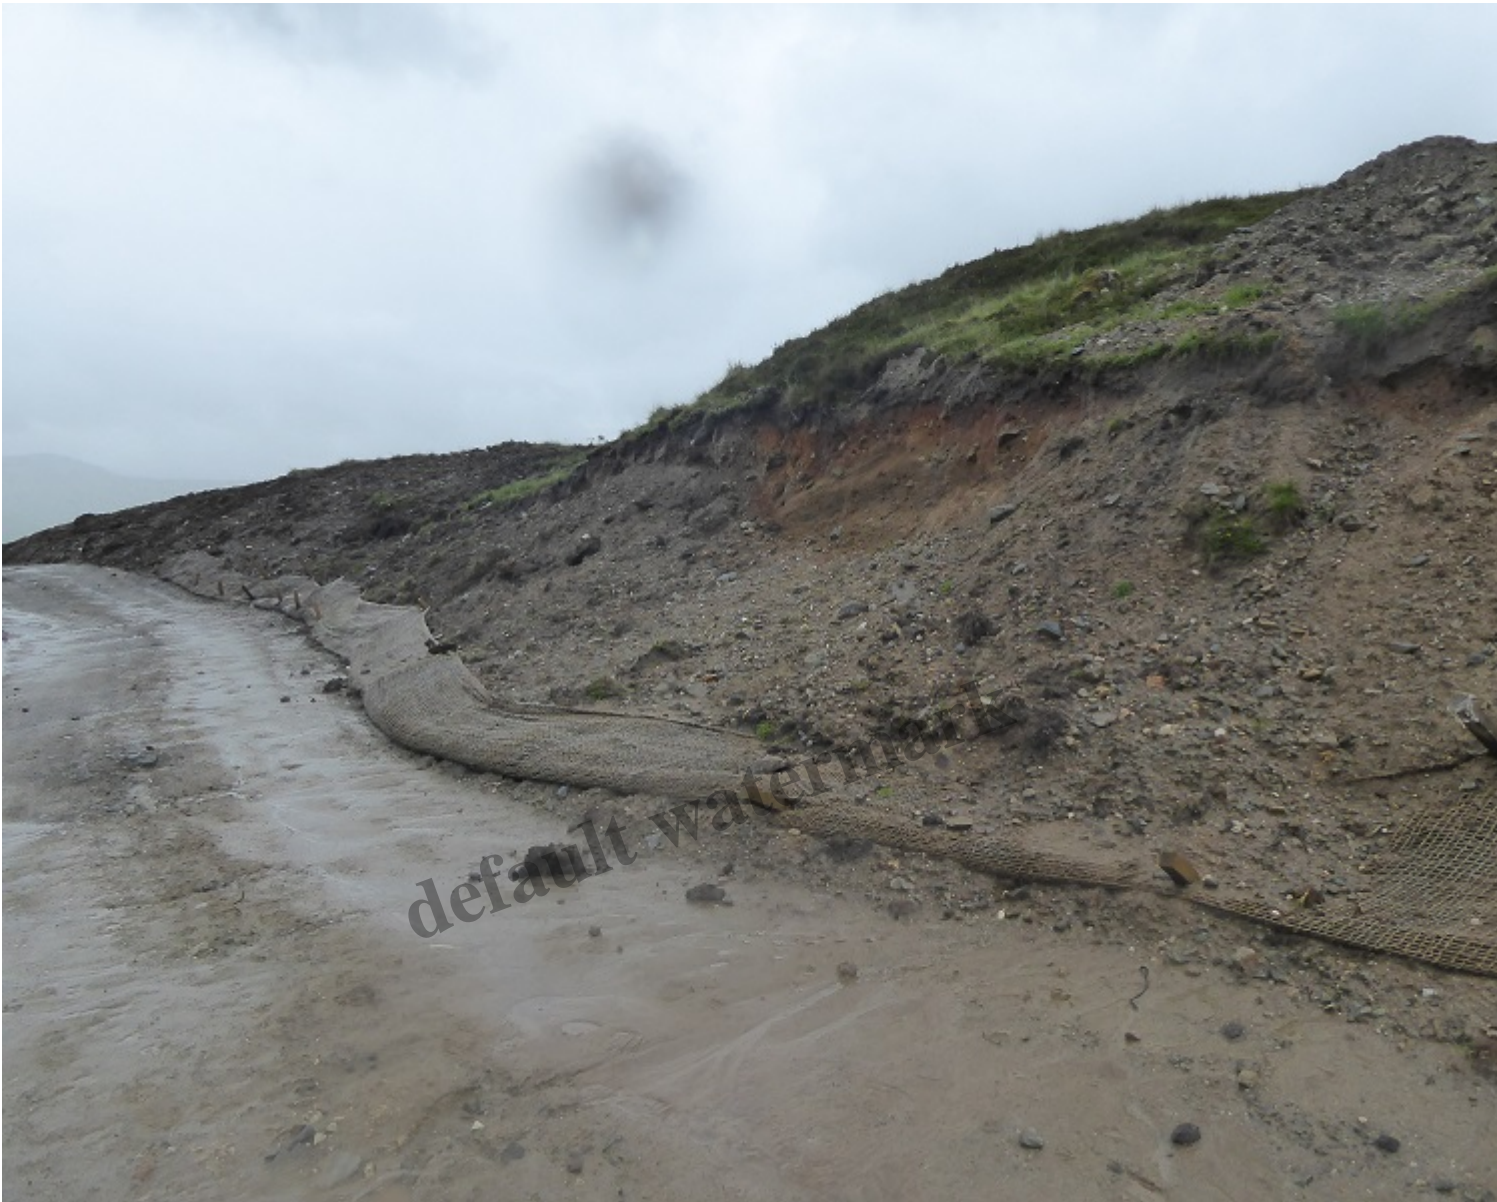
Another thing I had not seen was the use of netting in an attempt to hold soil in place at the edge of a track. Here the netting has totally failed and filled with material that has slumped down the slope, a consequence of the bank/edge of the batter being too steep. On the top right you can see how soil and rock, which could have been used to help reduce the angle of the slope, has been left dumped on top of vegetation.

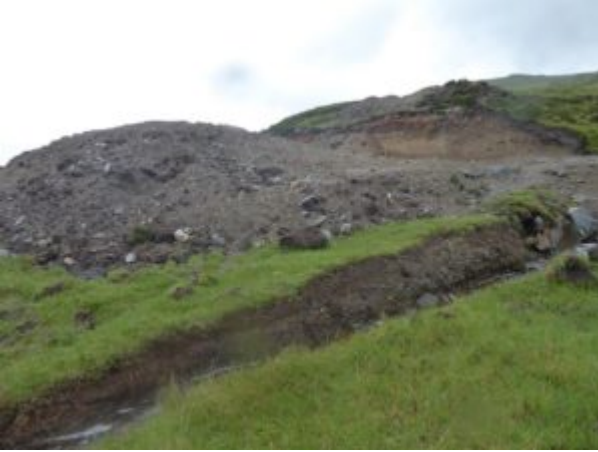
On the downside of the track, below the scar in the photo above, the material excavated to create the track had been dumped on vegetation and no attempt has been made to restore this. The drainage ditch is a later addition but, instead of using the new turves to help restore the ground elsewhere, they had been left scattered on the neighbouring ground (large turf centre)

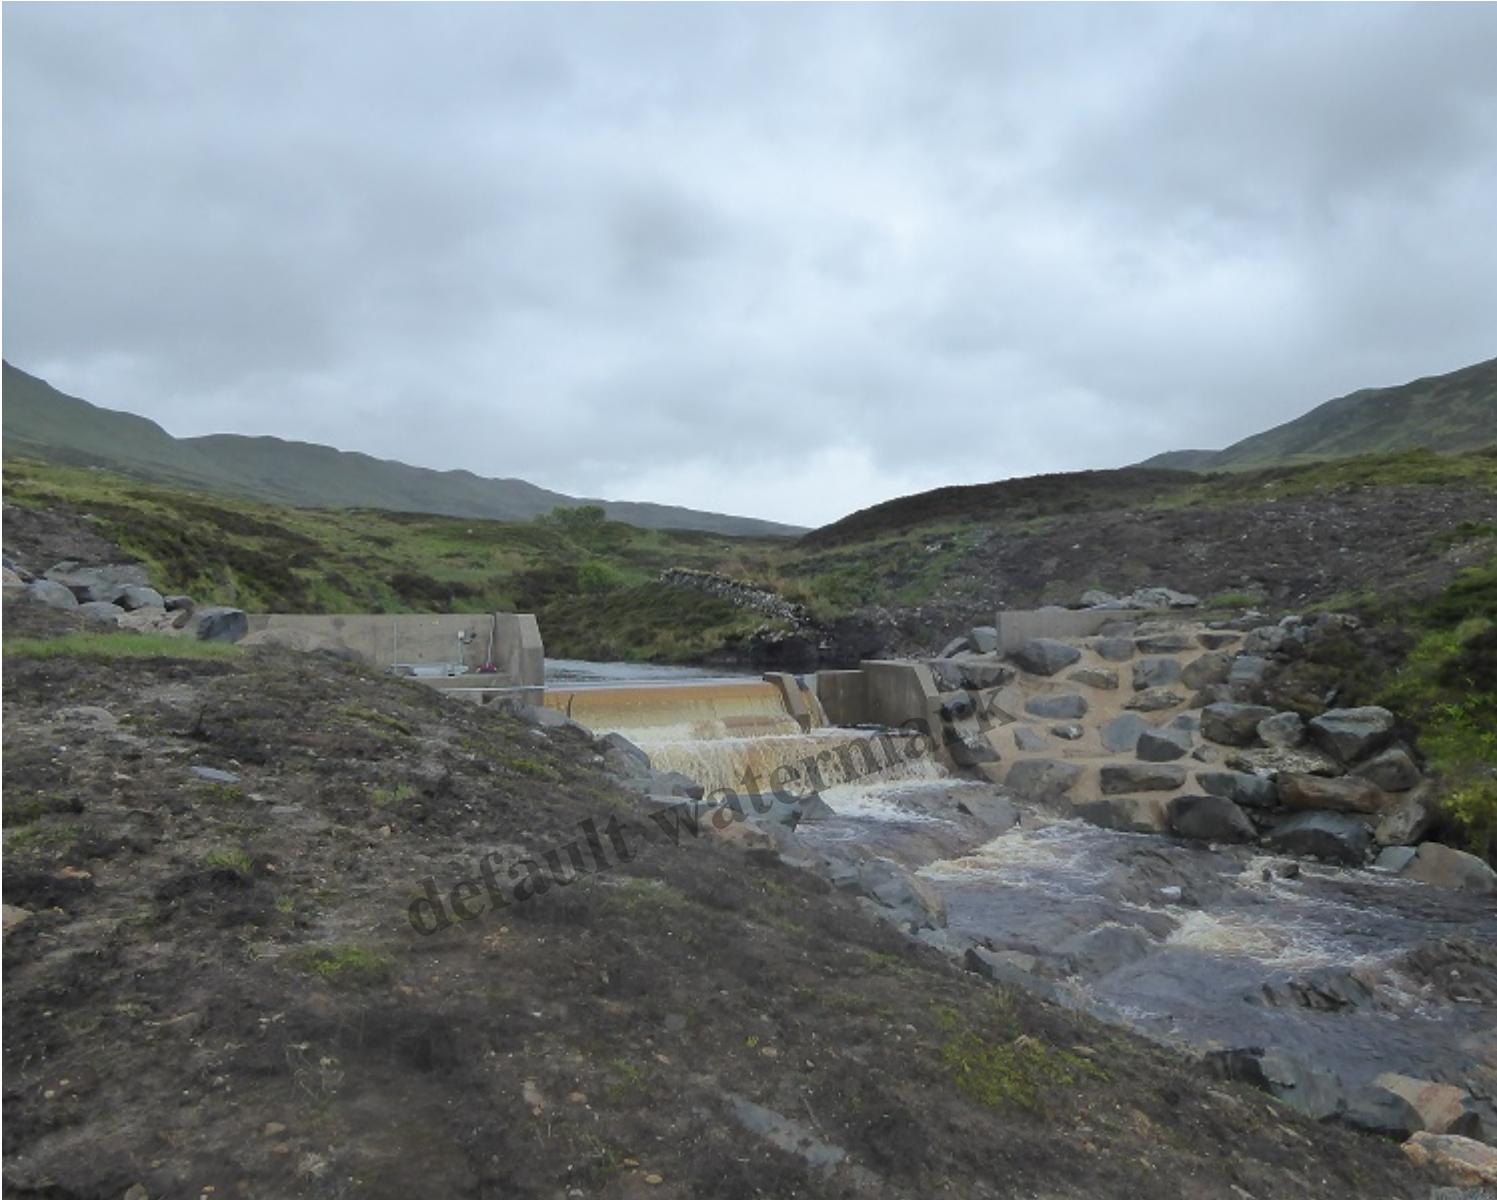
We had a good discussion about the main intake on the Ledcharrie burn. There was general agreement that the intake was well located being tucked below the level of the banks and surrounding ground and would not be visible from afar. There was debate about whether the rip rap embankment, in this case partially embedded in concrete, could have been designed better. I asked people about the concrete dam walls, pointing out the LLTNPA's Supplementary Guidance suggests these could be faced in stone, although I had never seen this. Someone pointed out there was plenty of material available to do this from the old dyke behind the intake (centre of photo). So why not?

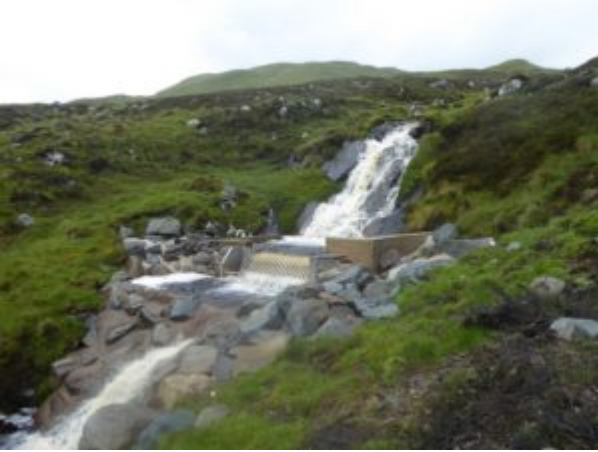
We then walked down the track a bit before heading up to the second intake which I had only realised was there because of the disturbed ground above the pipe. You could not see it from below and some of those present had doubts about whether there was a second intake – a really good sign! Again the visual impact of the intake itself was not significant in landscape terms, although the concrete walls could have been faced with stone.

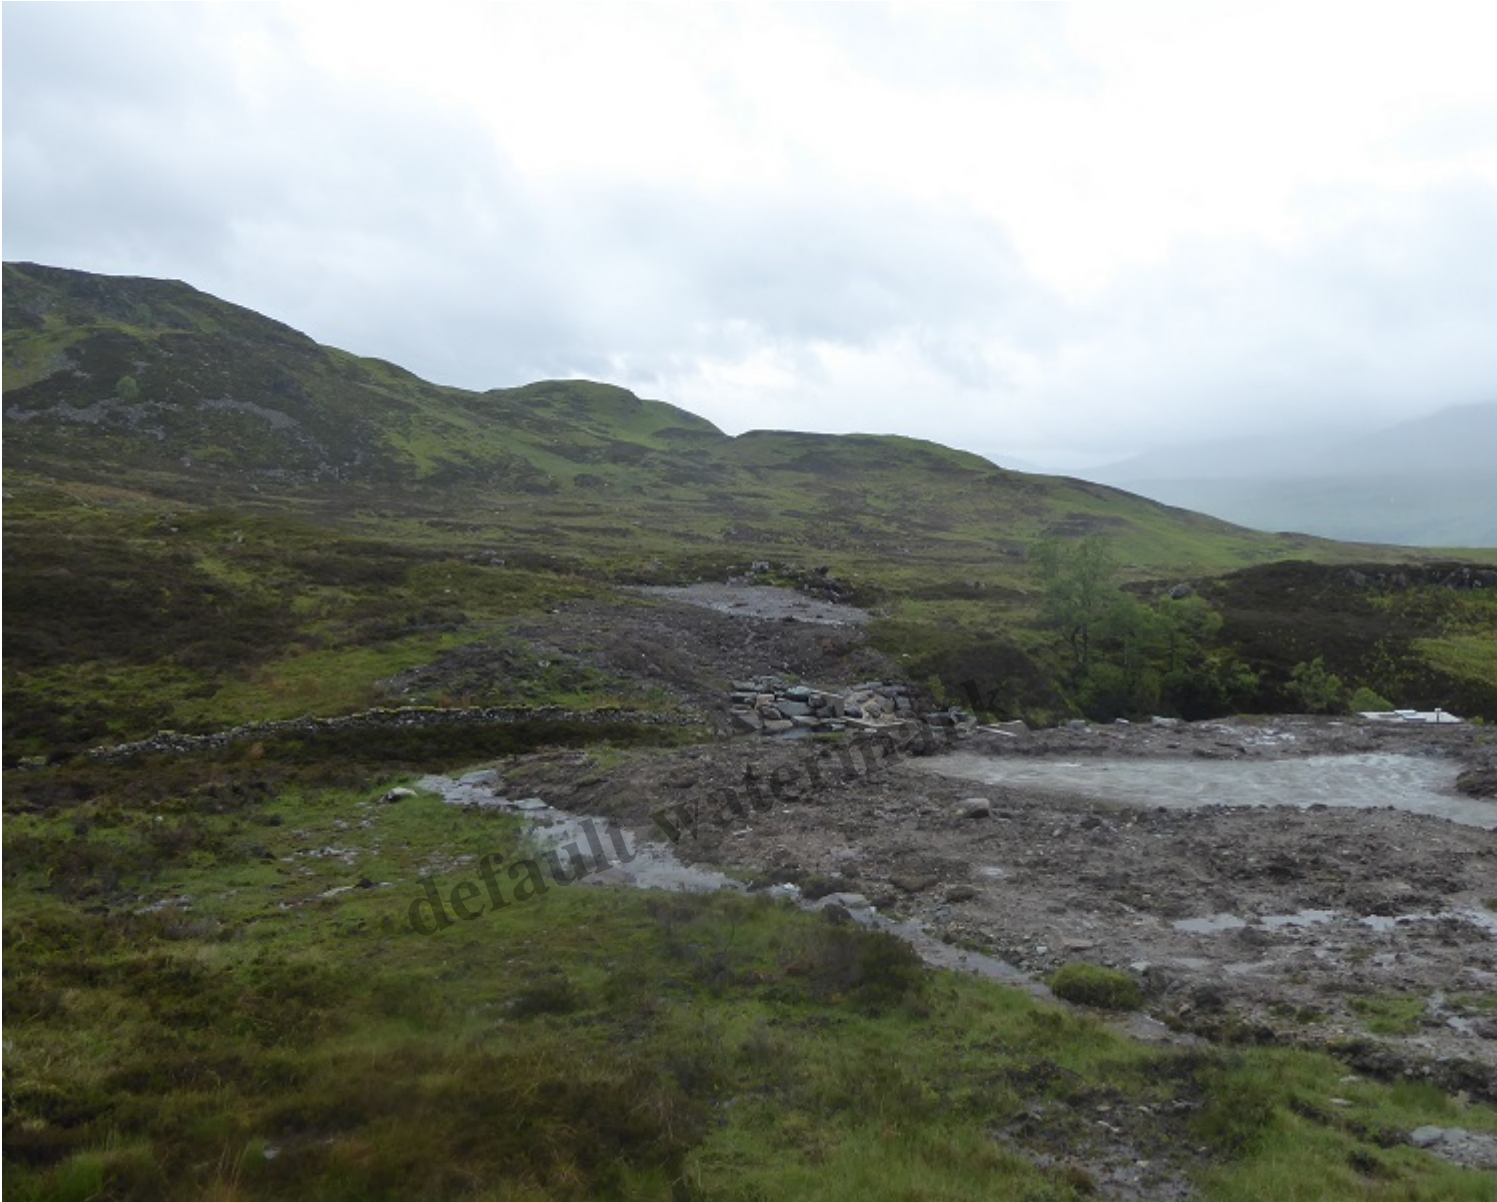
The first intake is hardly visible from 100m away except for the access track and turning area. (The burn slanting right to left has been diverted so it now enters the Ledcharrie burn above the intake. Another restoration failure can be seen centre far side of river – a patch of bare ground created because turves and topsoil were not properly stored).
