Ledcharrie Hydro – another plook in the Park

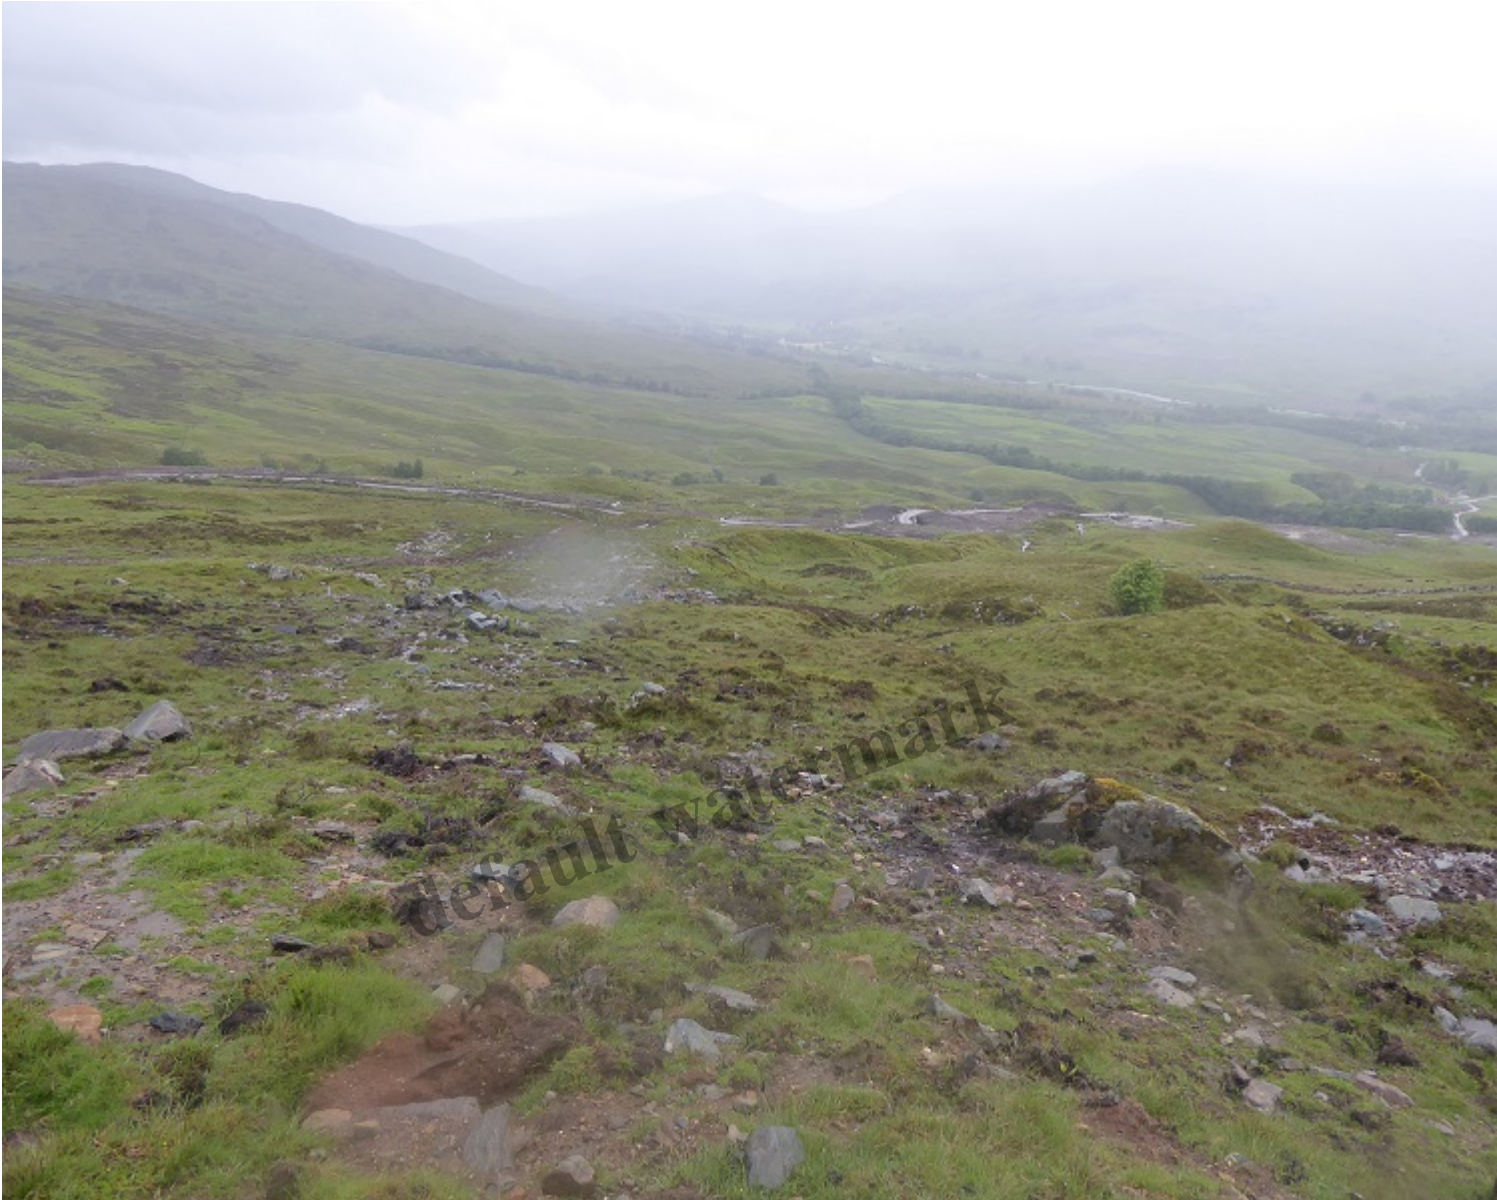
The second, and more minor intake, has no access track and the ground has been completely restored and to a higher standard than that on either side of the track below. The line of the pipe and temporary construction track will probably have disappeared within a couple of years. Everyone thought this was great, its how hydro schemes should be.

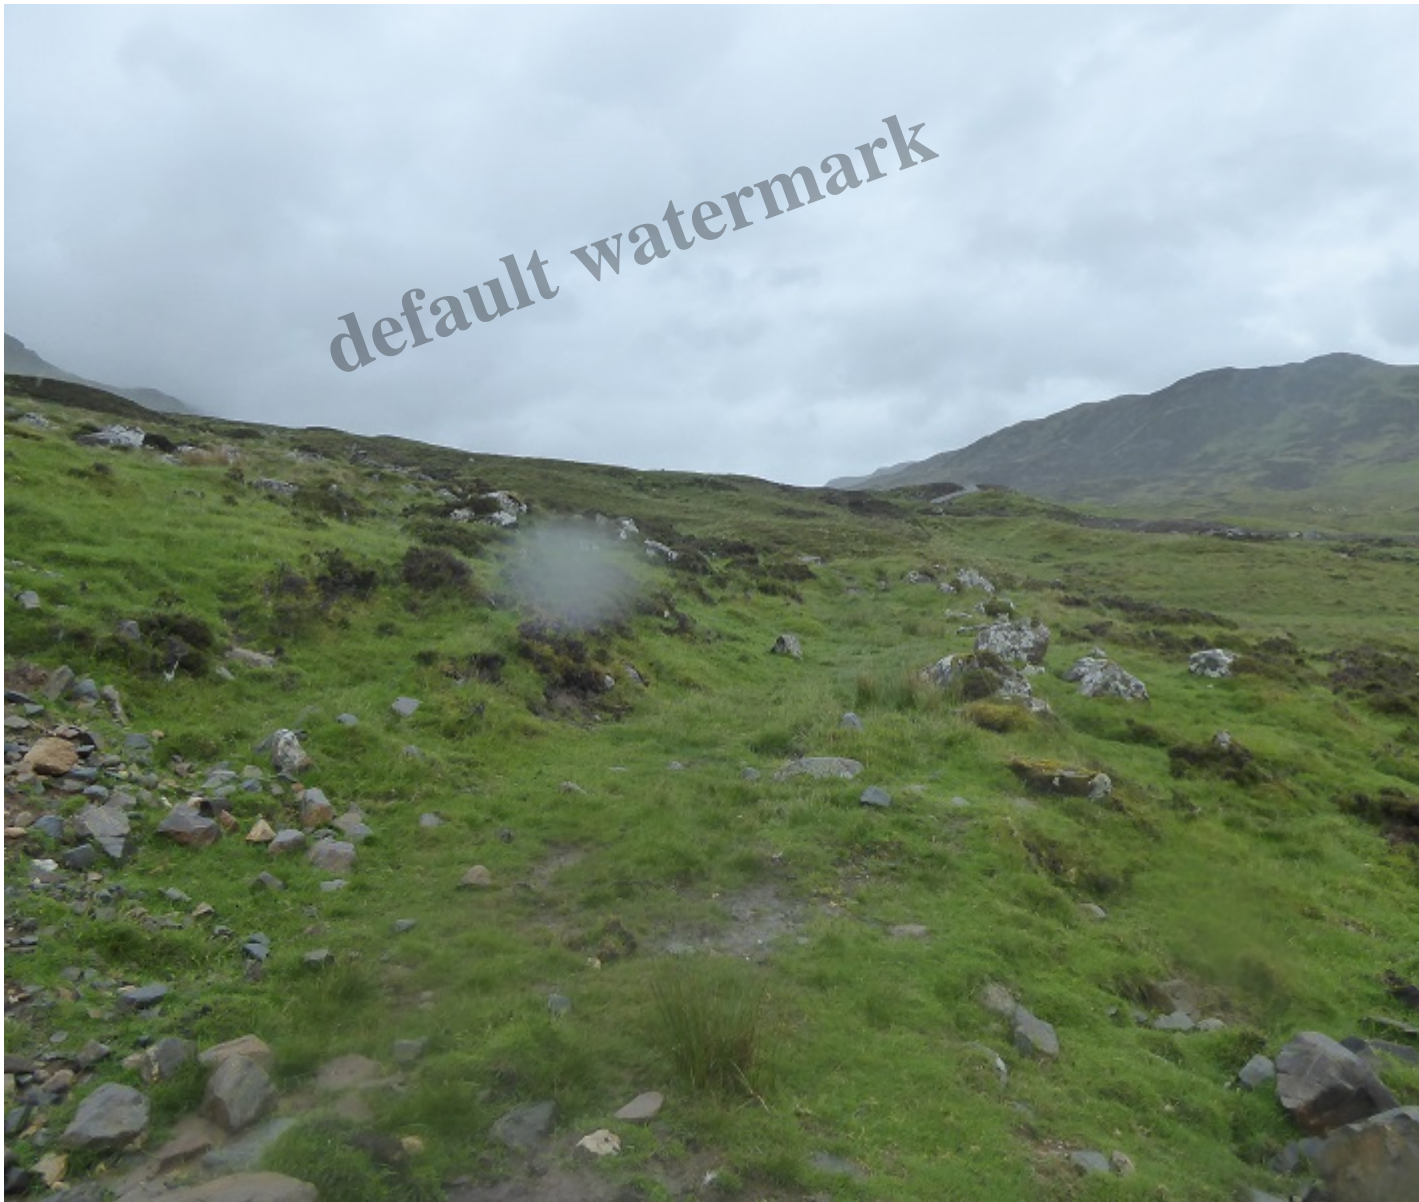
The old track over to Kirkton Glen is a “core path” – quite a contrast to the new track to the main Le intake. The loose stones in the foreground are “spill” from the recent construction works.
