Ledcharrie Hydro – another plook in the Park

Over the last couple of years, concerns in the outdoor community about the impact of hydro schemes has increased significantly and on Tuesday I went out with 6 members of the Munro Society <http://www.themunrosociety.com/> to share knowledge and views on the ground. The Munro Society's first objective is "To provide an informed and valued body of opinion on matters affecting the Munros and Scotland's mountain landscape" and as part of this they have decided to survey the impact of hydro schemes. We went to the recently completed – or should that be completed? – Ledcharrie

hydro in Glen Dochart on what was a pretty wet day.

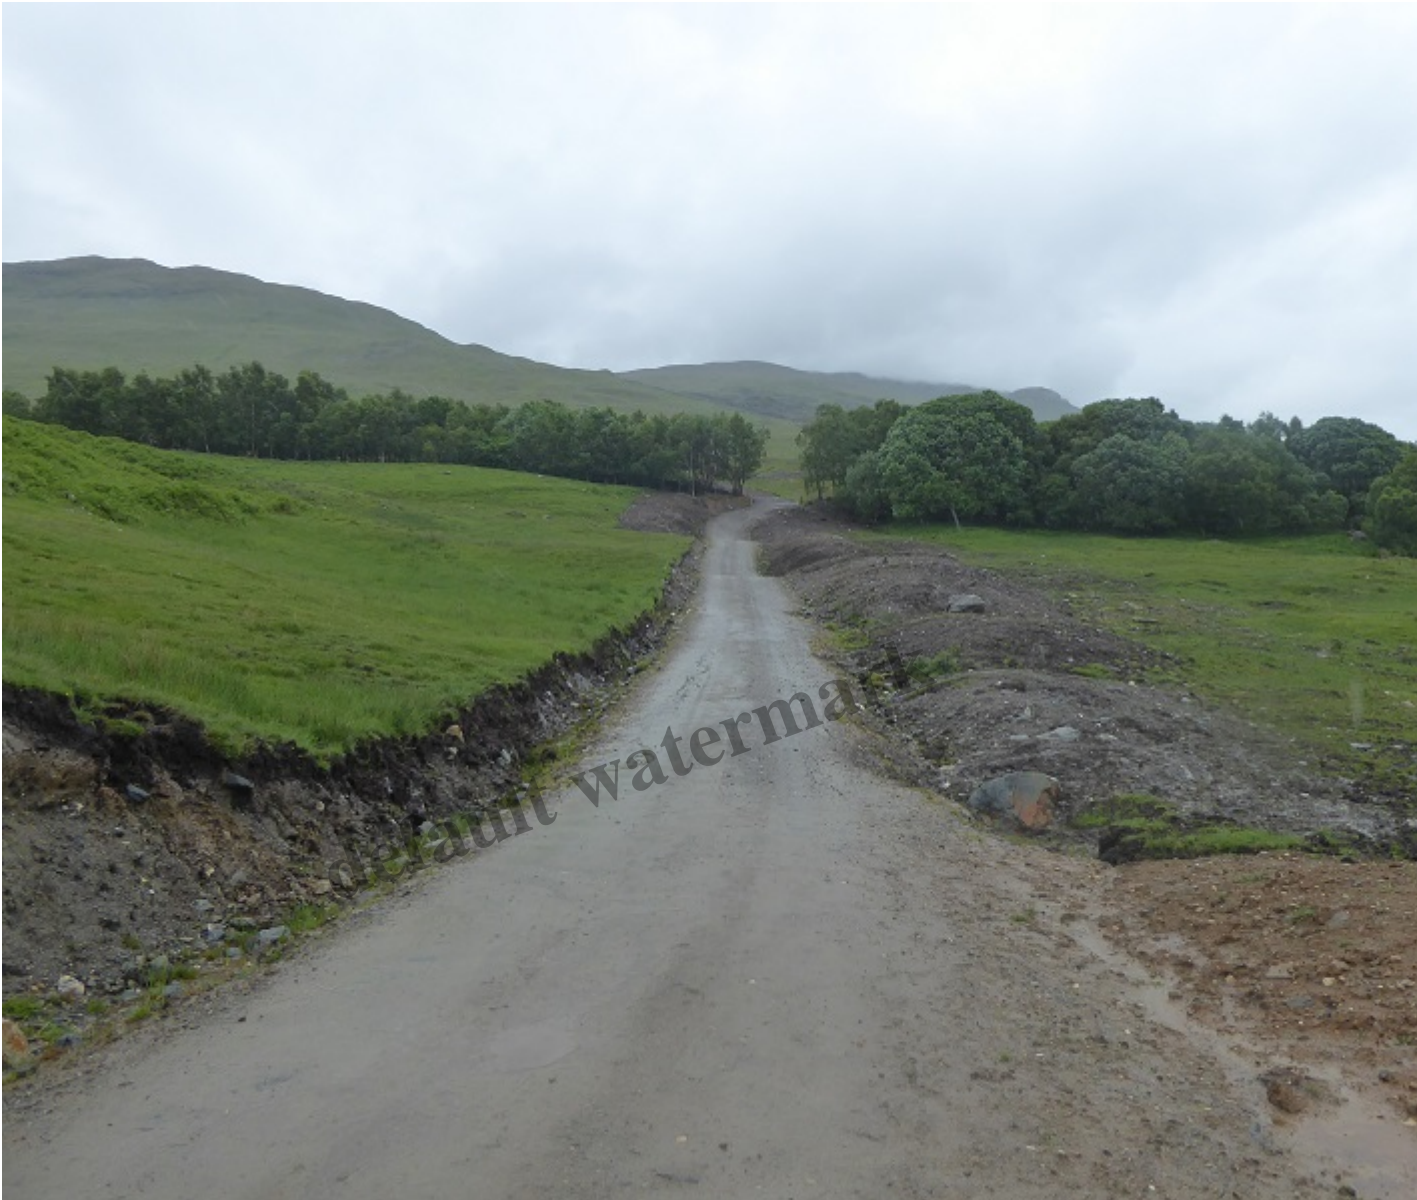
Looking uphill from the same position. The line of trees marks the former Callander – Crianlarich rail

There was no machinery left of site, which is an indication that the developer, Glen Hydro Development Ltd, believes the work is finished. While I had seen plenty of hydro tracks with oversteep batter sides (banks) – which is contrary to the Loch Lomond and Trossach’s National Park Authority’s Supplementary Guidance on Renewables ([see here](#)) – I had not seen mounds of earth, as on the right. The way the land lies here, they are totally out of place and have changed the landscape. These things should matter in a National park.

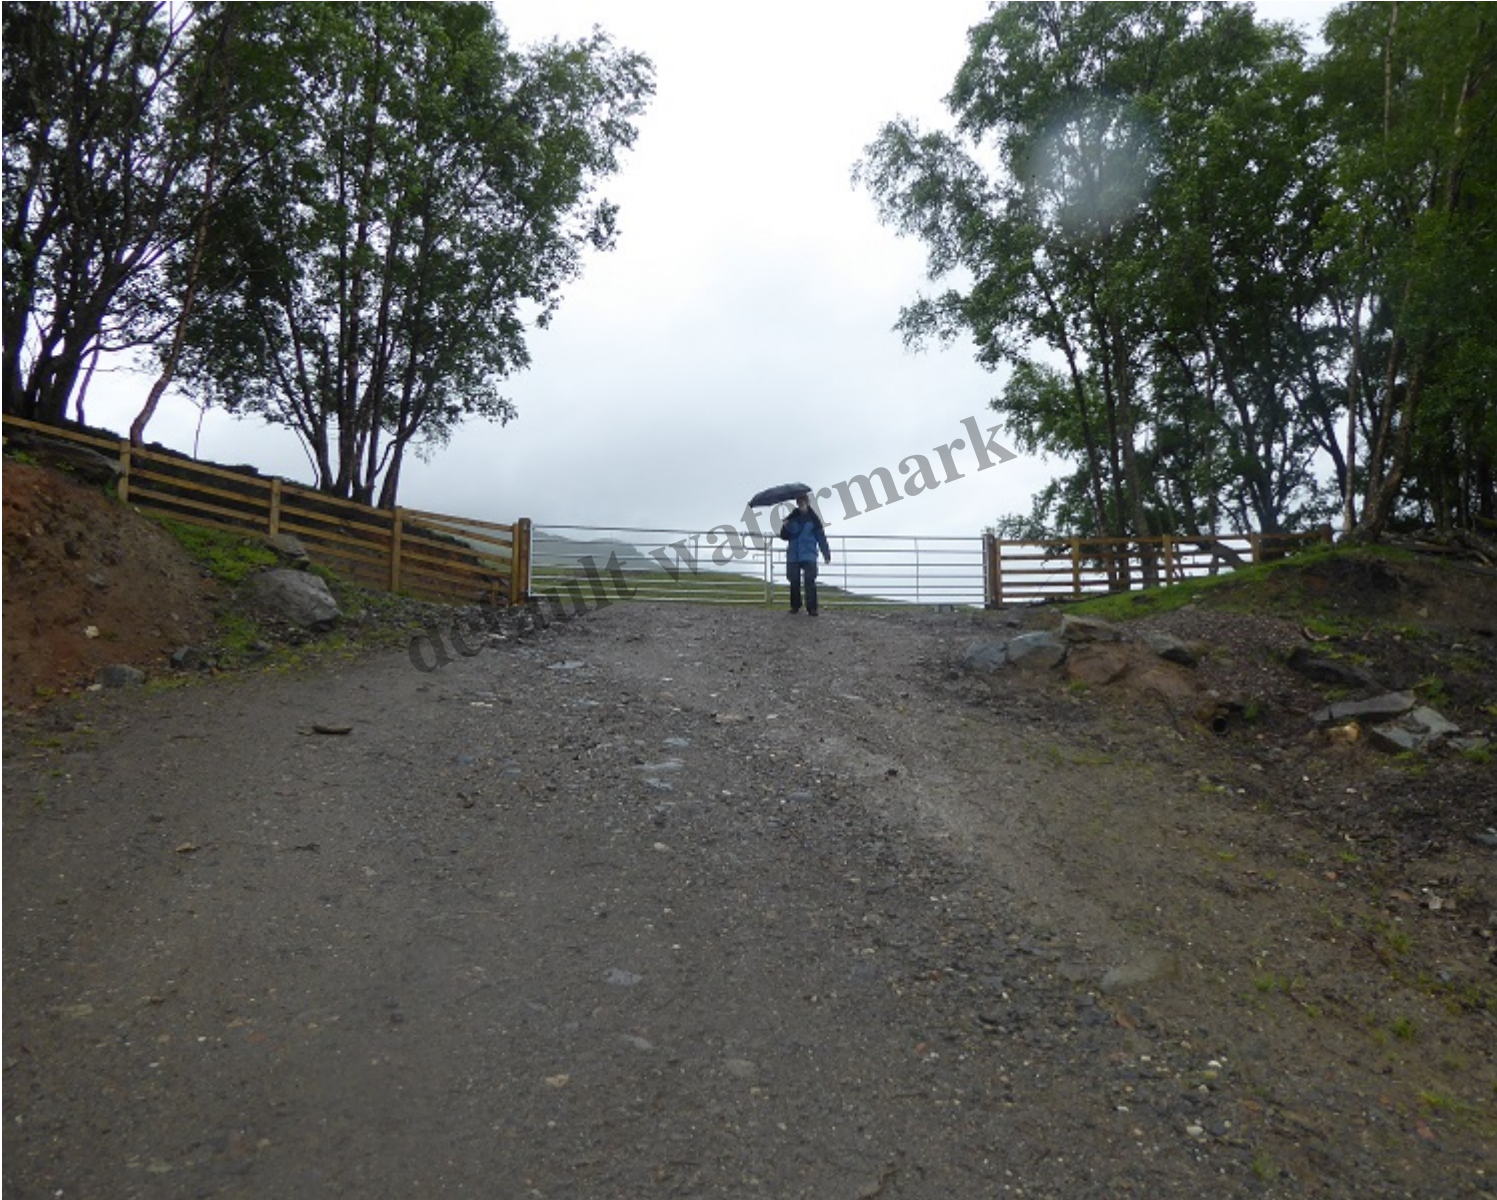
The width of the new track is in places extraordinarily wide, as the double gates illustrate. Double gates have also been left in place at the Glen Falloch Hydro Scheme. One way the LLTNPA could help ensure tracks are narrower is by requiring all double gates to be replaced by single gates after construction has finished.

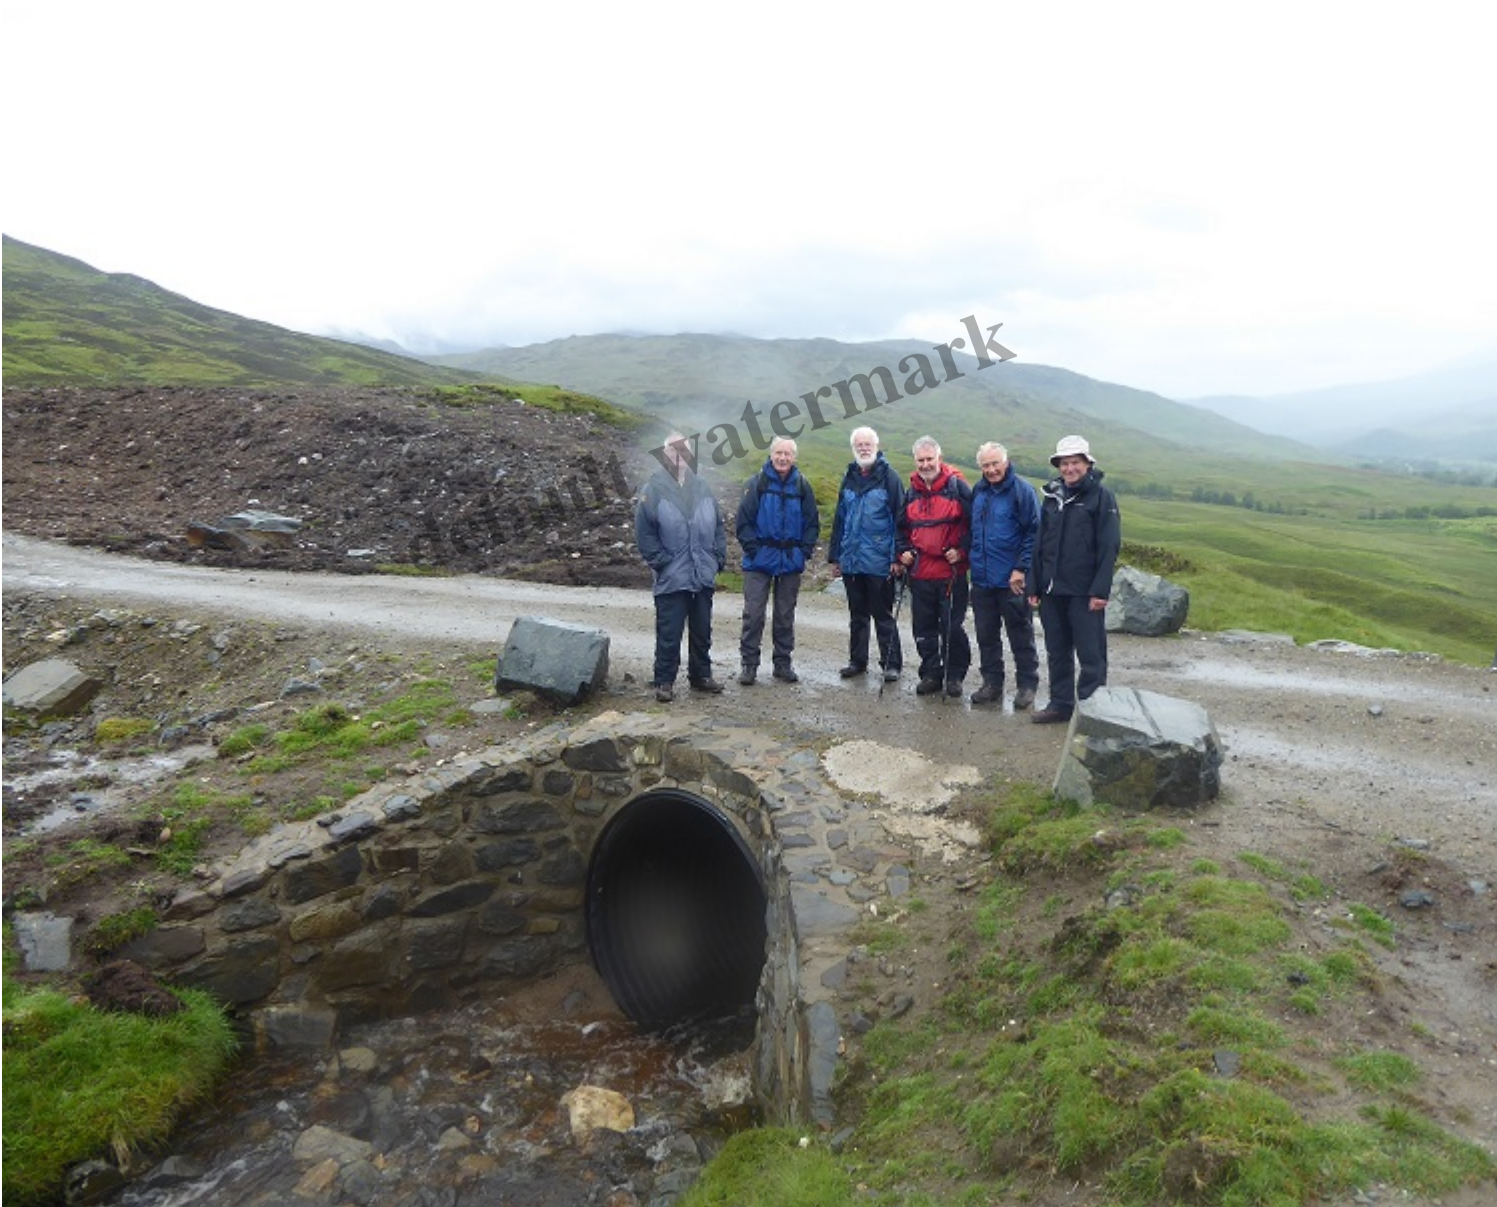
The Munro Society team had between them been up almost every 30m bump in Scotland and besides the hill chat, one of the pleasures of going out with them was hearing what such experienced hill goes thought about various aspects of the hydro development. I have rarely seen a constructed stone

culvert in the LLTNPA hydro schemes as above. They approved. While the track at Ledcharrie is far too broad, increasing its impact on the landscape, almost every culvert pipe had been properly finished, (unlike the Glen Falloch schemes). Just why contractors are good at one thing or in one area but then fail totally in others is another question that needs to be asked. I suspect the problem is a lack of monitoring from the LTNPA to ensure consistent high standards. If the problem is lack of resources to do this, the answer is simple: re-direct resources away from chasing innocent campers and direct them to protecting our landscape. The impact of even the most irresponsible of campers is temporary, the impact of these track is, in human timescales, permanent.

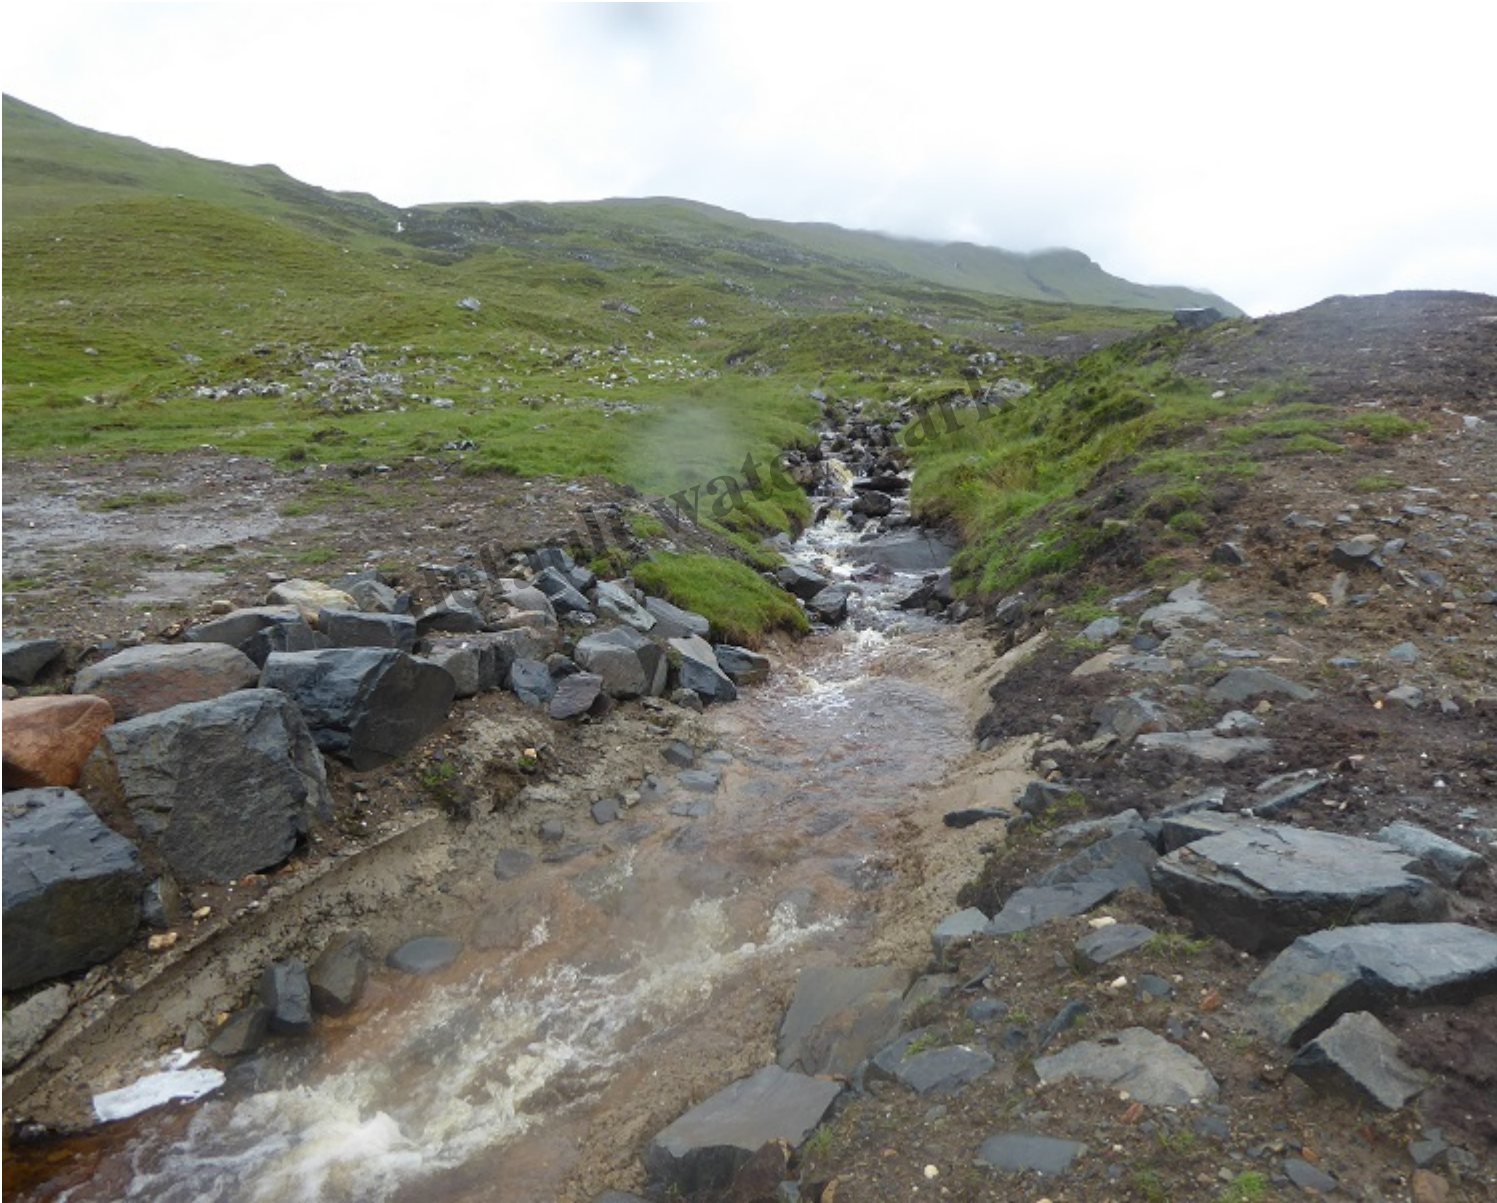
Just upstream of the culvert though, Stuart Logan, Munro Society President spotted that this. No-one present thought that lining stream beds with concrete is acceptable (this was the first time I had seen

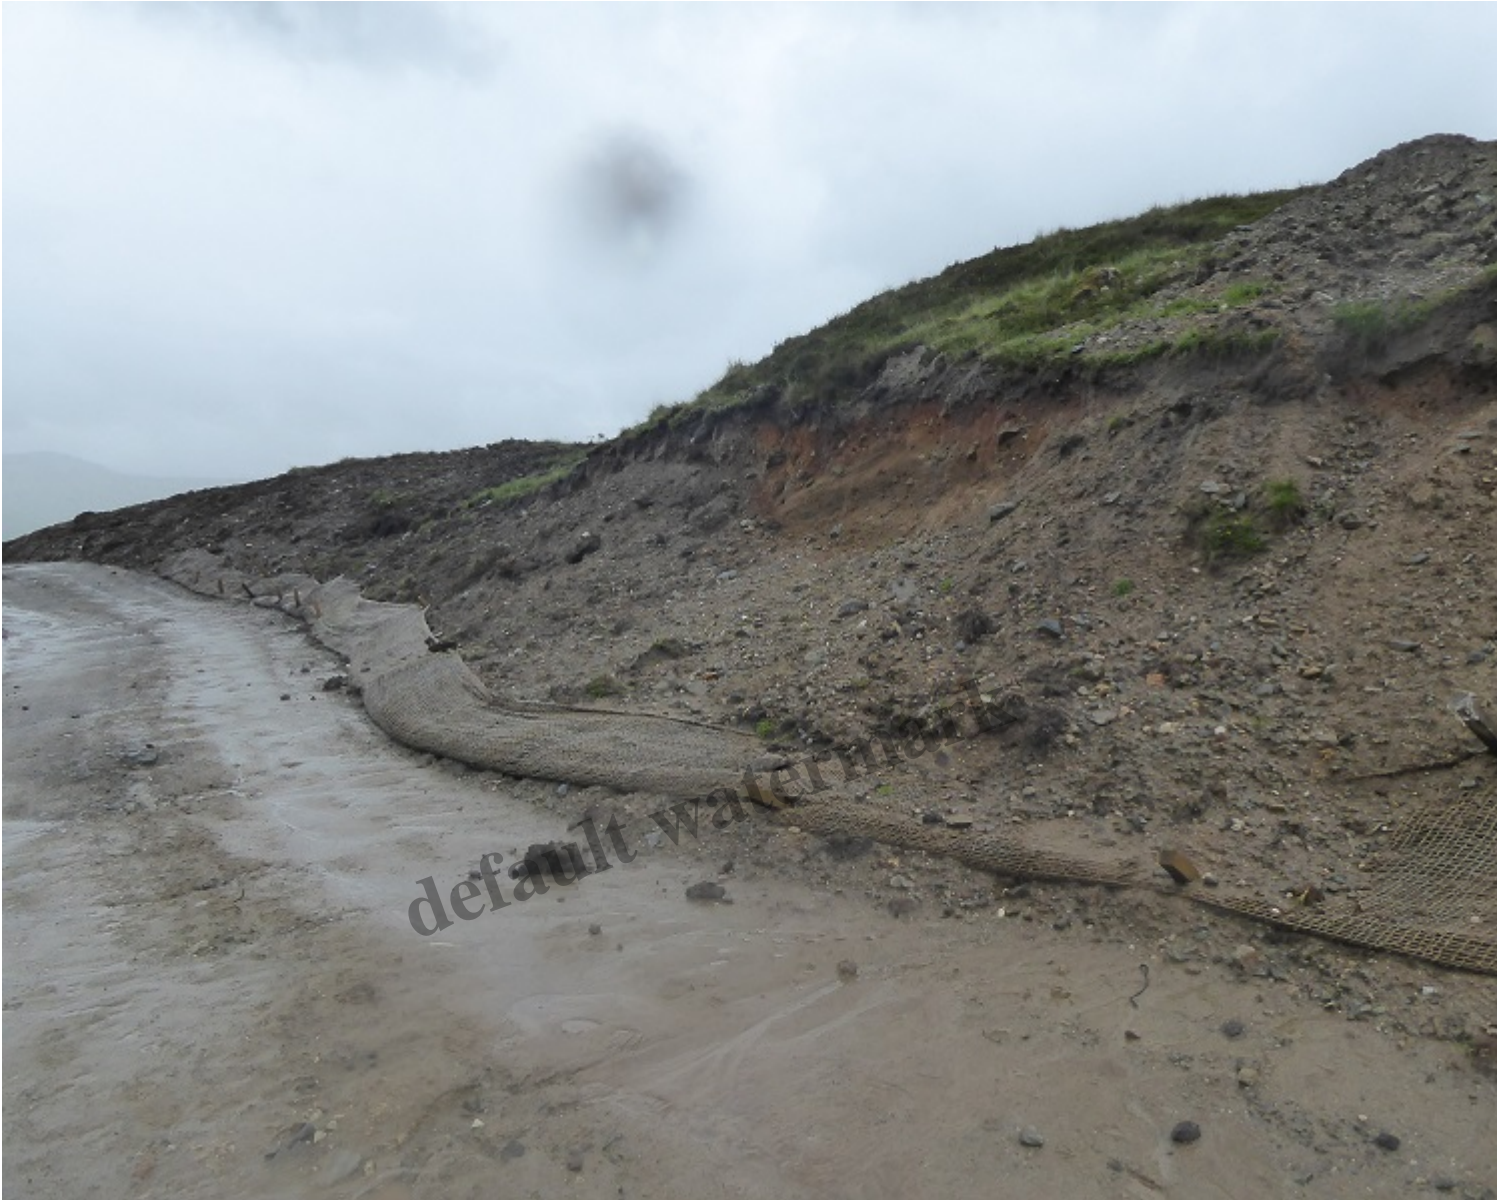
Another thing I had not seen was the use of netting in an attempt to hold soil in place at the edge of a track. Here the netting has totally failed and filled with material that has slumped down the slope, a consequence of the bank/edge of the batter being too steep. On the top right you can see how soil and rock, which could have been used to help reduce the angle of the slope, has been left dumped on top of vegetation.

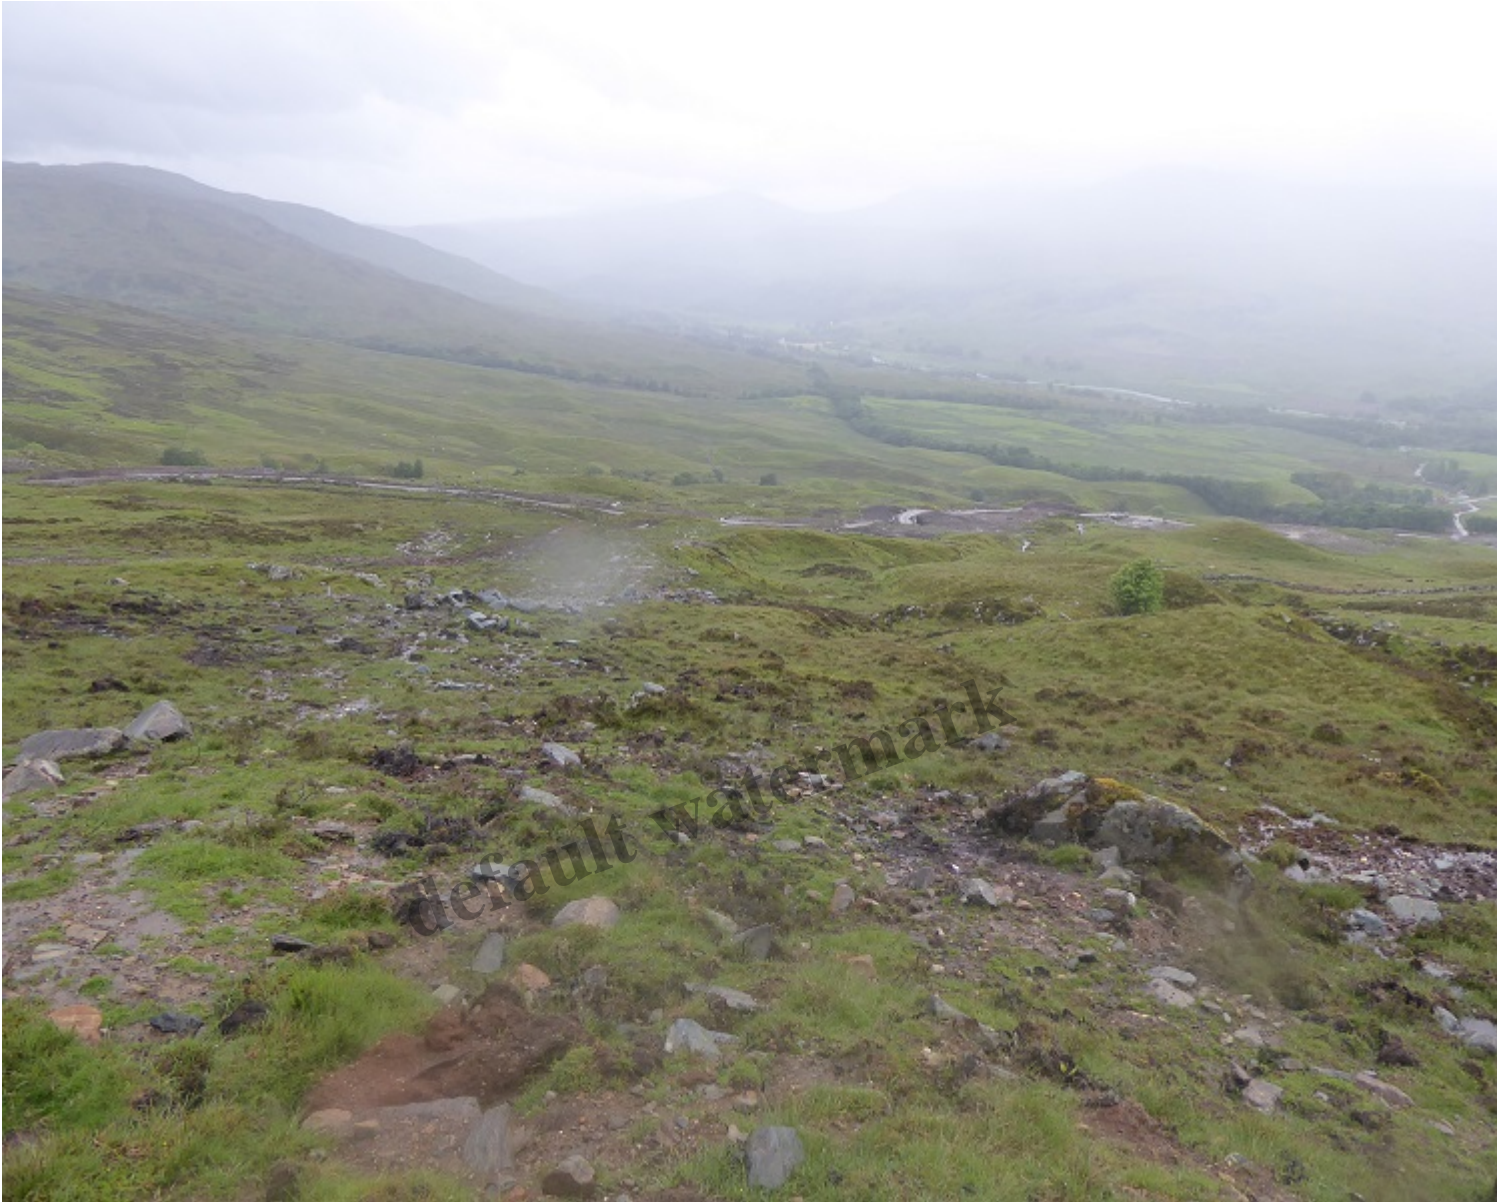
The second, and more minor intake, has no access track and the ground has been completely restored and to a higher standard than that on either side of the track below. The line of the pipe and temporary construction track will probably have disappeared within a couple of years. Everyone thought this was great, its how hydro schemes should be.
