Well designed hydro schemes (1) â?? Gynack

Gynack Scheme 1 â?? Kingussie Community Development Company

Gynack Scheme 2

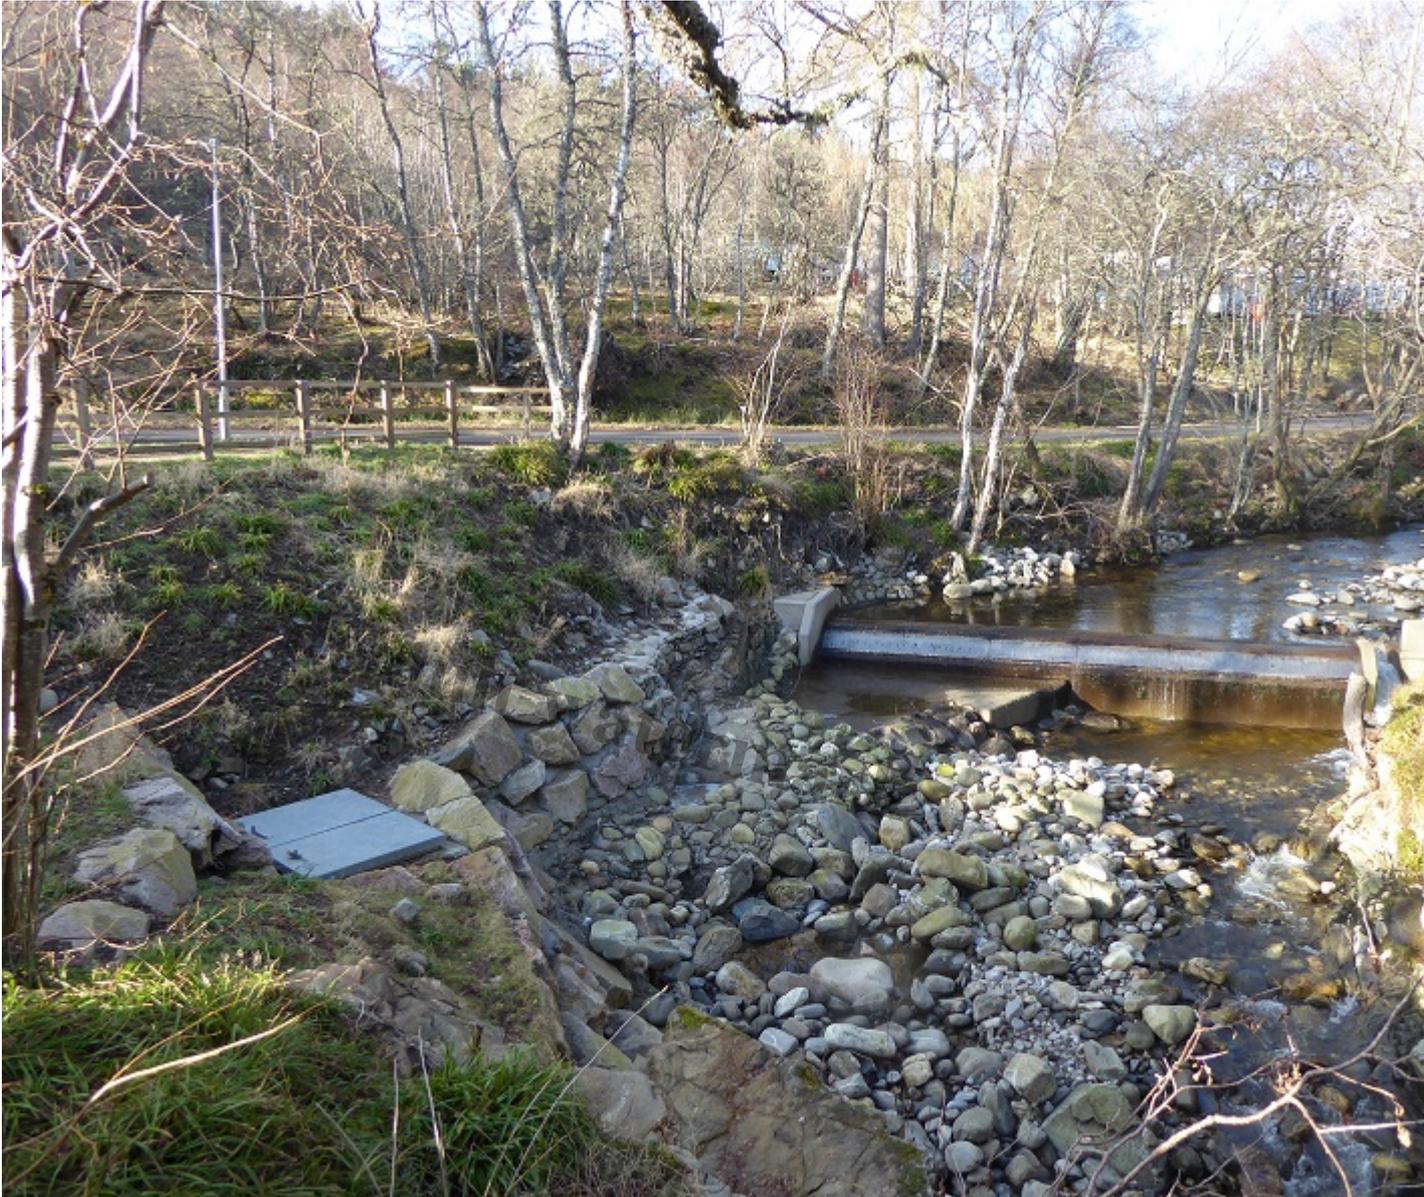
View from footbridge over Gynack

The intake weir has been constructed against the old 1920s intake. The key thing to note is its a true run of river scheme. There has been no significant damming of the river and as a result the intake structure has a very low profile, unlike many of the hydro intakes in the Loch Lomond and Trossachs National Park which have raised water levels and are taller structures as a consequence. There are still exposed section of concrete at the intake, but this is far less than usual and although they have not been faced with natural stone, the Cairngorms National Park Authority, to its credit did require:

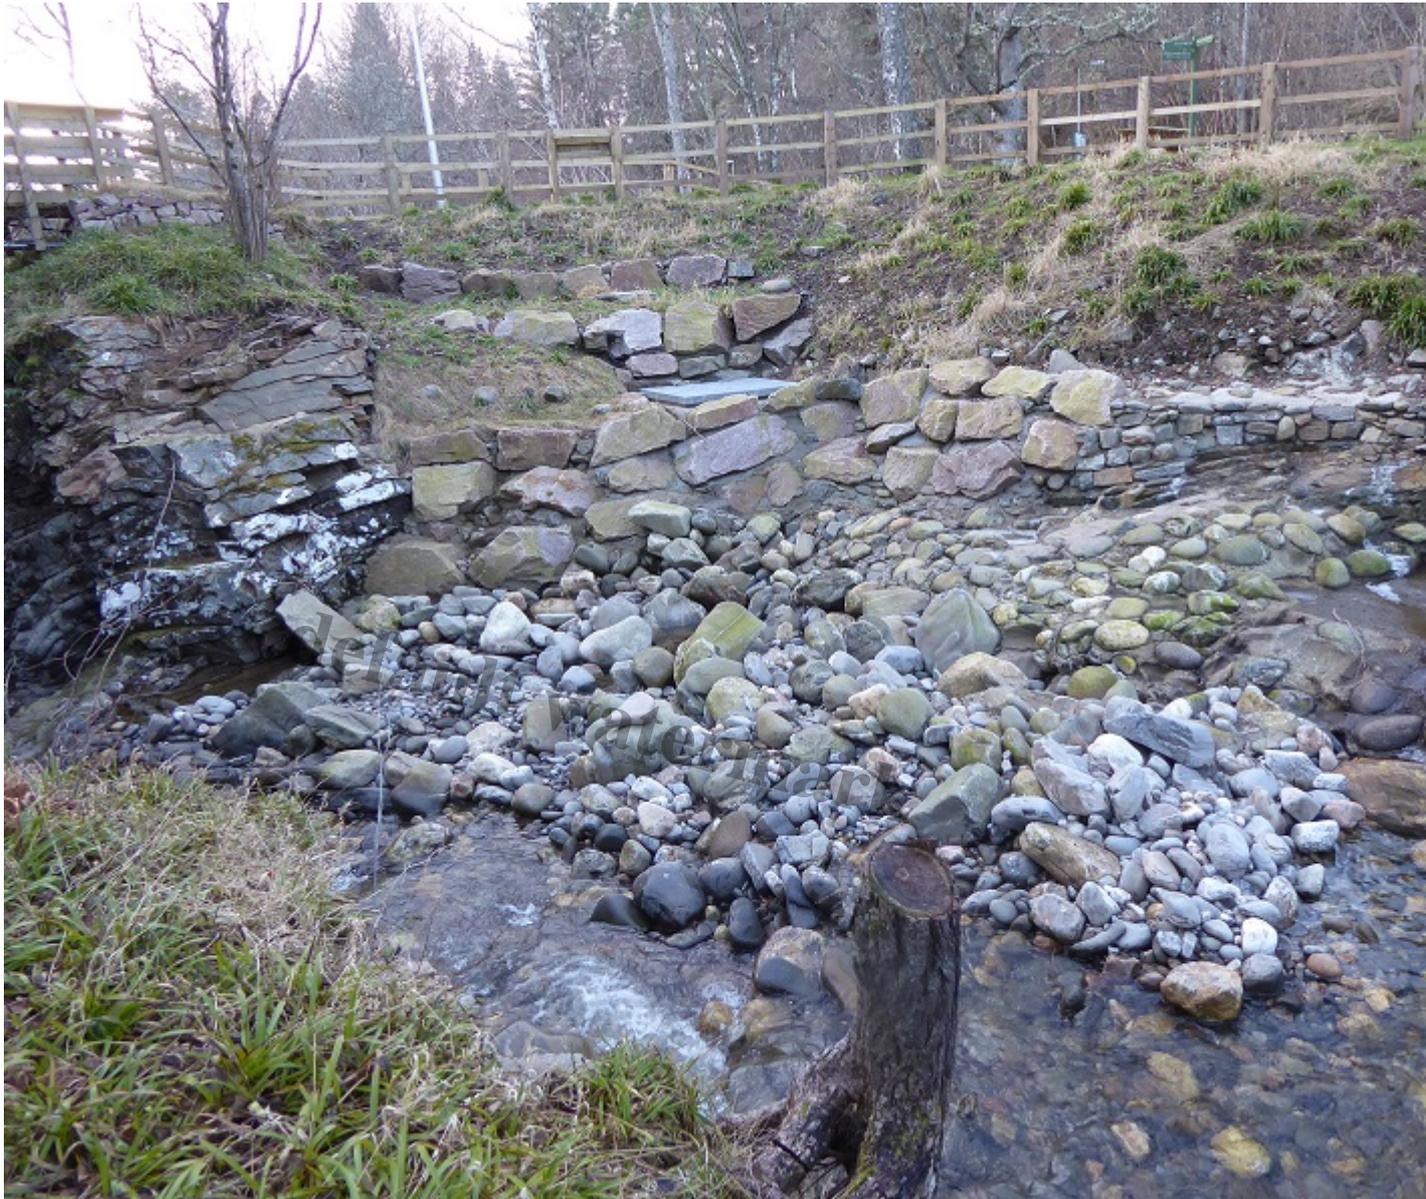
The line of the pipe, viewed from close to the intake, runs behind the line of the wall on the right.

This is probably the worst view of the scheme but positive features include: the edge of the pipe where it exits the dam (top left) has been finished in stone; the work to stabilise the river bed below this has been done by embedding rounded boulders in concrete mirroring the loose boulders in the river bed; and vegetation has been replaced around the rip rap bouldering that has been used to reconstruct the bank.

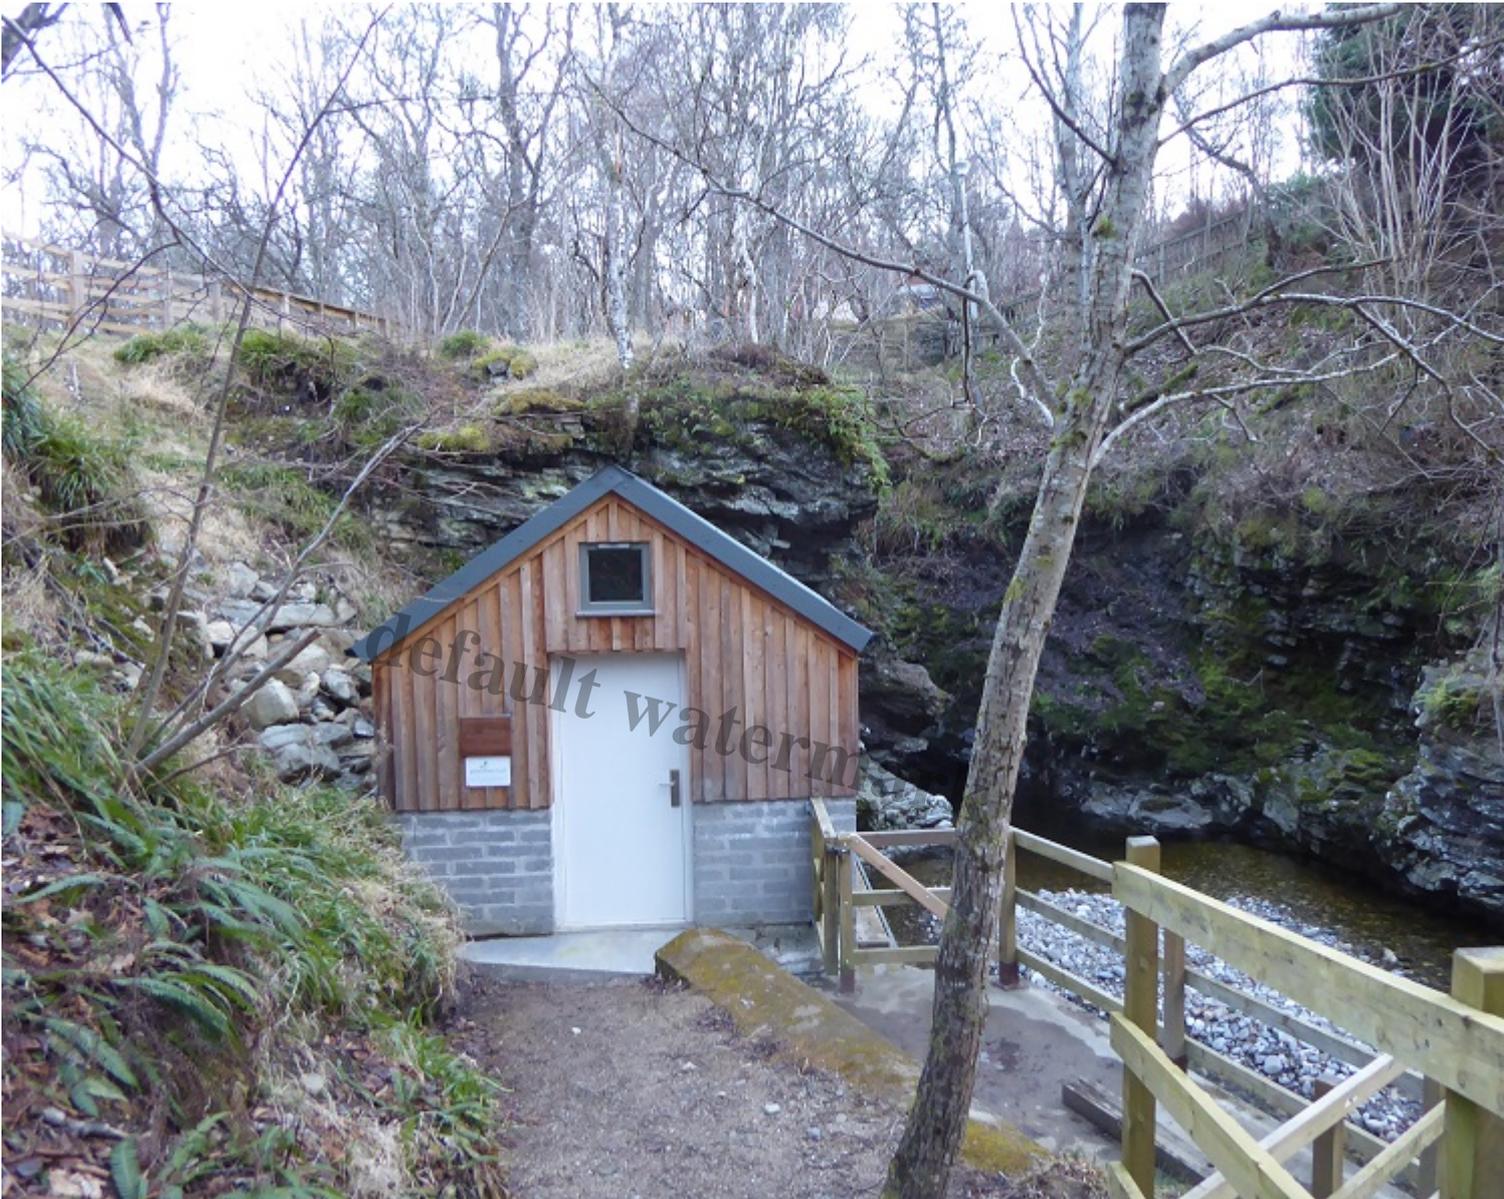
The section of former pipe

The power house has been constructed just 4m below the intake on a beautiful section of river by the former powerhouse (a remnant of the old pipe can be seen between the tree and powerhouse and there was a concrete base here previously). It is however tucked away and hard to see from above and the finishing, apart from the brick is good. The line of the pipe to the powerhouse is marked by the

boulders on the bank on the left. In summer, when the trees are in full leaf, it would be even easier to miss.

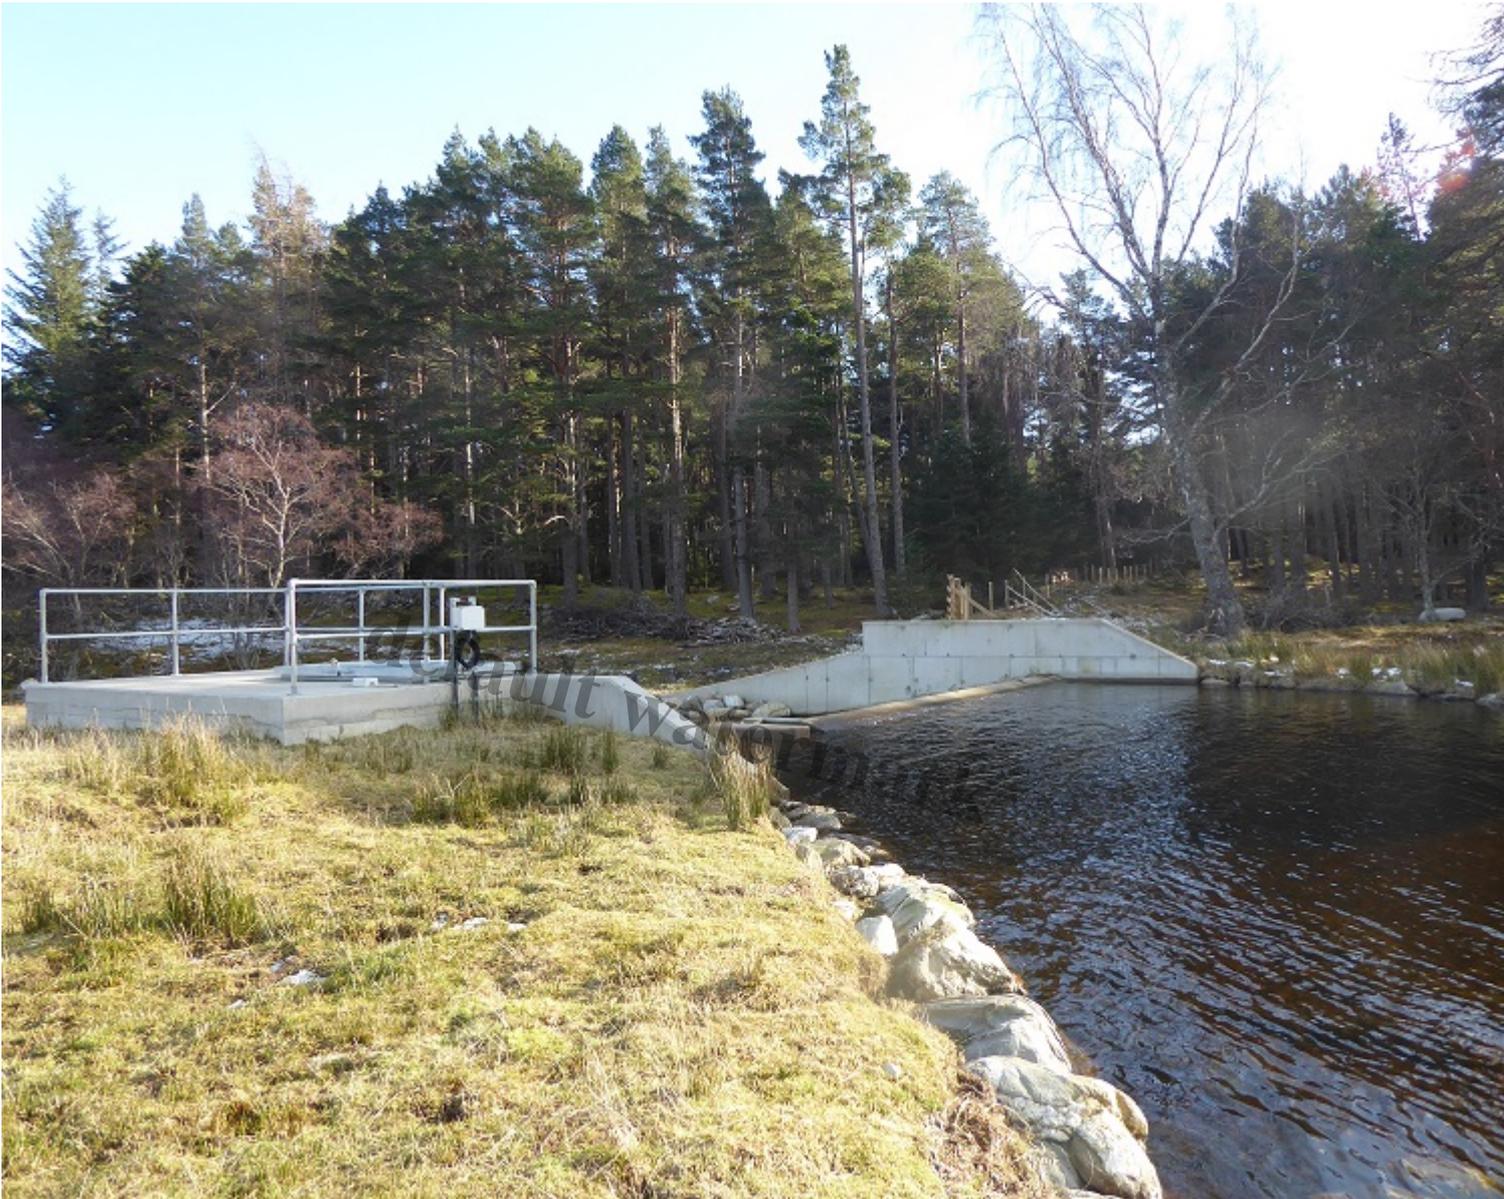
The profile of the new dam is low, and hardly visible from any distance, but close up the finishing is not good, with concrete wing walls which would be better faced with natural stone and metal railings contrasting with the wooden railings used in the Community Hydro. Why cannot our National Parks enforce a consistent approach which maximises use of natural materials?

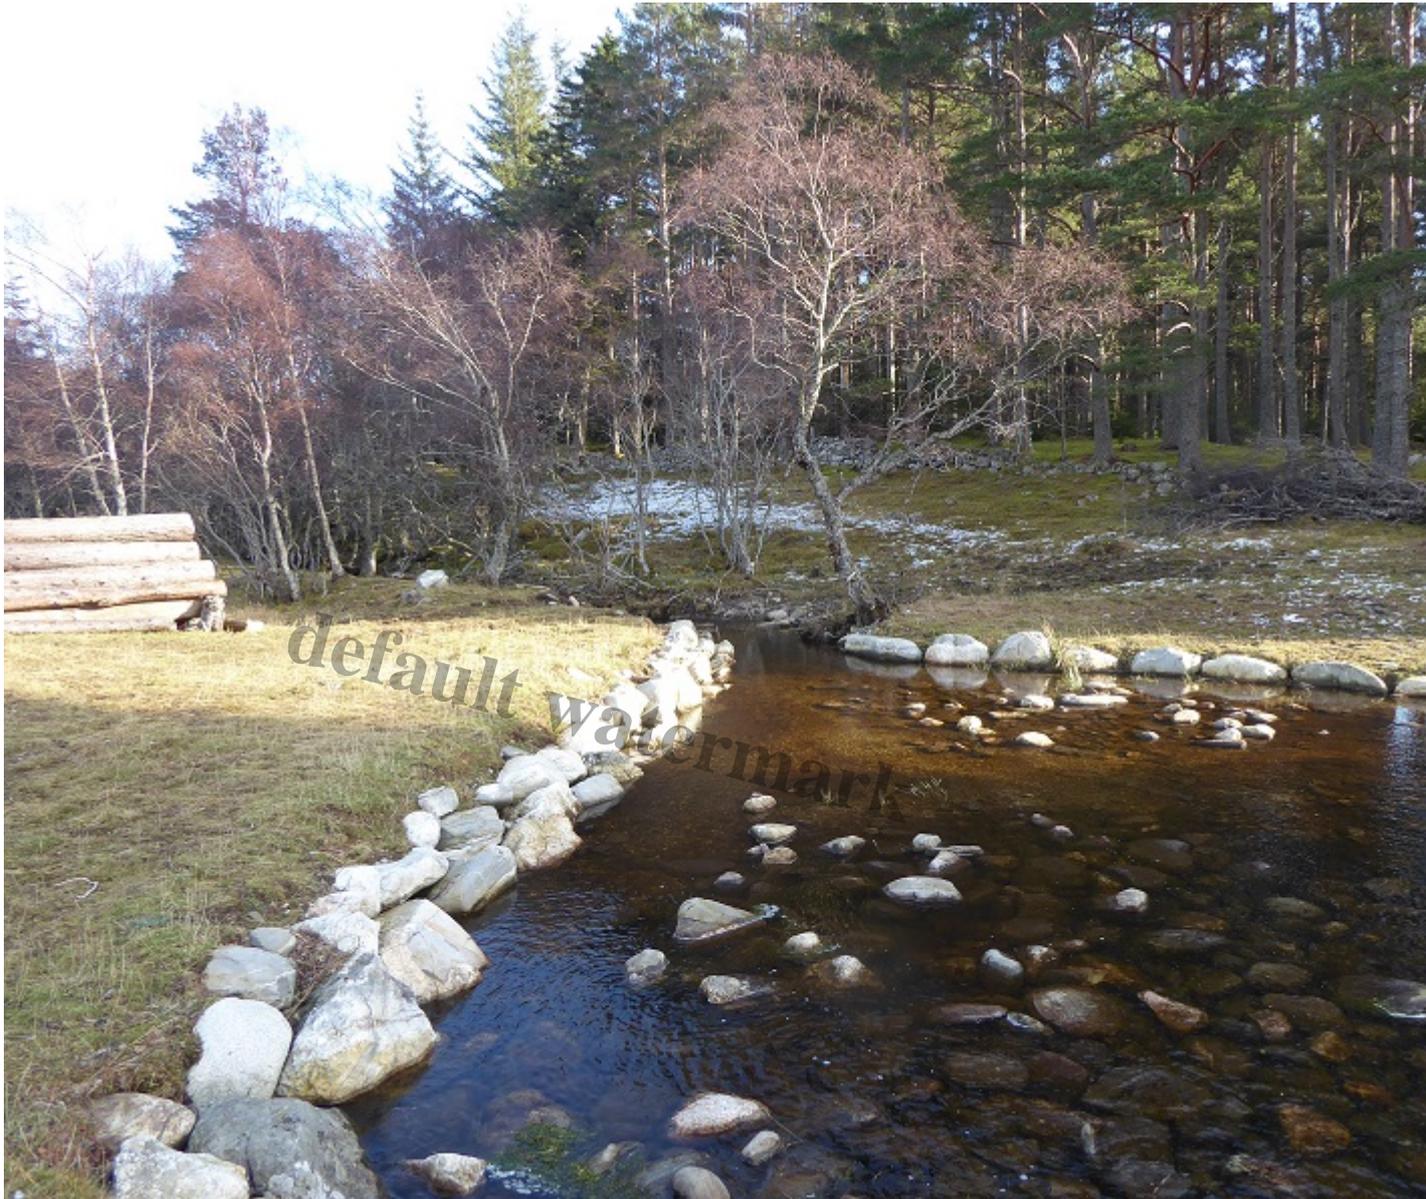
Close up of rip rap bouldering below the intake

However, and this is a big positive, the use of rip rap bouldering is minimal and may even revegetate in due course. Even better, I had not checked the line of the buried pipe beforehand, but could not see where it went, a sign of very successful restoration.

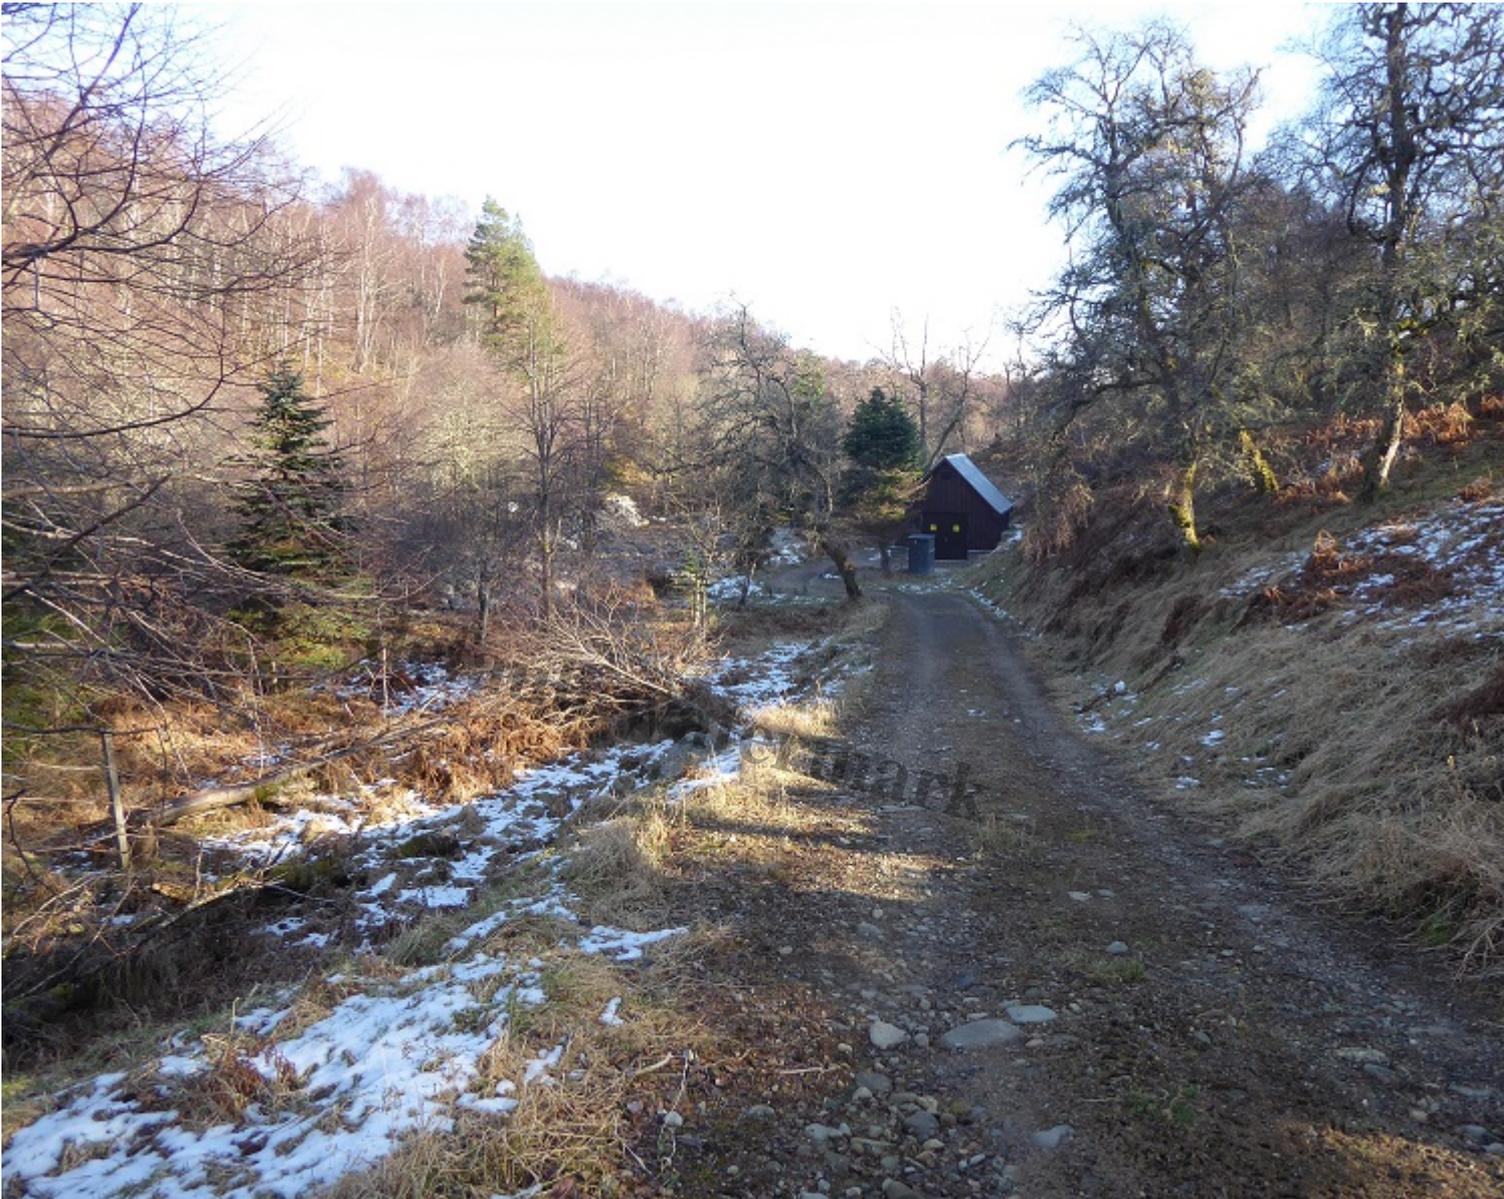
Lower down, I believe the pipeline runs under the track, although its been done so well it I cannot say this with certainty. The track however has already blended into the landscape, unlike most of the tracks featured on parkswatch. Positive features include: the edges of the track are vegetated and there was no sign of spoil spilling down the bank on left; the track is narrow, forcing vehicles to keep to the same line; and as a consequence the centre of the track is revegetating. This track, while going nowhere (its a dead end) provides a good walking experience.

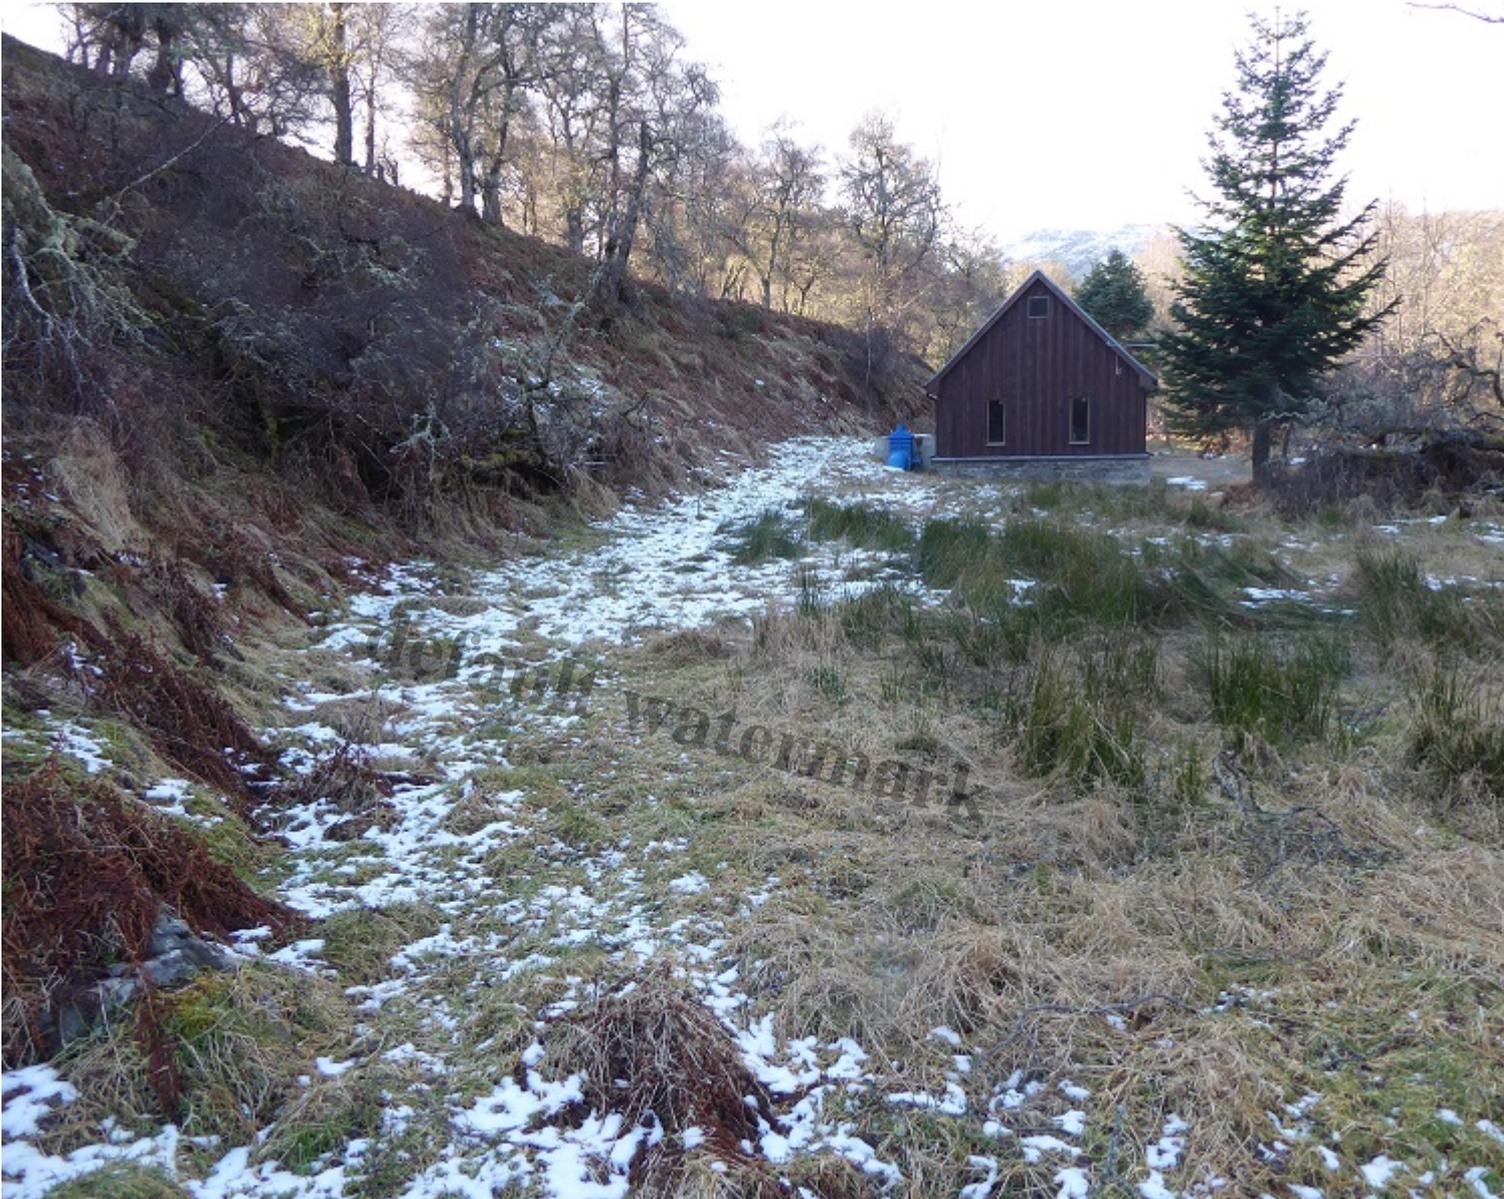
Close up of penstock

Another photo demonstrating how good the restoration of vegetation has been. The line of the buried pipe that leaves the powerhouse can be seen, mainly due to the lack of rushes, but there is no bare

ground at all. The contractor must have saved all the turf removed to bury the pipe and has then replaced it. This is something very rarely seen in hydro developments where failure to store and re-use turves is usually all too evident. The whole is only marred by the blue penstock.

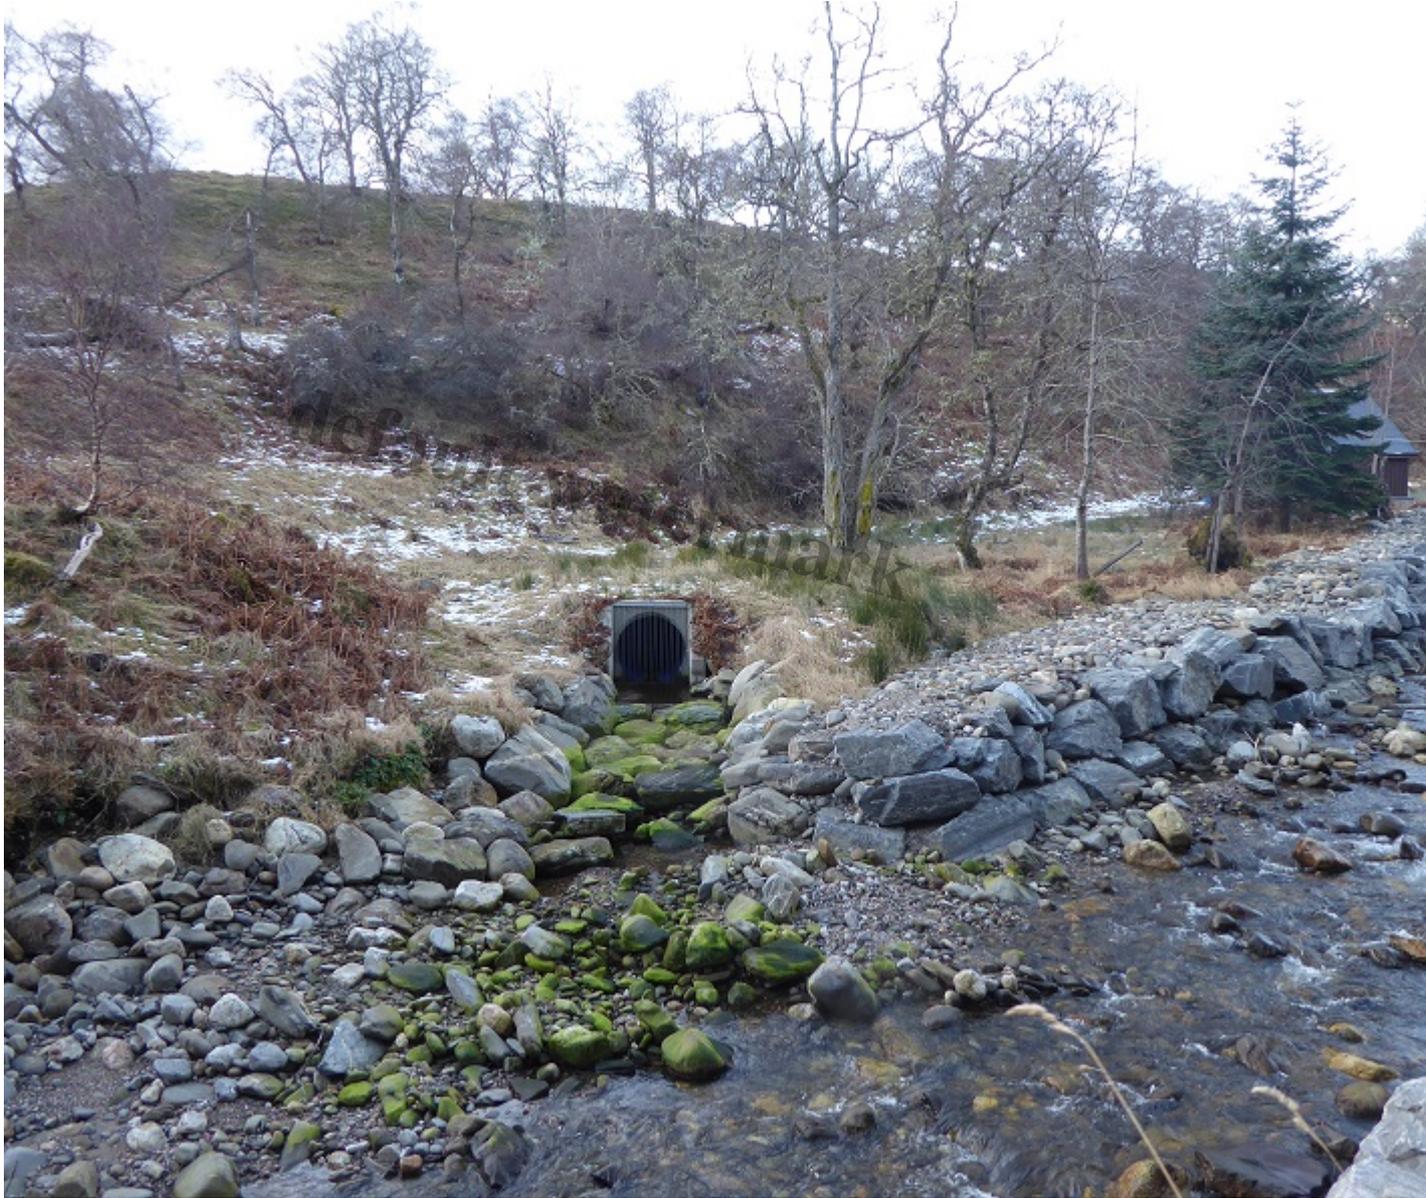
View from east side River Gynack of tailrace and powerhouse. The rip rap bouldering along the river the hydro scheme.

The tailrace has also been well finished and the concrete around the pipe is almost invisible while again the rip rap bouldering between the tailrace and the river has been kept to a minimum. The landscape and ecological issue here is not the hydro scheme, or how it has been constructed, but rather earlier attempts to engineer the River Gynack which can carry huge volumes of water and threatens Kingussie. As part of river engineering, a separate planning application has been approved to construct a flood overflow channel from higher up the river down into Loch Gynack which I will consider in a post on the Upper Gynack hydro scheme. Here, the consequence of the river engineering is to

narrow what once would have served as a flood plain, and the construction of a powerhouse here reduces the likelihood that will ever be reversed.

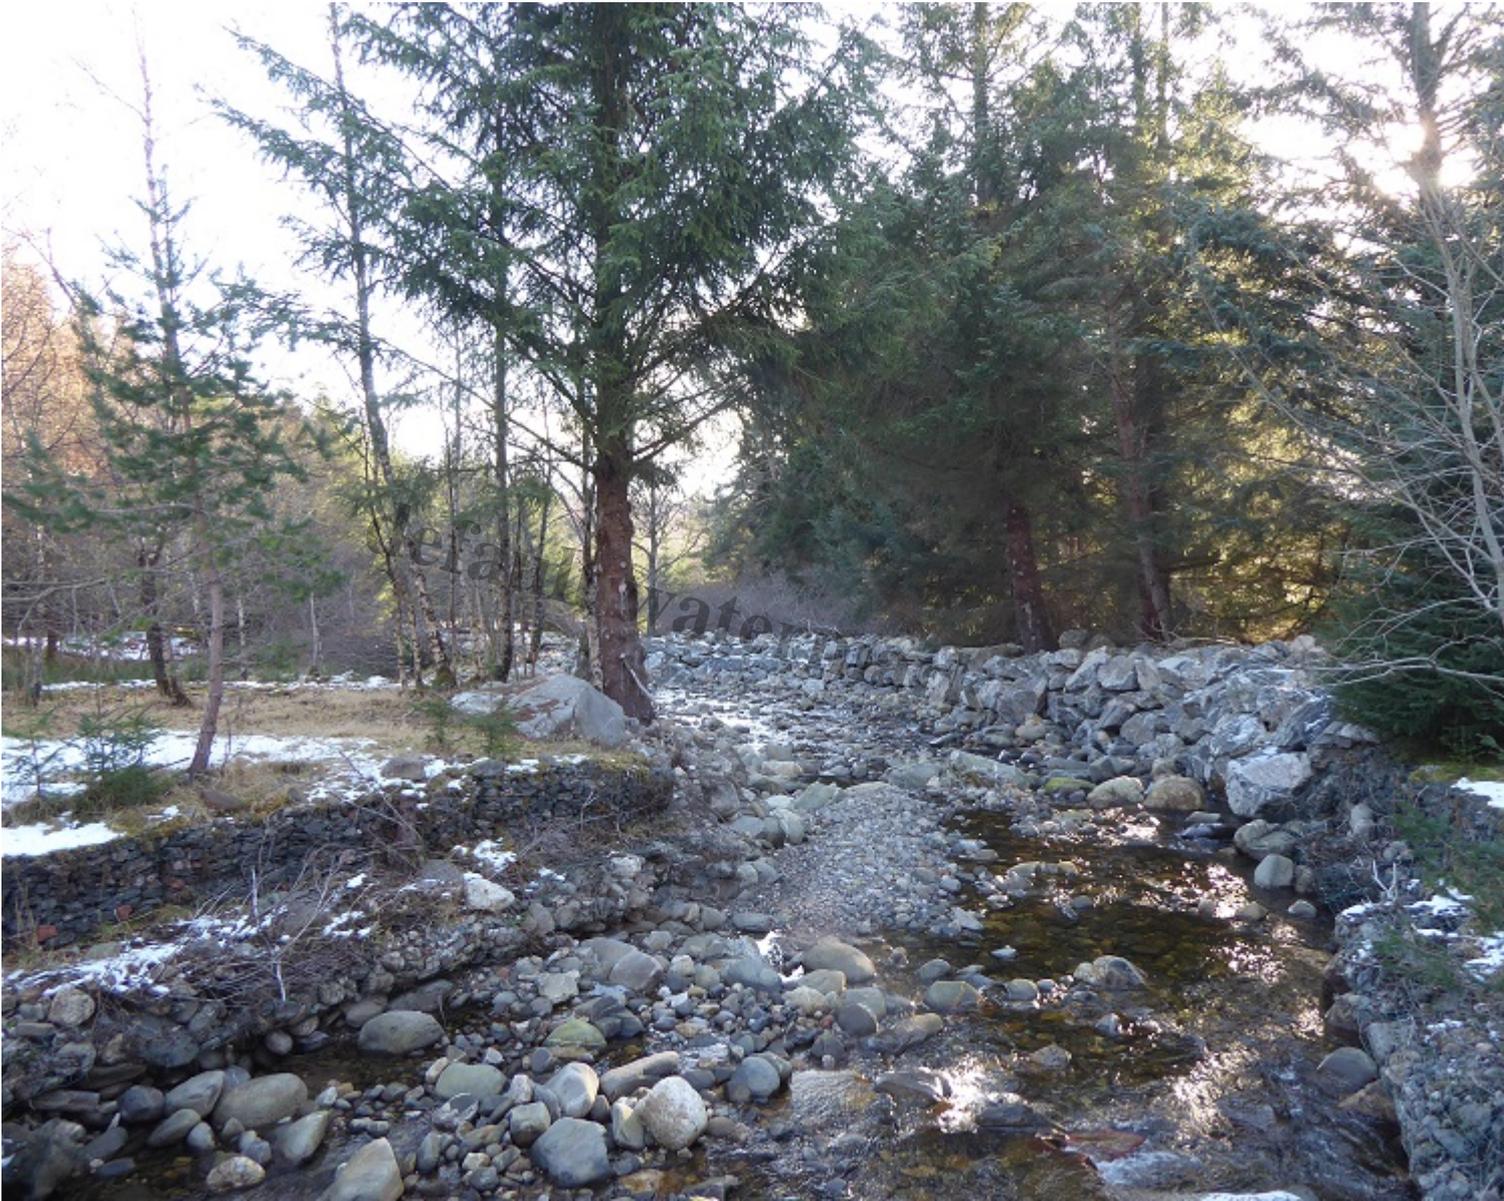
Above the intake, the River Gynack has been extensively engineered and you can see older engineering attempts to contain the river left and newer right.
