## Well designed hydro schemes (1) – Gynack

### Gynack Scheme 1 – Kingussie Community Development Company

## Gynack Scheme 2

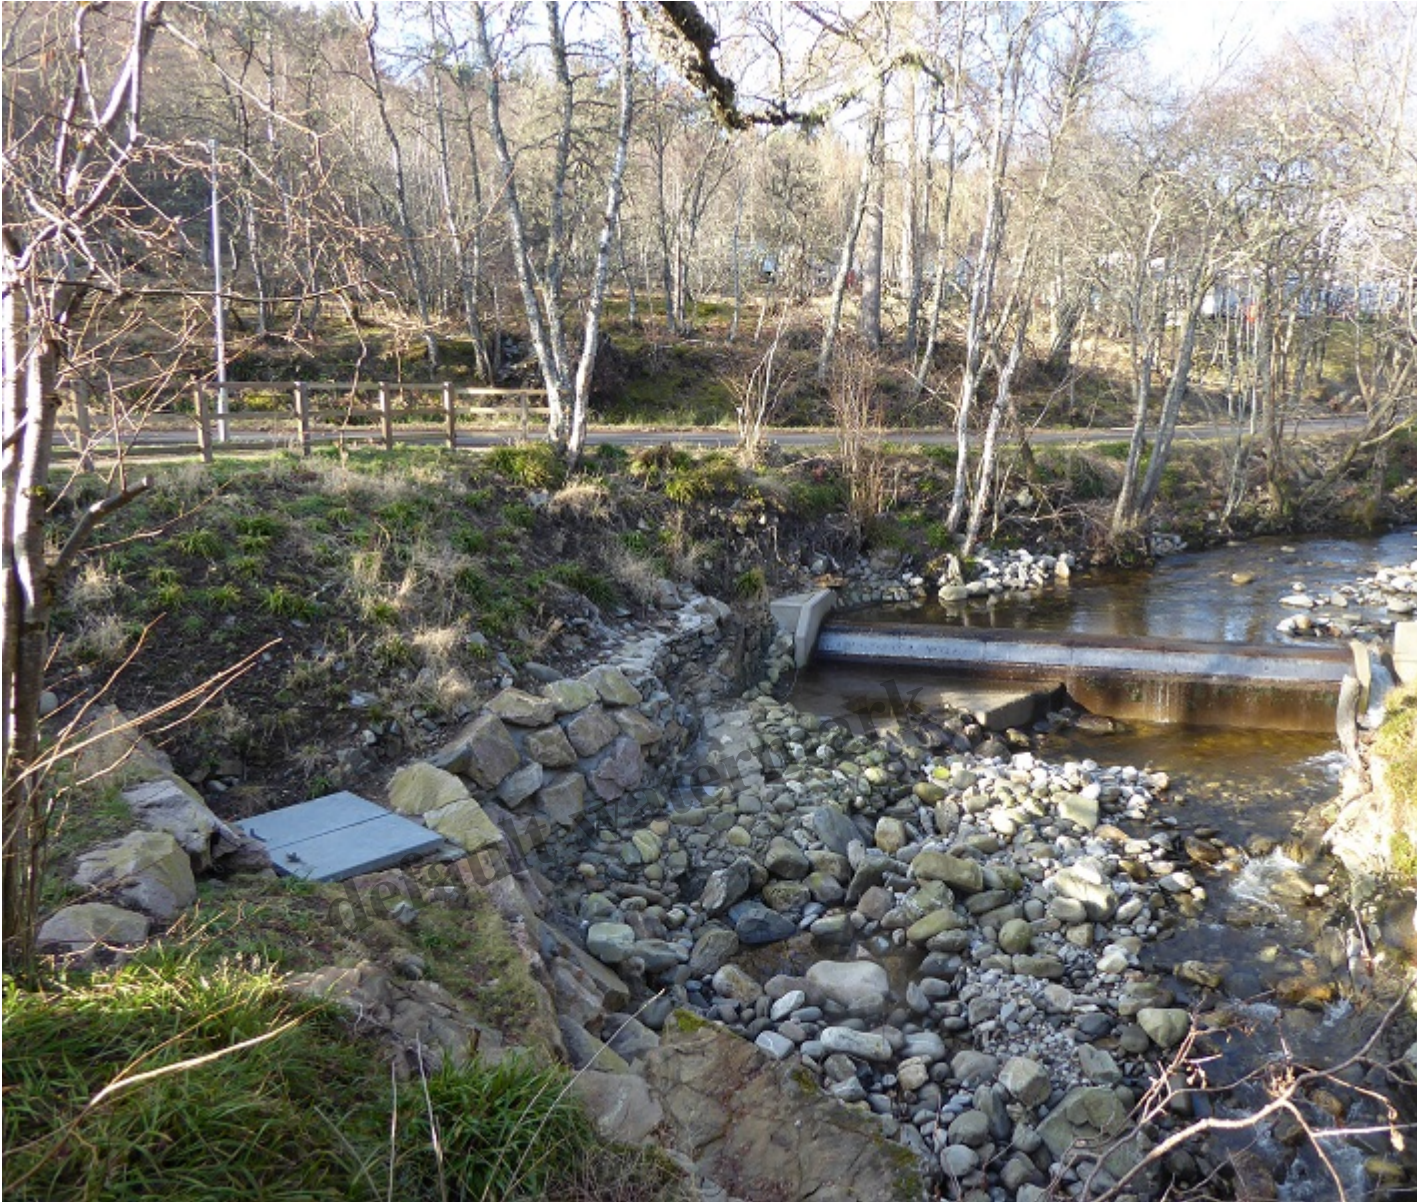
View from footbridge over Gynack

The intake weir has been constructed against the old 1920s intake. The key thing to note is its a true run of river scheme. There has been no significant damming of the river and as a result the intake structure has a very low profile, unlike many of the hydro intakes in the Loch Lomond and Trossachs National Park which have raised water levels and are taller structures as a consequence. There are still exposed section of concrete at the intake, but this is far less than usual and although they have not been faced with natural stone, the Cairngorms National Park Authority, to its credit did require:

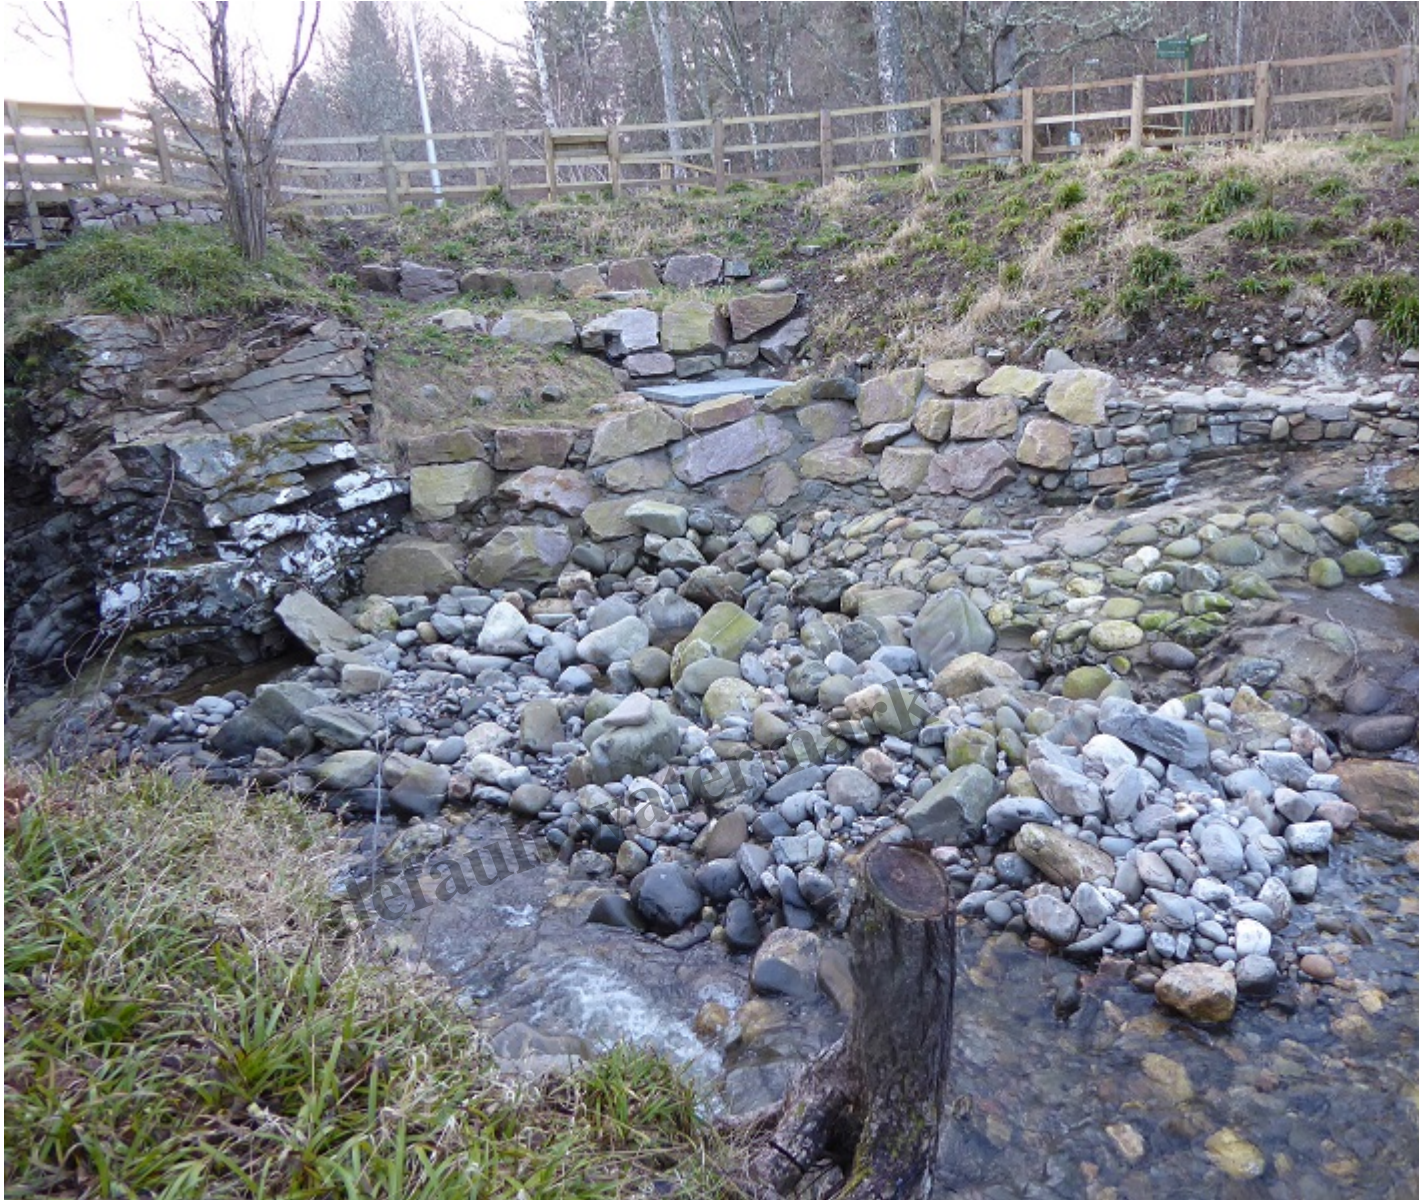
The line of the pipe, viewed from close to the intake, runs behind the line of the wall on the right.

This is probably the worst view of the scheme but positive features include: the edge of the pipe where it exits the dam (top left) has been finished in stone; the work to stabilise the river bed below this has been done by embedding rounded boulders in concrete mirroring the loose boulders in the river bed; and vegetation has been replaced around the rip rap bouldering that has been used to reconstruct the bank.

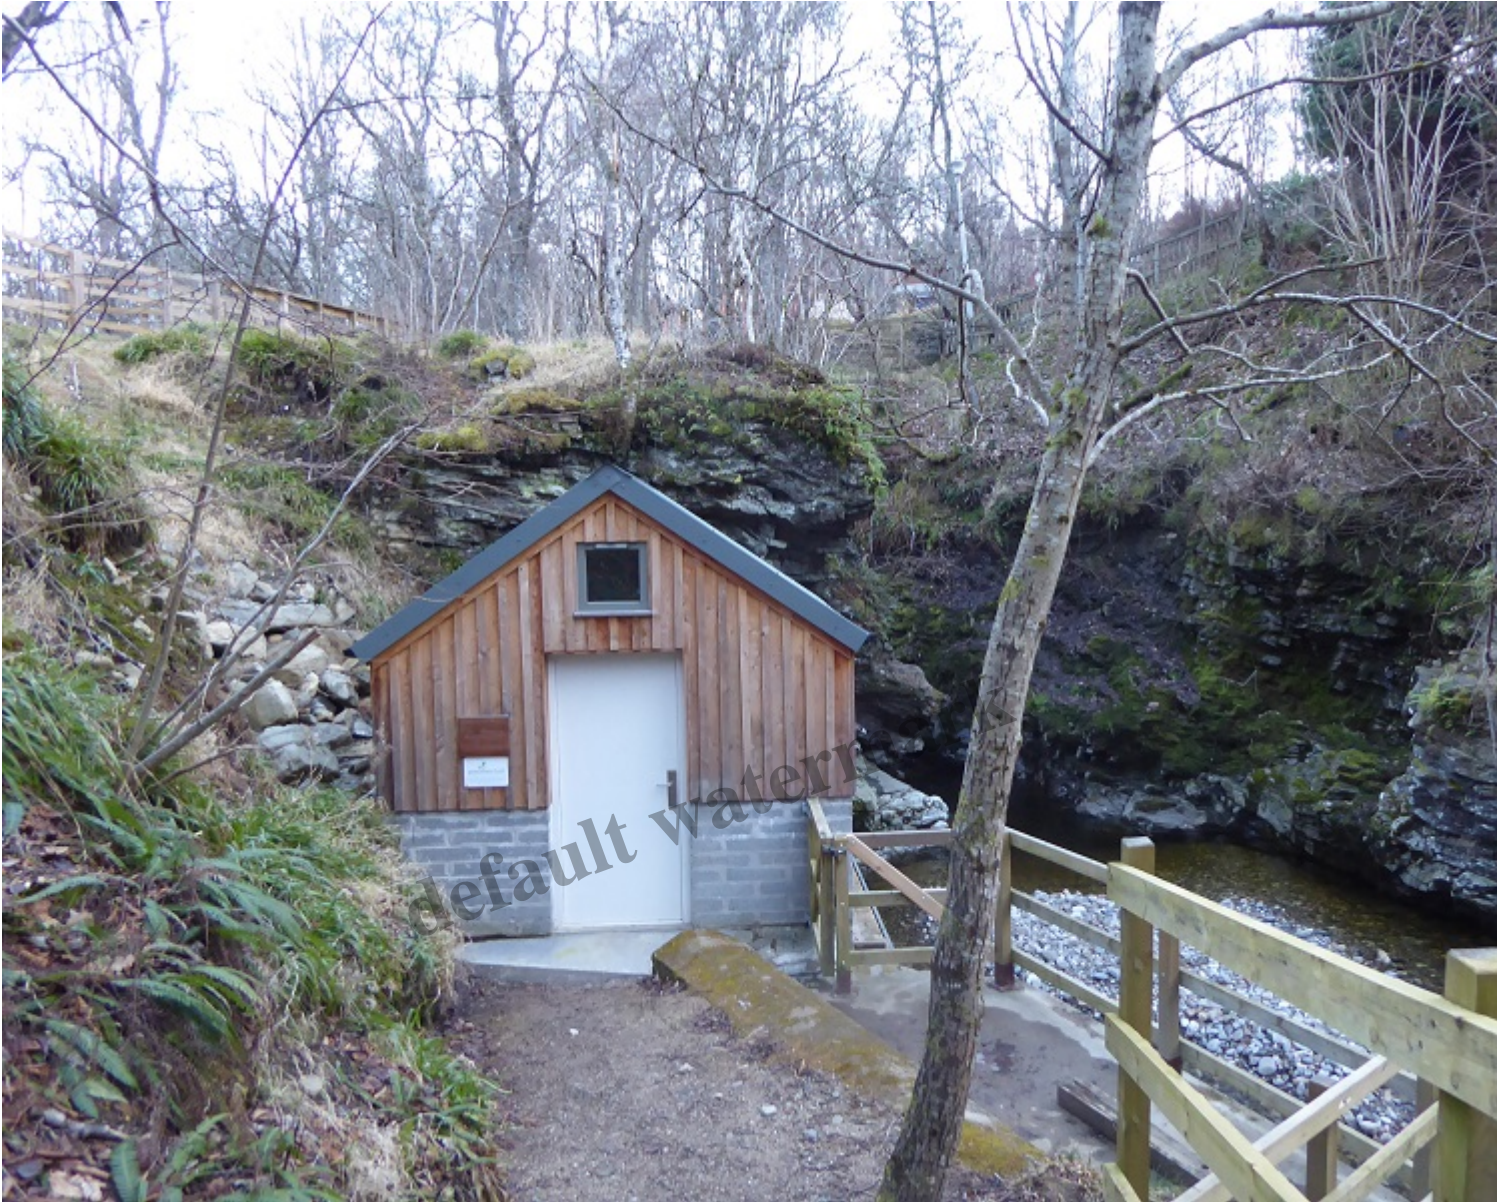
The power house has been constructed just 4m below the intake on a beautiful section of river by the former powerhouse (a remnant of the old pipe can be seen between the tree and powerhouse and there was a concrete base here previously). It is however tucked away and hard to see from above

and the finishing, apart from the brick is good. The line of the pipe to the powerhouse is marked by the boulders on the bank on the left. In summer, when the trees are in full leaf, it would be even easier to miss.

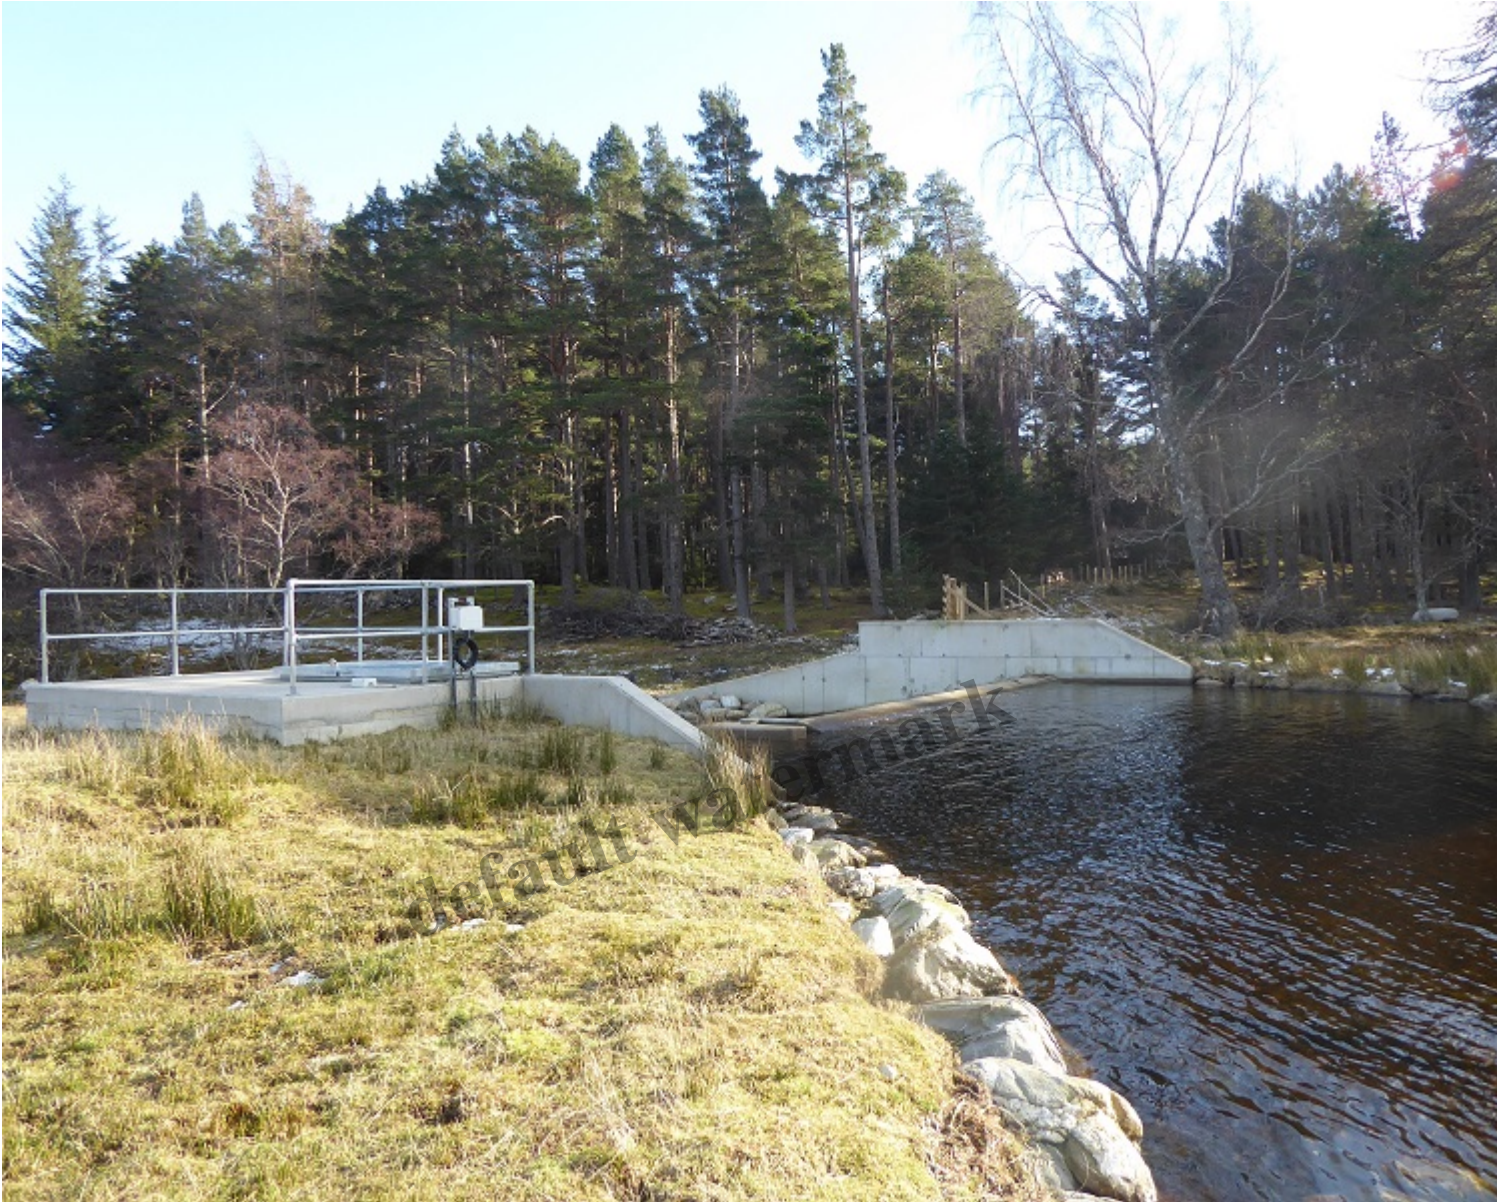
The profile of the new dam is low, and hardly visible from any distance, but close up the finishing is not good, with concrete wing walls which would be better faced with natural stone and metal railings contrasting with the wooden railings used in the Community Hydro. Why cannot our National Parks enforce a consistent approach which maximises use of natural materials?

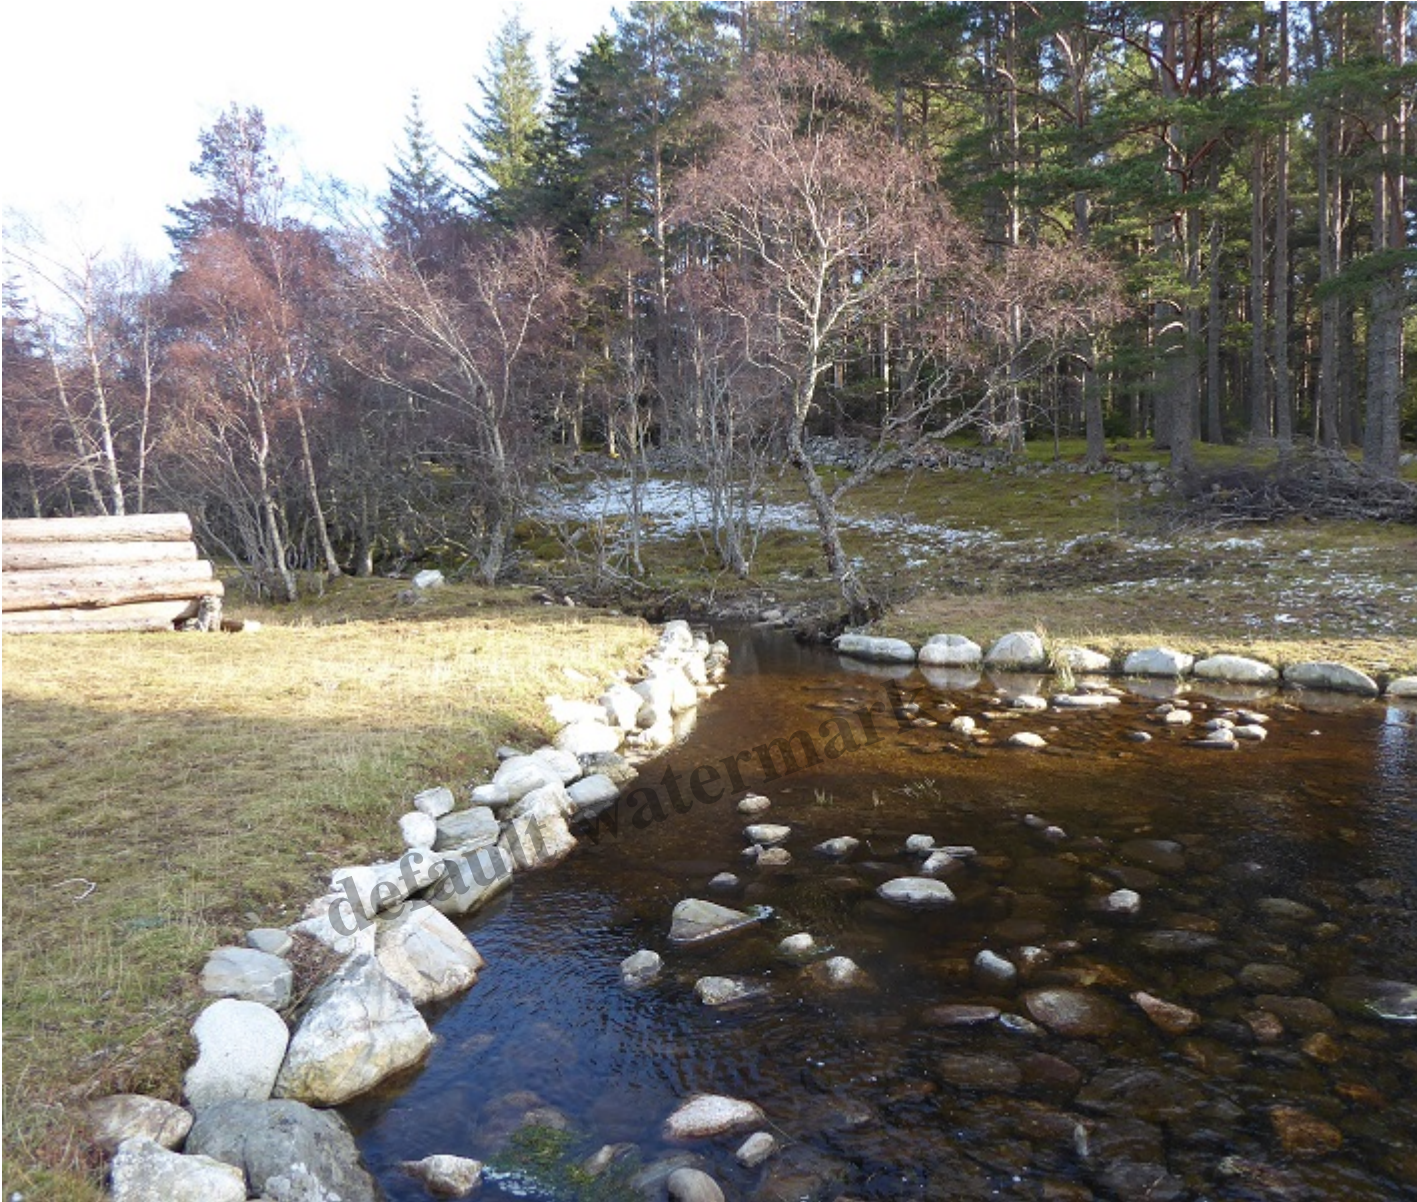
Close up of rip rap bouldering below the intake

However, and this is a big positive, the use of rip rap bouldering is minimal and may even revegetate in due course. Even better, I had not checked the line of the buried pipe beforehand, but could not see where it went, a sign of very successful restoration.

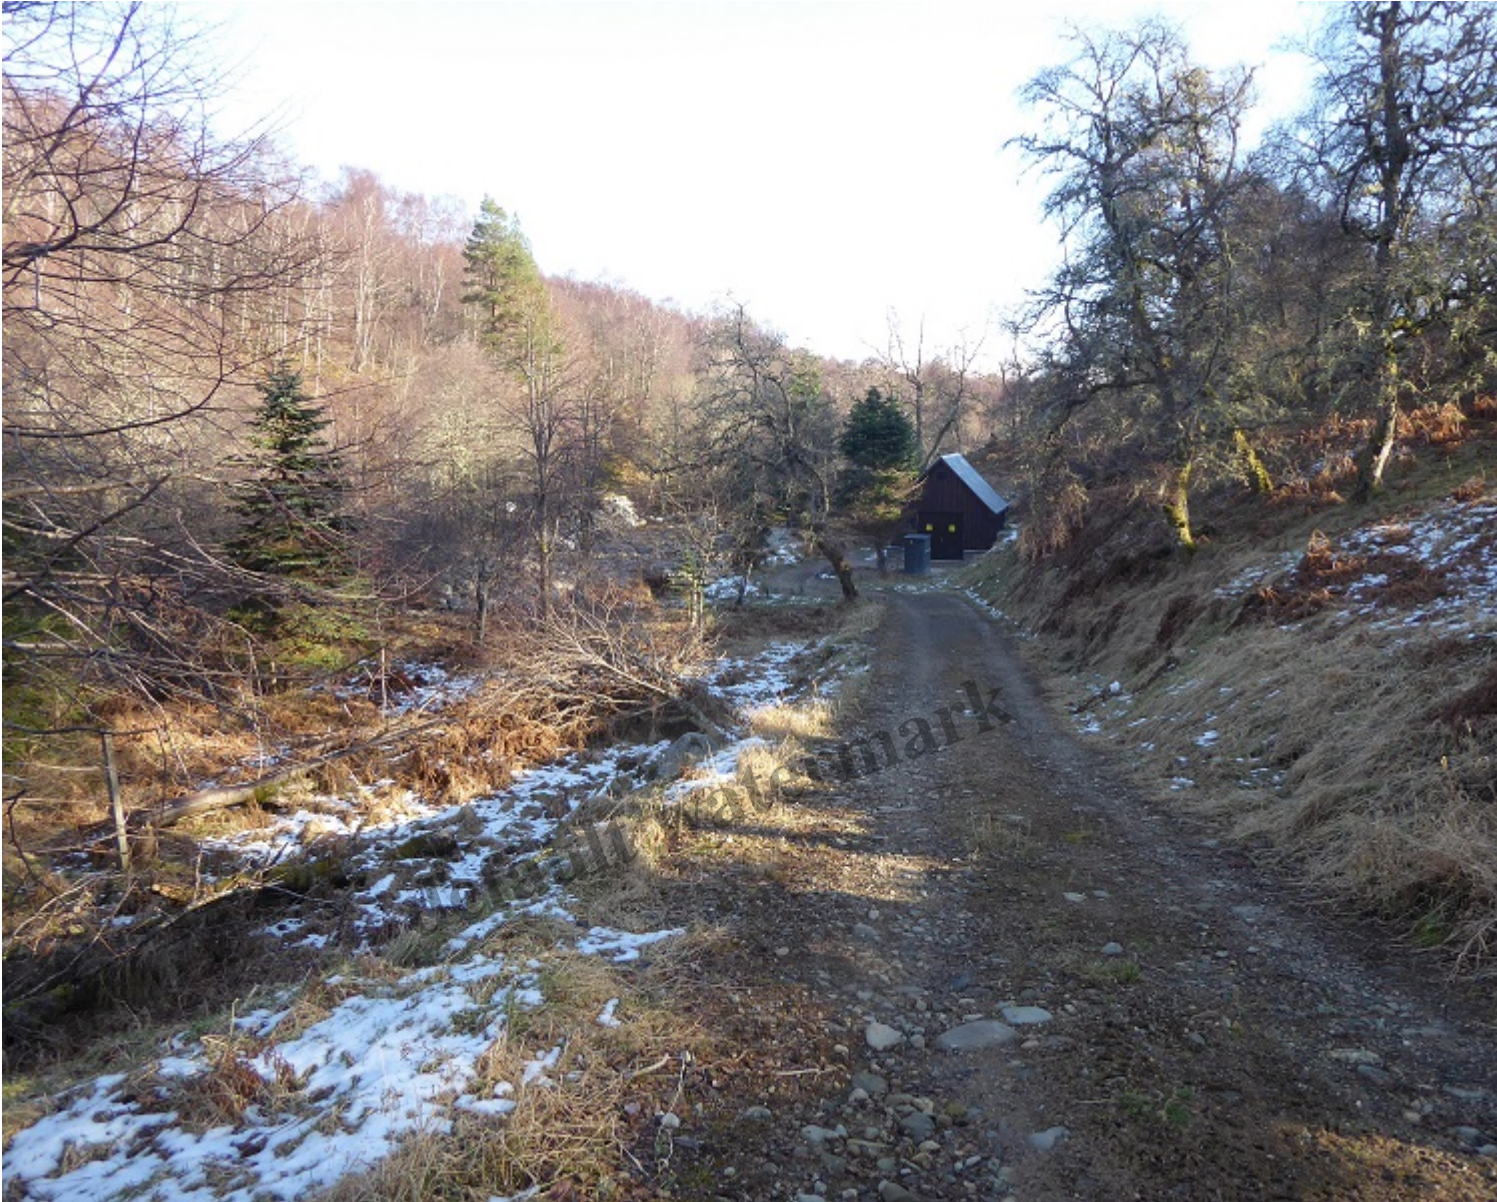
Lower down, I believe the pipeline runs under the track, although its been done so well it I cannot say this with certainty. The track however has already blended into the landscape, unlike most of the tracks featured on parkswatch. Positive features include: the edges of the track are vegetated and there was no sign of spoil spilling down the bank on left; the track is narrow, forcing vehicles to keep to the same line; and as a consequence the centre of the track is revegetating. This track, while going nowhere (its a dead end) provides a good walking experience.

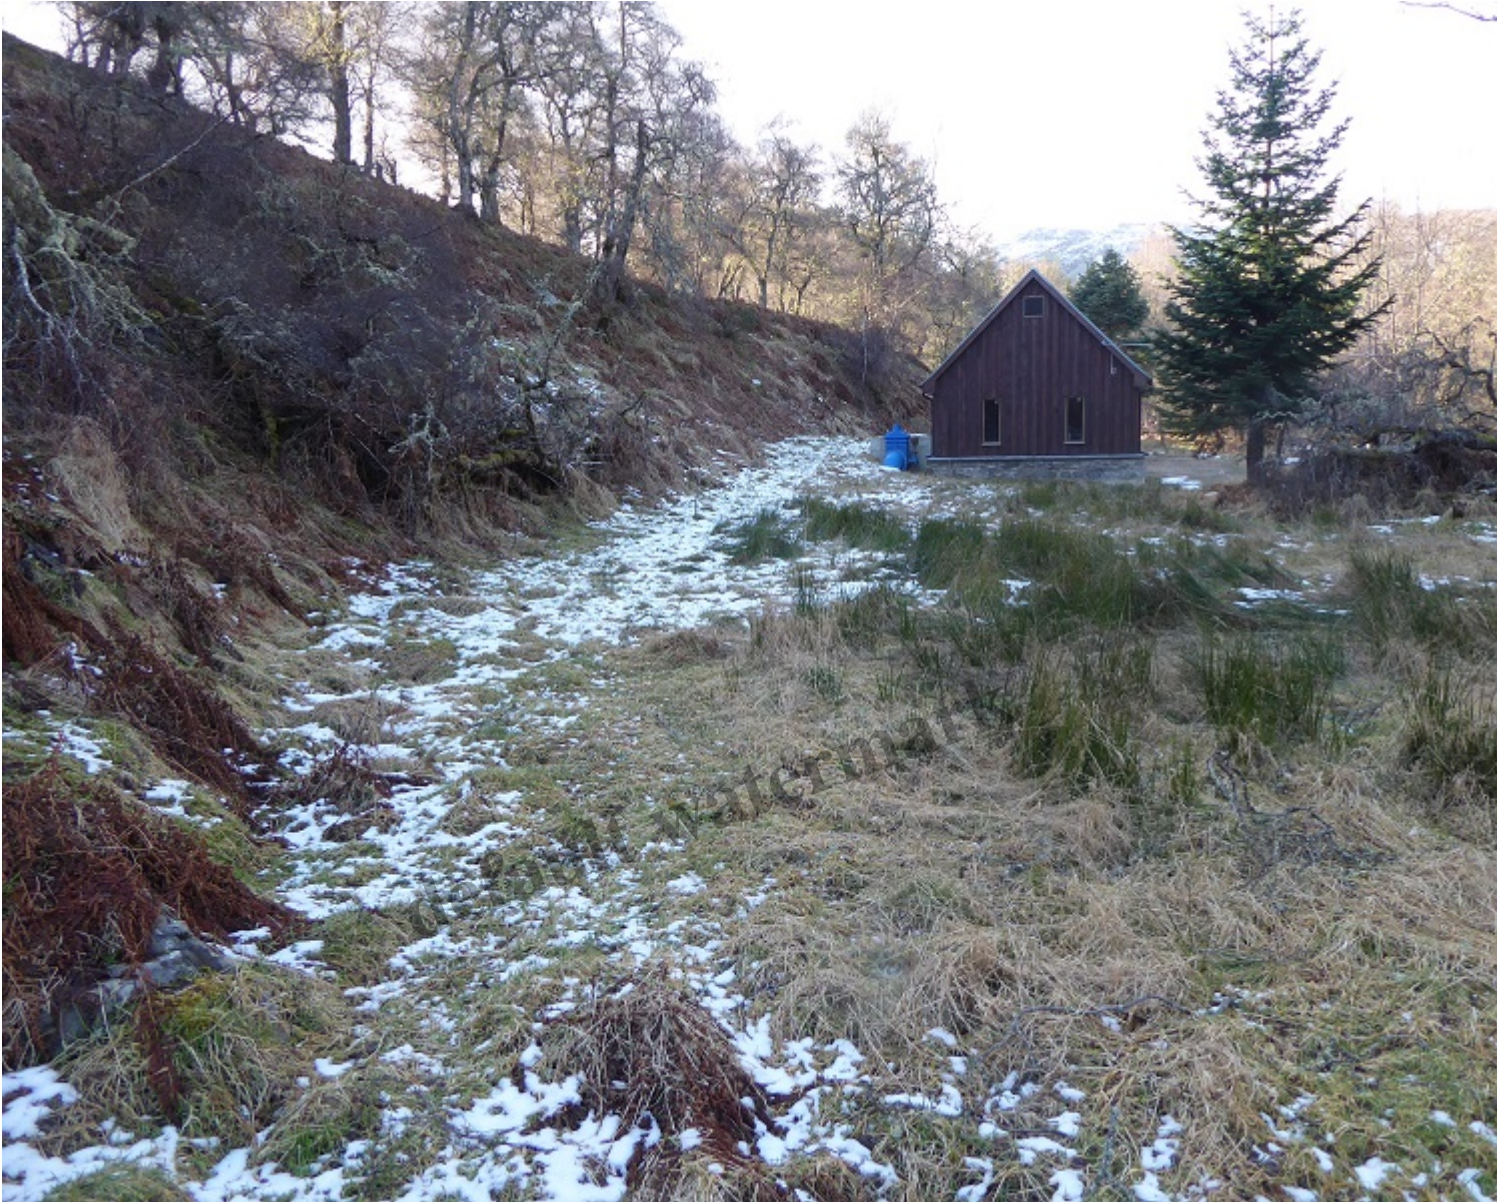
Close up of penstock

Another photo demonstrating how good the restoration of vegetation has been. The line of the buried

pipe that leaves the powerhouse can be seen, mainly due to the lack of rushes, but there is no bare ground at all. The contractor must have saved all the turf removed to bury the pipe and has then replaced it. This is something very rarely seen in hydro developments where failure to store and re-use turves is usually all too evident. The whole is only marred by the blue penstock.

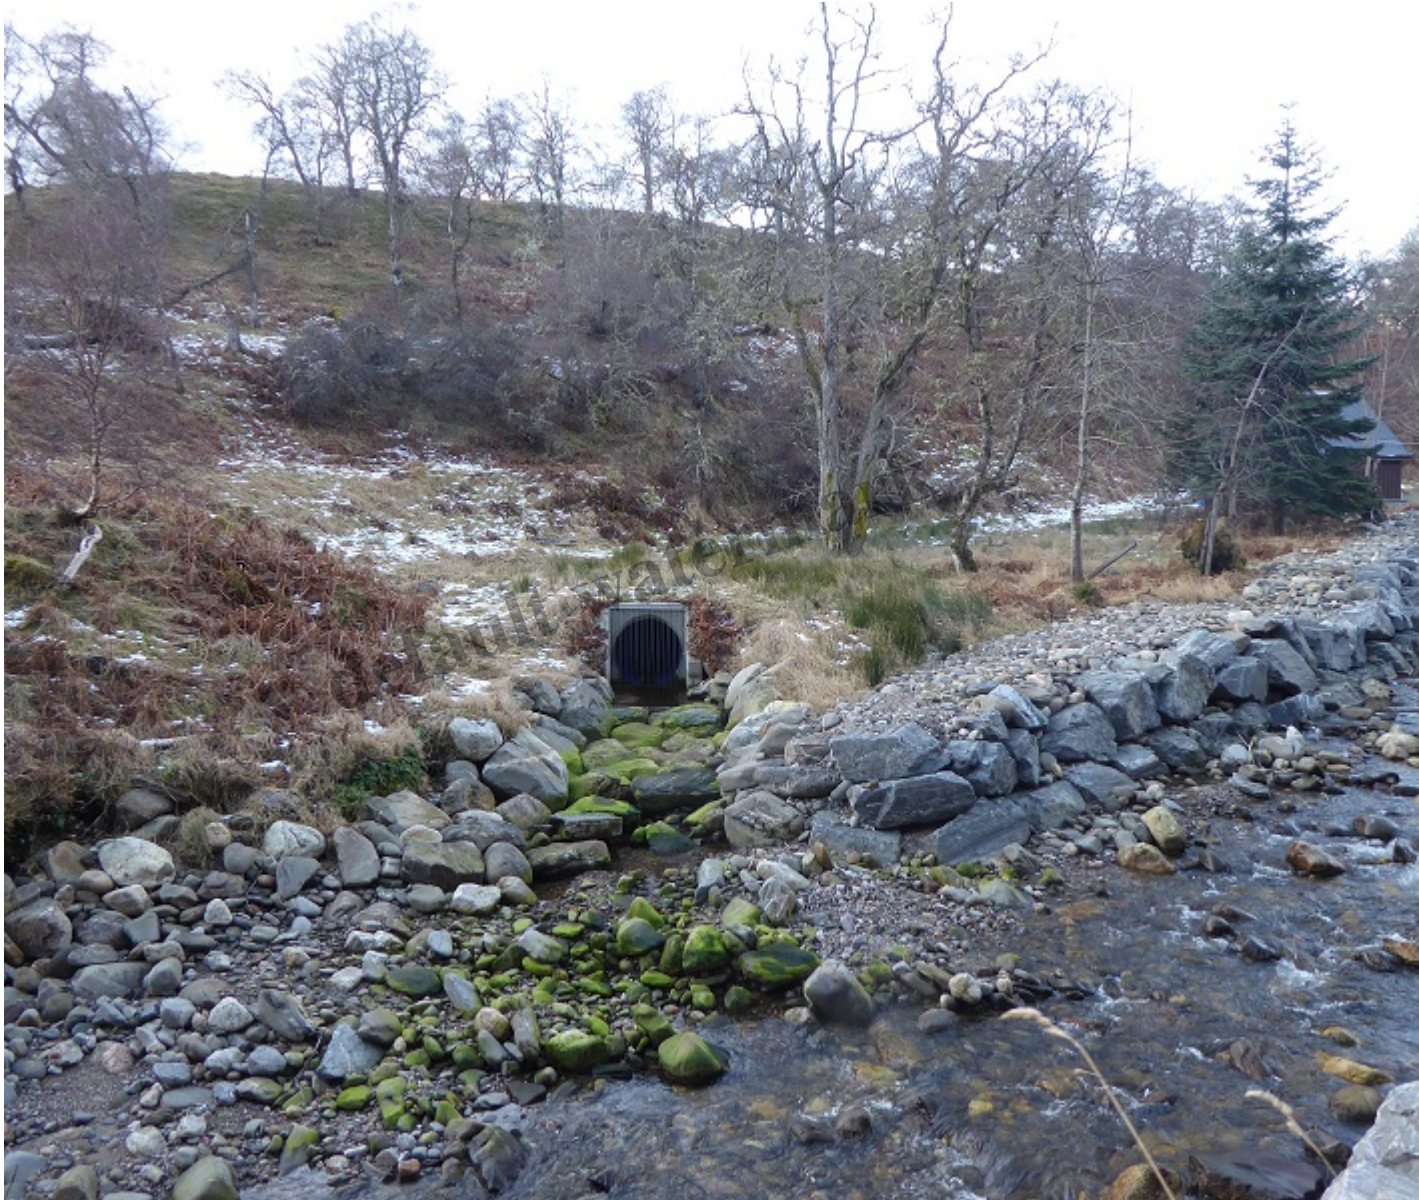
View from east side River Gynack of tailrace and powerhouse. The rip rap bouldering along the river is the hydro scheme.

The tailrace has also been well finished and the concrete around the pipe is almost invisible while again the rip rap bouldering between the tailrace and the river has been kept to a minimum. The landscape and ecological issue here is not the hydro scheme, or how it has been constructed, but rather earlier attempts to engineer the River Gynack which can carry huge volumes of water and threatens Kingussie. As part of river engineering, a separate planning application has been approved to construct a flood overflow channel from higher up the river down into Loch Gynack which I will

consider in a post on the Upper Gynack hydro scheme. Here, the consequence of the river engineering is to narrow what once would have served as a flood plain, and the construction of a powerhouse here reduces the likelihood that will ever be reversed.

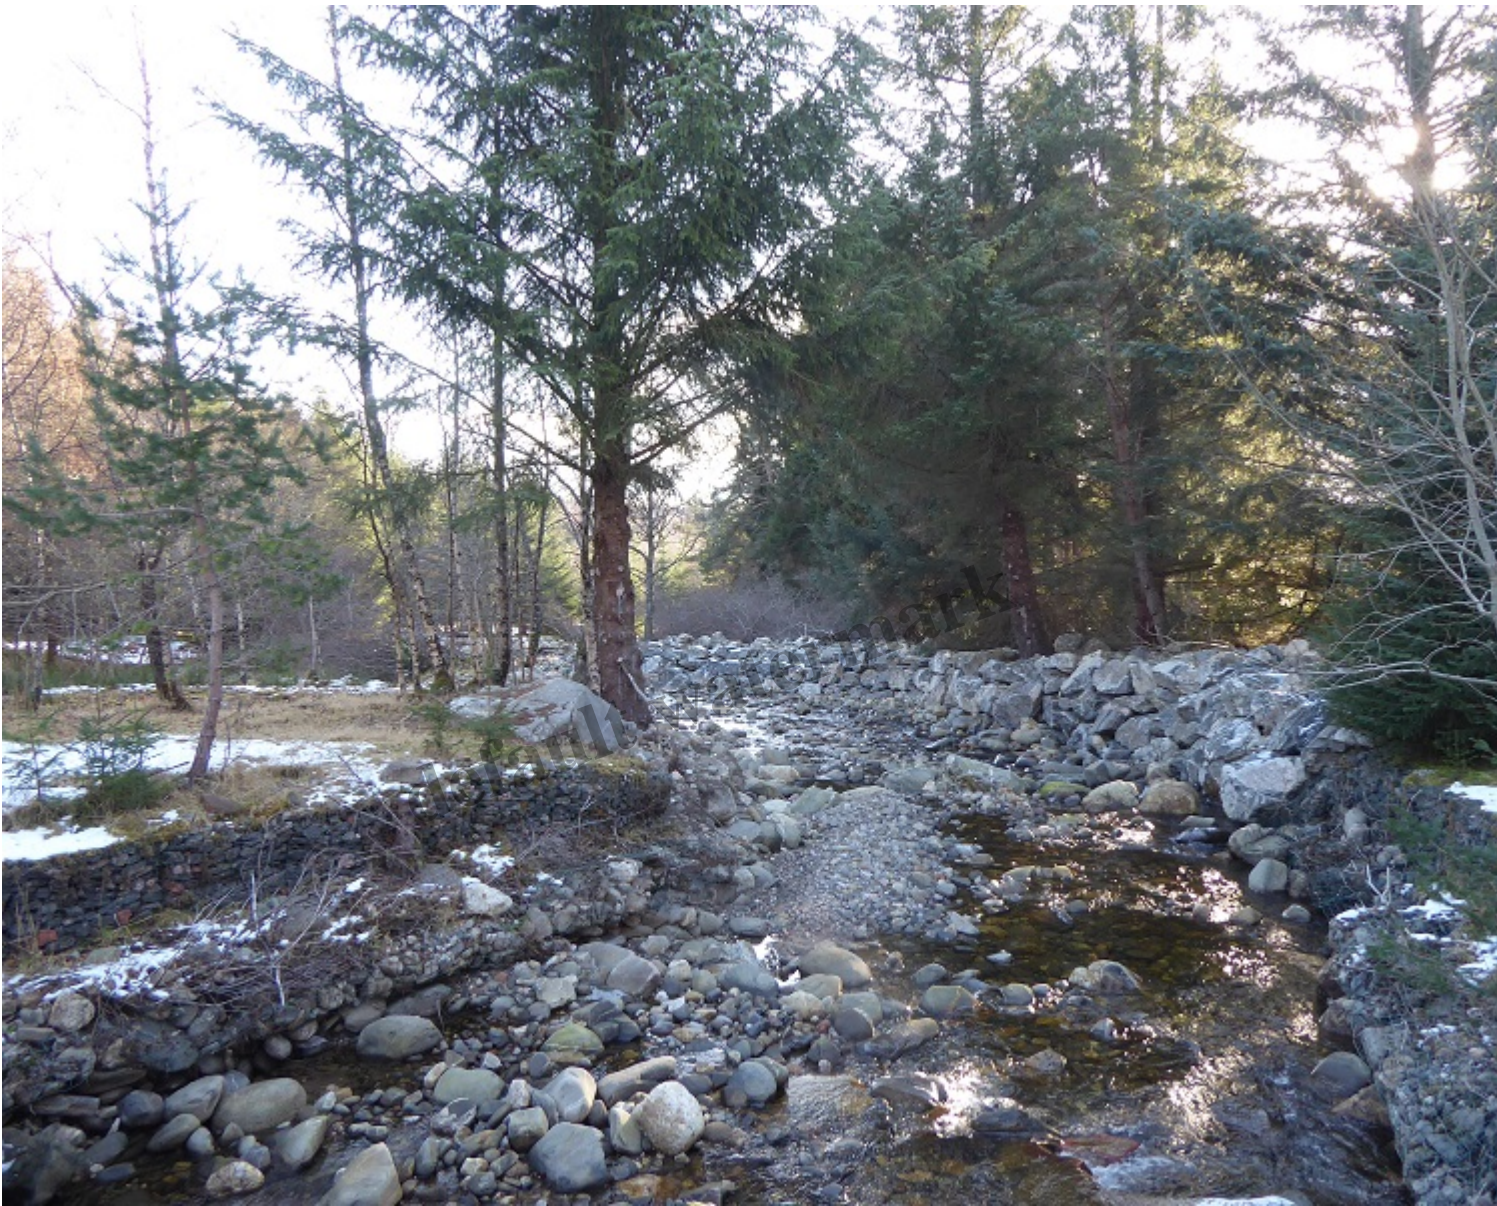
Above the intake, the River Gynack has been extensively engineered and you can see older engineering attempts to contain the river left and newer right.
