Well designed hydro schemes (1) – Gynack

Gynack Scheme 1 – Kingussie Community Development Company

Gynack Scheme 2

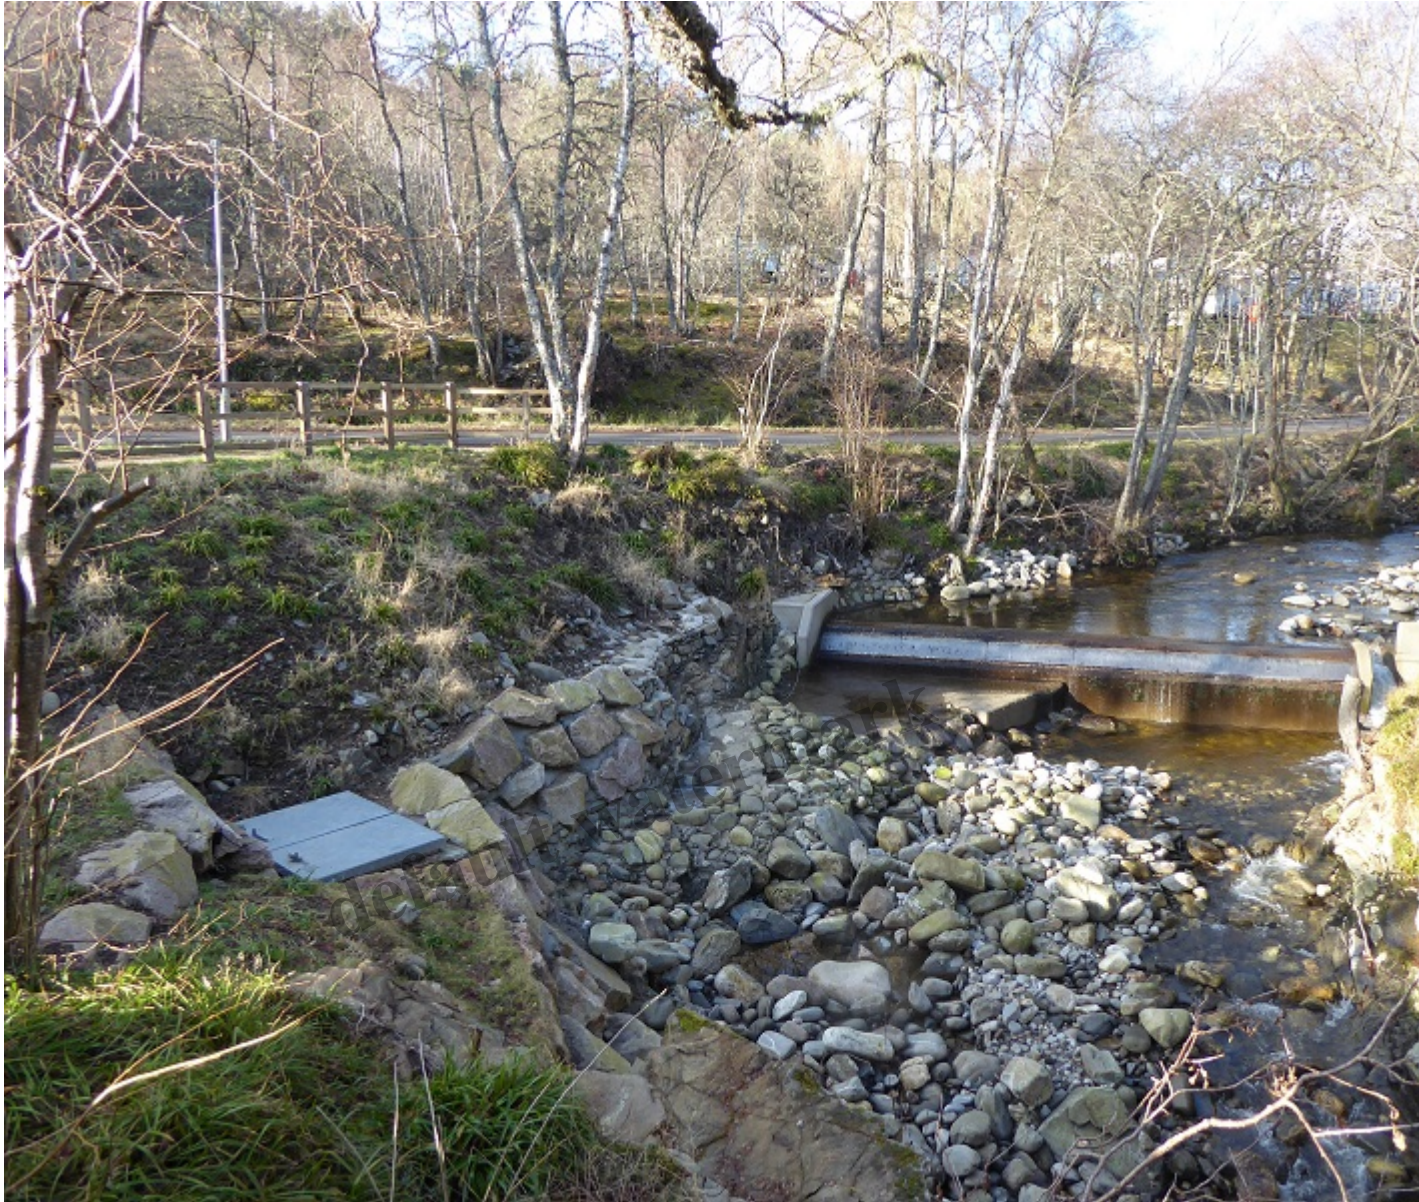
View from footbridge over Gynack

The intake weir has been constructed against the old 1920s intake. The key thing to note is its a true run of river scheme. There has been no significant damming of the river and as a result the intake structure has a very low profile, unlike many of the hydro intakes in the Loch Lomond and Trossachs National Park which have raised water levels and are taller structures as a consequence. There are still exposed section of concrete at the intake, but this is far less than usual and although they have not been faced with natural stone, the Cairngorms National Park Authority, to its credit did require:

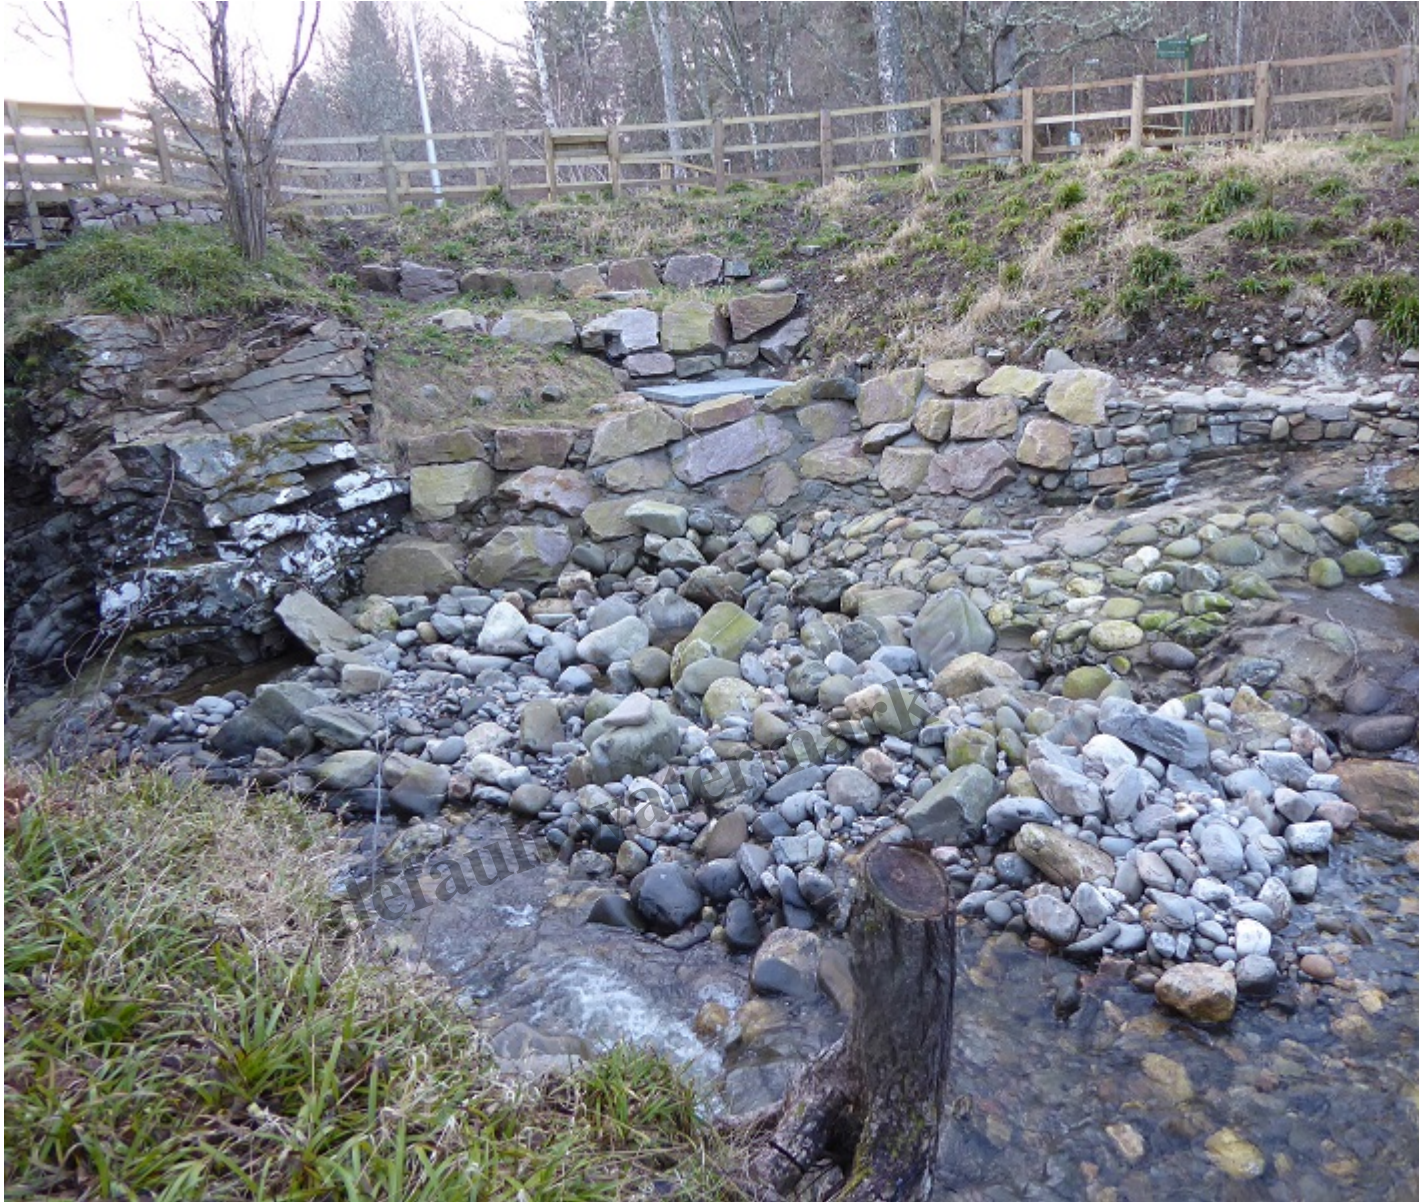
The line of the pipe, viewed from close to the intake, runs behind the line of the wall on the right.

This is probably the worst view of the scheme but positive features include: the edge of the pipe where it exits the dam (top left) has been finished in stone; the work to stabilise the river bed below this has been done by embedding rounded boulders in concrete mirroring the loose boulders in the river bed; and vegetation has been replaced around the rip rap bouldering that has been used to reconstruct the bank.

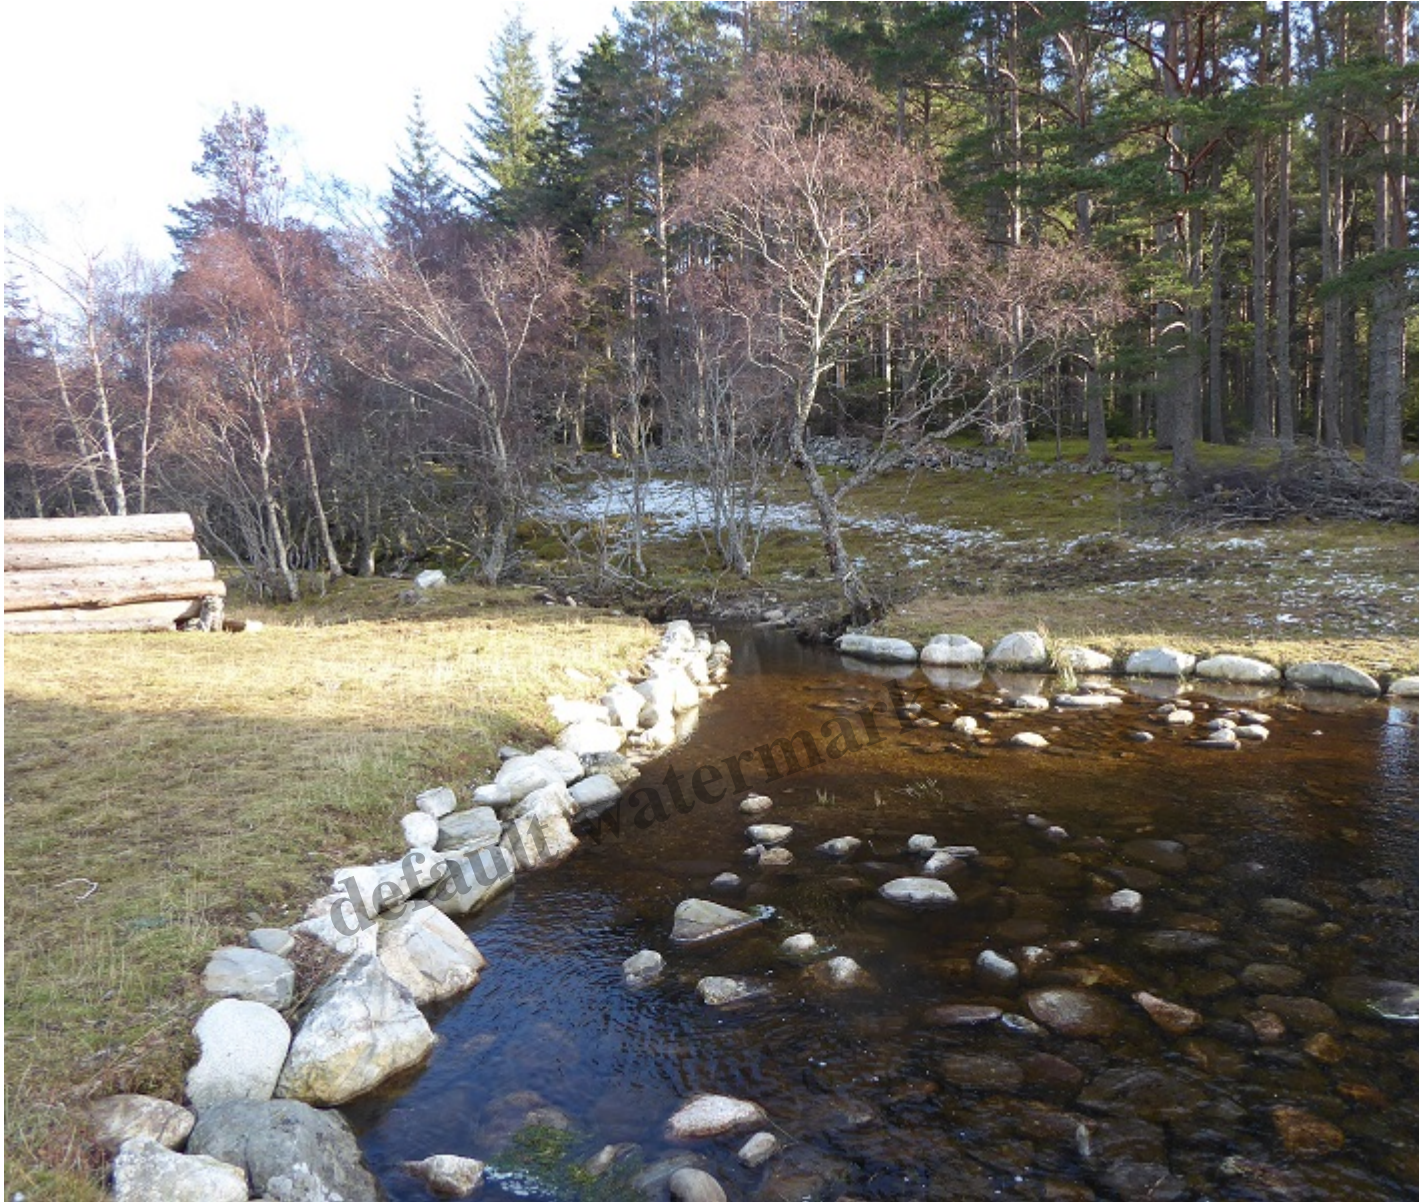
Close up of rip rap bouldering below the intake

However, and this is a big positive, the use of rip rap bouldering is minimal and may even revegetate in due course. Even better, I had not checked the line of the buried pipe beforehand, but could not see where it went, a sign of very successful restoration.
