Well designed hydro schemes (1) – Gynack

Gynack Scheme 1 – Kingussie Community Development Company

Gynack Scheme 2

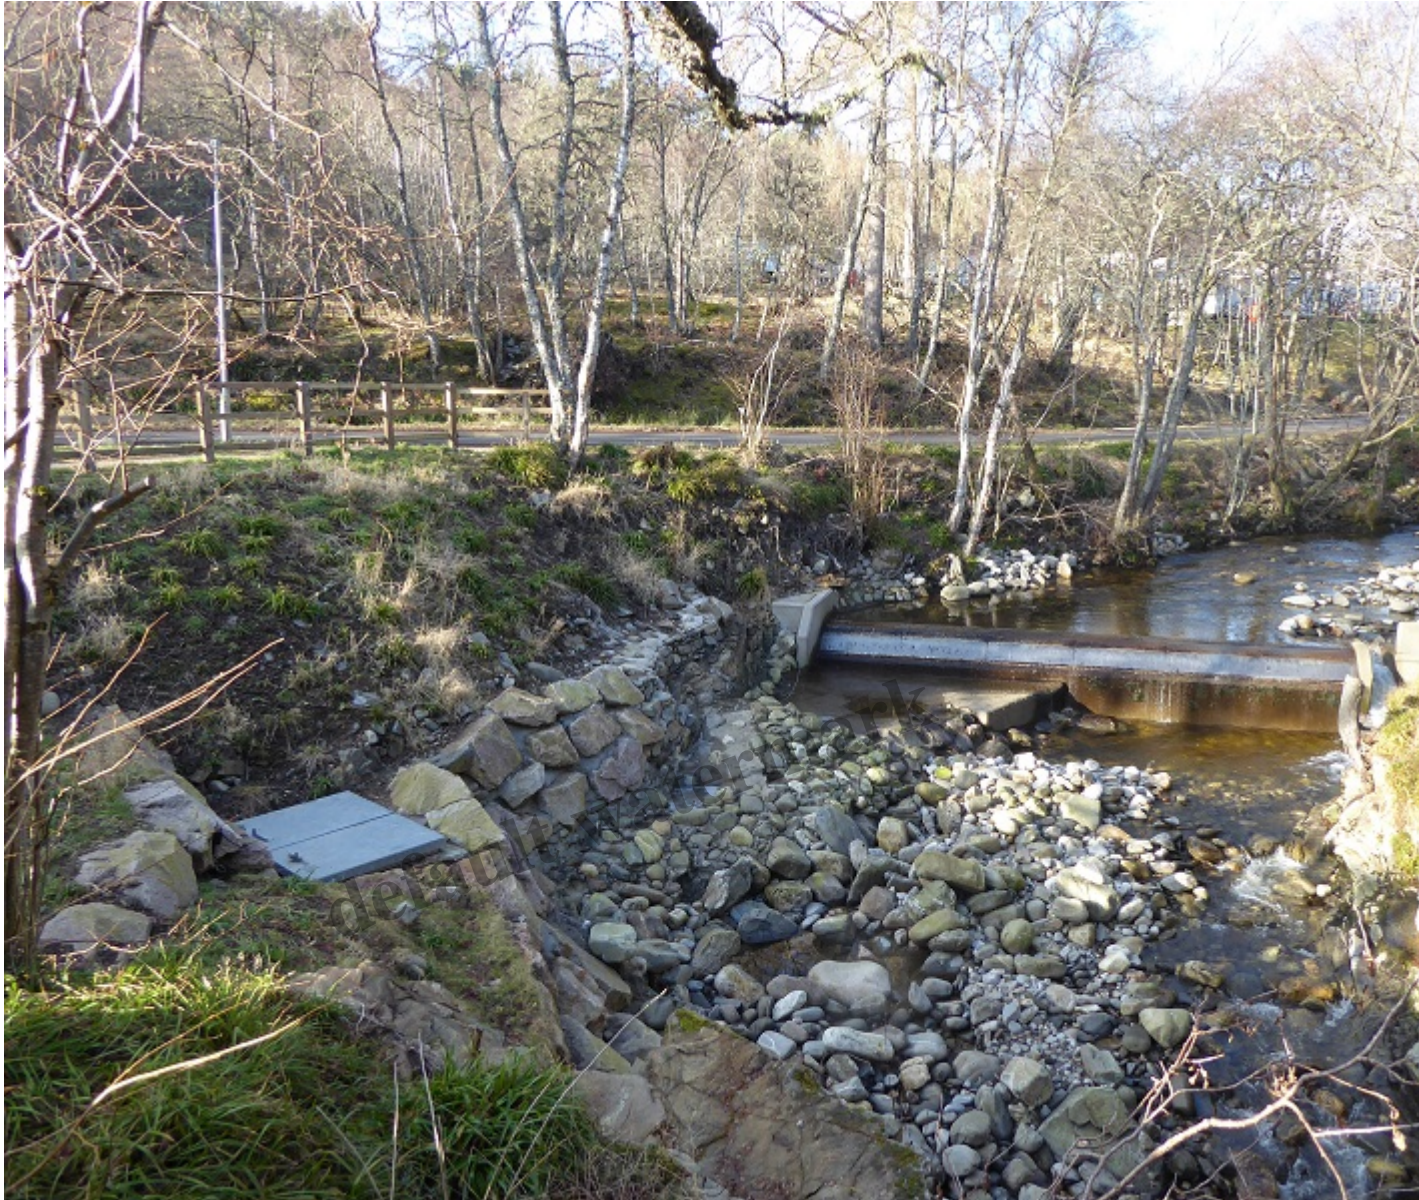
View from footbridge over Gynack

The intake weir has been constructed against the old 1920s intake. The key thing to note is its a true run of river scheme. There has been no significant damming of the river and as a result the intake structure has a very low profile, unlike many of the hydro intakes in the Loch Lomond and Trossachs National Park which have raised water levels and are taller structures as a consequence. There are still exposed section of concrete at the intake, but this is far less than usual and although they have not been faced with natural stone, the Cairngorms National Park Authority, to its credit did require:

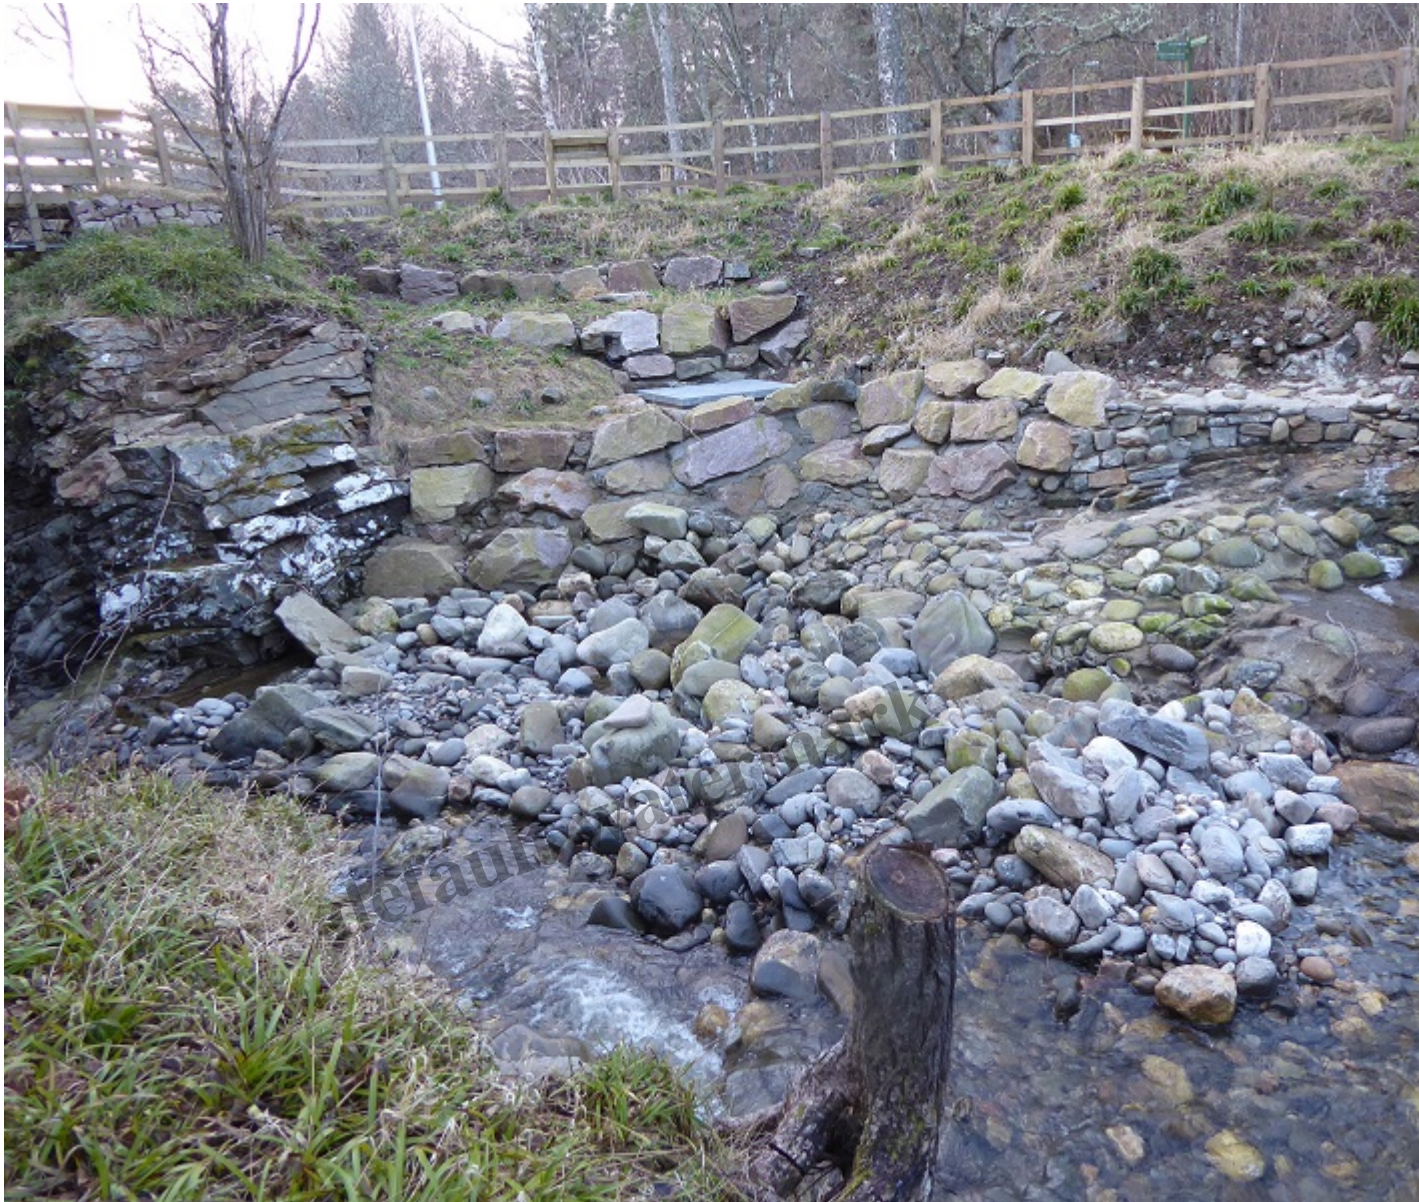
The line of the pipe, viewed from close to the intake, runs behind the line of the wall on the right.

This is probably the worst view of the scheme but positive features include: the edge of the pipe where it exits the dam (top left) has been finished in stone; the work to stabilise the river bed below this has been done by embedding rounded boulders in concrete mirroring the loose boulders in the river bed; and vegetation has been replaced around the rip rap bouldering that has been used to reconstruct the bank.

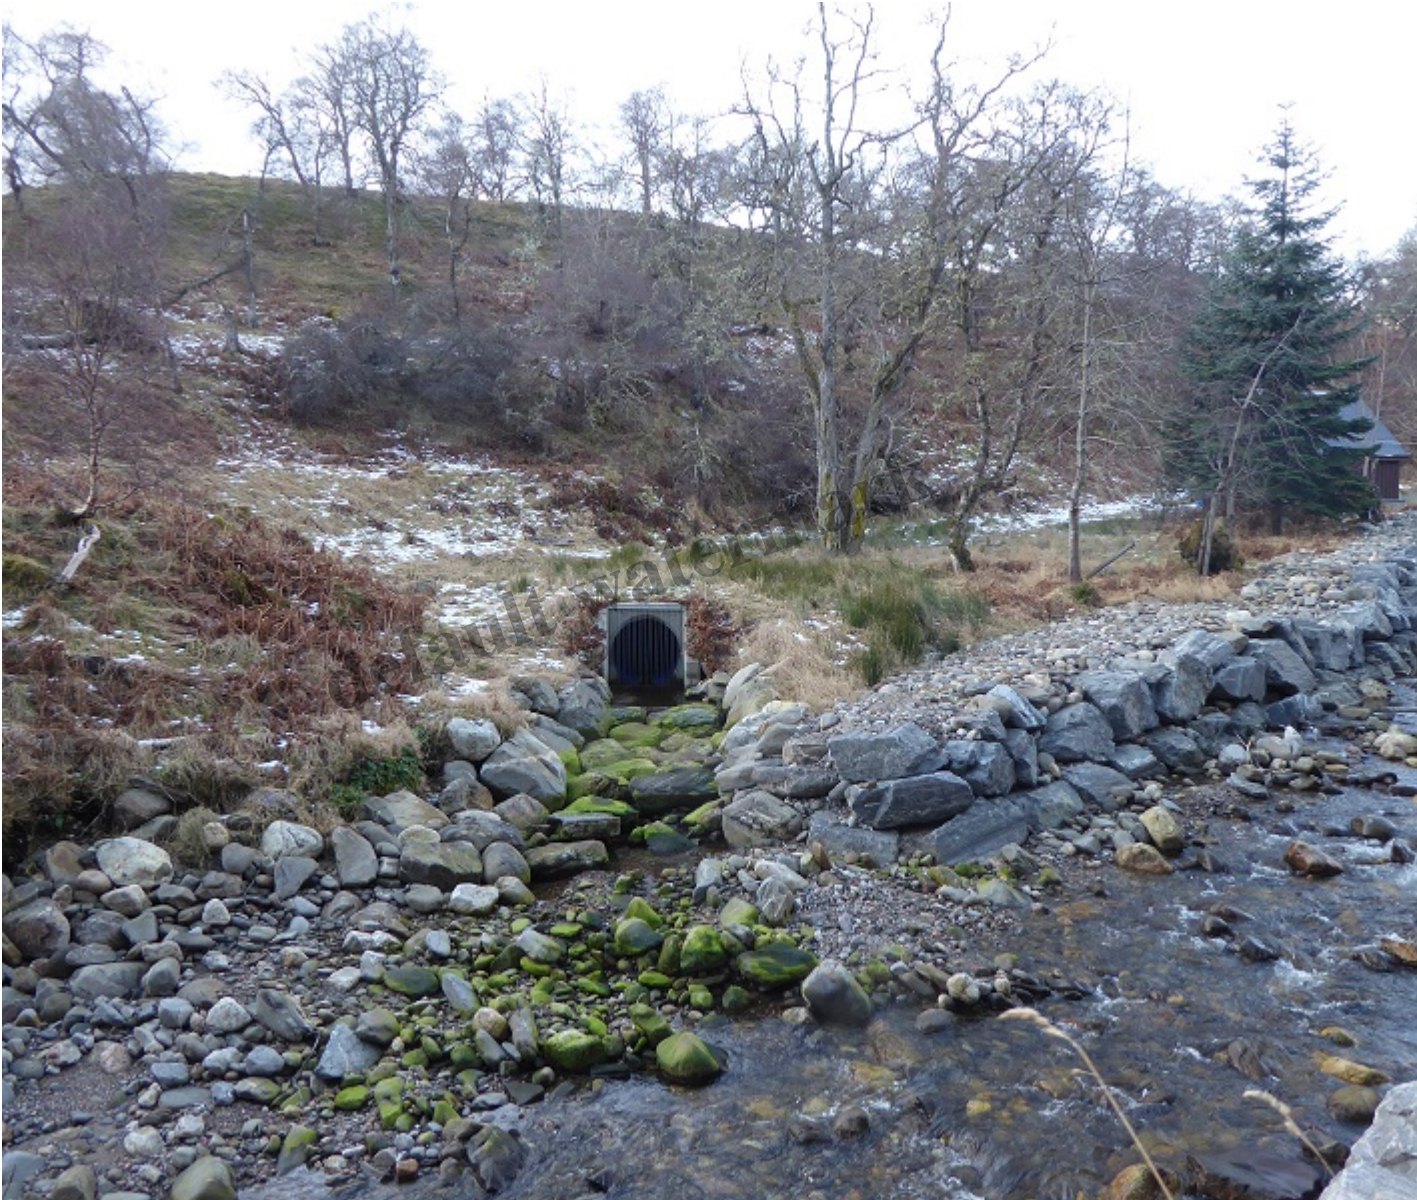
View from east side River Gynack of tailrace and powerhouse. The rip rap bouldering along the river the hydro scheme.

The tailrace has also been well finished and the concrete around the pipe is almost invisible while again the rip rap bouldering between the tailrace and the river has been kept to a minimum. The landscape and ecological issue here is not the hydro scheme, or how it has been constructed, but rather earlier attempts to engineer the River Gynack which can carry huge volumes of water and threatens Kingussie. As part of river engineering, a separate planning application has been approved to construct a flood overflow channel from higher up the river down into Loch Gynack which I will

consider in a post on the Upper Gynack hydro scheme. Here, the consequence of the river engineering is to narrow what once would have served as a flood plain, and the construction of a powerhouse here reduces the likelihood that will ever be reversed.
