Coilessan hill track “upgrade”

June 18, 2017

nickkempe

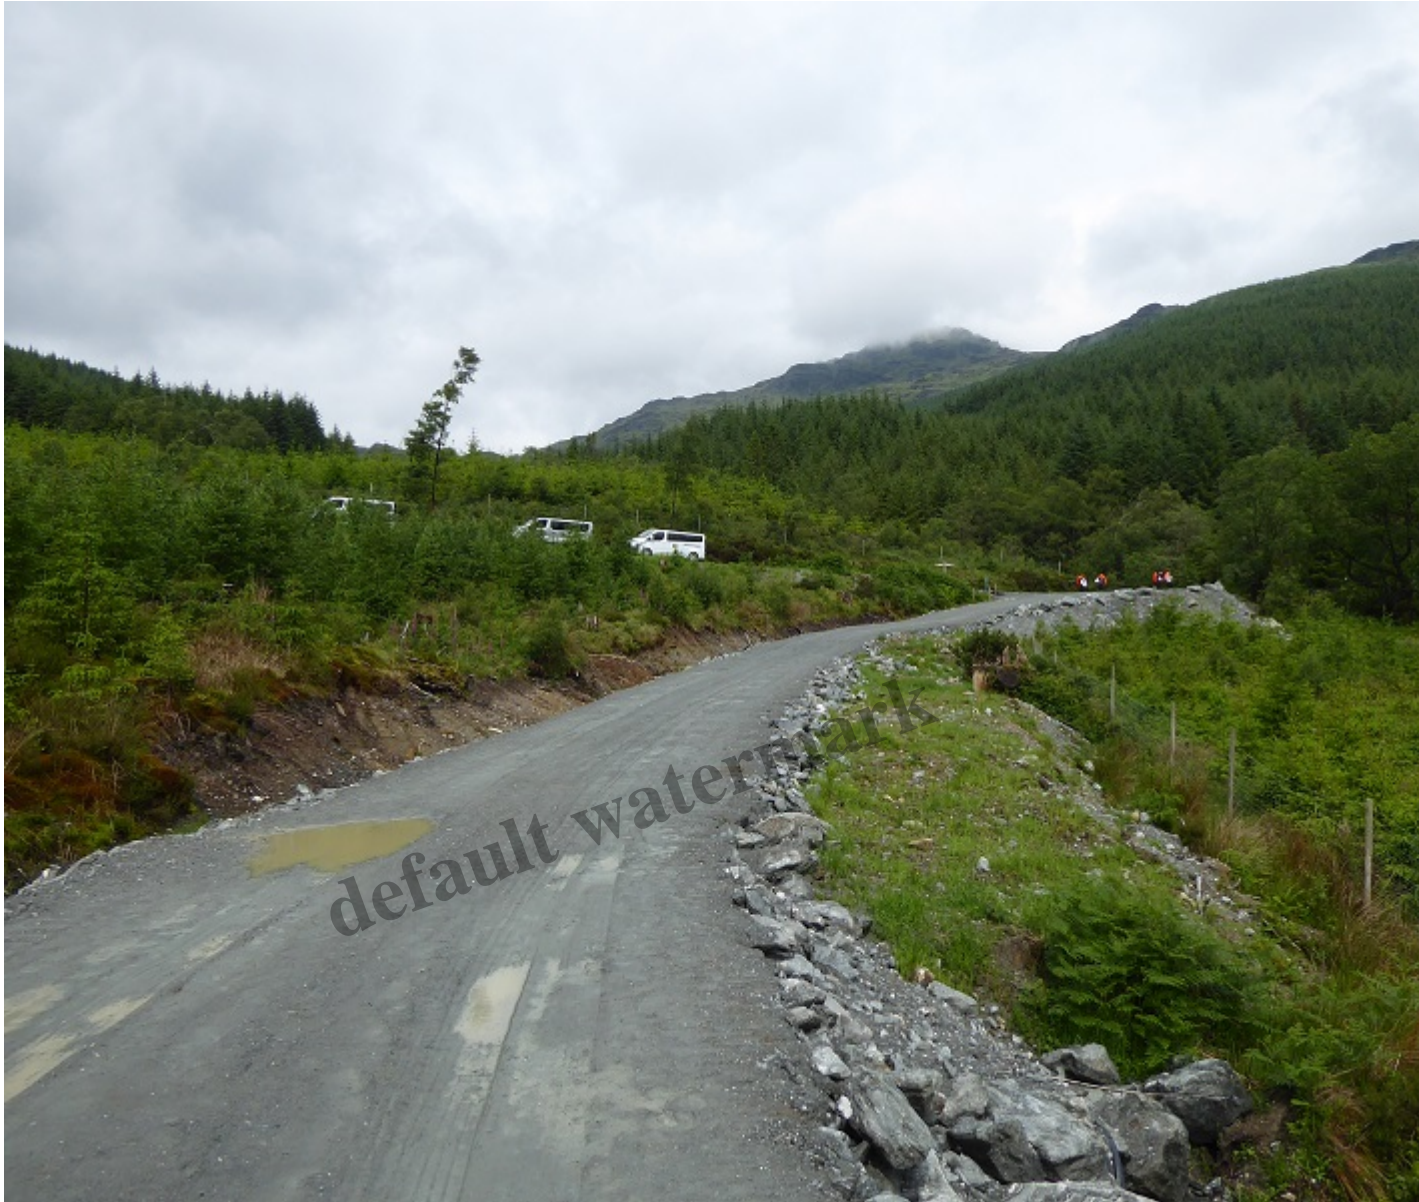
The upgraded track below the “Dukes Path”, the Coilessan burn is just beyond the Duke of Edinburgh centre right and the Brack behind

Instead FCS has upgraded part of the existing track network in Coilessan Glen by dumping aggregate on the earlier track. There is no planning application on the Loch Lomond and National Park Planning portal and the LINK Hill track group ([see here](#)) was not aware of the track through the prior notification system. While its possible the LINK hill track group missed the notification, its also possible that because this was an “upgrade” to an existing track the Loch Lomond and Trossachs National Park Authority did not have to be notified (I will try and find out).

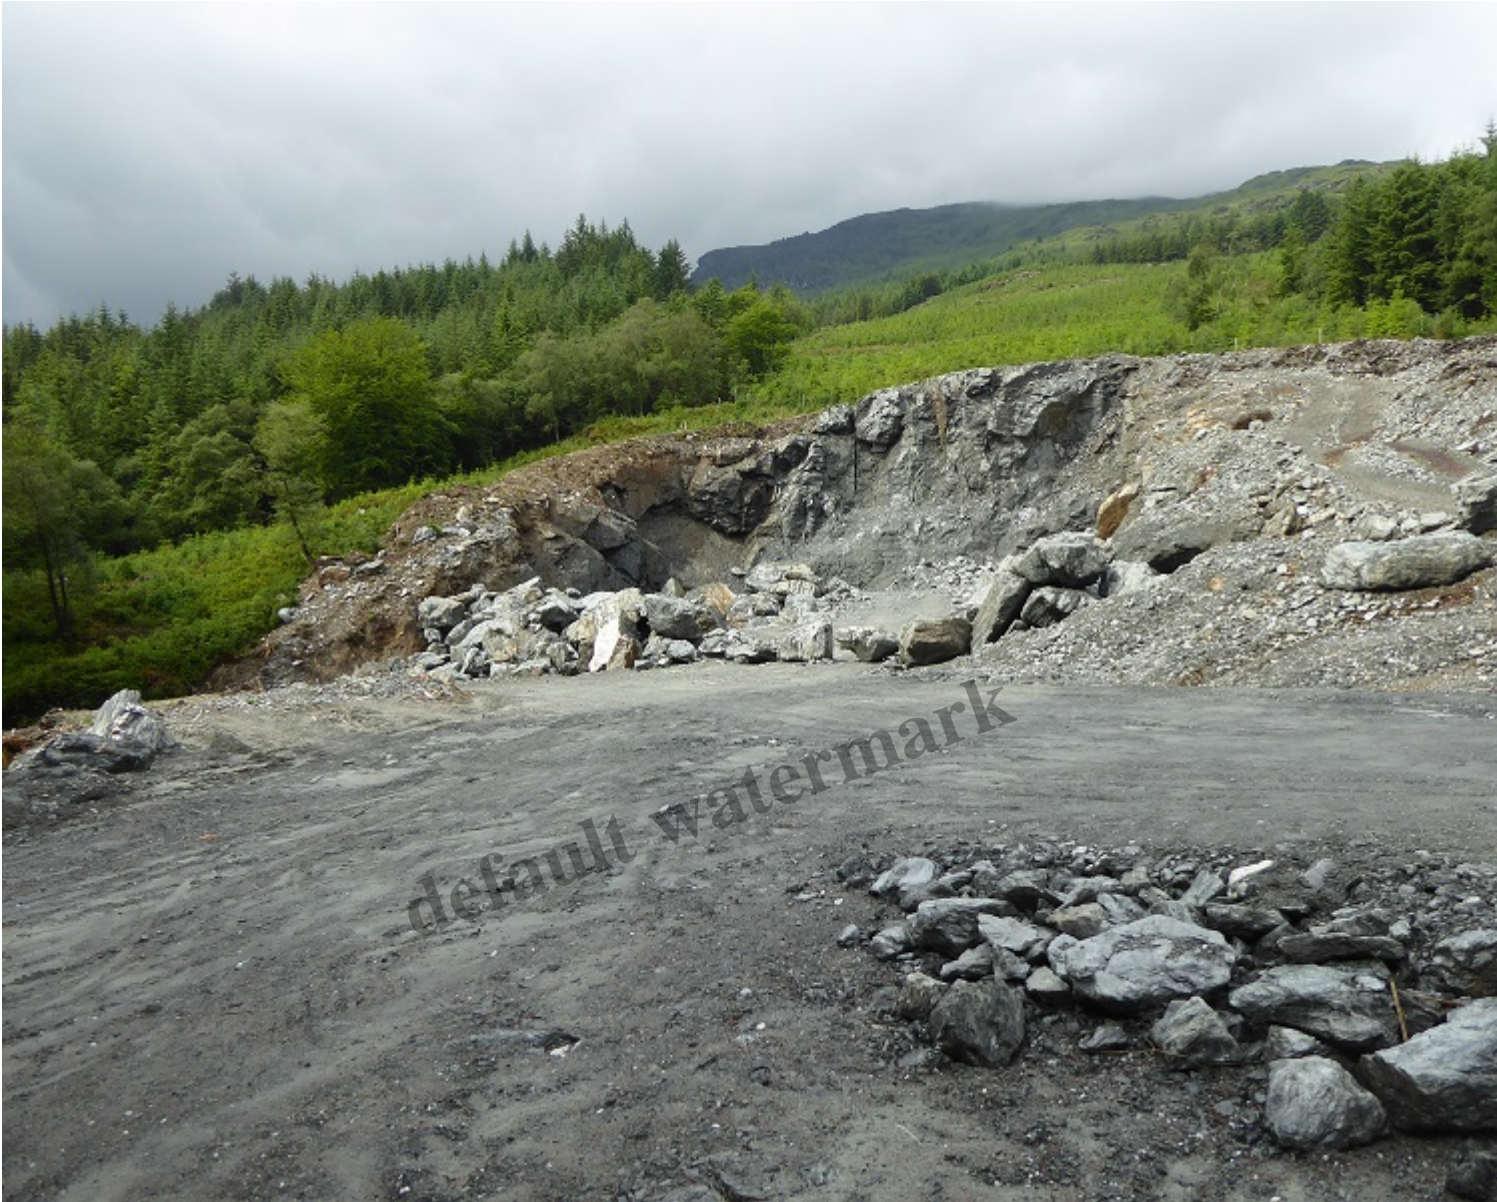
A sizeable new quarry has been created to source the new material for the track (the boulders in the middle ground are large) and gives some idea of how much aggregate has been dumped on top of the existing tracks. In my view this should have required planning permission in the National Park.

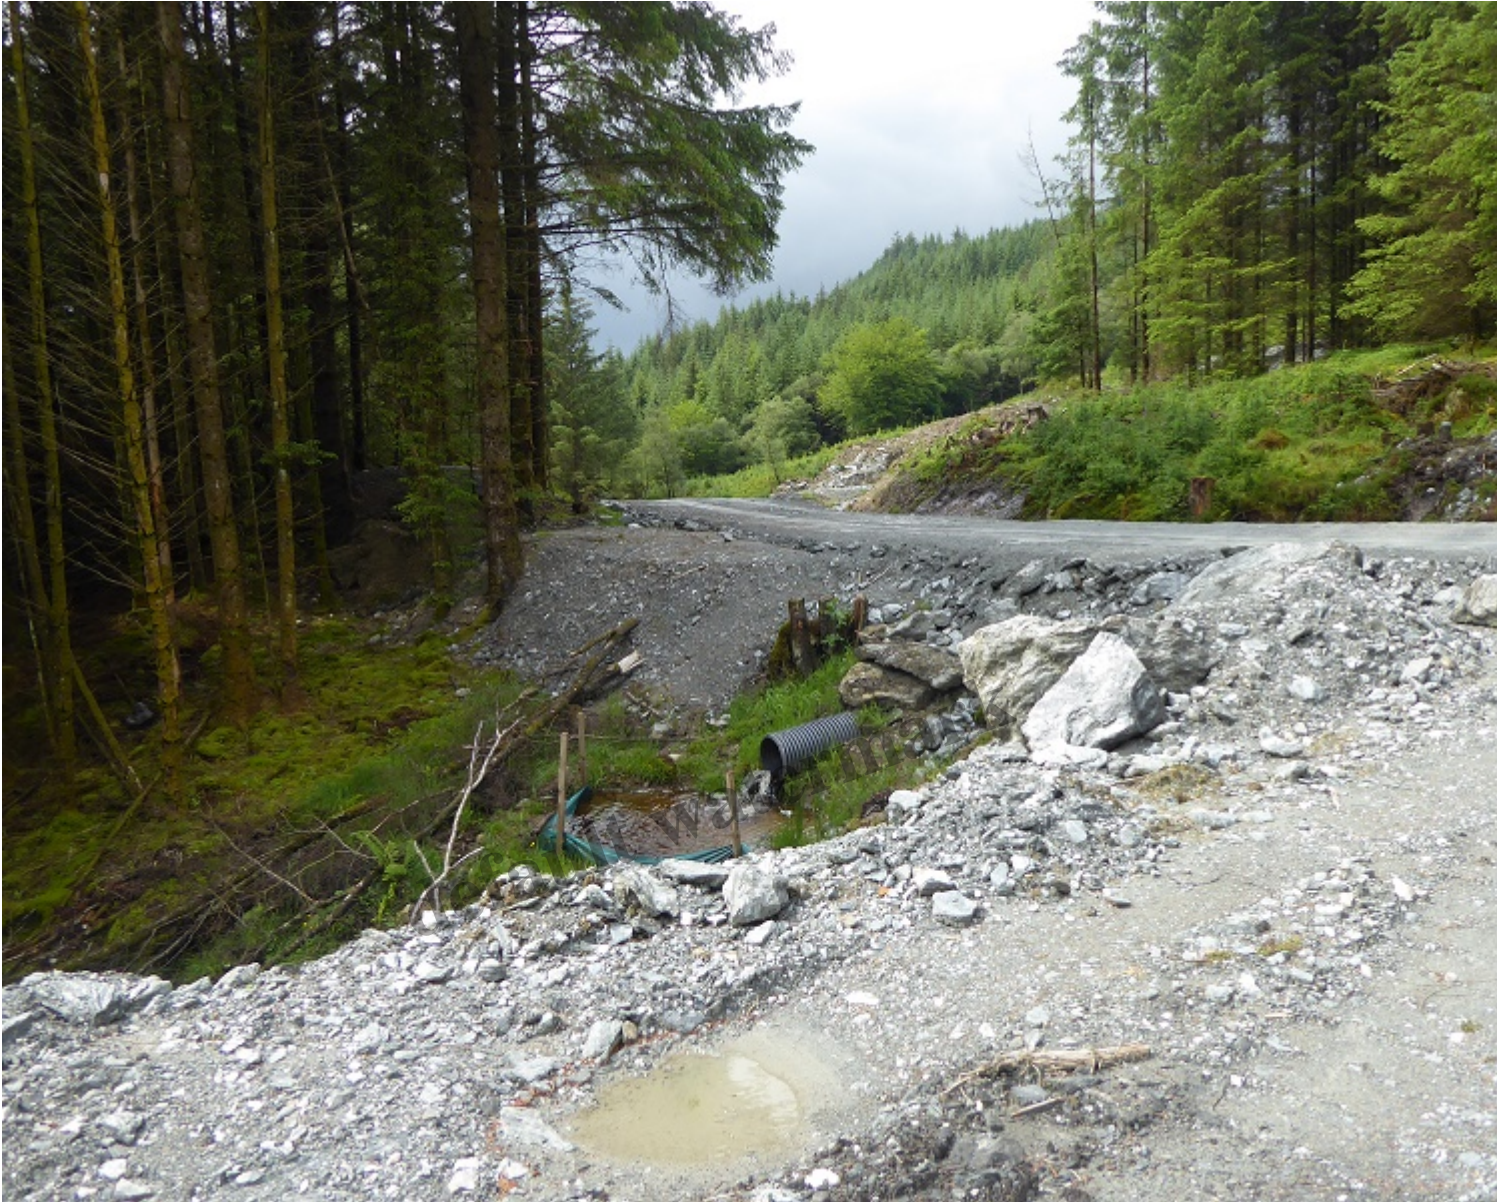
The quality of the finishing – there was no evidence that machines are still on site or that the work is not regarded as complete – is extremely poor. It might be more accurate to say non-existent in places. It does not appear likely that the FCS will try and extract trees up this corner so what is the argument for leaving it like this, apart from cost? This should not be acceptable in a National Park, whatever the commercial imperatives to extract timber.

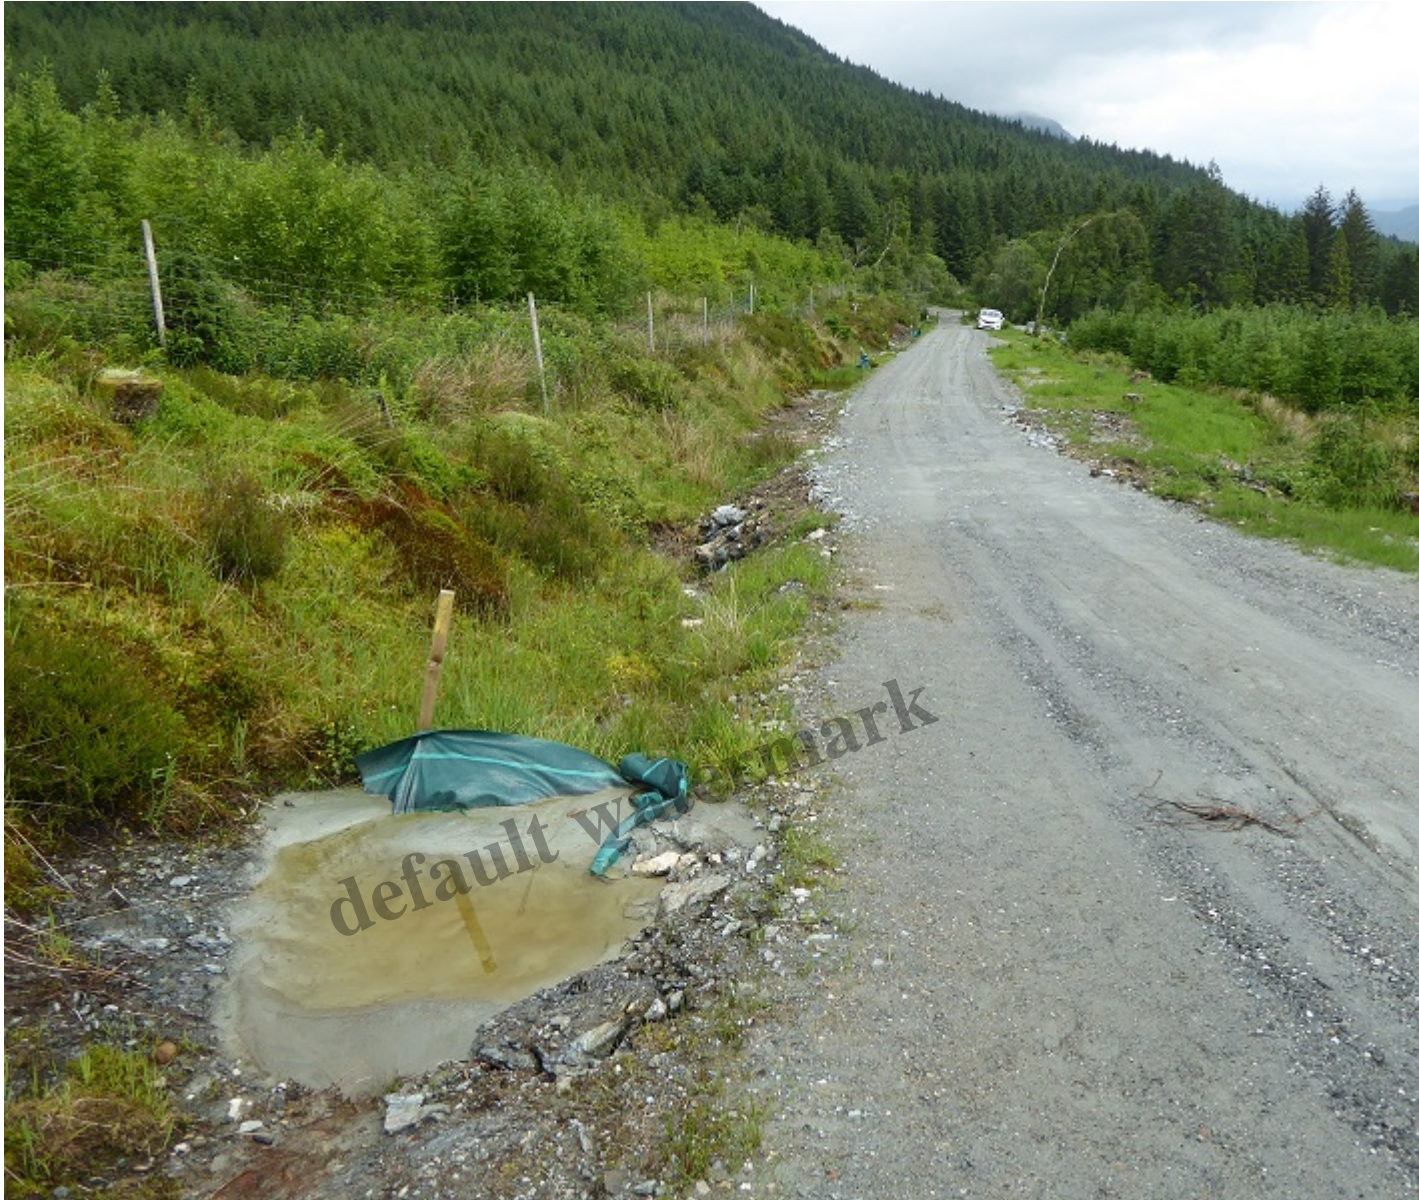
The Dukes path looking north. The turn off to lower track is just beyond the transit, while that to the upper track is just behind the viewer.

The Dukes Path has been spared the upgrading work so far and gives an idea of what the tracks looked like previously. The silt trap is to catch the silt that is being washed down from the new track just above. The crushed schist forms a very fine material which is likely to continue to wash out of the new track surface for some time.

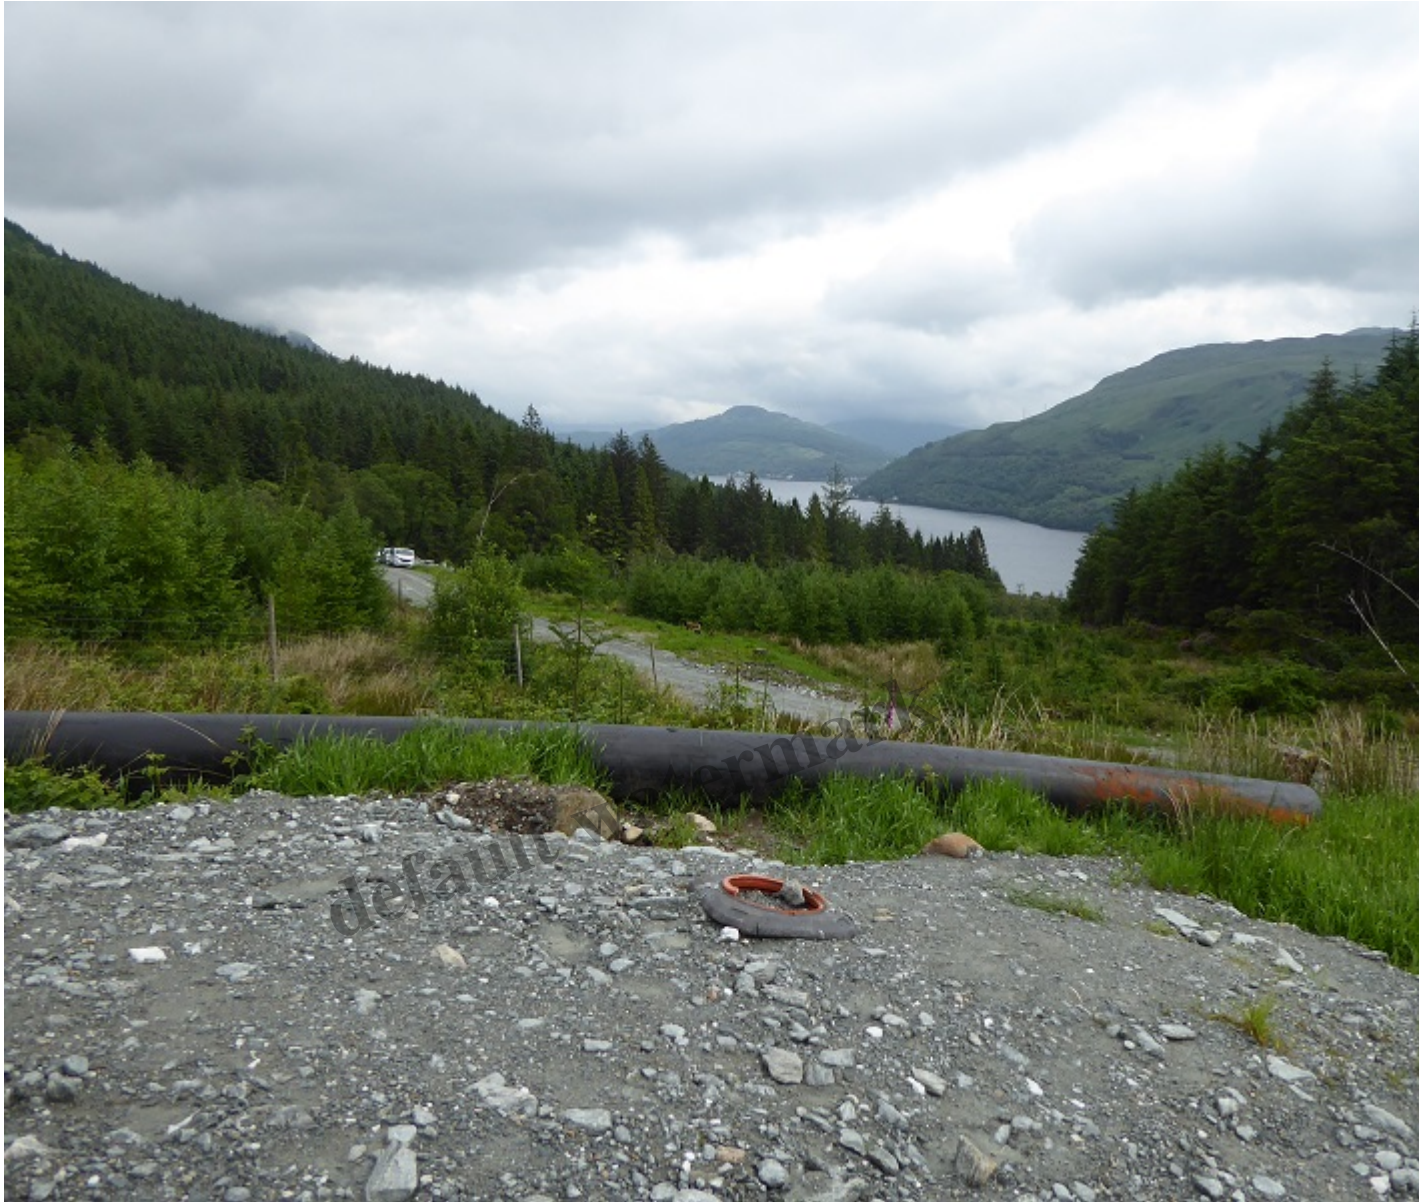
The Dukes path and Loch Long from start of the track as it heads up the glen

The lack of care for the landscape at the micro level is demonstrated not just by the abandoned pipe and decapitated cone but by the spoil heap at the side of the “new” track. The lack of care at the landscape level is demonstrated by the conifer replanting either side of the Dukes Path. This was one of the few sections of the Dukes Path where the walker is not hemmed in by forest on either side but but instead of using the felling as an opportunity to create a more diverse landscape, the replanting will have obscured the view completely in another 20 years.

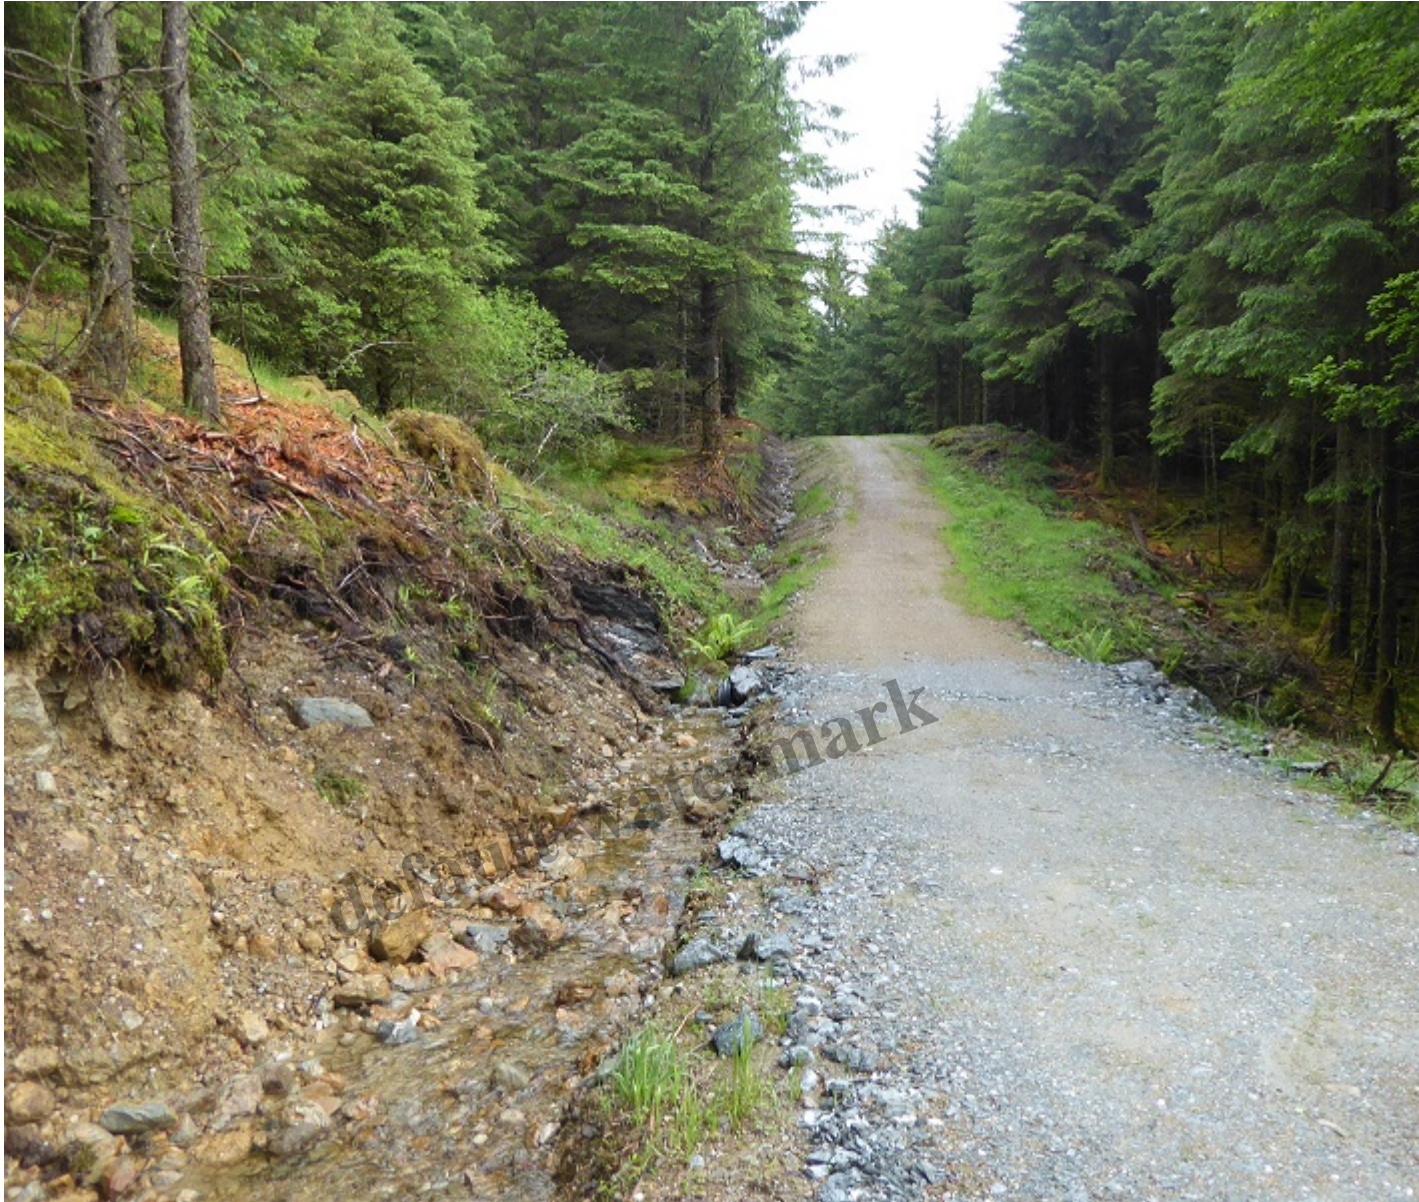
Section of Cat Craigs track north of Coilessan which offers no views.

This photo also illustrates difference between repairing a track surface compared to the upgrading work at Coilessan (below). The bare bank on left appears to date from original construction.

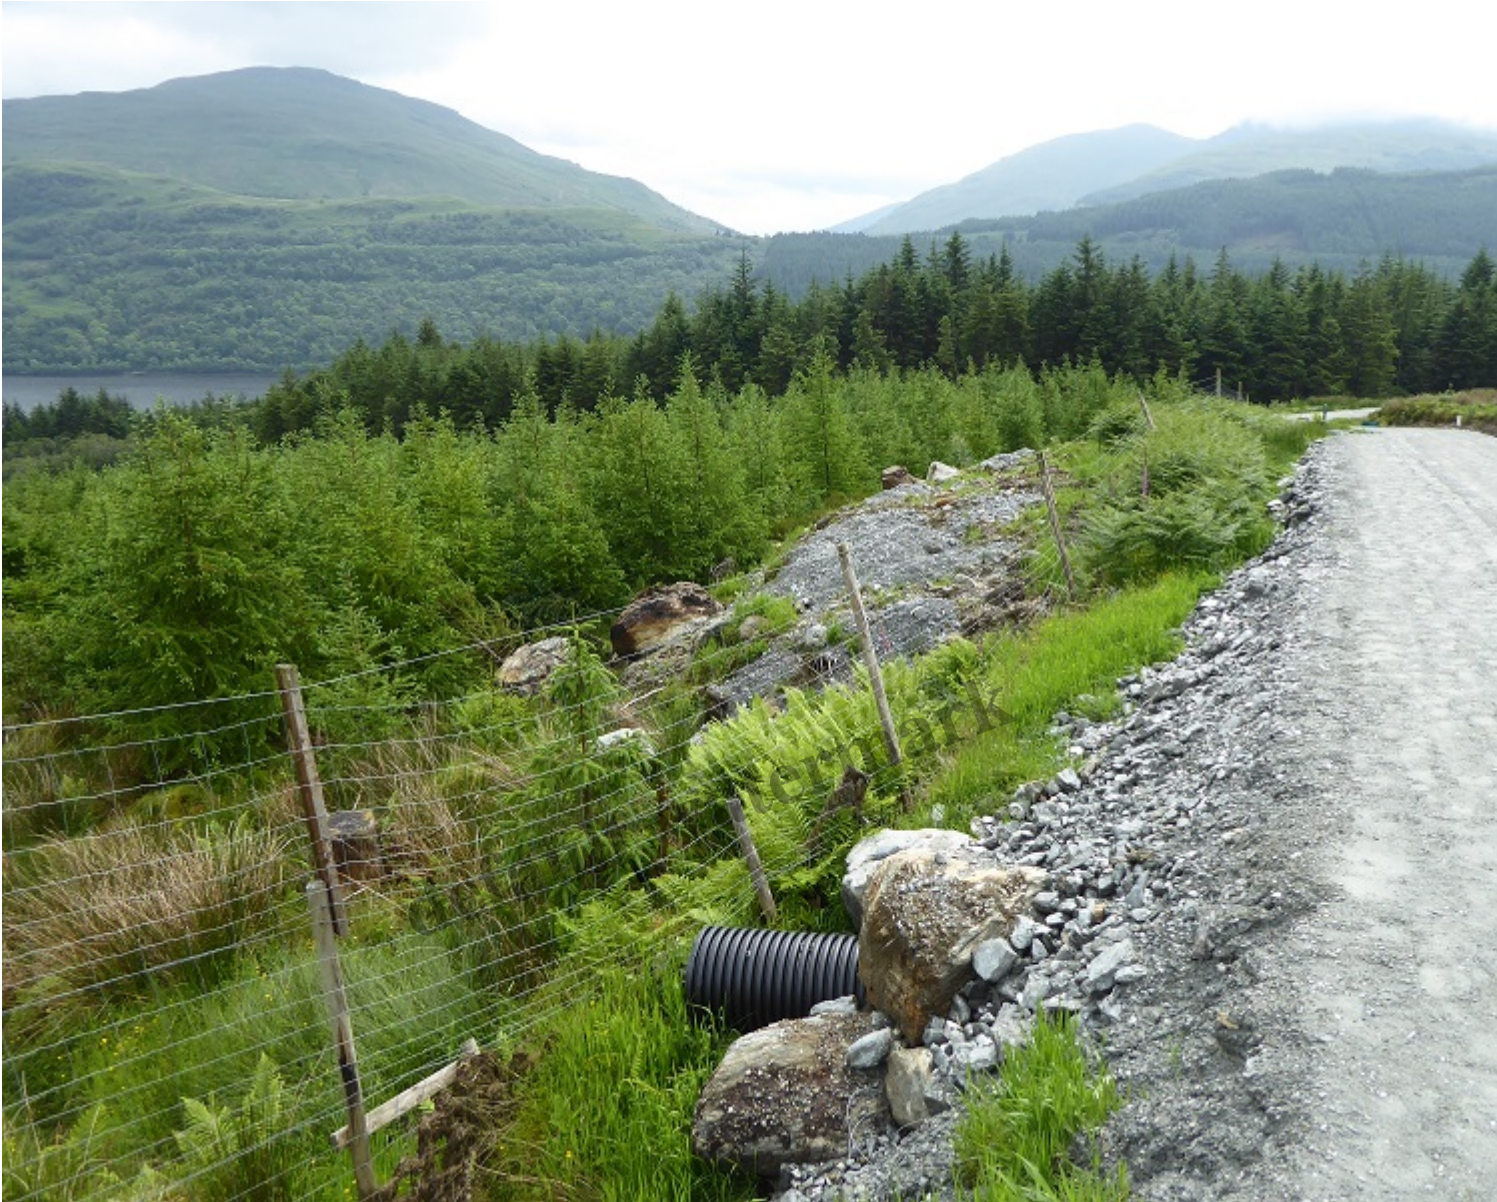
The history of a lack of care here is also demonstrated by the spoil to the left of the new track which has partly revegetated. It may date from earlier tree felling. Material from the new track will erode down the hillside.

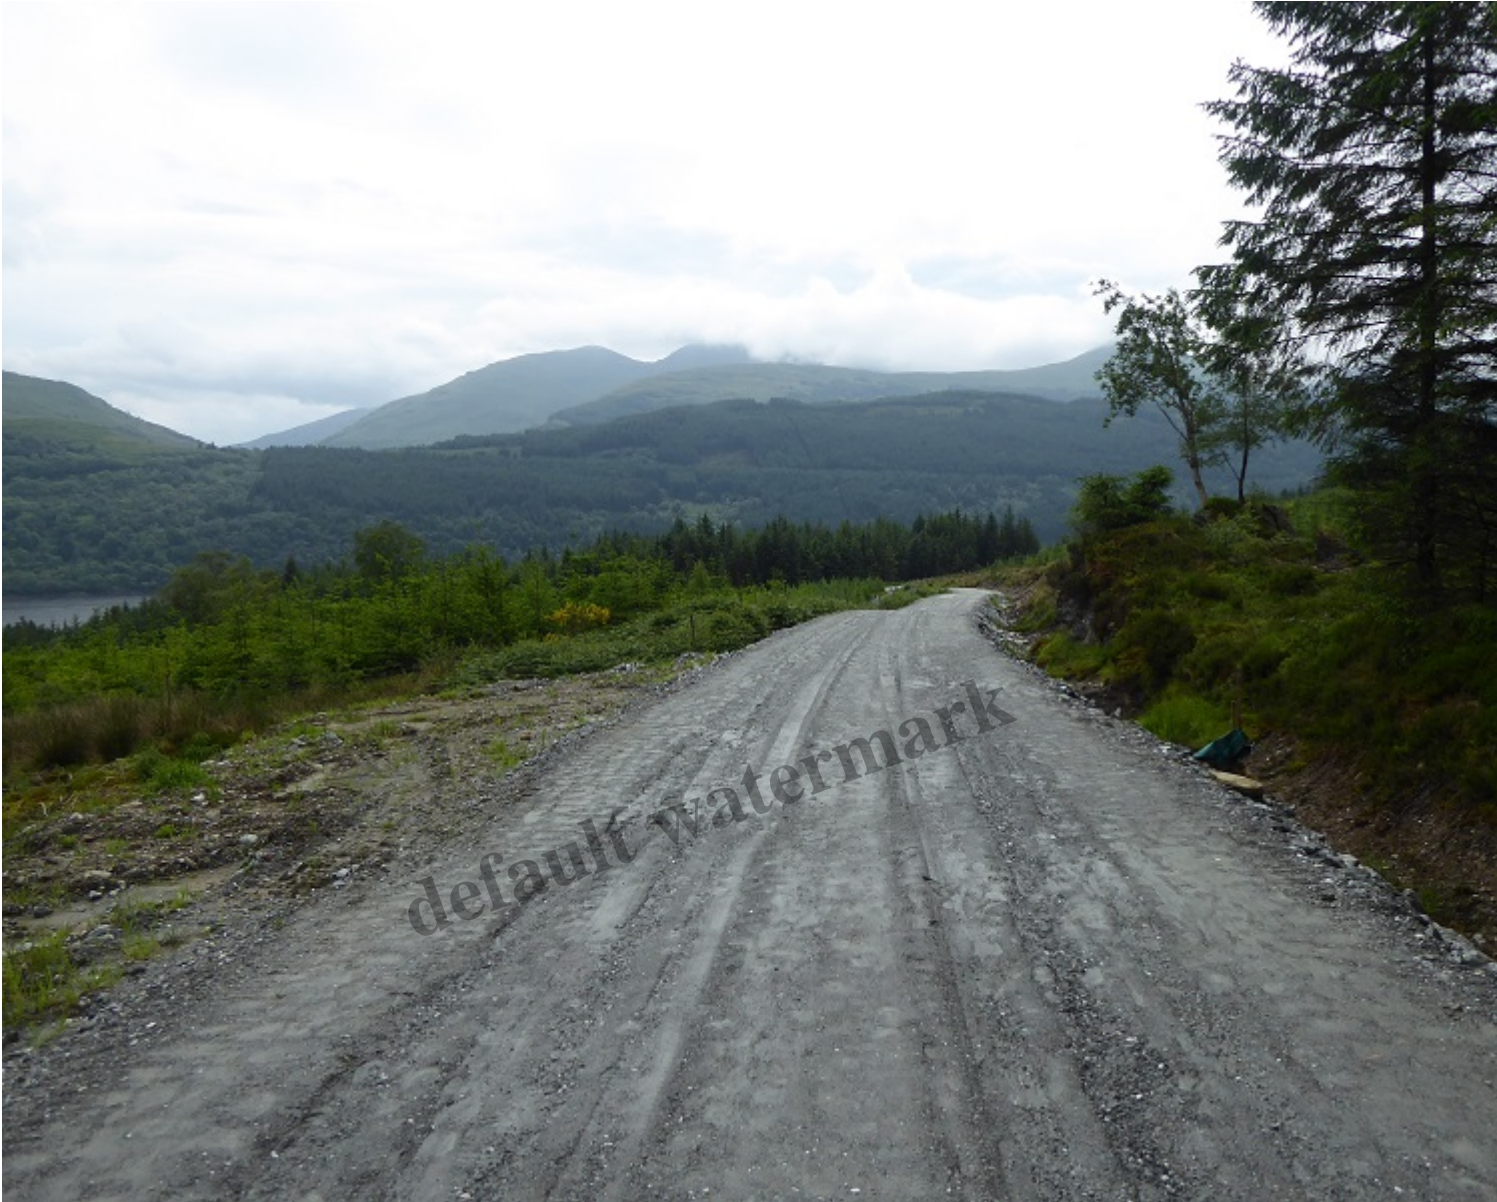
The surface of the track is now firmer than two months ago, when Rod McLeod took his photos, and appears to have consolidated to an extent. I passed the Duke of Edinburgh Group shortly after taking this photo and asked them to rate the track and the walking experience. “Terrible” was the response.

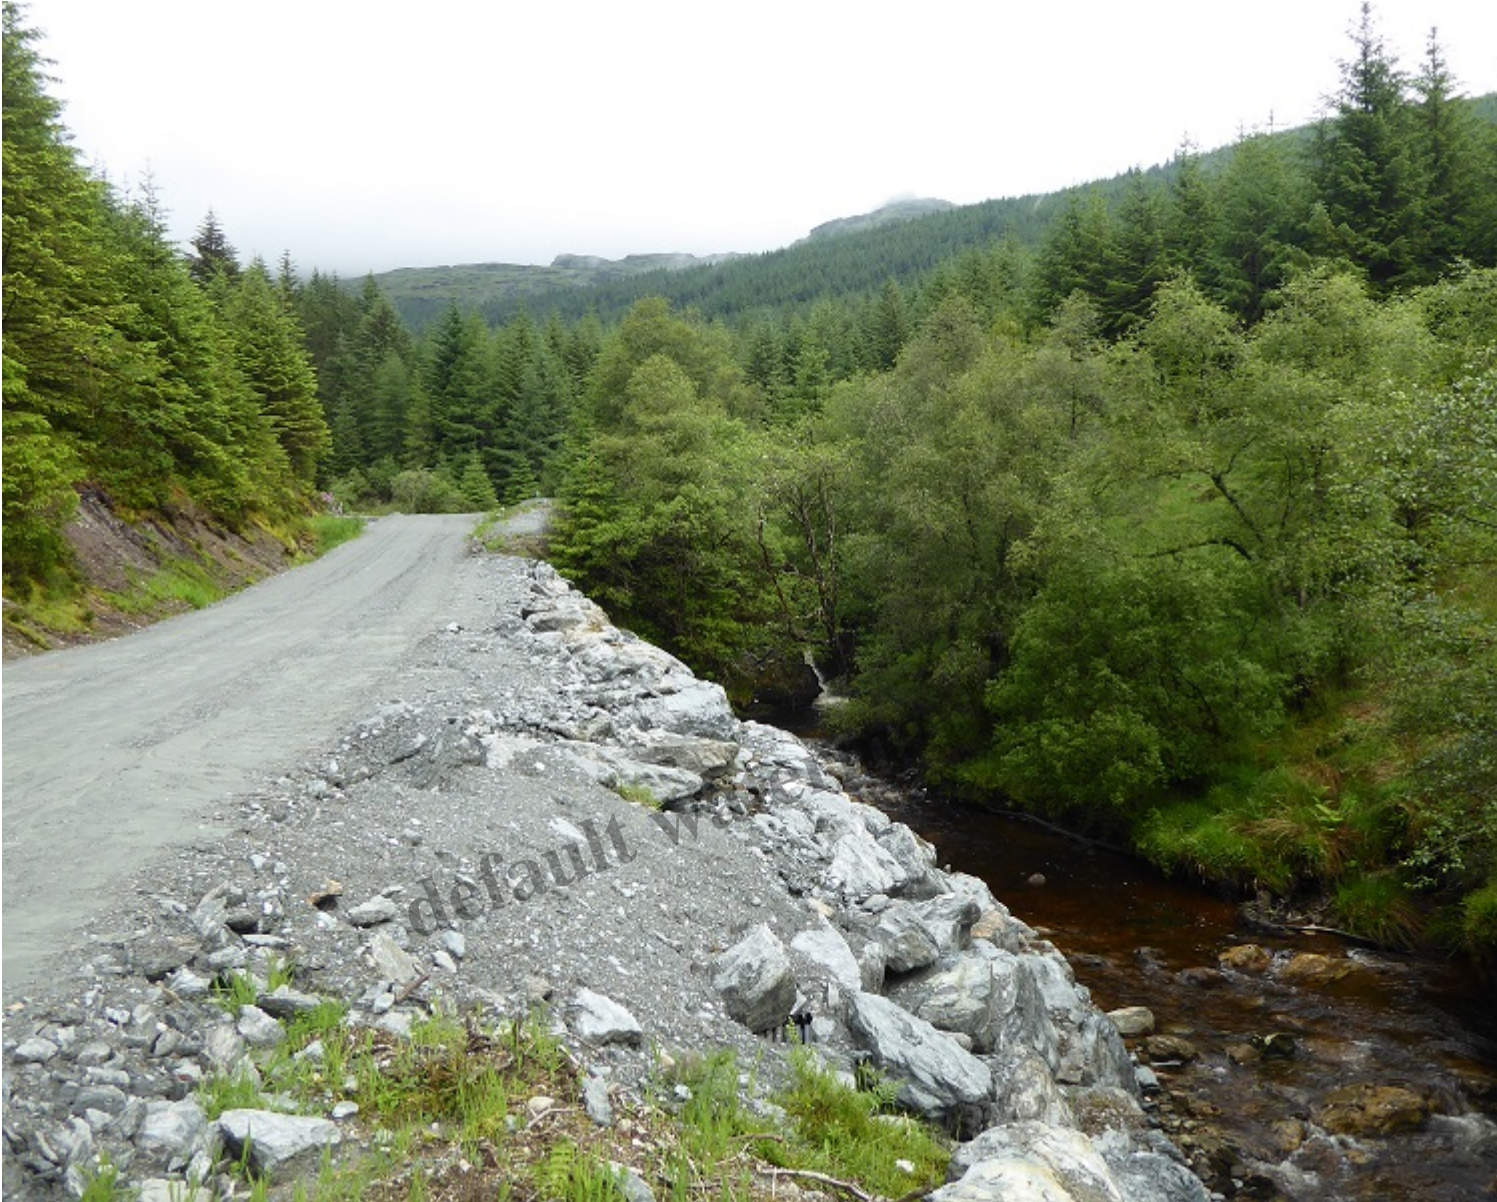
Is this the way we would be treating what was a fine section of burn?

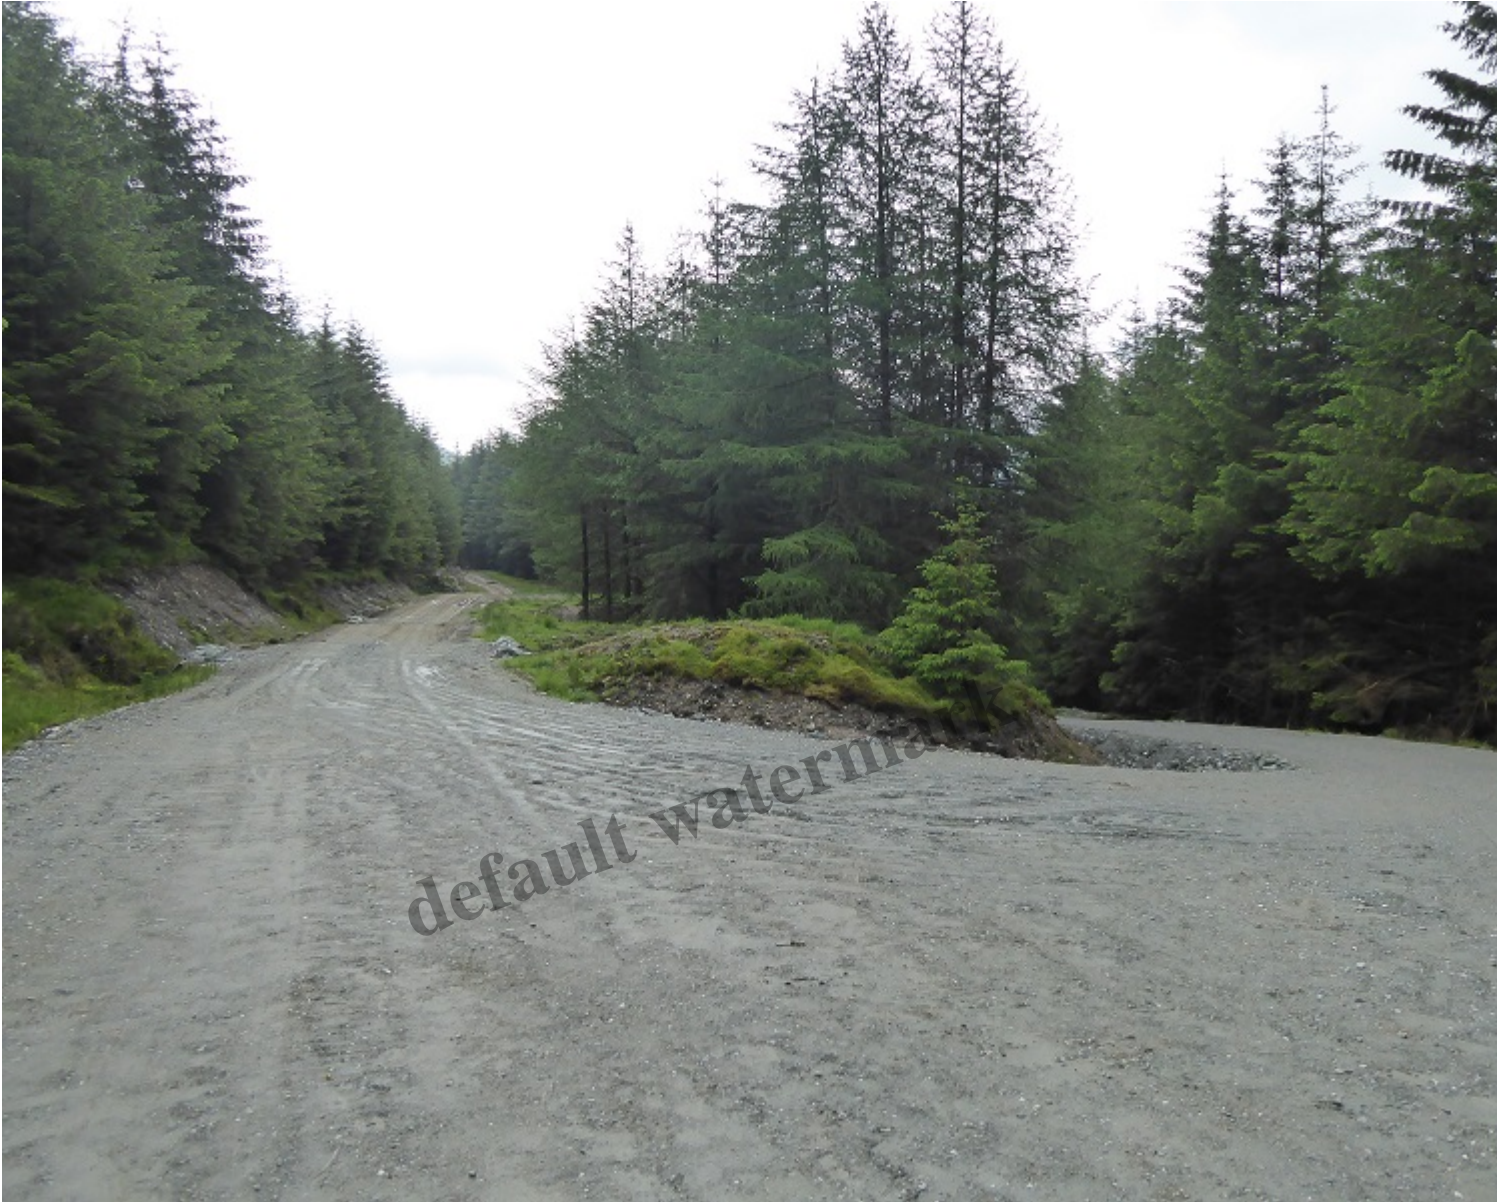
Compare the size of the former track on left with the upgraded one. Are bends this size really necessary?

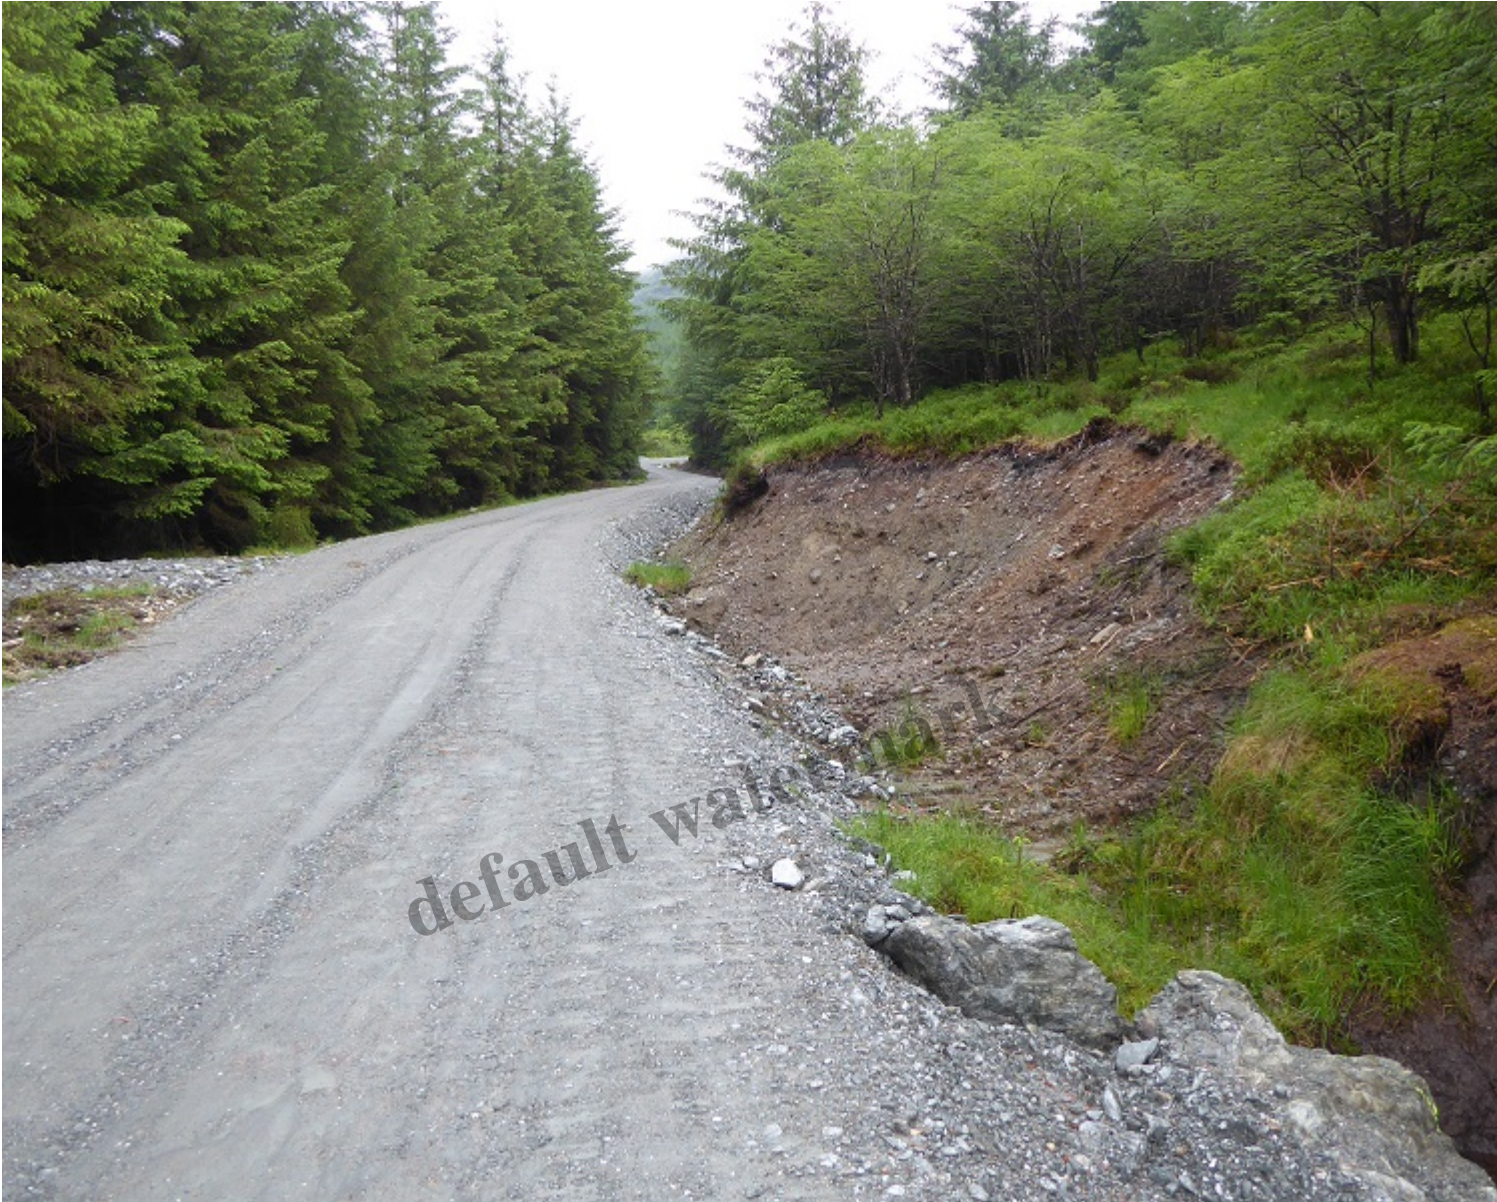
In order to widen the track, further excavation of banks and ditches has been undertaken in places. The vegetated area bottom right represents former bank, a section behind appears to have been scraped bank behind that vegetated. I could see not evidence that any attempt had been made to store and replace turf over excavated areas, even in places such as this where there are native trees behind which one would hope will be left in place during the felling. The LLTNPA rightly requires vegetation to be restored in hydro track construction – even if it does not happen much of the time – and similar standards should be applied to forest track construction.

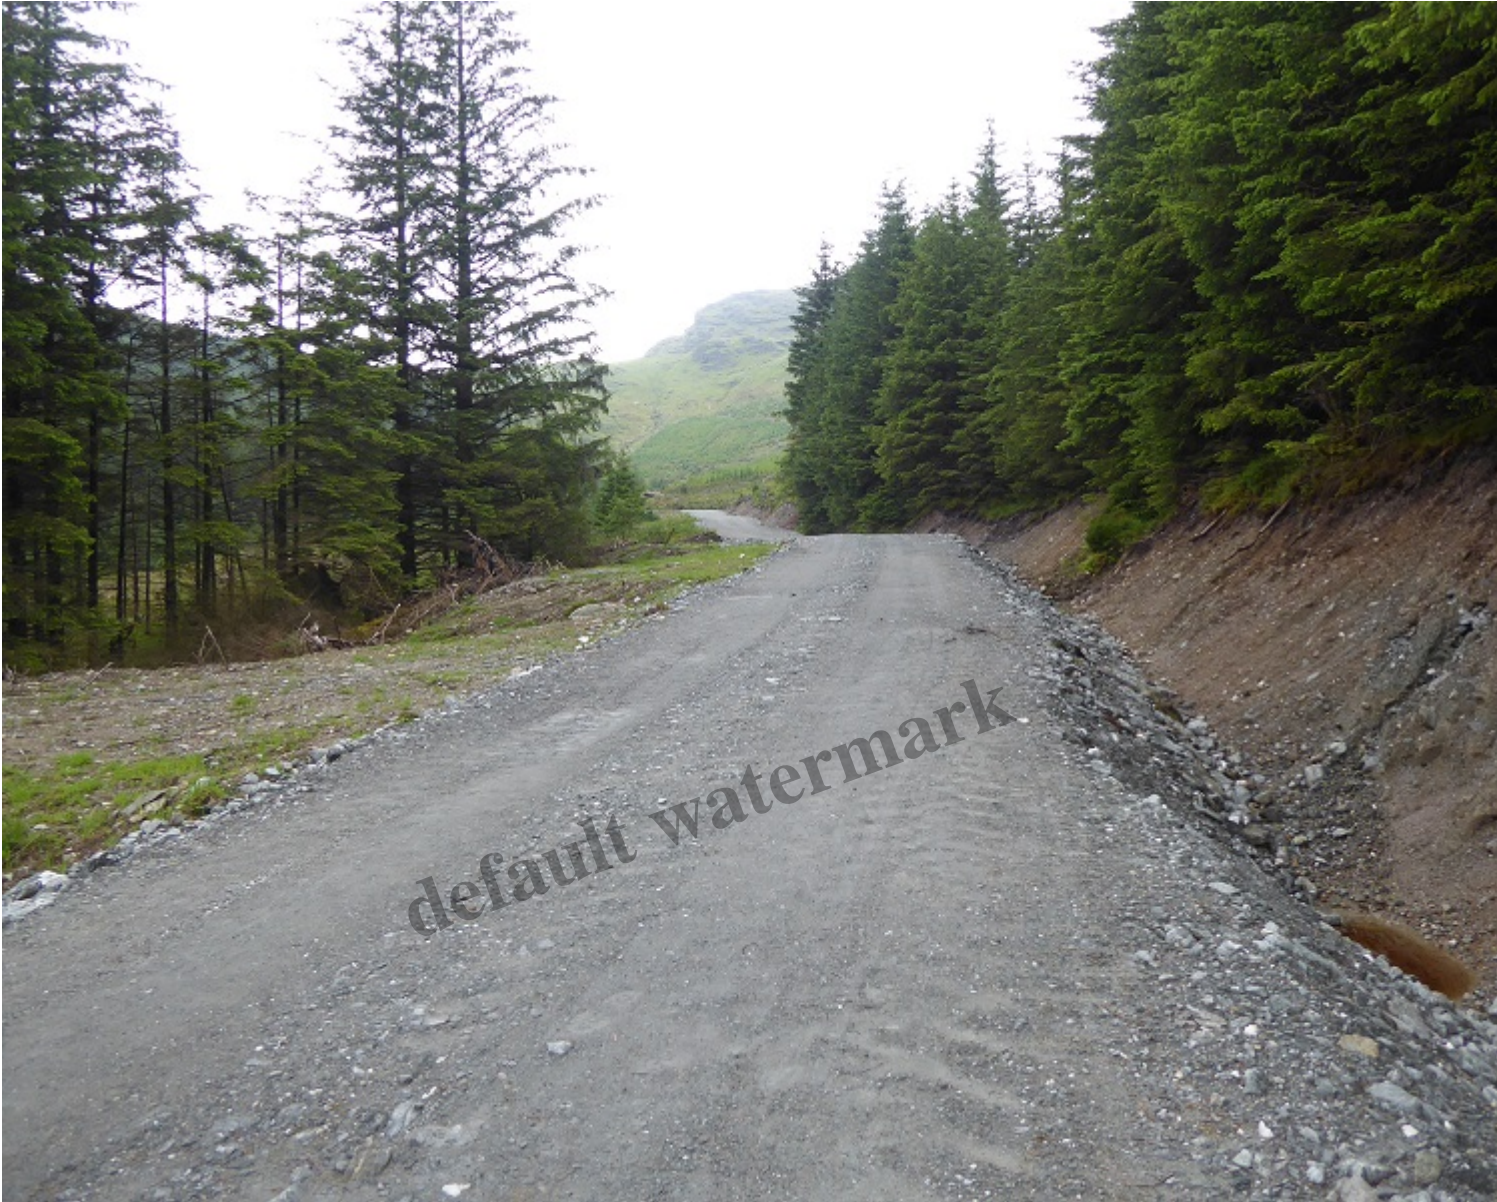
Will FCS do anything to improve this once the trees are extracted?
