Coilessan hill track “upgrade”

June 18, 2017

nickkempe

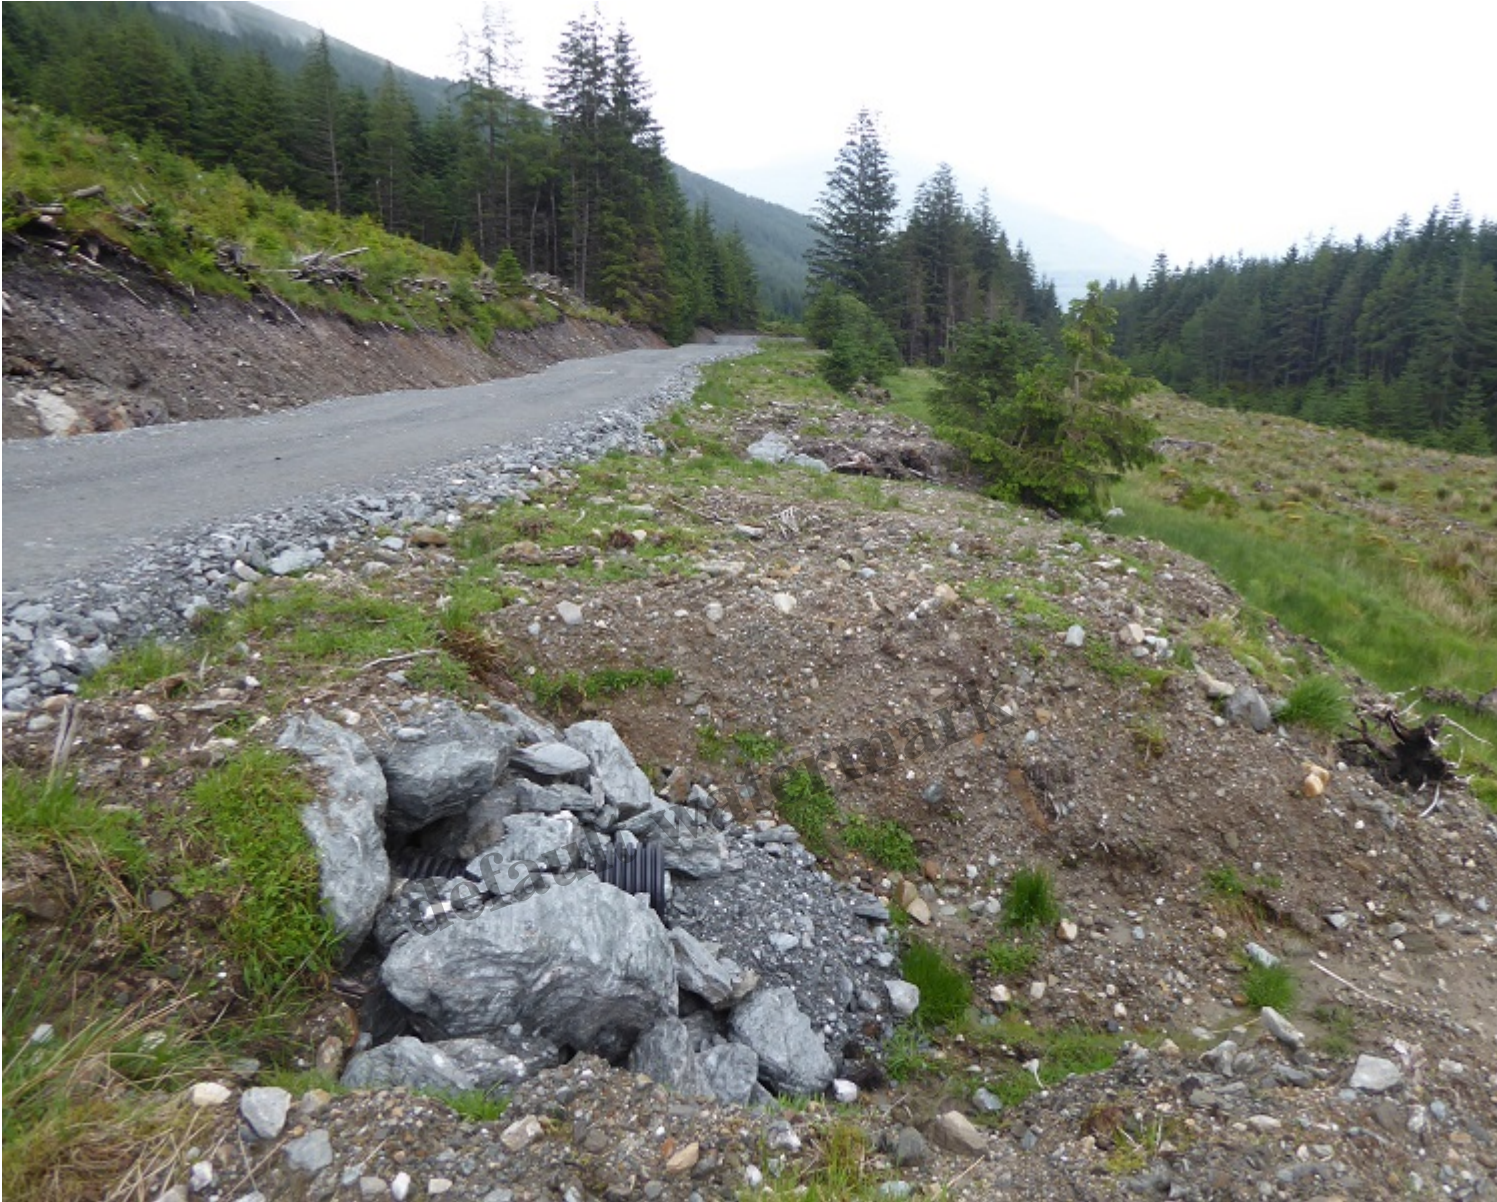
They have done very little to improve this section where felling is complete and indeed appears to have pre-dated the track. So, if the new track was not need for felling (top left) why is it needed now? Forest tracks have become larger and larger to accommodate bigger, heavier vehicles – just as in hydro track construction. The bigger the machines we use to work in the countryside, the bigger the tracks and the impact on landscape.

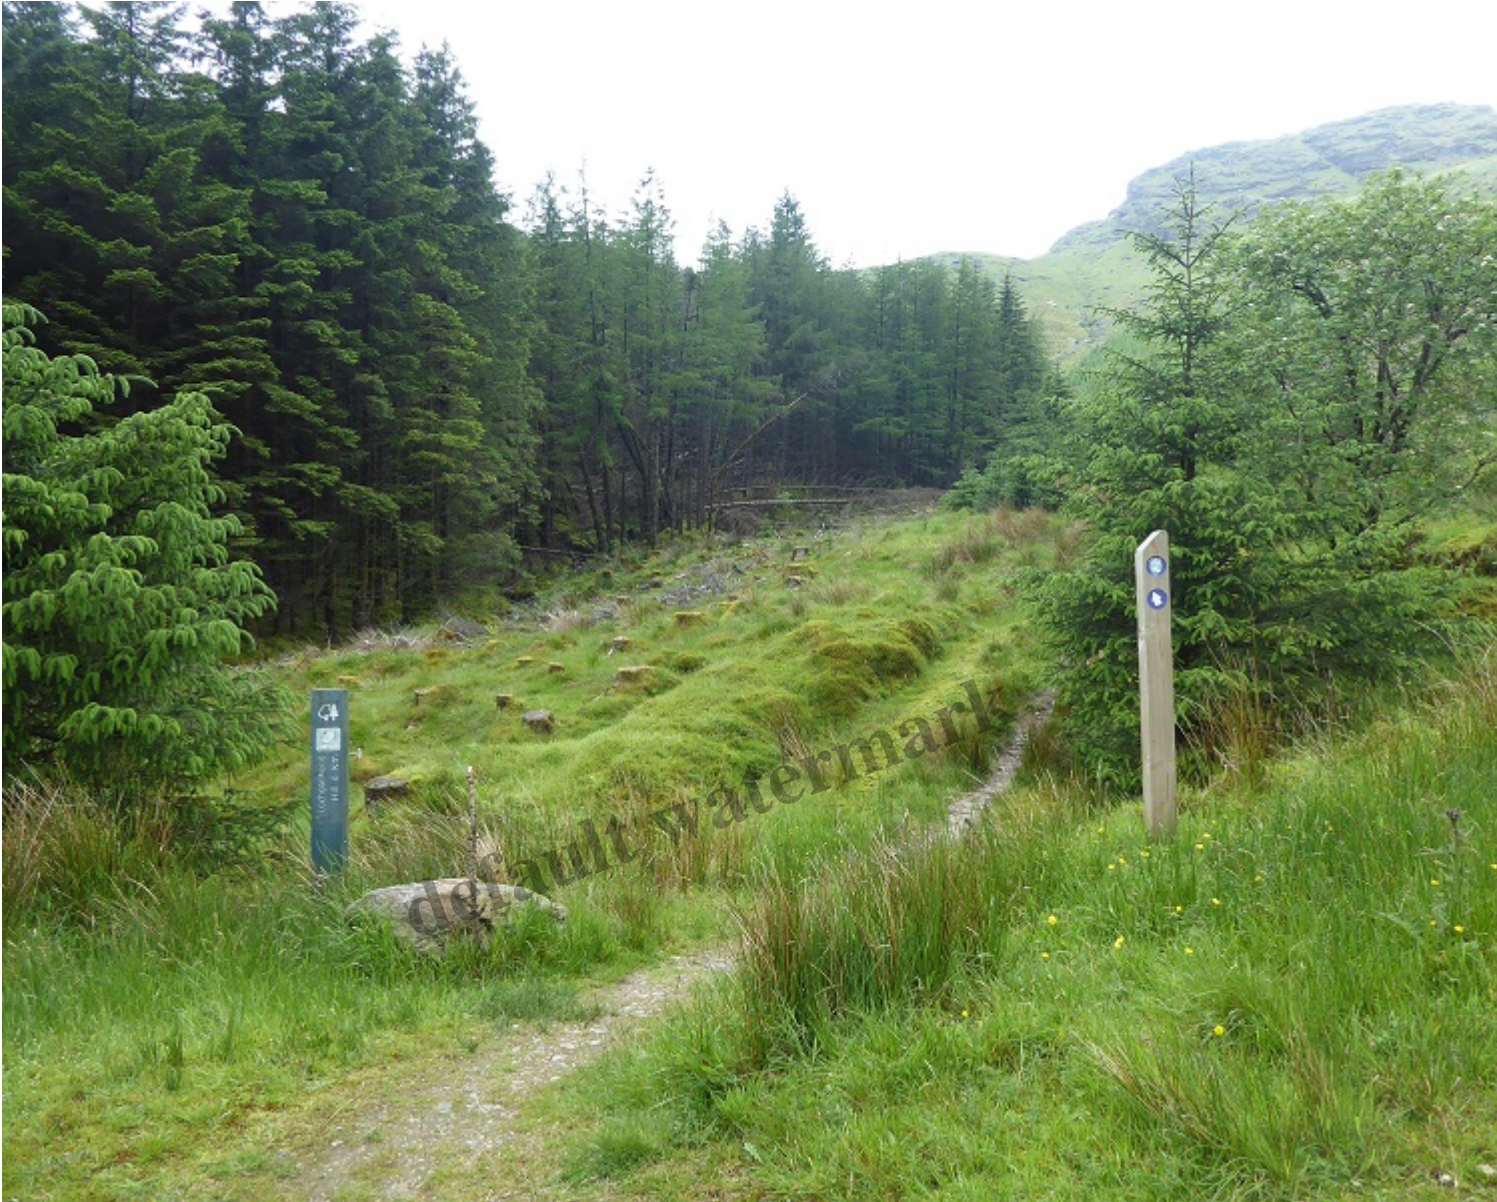
The contrast between the footpath construction in the upper part of the Glen and the track are quite stark. How can the FCS apply such difference standards? My 1980 1:50,000 map shows just a footpath, no track, up the Glen but now there is only a path in the upper part. A relief.

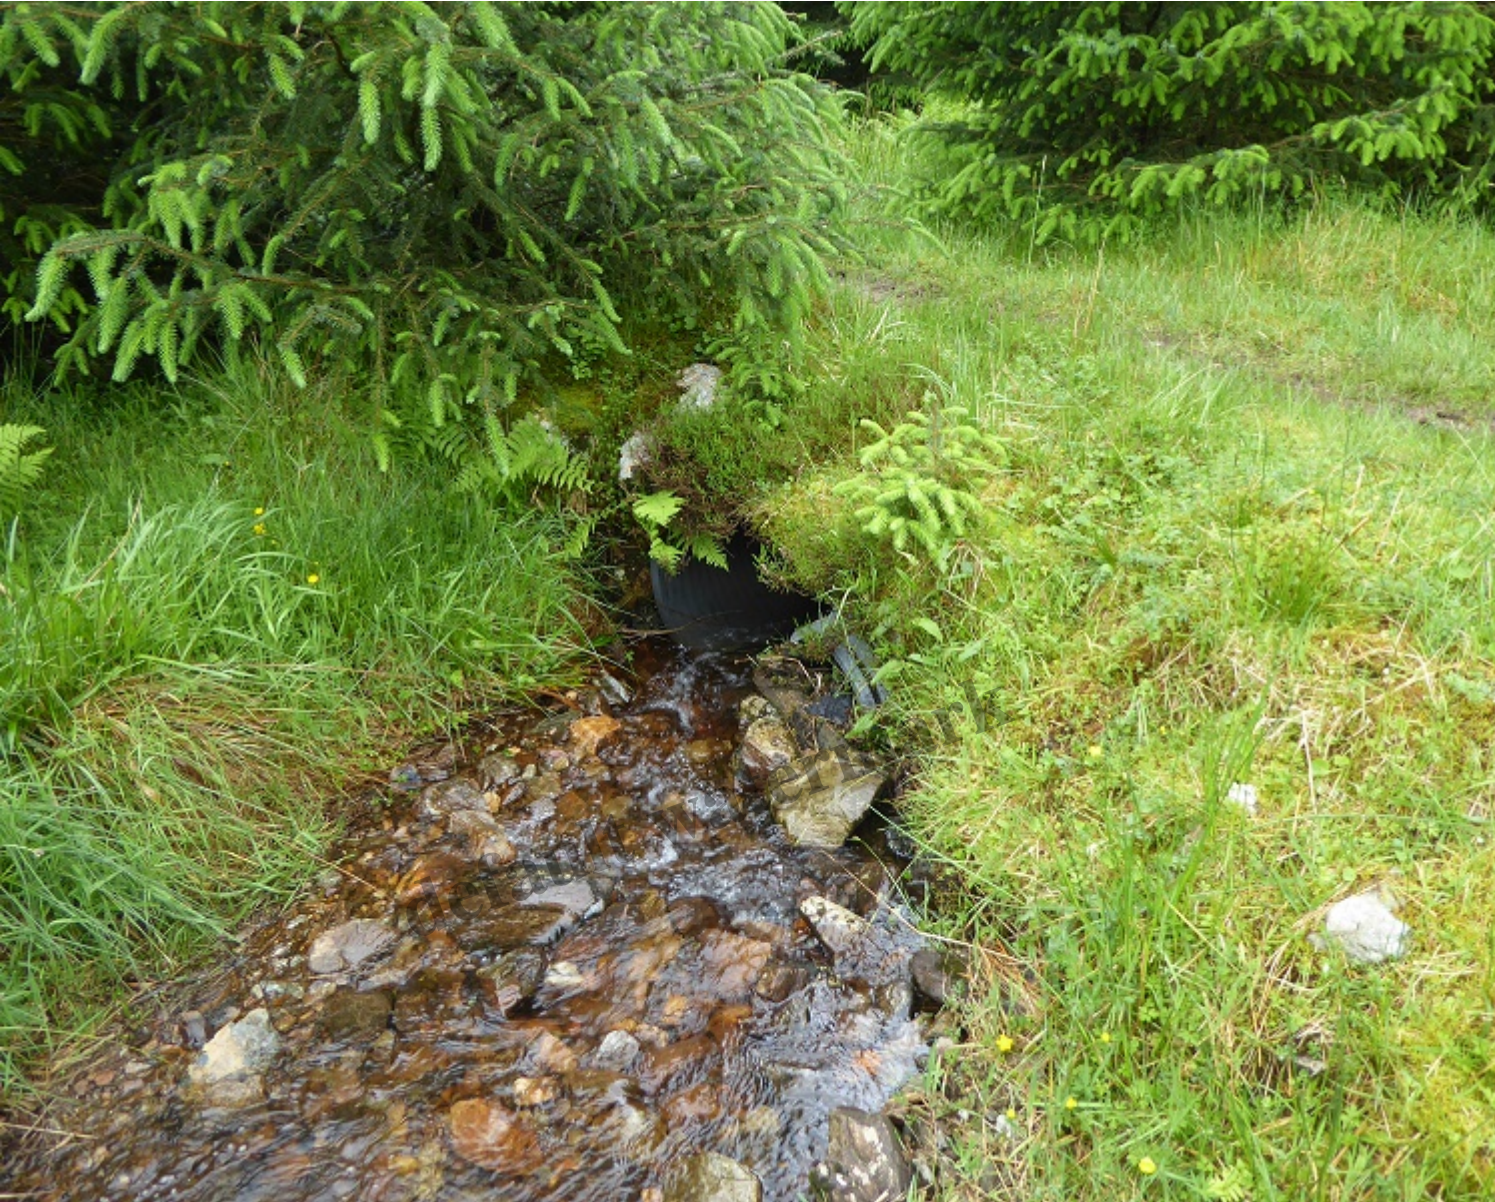
You can hardly see this plastic culvert under the path.

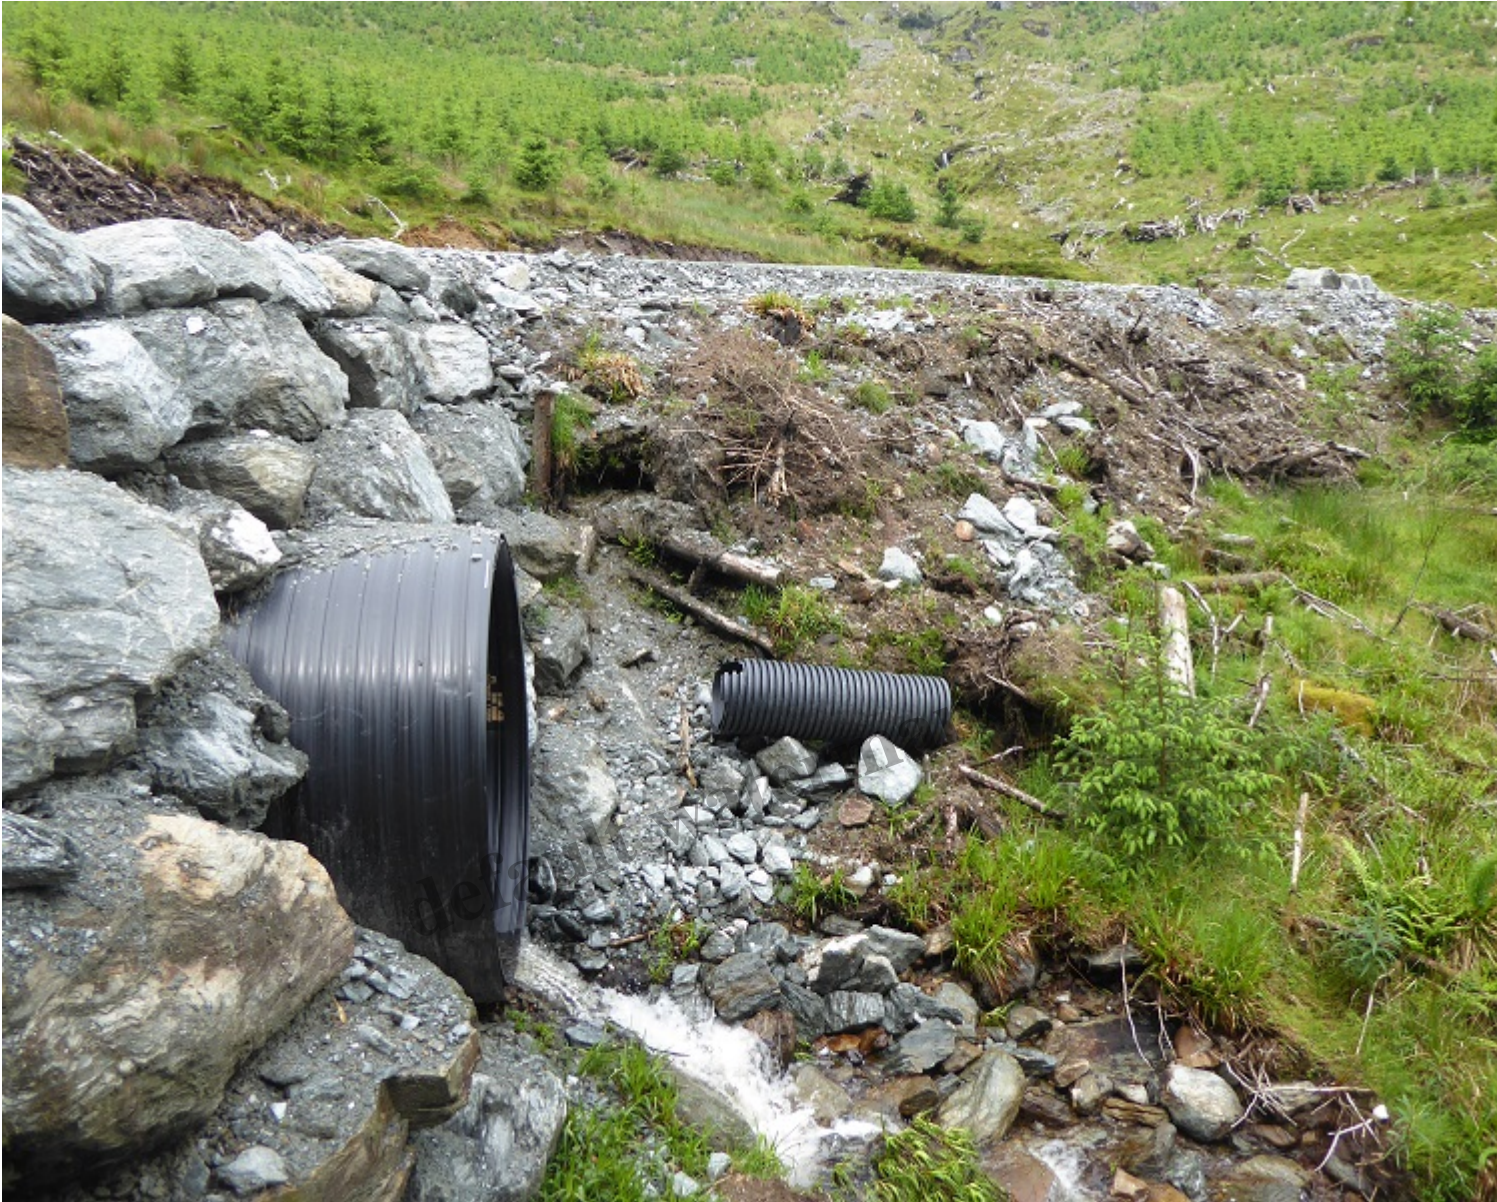
The care taken with the path contrast with the final section of the new track which finishes not far above.

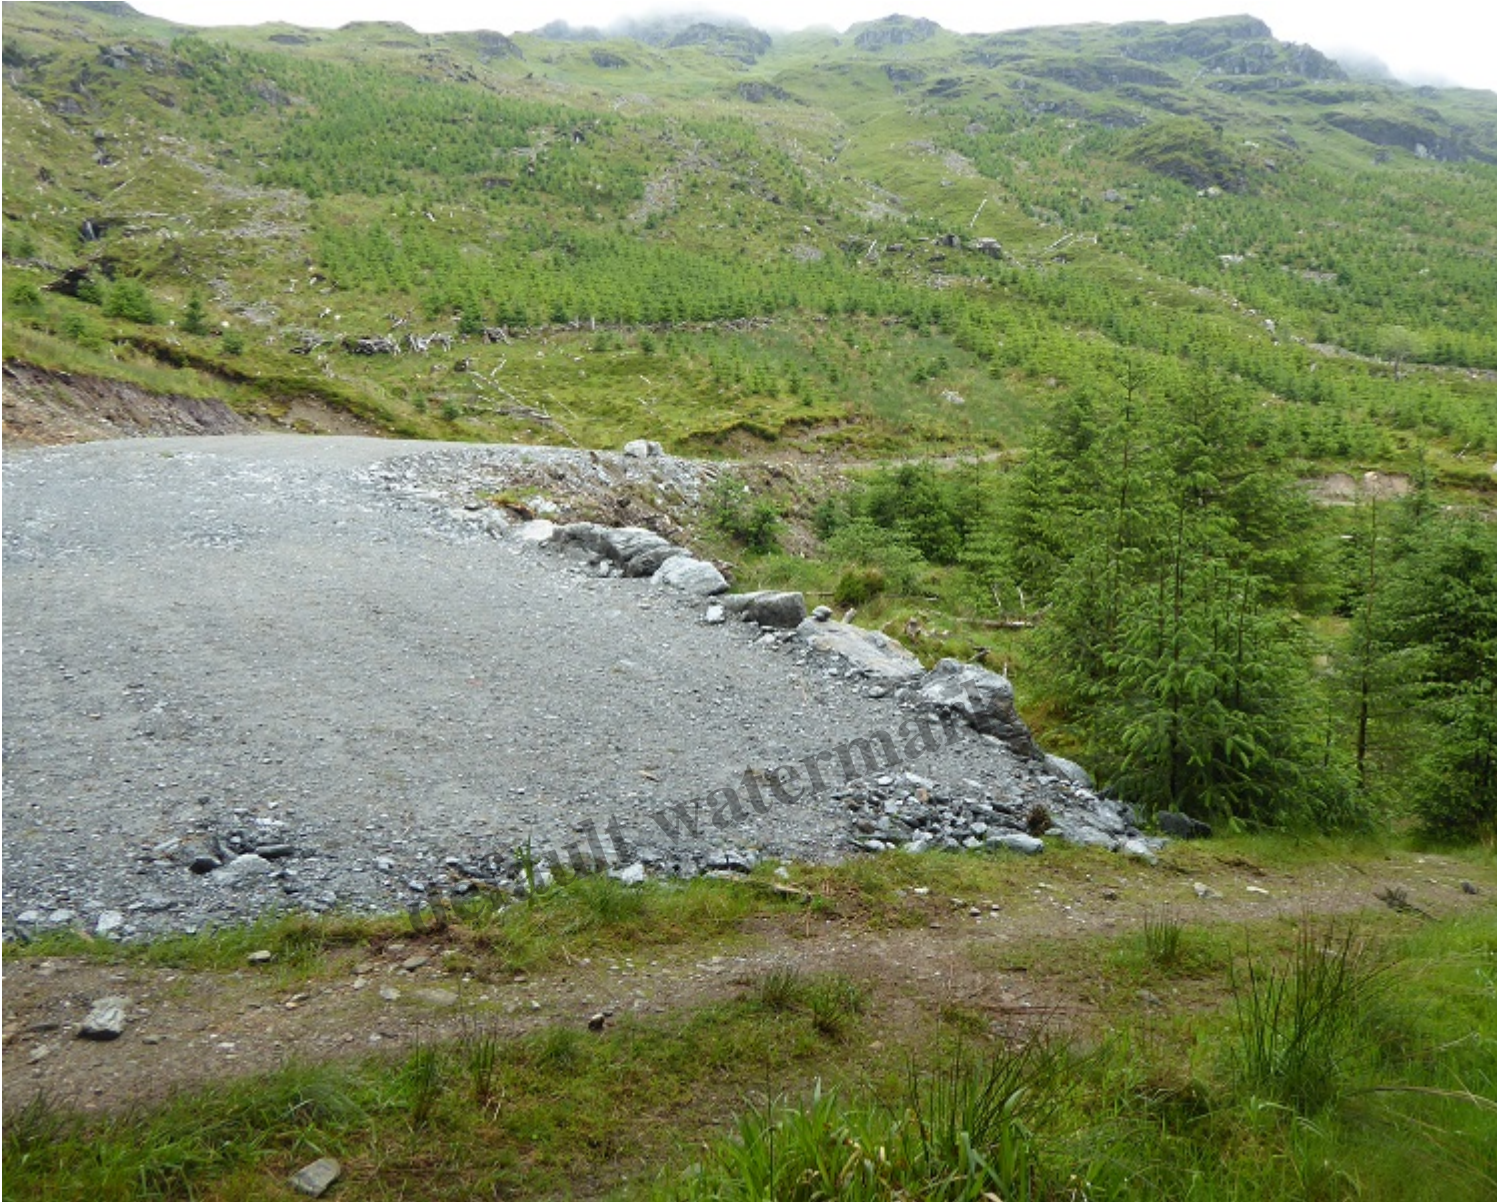
The felling and replanting in background (slopes of Brack) all took place without this track “upgrade” demonstrating that there was no need for works of anything like the extent of those that have been undertaken.

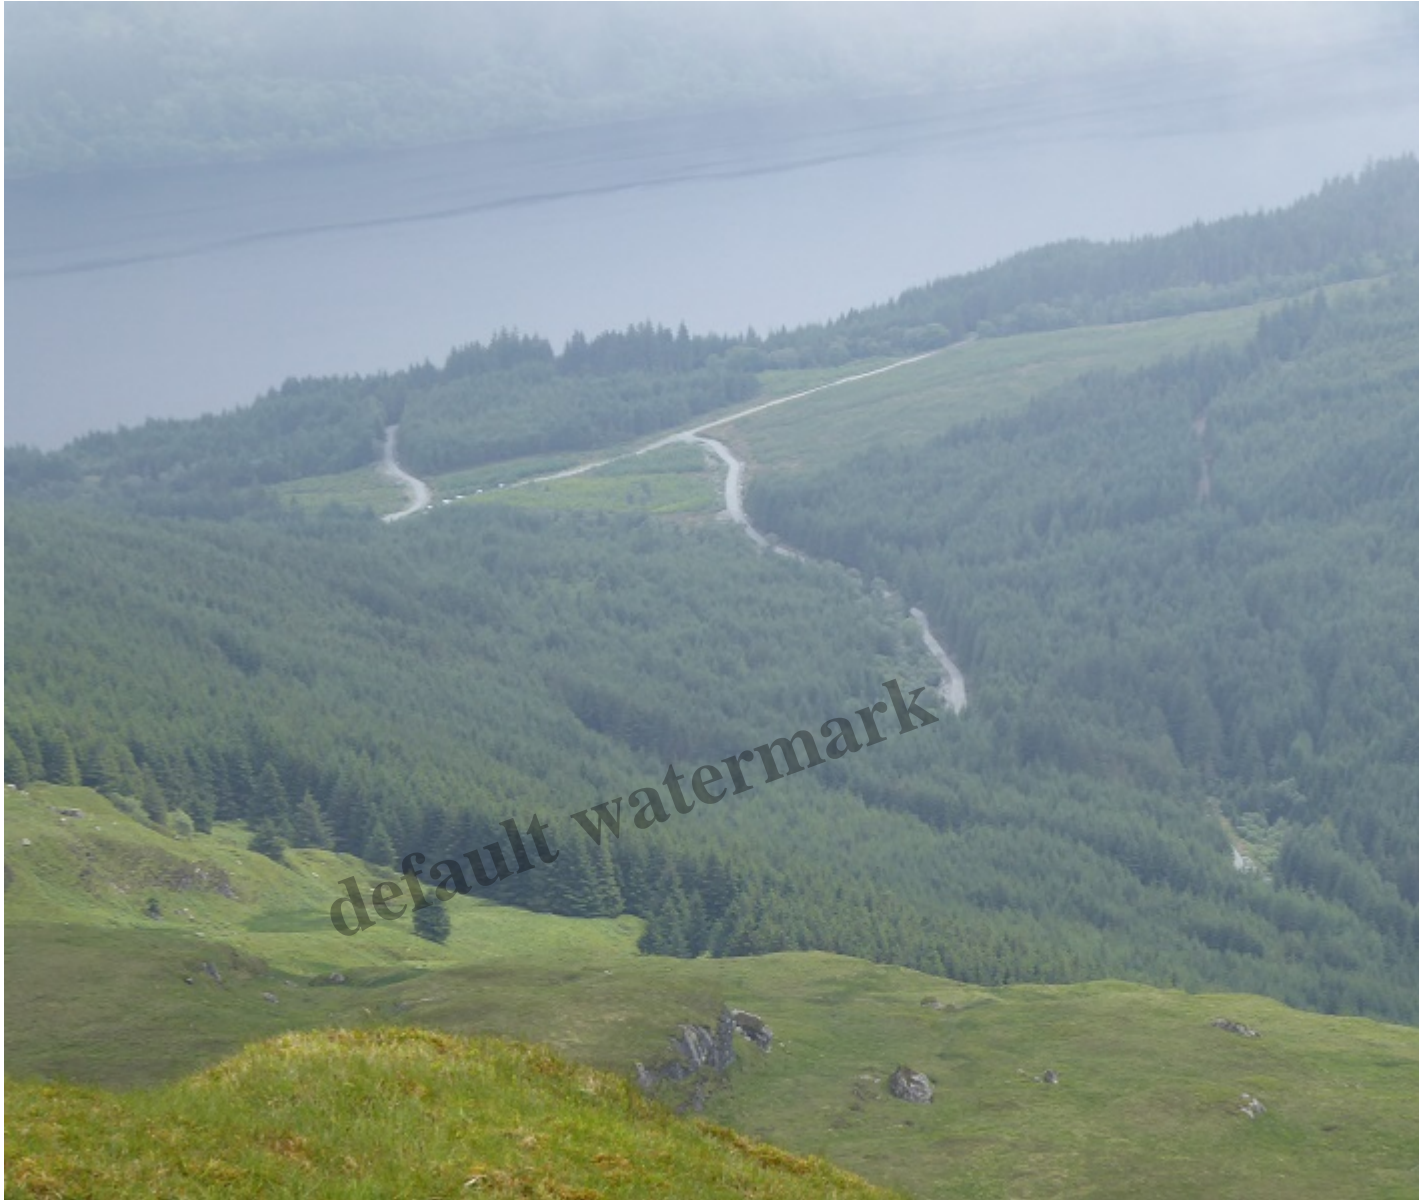
Lower sections of Coilessan Glen track from the Brack, Long Long behind

Even in the dense part of the forest, the upgraded track is visible from afar.

The FCS needs to apply consistent standards of practice and up its game in our National Parks. In places, such as on east Loch Lomond, its doing some fantastic work to remedy past mistakes, in others, like here, it appears nothing has changed.

The LLTNPA meantime needs to start focussing on stopping any further destruction of landscape quality in the National Park through track construction, whether hydro schemes or forestry. In my
