The Corriemulzie community hydro scheme

The Corriemulzie community hydro scheme <http://braemarhydro.org.uk/scheme/>, just west of Braemar on the road to Linn of Dee, provides an interesting case of how developments can go badly wrong despite the best intentions of the main players. I first visited this scheme, which became operational last summer, in September 2016 and was horrified by what I saw. Subsequent research and correspondence with the Cairngorms National Park Authority established the situation was a little more

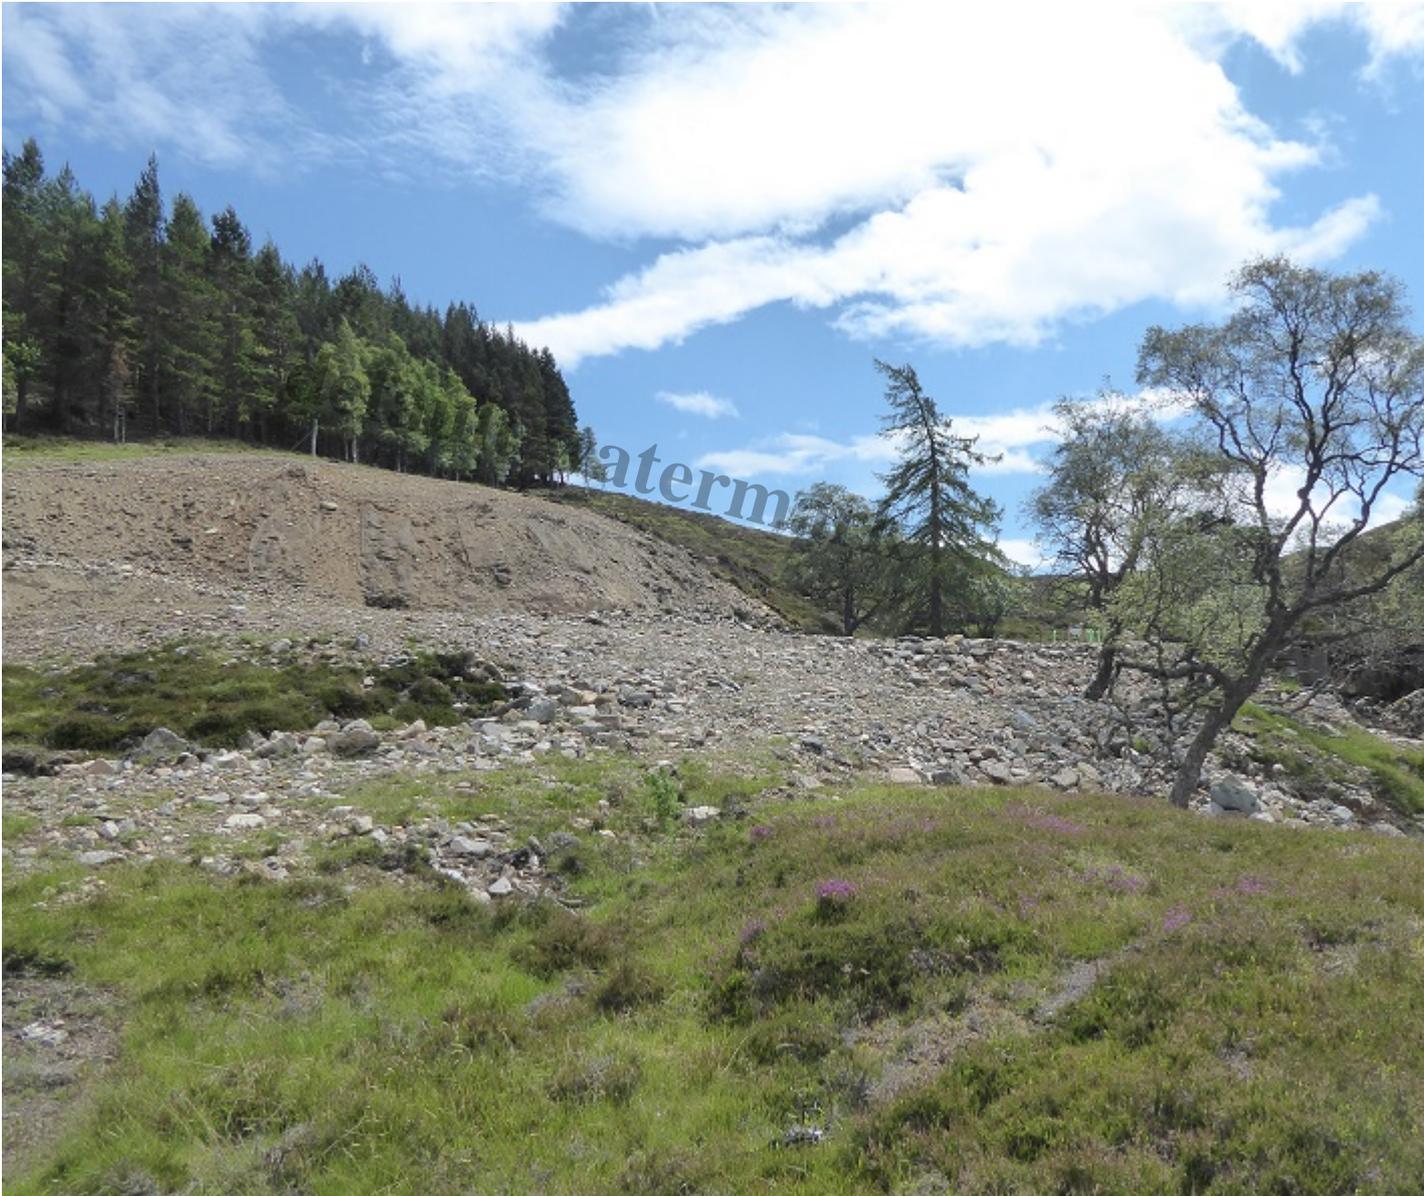
Destruction around the Corriemulzie intake. On first viewing this, I had assumed all the destruction had been caused by the construction of the hydro intake but the rocks in foreground, which partly envelope the two birch trees, were deposited by flood water during Storm Frank which devastated Deeside.

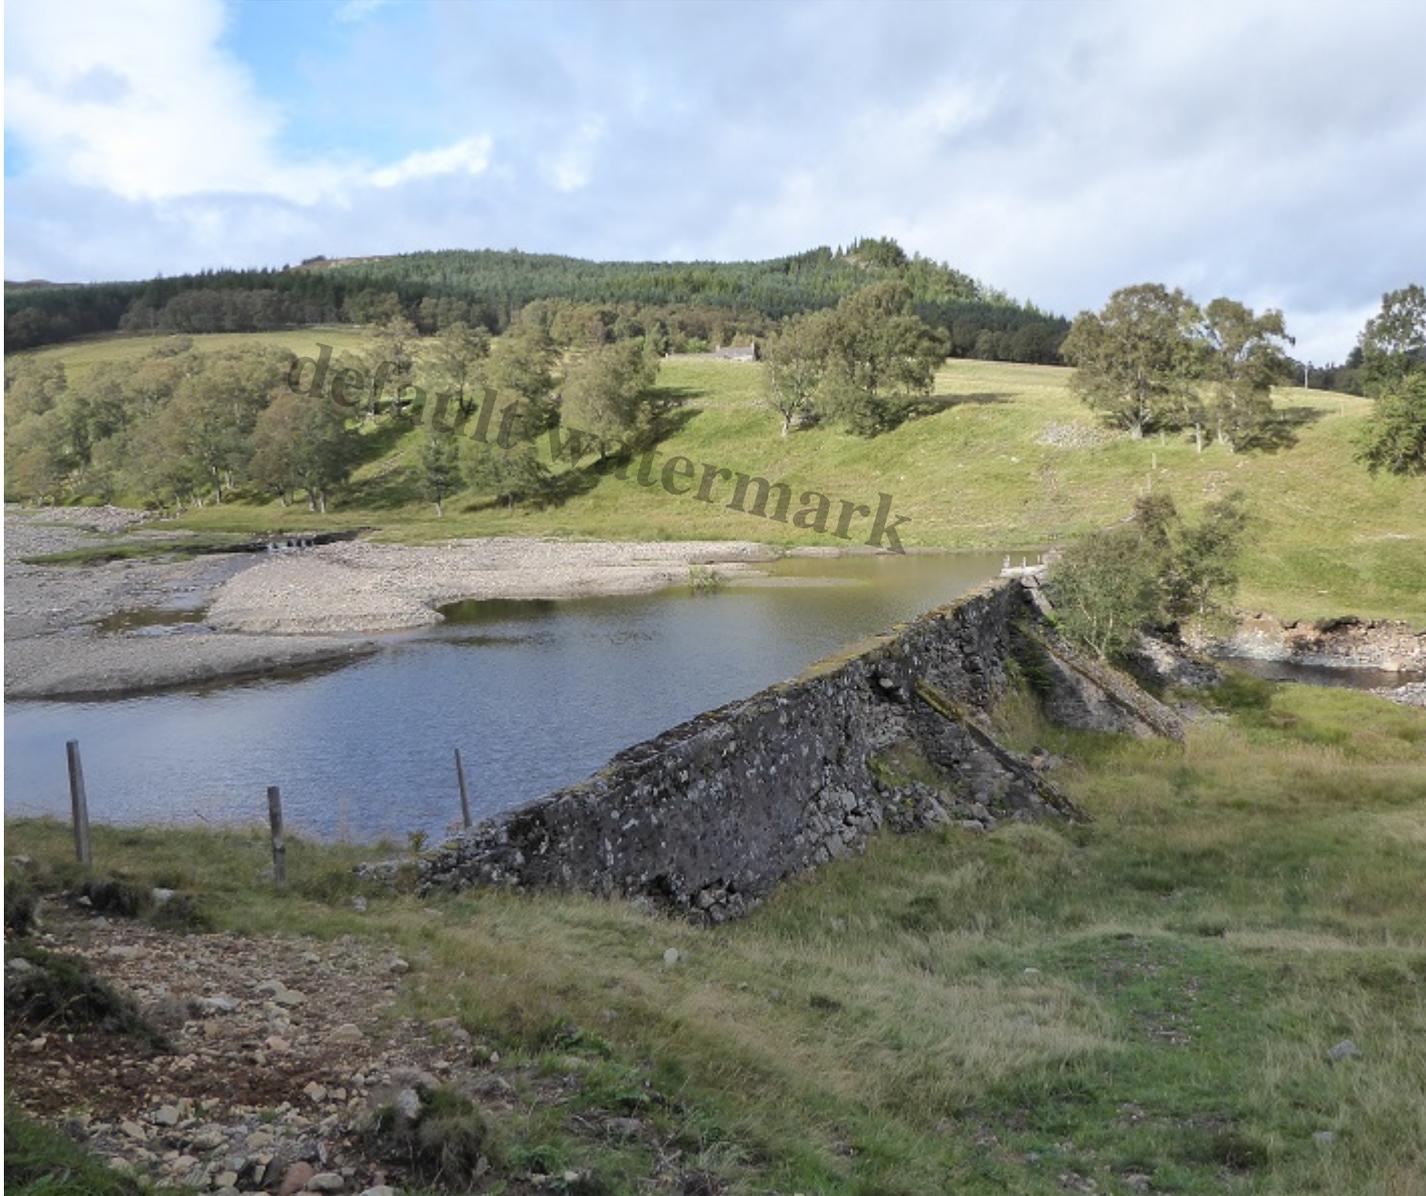
The old intake dam has been infilled with flood debris. You can just see old intake pipe centre left.

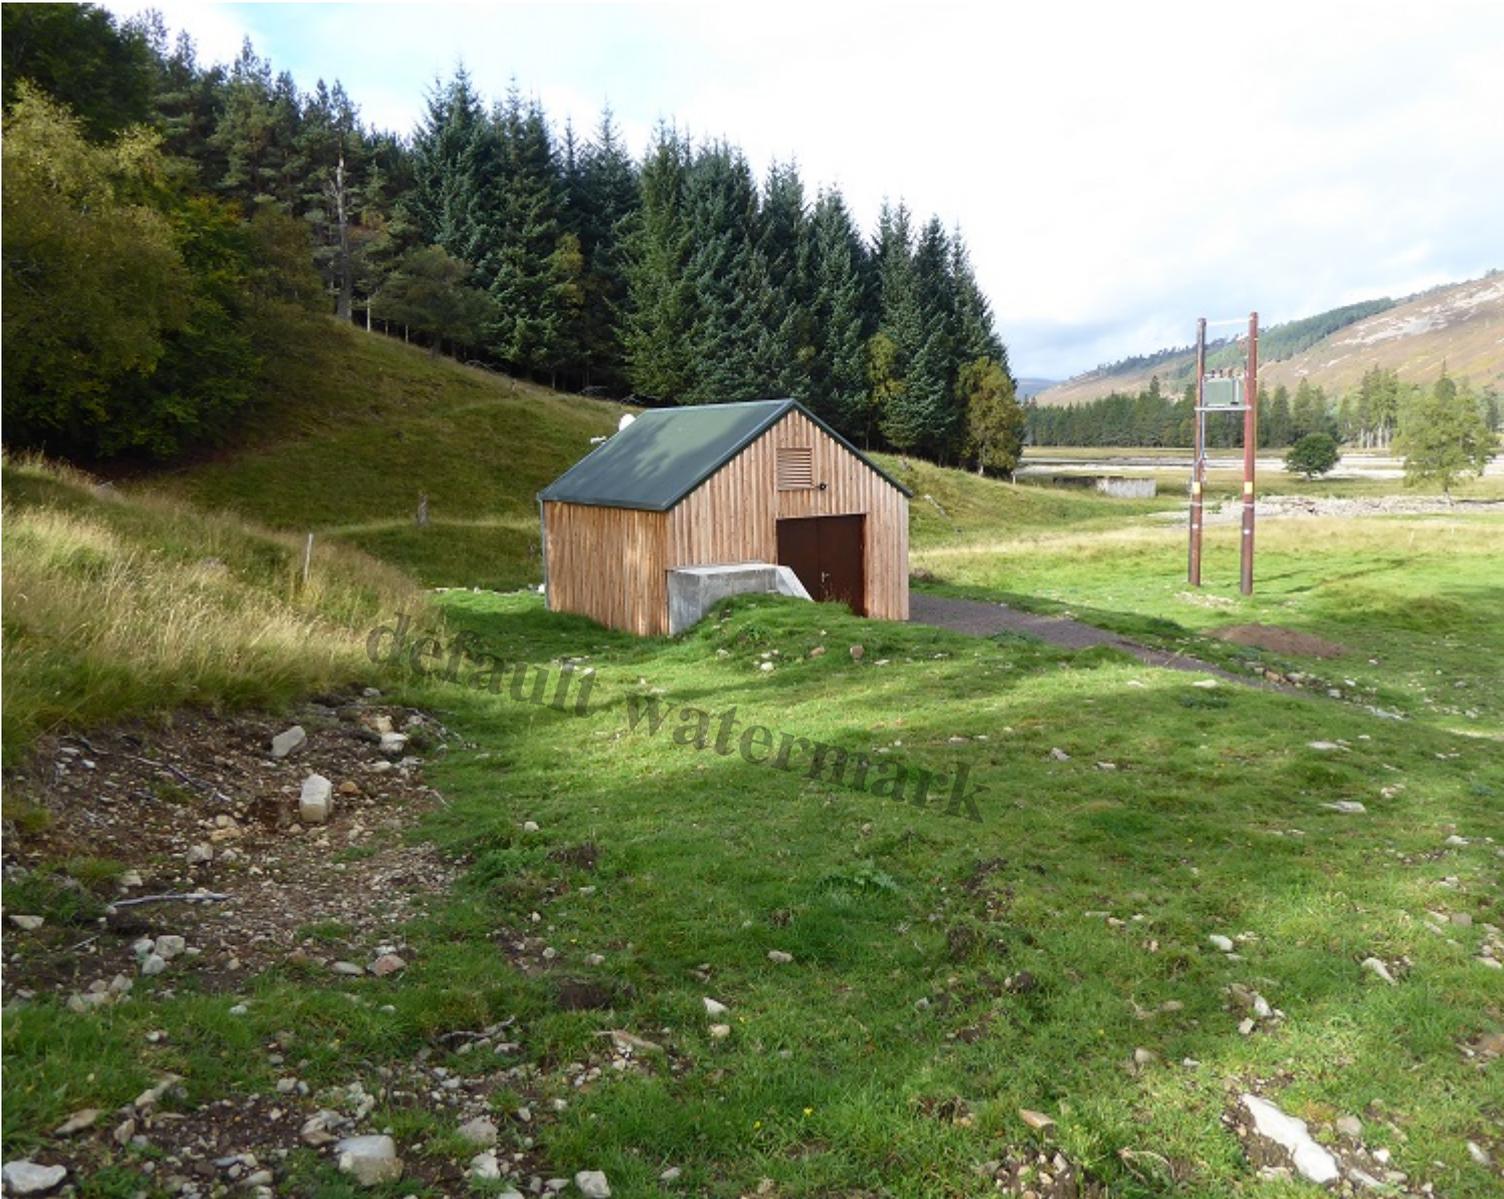
In design terms the power house is well located, close to bank and trees, and the turning area for vehicles is small. All positives. The ground above the pipeline had recovered quickly, with evidence of turfs having been stored and replaced. Incredible care needs to be taken with removal of turf and topsoil if all the surface area is to be re-covered in restoration and in this area there was not enough to use on the banks (bare patch left) though I suspect this has recovered by now.

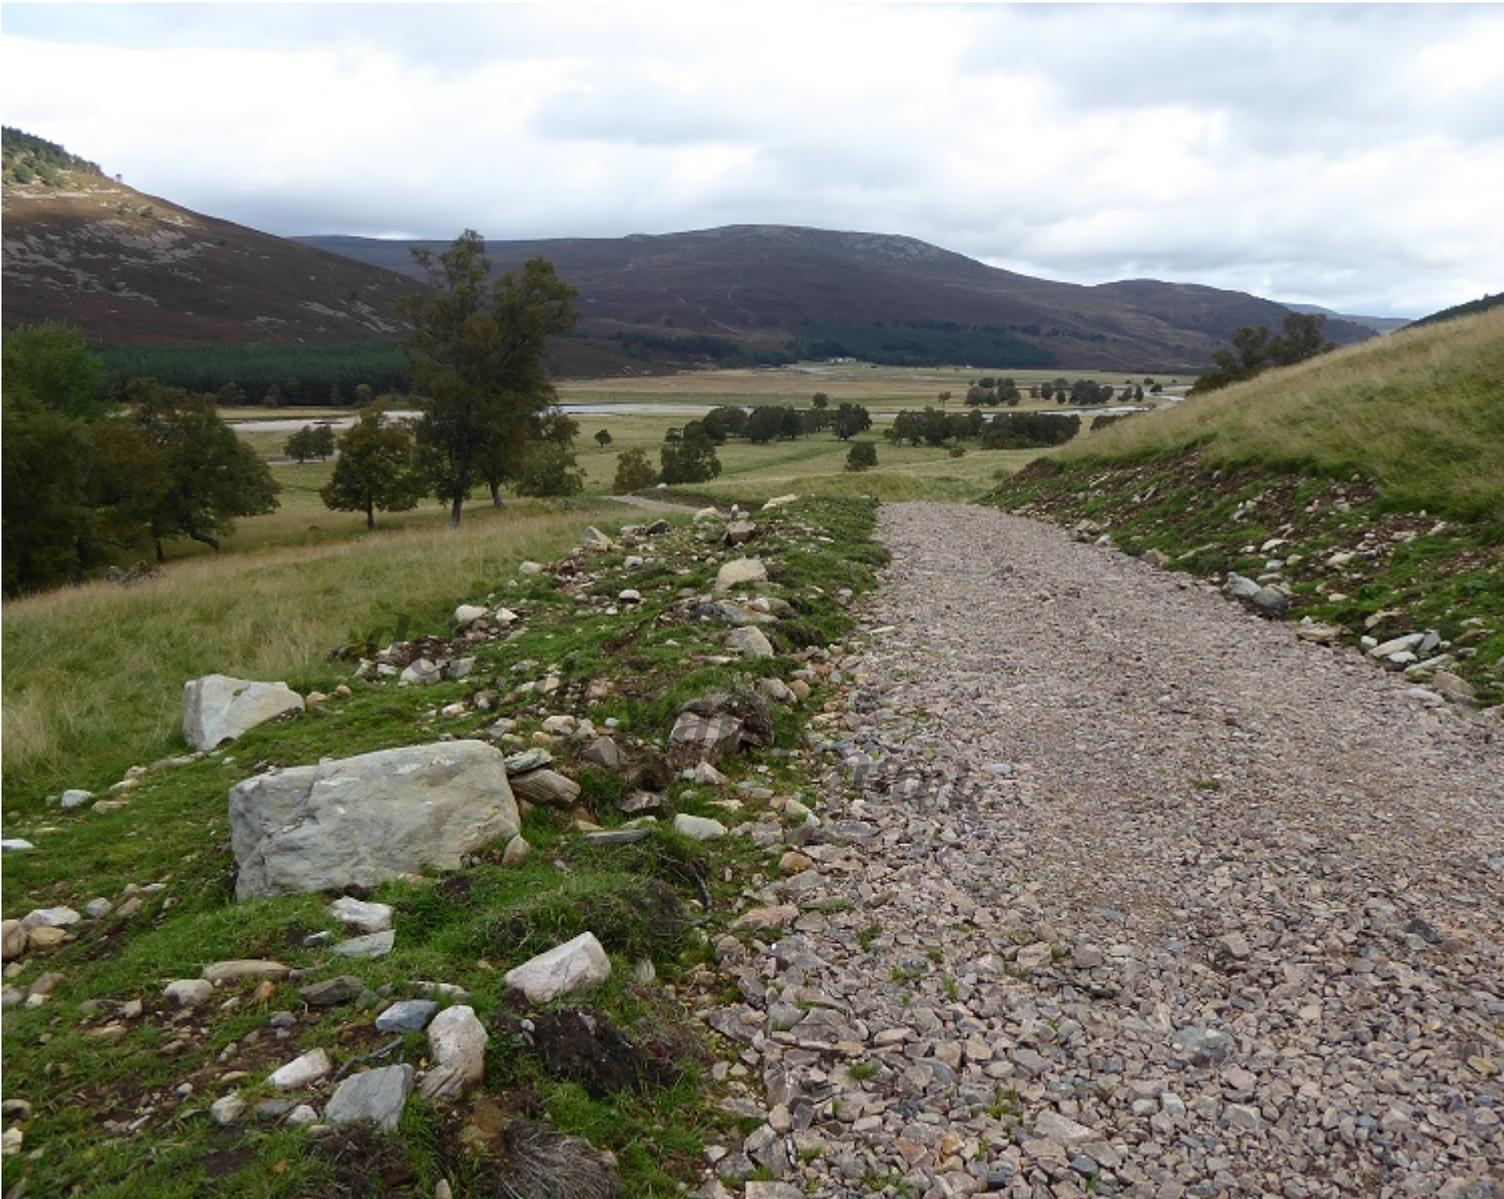
The track has been less well done, with large boulders left on the surface of what had previously been a grassy field. The bank on the right though is at a sufficiently low angle to recover quickly and a good example of track design.

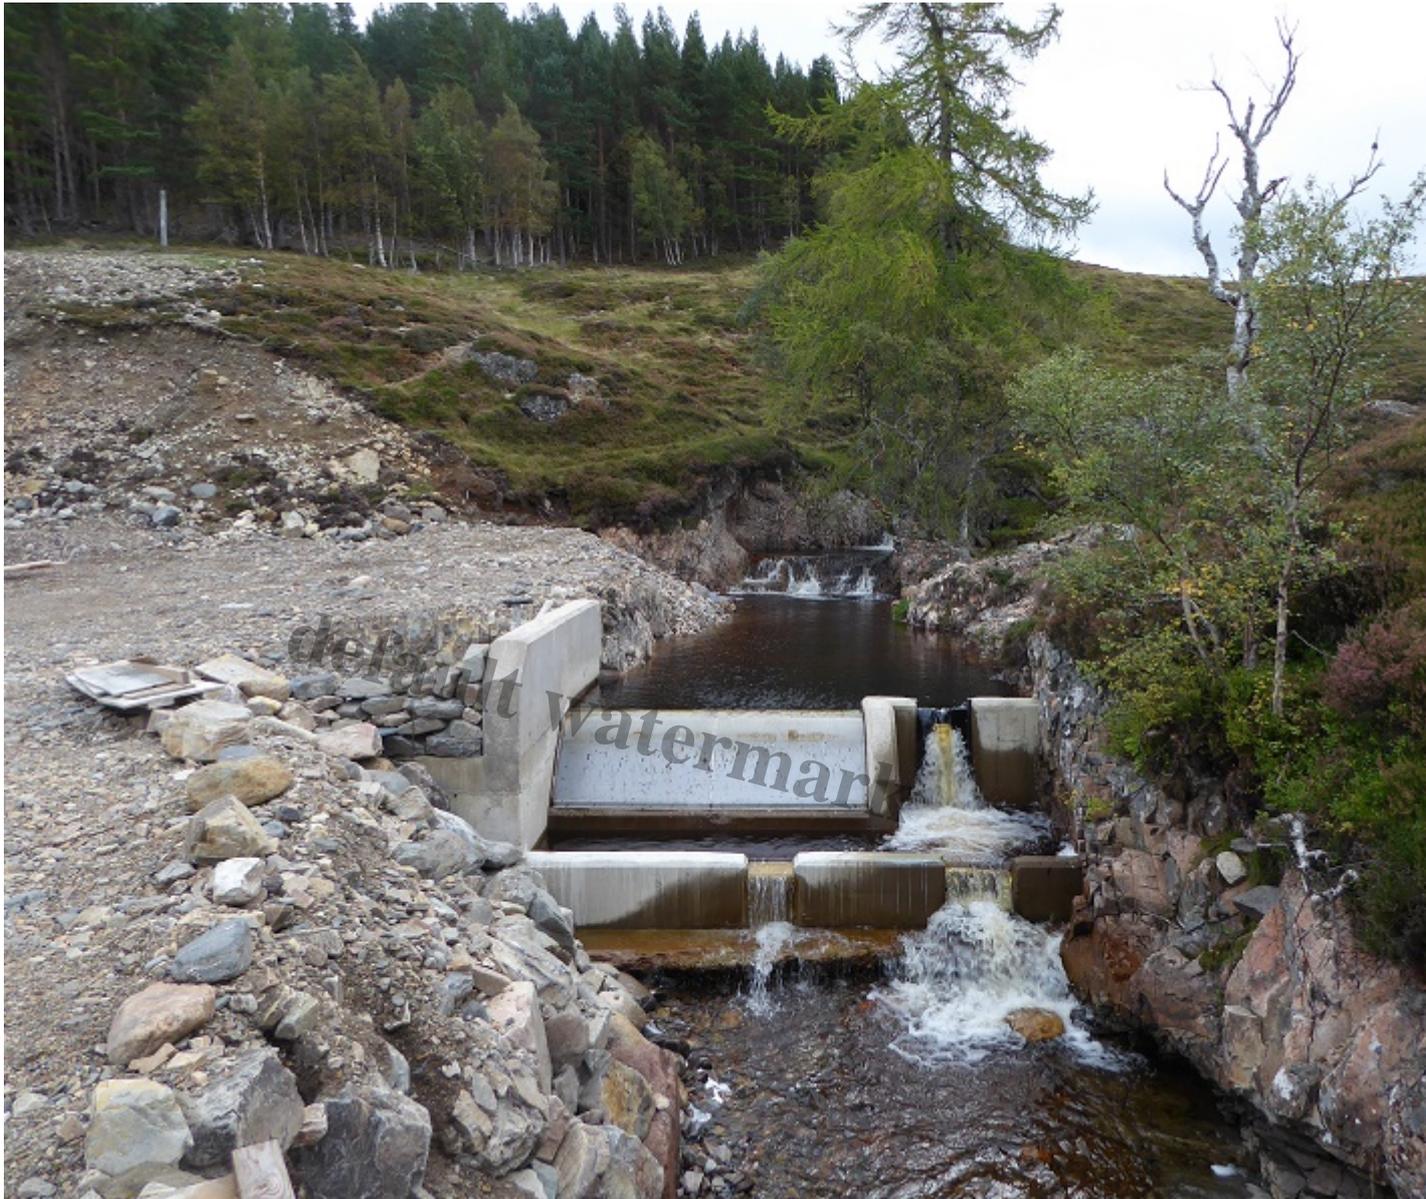
In order to build the dam the burn needed to be diverted through a channel created through the (true) above the intake. The intake as it appeared in September 2016.

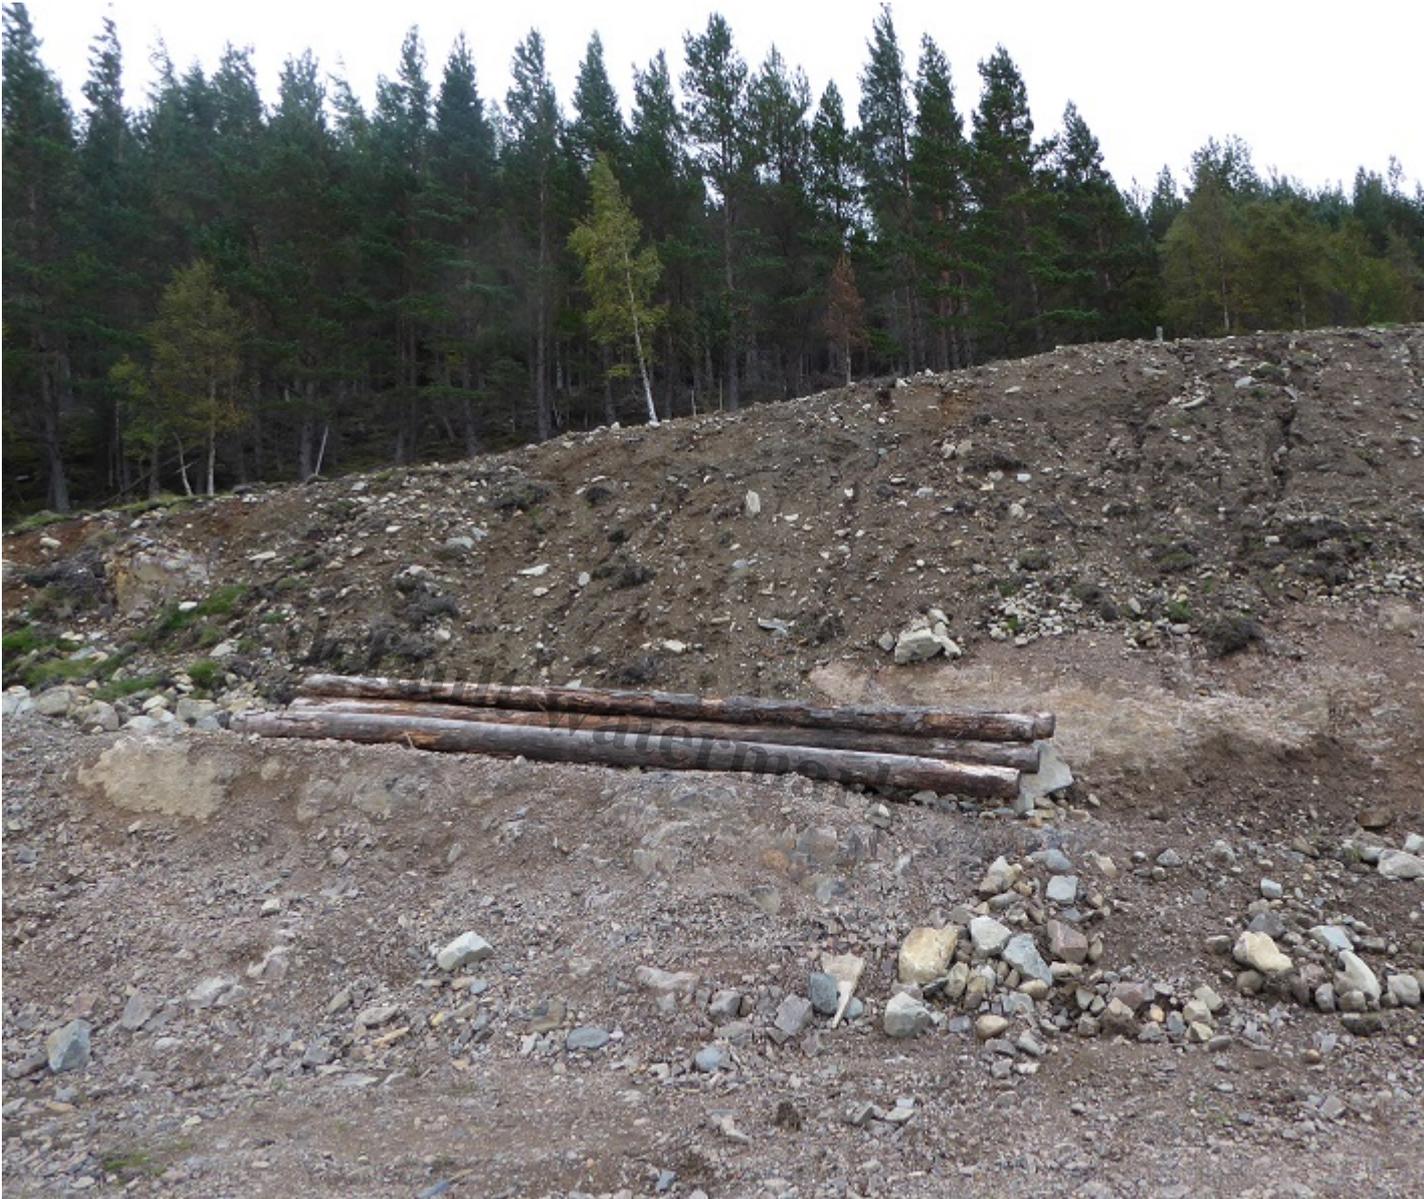
The bank as it appeared in September 2016

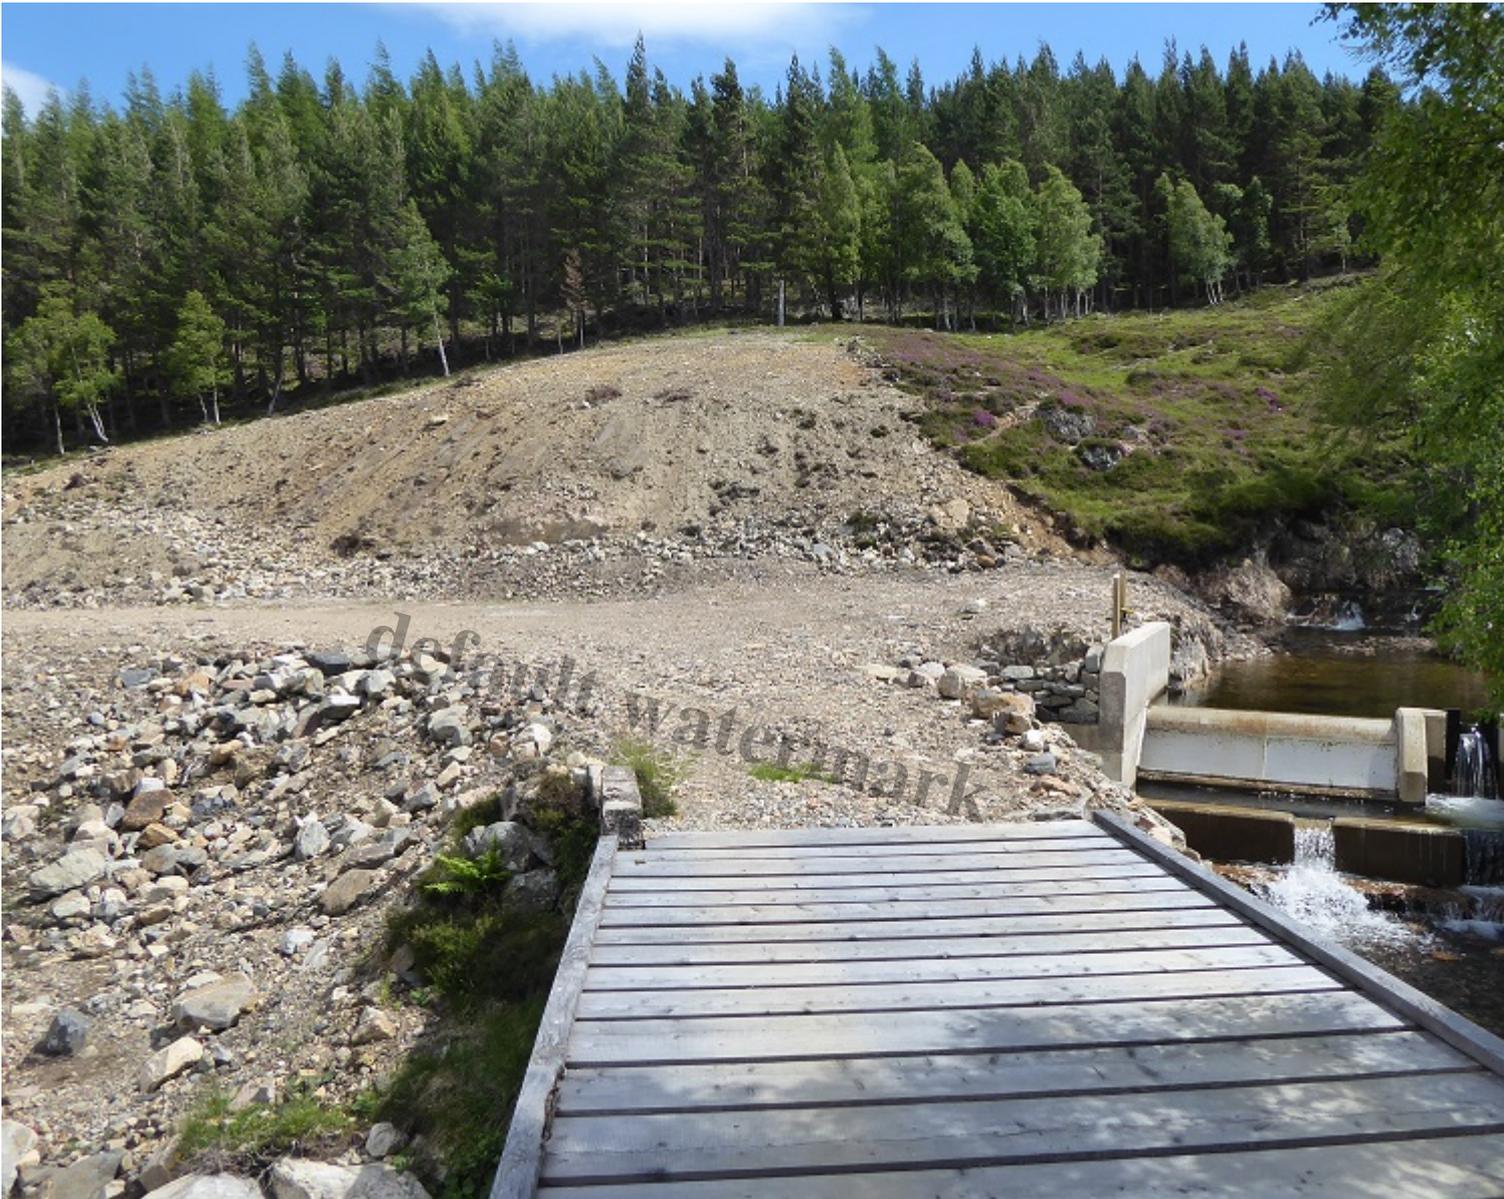
The fundamental issues here are:

- there has been no effective restoration of the bank along the burn;
- the bank on the hill was excavated and is far too steep to be restored;
- the track and turning area are far too wide.

While there had been obvious attempts at amelioration since September 2016 these have not in my view addressed the fundamental issues.

The focus of the CNPA and Braemar Community Hydro needs to be around addressing the landscape damage around the first intake. I think that to remedy the damage will require considerable expertise and require money. If the contractor cannot be made liable, it means the shareholders for the hydro, who were expecting a 5-8% return (there is interesting information on the finances on the community hydro website), Mar Estate which is charging rent (and was responsible for previous damage in the area) and the community may have to wait for their return. It seems to people that all the people who were going to gain from this development have a collective responsibility to ensure that this is not at the expense of the landscape. Success would then be being able to promote this as being a nice place to go for a walk again â?? a â??small gemâ?• in the National Park â?? as it was in the past.

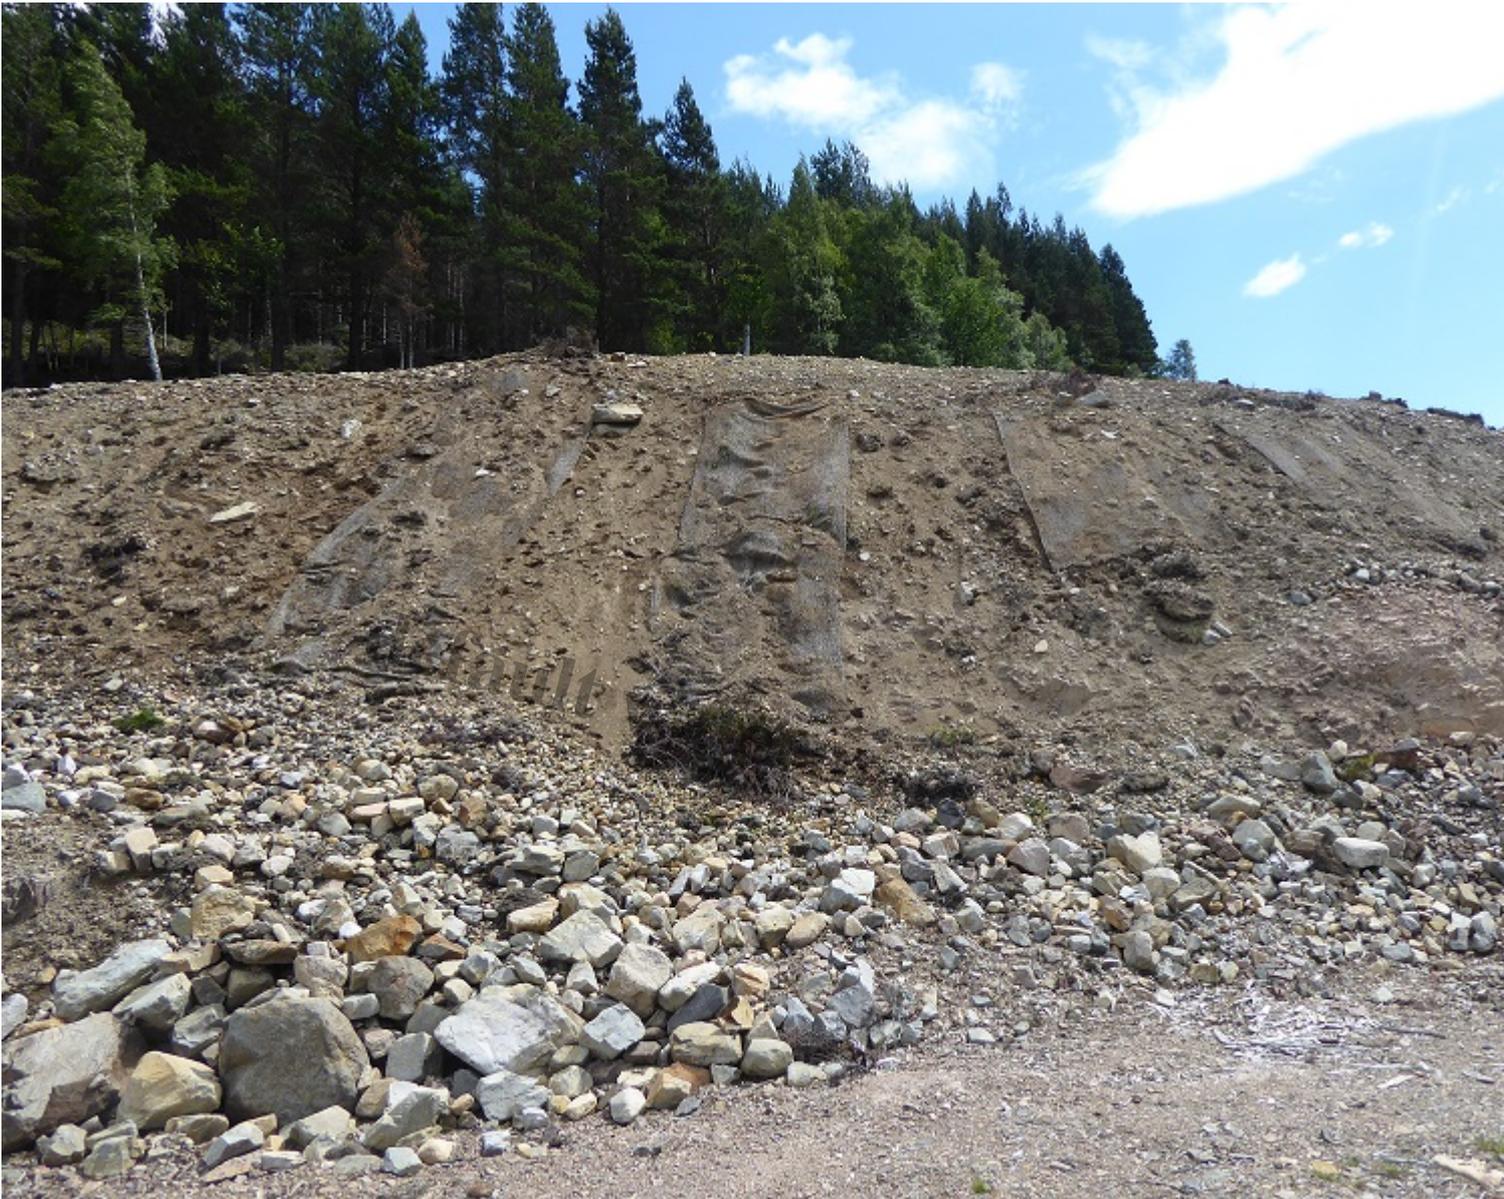
Four strips of fabric had been applied to the oversteep bank to reduce erosion but this has had no impact. There is no sign of vegetation re-establishing itself and the problems have been increased by deer (you can see hoof marks between 2nd and 3rd strips) walking down the slope.

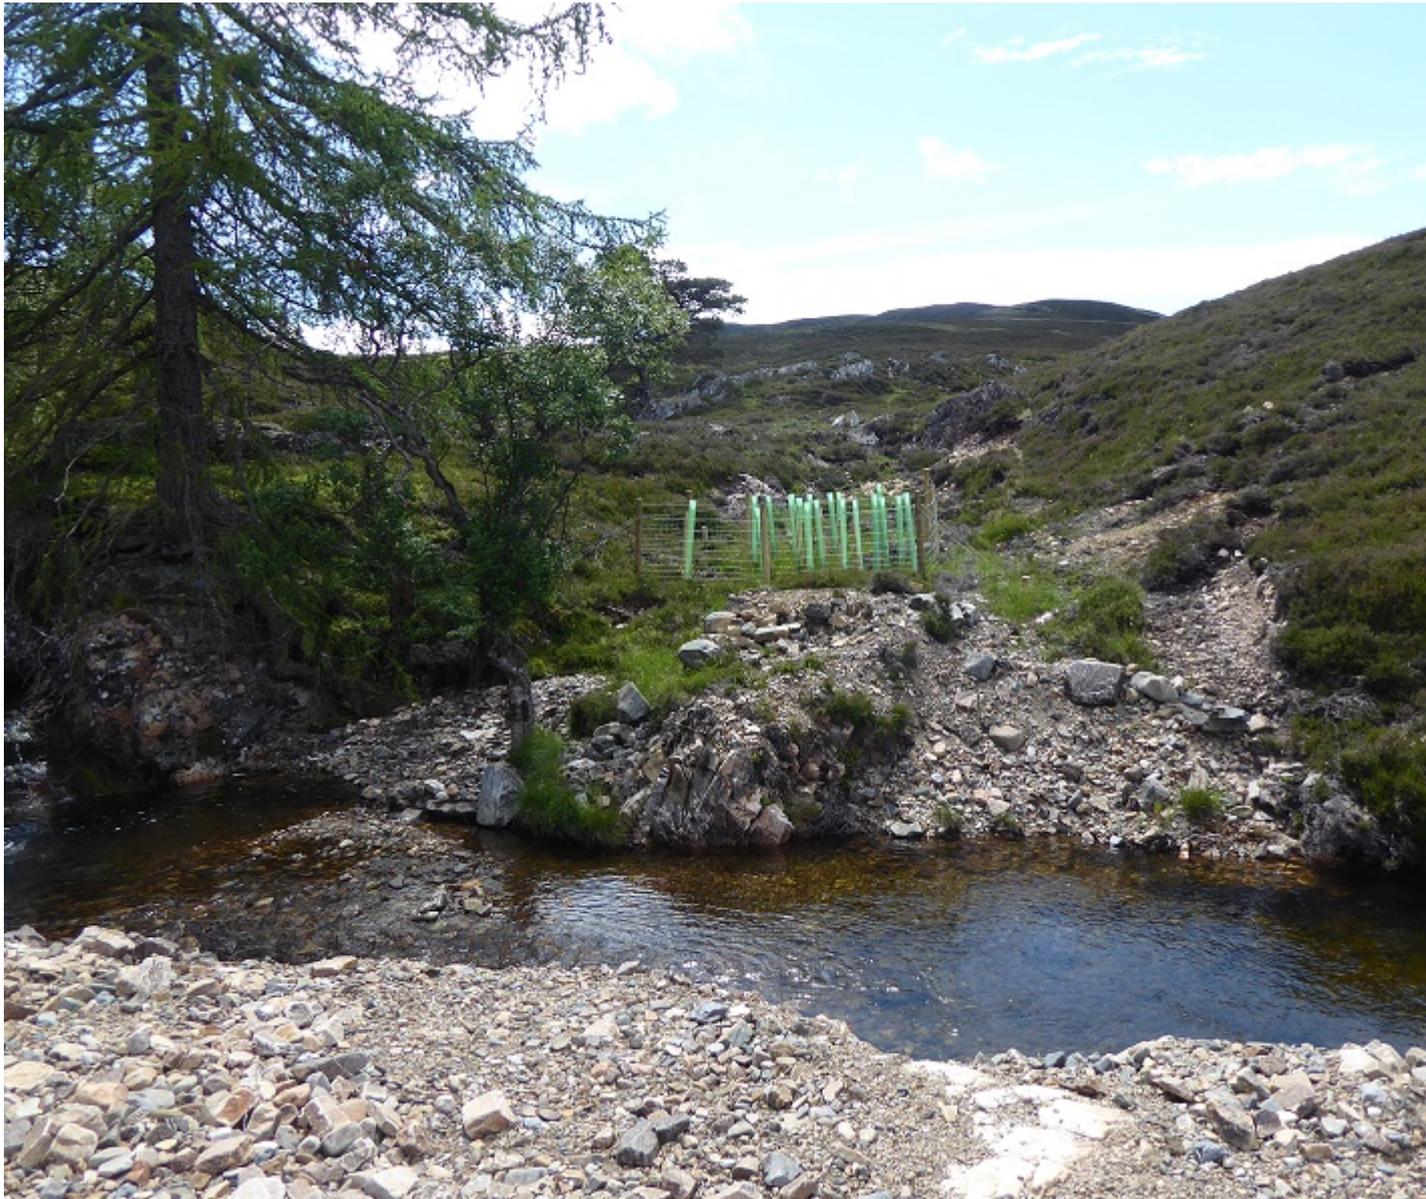
View across burn above intake

There has been ‘‘compensatory’’ tree planting but no attempt to restore vegetation to the bank of the burn. This should have been done months ago at the beginning of the growing season.

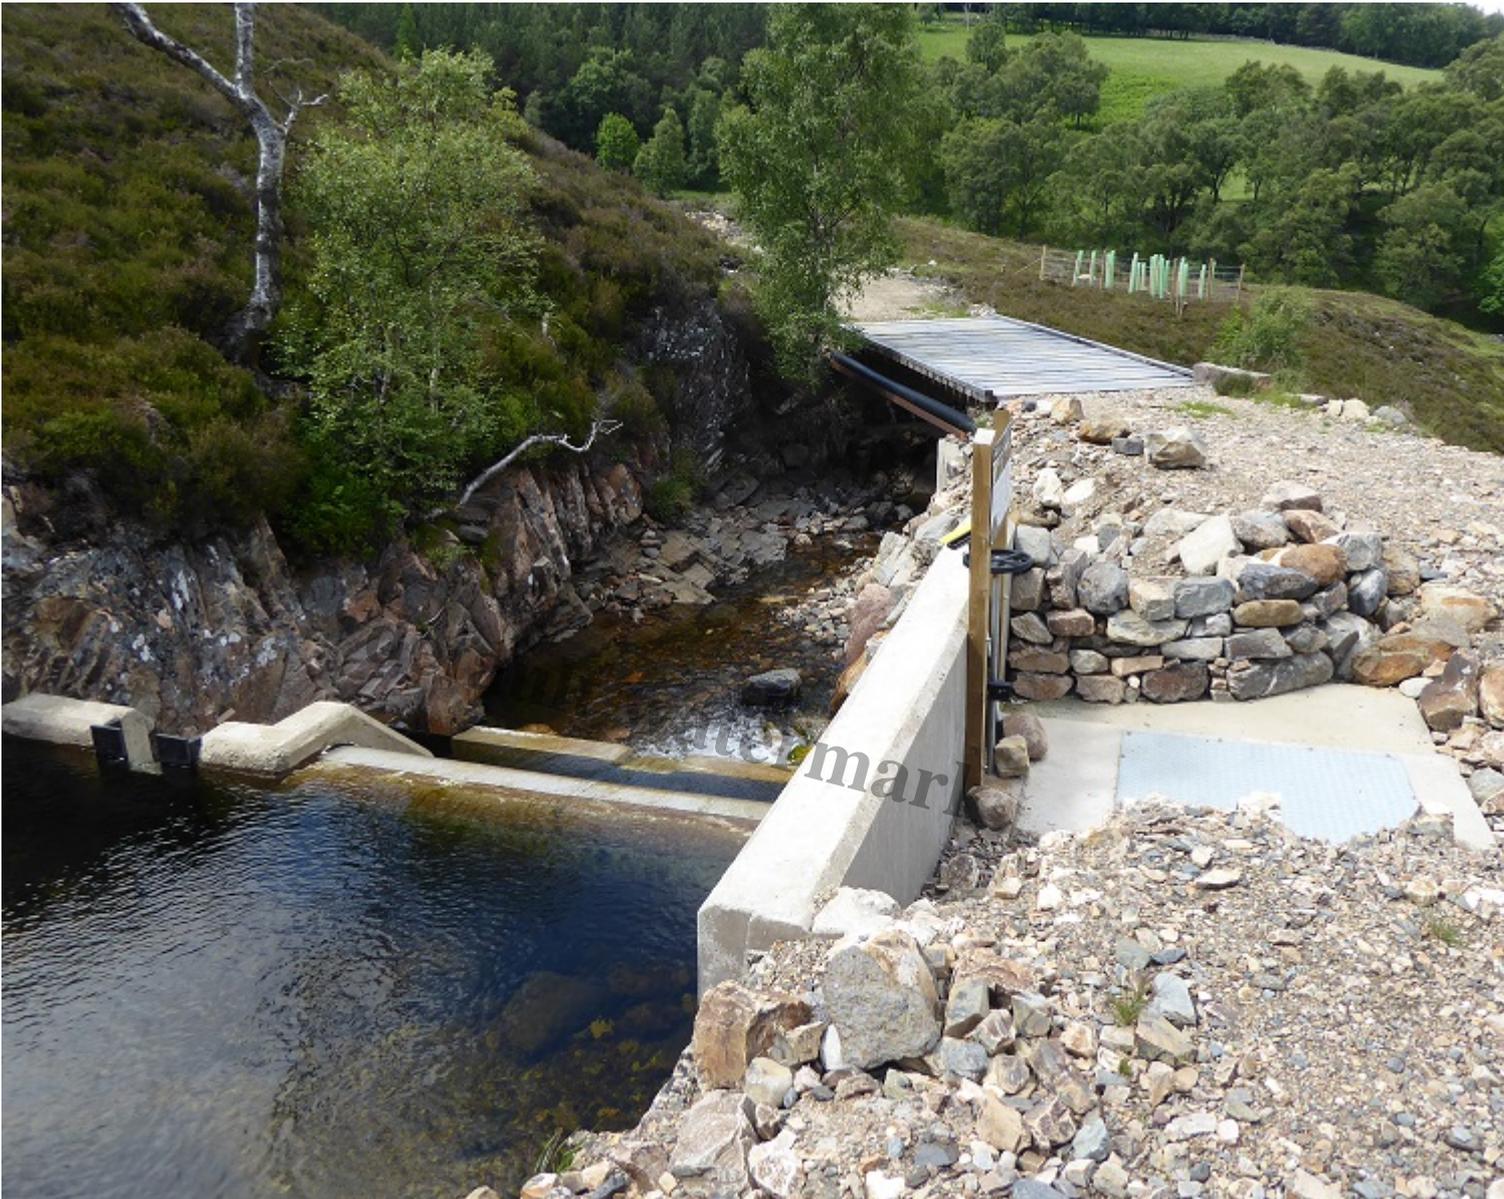
Despite the atrocious finishing along the bank and track, this photos shows some good things about the scheme. You can just see the pipe from the second hydro running below the bridge – you won’t see it unless you look out for it – and the CNPA told the developer there was no need to erect fencing around the intake. I agree. All that good design though counts for little if the destruction round about is not addressed.

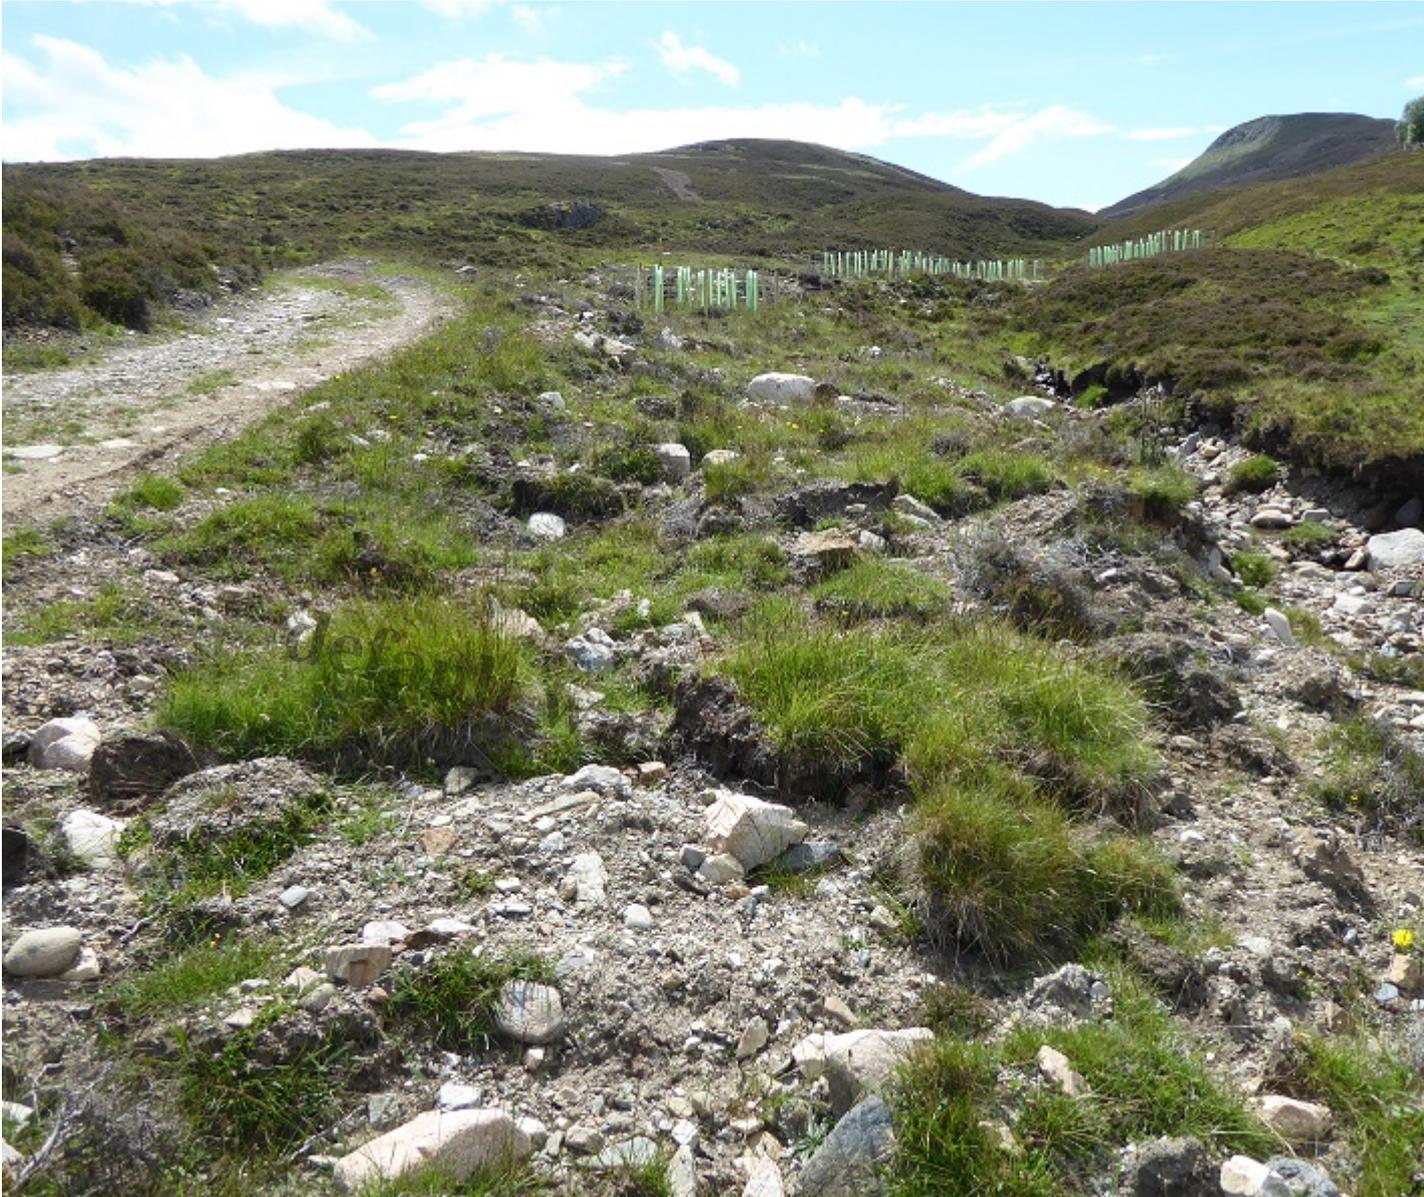
The ground above the pipeline to the second intake has not been restored well and will, as a result, take a longer time to recover than it should have with increased erosion.

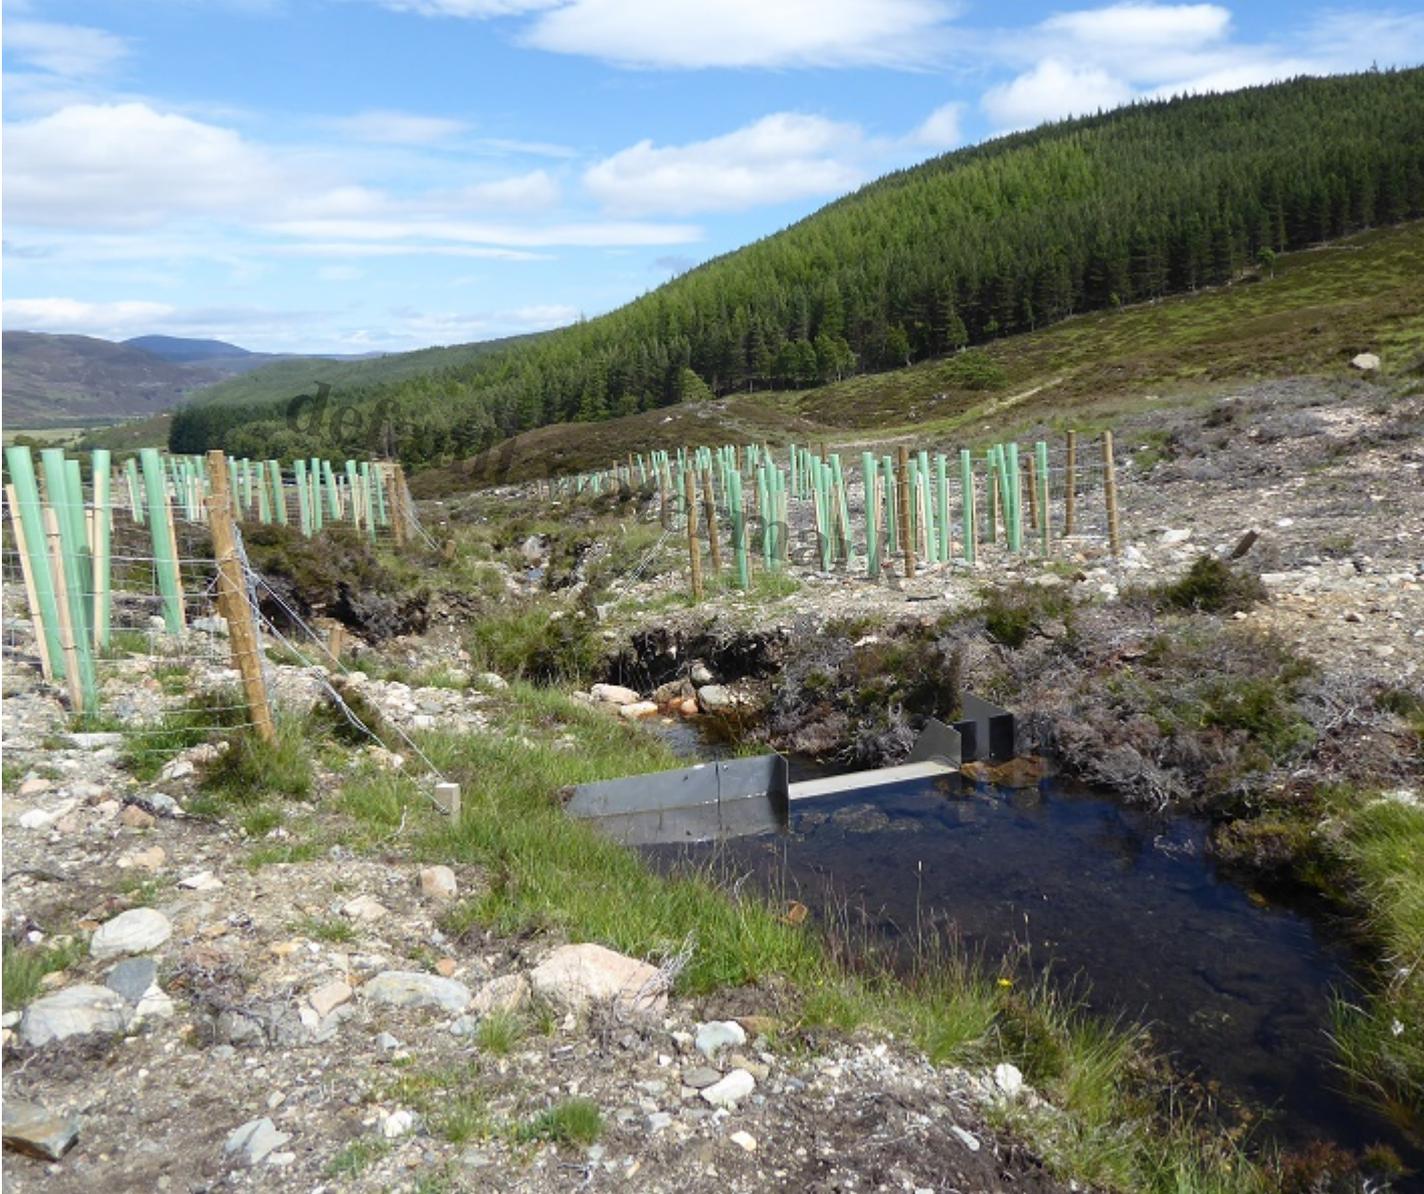
The small second intake, the pipe runs to the right of the blocks of trees which have been planted.

Lots of tree planting should not be seen as compensation for poor ground restoration work.
