## The Corriemulzie community hydro scheme

The Corriemulzie community hydro scheme <http://braemarhydro.org.uk/scheme/>, just west of Braemar on the road to Linn of Dee, provides an interesting case of how developments can go badly wrong despite the best intentions of the main players. I first visited this scheme, which became operational last summer, in September 2016 and was horrified by what I saw. Subsequent research and correspondence with the Cairngorms National Park Authority established the situation was a little more

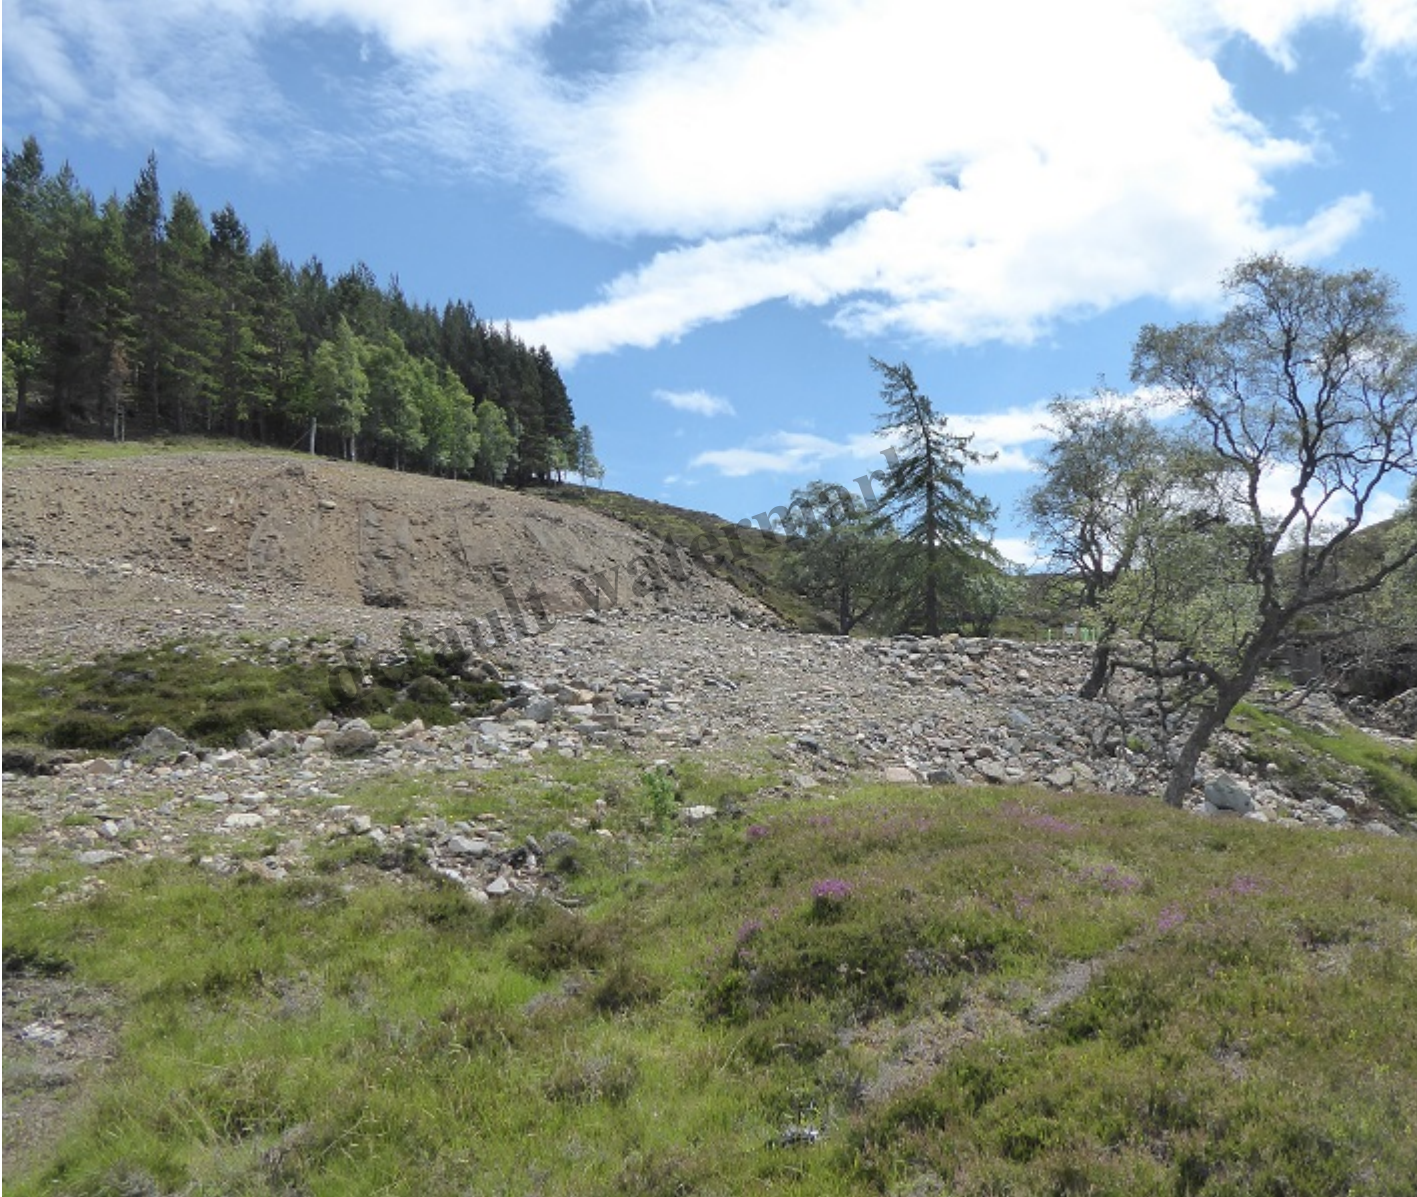
Destruction around the Corrimulzie intake. On first viewing this, I had assumed all the destruction had been caused by the construction of the hydro intake but the rocks in foreground, which partly envelope the two birch trees, were deposited by flood water during Storm Frank which devastated Deeside.

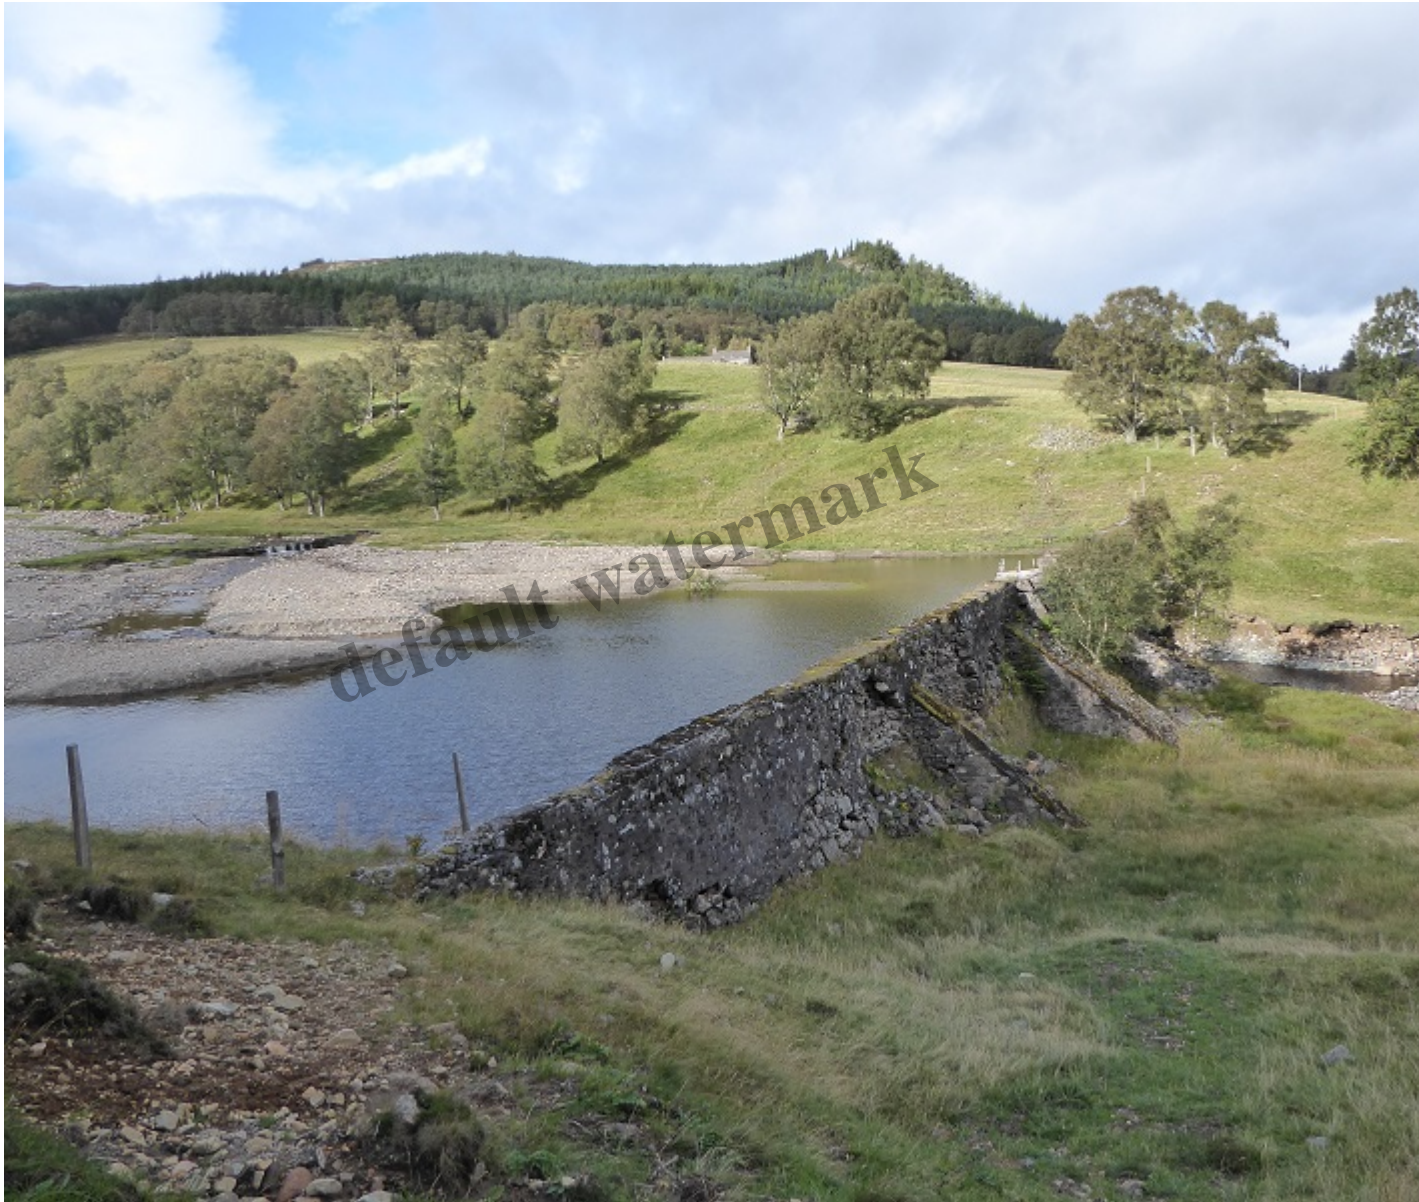
The old intake dam has been infilled with flood debris. You can just see old intake pipe centre left.

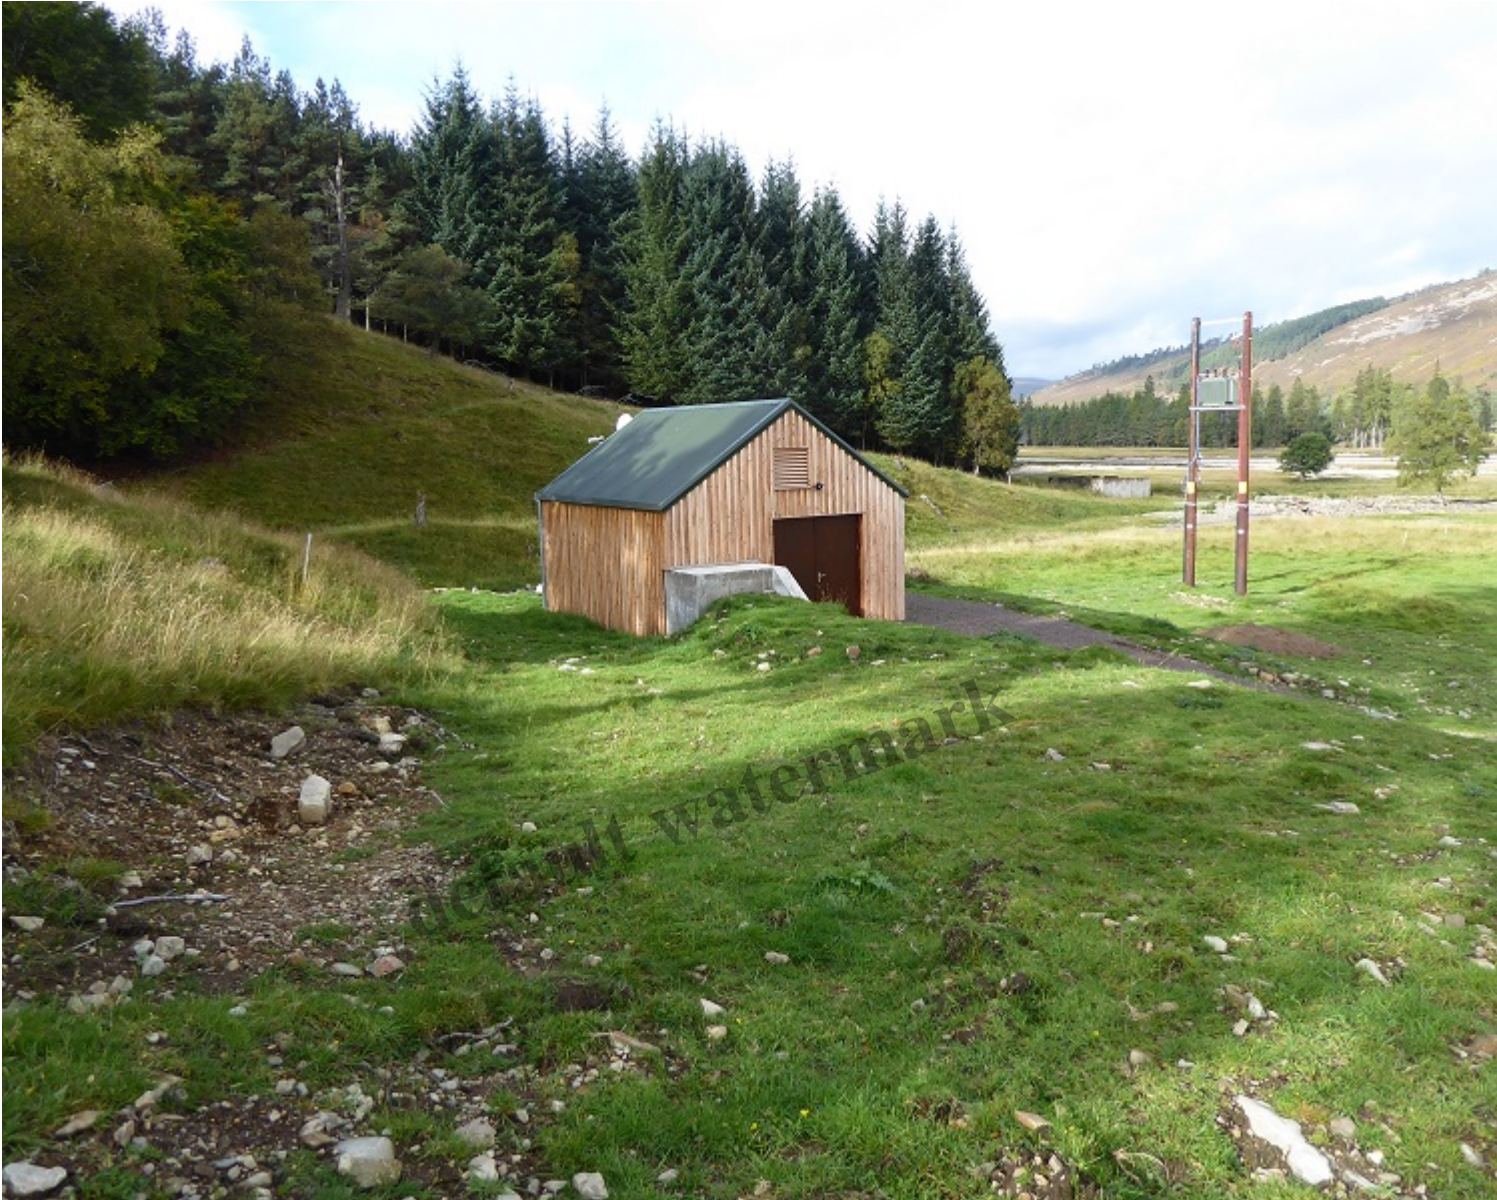
In design terms the power house is well located, close to bank and trees, and the turning area for vehicles is small. All positives. The ground above the pipeline had recovered quickly, with evidence of turfs having been stored and replaced. Incredible care needs to be taken with removal of turf and topsoil if all the surface area is to be re-covered in restoration and in this area there was not enough to use on the banks (bare patch left) though I suspect this has recovered by now.

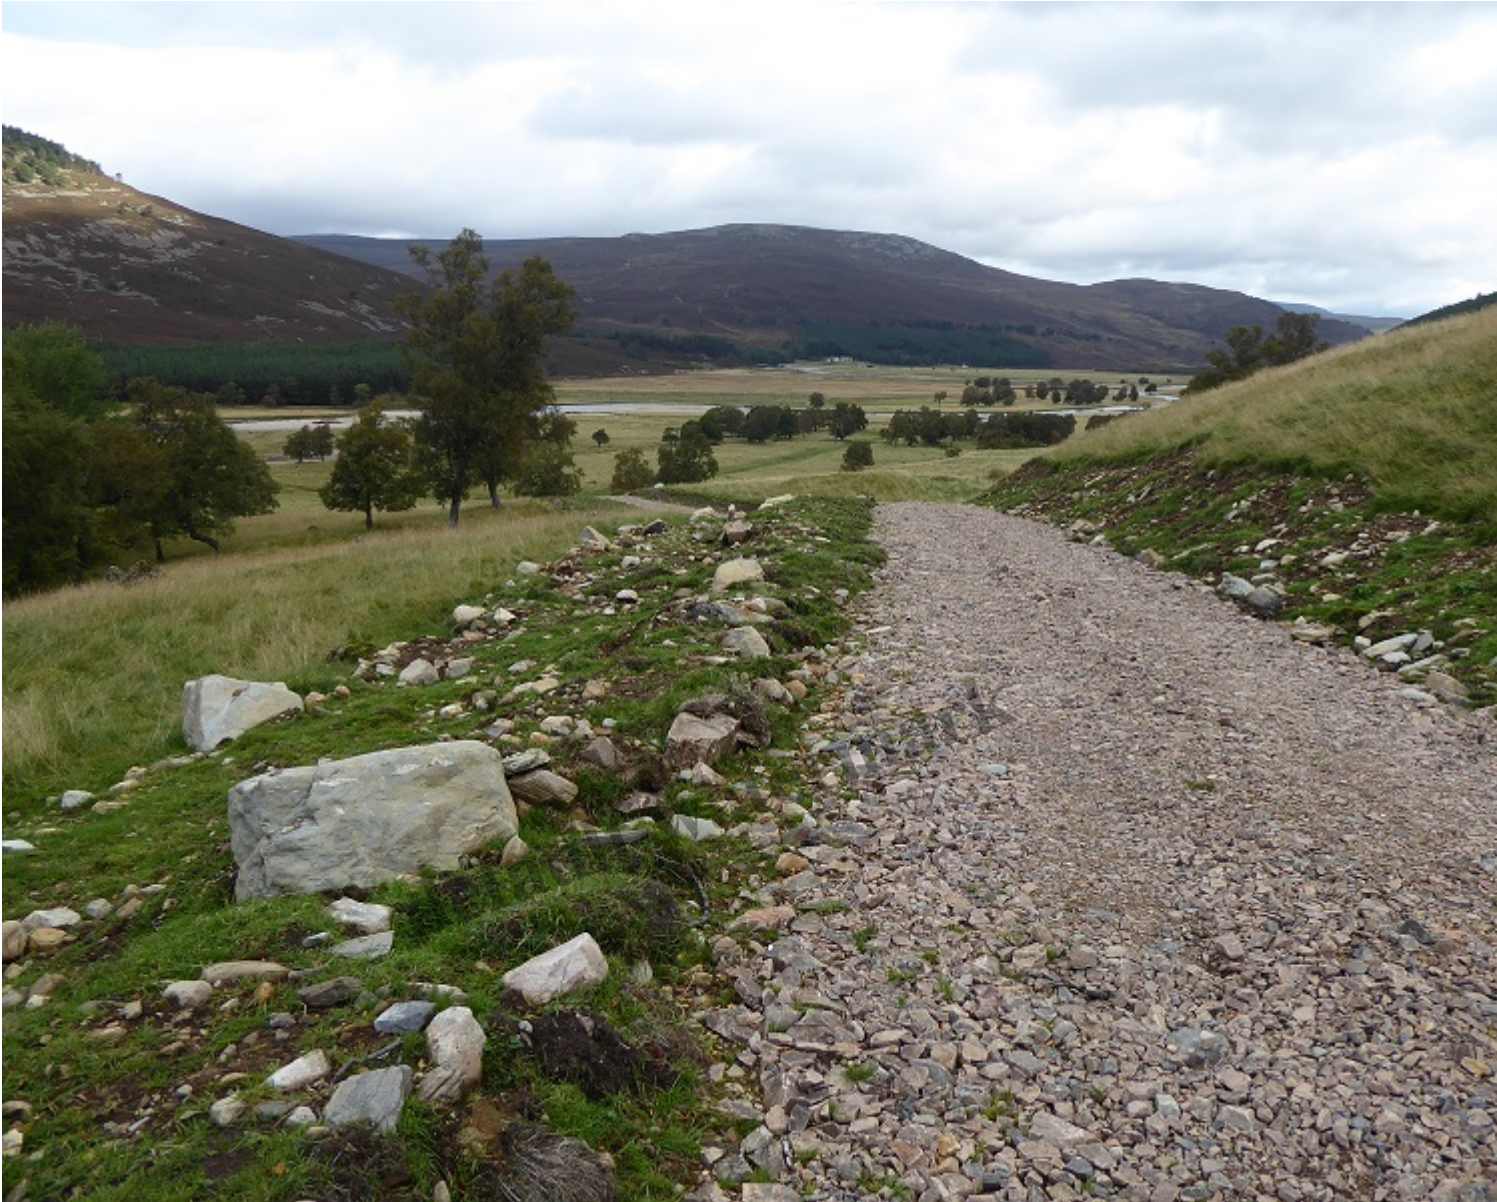
The track has been less well done, with large boulders left on the surface of what had previously been a grassy field. The bank on the right though is at a sufficiently low angle to recover quickly and a good example of track design.

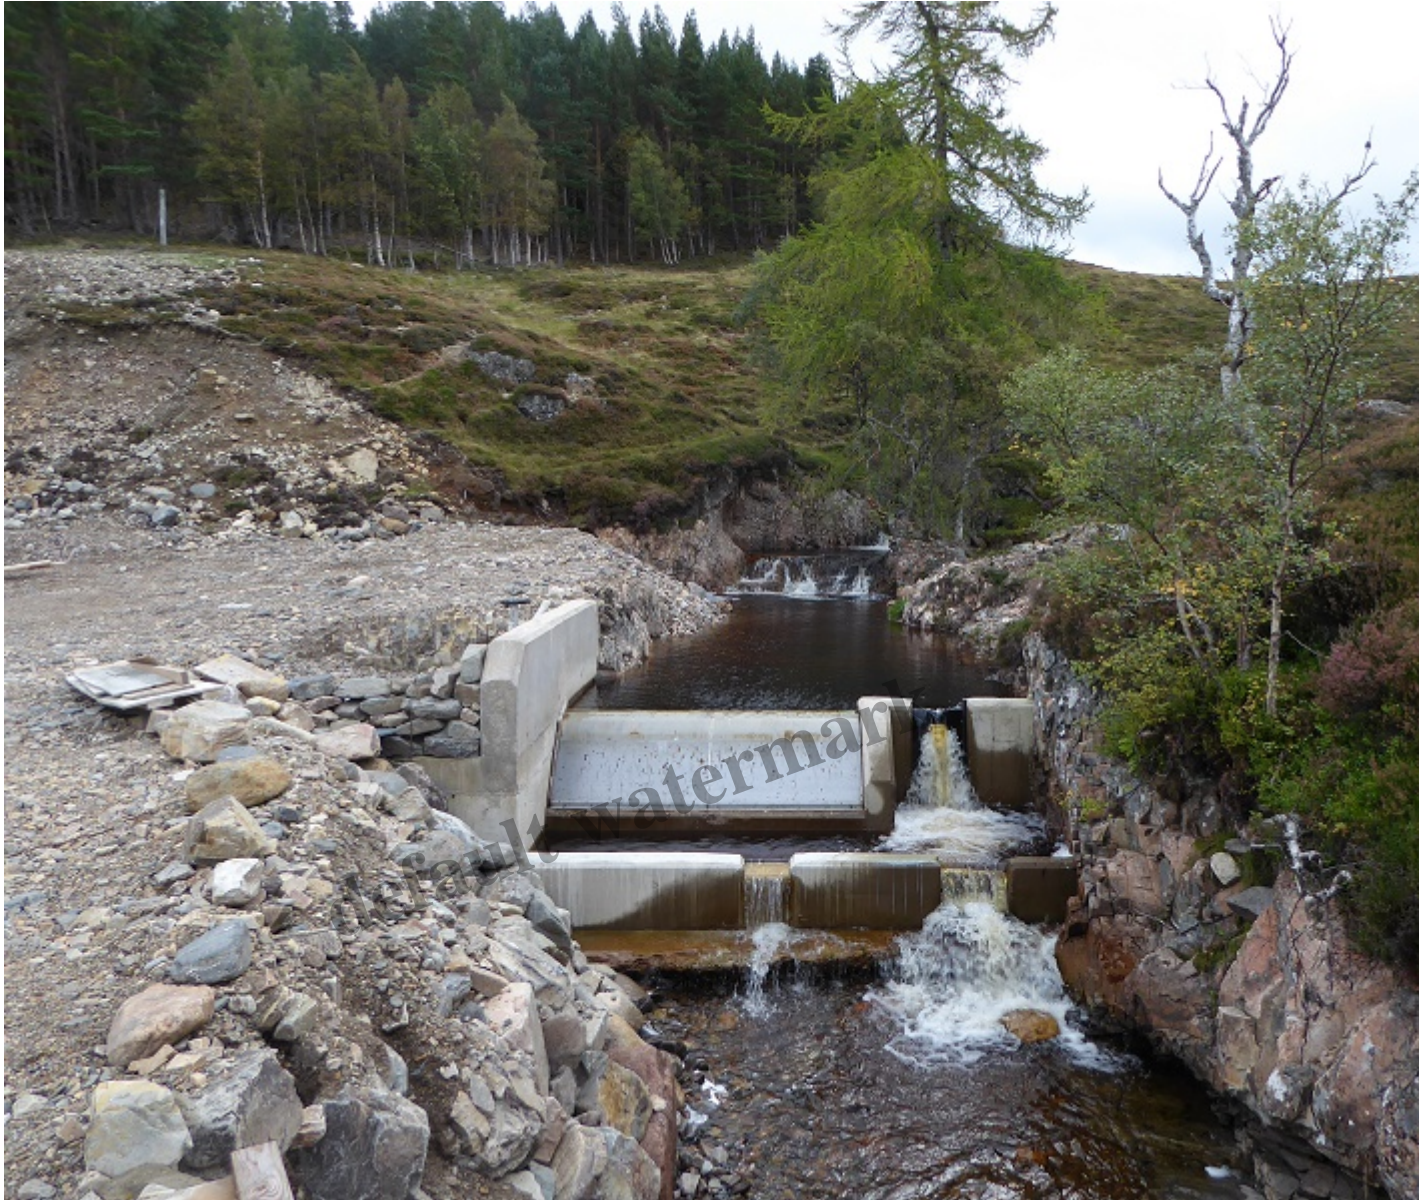
In order to build the dam the burn needed to be diverted through a channel created through the (true) above the intake. The intake as it appeared in September 2016.

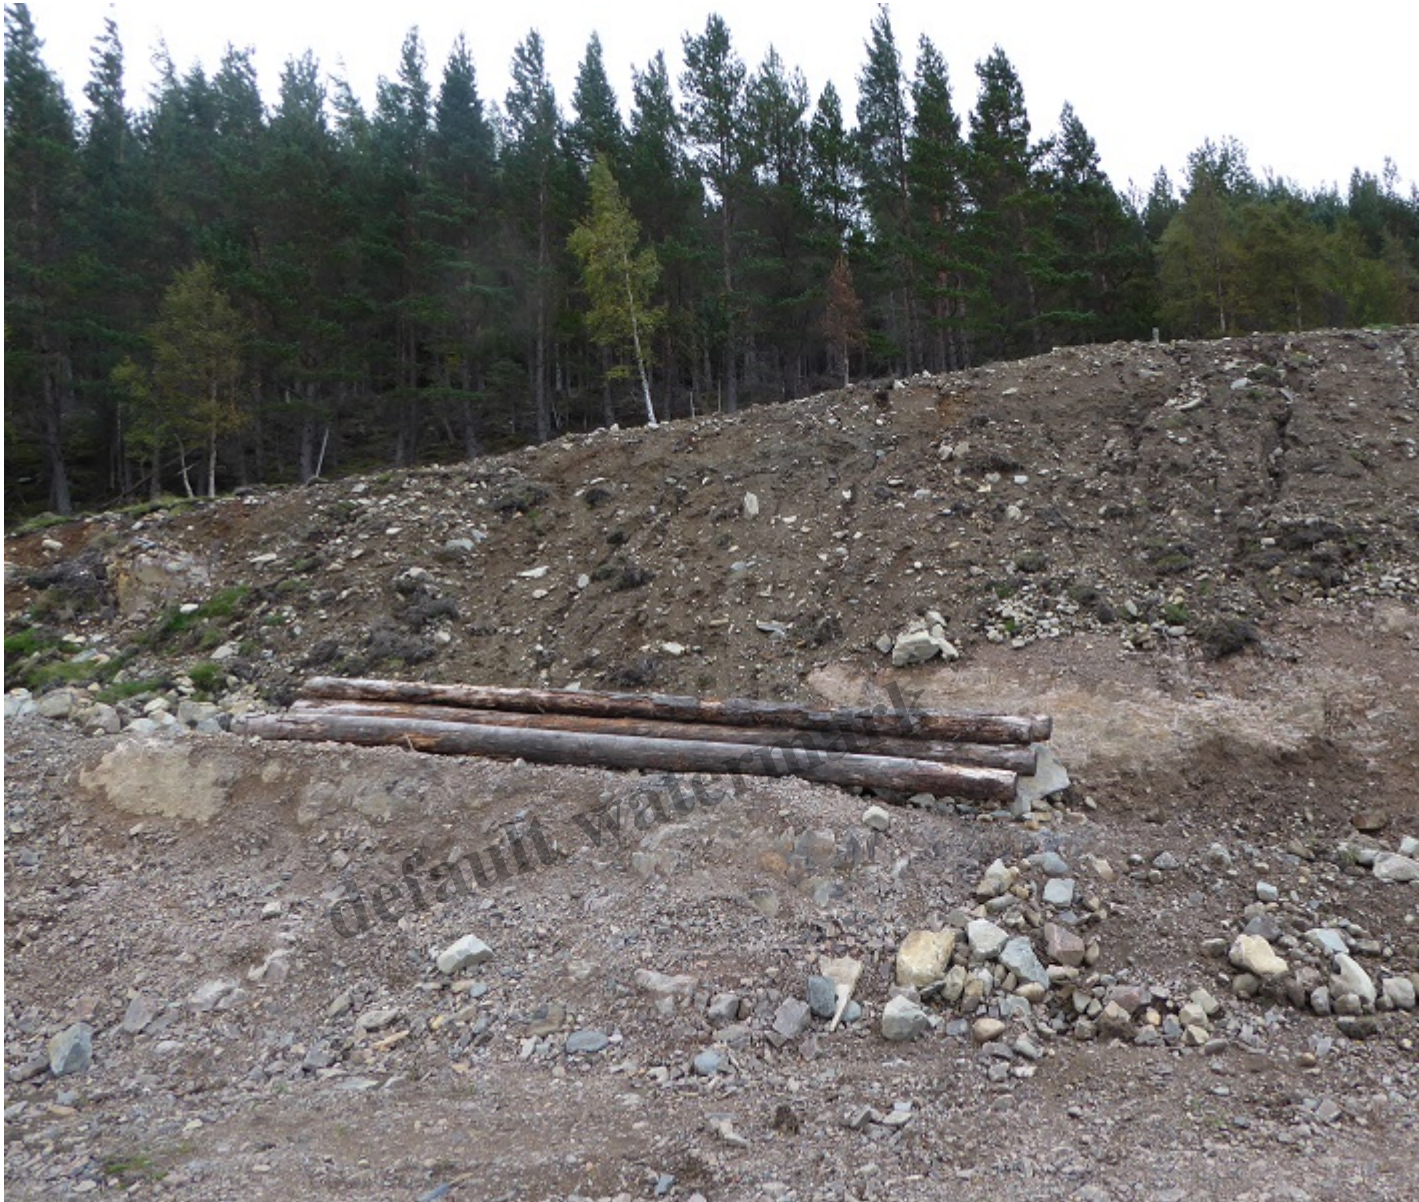
The bank as it appeared in September 2016

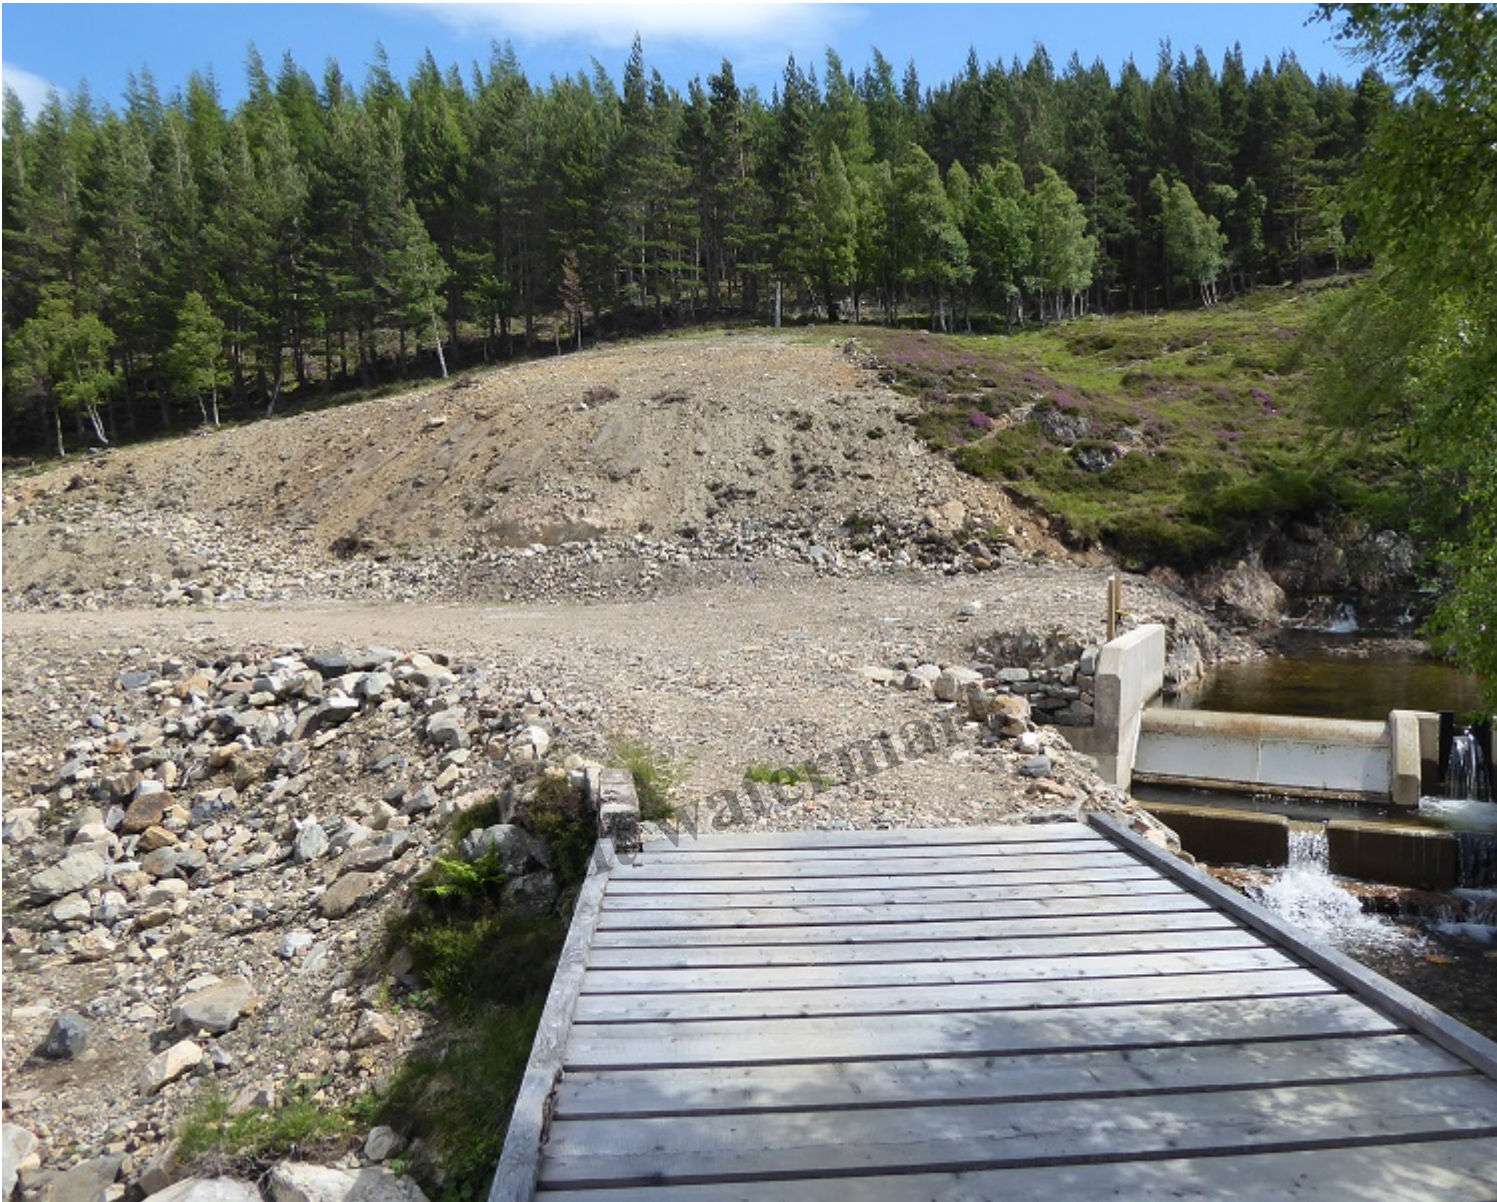
The fundamental issues here are:

- there has been no effective restoration of the bank along the burn;
- the bank on the hill was excavated and is far too steep to be restored;
- the track and turning area are far too wide.

While there had been obvious attempts at amelioration since September 2016 these have not in my view addressed the fundamental issues.

The focus of the CNPA and Braemar Community Hydro needs to be around addressing the landscape damage around the first intake. I think that to remedy the damage will require considerable expertise and require money. If the contractor cannot be made liable, it means the shareholders for the hydro, who were expecting a 5-8% return (there is interesting information on the finances on the community hydro website), Mar Estate which is charging rent (and was responsible for previous damage in the area) and the community may have to wait for their return. It seems to people that all the people who were going to gain from this development have a collective responsibility to ensure that this is not at the expense of the landscape. Success would then be being able to promote this as being a nice place to go for a walk again – a “small gem” in the National Park – as it was in the past.

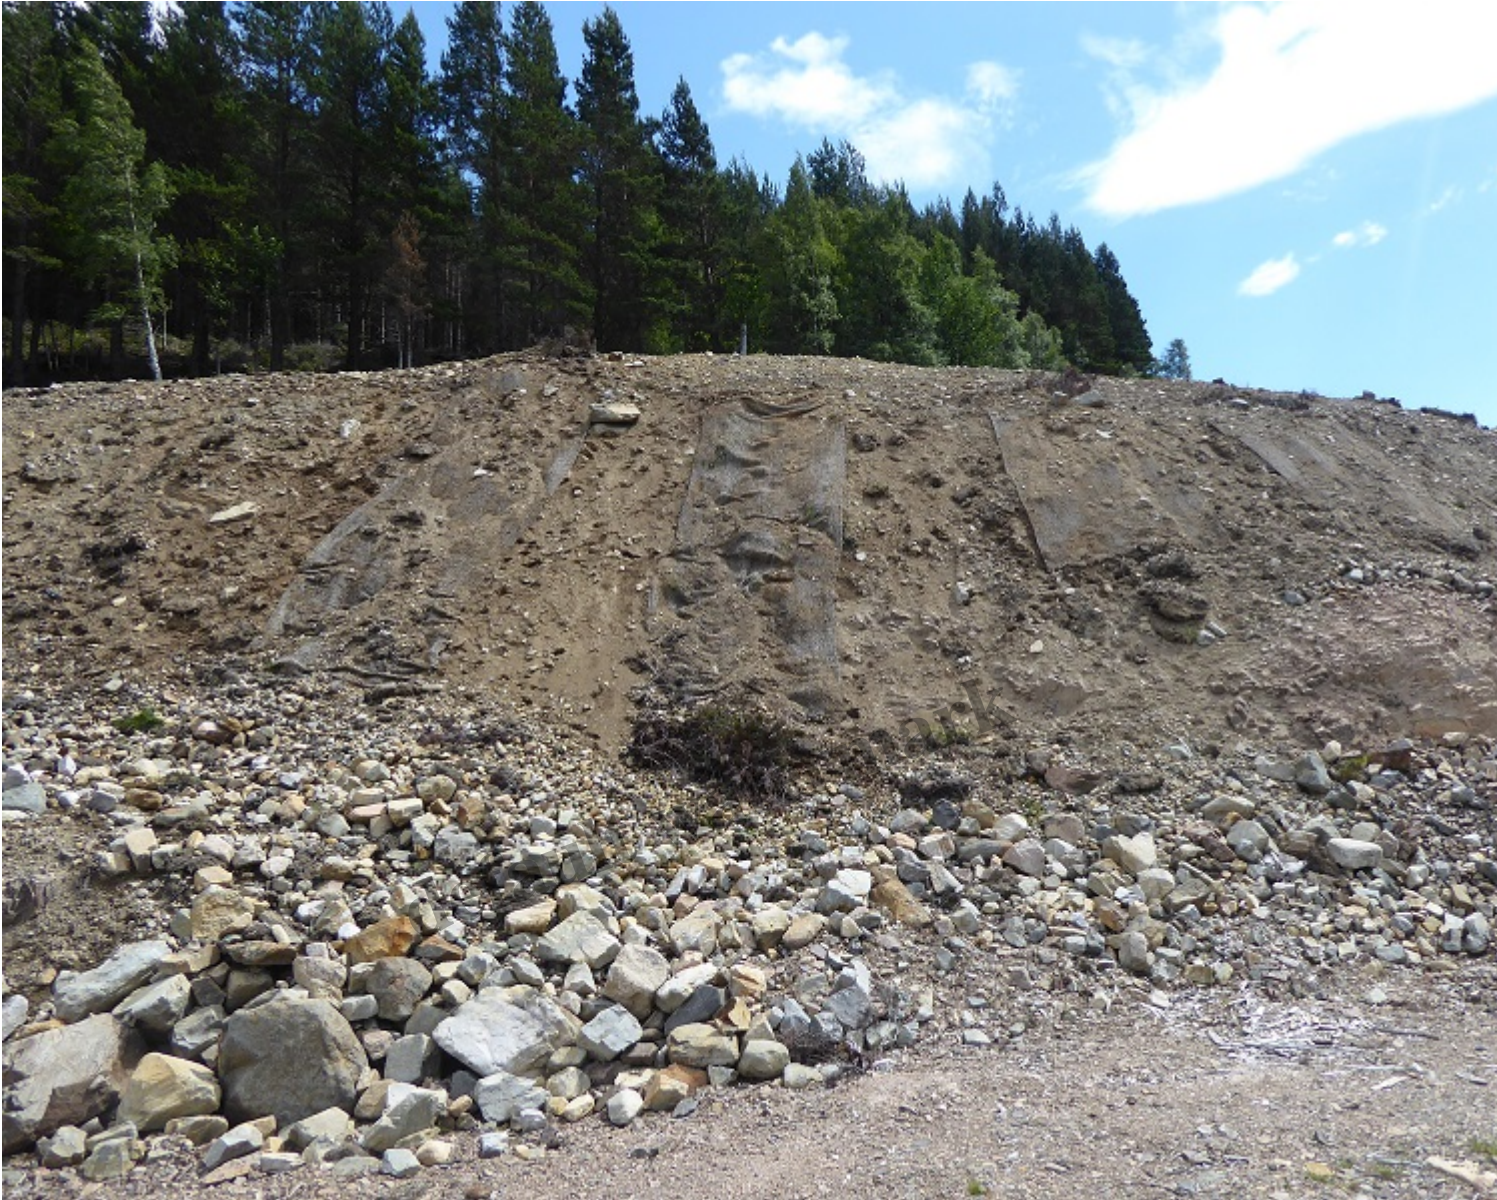
Four strips of fabric had been applied to the oversteep bank to reduce erosion but this has had no impact. There is no sign of vegetation re-establishing itself and the problems have been increased by deer (you can see hoof marks between 2nd and 3rd strips) walking down the slope.

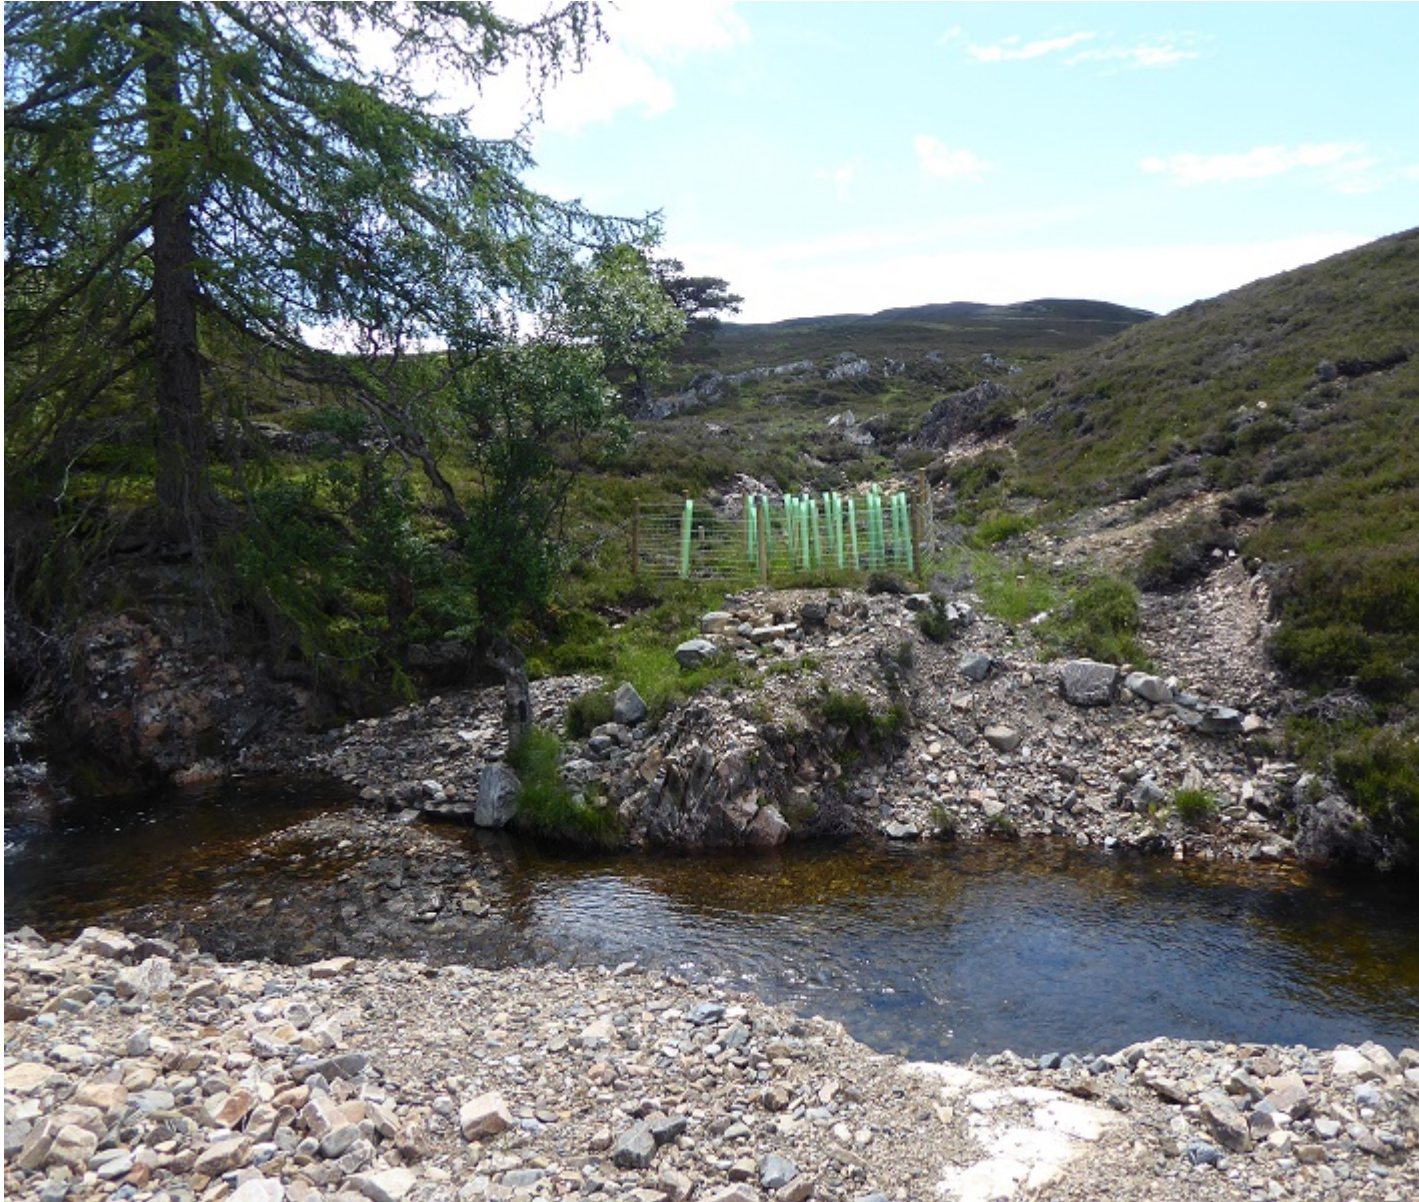
View across burn above intake

There has been “compensatory” tree planting but no attempt to restore vegetation to the bank of the burn. This should have been done months ago at the beginning of the growing season.

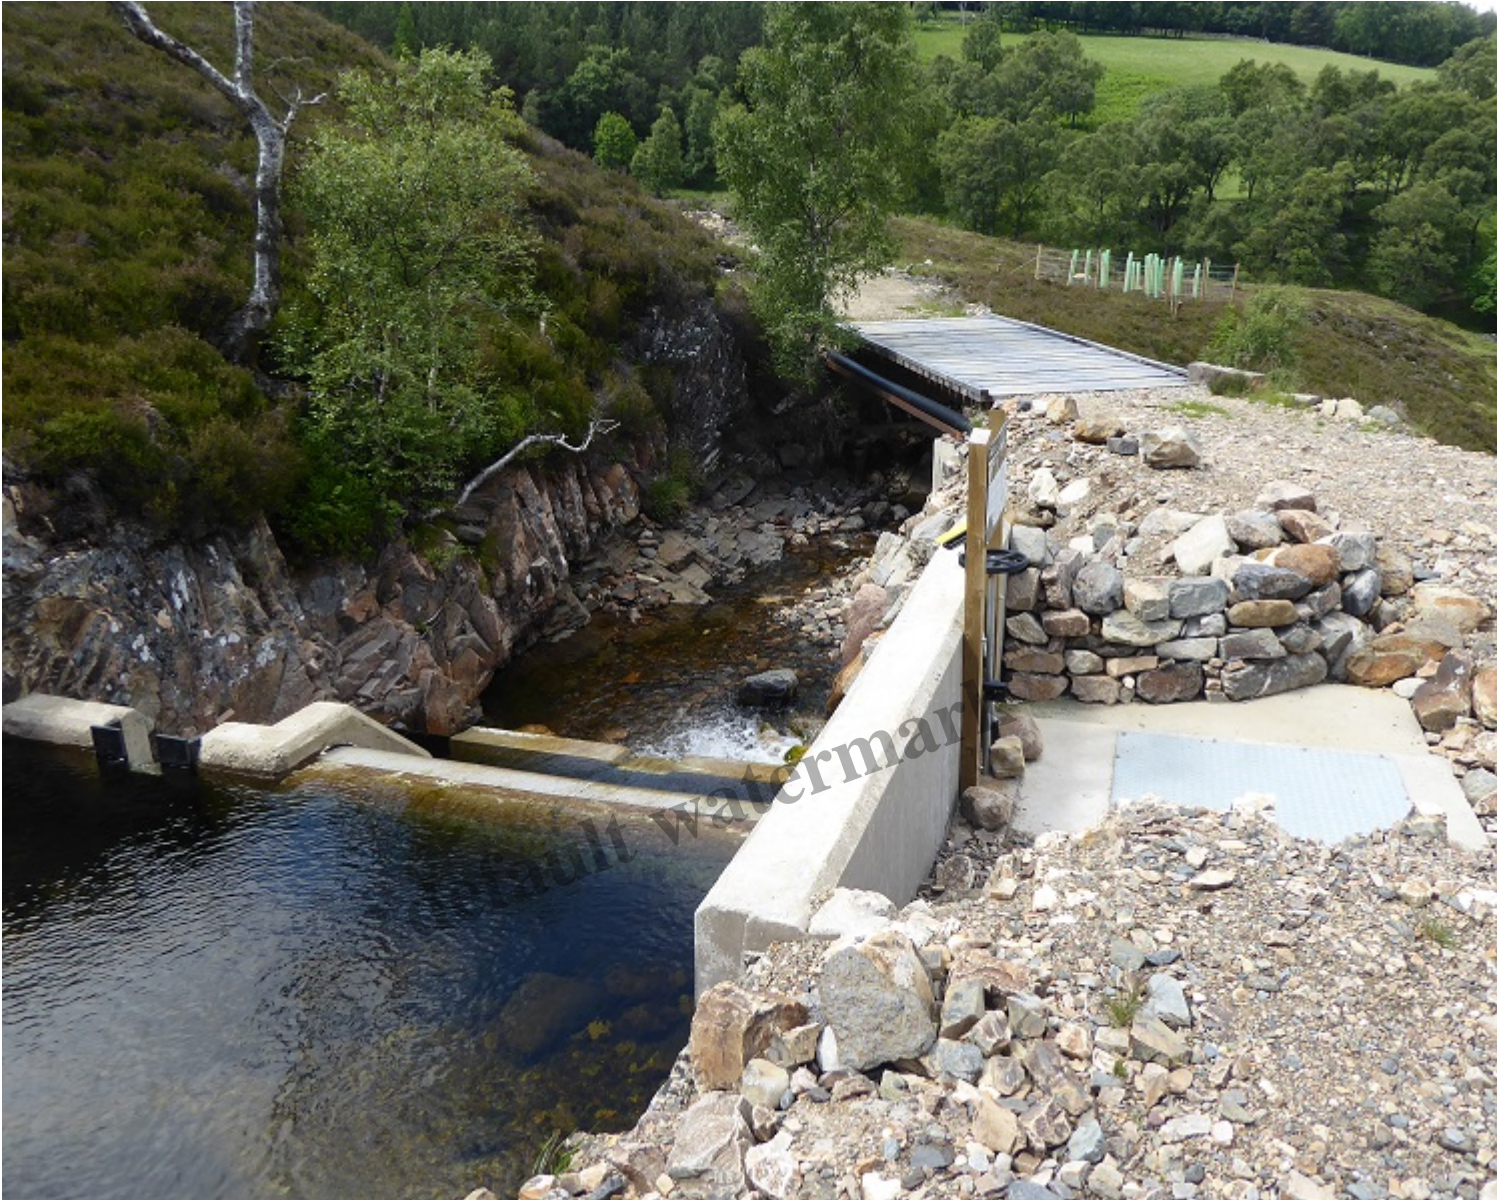
Despite the atrocious finishing along the bank and track, this photos shows some good things about the scheme. You can just see the pipe from the second hydro running below the bridge – you won't see it unless you look out for it – and the CNPA told the developer there was no need to erect fencing around the intake. I agree. All that good design though counts for little if the destruction round about is not addressed.

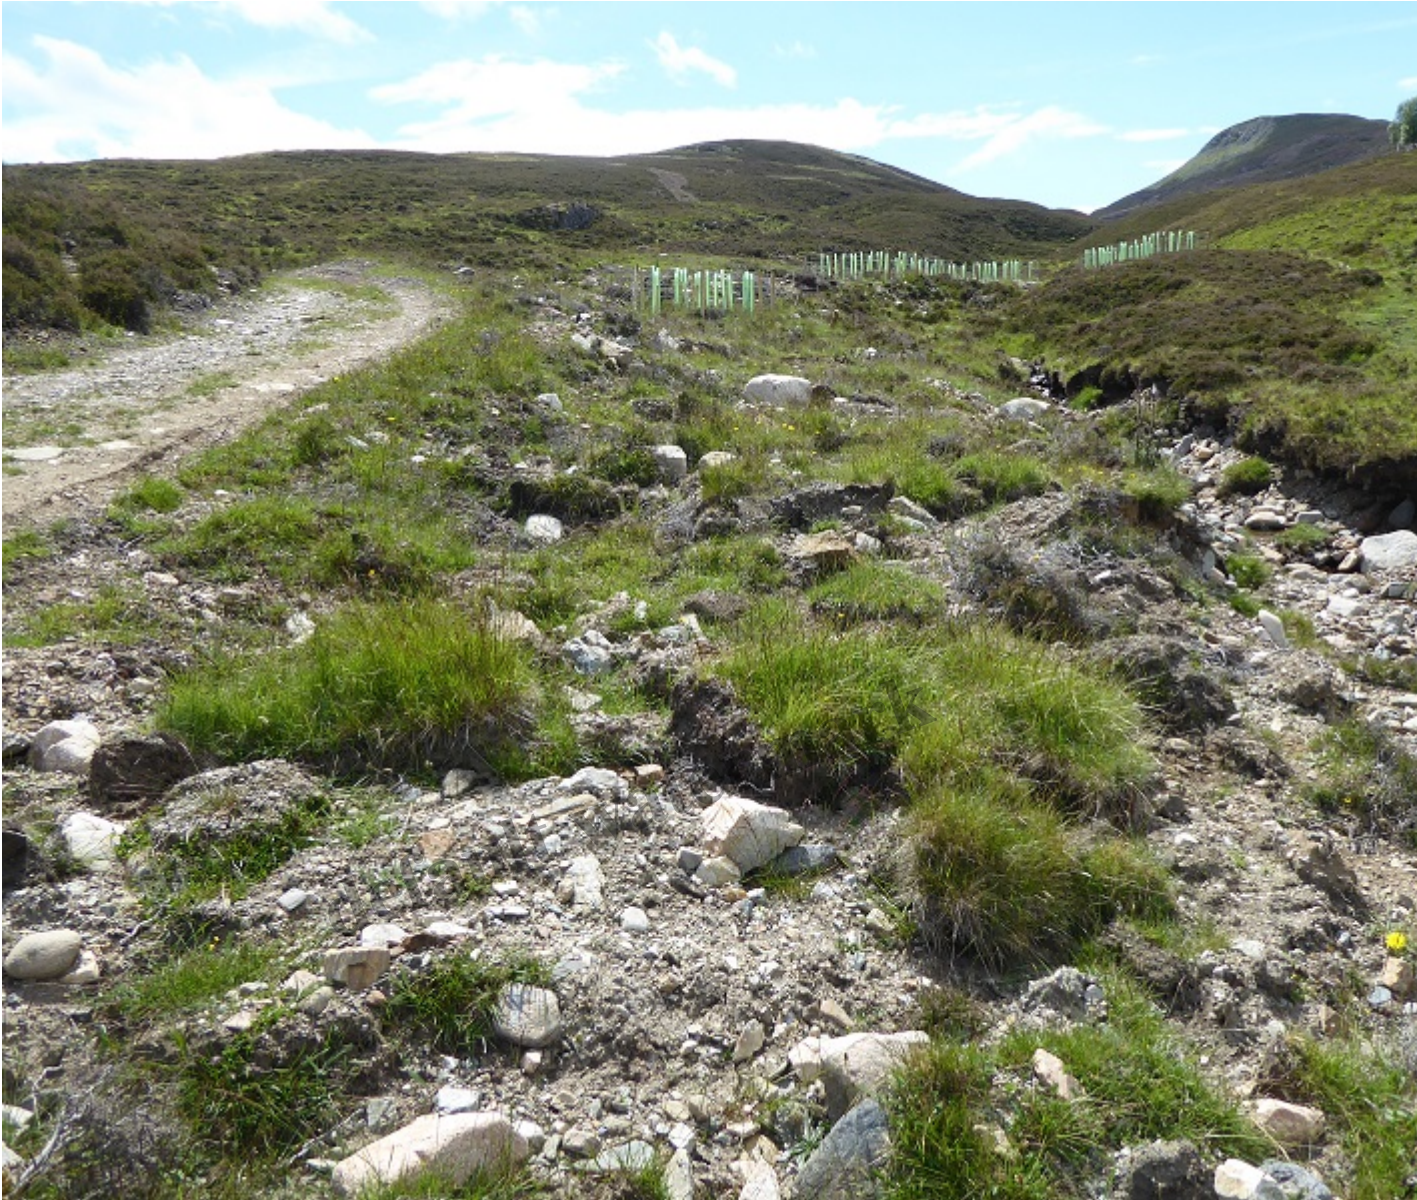
The ground above the pipeline to the second intake has not been restored well and will, as a result, take a longer time to recover than it should have with increased erosion.

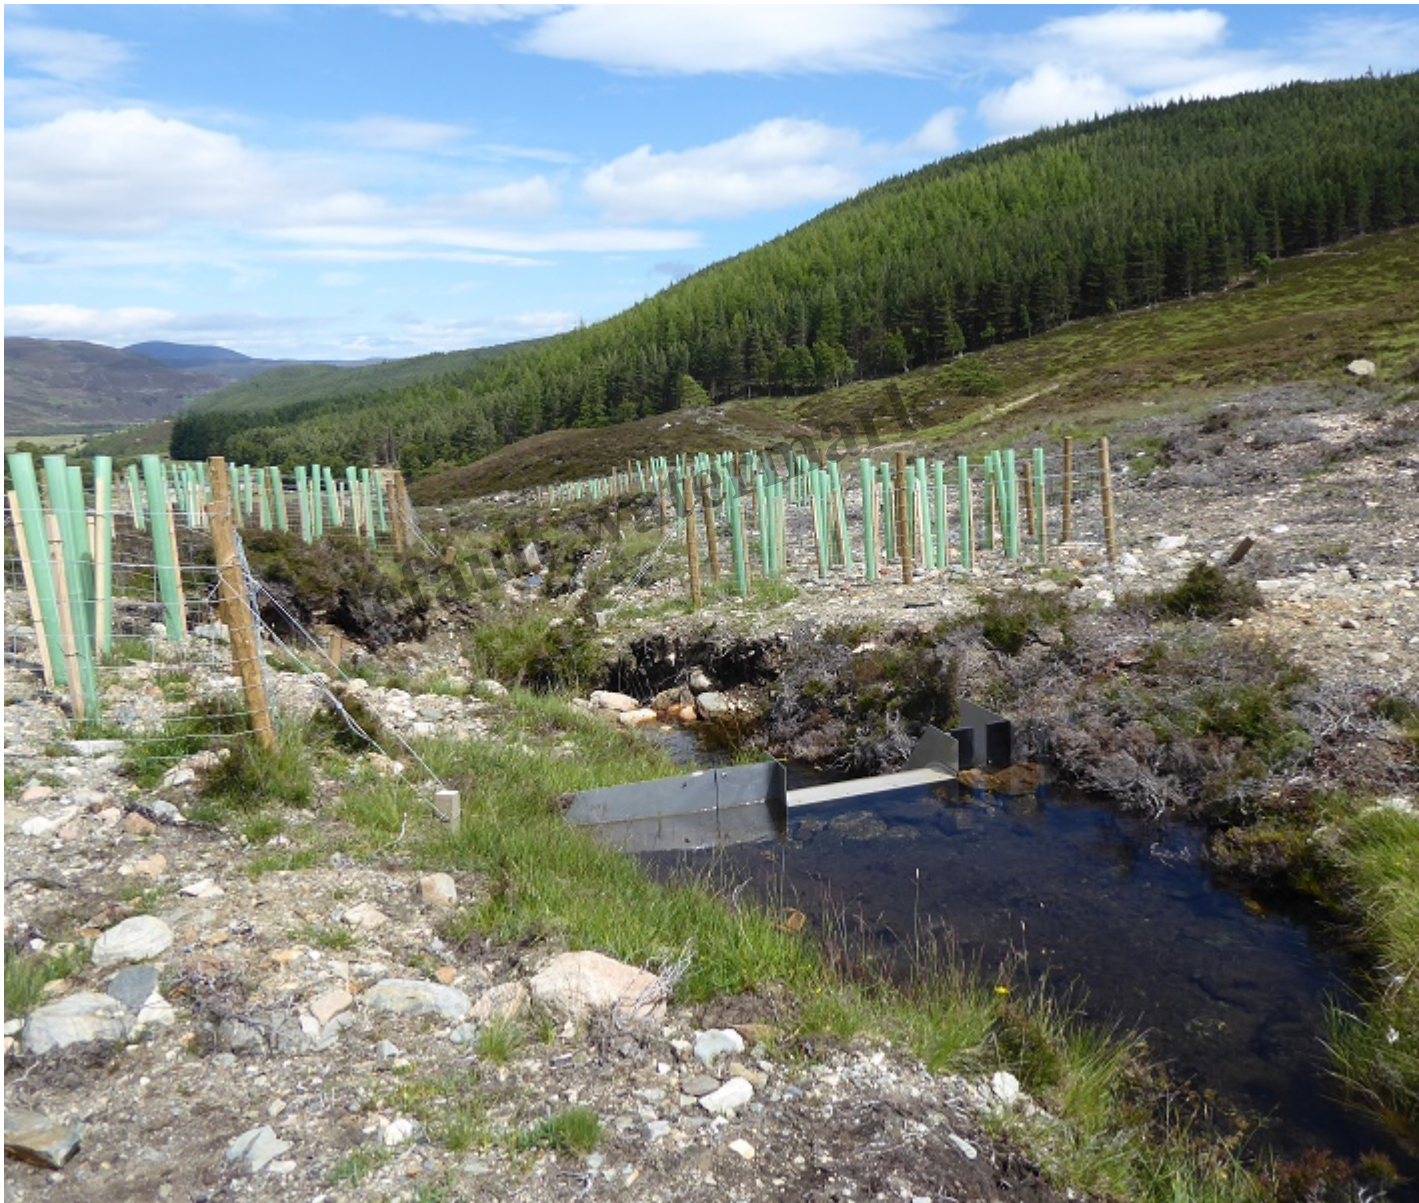
The small second intake, the pipe runs to the right of the blocks of trees which have been planted.

Lots of tree planting should not be seen as compensation for poor ground restoration work.
