The Corriemulzie community hydro scheme

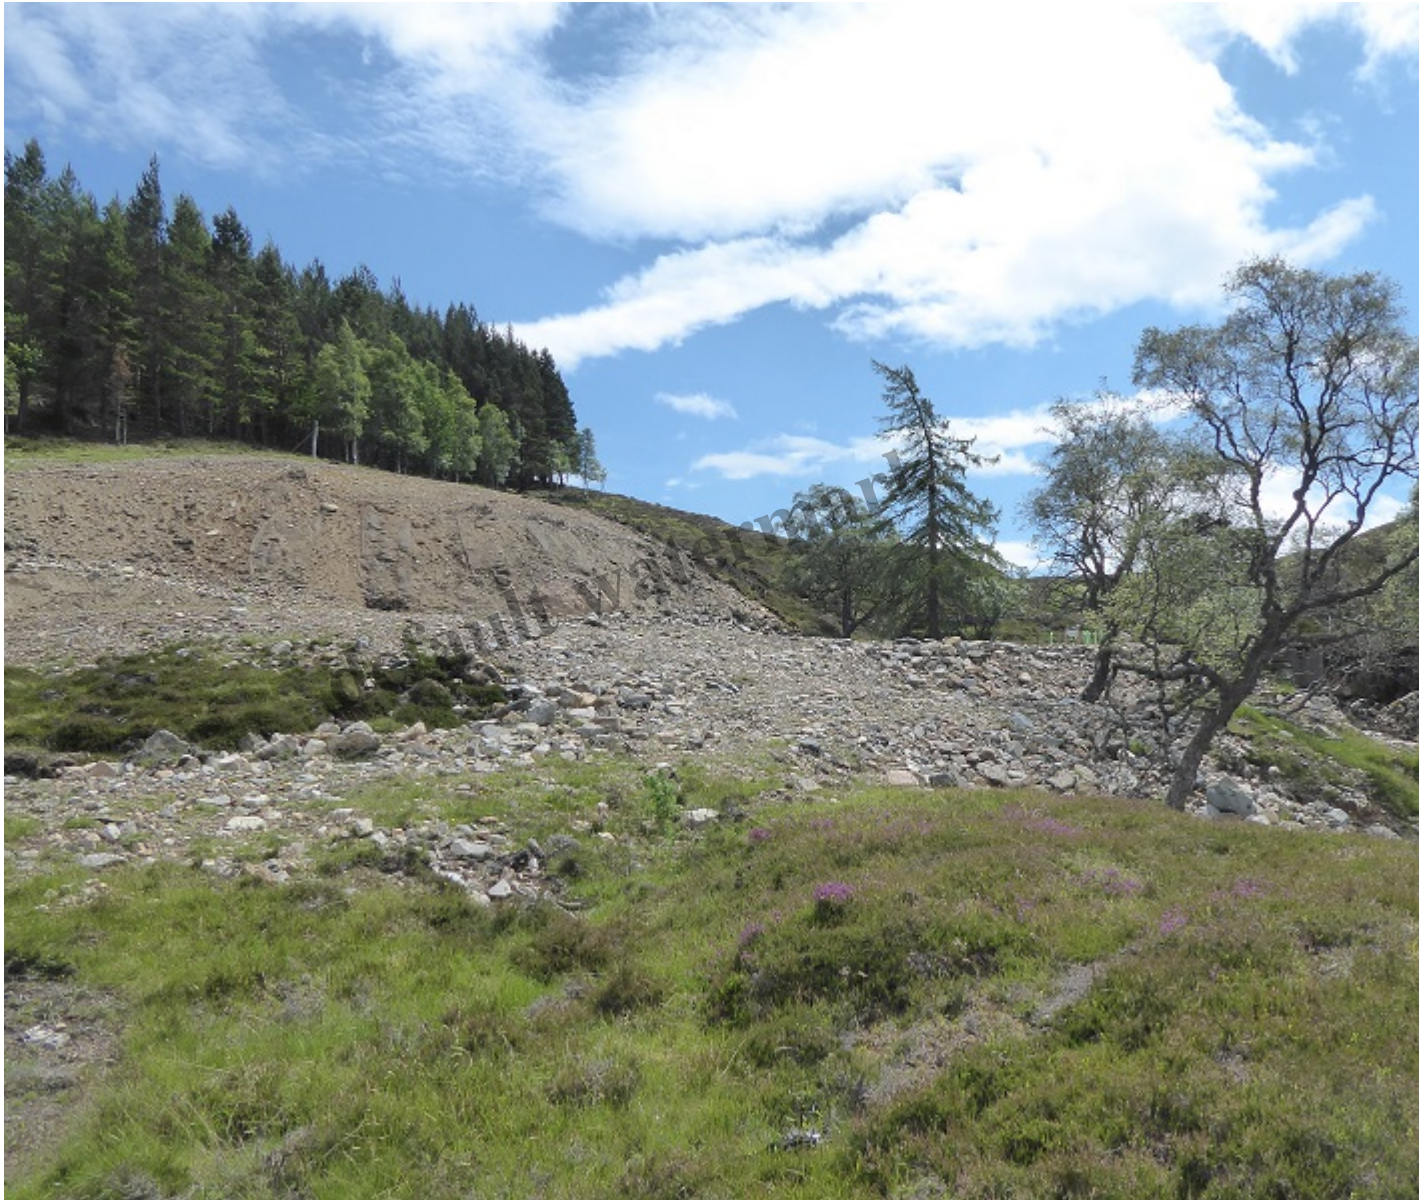
Destruction around the Corrimulzie intake. On first viewing this, I had assumed all the destruction had been caused by the construction of the hydro intake but the rocks in foreground, which partly envelope the two birch trees, were deposited by flood water during Storm Frank which devastated Deeside.

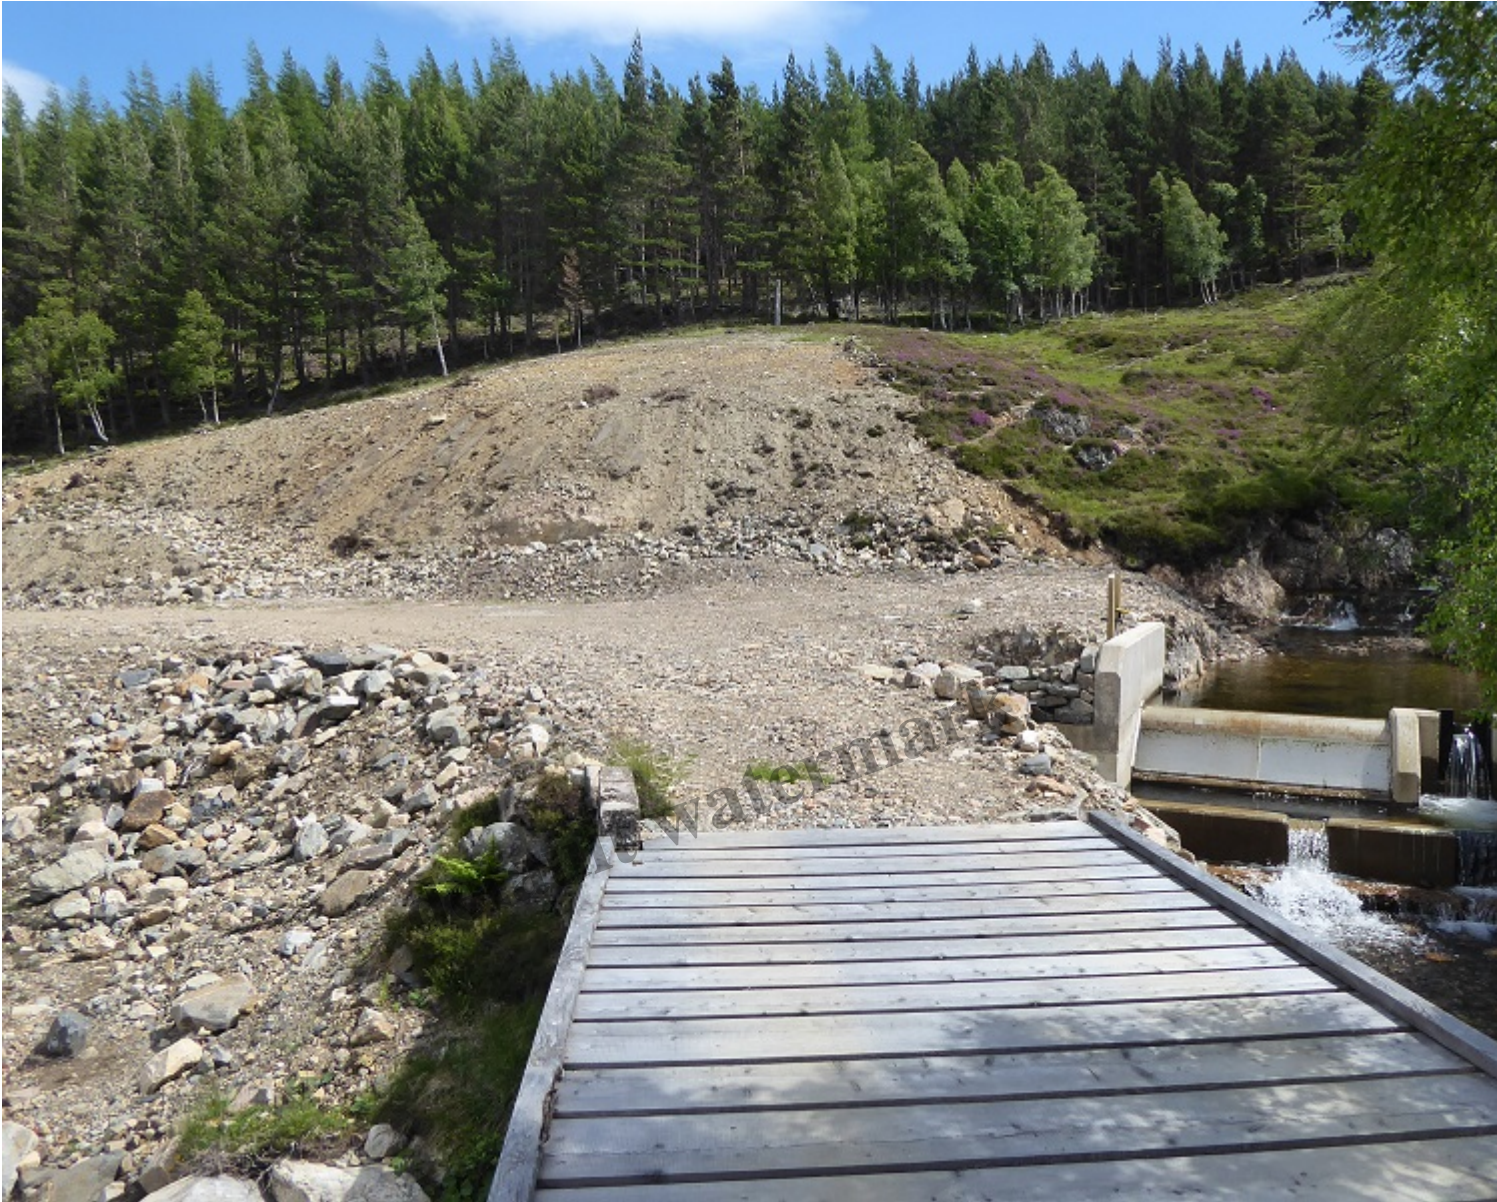
The fundamental issues here are:

- there has been no effective restoration of the bank along the burn;
- the bank on the hill was excavated and is far too steep to be restored;
- the track and turning area are far too wide.

While there had been obvious attempts at amelioration since September 2016 these have not in my view addressed the fundamental issues.

The focus of the CNPA and Braemar Community Hydro needs to be around addressing the landscape damage around the first intake. I think that to remedy the damage will require considerable expertise and require money. If the contractor cannot be made liable, it means the shareholders for the hydro, who were expecting a 5-8% return (there is interesting information on the finances on the community hydro website), Mar Estate which is charging rent (and was responsible for previous damage in the area) and the community may have to wait for their return. It seems to people that all the people who were going to gain from this development have a collective responsibility to ensure that this is not at the expense of the landscape. Success would then be being able to promote this as being a nice place to go for a walk again – a “small gem” in the National Park – as it was in the past.

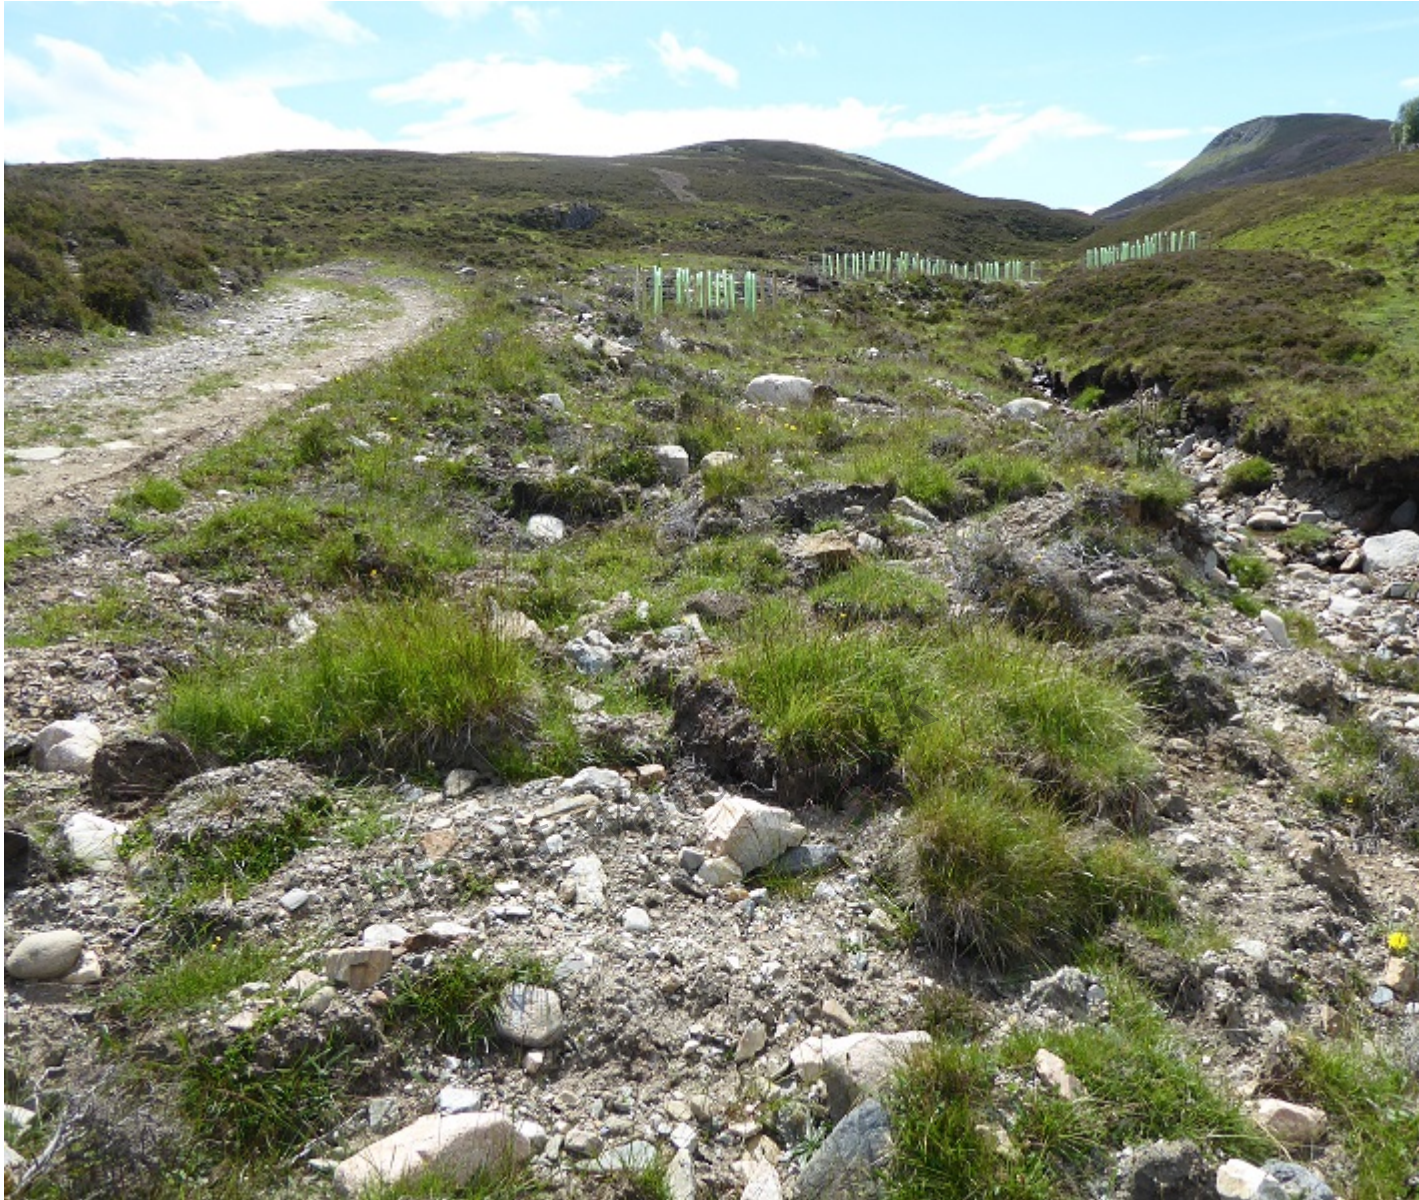
The ground above the pipeline to the second intake has not been restored well and will, as a result, take a longer time to recover than it should have with increased erosion.
