Public Opinion seems to be the only recourse to getting action from LLTNP

Our ref: snpa17/041 16/07/17

Complaint regarding handling of the camping development at Loch Chon

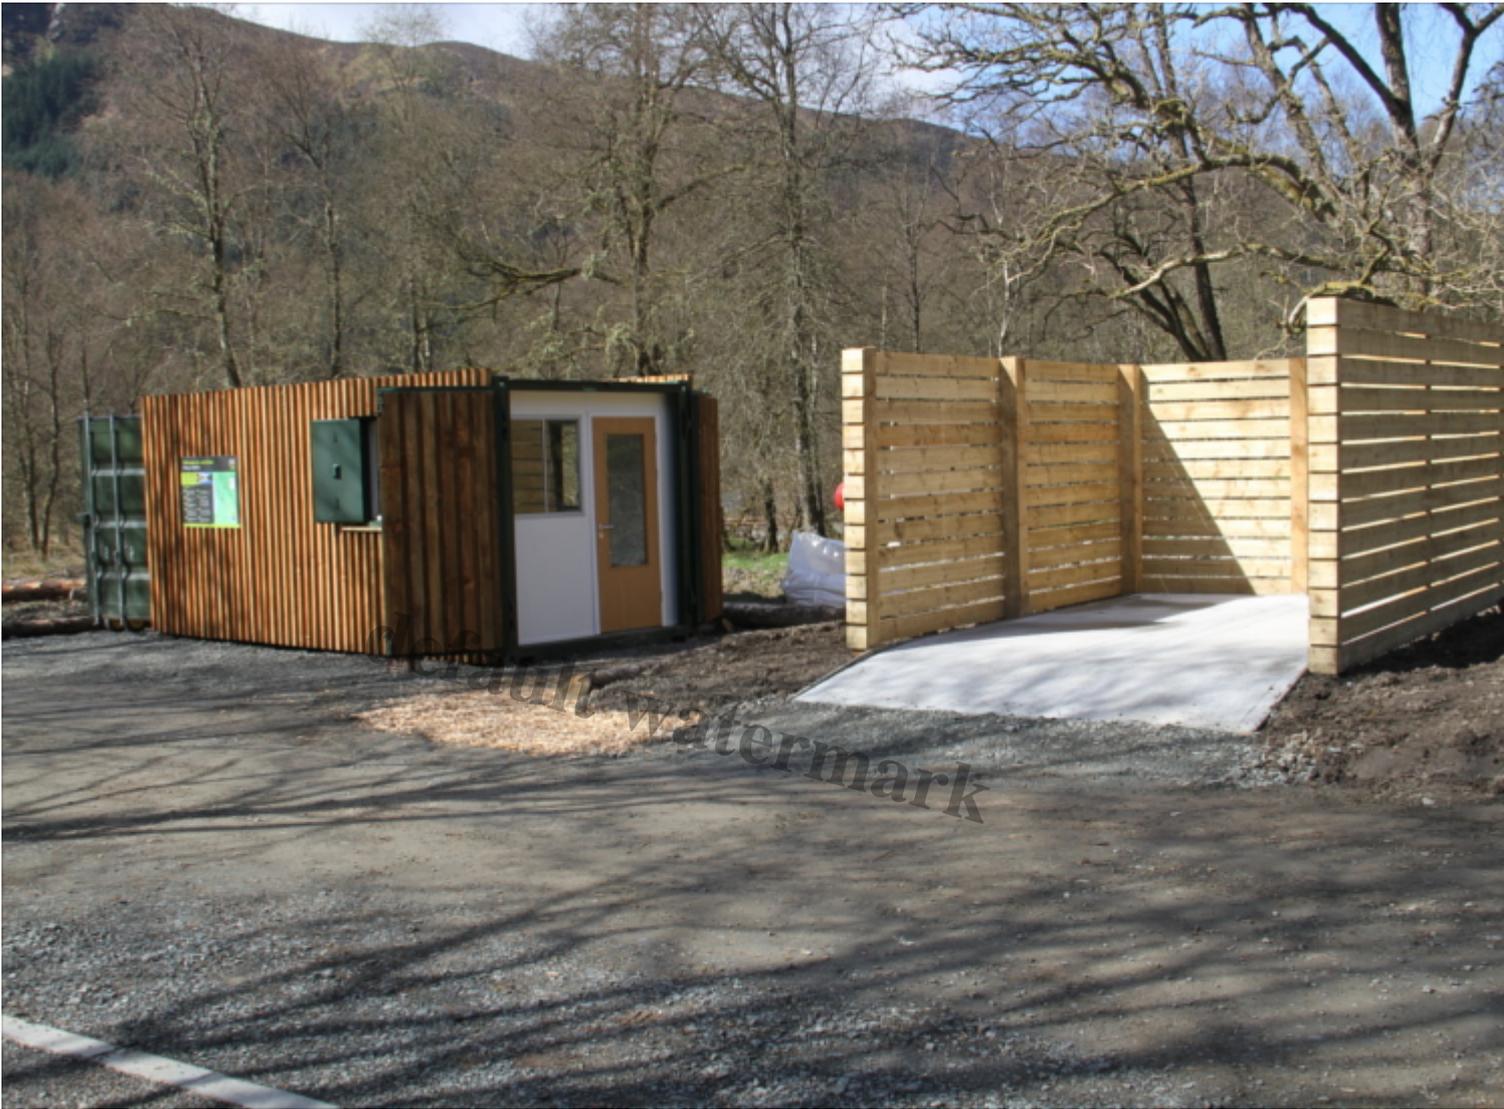
1. The bin store sited at the RHS the Ranger Base and Store does not appear on any of the plans for the site and is therefore a breach of planning consent. In addition as it is such a large structure it should not be considered an Non Material Variation as it has a major impact on the efficacy of the site and itâ??s rural and natural aspect. It seems almost inconceivable that the final purpose of this structure is a bin store and it appears to the casual onlooker that the National Park authority intends to re-task this structure for another purpose. It should therefore be removed and an investigation into itâ??s erection should commence as a matter of public concern.

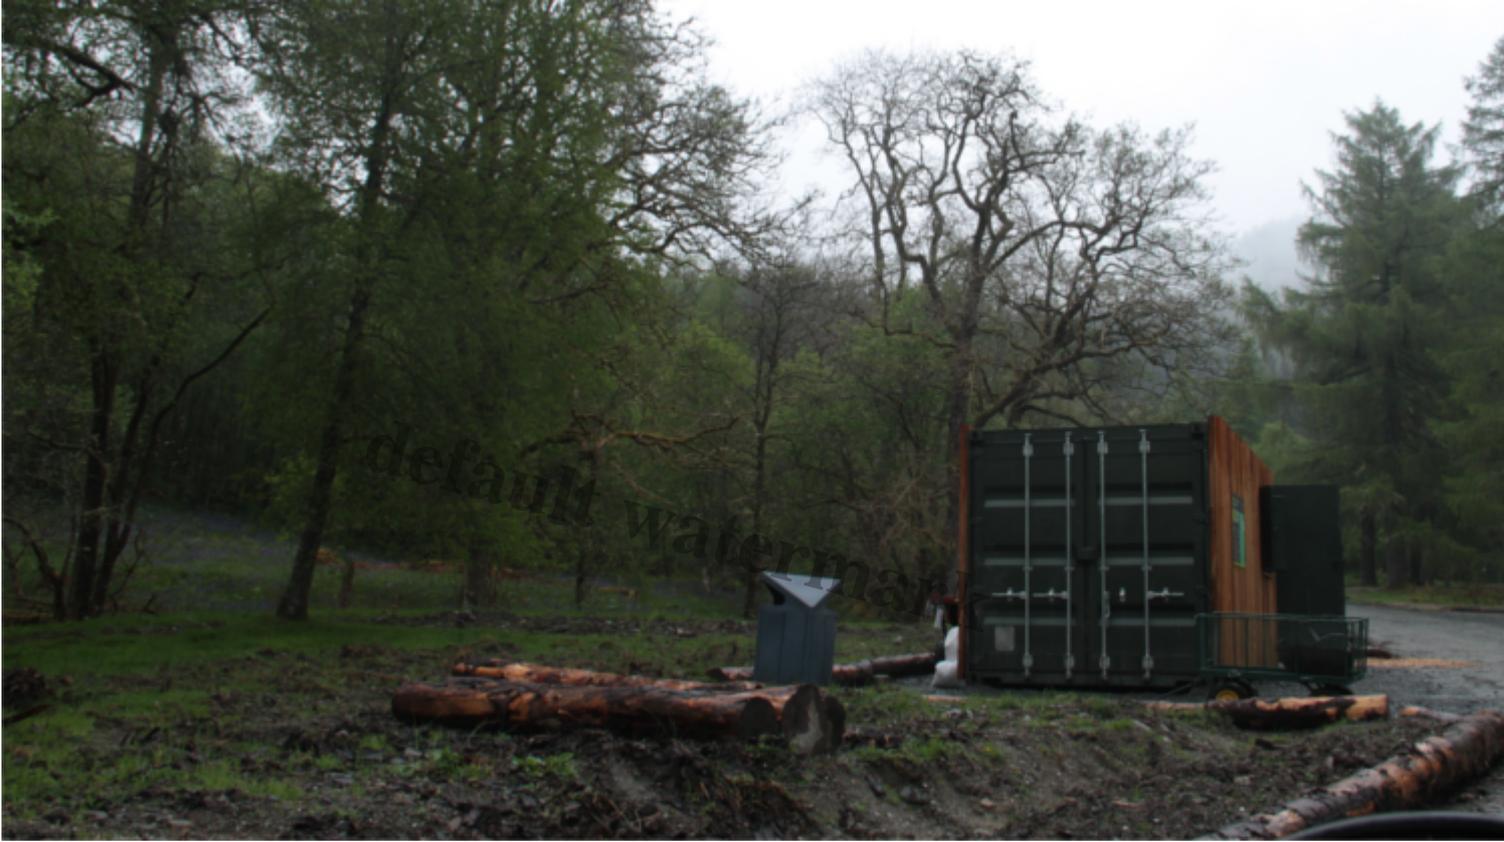
2. The containers used for the Rangers Base and the water purification plant do not correspond with the engineering drawings in respect to the size and finish to the end elevations shown in your documentation.

In both instances the doors fitted are taller than those specified which in turn has prevented fitting a wooden facing above them as specified.

In the case of the Ranger Base Store end the door fitted is larger and of a different design with locking bars on the surface which are totally unsuitable as a solution in this sensitive site.

The wood cladding to the exterior of the containers do not conform to the engineering drawings, the posts and concrete ground supports have not been fitted with the cladding being applied to the container surface directly, this contravenes the design specification and the resultant aspect is an industrial container which has no place in this sensitive area.

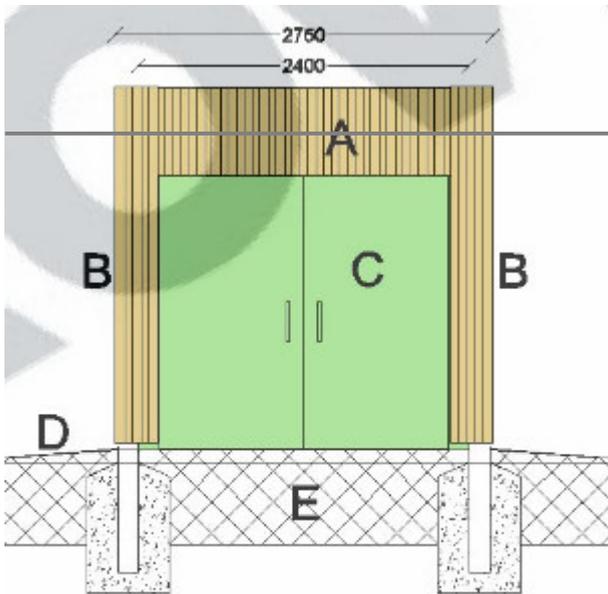
STORE ROOM / RANGER BASE
END ELEVATION 1:50

3. The wood cladding to the exterior of the containers does not conform to the engineering drawings, the posts and concrete ground supports have not been fitted and th

e cladding has instead be applied to the container surface,

this contravenes the design specification and the resultant aspect is an industrial container which has no place in this sensitive area.

The permanent nature that was presented in the original drawings and at the planning consultation meeting have been subverted by removing the concrete embedded posts which suggests the Park Authority as the applicant again have intentionally deceived the planning authority and have an intention to move, remove or in some way alter these structures and have pre-empted that requirement by violating the terms of the planning consent.

This requires investigation. If it is the intention to remove these structures from their position on site and deny access to the public out-with the management season this should have been made clear on the application, in any case the reason for this variation should be established.

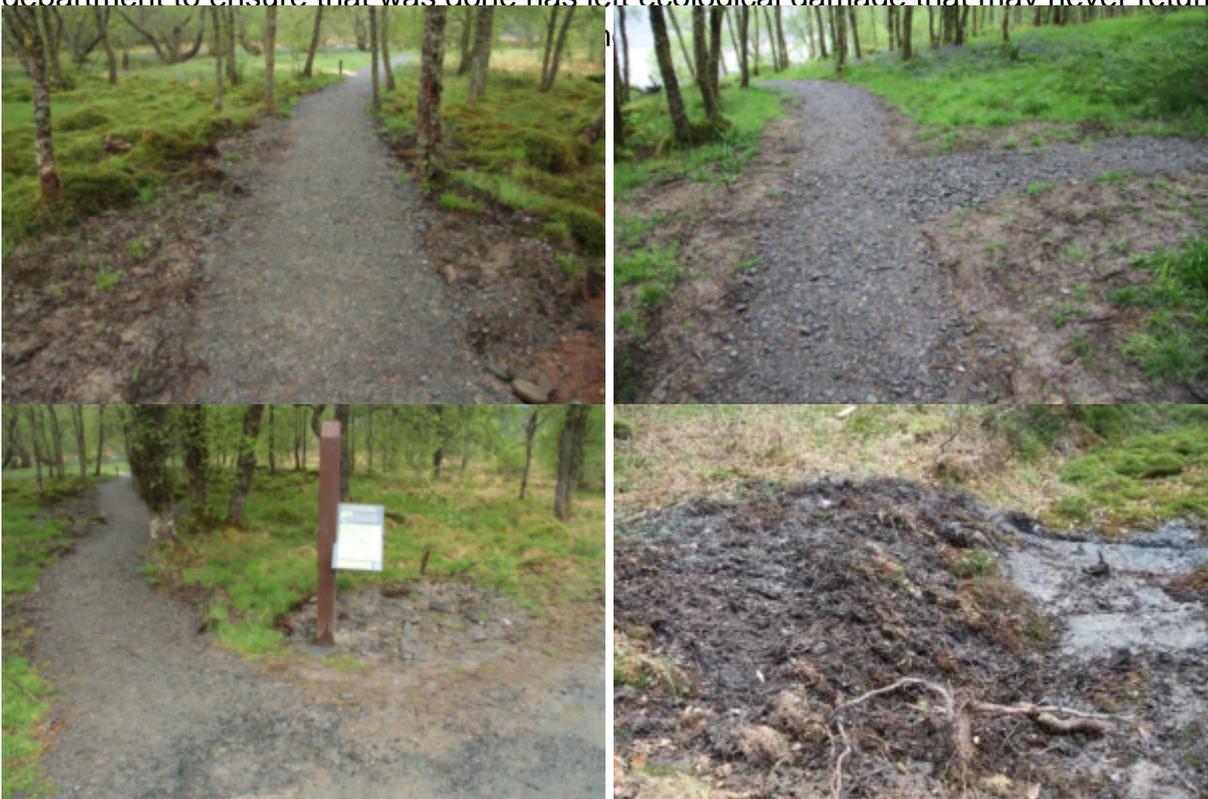
On the Path leading to pitch one, there has been no attempt to clear away the hardcore contamination of the surrounding vegetation and no seeding has taken place. No restoration of vegetation along many areas of path and the 4th image shows a failed attempt to remove a hardcore pile dumped on [redacted] using machines for removal have made matters worse.

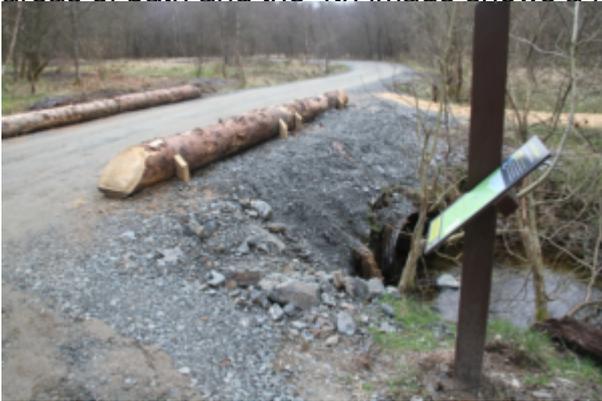
Bridge

The bridge solution is a mess. Hardcore is falling into the stream through very poor containment. The expansion of the path at the junction to an unacceptable width with hardcore marring the natural ground and vegetation cover without attempted restoration. The protruding pipe of the culvert should have a natural stone surround wall in a development such as this. The solution provided is not suitable for a flagship development in a National Park where even a pub in Tyndrum can provide a stone faced wall to a piped culvert.

The nature of this slope down to the river is an unnecessary hazard, it would be far better with a retaining wall and a vertical drop to the river where danger is apparent, this solution it invites children to [redacted] and once a slip begins the outcome is inevitable.

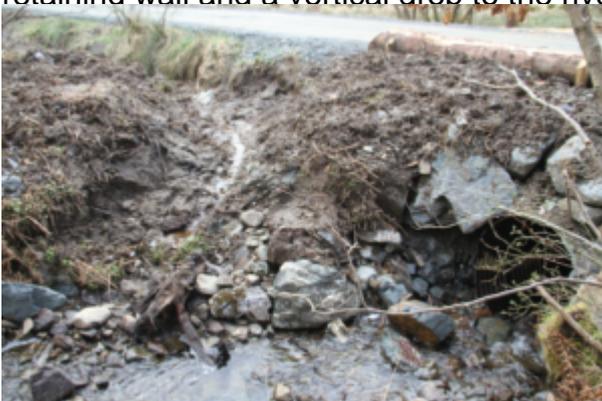
Attempts at restoring vegetation over this hardcore has been

made since this image was taken it is a piecemeal approach and as can be seen from the other side, where no attempt has been made to grade in the edges of the road and vegetation as required and no seeding.

The other side of the bridge has similar issues with attempted soil and vegetation replacement, how successful this will be, depends on the on going availability of water to the root system which may be an issue in dry weather. Monitoring of this area should continue to ensure the applicant provides a suitable long term solution should this restoration attempt fail.

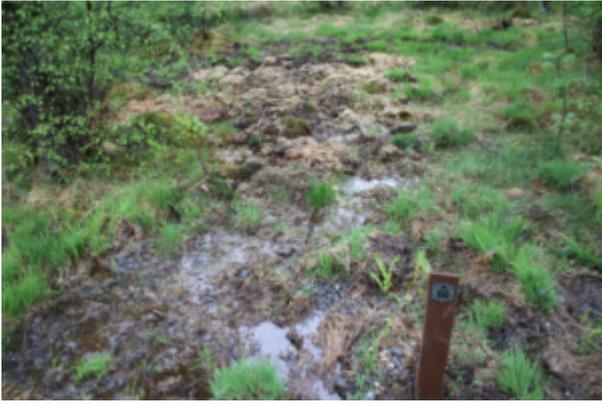
have not been completed using the vegetation that should have been retained for such purposes. Paths and pitches positioned wrongly and subsequently removed have not been restored to their former condition.

Pitch 10, the original stub path has been removed and not restored leaving this water filled hole

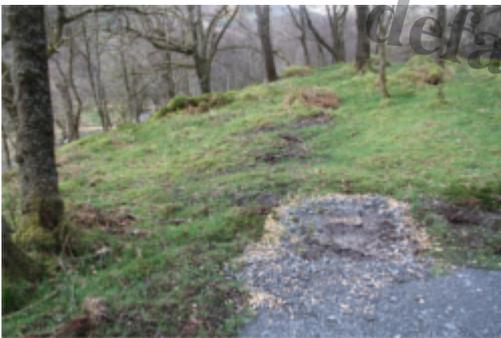
Pitch 12 the original stub path has been removed and not restored

leaving a hole and some hardcore in the environment.

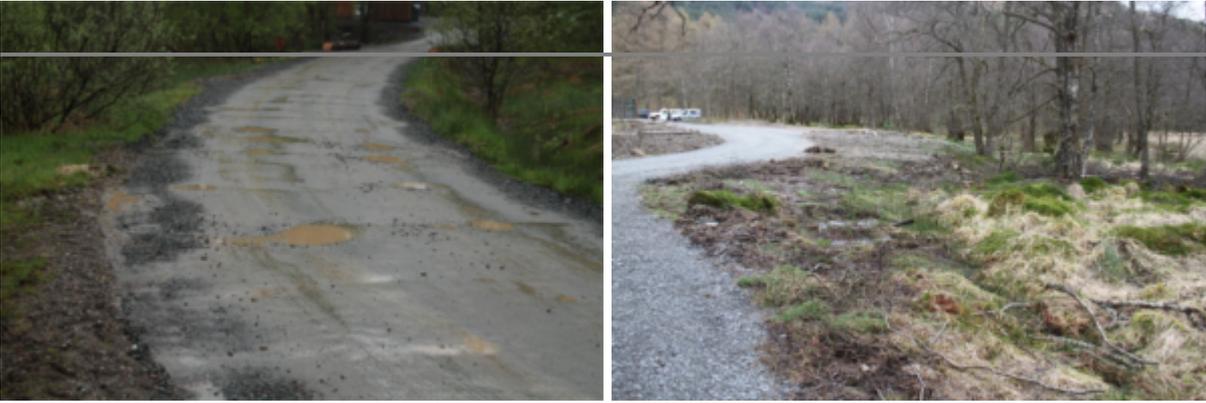
e. The use of grit (course sand consistency) as a pitch surface over quartz pebble was never and should not have been agreed, it's an abomination in a campsite and has been used by the applicant to hide material problems. It has been deposited over peat/moss wet areas, steep slopes and bramble patches to mask the underlying issues Pitches 6, 14, 15 and 19 are affected and the resultant mess in the ecosystem is unacceptable environmental destruction and a horrible visitor experience as a paid for pitch surface which in all cases should be grass..

f. The finish to the roads is abysmal, and it would appear they do not conform to what is detailed in the original specification, there is an expectation another material would provide the final finish over the hardcore base. It is also reasonable to expect a new road would not be pot holed and have 1â•• to 4â³ hardcore strewn over the road way and spreading on to the grass verges. There has been no attempt to restore the exploratory hole dug down to the water pipe which can be seen just above centre on the RHS image.

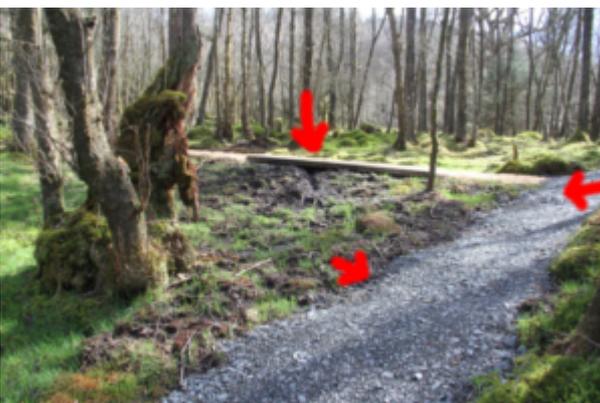
g. The slope between the bridge and the water purification building has had sand/grit, used for pitch surfaces and path infill dumped to the side of the road together with other materials. The extraneous building material appear in a number of locations on site and it is clear the applicant is just waiting for nature to grow over them instead of removing them as per terms of the planning consent to prevent cross contamination in a sensitive area. This contamination should never have taken place if the Ecological Clerk of Works had been present to monitor the work.

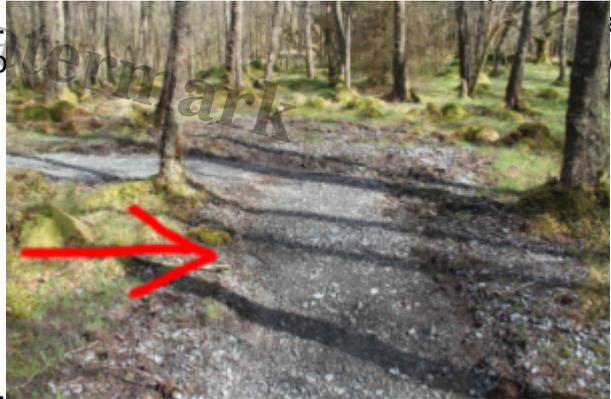
The central arrow in this image shows a channel created by the applicant in peat. This should be in filled to stop a new water course being created. The Applicant has destroyed the moss ecosystem in a large triangle from the bridge to the tree in the foreground and failed to restore the surface leaving grasses to encroach on what should be moss. The eco system here has been irreversibly destroyed.

Going further along this transverse path it is clear the path has interfered with the flow of water down the slope the ground immediately uphill from the path is wetter and in rainy weather fills with water which eventually overflows the barrier formed by the path crossing it in a number of locations.

There is also a spongy area on the path just down hill from the corner that according to planning consent should be corrected. The path where it turns back downhill is particularly affected, water crosses the path and flows down it's side until it finds an easier route down into pitch 17 where it maintains the permanent wet aspect of this pitch. the location of pitch 17 was fed from the water co

merely created a second route for water delivery.

This image also demonstrates the cross contamination of hardcore onto the surrounding ecology.

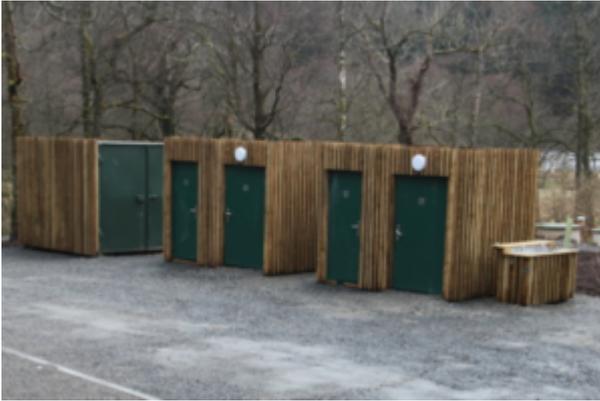
9. The lighting bulkheads do not comply with the dark skies initiative I would have thought that would have been a prerequisite for all lighting in the park but more especially in a location away from other light contamination where the benefits of such fittings would make a real difference.

The lighting has been recessed into the wood cladding since this image was taken but that has no material effect on light pollution of the sky and hillside opposite.

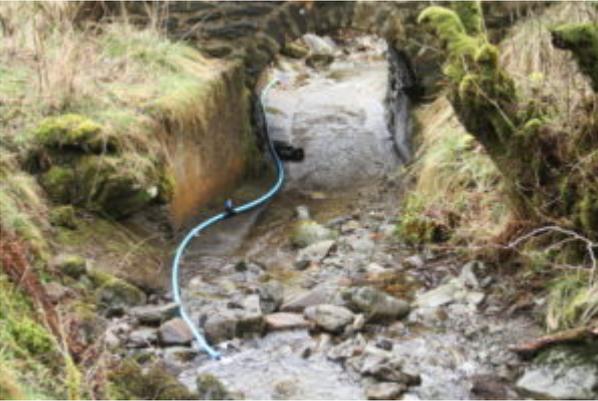
Intake Port.

The original drawings which you have removed from your system showed the water intake upstream from its current location as shown here, it is clear that this was the intended position due to pipe clips and small rock built dam.

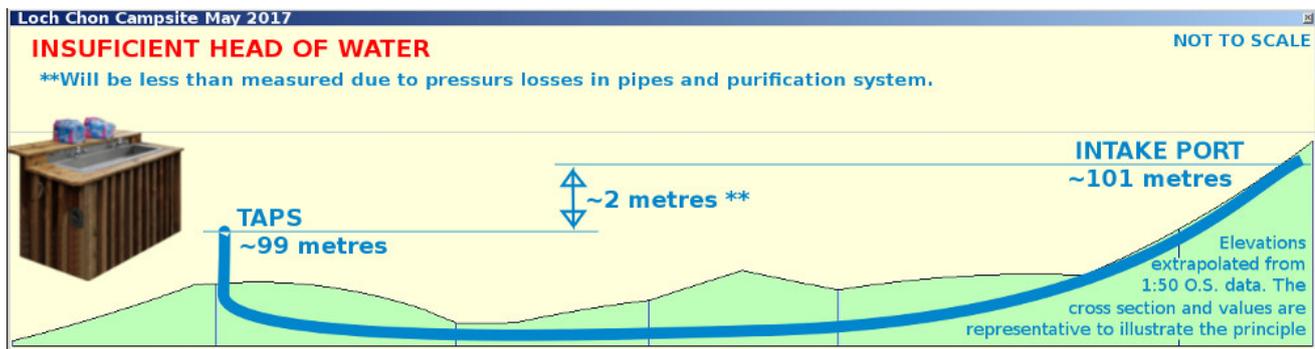
Due to a failure of the planning department to insist on construction drawings detailing the construction of the necessary reservoir or header tank, or the selection of a suitable natural alternative, to guarantee a sufficient head of water to operate the system, the applicant was not constrained. Their contractor fitted the intake pipe, in good faith, at a location that was later to prove unsuitable as the water level in the stream dropped in dry weather leaving the intake above the water level. This was however the location agreed in the planning consent and it would seem no proper evaluation or calculations of the technical requirements for the intake were carried out to support this location, not least the need to be underwater.

The diagram illustrates the issue

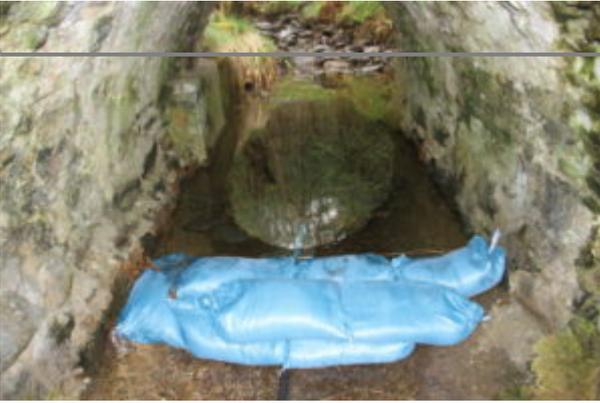
The new location for the intake port is under the cul

vert, I would think a wholly unsuitable location due to it

interfering with the requirement to have a smooth unimpeded surface in the culvert to stop build up of debris.

The resultant head of water has been reduced by a meter or so exacerbating the situation where this reservoir needs to be placed upstream to increase water pressure.

The interference of water flow in a culvert is also undesirable and is surely a matter for SEPA where the inevitable build up of debris behind the dam will cause problems.

The moving of the intake pipe downhill is in breach of planning consents as an NMV would not be adequate to cover a change requiring calculations and of water heads and pressures at the output of the sterilisation system.

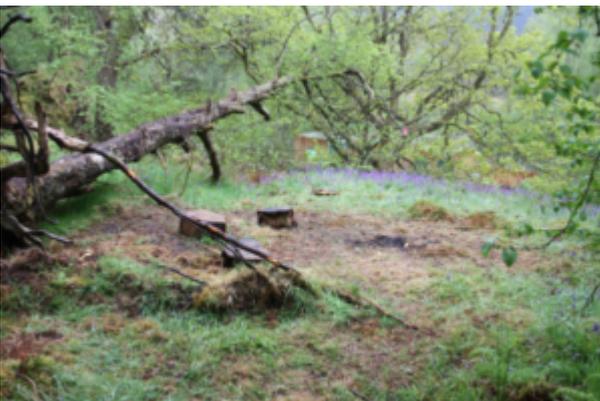
11. Other structures are appearing on site, this one in the form of communal seating area close to pitch

12. this areas look to be constructed by Park Rangers and are a contravention of the planning consent.
