## Public Opinion seems to be the only recourse to getting action from LLTNP

Our ref: snpa17/041 16/07/17

Complaint regarding handling of the camping development at Loch Chon

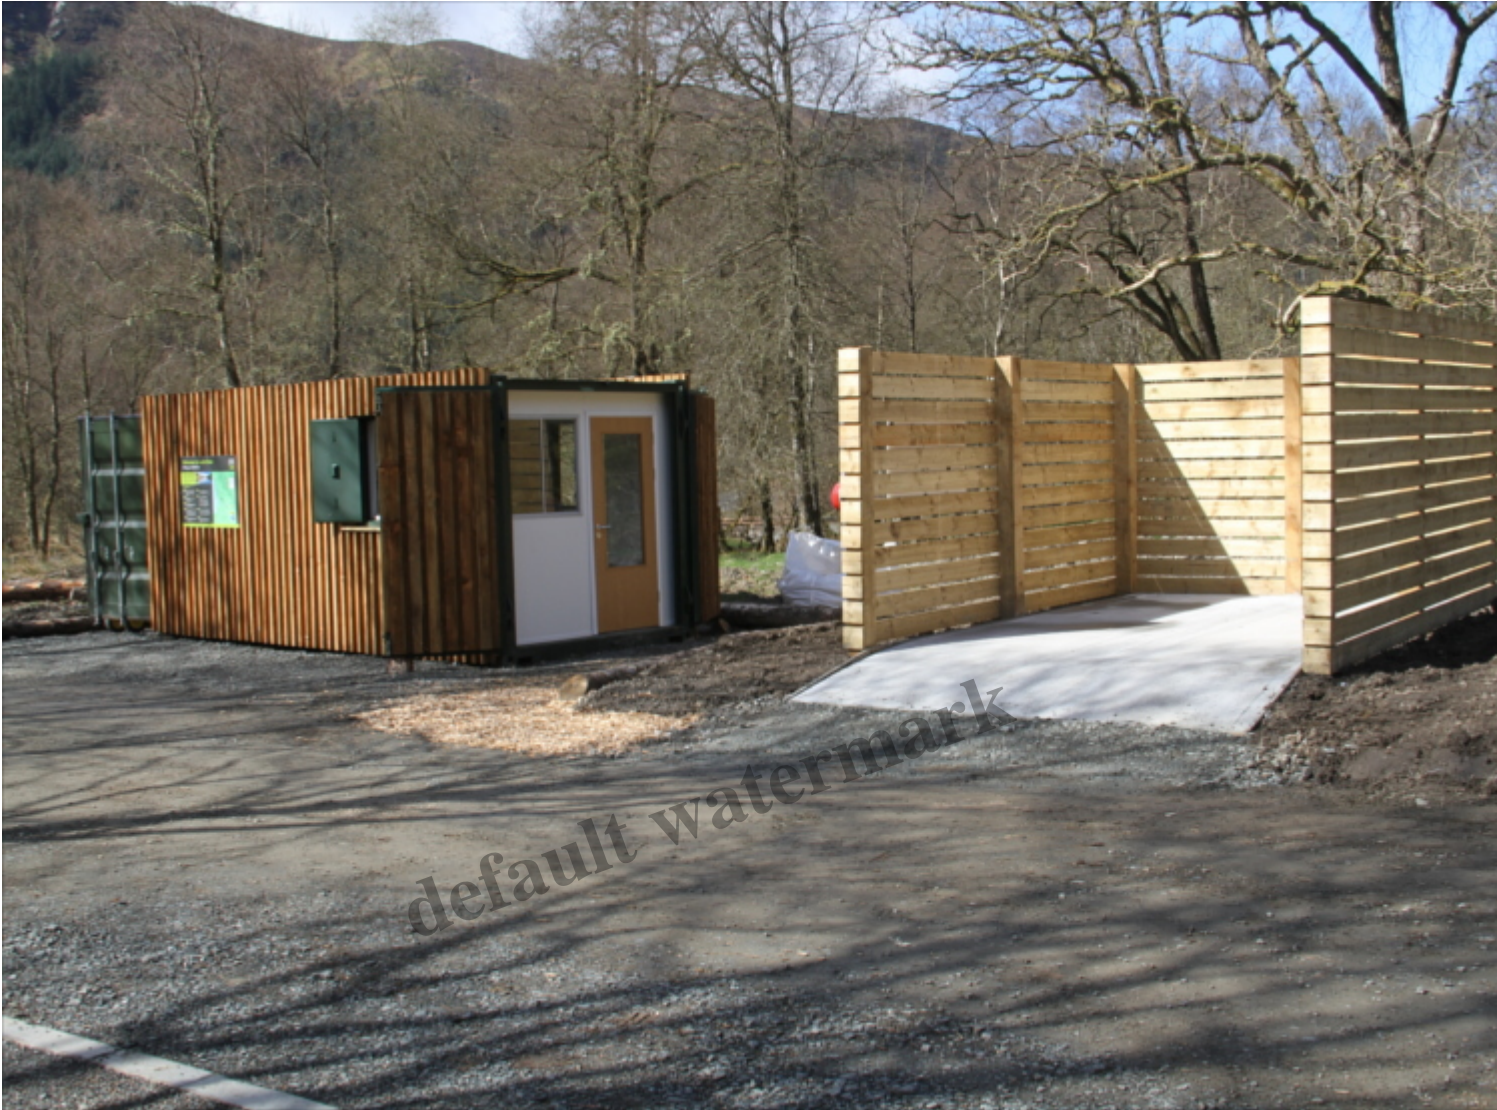
1. The bin store sited at the RHS the Ranger Base and Store does not appear on any of the plans for the site and is therefore a breach of planning consent. In addition as it is such a large structure it should not be considered an Non Material Variation as it has a major impact on the efficacy of the site and it's rural and natural aspect. It seems almost inconceivable that the final purpose of this structure is a bin store and it appears to the casual onlooker that the National Park authority intends to re-task this structure for another purpose. It should therefore be removed and an investigation into it's erection should commence as a matter of public concern.

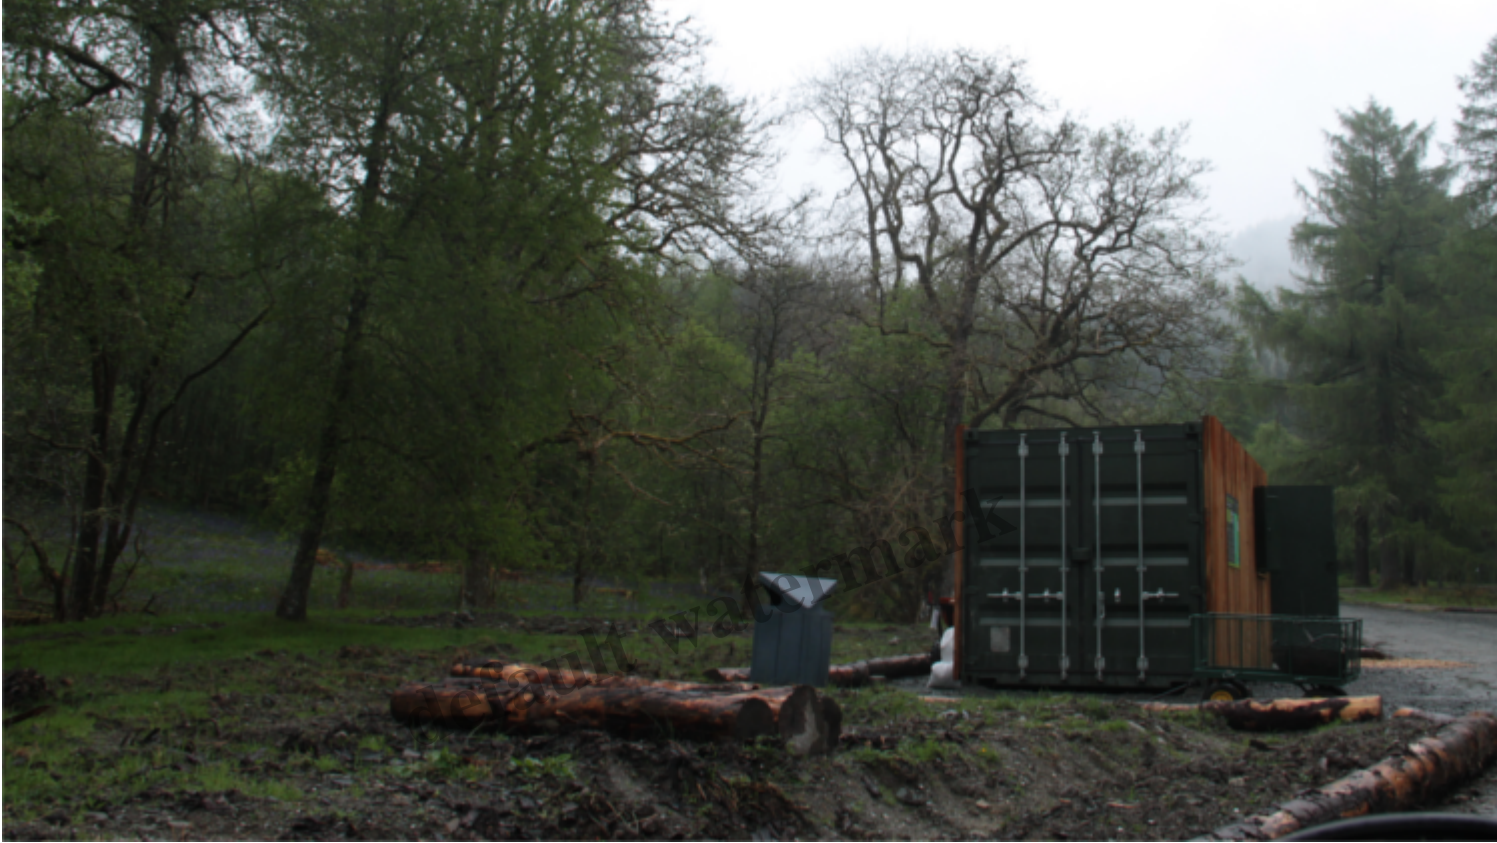
2. The containers used for the Rangers Base and the water purification plant do not correspond with the engineering drawings in respect to the size and finish to the end elevations shown in your documentation.

In both instances the doors fitted are taller than those specified which in turn has prevented fitting a wooden facing above them as specified.

In the case of the Ranger Base Store end the door fitted is larger and of a different design with locking bars on the surface which are totally unsuitable as a solution in this sensitive site.

The wood cladding to the exterior of the containers do not conform to the engineering drawings, the posts and concrete ground supports have not been fitted with the cladding being applied to the container surface directly, this contravenes the design specification and the resultant aspect is an industrial container which has no place in this sensitive area.

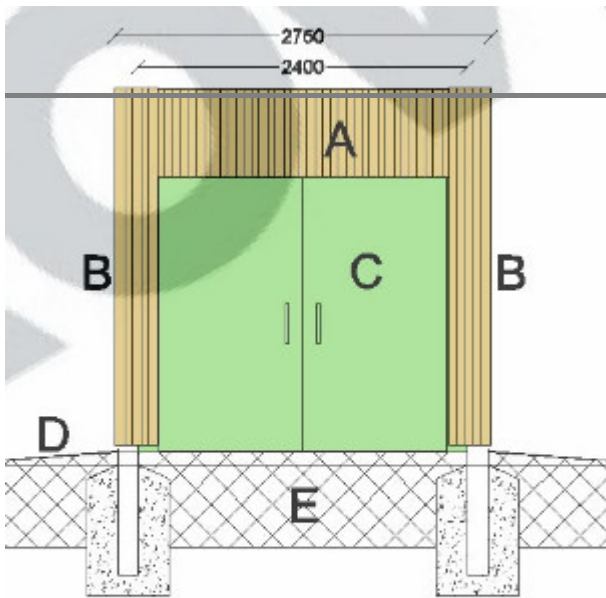
STORE ROOM / RANGER BASE  
END ELEVATION 1:50

3. The wood cladding to the exterior of the containers does not conform to the engineering drawings,

ive not been fitted and th

e cladding has instead be applied to the container surface,

this contravenes the design specification and the resultant aspect is an industrial container which has no place in this sensitive area.

The permanent nature that was presented in the original drawings and at the planning consultation meeting have been subverted by removing the concrete embedded posts which suggests the Park Authority as the applicant again have intentionally deceived the planning authority and have an intention to move, remove or in some way alter these structures and have pre-empted that requirement by violating the terms of the planning consent.

It is also strange why the planning authority approved drawings from the applicant which only showed one end elevation, this is highly irregular and also requires explanation.

This requires investigation. If it is the intention to remove these structures from their position on site and deny access to the public out-with the management season this should have been made clear on the application, in any case the reason for this variation should be established.

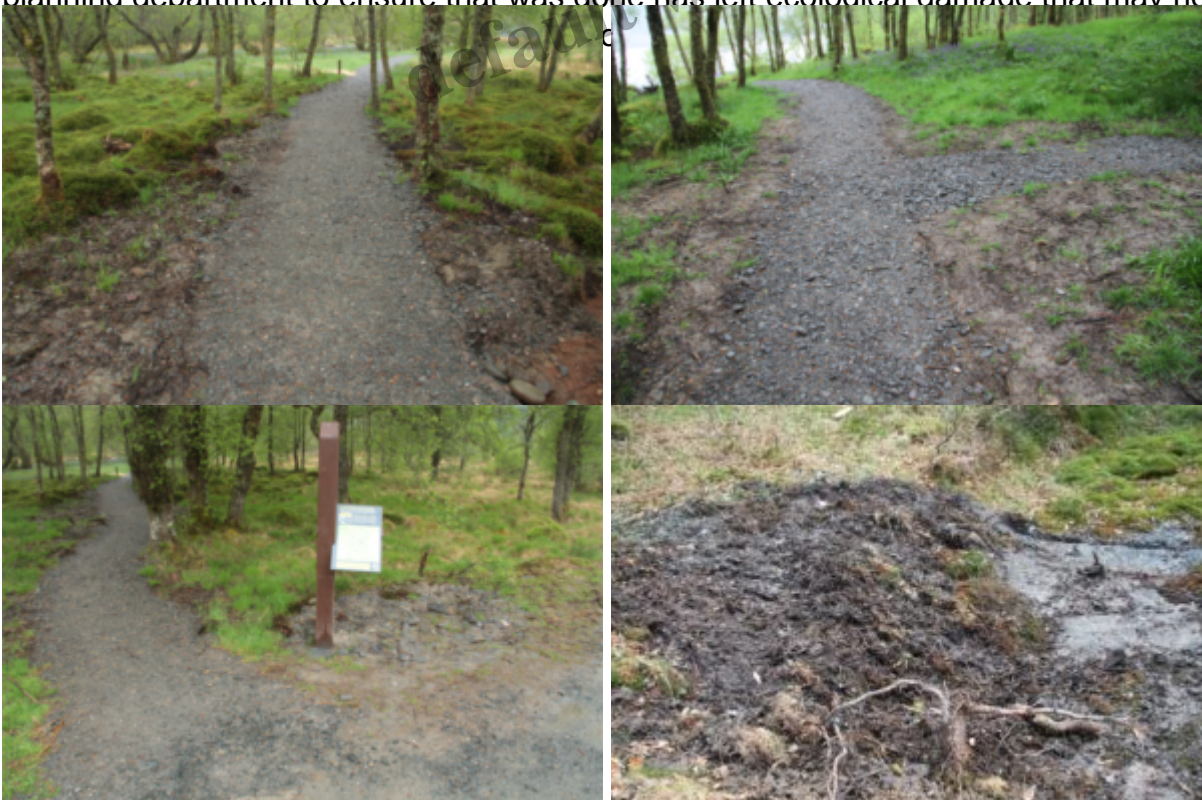
On the Path leading to pitch one, there has been no attempt to clear away the hardcore contamination of the surrounding vegetation and no seeding has taken place. No restoration of vegetation along many areas of path and the 4th image shows a failed attempt to remove a hardcore pile dumped on

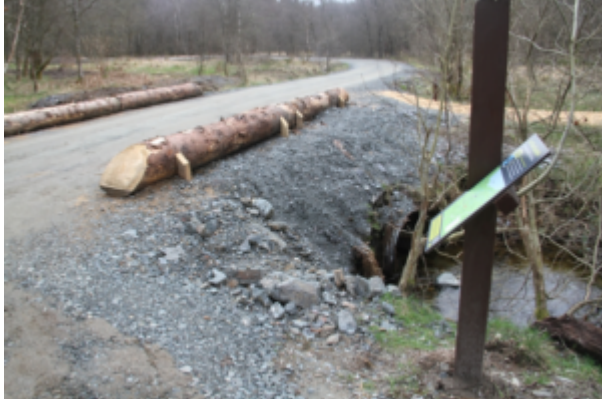
**Bridge**

using machines for removal have made matters worse.

The bridge solution is a mess. Hardcore is falling into the stream through very poor containment. The expansion of the path at the junction to an unacceptable width with hardcore marring the natural ground and vegetation cover without attempted restoration.

The protruding pipe of the culvert should have a natural stone surround wall in a development such as this. The solution provided is not suitable for a flagship development in a National Park where even a pub in Tyndrum can provide a stone faced wall to a piped culvert.

The nature of this slope down to the river is an unnecessary hazard, it would be far better with a retaining wall and a vertical drop to the river where danger is apparent, this solution it invites children to and once a slip begins the outcome is inevitable.

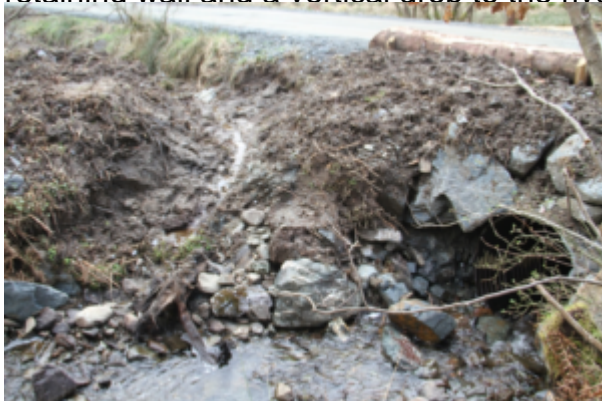
Attempts at restoring vegetation over this hardcore has been

made since this image was taken it is a piecemeal approach and as can be seen from the other side, where no attempt has been made to grade in the edges of the road and vegetation as required and no seeding.

The other side of the bridge has similar issues with attempted soil and vegetation replacement, how successful this will be, depends on the on going availability of water to the root system which may be an issue in dry weather. Monitoring of this area should continue to ensure the applicant provides a suitable long term solution should this restoration attempt fail.

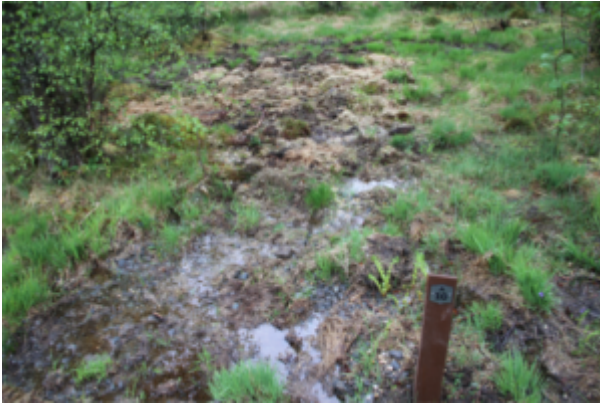
have not been completed using the vegetation that should have been retained for such purposes. Paths and pitches positioned wrongly and subsequently removed have not been restored to their former condition.

Pitch 10, the original stub path has been removed and not restored leaving this water filled hole

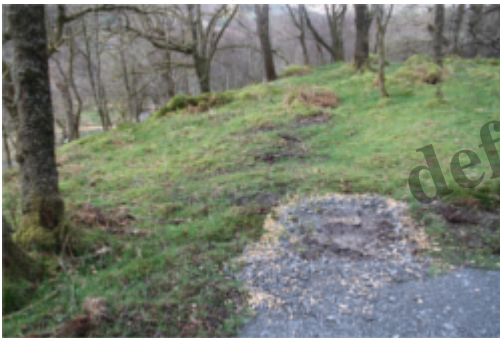
Pitch 12 the original stub path has been removed and not restored

leaving a hole and some hardcore in the environment.

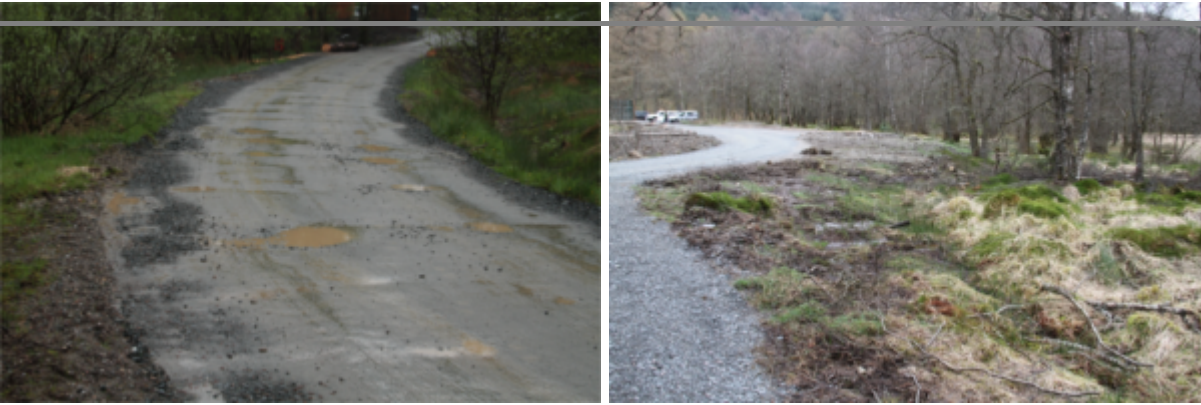
f. The finish to the roads is abysmal, and it would appear they do not conform to what is detailed in the original specification, there is an expectation another material would provide the final finish over the hardcore base. It is also reasonable to expect a new road would not be pot holed and have 1" to 4" hardcore strewn over the road way and spreading on to the grass verges. There has been no attempt to restore the exploratory hole dug down to the water pipe which can be seen just above centre on the RHS image.

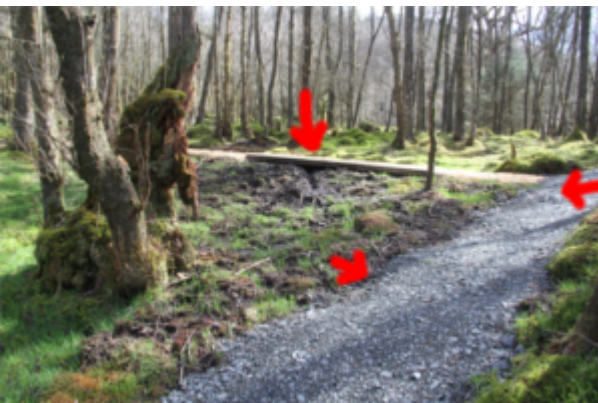
g. The slope between the bridge and the water purification building has had sand/grit, used for pitch surfaces and path infill dumped to the side of the road together with other materials. The extraneous building material appear in a number of locations on site and it is clear the applicant is just waiting for nature to grow over them instead of removing them as per terms of the planning consent to prevent cross contamination in a sensitive area. This contamination should never have taken place if the Ecological Clerk of Works had been present to monitor the work.

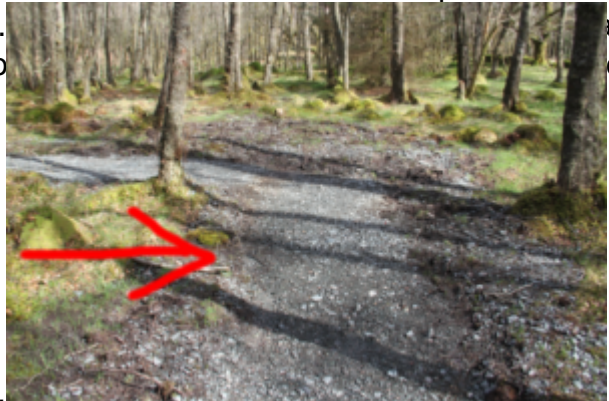
The central arrow in this image shows a channel created by the applicant in peat. This should be in filled to stop a new water course being created. The Applicant has destroyed the moss ecosystem in a large triangle from the bridge to the tree in the foreground and failed to restore the surface leaving grasses to encroach on what should be moss. The eco system here has been irreversibly destroyed.

Going further along this transverse path it is clear the path has interfered with the flow of water down the slope the ground immediately uphill from the path is wetter and in rainy weather fills with water which eventually overflows the barrier formed by the path crossing it in a number of locations.

There is also a spongy area on the path just down hill from the corner that according to planning consent should be corrected. The path where it turns back downhill is particularly affected, water crosses the path and flows down it's side until it finds an easier route down into pitch 17 where it maintains the permanent wet aspect of this pitch. the location of pitch 17 was fed from the water co

merely created a second route for water delivery.

This image also demonstrates the cross contamination of hardcore onto the surrounding ecology.

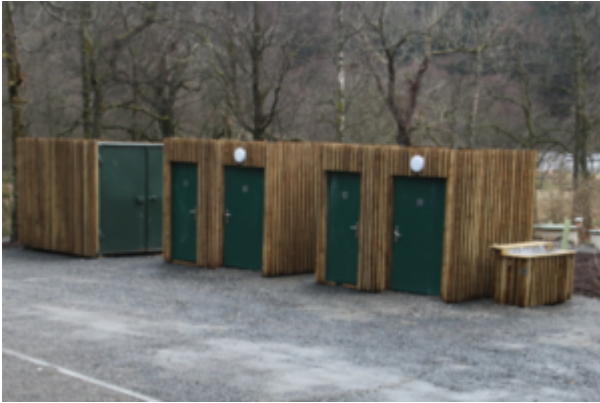
9. The lighting bulkheads do not comply with the dark skies initiative I would have thought that would have been a prerequisite for all lighting in the park but more especially in a location away from other light contamination where the benefits of such fittings would make a real difference.

The lighting has been recessed into the wood cladding since this image was taken but that has no material effect on light pollution of the sky and hillside opposite.

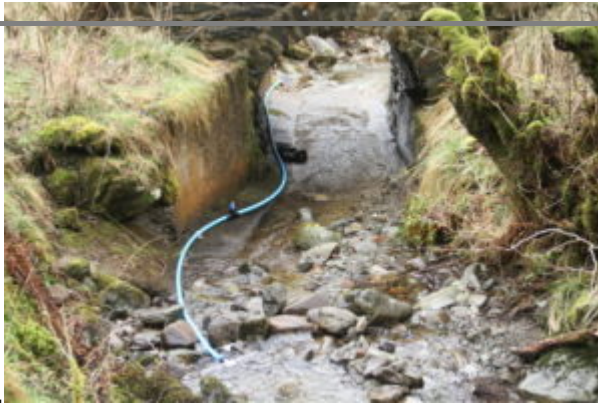
Intake Port.

The original drawings which you have removed from your system showed the water intake upstream from it's current location as shown here, it is clear that this was the intended position due to pipe clips and small rock built dam.

Due to a failure of the planning department to insist on construction drawings detailing the construction of the necessary reservoir or header tank, or the selection of a suitable natural alternative, to guarantee a sufficient head of water to operate the system, the applicant was not constrained. Their contractor fitted the intake pipe, in good faith, at a location that was later to prove unsuitable as the water level in the stream dropped in dry weather leaving the intake above the water level. This was however the location agreed in the planning consent and it would seem no proper evaluation or calculations of the technical requirements for the intake were carried out to support this location, not least the need to be underwater.

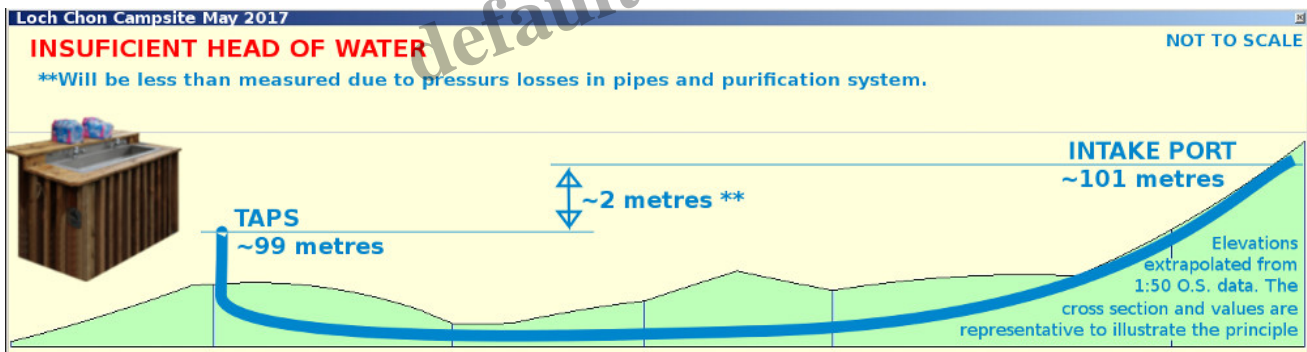
The diagram illustrates the issue

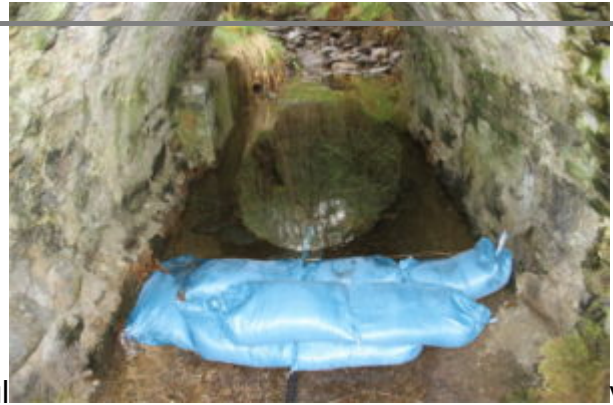
The new location for the intake port is under the culvert, I

would think a wholly unsuitable location due to it interfering with the requirement to have a smooth unimpeded surface in the culvert to stop build up of debris.

The resultant head of water has been reduced by a meter or so exacerbating the situation where this reservoir needs to be placed upstream to increase water pressure.

The interference of water flow in a culvert is also undesirable and is surely a matter for SEPA where the inevitable build up of debris behind the dam will cause problems.

The moving of the intake pipe downhill is in breach of planning consents as an NMV would not be adequate to cover a change requiring calculations and of water heads and pressures at the output of the sterilisation system.

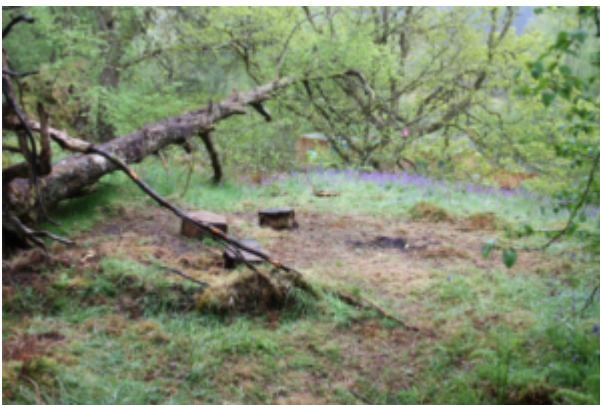
11. Other structures are appearing on site, this one in the form of communal seating area close to pitch

12. this areas look to be constructed by Park Rangers and are a contravention of the planning consent.
