The restoration of the Glen Bruar hydro scheme (2)

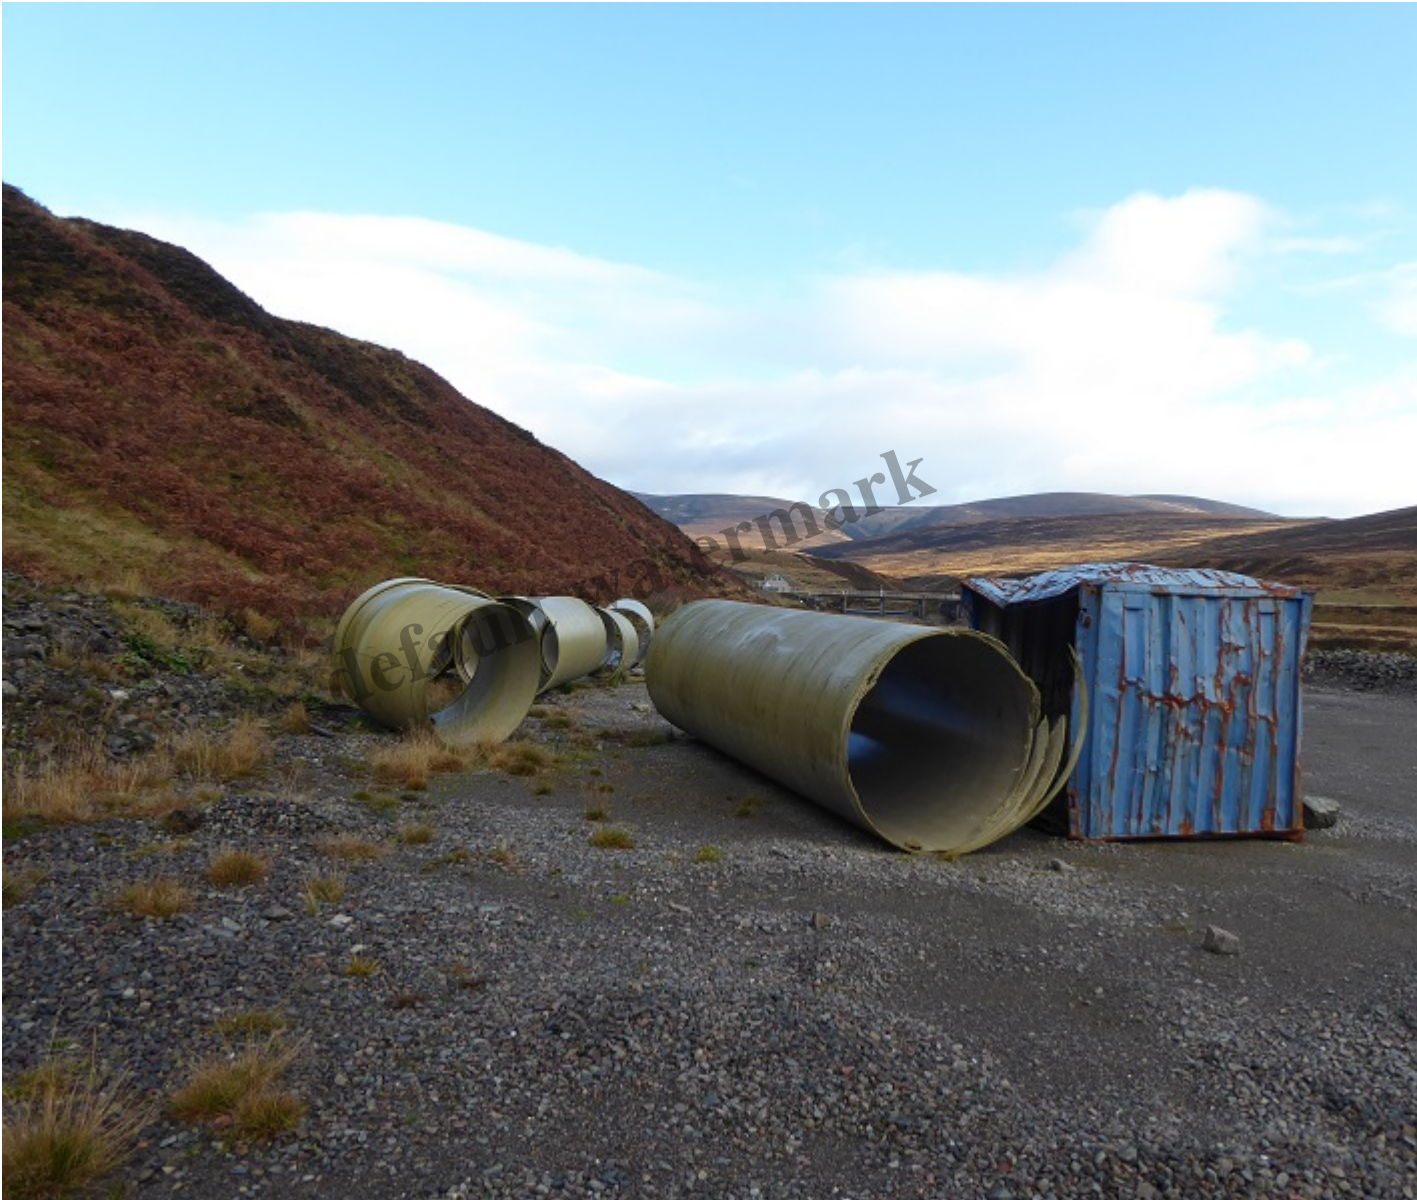
Its now two years since the Bruar hydro scheme opened and yet these broken sections of pipe and v container have still not been removed from the glen

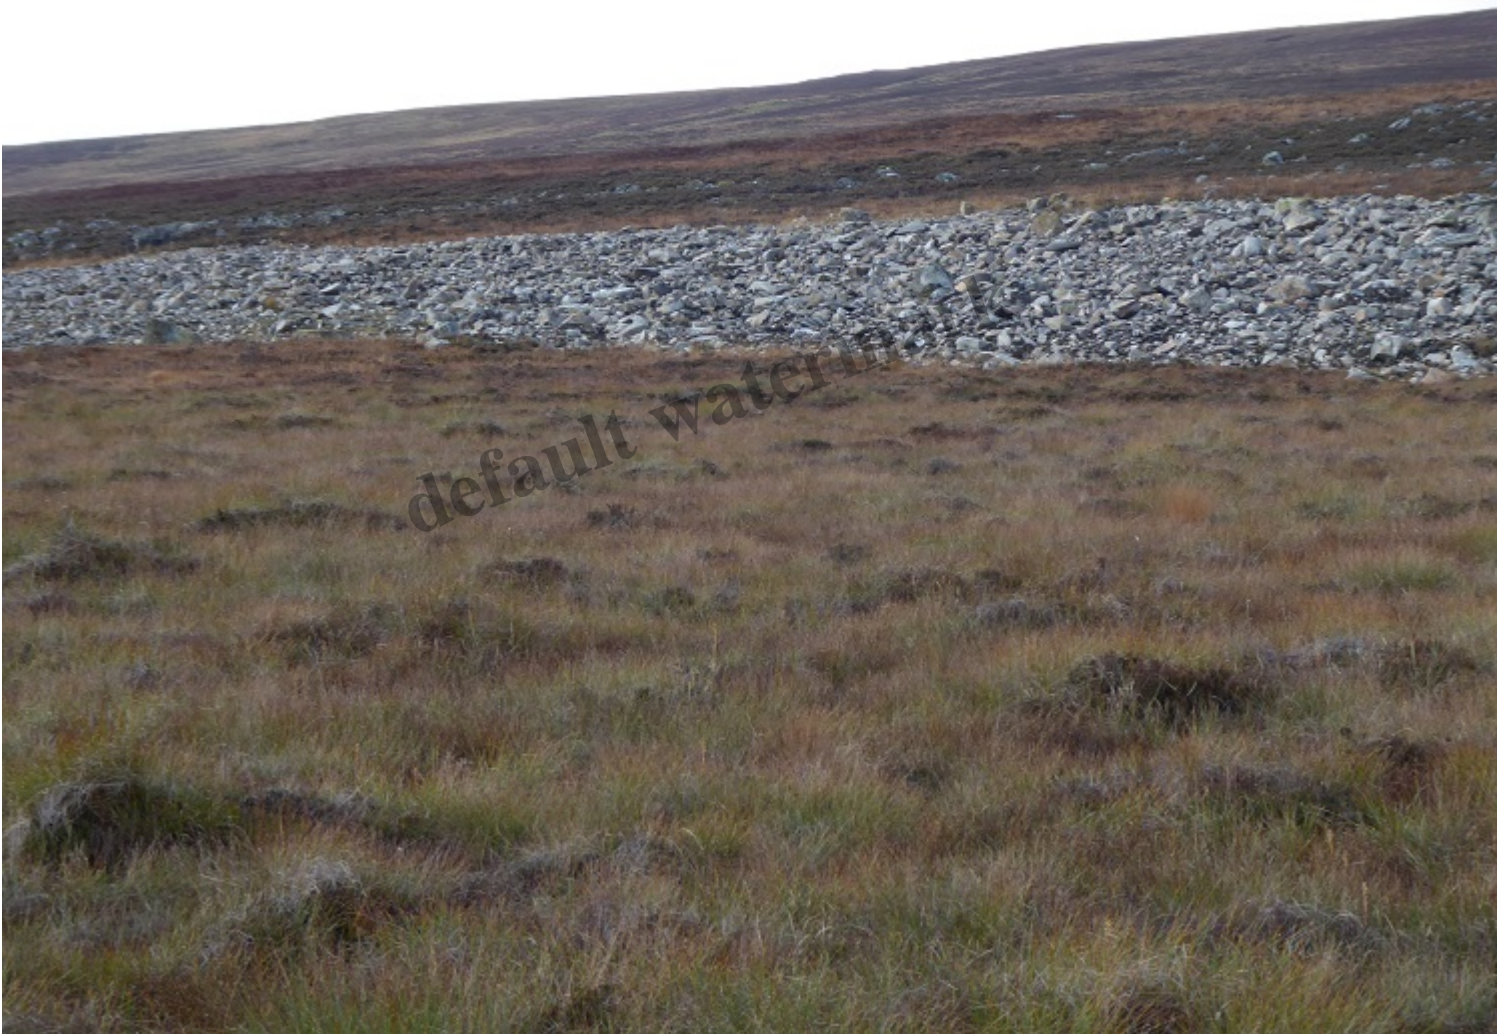
A section of the boulder scar which ran between the powerhouse and the intake which has not been restored. Somewhat paradoxically, what I regard as the most impressive aspect of the restoration work – the initial boulder scar was a landscape disaster ([see here](#)) – the “repair” of the land above the pipeline is least documented. While detailed plans were improved in July to the minor intake, the two pipe bridges and the power house embankment, there is no proper specification for the restoration of the pipeline. The documentation that has recently been added ([see here](#)), says little more than the [reinstatement note](#) from February 2016 which acknowledged the pipeline scar was an issue which would be fixed by removing some of the boulders and robbing turves from neighbouring areas.

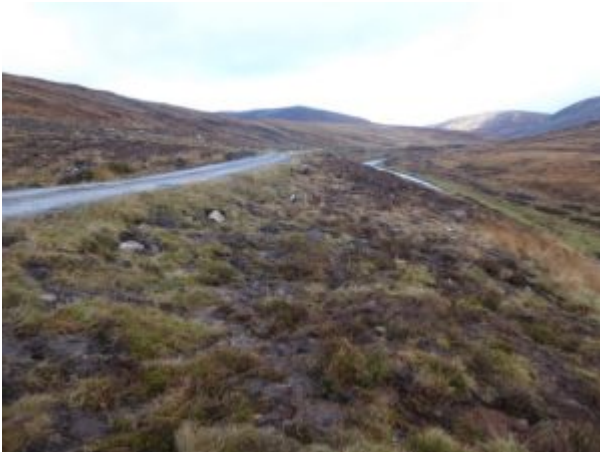
Photo showing robbed area to right of track and restored area to left

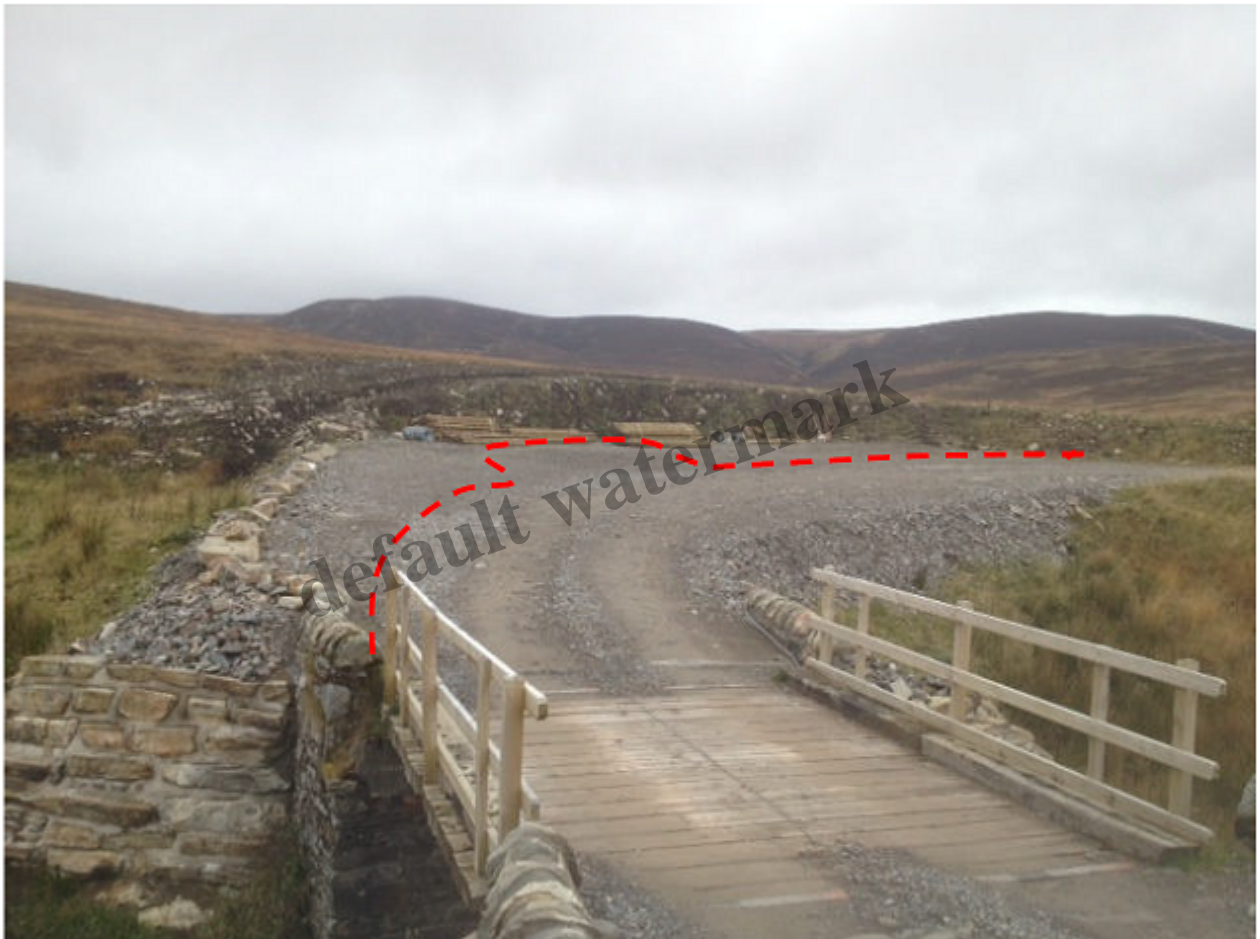
1) The narrowing of the access track on corners by restoring levels to match surrounding and proposals for reinstatement of vegetation/appropriate seeding.

The corner after the existing bridge will be narrowed and reduced, taken back to existing profiles with a small passing place retained - as the existing track had prior to construction.

The stones and as much of the type 1 road layer as possible will be removed. The mound at the rear of the widening (see picture above) will then be used to cover over the track. There is evidence of regrowth in this mound and this will be careful reutilised to assist in regenerating the area. Small areas of turfs will also be ‘robed locally’ and distributed across the area should the cover of vegetation be minimal. Removal of material in the bank will present the opportunity to smooth the banks and lessen the sharpness. The dashed line above in red shows the proposed profile.

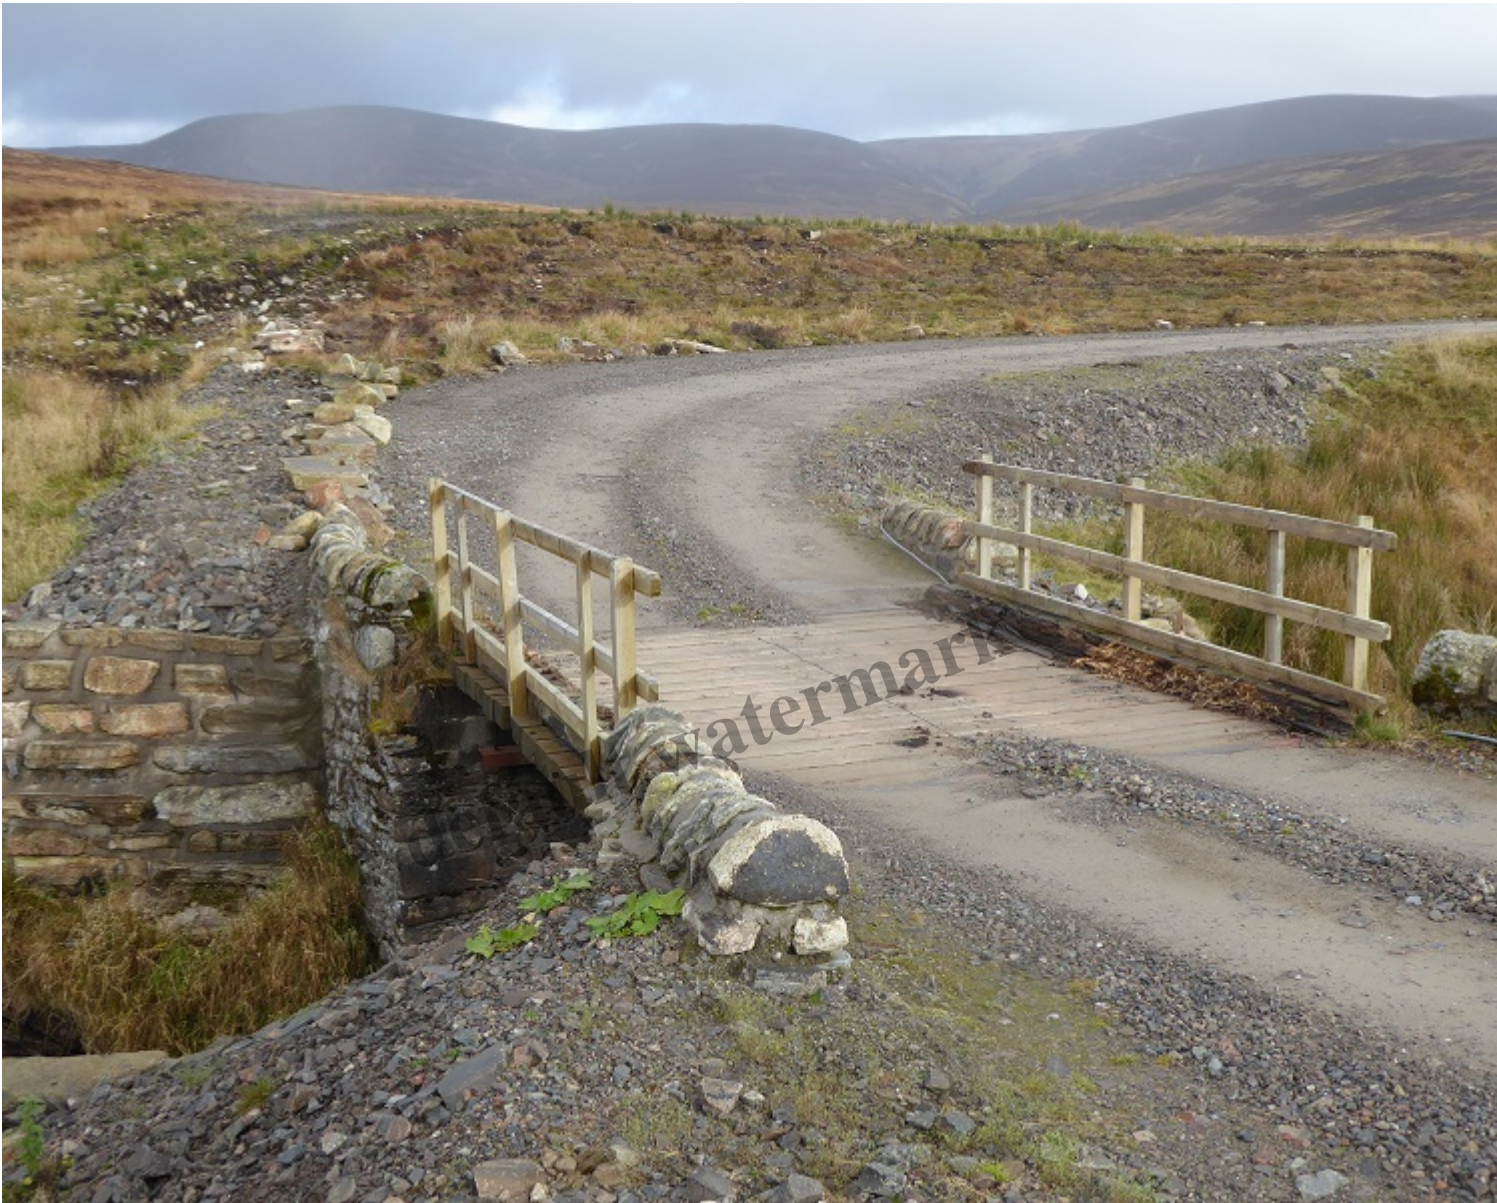
A significant improvement (although the right edge of the road has not been revegetated and is at high risk of erosion). Other parts of the road along the glen appear to have also been narrowed with the result it is no longer a race track.

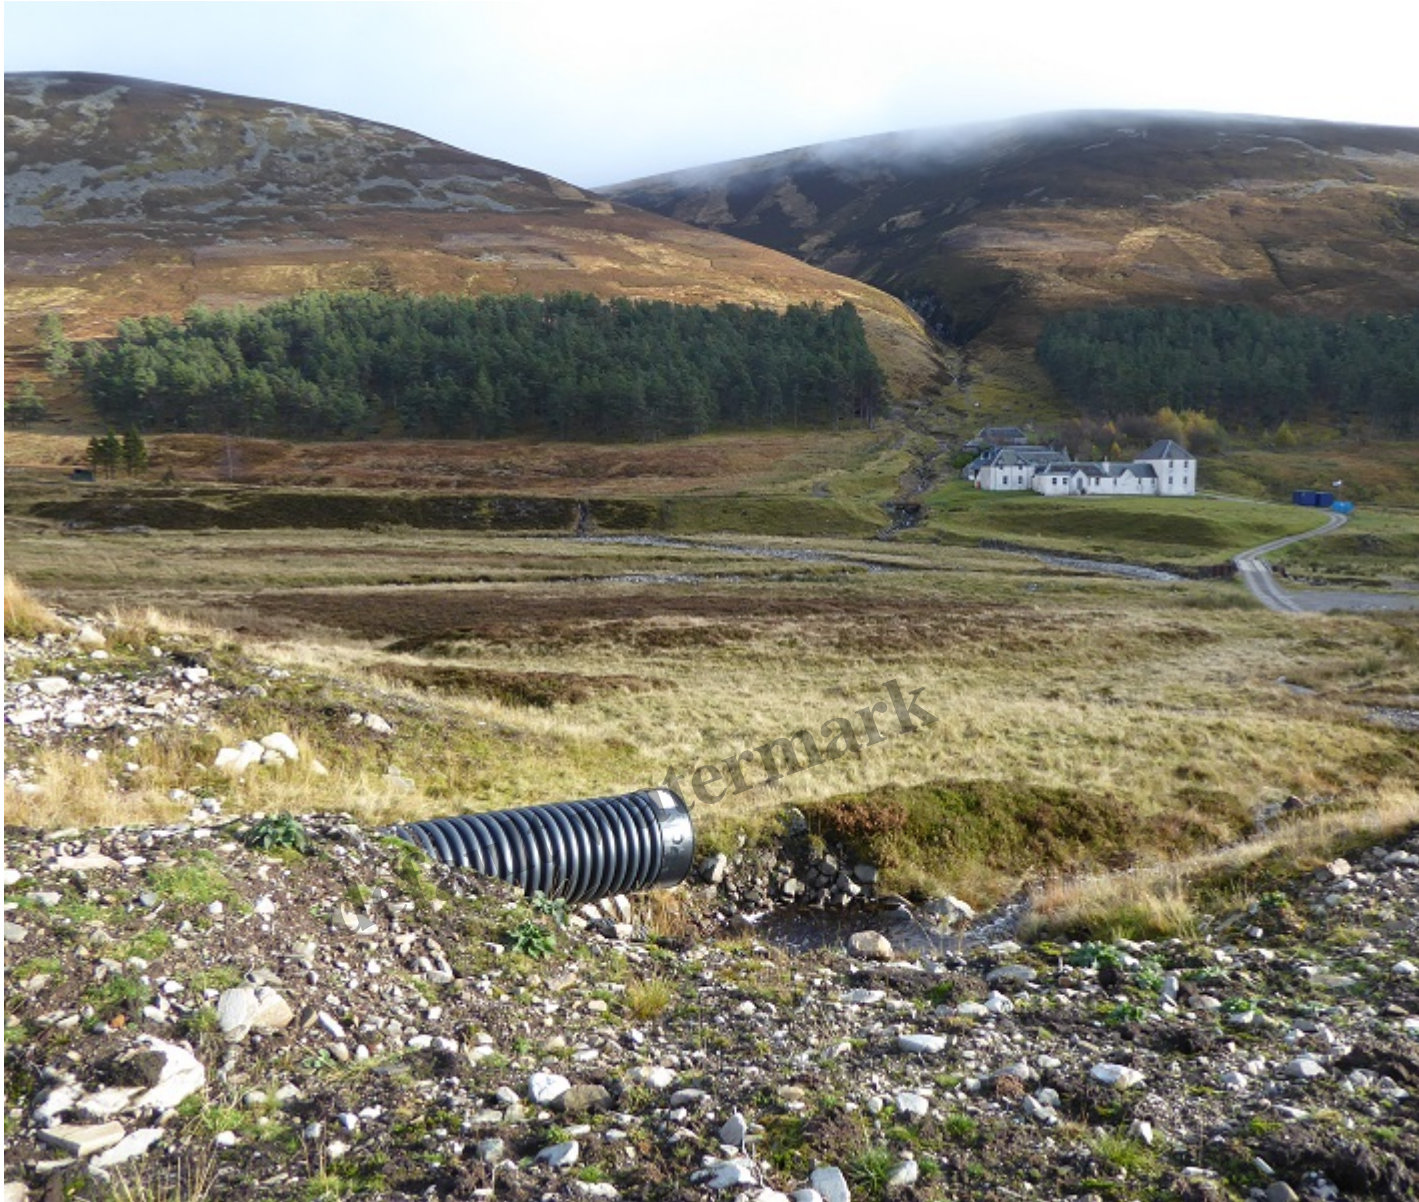
The worst of the protruding culverts

There are a significant number of what appear to be new protruding plastic culverts along the track and there appears to rhyme or reason to what has been fully finished, partially finished and what just left:

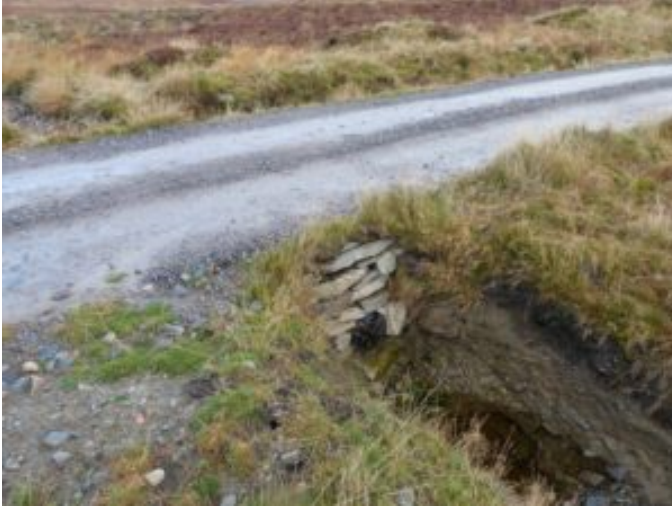
Finished culvert with turf placed above stone

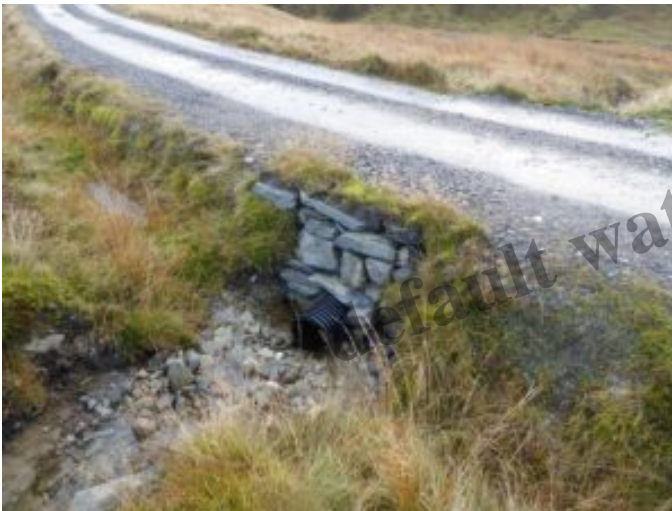
Same culvert, other side of road, protruding – why?

2) Culvert pipe ends exposed at water crossing near the st shall be trimmed back.

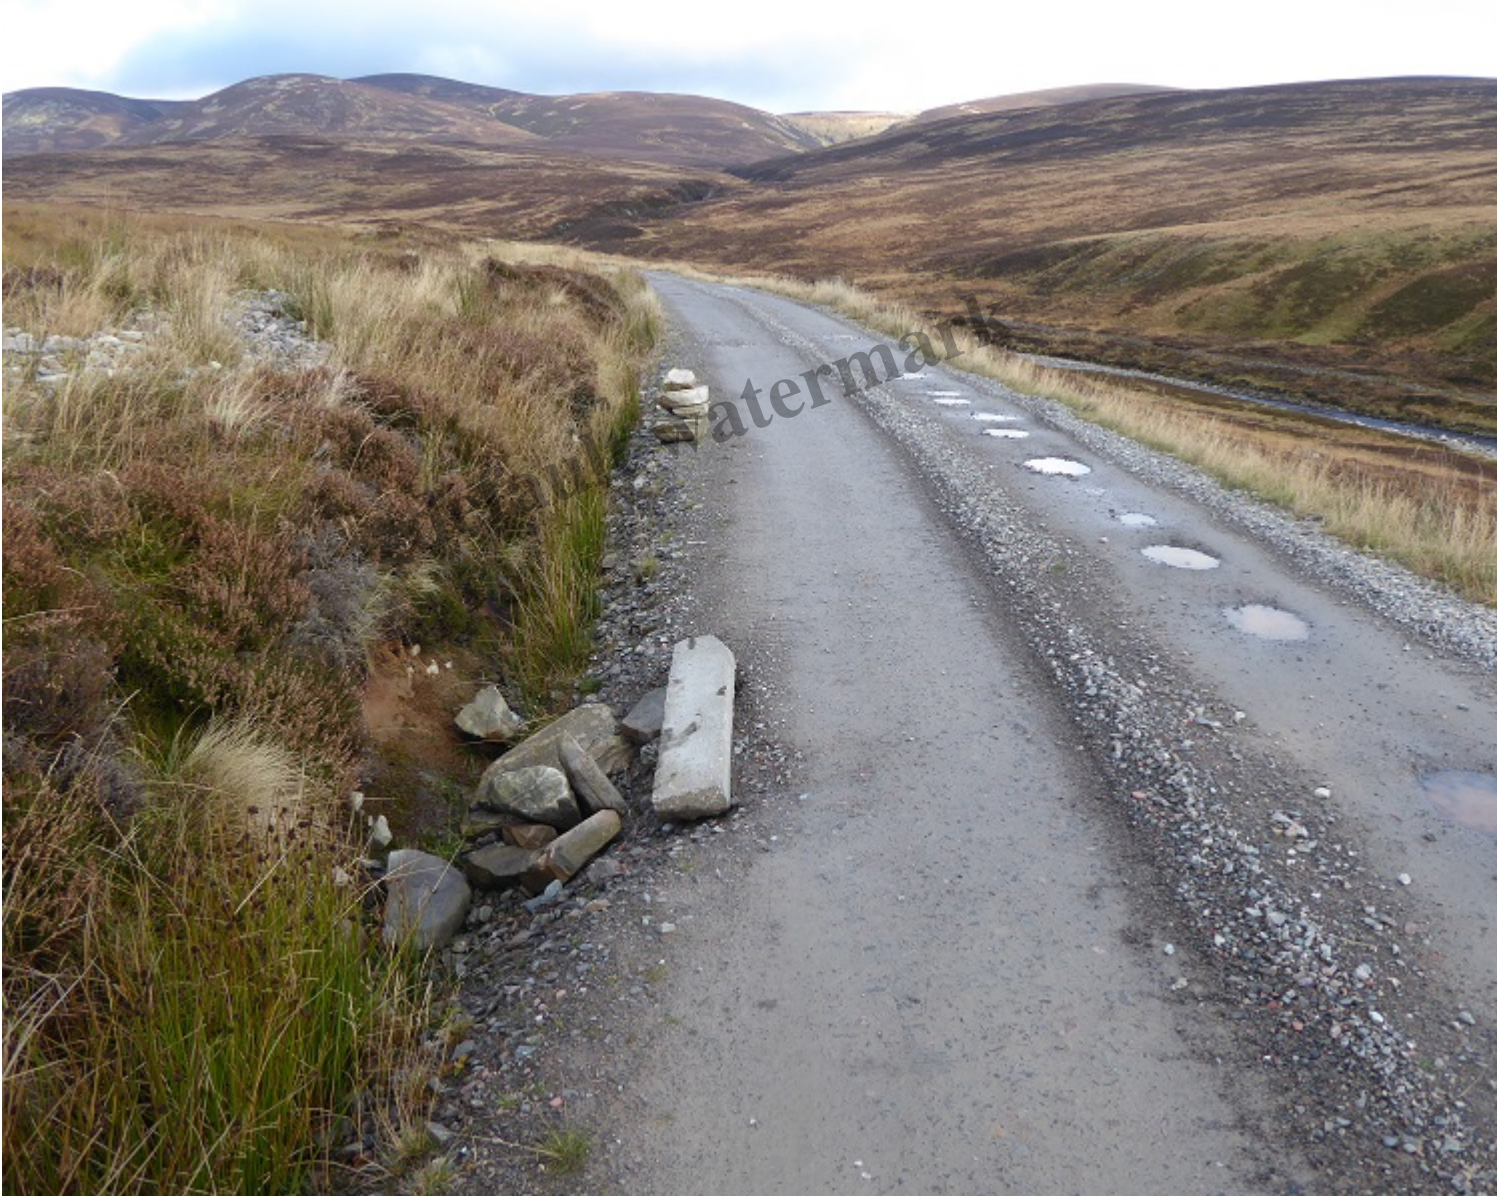
In several places the edge of the road is eroding. It is hard to tell if the stone has been placed there for work yet unfinished or to mark the holes.

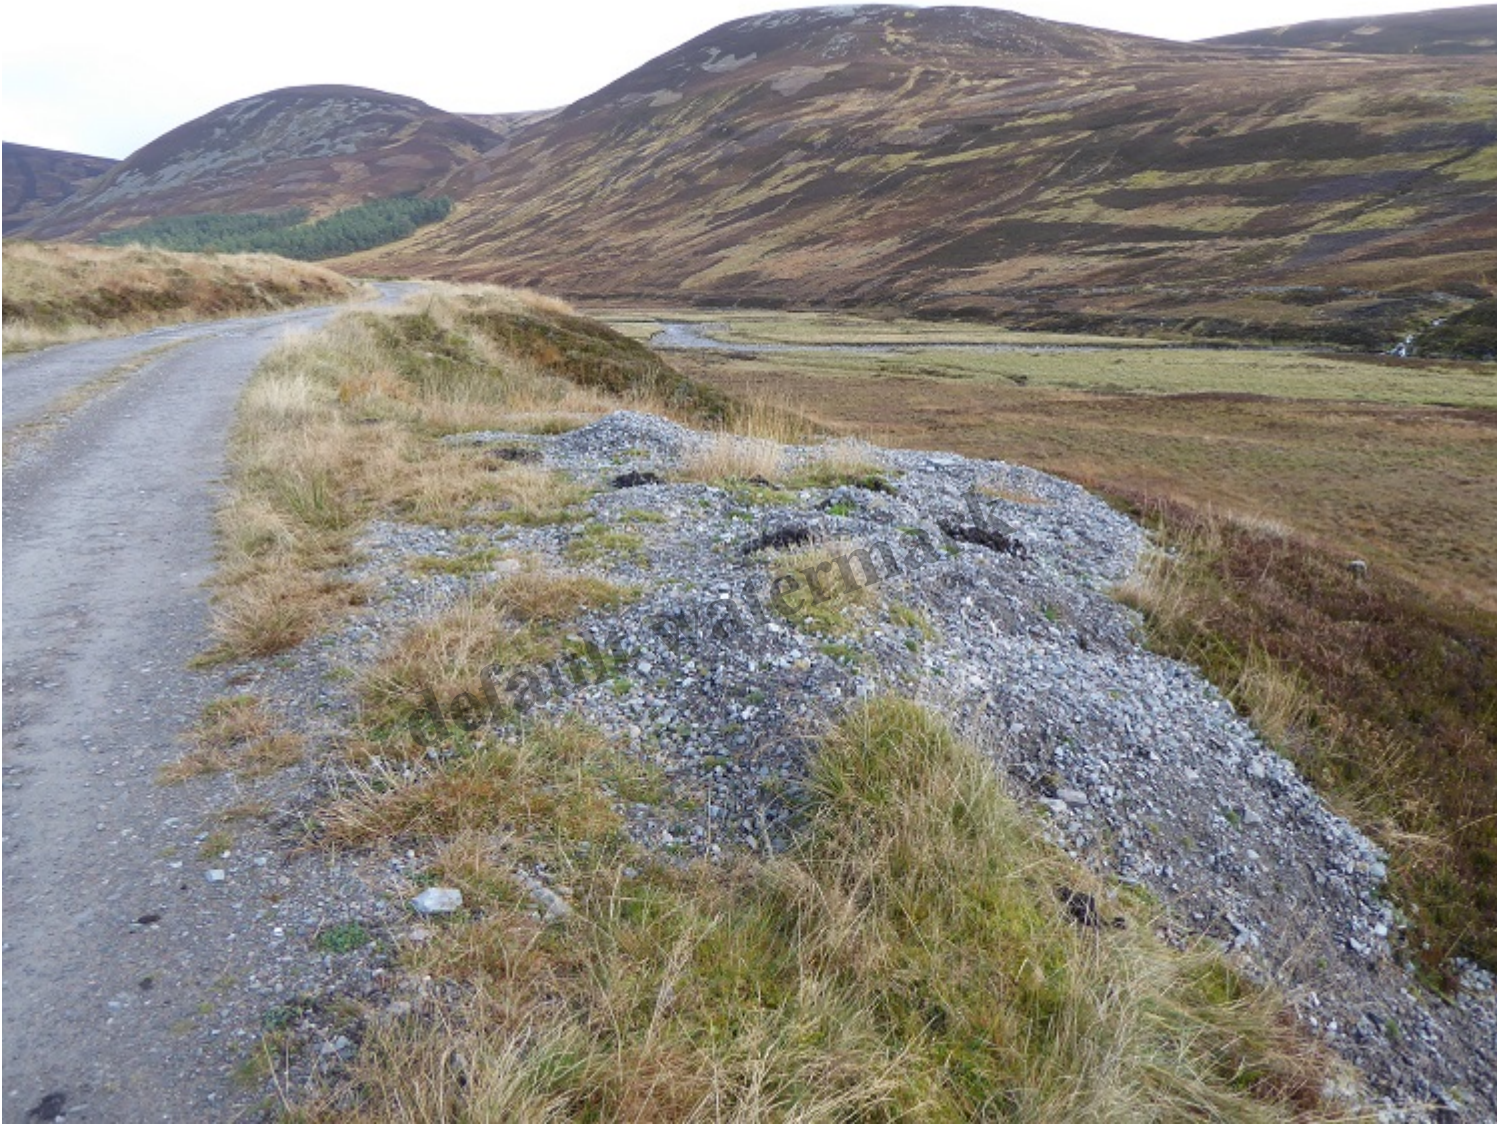
In other places dumped aggregate has not been removed and is spilling down the slopes beside the track.

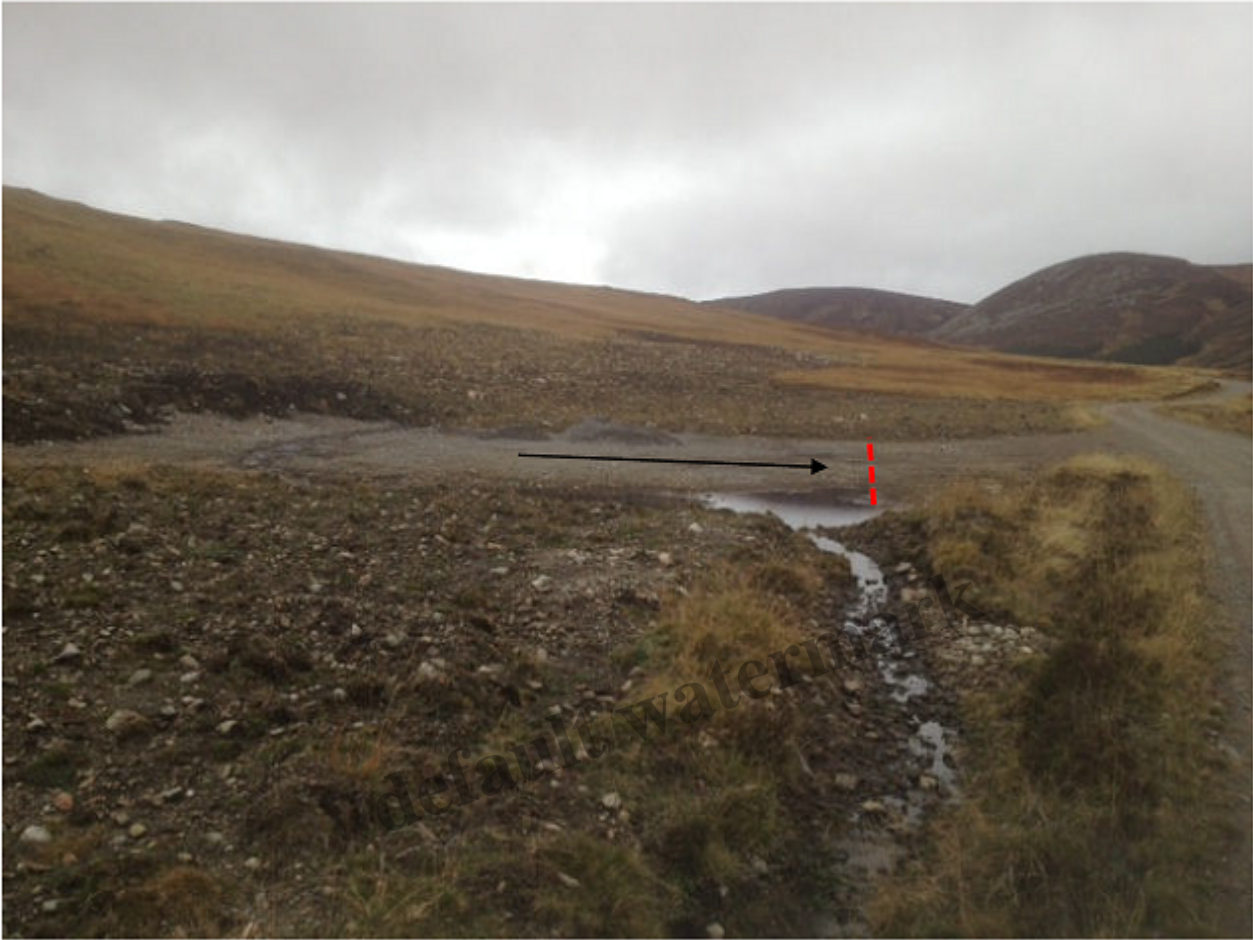
result for the largest area (featured above) leaves a lot to be desired, with no evidence so far of the robbing turves technique to restore bare ground as used so successfully on the pipeline:

There is a large laydown area on the midpoint of the pipeline route. Prior to construction this was originally a storage area for stone to repair the road – allowing a local stock pile to aid repair of pot holes. This is why it was proposed to retain this but following dialogue with CNPA we consider it would be better to reduce it significantly to a similar scale to the existing lay down prior to construction commencing. See picture below with arrow showing reduction in size.

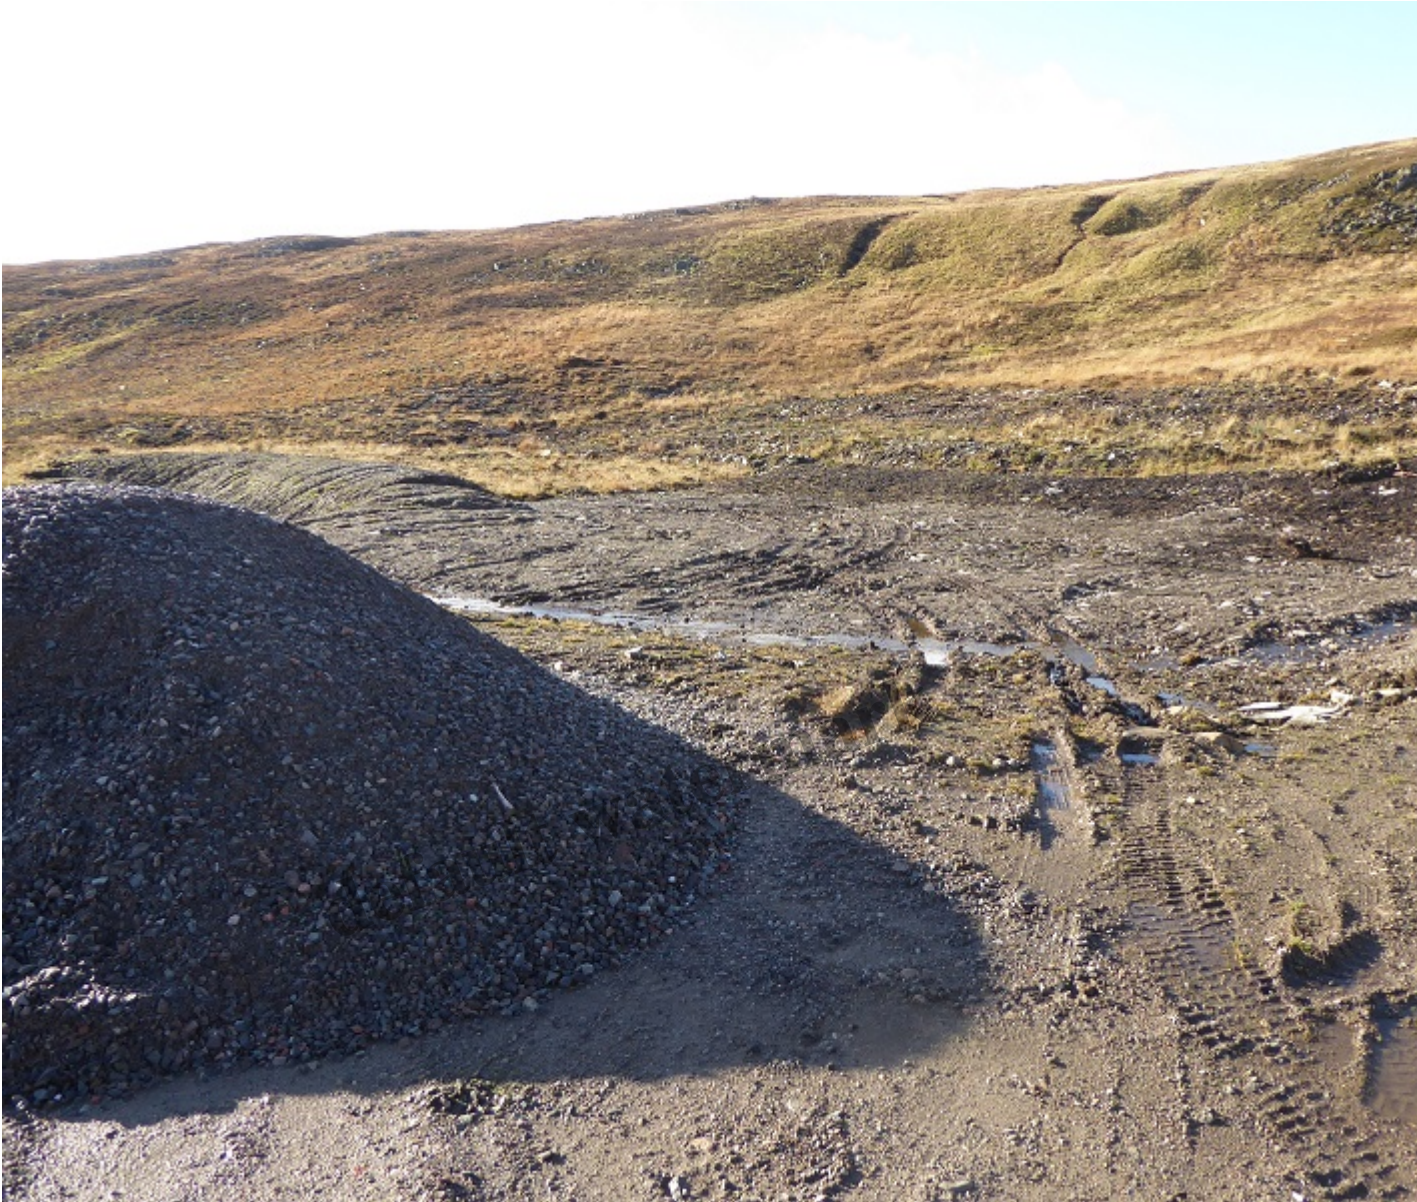
Same laydown area as in top photo, different angle – the pile of aggregate for filling potholes makes worse.

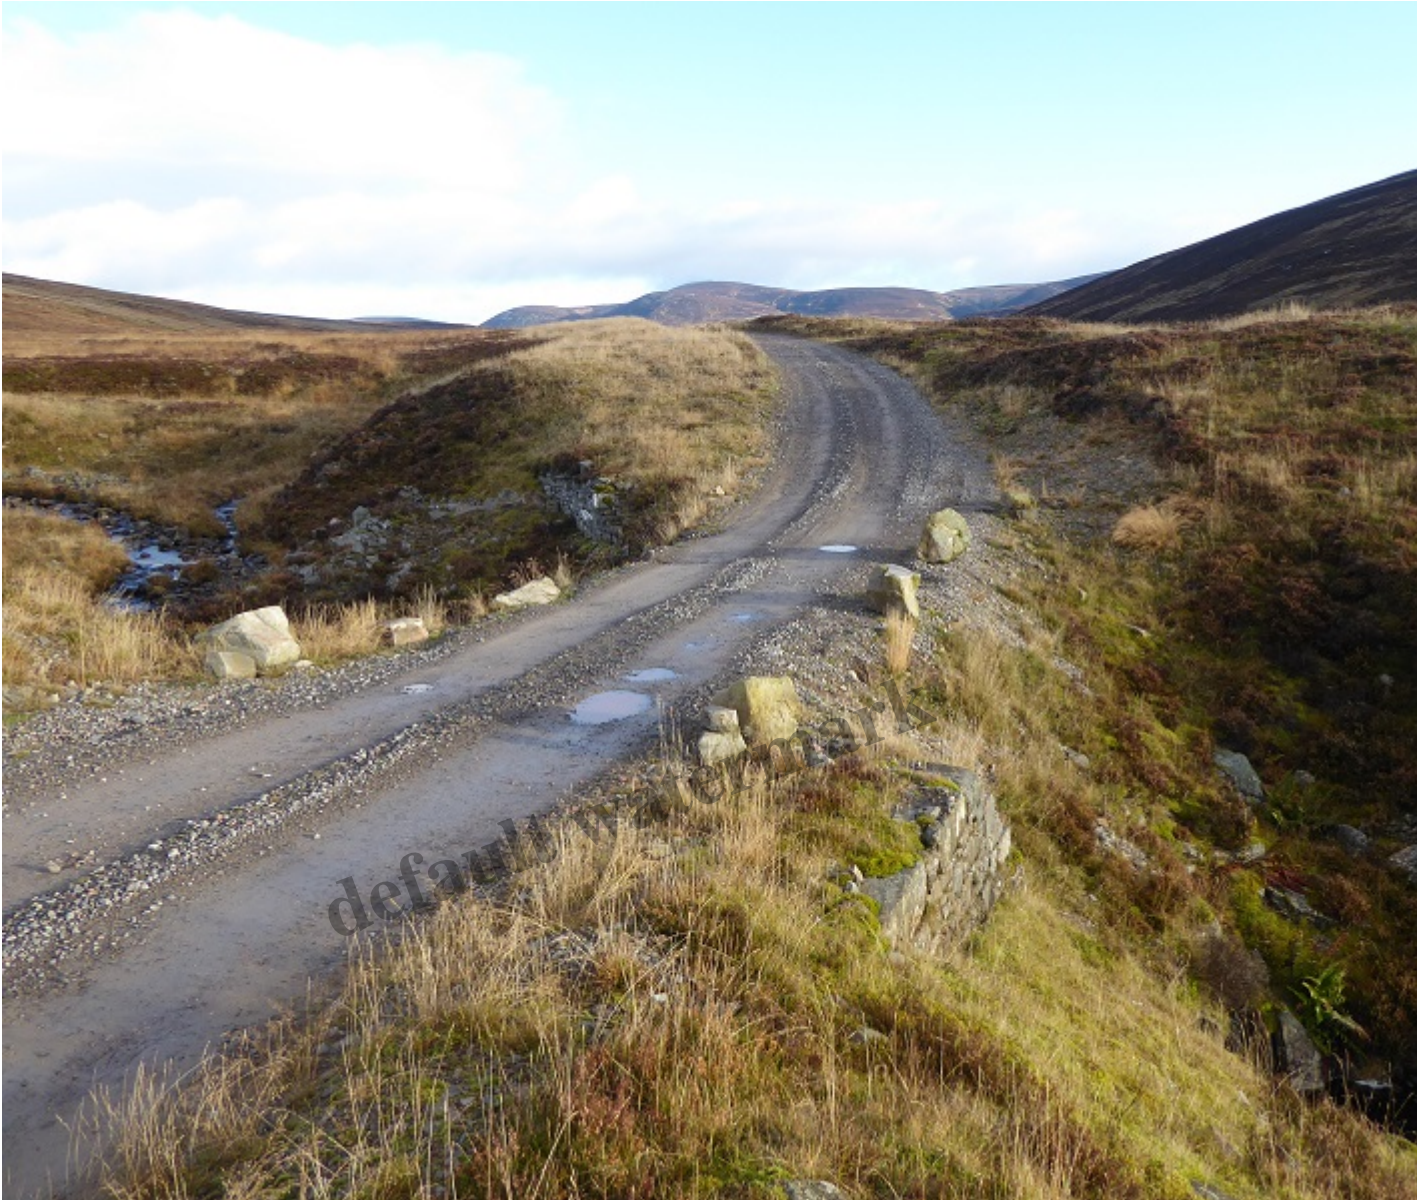
Poor finishing with material from the edge of the track spilling down towards the culverted burn below

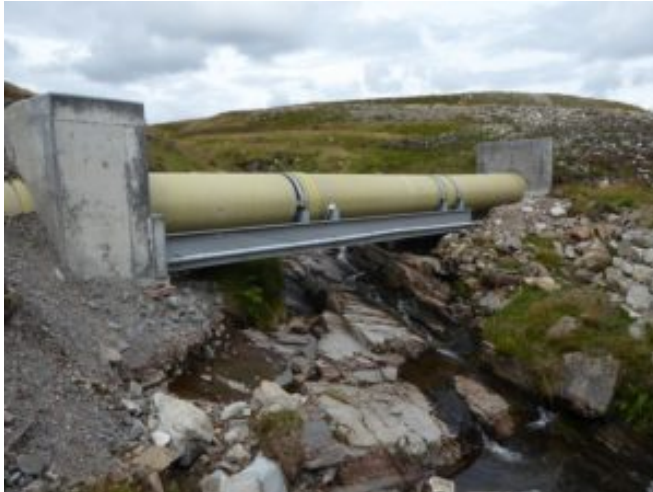
Before

The first pipe bridge close to the power house had last year looked a total mess with the river threatening to wash the plinth away. It is now much better:

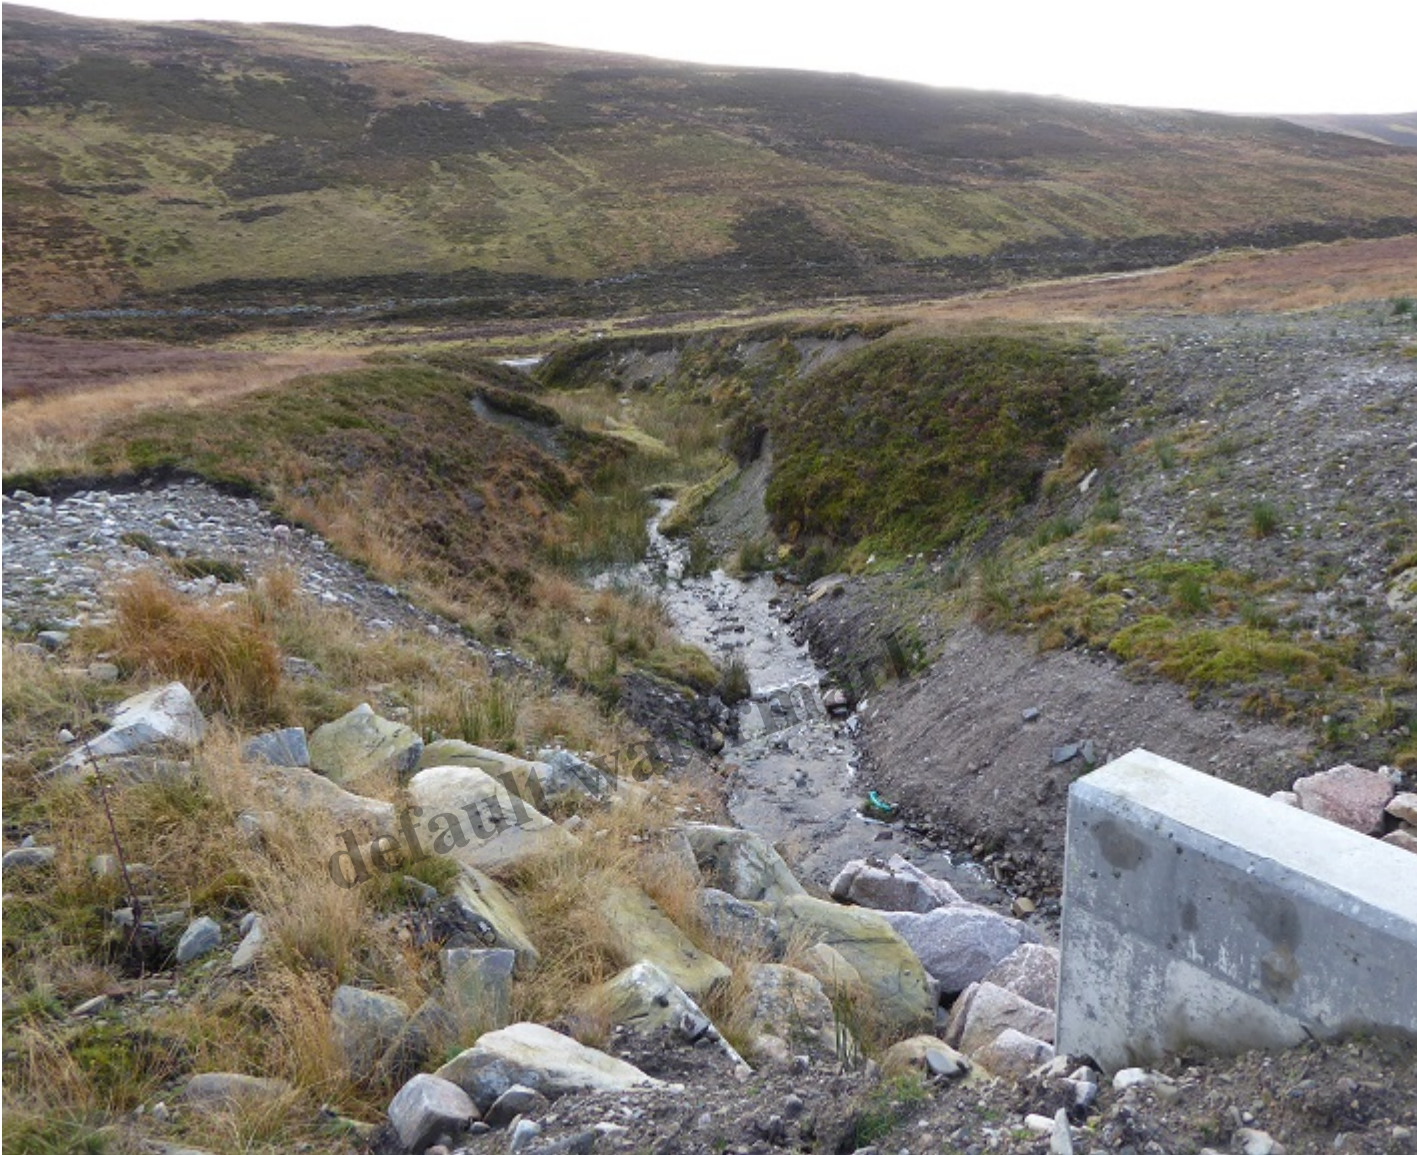
The banks of burn below the concrete plinth which are bare and will erode contrast with how the bank previously – heather covered. There is a very large patch of bare ground to the right.

The rip rap bouldering to protect the banks around the plinth looks a mess, there is a large patch of bare ground and the banks of the burn have not been restored with vegetation and one would have thought at risk of rapid erosion.

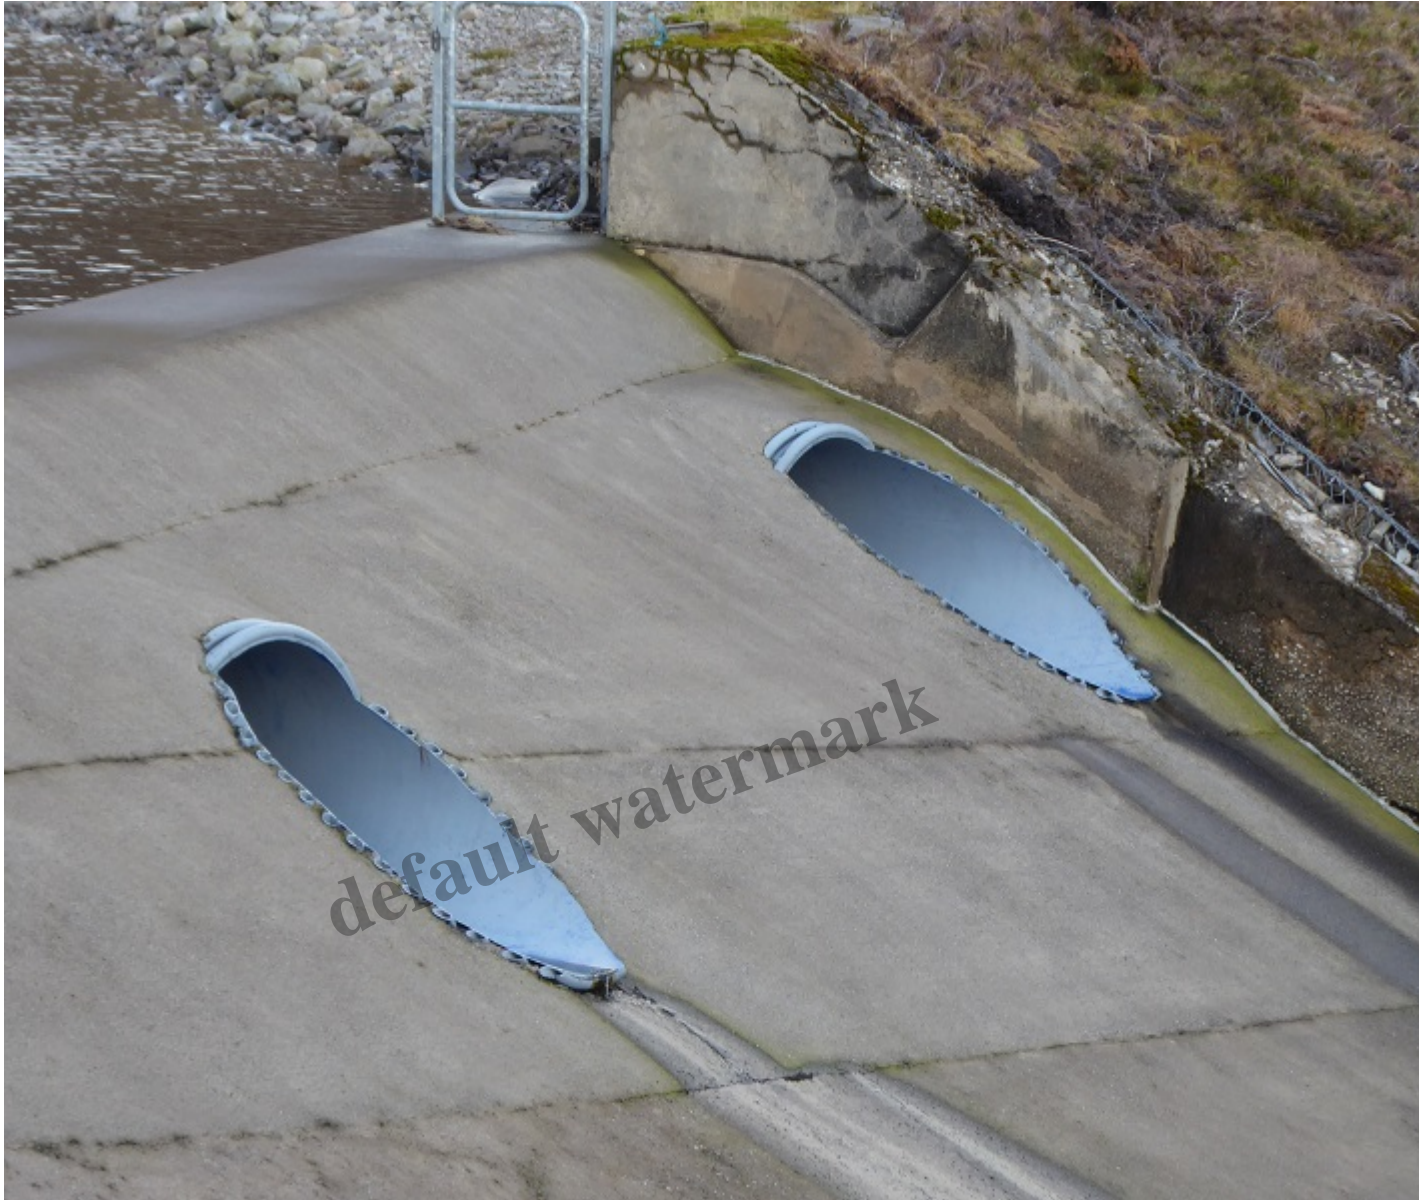
The intake overflow pipes – which were bright blue – have been painted and to my mind are far less
