The restoration of the Glen Bruar hydro scheme (2)

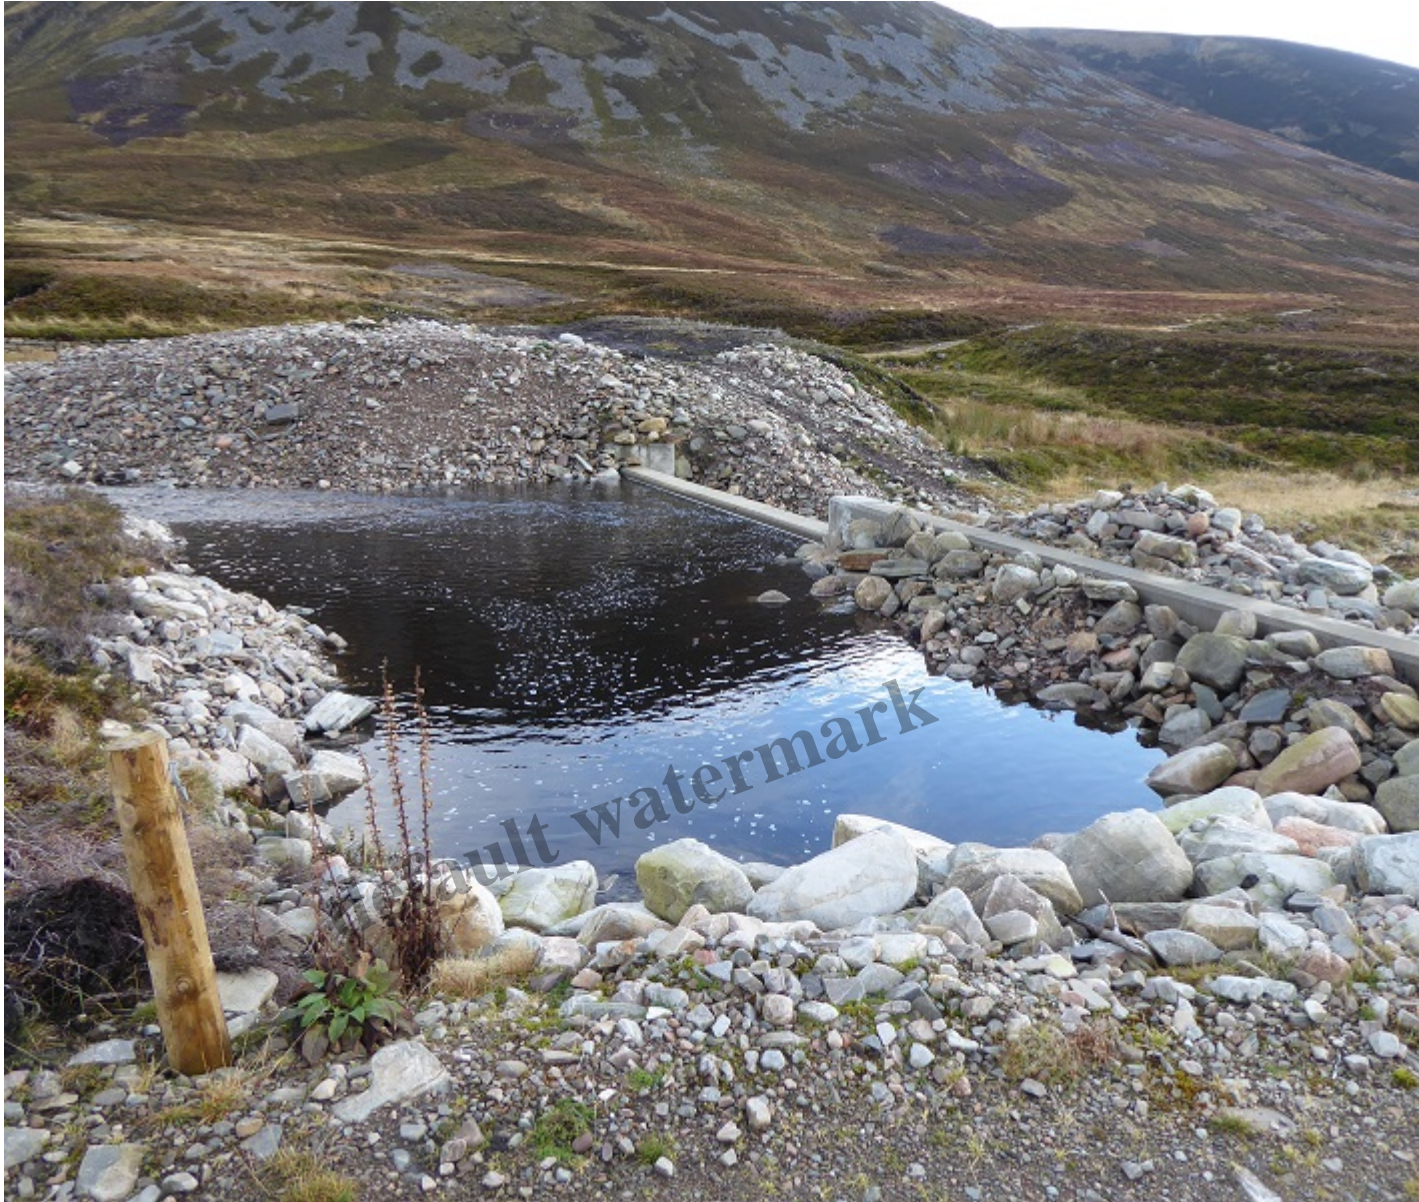
A pool was created at the secondary intake to make it appear more natural.

While there has been significant improvements in revegetating ground around the top intakes, I am not sure that the work to improve the secondary intake has been successfully. The river bed here was bouldery but the piles of boulders created to make the dam and cover up the concrete still look as though they have been bulldozed into place rather than deposited naturally.

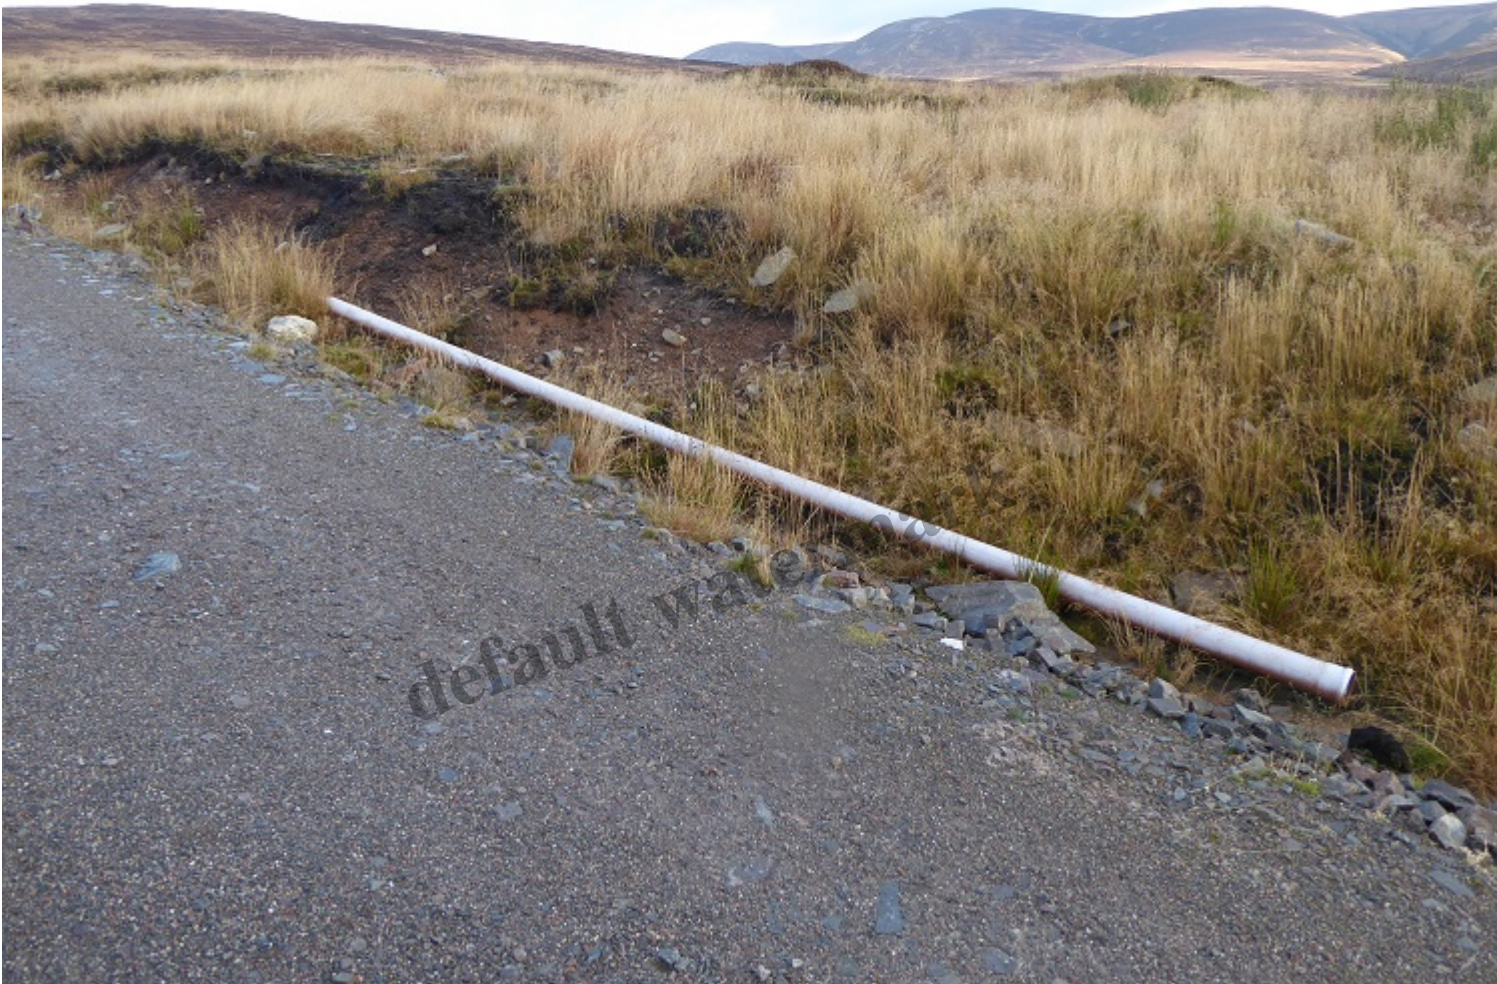
There are also other major (first photo) and minor bits (photo above) of clear up required.
