The restoration of the Glen Bruar hydro scheme (2)

December 1, 2017

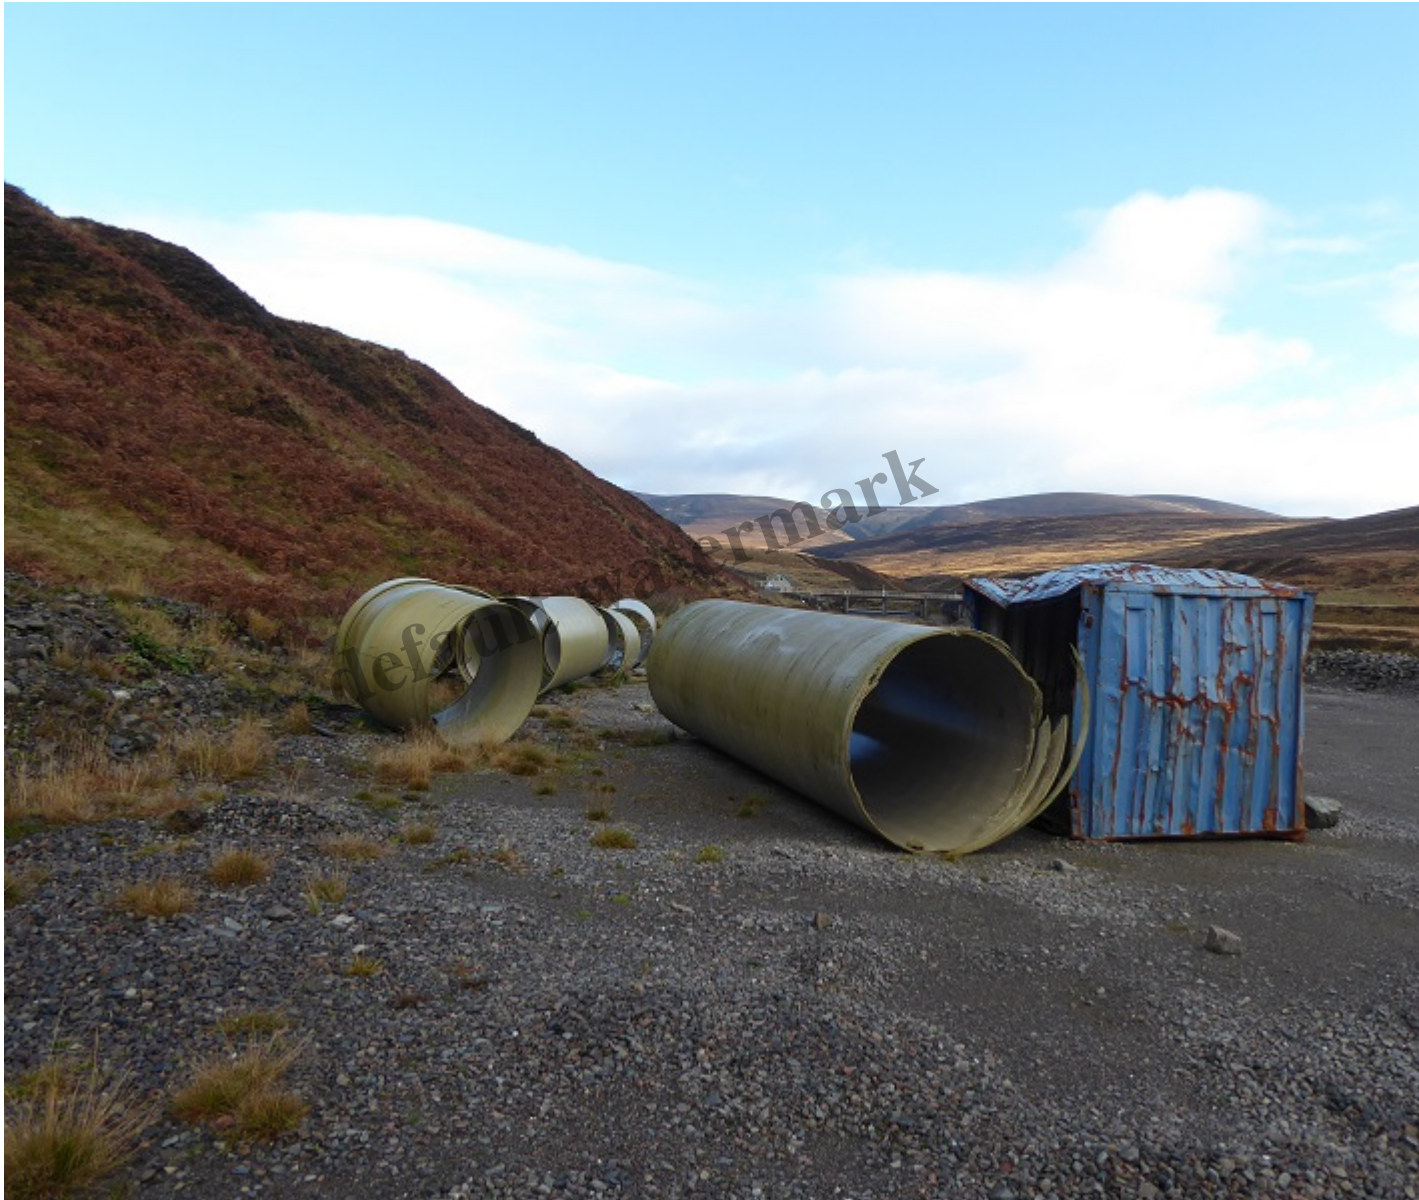
Its now two years since the Bruar hydro scheme opened and yet these broken sections of pipe and v container have still not been removed from the glen

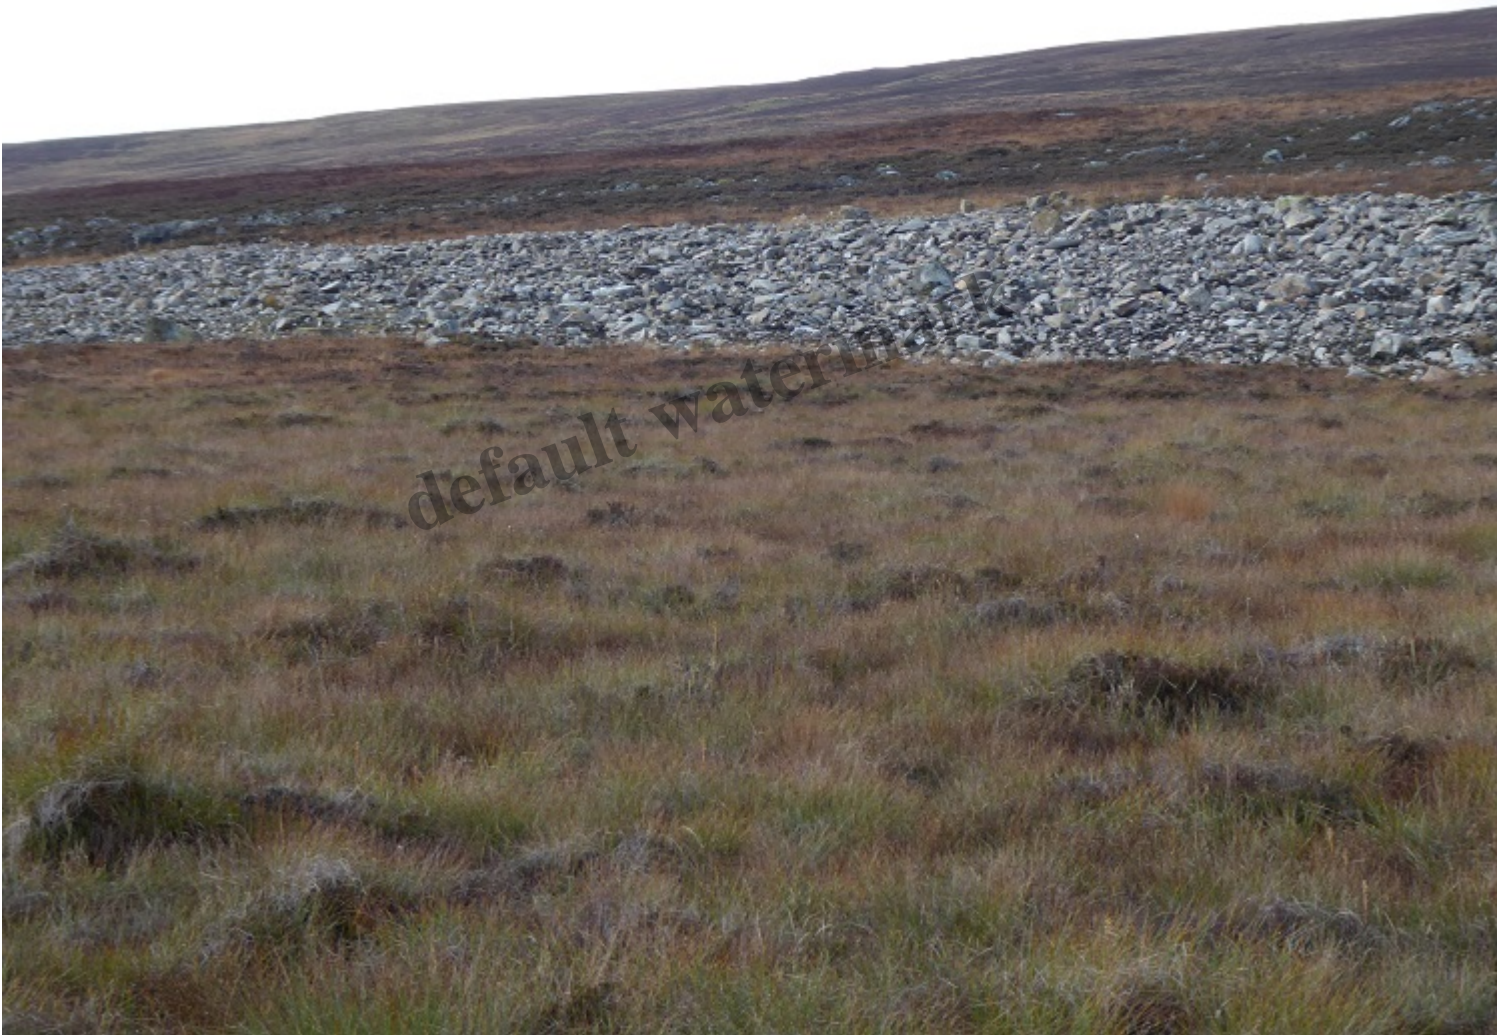
A section of the boulder scar which ran between the powerhouse and the intake which has not been restored. Somewhat paradoxically, what I regard as the most impressive aspect of the restoration work – the initial boulder scar was a landscape disaster ([see here](#)) – the “repair” of the land above the pipeline is least documented. While detailed plans were improved in July to the minor intake, the two pipe bridges and the power house embankment, there is no proper specification for the restoration of the pipeline. The documentation that has recently been added ([see here](#)), says little more than the [reinstatement note](#) from February 2016 which acknowledged the pipeline scar was an issue which would be fixed by removing some of the boulders and robbing turves from neighbouring areas.

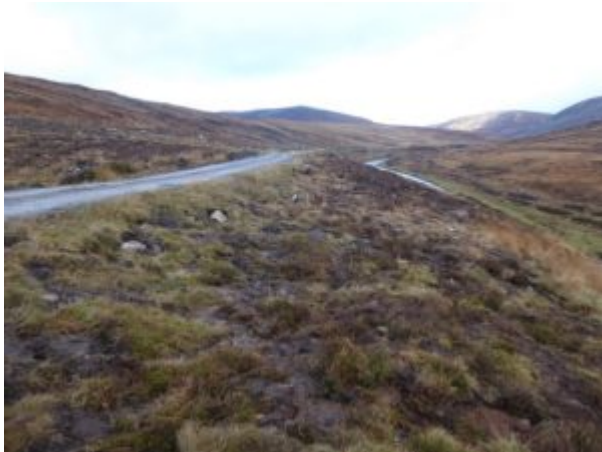
Photo showing robbed area to right of track and restored area to left

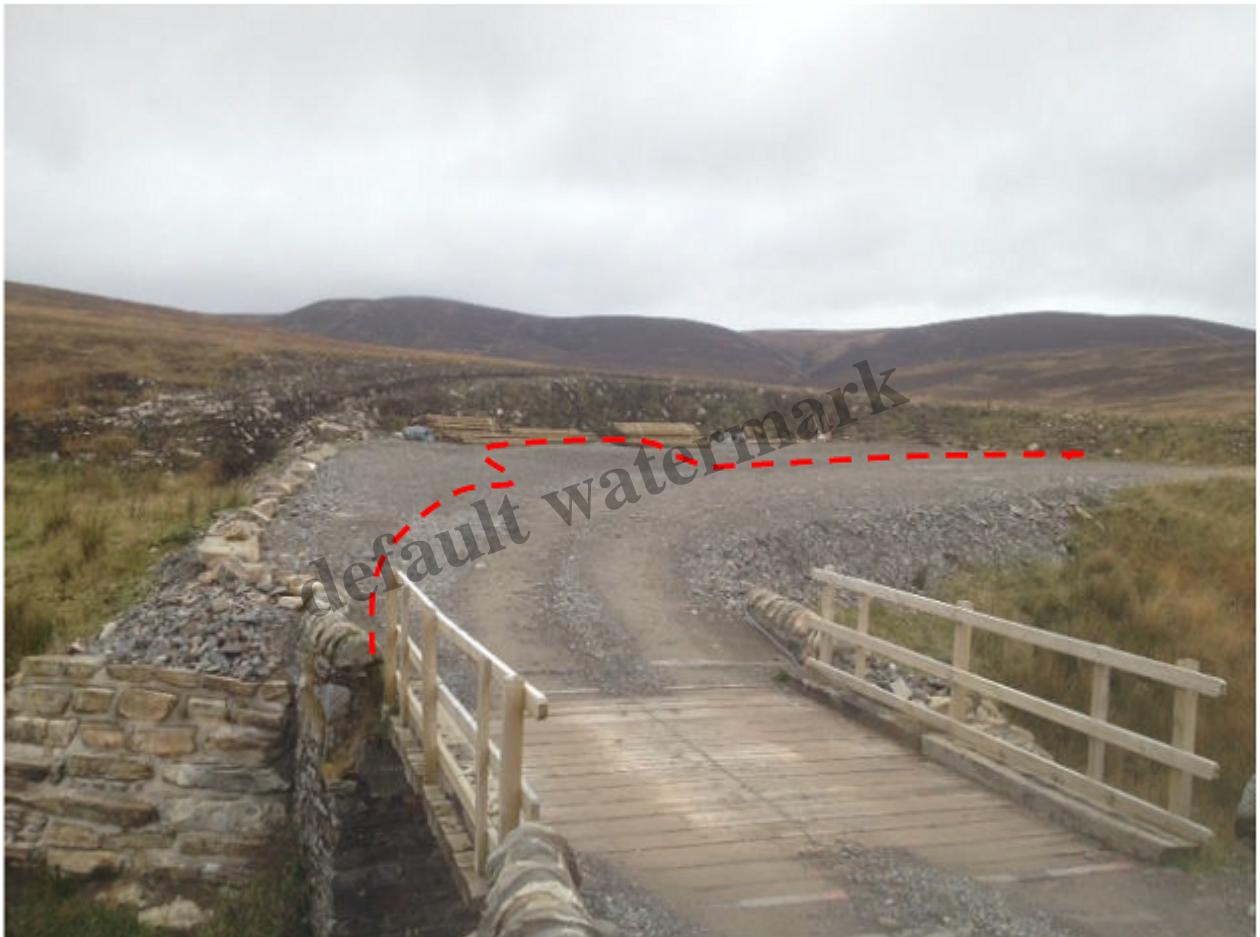
1) The narrowing of the access track on corners by restoring levels to match surrounding and proposals for reinstatement of vegetation/appropriate seeding.

The corner after the existing bridge will be narrowed and reduced, taken back to existing profiles with a small passing place retained - as the existing track had prior to construction.

The stones and as much of the type 1 road layer as possible will be removed. The mound at the rear of the widening (see picture above) will then be used to cover over the track. There is evidence of regrowth in this mound and this will be careful reutilised to assist in regenerating the area. Small areas of turfs will also be ‘robed locally’ and distributed across the area should the cover of vegetation be minimal. Removal of material in the bank will present the opportunity to smooth the banks and lessen the sharpness. The dashed line above in red shows the proposed profile.

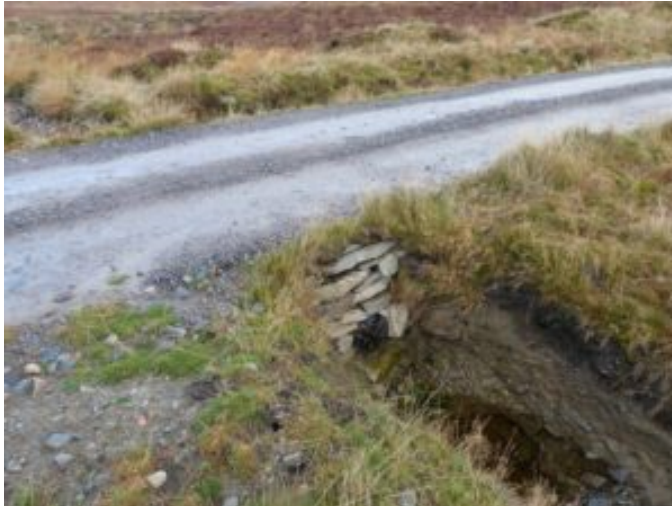
Finished culvert with turf placed above stone

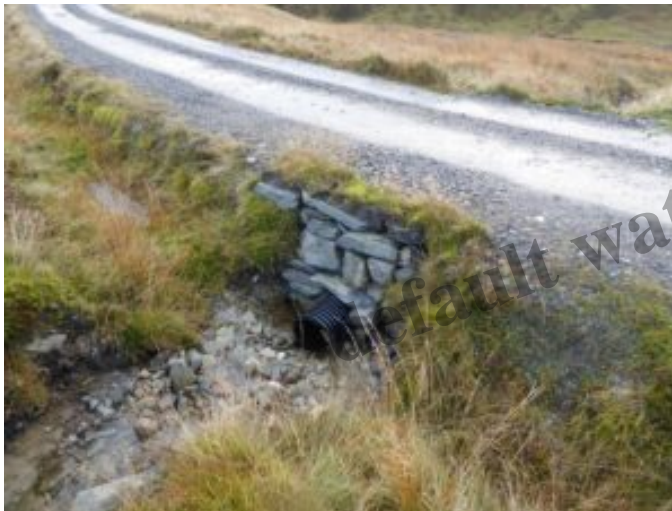
Same culvert, other side of road, protruding – why?

2) Culvert pipe ends exposed at water crossing near the st shall be trimmed back.

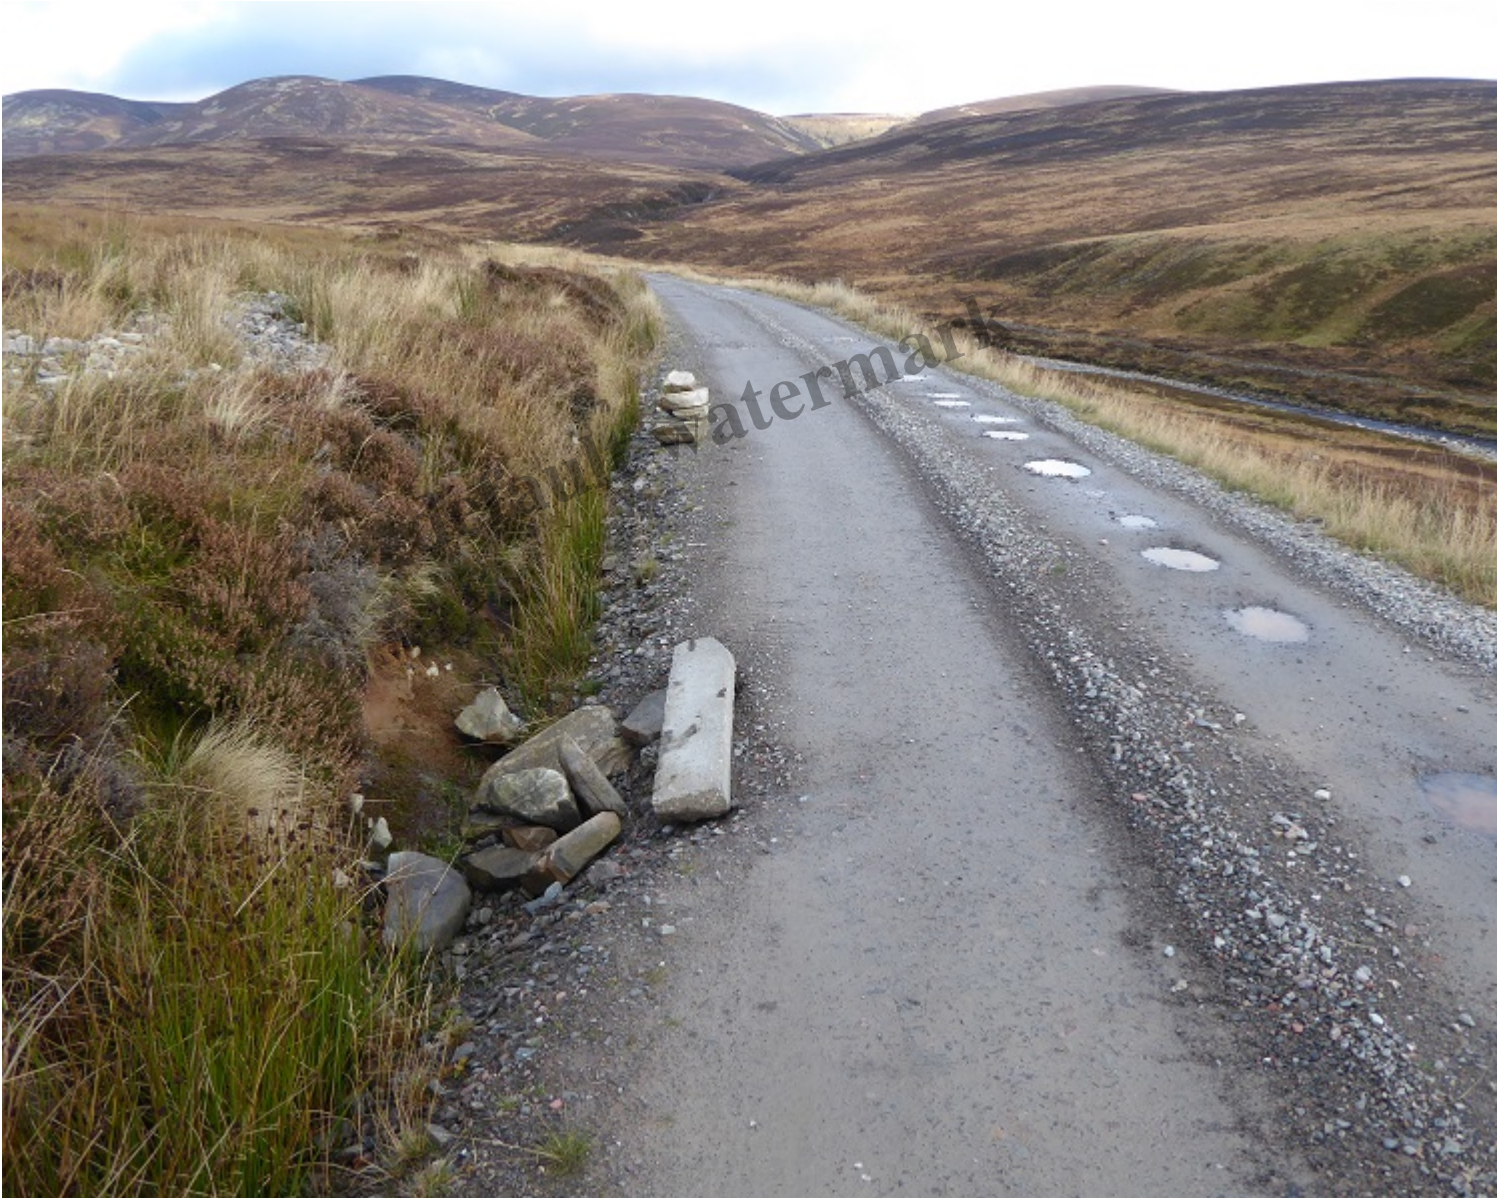
In several places the edge of the road is eroding. It is hard to tell if the stone has been placed there for work yet unfinished or to mark the holes.

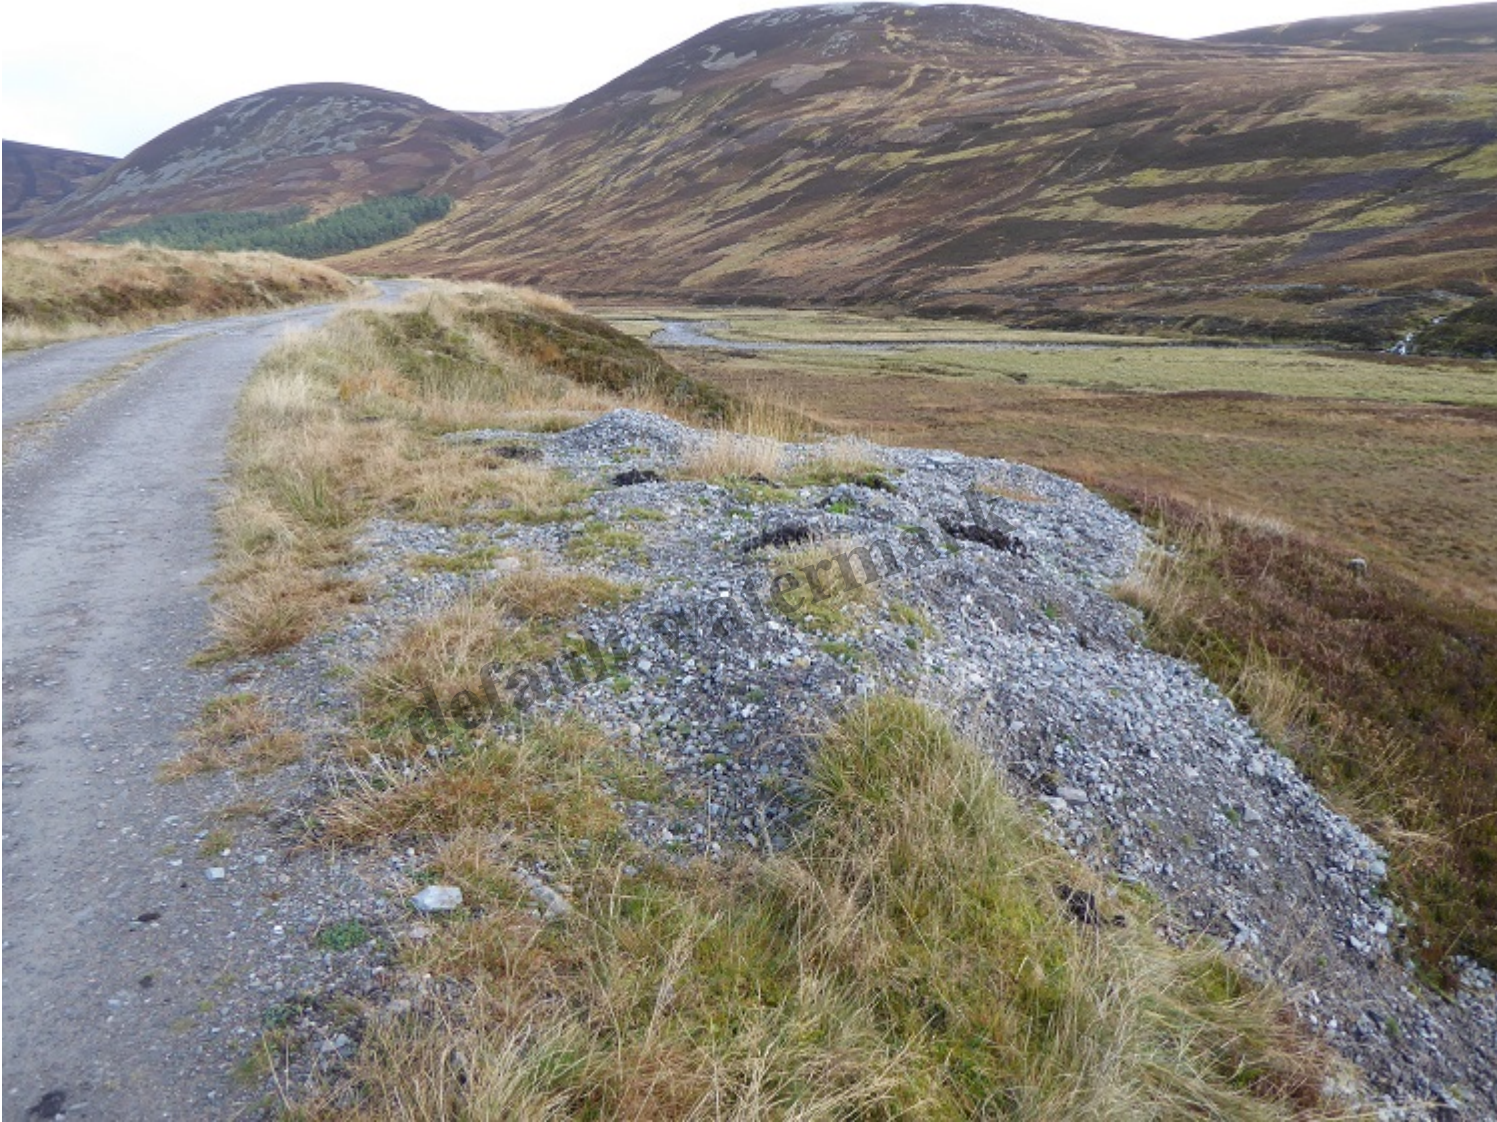
In other places dumped aggregate has not been removed and is spilling down the slopes beside the track.

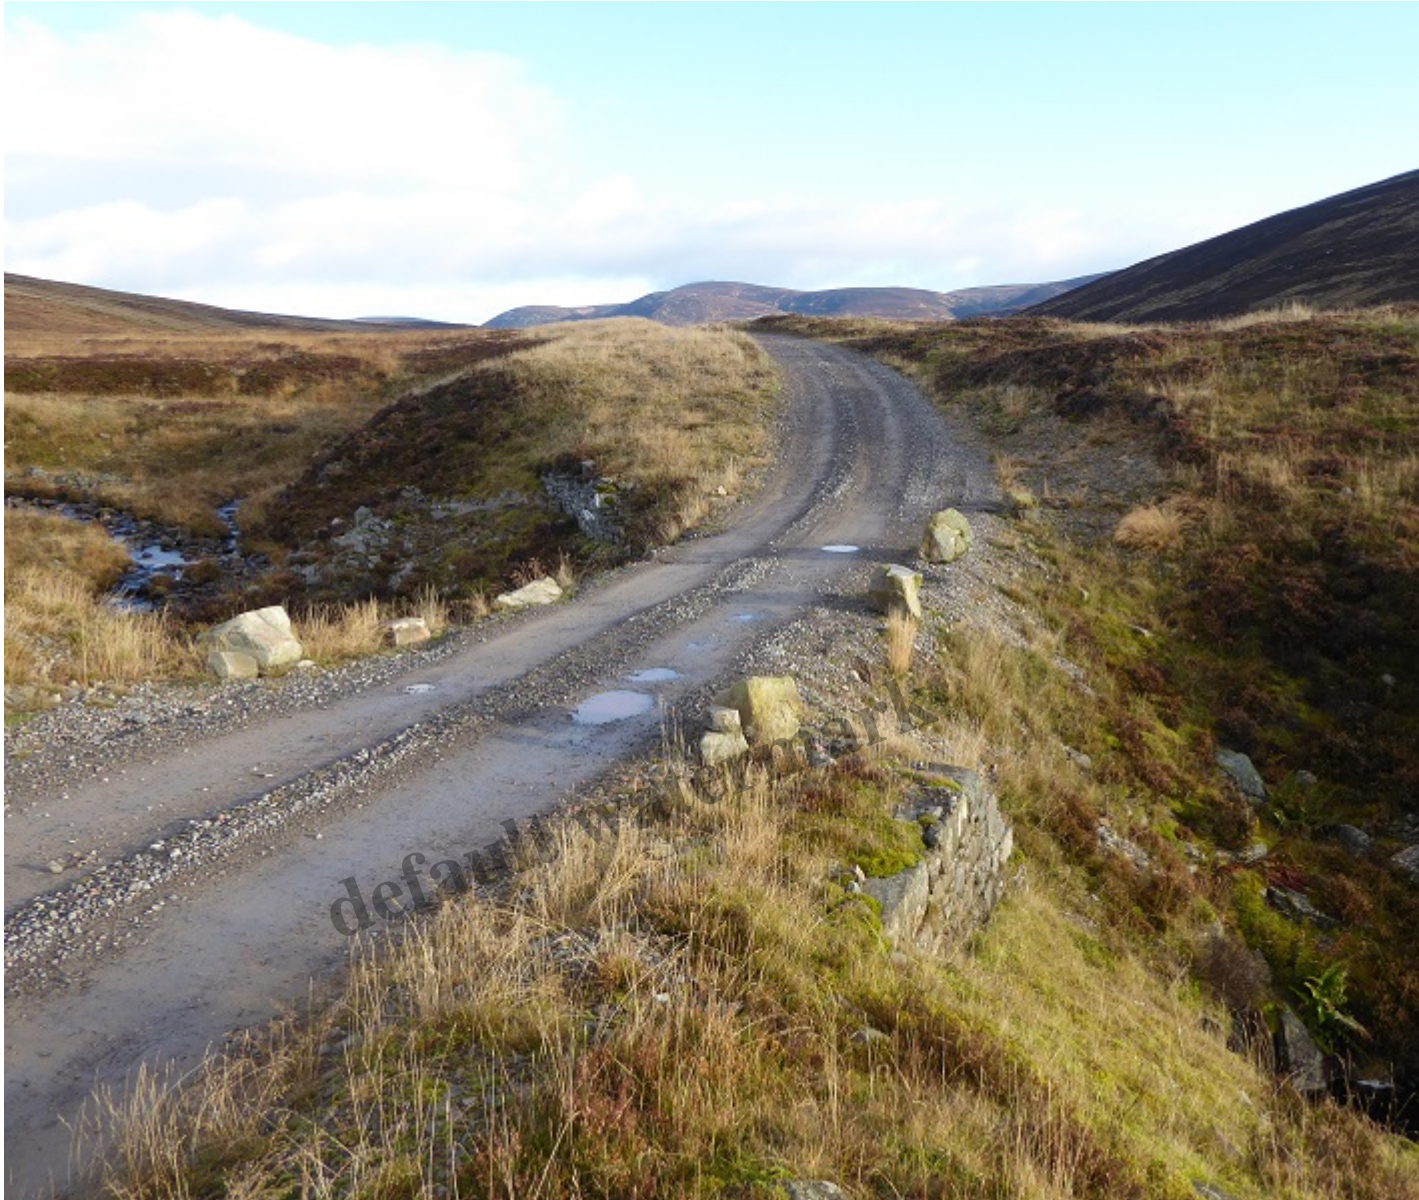
Poor finishing with material from the edge of the track spilling down towards the culverted burn below

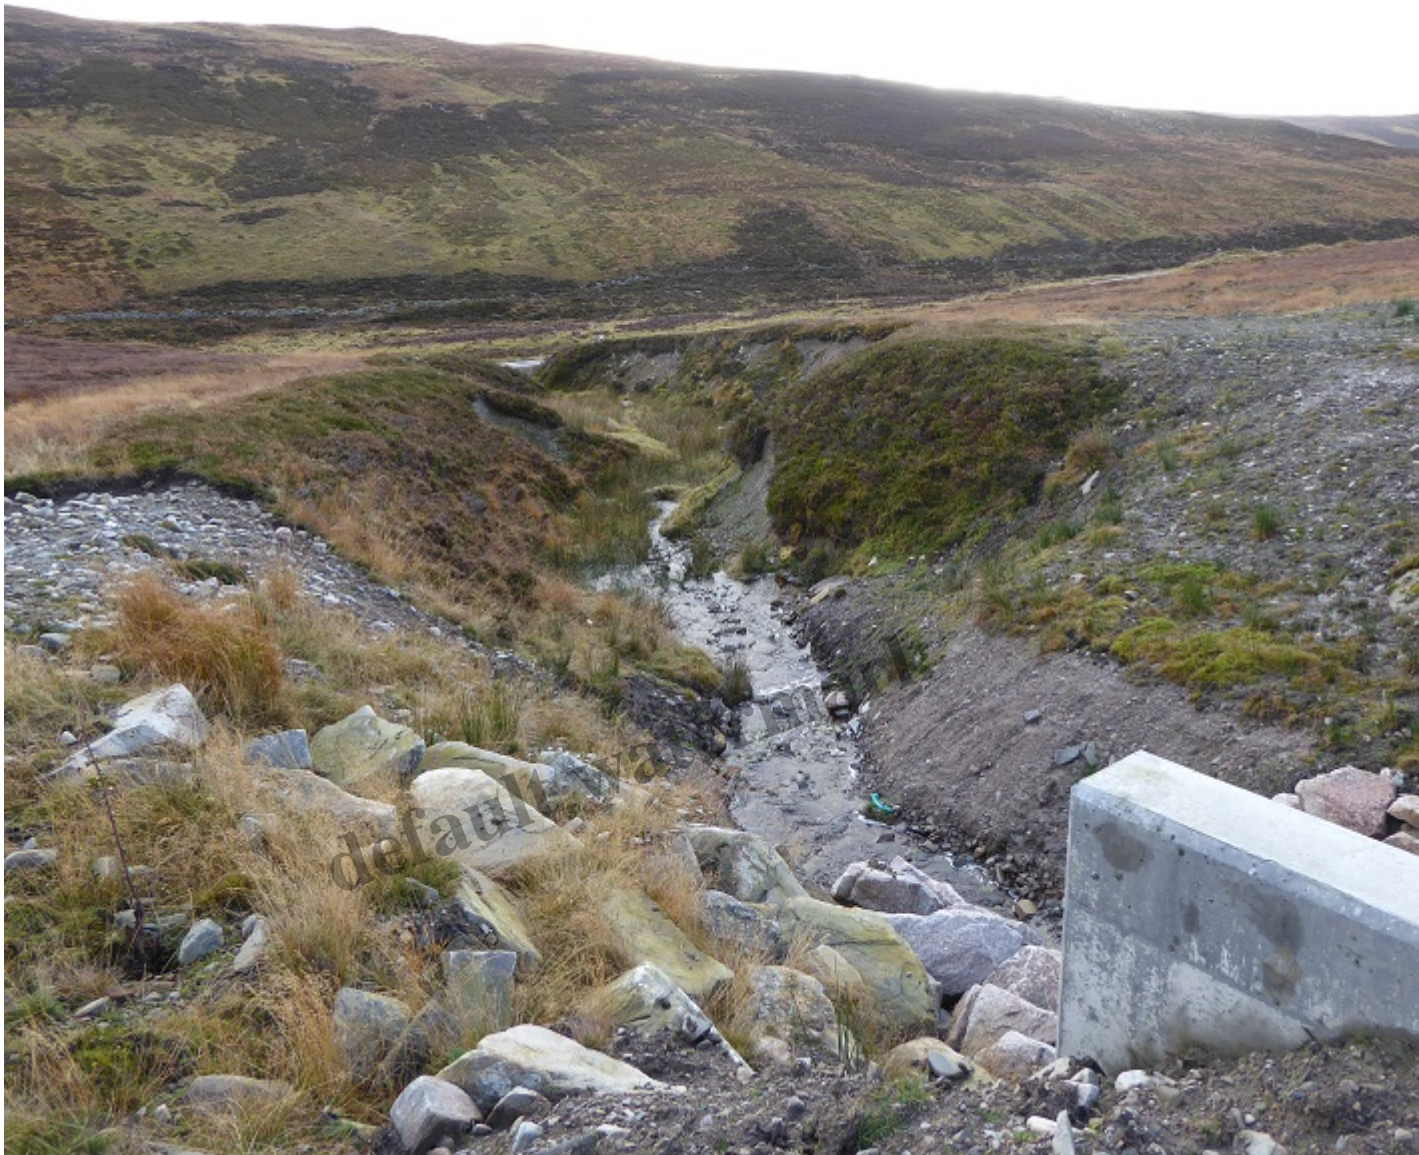
The banks of burn below the concrete plinth which are bare and will erode contrast with how the bank previously – heather covered. There is a very large patch of bare ground to the right.

The rip rap bouldering to protect the banks around the plinth looks a mess, there is a large patch of bare ground and the banks of the burn have not been restored with vegetation and one would have thought at risk of rapid erosion.
