The restoration of the Glen Bruar hydro scheme (2)

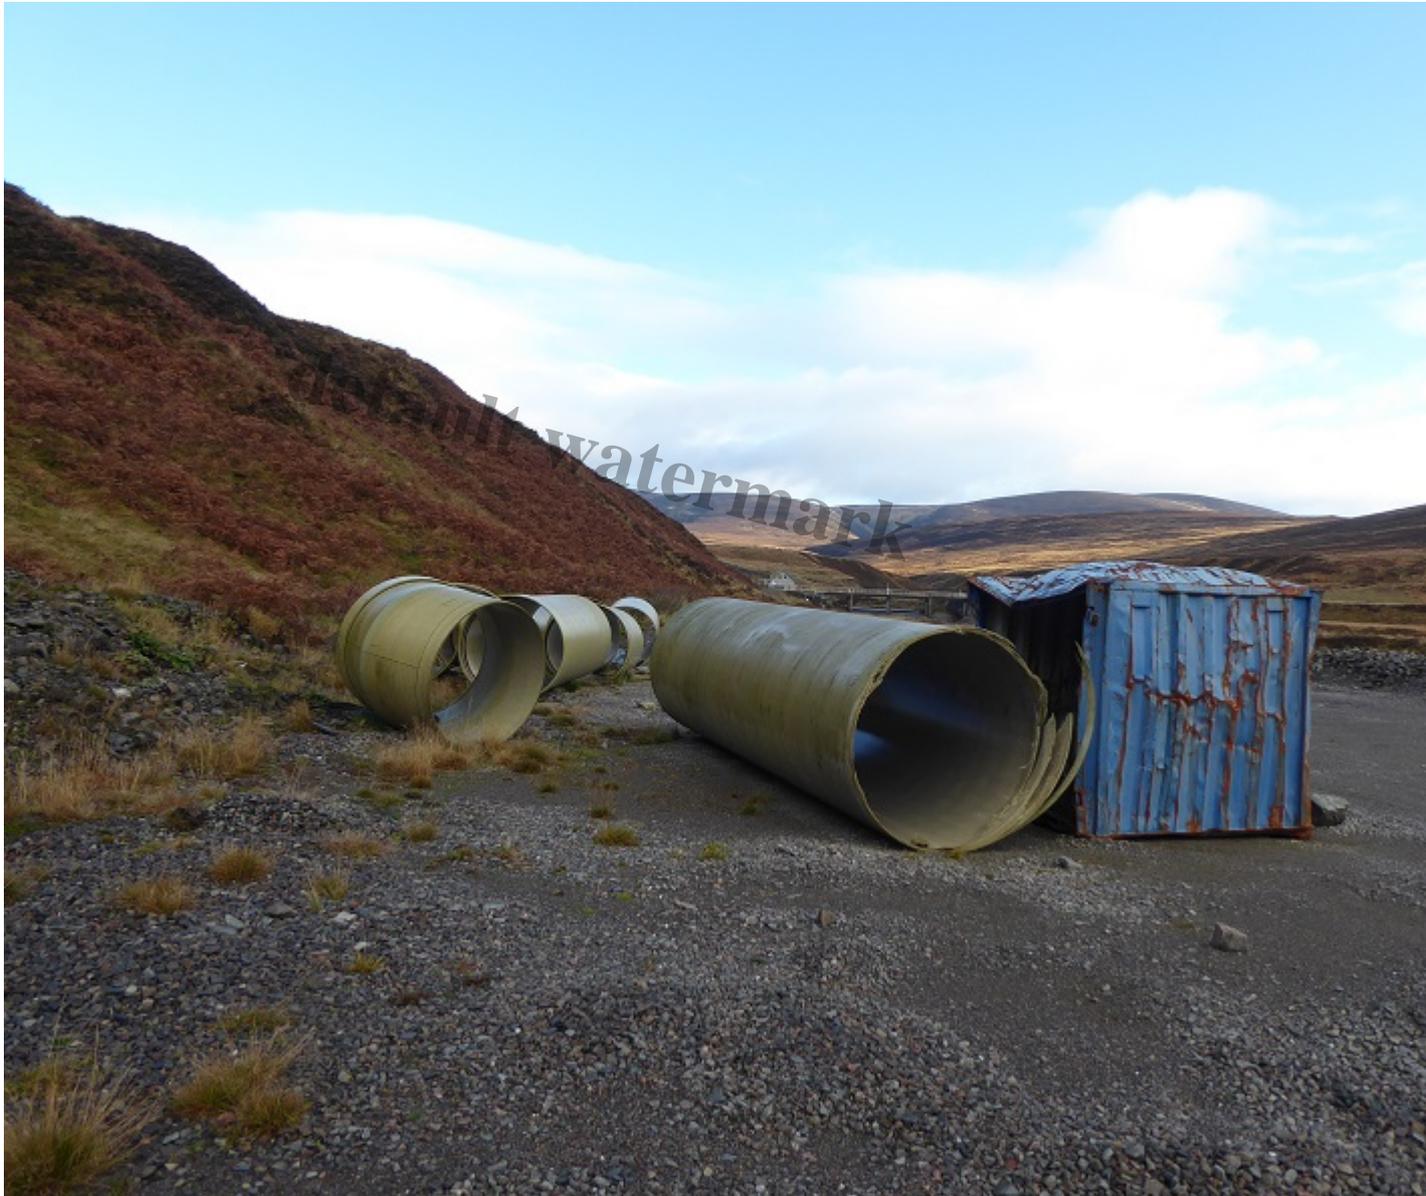
Its now two years since the Bruar hydro scheme opened and yet these broken sections of pipe and v container have still not been removed from the glen

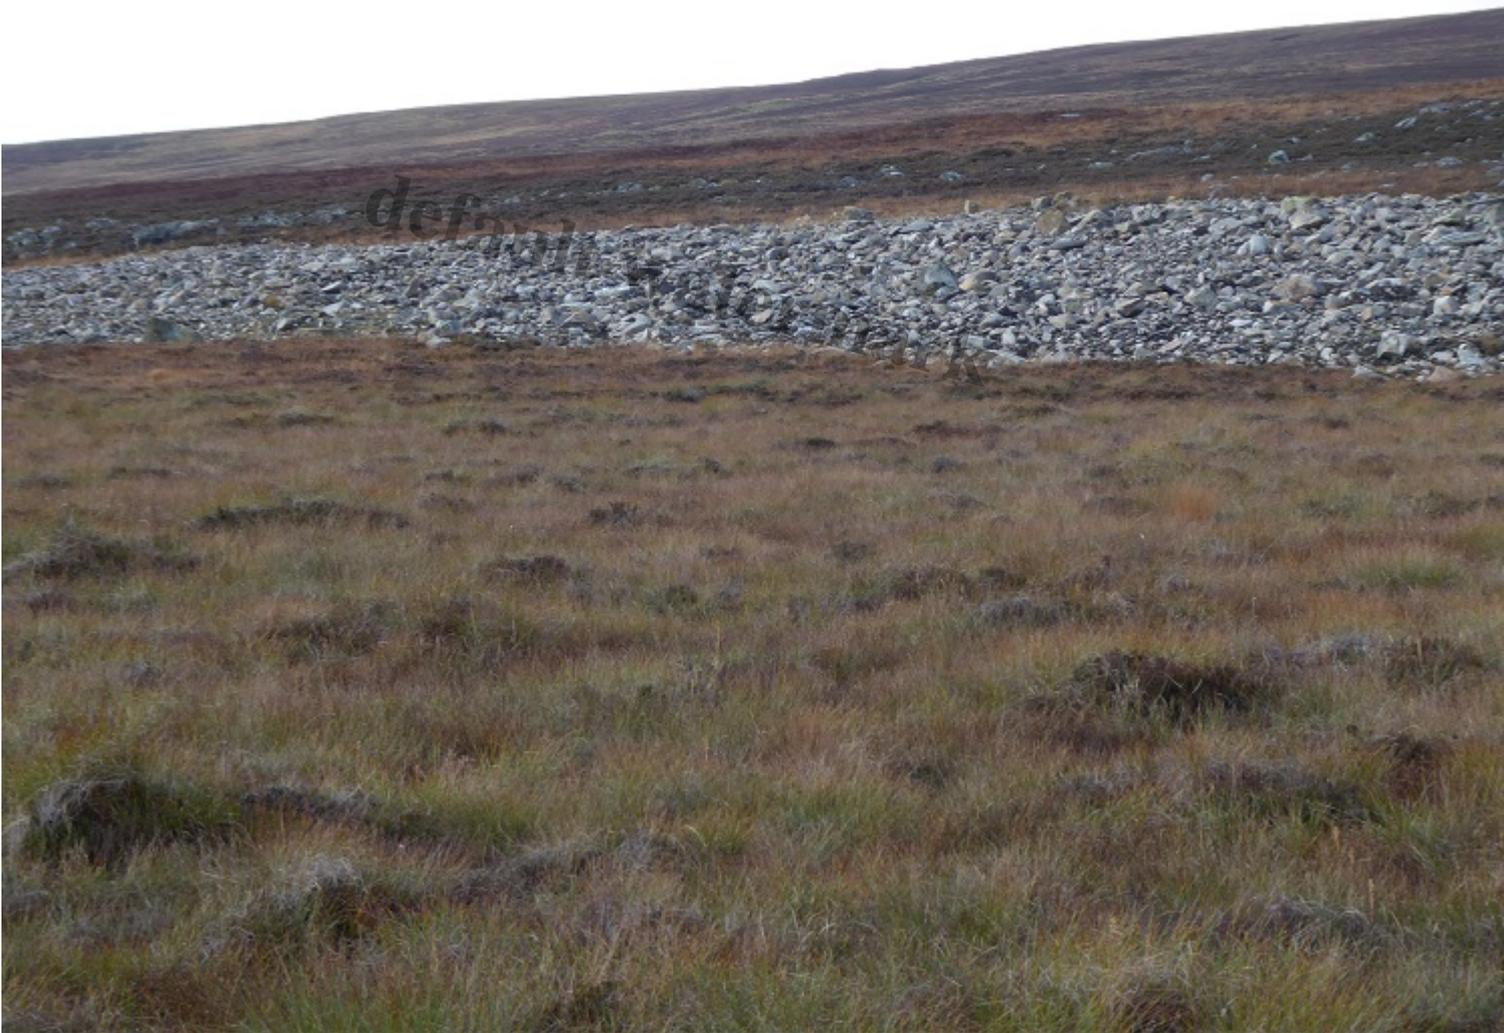
A section of the boulder scar which ran between the powerhouse and the intake which has not been restored. Somewhat paradoxically, what I regard as the most impressive aspect of the restoration work â?? the initial boulder scar was a landscape disaster ([see here](#)) â?? the â??repairâ?• of the land above the pipeline is least documented. While detailed plans were improved in July to the minor intake, the two pipe bridges and the power house embankment, there is no proper specification for the restoration of the pipeline. The documentation that has recently been added ([see here](#)), says little more than the [reinstatement note](#) from February 2016 which acknowledged the pipeline scar was an issue which would be fixed by removing some of the boulders and robbing turves from neighbouring areas.

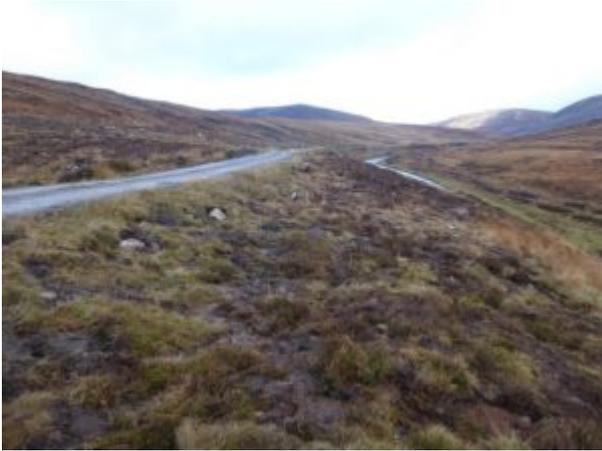
Photo showing robbed area to right of track and restored area to left

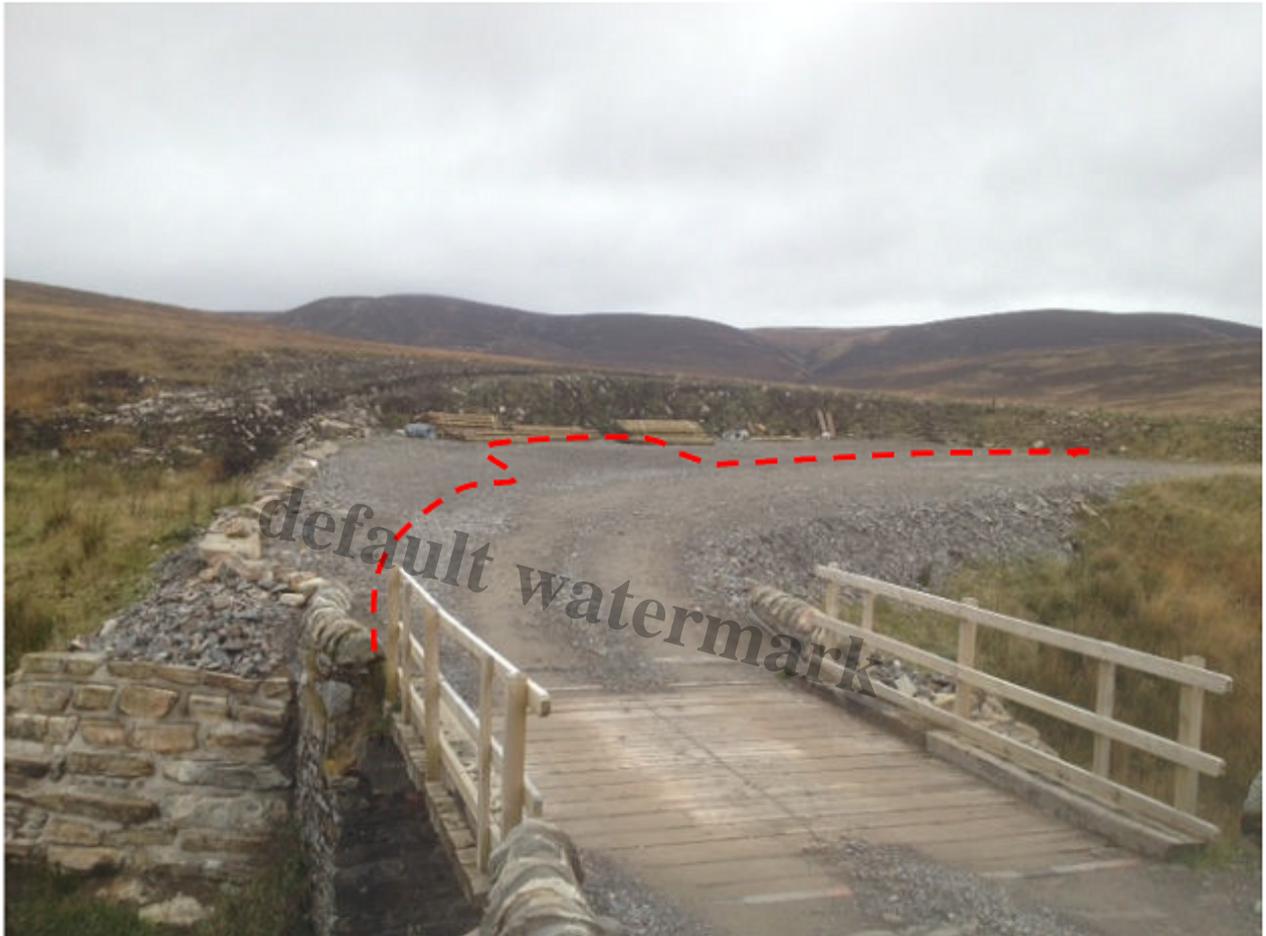
1) *The narrowing of the access track on corners by restoring levels to match surrounding and proposals for reinstatement of vegetation/appropriate seeding.*

The corner after the existing bridge will be narrowed and reduced, taken back to existing profiles with a small passing place retained - as the existing track had prior to construction.

The stones and as much of the type 1 road layer as possible will be removed. The mound at the rear of the widening (see picture above) will then be used to cover over the track. There is evidence of regrowth in this mound and this will be carefully reutilised to assist in regenerating the area. Small areas of turfs will also be 'robed locally' and distributed across the area should the cover of vegetation be minimal. Removal of material in the bank will present the opportunity to smooth the banks and lessen the sharpness. The dashed line above in red shows the proposed profile.

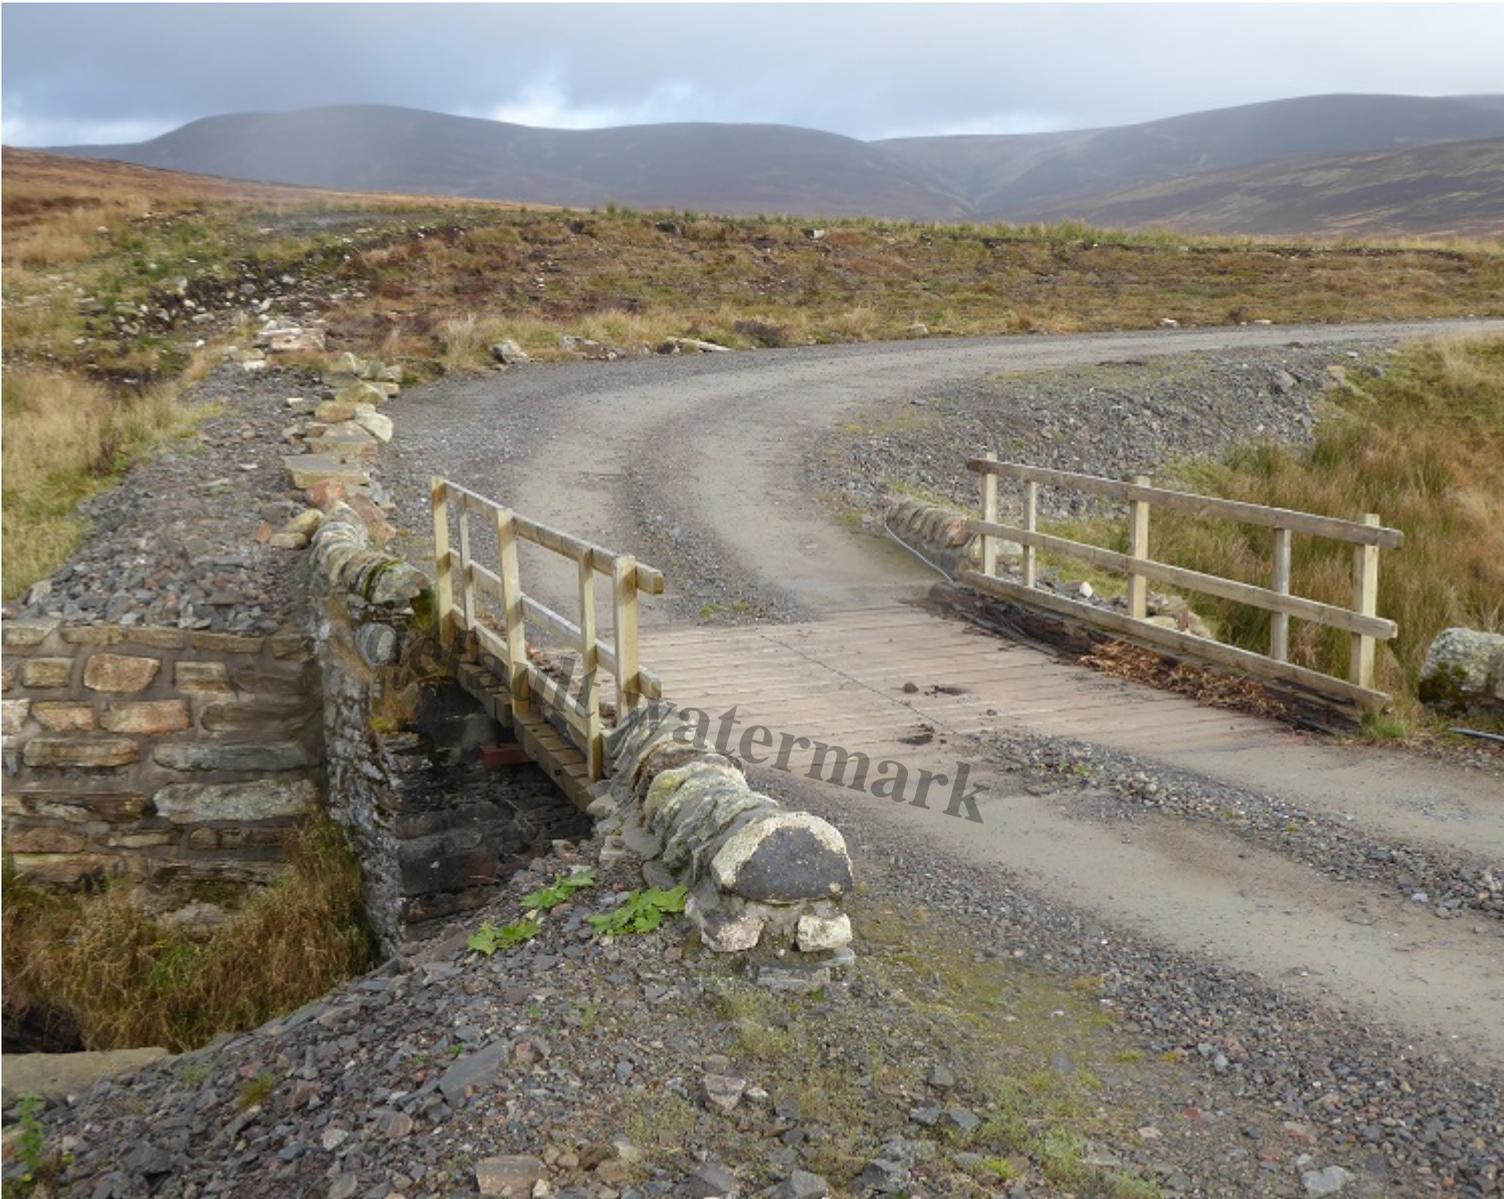
A significant improvement (although the right edge of the road has not been revegetated and is at high risk of erosion). Other parts of the road along the glen appear to have also been narrowed with the result it is no longer a race track.

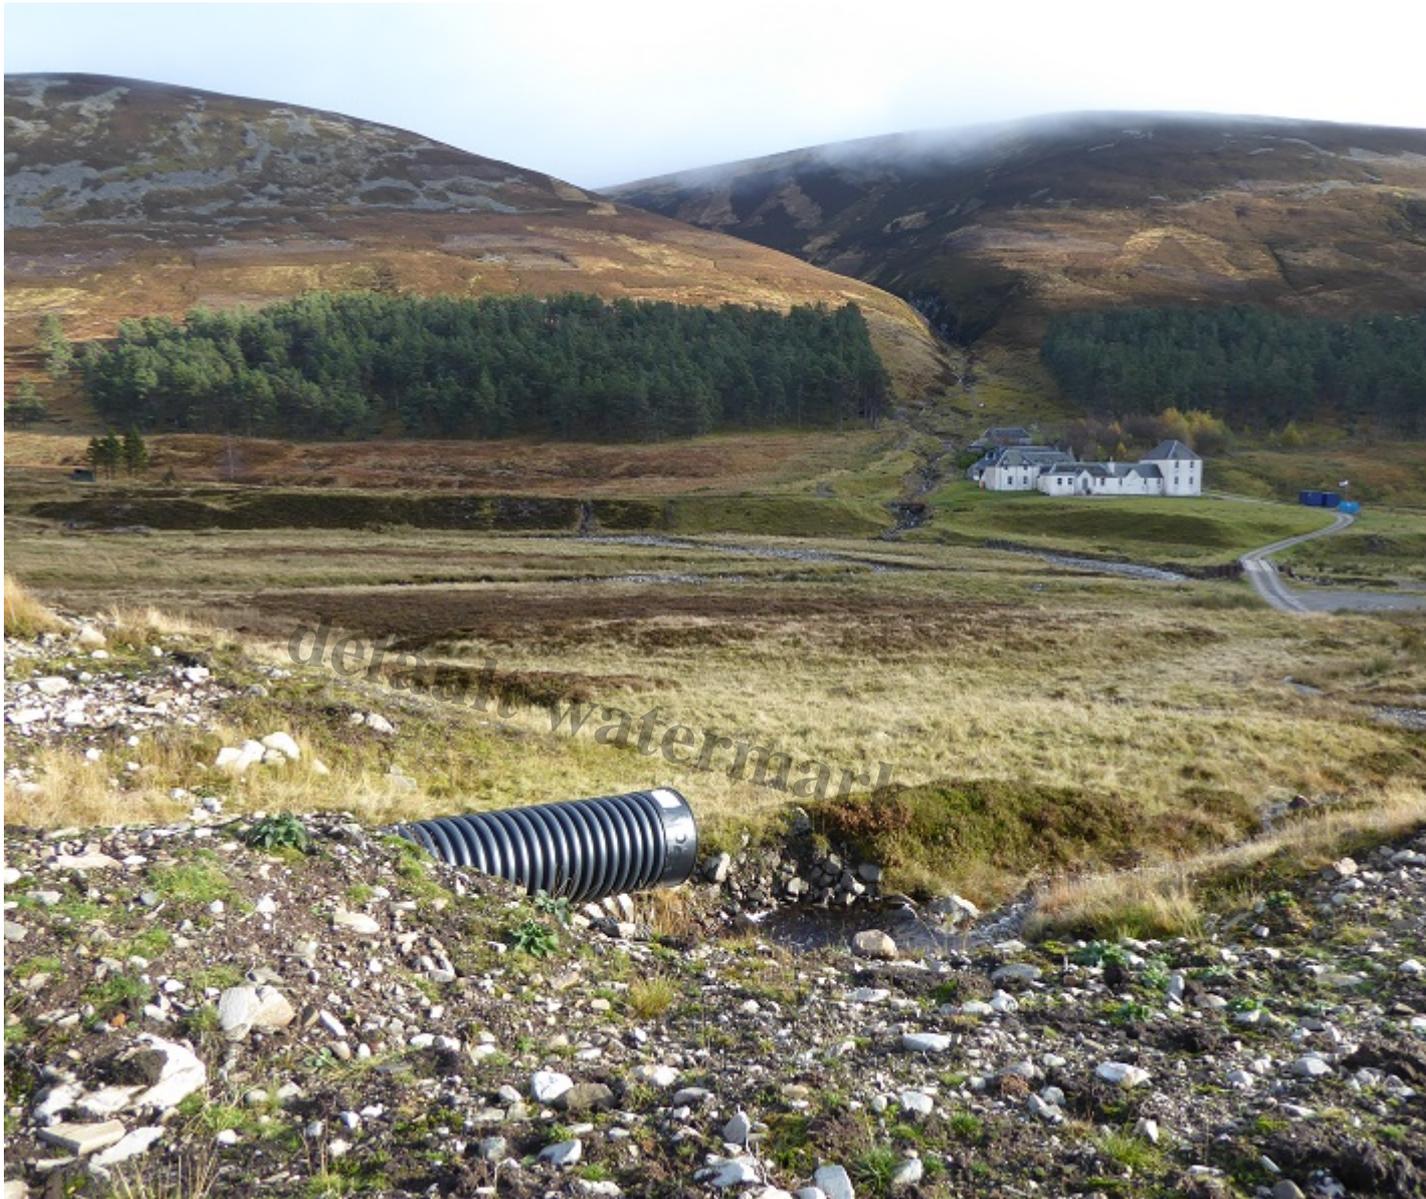
The worst of the protruding culverts

There are a significant number of what appear to be new protruding plastic culverts along the track and there appears to rhyme or reason to what has been fully finished, partially finished and what just left:

2) Culvert pipe ends exposed at water crossing near the st shall be trimmed back.

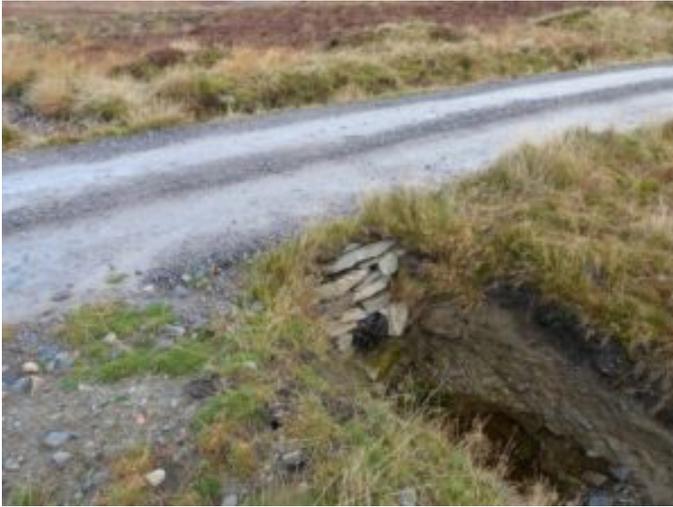
Finished culvert with turf placed above stone

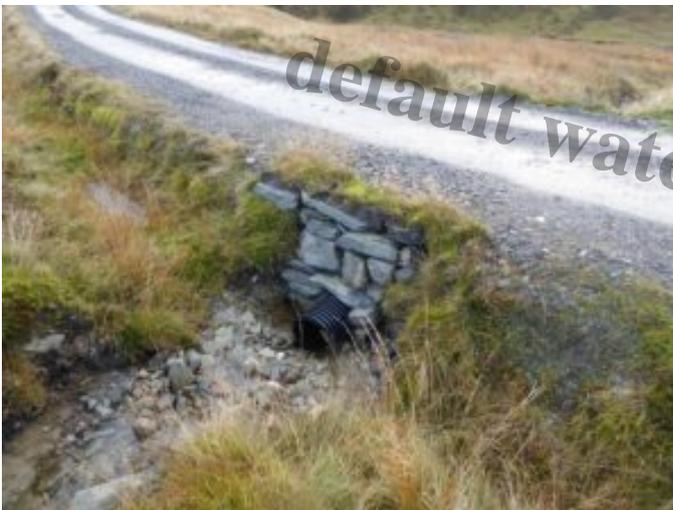
Same culvert, other side of road, protruding
â?? why?

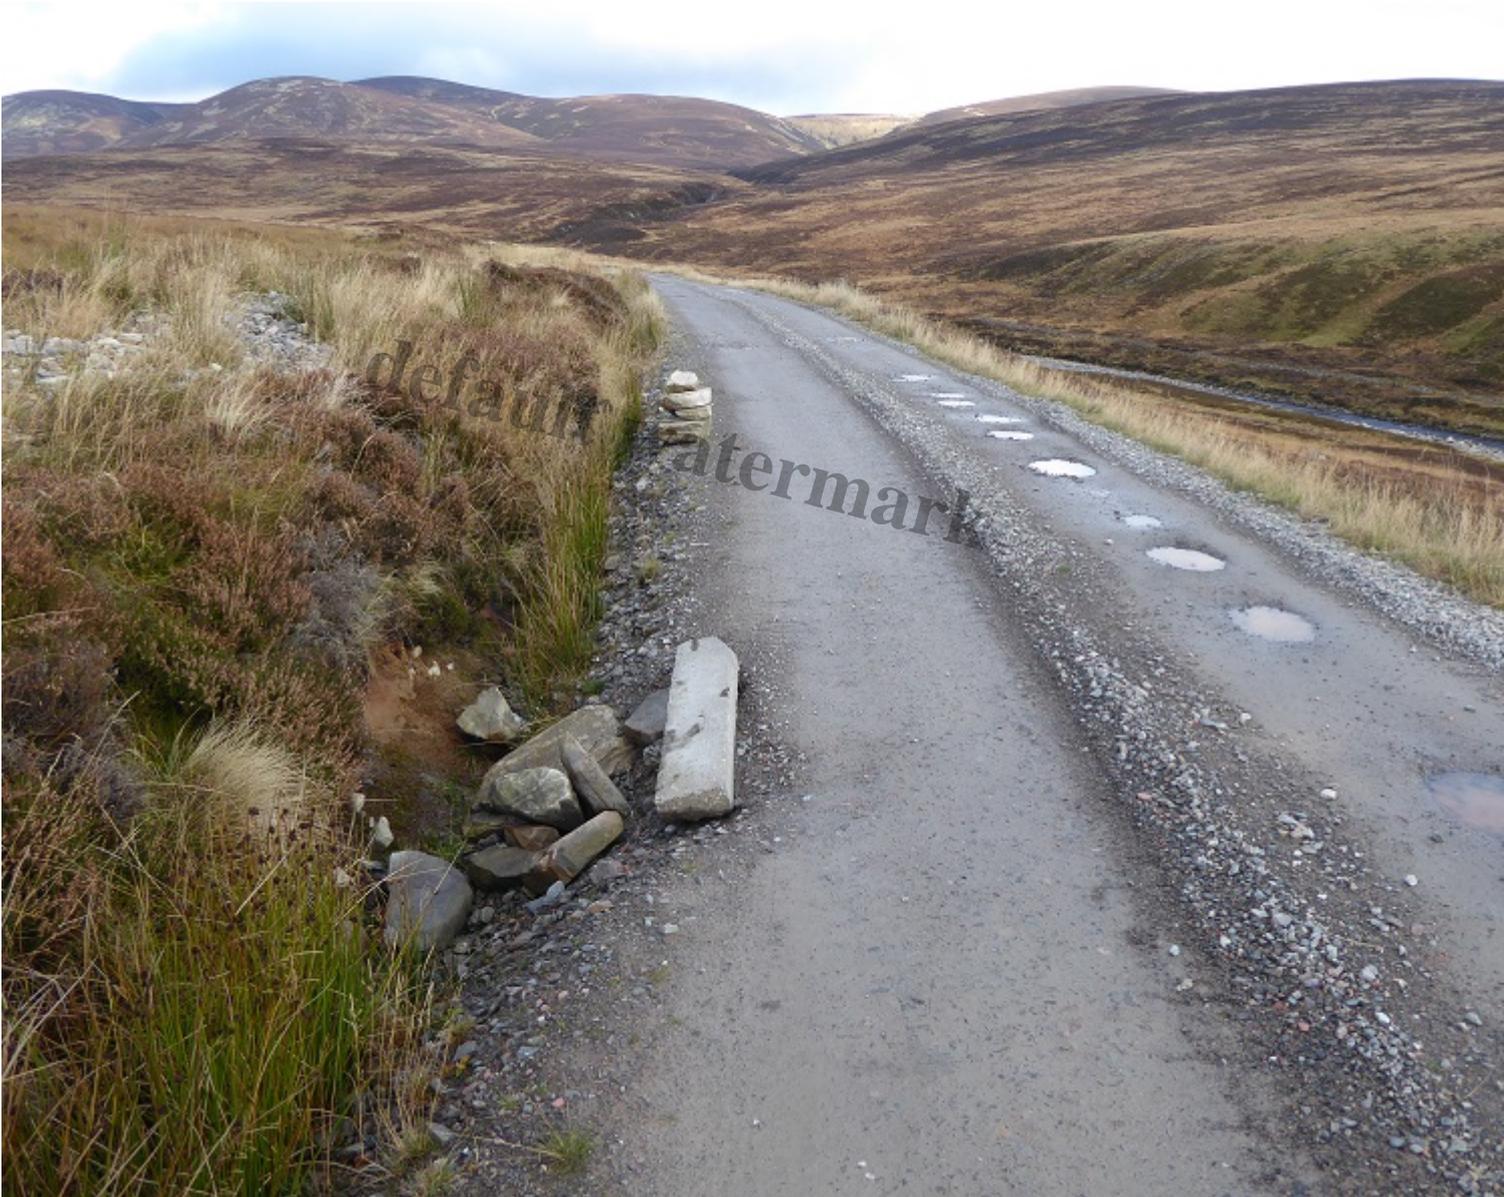
In several places the edge of the road is eroding. It is hard to tell if the stone has been placed there for work yet unfinished or to mark the holes.

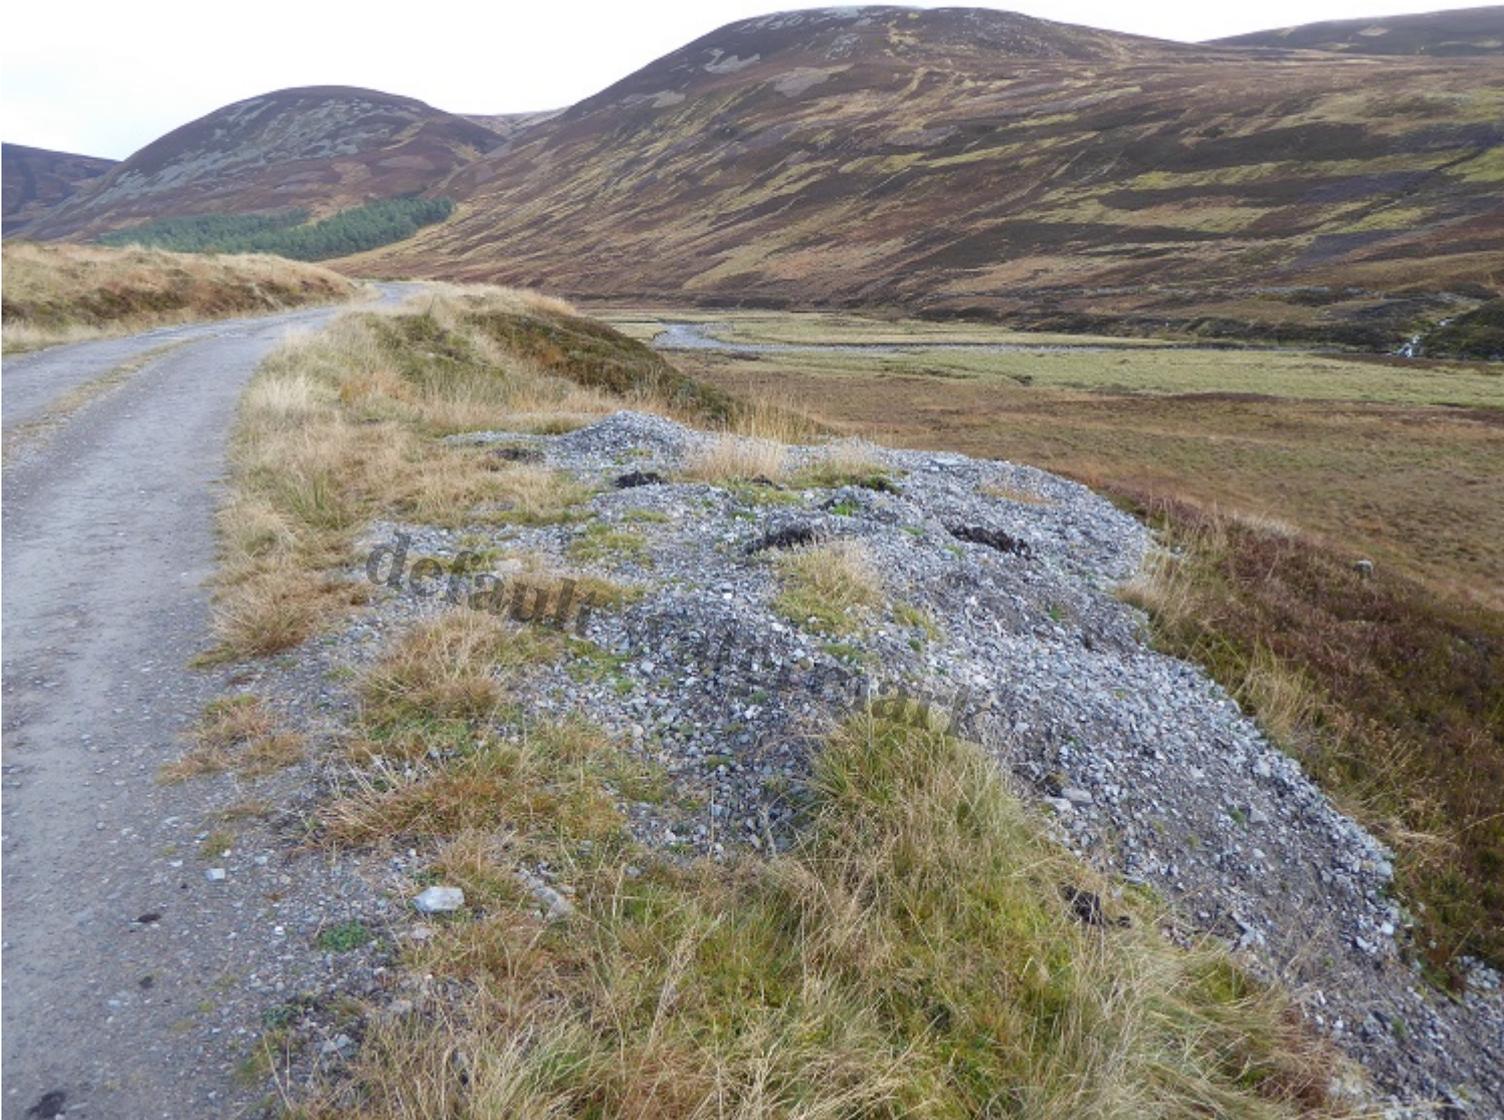
In other places dumped aggregate has not been removed and is spilling down the slopes beside the track.

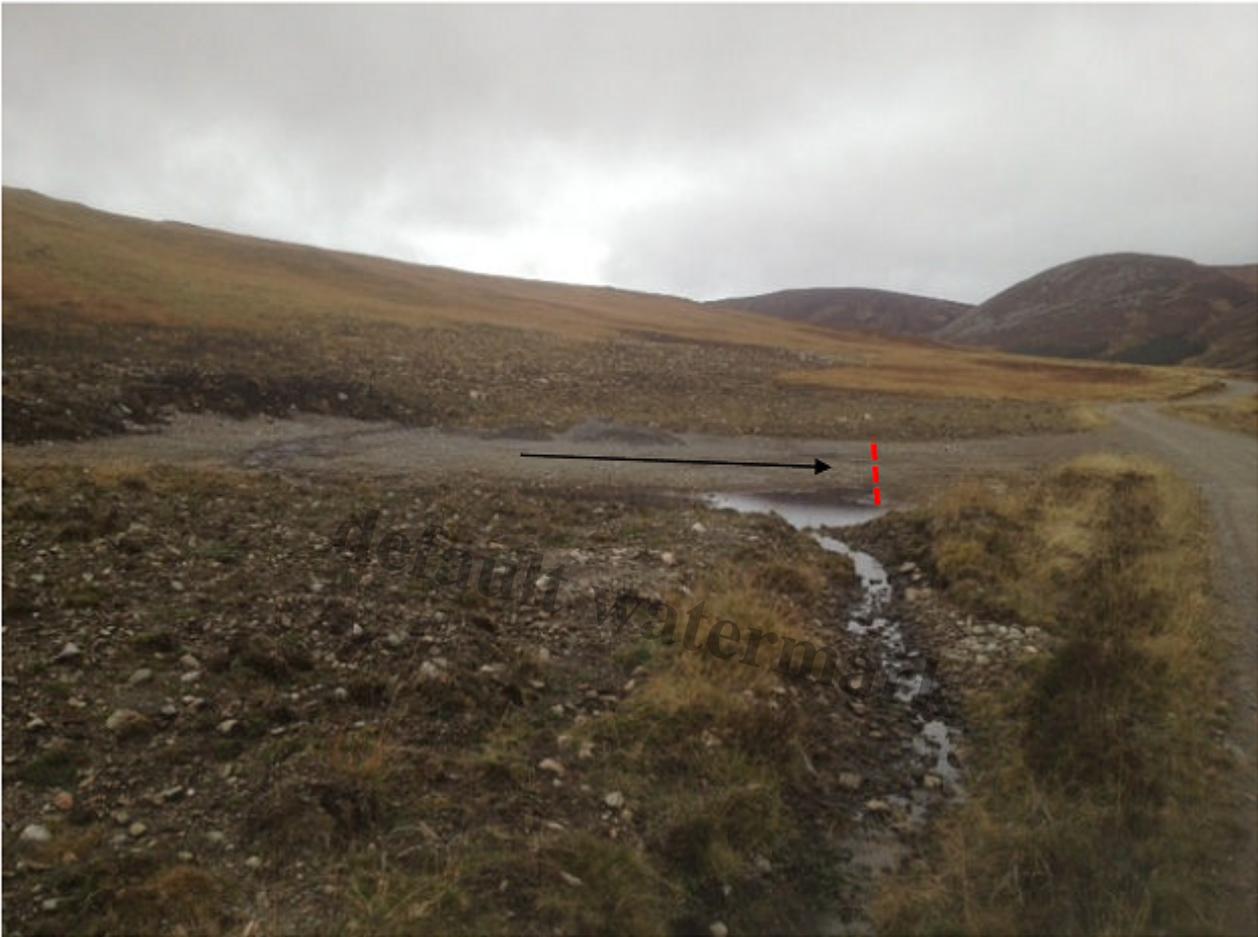
result for the largest area (featured above) leaves a lot to be desired, with no evidence so far of the robbing turves technique to restore bare ground as used so successfully on the pipeline:

There is a large laydown area on the midpoint of the pipeline route. Prior to construction this was originally a storage area for stone to repair the road – allowing a local stock pile to aid repair of pot holes. This is why it was proposed to retain this but following dialogue with CNPA we consider it would be better to reduce it significantly to a similar scale to the existing lay down prior to construction commencing. See picture below with arrow showing reduction in size.

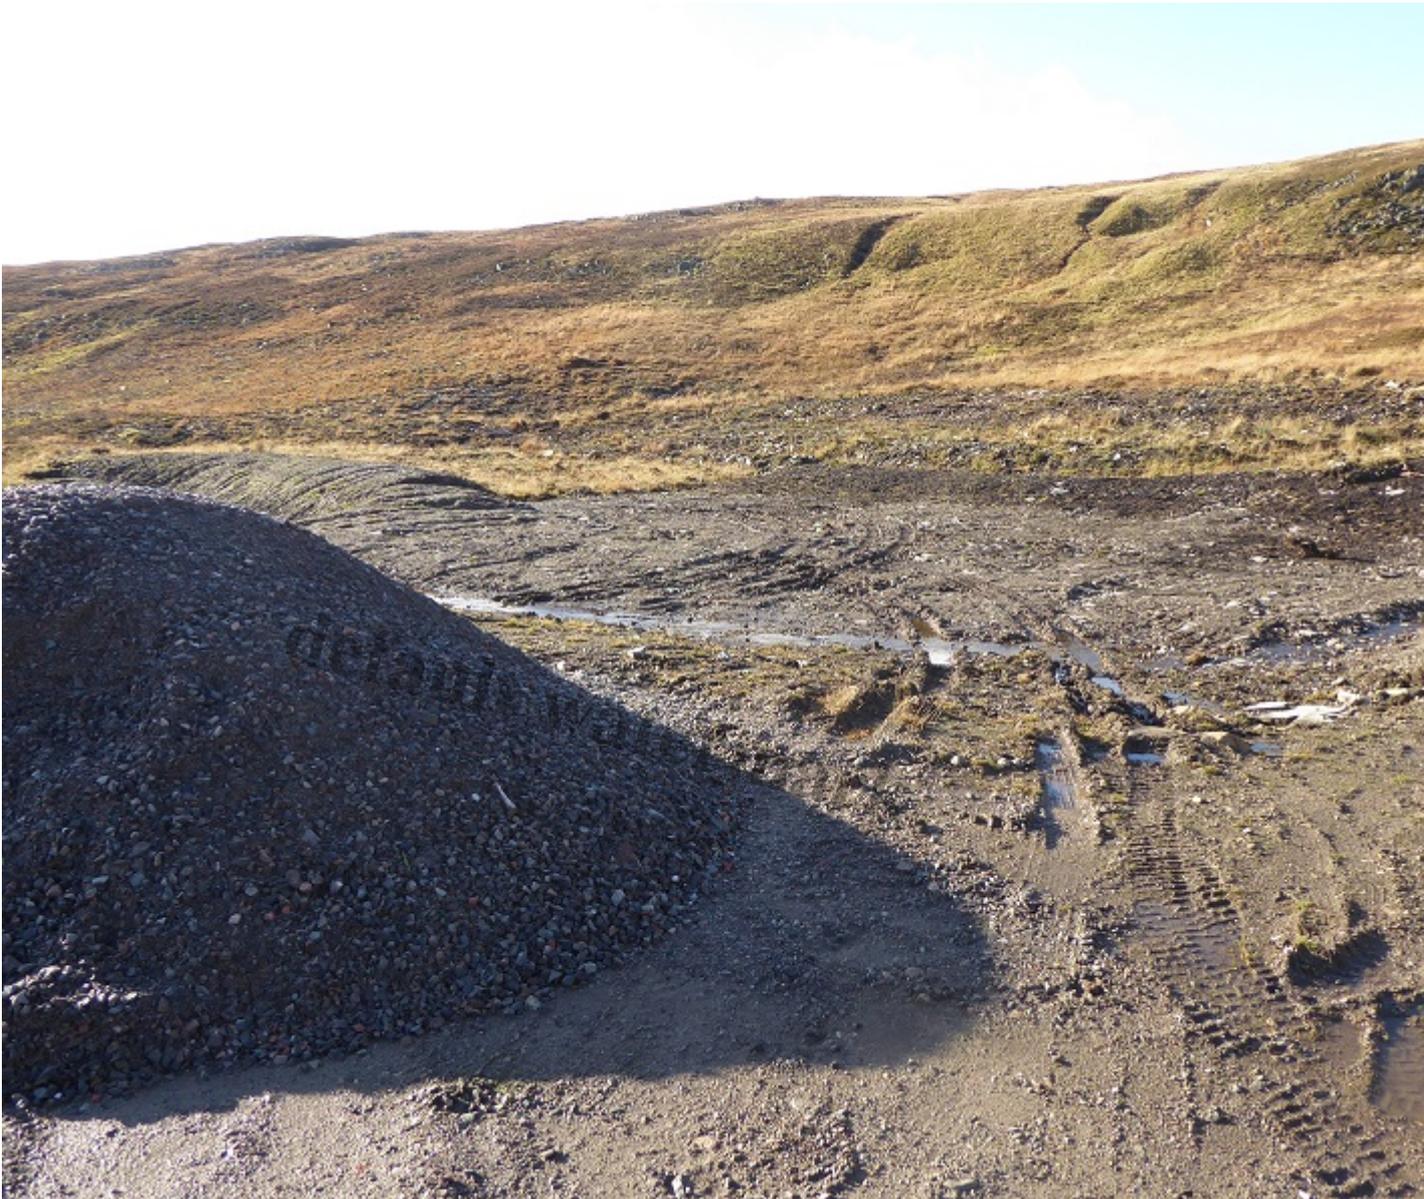
Same laydown area as in top photo, different angle â?? the pile of aggregate for filling potholes make worse.

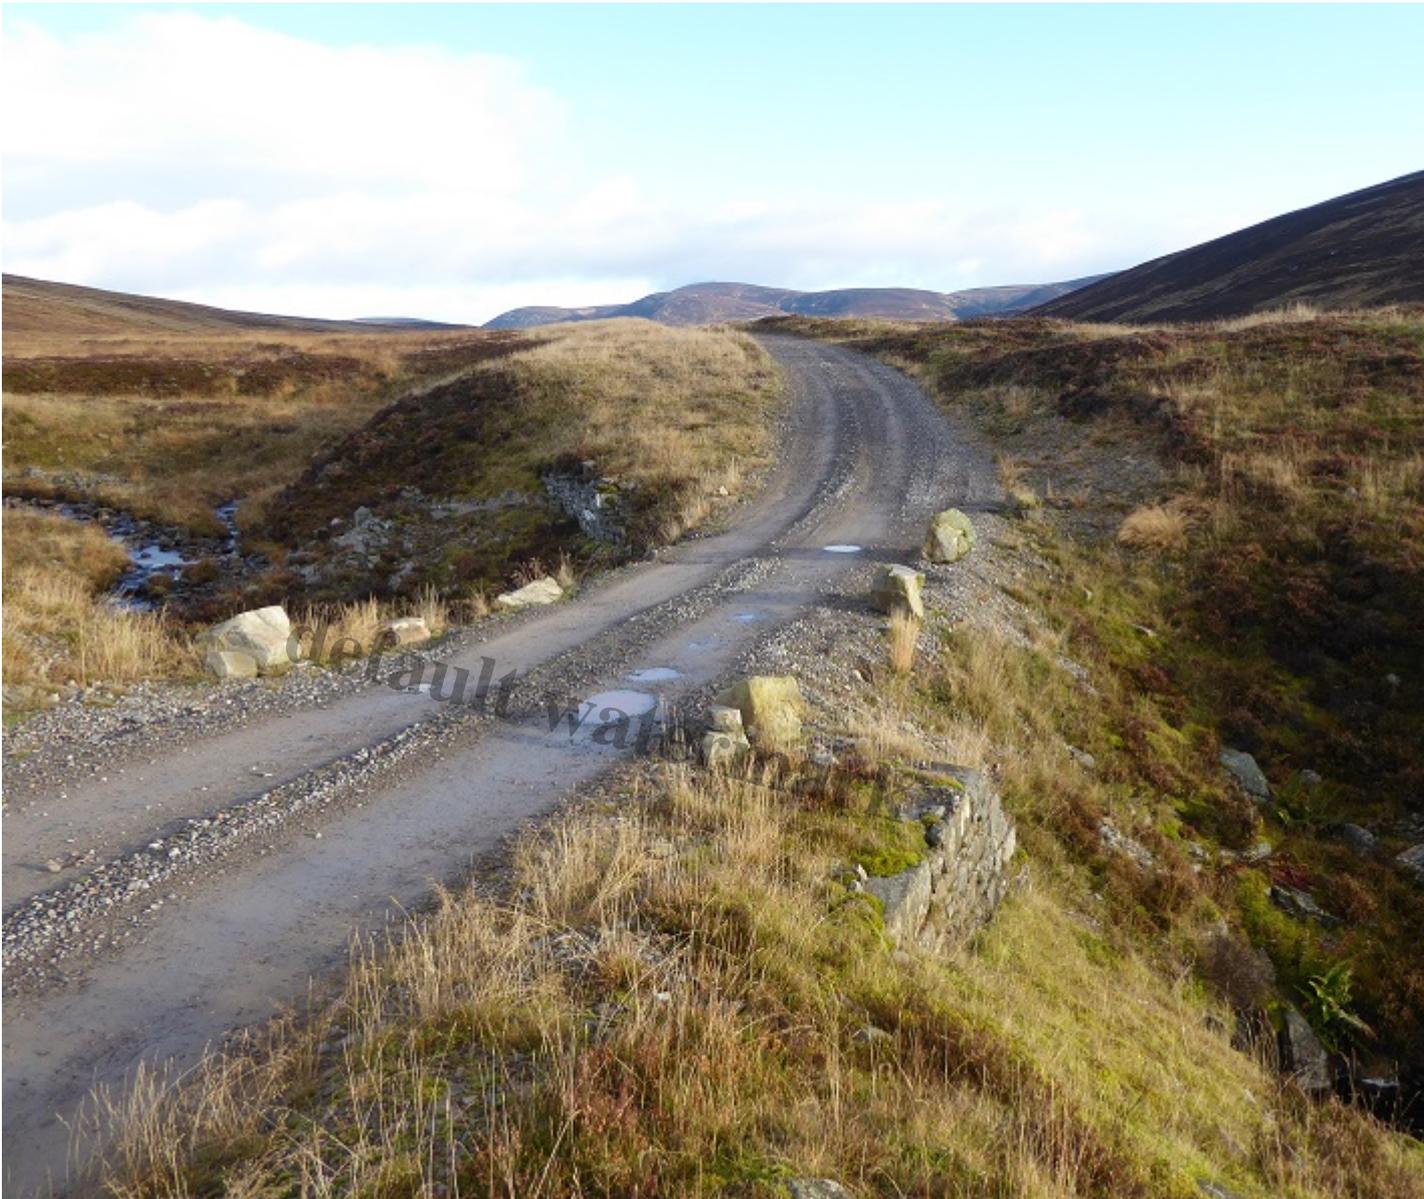
Poor finishing with material from the edge of the track spilling down towards the culverted burn below

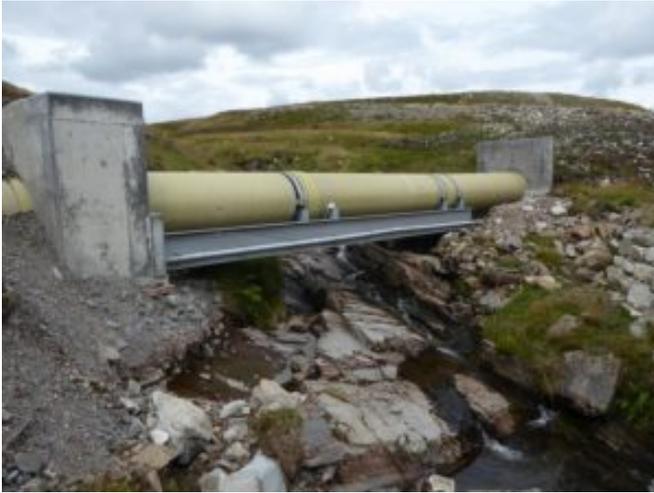
Before

The first pipe bridge close to the power house had last year looked a total mess with the river threatening to wash the plinth away. It is now much better:

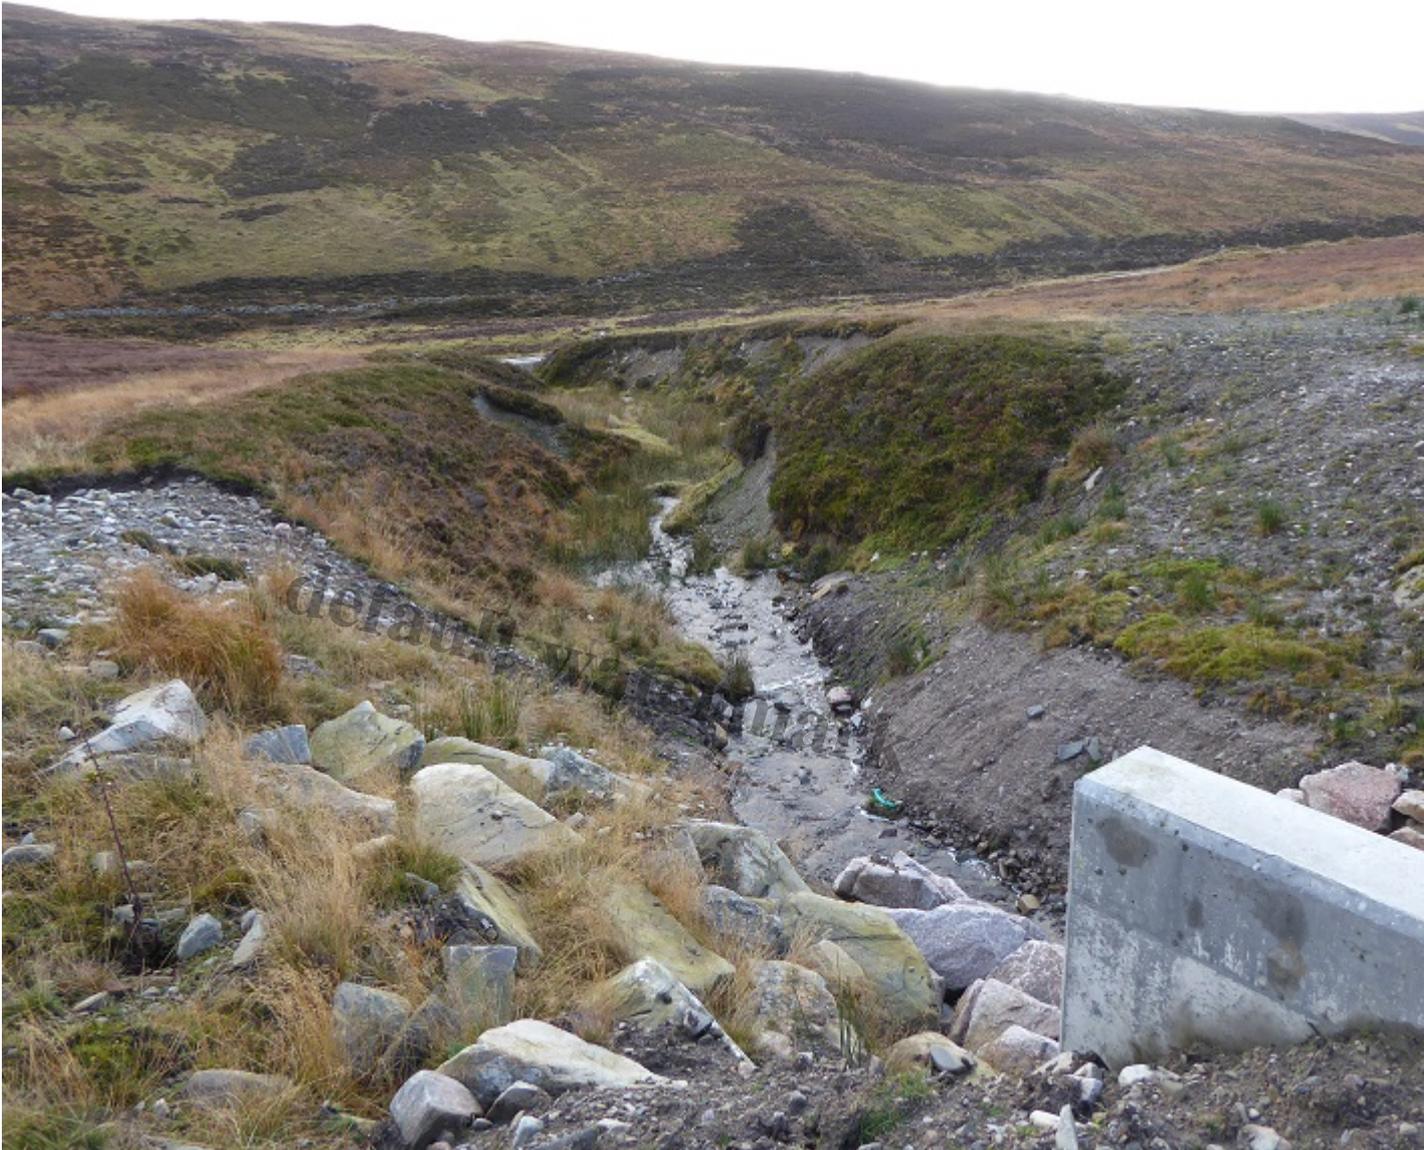
The banks of burn below the concrete plinth which are bare and will erode contrast with how the bank previously was heather covered. There is a very large patch of bare ground to the right.

The rip rap bouldering to protect the banks around the plinth looks a mess, there is a large patch of bare ground and the banks of the burn have not been restored with vegetation and one would have thought at risk of rapid erosion.

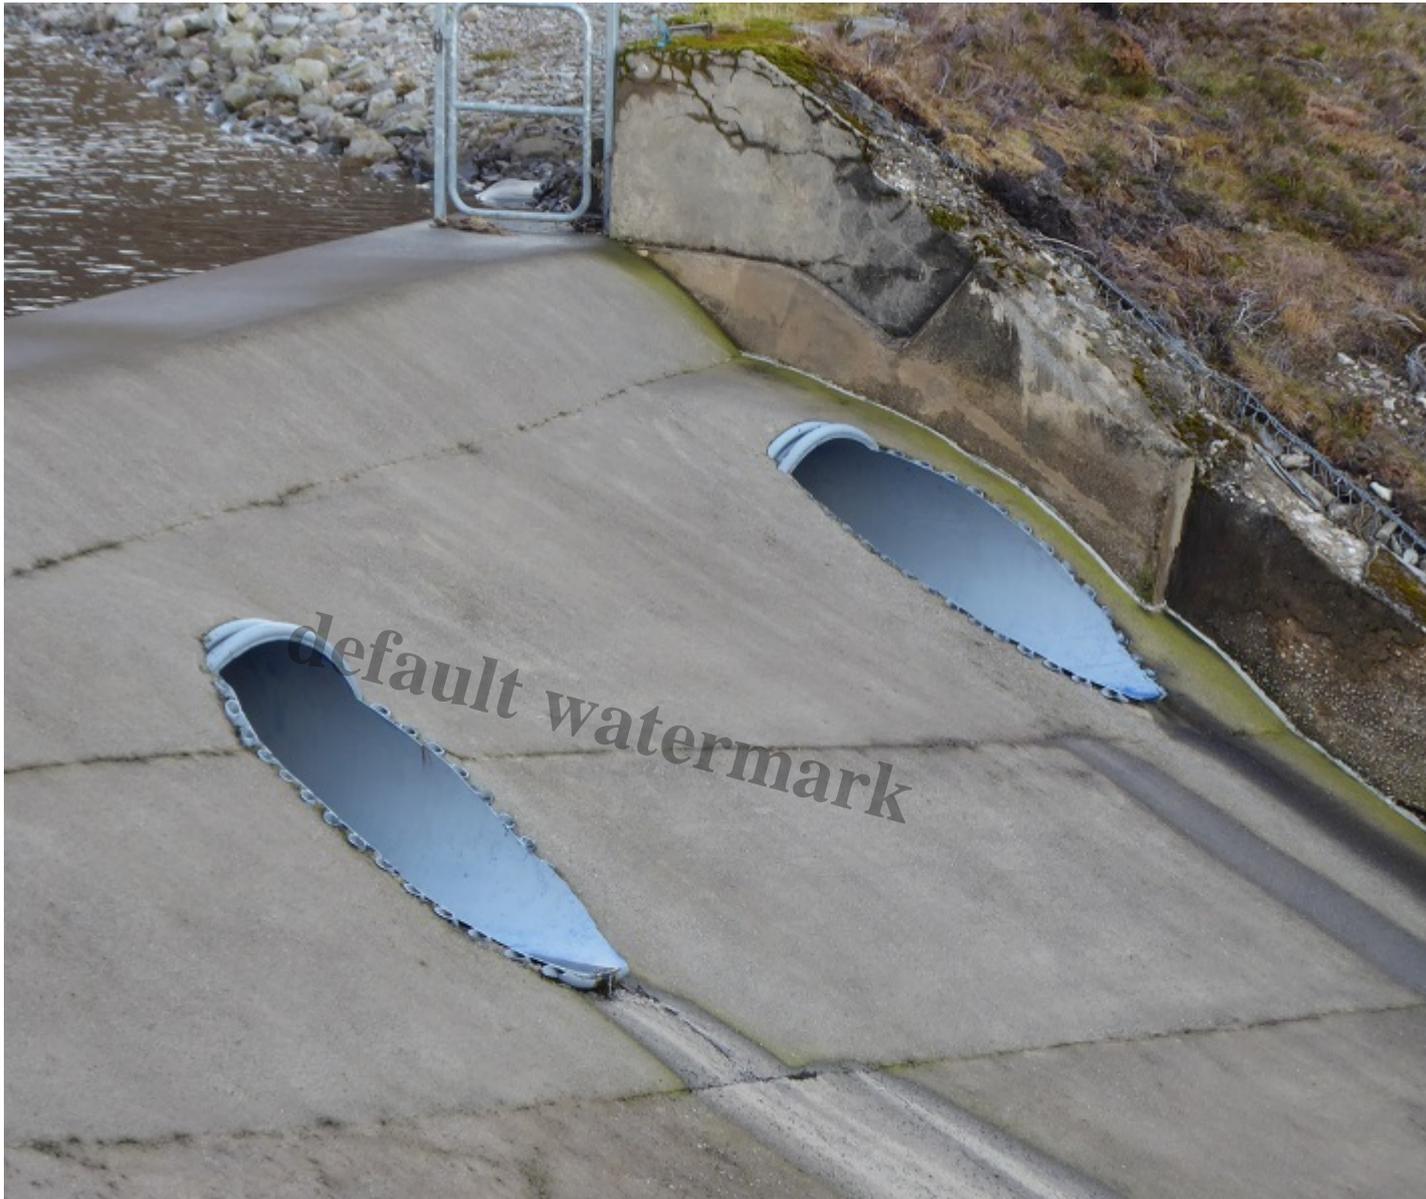
The intake overflow pipes – which were bright blue – have been painted and to my mind are far more prominent.
